# Design and Rehabilitation Strategies for Permeable Friction Course Pavements

Technical Report 0-7110-R1

TEXAS A&M TRANSPORTATION INSTITUTE  
COLLEGE STATION, TEXAS

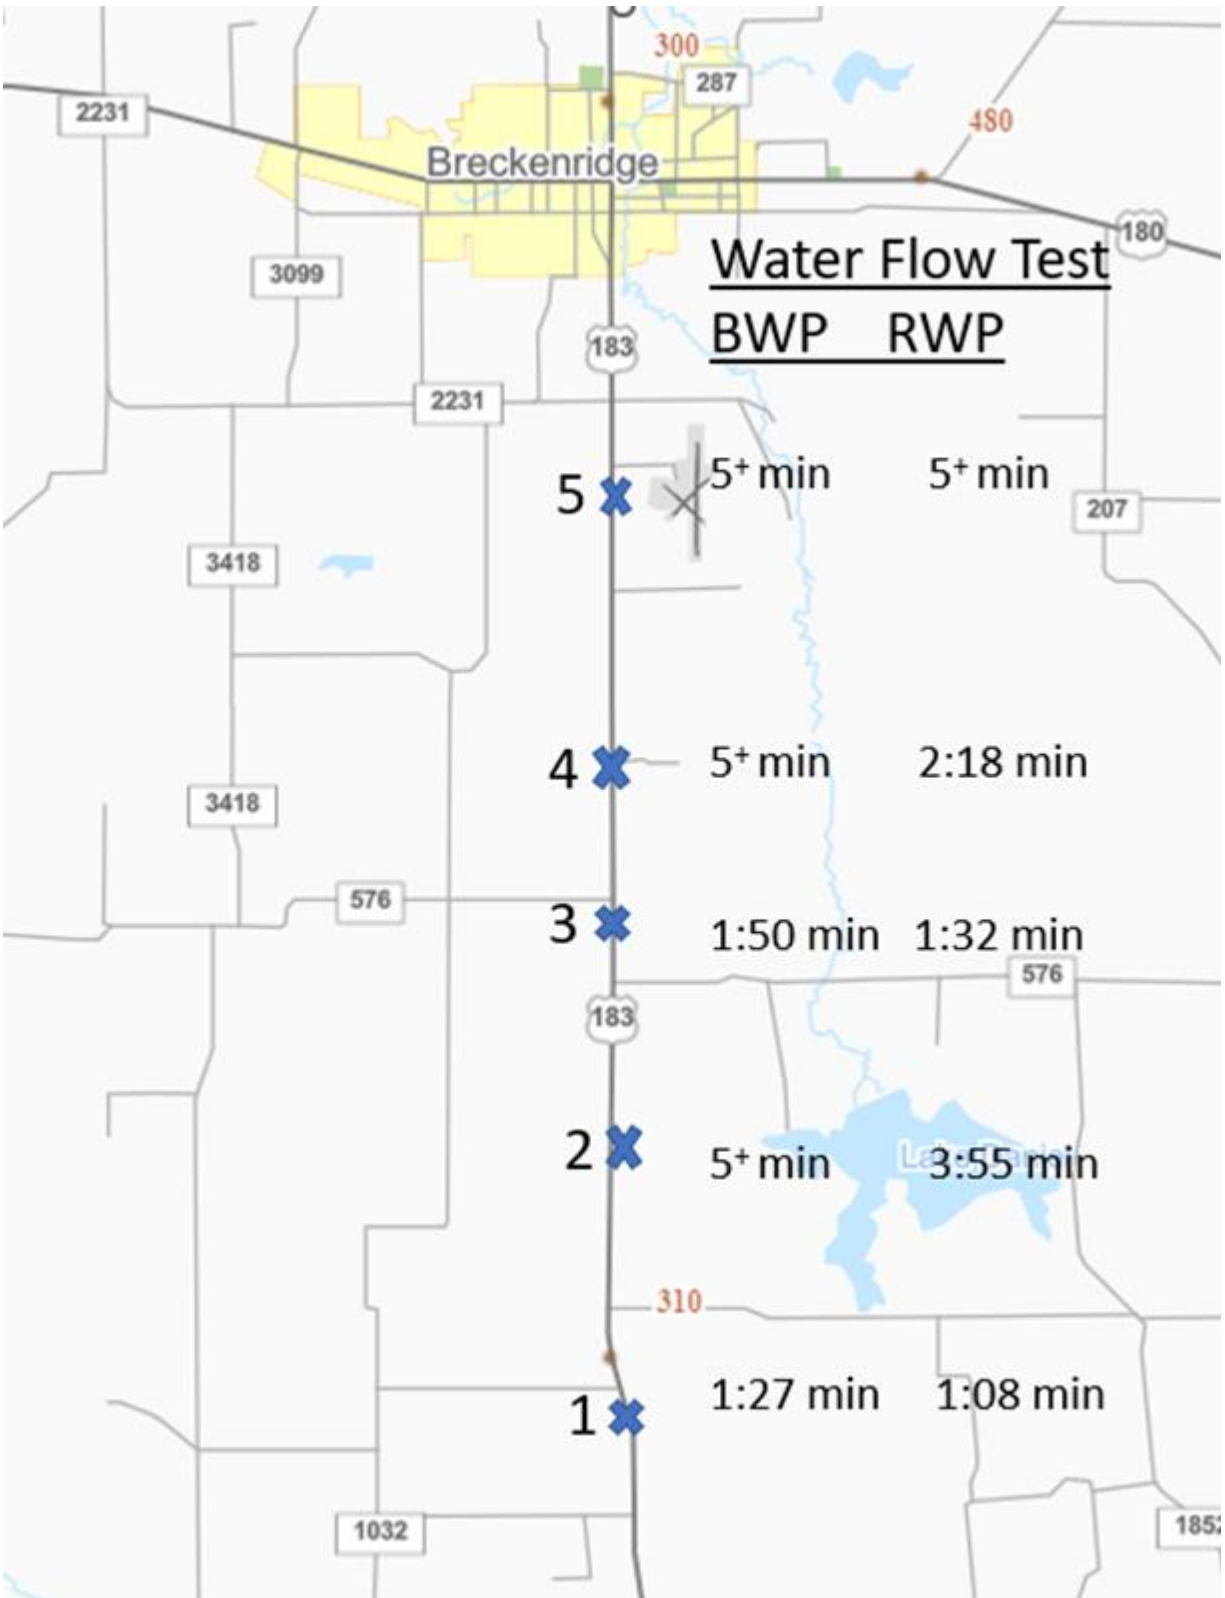
In March of 2023, TTI researchers conducted field testing on this section of roadway. Five locations were selected for water flow testing and for coring. Water flow tests were conducted in the outside wheel path and between the wheel paths, as shown in Figure 71. For the most part, the PFC was clogged, but there were a few locations where the PFC could be taking in water. The results of the water flow tests are shown in Figure 72.

Figure 72. Coring and water flow testing locations along with water flow test results.

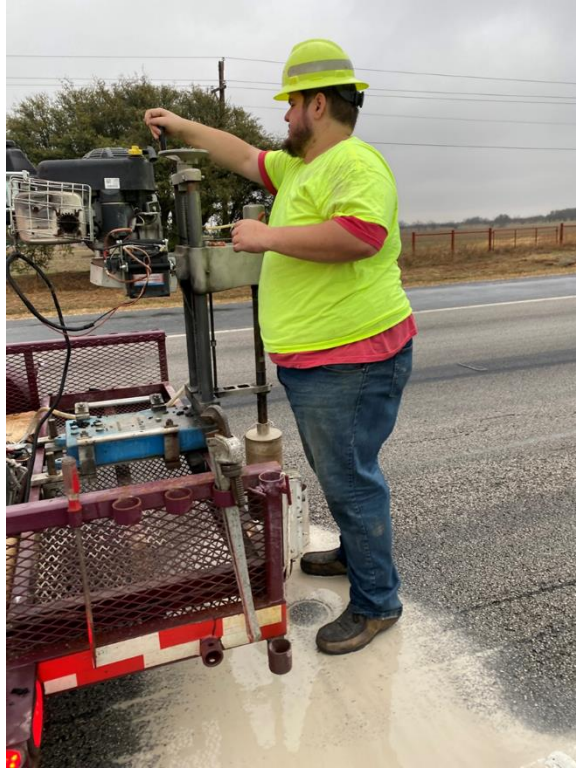
**Figure 73. Coring of fine PFC.**

Cores were also taken at each of these five locations and brought back to TTI's laboratory for further evaluation. The coring operation is shown in Figure 73. A close-up of the core is shown in Figure 74. The cross section of the pavement consists of a flex base with a seal coat and then the fine PFC on top of the seal coat. The fine PFC is very thin (less than 1 inch thick).

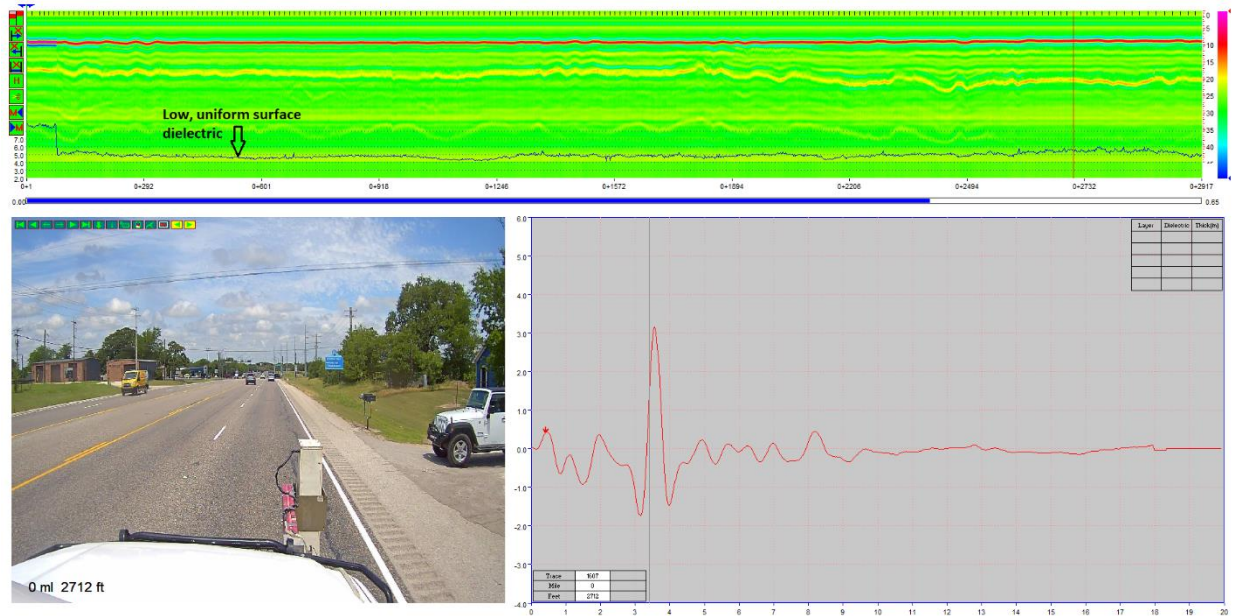
**Figure 75. GPR data from SH 30 in the Bryan District.**

The research team reached out to the Bryan District, which is considering maintenance strategies for a PFC on SH 30 in Bryan. This is a relatively short section (less than 1 mi) placed at an intersection to improve safety, and it is starting to show some signs of raveling.

Video and GPR data are shown in Figure 75 and indicate that the surface is still draining.

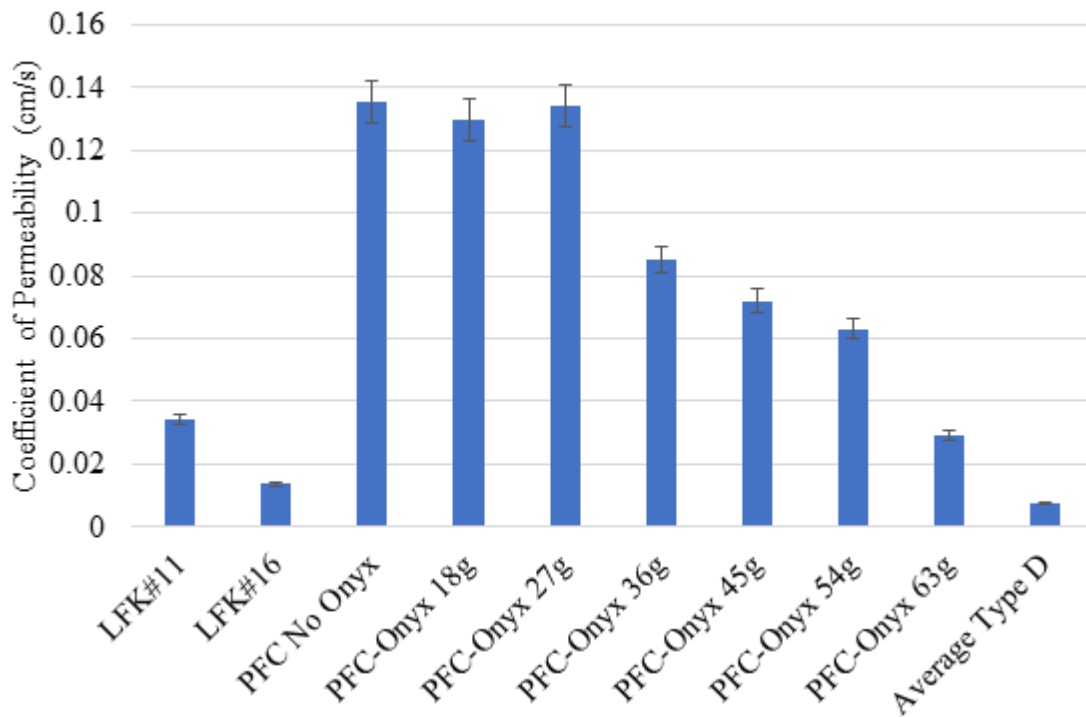
**Figure 89. Coefficient of permeability of Lufkin US 69 cores versus other mix types.**

Table 18 shows the permeability coefficient of the PFC cores collected from Lufkin US 69. The observed permeability coefficient is lower than the recommended minimum permeability (0.11 cm/s) for PFC mix design per AASHTO PP 77.

The research team compared the permeability of the field cores with other treated and untreated specimens prepared in the laboratory. The results indicate that the permeability of field cores was lower than typical PFC specimens prepared in the laboratory, yet the field cores' permeability was slightly higher than Type D HMA mixtures (Figure 89). In general, the permeability measurements indicate that the newer PFC inlay on US 69 in Lufkin was relatively sealed. However, the water flow measurements obtained in the field suggest that the PFC inlay had moderate drainability (Figure 57), which may indicate that the Florida permeameter may not be the best candidate to measure permeability of thin field cores.

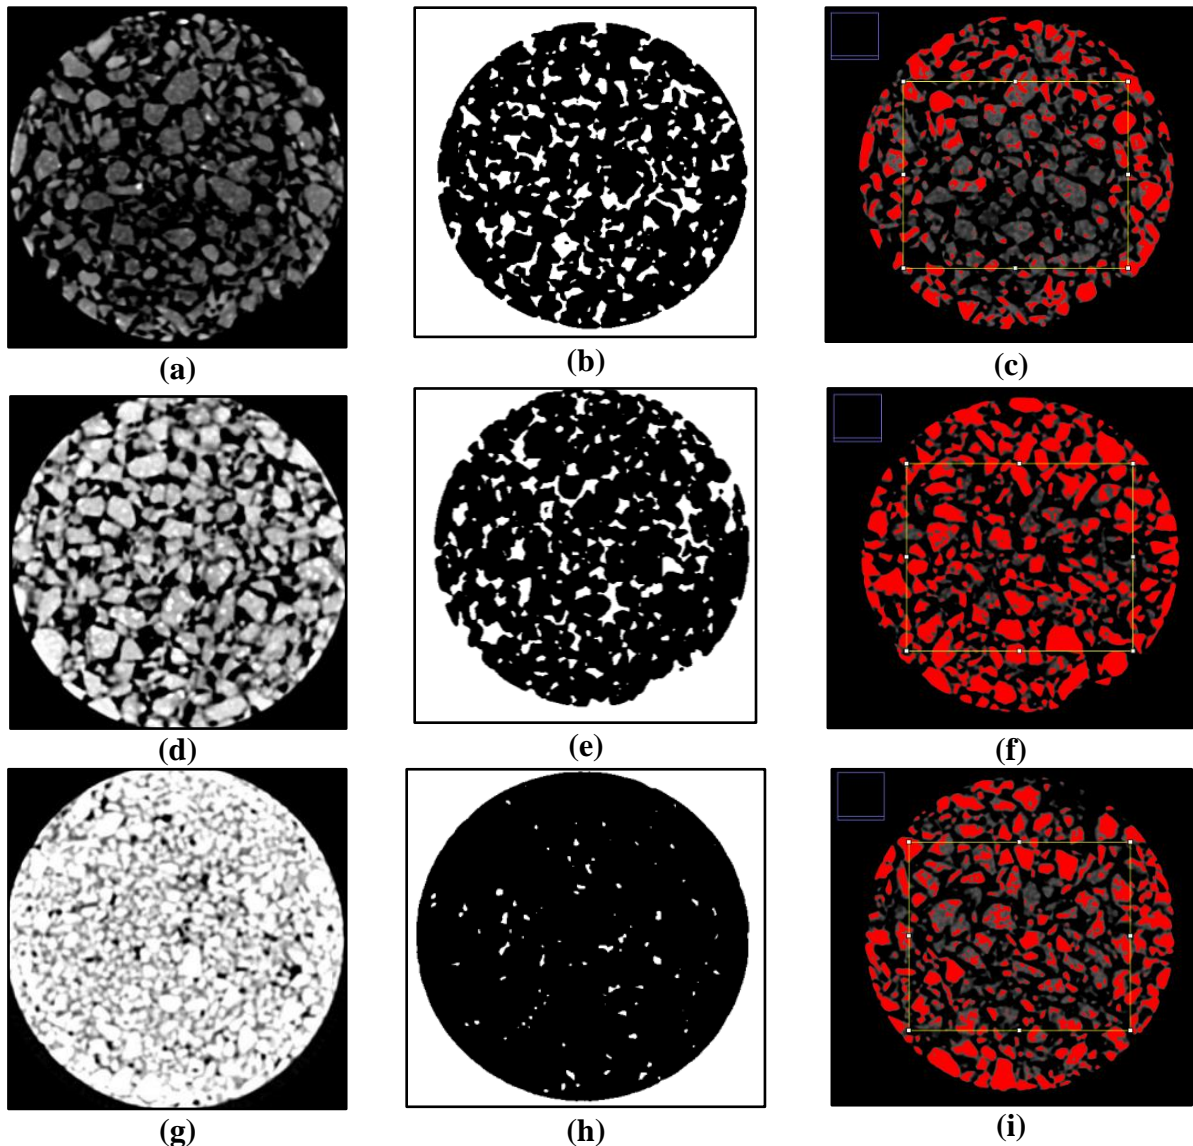
The upper layer of the core (i.e., the PFC layer) was the area of interest. Sample images obtained from the X-ray CT scan for the three cores are shown in Figure 91. These results seem to align well in terms of water flow with the field observations previously described in Chapter 5.

**Figure 91. Images from the X-ray CT scan: (a), (d), and (g) show grayscale images; (b), (e), and (h) show black and white images; (c), (f), and (i) show images after ImageJ analysis; (a), (b), and (c) are the Lufkin US 69 core on the inlaid patch; (d), (e), and (f) are the Lufkin US 69 core of the older PFC; and (g), (h), and (i) are the Breckenridge US 183 core.**

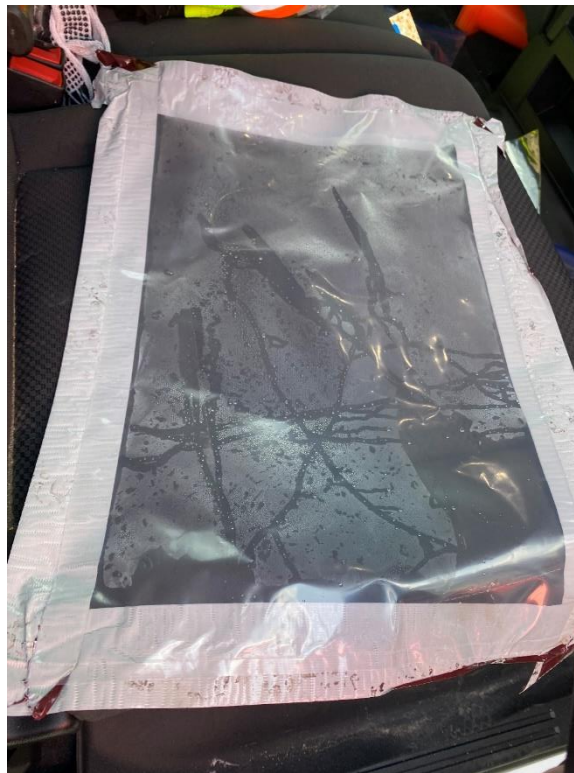
Within 5 minutes, moisture became visible on the underside of the plastic sheet, as shown in Figure 94. Some condensation was also observed under the roofing paper (Figure 95); however, it was much easier to see the condensation through the plastic as it began to appear. After 10 minutes, a significant amount of moisture was visible on the underside of the plastic, as shown in Figure 96, after it was removed from the pavement surface.

**Figure 96. Plastic sheeting after removal from pavement surface after 10 minutes.**

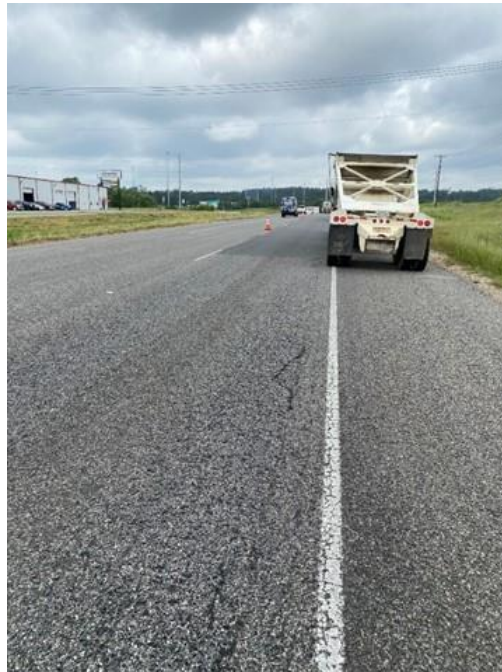
**Figure 97. Newer PFC inlaid patch in the travel lane.**

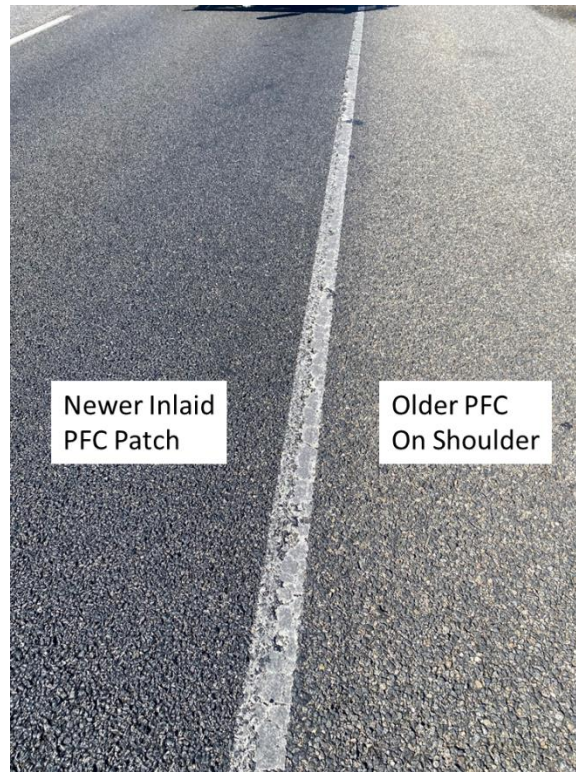
**Figure 98. Close-up of newer PFC patch next to older PFC in shoulder.**

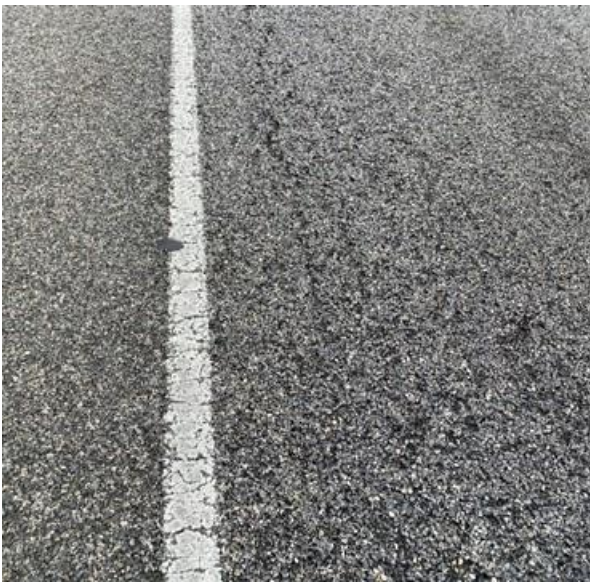
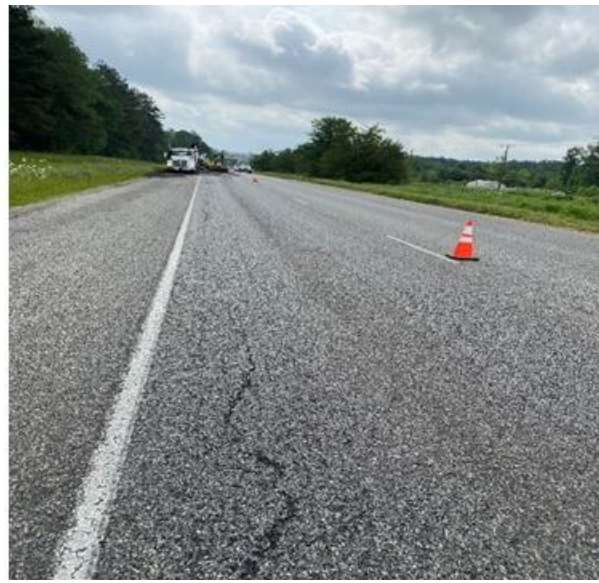
**Figure 99. Typical distress shown in test section area of the old PFC: (a) raveling, and (b) cracking.**

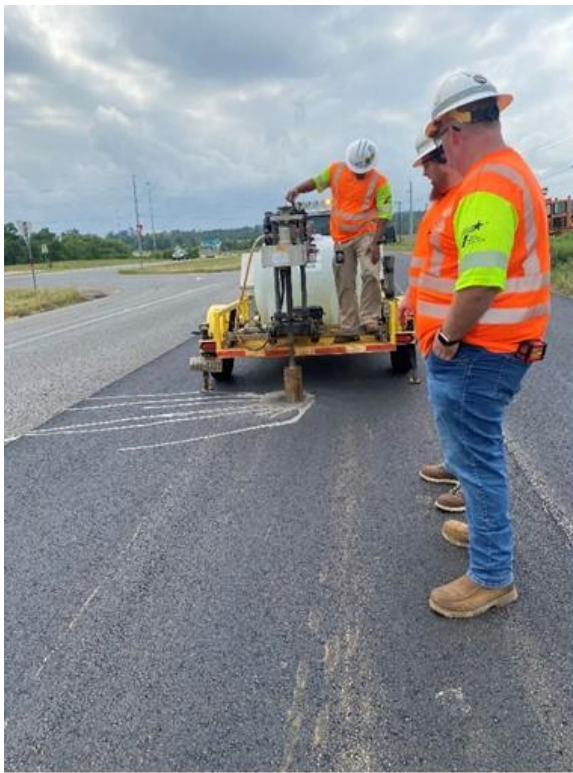
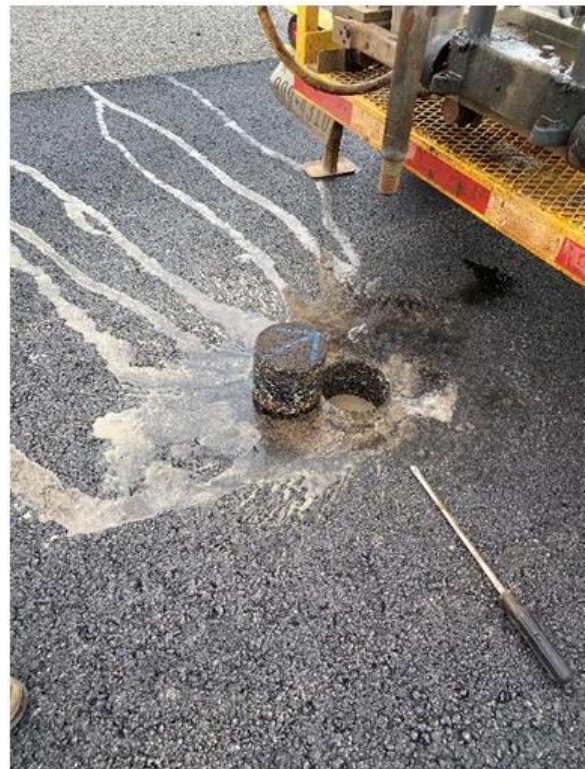
behaving as if it were tender or unbonded and was moving laterally, causing the edges to crack (Figure 104). The roller operator immediately ceased all rolling, paving was halted, and the district lab was called out to take cores to check the bond. Cores were taken immediately over the bulged areas (Figure 105). The cores came out intact, and the bond was secure. Later, the district lab measured the shear strength of the bond (Table 21), and the bond strengths of the two cores were 21.8 and 11.9 psi. While this may not be a great bond, nonetheless there was a bond of the new surface to the old, so the bond did not appear to be the culprit for the problems seen in the field. A photo of the core after shear testing is shown in Figure 106. After this occurred, the tack rate was also increased to 0.1 gal/yd<sup>2</sup> for the rest of the test section construction.

**Figure 105. Coring operation over bulged pavement area: (a) coring rig, and (b) cores taken showing the new overlay bonded to the old PFC.**

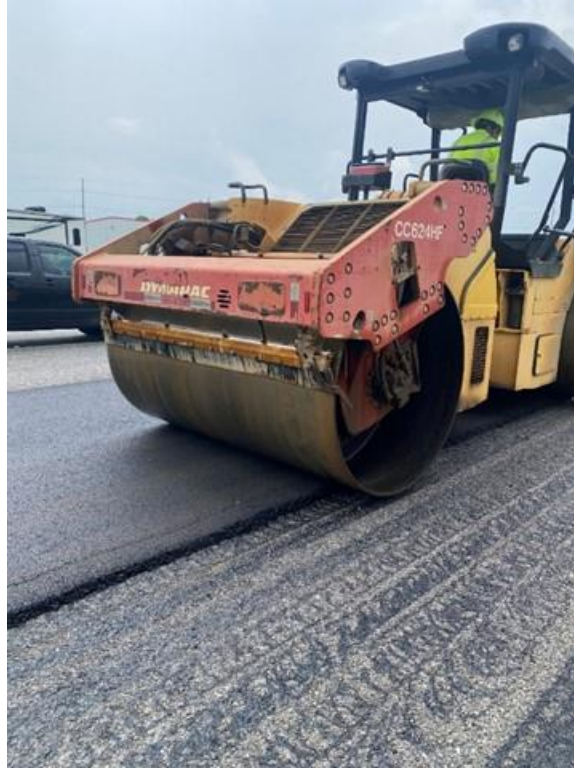
After coring, and after the mat had cooled significantly, a few more static passes of the roller were made in the problem areas, which smoothed the mat (Figure 107). There was still a slight visible crack on each edge of the mat (Figure 108).

**Figure 107. Additional static rolling on the problem areas after mat cooled down.**

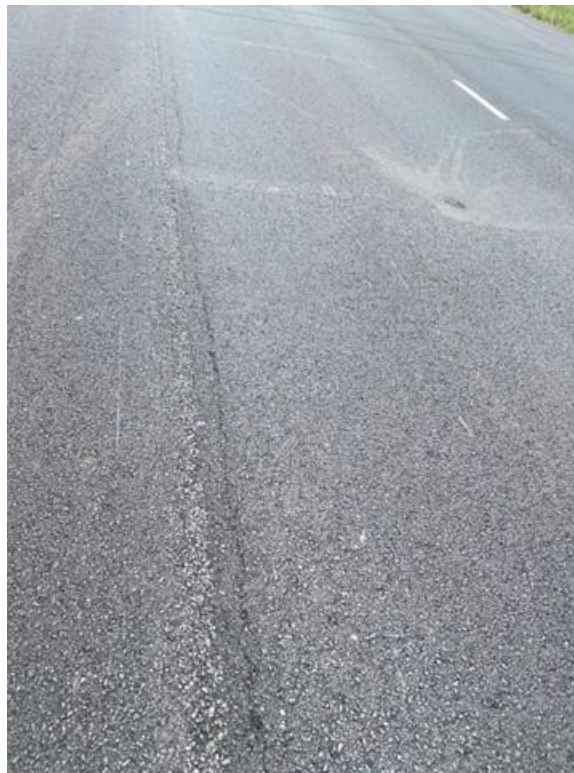
This specific mix design had been produced by this plant and placed by this crew many times previously without these types of issues showing up. In fact, the only time the problem showed up in this entire contract was on this noticeably short section. It is not clear what caused this problem; however, researchers theorize that this portion of the paving was on top of the newer PFC inlaid patch, which may have been holding water at the time of paving. When the mat was placed on the surface of this patch, steam was created and tried to escape through the new mat, causing the mix to behave as if it were tender.

Figure 108 shows the overlay 1 week after traffic, and a crack was visible but did not appear to have gotten any worse. A GPR test was also performed about a week later, and based on the radar (Figure 109), there did not appear to be any moisture trapped in the underlying PFC (Figure 110).

**Figure 108. After 1 week of traffic.**

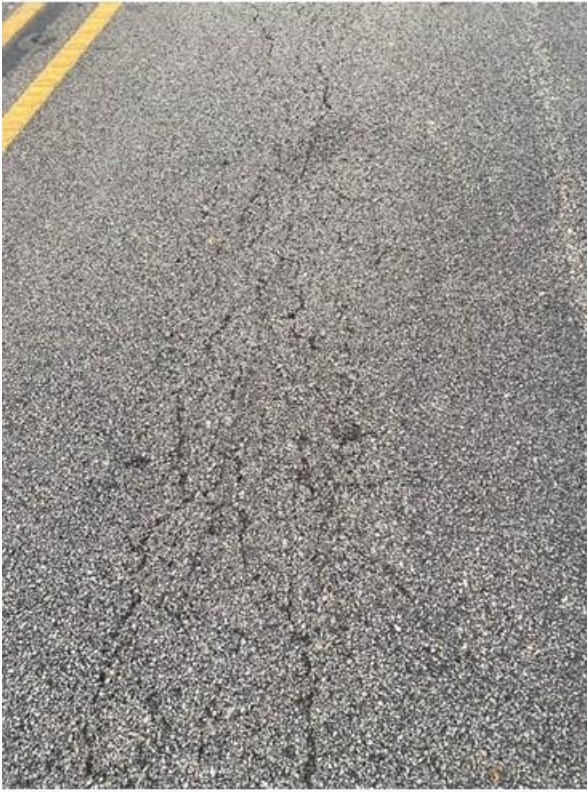
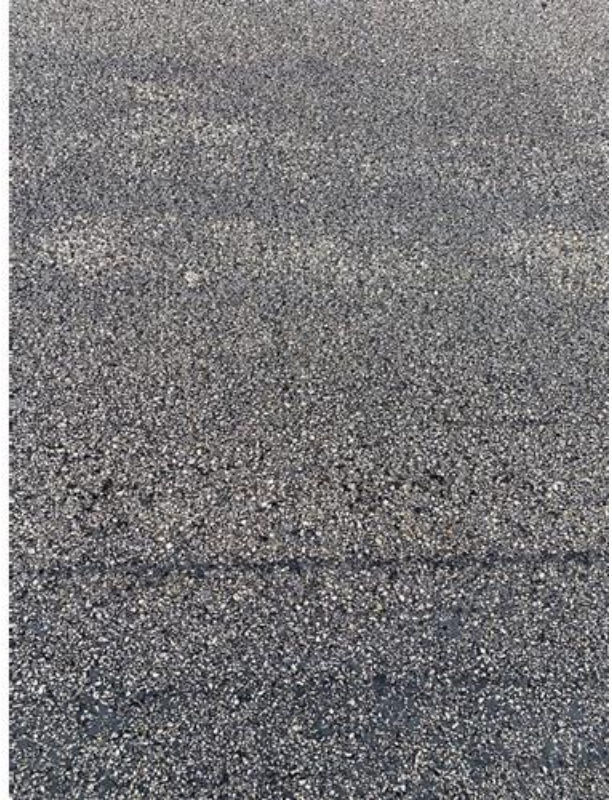
The existing surface condition is shown in Figure 111 and Figure 112. The PFC looks very dry, with some moderate cracking and minor raveling. Maintenance crews had placed some cold-mix level-up patches at several locations throughout the project, as shown in Figure 113. Photographs of the construction process are documented in Figure 114.

**Figure 112. Pavement distress observed in the PFC surface: (a) cracking, and (b) slight raveling.**

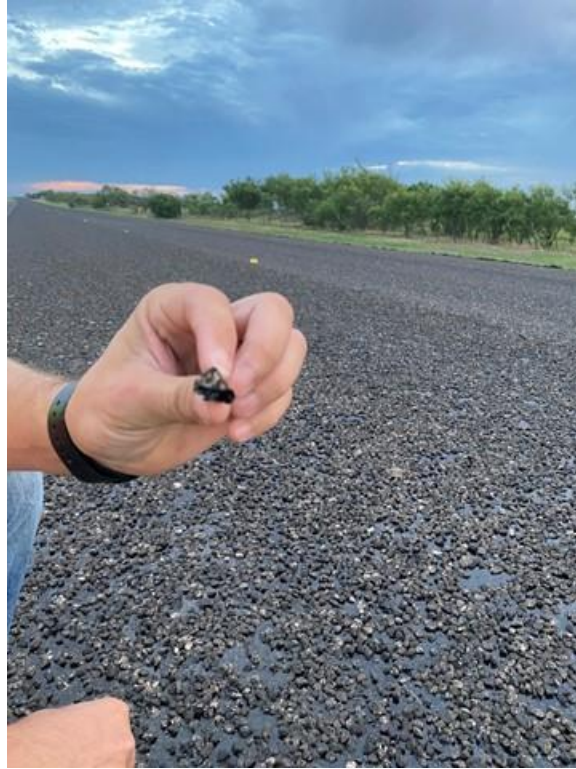
Initial asphalt application rates were selected at 0.45 gal/yd<sup>2</sup> for the main lanes and 0.48 for the shoulder. While these rates were thought to be high compared to what the district was shooting on other roadways for this contract, it still did not seem to be quite enough. Initial embedment depth after rolling is shown in Figure 115. It looks to be about 25 percent. Asphalt rate was eventually increased for the main lanes to 0.5 gal/yd<sup>2</sup>. The district seal coat specialist who was setting the rates did not think that asphalt was soaking into the PFC; he believed that the surface was very aged and hard and there was zero penetration of the aggregate into the old surface after rolling. The aggregate application rate started out at 125 yd<sup>2</sup>/yd<sup>3</sup> but was increased to 120 yd<sup>2</sup>/yd<sup>3</sup> (Figure 116).

**Figure 115. Initial embedment after rolling.**

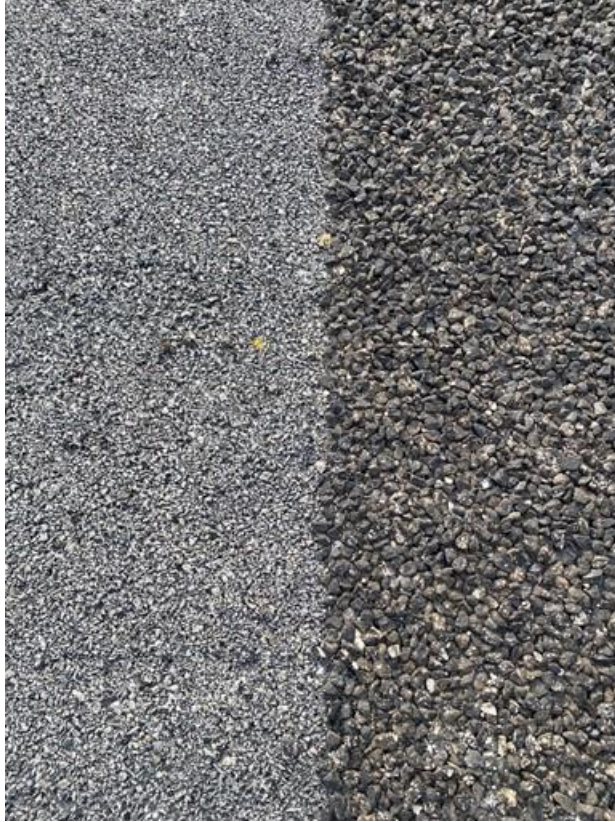
The seal coat surface compared to the old PFC is shown in Figure 119 and Figure 120. Thus far, this test section has been successful. At the time of this report, it had seen about 3 weeks of traffic and extremely hot temperatures and had performed well. All current indications are that this PFC may remain in place indefinitely for future resurfacings.

**Figure 119. Close-up of seal coat next to PFC surface.**

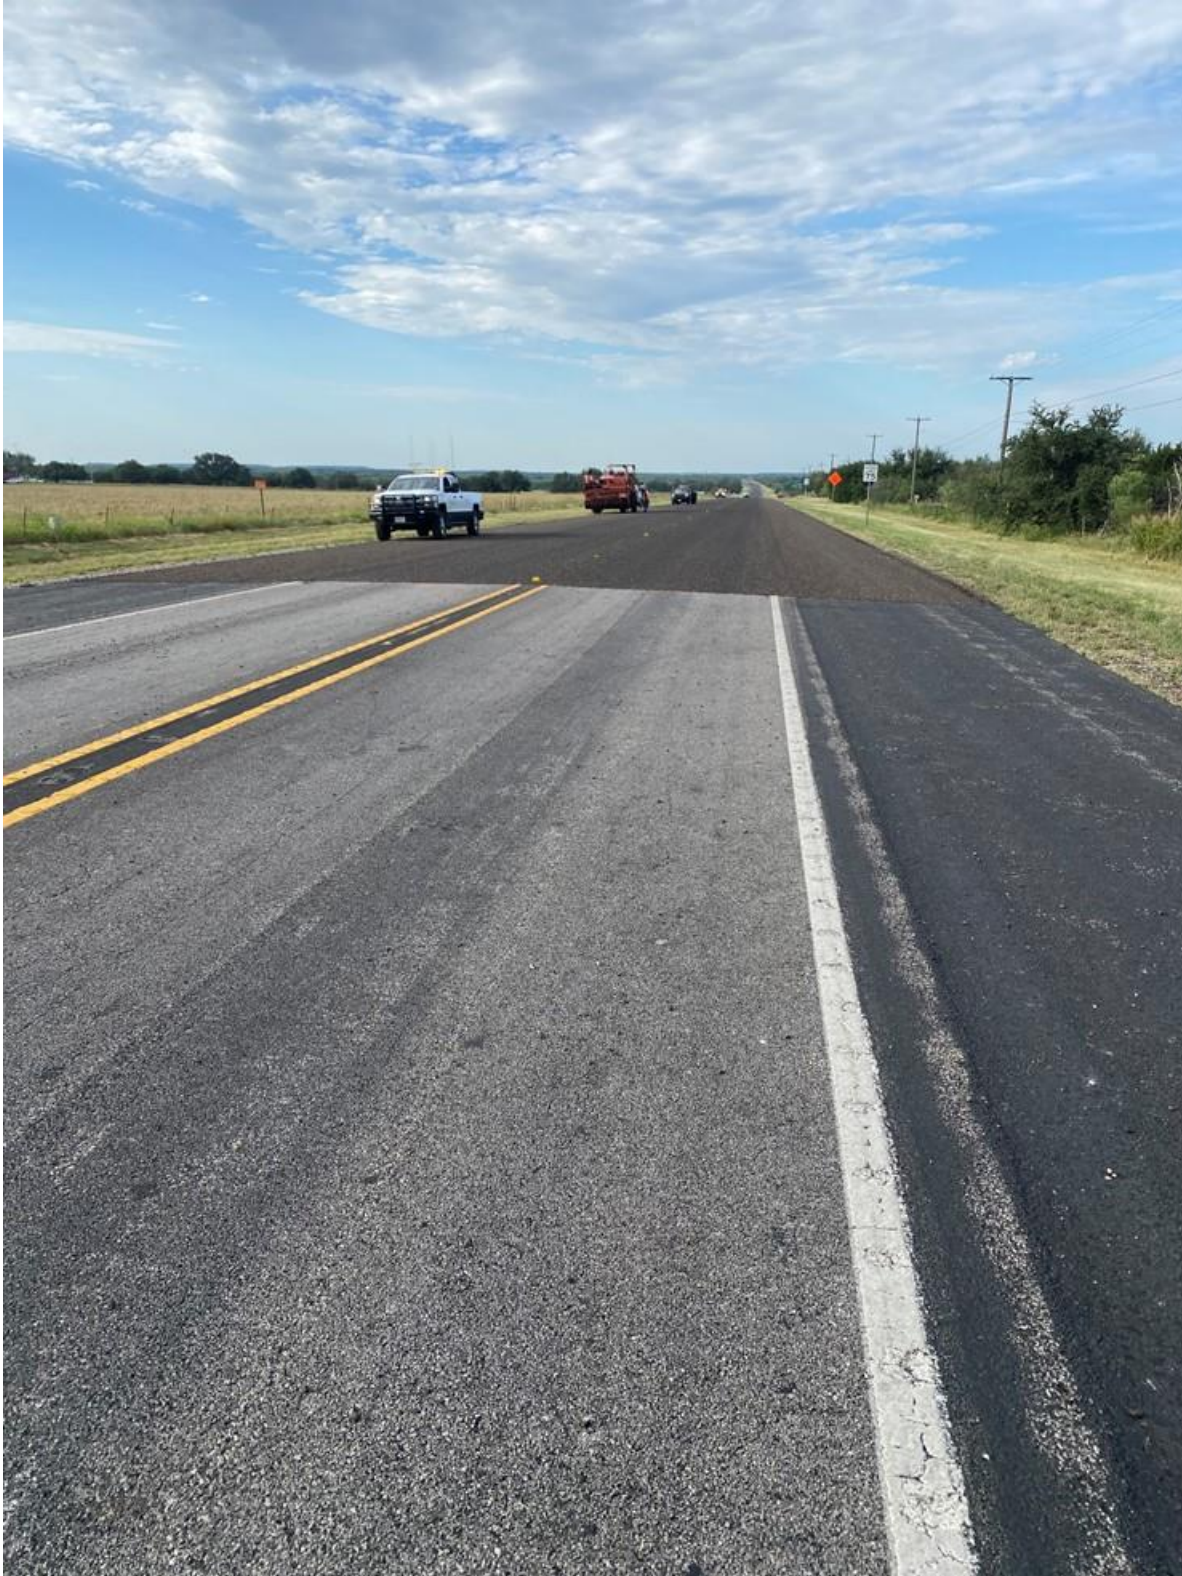
**Figure 120. View of seal coat and PFC surface.**

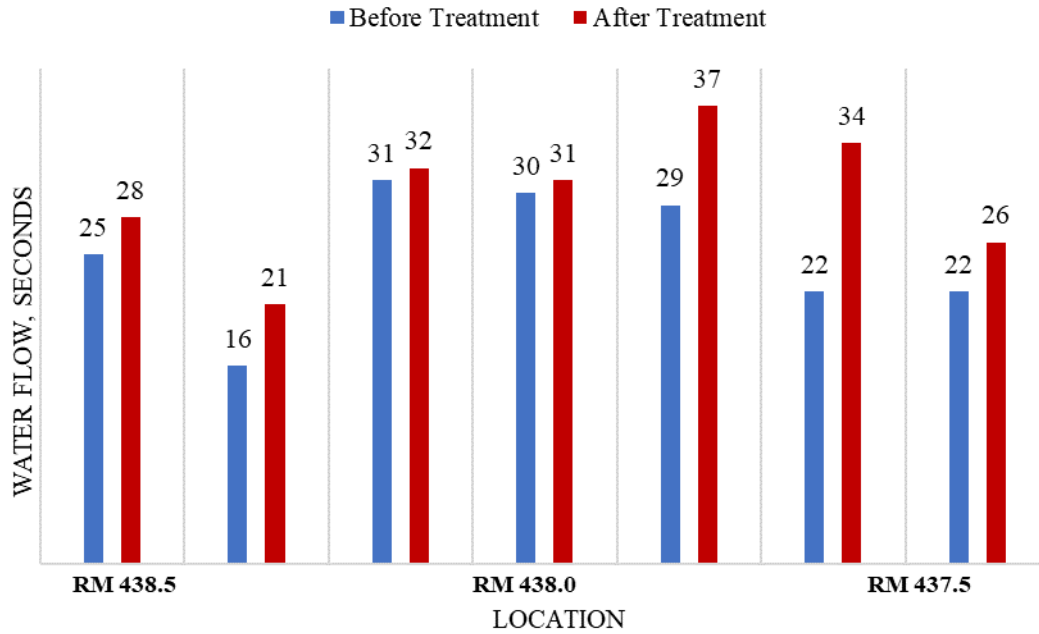
TTI performed water flow tests before and after placement of the fog seal (Figure 121). Seven stations were evaluated, and at each station, water flow in the right wheel path and between the wheel paths was tested. These results are shown in Figure 122 and Figure 123. The fog seal reduced the water flow in the right wheel path an average of almost 5 seconds and reduced the water flow between the wheel paths by an average of 3 seconds.

**Figure 122. Water flow results before and after treatment for right wheel path: average before 25.0 seconds, average after 29.8 seconds.**

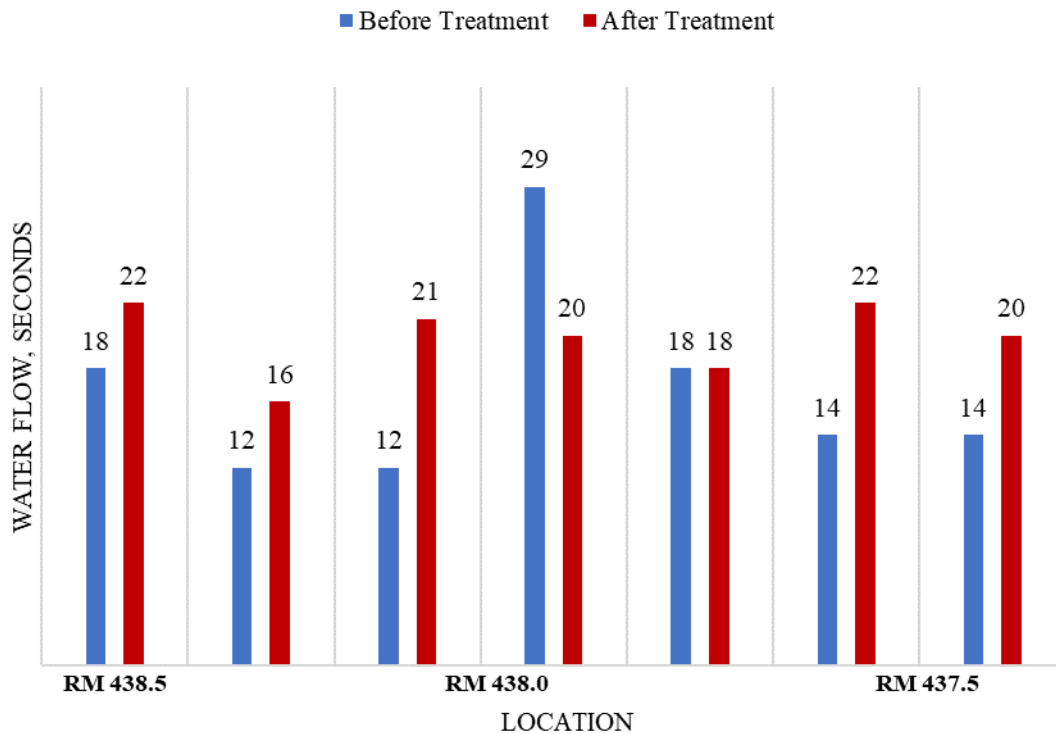
**Figure 123. Water flow results before and after treatment for between wheel paths: average before 16.7 seconds, average after treatment 19.8 seconds.**
