DIAGNOSTIC STUDIES OF HIGHWAY VISUAL COMMUNICATION SYSTEMS

STUDY SITE NO. 10

ALASKA STATE HIGHWAY 1 - SEWARD HIGHWAY - ANCHORAGE, ALASKA

TM2(108-10)

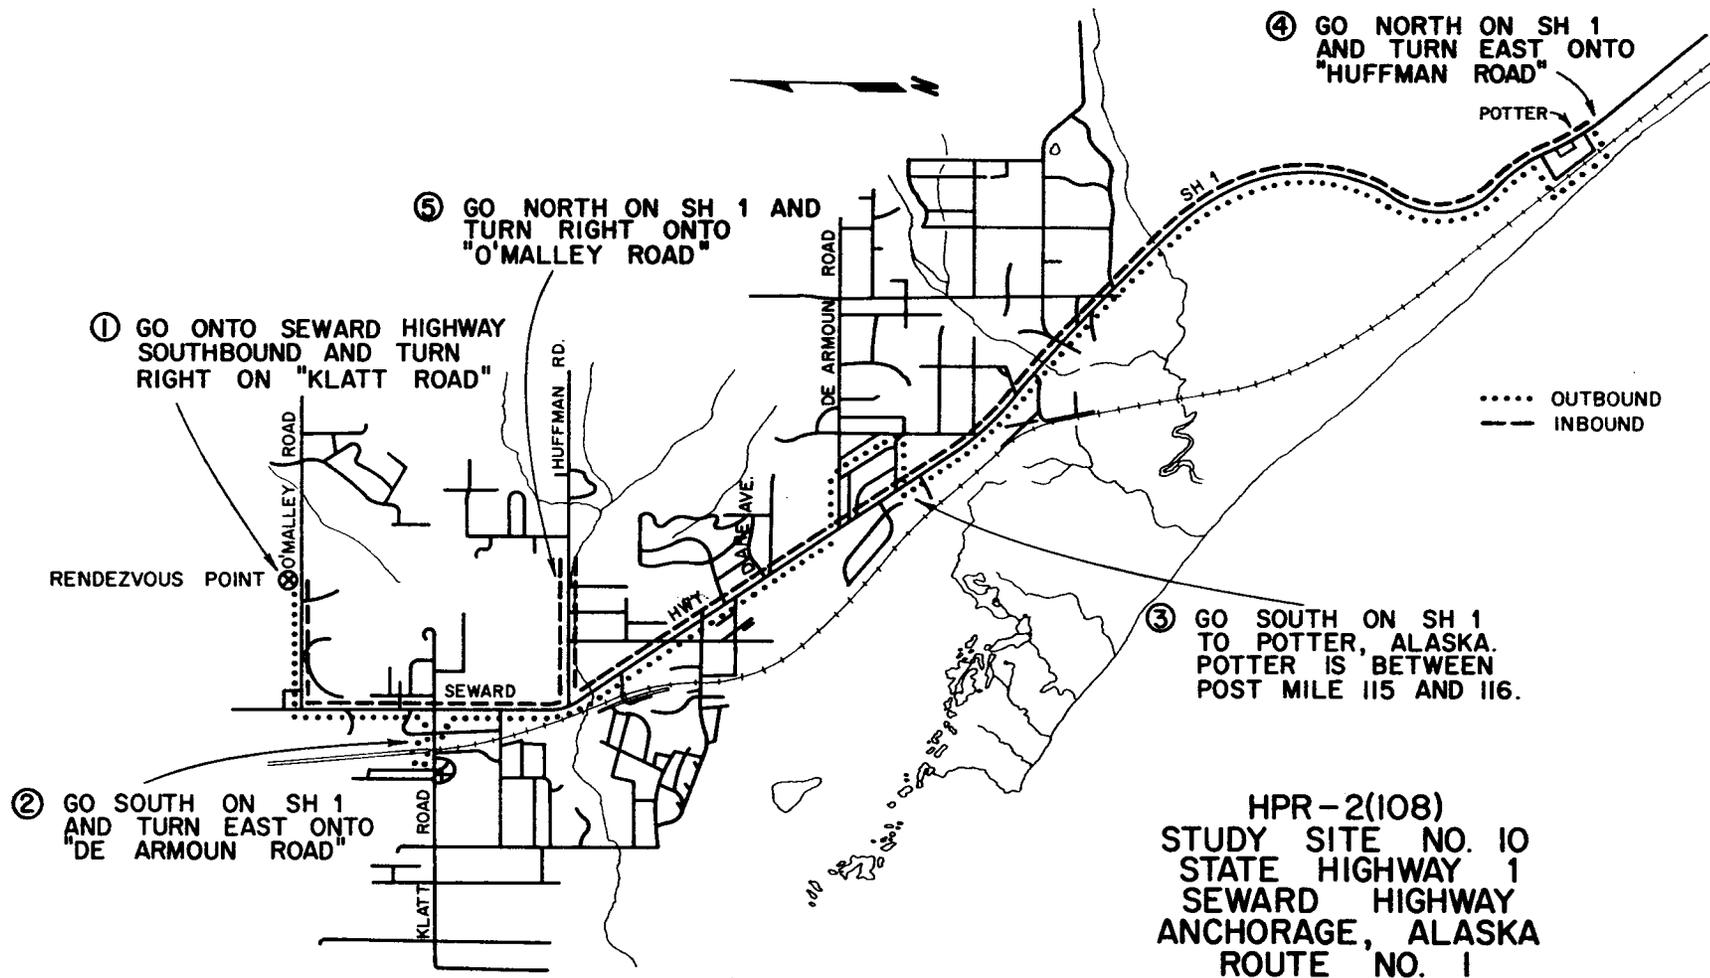
Figure 1.

Strip Map of Study Site 10 Indicating Driving Route 1

This roadway could best be classified as a rural two-lane highway at the periphery of an urban area. The study section was 5.43 miles in length and contained six intersecting roadways that could be classified as major streets or major roads. There were two sections of strip commercial development and some rather extensive residential areas just off of the facility. This basically two-lane highway section had gravel shoulders of varying widths throughout the study section. In general, the shoulder width was approximately six feet, but at points it was in excess of ten feet and at others, narrower than two feet. All of the intersections are at-grade, and there are several bridges over minor drainages. The primary control of the intersecting roadways is stop control; however, there are several minor roadways that have no control at all. The access to abutting properties is uncontrolled, and many of the commercial developments have very extensive driveways. A strip map of the study section is presented in Figures 1 and 2.

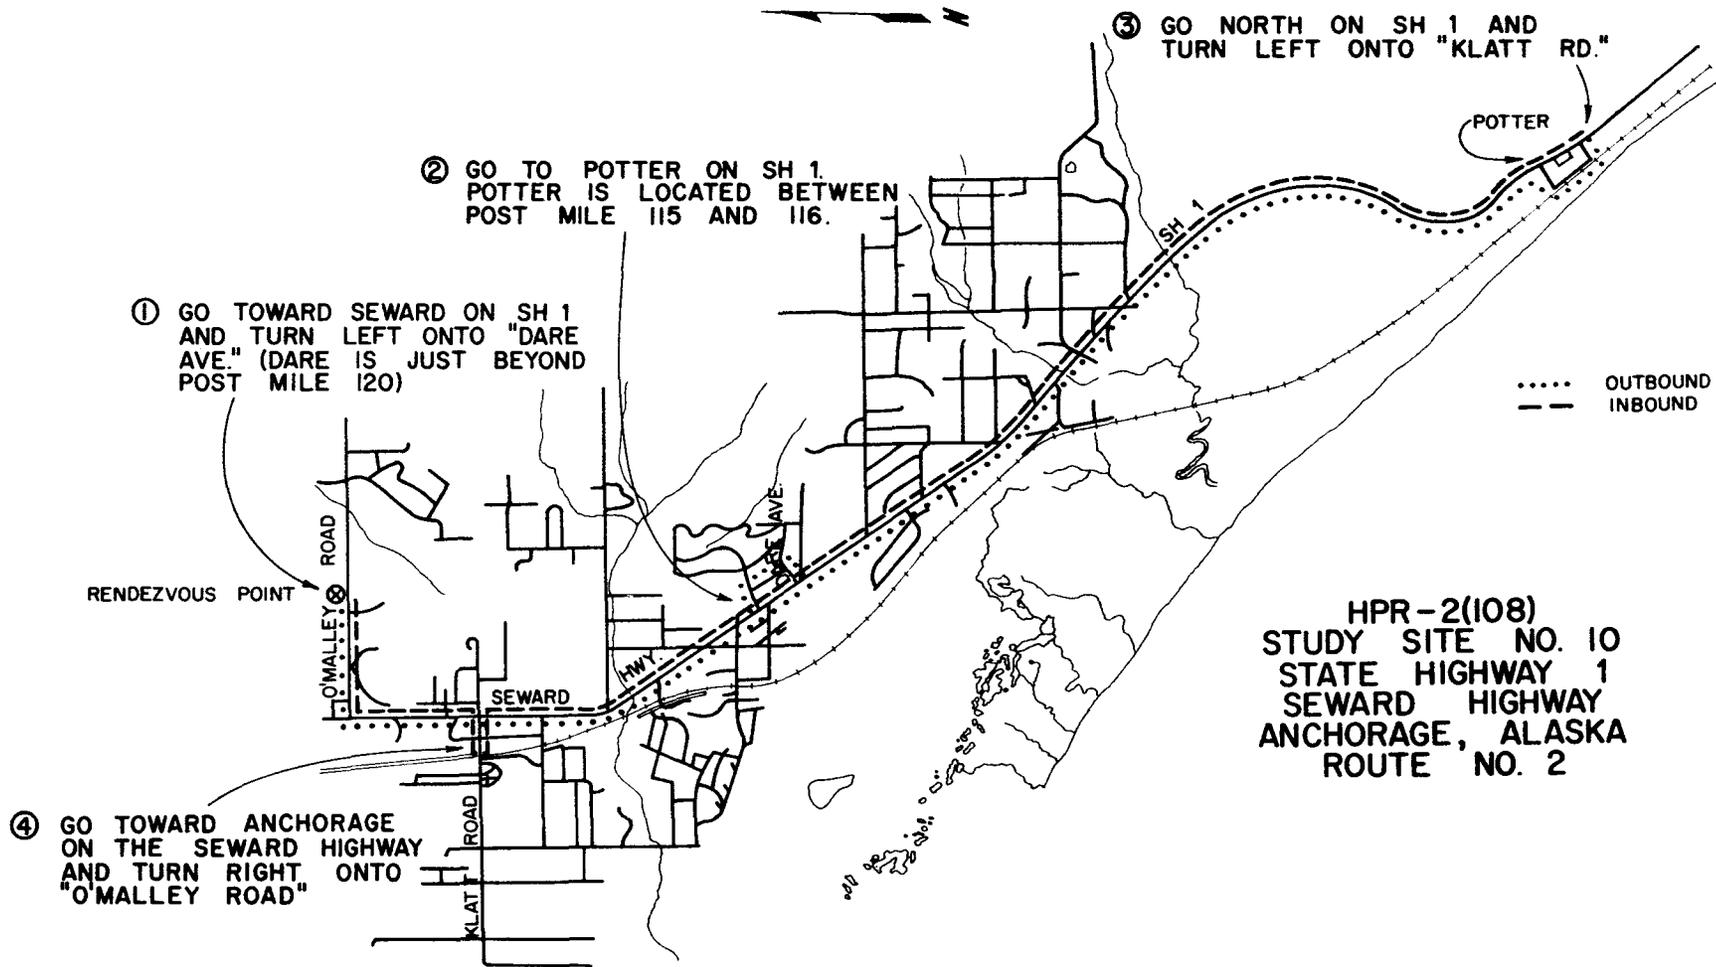
Figure 2

Strip Map of Study Site 10 Indicating Driving Route 2
