l echnical Repo	ort Documentation Page
1. Report No. FHWA/TX-05/0-4048-5	2. Government Accession	n No.	3. Recipient's Catalog No.	Э.
4. Title and Subtitle PRELIMINARY EVALUATIONS OF SAFETY TREATMENTS RURAL HIGHWAYS IN TEXAS		ATMENTS ON	5. Report Date October 2004

PRELIMINARY EVALUATIONS OF SAFETY TREATMENTS ON RURAL HIGHWAYS IN TEXAS

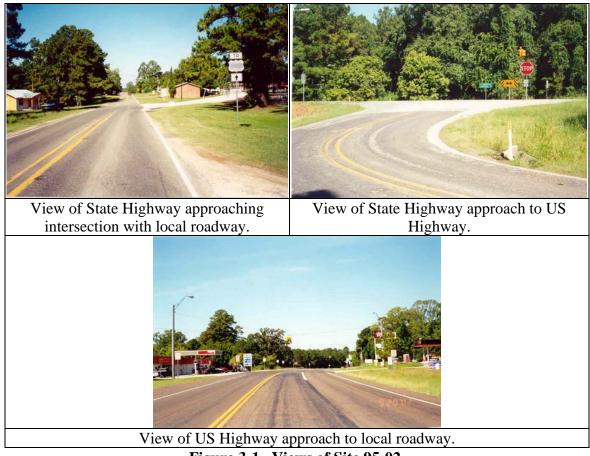
Figure 3-1. Views of Site 95-02.

Site 95-02 involves two intersections 500 ft (152 m) apart: a T-intersection of a US highway with a state highway and a four-leg intersection with the same US highway and a local roadway. The state highway has a sharp curve near the T-intersection and runs roughly parallel to the US highway; thus, the state highway also intersects the local roadway in close proximity to the study site. Figure 3-1 shows pictorial views of the site, and Figure 3-2 contains a sketch of the site after improvement.

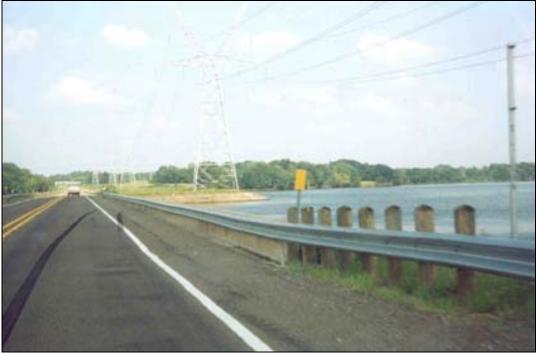
Figure 3-3. View of Bridge on Lake.

This site is on a rural two-lane farm-to-market (FM) highway with a 2002 ADT of approximately 2600 vehicles. The location under evaluation, shown in Figures 3-3 and 3-4, is a 1.5-mile (2.4 km) section containing a bridge over a lake that is near a power plant. The power plant feeds into the lake, causing the lake water to be warm, and inducing fog under certain weather conditions. Thus, this section of roadway has been subject to heavy fog, which greatly reduces visibility near the bridge. TxDOT personnel were looking for a low-cost means of providing better information to drivers in the area. They had considered installation of a full-function weather station with variable message signs; however, the cost for such a treatment exceeded available resources. A simpler, and less costly, alternative was to increase the visibility of the centerline and edgelines of the roadway through improved delineation.

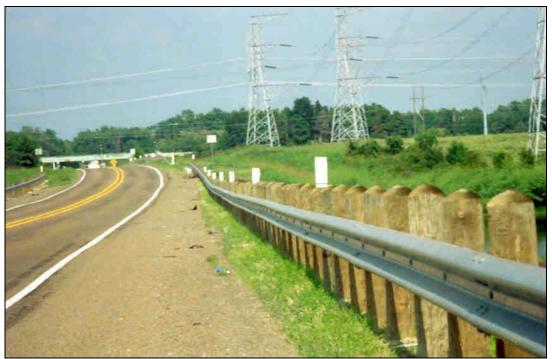
Figure 3-4. View of Added Raised Pavement Markers and Delineation.

both solid yellow lines. These markers begin about 100 ft (30.4 m) in advance of the beginning of the guardrail and continue throughout the section to the other side of the bridge. The delineators, rectangular white or yellow reflectors on metal posts, were attached to wooden guardrail posts at regular intervals throughout the length of the guardrail (see Figure 3-3); white delineators were used throughout the length of the guardrail, while yellow ones were used at the last guardrail post to signify the end of the guardrail.

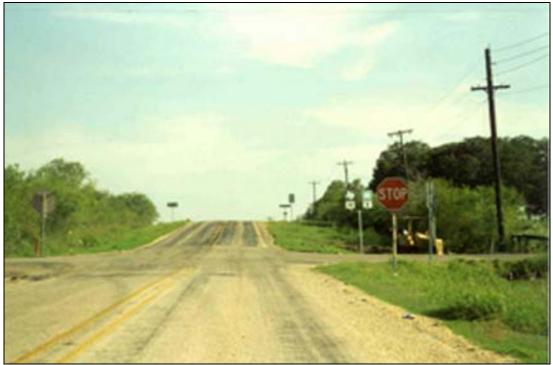
Figure 3-5. All-Way Stop-Controlled Intersection, Looking East.

This site is an intersection of two two-lane rural highways, with a 2002 ADT of approximately 1000 on the primary highway and 500 on the secondary highway (see Figure 3-5). Prior to improvements, this intersection was two-way stop-controlled on the secondary highway. The westbound approach on the primary highway has a crest vertical curve approximately 1000 ft (305 m) prior to the intersection; this curve limits the line of sight between drivers approaching the intersection on the primary highway and drivers stopped on the secondary highway. District personnel decided to address this safety concern with an all-way stop control at the intersection.

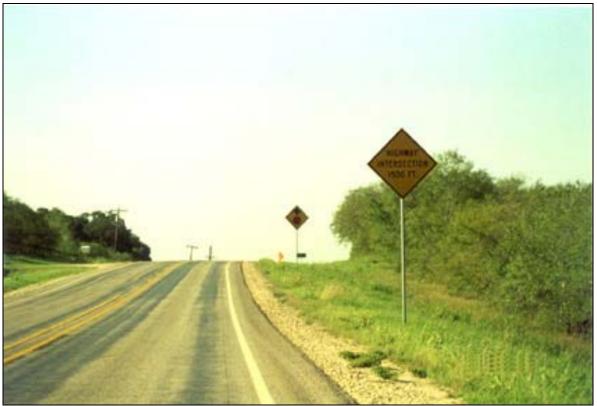
Figure 3-6. Advance Warning Signs for Approach to Intersection.

District personnel installed a four-way stop control at this intersection, along with advance warning signs. This consisted of symbolic STOP AHEAD signs and HIGHWAY INTERSECTION 1500 FT (458 m) signs on each approach. Figure 3-6 shows a view of these signs on one approach.

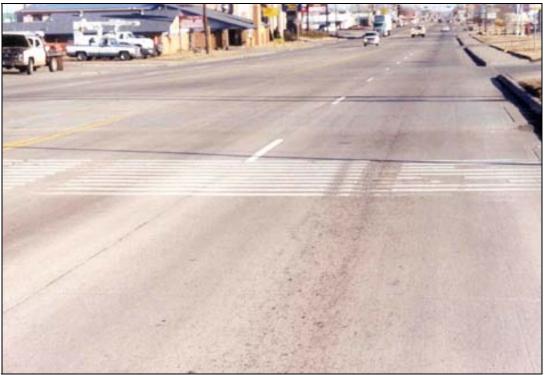
Figure 3-7. View of Approach Rumble Strips.

One of the treatments to be installed at this site was approach rumble strips, shown in Figure 3-7. These thermoplastic strips are installed in two places across the lanes of the eastbound approach to the intersection. The second treatment at this site is the installation of white strobe lights in the red signal heads facing west, shown in Figure 3-8. These strobe lights flash at regular intervals when the red signal is lit. Because the primary highway is almost directly east-west through the city, visibility at dusk and dawn can be impeded due to the rising and setting sun. Engineers in the district felt the strobe lights would especially aid drivers during these times of day. Additionally, engineers theorized that these devices would give travelers a better recognition of a change in the roadway environment.

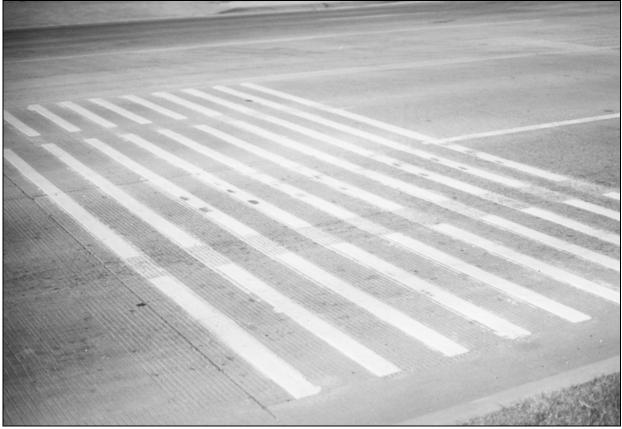
Figure 3-9. Close-Up View of Approach Rumble Strips.

The rumble strips, installed in August 1997, were placed in two sets. Each set consisted of 10 strips, 24 ft \times 4.5 inches (7.3 m \times 11.4 cm), with a space of 9.5 inches (24.1 cm) between each strip. A close-up view of the rumble strips is shown in Figure 3-9. The first set is 1236 ft (377 m) from the traffic signal, and the second set is 480 ft (146.3 m) from the traffic signal. There is also a 36-inch \times 36-inch (91.4 cm \times 91.4 cm) "RUMBLE STRIPS AHEAD" sign located 985 ft (300 m) west of the first set of rumble strips. The cost to install the rumble strips and advance sign amounted to approximately \$500. The strobe lights, installed in March 1997, are mounted to the red lenses of the traffic signals. The cost of purchasing and installing the strobe lights was approximately \$3200.

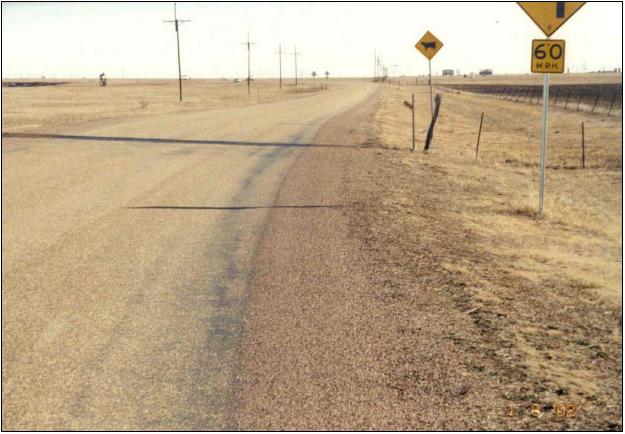
Figure 3-10. View of Roadway Widening.

The roadway was widened to match the cross-section of the adjacent roadway, shown in Figure 3-10. An additional 3 ft (0.9 m) of lane width and 2 ft (0.6 m) of shoulder width on either side of the roadway augmented this segment, for a total pavement width of 30 ft (9.2 m).

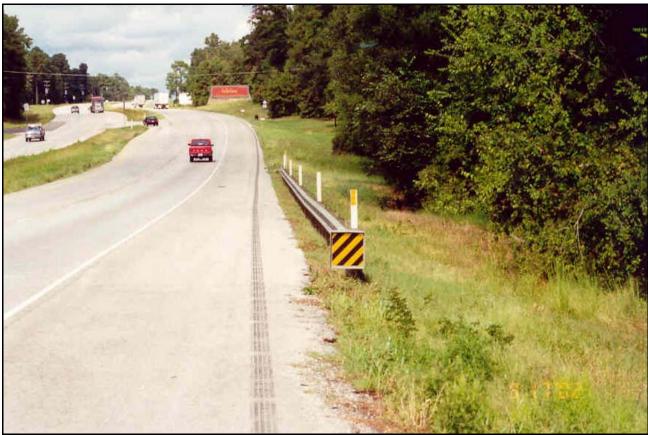
Figure 3-11. Safety Treated Guardrail.

The improvement at the site was to safety treat fixed objects (installation of ET 2000s and guardrails as shown in Figure 3-11) throughout the section; installation was completed in June 1997 at a cost of \$528,000.

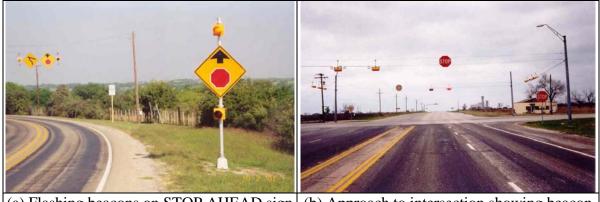
Figure 3-12.	Improvements at Site 98-01.
--------------	------------------------------------

Site 98-01 is a T-intersection of two state highways. An unusual curve is present on the minor road approach near the intersection (see Figure 3-12).

(a) Flashing beacons on STOP AHEAD sign on approach with sharp horizontal curve.(b) Approach to intersection showing beacon on STOP sign.

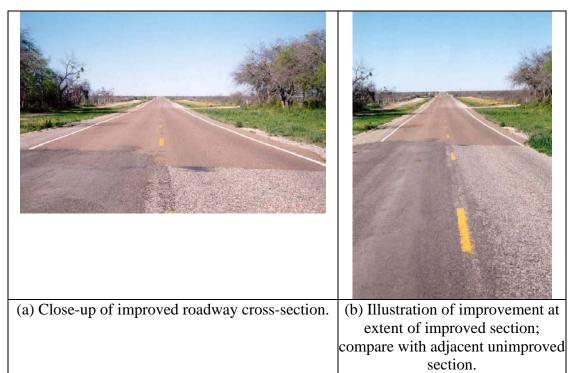
Figure 3-13.	Improved	Roadway S	Section	at Site 98-02.
I Bare e Iet	mprovea	L oud nug h

Treatment at site 98-02 included widening the roadway and adding edgeline to denote presence of shoulders (see Figure 3-13). Installation was completed in February of 1998.

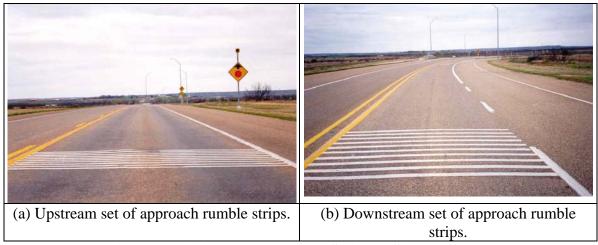
Figure 3-14. Approach Rumble Strips at Site 98-03.

Approach rumble strips were installed on the leg of the tee in two sets. Each set consisted of ten 24-inch \times 4.5-inch (61.0 cm \times 11.43 cm) strips with 9.5 inches (24.1 cm) of space between each strip. The first set was located 1236 ft (377 m) from the stop line at the intersection; the second was located 480 ft (146 m) from the stop line. Figure 3-14 shows views of both sets of rumble strips. The installation was completed in April 1998 at a cost of \$456.

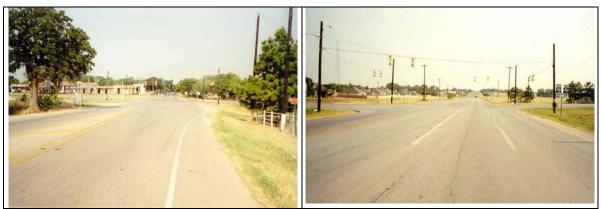
An intersection flashing beacon was installed, as shown in the approach views in Figure 3-15. Installation was completed June 1, 1998; no cost information was available.

(a) Approach to intersection on FM roadway. (b) Approach to intersection on US highway. **Figure 3-15. Views of Site 98-04.**

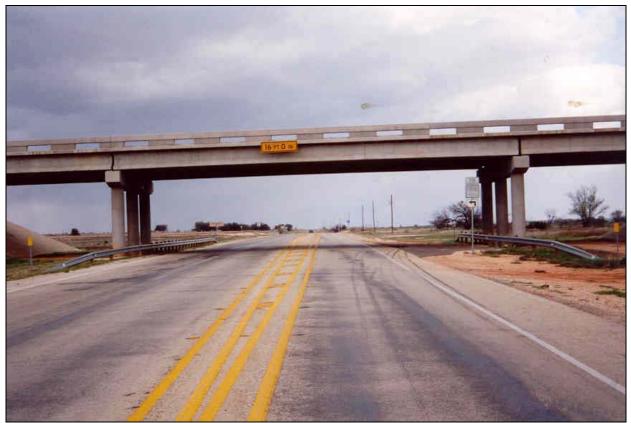
Figure 3-16. View of Grade Separation Structure at Site 98-05.

The improvement at this site was the installation of a grade separation structure, seen in Figure 3-16. It was completed in July 1998; cost information was not provided.

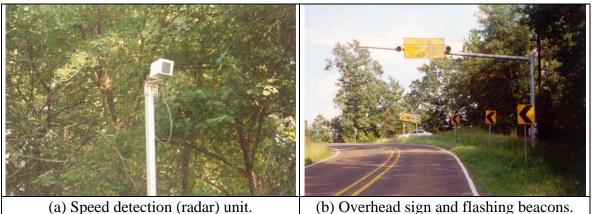
Figure 3-17. Components of Speed Detection and Notification Device.

A speed detection and notification device was installed in September 1998 at a cost of \$18,000. The device has a radar unit (Figure 3-17a) that detects the speeds of oncoming vehicles and activates the overhead beacons (Figure 3-17b) when vehicles are exceeding the advisory speed for the curve (25 mph).

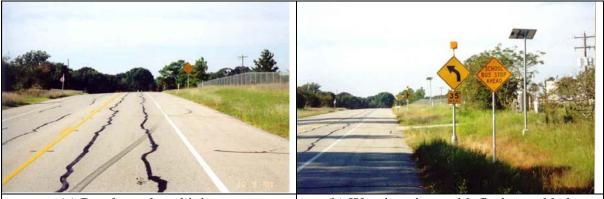
Site 98-07 is a 1.6-mile (2.6 km) section of FM roadway as seen in Figure 3-18a. This section contains a sharp (35-mph) curve and a highway intersection, both of which have advance warning signs.

This project added flashers on the advance warning signs. The installation was completed in November 1998. The flashers on the advance warning signs at the curve can be seen in Figure 3-18b.

(a) Rural two-lane highway.(b) Warning signs with flashers added.Figure 3-18. Views of Site 98-07.

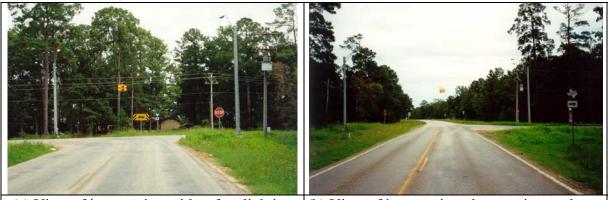
Figure 3-19. Approach Views of Site 98-08.

Site 98-08 is a T-intersection of two FM roadways. The views in Figure 3-19 show that the leg of the T is stop-controlled.

(a) View of intersection with safety lighting along stop-controlled approach.(b) View of intersection along major roadway.

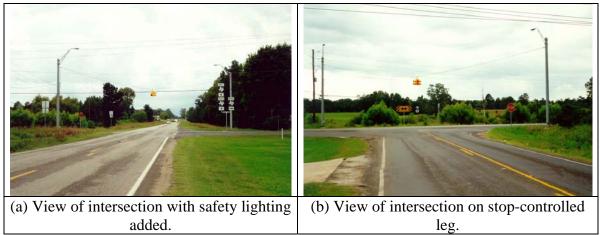
Figure 3-20. Views of 98-09 with Safety Lighting Installed.

Site 98-09 is a T-intersection of two FM roadways. Views of both roadways are shown in Figure 3-20.

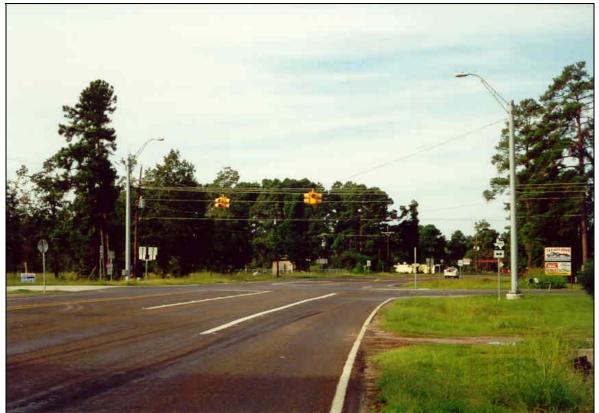
Figure 3-21. View of Safety Lighting at Site 98-10.

Safety lighting was installed on November 6, 1998, as seen in Figure 3-21.

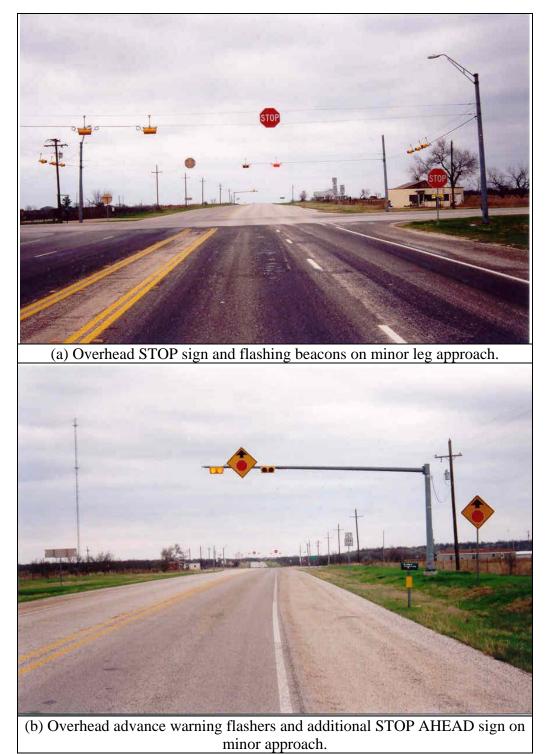
Figure 3-22. Flashing Beacon Improvements at Site 98-11.

The purpose of the improvement to this site was to upgrade the intersection flashing beacon and install advance warning beacons. The improved intersection has a pair of overhead flashing beacons over each lane at the intersection, with supplemental overhead STOP signs over the minor approaches (see Figure 3-22a). An overhead STOP AHEAD sign with two pairs of alternating flashing beacons (see Figure 3-22b) were also added on the minor road approaches, to supplement existing roadside STOP AHEAD signs. The installation was completed on December 11, 1998, at an approximate cost of \$37,500.

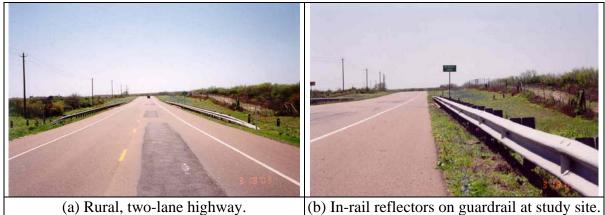
Figure 3-23. In-Rail Guardrail Reflectors.

Site 98-12 is a rural two-lane section of state highway (see Figure 3-23a). This 3.1-mile (5.0 km) site is located on the northern edge of a small town; the first 2.8 miles (4.5 km) are in rural conditions, while the last 0.3 mile (0.5 km) is in the city limits with an increasing ADT and a major intersection. The section termini are a county line and a second major intersection.

In-line guardrail reflectors (see Figure 3-23b) were installed on existing guardrails throughout a 3.1-mile (5.0 km) section. The installation was completed in the summer of 1998 at a cost of \$2.72 per reflector.

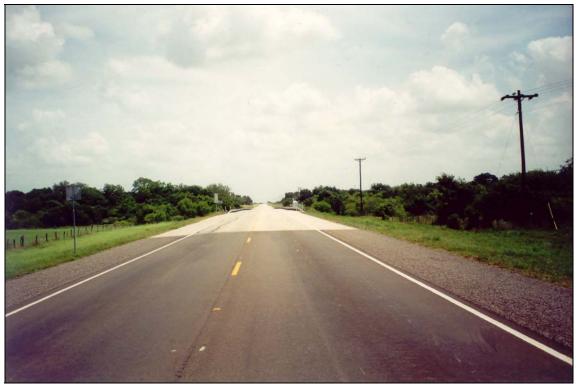
Figure 4-1. Limit of Improved Section of Roadway.

The improvement project involved adding shoulders, safety treating fixed objects, and resurfacing. Figure 4-1 shows the improved section compared to the adjacent unimproved roadway. Improvements were completed on July 30, 1999; approximate cost of installation was not available.

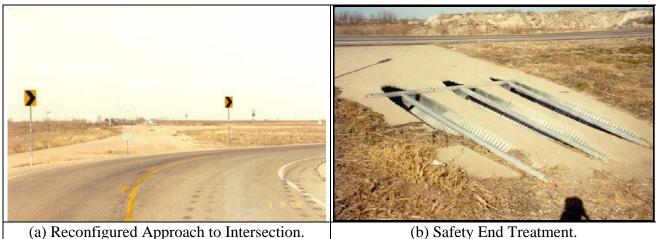
Figure 4-2. Improvements at Site 99-04.

Engineers reconfigured the intersection to provide an improved approach on the curve on the minor FM road (Figure 4-2a). Chevrons were also added on the curve, and the approach on the previous alignment was closed off. Safety end treatments were also added on the 18-mile (29.0 km) segment of the major FM road (Figure 4-2b). Completion of the installation occurred in August 1999; approximate cost of installation was not available.

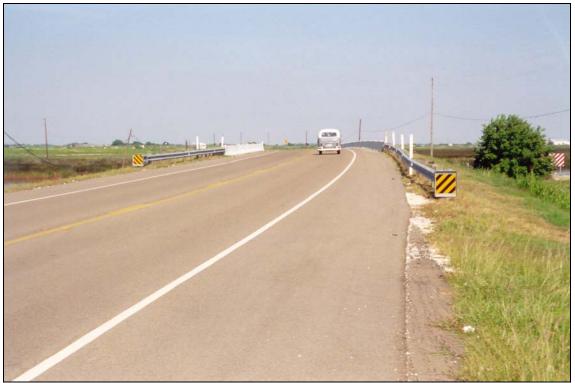
Figure 4-3. Added Shoulders, Resurfacing, and Safety Treatments.

The improvement project involved adding shoulders, safety treating fixed objects, and resurfacing. Improvements were completed on August 2, 1999; approximate cost of installation was not available. Figure 4-3 shows a portion of the improved segment.

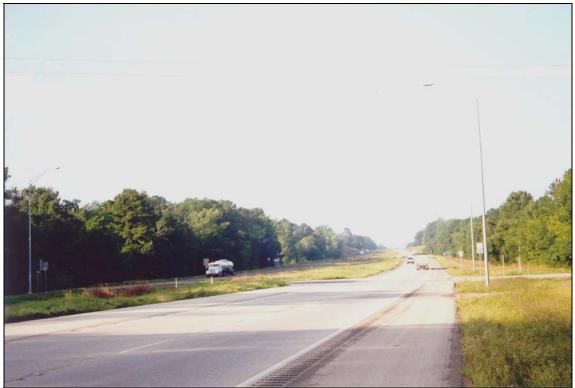
Figure 4-4. Safety Lighting at Site 99-06.

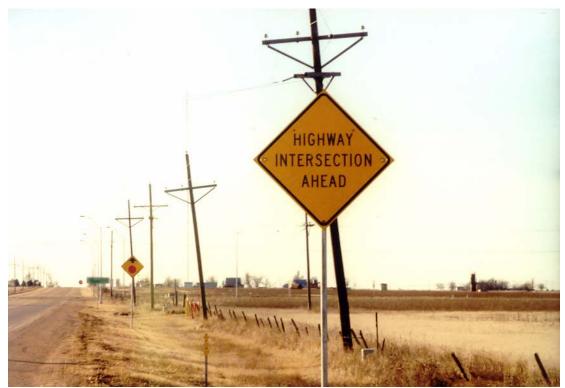
Figure 4-5. Advance Warning Signs on Intersection Approach.

STOP AHEAD (W1-10) signs, HIGHWAY INTERSECTION AHEAD signs, and approach rumble strips were installed at this intersection, completed in September 1999. The approximate cost of installation was unavailable. Examples of the signs are shown in Figure 4-5.

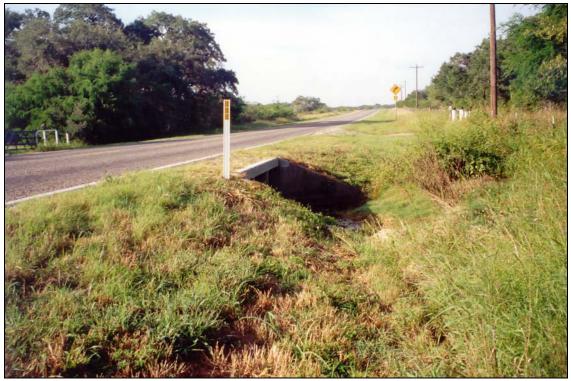
Figure 4-6. Improvements at Site 99-08.

The roadway was widened, trees were removed, and headwalls received safety treatments (see Figure 4-6). Completion of the installation occurred in September 1999; approximate cost of installation was not available.

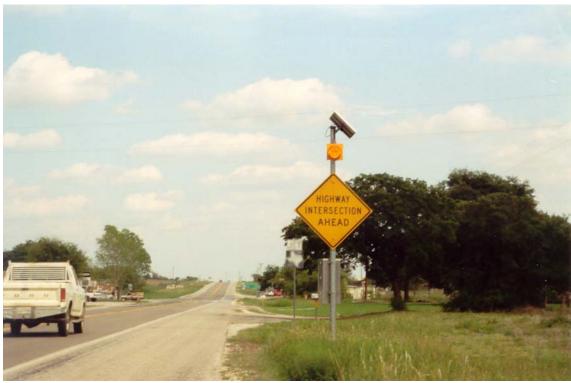
Figure 4-7. Advance Warning Sign with Flashing Beacons on Obscured Approach.

A HIGHWAY INTERSECTION AHEAD sign with a flashing beacon (Figure 4-7) was installed on the approach upstream of the hill's upgrade to improve advance warning to drivers about the upcoming intersection. Completion of the installation occurred in October 1999; approximate cost of installation was not available.

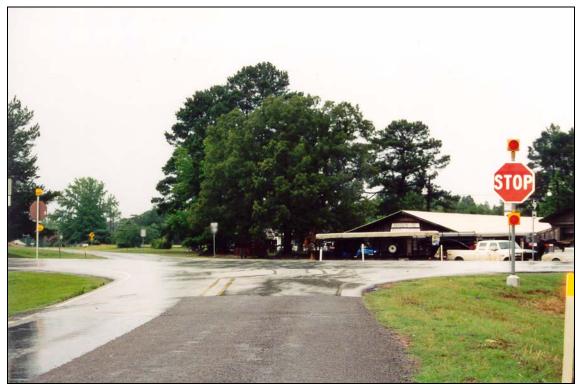
Figure 4-8. Beacons Mounted on STOP Sign.

The improvement project included adding "bouncing" beacons, pavement marker buttons, and turning lanes at the intersection. Installation was completed on October 7, 1999; the approximate cost of installation was not available. The STOP sign-mounted beacons are shown in Figure 4-8.

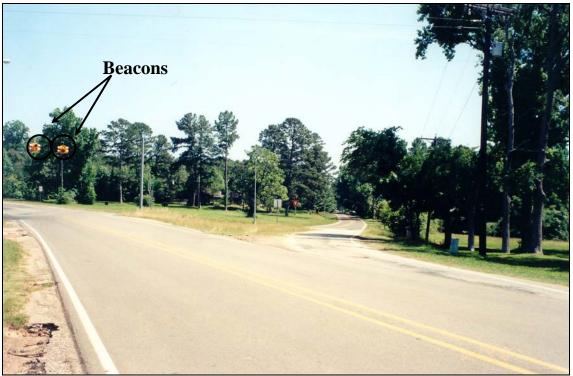
Figure 4-9. Overhead "Bouncing" Beacons.

Two sets of four-directional overhead alternating beacons were installed at the intersection, as shown in Figure 4-9. Completion of the installation occurred on October 7, 1999; approximate cost of installation was not available.

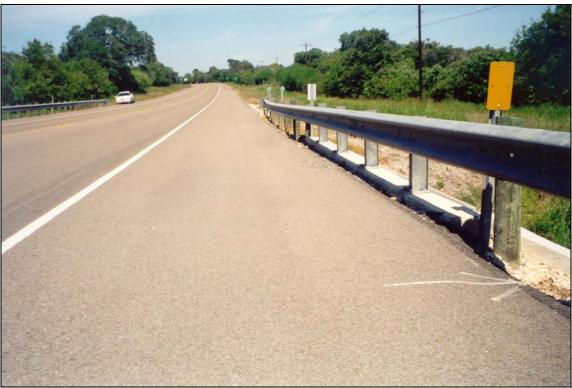
Figure 5-1. New Shoulders and Resurfacing at Site 100-02.

This segment of roadway was resurfaced, shoulders were added, and safety treatments were applied to fixed objects, pictured in Figure 5-1. Completion of the installation occurred on February 22, 2000; approximate cost of installation was not available.

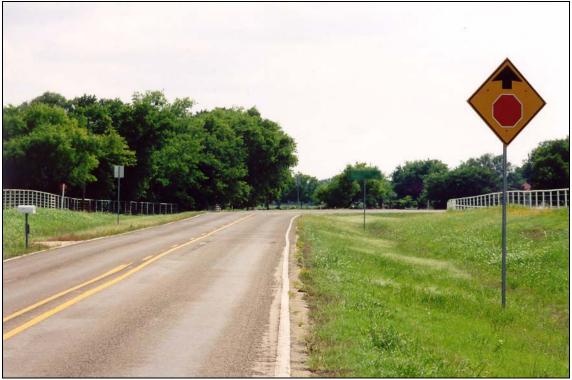
Figure 5-2. STOP AHEAD Sign on Intersection Approach in Advance of Curve.

This site is a rural T-intersection of two farm-to-market highways. The leg of the T has a series of moderate and sharp curves on the approach to the intersection, which reduces the visibility of the intersection for approaching drivers. One such curve is pictured in Figure 5-2.

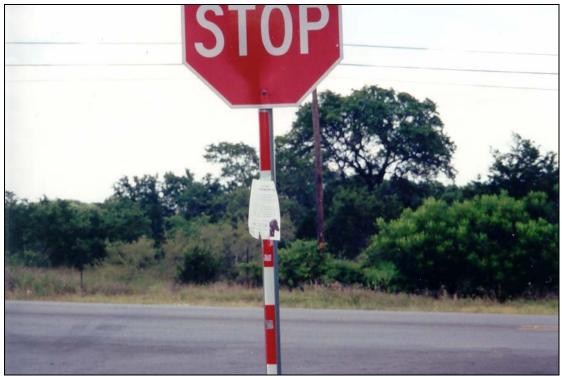
Figure 5-3. Reflective Strips on STOP Sign Post.

In May 2000, red reflective strips were installed on the STOP sign post on the local road to increase visibility, as shown in Figure 5-3. Approximate cost of installation was not available.

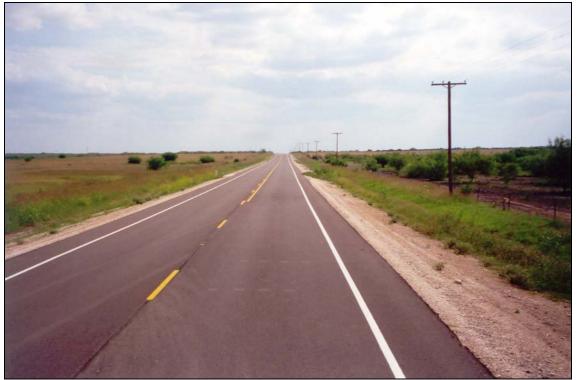
Figure 5-4. Widened Roadway at Site 100-05.

The roadway was widened along the entire 24-mile (38.6 km) segment. The project was completed in May 2000; approximate cost of installation was not available. Figure 5-4 shows the improved roadway.

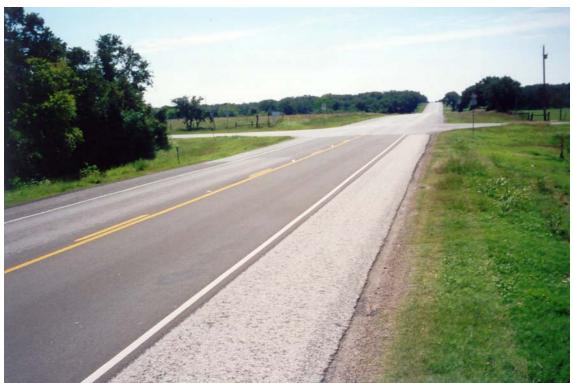
Figure 5-5. View of Resurfaced Roadway and Added Shoulders at Site 100-06.

The roadway was resurfaced, 10-ft (3.0 m) shoulders were added, and safety treatments were added to structures throughout the section, a portion of which is shown in Figure 5-5. Installation was completed in June 2000; approximate cost of installation was not available.

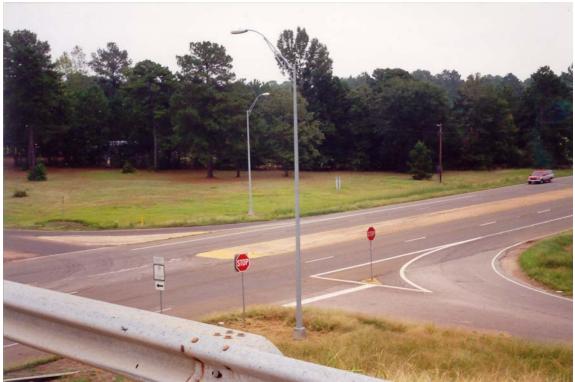
Figure 5-6. Safety Lighting at Site 100-07.

Safety lighting was added in the form of four luminaires placed at both approaches of the state highway bridge and the entrance of both ramps from the US highway. Installation was completed on June 6, 2000; the cost of installation was approximately \$40,600. Two of the four luminaires are shown in Figure 5-6.

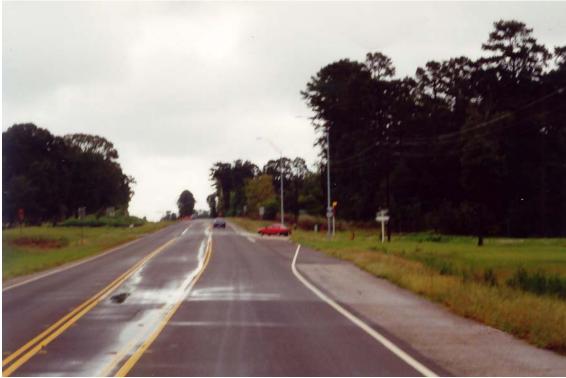
Figure 5-7. Luminaires at T-Intersection.

Two luminaires were installed, one on either corner of the FM road approach (see Figure 5-7), to provide additional safety lighting. Installation was completed on June 6, 2000; the cost of installation was approximately \$19,000.

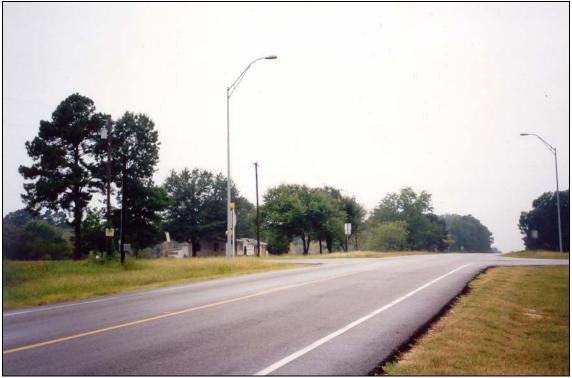
Figure 5-8. Luminaires on Opposite Corners of Four-Leg Intersection.

Two luminaires were installed on opposite corners of the intersection to improve lighting conditions, as shown in Figure 5-8. Installation was completed on June 6, 2000; the cost of installation was approximately \$23,300.

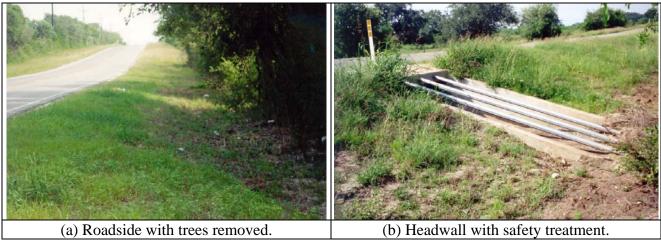
Figure 5-9. Improvements at Site 100-10.

This site is a section of rural, two-lane FM highway approximately 8 miles (12.9 km) in length (see Figure 5-9).

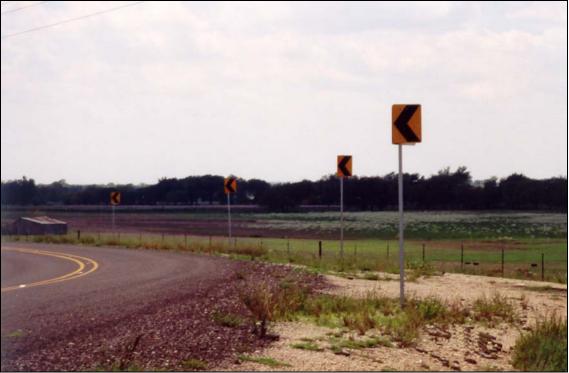
Figure 5-10. Chevrons on Horizontal Curve.

Chevrons were installed on curves throughout the section, one of which is shown in Figure 5-10. The chevrons were completely installed by July 2000; approximate cost of installation was \$55 per chevron.

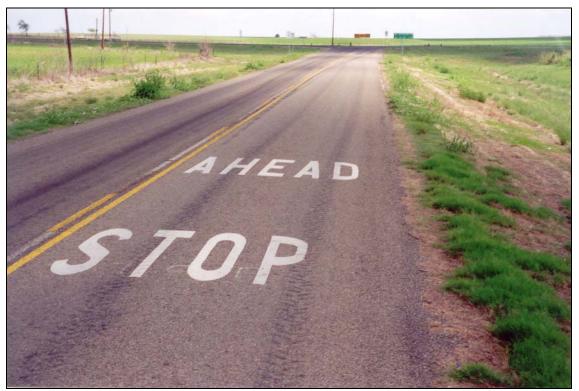
Figure 5-11. Advance Warning Pavement Markings on Intersection Approach.

Advance warning signs, including STOP AHEAD pavement markings, were installed on the stop-controlled approach. Completion of the installation occurred in July 2000; approximate cost of installation was \$450. Figure 5-11 shows one set of pavement markings.

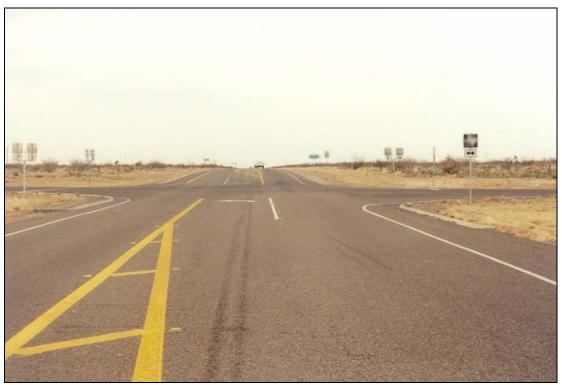
Figure 5-12. New Left-Turn Lanes at Intersection.

New pavement markings were added, and left-turn lanes were installed on the major road. As seen in Figure 5-12, the turning lanes were installed to allow turning vehicles in either direction of the major road to approach their turns separated from through traffic. Completion of the installation occurred in July 2000; approximate cost of installation was not available.

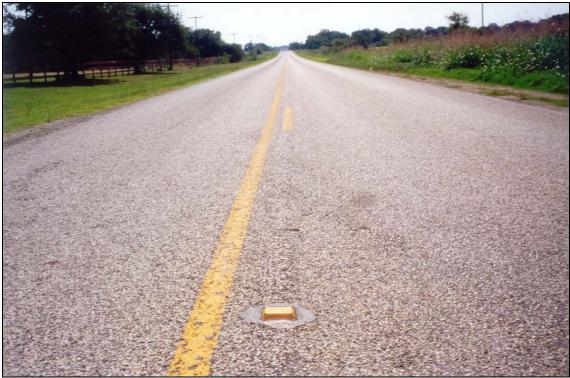
Figure 5-13. Centerline Raised Pavement Marker.

Raised pavement markers (shown in Figure 5-13) were installed throughout this section as part of a statewide action to improve nighttime visibility. Installation was completed in August 2000. Installation costs were approximately \$350 per mile.

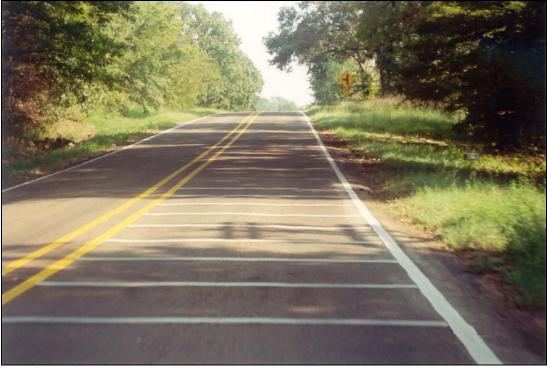
Figure 5-14. Approach Rumble Strips and Intersection Advance Warning Sign.

Approach rumble strips and a T-intersection advance warning sign were installed on the approach to provide visual notification to drivers approaching on the FM road and audible notification of approaching vehicles to drivers stopped at the intersection on the county road. These improvements are illustrated in Figure 5-14. Completion of the installation occurred in October 2000; approximate cost of installation was \$2000.

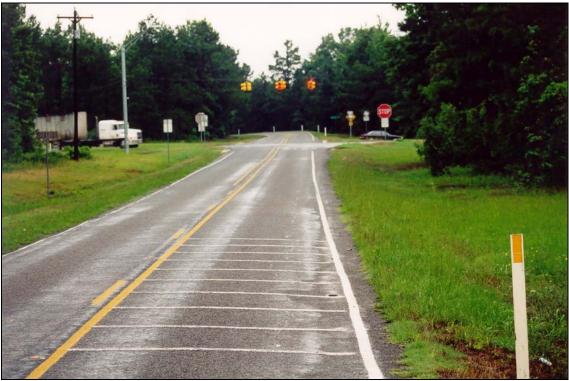
Figure 5-15. Multiple Treatments at Site 100-17.

New pavement markings, approach rumble strips, and flashing beacons were installed at this intersection to increase drivers' awareness of the presence of the intersection. Completion of the installation occurred in October 2000; approximate cost of installation was \$15,000. An example of each treatment is shown in Figure 5-15.

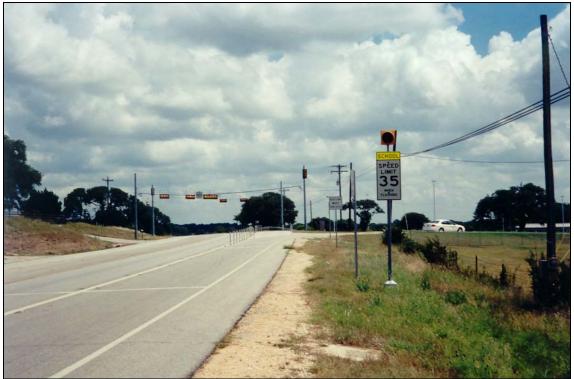
Figure 5-16. Right-Turn Lane Adjacent to School.

A right-turn lane (shown in Figure 5-16) was added to the FM road for vehicles turning into the school, and NO PARKING signs were added to the roadside adjacent to the school on the FM road. Completion of the installation occurred in October 2000; approximate cost of installation was not available.

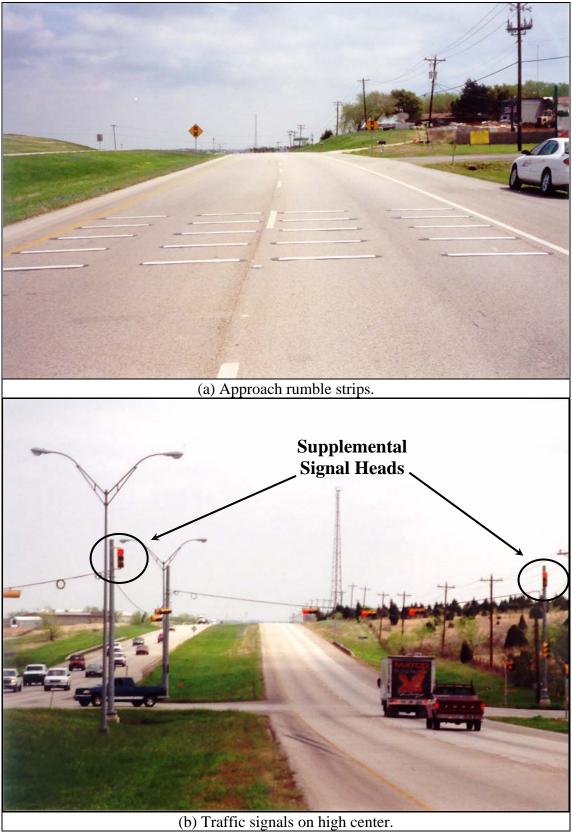
Figure 5-17. Improvements at Site 100-20.

Supplemental traffic signal heads, advance signing, and approach rumble strips were installed at this intersection to accommodate increasing traffic volumes and address the issue of approach visibility. Supplemental signal heads were mounted near the top of the support poles on both sides of the travel lanes on the US highway. These high-centered signals are more visible to drivers on the upgrade of the vertical curves approaching the intersection. The rumble strips are placed on the upgrade of those vertical curves to notify drivers that the intersection is ahead. Figure 5-17 shows examples of these treatments. Installation was completed on October 4, 2000; approximate cost of installation was not available.

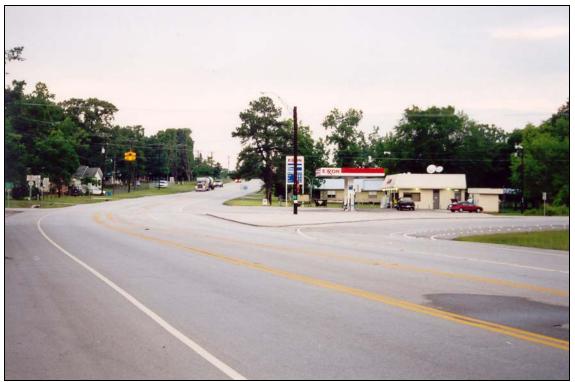
Figure 5-18. Right-Turn Lane with Channelizing Island.

Channelizing islands were added to this intersection, completed on October 30, 2000. The cost of the treatment was approximately \$251,000. One island is shown in Figure 5-18.

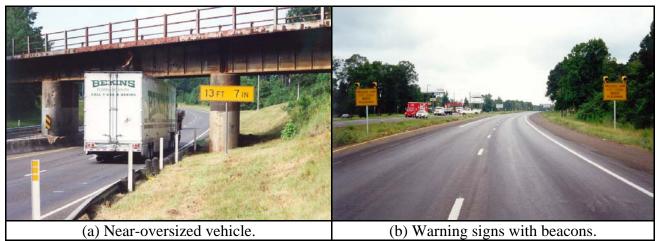
Figure 5-19. Warning System and Railroad Bridge at Site 100-23.

This site consists of a railroad bridge over a divided four-lane rural US highway. The highway under the railroad bridge has limited height and width, causing significant potential for oversized trucks to strike the bridge when passing through the site. Figure 5-19a shows a near-oversized vehicle traveling under the bridge.

The roadway was fitted with an overheight warning system that detected the height of approaching vehicles upstream of the railroad bridge. When an oversized vehicle passed through the system, the detectors recognized the height of the vehicle and activated beacons on a warning sign (Figure 5-19b), which informed drivers of an alternate route they should take. The system was completed on November 13, 2000, at an approximate cost of \$65,800.

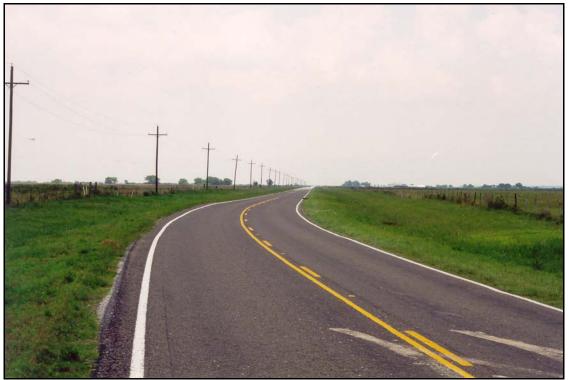
Figure 5-20. Widened Lanes at Site 100-24.

The project added 2 ft of lane width to each site of the roadway. Construction ended on December 4, 2001; approximate cost of installation was not available. Figure 5-20 shows a portion of the section.
