1. Report No. FHWA/TX-06/0-5210-2		2. Government Accession No.		3. Recipient's Catalog No.	
4. Title and Subtitle CRASH TESTING AND EVALUATION OF THE SHUR-TITE® MULTIPLE-MAILBOX MOUNT				5. Report Date August 2006 Published: November 2006

16. Abstract Texas Department of Transportation desires to adopt a new multiple-mailbox mount design that provides improved ease of installation and maintenance. Shur-Tite® has developed a design that is considered to provide the desired ease of installation and maintenance. Two full-scale crash tests were conducted to evaluate the safety performance of the Shur-Tite® multiple-mailbox support in accordance with <i>NCHRP Report 350</i> . The Shur-Tite® Multiple-Mailbox Mount design successfully passed all requirements of <i>NCHRP Report 350</i> and is ready for field implementation.

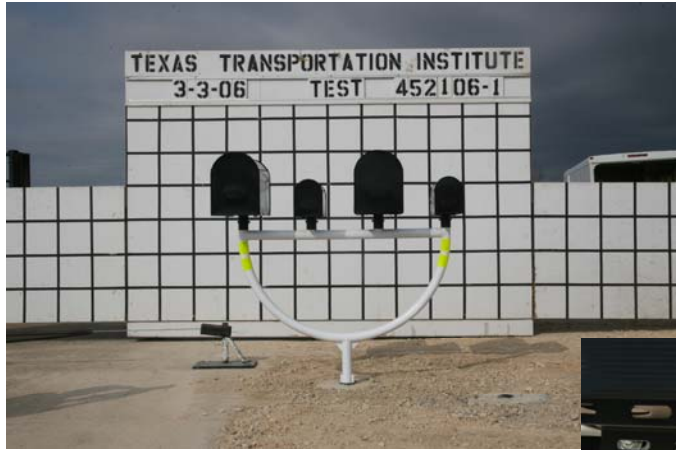
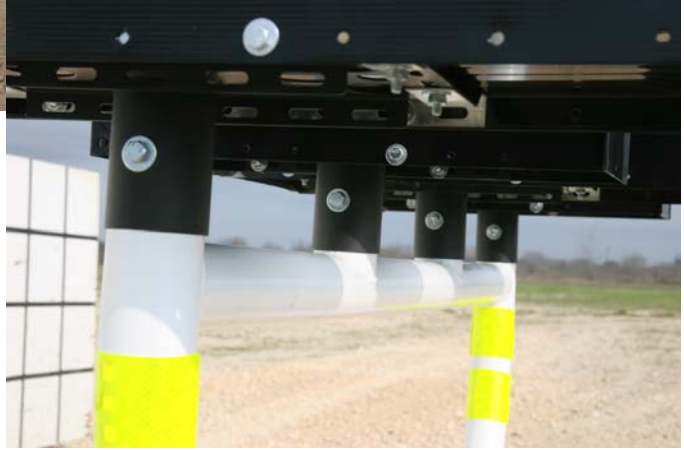
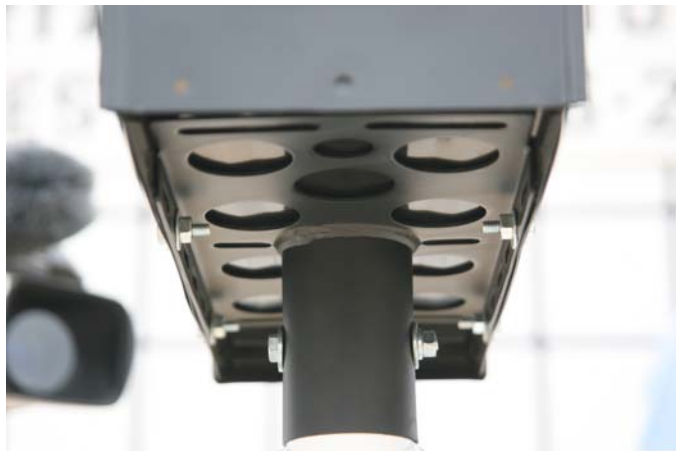
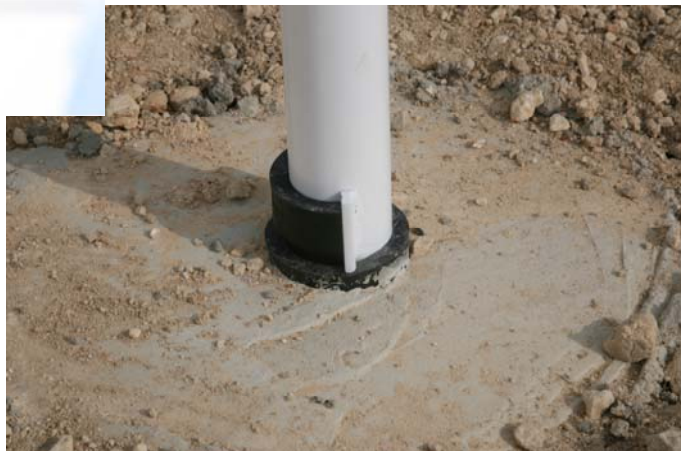
Figure 2. Shur-Tite® Multiple-Mailbox Mount before Testing.

Test articles for both crash tests were identical. [Figure 2](#) shows photographs of the completed installation.

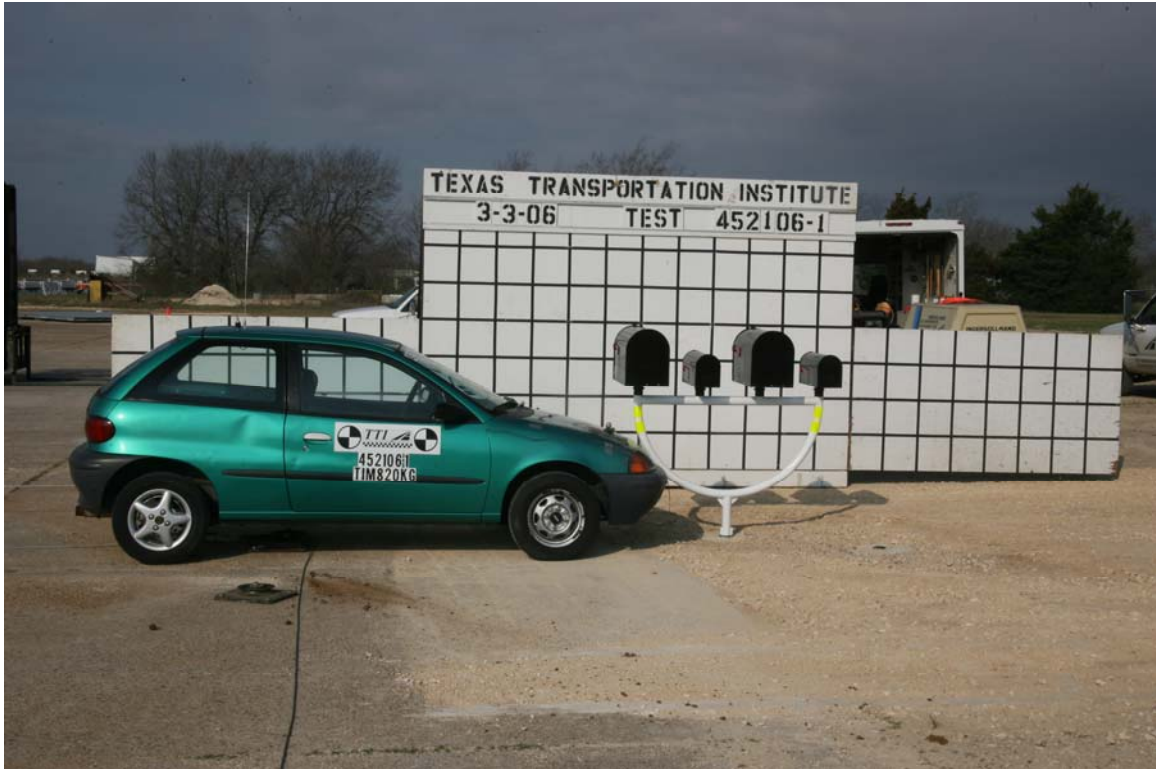
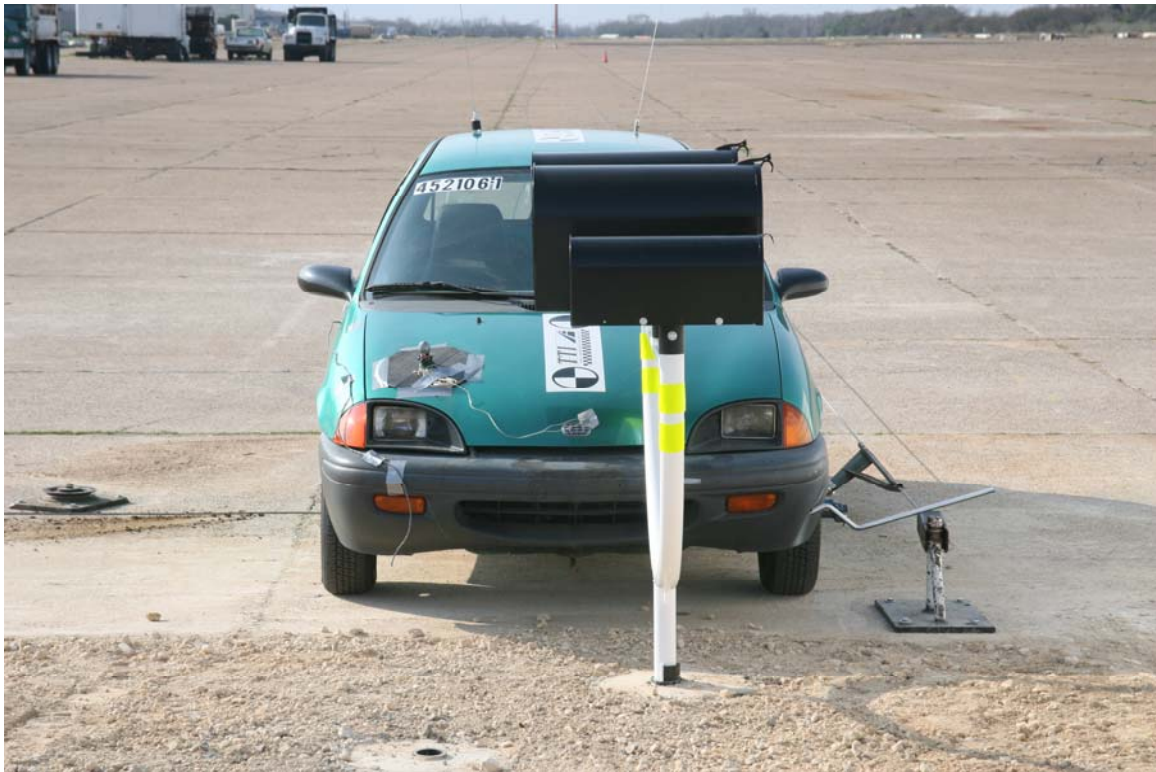
Figure 3. Vehicle/Installation Geometries for Test No. 452106-1.

A 1995 Geo Metro, shown in Figures 3 and 4, was used for the crash test. Test inertia weight of the vehicle was 1808 lb, and its gross static weight was 1978 lb. The height to the lower edge of the vehicle bumper was 15.75 inches, and it was 20.7 inches to the upper edge of the bumper. Figure 17 in Appendix B gives additional dimensions and information on the vehicle. The vehicle was directed into the installation using the cable reverse tow and guidance system, and was released to be free-wheeling and unrestrained just prior to impact.

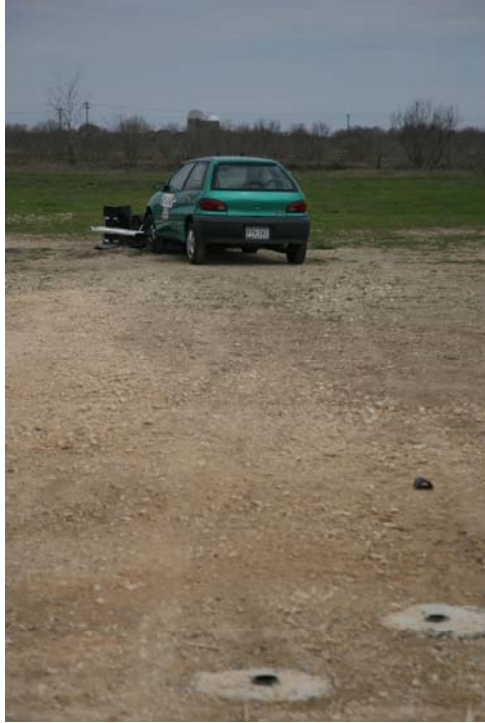
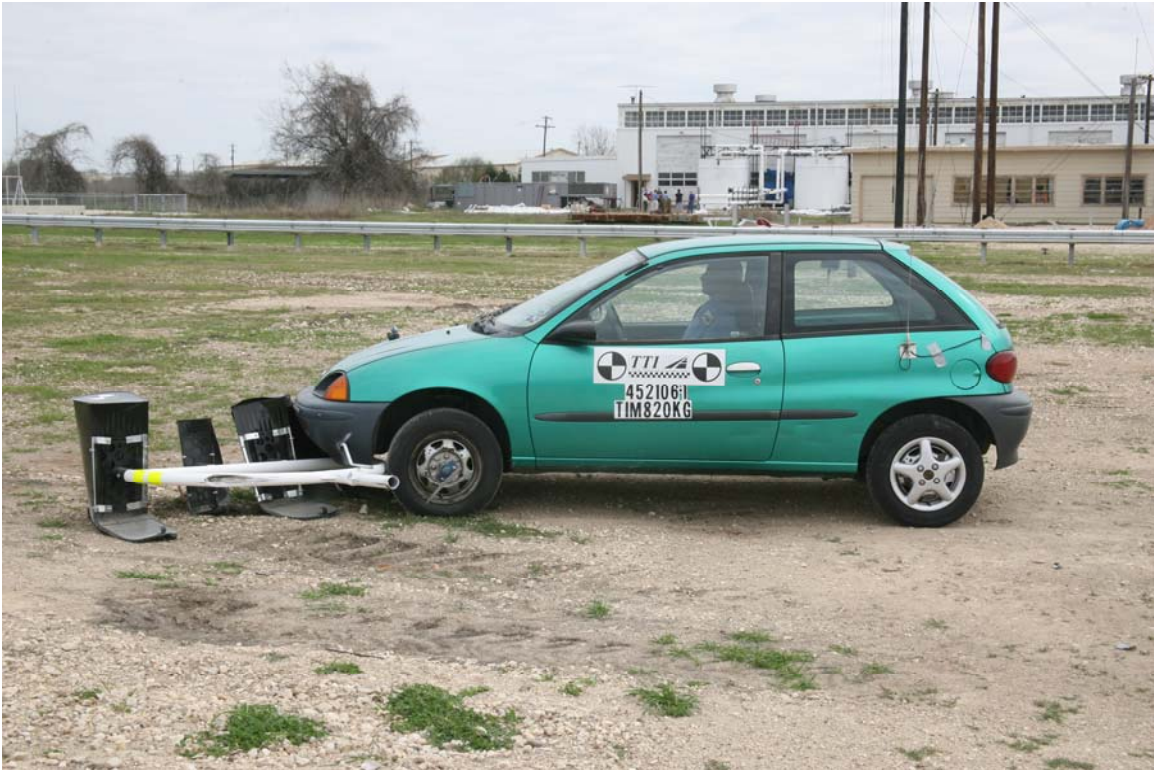
Figure 5. After Impact Trajectory Path for Test No. 452106-1.

The 1995 Geo Metro, traveling at an impact speed of 22.1 mi/h, contacted the Shur-Tite® multiple-mailbox mount at an impact angle of 0 degree, with the left quarter point of the vehicle aligned with the centerline of the mount. At 0.080 s after impact, the upright support pulled out of the ground socket. At 0.264 s, the vehicle (while still in contact with the support) exited the view of the camera used to calculate the exit speed at loss of contract. The corner of the end mailbox contacted the windshield at 0.673 s. The mailbox mount traveled along with the vehicle and subsequently came to rest in front of the vehicle 73 ft downstream of impact and 3 ft to the left of the original position of the mount. Figure 18 in Appendix C shows sequential photographs from the test.

The support pulled out of the ground base, as designed, and rode along with the vehicle. The ground base was only slightly disturbed. The support was deformed 15.75 inches above the end of the support and on the impact side of the curved portion. The mailboxes remained attached, but were deformed, as shown in Figures 5 and 6.

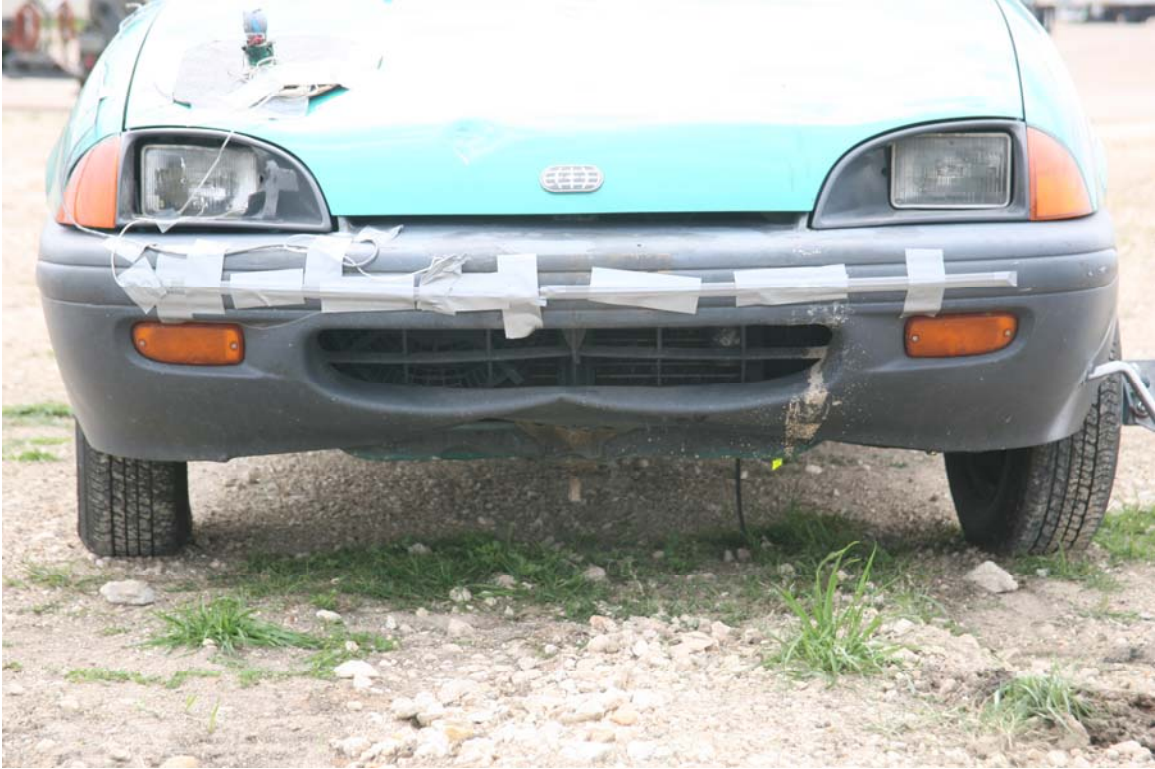
Figure 7. Vehicle after Test No. 452106-1.

The vehicle sustained minimal damage as shown in Figure 7. The front bumper had a slight indentation at point of contact with the support, and the hood had two indentations; one at 5.1 inches to the right of centerline measuring 2.75 inches \times 3.75 inches, and the second at 8.25 inches to the left at center (impact side) measuring 6.25 inches \times 1.6 inches. No occupant compartment deformation occurred during the test. Photographs of the interior of the vehicle are shown in Figure 8. Exterior vehicle crush and occupant compartment measurements are shown in Appendix B, Tables 3 and 4.

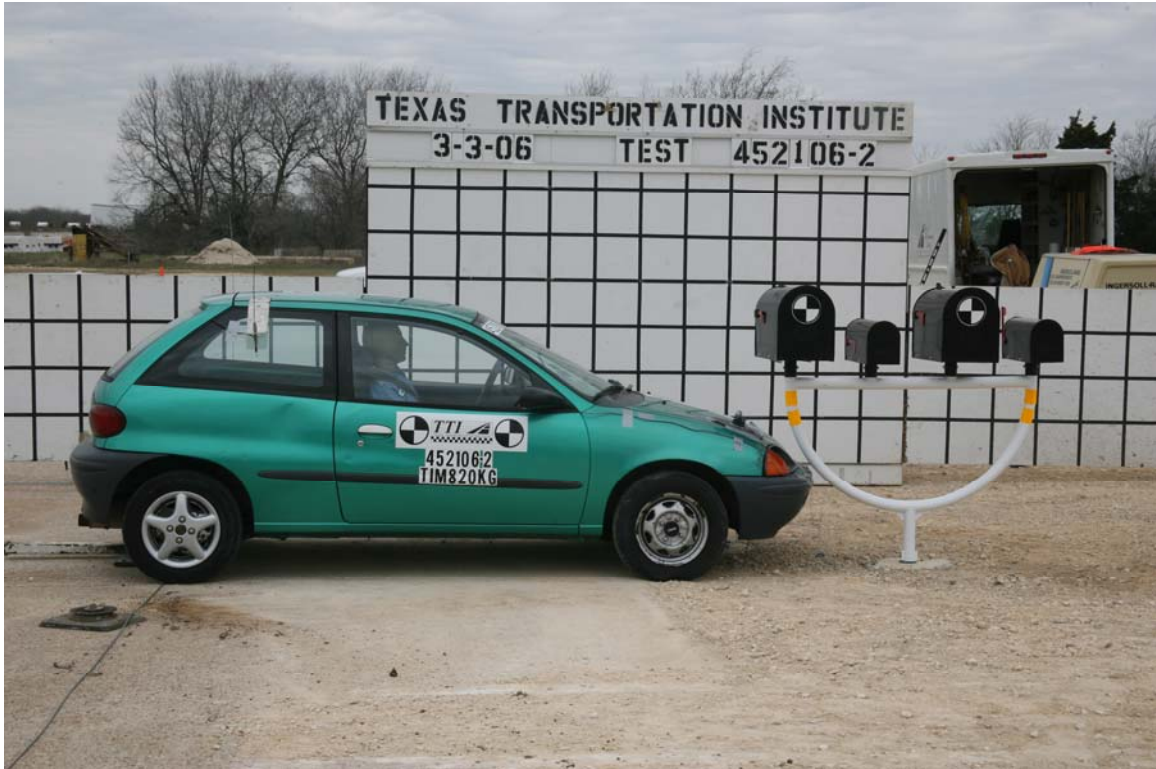
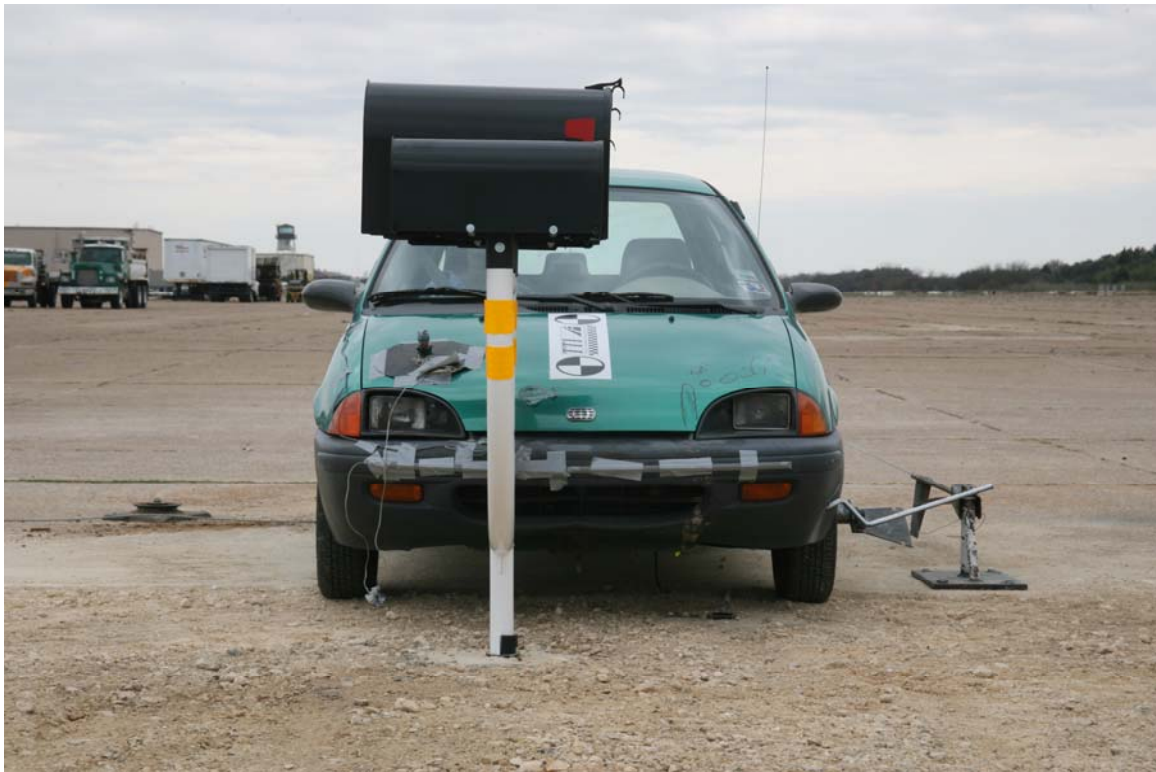
Figure 10. Vehicle/Installation Geometrics for Test No. 452106-2.

The 1995 Geo Metro used in the previous test, and shown in Figures 10 and 11, was used for the crash test. Test inertia weight of the vehicle was 1808 lb, and its gross static weight was 1978 lb. The height to the lower edge of the vehicle bumper was 15.75 inches, and it was 20.7 inches to the upper edge of the bumper. Figure 17 in Appendix B gives additional dimensions and information on the vehicle. The vehicle was directed into the installation using the cable reverse tow and guidance system, and was released to be free-wheeling and unrestrained just prior to impact.

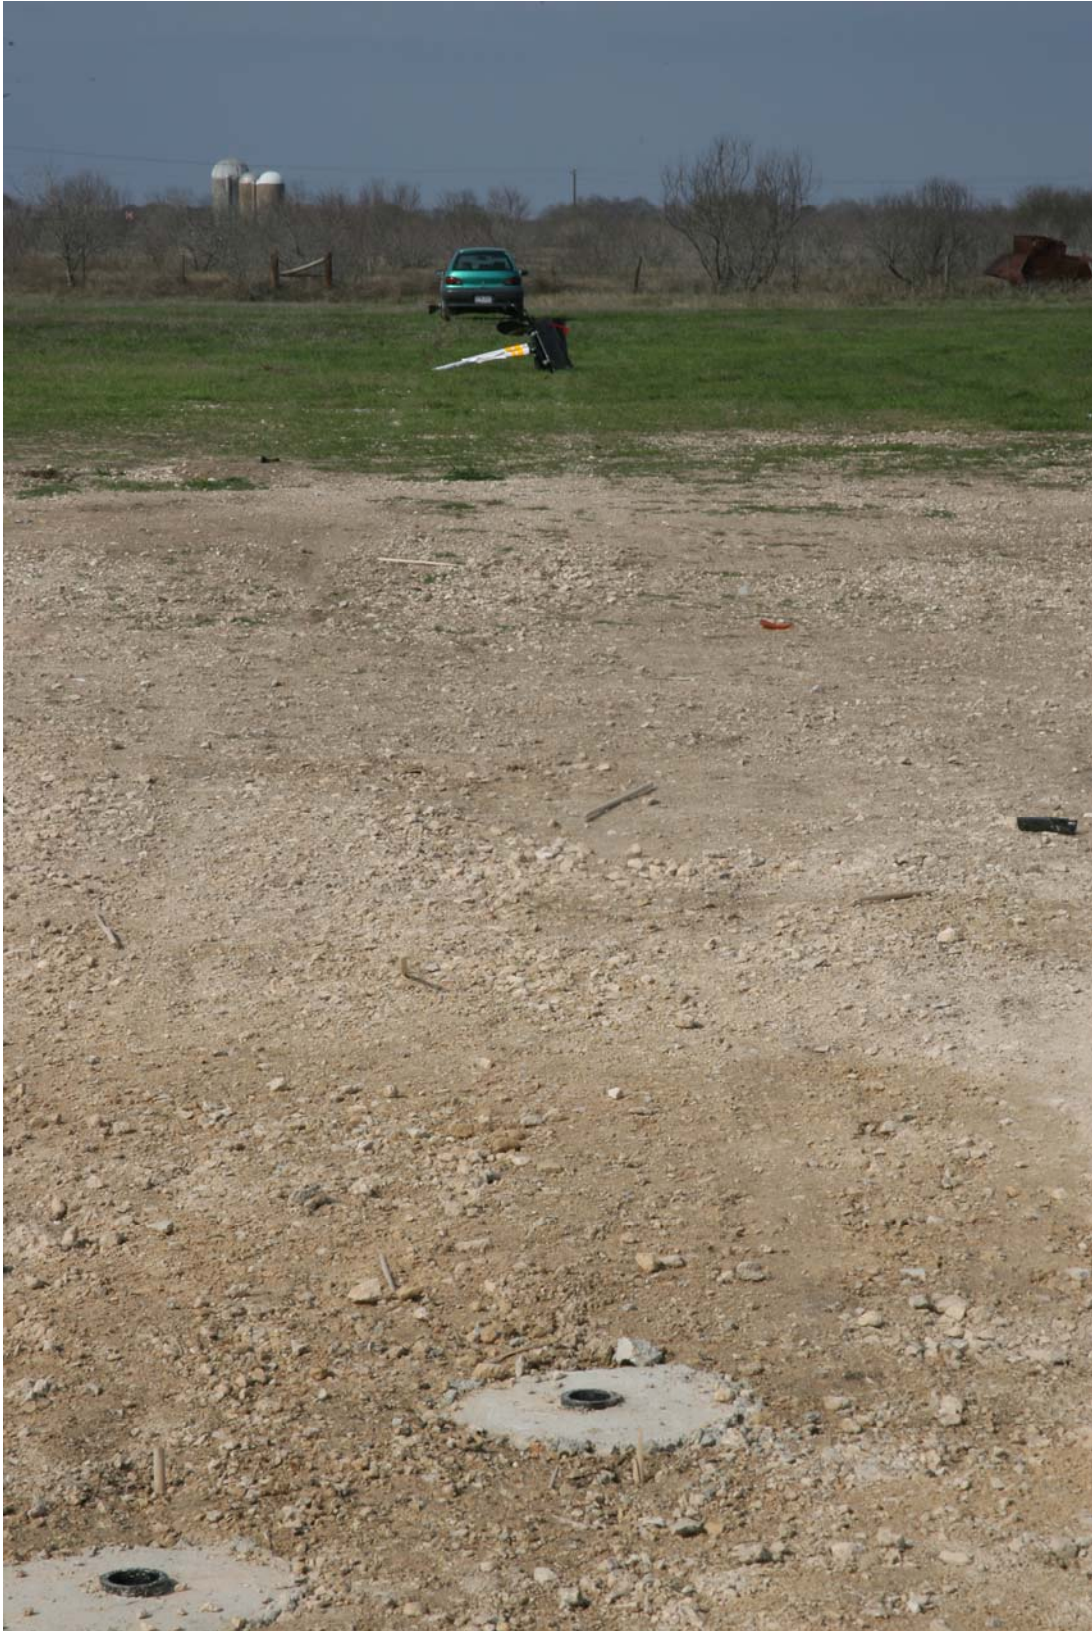
Figure 12. After Impact Trajectory Path for Test No. 452106-2.

The 1995 Geo Metro, traveling at an impact speed of 62.6 mi/h, contacted the Shur-Tite® Multiple-mailbox Mount at an impact angle of 0 degree, with the right quarter point of the vehicle aligned with the centerline of the support. Shortly after impact, the support pulled out of the ground base as designed, and at 0.047 s, the mailboxes contacted the windshield of the vehicle. At 0.072 s, the mailbox support lost contact with the front bumper of the vehicle, as the vehicle was traveling at a speed of 57.7 mi/h. The mailboxes lost contact with the windshield at 0.152 s. Brakes on the vehicle were applied 130 ft downstream of impact, and the mailboxes fell from the vehicle 143 ft downstream of impact. The vehicle came to rest 276 ft downstream of impact and 2 ft to the left of centerline. Figure 19 in Appendix C shows sequential photographs of the test period.

As shown in Figures 12 and 13, the support pulled out of the ground base as designed. All the mailboxes remained attached to the support; however, the mailboxes were deformed. The upright support was deformed at 11.8 inches from the end, and the arc of the support was severely deformed.

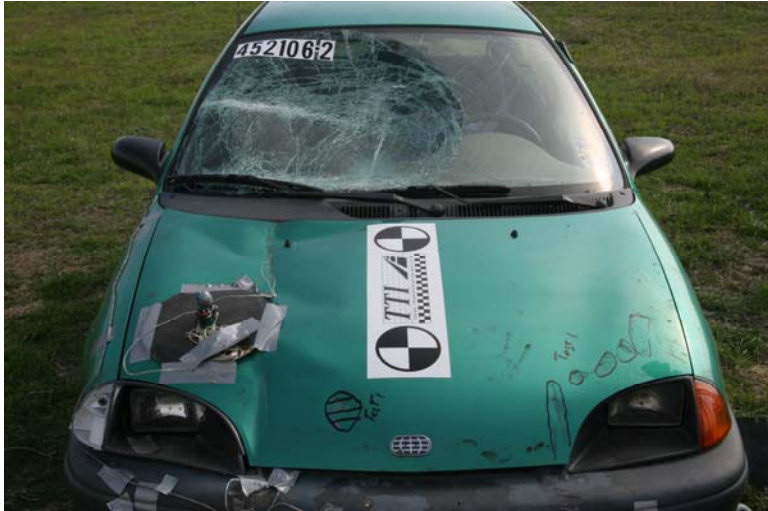
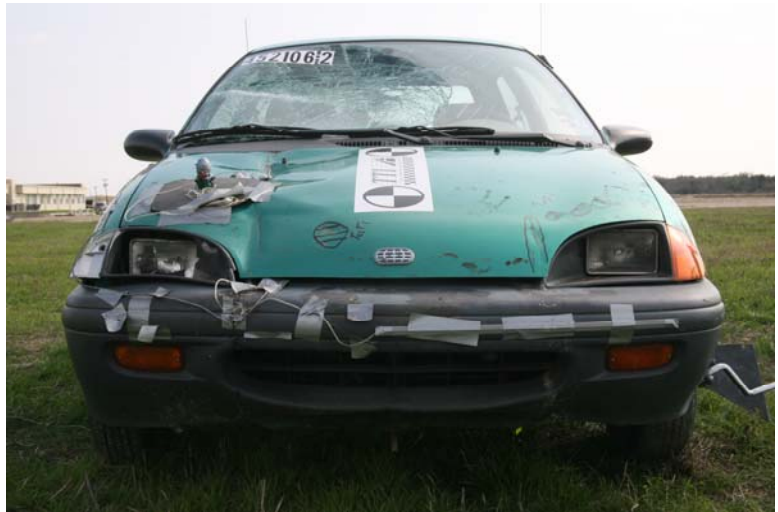
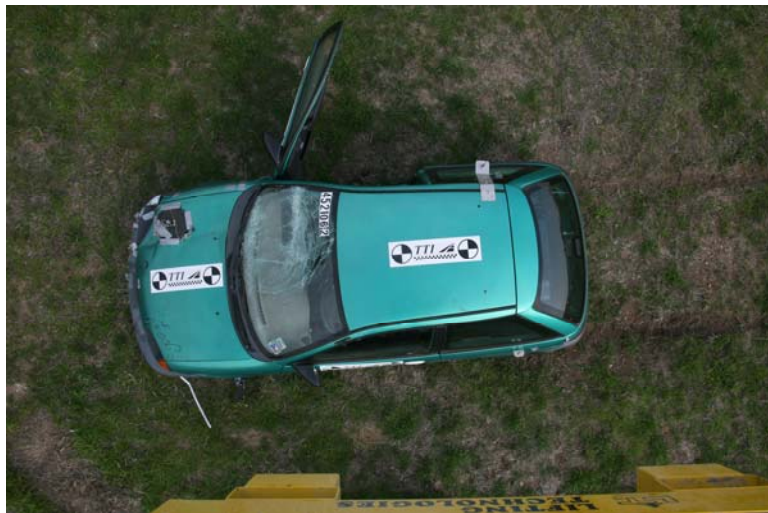
Figure 14. Vehicle after Test No. 452106-2.

The vehicle sustained minimal damage to the hood and bumper as shown in Figure 14. The front bumper has a slight indentation at point of contact with the support, and the hood had one indentation on the impact side which measured 33.5 inches x 5.9 inches. The windshield was shattered over an area of 31.5 inches in diameter and depressed 3.2 inches inward toward the occupant compartment. Photographs of the interior of the vehicle are shown in Figure 15. Exterior vehicle crush and occupant compartment measurements are shown in Appendix B, Tables 5 and 6.

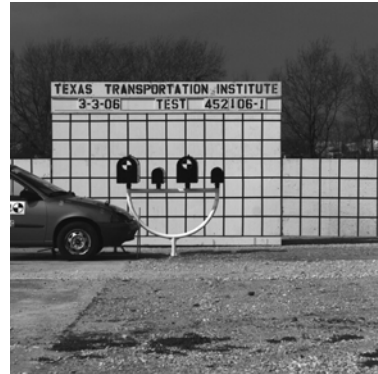
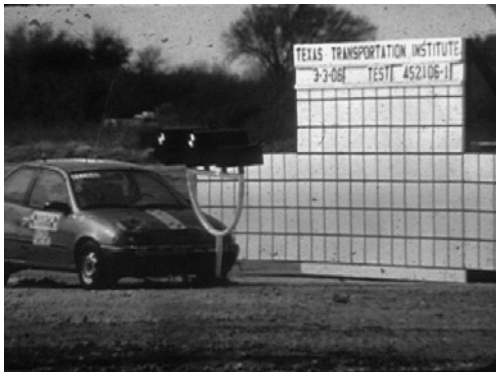
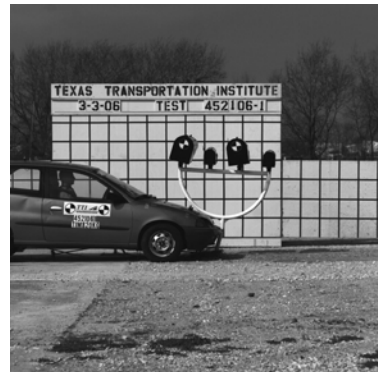
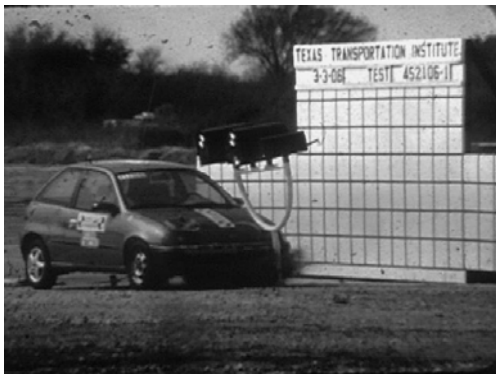
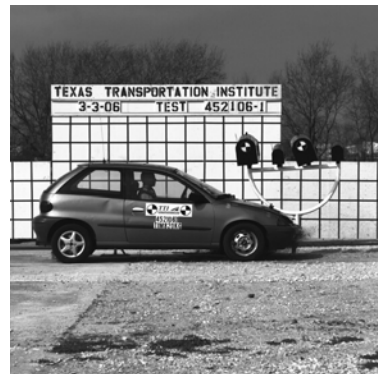
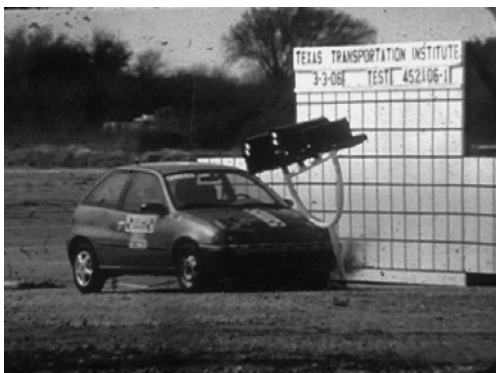
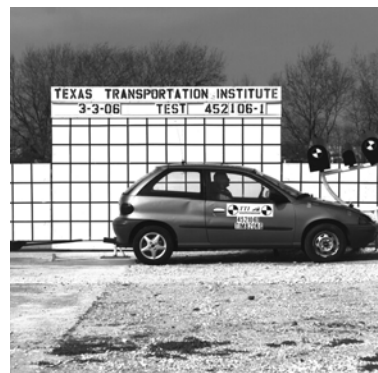
Figure 18. Sequential Photographs for Test 452106-1 (Oblique and Perpendicular Views).

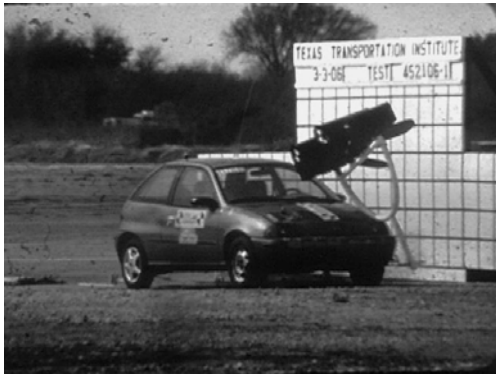
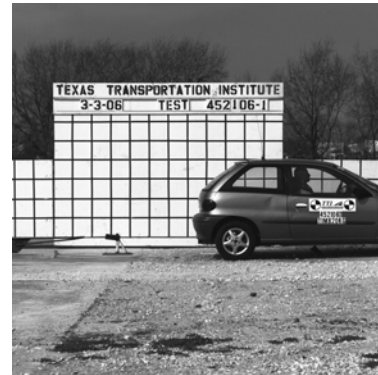
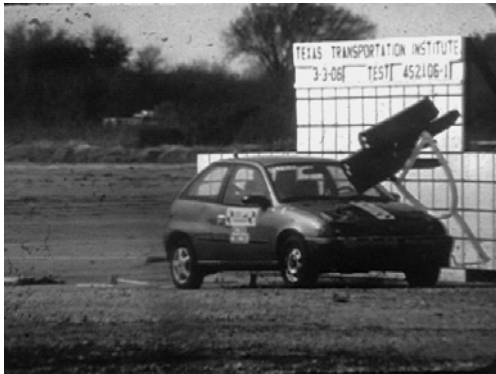
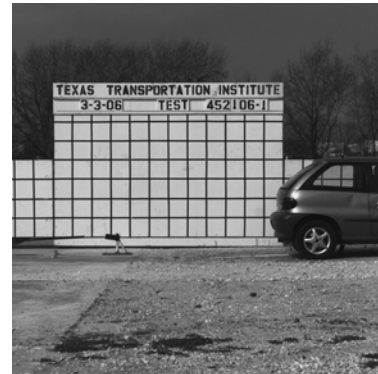
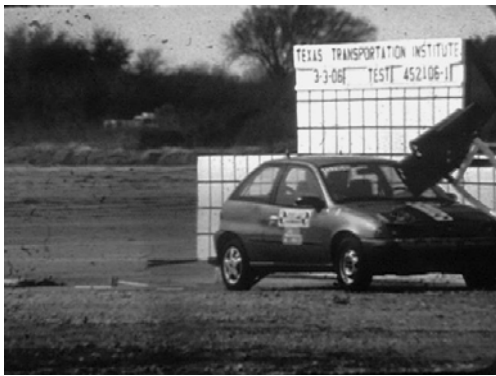
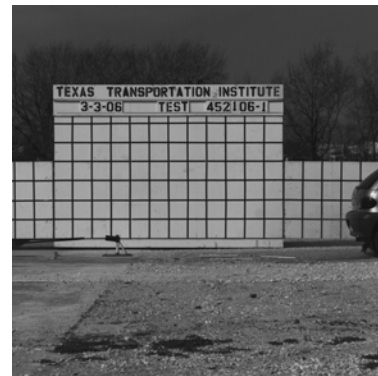
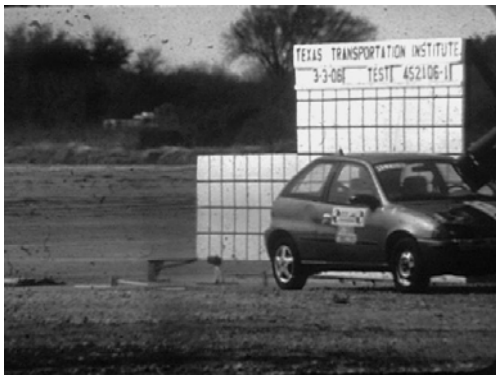
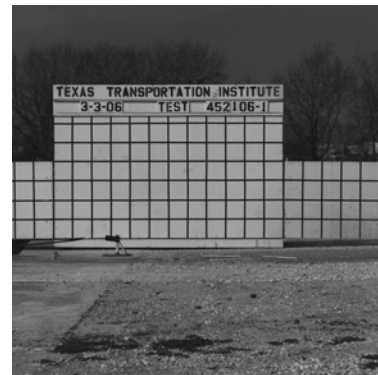
Figure 18. Sequential Photographs for Test 452106-1 (Oblique and Perpendicular Views) (continued).

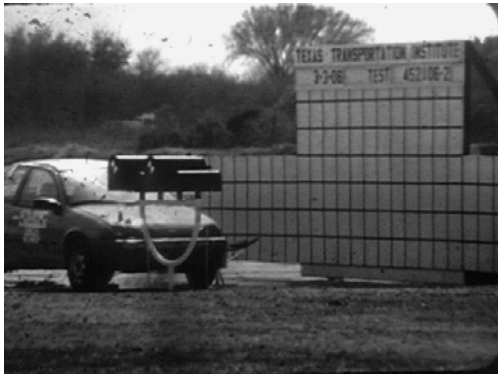
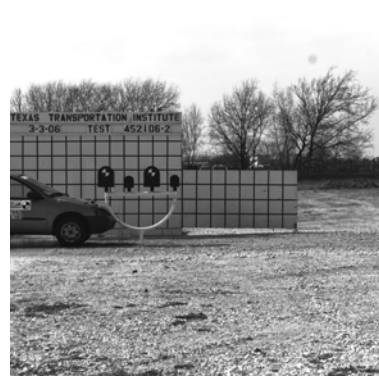
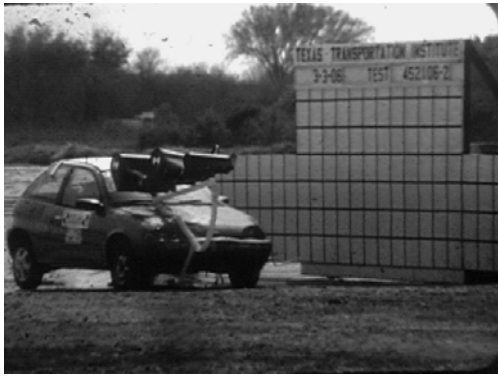
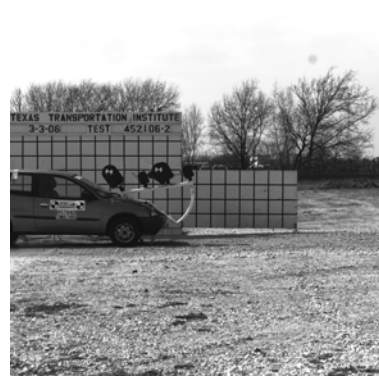
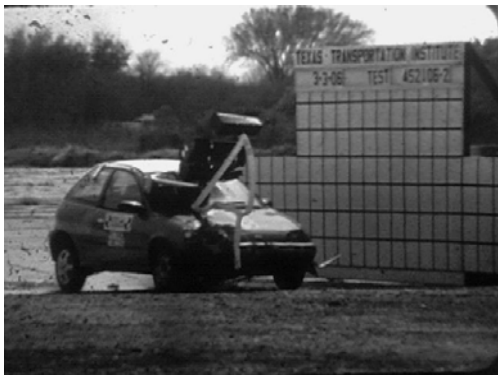
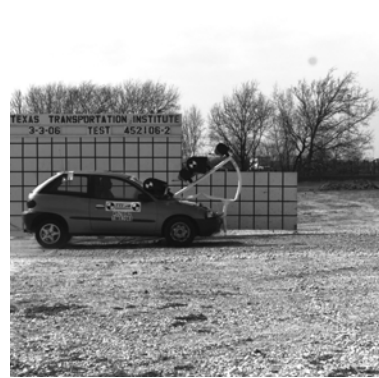
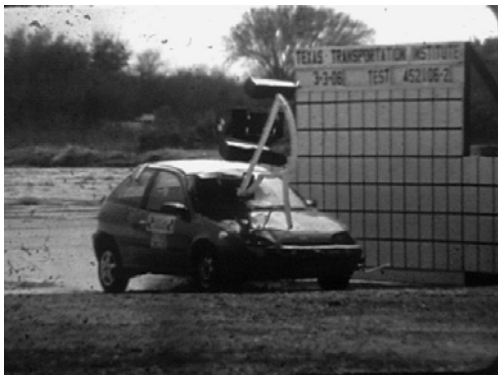
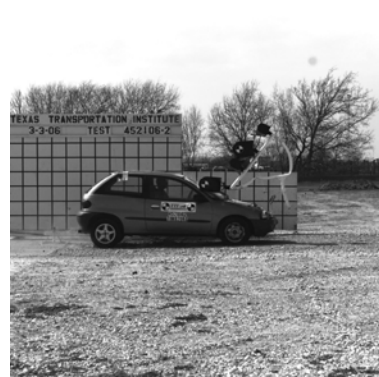
Figure 19. Sequential Photographs for Test 452106-2 (Oblique and Perpendicular Views).

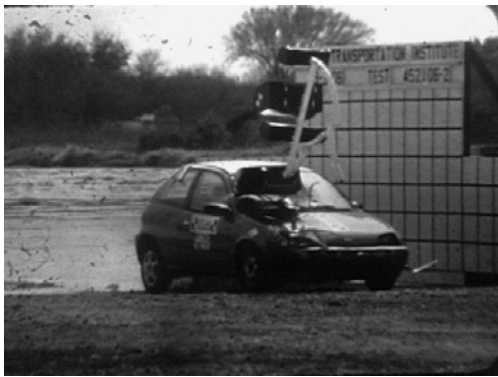
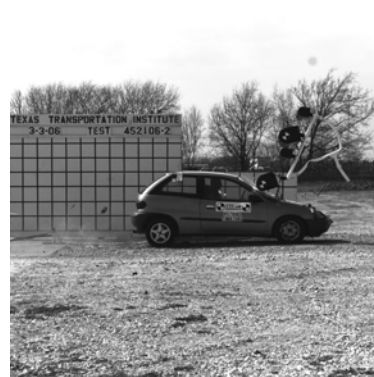
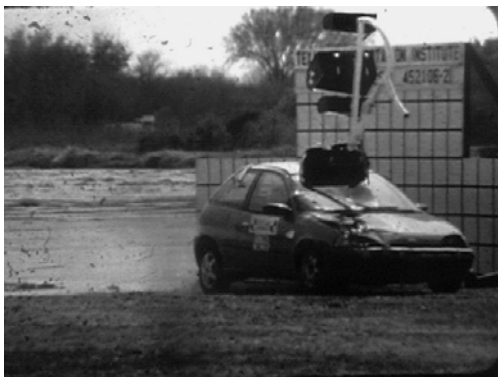
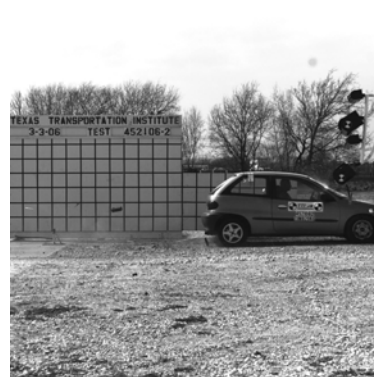
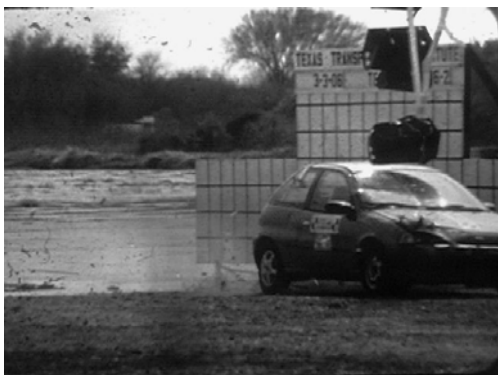
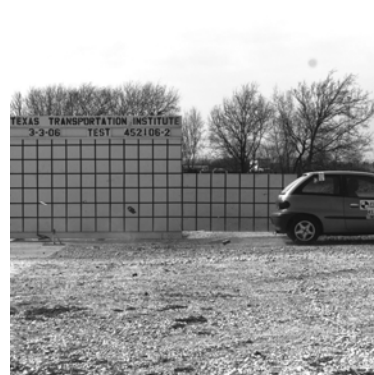
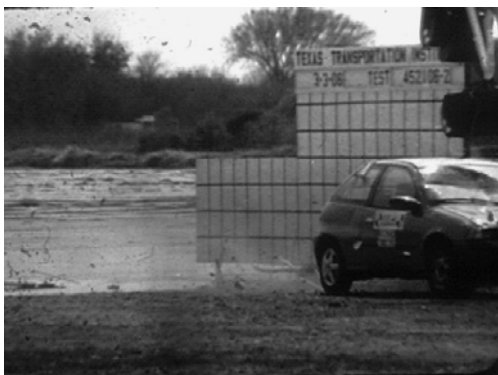
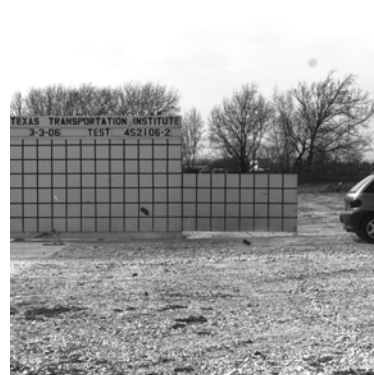
Figure 19. Sequential Photographs for Test 452106-2 (Oblique and Perpendicular Views) (continued).

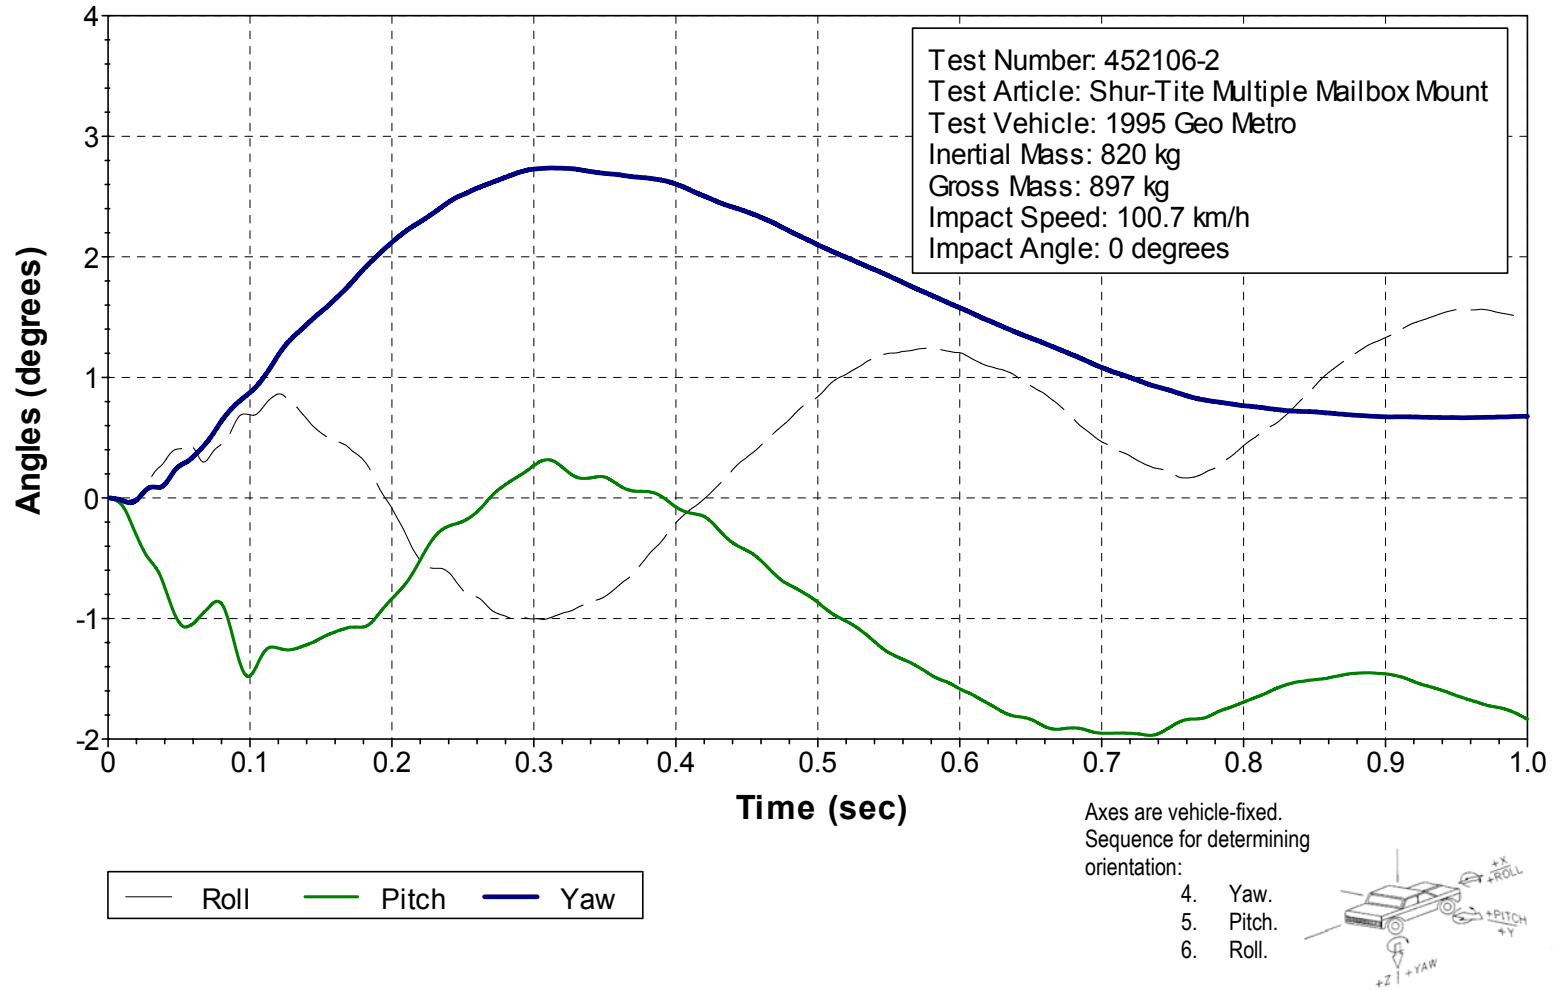
Roll, Pitch and Yaw Angles

Figure 27. Vehicle Angular Displacements for Test 452106-2.

Data from the accelerometer, located at the vehicle center of gravity, were digitized for evaluation of occupant risk. In the longitudinal direction, the occupant impact velocity was 4.9 ft/s at 0.505 s, the highest 0.010-s occupant ridedown acceleration was -0.3 g's from 0.578 to 0.588 s, and the maximum 0.050-s average acceleration was -2.1 g's between 0.000 and 0.050 s. In the lateral direction, the occupant impact velocity was 2.3 ft/s at 0.505 s, the highest 0.010-s occupant ridedown acceleration was -0.4 g's from 0.741 to 0.751 s, and the maximum 0.050-s average was 0.3 g's between 0.138 and 0.188 s. Figure 16 presents these data and other pertinent information from the test. Figures 27 through 33 in Appendix D present vehicle angular displacements and accelerations versus time traces.

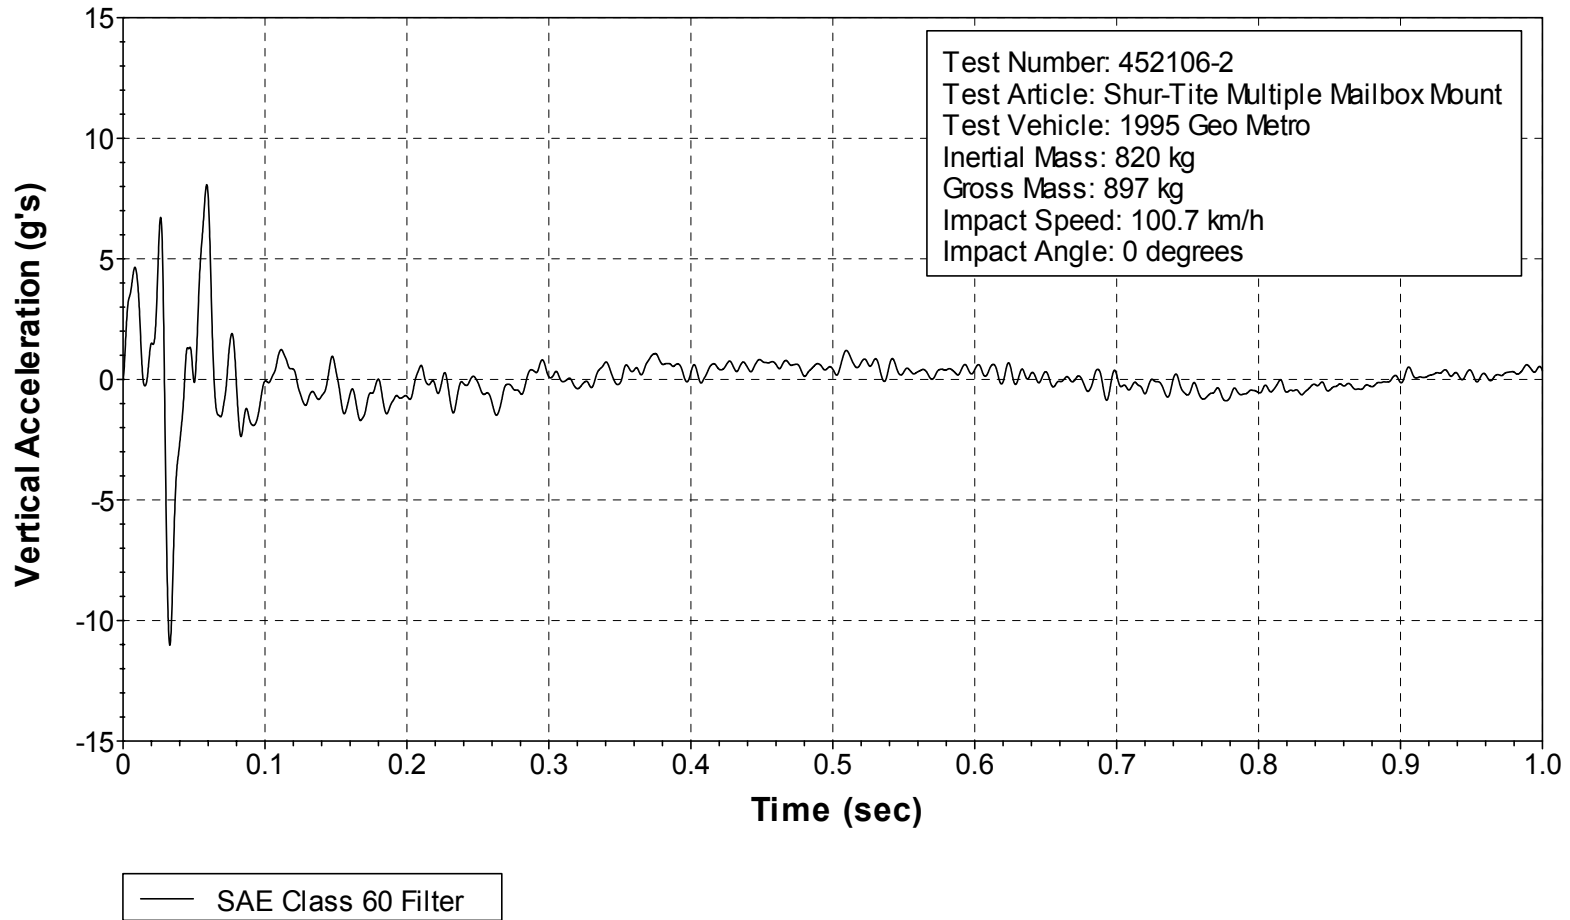
Z Acceleration at CG

**Figure 30. Vehicle Vertical Accelerometer Trace for Test 452106-2
(Accelerometer Located at Center of Gravity).**

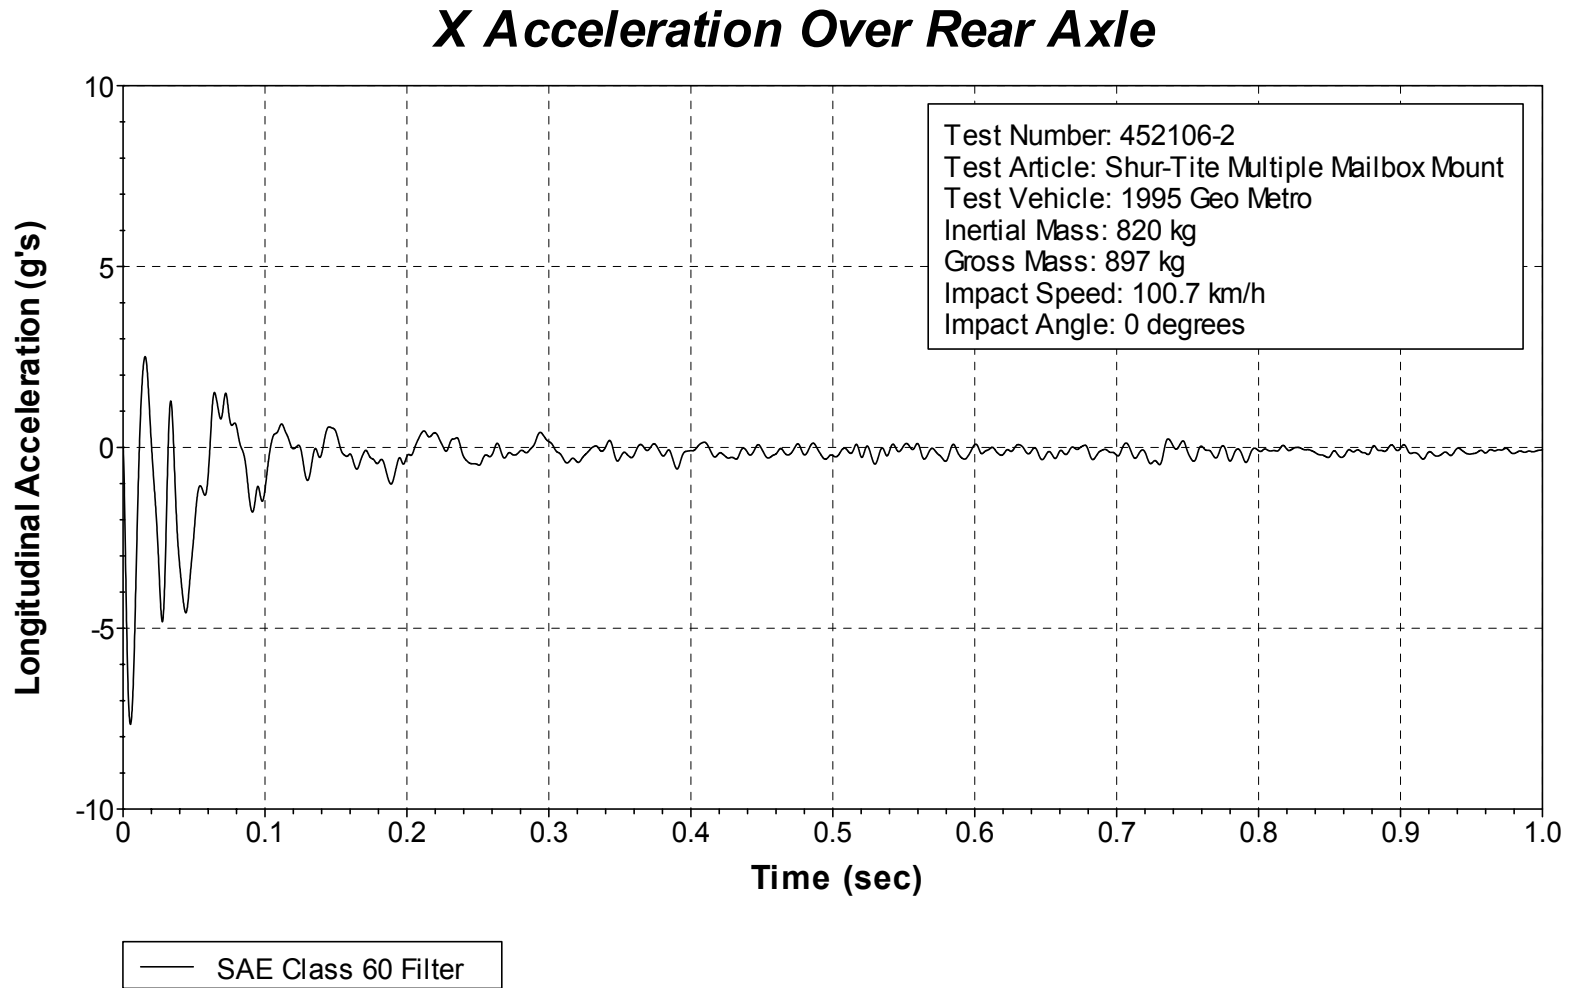
**Figure 31. Vehicle Longitudinal Accelerometer Trace for Test 452106-2
(Accelerometer Located Over Rear Axle).**
