1. Report No. FHWA/TX-08/0-5210-5		2. Government Accession No.		3. Recipient's Catalog No.	
4. Title and Subtitle CRASH TESTING AND EVALUATION OF TXDOT BURN BAN SIGNS				5. Report Date December 2008 Published: August 2009

**CRASH TESTING AND EVALUATION OF  
TXDOT BURN BAN SIGNS**

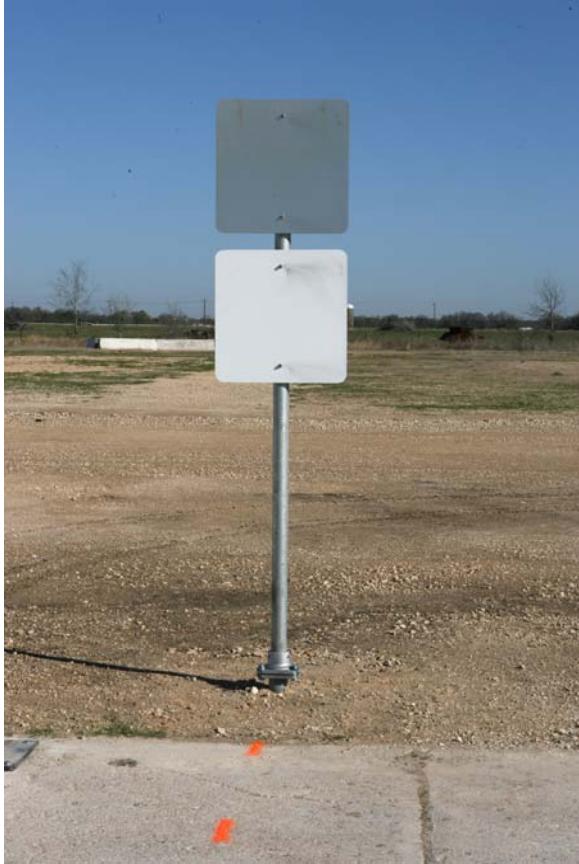
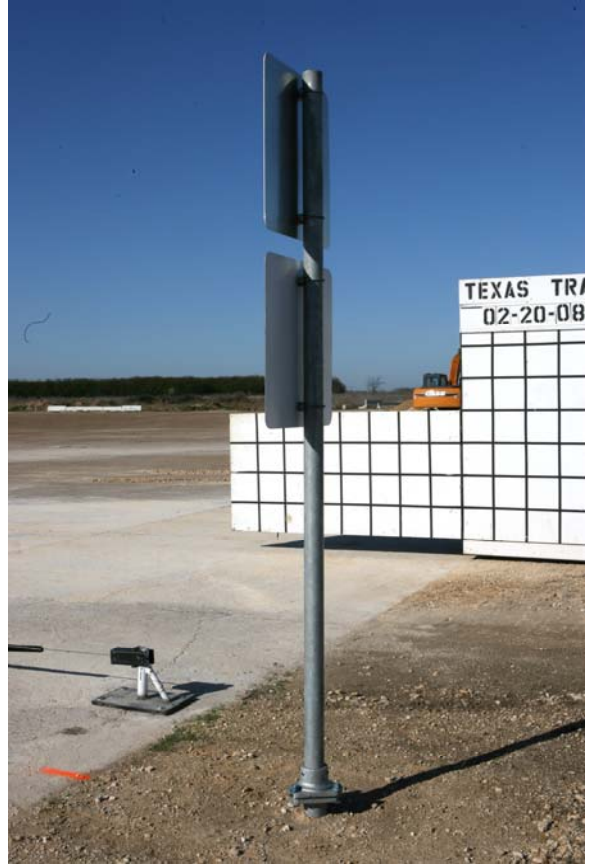
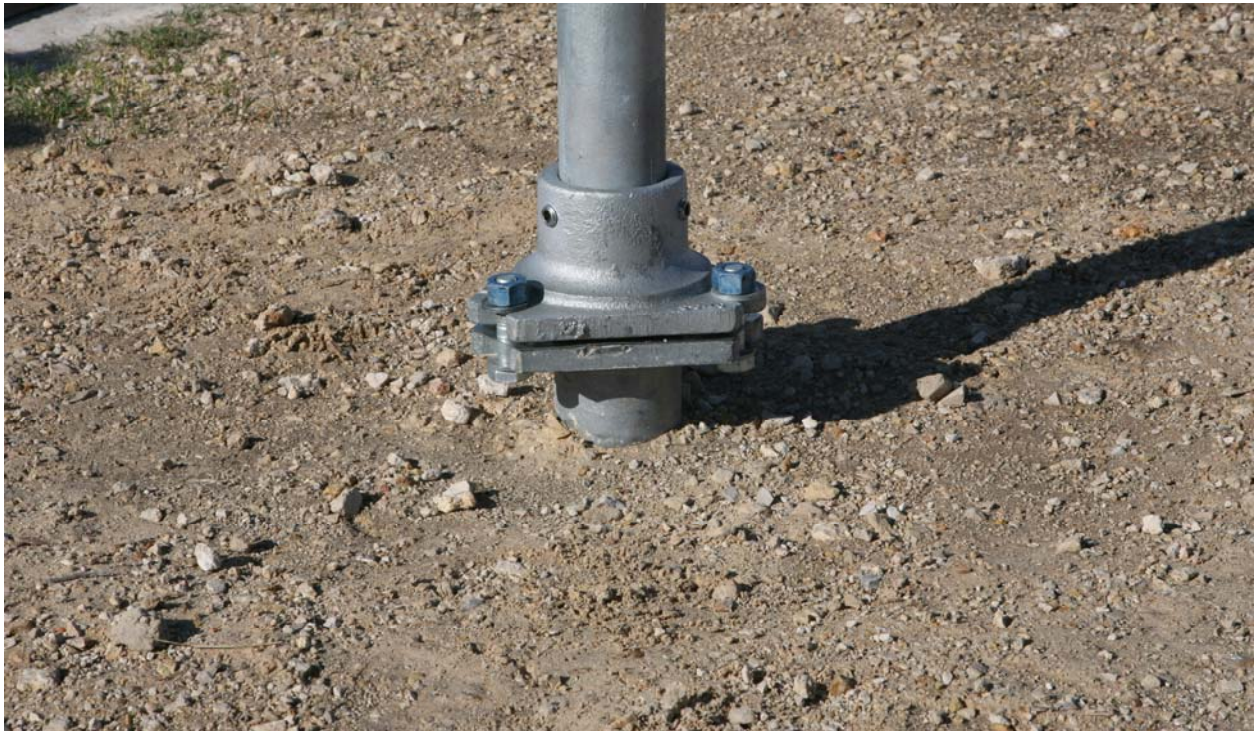
**Figure 3.3. Test Article/Installation before Test 452108-1 and 2.**

The lower slip base plate was welded to a 36-inch length of 3-inch nominal diameter schedule 40 pipe. The pipe stub was embedded in a 12-inch diameter × 42-inch deep concrete footing installed in *NCHRP Report 350* standard soil. The distance from the ground surface to the top face of the lower triangular slip plate was 3.5 inches. The triangular slip base was oriented such that the upstream side was perpendicular to the direction of impact. A 30 gauge galvanized steel keeper plate was placed between the upper and lower slip plates. A washer was placed between the bolt keeper plate and upper slip plate to reduce the contact area between the plates. The two slip plates were clamped together using three 0.625 inch diameter × 2.5-inch long, ASTM A325 bolts that were tightened to a prescribed torque of 40 ft-lb. High strength washers were used under both the head and nut of each bolt. Photographs of the completed sign support installation are shown in Figure 3.3.

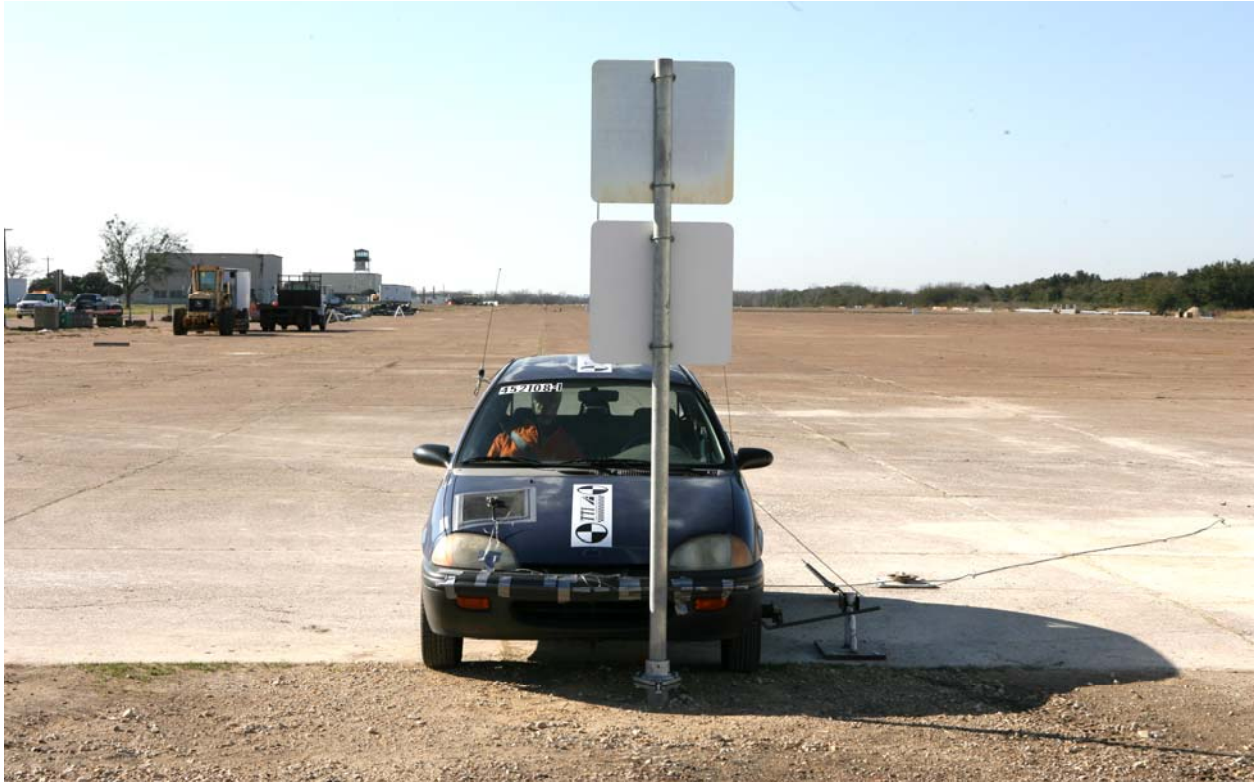
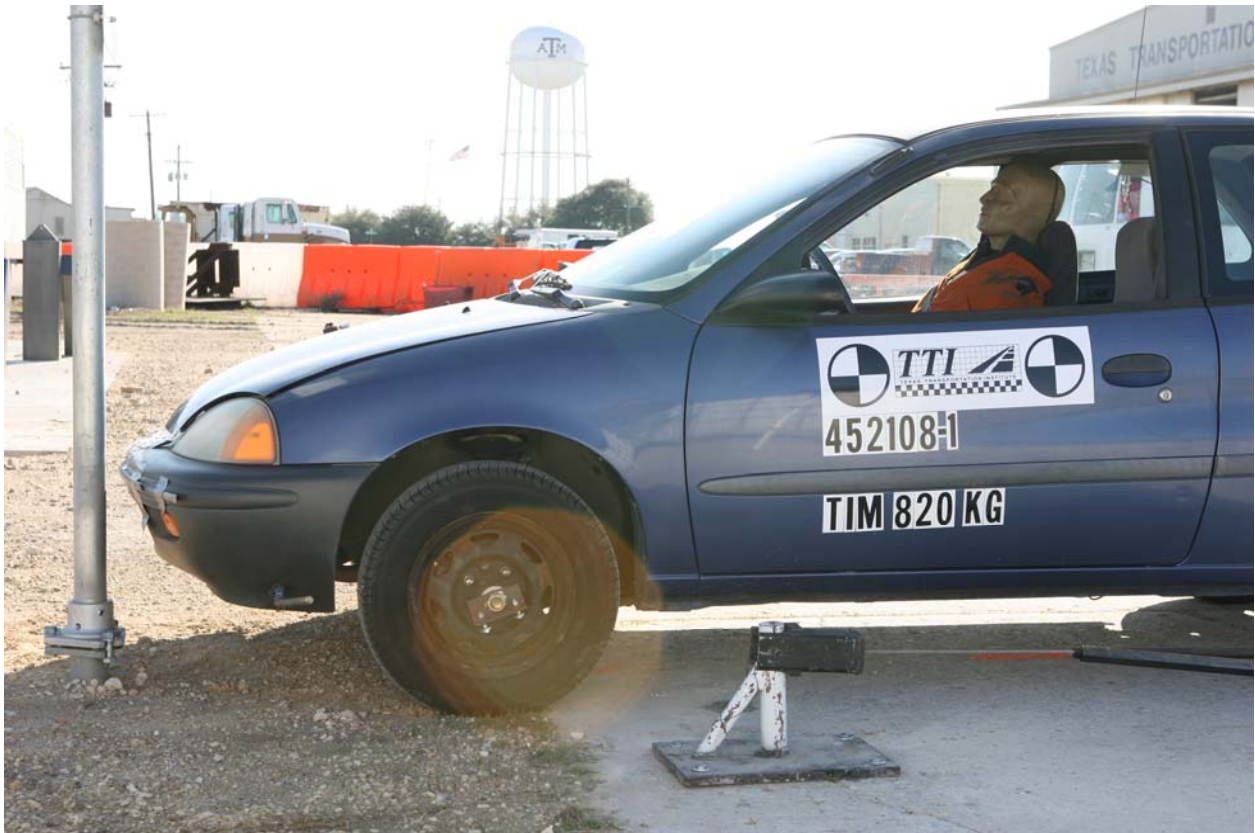
**Figure 3.4. Vehicle/Installation Geometrics for Test 452108-1.**

A 1995 Geo Metro, shown in Figures 3.4 and 3.5, was used for the crash test. Test inertia weight of the vehicle was 1784 lb, and its gross static weight was 1953 lb. The height to the lower edge of the vehicle bumper was 15.75 inches, and the height to the upper edge of the vehicle bumper was 20.25 inches. Figure B1 in Appendix B gives additional dimensions and information on the vehicle. The vehicle was directed into the installation using a cable reverse tow and guidance system and was released to be free-wheeling and unrestrained just prior to impact.

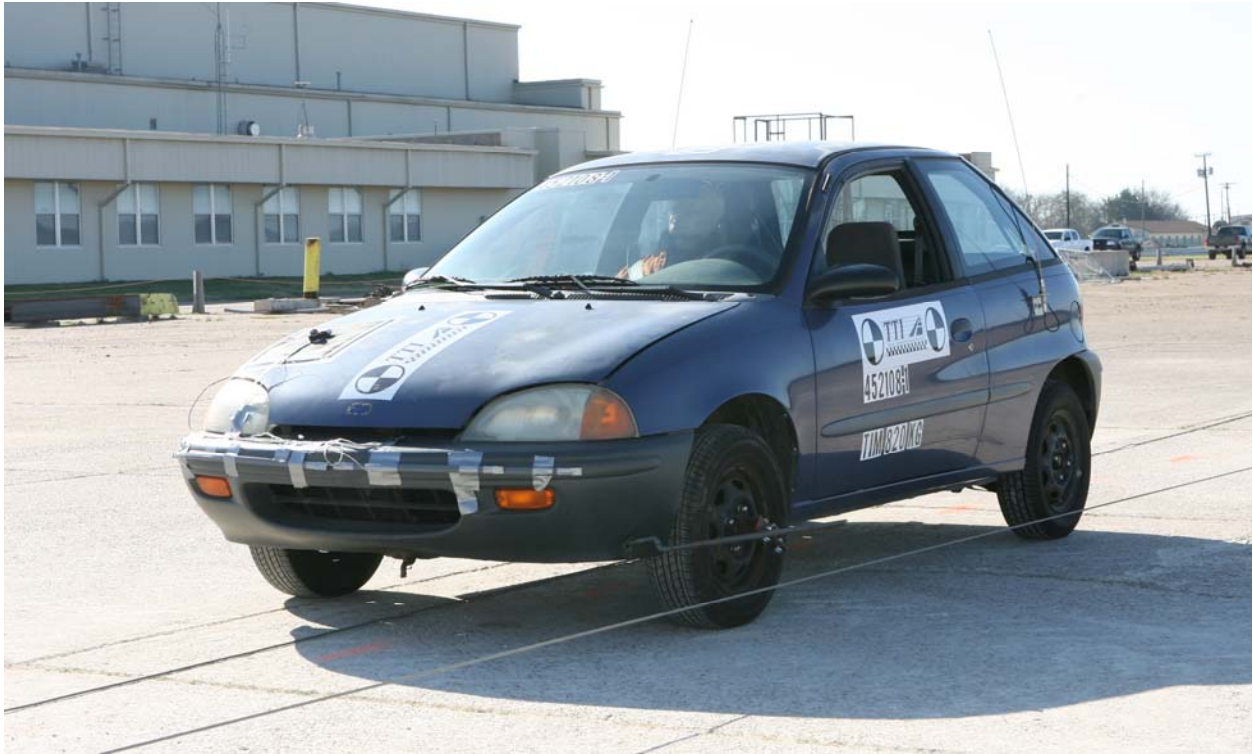
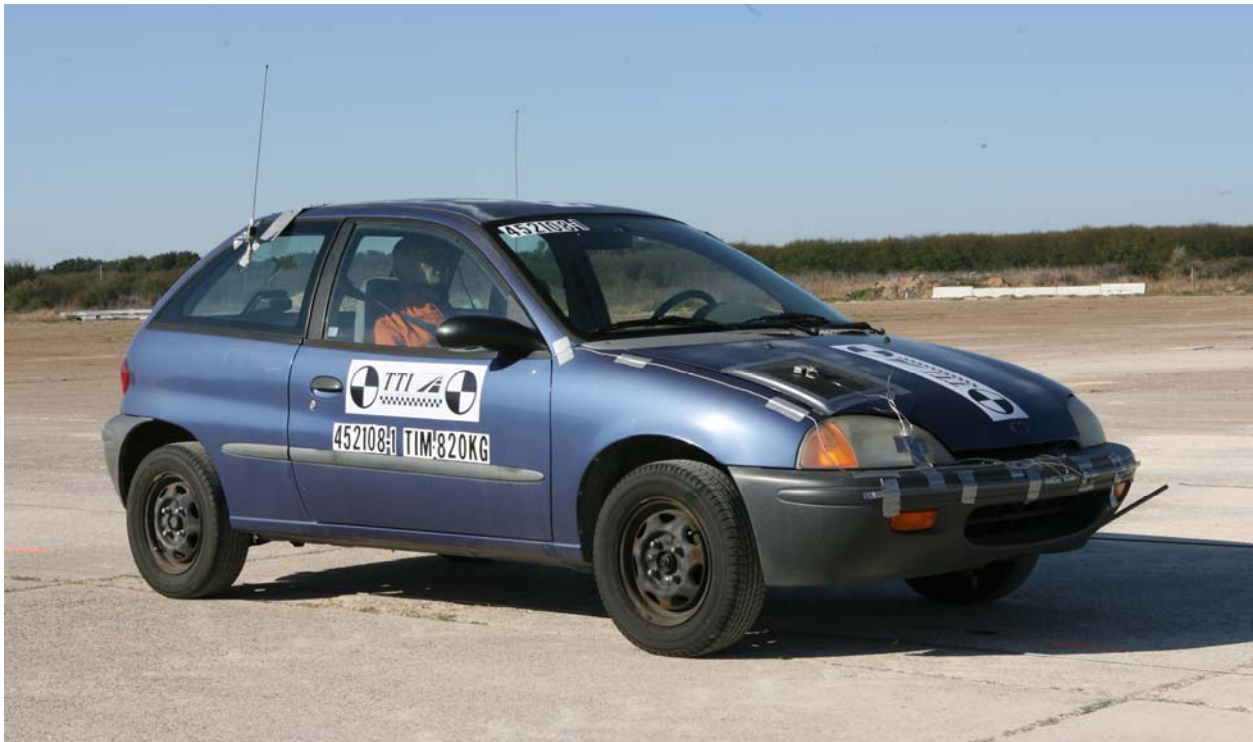
**Figure 3.5. Vehicle before Test 452108-1.**

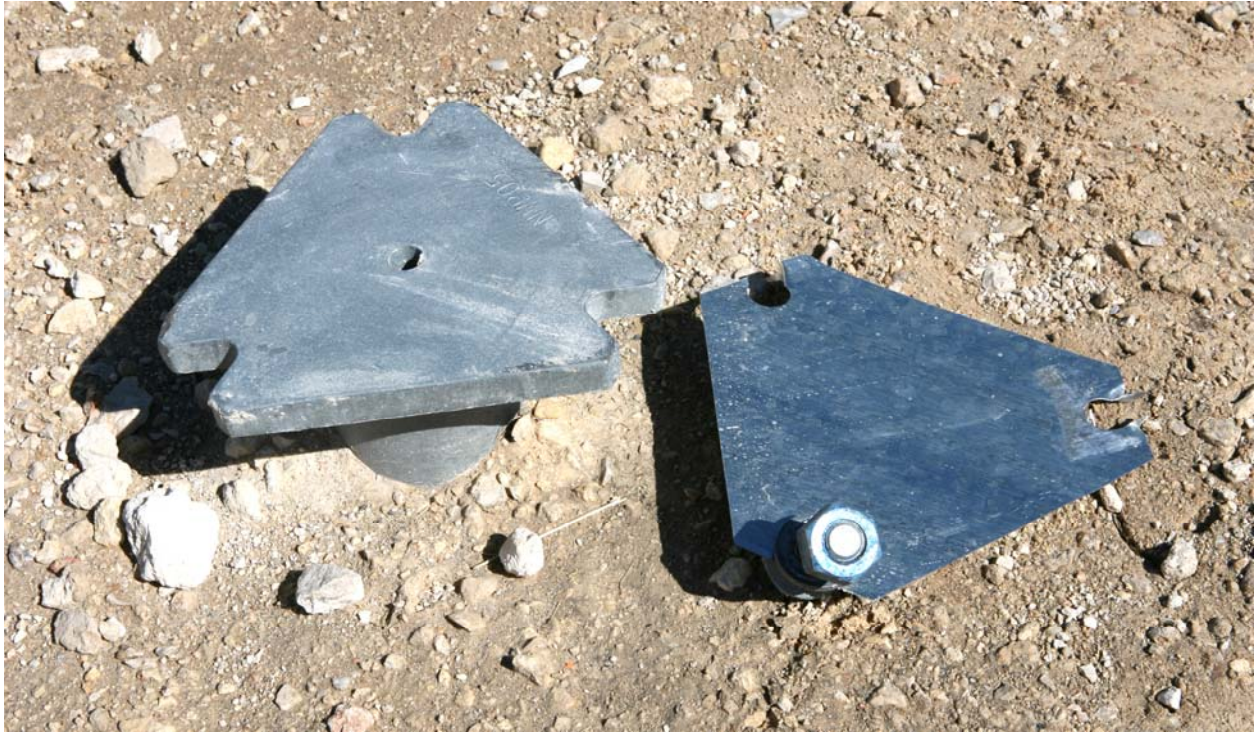
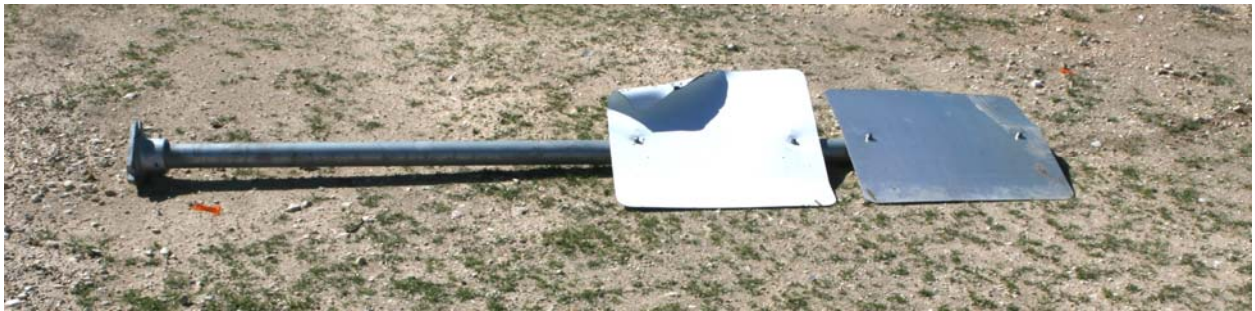
**Figure 3.7. Installation after Test 452108-1.**

Damage to the sign support installation is shown in Figures 3.6 and 3.7. The base showed no movement in the ground. The keeper plate and one bolt remained at the base, one bolt came to rest 12.5 ft downstream of impact, and the third was resting 57.5 ft downstream of impact. The sign panels and support came to rest under the vehicle, which came to rest 92.5 ft downstream from the point of impact.

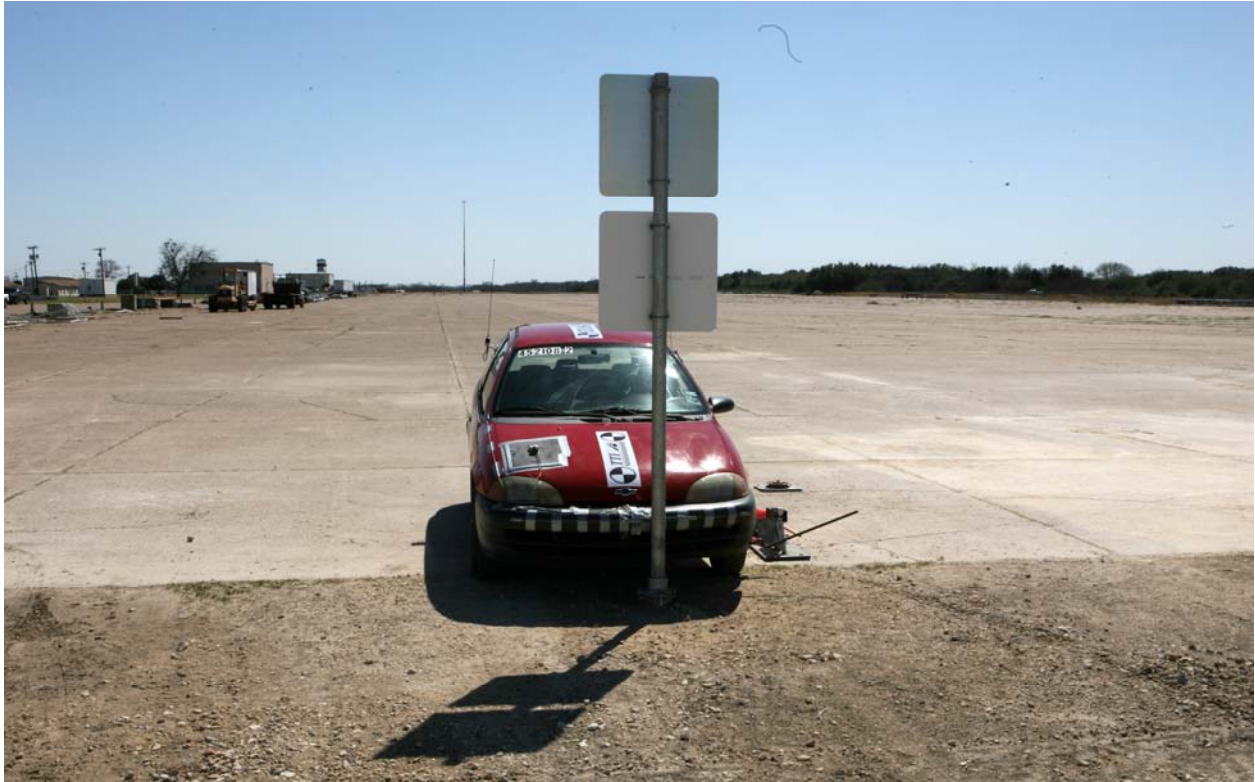
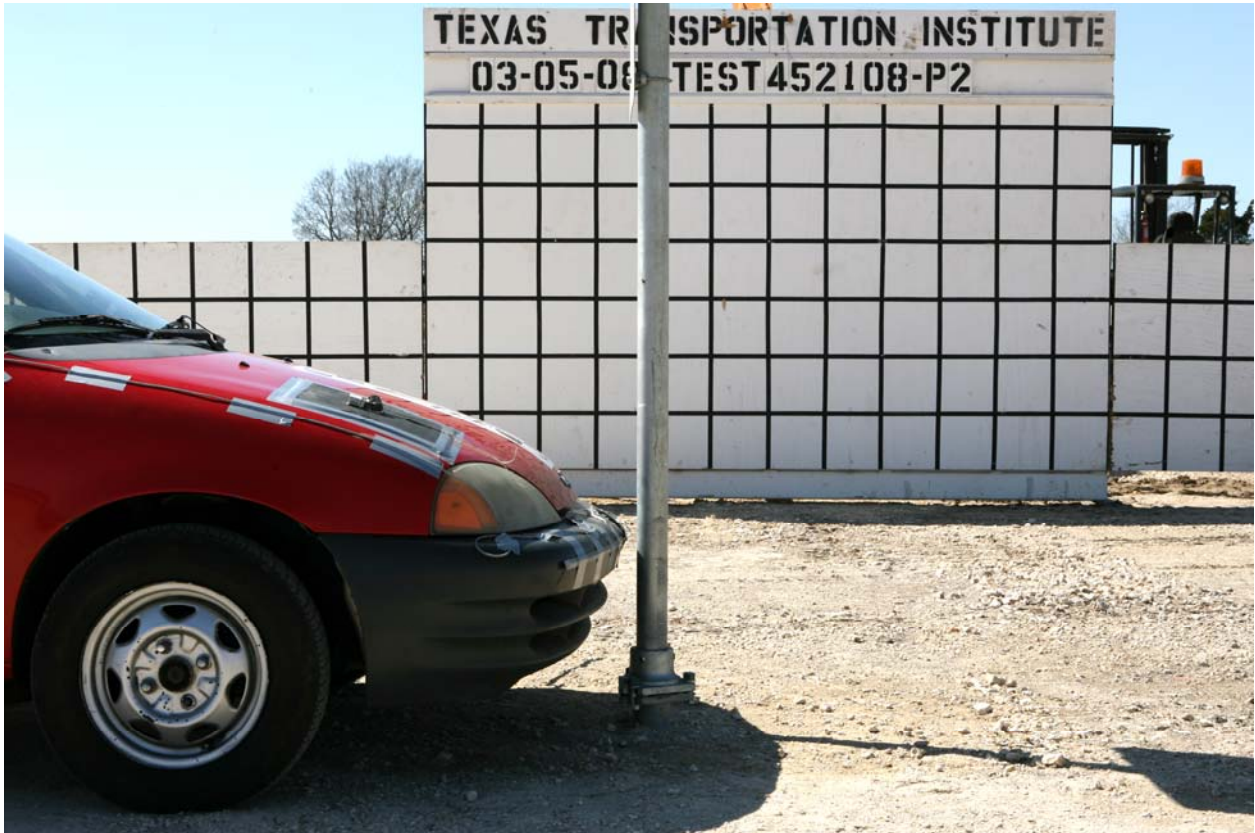
**Figure 3.11. Vehicle/Installation Geometrics for Test 452108-2.**

A 1998 Geo Metro, shown in Figures 3.11 and 3.12, was used for the crash test. Test inertia weight of the vehicle was 1812 lb, and its gross static weight was 1980 lb. The height to the lower edge of the vehicle bumper was 15.75 inches, and the height to the upper edge of the vehicle bumper was 20.25 inches. Figure B2 in Appendix B gives additional dimensions and information on the vehicle. The vehicle was directed into the installation using a cable reverse tow and guidance system and was released to be free-wheeling and unrestrained just prior to impact.

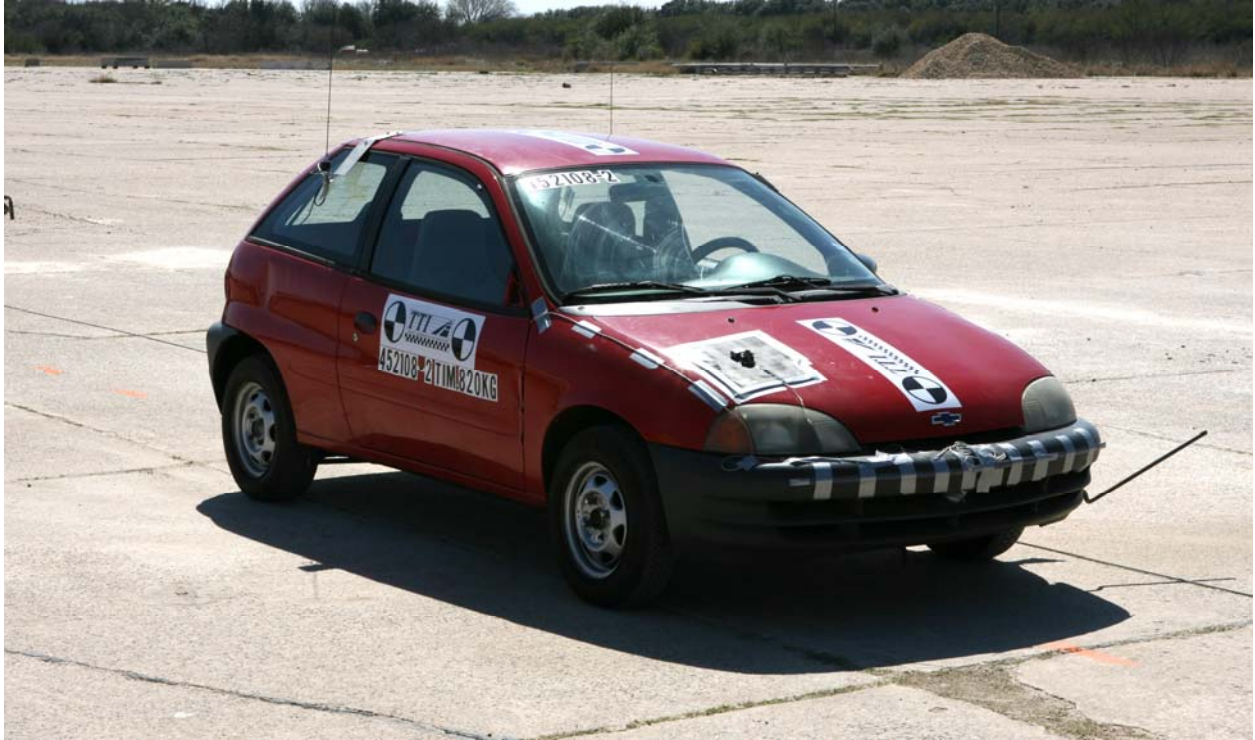
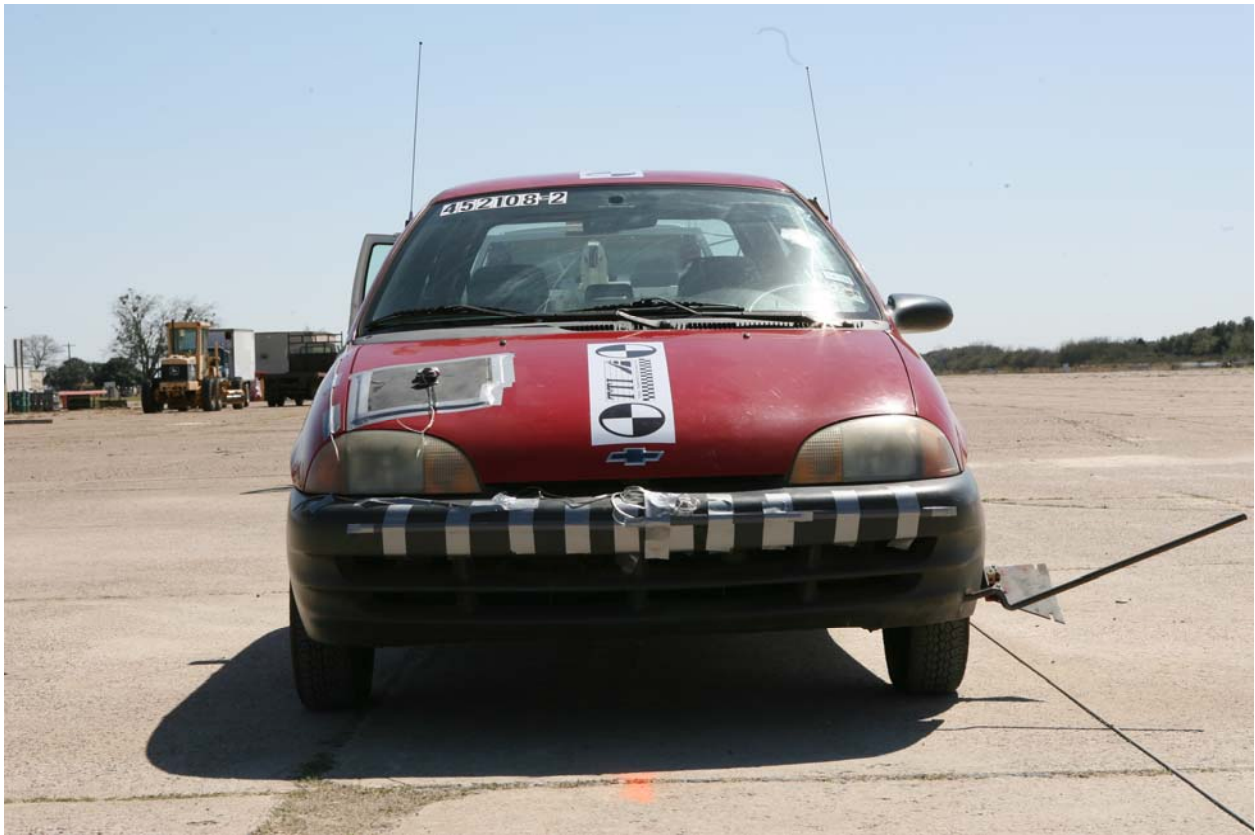
**Figure 3.12. Vehicle before Test 452108-2.**

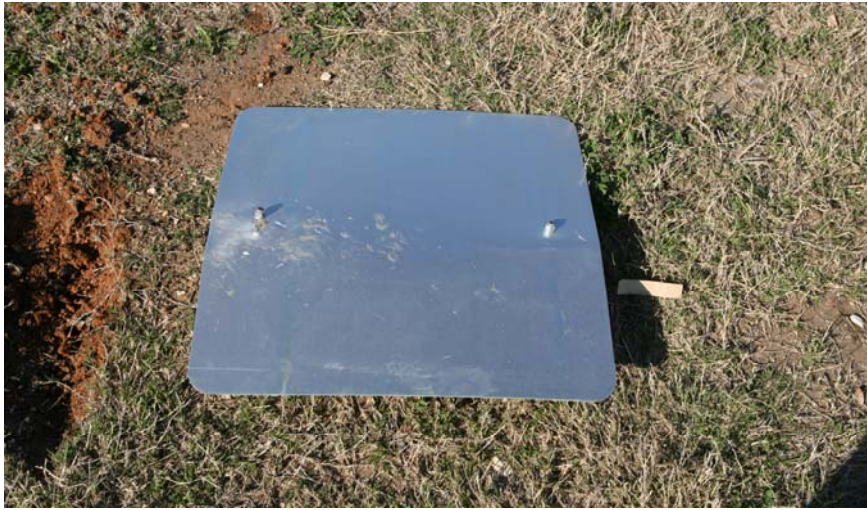
**Figure 3.14. Installation after Test 452108-2.**

Damage to the installation is shown in Figures 3.13 and 3.14. The base showed no movement in the ground. The keeper plate came to rest 28.5 ft downstream from impact and 30 inches to the right of centerline. One bolt remained at the base, one bolt came to rest 12.5 ft downstream of impact, and the third was resting 51 ft downstream of impact. The confirmation sign panel separated from the support came to rest near the support and confirmation sign panel, which came to rest 150 ft downstream from impact.

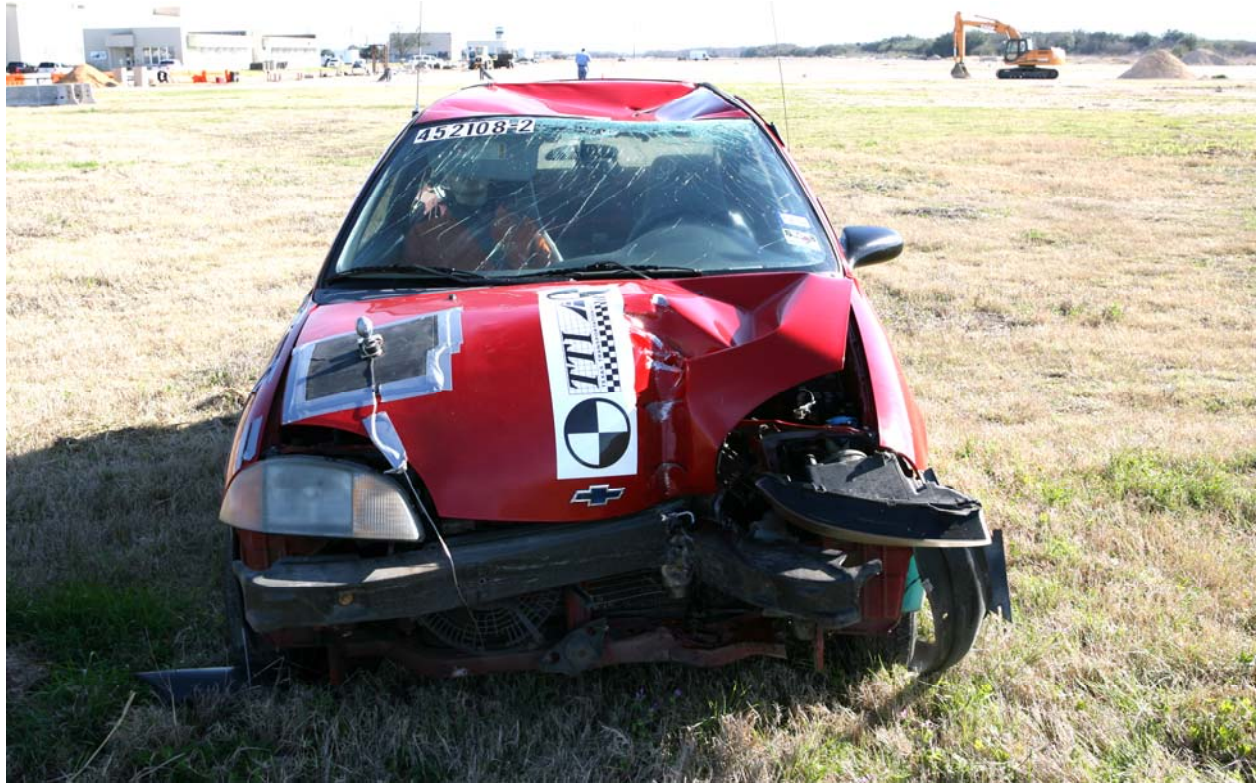
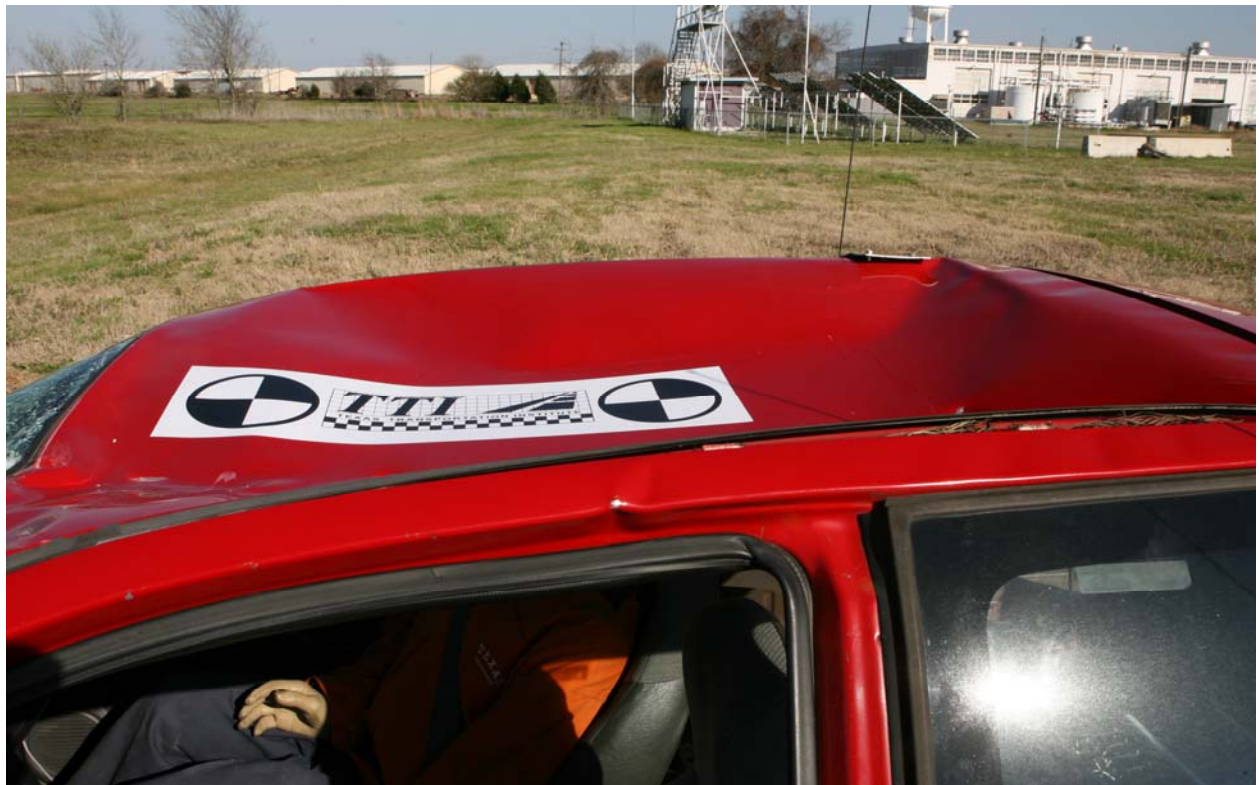
**Figure 3.15. Vehicle after Test 452108-2.**

Damage to the vehicle is shown in [Figure 3.15](#). The front bumper, grill, hood, radiator, and radiator support were deformed. Maximum exterior crush in the frontal plane at the front bumper was 9.8 inches. The windshield was shattered downward from the roofline, but there was no loss of visibility. Two small cuts were noted in the roof, the largest measuring 0.6 × 1.6 inches. The roof was deformed downward a maximum of 5.1 inches on the exterior of the vehicle and deformed into the occupant compartment 5.0 inches. Photographs of the interior of the vehicle are shown in [Figure 3.16](#). Exterior crush and occupant compartment measurements are shown in [Appendix B](#), Tables [B3](#) and [B4](#), respectively.

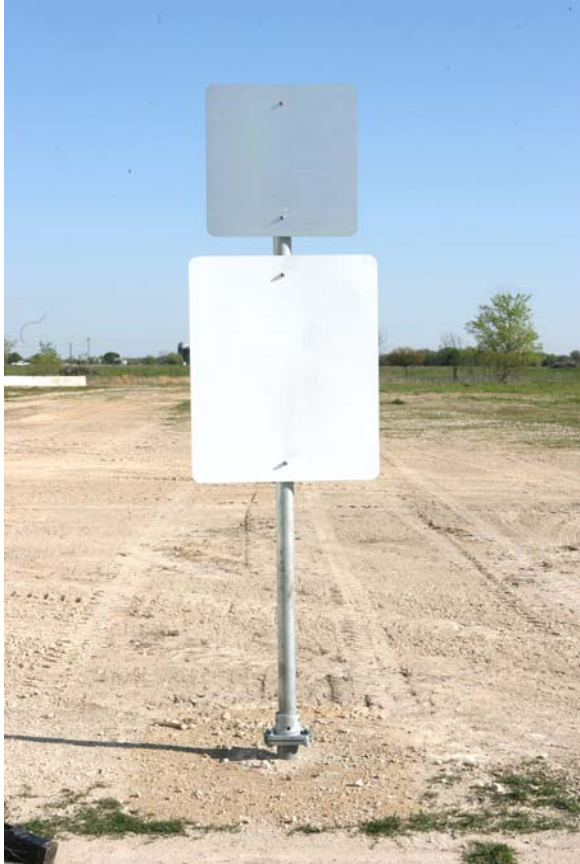
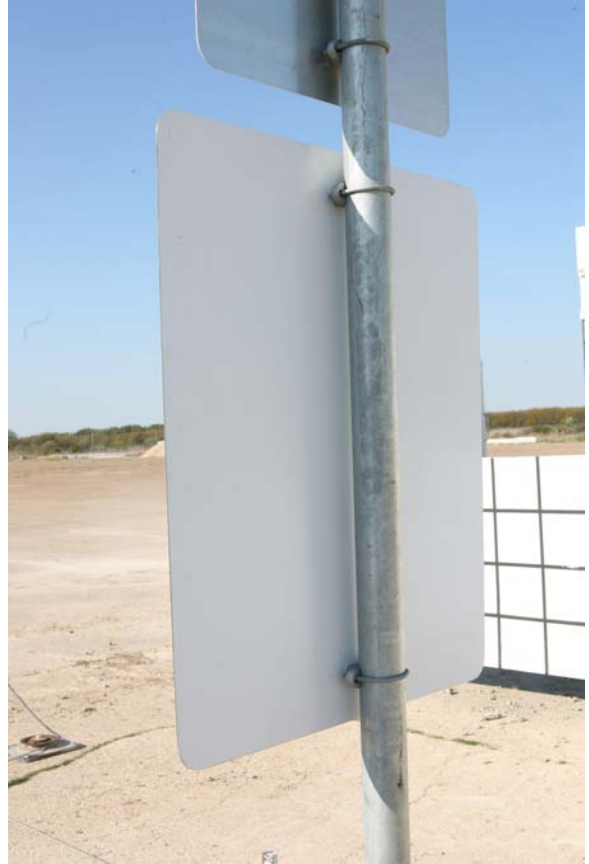
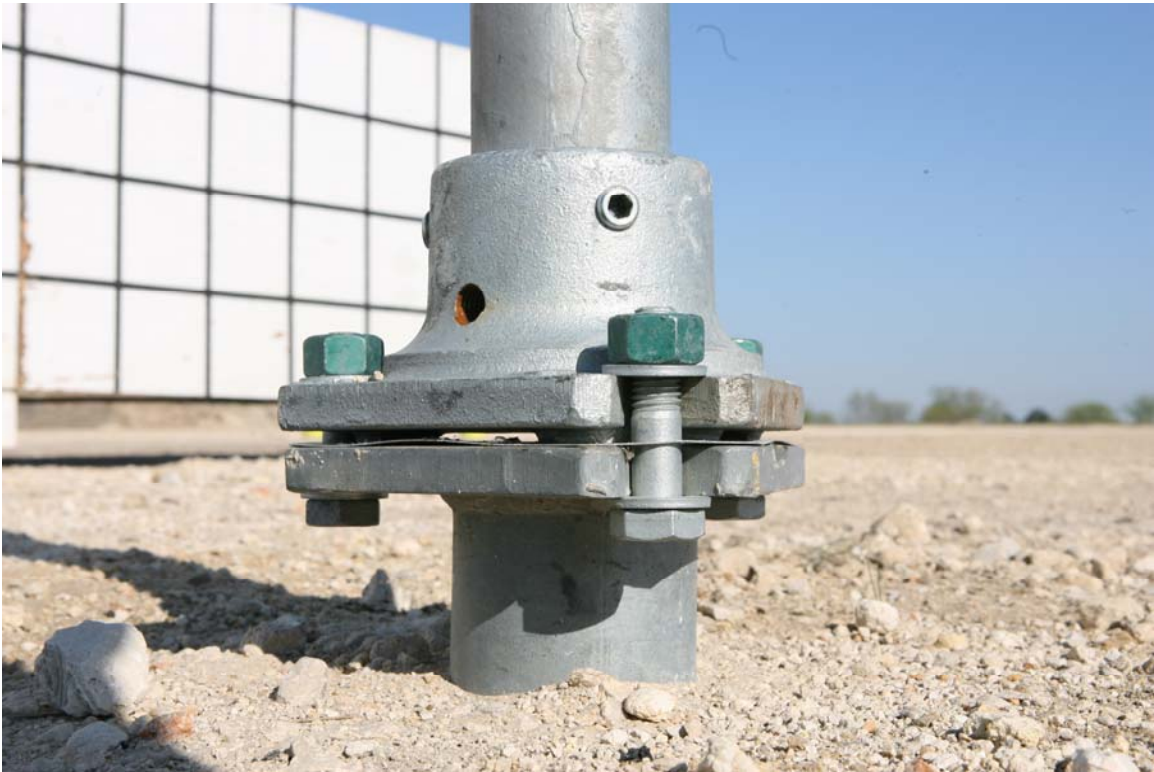
**Figure 4.3. Test Article/Installation before Test 452108-3 and 4.**

The lower slip base plate was welded to a 36-inch length of 3-inch nominal diameter schedule 40 pipe. The pipe stub was embedded in a 12-inch diameter × 42-inch deep concrete footing installed in *NCHRP Report 350* standard soil. The distance from the ground surface to the top face of the lower triangular slip plate was 3.5 inches. The triangular slip base was oriented such that the upstream side was perpendicular to the direction of impact. A 30 gauge galvanized steel keeper plate was placed between the upper and lower slip plates. A washer was placed between the bolt keeper plate and upper slip plate to reduce the contact area between the plates. The two slip plates were clamped together using three 0.625-inch diameter × 2.5-inch long, ASTM A325 bolts that were tightened to a prescribed torque of 40 ft-lb. High strength washers were used under both the head and nut of each bolt. Photographs of the completed sign support installations for tests 452108-3 and 452108-4 are shown in Figure 4.3.

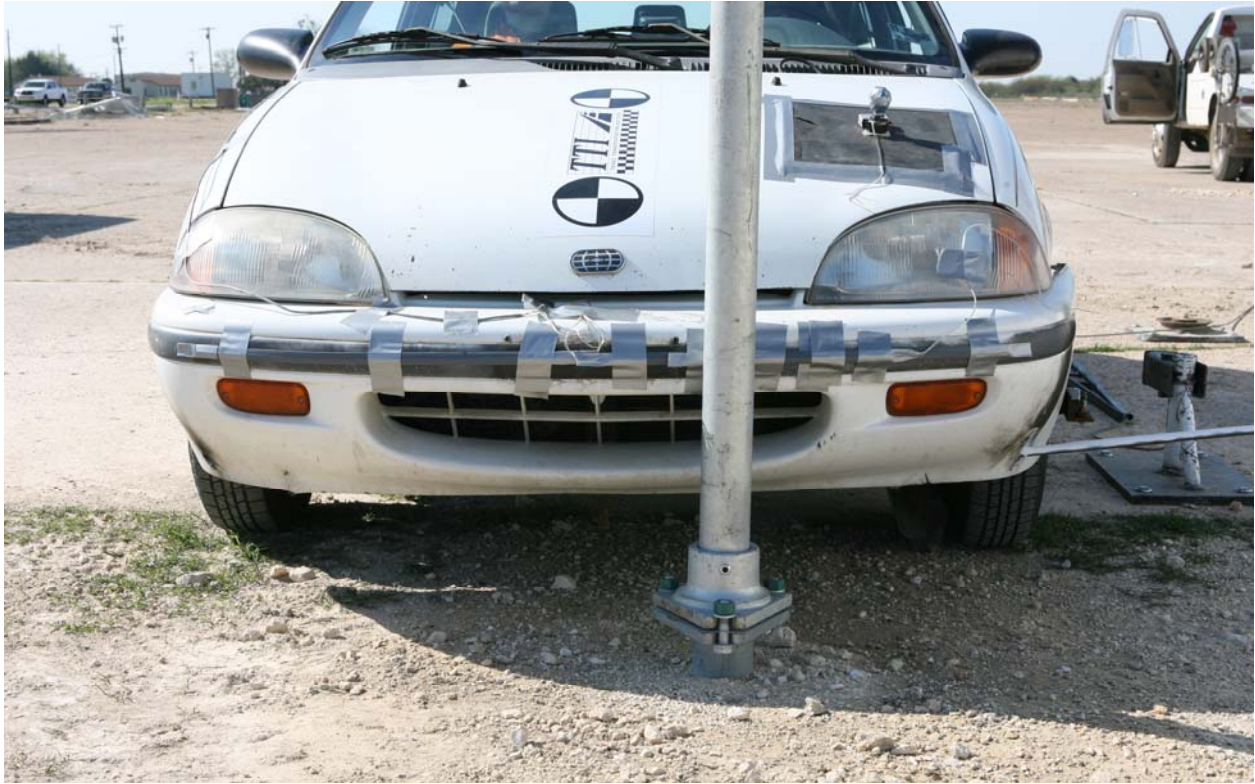
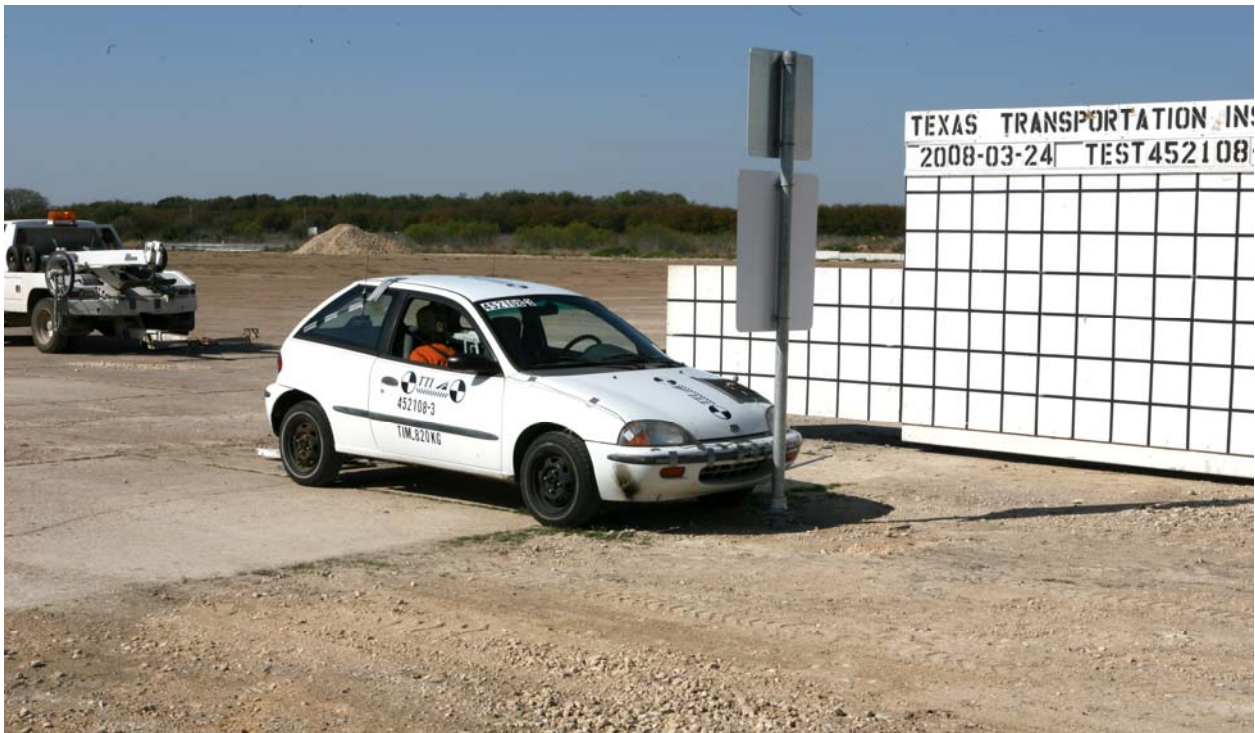
**Figure 4.4. Vehicle/Installation Geometrics for Test 452108-3.**

A 1997 Geo Metro, shown in Figures 4.4 and 4.5, was used for the crash test. Test inertia weight of the vehicle was 1865 lb, and its gross static weight was 2035 lb. The height to the lower edge of the vehicle bumper was 15.75 inches, and the height to the lower edge of the vehicle bumper was 20.25 inches. Figure B3 in Appendix B gives additional dimensions and information on the vehicle. The vehicle was directed into the installation using a cable reverse tow and guidance system and was released to be free-wheeling and unrestrained just prior to impact.

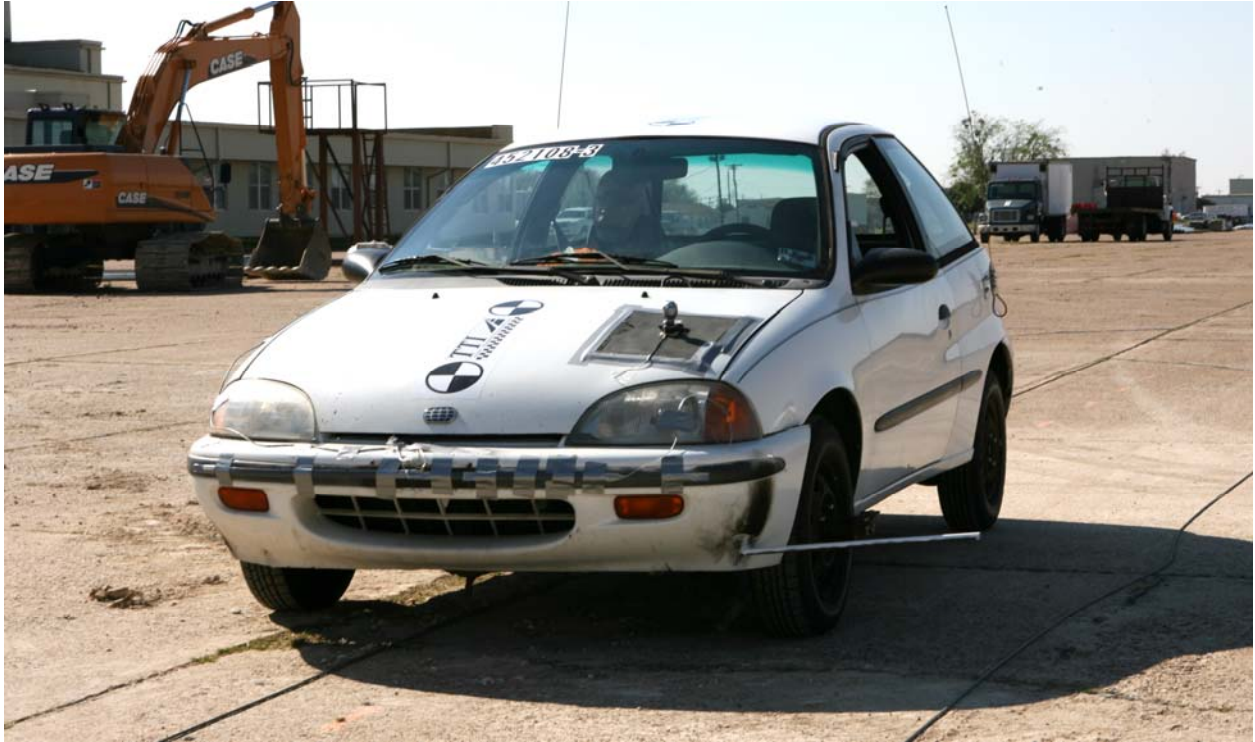
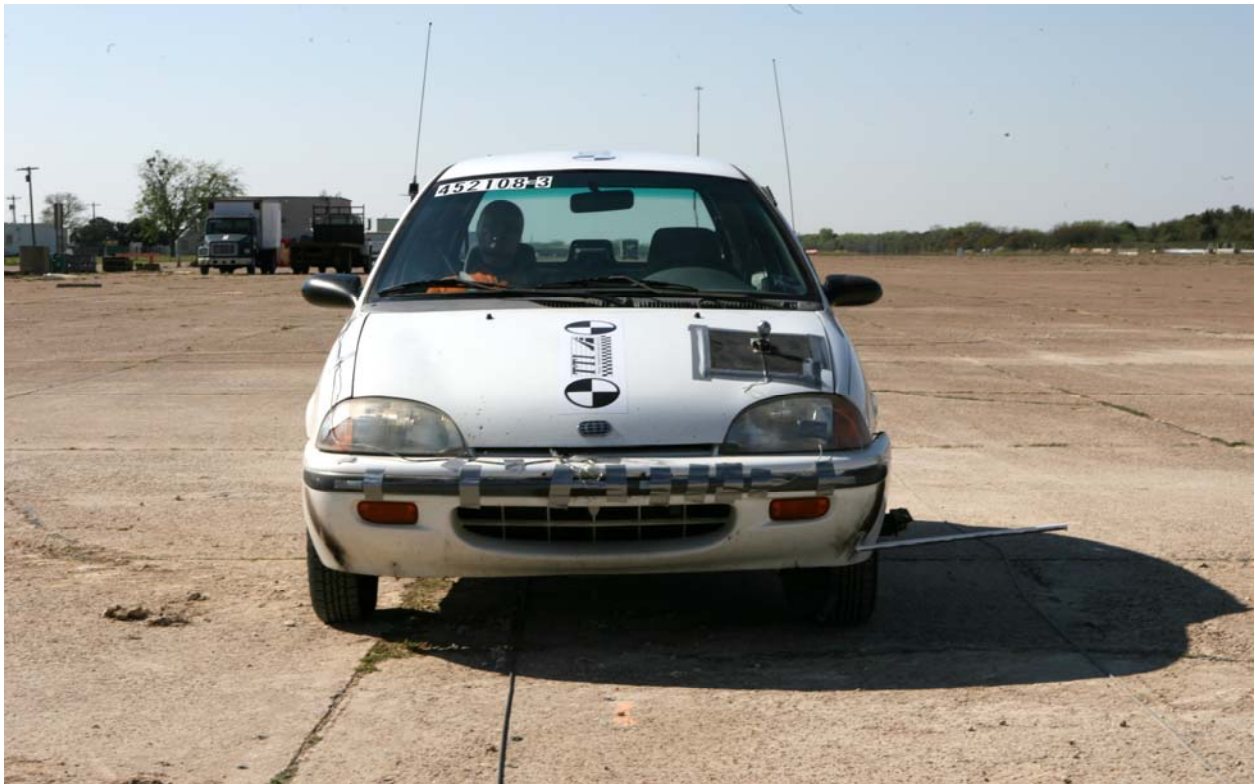
**Figure 4.5. Vehicle before Test 452108-3.**

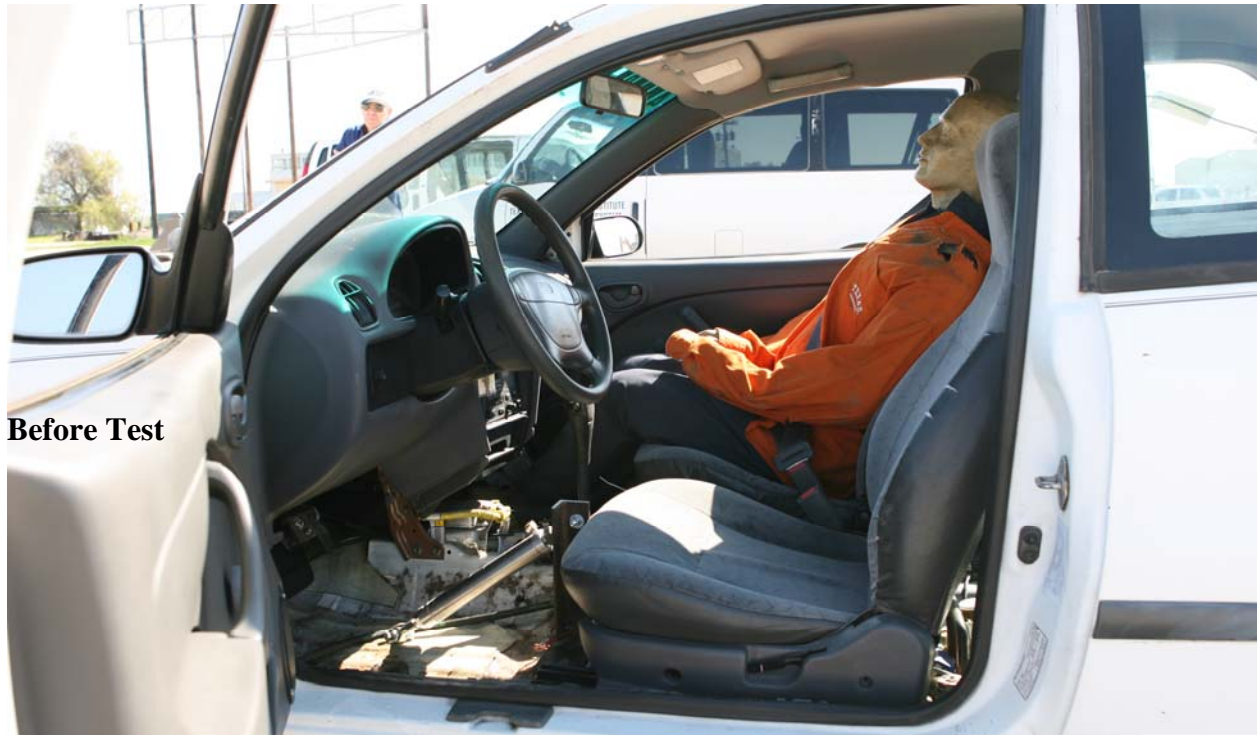
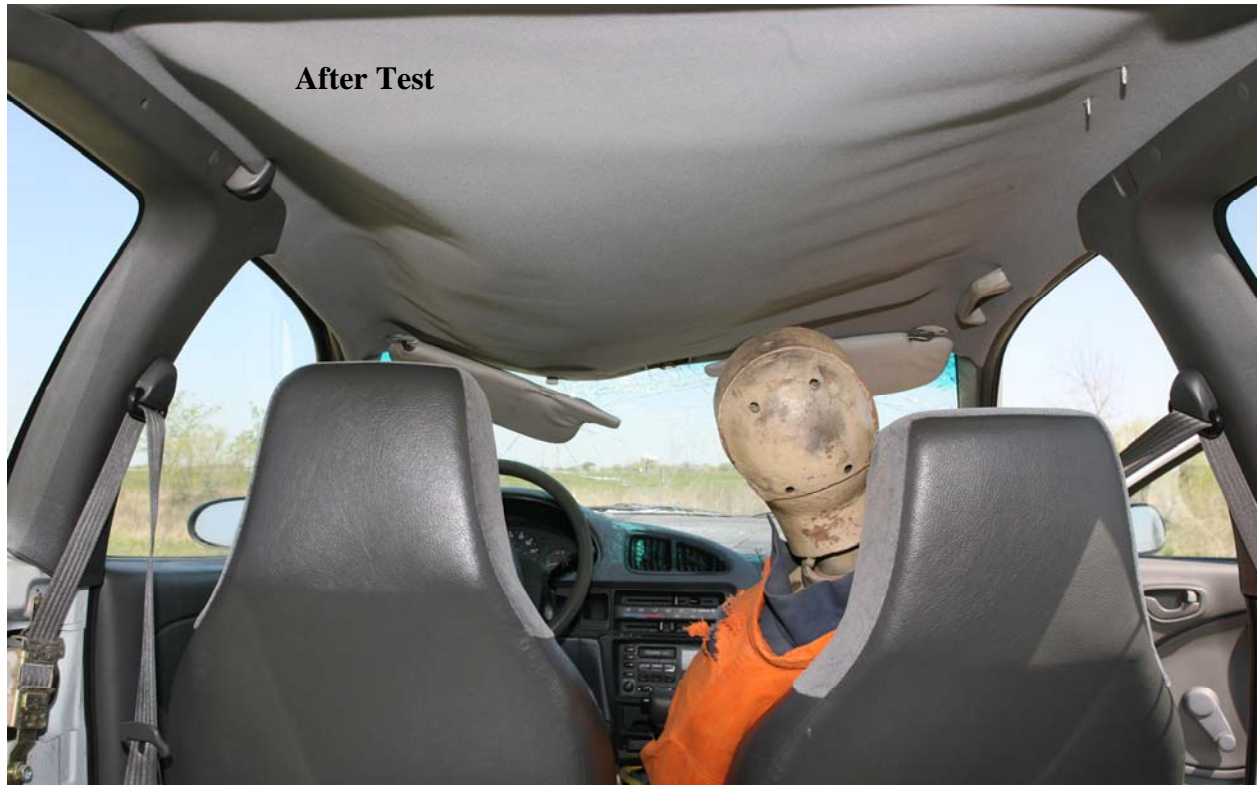
**Figure 4.9. Interior of Vehicle for Test 452108-3.**

Figures 4.8 and 4.9 show the damage to the exterior and interior of the vehicle, respectively. The front bumper, hood, radiator, and radiator support were deformed. The windshield was cracked near the roof line, but there was no hole. Maximum exterior crush in the frontal plane at the front bumper was 6.0 inches at a point, 6 inches to the left (toward the driver's side) of centerline. Maximum occupant compartment deformation was 5.6 inches in the roof area. Exterior crush and occupant compartment measurements are shown in Appendix B, Tables B5 and B6, respectively.
