1. Report No. FHWA/TX-08/0-5210-5		2. Government Accession No.		3. Recipient's Catalog No.	
4. Title and Subtitle CRASH TESTING AND EVALUATION OF TXDOT BURN BAN SIGNS				5. Report Date December 2008 Published: August 2009

**CRASH TESTING AND EVALUATION OF  
TXDOT BURN BAN SIGNS**

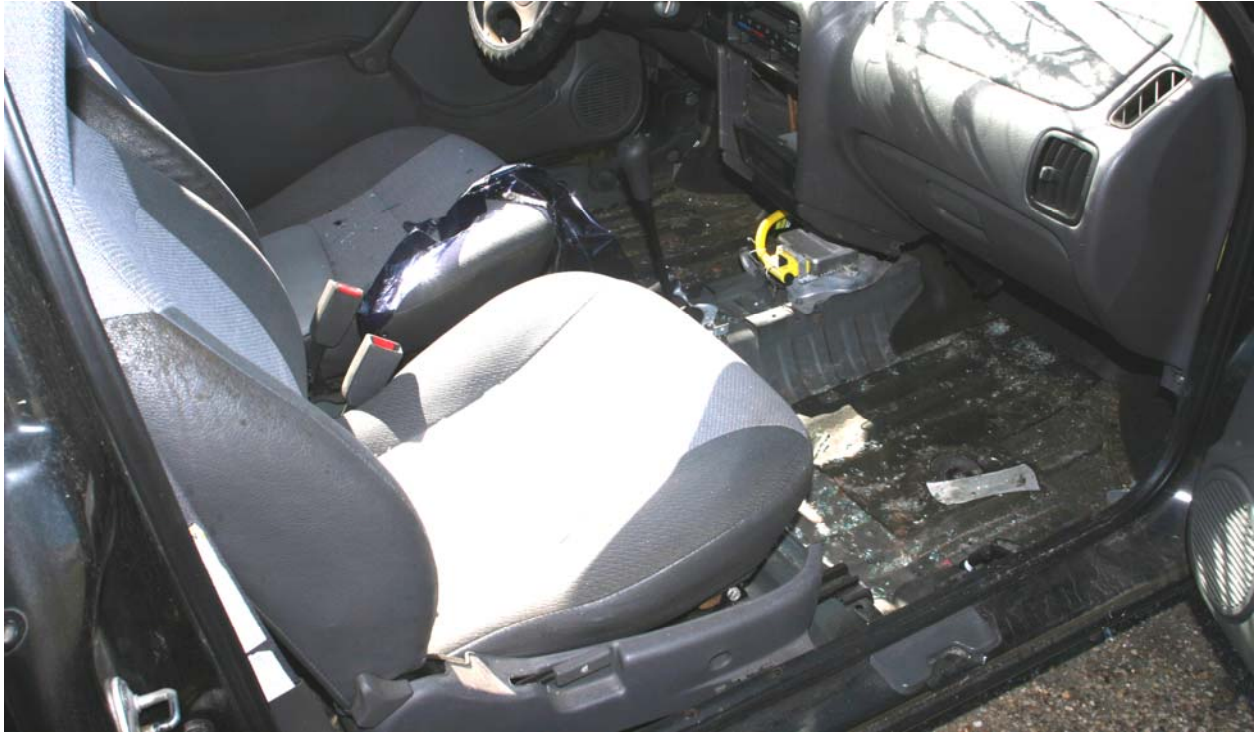
**NOTE:** Photographs were taken after vehicle was removed from test site. Movement jarred the windshield loose from the top of the windshield/roof frame.

Damage to the vehicle is shown in [Figure 4.15](#). The front bumper, grill, hood, radiator, and radiator support were deformed. Maximum exterior crush in the frontal plane at the front bumper was 5.9 inches. The windshield was shattered downward from the roofline, but there was no loss of visibility. The roof was deformed downward a maximum of 5.5 inches on the exterior of the vehicle and deformed into the occupant compartment 4.8 inches. Photographs of the interior of the vehicle are shown in [Figure 4.16](#). Exterior crush and occupant compartment measurements are shown in [Appendix B](#), Tables [B7](#) and [B8](#), respectively.

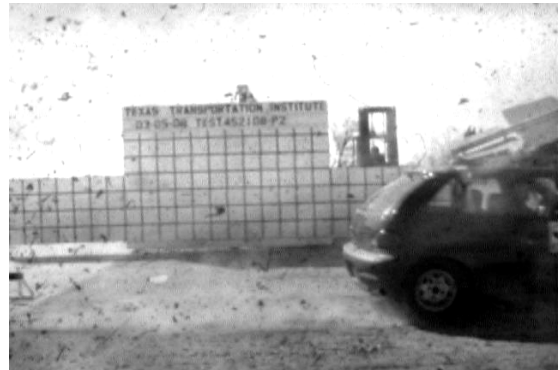
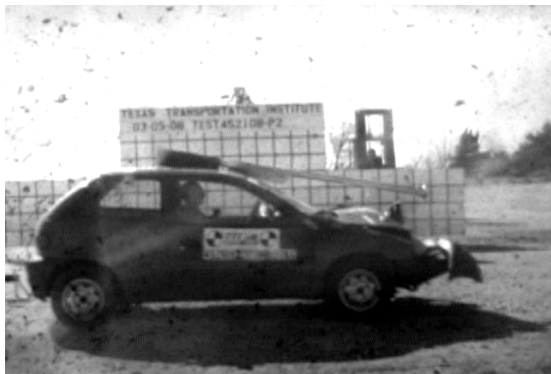
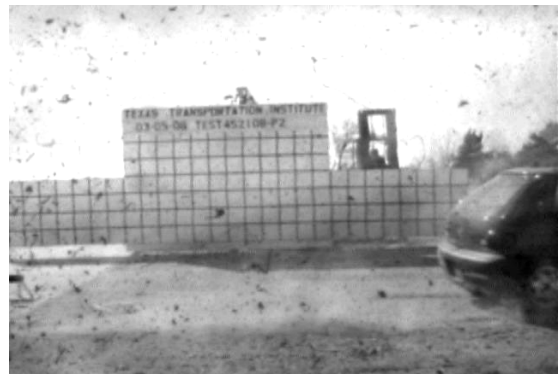
**Figure C2. Sequential Photographs for Test 452108-2  
(Perpendicular View).**

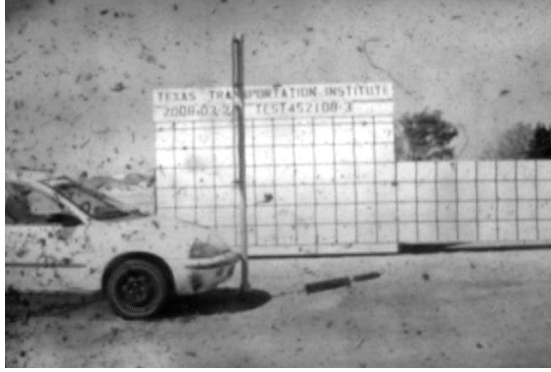
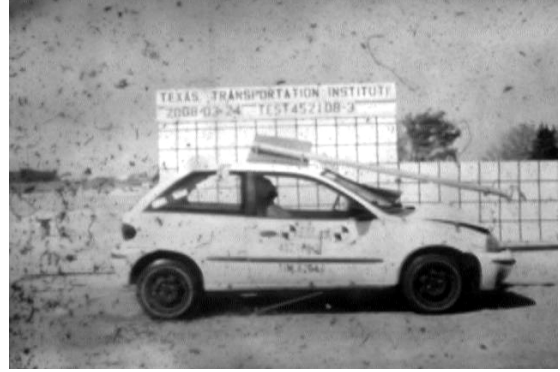
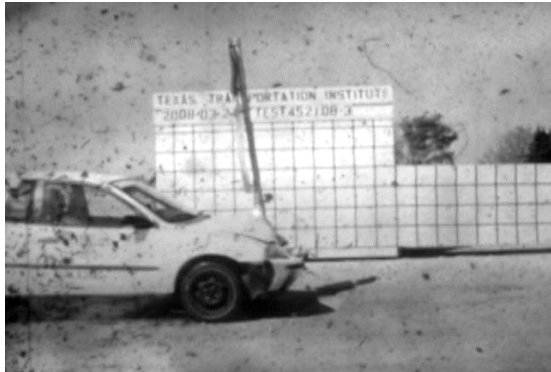
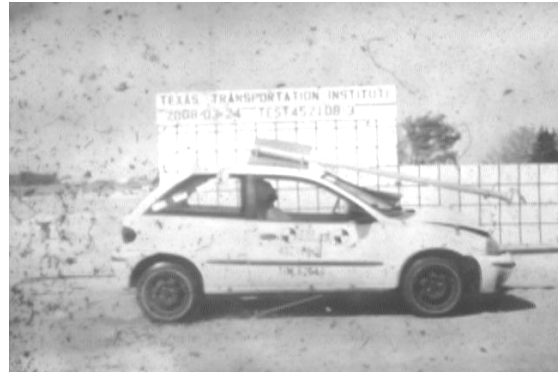
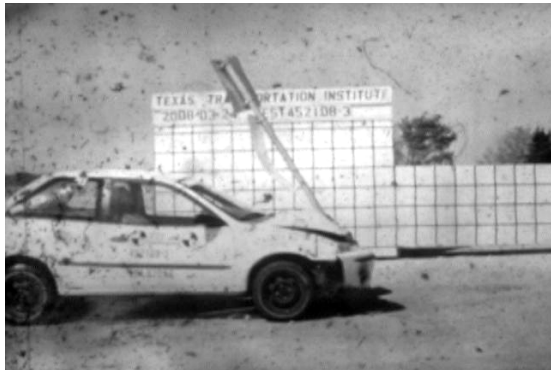
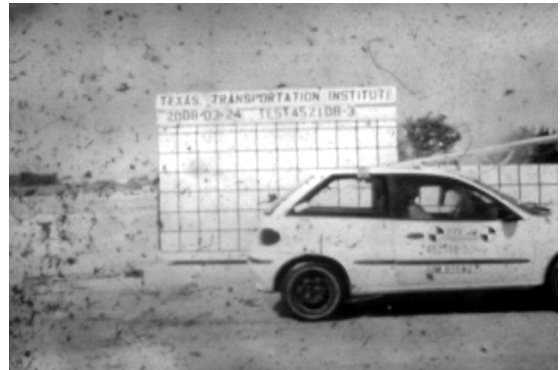
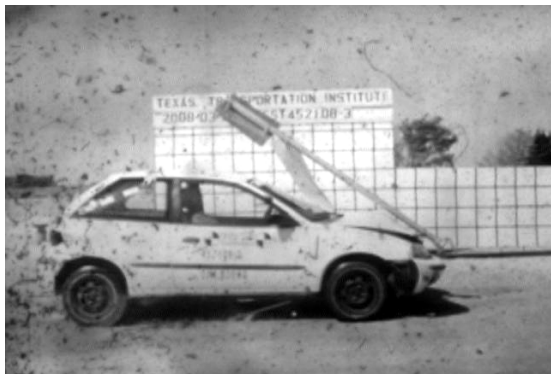
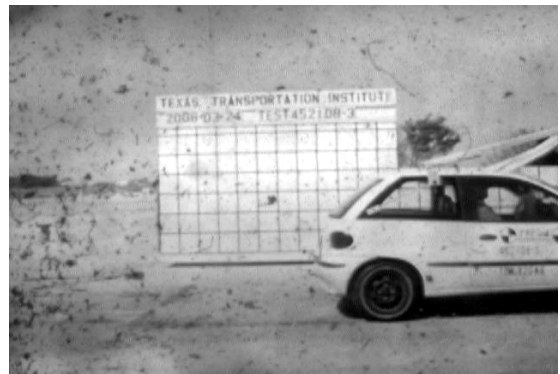
**Figure C3. Sequential Photographs for Test 452108-3 (Perpendicular View).**

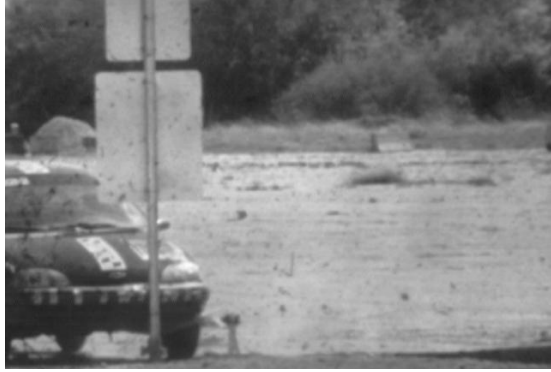
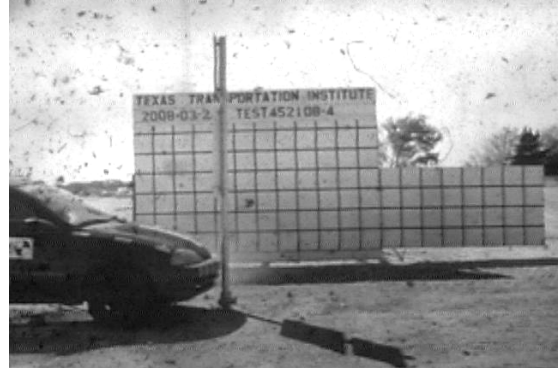
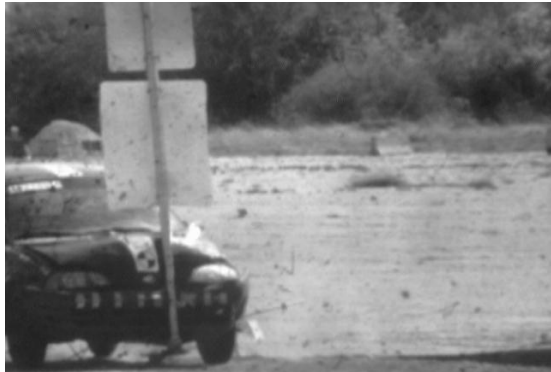
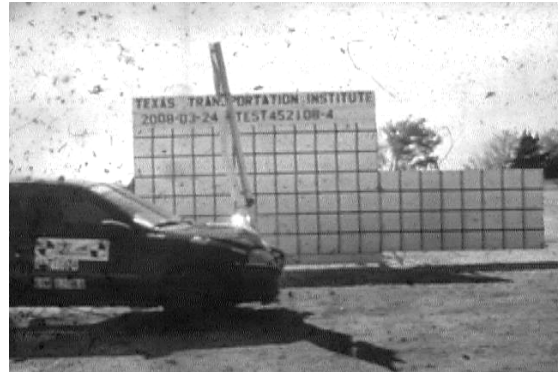
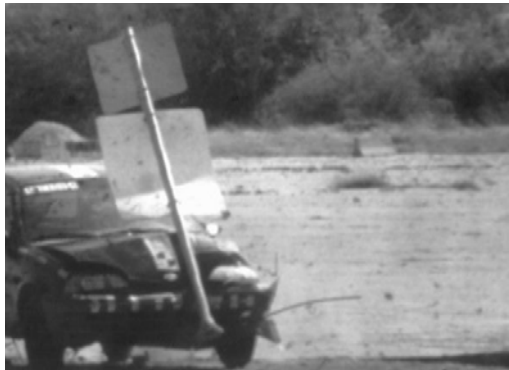
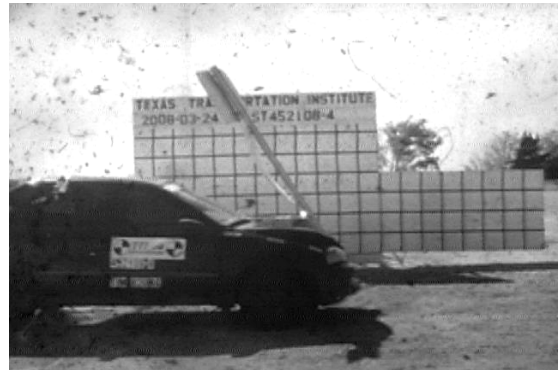
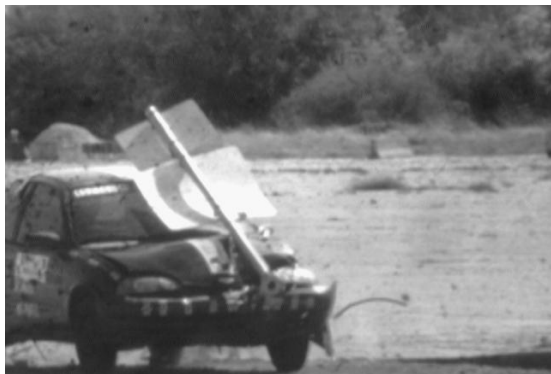
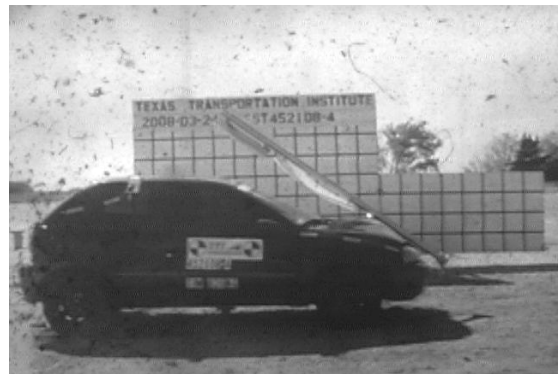
**Figure C4. Sequential Photographs for Test 452108-4 (Oblique and Perpendicular Views).**

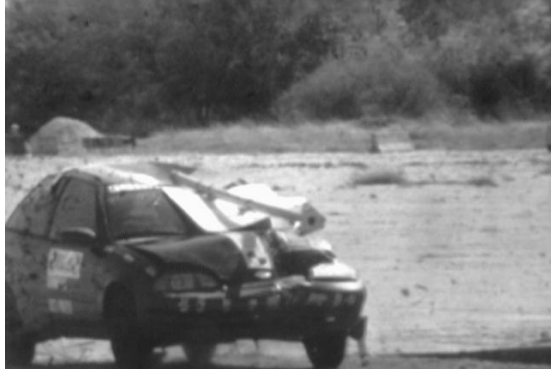
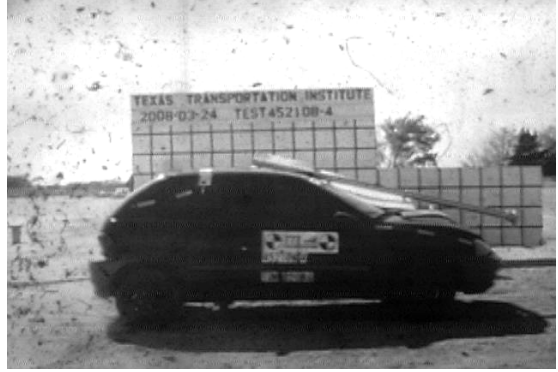
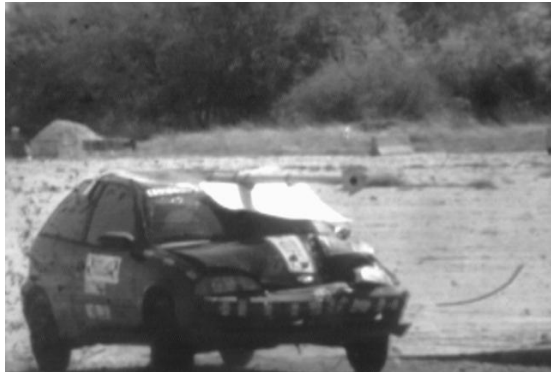
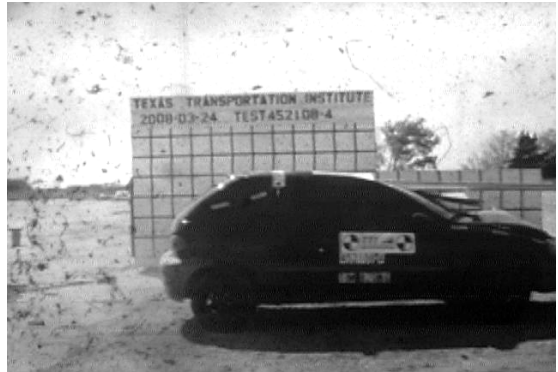
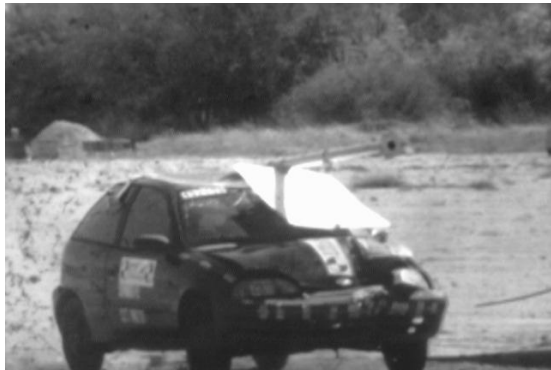
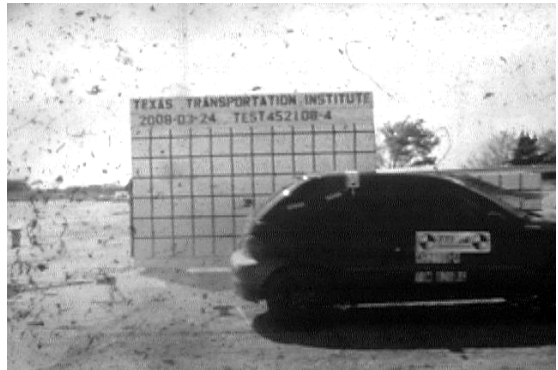
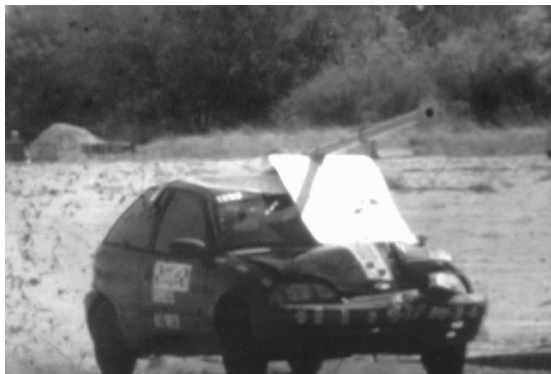
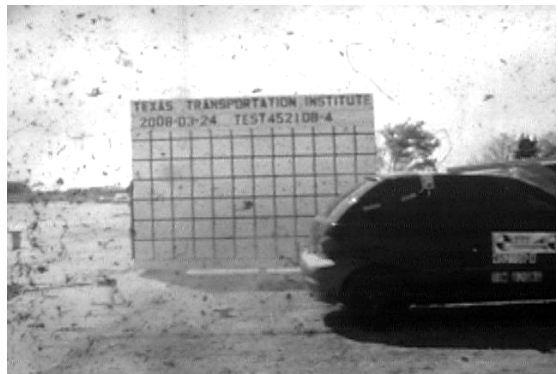
**Figure C4. Sequential Photographs for Test 452108-4 (Oblique and Perpendicular Views) (continued).**

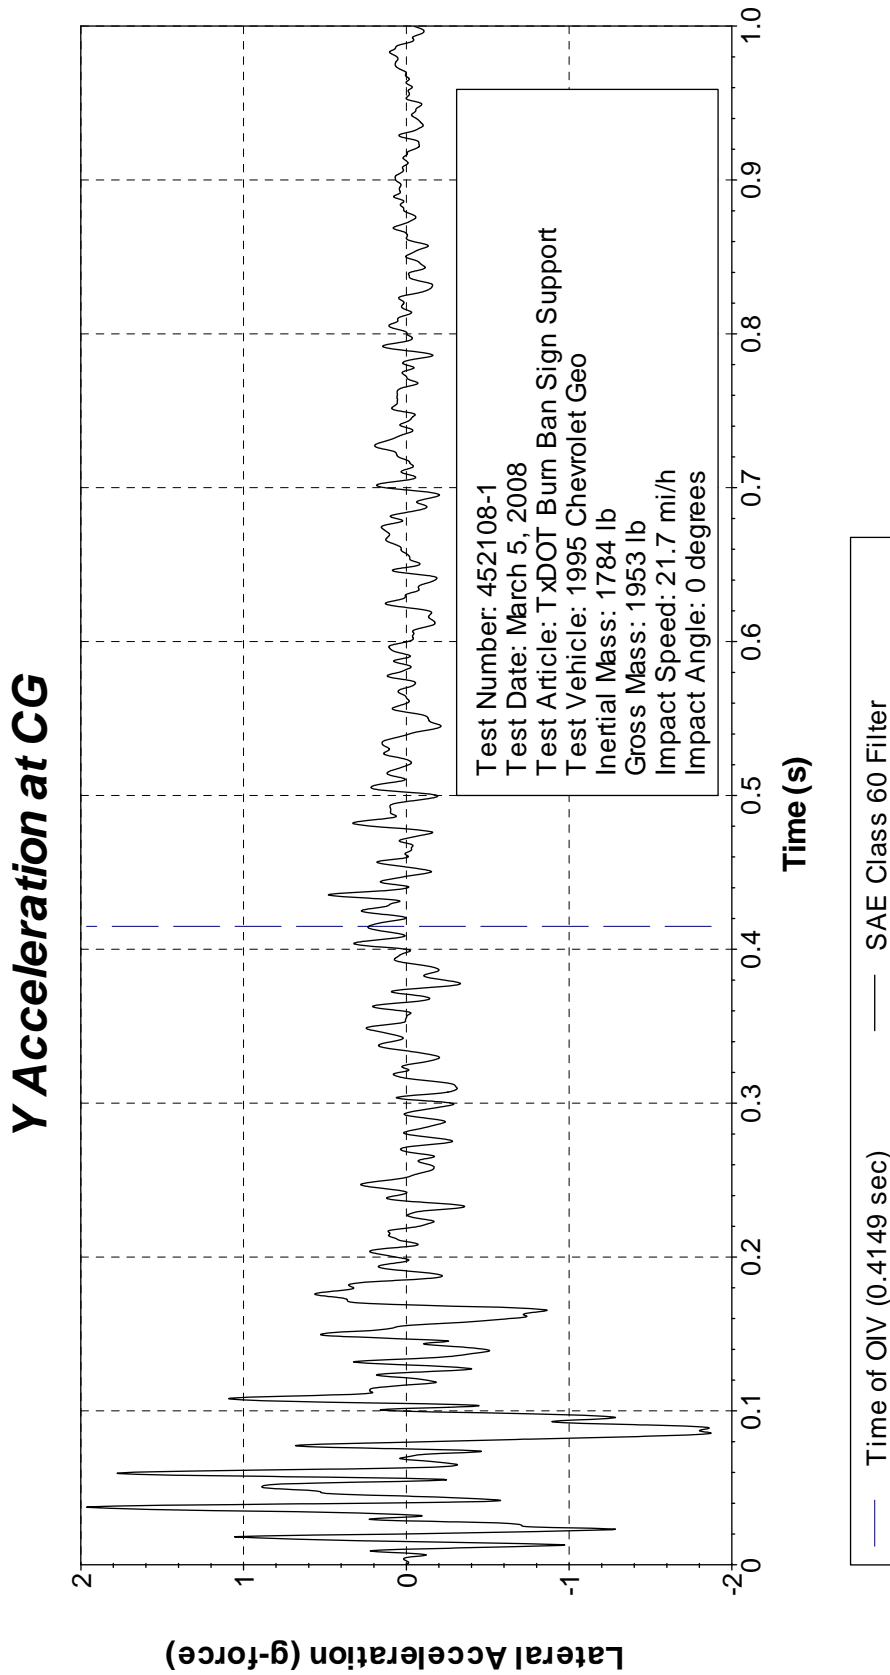
**Figure D3. Vehicle Lateral Accelerometer Trace for Test 452108-1  
(Accelerometer Located at Center of Gravity).**

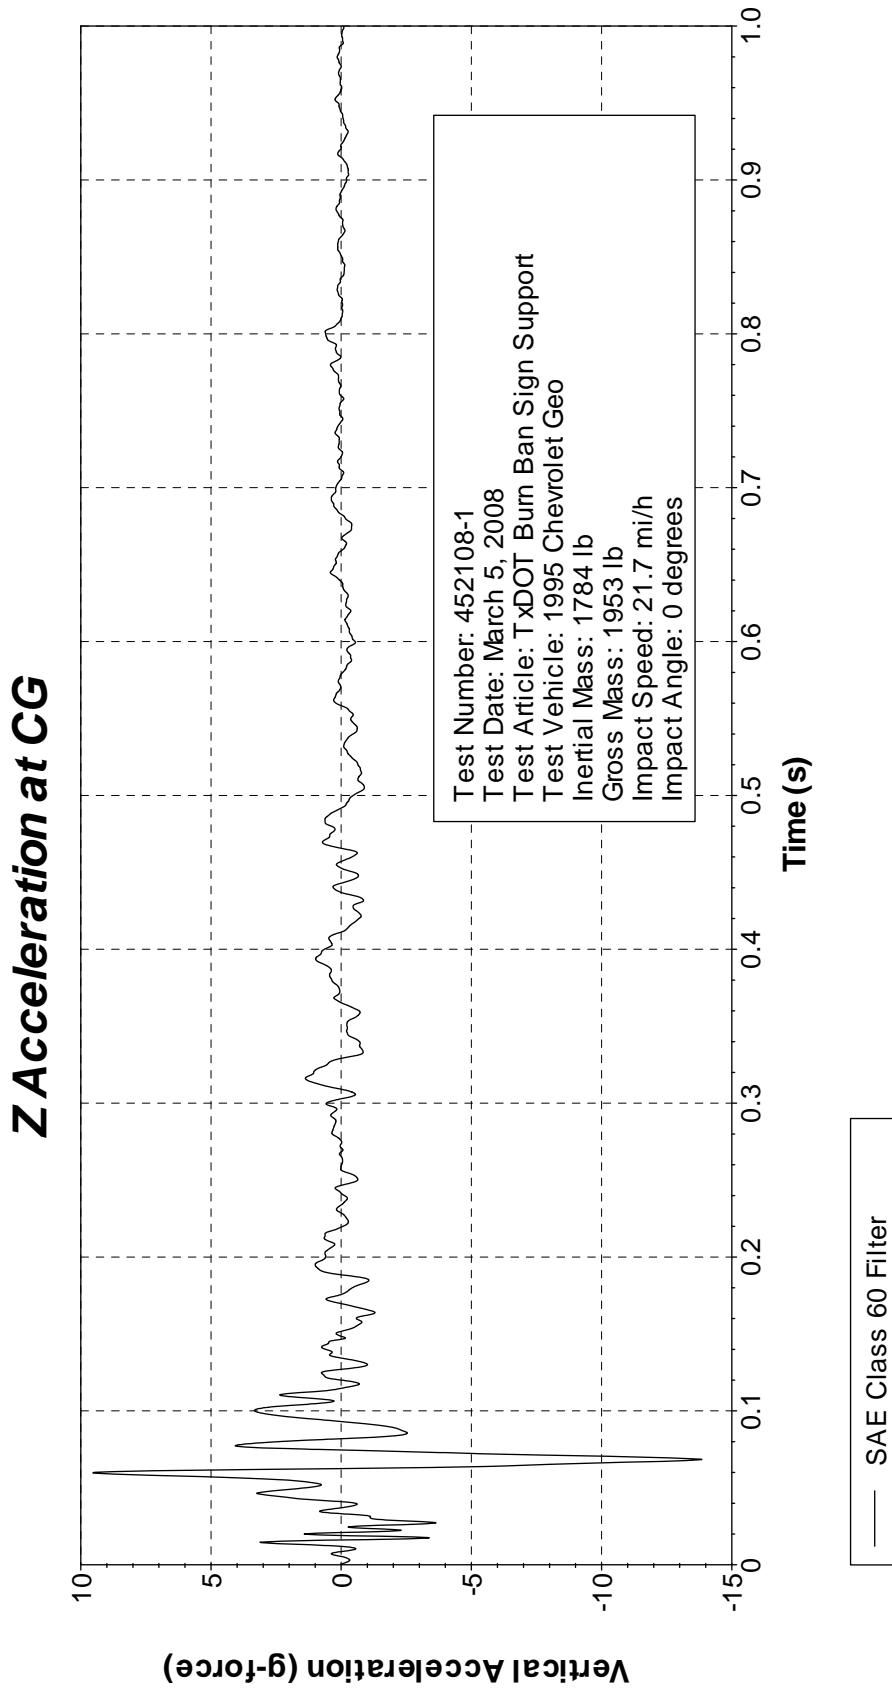
**Figure D4. Vehicle Vertical Accelerometer Trace for Test 452108-1  
(Accelerometer Located at Center of Gravity).**
