| 4. Title and Subtitle<br>GUIDELINES FOR ROUTINE MAINTENANCE OF CONCRETE PAVEMENT | | | | 5. Report Date<br>May 2008<br>Published: July 2008 | |
| 7. Author(s)<br>Youn su Jung, Thomas J. Freeman, and Dan G. Zollinger | | | | 8. Performing Organization Report No.<br>Report 0-5821-1 | |
| 9. Performing Organization Name and Address<br>Texas Transportation Institute<br>The Texas A&M University System<br>College Station, Texas 77843-3135 | | | | 10. Work Unit No. (TRAIS) | |

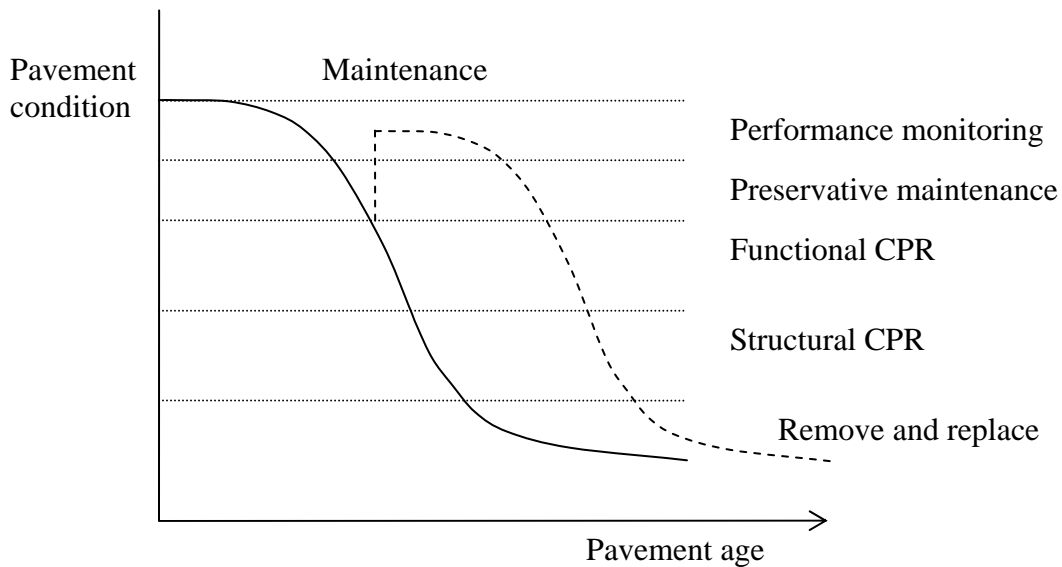
**Figure 1 Pavement Condition and Maintenance Stages.**

Figure 1 shows the concept of pavement condition degradation with pavement age. Proper maintenance stages are noted as a means to address specific pavement conditions. As pavement condition degrades, higher repair costs and more time are needed to make corrections causing more traffic congestion. Therefore, preservative or minor concrete pavement repair (CPR) should be executed at early stages of pavement deterioration to extend pavement life at lower cost. Key routine maintenances activities are categorized into five levels:

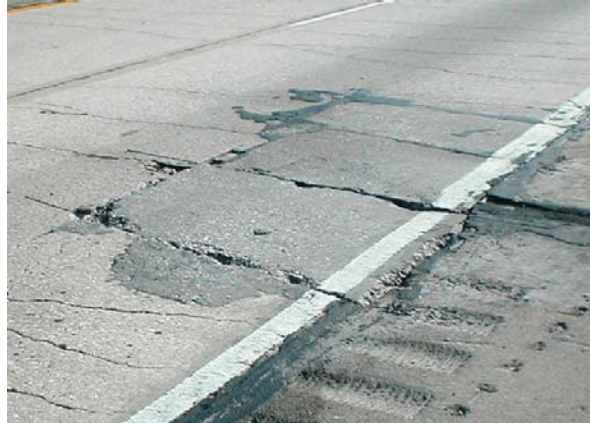
**Figure 13 Patch Deterioration.**

A concrete patch (a “longer lasting” repair) is a localized area of newer concrete that has been placed to the full depth of the existing slab as a method of correcting surface or structural defects. [Figure 13](#) shows an example of patch deterioration.

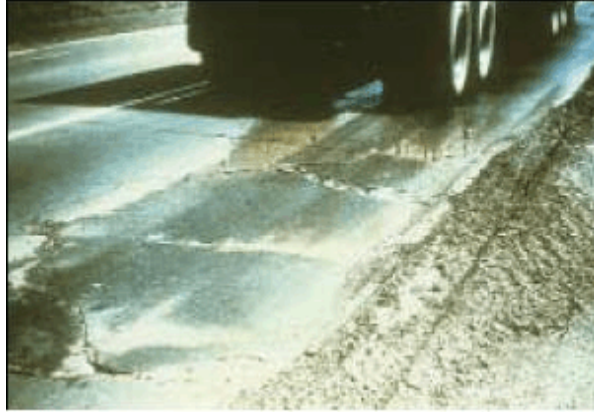
**Figure 14 Pumping.**

Pumping is the expulsion of water and silts, sands, or clays from joints or cracks when load is applied to the pavement. If water enters the joint or crack, it may erode the underlying layers of the pavement. When load is applied to the approach slab, the water will propel underneath the departure slab. When the load moves to the departure slab, the water will propel back underneath the approach slab. The constant movement of water back and forth will erode the base layers and create cavities underneath the pavement. The cavities may also create slab rocking where the edge of the slab moves vertically when load is applied to an undowelled pavement. Pumping of the pavement can be considered a major distress. After pumping is observed, failure of the pavement is not far behind. [Figure 14](#) shows an example of pumping.

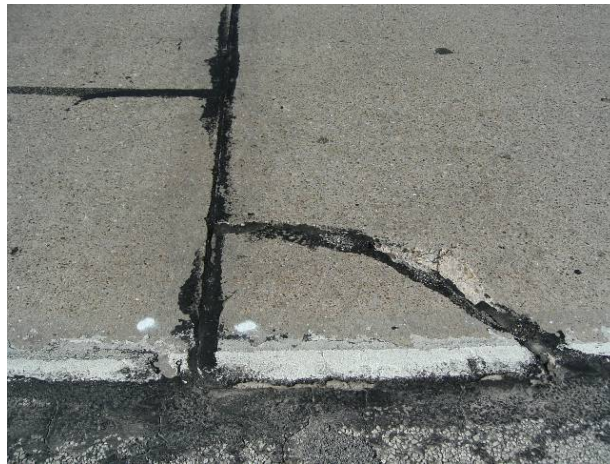
**Figure 15 Corner Breaks.**

A corner break is a crack that extends from a transverse joint or crack to a longitudinal joint or the pavement edge. Each end of the crack should be less than 6 ft from the corner of the slab. If one end of the crack is further than 6 ft from the corner of the slab, the crack should be categorized as a diagonal crack and not a corner break. A corner break extends through the thickness of the slab. Settlement of the corner after breaking creates a ride quality and safety problem. [Figure 15](#) shows an example of corner breaks.

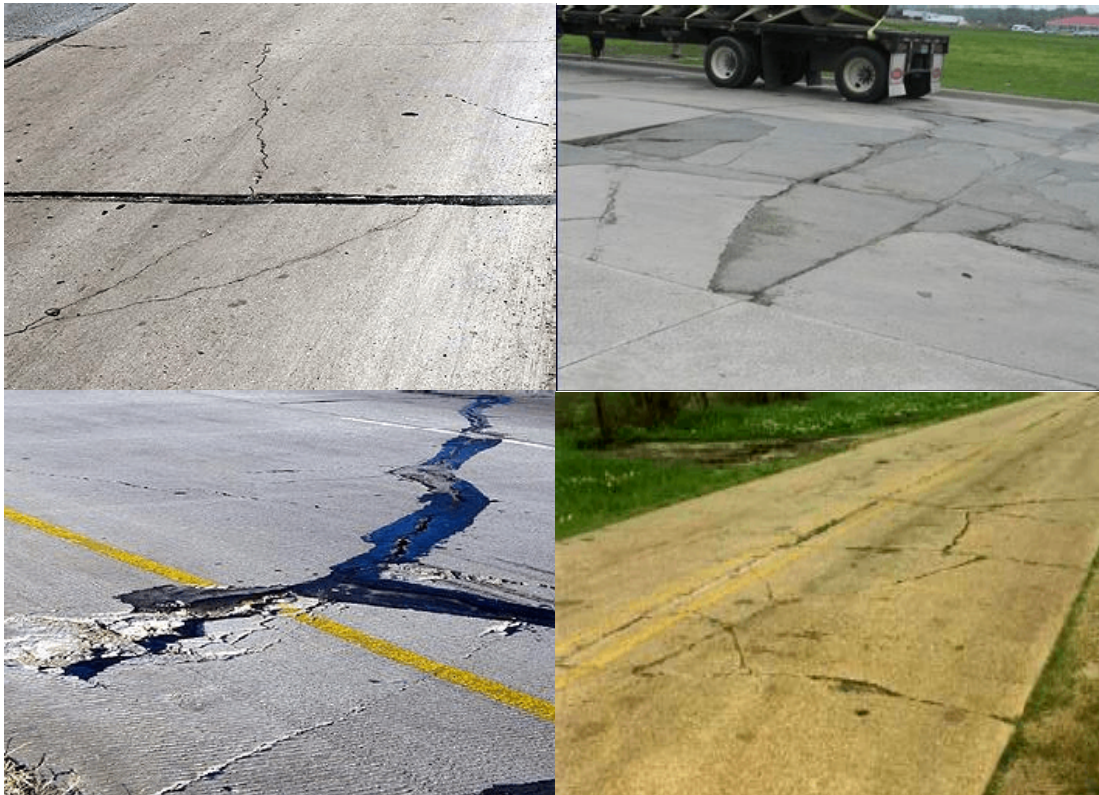
**Figure 17 Shattered Slabs.**

Shattered slabs are formed when a series of cracks intersect to divide the slab into four or more pieces. Although the pieces still remain in their original position, they may settle below the original elevation of the pavement. Also, the intersecting cracks are usually accompanied by severe spalling. Shattered slabs decrease the riding quality of the pavement as well as the structural capacity. [Figure 17](#) shows some examples of shattered slabs.

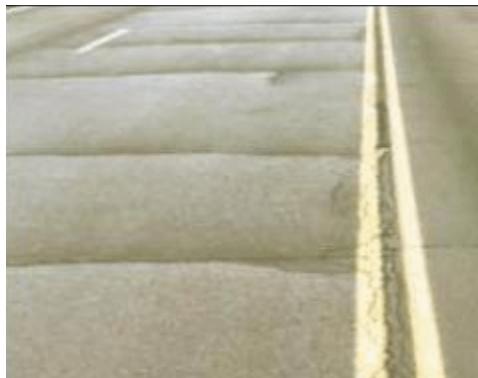
**Figure 18 Reflection Cracking.**

Typically, within a few years, cracks on asphalt overlays form above the joints and cracks in the existing concrete pavements. These cracks are typically very straight and regular, matching the joint pattern of the existing concrete pavements. [Figure 3](#) shows an example of joint failure and schematic diagrams. [Figure 18](#) shows an example of reflection cracking.

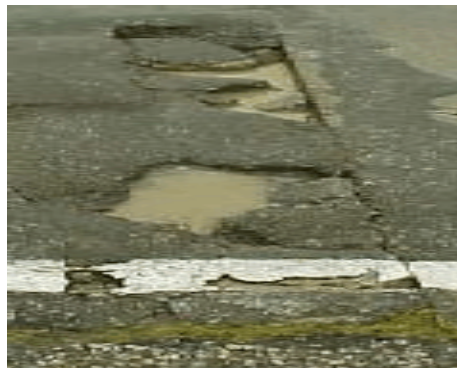
**Figure 19 Reflection Failure.**

A reflection failure is an area of pavement that is badly deteriorated due to the condition of the underlying pavement. The area is usually very broken, and pieces may be missing. [Figure 19](#) shows an example of reflection failure.

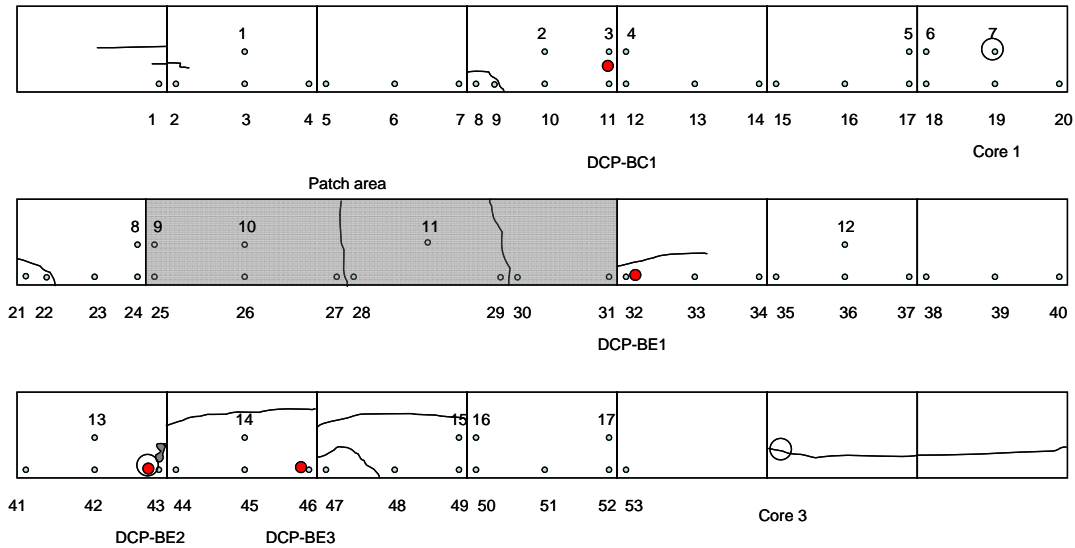
**Figure 20 Example of FWD Testing Locations.**

LTE and deflection testing can be used as a simple means of determining routine maintenance needs. Deflection testing using FWD can evaluate the structural condition of pavement such as layer stiffness, LTE, and loss of support below the slab (4). Therefore, the areas selected from the checklist of visual survey items needs to be evaluated relative to structural capacity for such stiffening measures as load transfer retrofitting. Figure 20 shows an example of FWD testing along the edge and center of slab locations. Highly spalled or faulted joints and cracks should be tested to evaluate LTE and continuity of support. Moreover, deflection and LTE at the center of the slab should be tested occasionally as a reference of good support conditions.

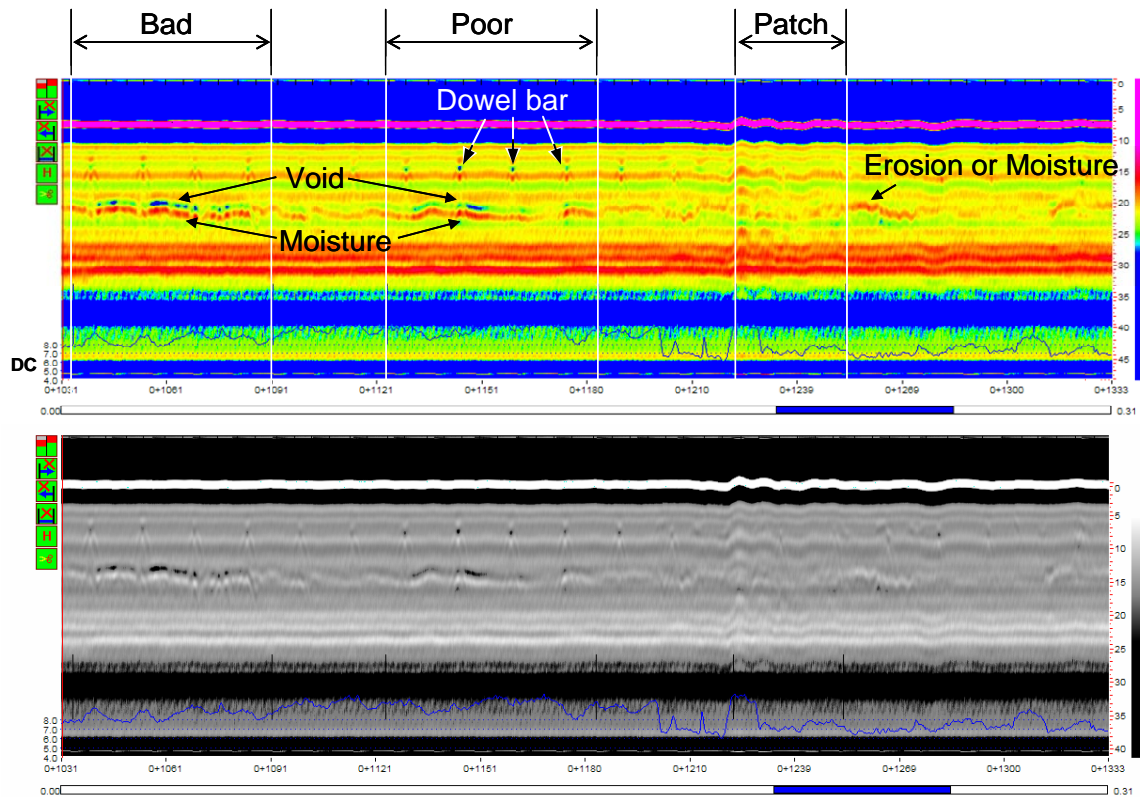
Figure 23 GPR Testing Image Analysis.

GPR testing is a fast and effective test method to determine base conditions such as voids and the presence of water trapped in and between underlying pavement layers. Moreover, GPR survey can be used for PCC pavement layer thickness estimation, layer interface condition assessment, and dowel misalignment evaluation (4). In pumping areas, dowel locations, voids, and subsurface water under the slab can be detected using an air-coupled or ground-coupled system, as shown in Figure 23. Although no standard procedures have been documented for detection of voids under the concrete slab using GPR, image analysis or DC analysis can be used to detect void and subsurface moisture for routine maintenance purposes.

Detection of voids under concrete slabs may require trained personnel, but generally the following can help to analyze GPR images (Figure 23): Blue areas (color image, top) or black areas (grayscale image, bottom) represent voids. Red areas (color image, top) or white areas (grayscale image, bottom) represent moisture. Intermittent blue dots (color image, top) or black dots (grayscale image, bottom) indicate dowel locations.

The DC value of GPR is shown as a blue line below the layer image in [Figure 23](#). It can be used to detect subsurface moisture. DC values range from 1 (air) to 81 (distilled water), and generally the DC of the aggregate base is around 6 to 7. In the pavement system, DC is an efficient indicator of the presence of subsurface water if the DC of the base or subgrade is higher than 9.

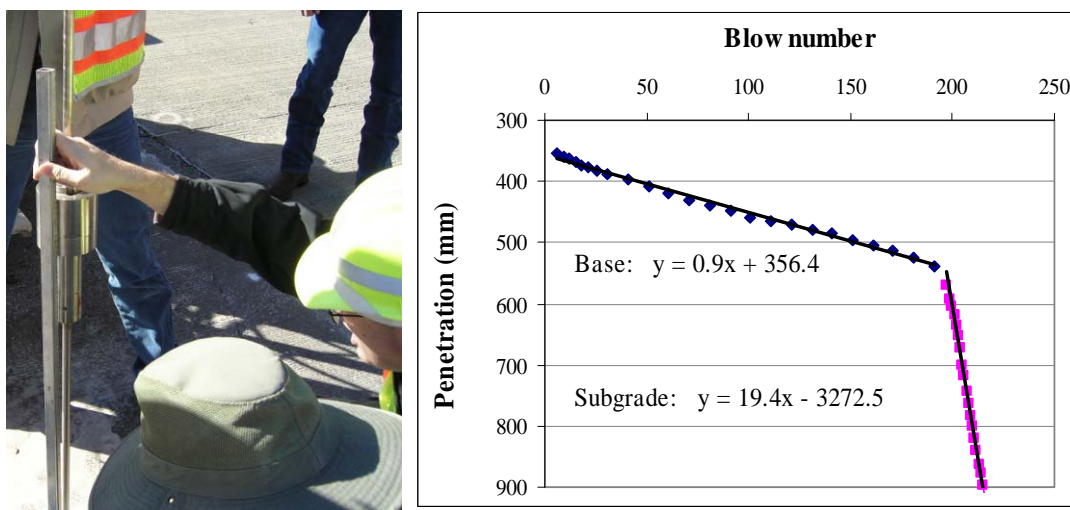
**Figure 24 DCP Testing and Analysis.**

Where E = Elastic modulus, psi;  
CBR = California bearing ratio; and  
PR = Penetration ratio, mm/blow.

[Figure 24](#) shows an example of the calculation of the penetration ratio. A plot of the DCP data is useful to find the slope of the linear trend line. The typical flexible base modulus is 60 to 80 ksi, or PR is 1 to 2 mm/blow (0.05 to 0.1 in./blow). If the PR value is higher than 50 mm/blow (2 in./blow), this indicates very soft subgrade materials, which implies the soil modulus is less than 6000 psi.

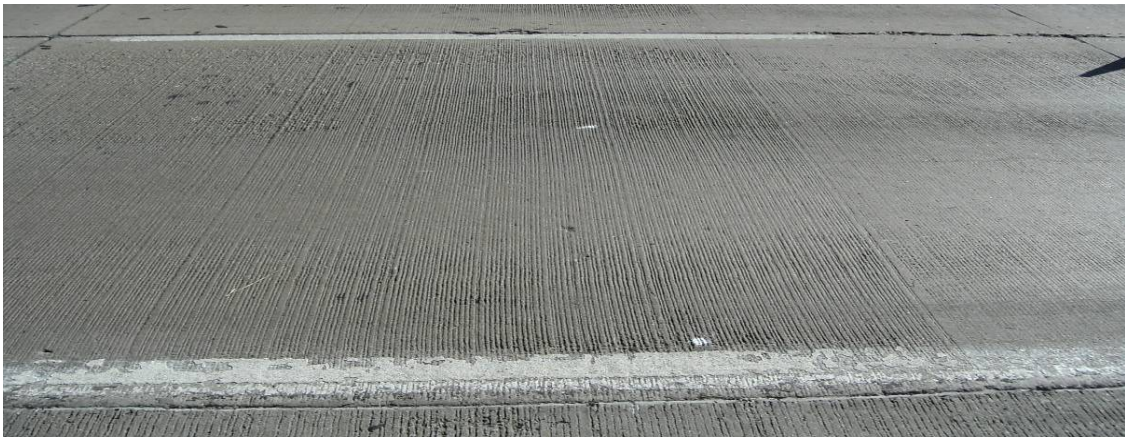
Good Performing Section

The good performing area showed no distress where the joint seal condition between the lane and shoulder was good condition. It appeared to be well maintained and accordingly blocked surface water from intruding into the pavement section. The patched areas also showed a good joint seal condition and no distress in the sections. Poorly performing sections typically showed significant joint seal deterioration at the joint between the lane and shoulder, which may ultimately lead to base and subgrade erosion damage.

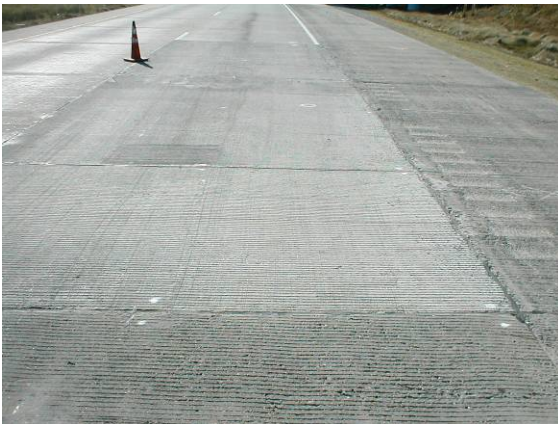
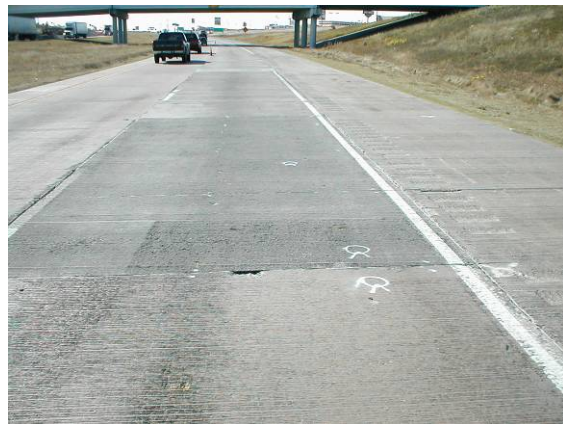
Newly Patched Section

Old Patched Section

**Figure 25 Good and Patched Condition Areas.**

This pavement is a jointed 15 ft interval pavement built in 1983. This JC pavement has exhibited poor performance since the early 1990s. Slab settlement issues (but no major cracks) were getting worse because pumping and poor drainage weakened the base and subgrade. Figure 25 shows a good performing section and patched sections, and Figure 26 shows a relatively poorly performing section on US 75 in Sherman, Texas (a recent patching project eliminated some of the worst areas). Table 5 shows the visual condition survey results.

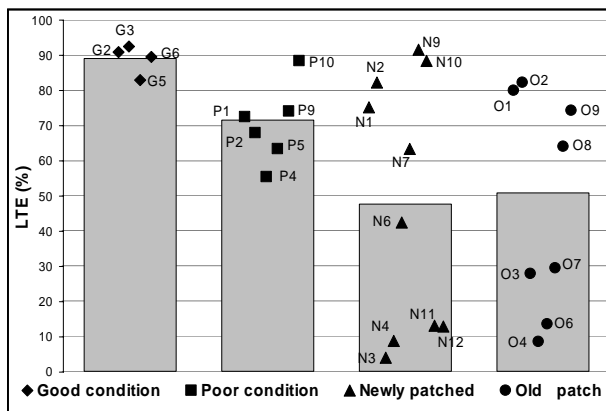
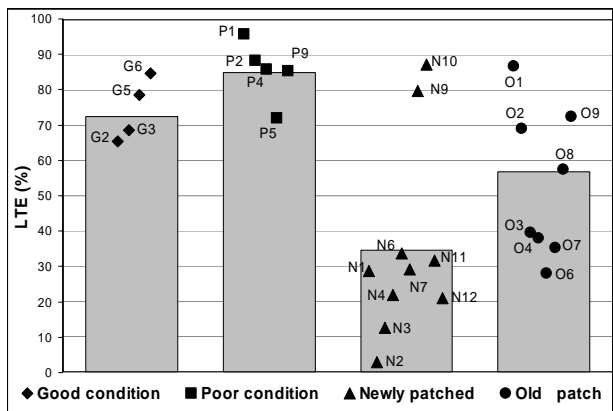
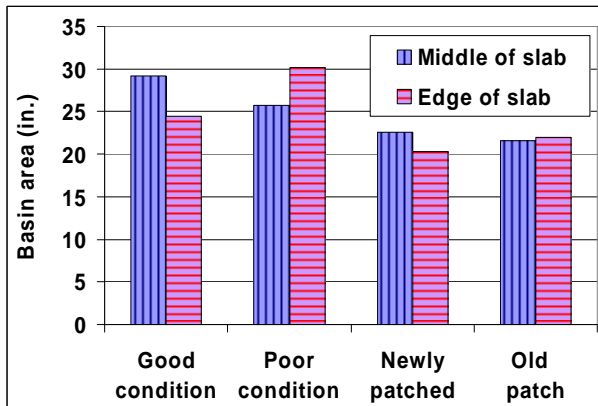
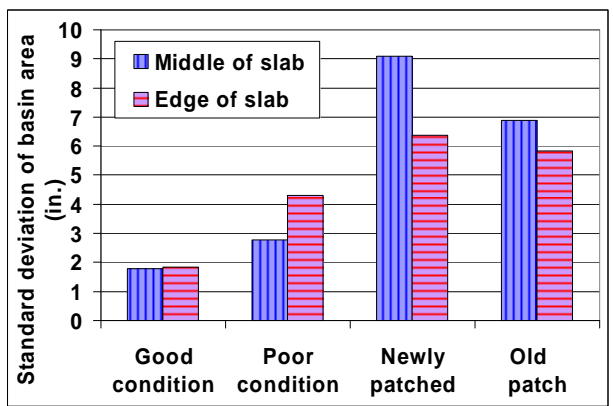
a) Test Sections and FWD Location ID Numbers

b) Joint LTE of Lane Center Drop

c) Joint LTE of Lane Edge Drop

d) Mean and Standard Deviation of Basin Area

Figure 28 FWD Testing Result Analysis.

FWD testing is commonly used to check overall structural capacity such as slab stiffness, loss of support (voids), LTE of the joint, and basin area. Although backcalculation analysis involves theoretical related assumption, FWD test procedures are well established and simple to apply for investigation of pavement condition. Test locations consisted of testing before and after the joint and at the mid-slab location. These locations were tested along the edge of the slab, in the wheel paths, and at the center of the slab. [Figure 28-a](#) illustrates the FWD testing locations. LTE and basin area were backcalculated from FWD data to evaluate the relative pavement stiffness.

[Figures 28-b](#) and [28-c](#) show joint LTE center and edge of slab. The LTEs before and after the joint are shown in the bar charts for each pavement condition. Unexpectedly, the poor condition section had the highest LTE along the slab edge, while the newly patched section had the lowest LTE (which was less than 40 percent). FDR efficiencies for the old patches are relatively low. Two out of five points associated with new patches had good LTE (approximately 80 percent and 90 percent), while the other three joints had poor LTE (approximately 50 percent, 10 percent, and 7 percent). The older patched sections providing good performance had better load transfer (approximately 70 to 80 percent). The reason for the failure of the FDR shown in [Figure 27](#) is low LTE along with degraded base support.

[Figure 28-d](#) shows the mean and standard deviation of FWD basin areas. Patched sections show a lower mean basin area with a higher standard deviation than the cracked poorly performing area, which means the general structural capacity of FDR is lower than even the problematic pavement areas manifesting non-uniform support resulting in premature slab cracking. Existing patched areas can be checked using the FWD for structural adequacy; proper maintenance includes activities such as joint resealing and retrofit doweling to prolong the life of patched areas.

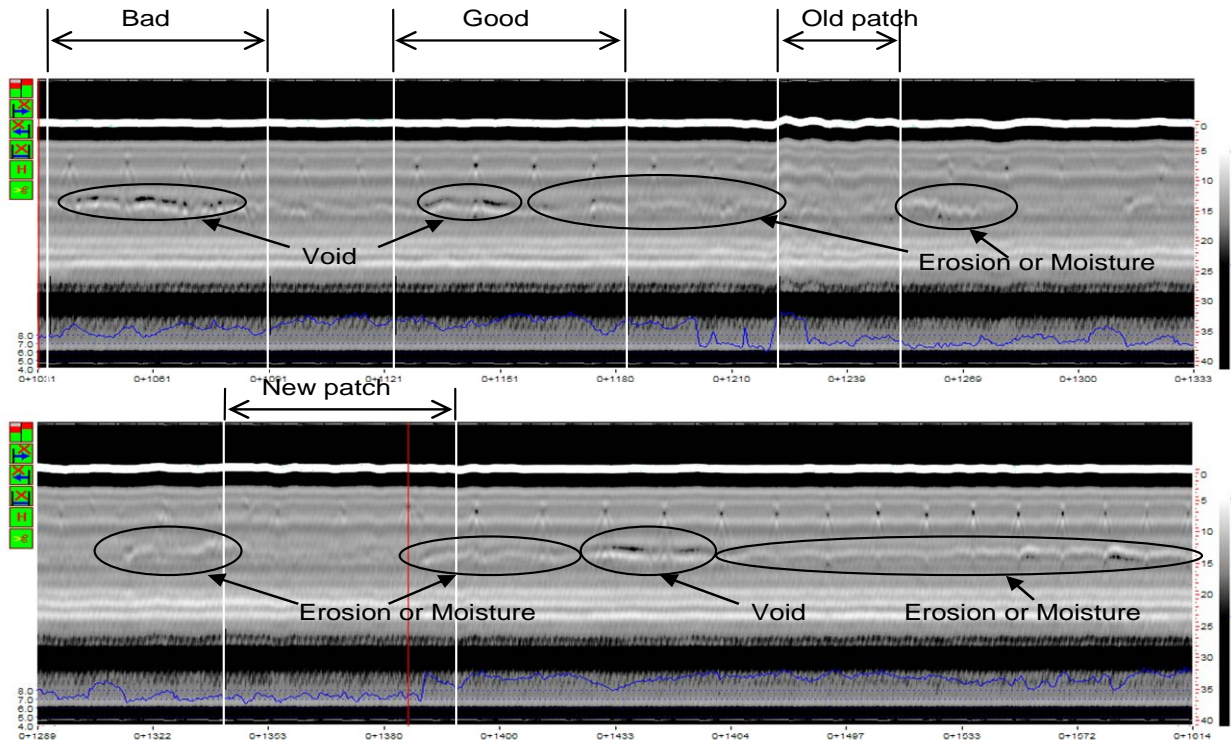
Figure 29 shows GPR images where black areas represent voids and yellow or orange strips (white strip in the grayscale image) represent eroded or wet areas. Poorly performing sections show many voids and wet areas, while good performing sections show some areas with erosion and moisture. The blue line at the bottom in Figure 29-b indicates the surface dielectric value, which represents the moisture intensity of the subgrade. When a DC value is higher than 9, a wet condition below the subbase may exist.

a) GPR along FWD Lane Center Drop Points (Ground-Coupled System)

b) GPR along Edge Side Wheel Path (Air-Coupled Vehicle System)

**Figure 29 GPR Image Analysis.**

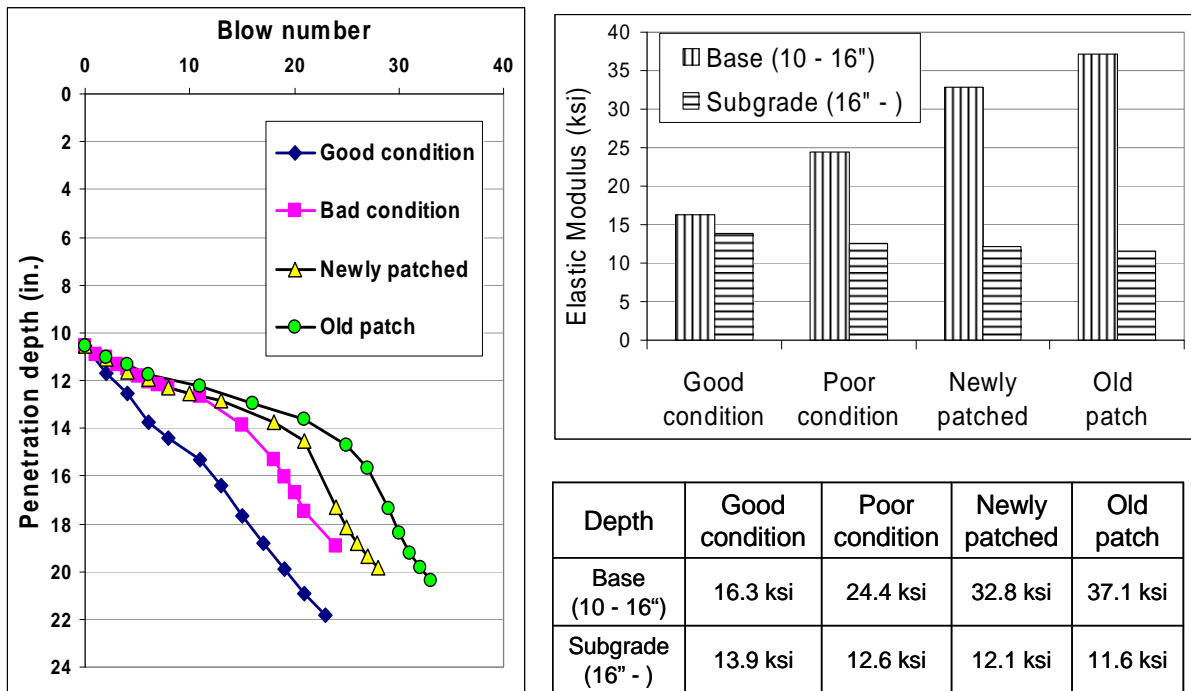
a) Penetration versus Blow Number

b) Elastic Modulus versus Depth and Pavement Conditions

**Figure 30 DCP Testing Results.**

The base type for all sections investigated was an unbounded aggregate base where the estimated elastic moduli appeared to be quite low, as shown in Figure 30. The base in the good performing areas has nearly the same modulus as that of the subgrade, and there appears to be a significant loss of base strength in unrepaired areas; the typical elastic modulus for an unbounded aggregate base ranges from 15 to 45 ksi (5).

Patched areas show relatively higher modulus than unrepaired sections for the base layer but no significant difference for the subgrade layer. This low modulus for the subgrade could be considered a wet subgrade condition. The presence of standing water along the shoulder joint indicates poor drainage, contributing to degradation of the modulus for the base and subgrade, particularly when damage to the longitudinal joint seal is present.

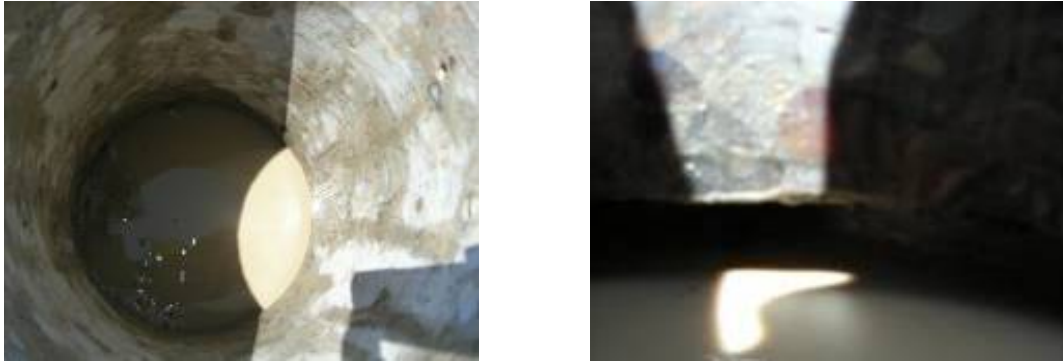
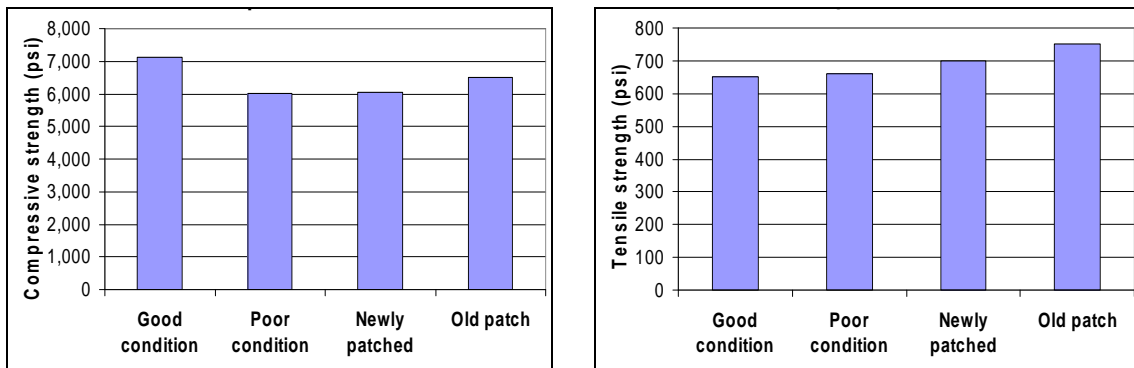
a) Void and Erosion under the Concrete Slab of Poor Condition Section

b) Top and Bottom Surface of the Cores

c) Compressive and Tensile Strength of Concrete Slabs

**Figure 31 Findings from Sample Coring and Strength of Cores.**

Figure 31-a shows a core hole located in a poorly performing section exposing a voided area of the base material due to erosion. Figure 31-b shows the bottom surface of a core indicating the condition of the bond between the concrete and base. The core sample from the poor condition section shows evidence of separation (caused by erosion

and pumping action), while the sample from the good condition section shows partial debonding between the concrete slab and base. Cores from patched areas do not show evidence of separation. Concrete strength test results, shown in Figure 31-c, indicate that the concrete material is sound and there is no evidence of problems related to the strength of the concrete.

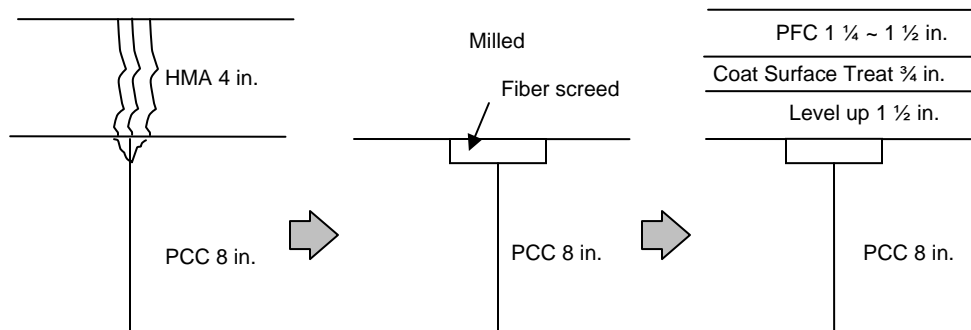
**Figure 35 US 59 Underlying JC Pavement Joint Repairs Using Fiber Screenshot in Section 4.**

Section 4 was repaired in 2002 during replacement of the AC overlay. The repair crew milled off 2.4 miles of HMA. Concrete pavement joints were repaired using fiber screed and overlaid, as shown in Figure 35. Overall condition of the section is good after 5 years of service. Figure 35 shows the standard plan and repair details. Repair steps are as follows:

1. mill off the overlay,
2. remove 1 in. depth cracked joint area,
3. filled out using fiber screed,
4. level up 1.5 in., and
5. overlay using coat surface treatment and PFC.

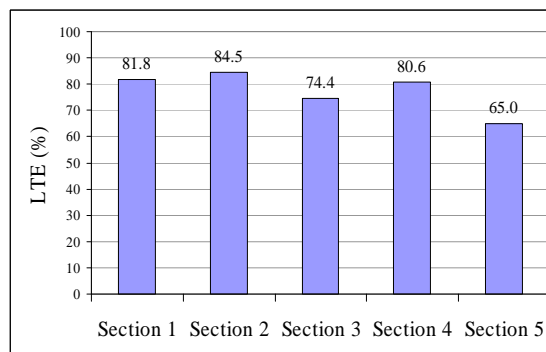
**Figure 41 LTE at Joint Locations.**

Figure 40 shows the deflections at the joint locations. Figure 41 shows the joint LTEs. There was little variation except in Section 5, which shows LTEs lower than 70 percent. Since the service life is now more than 5 years and the LTE is lower than 70 percent, this section should be carefully monitored to prevent further joint deterioration.

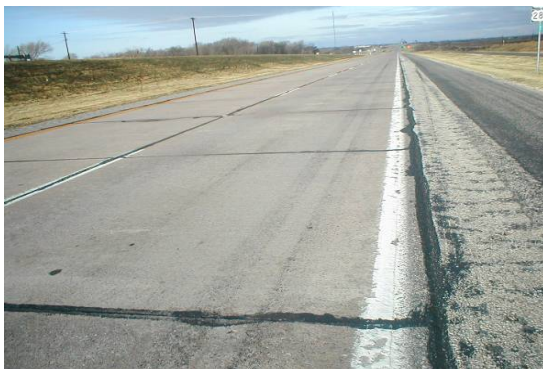
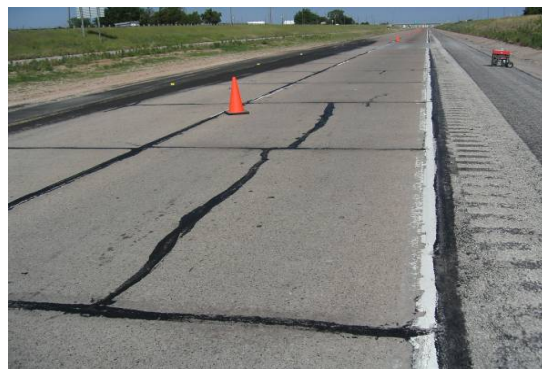
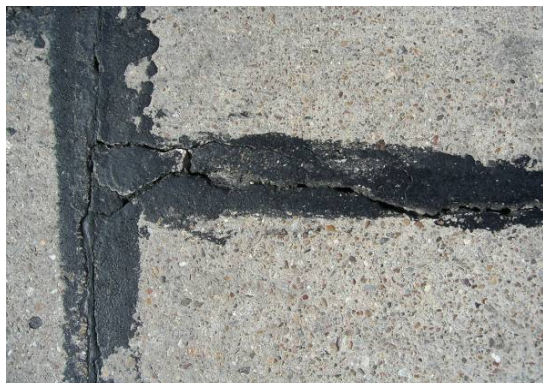
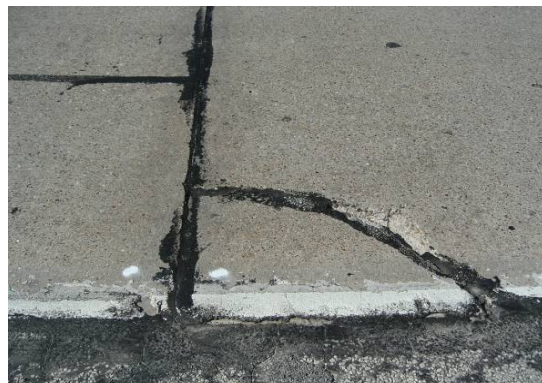
Good Condition Section

Poor Condition Section

Crack and Deteriorated Joint Sealing in Poor Condition Section

**Figure 43 Test Sections in Vernon.**

US 287 northbound JC pavement sections near Vernon, Texas, were tested using FWD, DCP, and coring. Figure 43 shows good and poor condition sections based on visual distress survey results. Both sections consist of 10 in., 15 ft jointed concrete pavement located 3 miles apart. The significant difference between them is that the good condition section has better joint sealing than the poor condition section. The crack and joint sealing in the poor condition section is damaged in many areas, and the shoulder joint is wide, as shown in Figure 43. Different aggregate type may be a factor in joint sealing problems. The aggregate type of the good condition area is limestone, and that of the poor condition area is gravel. Gravel has an approximately 50 percent higher coefficient of thermal expansion than limestone; therefore, joints and cracks in the poor condition section may have repeated wider opening and closing and more joint seal deterioration than the good condition section. Moreover, bounding gravel is negatively charged and more highly attracted to water.

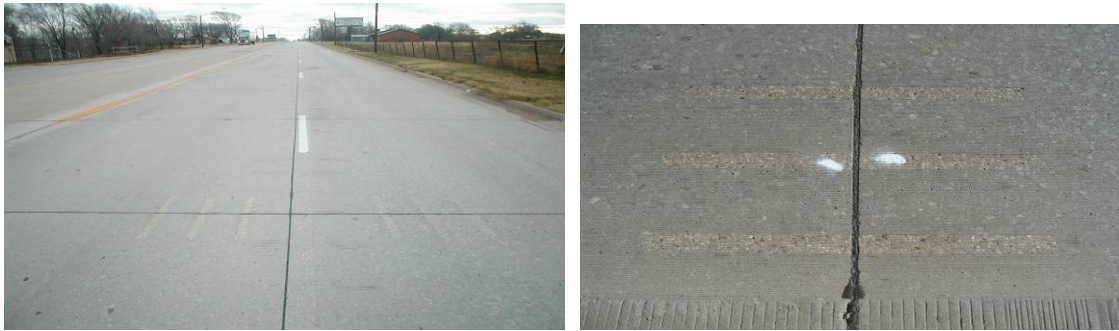
Figure 44 Repaired Section Using DBR and DG in Quanah.

Figure 44 shows the JC pavement in Quanah, Texas, which was recently repaired effectively and which shows good performance. This section was constructed using a contraction joint design without dowels in the early 1990s. The concrete slab thickness is 13 in., and the lime-treated subbase is 9 in. It had serious faulting about 10 years after construction because of poor LTE at the joint. Since there are no material problems, structural CPR using dowel bar retrofit and diamond grinding techniques were employed to repair the joints. Also, the joints and cracks were resealed to prevent water infiltration. Figure 44 shows a good joint sealing condition with no faulting after repair.

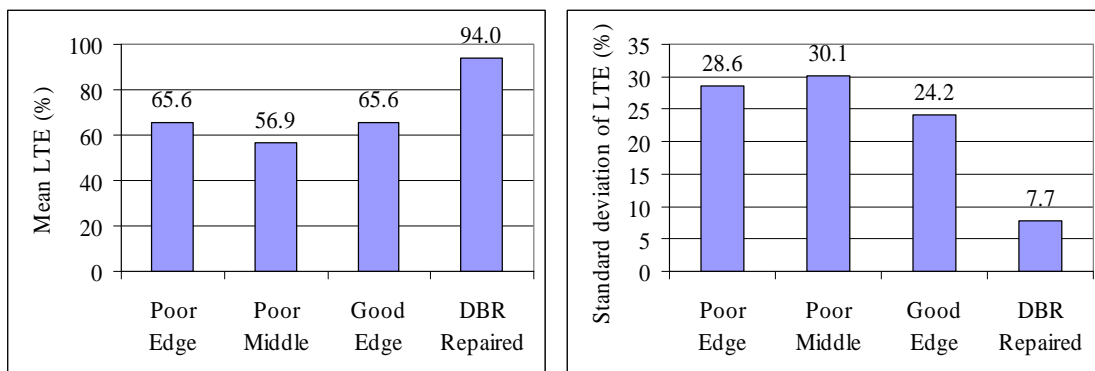
Figure 45 Load Transfer Efficiency of Test Sections in US 287.

FWD test results in Figures 45 and 46 visually show good and poor condition areas with no significant difference in LTE and BA. Both good and poor sections have lower than 70 percent of LTE with high standard deviation and an apparent restoration of load transfer to prevent further deterioration. As mentioned previously, a good joint sealing condition may result in relatively good performance even though the LTE is low. The Quanah DBR repairs show very good LTE, proving this method of repair with using diamond grinding works very well.

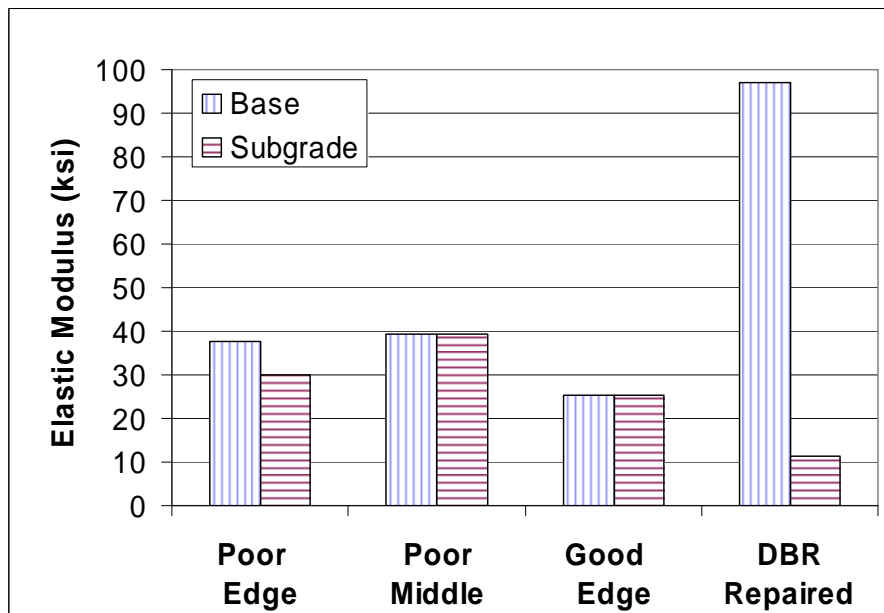
**Figure 47 Elastic Moduli of Test Sections on US 287.**

DCP test results shown in Figure 47 indicate a weak base condition for both sections in the Vernon area. It is noted, however, that the modulus of the good performing area is lower than the modulus in the poorly performing area. A possible reason is that the good condition section has experienced less base erosion and pumping damage (due to good joint sealing) but the poor condition section has experienced more damaged due to surface water infiltration through opened cracks and joints. The repaired section in Quanah shows no base layer problem but shows a low strength subgrade, which may have been related to the faulting problems in the past. However, no damage from pumping or settlement has been detected in spite of the weak subgrade condition.

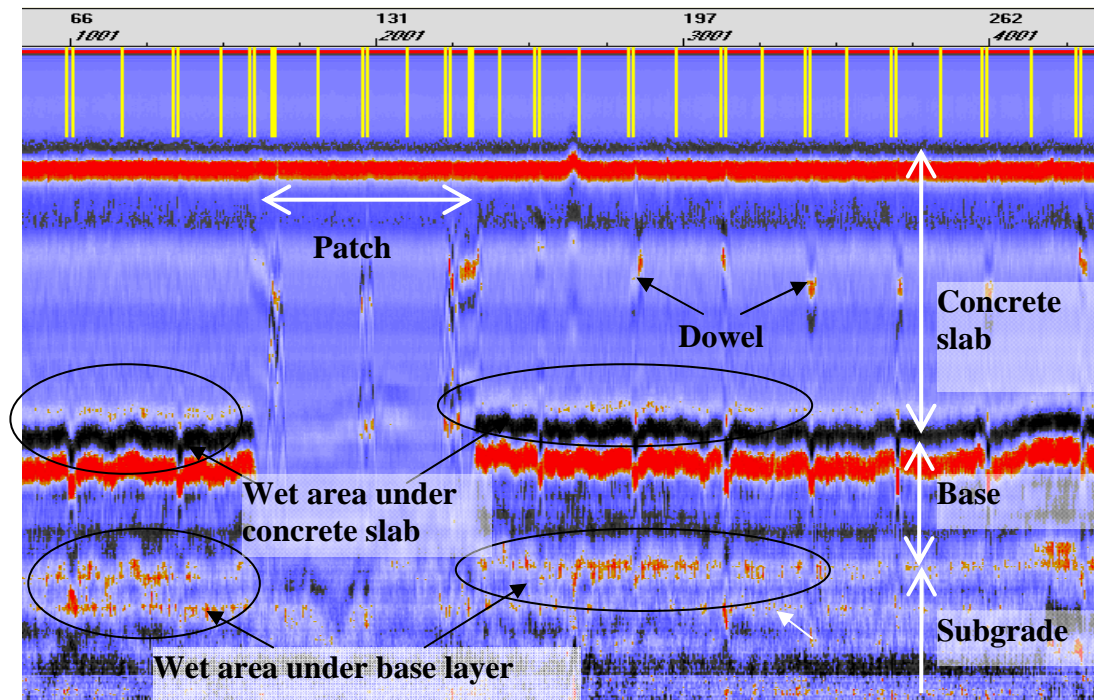
Figure 48 GPR Image of Test Section in Quanah.

Figure 48 shows a GPR image from the test section in Quanah. Some trapped moisture was observed under the concrete slab, and a significant amount of moisture was detected under the base layer. The full depth repair area shows less moisture presence because of replacement of the weak base and subgrade material during the repair process. As mentioned previously, dowel bar retrofitting and joint resealing were effective in this section. However, due to the thickness of the concrete slab and base, erosion and drainage have not been an issue. Otherwise proper repair for an eroded subgrade and installation of edge drainage may be employed prior to structural CPR to prevent premature failure of the repair area.

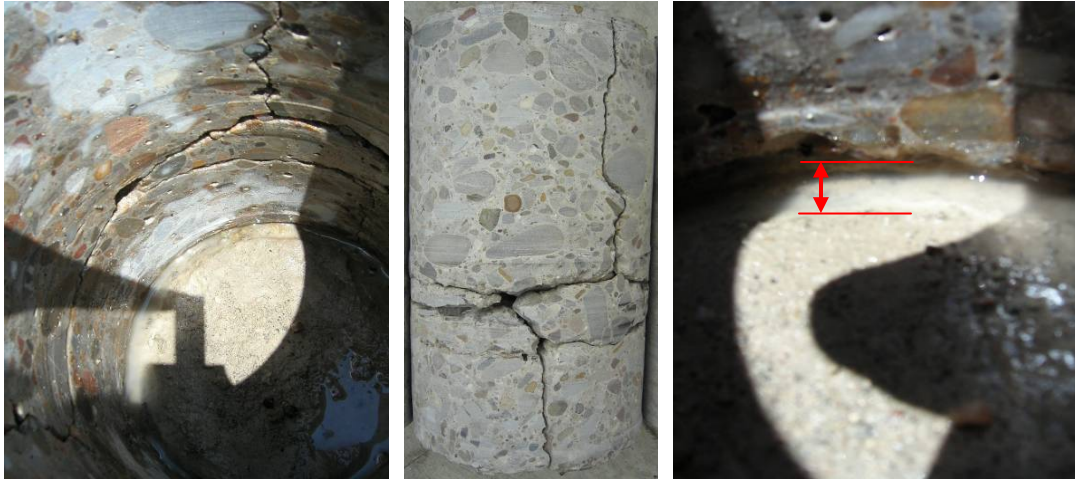
**Figure 49 Coring in Poor Condition Section.**

Figure 49 shows the core hole over a longitudinal crack location in the poor condition section. A horizontal crack at mid-depth and erosion in the base layer are noted. Eroded fines were detected, and the erosion depth was about 1 to 1.5 in. in the poor condition section. Since the aggregate type of the poor condition section is river gravel, the crack/joint opening with a higher curling effect may have contributed to pumping and erosion damage to the base material. The good condition section showed a smaller depth of erosion, and the repaired section in Quanah showed no erosion damage.

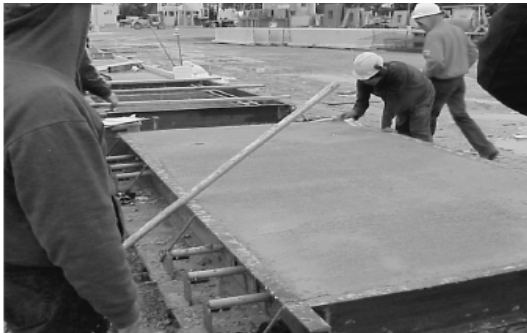
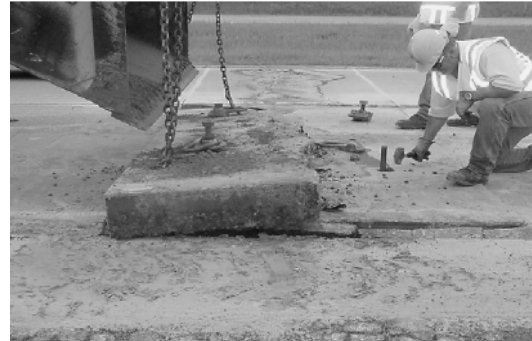
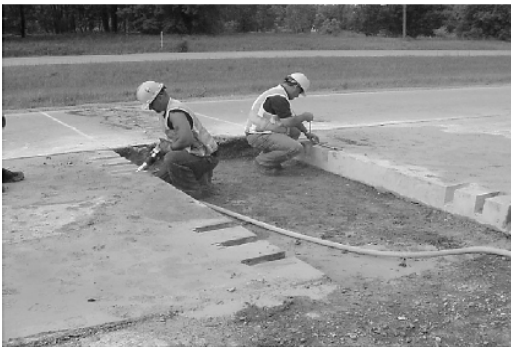
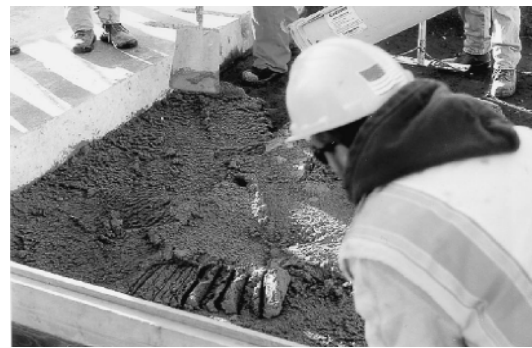
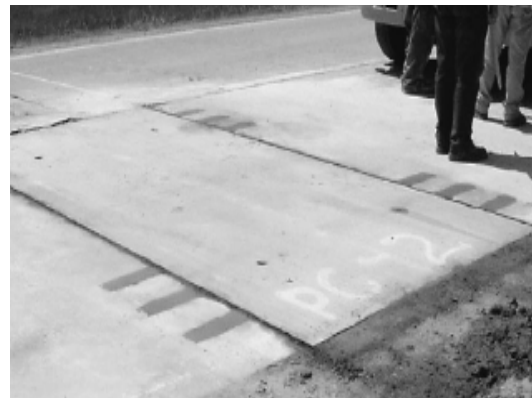
**Figure 72 Precast Concrete Slabs as Full Depth Repairs (35).**

(a) Precast PCC panel

(b) Slab removal

(c) Dowel slots

(d) Flowable fill

(e) PCC panel installation

(f) Finishing

Figure 72 shows snapshots of full depth repair in Michigan using precast concrete slab, which can reduce lane closure time by eliminating curing time. It can also expect a higher quality of concrete and less impacts from built-in curl (35).
