Evaluation of Barriers for Very High Speed Roadways

Research/Test Report 0-6071-2

**TEXAS TRANSPORTATION INSTITUTE
THE TEXAS A&M UNIVERSITY SYSTEM
COLLEGE STATION, TEXAS**

EVALUATION OF BARRIERS FOR VERY HIGH SPEED ROADWAYS

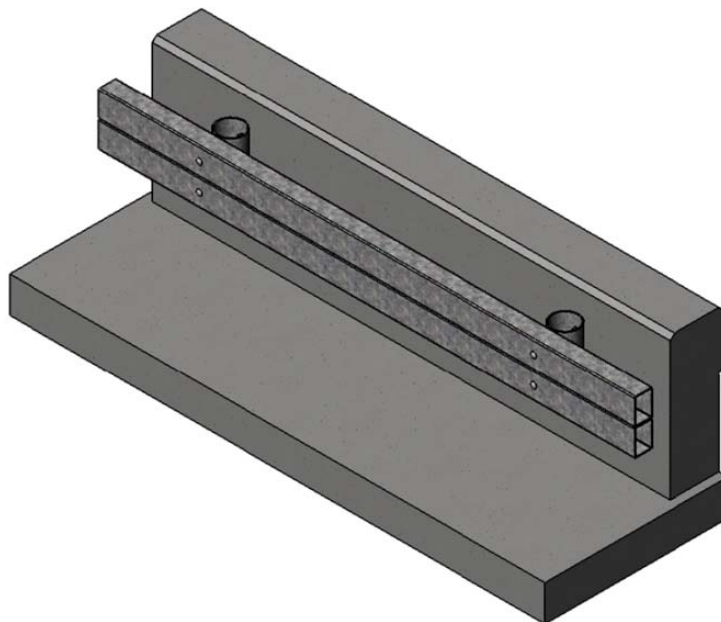
Therefore, the basic concept of the energy absorbing bridge rail shown in [Figure 2.1](#) was conceived. This concept involves using a vertical concrete wall to support two tubular steel rails. Pipe spacers are incorporated into the system to offset the tubular rails from the rigid concrete parapet and to function as an energy-absorbing mechanism. The spacers are intended to deform upon vehicle impact and, thereby, absorb some of the vehicle's kinetic energy to lessen the impact severity below that of impacting a rigid concrete wall.

Figure 2.1. Conceptual Drawing of the Energy Absorbing Bridge Rail.

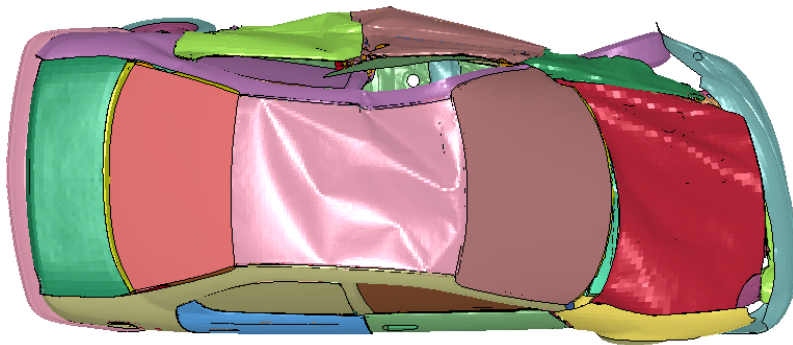
The researchers also evaluated the affect of pipe spacing on the overall performance of the rail. It was expected the by placing the pipes closer, the collapse of the pipes will occur at a slower rate, which may reduce the occupant compartment deformation in the small passenger vehicle and/or improve stability of the pickup. A small passenger car impact simulation was performed with the Schedule 40 pipes spacing on 4-ft centers along the length of the rail. The results were compared to those for the rail with 6.25-ft pipe spacing. The results are shown in [Figure 2.7](#). While the pipes collapsed at a slower rate when placed closer together, no significant differences were observed in the occupant compartment deformation. Thus the larger pipe spacing of 6.25-ft was selected for the final design.

4-ft pipe spacing

6.25-ft pipe spacing

Figure 2.7. Affect of Pipe Spacing.

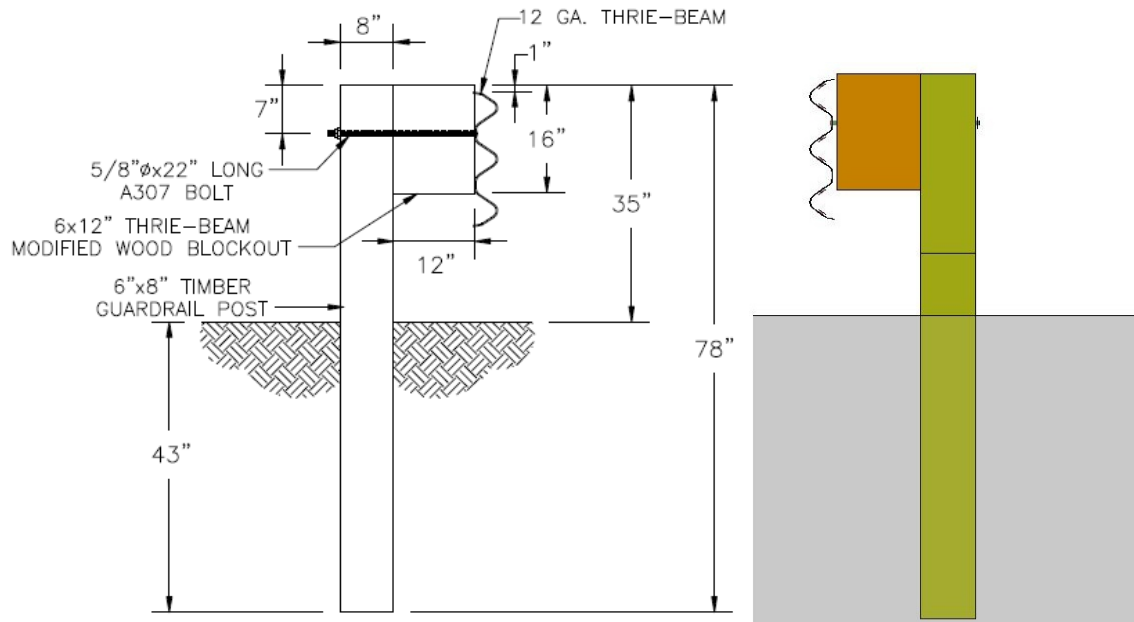
The modified wood post thrie-beam guardrail that was modeled is shown in [Figure 3.1](#). The thrie beam rail is mounted on 6-inch × 8 inch wood posts at a height of 34 inches. The rail is offset from the post using partial depth 6-inch × 12-inch wood spacer blocks. The bottom

corrugation of the thrie beam rail is left unsupported. The rail and the blockout are attached to the post using a 5/8-inch diameter × 22-inch long bolt.

Figure 3.1. Cross Section of the Modified Wood Post Thrie-Beam System from Drawings and Model.

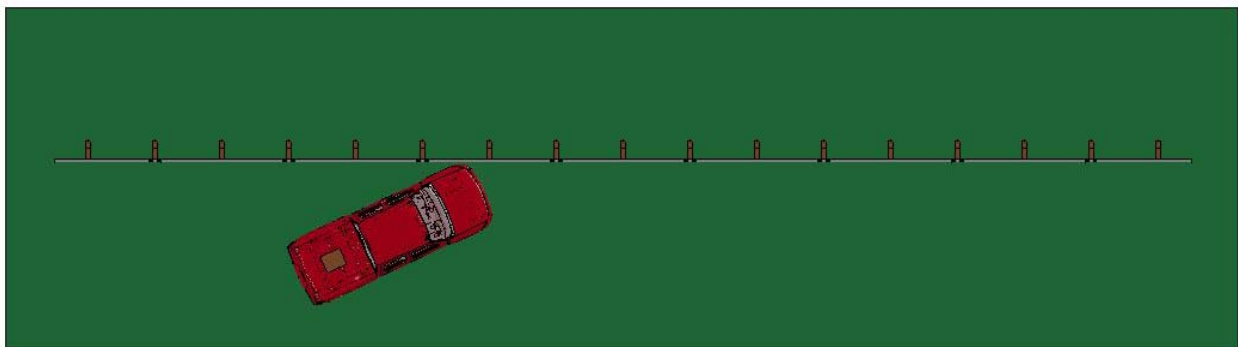
The length of the system modeled was 106 ft-3 inches and had 17 wood posts spaced 6 ft-3 inches center to center as shown in Figure 3.2. The ends of the thrie-beam rail were attached to springs that were assigned properties representative of the stiffness of a 37.5-ft long, *NCHRP Report 350* TL-3 compliant terminal system.

Figure 3.2. System Layout with Vehicle Impact Location.

The vehicle model used in the impact simulation was a ½-ton, 4-door, Chevrolet Silverado that is representative of the 2270P design vehicle in *MASH*. This vehicle model was developed by the National Crash Analysis Center under the sponsorship of the Federal Highway Administration. The vehicle was assigned an initial velocity of 85 mi/h and had a 25 degree impact angle with the barrier as shown in [Figures 3.2 and 3.3](#). The vehicle impact location was just before the 7th post from the upstream end of the barrier as shown in [Figure 3.2](#).

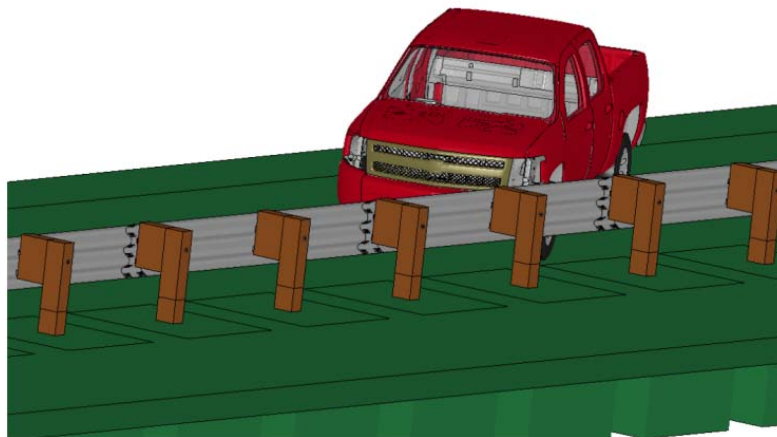
Figure 3.3. Iso-Parametric View of the 2270 kg Vehicle Set Up with the Modified Thrie-Beam Rail.

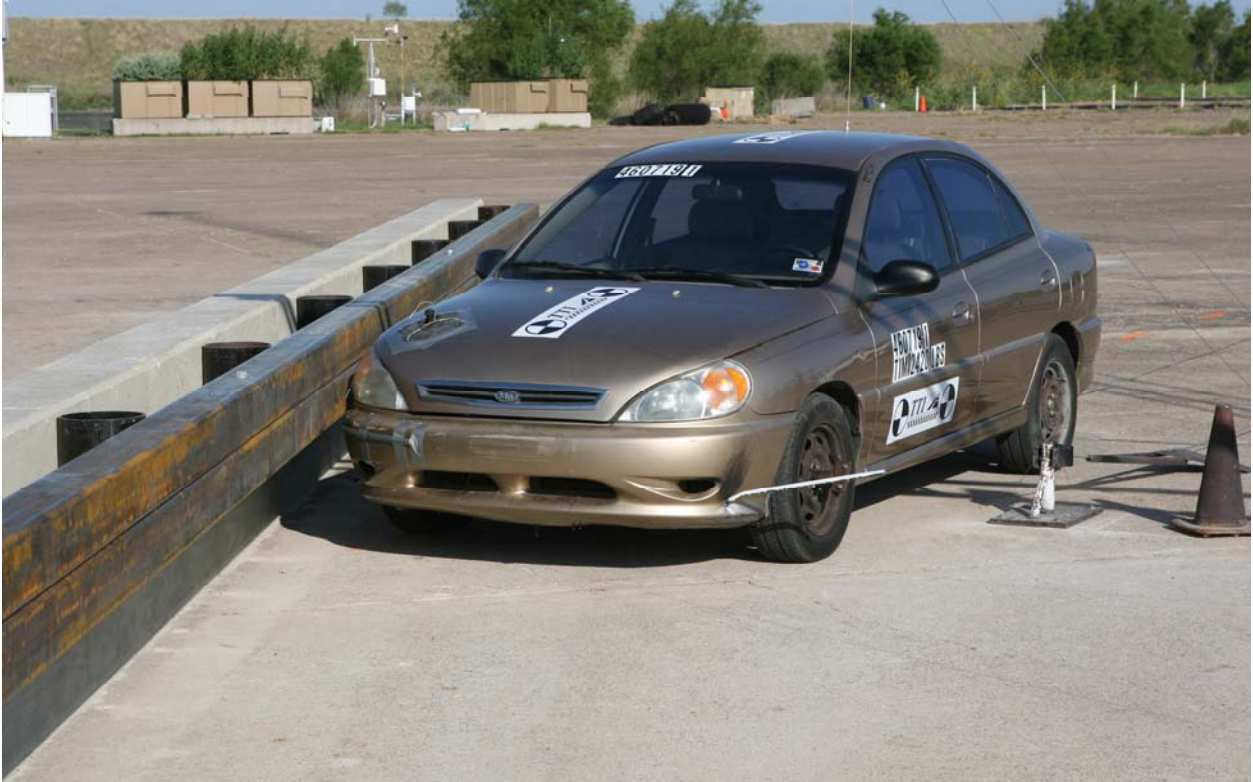
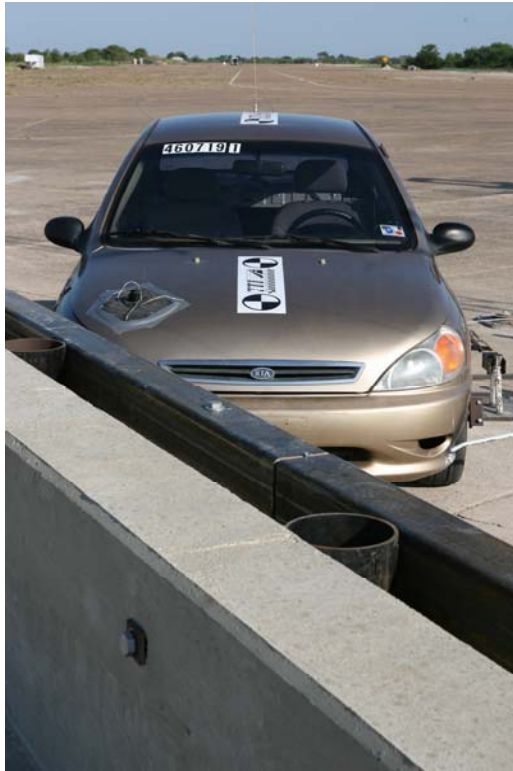
A 2002 Kia Rio, shown in [Figures 5.3](#) and [5.4](#), was used for the crash test. Test inertia weight of the vehicle was 2438 lb, and its gross static weight was 2606 lb. The height to the lower edge of the vehicle bumper was 8.50 inches, and the height to the upper edge of the bumper was 22.75 inches. [Figure C1](#) in [Appendix C](#) gives additional dimensions and information on the vehicle. The vehicle was directed into the installation using the cable reverse tow and guidance system and was released to be free-wheeling and unrestrained just prior to impact.

Figure 5.3. Vehicle/Installation Geometrics for Test No. 460719-1.

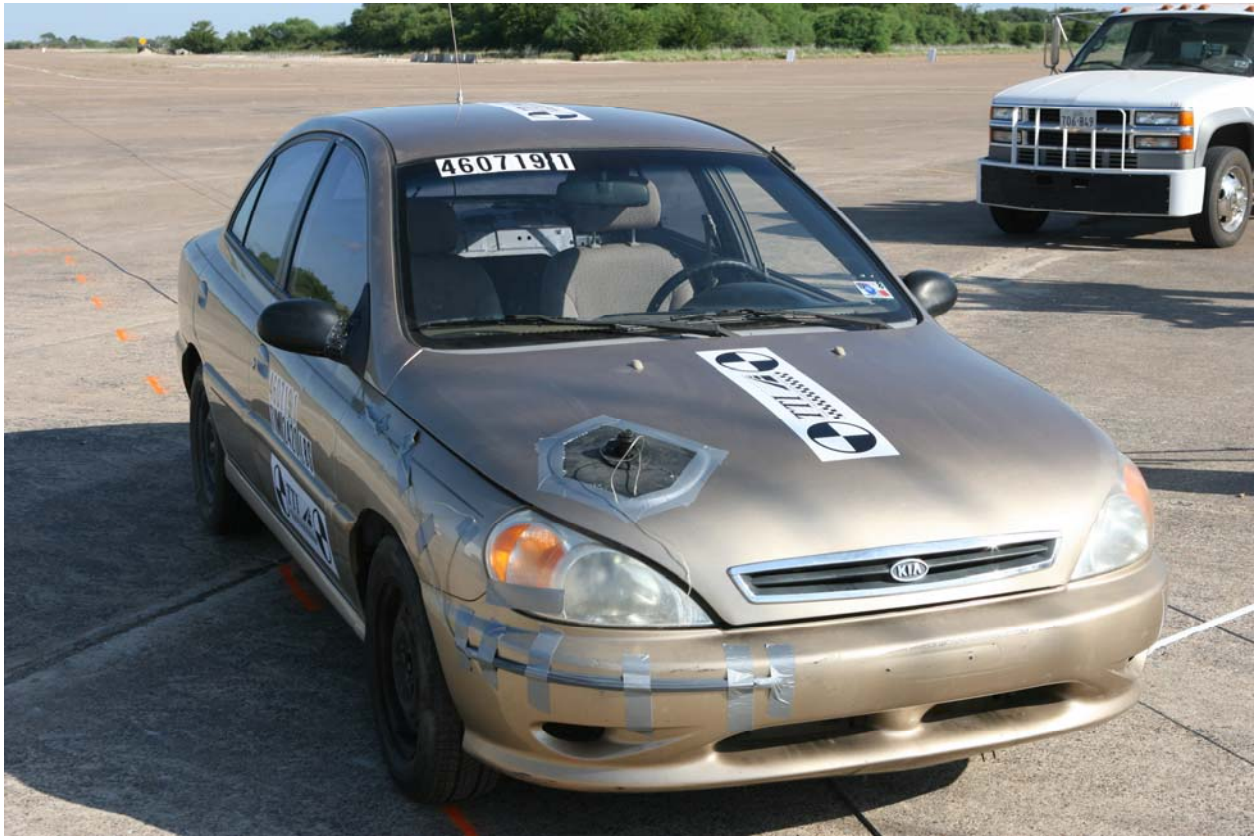
Figure 5.4. Vehicle before Test No. 460719-1.

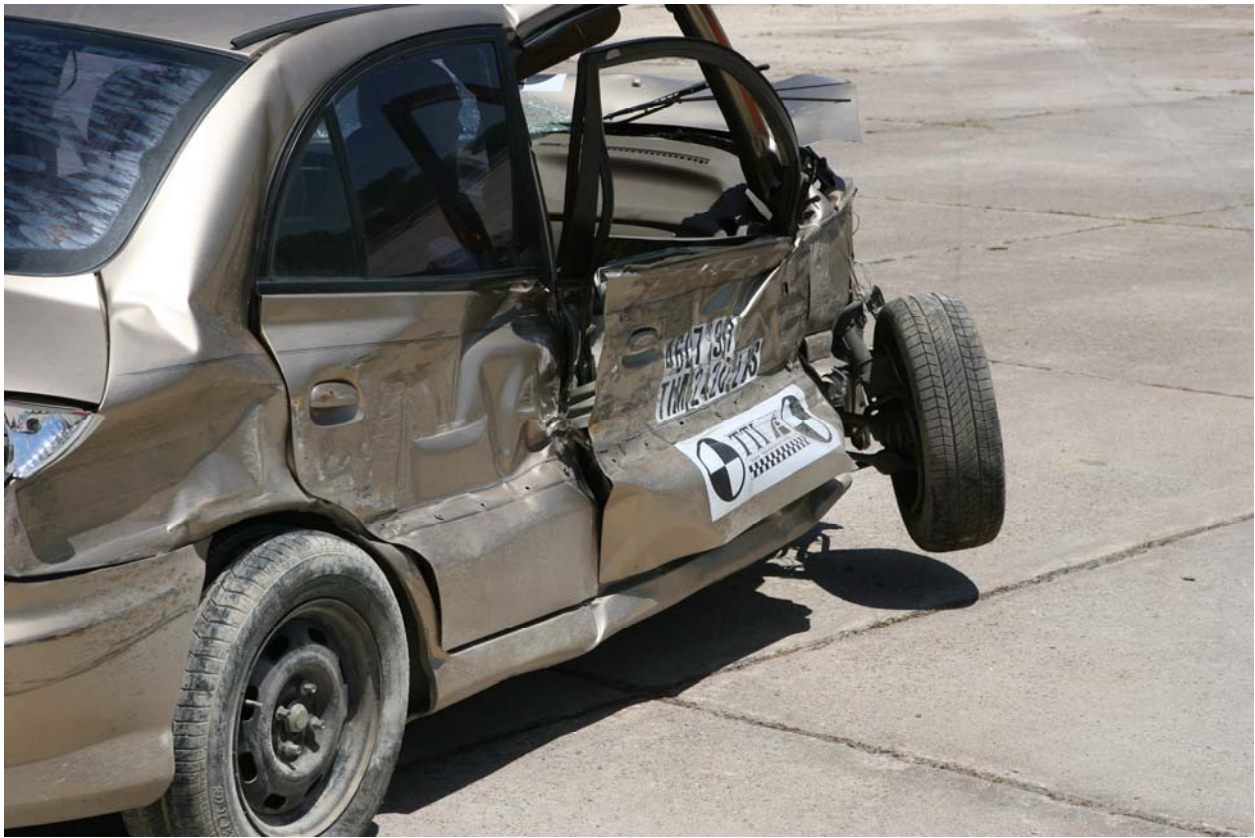
A secondary frontal impact of the redirected vehicle with the end of another rigid concrete barrier complicated the damage assessment of the vehicle. The secondary impact occurred on the left side of the vehicle and, therefore, the following damage on the right side of the vehicle was attributed to the initial impact with the bridge rail. The front bumper, hood, right front fender, right front tire and wheel rim, roof over the passenger side, right B-post, right door and door glass, right rear quarter panel, rear bumper, right side floor pan, right side firewall, and right side kickpanel were damaged due to impact with the energy-absorbing bridge rail. Maximum exterior crush to the right side of the vehicle was 16 inches in the side plane at the right front corner at bumper height. Maximum occupant compartment deformation (OCD) on the right side was 9.0 inches in the firewall area. It is believed that the secondary impact likely contributed to the damage in this area, but the OCD measurement was not adjusted for this. Photographs of the vehicle after the test are shown in [Figures 5.6 and 5.7](#). Exterior crush and occupant compartment measurements are documented in [Appendix C](#), [Tables C1 and C2](#).

Figure 5.6. Vehicle after Test No. 460719-1.

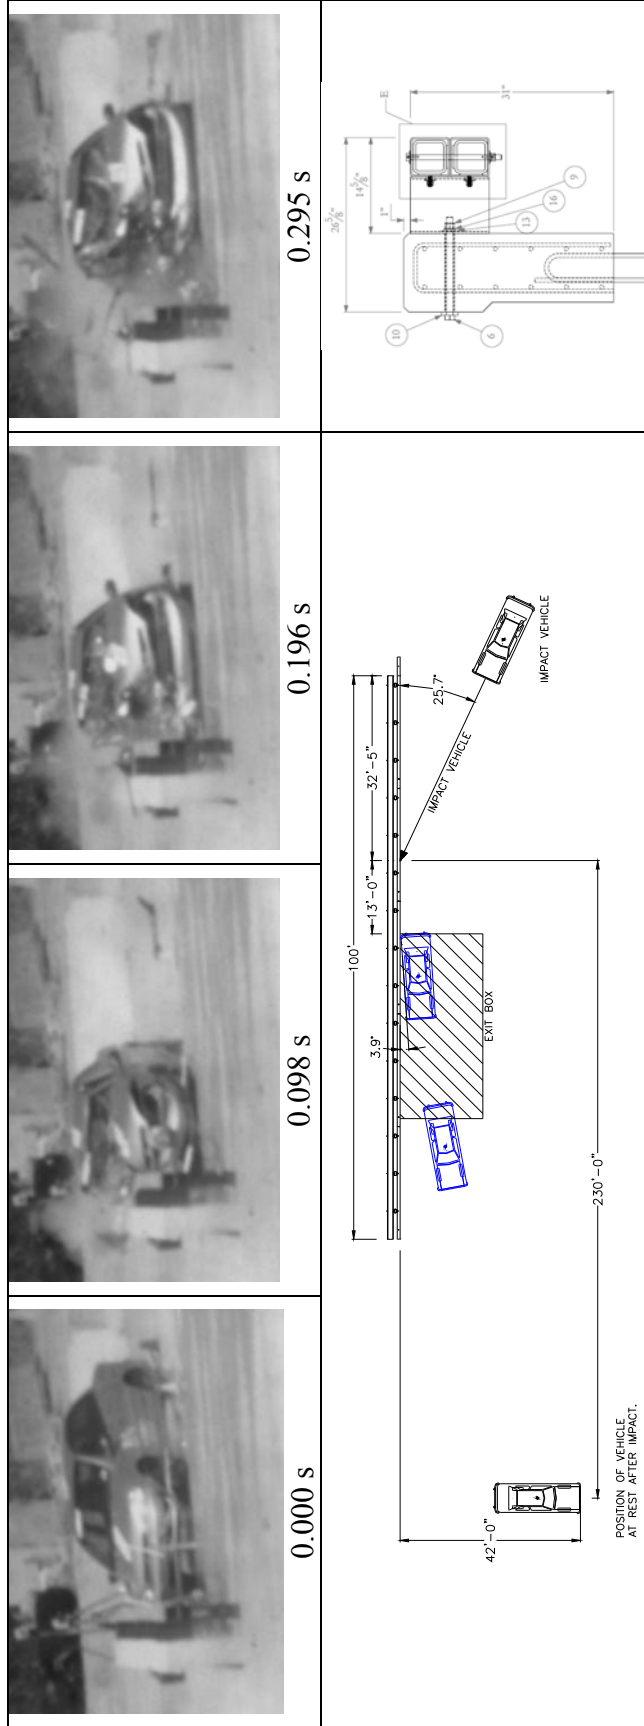
General Information		Impact Conditions		Post-Impact Trajectory	
Test Agency	Texas Transportation Institute	Speed	85.2 mi/h	Stopping Distance	230 ft down traffic
Test No.	406719-1	Angle	25.7 degrees	Location/Orientation	1/3 point
Date	2009-08-07	Exit Conditions		Vehicle Stability	
Test Article		Speed	67.6 mi/h	Maximum Yaw Angle	-40 degrees
Type	Longitudinal Barrier	Angle	3.9 degrees	Maximum Pitch Angle	10 degrees
Name	High-Speed Energy-Absorbing Bridge Rail	Occupant Risk Values		Maximum Roll Angle	12 degrees
Installation Length	100 ft	Impact Velocity		Vehicle Snagging	No
Material or Key Elements	Reinforced concrete parapet; tubular steel rails; collapsible pipe spacers	Longitudinal	24.6 ft/s	Vehicle Pocketing	No
Soil Type and Condition		Lateral	40.7 ft/s	Test Article Deflections	
Test Vehicle		THIV	48.2 km/h	Dynamic	7.5 inches
Type/Designation	1100C	Ridedown Accelerations		Permanent	5.25 inches
Make and Model	2002 Kia Rio	Longitudinal	-16.3 G	Working Width	1.0 ft

Curb	2399 lb	Lateral	-10.0 G	Vehicle Damage	
Test Inertial	2438 lb	PHD	19.0 G	VDS	01RFQ6
Dummy	168 lb	ASI	2.94	CDC	01FREW6
Gross Static	2606 lb	Max. 0.050-s Average		Max. Exterior Deformation	16.0 inches
		Longitudinal	-16.1 G	Max. Occupant Compartment Deformation	9.0 inches
		Lateral	-24.0 G		
		Vertical	-5.0 G

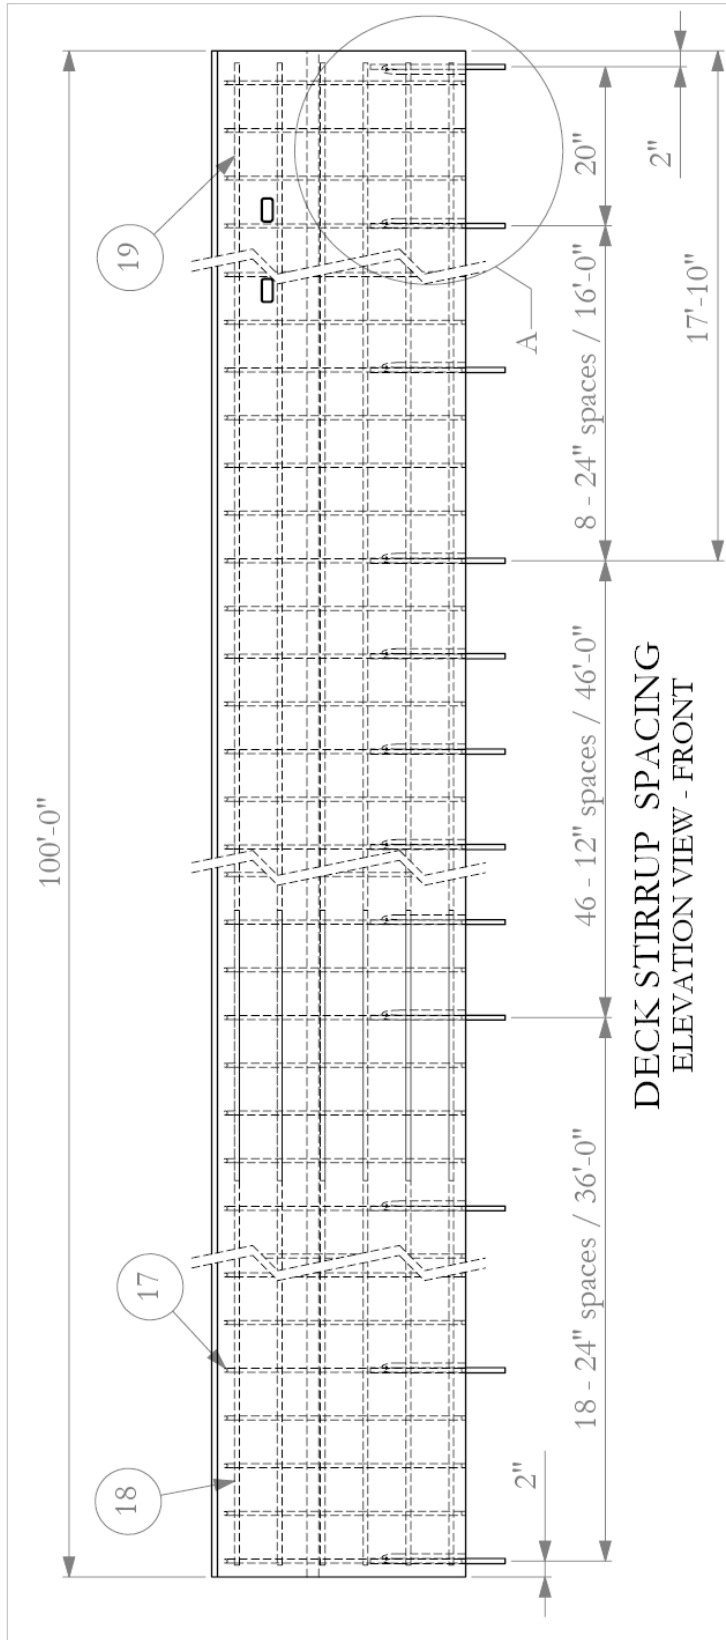
**DECK STIRRUP SPACING
ELEVATION VIEW - FRONT**

DECK STIRRUPS (20) TURNED TO AVOID 17" #5 REBAR (21)

DECK STIRRUPS AND 17" #5 BARS IN 3/4" x 5" HOLES DRILLED IN CONCRETE, ANCHORED WITH HILTI RE500 EPOXY.

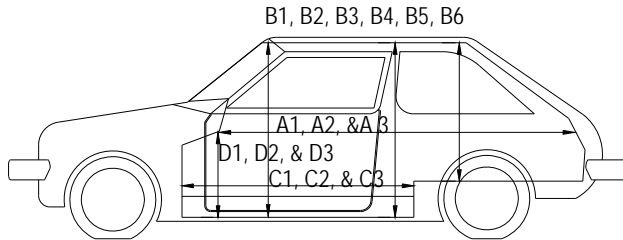
Table C2. Occupant Compartment Measurements for Test No. 460719-1.

OCCUPANT COMPARTMENT DEFORMATION MEASUREMENT

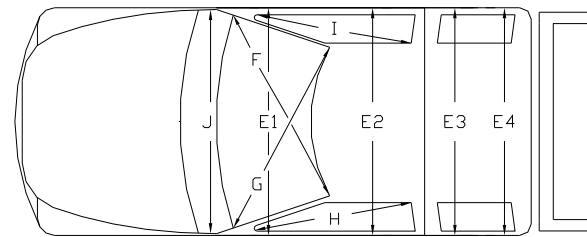
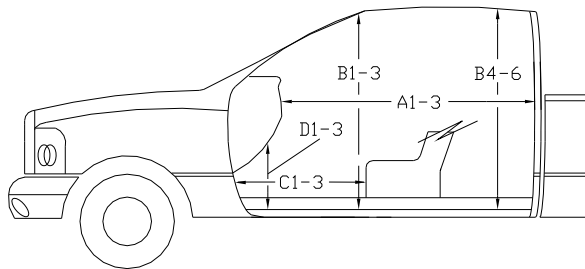
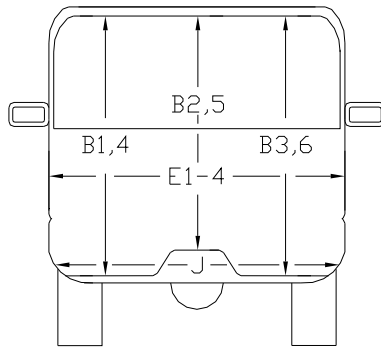
OCCUPANT COMPARTMENT DEFORMATION MEASUREMENT

Date: 2009-08-14 Test No.: 460719-2 VIN No.: 3D7HA18N22G161086
 Year: 2002 Make: Dodge Model: Ram 1500

Before (inches)	After (inches)
A1	64.50	64.25
A2	64.25	63.50
A3	65.25	63.25
B1	44.50	48.75
B2	39.38	71.69
B3	45.25	47.25
B4	42.18	43.31
B5	42.50	43.44
B6	42.19	38.50
C1	29.50	-----
C2	-----	-----
C3	27.25	26.00
D1	12.75	-----
D2	2.62	N/A
D3	11.62	14.75
E1	62.50	N/A
E2	64.75	N/A
E3	64.50	N/A
E4	64.12	62.38
F	60.00	59.00
G	60.00	57.00
H	39.75	N/A
I	39.75	37.25
J*	24.56	16.25

*Lateral area across the cab from driver's side kickpanel to passenger's side kickpanel.

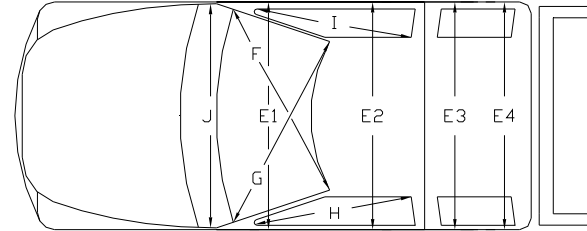
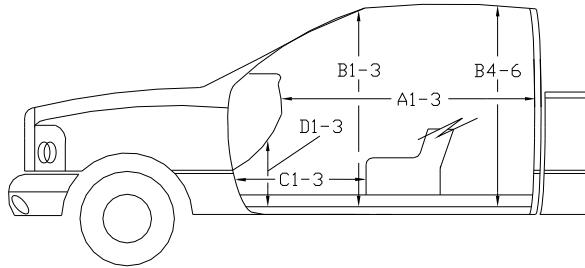
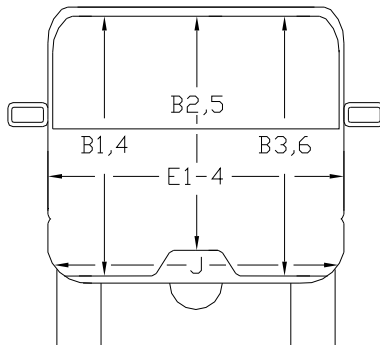
OCCUPANT COMPARTMENT DEFORMATION MEASUREMENT

Year: 2003 Make: Dodge Model: Ram 1500 Quad-Cab

Before (inches)	After (inches)
A1	64.44	64.44
A2	64.50	64.50
A3	65.12	65.12
B1	45.25	45.25
B2	39.25	39.25
B3	45.50	45.50
B4	52.25	52.25
B5	42.75	42.75
B6	42.75	42.75
C1	29.75	29.75
C2	-----	-----
C3	27.75	27.75
D1	12.75	12.75
D2	2.50	2.50
D3	11.62	11.62
E1	62.50	62.50
E2	64.50	64.50
E3	64.31	64.31
E4	64.00	64.00
F	59.50	59.50
G	59.50	59.50
H	39.00	39.00
I	39.00	39.00
J*	62.12	62.12

*Lateral area across the cab from driver's side kickpanel to passenger's side kickpanel.

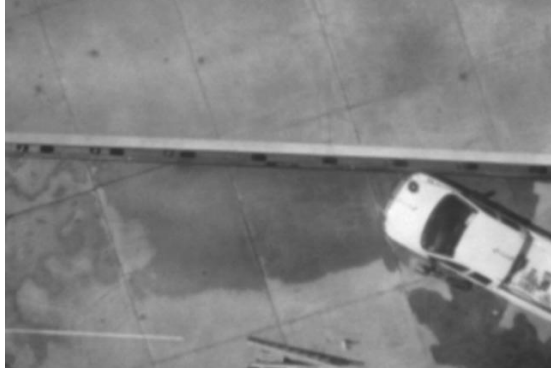
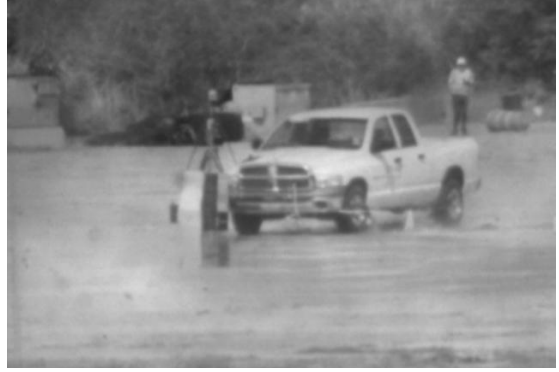
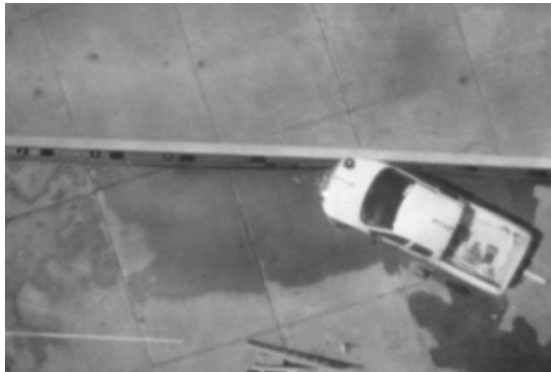
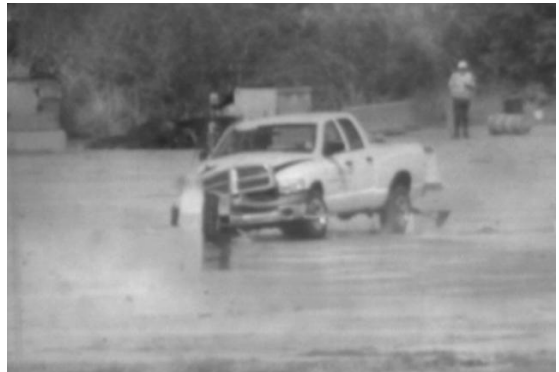
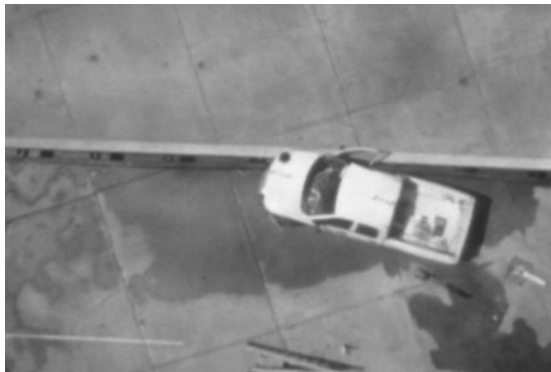
Figure D3. Sequential Photographs for Test 460719-2 (Overhead and Frontal Views).

0.000 s

0.049 s

0.098 s

0.147 s

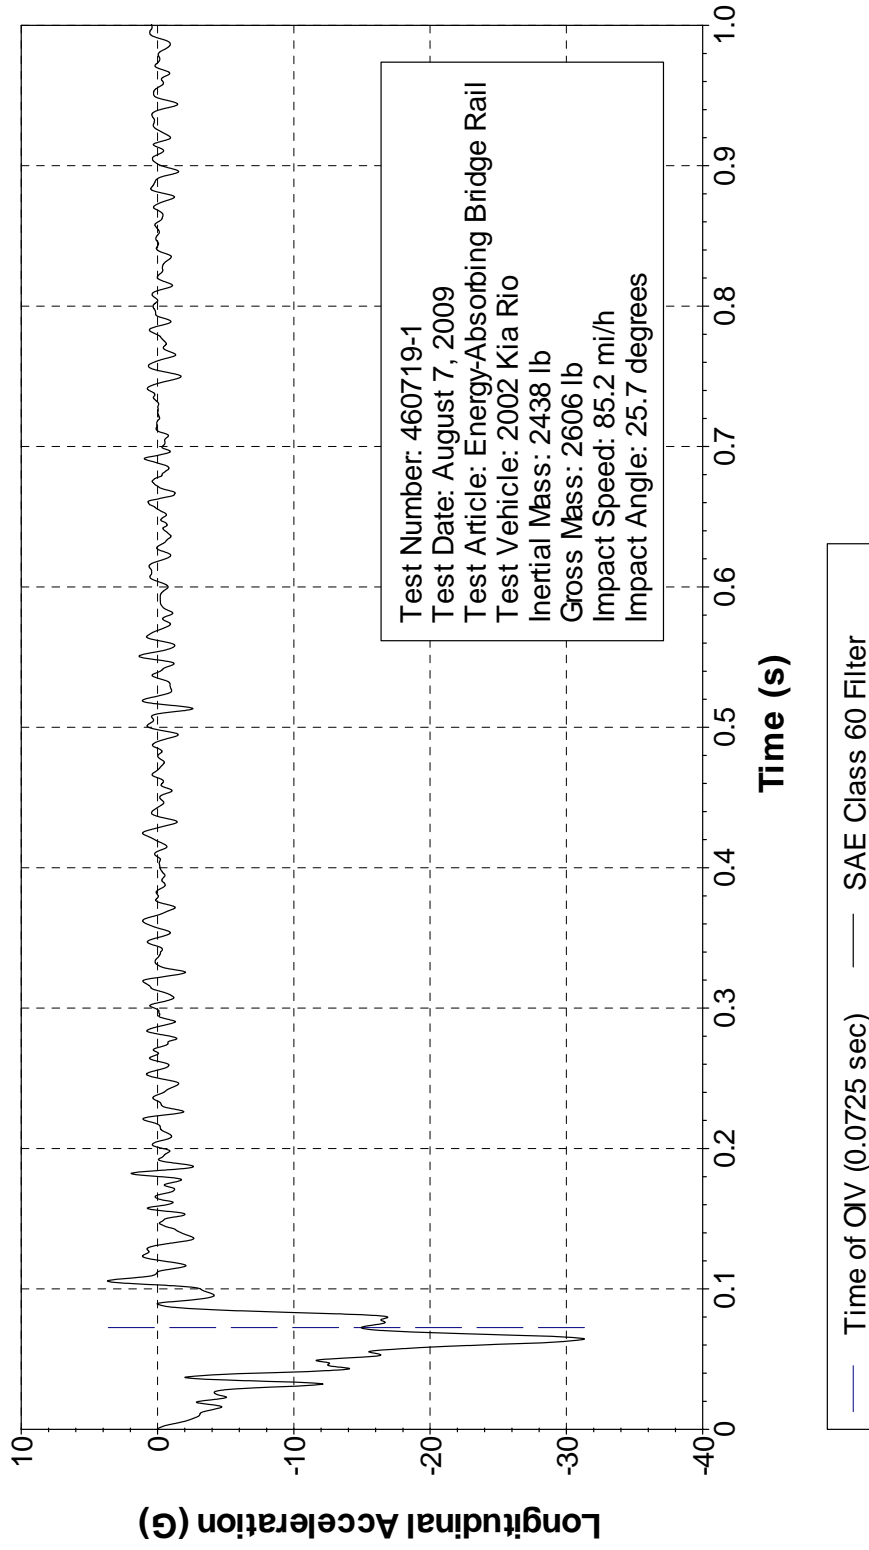
Figure E2. Vehicle Longitudinal Accelerometer Trace for Test No. 460719-1 (Accelerometer Located at Center of Gravity).

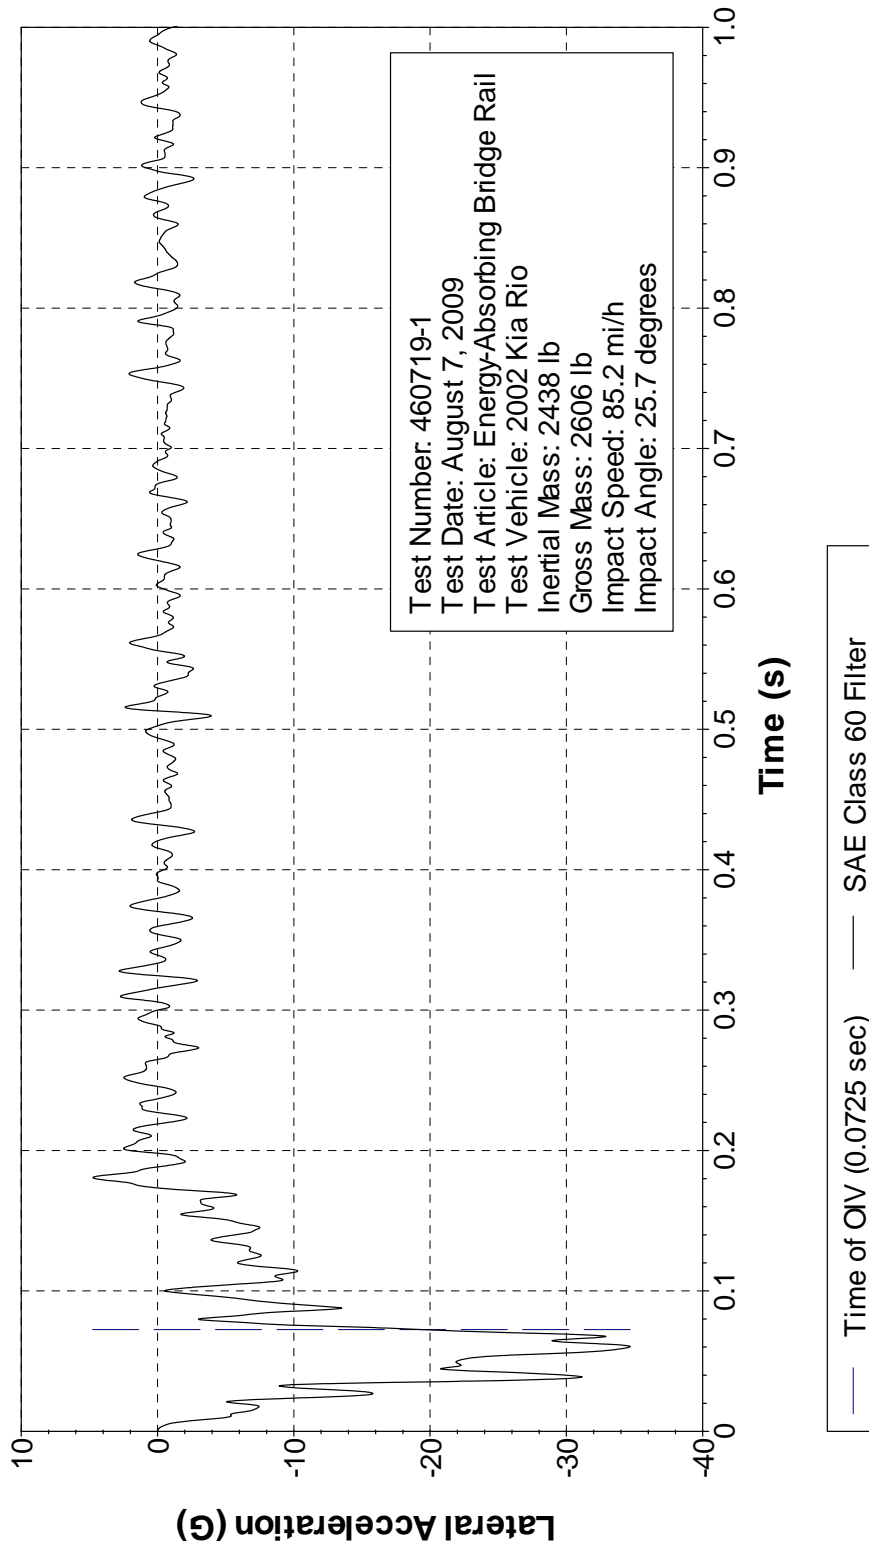
Figure E3. Vehicle Lateral Accelerometer Trace for Test No. 460719-1 (Accelerometer Located at Center of Gravity).

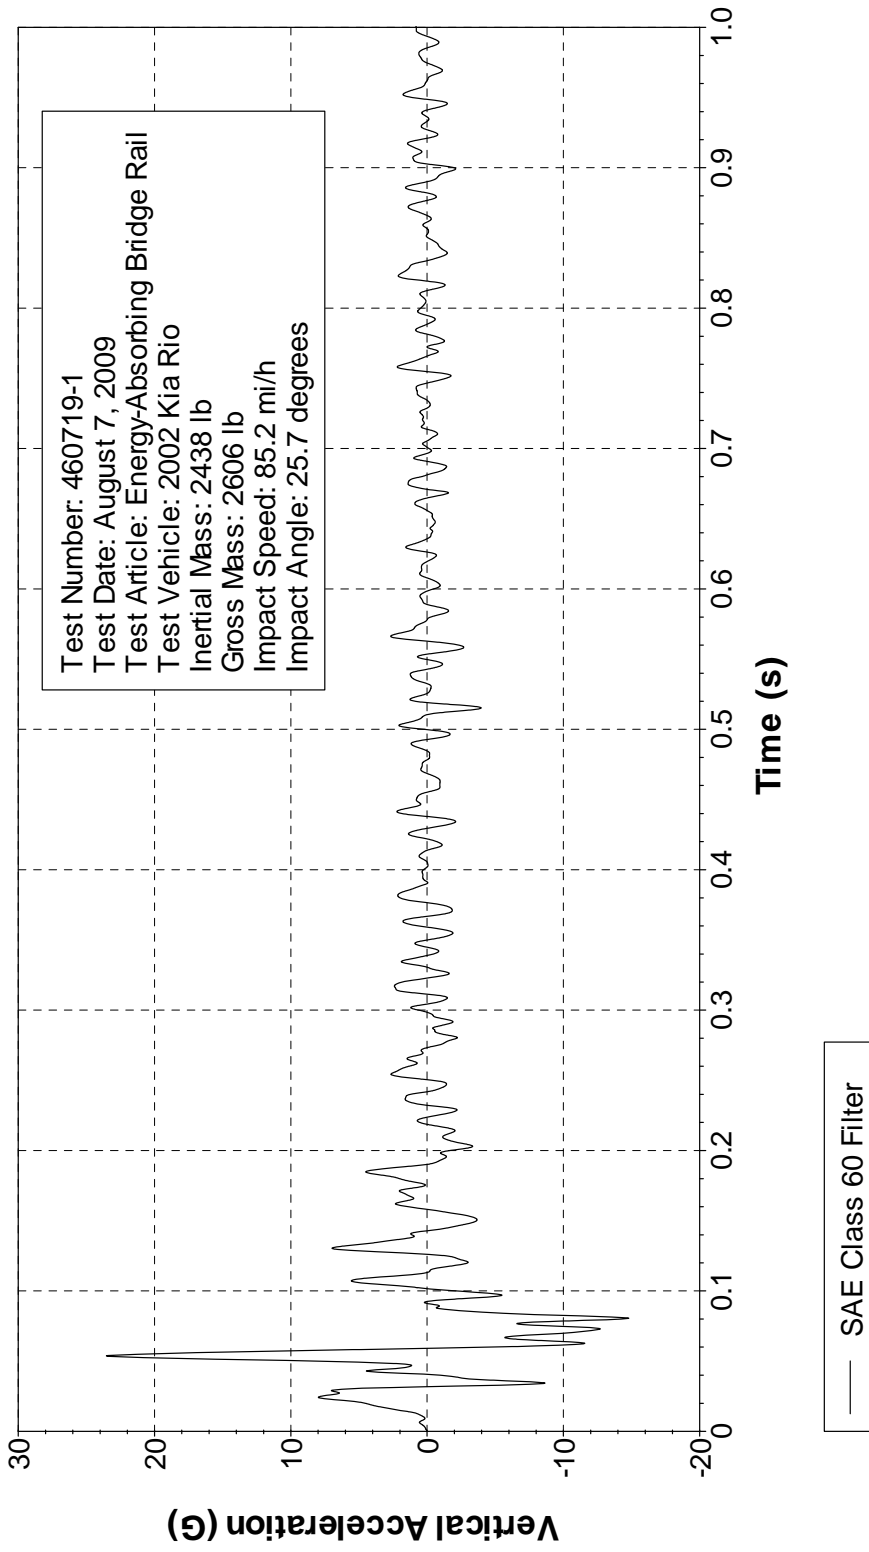
**Figure E4. Vehicle Vertical Accelerometer Trace for Test No. 460719-1
(Accelerometer Located at Center of Gravity).**

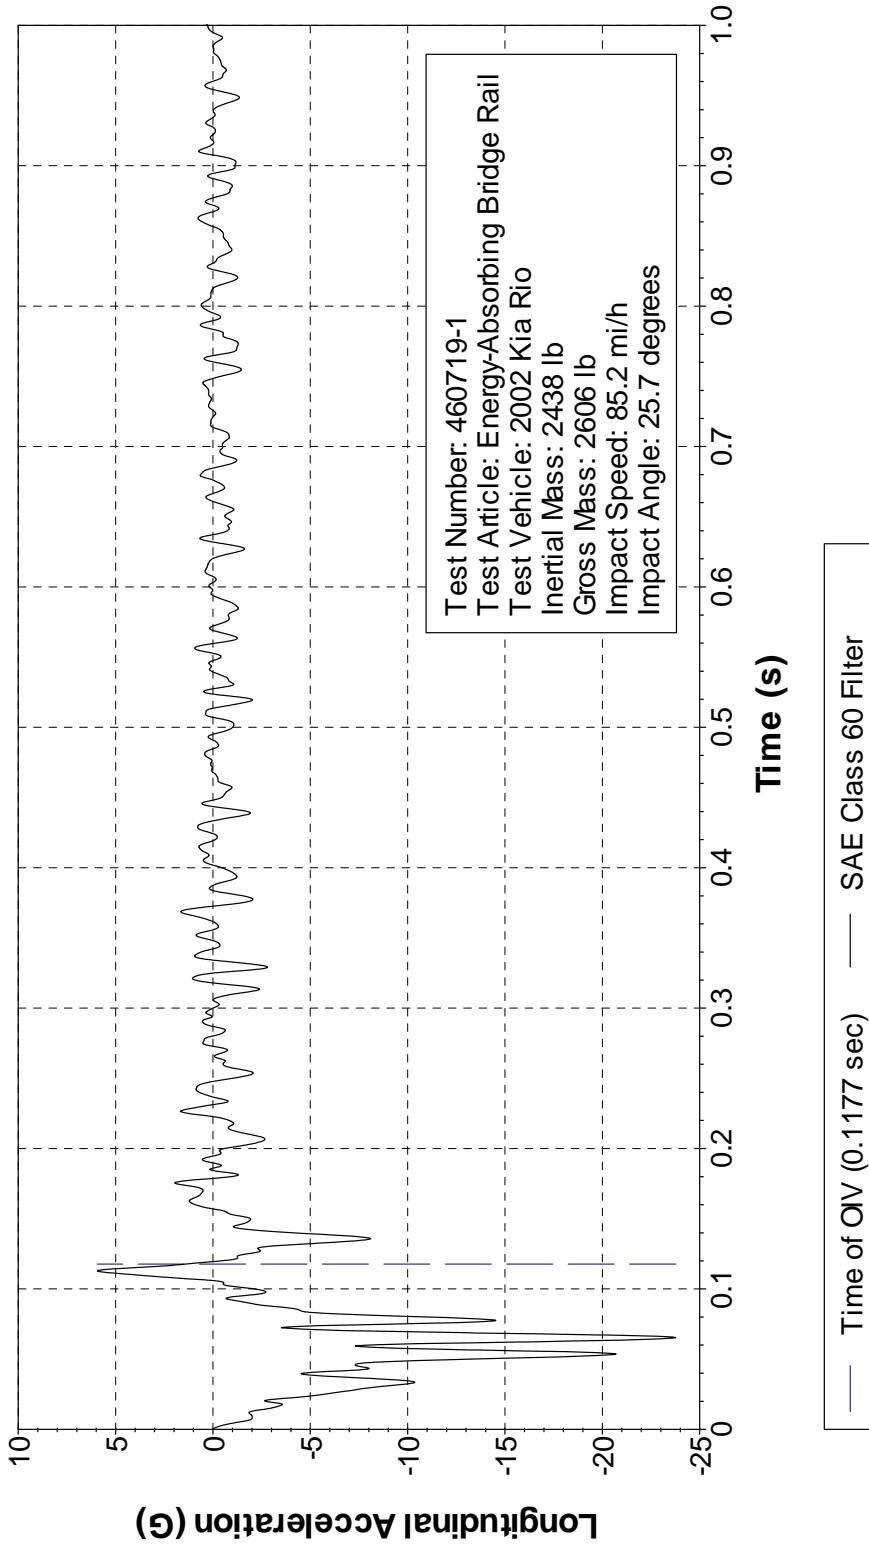
Figure E5. Vehicle Longitudinal Accelerometer Trace for Test No. 460719-1 (Accelerometer Located over Rear Axle).

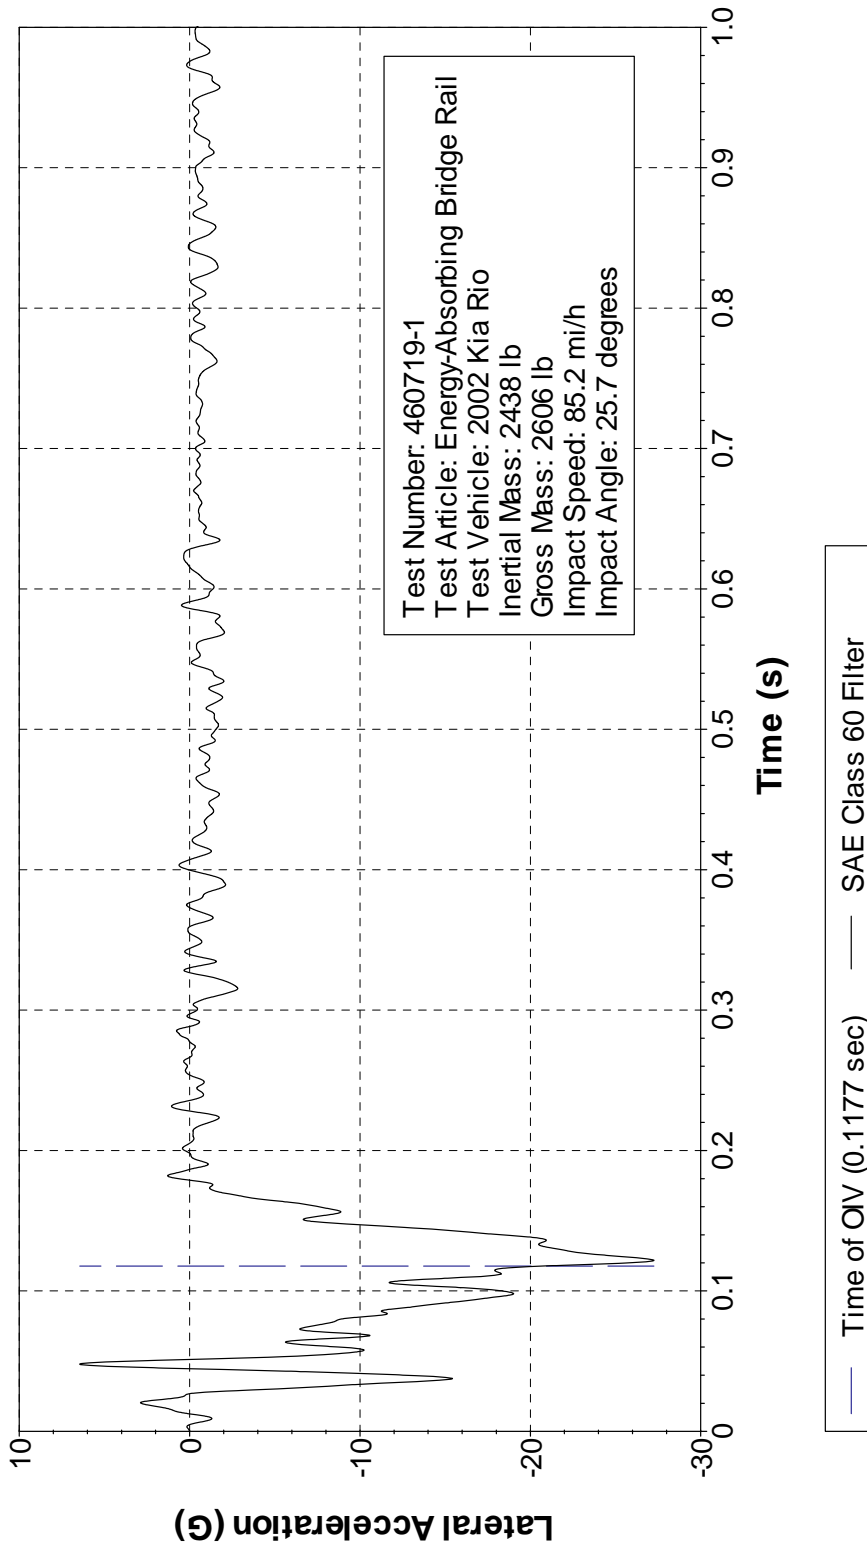
Figure E6. Vehicle Lateral Accelerometer Trace for Test No. 460719-1
(Accelerometer Located over Rear Axle).

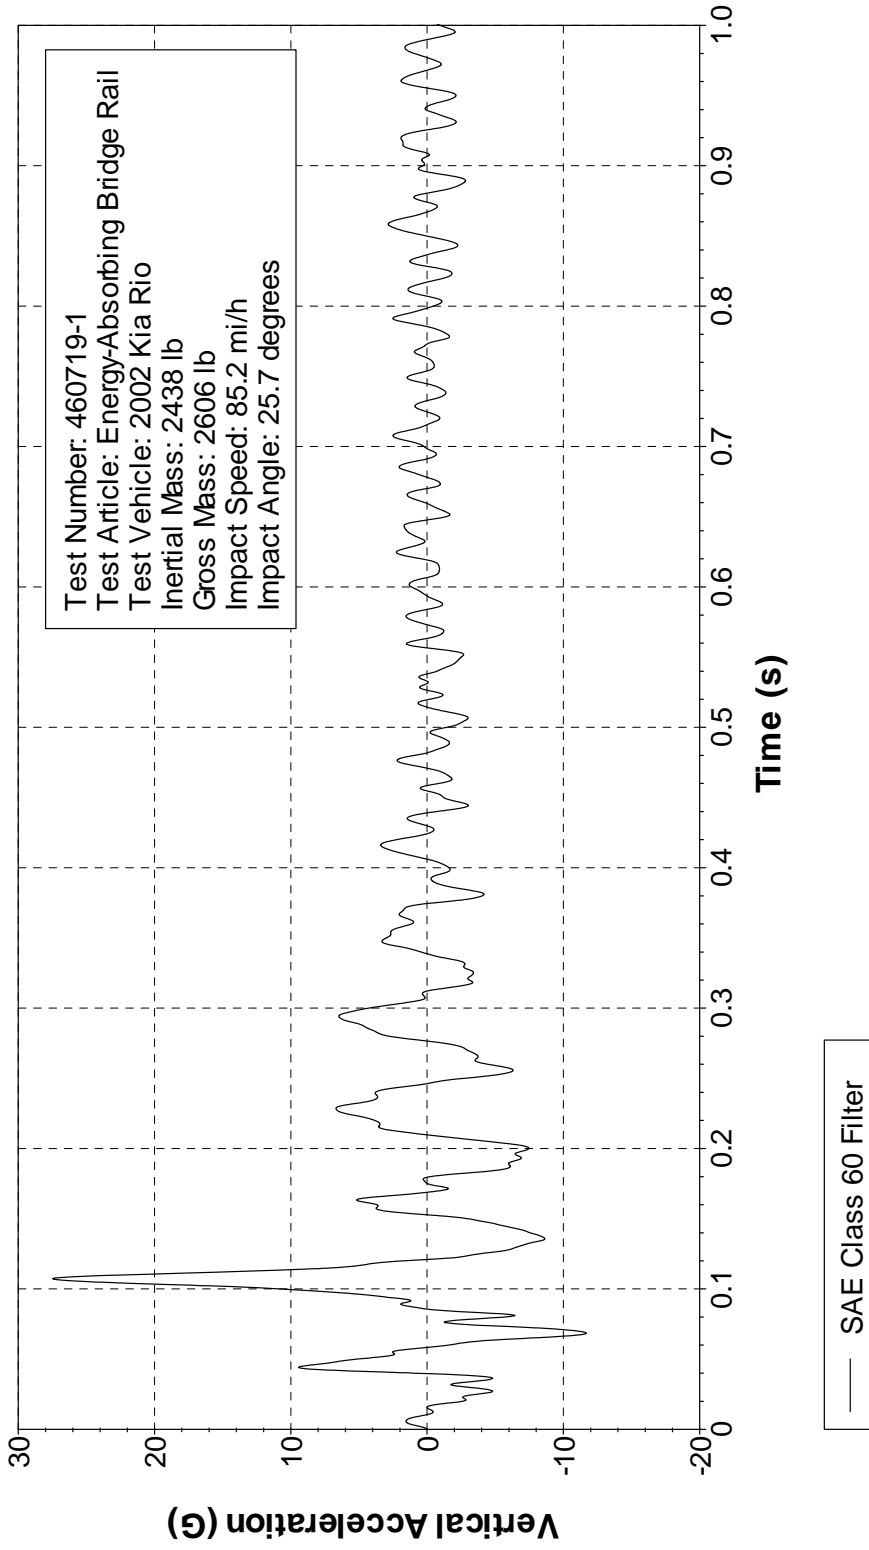
**Figure E7. Vehicle Vertical Accelerometer Trace for Test No. 460719-1
(Accelerometer Located over Rear Axle).**

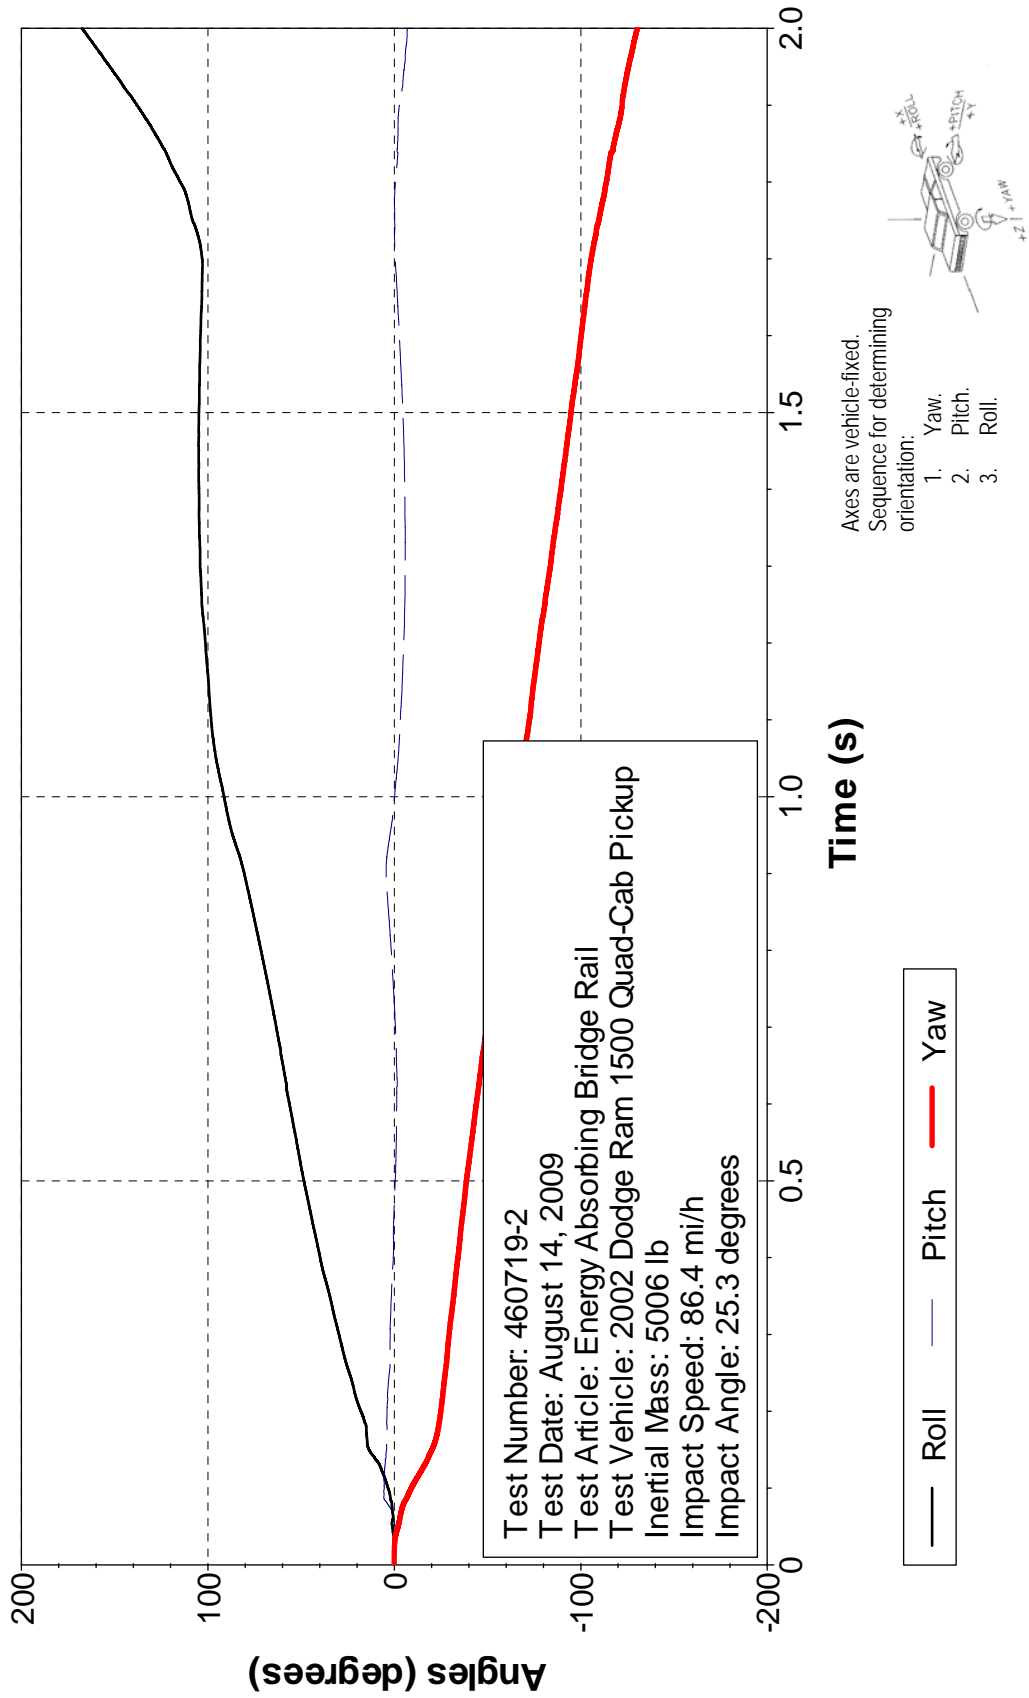
Figure E8. Vehicle Angular Displacements for Test No. 460719-2.

The energy-absorbing bridge rail contained and redirected the 1100C vehicle. The 1100C vehicle remained upright during and after the collision event. Maximum roll angle was 13 degrees at 1.7 s, and maximum pitch angle was 10 degrees at 2.00 s. Maximum occupant compartment deformation was 9.0 inches in the right side floor pan/toe pan area, which is the allowable limit for this area recommended in *MASH*. Longitudinal occupant impact velocity was 24.6 ft/s, and lateral occupant impact velocity was 40.7 ft/s. The maximum limit according to *MASH* is 40 ft/s, which was slightly exceeded in the lateral direction. It is noted that under NCHRP Report 350, a value of 41 ft/s (12.49 m/s) was considered acceptable by FHWA. Longitudinal and lateral ridedown accelerations were -16.3 G and -10.0 G, respectively, both of which are below the recommended threshold of 20 G. As summarized in [Table 7.1](#), the performance of the energy absorbing bridge rail was considered marginal.
