Evaluation of Barriers for Very High Speed Roadways

Research/Test Report 0-6071-2

**TEXAS TRANSPORTATION INSTITUTE
THE TEXAS A&M UNIVERSITY SYSTEM
COLLEGE STATION, TEXAS**

EVALUATION OF BARRIERS FOR VERY HIGH SPEED ROADWAYS

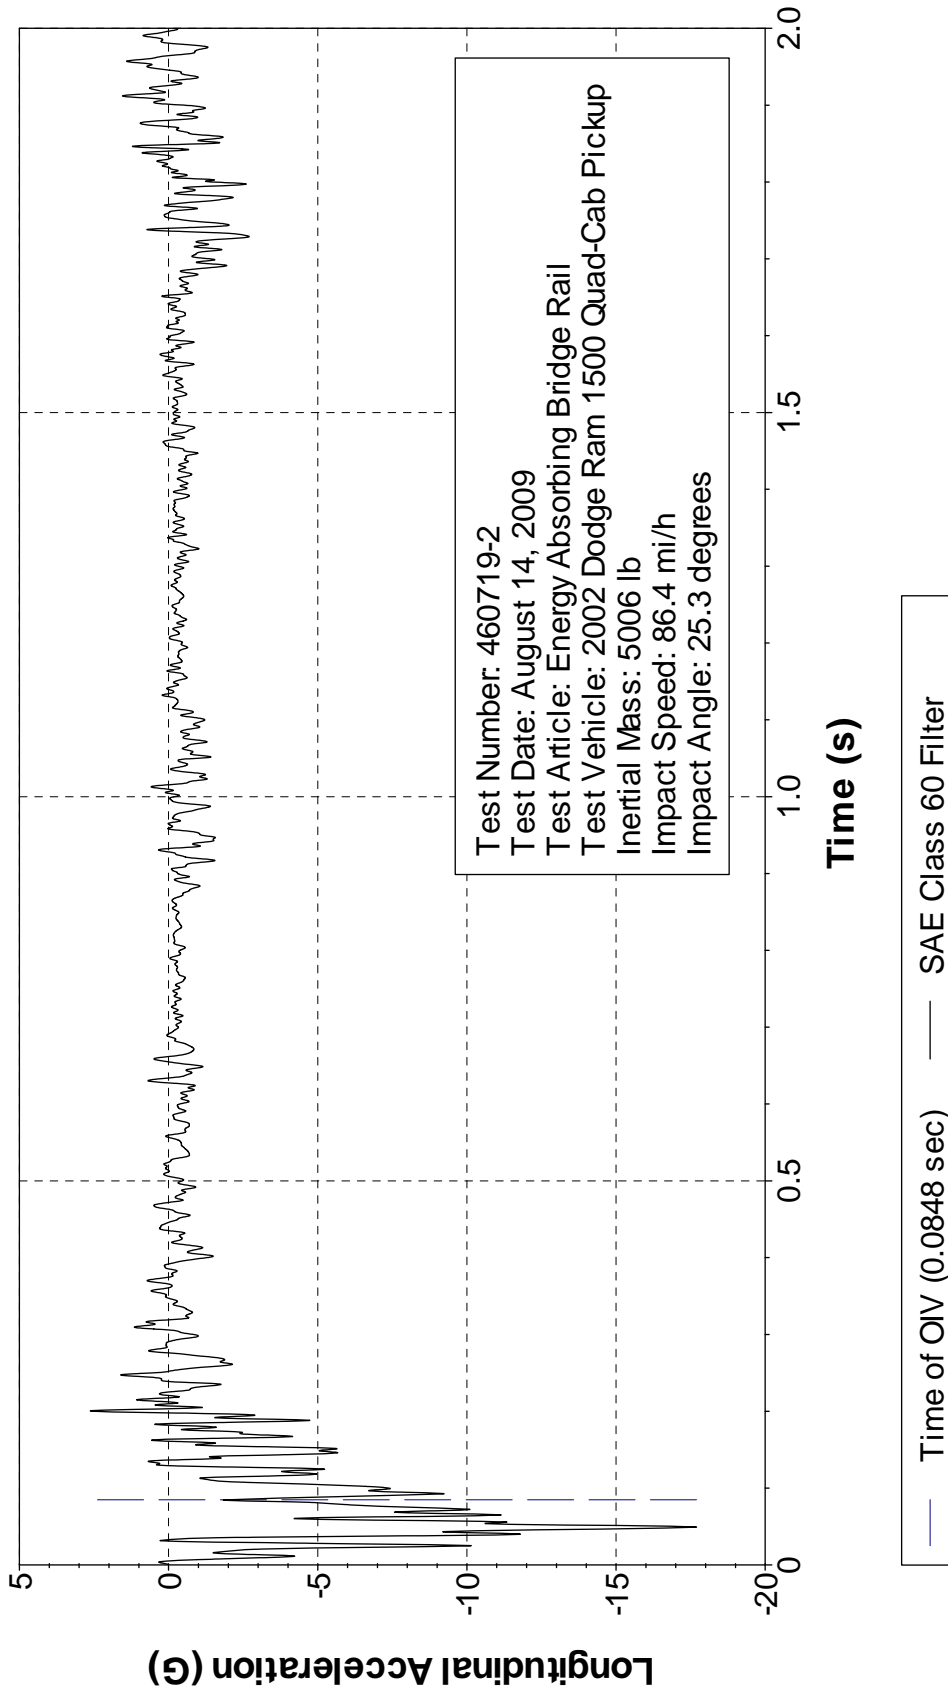
**Figure E9. Vehicle Longitudinal Accelerometer Trace for Test No. 460719-2
(Accelerometer Located at Center of Gravity).**

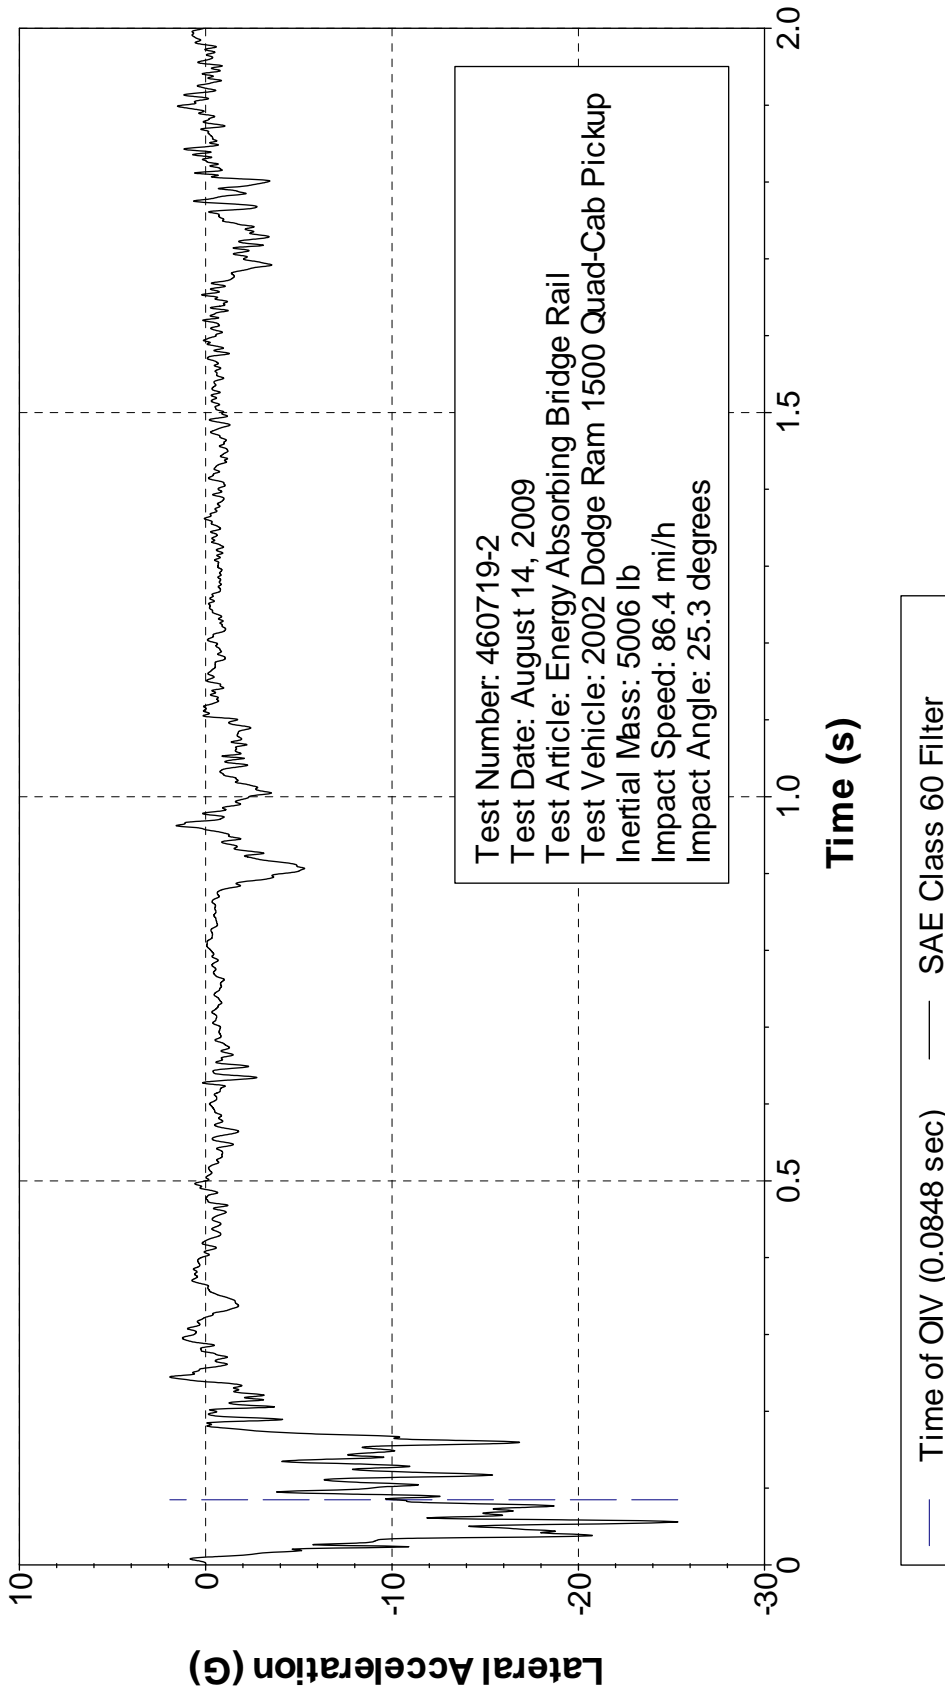
Figure E10. Vehicle Lateral Accelerometer Trace for Test No. 460719-2 (Accelerometer Located at Center of Gravity).

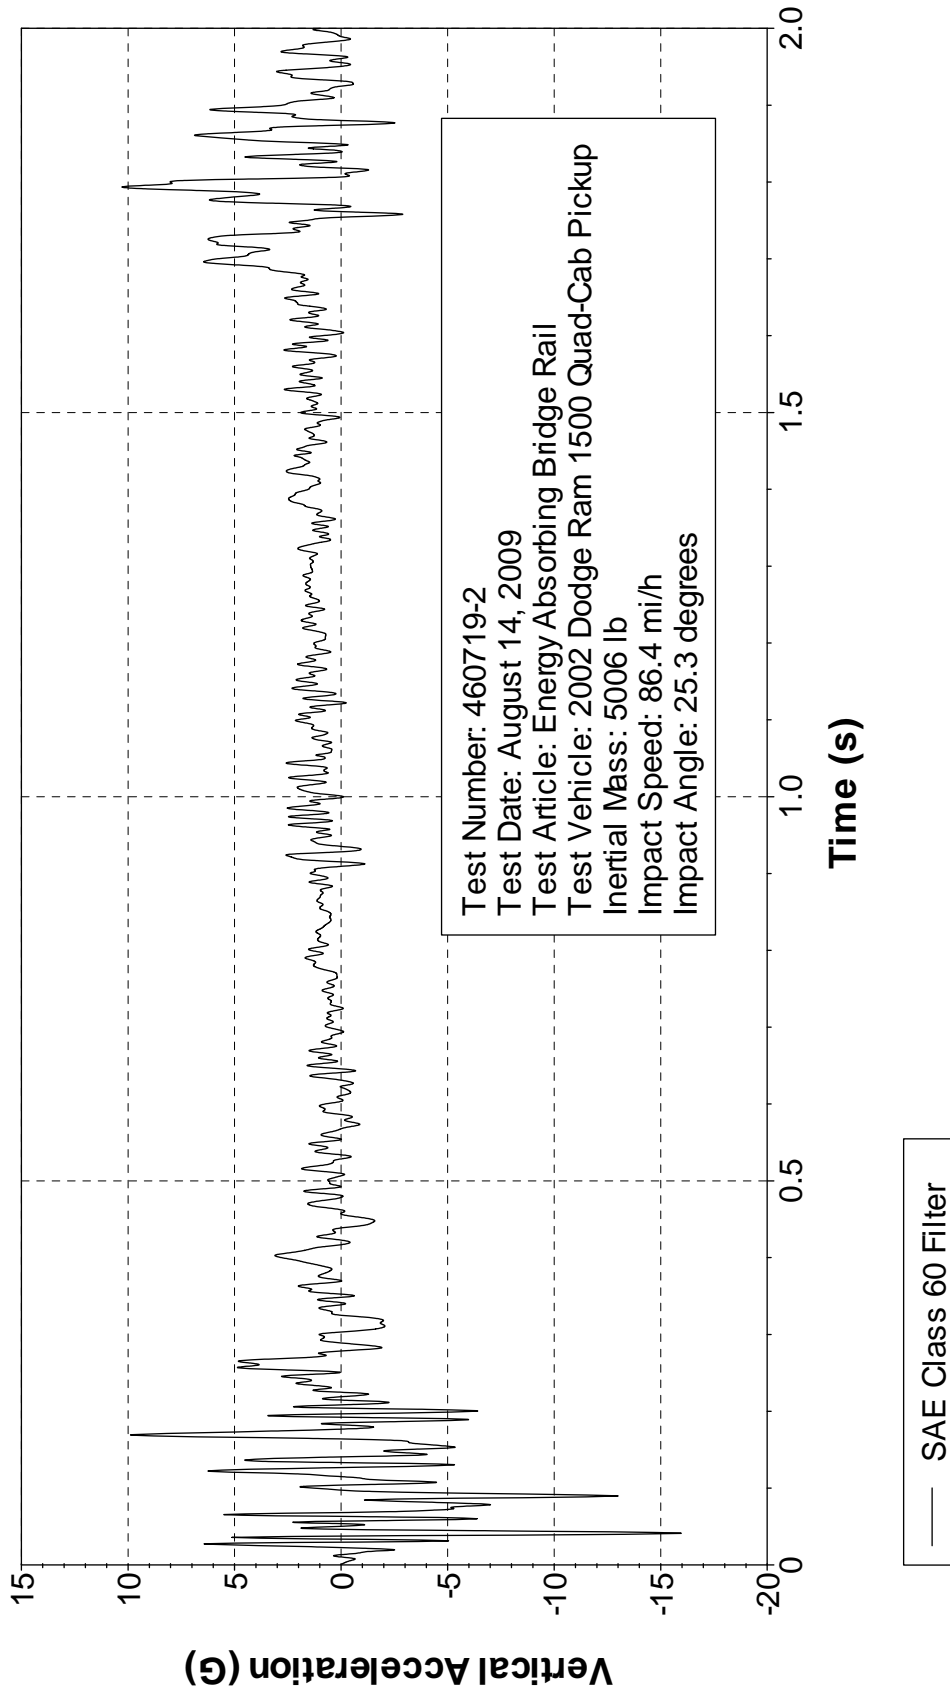
Figure E11. Vehicle Vertical Accelerometer Trace for Test No. 460719-2 (Accelerometer Located at Center of Gravity).

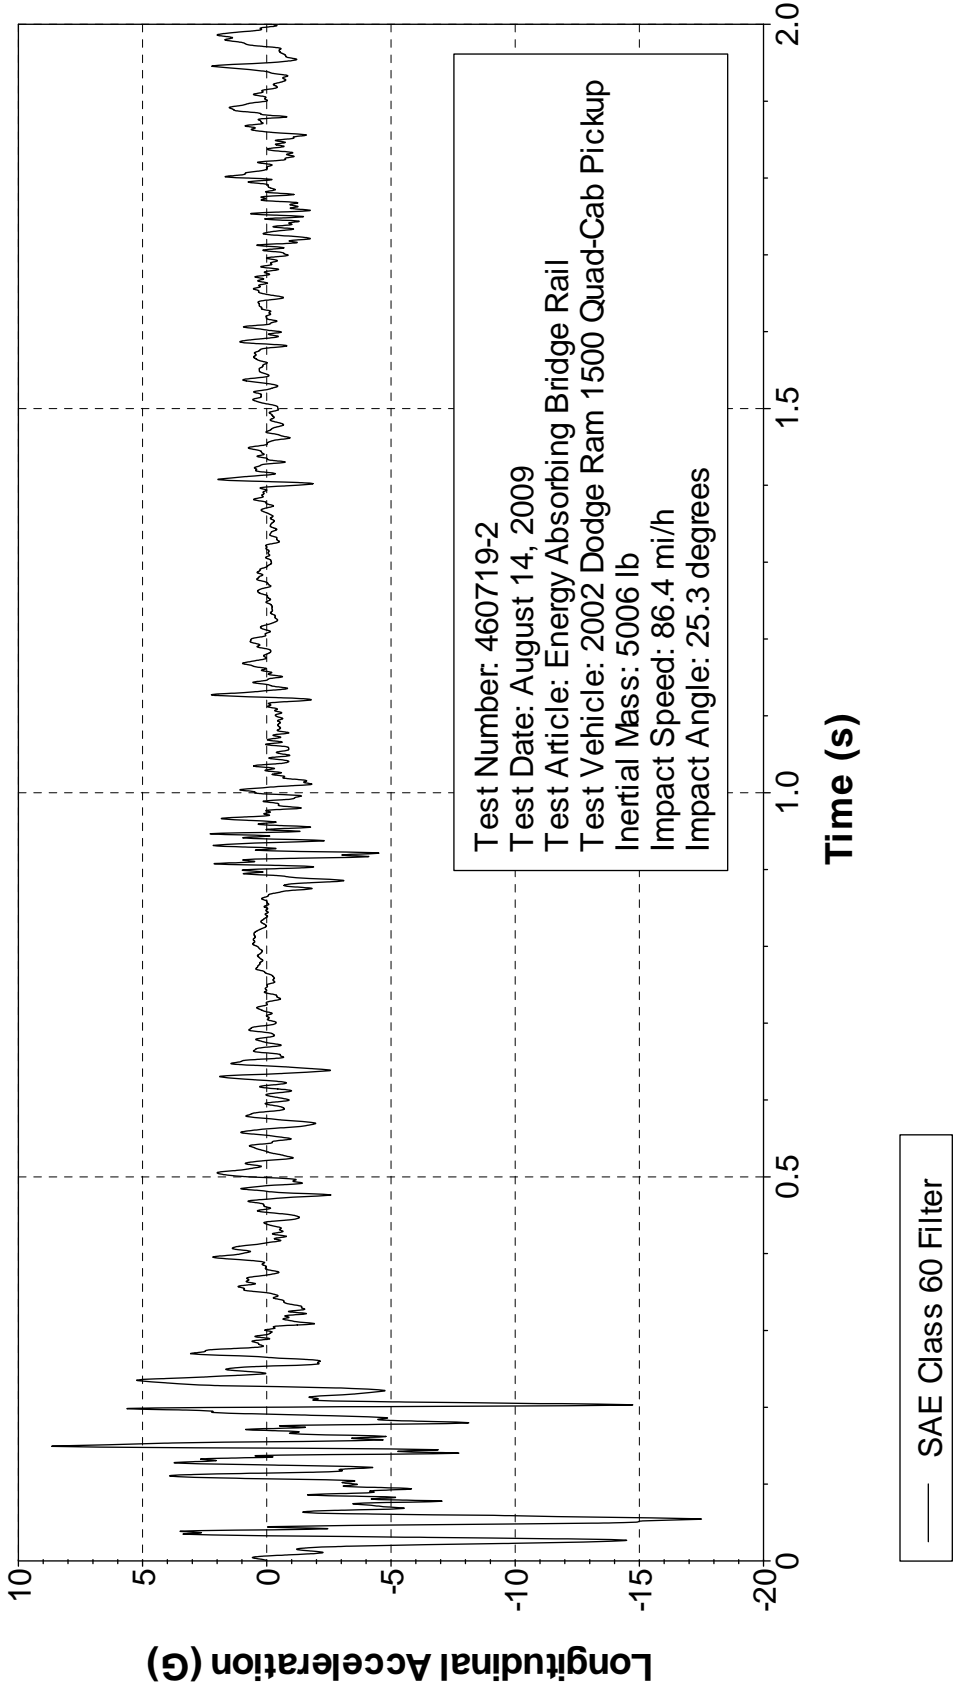
Figure E12. Vehicle Longitudinal Accelerometer Trace for Test No. 460719-2 (Accelerometer Located over Rear Axle).

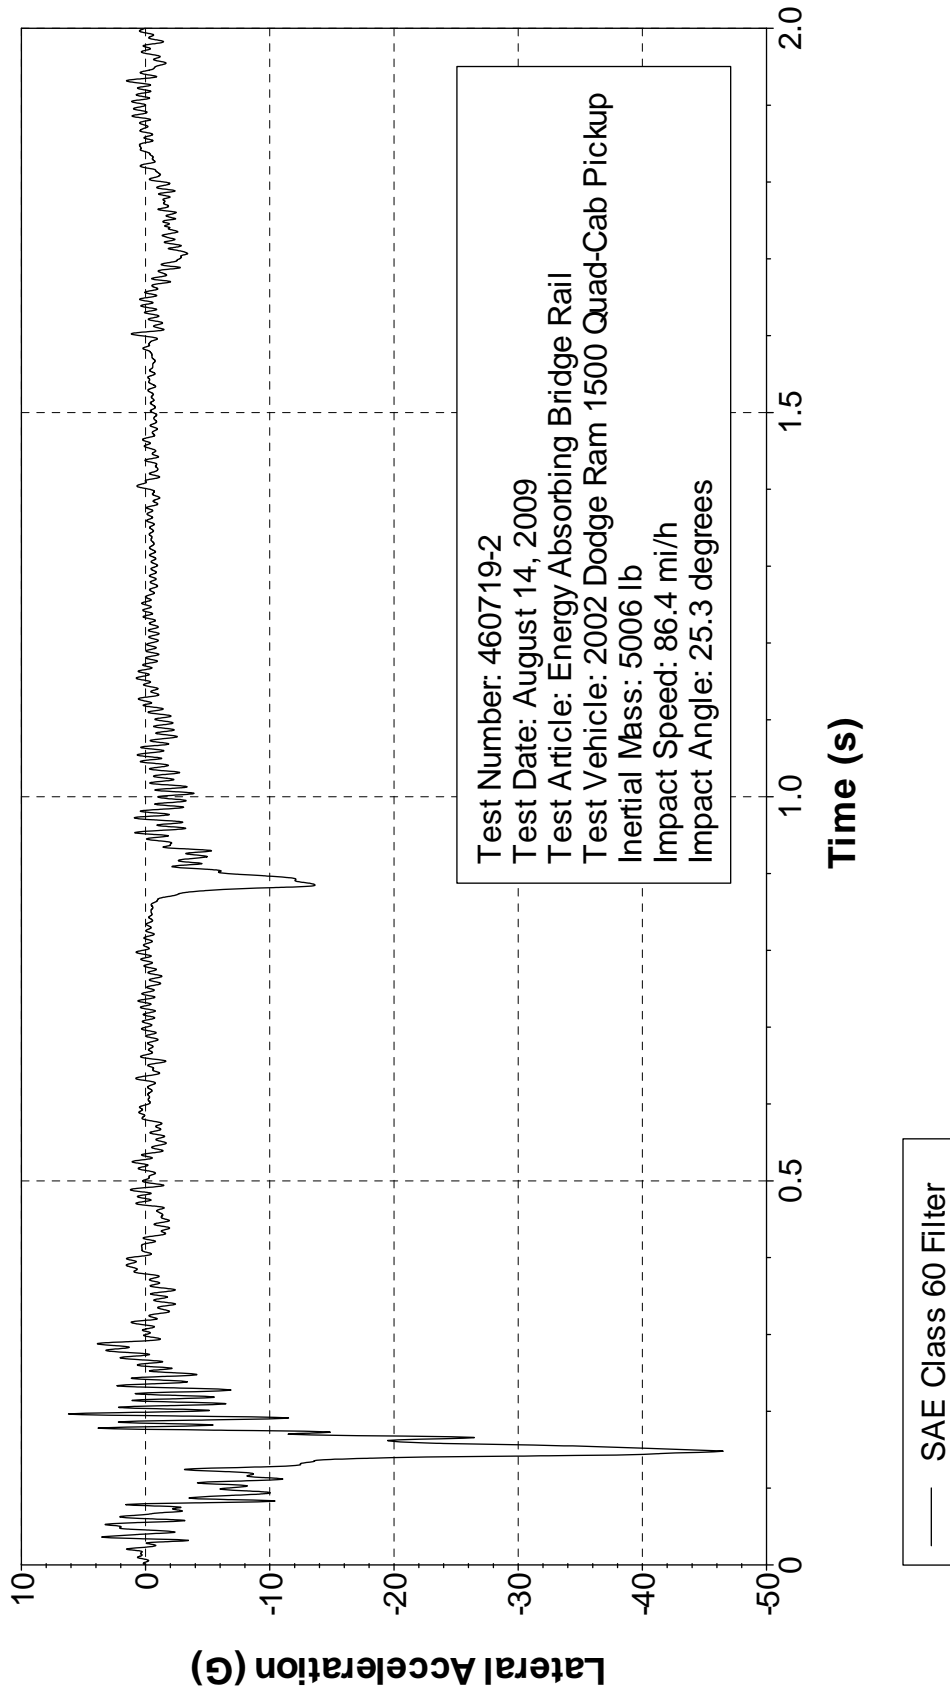
**Figure E13. Vehicle Lateral Accelerometer Trace for Test No. 460719-2
(Accelerometer Located over Rear Axle).**

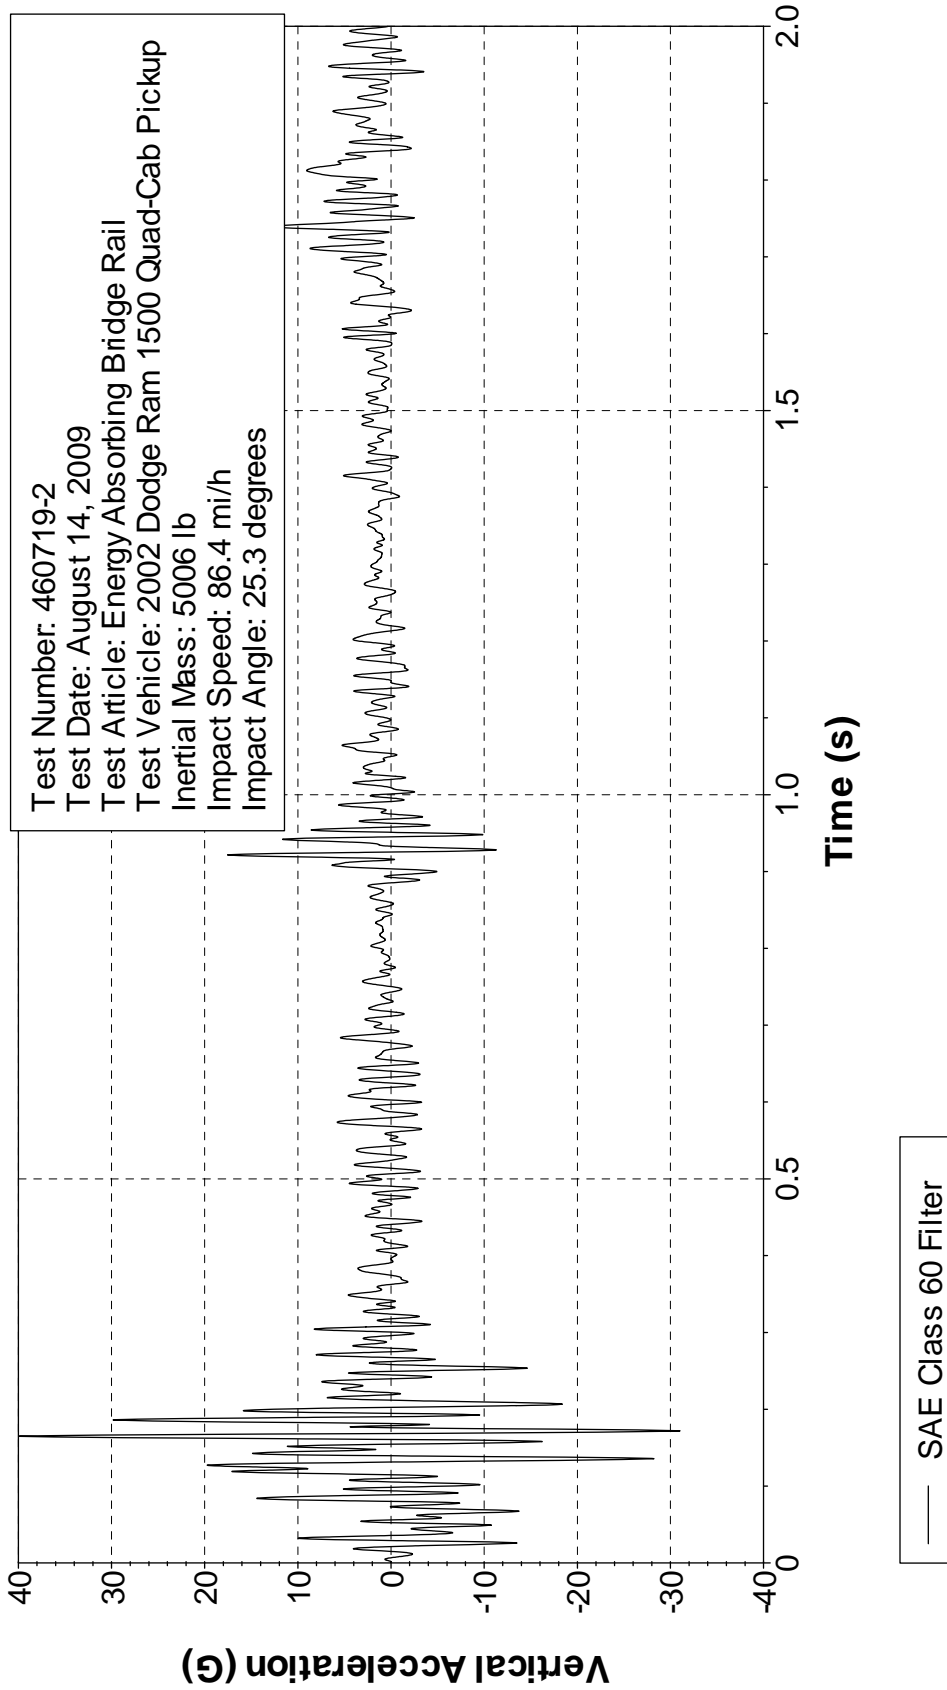
Figure E14. Vehicle Vertical Accelerometer Trace for Test No. 460719-2 (Accelerometer Located over Rear Axle).

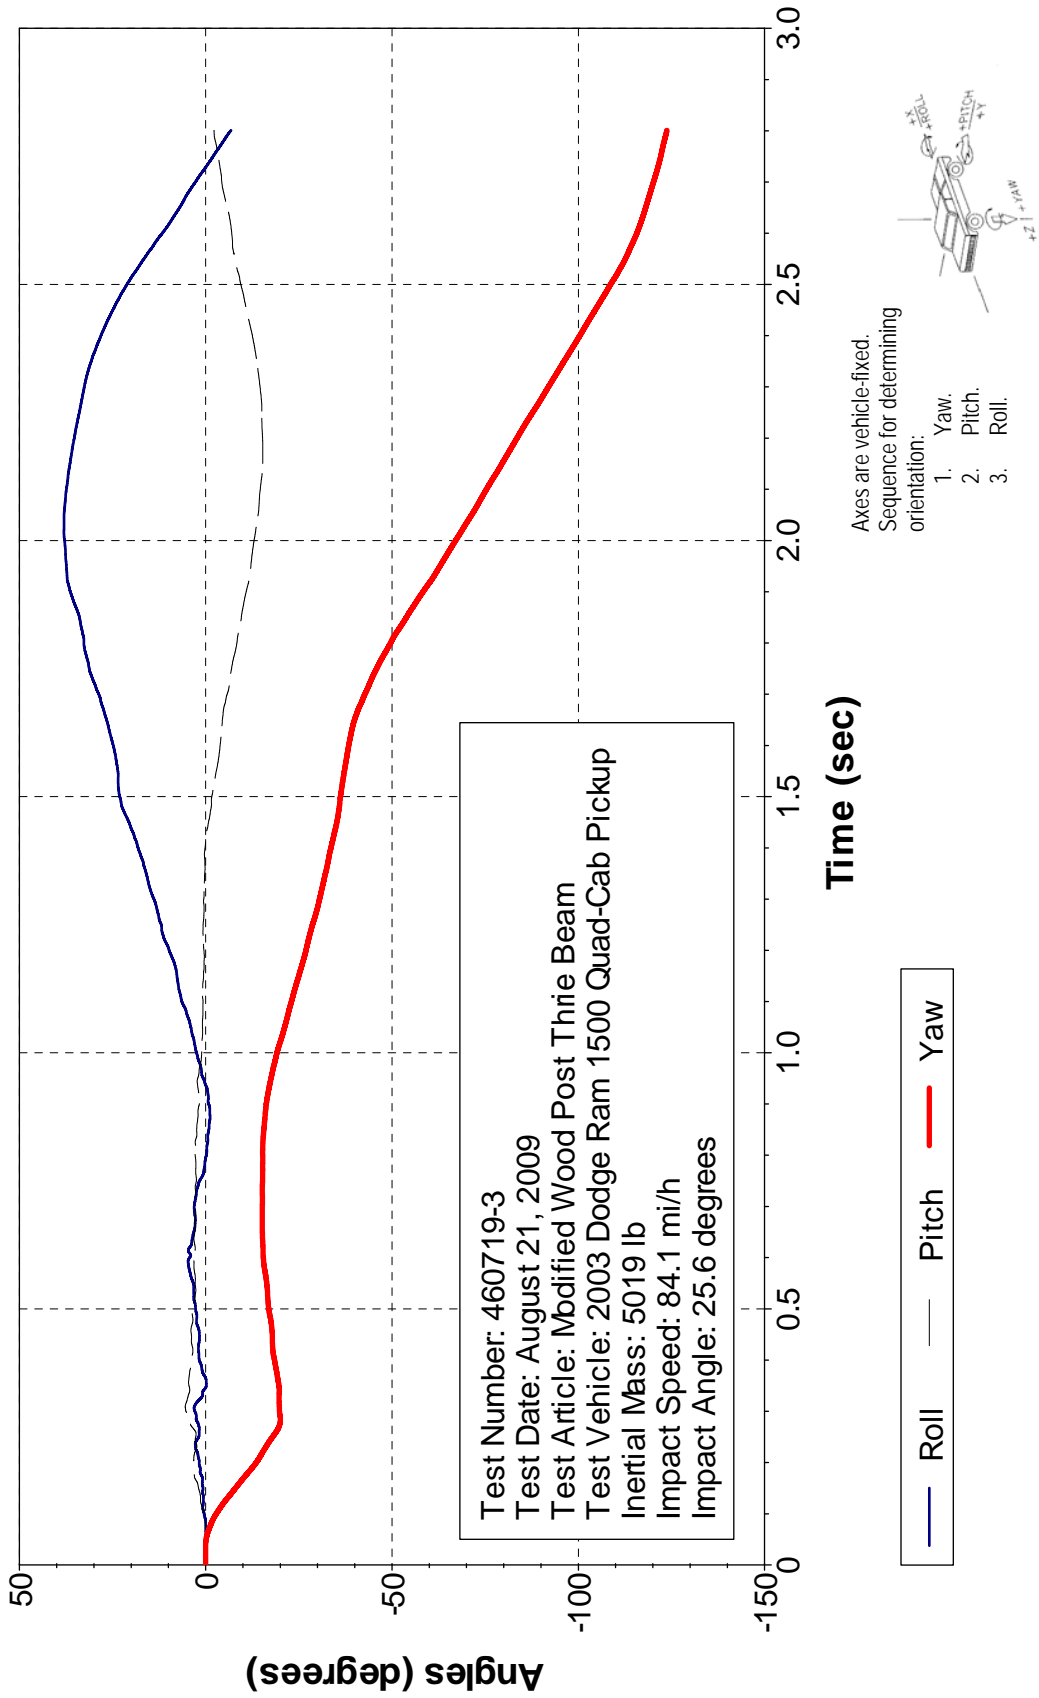
Figure E15. Vehicle Angular Displacements for Test No. 460719-3.

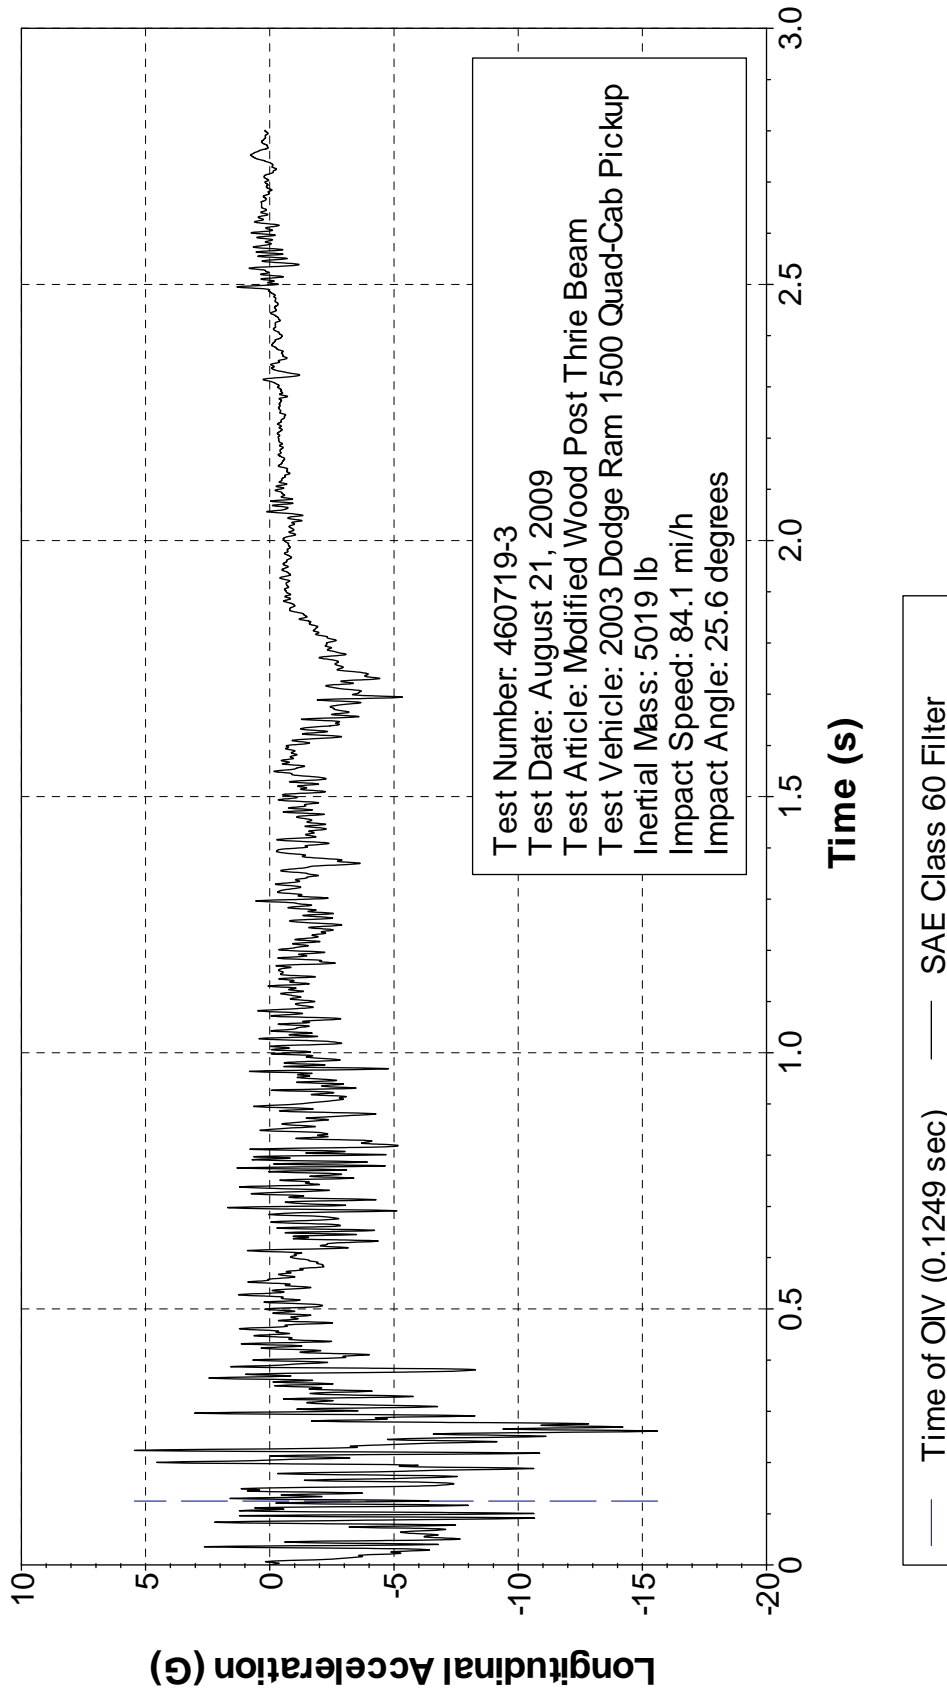
**Figure E16. Vehicle Longitudinal Accelerometer Trace for Test No. 460719-3
(Accelerometer Located at Center of Gravity).**

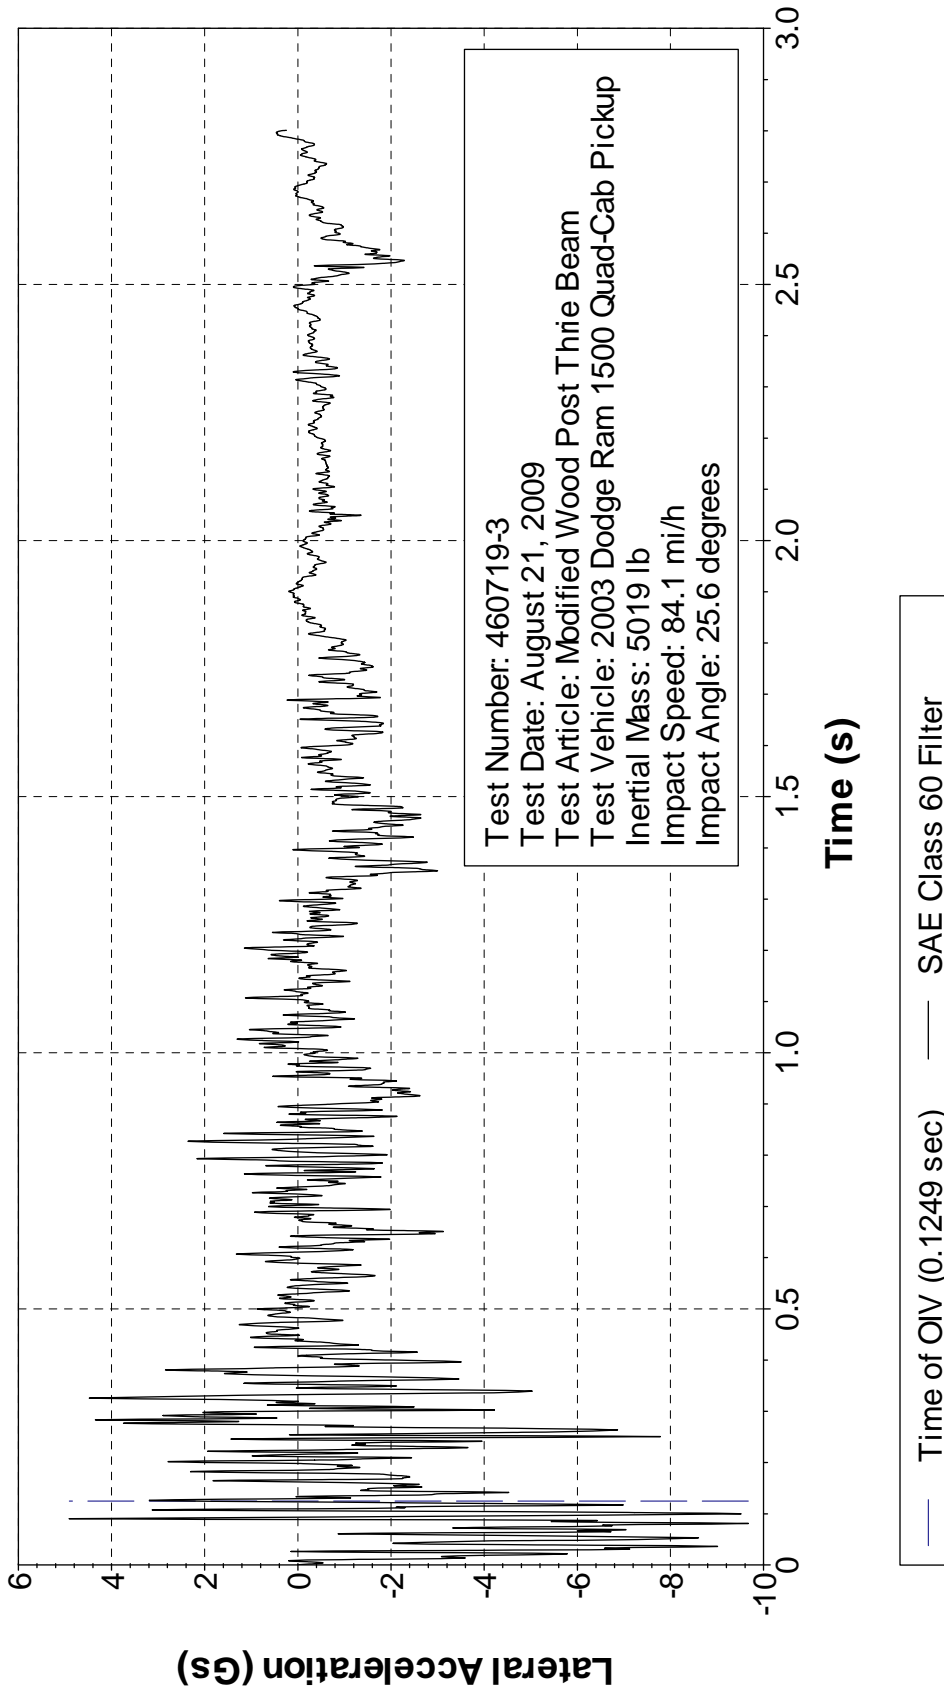
Figure E17. Vehicle Lateral Accelerometer Trace for Test No. 460719-3 (Accelerometer Located at Center of Gravity).

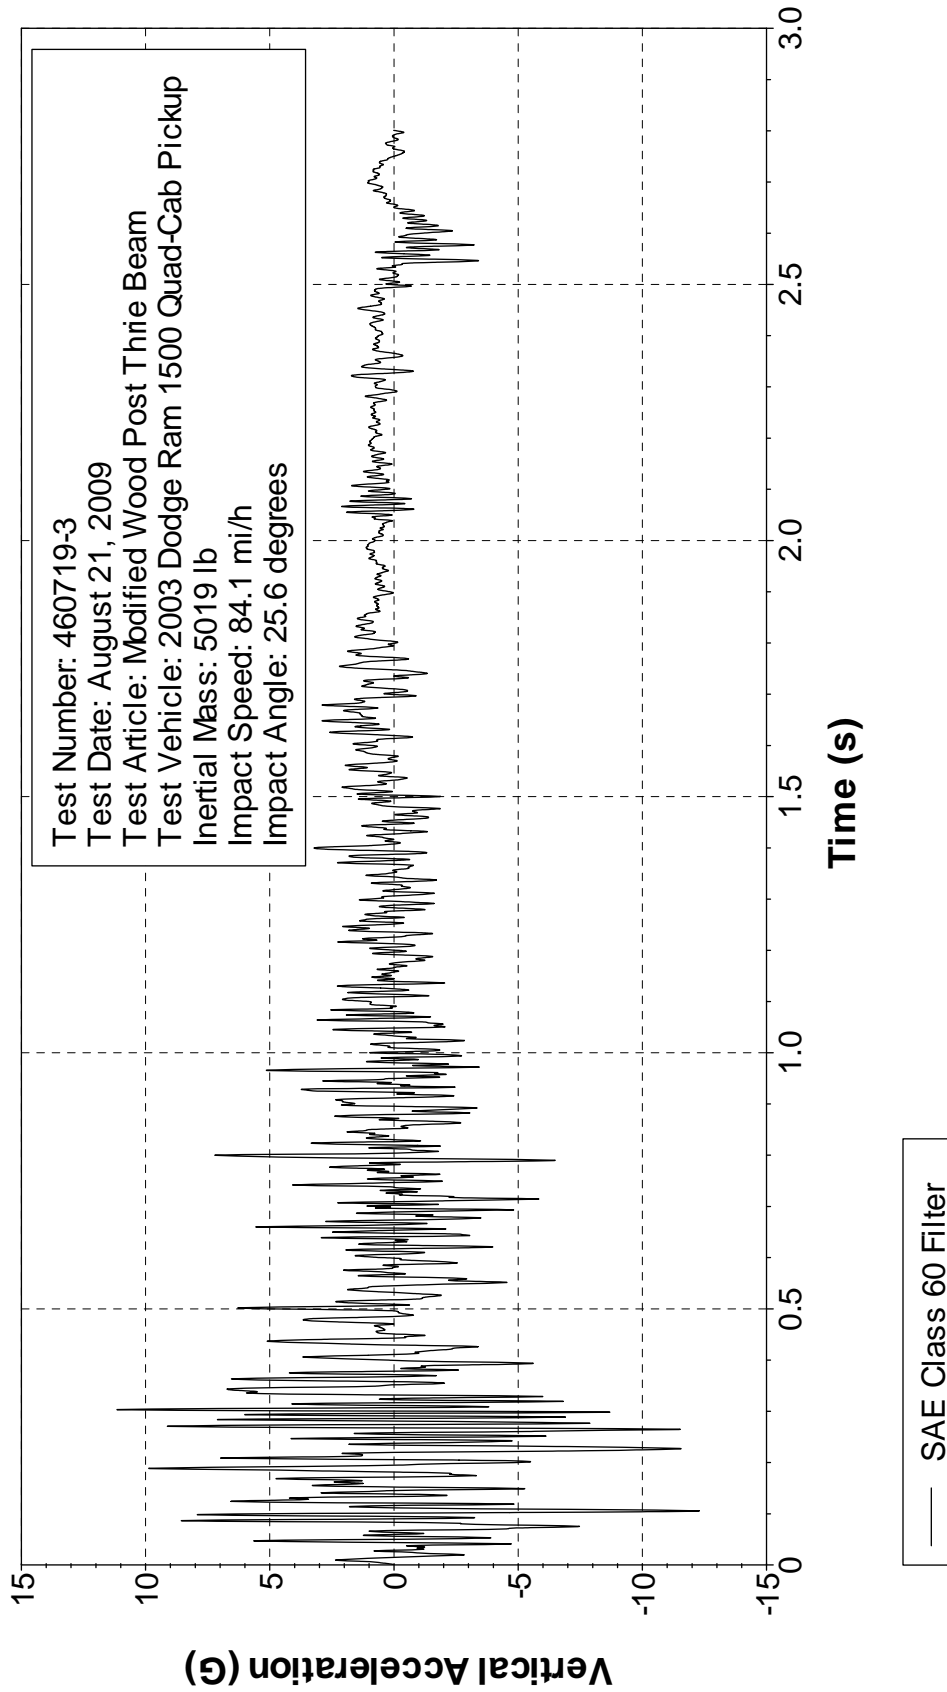
Figure E18. Vehicle Vertical Accelerometer Trace for Test No. 460719-3 (Accelerometer Located at Center of Gravity).

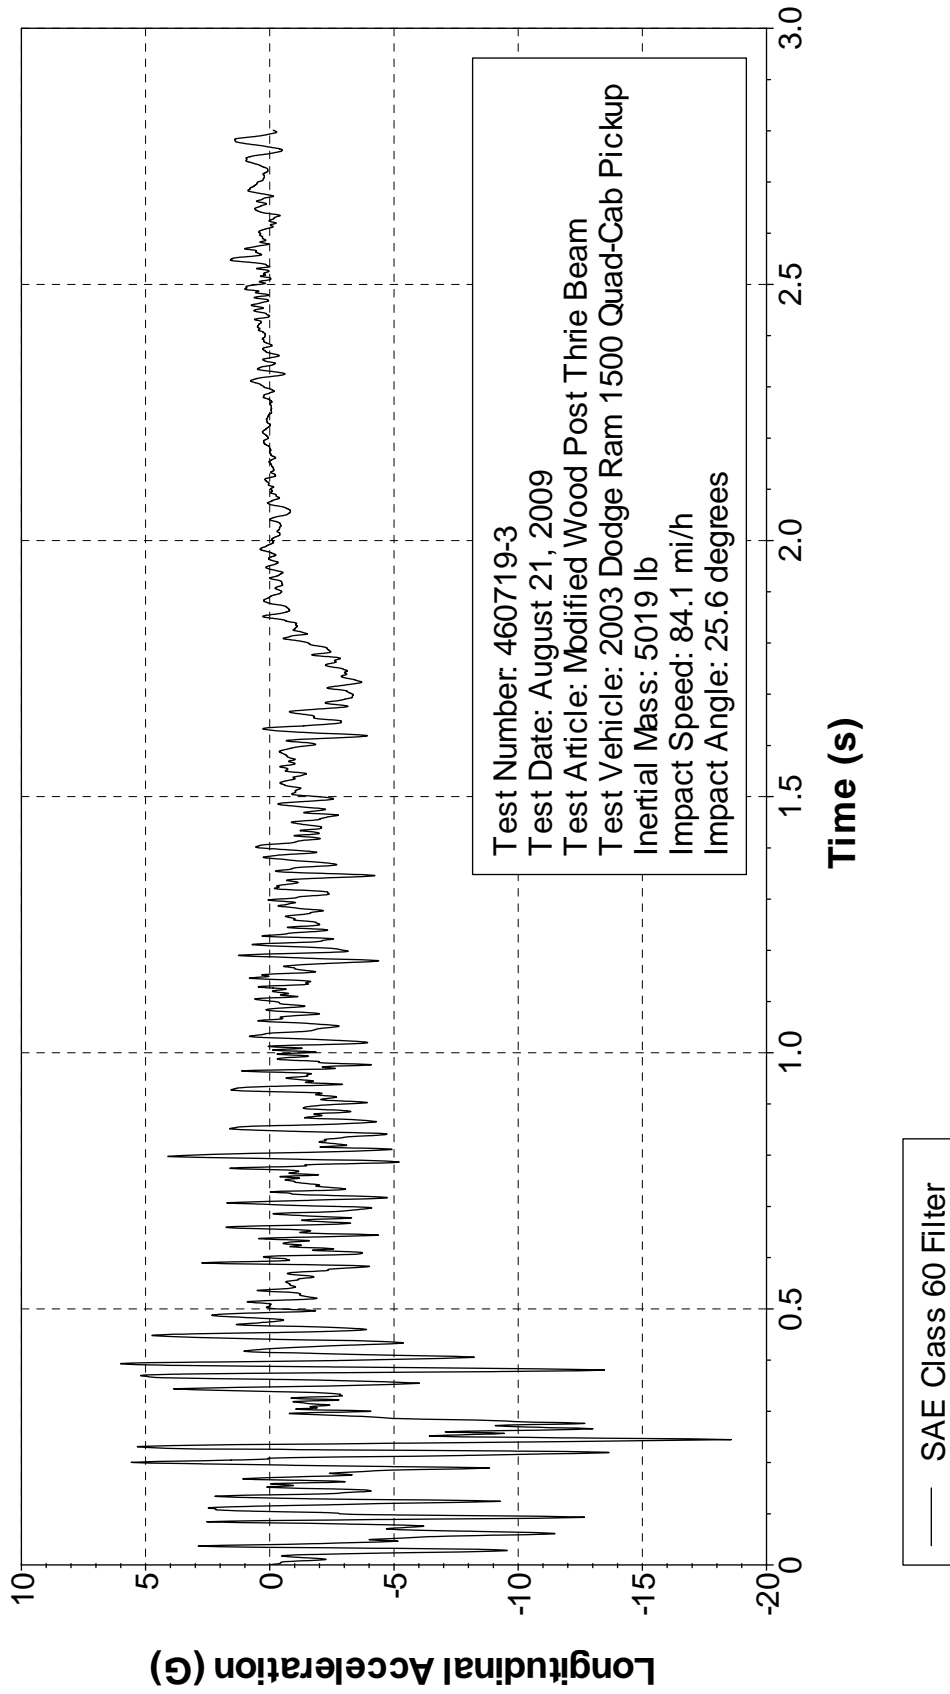
Figure E19. Vehicle Longitudinal Accelerometer Trace for Test No. 460719-3
(Accelerometer Located over Rear Axle).

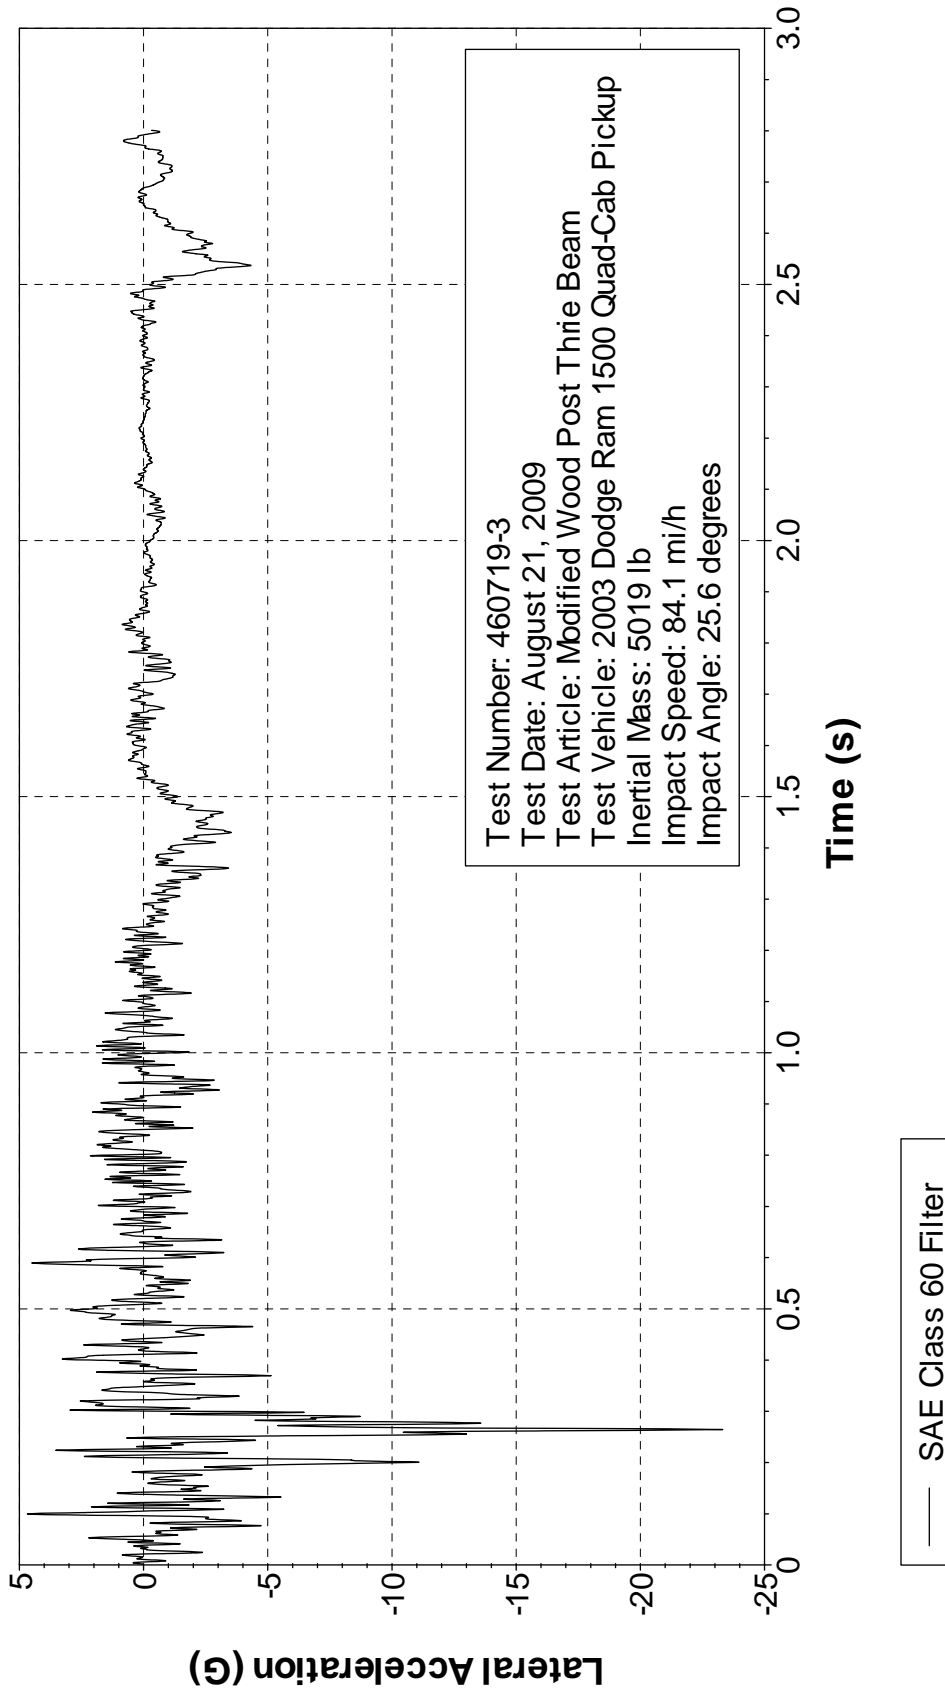
Figure E20. Vehicle Lateral Accelerometer Trace for Test No. 460719-3 (Accelerometer Located over Rear Axle).

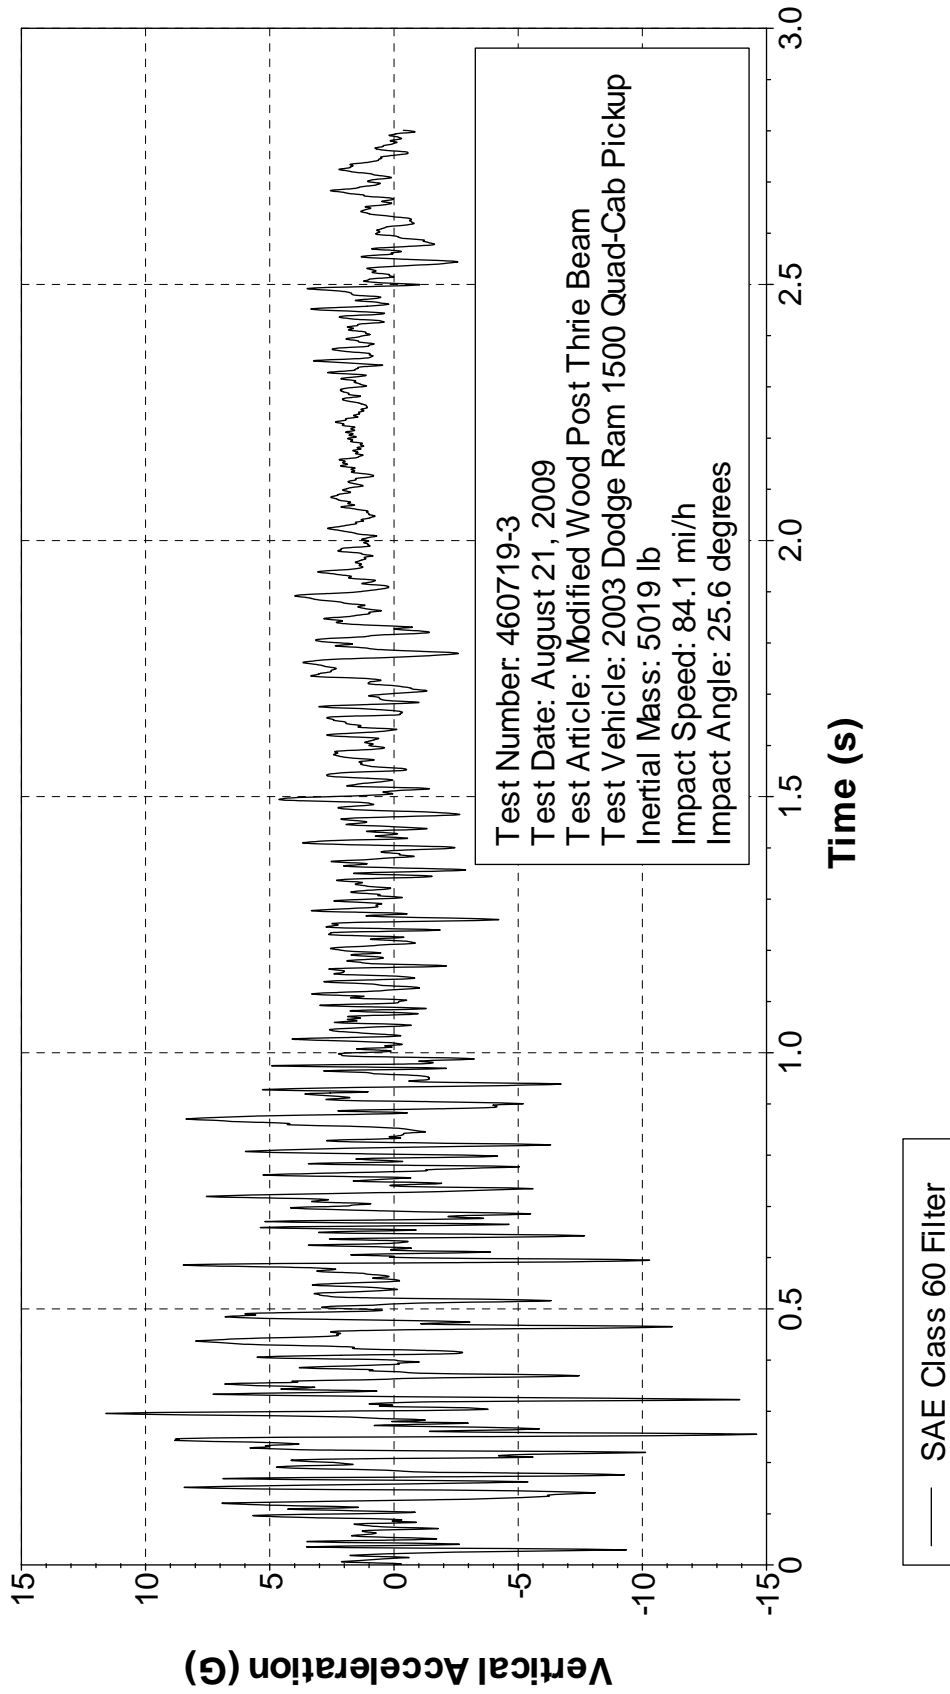
Figure E21. Vehicle Vertical Accelerometer Trace for Test No. 460719-3
(Accelerometer Located over Rear Axle).
