Evaluation of Barriers for Very High Speed Roadways

Research/Test Report 0-6071-2

**TEXAS TRANSPORTATION INSTITUTE
THE TEXAS A&M UNIVERSITY SYSTEM
COLLEGE STATION, TEXAS**

EVALUATION OF BARRIERS FOR VERY HIGH SPEED ROADWAYS

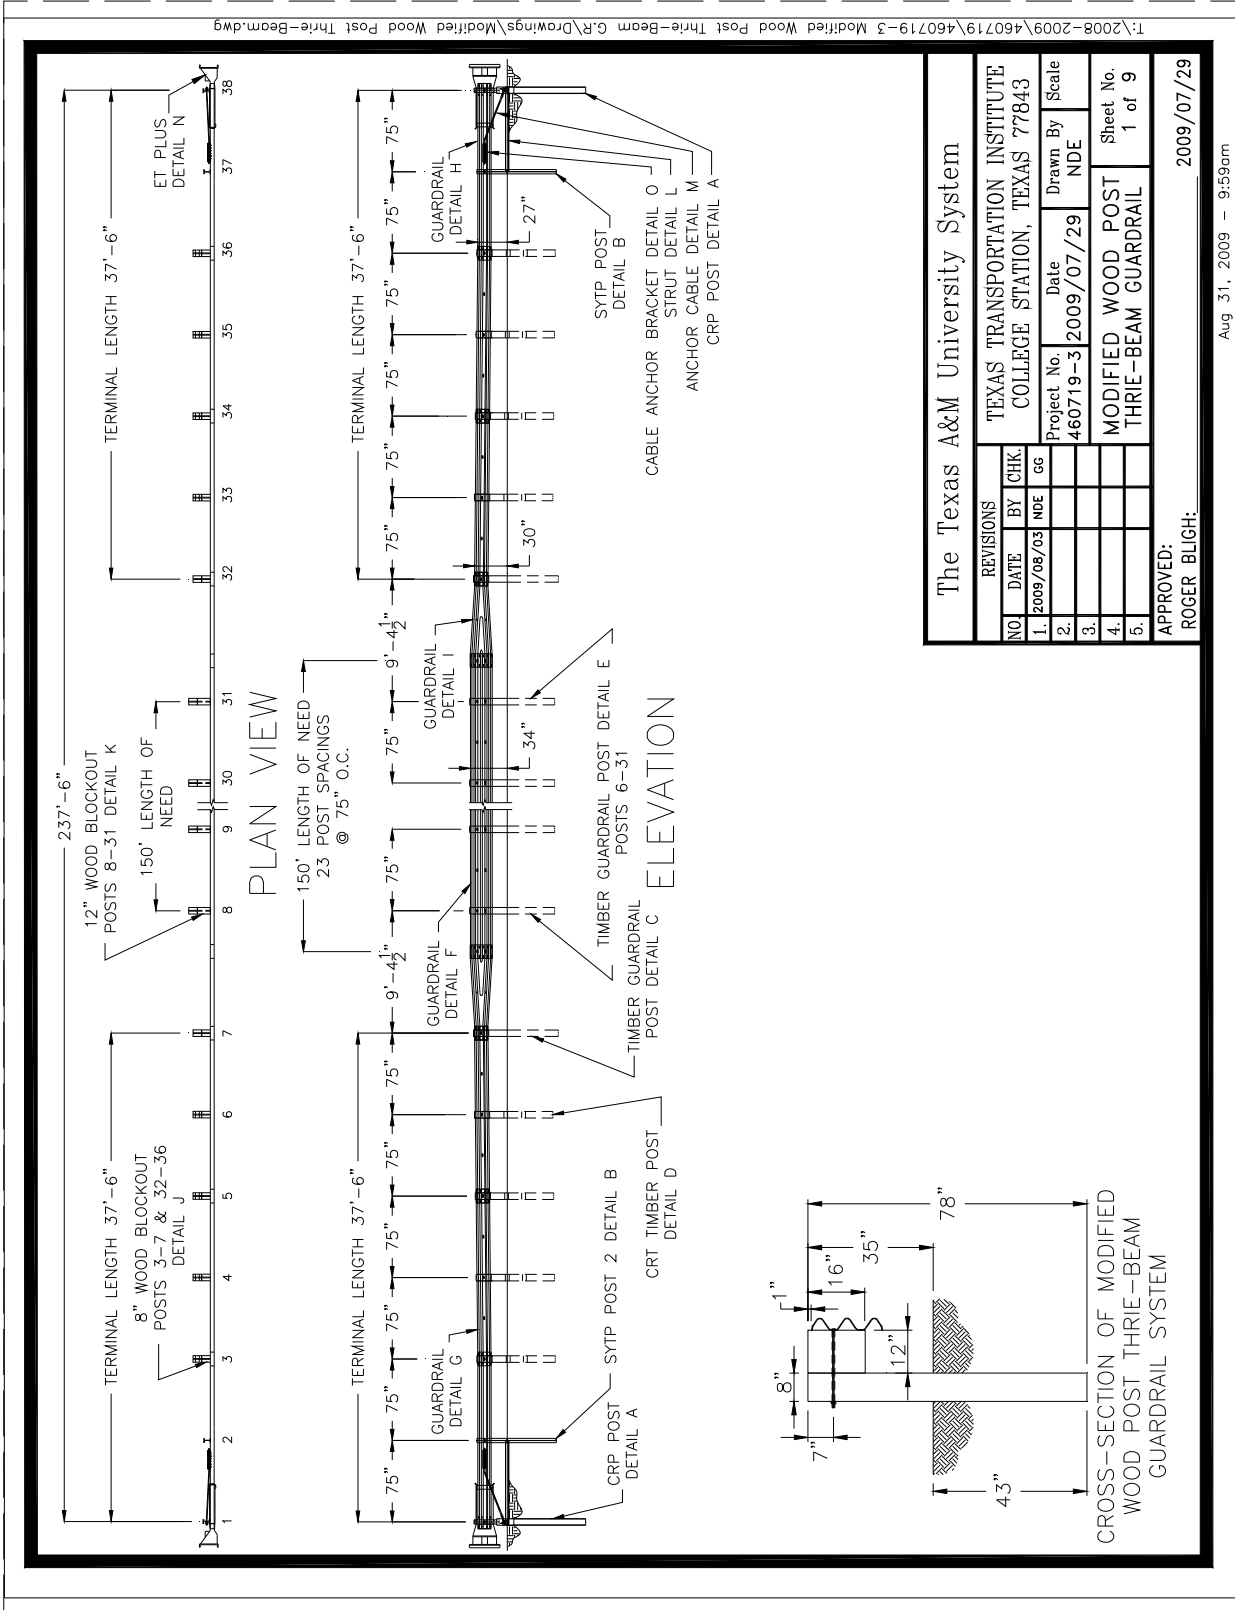
APPENDIX F. DETAILS OF THE HIGH-SPEED THRIE BEAM GUARDRAIL

The researchers proposed some modifications to mitigate this behavior. It was recommended that the steel posts and the blockouts be replaced with wood posts and wood blockouts. The objective was to eliminate vehicle climb by preventing collapse of the blockouts and changing the failure mode of the posts. The impact simulation of this modified wood post three beam guardrail predicted stable containment and redirection of the pickup truck.

During the full-scale crash test, the upstream end anchorage failed and released the rail. This allowed the pickup truck to penetrate behind the guardrail system. The terminal system was not explicitly modeled in the simulation. The length of the guardrail installation was believed to be sufficient to limit the forces reaching the anchor assembly.

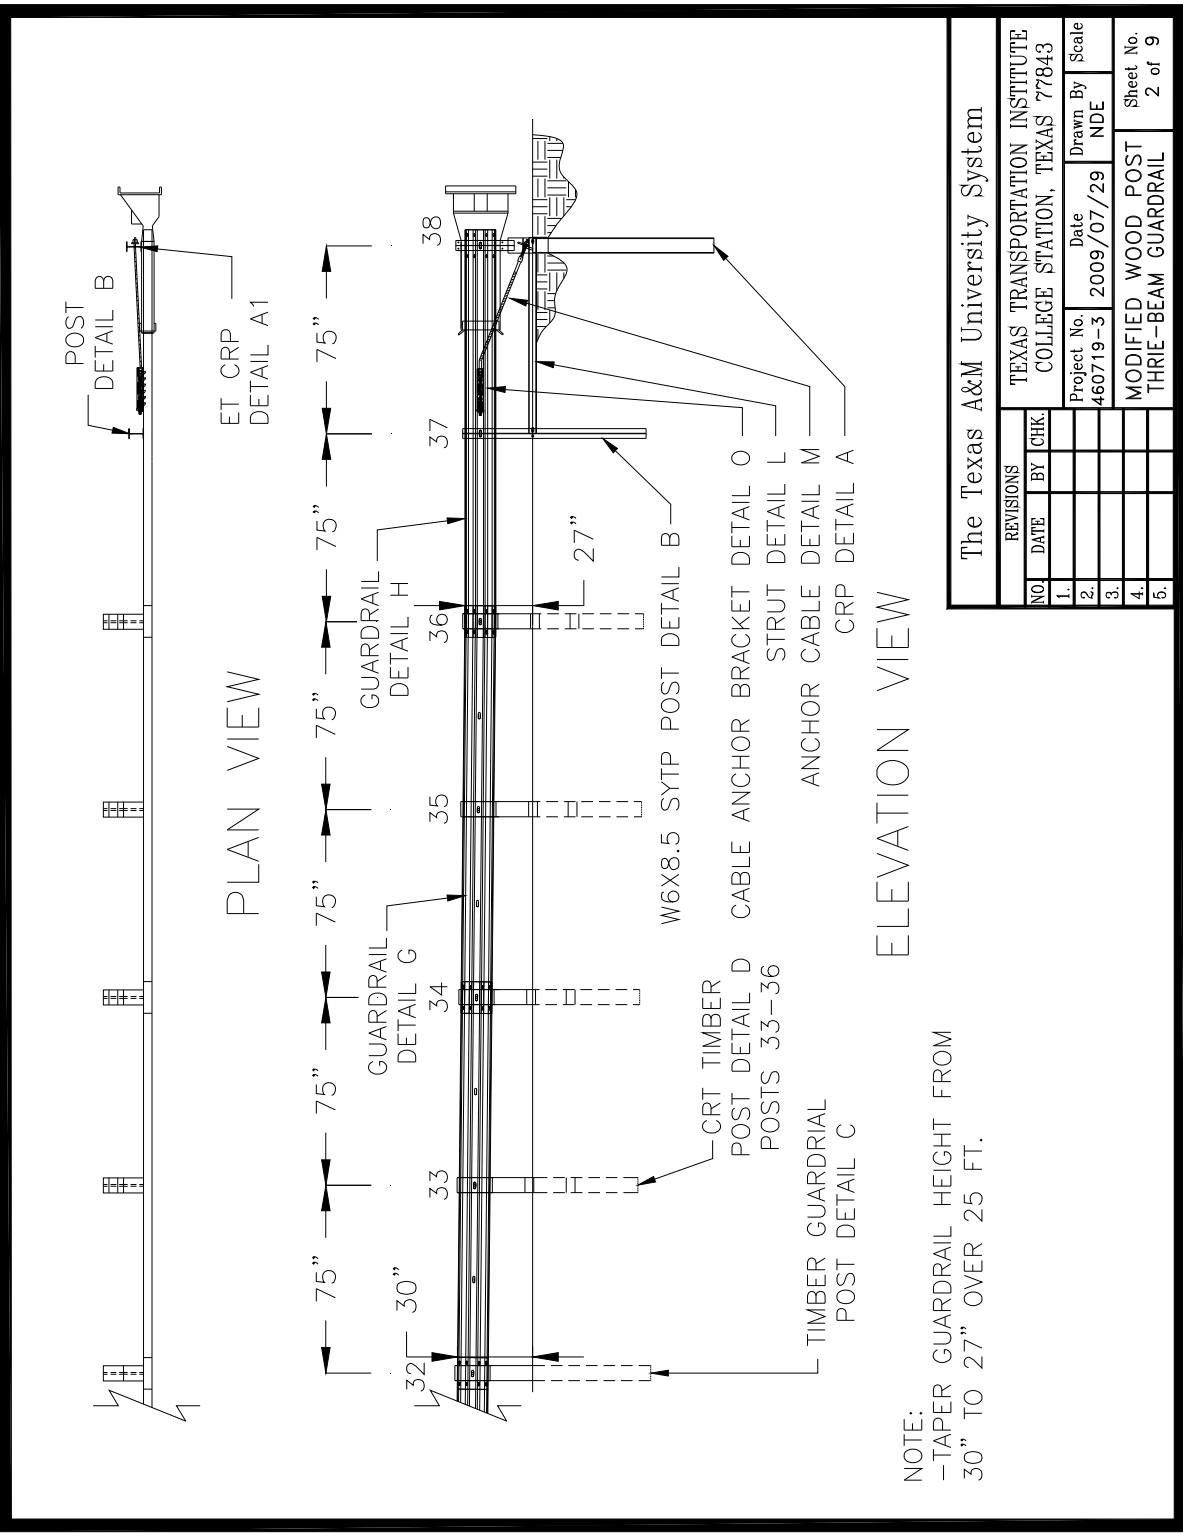
NOTE:
 -TAPER GUARDRAIL HEIGHT FROM
 30" TO 27" OVER 25 FT.

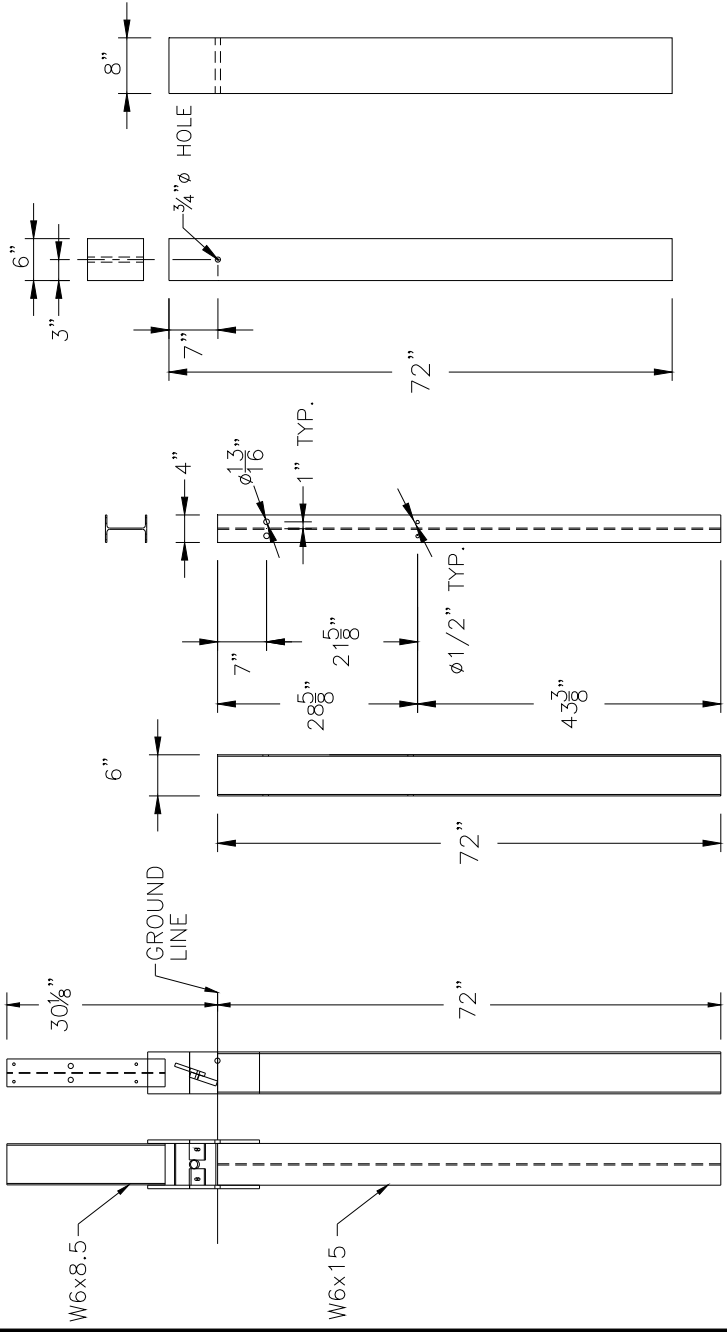
STANDARD CRP WITH 20° OFFSET
 DETAIL A

SYTP-W6X8.5
 DETAIL B

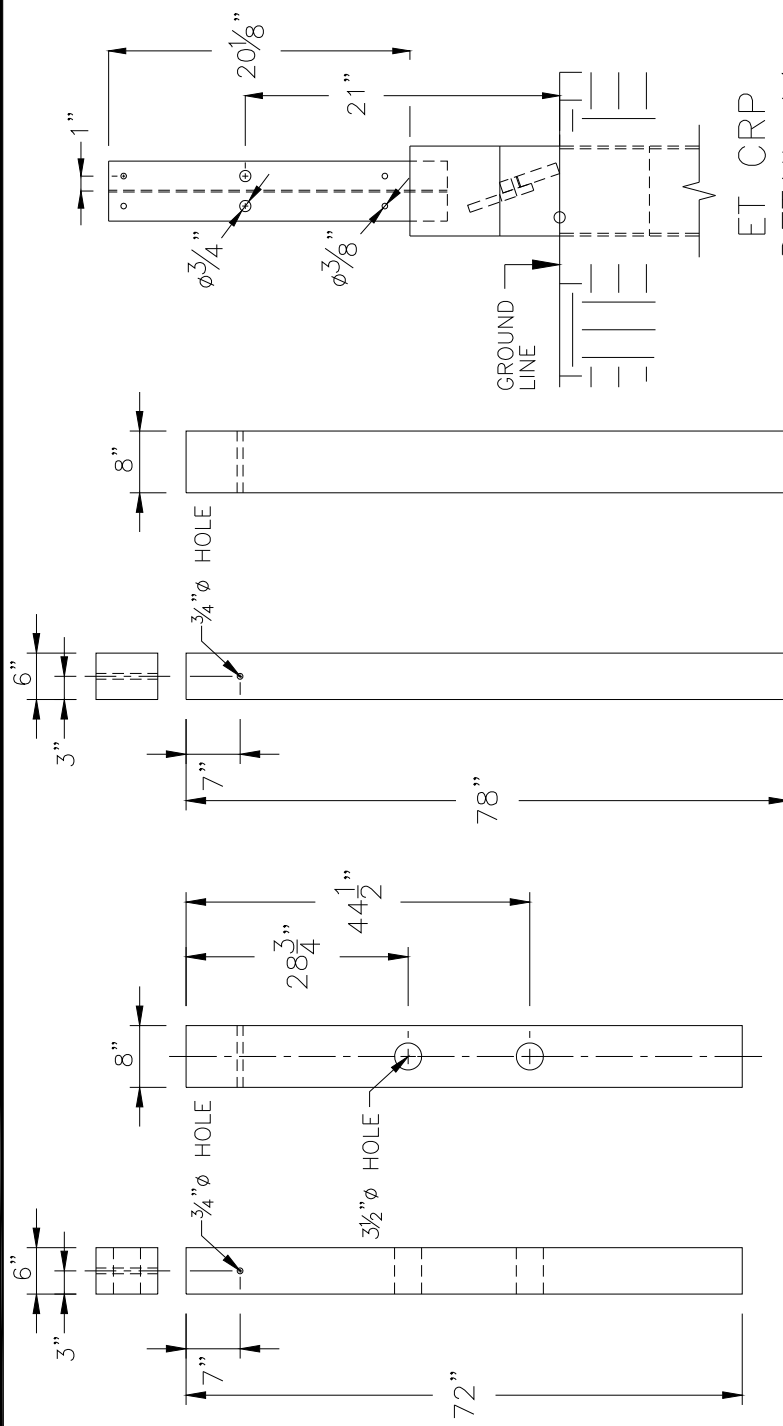
CRT TIMBER GUARDRAIL POST
DETAIL D
(AASHTO-AGC-ARTBA #PDE09)

TIMBER GUARDRAIL POST
DETAIL E
(AASHTO-AGC-ARTBA #PDE03)

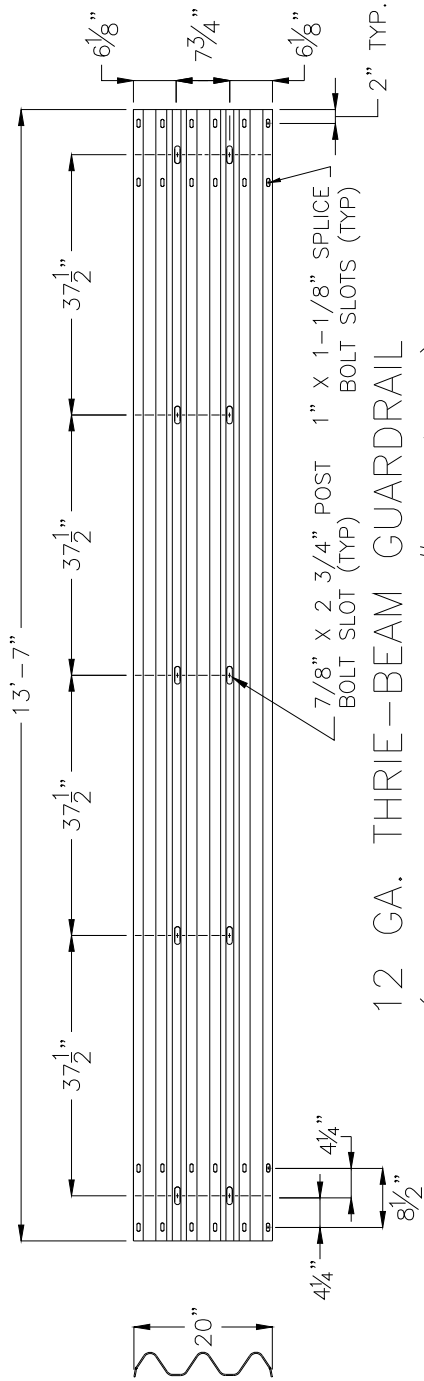
12 GA. THRIE-BEAM GUARDRAIL
(AASHTO-AGC-ARTBA# RTM04A)
DETAIL F

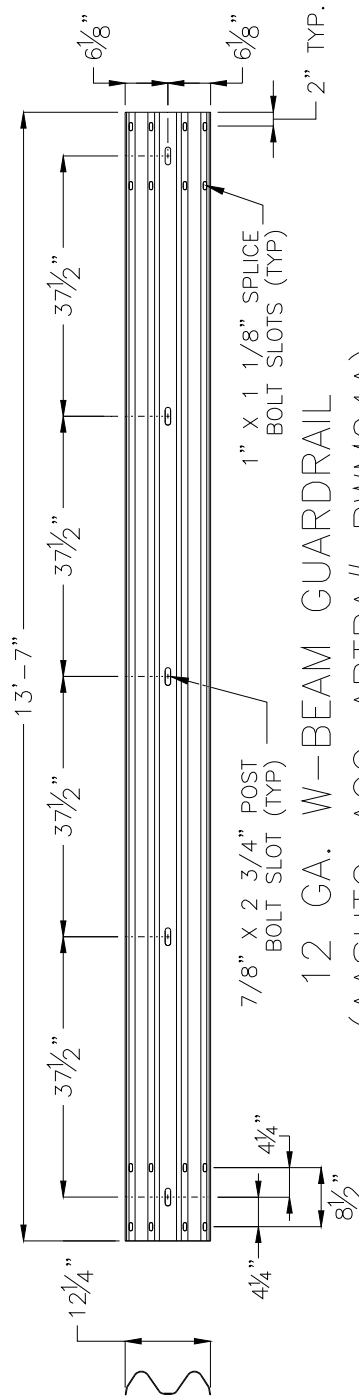
12 GA. W-BEAM GUARDRAIL
(AASHTO-AGC-ARTBA# RWM04A)
DETAIL G

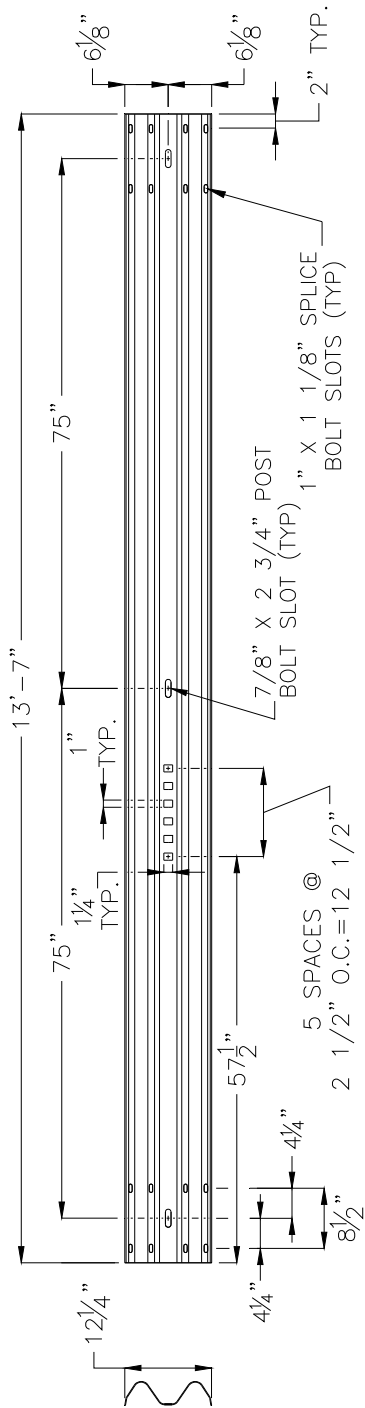
12 GA. W-BEAM END TERMINAL
GUARDRAIL DETAIL H

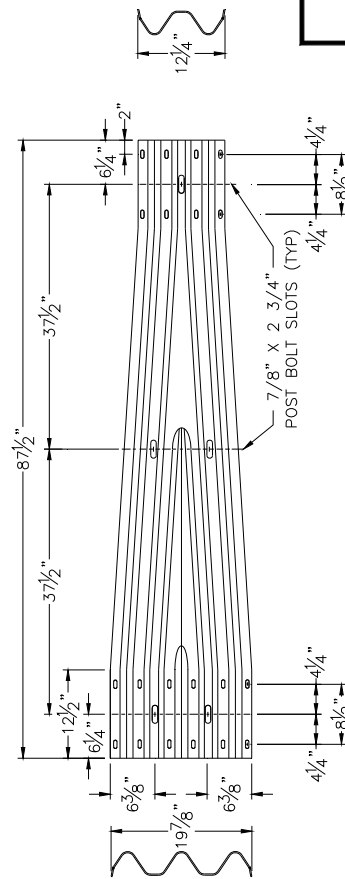
12 GA. THRIE-BEAM TRANSITION
(AASHTO-AGC-ARTBA# RWTO1A)
DETAIL I

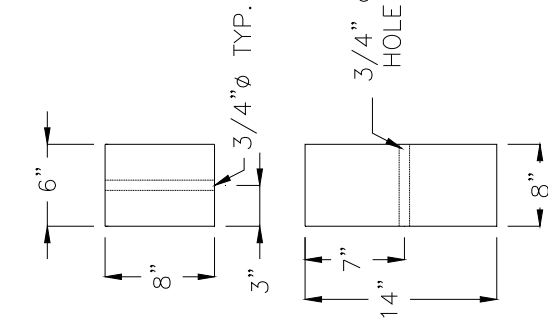
8" W-BEAM WOOD
BLOCKOUT DETAIL J
(AASHTO-AGC-ARTBA# PDB01)

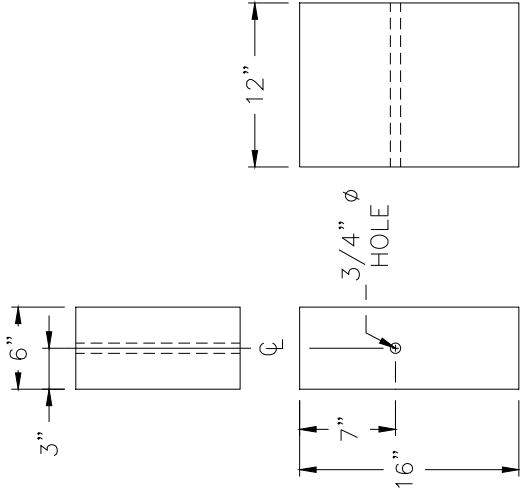
12" THRIE-BEAM
WOOD BLOCKOUT
DETAIL K

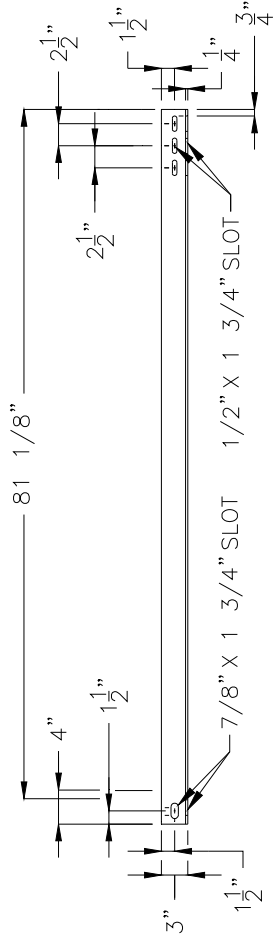
3" X 3" X 1/4"
STRUT DETAIL L

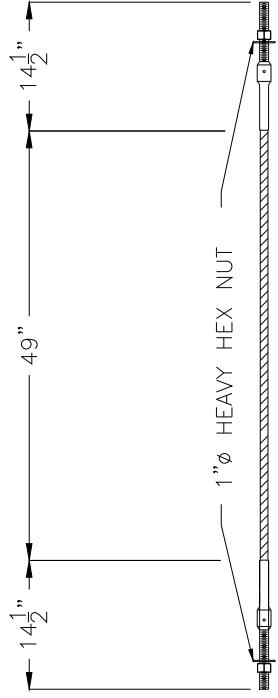
ANCHOR BRACKET CABLE
DETAIL M

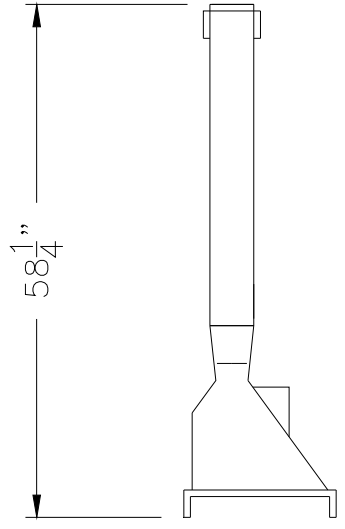
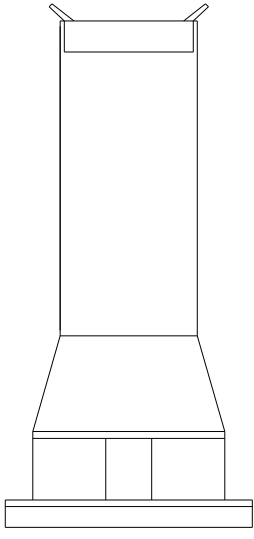
ET PLUS
DETAIL N

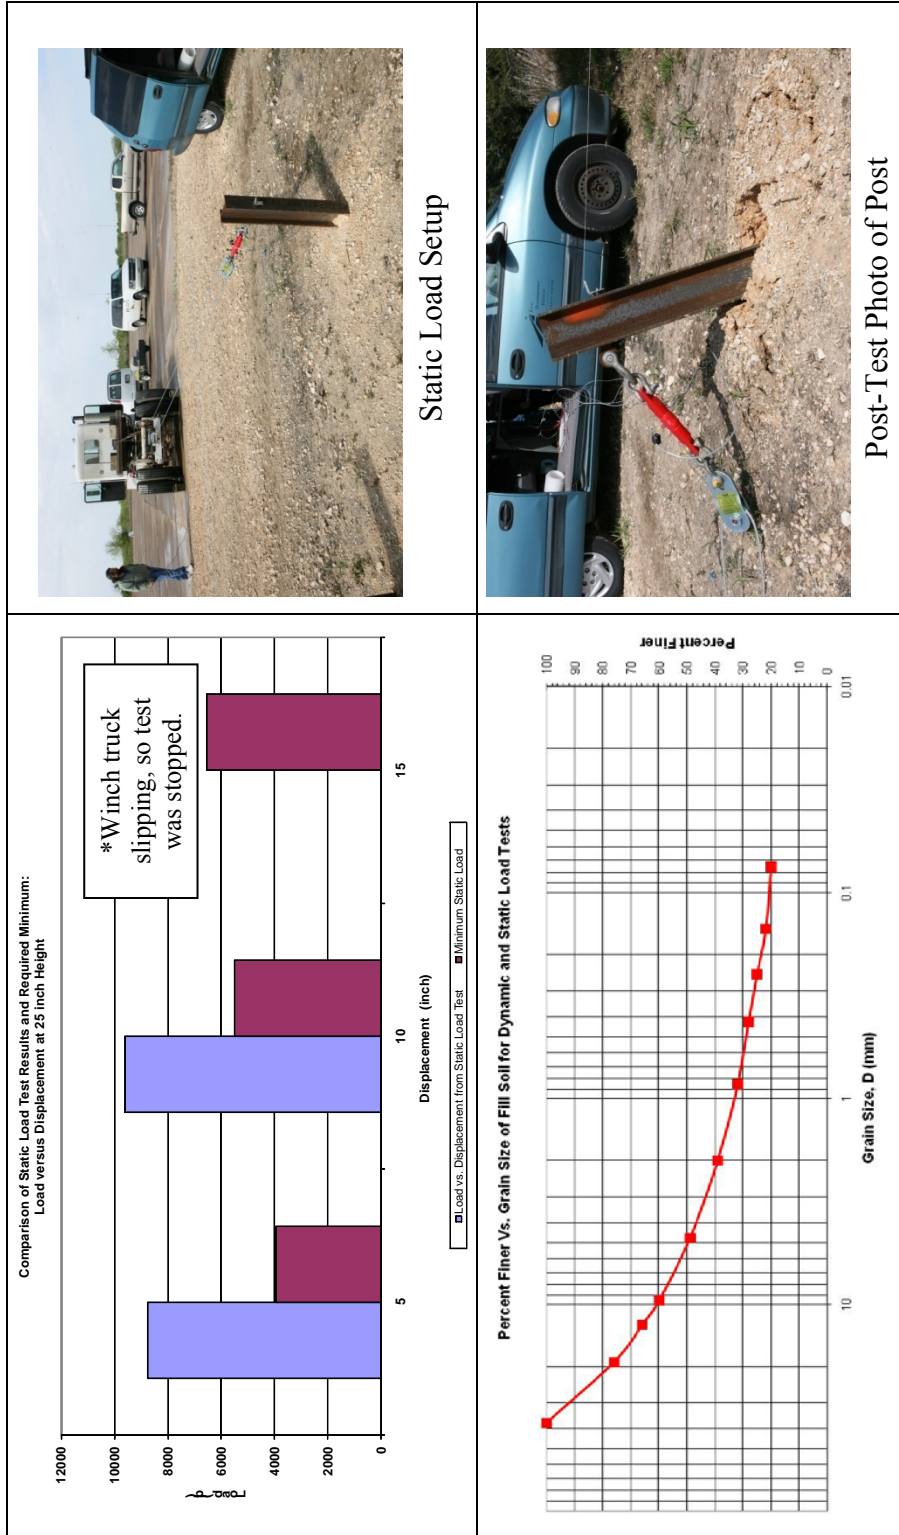
Description of Fill Placement Procedure 6-inch lifts tamped with a pneumatic compactor

Figure G1. Test Day Static Soil Strength Documentation.

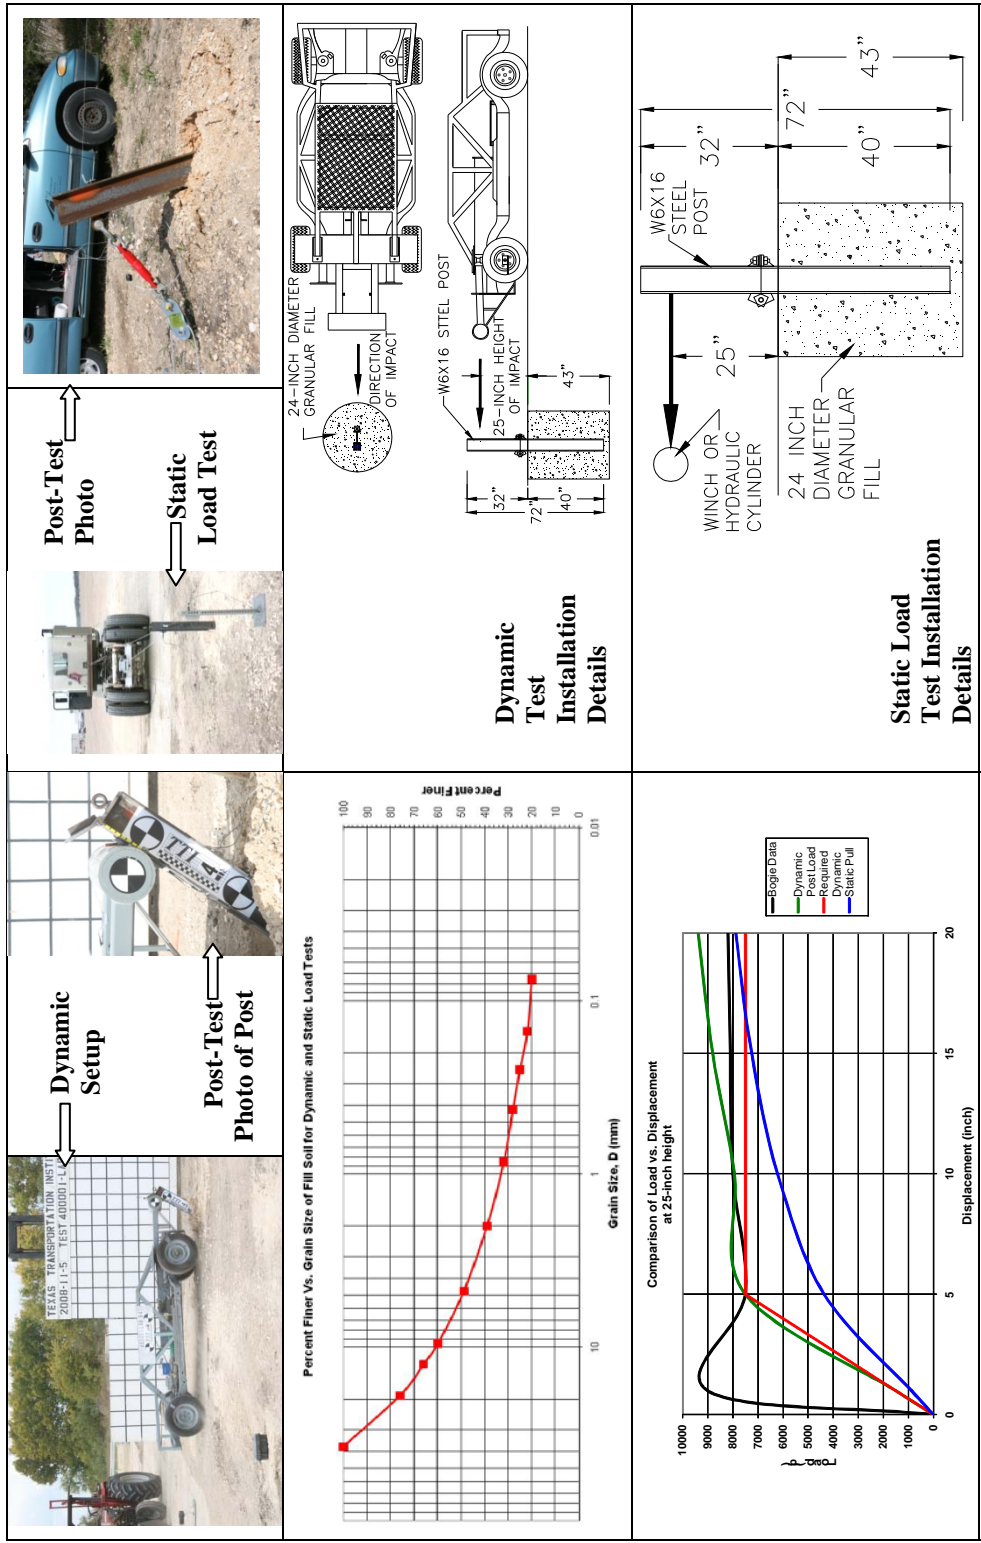
Date.....	2008-11-05
Test Facility and Site Location.....	TTI Proving Ground, 3100 SH 47, Bryan, TX, 77807
In Situ Soil Description (ASTM D2487).....	Sandy gravel with silty fines
Fill Material Description (ASTM D2487) and sieve analysis.....	AASHTO Grade B Soil-Aggregate (see sieve analysis above)
Description of Fill Placement Procedure.....	6-inch lifts tamped with a pneumatic compactor
Bogie Weight.....	5009 lb
Impact Velocity.....	20.5 mi/h

Figure G2. Summary of Strong Soil Test Results for Establishing Installation Procedure.
