## SKID-MOUNTED SUPPORT SYSTEM FOR TEMPORARY GUIDE SIGNS

**Test Report No. 0-6782-2**

TEXAS A&M TRANSPORTATION INSTITUTE  
COLLEGE STATION, TEXAS

16. Abstract <p>A common issue during phased highway construction projects is the need to temporarily relocate large guide signs on the roadside or install new guide signs for temporary use. The conventional concrete foundations used for these signs are costly and time-consuming to install and remove after construction is completed.</p> <p>A freestanding, skid-mounted support system for temporary large guide signs was developed and successfully crash-tested in accordance with the <i>Manual for Assessing Safety Hardware (MASH)</i> guidelines. The design considered wind loads, ballast requirements, and impact performance. The skid-mounted design eliminates the need for below-ground footers, and permits rapid movement and relocation of the sign.</p> <p>The results of the research have been used to establish guidelines for both the direct embedded temporary wood support system (developed in the first year of the project) and the skid-mounted support system. The guidelines provide the designer with a means of selecting the appropriate numbe

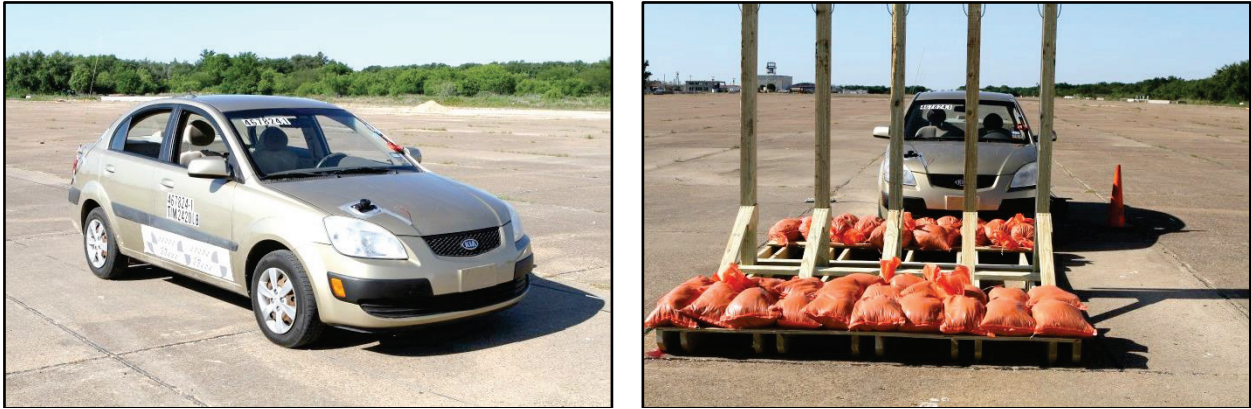
**Figure 4.3. Vehicle before Test No. 467824-1.**

A 2008 Kia Rio, shown in [Figure 4.3](#), was used for the crash test. Test inertia weight of the vehicle was 2440 lb, and its gross static weight was 2605 lb. The height to the lower edge of the vehicle bumper was 8.0 inches, and the height to the upper edge of the bumper was 21.0 inches. [Table C1](#) in [Appendix C](#) gives additional dimensions and information on the test vehicle. The vehicle was directed into the installation using a cable reverse tow and guidance system, and was released to be freewheeling and unrestrained just prior to impact.

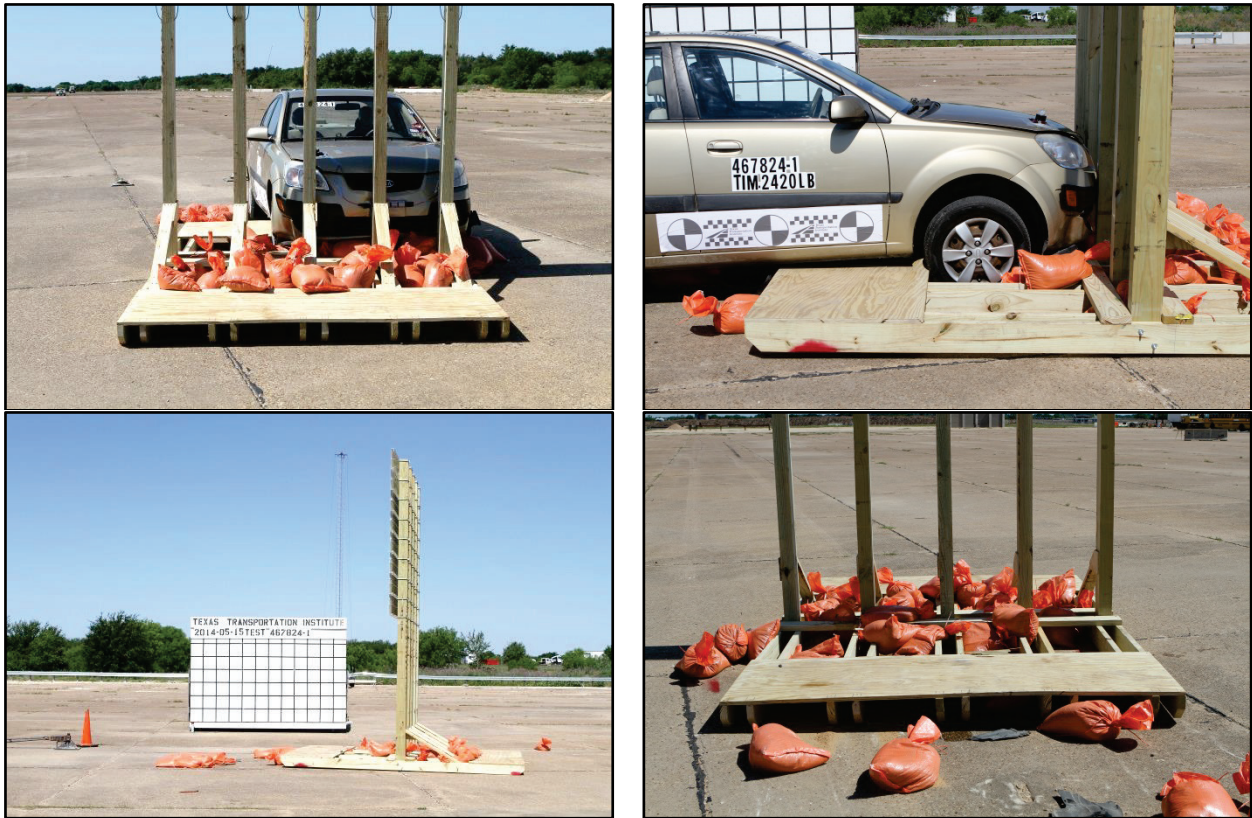
**Figure 4.4. Skid-Mounted Support System for Temporary Guide Signs after Test No. 467824-1.**

[Figure 4.4](#) shows damage to the skid-mounted sign support system after the test. Cracking was observed in the middle support near bumper level, but the support was not fractured. The right front corner of the skids was pushed forward 82 inches and left 2 inches. The right front corner of the skids was pushed forward 34 inches. The vehicle bumper was resting against support posts 1 through 3.

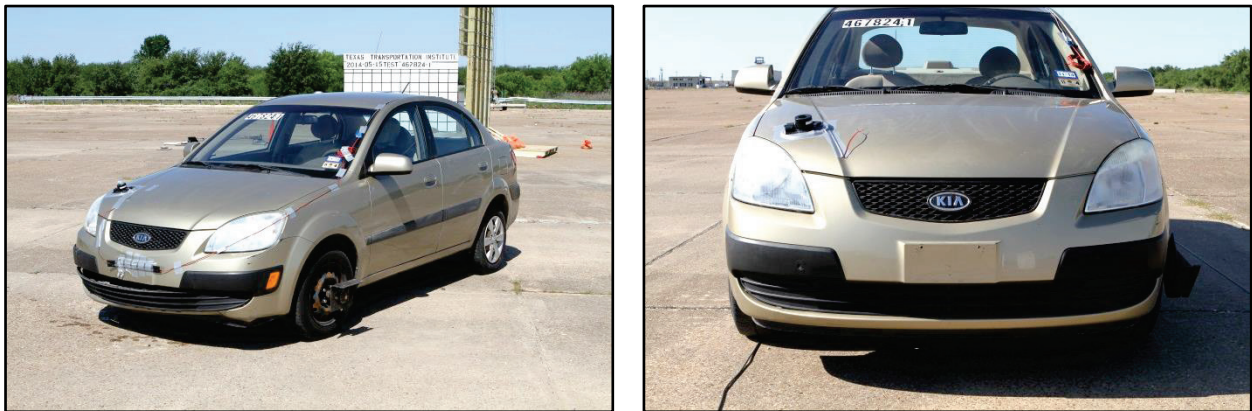
**Figure 4.5. Vehicle after Test No. 467824-1.**

[Figure 4.5](#) shows the minimal damage that the vehicle sustained during the test, which included a small indentation in the front bumper and the radiator. No measureable exterior crush occurred, and no occupant compartment deformation or intrusion was noted. [Tables C2](#) and [C3](#) of [Appendix C](#) show the exterior crush and occupant compartment measurements.

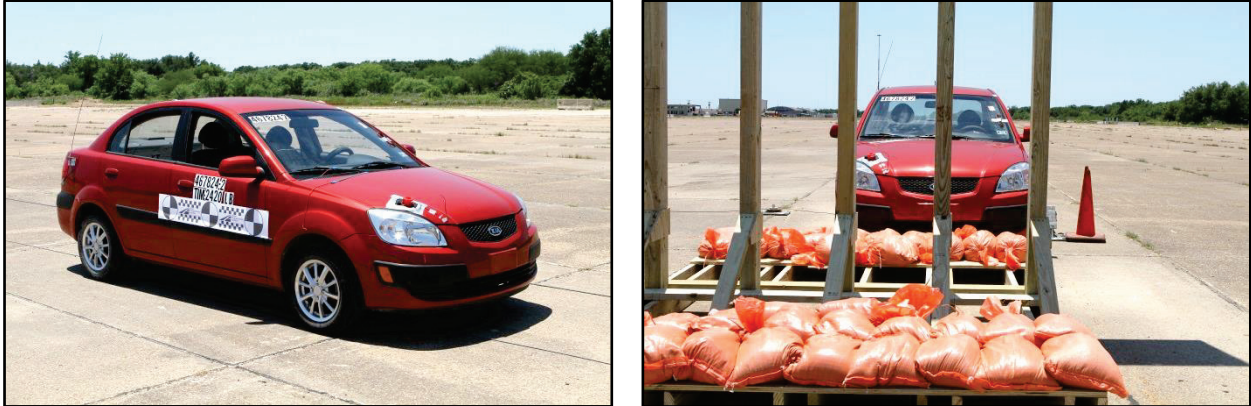
**Figure 4.7. Vehicle before Test No. 467824-2.**

A 2008 Kia Rio, shown in [Figure 4.7](#), was used for the crash test. The test inertia weight of the vehicle was 2425 lb, and the gross static weight was 2590 lb. The height to the lower edge of the vehicle bumper was 8.75 inches, and the height to the upper edge of the bumper was 21.0 inches. [Table D1](#) in [Appendix D](#) gives additional dimensions and information on the vehicle. The vehicle was directed into the installation using a cable reverse tow and guidance system, and was released to be freewheeling and unrestrained just prior to impact.

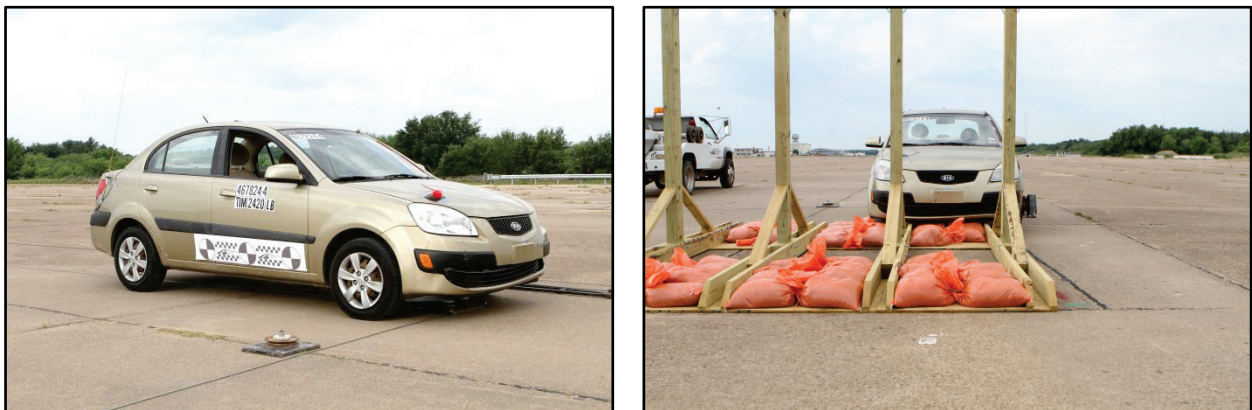
Figure 4.12. Vehicle before Test No. 467824-4.

A 2008 Kia Rio, shown in [Figure 4.12](#), was used for the crash test. The test inertia weight of the vehicle was 2440 lb, and the gross static weight was 2605 lb. The height to the lower edge of the vehicle bumper was 8.0 inches, and the height to the upper edge of the bumper was 21.0 inches. [Table G1](#) in [Appendix G](#) gives additional dimensions and information on the vehicle. The vehicle was directed into the installation using a cable reverse tow and guidance system, and was released to be freewheeling and unrestrained just prior to impact.

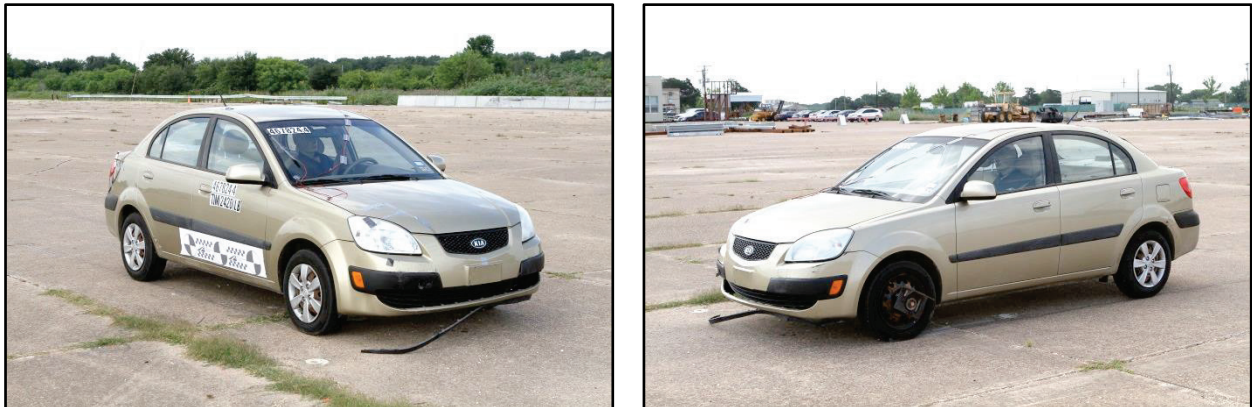
Figure 4.14. Vehicle after Test No. 467824-4.

Figure 4.14 shows the damage that the vehicle sustained during the test, which included only cosmetic damage in the form of scratches to the front bumper. No measureable exterior crush to the vehicle was noted. No occupant compartment deformation occurred. Tables G2 and G3 in Appendix G give exterior crush and occupant compartment measurements.

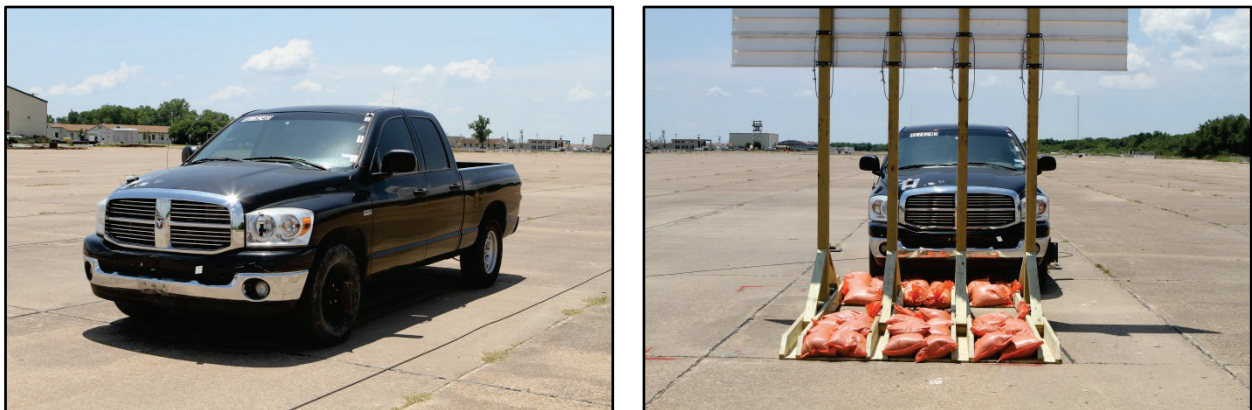
Figure 4.16. Vehicle before Test No. 467824-3.

Figure 4.16 shows a 2008 Dodge Ram 1500 pickup truck was used for the crash test. The test inertia weight of the vehicle was 5016 lb, and the gross static weight was 5016 lb. The height to the lower edge of the vehicle bumper was 16.0 inches, and the height to the upper edge of the bumper was 27.75 inches. Tables H1 and H2 in Appendix H gives additional dimensions and information on the vehicle. The vehicle was directed into the installation using a cable reverse tow and guidance system, and was released to be freewheeling and unrestrained just prior to impact.

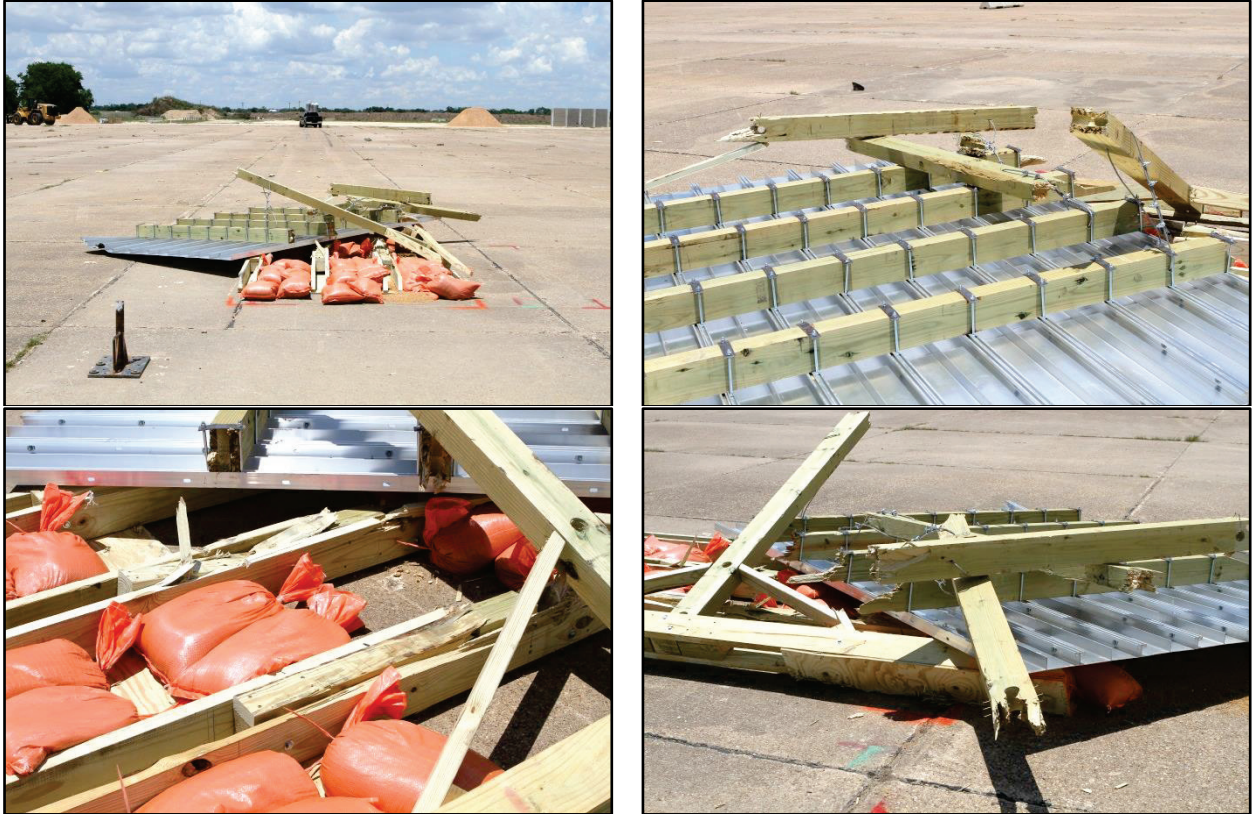
**Figure 4.17. Modified Skid-Mounted Support System for Temporary Guide Signs after Test No. 467824-3.**

[Figure 4.17](#) shows damage to the skid-mounted sign support system after the test. The impacted support posts fractured at bumper height and below the sign panel as designed. The skids slid 18 inches forward, and the sign panel and support posts came to rest on top of the skids. The braces from support posts 2 and 3 traveled along with the vehicle and came to rest 225 ft downstream and 52 ft to the right of impact. The vehicle came to rest 357 ft downstream of the impact point.

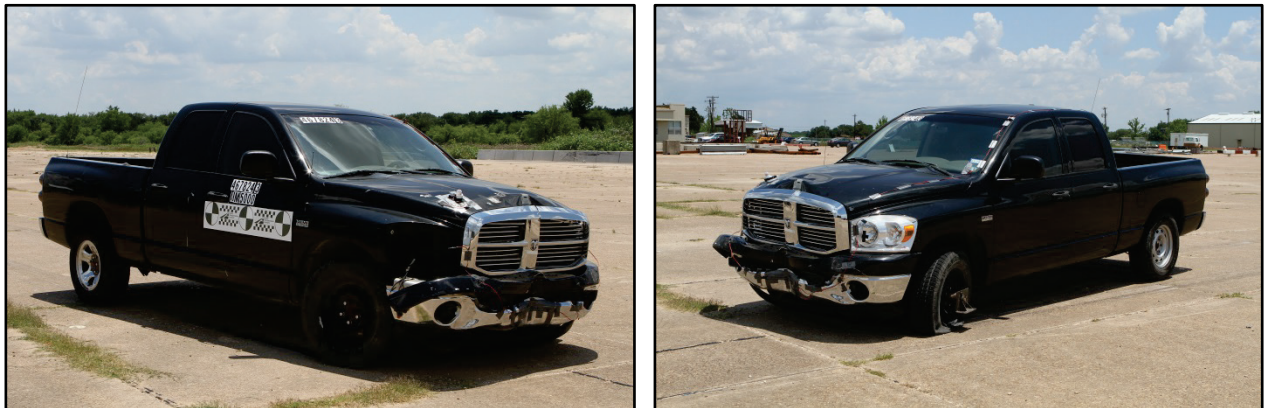
**Figure 4.18. Vehicle after Test No. 467824-3.**

[Figure 4.18](#) shows the damage that the vehicle sustained during the test, which included the front bumper, hood, and grill. Additionally, the left front tire was deflated. Maximum exterior crush was 3.0 inches in the front plane on the right corner at bumper height. No occupant compartment deformation was noted. [Tables H3](#) and [H4](#) of [Appendix H](#) provide exterior crush and occupant compartment measurements.

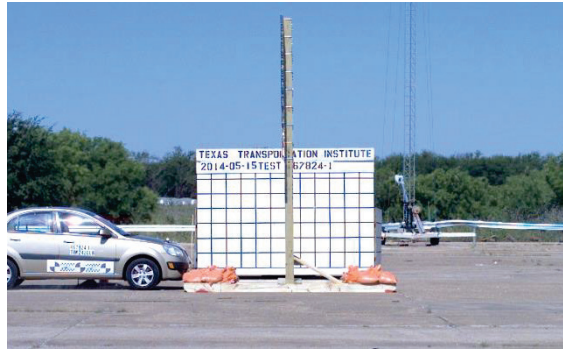
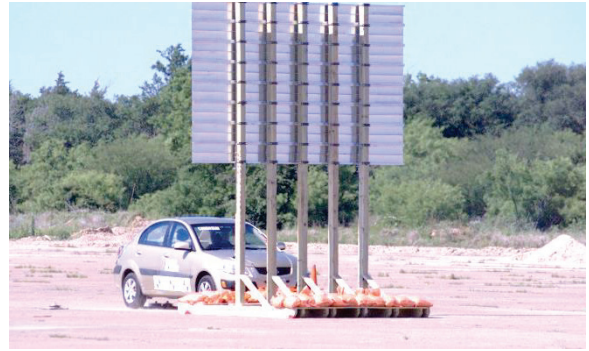
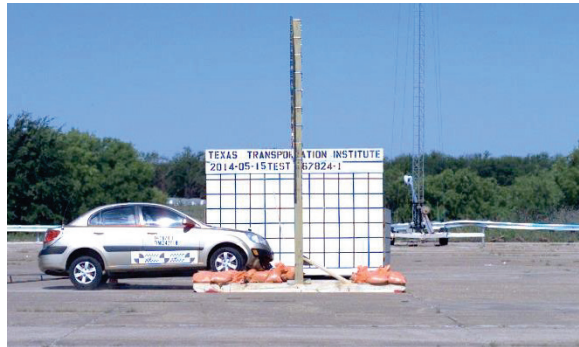
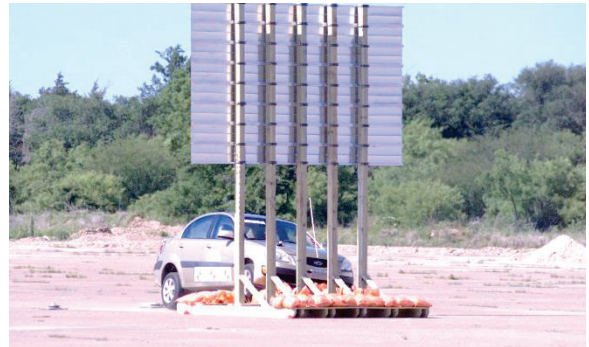
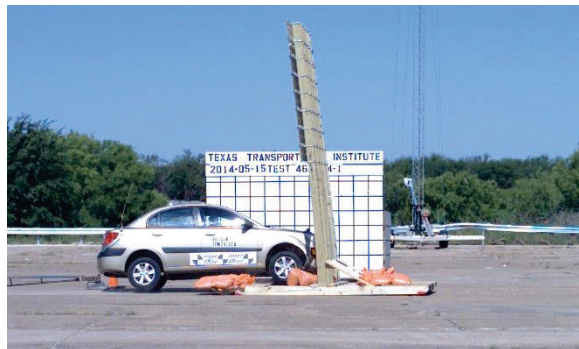
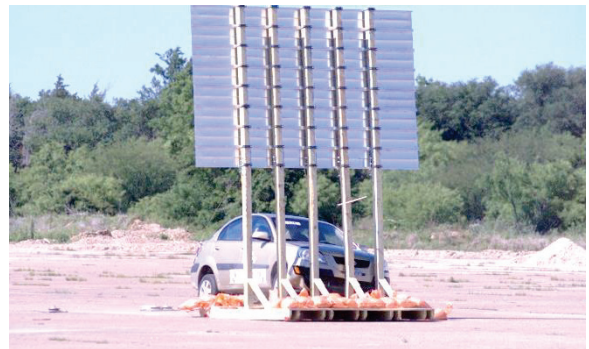
**Figure C1. Sequential Photographs for Test No. 467824-1 (Perpendicular and Oblique Views).**

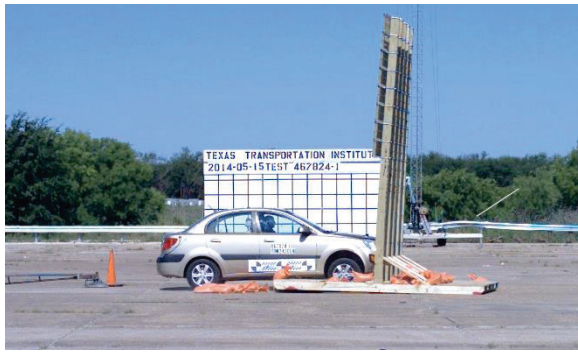
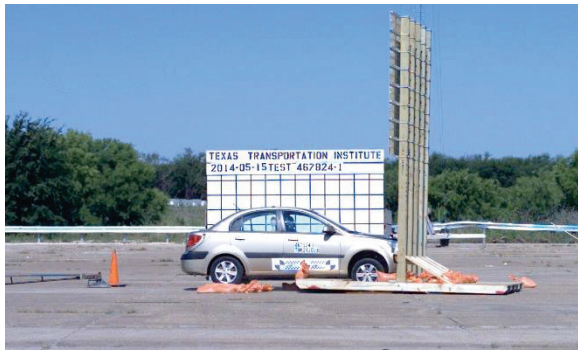
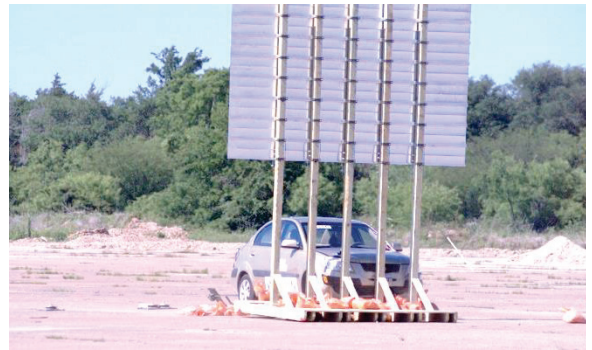
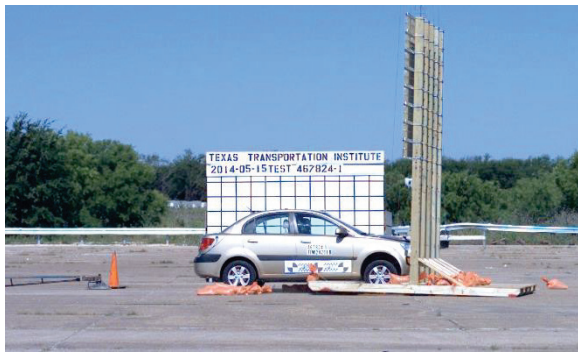
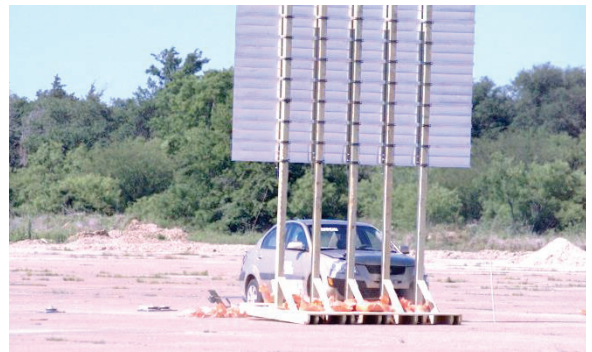
**Figure C1. Sequential Photographs for Test No. 467824-1 (Perpendicular and Oblique Views) (Continued).**

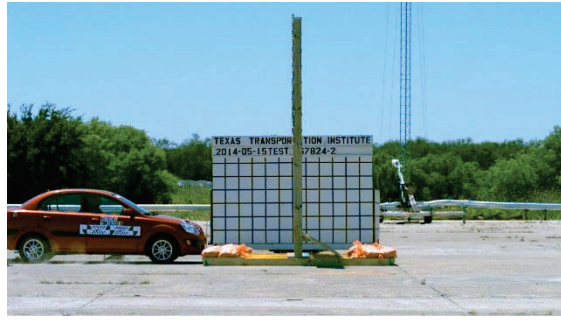
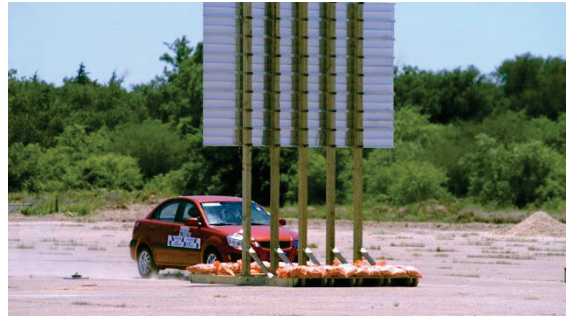
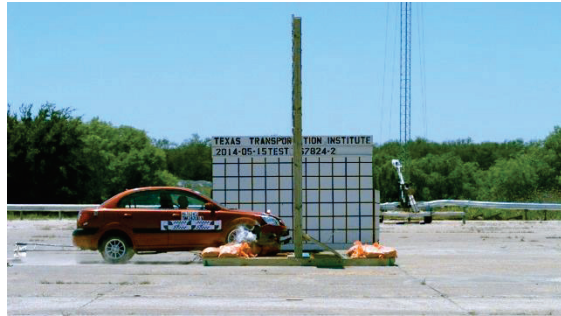
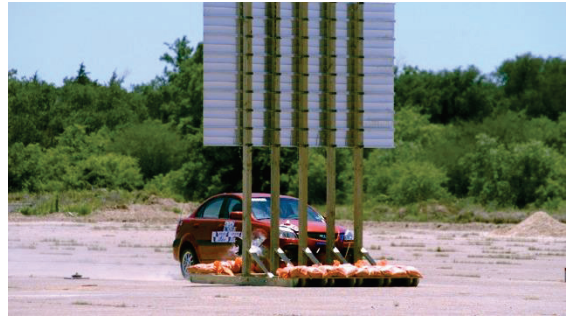
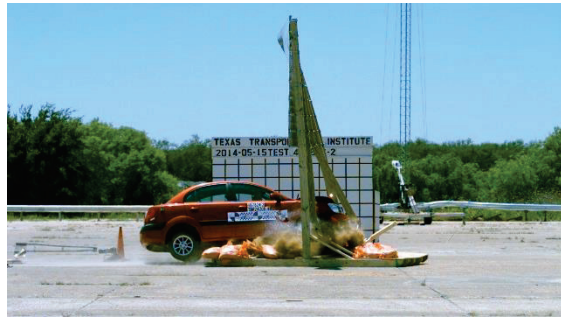
**Figure D1. Sequential Photographs for Test No. 467824-2 (Perpendicular and Oblique Views).**

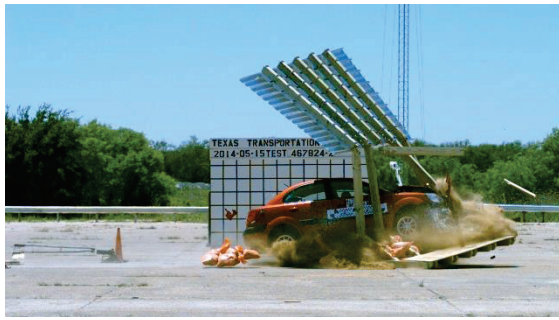
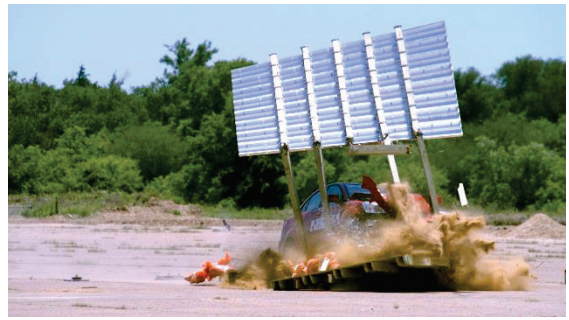
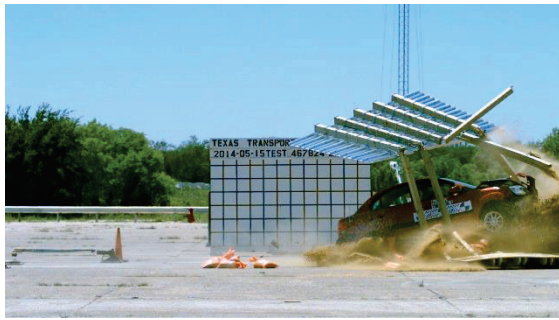
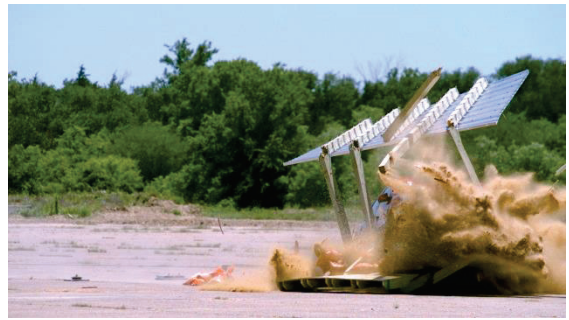
**Figure D1. Sequential Photographs for Test No. 467824-2 (Perpendicular and Oblique Views) (Continued).**

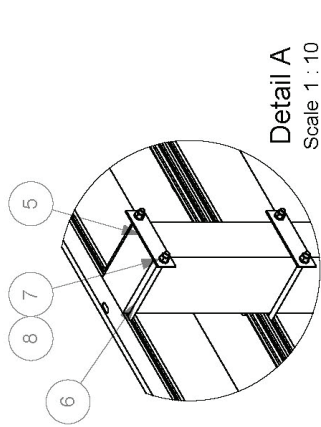
Project 467824-4 Large Temporary Sign  
 Drawn By GES Scale 1:50 Sheet 1 of 7 Isometric Views  
 Approved: *Roger Bligh* Date: 2014-05-21  
 Roger Bligh

Assembly Parts		QTY.
#	Part Name	
1	Panel Assembly	1
2	Frame Assembly	1
3	Cable Assembly	4
4	40lb Sandbag	44
5	Clamp Plate	36
6	Bolt, 3/8 x 6-1/2 hex	72
7	Washer, 3/8 lock	72
8	Nut, 3/8 hex	72

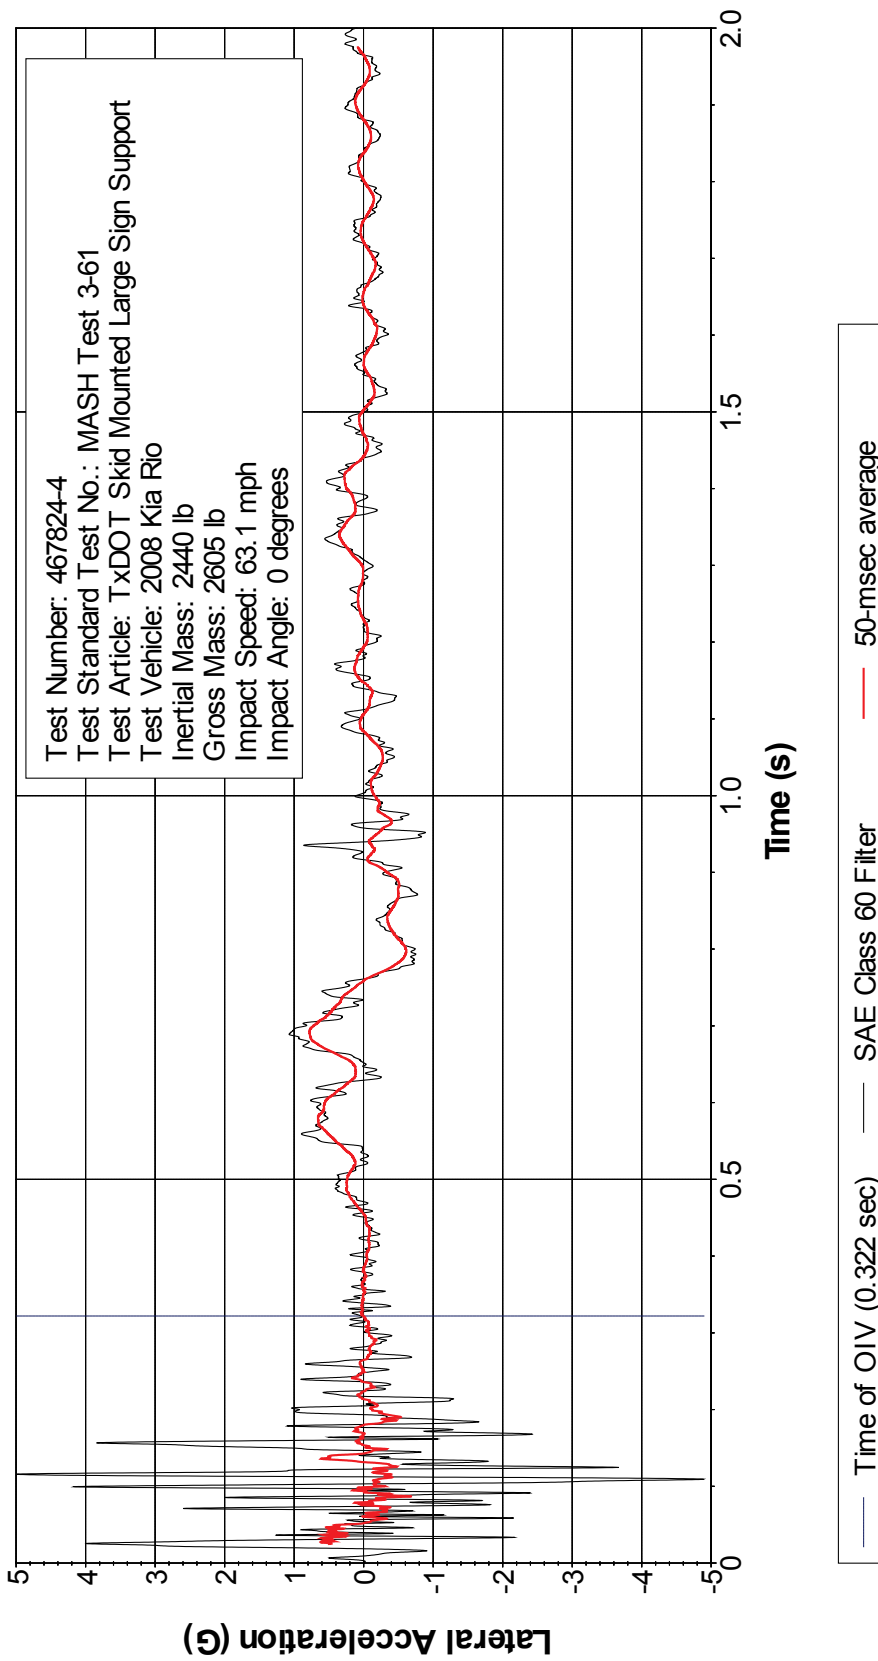
**Figure G4. Vehicle Lateral Accelerometer Trace for Test No. 467824-4 (Accelerometer Located at Center of Gravity).**

# Y Acceleration at CG

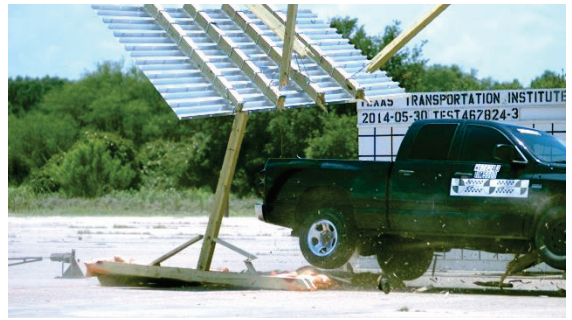
**Figure H1. Sequential Photographs for Test No. 467824-3 (Perpendicular and Oblique Views) (Continued).**
