1. Report No. FHWA/TX-90/1122-1F		2. Government Accession No.		3. Recipient's Catalog No.	
4. Title and Subtitle Generic Small Sign Support System and Validation of Acceptable Support Performance				5. Report Date April 1990 /Revised

14. Sponsoring Agency Code	
15. Supplementary Notes Research performed in cooperation with DOT, FHWA					
16. Abstract Small sign systems include everything from stop signs and delineator posts to signs up to about 25 square feet. In some cases, multiple small sign support systems are used to support much larger signs (40-50 square feet). This broad class of sign has been and is currently being used along Texas highways. To insure the safety of vehicle occupants, there have been a series of specifications, guidelines and recommendations which define acceptable vehicle impact performance criteria. Most small sign systems have been tested with vehicles larger than the current standard 1800 pound car. As a result, the first phase of this study was to undertake a series of recertification tests for those systems currently being used in Texas. An analytical model also was developed to aid in the evaluation of data from previous crash tests. Although certif

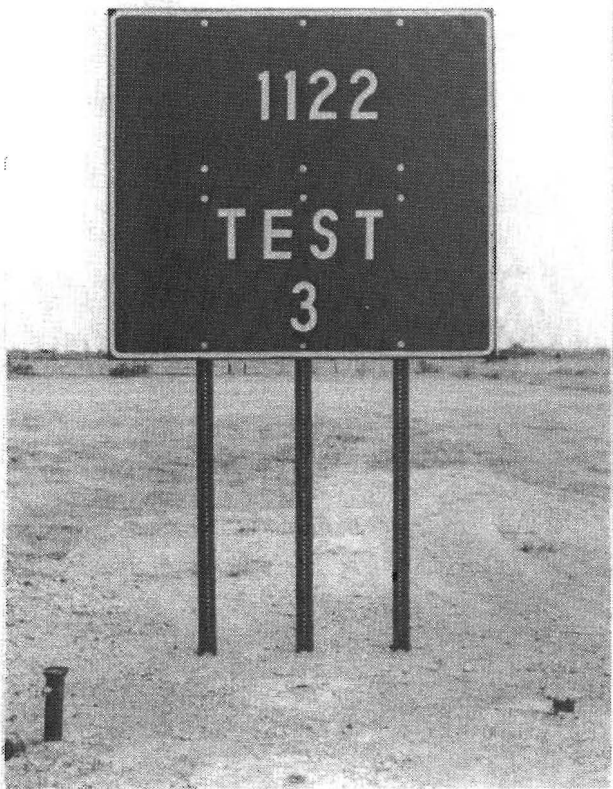
Figure 14. Sign installation before test 1122-3.

The sign installation used in these tests consisted of a 6 ft-0 in wide x 5 ft-0 in high plywood sign panel mounted on three Franklin 4.0 lb-ft steel supports. These supports were attached to three 60 inch stubs which had been driven into crushed limestone (NCHRP Report 230 "strong" soil) at 21 inches on center spacing. The supports were attached to the stubs in a nested splice (stubs in front of sign supports) with 1/2 inch spacers and 5/16 inch grade 9 bolts, nuts and washers. The bottom of sign mounting height was 5 ft. Details of the sign installation are shown in Figures 13 and 14.

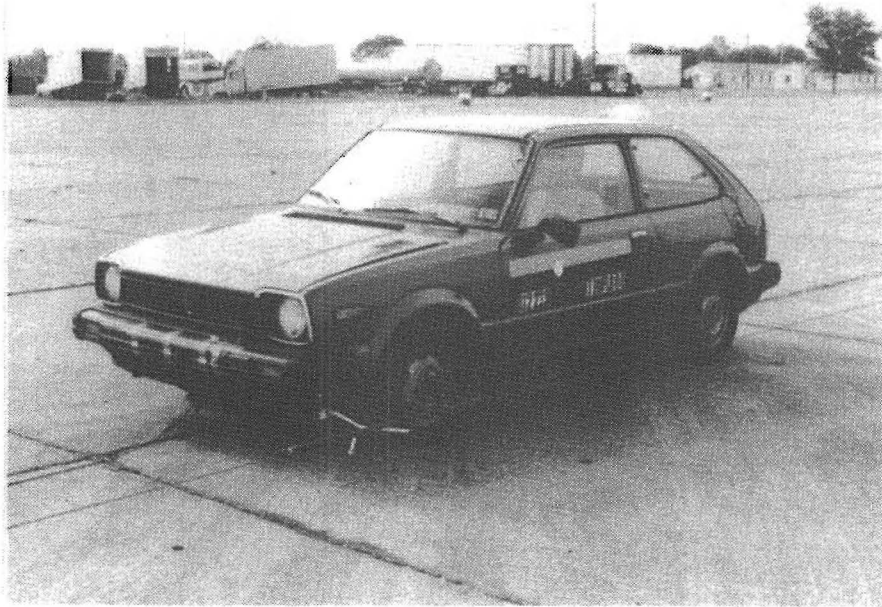
Figure 15. Vehicle before test 1122-3.

A 1980 Honda Civic (shown in Figure 15) impacted the sign installation at 20.3 miles per hour (32.6 km/h) using a cable reverse tow and guidance system. Test inertia mass of the vehicle was 1,800 lb (817 kg) and its gross static mass was 1,963 lb (890 kg). The height to the lower edge of the vehicle bumper was 14.0 inches (35.6 cm) and 19.5 inches (49.5 cm) to the top of the bumper. Other dimensions and information on the vehicle are given in Figure 16.

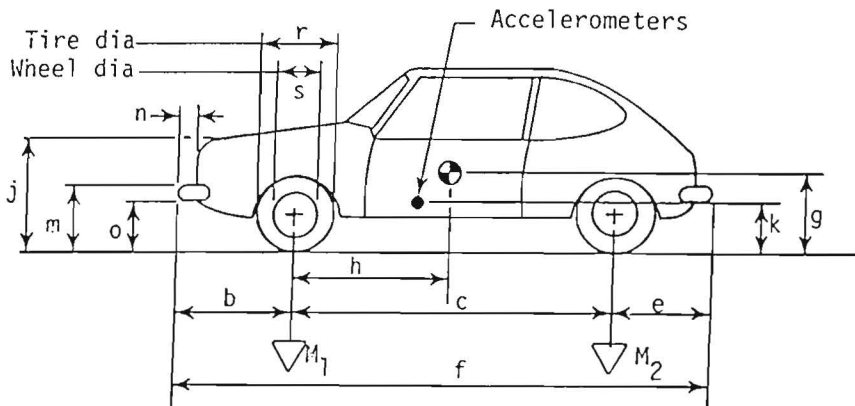
a 62 b 28
 c 88 1/4 d* 52
 e 28 1/2 f
 g h 31.8
 i j 29 1/2
 k 16 1/2 l 26
 m 19 1/2 n 5
 o 14 p 53 1/2
 r 21 s 13 1/4

Figure 16. Test vehicle properties (1122-3).

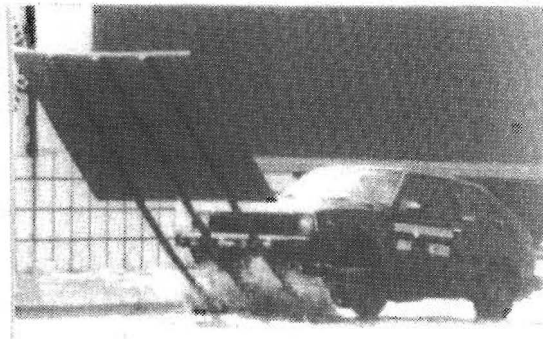
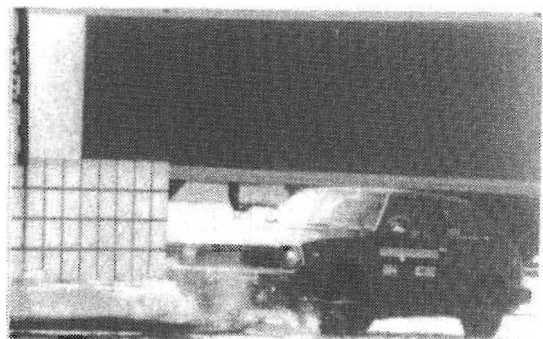
Figure 17. Sequential photographs for test 1122-3.

The vehicle was freewheeling and unrestrained just prior to impact. The point of impact was the center line of the sign with the center of the vehicle. Upon impact, the sign supports began to deform and the vehicle started climbing the sign installation. At approximately 0.138 seconds, the front wheels were clear of the ground and the sign support bolts had fractured. At approximately 0.188 seconds, the vehicle lost contact with the sign installation, as the vehicle ceased forward motion and the sign installation yielded. As the front of the vehicle came into contact with the ground, the brakes were applied and the vehicle came to rest over the installation stubs at the point of impact. Sequential photographs of the test are shown in Figure 17.

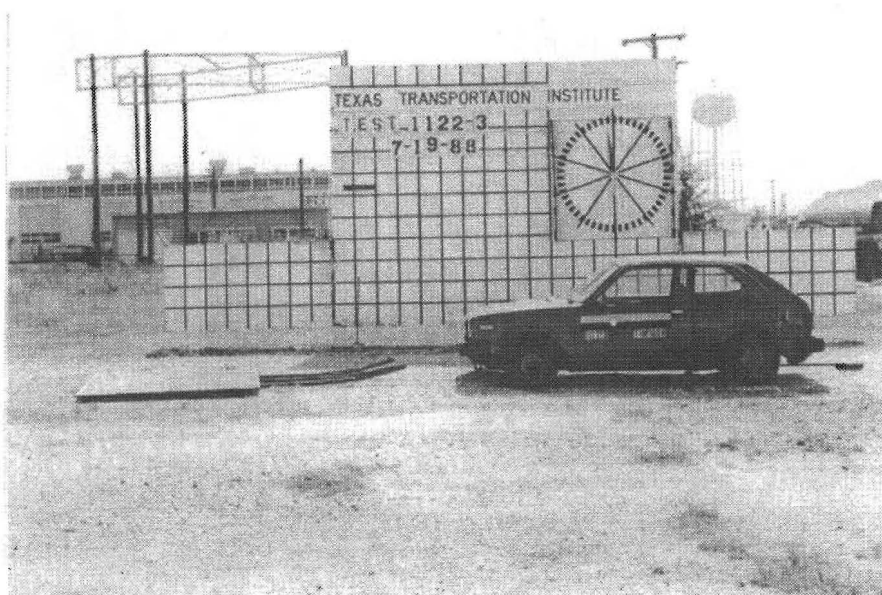
Figure 18. Sign installation after test 1122-3.

The sign installation stubs were pushed rearward 4.0 in (10.16 cm) and the three sign supports were bent 19.0 in (48.3 cm) to 23.0 in (54.4 cm) above their original ground mounting height. In addition, the end of the sign supports came to rest 22.0 in (55.9 cm) from the front of the vehicle (see Figure 18). The vehicle sustained minor damage to the bumper and windshield as shown in Figure 19.

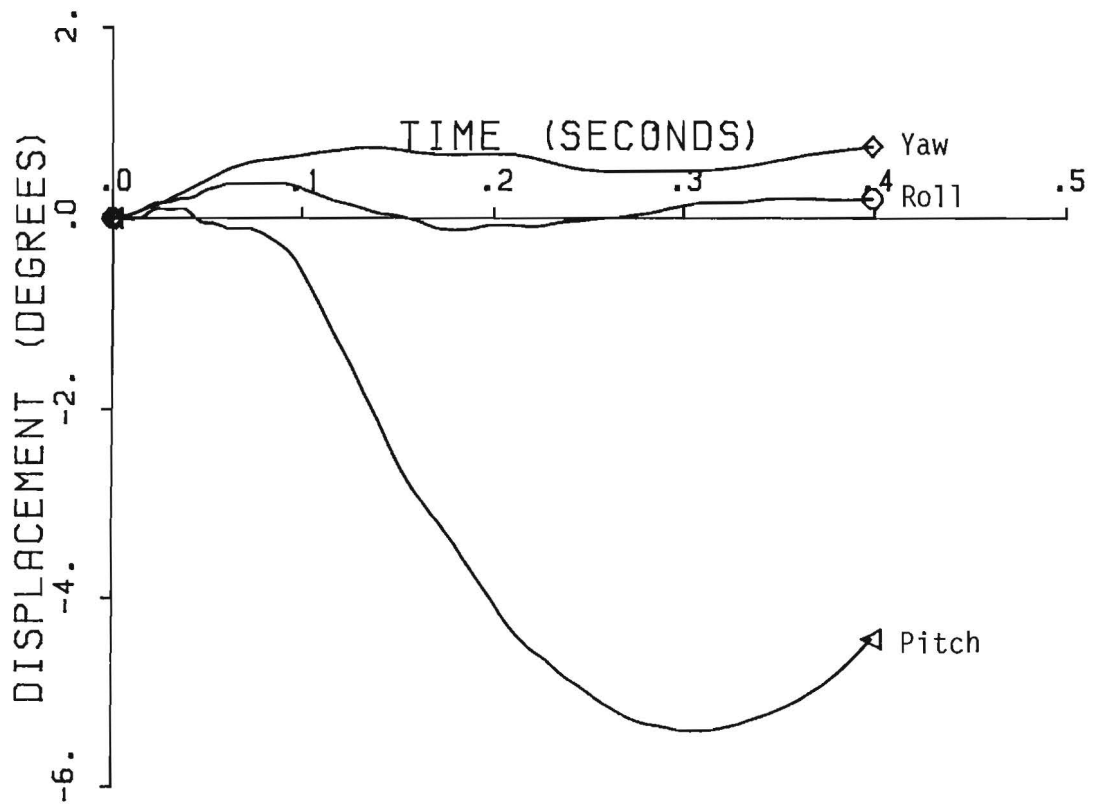
Figure 21. Vehicle angular displacements for test 1122-3.

Axes are vehicle fixed.
 Sequence for determining
 orientation is:

1. Yaw
2. Pitch
3. Roll

A summary of the test results and other information pertinent to this test are given in Figure 20. The maximum 0.050 second average acceleration experienced by the vehicle was -8.3 g in the longitudinal direction and -1.0 g in the lateral direction. Vehicle angular displacements are plotted in Figure 21 and vehicle accelerometer traces are displayed in Figure 22 through 24. Occupant impact velocity in the longitudinal direction was 28.2 feet per second (8.6 m/s) and no occupant impact velocity existed in the lateral direction. The highest 0.10 second occupant ridedown acceleration was -2.1 g (longitudinal). Change in velocity was 21.8 mi/h (35.0 km/h) and change in momentum was 1785 lb-s.

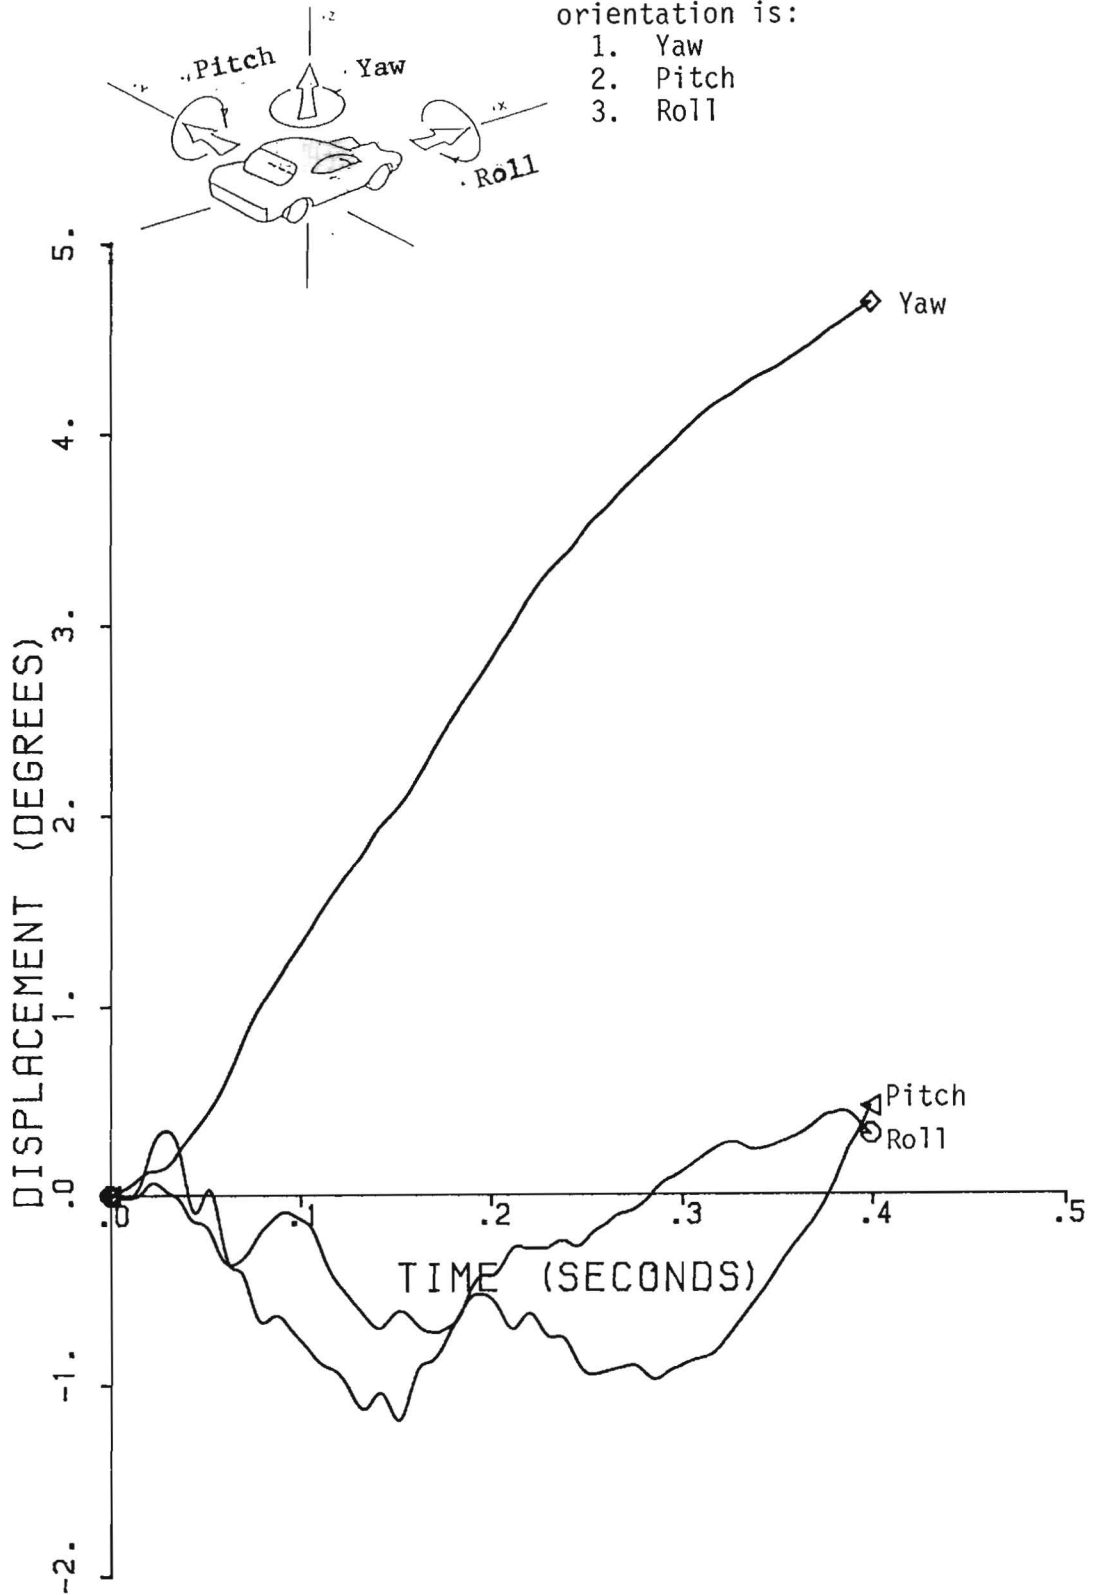
Figure 3I. Vehicle angular displacements for test 1122-4.

Axes are vehicle fixed.
Sequence for determining
orientation is:

1. Yaw
2. Pitch
3. Roll

A summary of the test results and other information pertinent to this test are given in Figure 30. The maximum 0.050 second average acceleration experienced by the vehicle was -8.7 g in the longitudinal direction and 1.3 g in the lateral direction. Vehicle angular displacements are plotted in Figure 31 and vehicle accelerometer traces are displayed in Figure 32 through 34. Occupant impact velocity in the longitudinal direction was 15.5 feet per second (4.7 m/s) and no occupant impact velocity existed in the lateral direction. The highest 0.10 second occupant ridedown acceleration was -3.4 g (longitudinal). Change in velocity was 11.8 mi/h (18.9 km/h) and change in momentum was 963 lb-s.

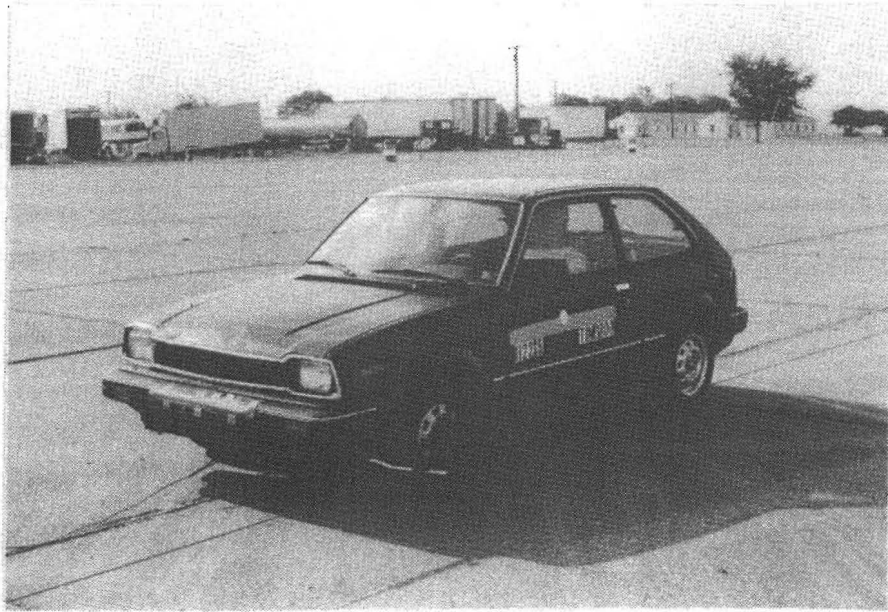
Figure 37. Vehicle before test 1122-5.

A 1982 Honda Civic (shown in Figure 37) impacted the sign installation at 19.5 miles per hour (31.4 km/h) using a cable reverse tow and guidance system. Test inertia mass of the vehicle was 1,800 lb (817 kg) and its gross static mass was 1,970 lb (894 kg). The height to the lower edge of the vehicle bumper was 13.8 inches (34.9 cm) and 19.5 inches (49.5 cm) to the top of the bumper. Other dimensions and information on the vehicle are given in Figure 38.

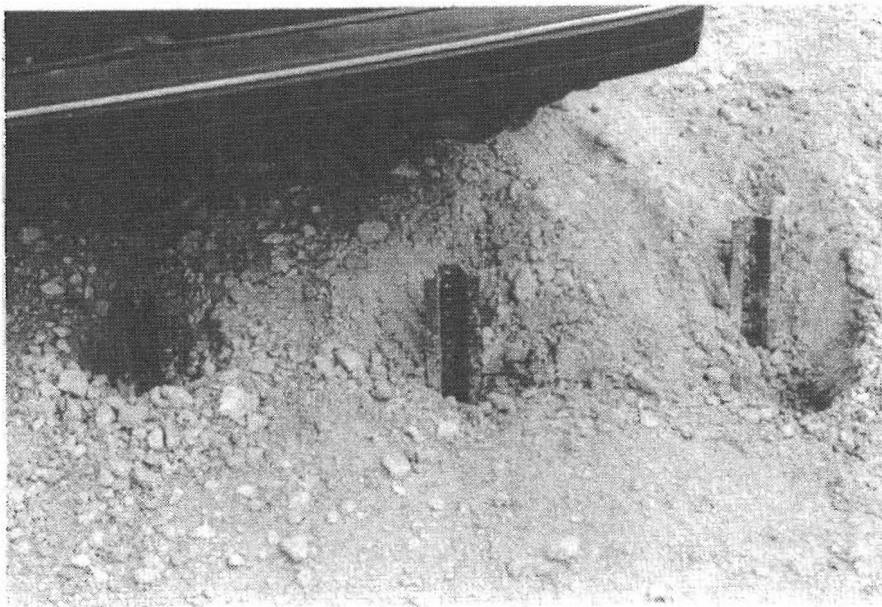
Figure 40. Sign installation after test 1122-5.

The left sign support was fractured and the center support partially fractured 22.0 inches (55.88 cm) above ground level. The right support stub was pushed rearward 9.0 inches (22.86 cm). After impact, the sign installation came to rest 21 ft (6.4 m) from the impact site. The vehicle sustained minor damage to the bumper and windshield as shown in Figure 41.

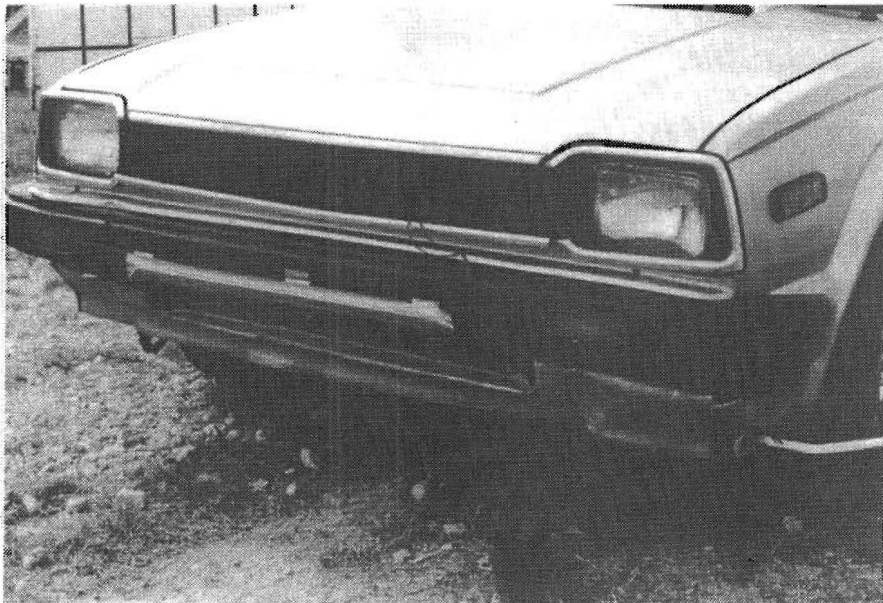
Figure 53. Vehicle after test 1122-6.

point of impact. The vehicle sustained minor damage to the bumper and windshield as shown in Figure 53

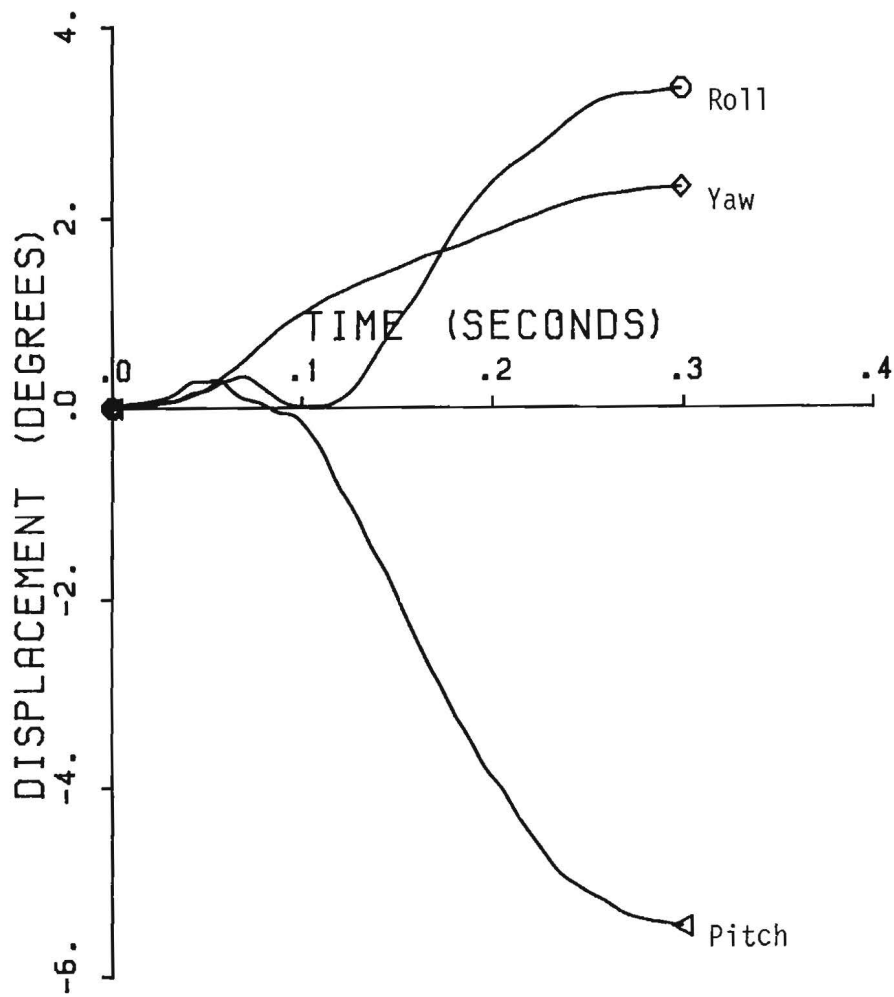
Axes are vehicle fixed.
 Sequence for determining
 orientation is:

1. Yaw
2. Pitch
3. Roll

Figure 55. Vehicle angular displacements for test 1122-6.

A summary of the test results and other information pertinent to this test are given in Figure 54. The maximum 0.050 second average acceleration experienced by the vehicle was -5.8 g in the longitudinal direction and -1.1 g in the lateral direction. Vehicle angular displacements are plotted in Figure 55 and vehicle accelerometer traces are displayed in Figure 56 through 58. Occupant impact velocity in the longitudinal direction was 20.1 feet per second (6.1 m/s) and no occupant impact velocity existed in the lateral direction. The highest 0.10 second occupant ridedown acceleration was -0.8 g (longitudinal). Change in velocity was 14.9 mi/h (23.9 km/h) and change in momentum was 1218 lb-s.

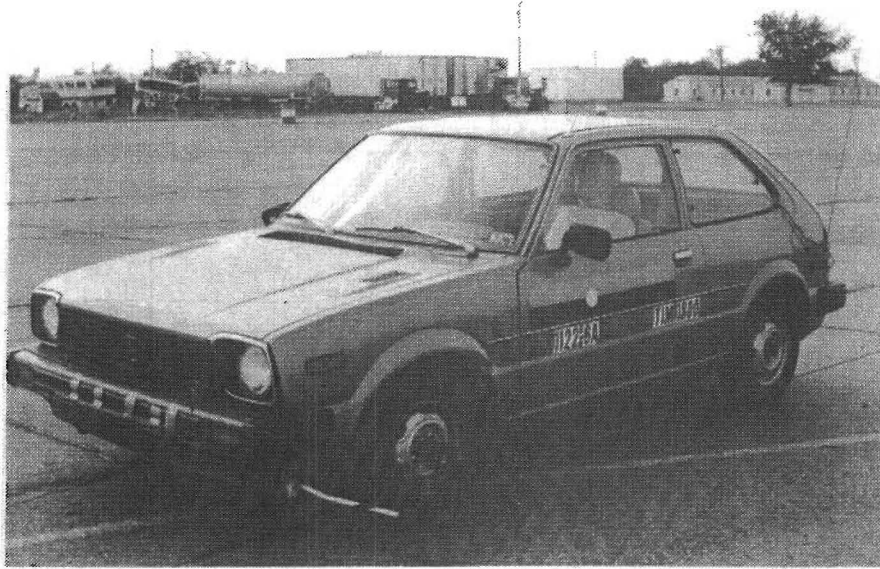
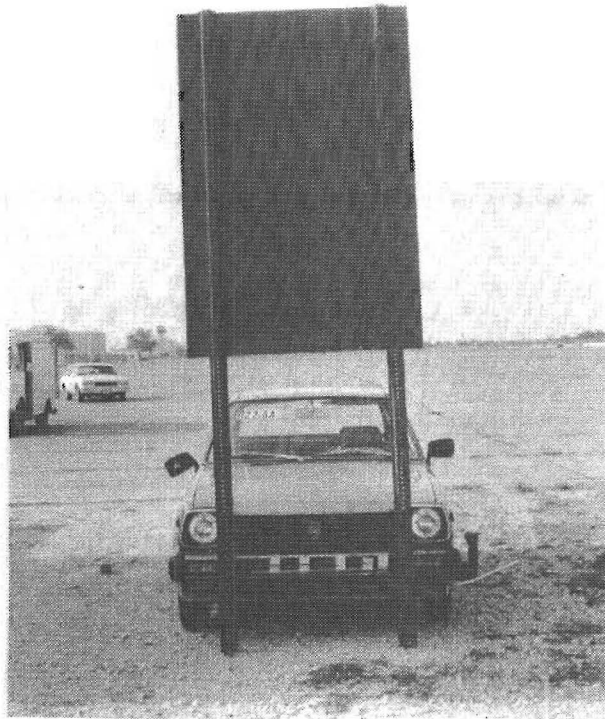
Figure 59. Vehicle before test 1122-6A.

A 1981 Honda Civic (shown in Figure 59) impacted the sign installation at 18.9 miles per hour (30.4 km/h) using a cable reverse tow and guidance system. Test inertia mass of the vehicle was 1,800 lb (817 kg) and its gross static mass was 1,967 lb (892 kg). The height to the lower edge of the vehicle bumper was 13.5 inches (34.3 cm) and 19.5 inches (49.5 cm) to the top of the bumper. Other dimensions and information on the vehicle are given in Figure 60.

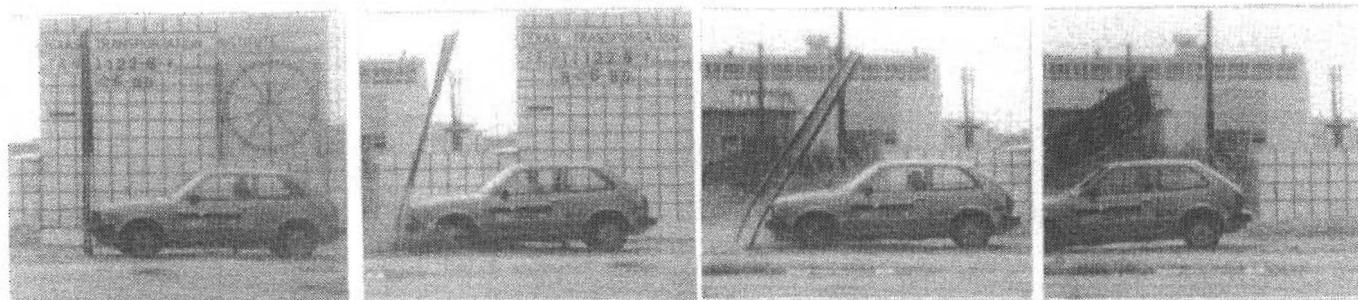
Figure 64. Summary of results for test 1122-6A.

Test No.	1122-6A	Impact Speed.	18.9 mi/h (30.4 km/h)
Date	08/26/88	Change in Velocity . . .	7.2 mi/h (11.6 km/h)
Test Article	Sign Installation	Change in Momentum. . . .	590 lb-s
Support	Two Franklin 4 lb-ft	Vehicle Accelerations	
	Supports	(Max. 0.050-sec Avg)	
Vehicle	1981 Honda Civic	Longitudinal.	-3.6 g
Vehicle Weight		Lateral	-1.0 g
Test Inertia	1,800 lb (817 kg)	Occupant Impact Velocity	
Gross Static	1,967 lb (892 kg)	Longitudinal.	10.2 ft/s (3.1 m/s)
Vehicle Damage Classification		Lateral	None
TAD	12FD1	Occupant Ridedown Accelerations	
SAE	12FDEW1	Longitudinal	-0.6 g
		Lateral	No Contact

A summary of the test results and other information pertinent to this test are given in Figure 64. The maximum 0.050 second average acceleration experienced by the vehicle was -3.6 g in the longitudinal direction and -1.0 g in the lateral direction. Vehicle angular displacements are plotted in Figure 65 and vehicle accelerometer traces are displayed in Figure 66 through 68. Occupant impact velocity in the longitudinal direction was 10.2 feet per second (3.1 m/s) and no occupant impact velocity existed in the lateral direction. The highest 0.10 second occupant ridedown acceleration was -0.6 g (longitudinal). Change in velocity was 7.2 mi/h (11.6 km/h) and change in momentum was 590 lb-s.

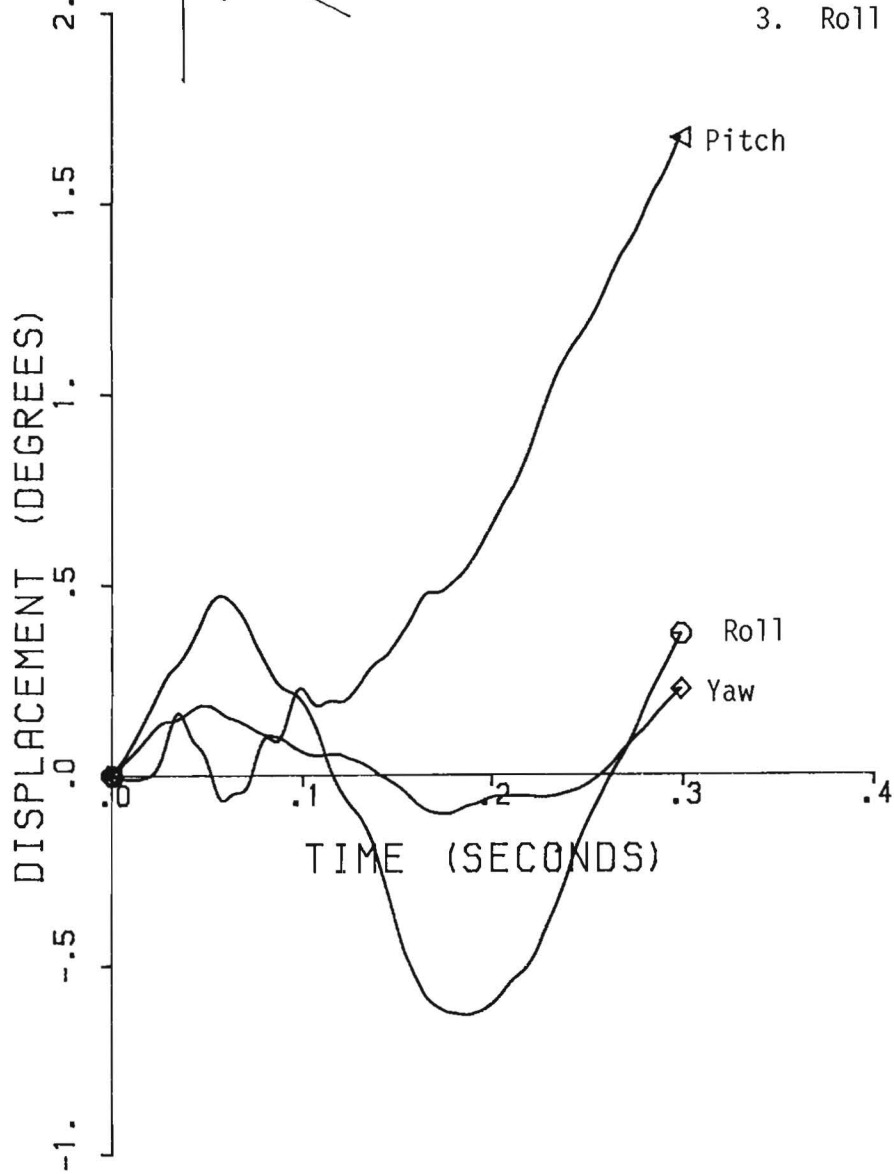
Figure 65. Vehicle angular displacements for test 1122-6A.

Axes are vehicle fixed.
 Sequence for determining
 orientation is:

1. Yaw
2. Pitch
3. Roll

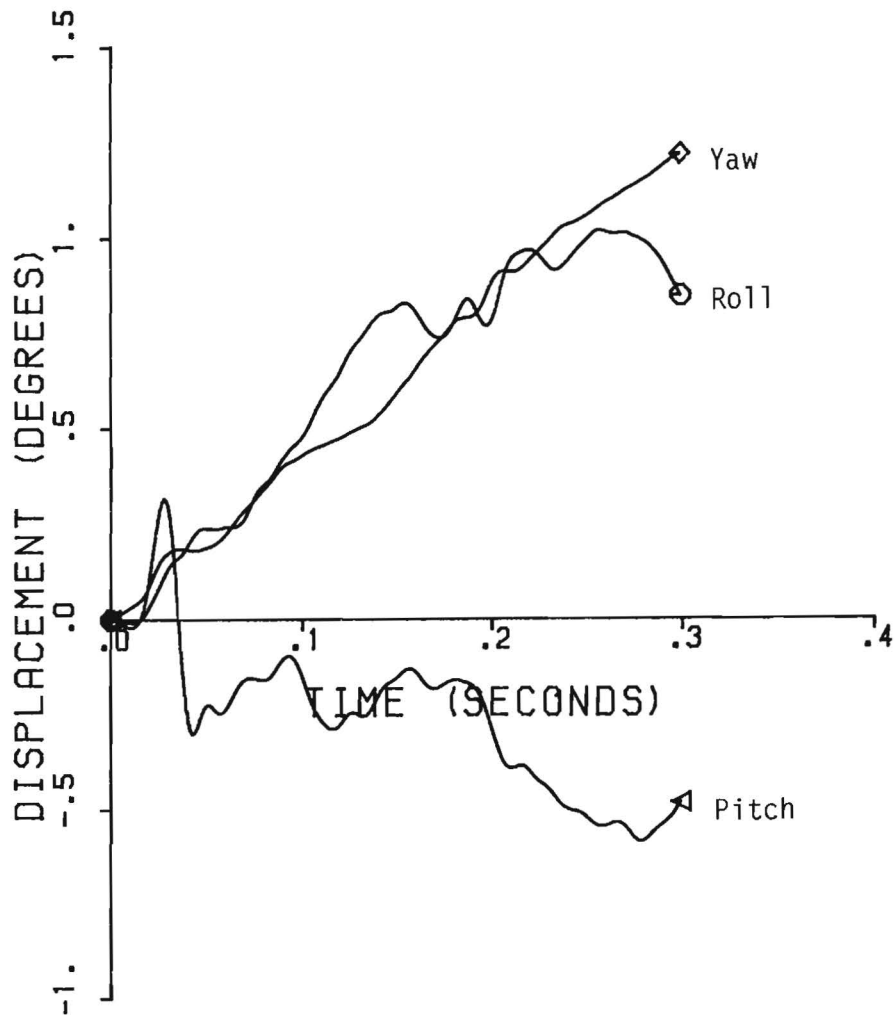
Figure 75. Vehicle angular displacements for test 1122-7.

Axes are vehicle fixed.
 Sequence for determining orientation is:

1. Yaw
2. Pitch
3. Roll

A summary of the test results and other information pertinent to this test are given in Figure 74. The maximum 0.050 second average acceleration experienced by the vehicle was -3.1 g in the longitudinal direction and -0.7 g in the lateral direction. Vehicle angular displacements are plotted in Figure 75 and vehicle accelerometer traces are displayed in Figure 76 through 78. No contact by the anthropomorphic dummy was made. Therefore, no occupant impact velocity or ridedown accelerations were recorded in the longitudinal or lateral direction. Change in velocity was 5.4 mi/h (8.7 km/h) and change in momentum was 445 lb-s.

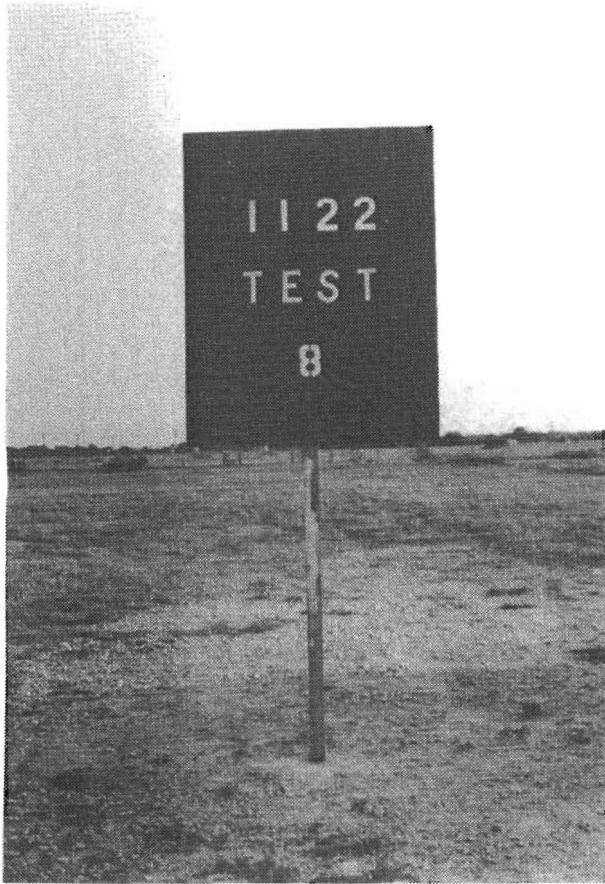
Figure 80. Sign installation before 1122-8.

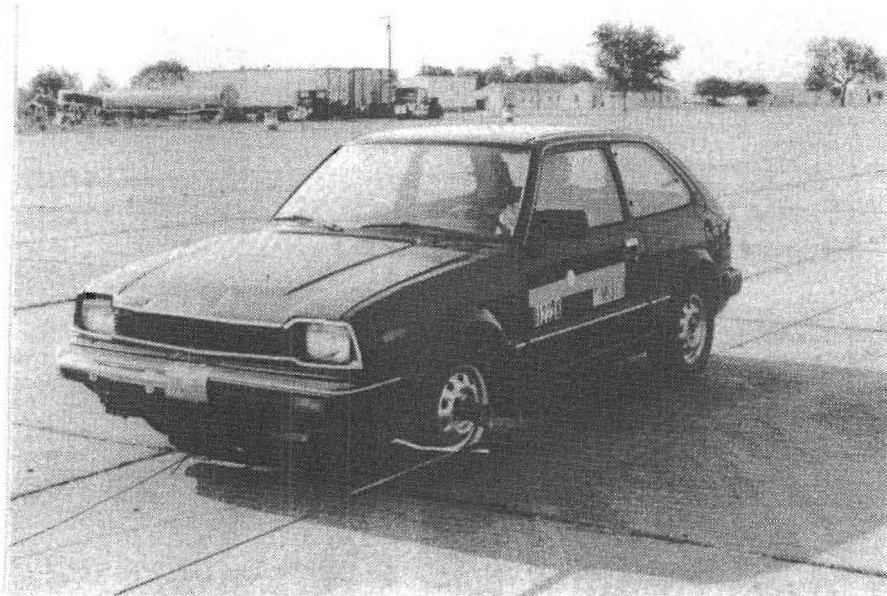
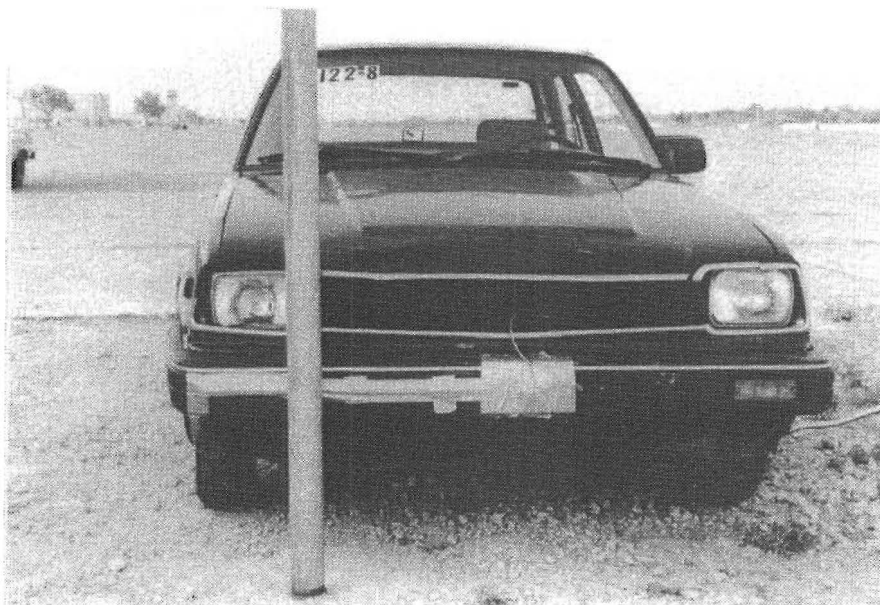
Figure 81. Vehicle before test 1122-8.

A 1982 Honda Civic (shown in Figure 81) impacted the sign installation at 20.6 miles per hour (33.1 km/h) using a cable reverse tow and guidance system. Test inertia mass of the vehicle was 1,800 lb (817 kg) and its gross static mass was 1,970 lb (894 kg). The height to the lower edge of the vehicle bumper was 13.8 inches (34.9 cm) and 19.5 inches (49.5 cm) to the top of the bumper. Other dimensions and information on the vehicle are given in Figure 82.

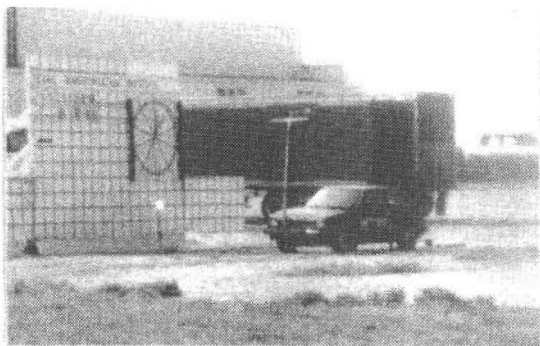
Figure 83. Sequential photographs for test 1122-8.

The vehicle was freewheeling and unrestrained just prior to impact. The point of impact was the center line of the sign with the quarter point on the passenger side of the vehicle. Upon impact, the sign support began to deform and the vehicle started to climb the post. At approximately 0.118 second, the right front wheel became airborne. Shortly thereafter, at 0.138 second the sign support pulled from the pipe collar coupling. As the sign installation yielded, the brakes were applied and the vehicle came to rest 10 ft (3.0 m) from the point of impact. Sequential photographs of the test are shown in Figure 83.

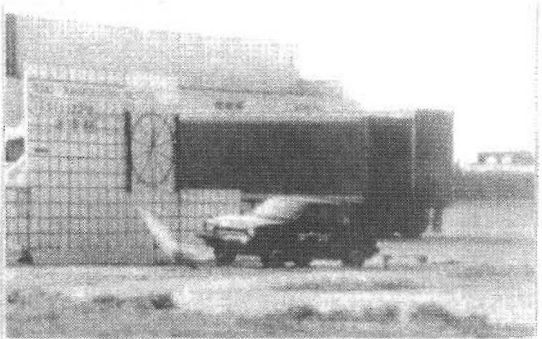
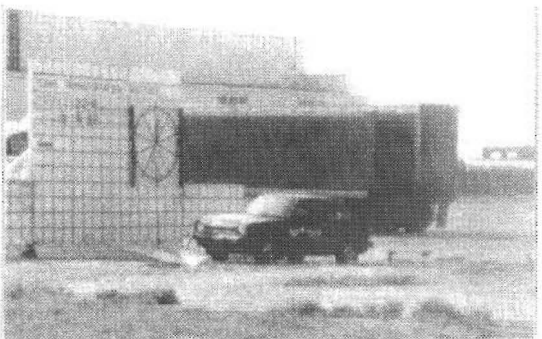
Figure 83. Sequential photographs for test 1122-8.
(Continued)

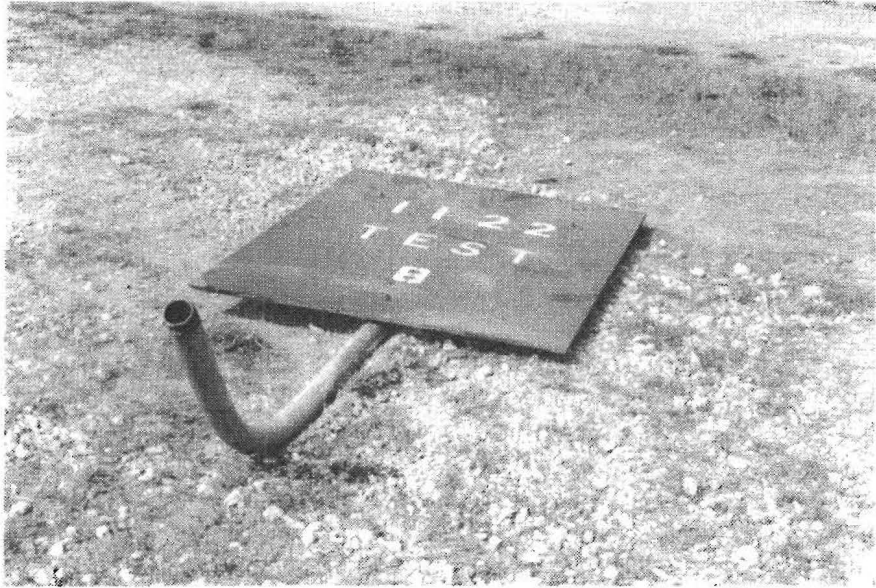
Figure 84. Sign installation after test 1122-8.

The sign support and panel came to rest directly beneath the test vehicle. The support anchor received only minor damages and could be placed back into

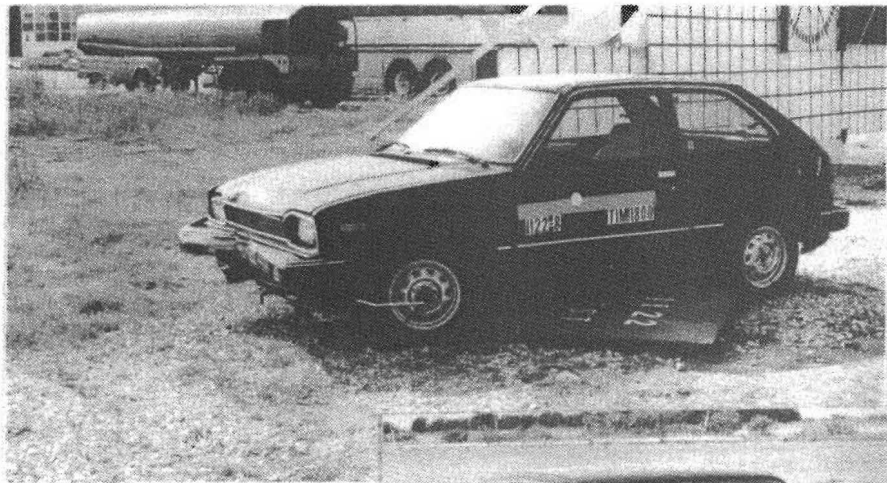
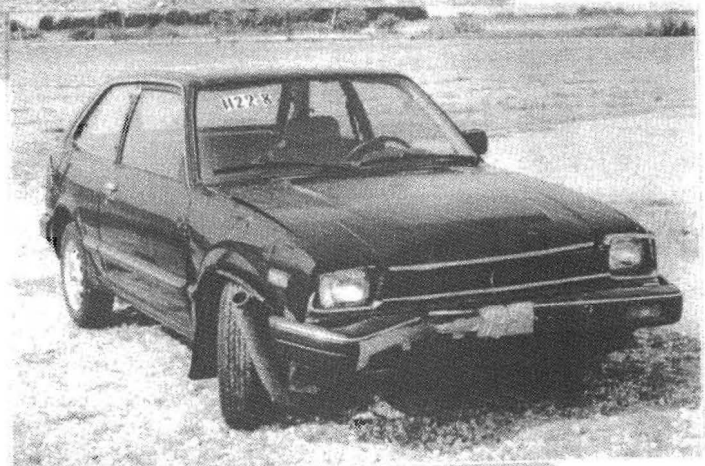
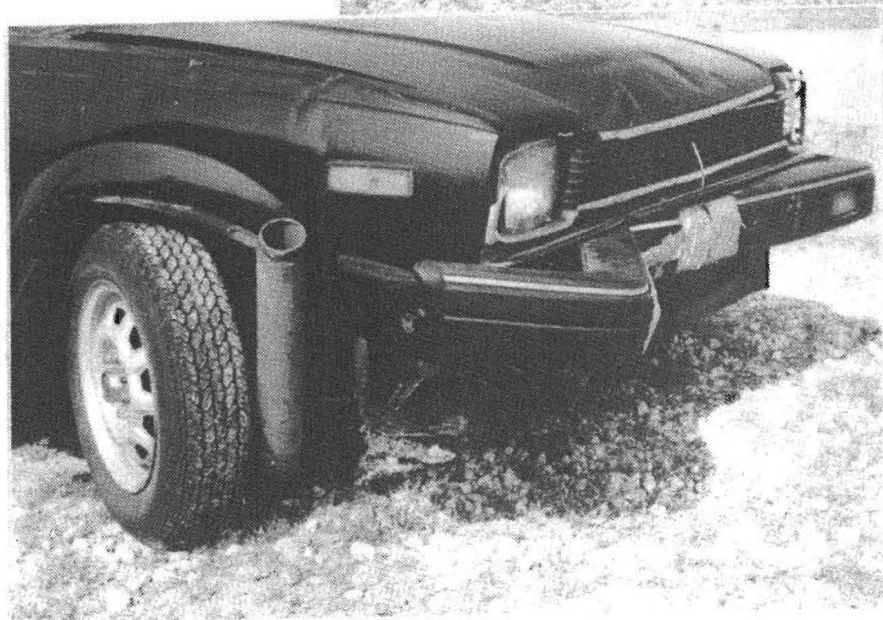
Figure 85. Vehicle after test 1122-8.

service. The vehicle sustained minor damage to the bumper, hood, fender, right front control arm and strut assembly, as shown in Figure 85.

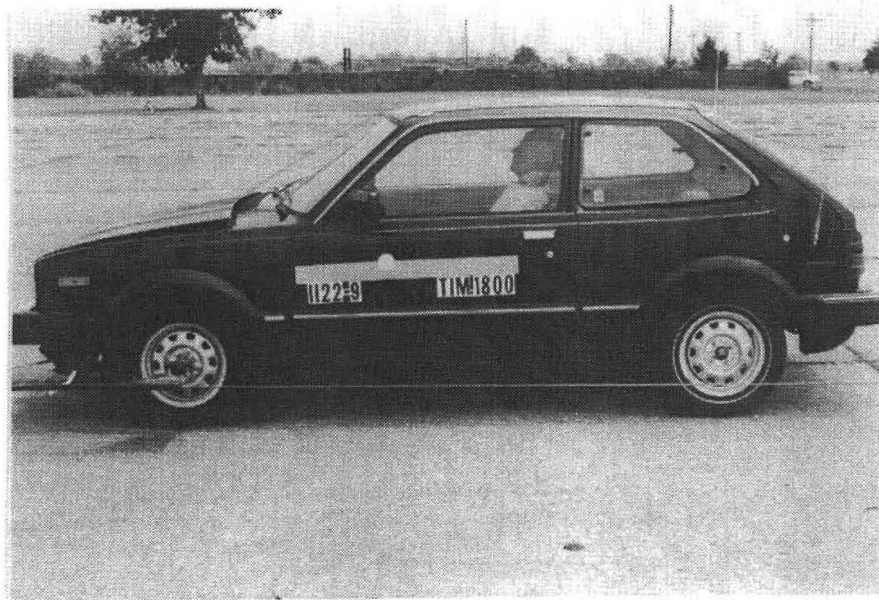
Figure 91. Vehicle before test 1122-9.

A 1982 Honda Civic (shown in Figure 91) impacted the sign installation at 60.0 miles per hour (97.7 km/h) using a cable reverse tow and guidance system. Test inertia mass of the vehicle was 1,800 lb (817 kg) and its gross static mass was 1,970 lb (894 kg). The height to the lower edge of the vehicle bumper was 13.8 inches (34.9 cm) and 19.5 inches (49.5 cm) to the top of the bumper. Other dimensions and information on the vehicle are given in Figure 92.

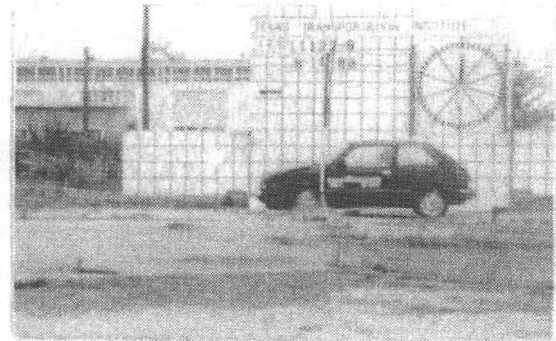
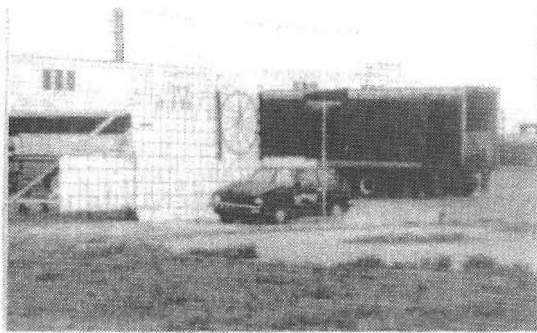
Figure 93. Sequential photographs for test 1122-9.

0.000 s

0.045 s

0.091 s

0.136 s

fender and guide plate attached to the vehicle. Upon impact, the sign support began to deform and at approximately 0.045 second, the sign support became detached from the pipe collar coupling. As the sign installation yielded and the vehicle lost contact, at approximately 0.151 second, the brakes were applied and the vehicle came to rest 210 ft (64.0 m) from the point of impact. Sequential photographs of the test are shown in Figure 93.

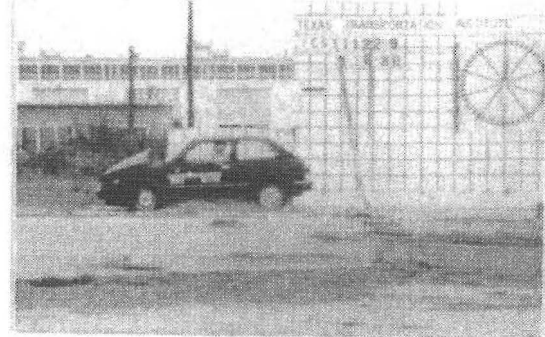
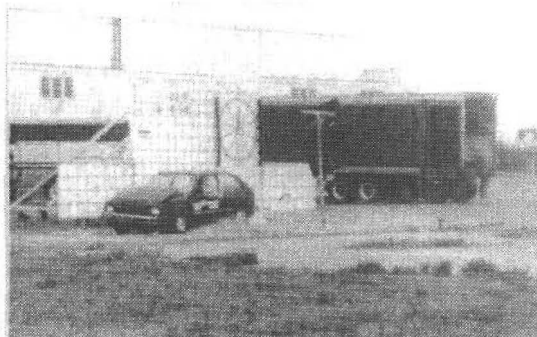
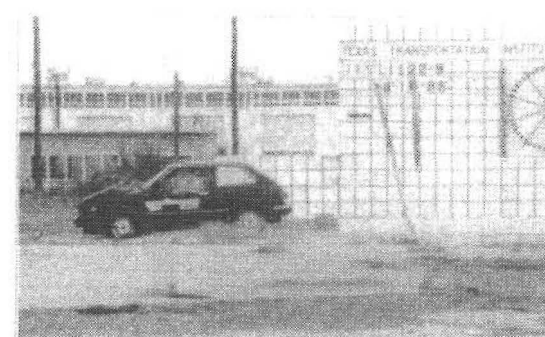
Figure 93. Sequential photographs for test 1122-9.
(Continued)

0.181 s

0.227 s

0.272 s

0.317 s

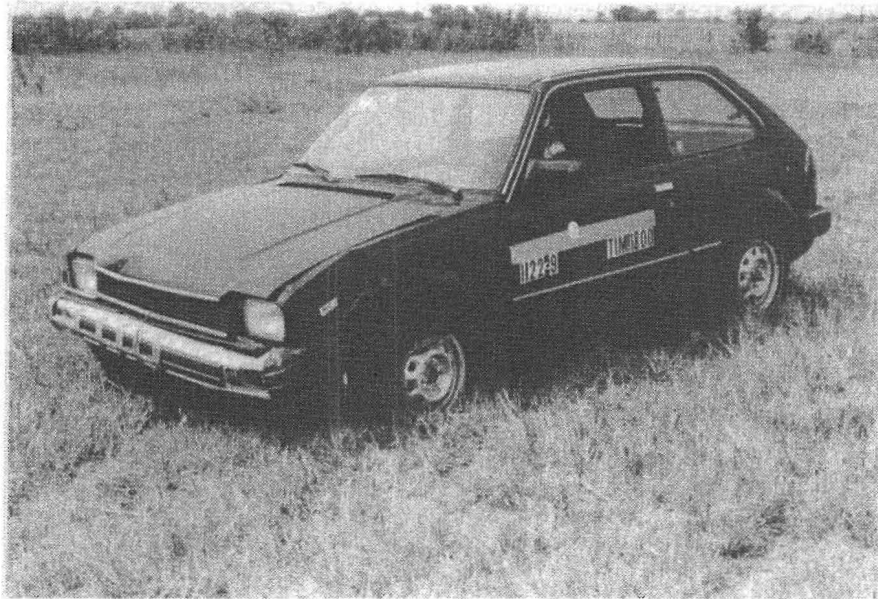
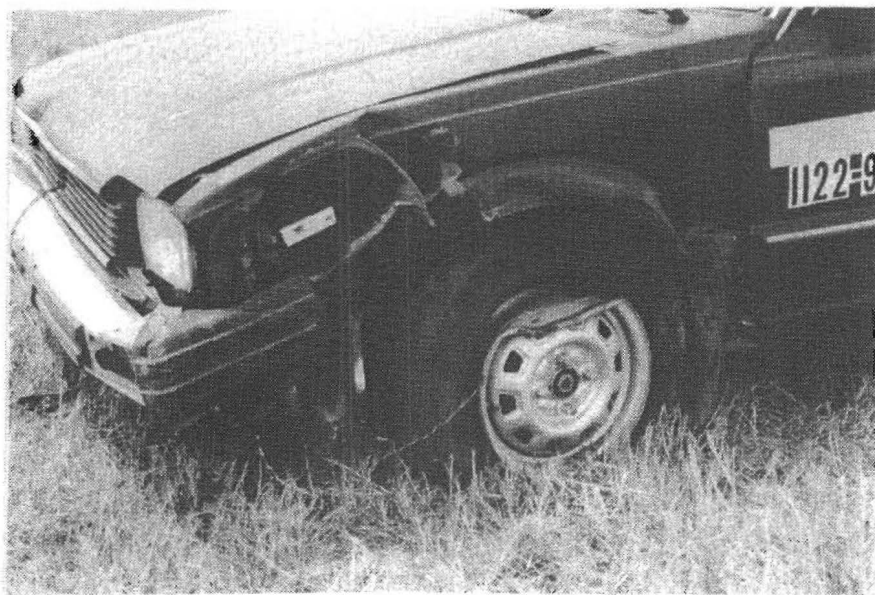
Figure 95. Vehicle after test 1122-9.

The sign support and panel came to rest directly behind the point of impact. The support anchor received only minor damages and could possibly be placed back into service. The vehicle sustained minor damage to the bumper, fender, left front tire, control arm, and strut assembly, as shown in Figure 95.

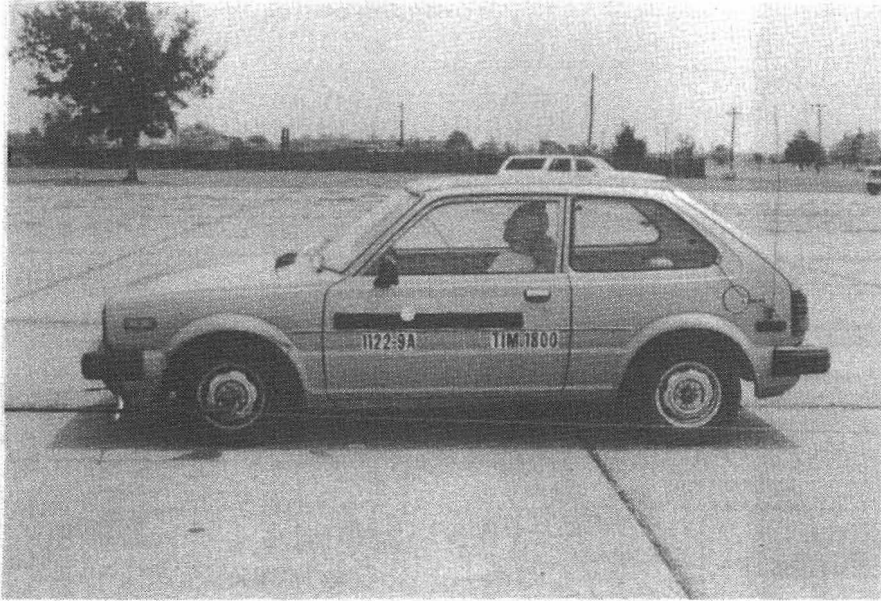
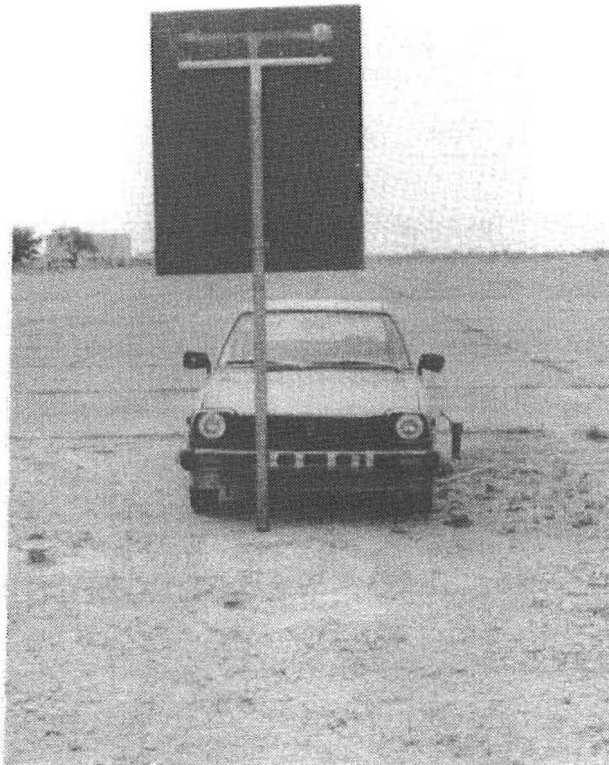
Figure 101. Vehicle before test 1122-9A.

A 1981 Honda Civic (shown in Figure 101) impacted the sign installation at 61.0 miles per hour (98.2 km/h) using a cable reverse tow and guidance system. Test inertia mass of the vehicle was 1,800 lb (817 kg) and its gross static mass was 1,967 lb (892 kg). The height to the lower edge of the vehicle bumper was 13.5 inches (34.3 cm) and 19.5 inches (49.5 cm) to the top of the bumper. Other dimensions and information on the vehicle are given in Figure 102.

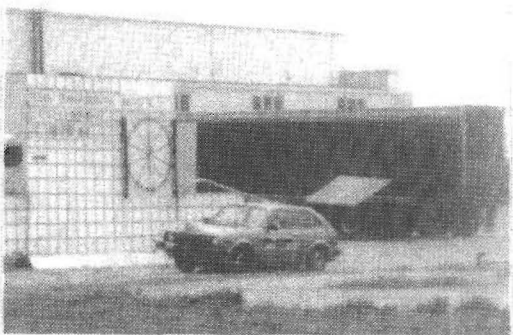
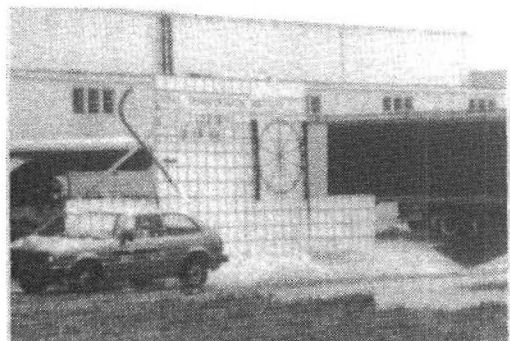
Figure 103. Sequential photographs for test 1122-9A.
(Continued)

The vehicle was freewheeling and unrestrained just prior to impact. Upon impact, the sign support began to deform and the sign face began to separate from the support. At approximately 0.020 second, the sign support became detached from the pipe collar coupling. Shortly thereafter, as the vehicle passed beneath the installation, the sign struck the roof of the vehicle. At 0.505 second, the vehicle lost contact with the installation, the brakes were applied and the vehicle came to rest 185 ft (56.4 m) from the point of impact. Sequential photographs of the test are shown in Figure 103.
