1. Report No. FHWA/TX-90/1122-1F		2. Government Accession No.		3. Recipient's Catalog No.	
4. Title and Subtitle Generic Small Sign Support System and Validation of Acceptable Support Performance				5. Report Date April 1990 /Revised

14. Sponsoring Agency Code	
15. Supplementary Notes Research performed in cooperation with DOT, FHWA					
16. Abstract Small sign systems include everything from stop signs and delineator posts to signs up to about 25 square feet. In some cases, multiple small sign support systems are used to support much larger signs (40-50 square feet). This broad class of sign has been and is currently being used along Texas highways. To insure the safety of vehicle occupants, there have been a series of specifications, guidelines and recommendations which define acceptable vehicle impact performance criteria. Most small sign systems have been tested with vehicles larger than the current standard 1800 pound car. As a result, the first phase of this study was to undertake a series of recertification tests for those systems currently being used in Texas. An analytical model also was developed to aid in the evaluation of data from previous crash tests. Although certif

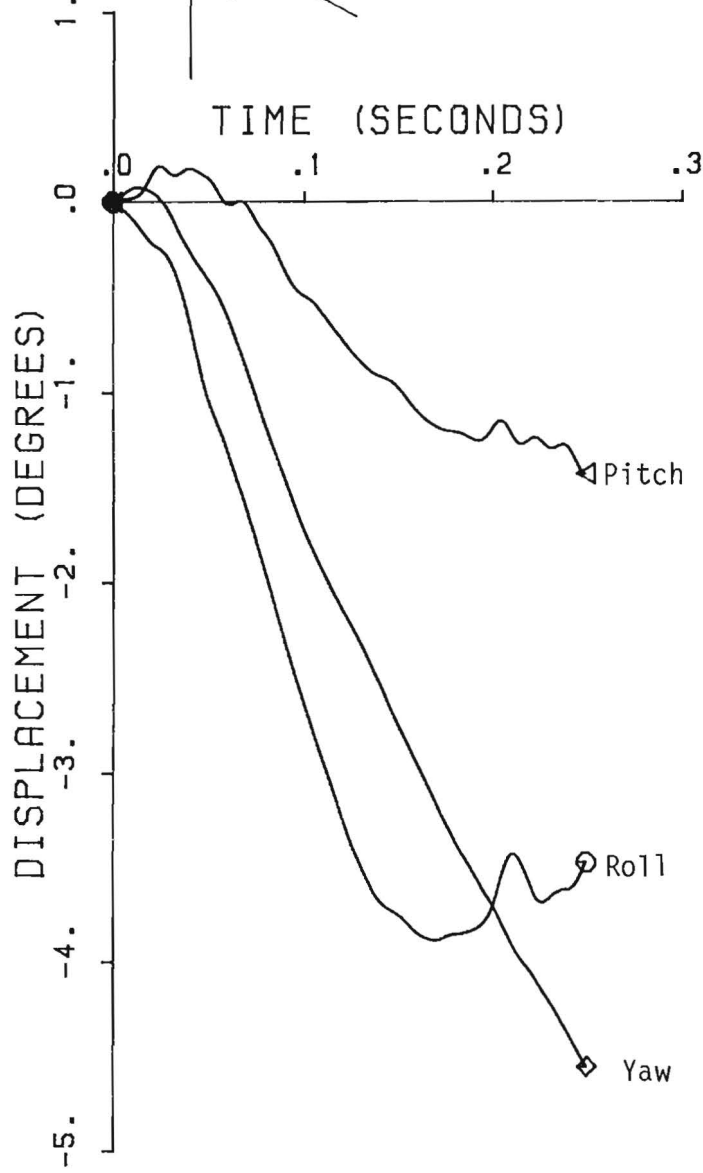
Figure 107. Vehicle angular displacements for test 1122-9A.

Axes are vehicle fixed.
 Sequence for determining orientation is:

1. Yaw
2. Pitch
3. Roll

A summary of the test results and other information pertinent to this test are given in Figure 106. The maximum 0.050 second average acceleration experienced by the vehicle was -4.2 g in the longitudinal direction and -1.8 g in the lateral direction. Vehicle angular displacements are plotted in Figure 107 and vehicle accelerometer traces are displayed in Figure 108 through 110. No contact by the anthropomorphic dummy was made. Therefore, no occupant impact velocity or ridedown accelerations were recorded in the longitudinal or lateral direction. Change in velocity was 6.7 mi/h (10.7 km/h) and change in momentum was 545lb-s.

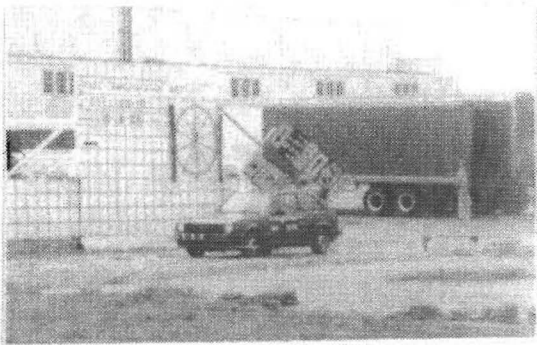
Figure 115. Sequential photographs for test 1122-10.
(Continued)

the base of the sign support came down into the vehicle's rear hatch window. Shortly thereafter, the brakes were applied and the vehicle came to rest 110 ft (33.5 m) from the point of impact. Sequential photographs of the test are shown in Figure 115.

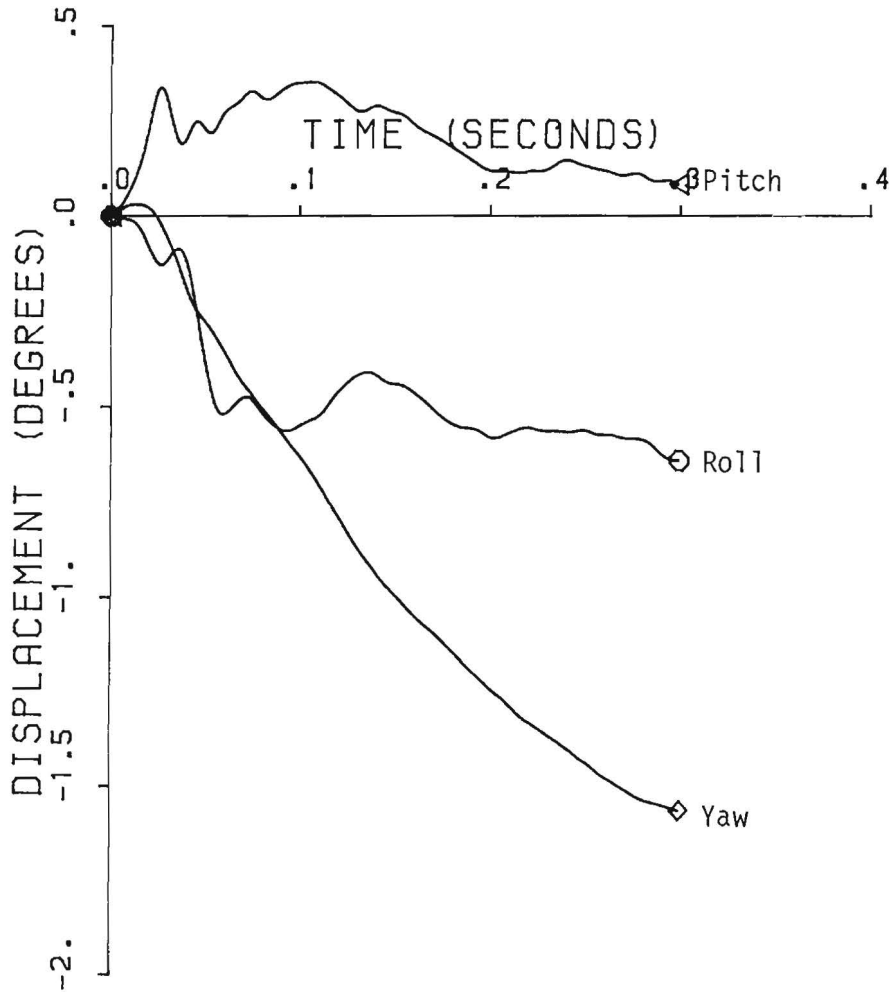
Figure 119. Vehicle angular displacements for test 1122-10.

Axes are vehicle fixed.
 Sequence for determining orientation is:

1. Yaw
2. Pitch
3. Roll

A summary of the test results and other information pertinent to this test are given in Figure 118. The maximum 0.050 second average acceleration experienced by the vehicle was -1.8 g in the longitudinal direction and -0.6 g in the lateral direction. Vehicle angular displacements are plotted in Figure 119 and vehicle accelerometer traces are displayed in Figure 120 through 122. No contact by the anthropomorphic dummy was made. Therefore, no occupant impact velocity or ridedown accelerations were recorded in the longitudinal or lateral direction. Change in velocity was 4.0 mi/h (6.4 km/h) and change in momentum was 328 lb-s.

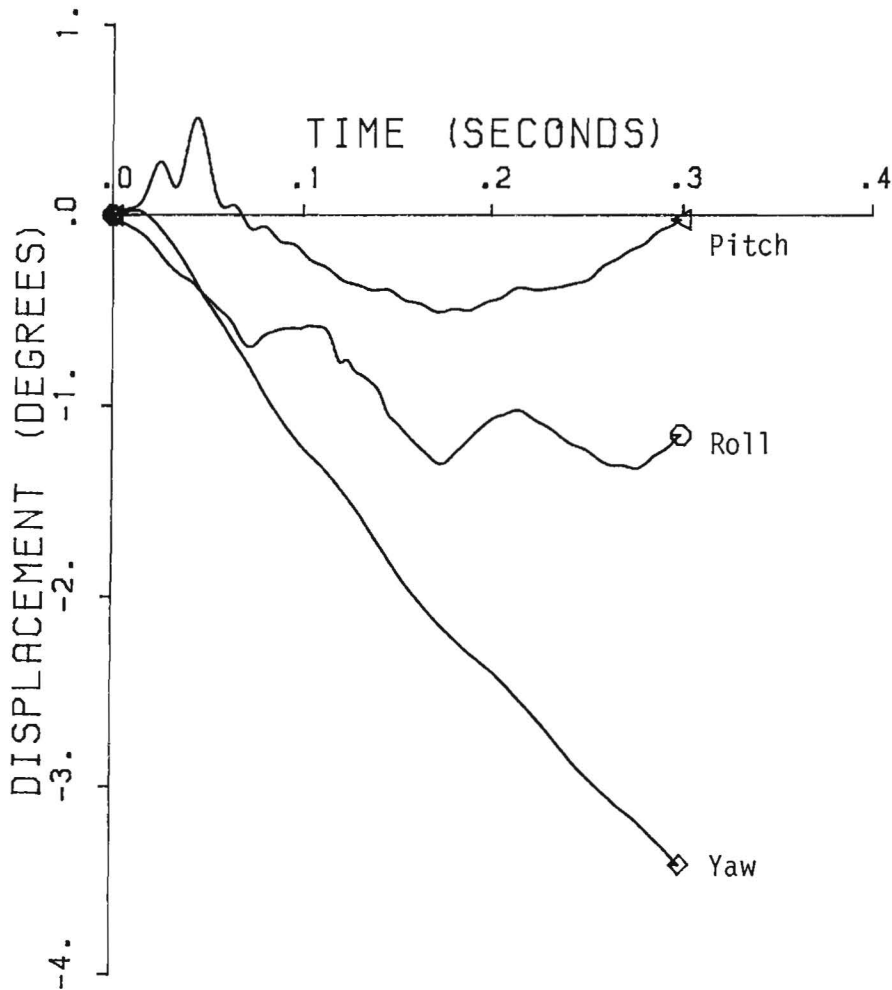
Figure 129. Vehicle angular displacements for test 1122-11.

Axes are vehicle fixed.
 Sequence for determining orientation is:

1. Yaw
2. Pitch
3. Roll

A summary of the test results and other information pertinent to this test are given in Figure 128. The maximum 0.050 second average acceleration experienced by the vehicle was -3.3 g in the longitudinal direction and -0.9 g in the lateral direction. Vehicle angular displacements are plotted in Figure 129 and vehicle accelerometer traces are displayed in Figure 130 through 132. No contact by the anthropomorphic dummy was made. Therefore, no occupant impact velocity or ridedown accelerations were recorded in the longitudinal or lateral direction. Change in velocity was 5.5 mi/h (8.9 km/h) and change in momentum was 451 lb-s.

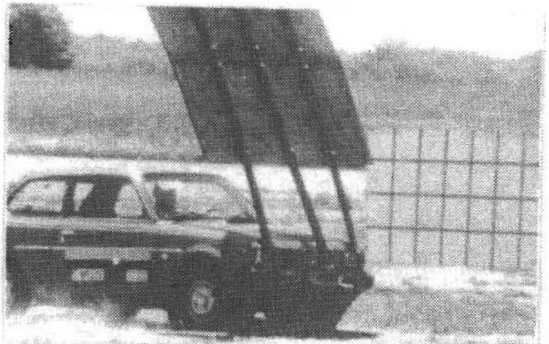
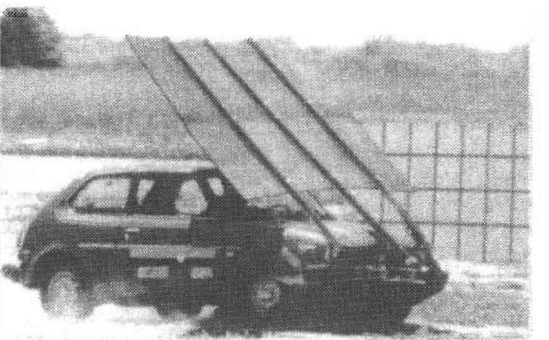
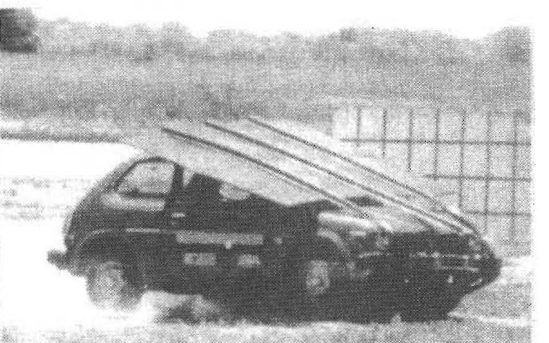
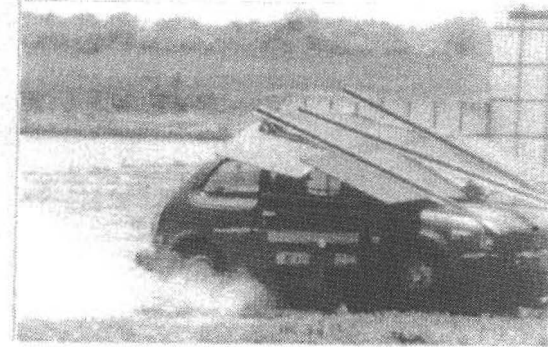
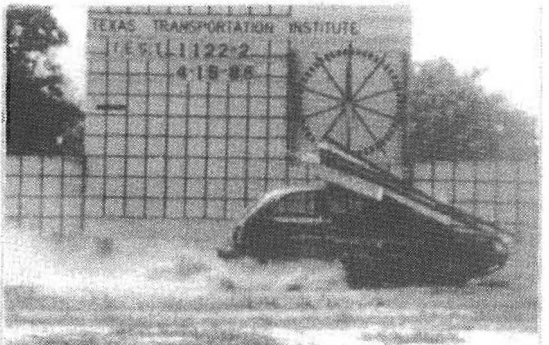
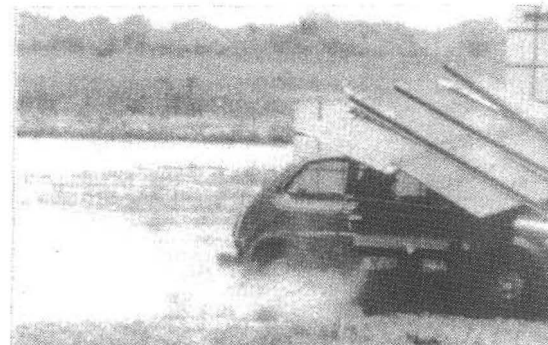
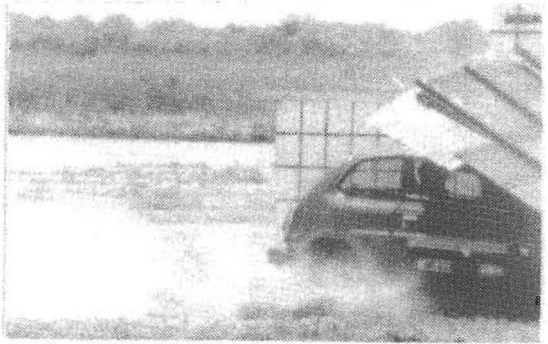
Figure 147. Sequential photographs for test 1122-2.

Figure 147. Sequential photographs for test 1122-2.
(Continued)

The vehicle was freewheeling and unrestrained just prior to impact. The point of impact was the center line of the sign with the center of the vehicle. Upon impact, the sign legs began to deform and the vehicle started climbing the sign installation. At approximately 0.025 seconds after impact, the outer legs of the installation were pulled from the ground and the center leg fractured. Shortly thereafter, at 0.099 seconds, the sign face struck the roof of the vehicle. The sign installation remained in front of and attached to the vehicle after impact. As the vehicle exited the impact site, the brakes were applied and the vehicle came to rest approximately 168.0 ft (51.22 m) from the point of impact. Sequential photographs of the test are shown in Figure 147.

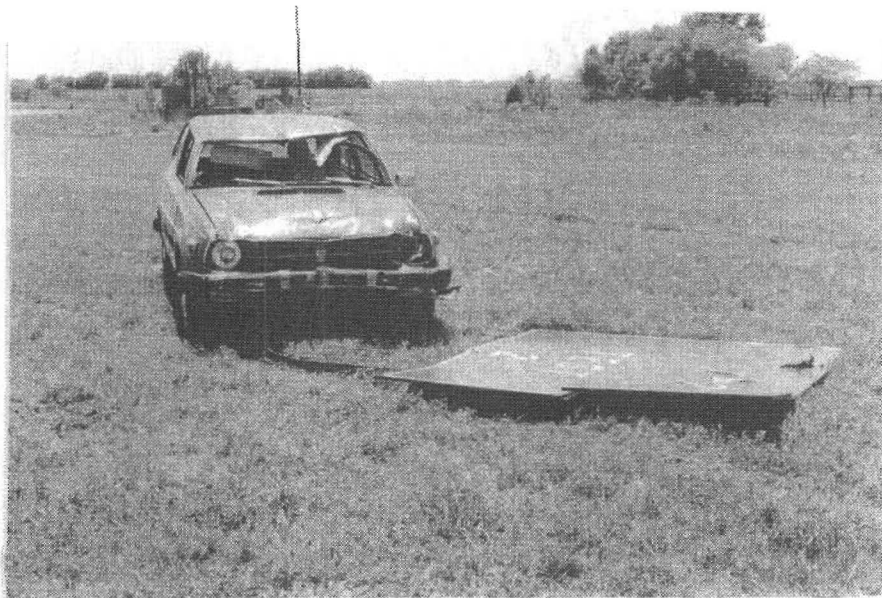
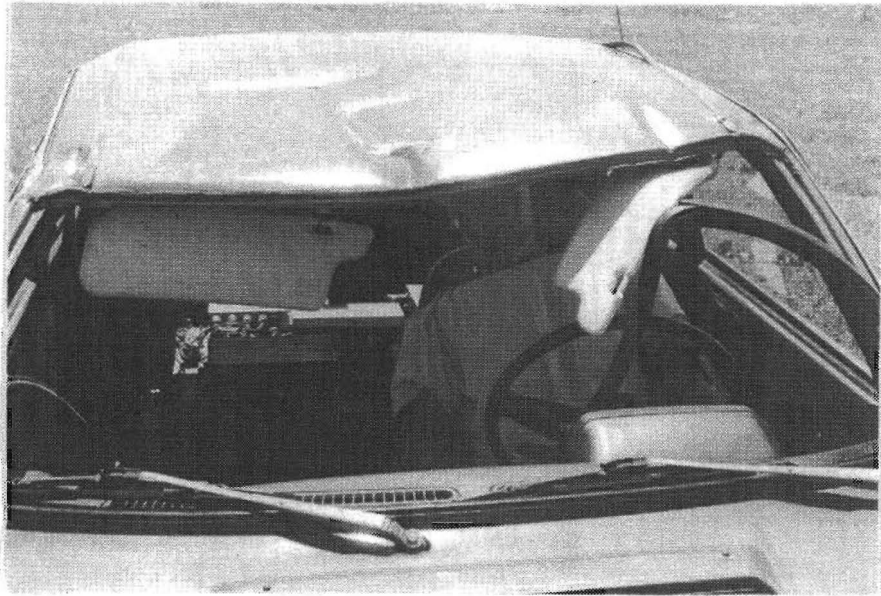
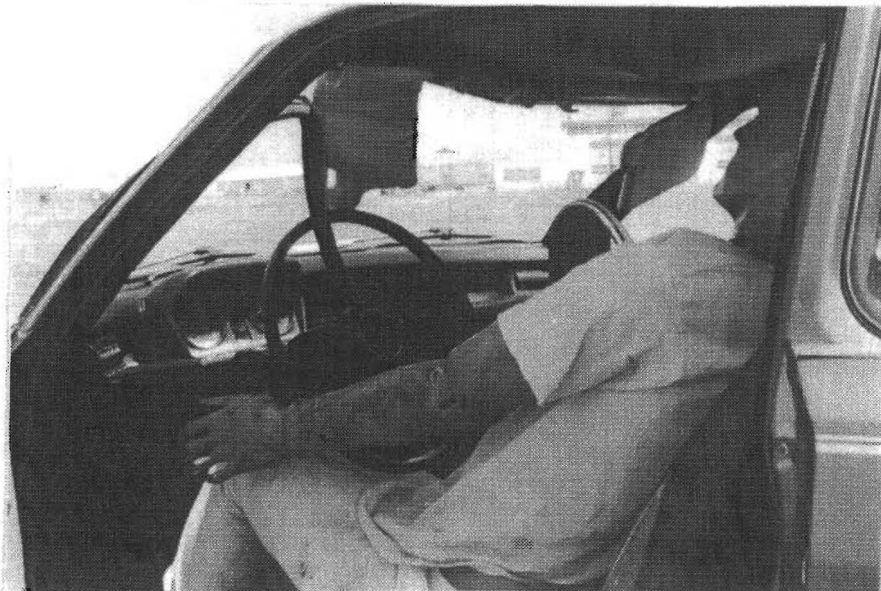
Figure 149. Vehicle after test 1122-2.

Figure 149. Vehicle after test 1122-2.
(Continued)

The two outside sign support stubs were pulled from the soil. In addition, the center support was fractured 22 in above the soil surface and pushed rearward approximately 7.0 in (17.78 cm). The vehicle sustained minor damage to the bumper, lower valance panel, roof and windshield, as shown in Figure 149.

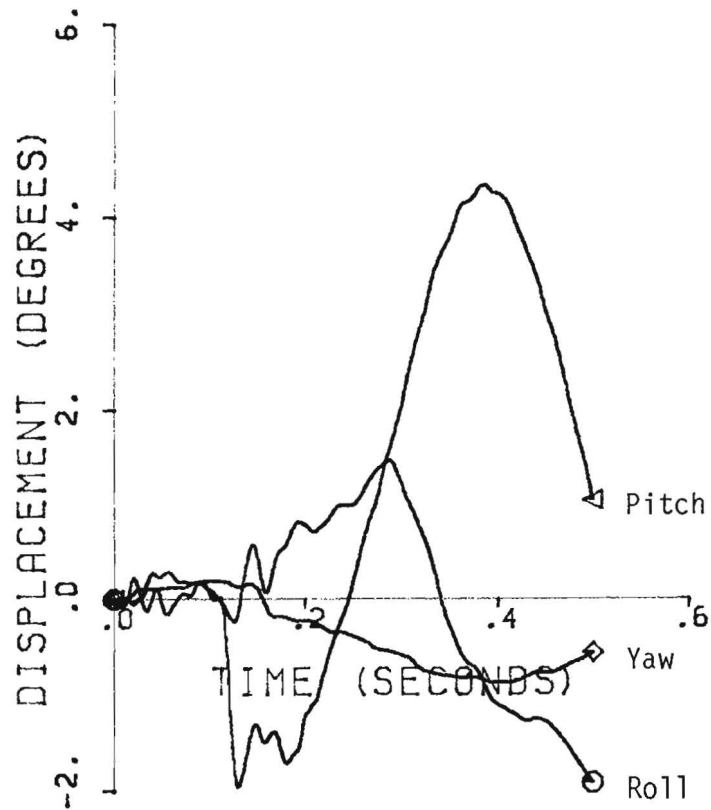
Axes are vehicle fixed.
Sequence for determining orientation is:

1. Yaw
2. Pitch
3. Roll

Figure 151. Vehicle angular displacements for test 1122-2.

A summary of the test results and other information pertinent to this test are given in Figure 150. The maximum 0.050 second average acceleration experienced by the vehicle was -8.6 g in the longitudinal direction and -1.3 g in the lateral direction. Vehicle angular displacements are plotted in Figure 151 and vehicle accelerometer traces are displayed in Figure 152 through 154. Occupant impact velocity in the longitudinal direction was 21.57 feet per second (6.58 m/s) and no occupant impact velocity existed in the lateral direction. The highest 0.10 second occupant ridedown acceleration was -2.59 g (longitudinal). Change in velocity was 17.07 mi/h (27.47 km/h) and change in momentum was 1,340 lb-s.

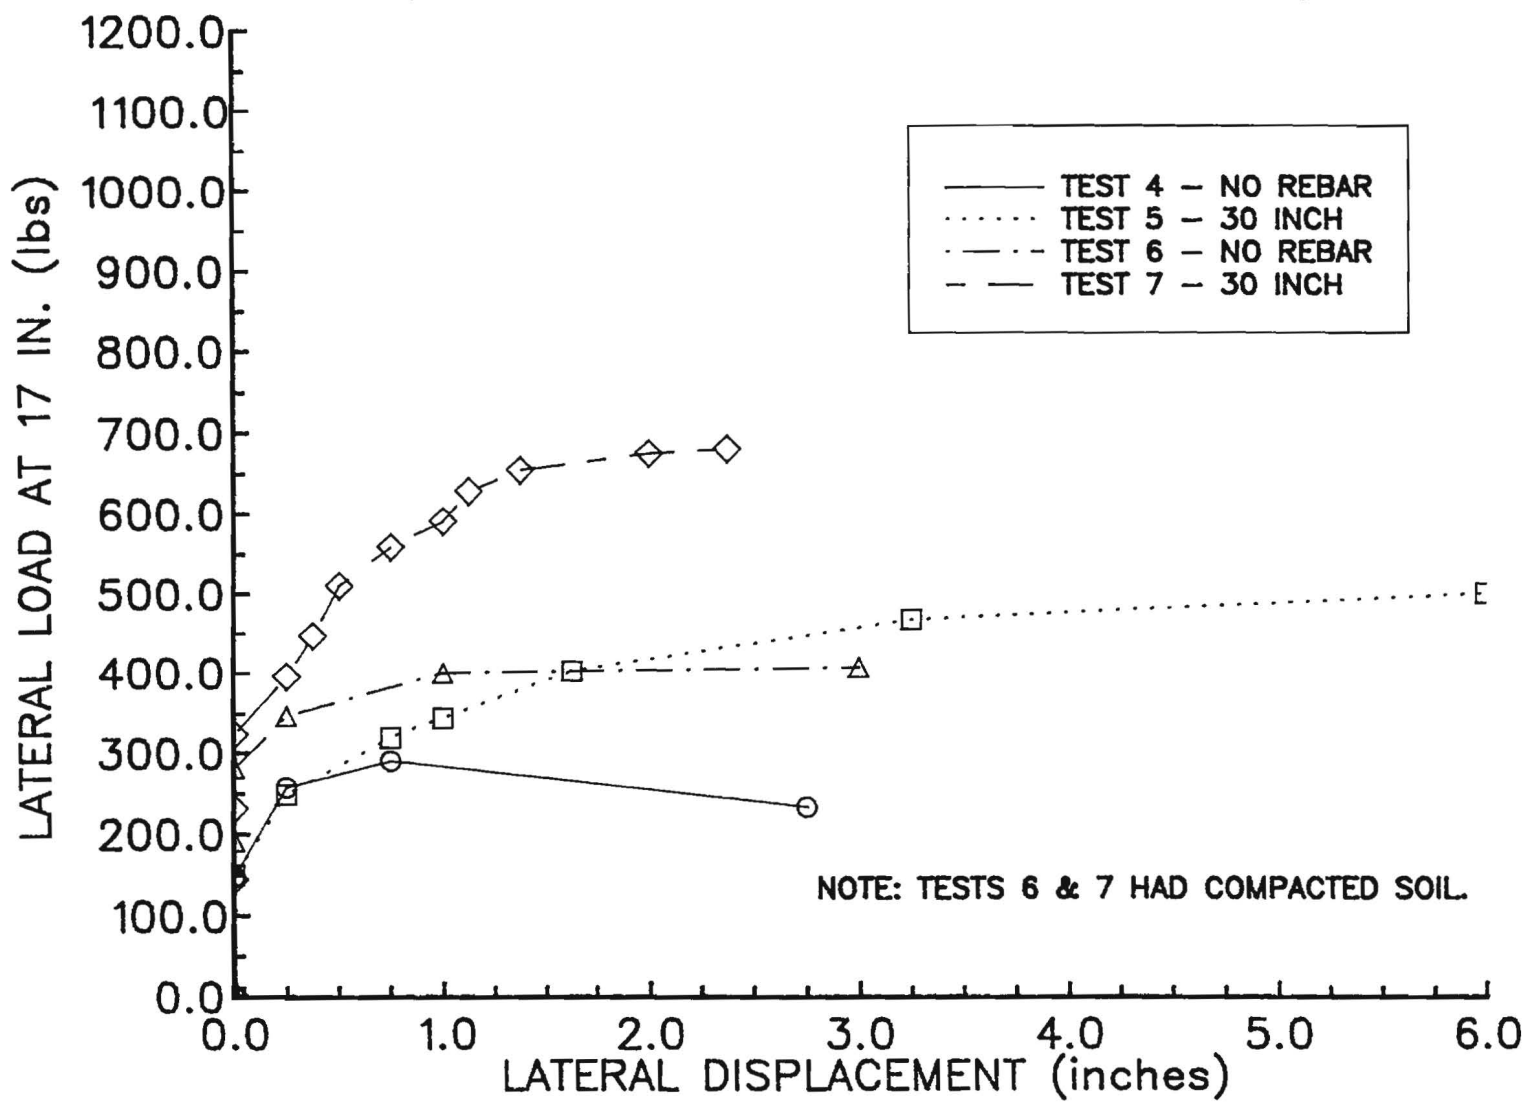
WINGED ANCHOR FOR 3 IN. FRP TUBE
 (NOTING EFFECTS OF No. 4 REBAR AND SOIL COMPACTION)

NOTE: TESTS 6 & 7 HAD COMPACTED SOIL.

Figure 171. Lateral Load for Winged Anchor w/FRP Post.

Several prototype anchors were constructed and tested in the "weak" soil pit. The first generation included both winged extensions and spread anchor rods. These anchors were built to accept both fiber reinforced plastic (FRP, Figures 171 and 172) and steel uprights (Figure 173). Several tests were done varying the length and diameter of the anchor rods. It was concluded from these tests that 30 inch #6 rebar was sufficient to develop the FRP posts in shear and 36 inch #6 rebar for the 2-3/8 steel posts. (The 42 inch rebar yielded with the steel posts and did not supply any significant lateral strength gain.)

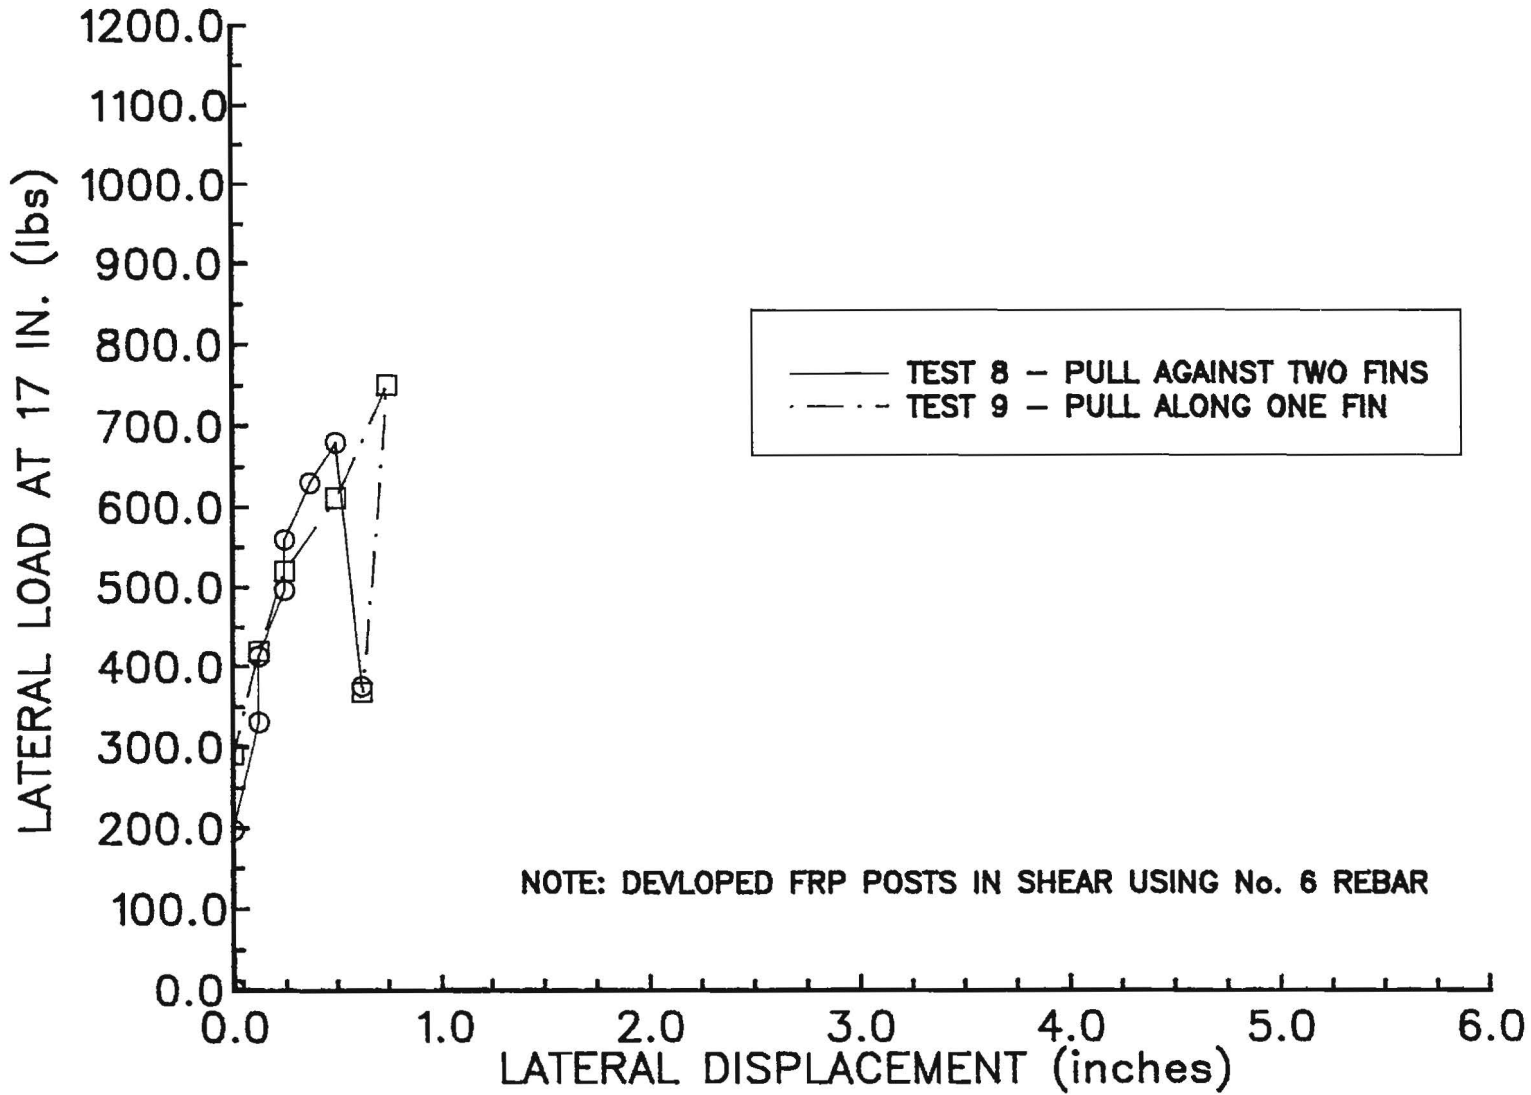
WINGED ANCHOR FOR 3 IN. FRP TUBE (COMPARING ORIENTATION - BOTH USE 30" No.6 REBAR)

Figure 172. Lateral Load for Anchor varying orientation.

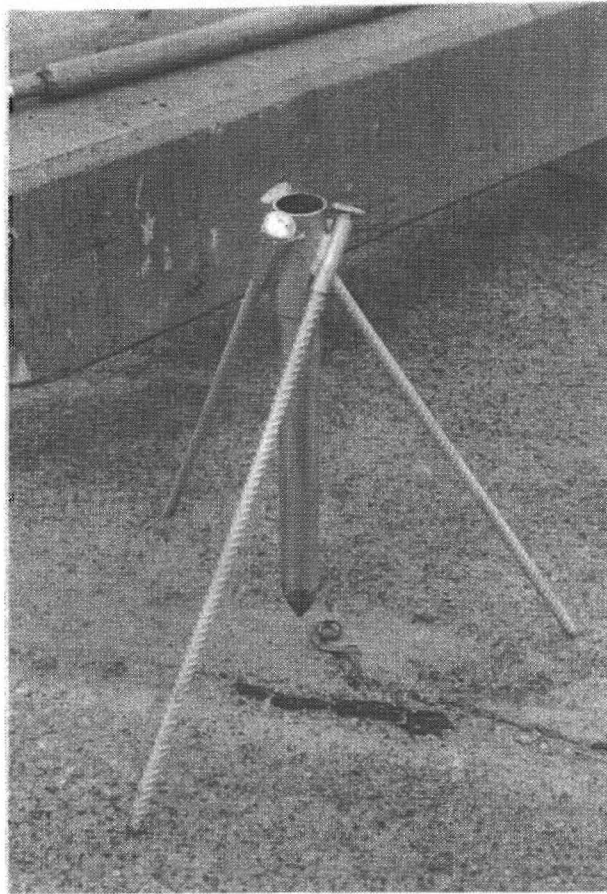
Figure 177. Texas Generic Sign Anchor.

The completed anchor assembly is driven into the ground and cross anchored using the steel reinforcing rods. The sign support is then placed into the 2-1/2 in sleeve and secured by means of a 5/16 in set screw (ASTM grade 5). The set screw is turned one full turn following contact with the support. Details of the completed anchor and sign installation are shown in Figure 175 through 179.

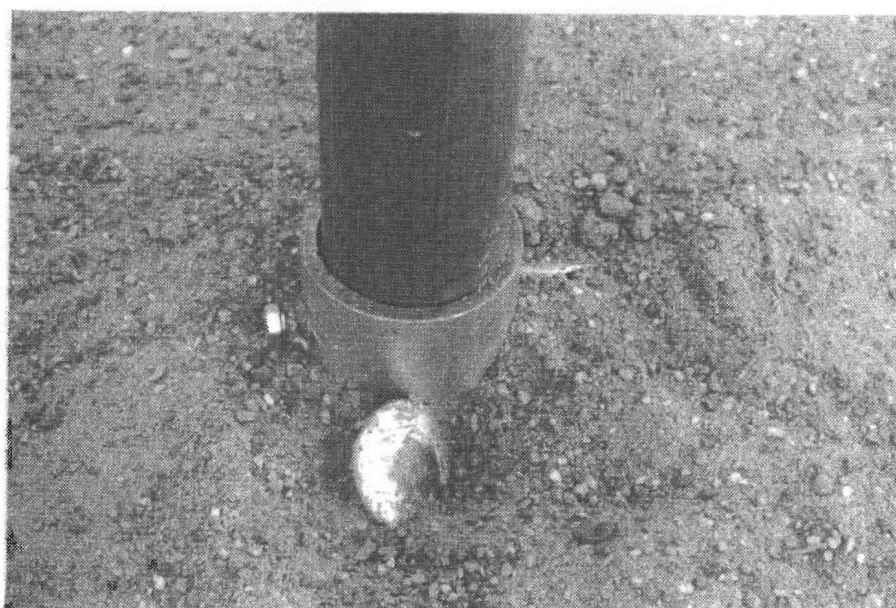
Figure 178. Test installation before test 1122-i2.

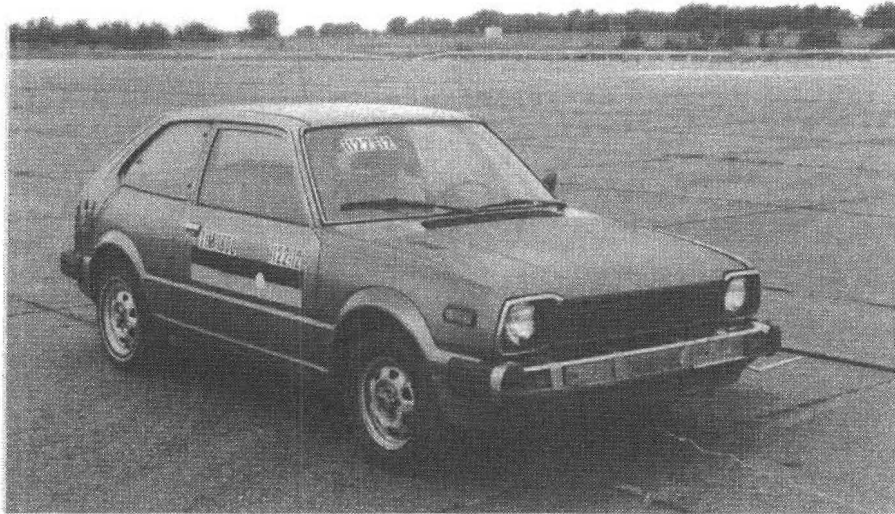
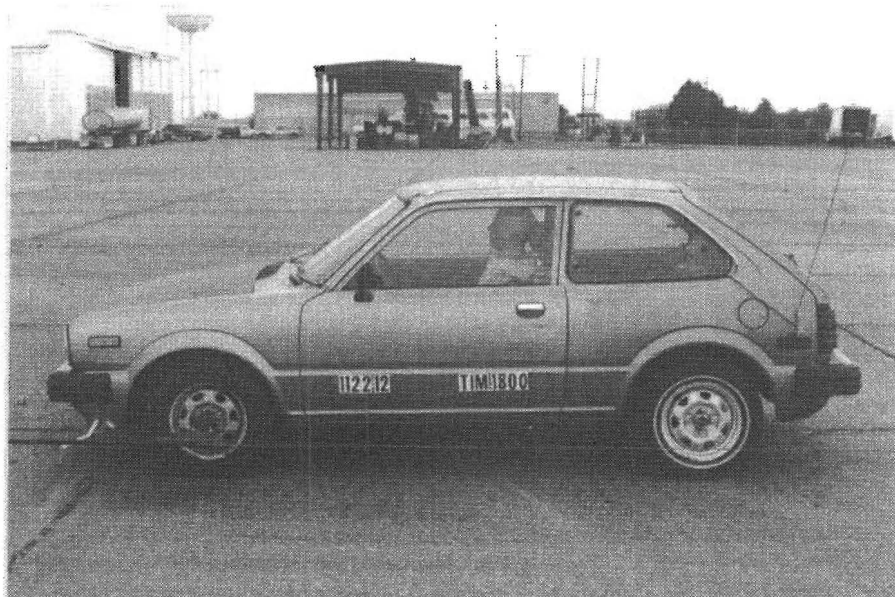
Figure 180. Vehicle before test 1122-12.

A 1981 Honda Civic (shown in Figure 180) impacted the sign installation at 19.7 miles per hour (31.7 km/h) using a cable reverse tow and guidance system. Test inertia mass of the vehicle was 1,800 lb (817 kg) and its gross static mass was 1,970 lb (894 kg). The height to the lower edge of the vehicle bumper was 14.75 inches (37.5 cm) and 20.25 inches (51.4 cm) to the top of the bumper. Other dimensions and information on the vehicle are given in Figure 181.

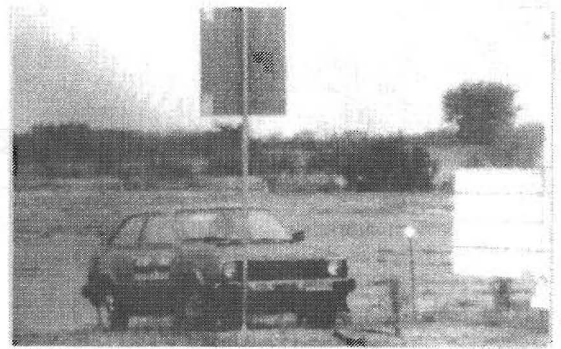
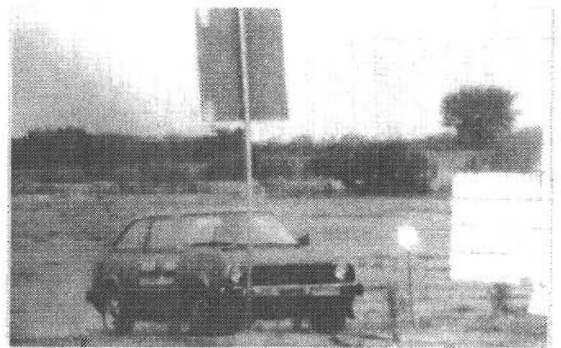
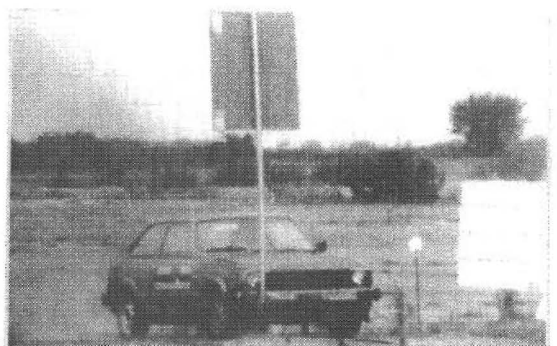
Figure 182. Sequential photographs of test 1122-12.

The vehicle was freewheeling and unrestrained just prior to impact. The point of impact was the center line of the sign with the quarter point on the passenger side of the vehicle. Upon impact, the sign support began to bend at bumper height. At approximately 0.050 second, the support had completely detached from the anchored base. As the vehicle continued forward, the sign support remained in contact with the vehicle. After exiting the immediate test site, the brakes were applied and the vehicle and sign support came to rest 75 ft (22.9 m) from the point of impact. Sequential photographs of the test are shown in Figure 182.

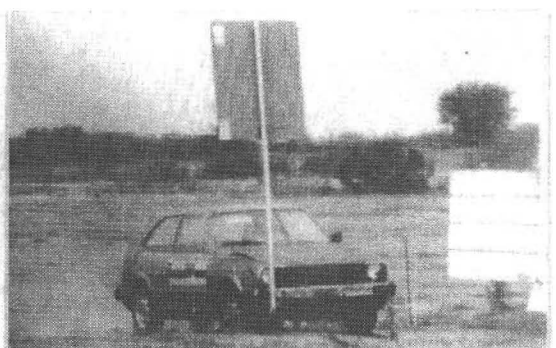
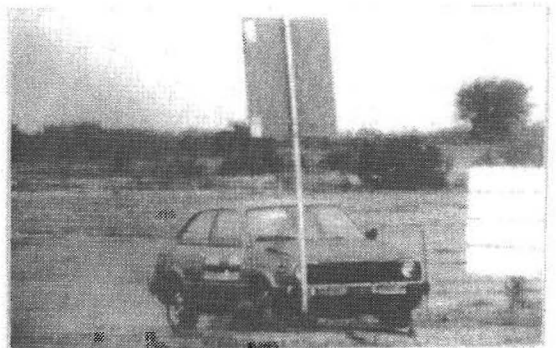
Figure 182. Sequential photographs of test 1122-12.
(Continued)

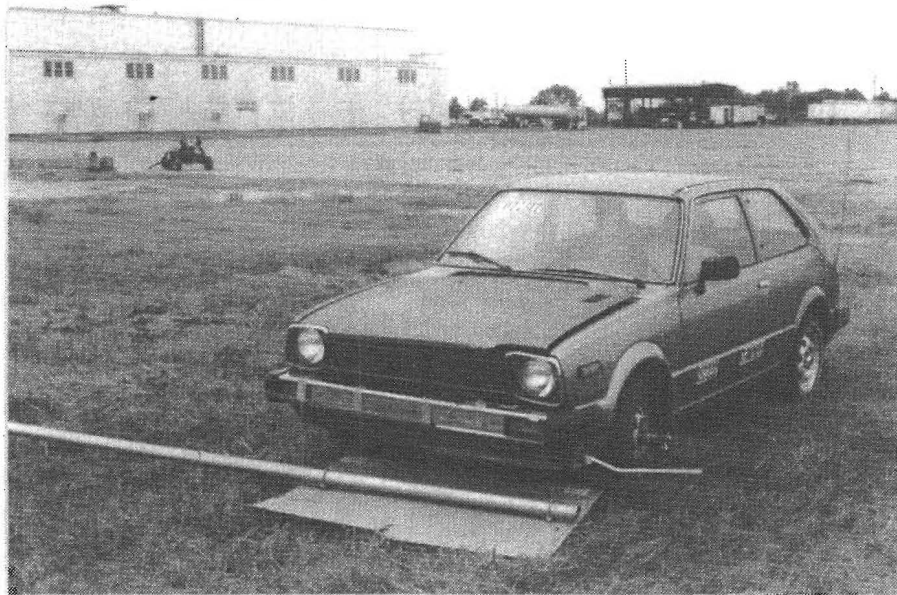
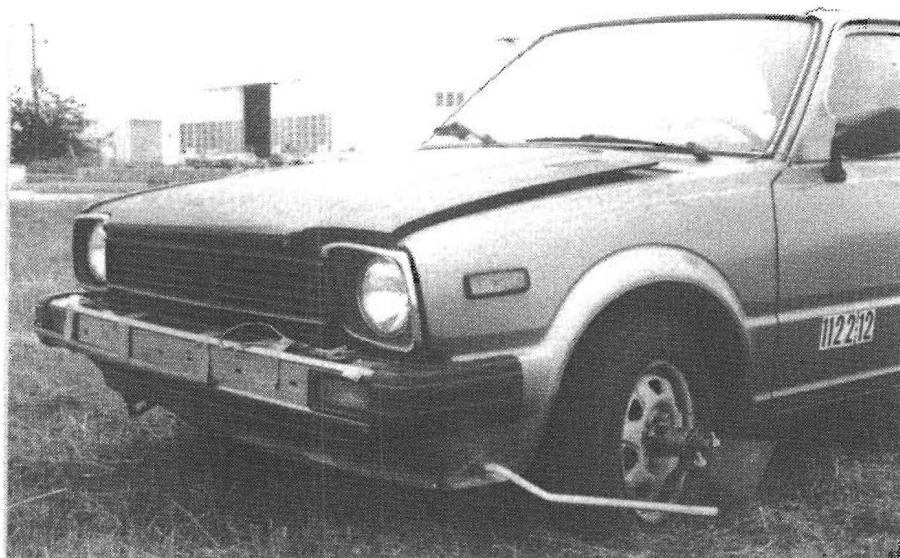
Figure 183. Vehicle after test 1122-12.

vehicle. The base was pushed back 4.0 in (10.2 cm). The vehicle sustained minimal damage to the bumper, as shown in Figure 183.

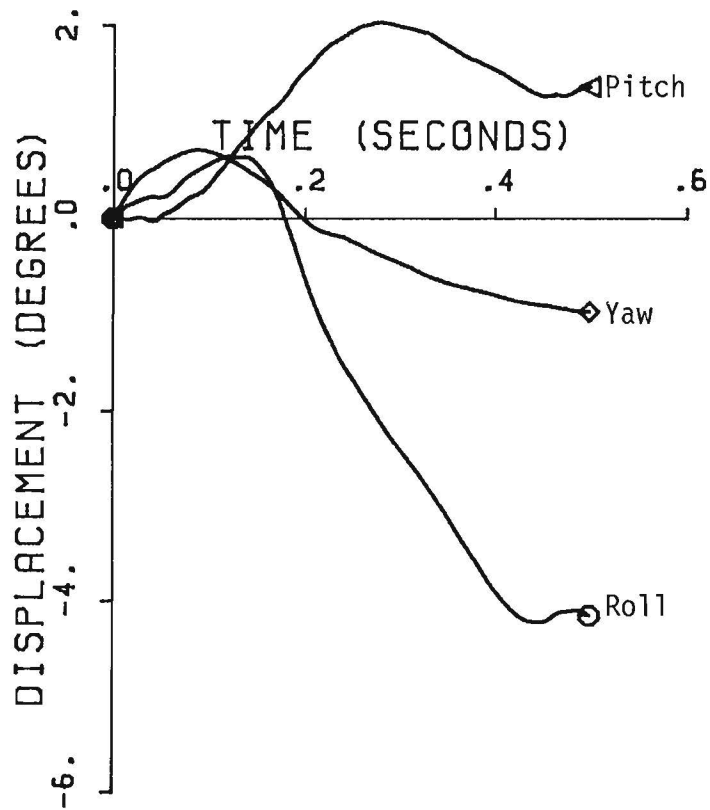
Figure 186. Vehicle angular displacement for test 1122-12.

Axes are vehicle fixed.
 Sequence for determining
 orientation is:

1. Yaw
2. Pitch
3. Roll

A summary of the test results and other information pertinent to this test are given in Figure 185. The maximum 0.050 second average acceleration experienced by the vehicle was -2.2 g in the longitudinal direction and -1.3 g in the lateral direction. Vehicle angular displacements are plotted in Figure 186 and vehicle accelerometer traces are displayed in Figure 187 through 189. Occupant impact velocity in the longitudinal direction was 11.8 ft/s (3.6 m/s) and in the lateral direction it was 7.3 ft/s (2.2 m/s). Occupant ridedown accelerations were -1.4 g in both the longitudinal and lateral direction. Change in velocity was 2.4 mi/h (3.9 km/h) and change in momentum was 197 lb-s.

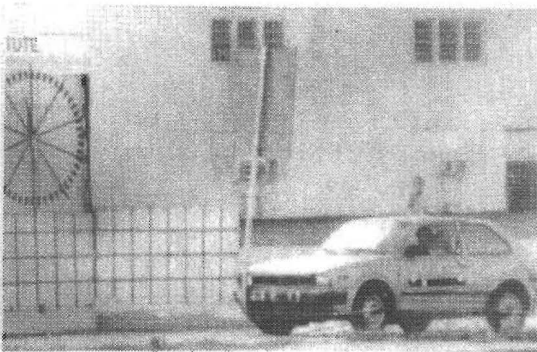
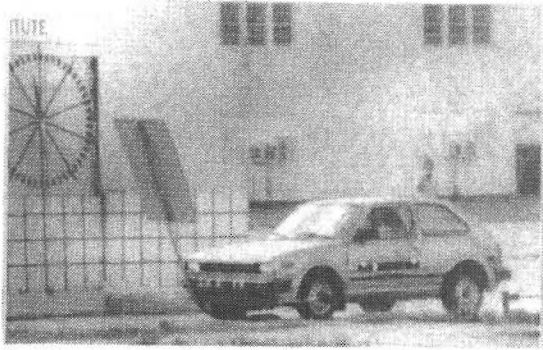
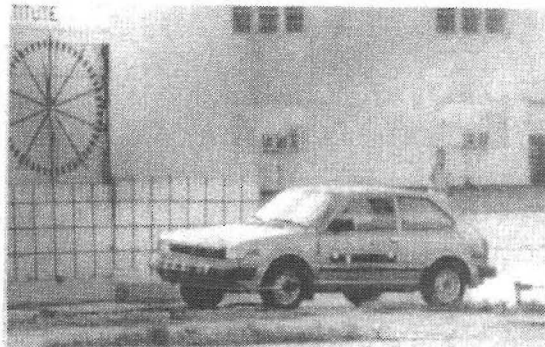
0.000 s

0.050 s

0.100 s

0.149 s

0.199 s

0.266 s

0.318 s

0.425 s

Figure 203. Sequential photographs for test 1122-14.
(Continued)

The vehicle was freewheeling and unrestrained just prior to impact. The point of impact was the center line of the sign with the right quarter point of the vehicle. Upon impact, the sign support began to yield. As the support yielded, the vehicle traveled over the installation. At approximately 0.261 second, the vehicle lost contact with the installation, traveling 11.7 mi/h (18.8 km/h). As the vehicle moved away from the impact site, the brakes were applied and the vehicle came to rest 78 ft (23.8 m) from the point of impact. Sequential photographs of the test are shown in Figure 203.

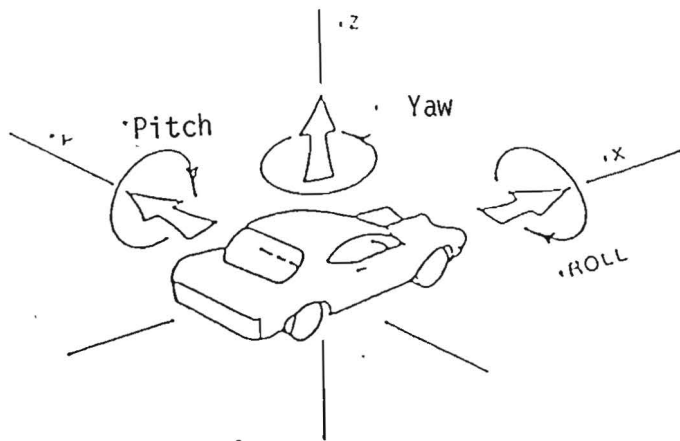
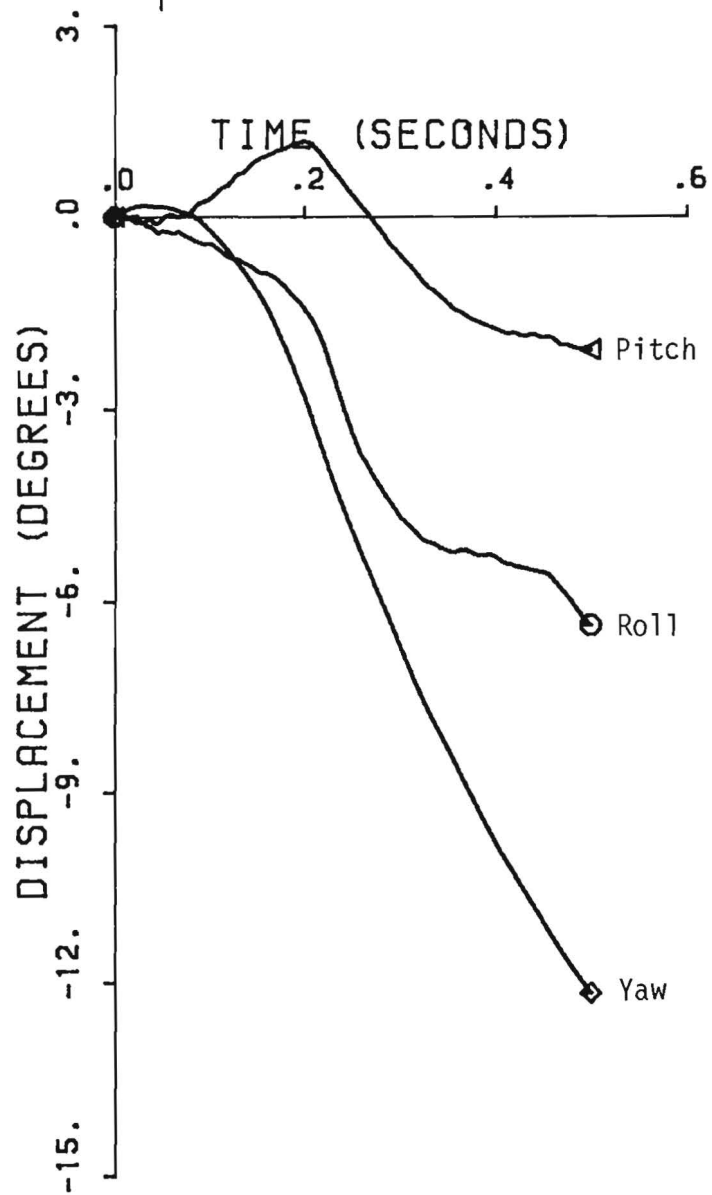
Figure 207. Vehicle angular displacements for test 1122-14.

Axes are vehicle fixed.
Sequence for determining orientation is:

1. Yaw
2. Pitch
3. Roll

A summary of the test results and other information pertinent to this test are given in Figure 206. The maximum 0.050 second average acceleration experienced by the vehicle was -2.6 g in the longitudinal direction and -1.4 g in the lateral direction. Vehicle angular displacements are plotted in Figure 207 and vehicle accelerometer traces are displayed in Figure 208

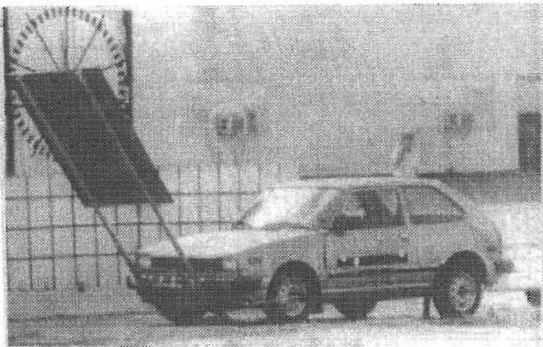
Figure 216. Sequential photographs for test 1122-15.
(Continued)

with the installation traveling 4.7 mi/h (7.6 km/h). Sequential photographs of the test are shown in Figure 216.

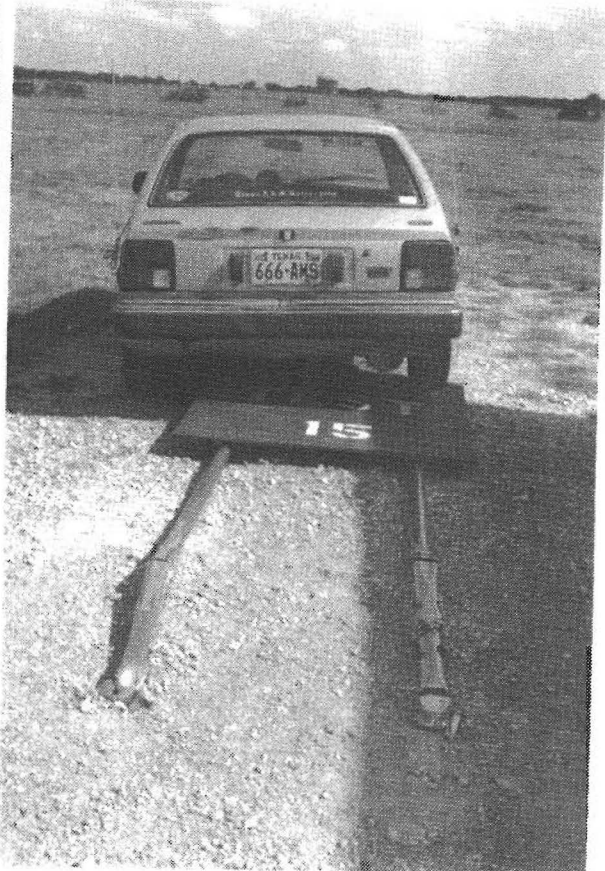
Figure 217. Sign installation after test 1122-15.

The sign installation came to rest at the point of impact. The supports did not disengage from the anchors. The anchors were pushed rearward a maximum of 0.8 in (1.9 cm). In addition, the left support was either bent or fractured at 17 in (43.2 cm), 28.5 in (72.4 cm), and 38.5 in (97.8 cm) up from the roadway. The right support also was bent or fractured at 18 in (45.7 cm), 30 in (76.2 cm), and 42 in (106.7 cm). The vehicle sustained only minor damage to the bumper and windshield, as shown in Figure 218.

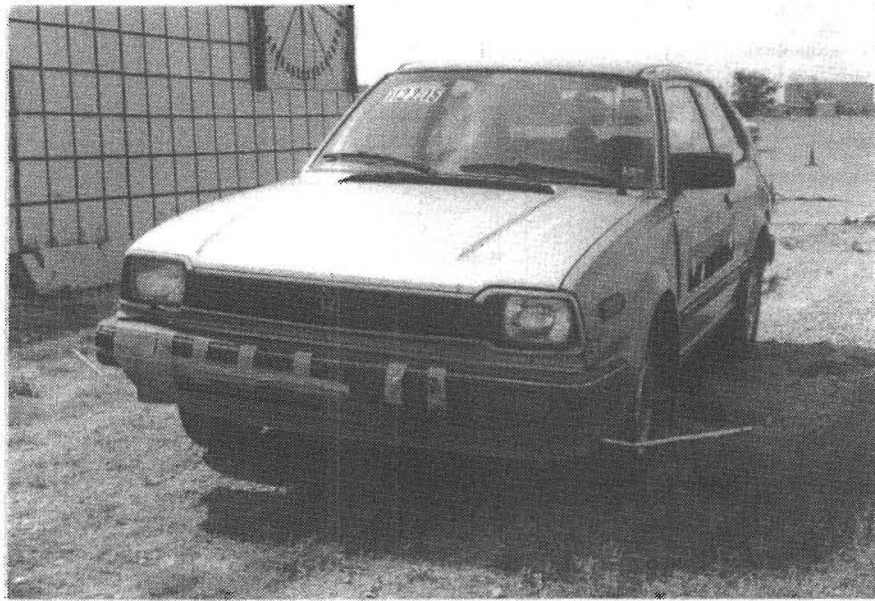
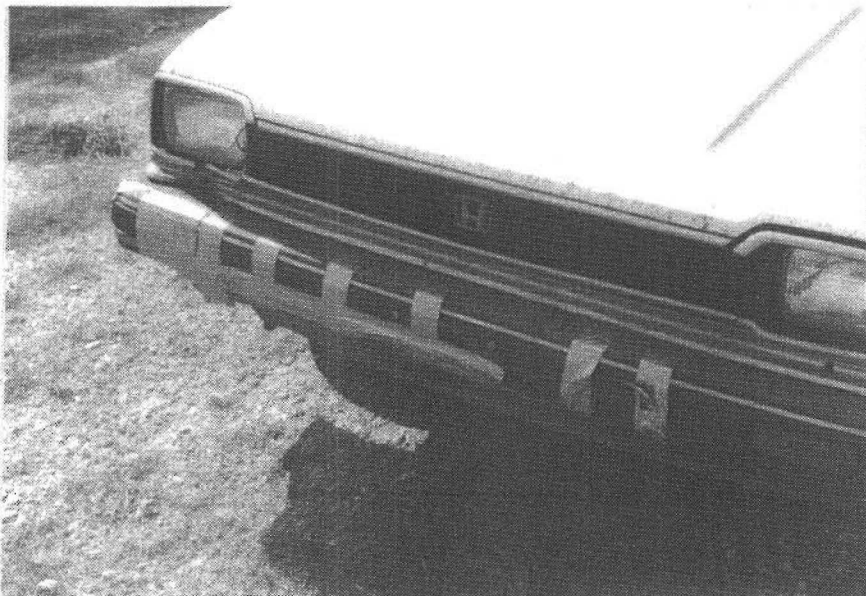
Figure 218. Vehicle after test 1122-15.

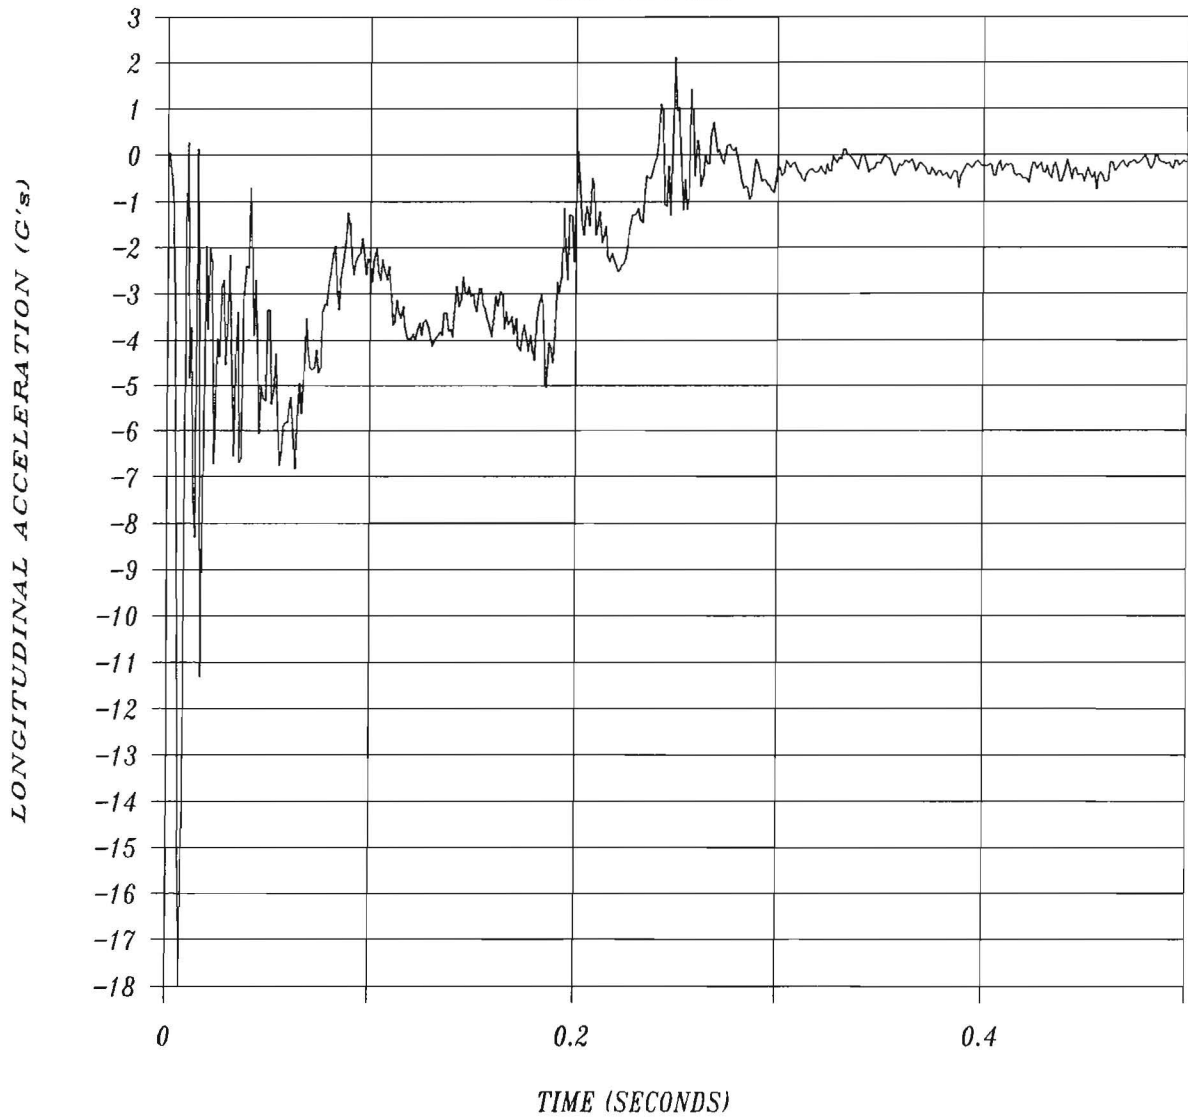
Class 180 Filter

Figure 221. Longitudinal accelerometer trace for test 1122-15.
