1. Report No. FHWA/TX-90/1122-1F		2. Government Accession No.		3. Recipient's Catalog No.	
4. Title and Subtitle Generic Small Sign Support System and Validation of Acceptable Support Performance				5. Report Date April 1990 /Revised

14. Sponsoring Agency Code	
15. Supplementary Notes Research performed in cooperation with DOT, FHWA					
16. Abstract Small sign systems include everything from stop signs and delineator posts to signs up to about 25 square feet. In some cases, multiple small sign support systems are used to support much larger signs (40-50 square feet). This broad class of sign has been and is currently being used along Texas highways. To insure the safety of vehicle occupants, there have been a series of specifications, guidelines and recommendations which define acceptable vehicle impact performance criteria. Most small sign systems have been tested with vehicles larger than the current standard 1800 pound car. As a result, the first phase of this study was to undertake a series of recertification tests for those systems currently being used in Texas. An analytical model also was developed to aid in the evaluation of data from previous crash tests. Although certif

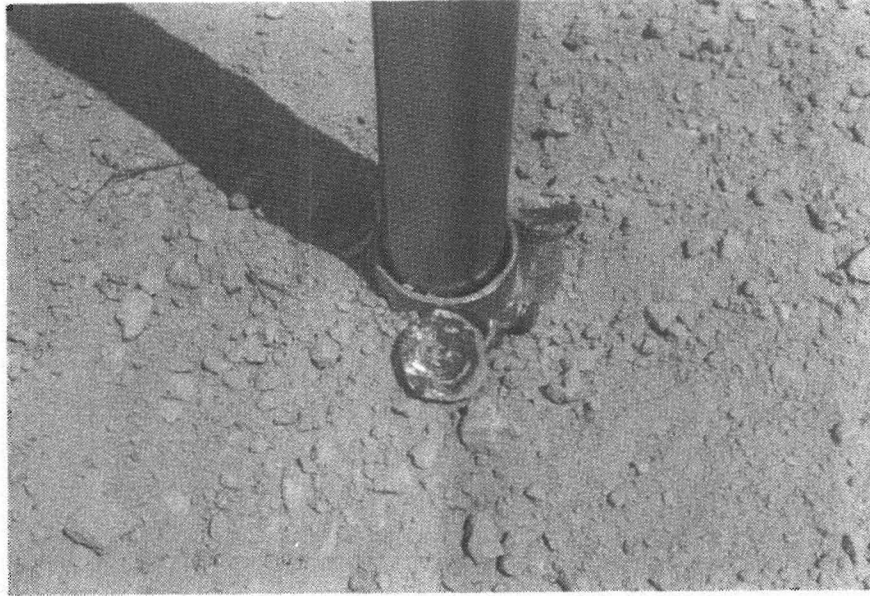
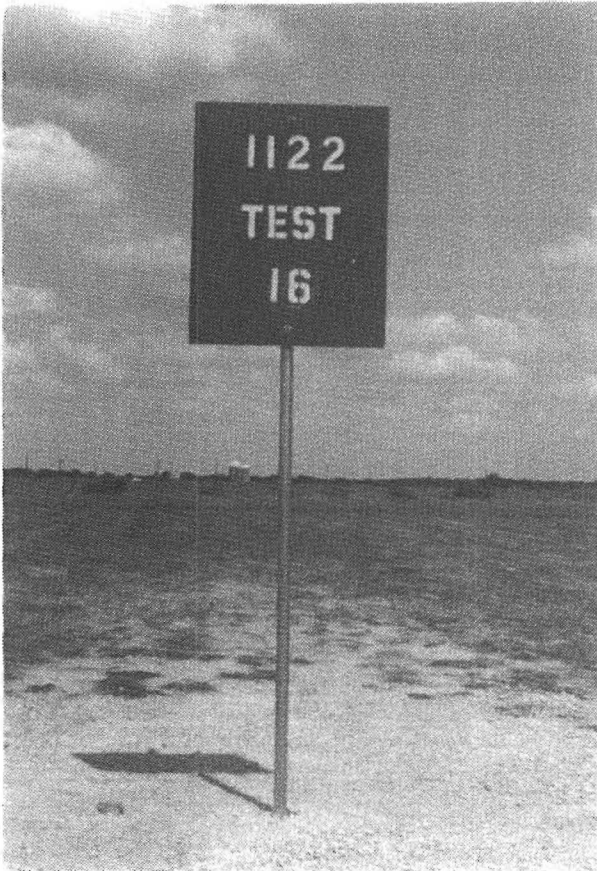
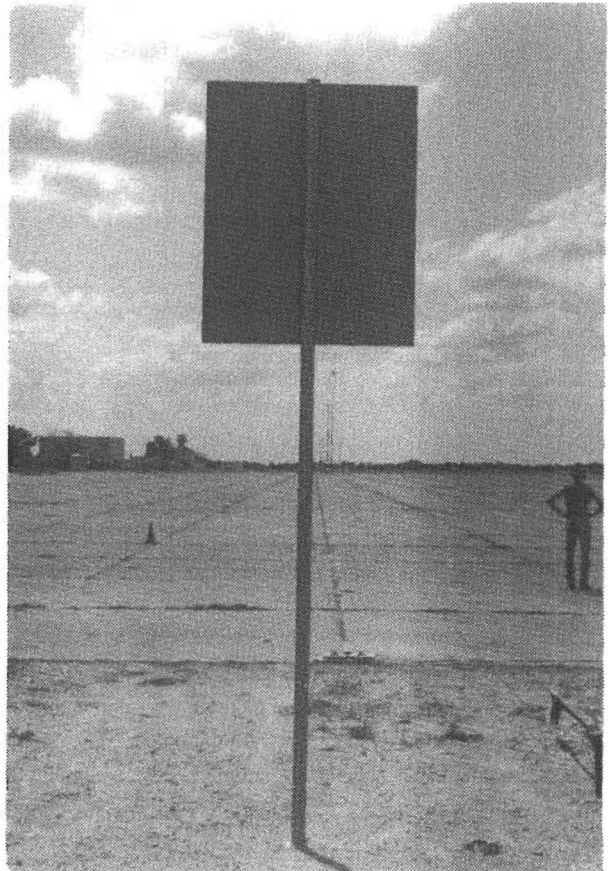
Figure 225. Sign installation before test 1122-16.

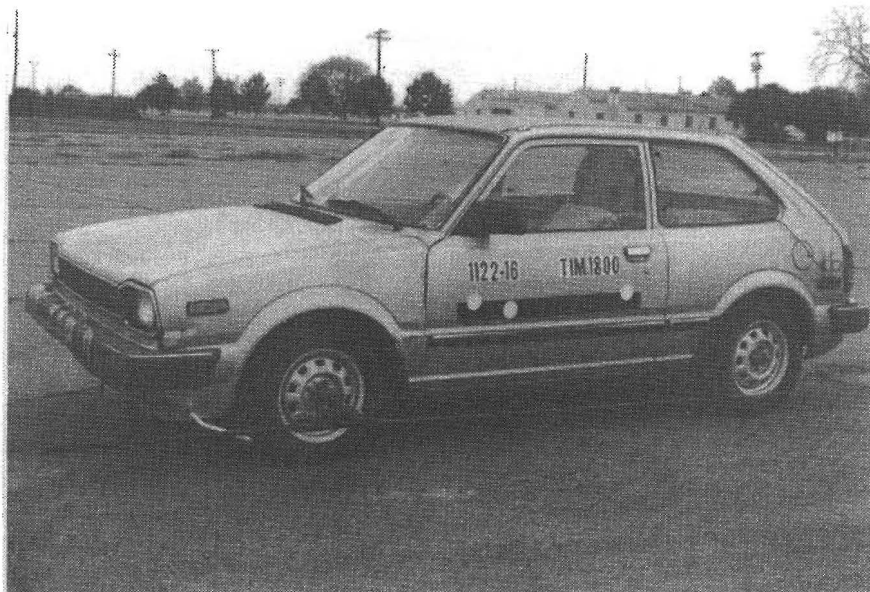
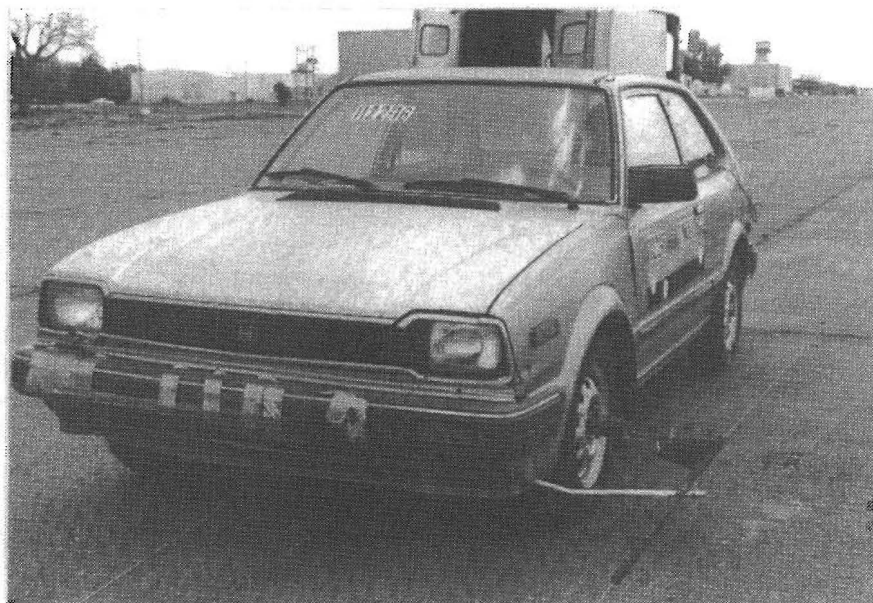
Figure 226. Vehicle before test 1122-16.

A 1982 Honda Civic (shown in Figure 226) impacted the sign installation at 61.5 miles per hour (99.0 km/h) using a cable reverse tow and guidance system. Test inertia mass of the vehicle was 1,800 lb (816 kg) and its gross static mass was 1,968 lb (893 kg). The height to the lower edge of the vehicle bumper was 14.0 inches (35.6 cm) and 20.0 inches (50.8 cm) to the top of the bumper. Other dimensions and information on the vehicle are given in Figure 228.

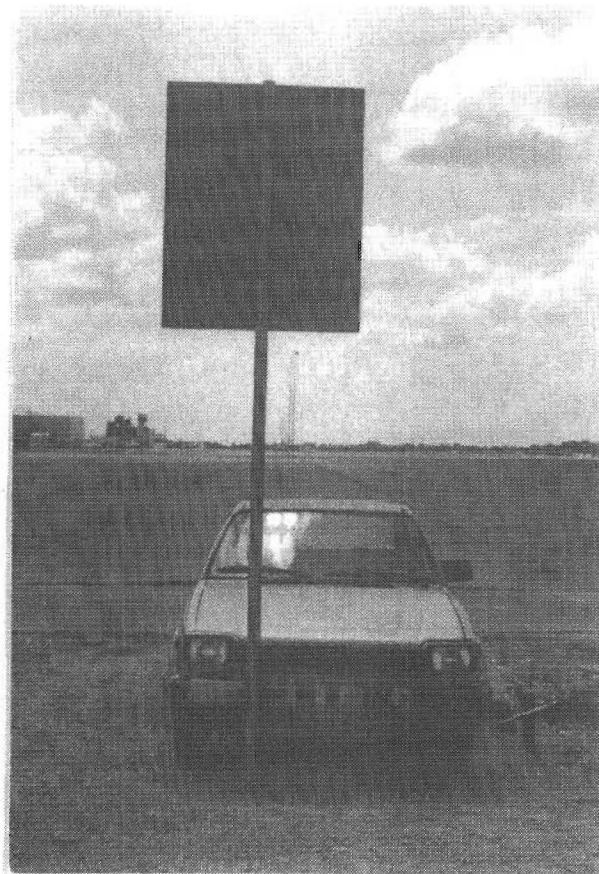
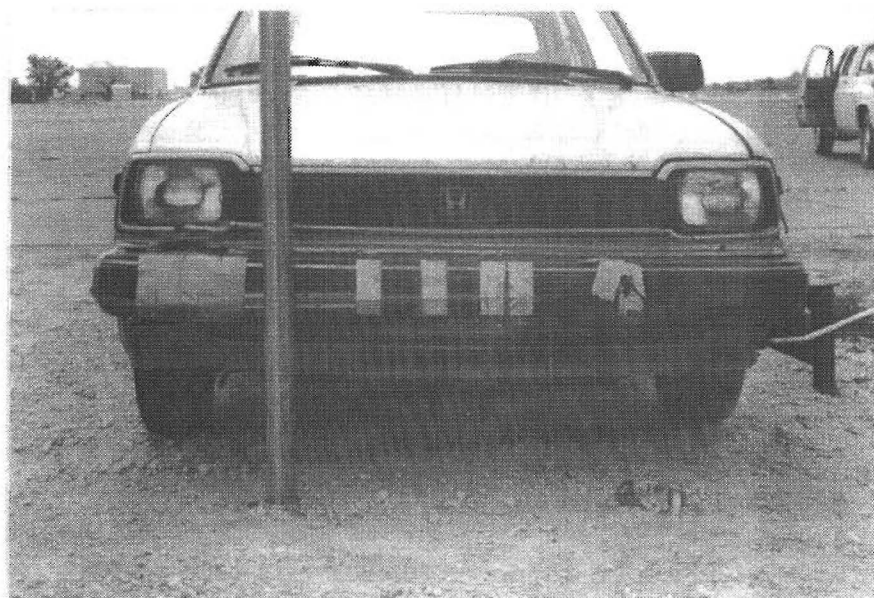
Figure 227. Sign/vehicle geometrics for test 1122-16.

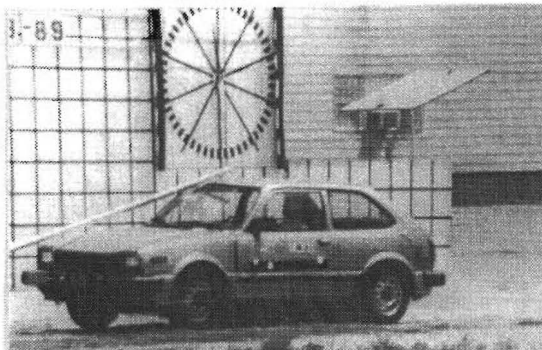
Figure 229. Sequential photographs for test 1122-16.

The vehicle was freewheeling and unrestrained just prior to impact. The point of impact was the center line of the sign with the right quarter point of the vehicle. Upon impact, the sign support began to yield. At approximately 0.028 second, the support disengaged from the anchor. As the vehicle traveled over the anchor and under the support, the vehicle lost initial contact with the installation at approximately 0.100 second. Shortly thereafter, the sign support struck the right side of the vehicle's roof. As the vehicle lost contact with the installation, traveling 58.4 mi/h (94.0 km/h), the brakes were applied and the vehicle came to rest 280 ft (85.4 m) from the point of impact. Sequential photographs of the test are shown in Figure 229.

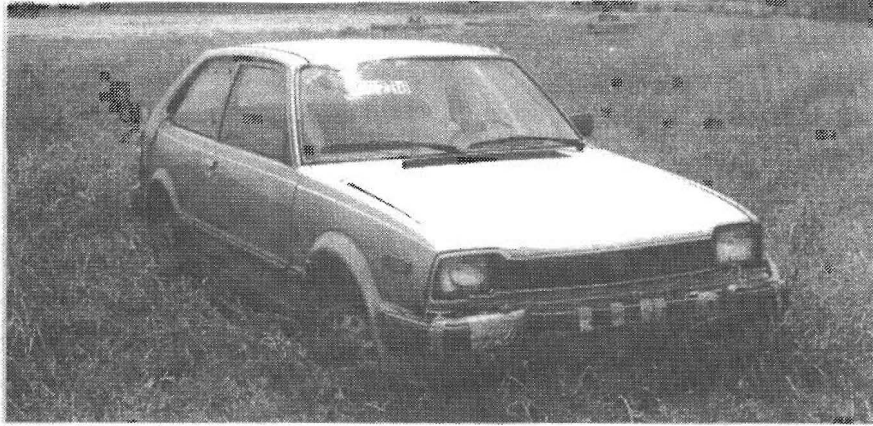
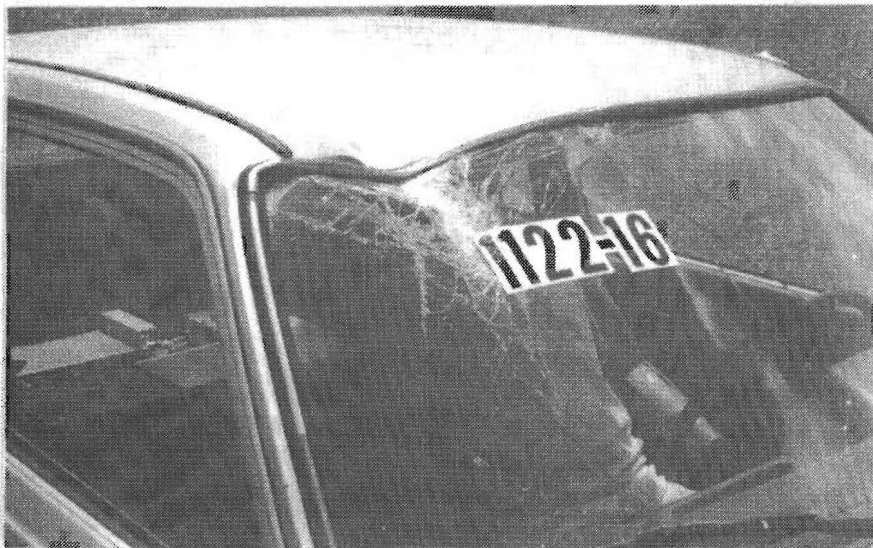
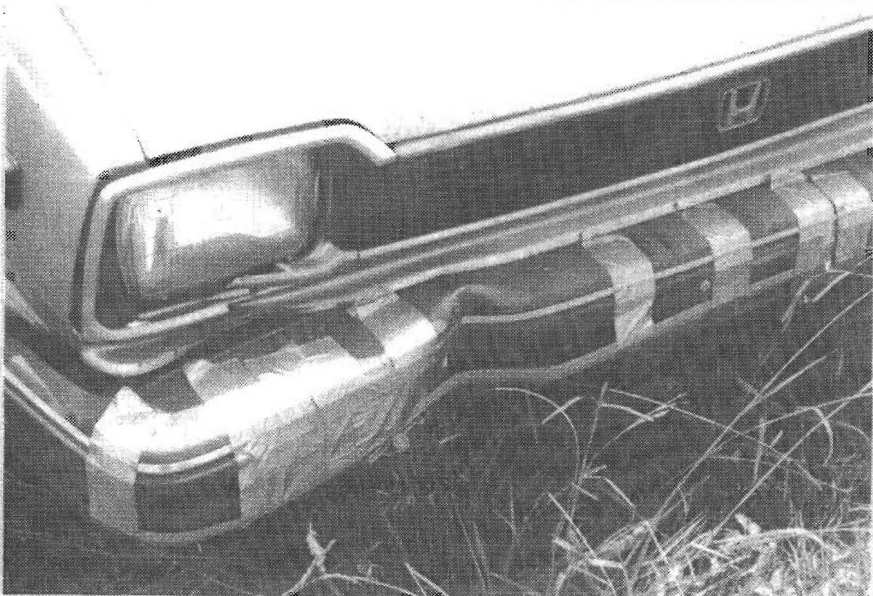
Figure 231. Vehicle after test 1122-16.

The sign support stayed with the vehicle and the sign blank remained near the point of impact. The support disengaged from the anchor. The anchor was pushed rearward 2.8 in (7.0 cm). In addition, the support was either fractured or bent between 5.8 in (14.6 cm) and 19.0 in (48.3 cm) above the roadway. The vehicle sustained only minor damages to the bumper, roof and windshield, as shown in Figure 231.
