**DEPARTMENTAL  
INFORMATION  
EXCHANGE**

# **ANALYZING PAVEMENT DISTRESS: NEW AUTOMATION OF DATA INTERPRETATION**

## **Summary Report**

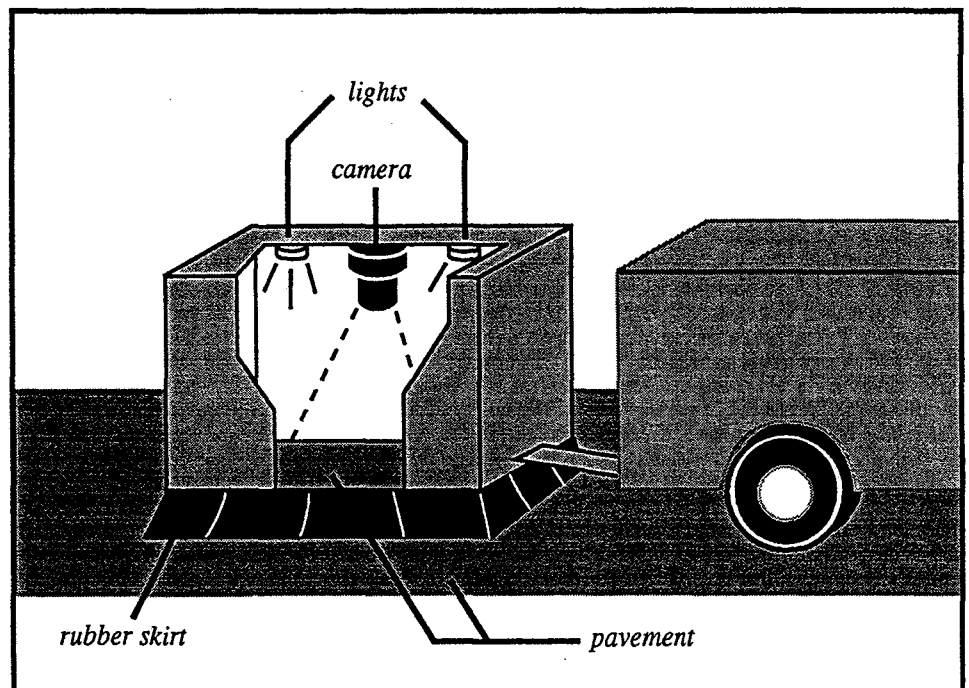
*For collecting pavement distress video, the recommended system is a survey vehicle pulling an open-bottom trailer with lights and camera inside, and a rubber skirt along the bottom to prevent shadow distortions.*

- an open-bottom enclosed trailer with a rubber skirt to block out the sunlight;
- a special lighting system inside the trailer to give enough illumination for a clear image at 1/4000th of a second shutter speed with the survey vehicle traveling at 50 mph;
- two high resolution shuttered cameras (SONY XC-77RR) with remote camera heads and high signal-to-noise ratios;
- an image processing workstation using a Sun IPX host system that is computer interfaced to a digital effect VCR (Panasonic AG 1830).
