1. Report No. FHWA/TX-01/1792-4		2. Government Accession No.		3. Recipient's Catalog No.	
4. Title and Subtitle TESTING AND EVALUATION OF THE SOLAR PANEL SIGN SUPPORT SYSTEM				5. Report Date January 2001

16. Abstract <p>The purpose of this series of tests is to verify the performance of the pedestal base sign installation when attached to the ground with a helical type screw-in foundation anchor assembly and equipped with the solar power (photovoltaic) hardware necessary to operate flashing signal beacons. Additionally, wind load analysis was also performed to determine the strength of the installation under extreme wind conditions.</p> <p>A pedestal base sign installation equipped with photovoltaic equipment and attached to the ground with a helical type screw-in foundation anchor assembly successfully met the evaluation criteria set forth in National Cooperative Highway Research Program (<i>NCHRP Report 350</i>). The installation was fabricated using a Pelco (model SP 1014 TX) square cast aluminum traffic signal base with a 114 mm (4.5 in) outside diameter × 3.96 m (13 ft) long spun aluminum pole. Attached to the pole was a 16 mm × 1.2 m × 1.2 m (0.625 in × 48 in × 48 in) plywo

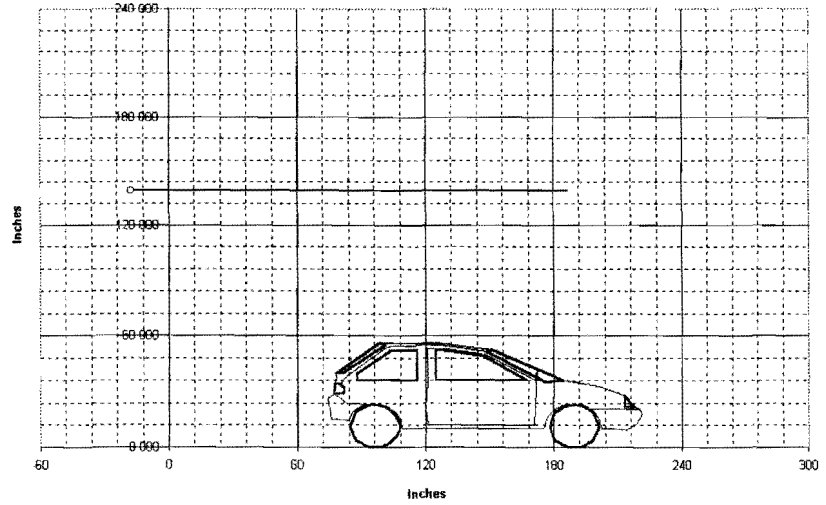
(a) Support at 0 degree (impact)

(c) Support at 90 degrees

(b) Support at 45 degrees

(d) Support at 135 degrees

Figure 2. Simulation Results for Dual Beacon at 62.2 mi/h (100 km/h).

It was determined that the most effective method for determining the point of impact of the sign support on the vehicle was to present the results of the analysis graphically, as shown in Figures 1 through 4. Coordinates from a Geo Metro (which is currently the most common small car test vehicle) were used to create a vehicle side profile. The positions of the vehicle and support post were then tracked to the point of impact.

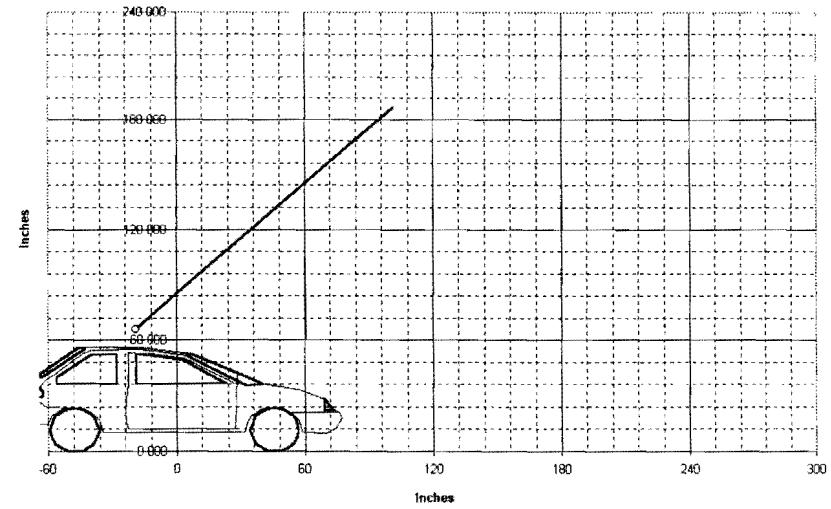
(a) Support at 0 degree (impact)

(c) Support at 90 degrees

(b) Support at 45 degrees

(d) Support at 135 degrees

Figure 3. Simulation Results for Single Beacon at 21.7 mi/h (35 km/h).

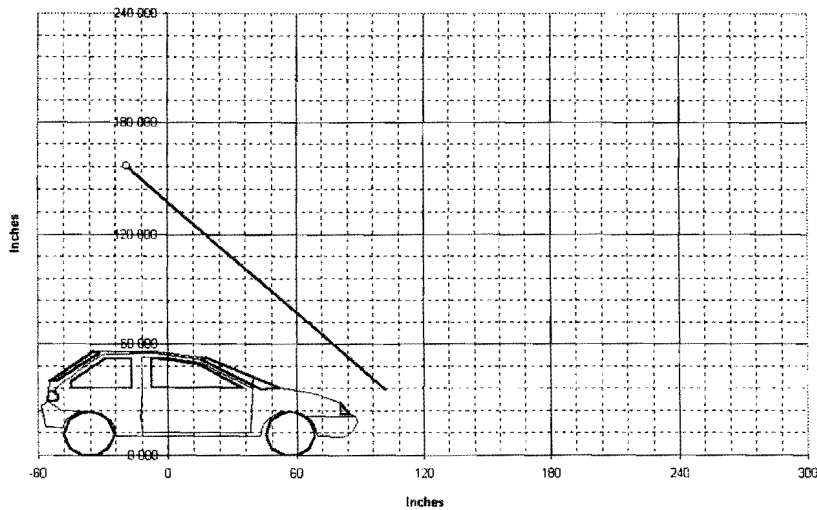
(a) Support at 0 degree (impact)

(c) Support at 90 degrees

(b) Support at 45 degrees

(d) Support at 135 degrees

Figure 4. Simulation Results for Single Beacon at 62.2 mi/h (100 km/h).

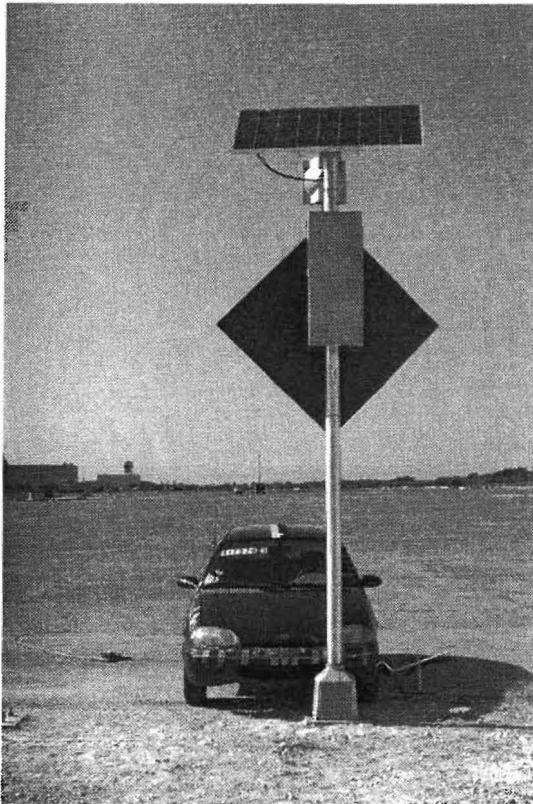
Figure 9. Vehicle/Installation Geometrics for Test 417920-3.

The crash test used a 1995 Geo Metro, shown in Figures 9 and 10. Test inertia weight of the vehicle was 820 kg (1806 lb), and its gross static weight was 896 kg (1974 lb). The height to the lower edge of the vehicle bumper was 400 mm (15.7 in), and it was 525 mm (20.7 in) to the upper edge of the bumper. Additional dimensions and information on the vehicle are given in Appendix B, Figure 23. The vehicle was directed into the installation using the cable reverse tow and guidance system, and was released to be free-wheeling and unrestrained just prior to impact.

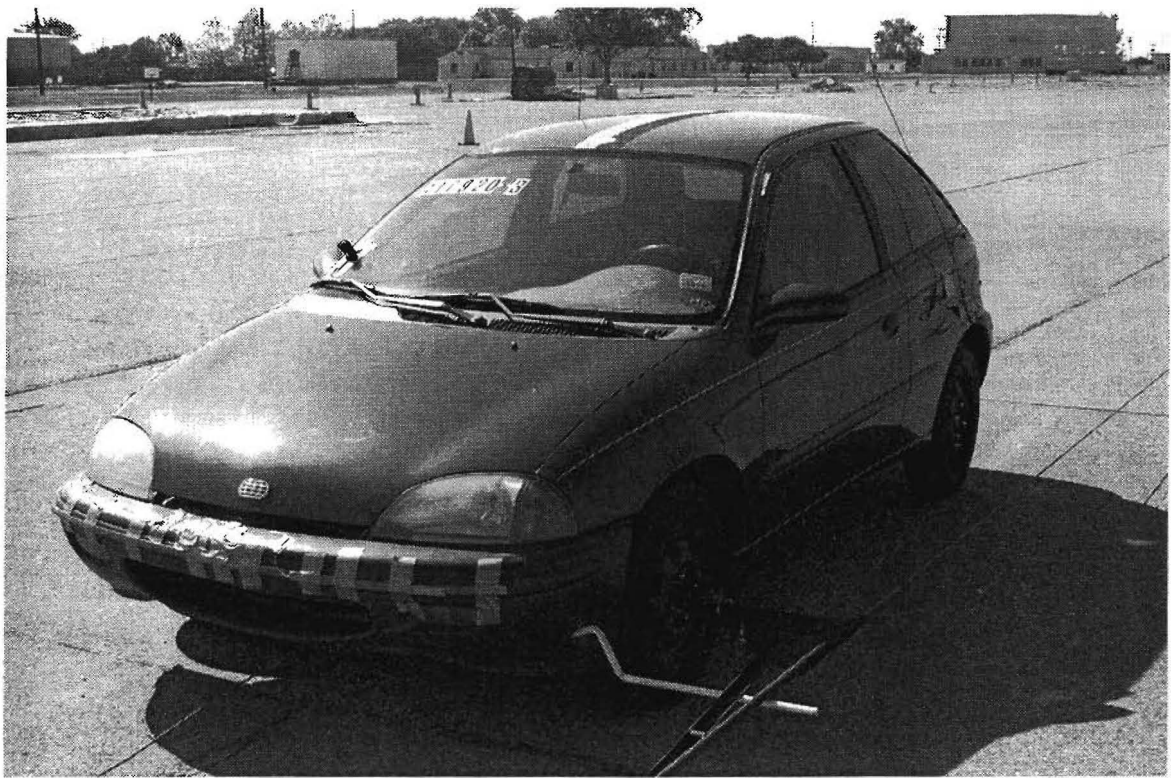
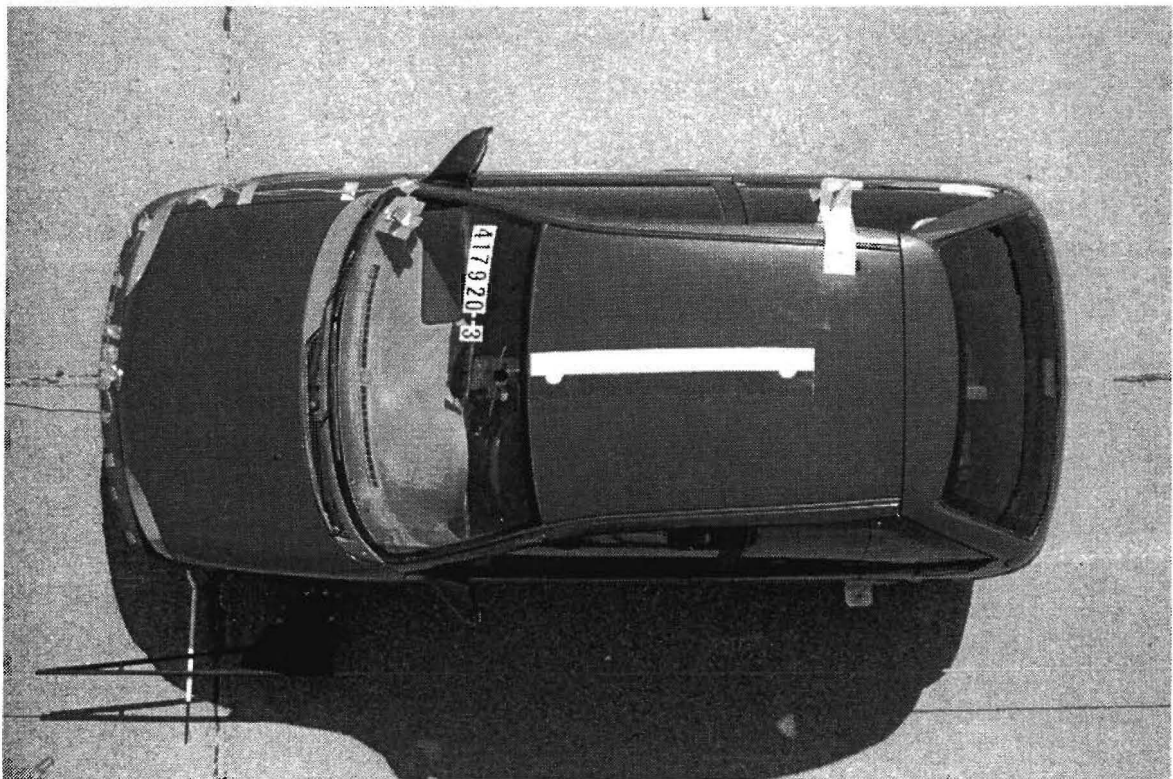
Figure 10. Vehicle before Test 417920-3.

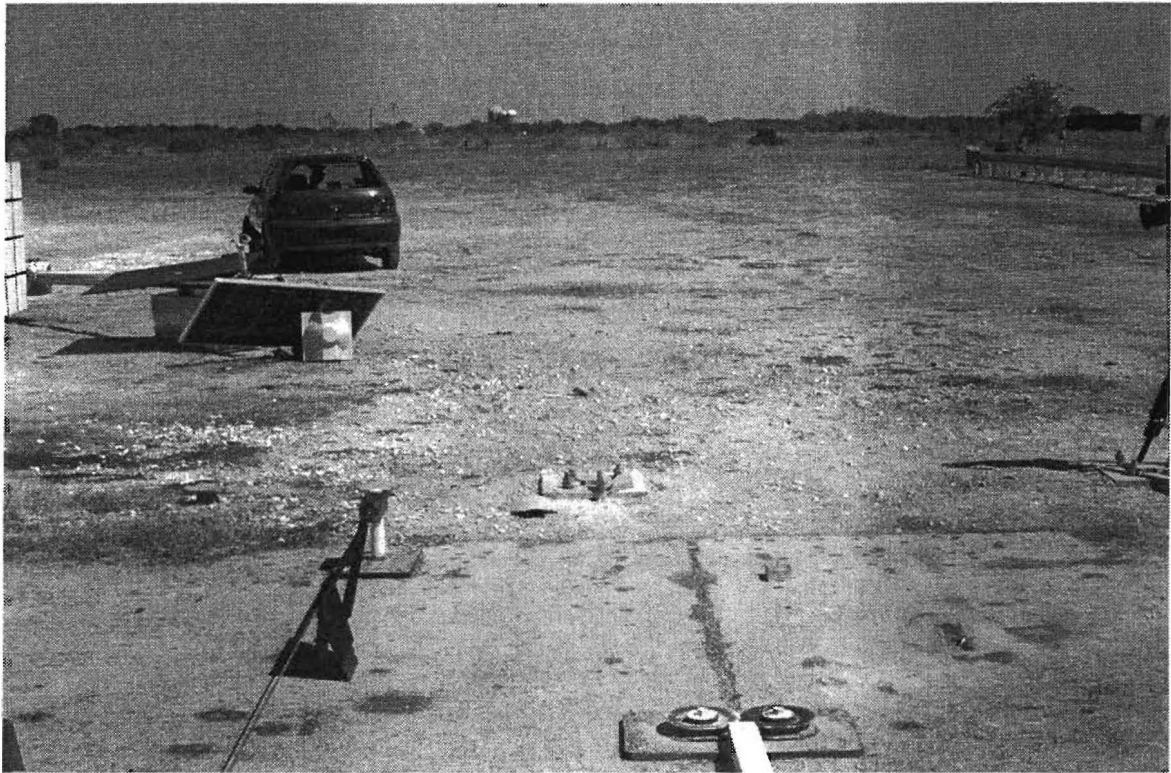
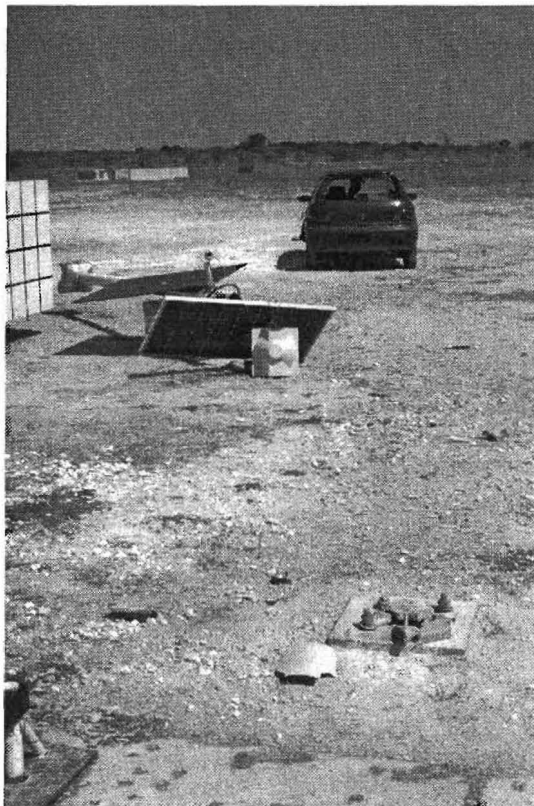
Figure 11. After Impact Trajectory for Test 417920-3.

Damage to the test installation is shown in Figures 11 and 12. The solar panel sign support system readily yielded to the vehicle by fracturing at the pedestal base. Test procedures fractured the base and broke the flashing signal beacon unit, but the rest of the unit remained usable. The sign system came to rest 7.0 m (23.0 ft) behind the point of contact.

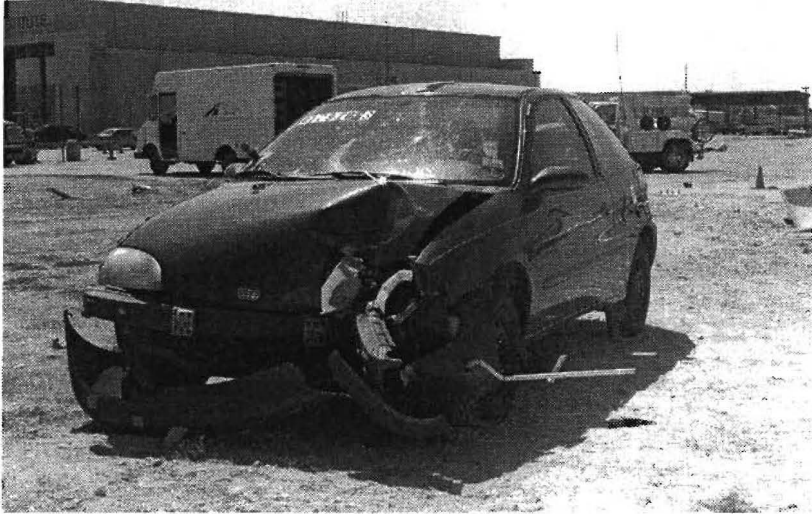
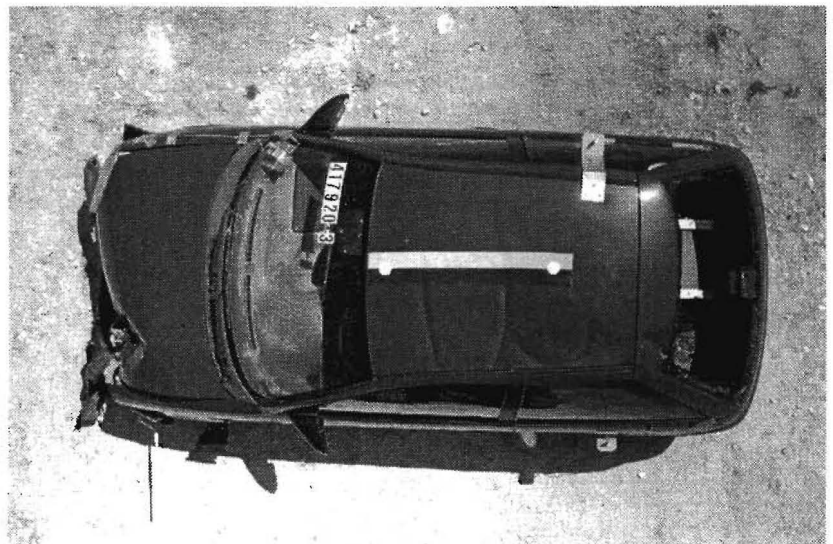
Figure 13. Vehicle after Test 417920-3.

The 820 kg (1806 lb) vehicle sustained damage to the left front corner, hood, roof and rear hatch as shown in Figure 13. The left side strut and CV joint were damaged, as well as the front bumper, hood, fan, radiator, radiator support, and rear window. Maximum crush to the exterior of the vehicle was 260 mm (10.2 in) at the left front quarter point. Maximum occupant compartment deformation was 25 mm (1.0 in) in the floor pan area. Photographs of the interior of the vehicle are shown in Figure 14, and exterior vehicle crush and occupant compartment measurements are shown in Appendix B, Tables 6 and 7.

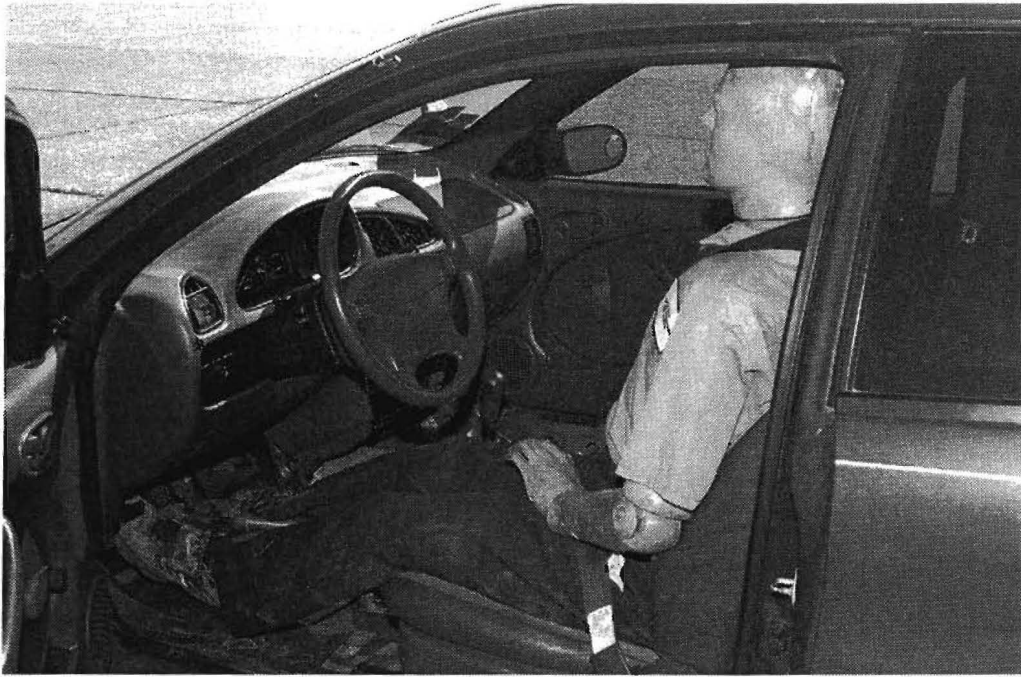
Before test

After test

Figure 14. Interior of Vehicle for Test 417920-3.

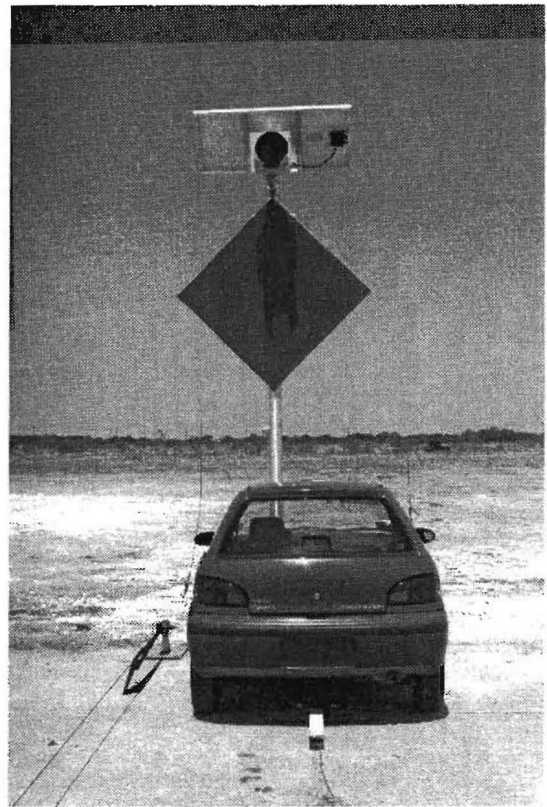
Figure 16. Vehicle/Installation Geometrics for Test 417920-4.

A 1996 Geo Metro, shown in Figures 16 and 17, was used for the crash test. Test inertia weight of the vehicle was 820 kg (1806 lb), and its gross static weight was 895 kg (1971 lb). The height to the lower edge of the vehicle bumper was 400 mm (15.7 in), and it was 525 mm (20.7 in) to the upper edge of the bumper. Additional dimensions and information on the vehicle are given in Appendix B, Figure 24. The vehicle was directed into the installation using the cable reverse tow and guidance system, and was released to be free-wheeling and unrestrained just prior to impact.

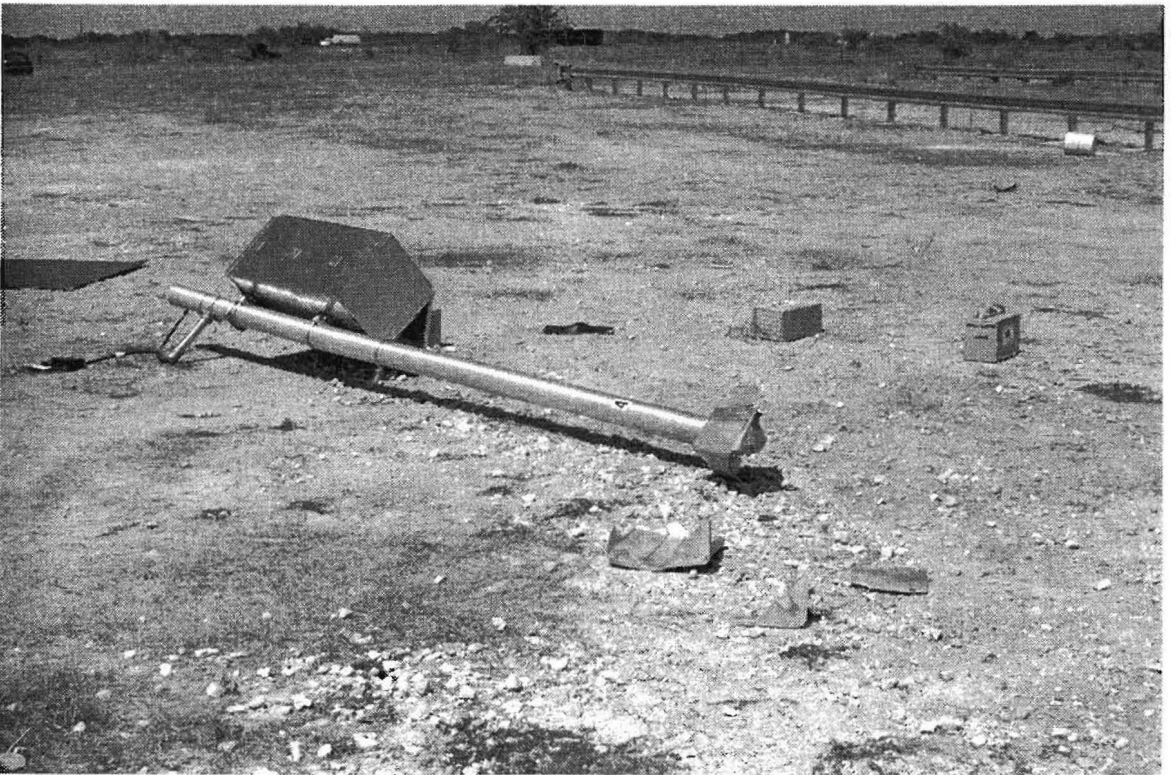
Figure 18. After Impact Trajectory for Test 417920-4.

The solar panel sign support system separated into several pieces as shown in Figures 18 and 19. The debris was scattered from 7.0 m (23.0 ft) in front of the impact point to 10.7 m (35.1 ft) behind the impact point and 1.5 m (4.9 ft) to the left side and 2.3 m (7.5 ft) to the right side.

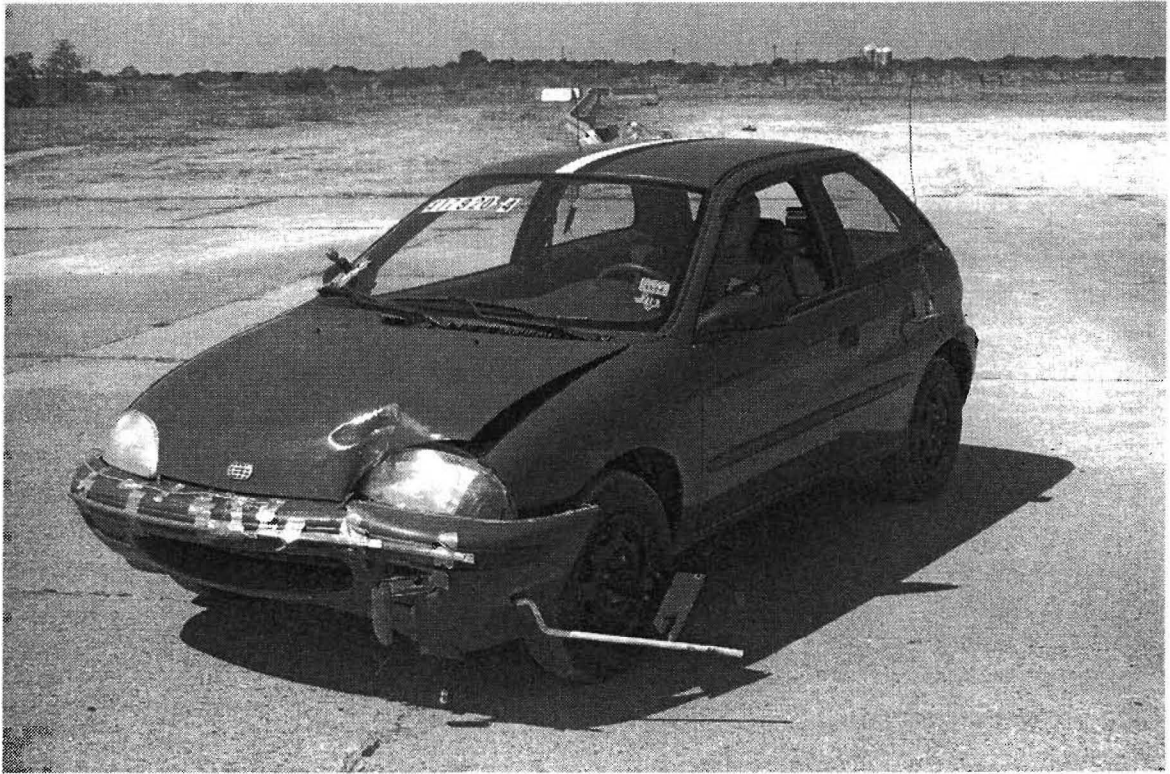
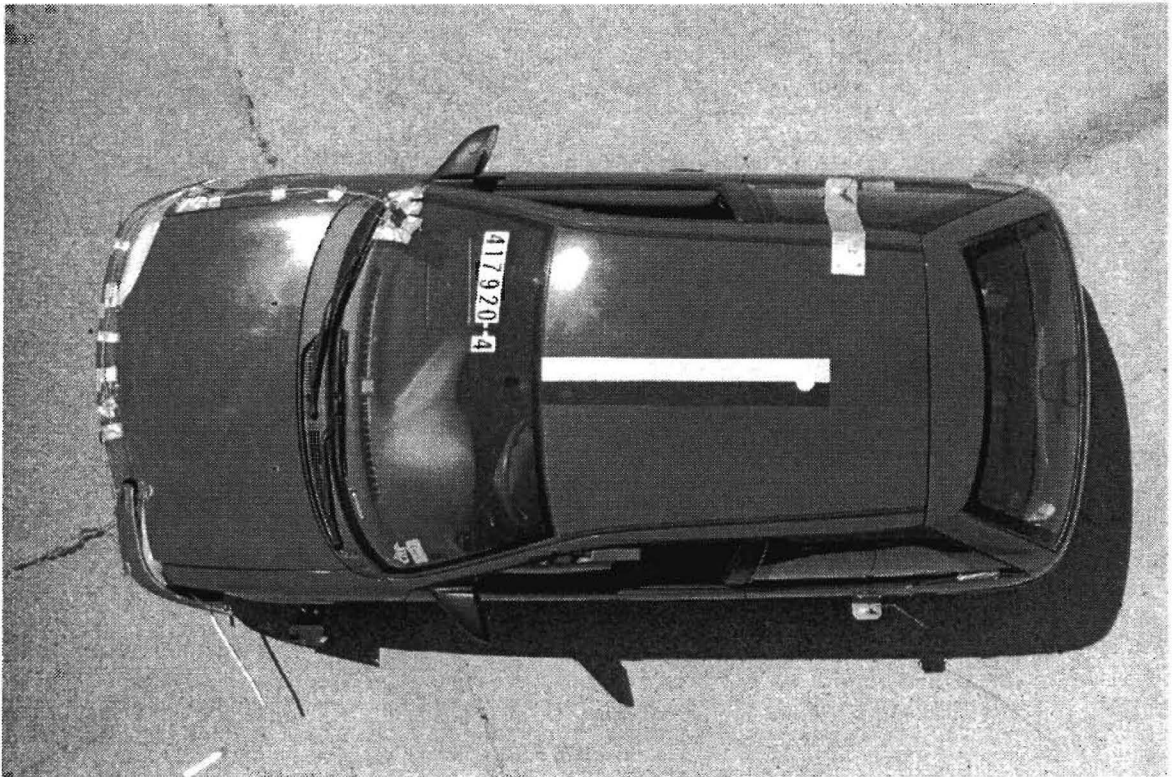
Figure 20. Vehicle after Test 417920-4.

The vehicle sustained minimal damage to the left front quarter point as shown in Figure 20. The front bumper, inner bumper, radiator support, left front headlight, and the hood were damaged. Maximum exterior vehicle crush was 35 mm (1.38 in) at the left front quarter point. No deformation or intrusion of the occupant compartment occurred. Photographs of the interior of the vehicle are shown in Figure 21, and exterior vehicle crush and occupant compartment measurements are shown in Appendix B, Tables 8 and 9.

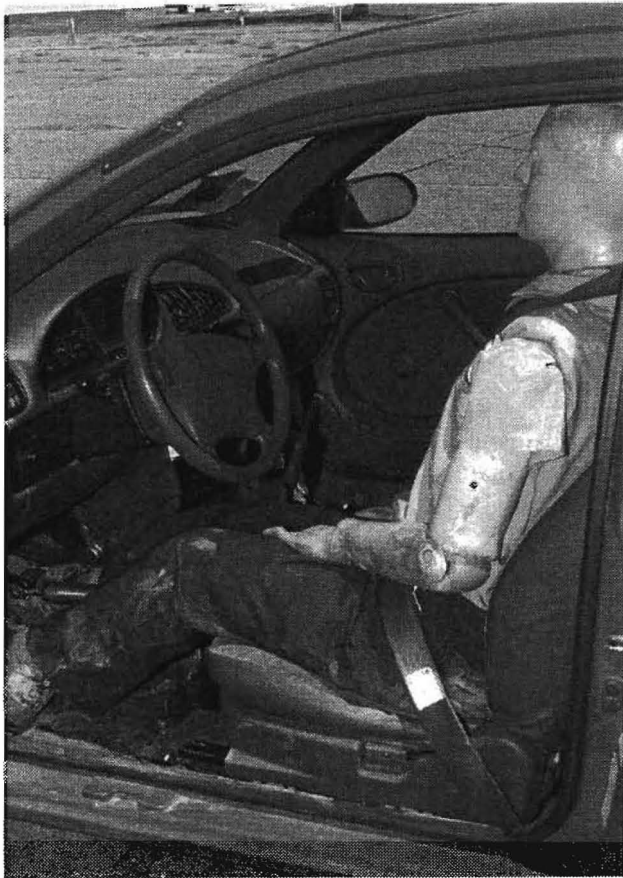
Figure 21. Interior of Vehicle for Test 417920-4.

Before test

After test

Result: The detached elements did not penetrate or show potential for penetrating the occupant compartment, or to present undue hazard to others in the area. Maximum deformation of the occupant compartment was 35 mm (1.38 in) in the floor pan area.

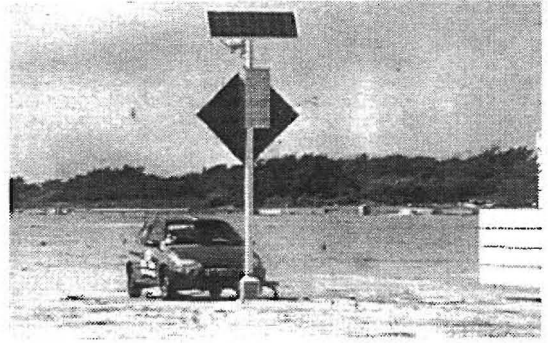
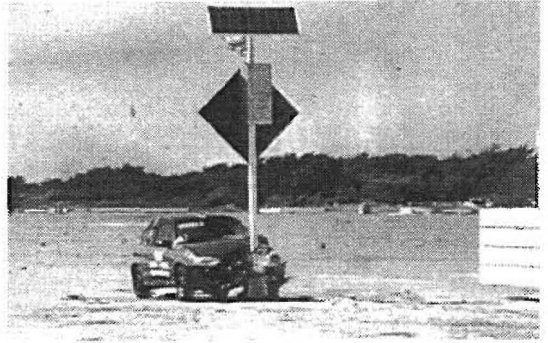
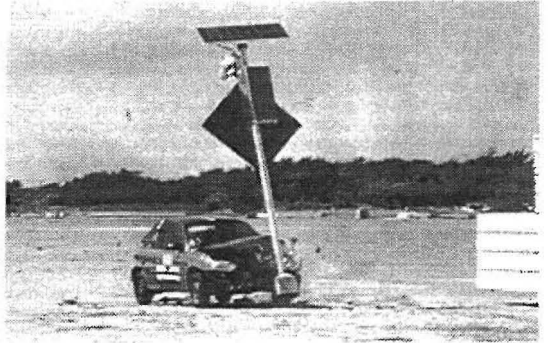
Figure 25. Sequential Photographs for Test 417920-3 (Perpendicular and Oblique Views).

0.000 s

0.096 s

0.239 s

0.478 s

The 820 kg (1806 lb) vehicle, traveling at 35.6 km/h (22.1 mi/h), contacted the solar powered sign support system with the left quarter point of the bumper. Shortly after contact the sign support system began to move and at 0.034 s the vehicle began to rotate slightly counterclockwise. The pedestal base fractured near ground level at 0.076 s, and the vehicle continued moving forward as the sign support system rotated upward in front of the vehicle. At 0.287 s, the vehicle lost contact with the sign support system and was traveling at a speed of 20.1 km/h (12.5 mi/h). The sign support system continued upward and over the roof of the vehicle. The flashing signal beacon on the sign support system contacted the rear hatch window at 0.688 s, and the sign panel contacted the roof at 0.707 s. While still in contact with the rear hatch of the vehicle, the sign support system became parallel with the ground at 0.760 s. The vehicle lost contact with the sign support system at 2.086 s. Brakes on the vehicle were applied shortly after loss of contact, and the vehicle subsequently came to rest 19.1 m (62.7 ft) behind the point of impact. Sequential photographs of the test can be found in Appendix C, Figure 25.

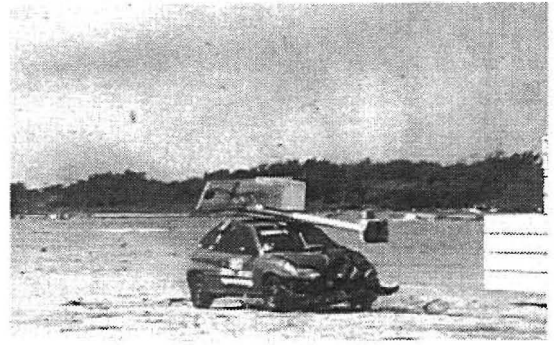
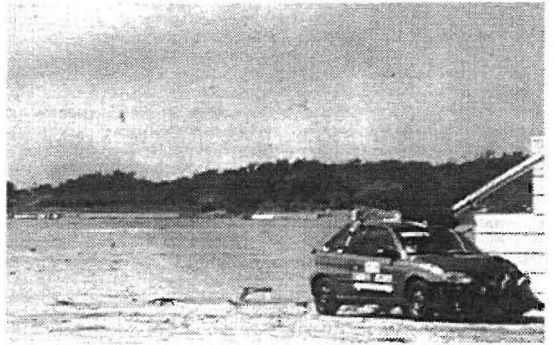
Figure 25. Sequential Photographs for Test 417920-3 (Perpendicular and Oblique Views) (continued).

0.717 s

1.075 s

1.673 s

2.868 s

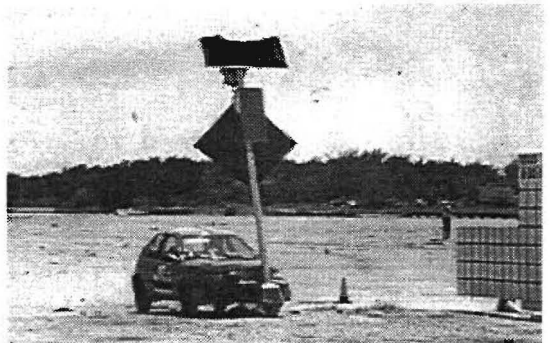
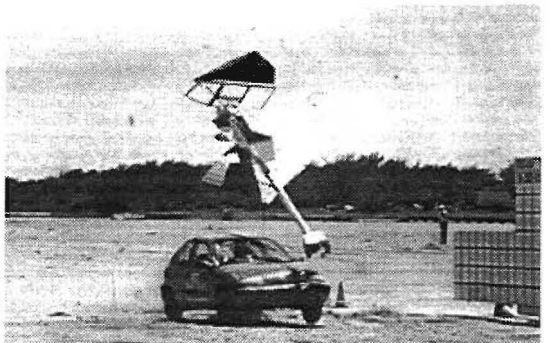
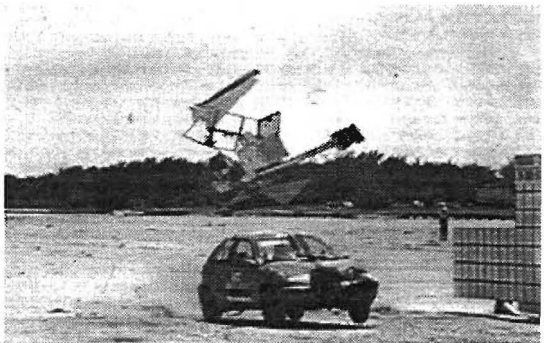
Figure 26. Sequential Photographs for Test 417920-4 (Perpendicular and Oblique Views).

Figure 26. Sequential Photographs for Test 417920-4 (Perpendicular and Oblique Views) (continued).

The vehicle, traveling at a speed of 99.0 km/h (61.5 mi/h), impacted the solar powered sign support system with the left front quarter point. Shortly after impact the sign support system moved, and at 0.010 s the base fractured near ground level. The sign support system began to rise in front of the vehicle at 0.024 s, and the flashing signal beacon separated from the support at 0.041 s. At 0.052 s the sign panel separated from the support, and at 0.073 s the battery cabinet opened. The solar panel separated from the support at 0.090 s. At 0.095 s, the vehicle lost contact with the sign support system and was traveling at a speed of 93.4 km/h (58.0 mi/h). As the vehicle exited the test site, the sign support continued up and over the top of the vehicle and eventually recontacted the ground at 0.373 s. Brakes on the vehicle were applied at 0.850 s after impact, and the vehicle subsequently came to rest 100.0 m (328.1 ft) behind the impact point. Sequential photographs of the test can be found in Appendix C, Figure 26.

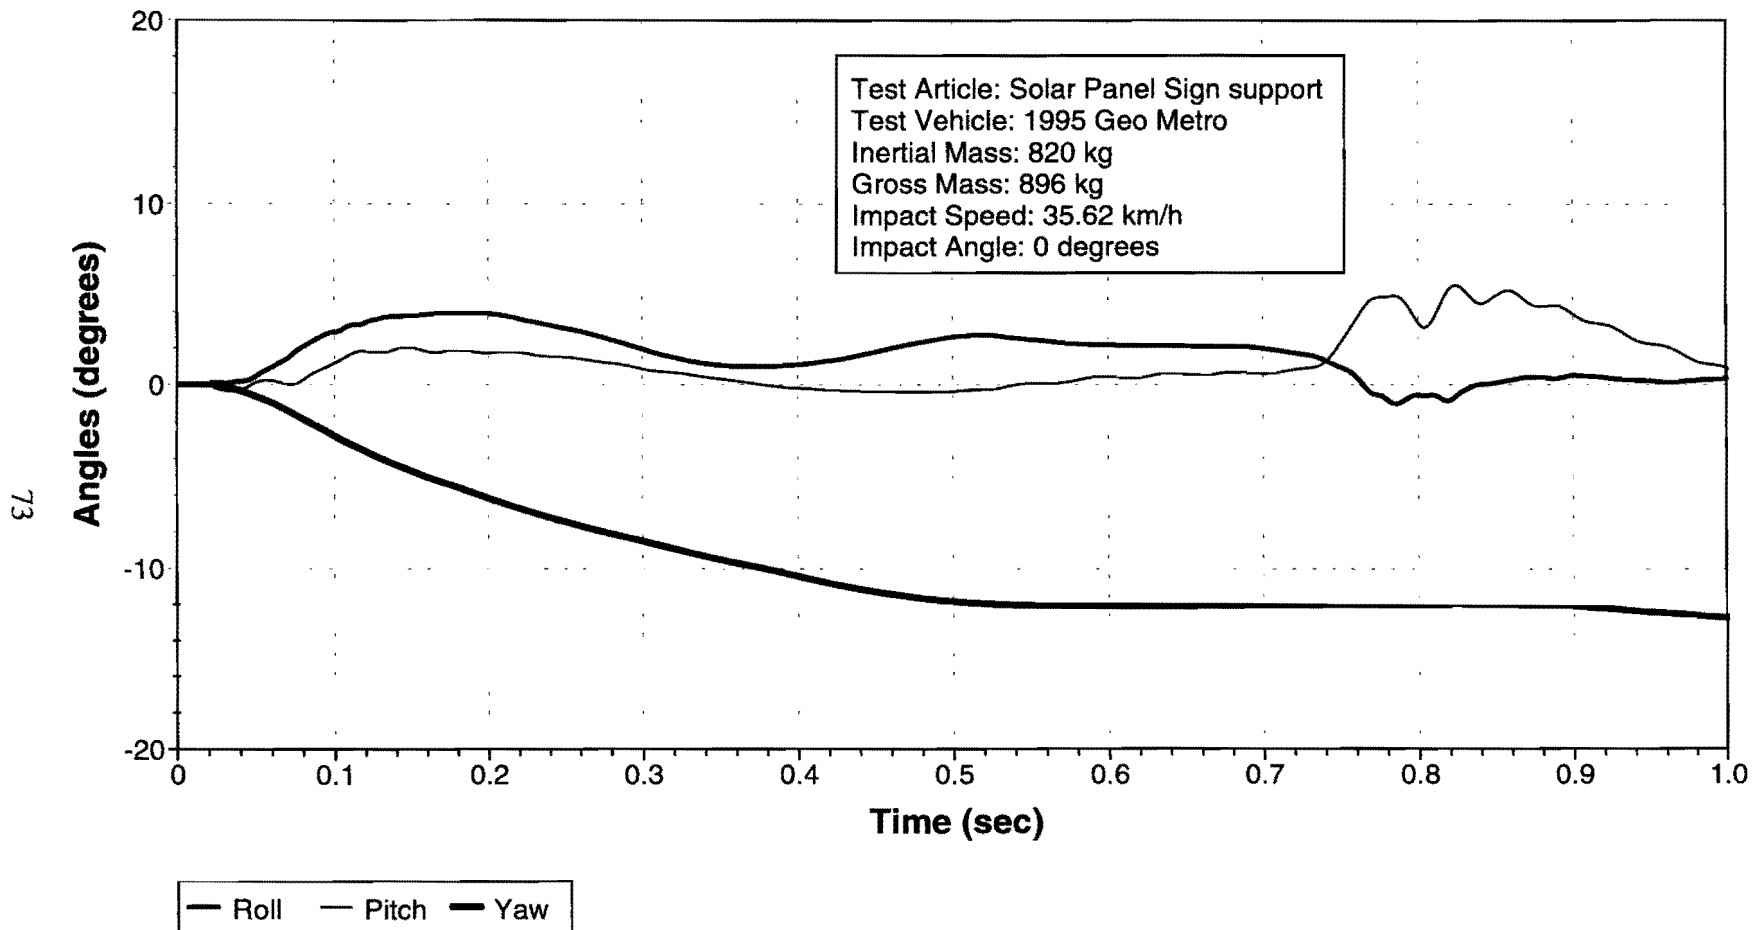
Roll, Pitch and Yaw Angles

Figure 27. Vehicular Angular Displacements for Test 417920-3.

Data from the accelerometer located at the vehicle center of gravity were digitized for evaluation of occupant risk and were computed as follows. In the longitudinal direction, the occupant impact velocity was 4.3 m/s (14.1 ft/s) at 0.189 s, the highest 0.010-s occupant ridedown acceleration was -1.6 g's from 0.721 to 0.731 s, and the maximum 0.050-s average acceleration was -6.5 g's between 0.031 and 0.081 s. In the lateral direction, the occupant impact velocity was 0.3 m/s (1.0 ft/s) at 0.189 s, the highest 0.010 s occupant ridedown acceleration was -1.1 g's from 0.784 to 0.794 s, and the maximum 0.050 s average was -0.6 g's between 0.015 and 0.065 s. These data and other pertinent information from the test are summarized in Figure 15. Vehicle angular displacements are shown in Appendix D, Figure 27, and vehicle accelerations versus time traces are presented in Appendix E, Figures 29 through 31.

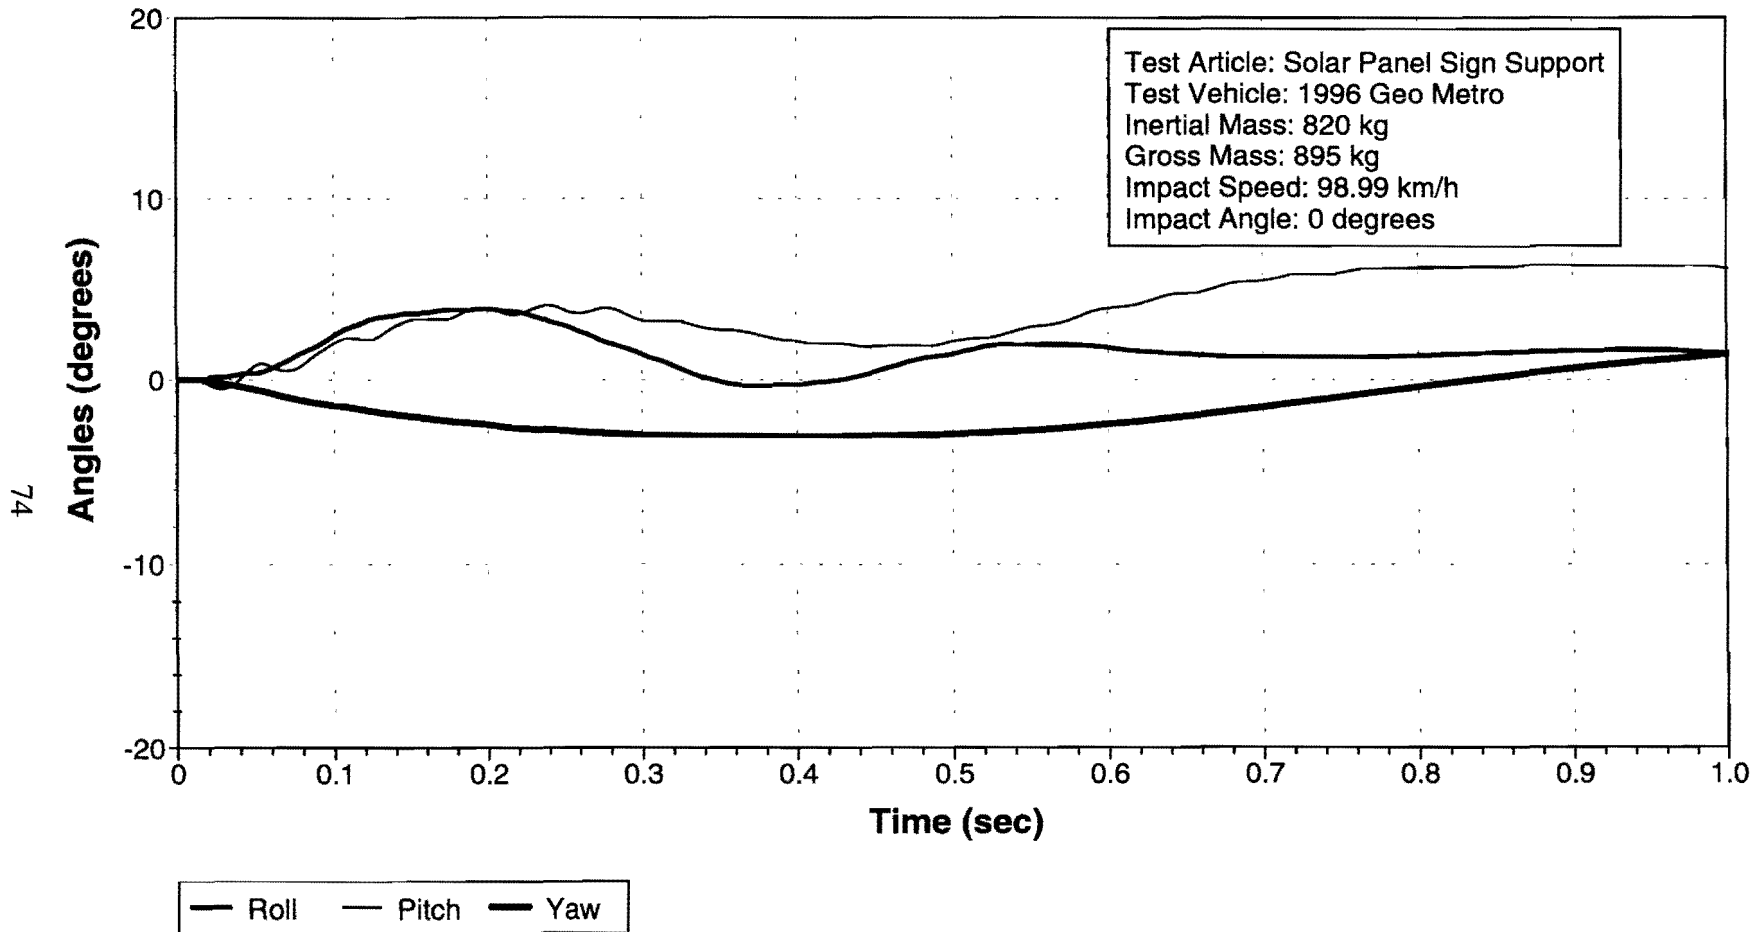
Roll, Pitch and Yaw Angles

Figure 28. Vehicular Angular Displacements for Test 417920-4.

Data from the accelerometer located at the vehicle center of gravity were digitized for evaluation of occupant risk and were computed as follows. In the longitudinal direction, the occupant impact velocity was 1.4 m/s (4.6 ft/s) at 0.515 s, the highest 0.010 s occupant ridedown acceleration was -1.5 g's from 1.550 to 1.560 s, and the maximum 0.050 s average acceleration was -2.0 g's between 0.000 and 0.050 s. In the lateral direction, the occupant impact velocity was 0.9 m/s (3.0 ft/s) at 0.515 s, the highest 0.010 s occupant ridedown acceleration was -0.7 g's from 1.644 to 1.654 s, and the maximum 0.050 s average was -0.8 g's between 0.004 and 0.054 s. These data and other pertinent information from the test are summarized in Figure 22. Vehicle angular displacements are shown in Appendix D, Figure 28, and vehicle accelerations versus time traces are presented in Appendix E, Figures 32 through 34.

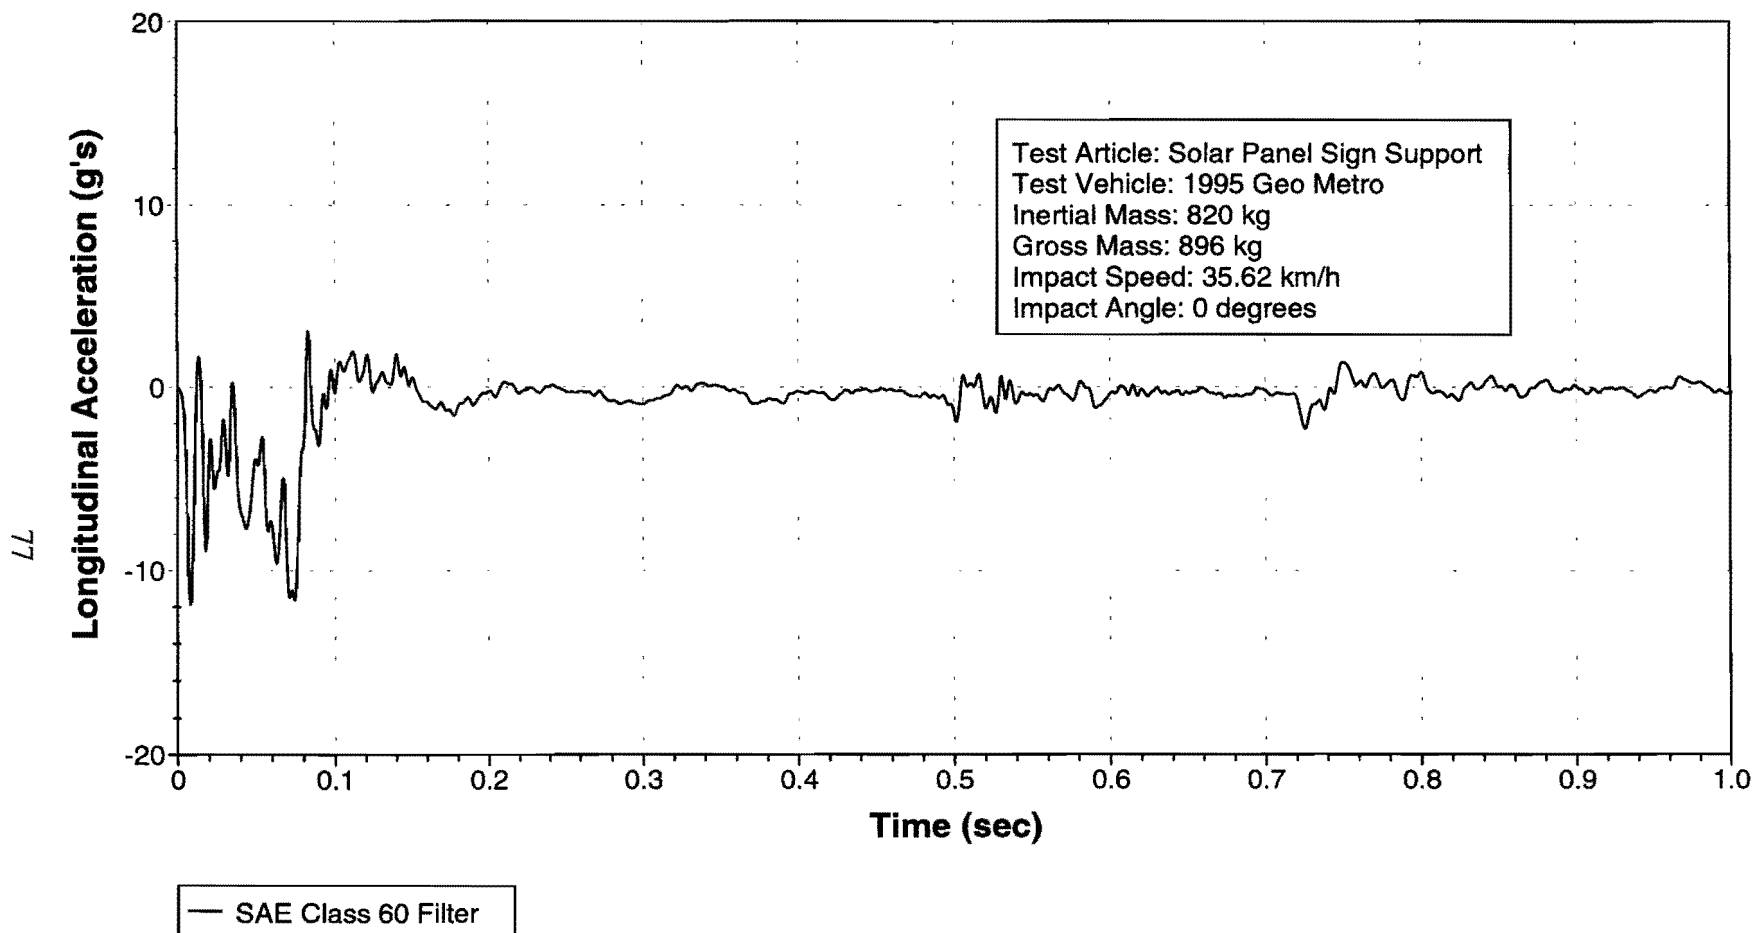
X Acceleration at CG

Figure 29. Vehicle Longitudinal Accelerometer Trace for Test 417920-3.

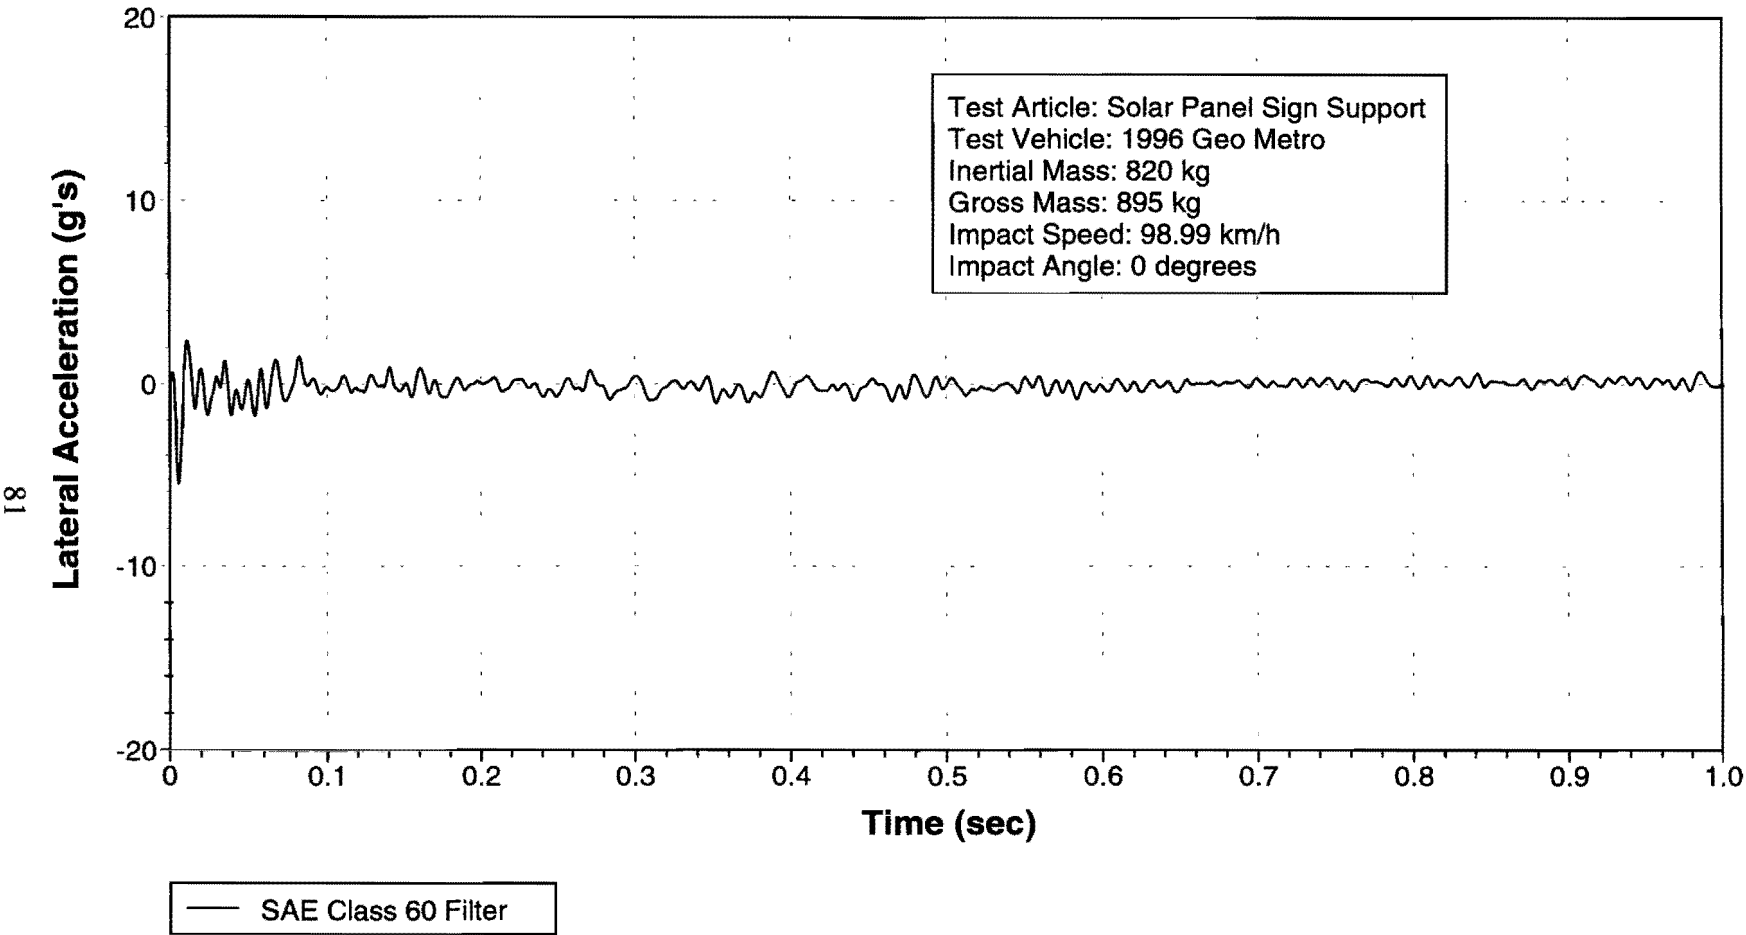
Y Acceleration at CG

Figure 33. Vehicle Lateral Accelerometer Trace for Test 417920-4.
