1. Report No. FHWA/TX-03/1792-8		2. Government Accession No.		3. Recipient's Catalog No.	
4. Title and Subtitle EVALUATION OF DUAL SUPPORT, TRIANGULAR SLIP-BASE SIGN INSTALLATIONS				5. Report Date September 2002

6. Performing Organization Code	
7. Author(s) Roger P. Bligh, Dean C. Alberson, Wanda L. Menges, and Rebecca R. Haug				8. Performing Organization Report No. Report 1792-8

9. Performing Organization Name and Address Texas Transportation Institute The Texas A&M University System College Station, Texas 77843-3135				10. Work Unit No. (TRAIS)

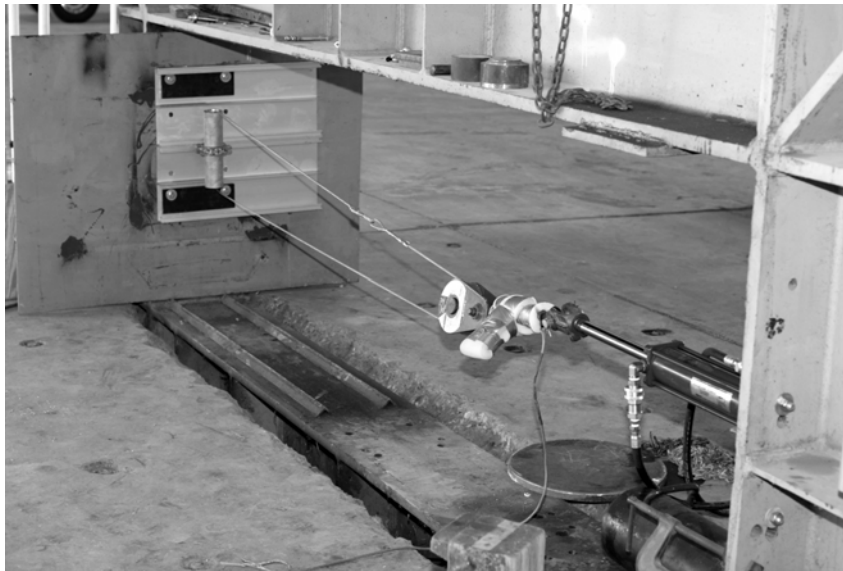
Figure 2. Typical Set-up for Static Load Testing.

A 12-in (305 mm) long section of 2.5-in (64 mm) diameter schedule 80 pipe was attached to a short section of extruded aluminum panel with the standard universal pipe clamp used by TxDOT in small sign supports. [Figure 1](#) shows details of the extruded aluminum panel and clamp. The extruded aluminum panel was clamped to a rigid backup structure using 3/8-in (9.5 mm) thick steel strap and 5/8-in (15.8 mm) diameter bolts. The edges of the steel strap were rounded to prevent high localized stresses. Stranded cable was passed through the pipe and attached to a hydraulic ram (see [Figure 2](#)). The specimens were loaded in tension until failure. The test clamp points were adjusted during the test program to minimize localized effects and more closely simulate potential wind load conditions. [Figures 3](#) through [5](#) depict the different test conditions evaluated.

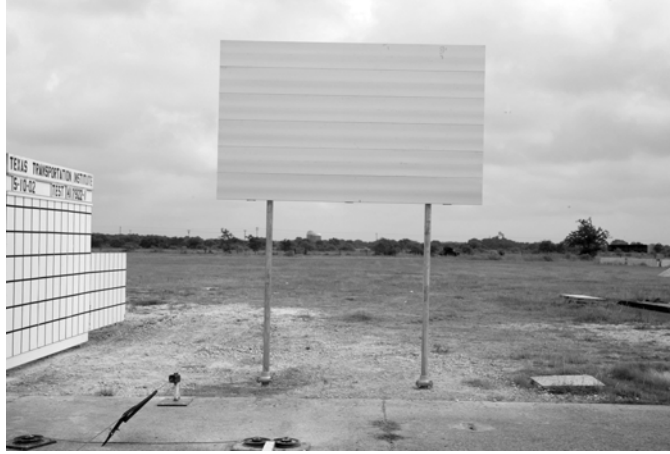
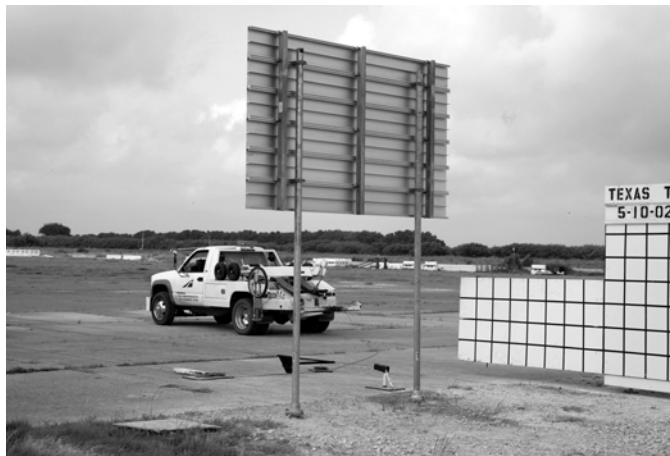
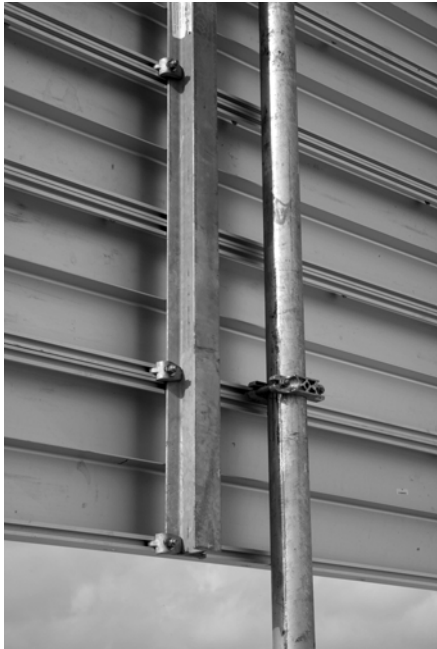
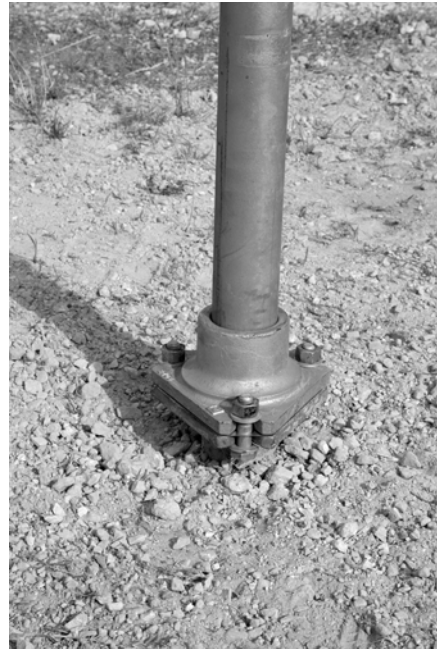
Figure 7. Test Article/Installation before Test 417922-1.

[Figure 6](#) features other dimensional information. [Figures 7](#) and [8](#) show photographs of the installations.

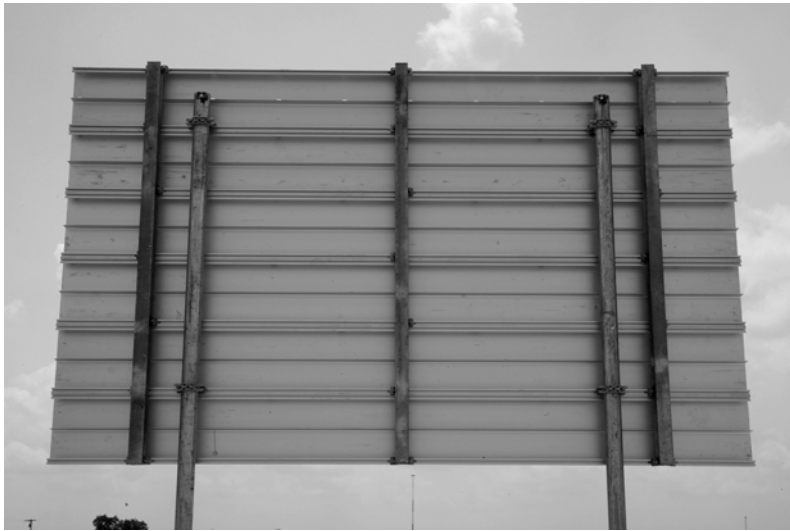
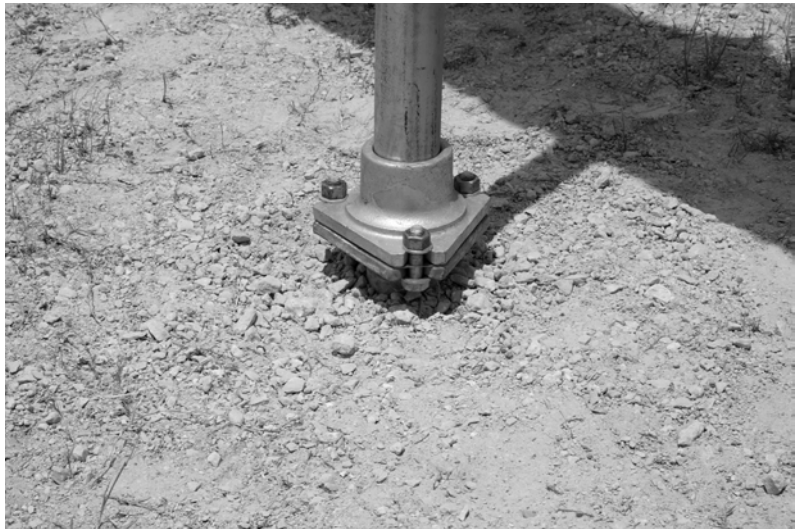
Figure 8. Test Article/Installation before Test 417922-2.

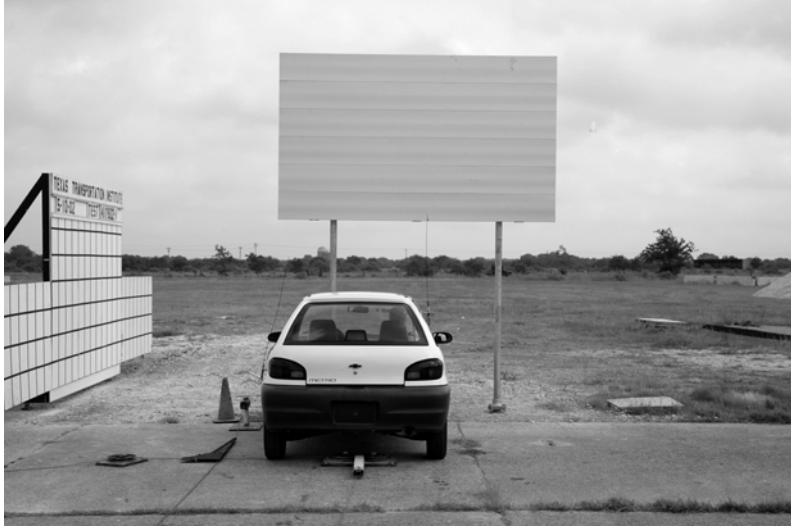
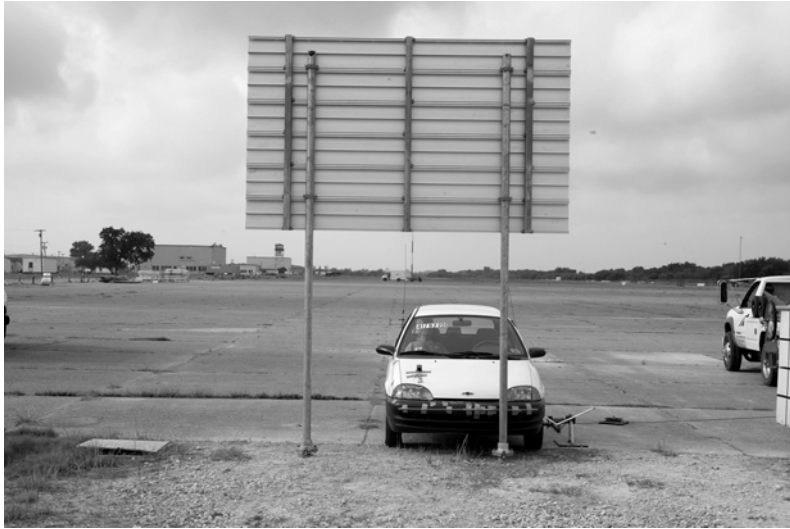
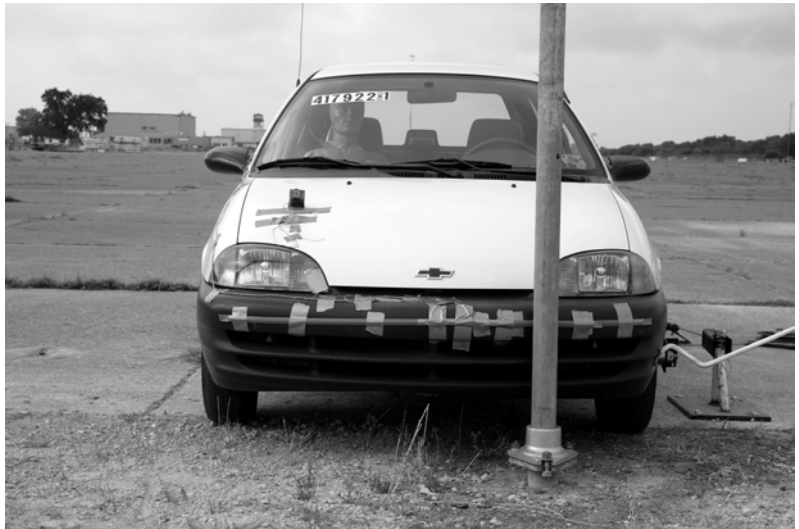
Figure 9. Vehicle/Installation Geometrics for Test 417922-1.

The crash test used a 1998 Geo Metro, shown in Figures 9 and 10. Test inertia mass of the vehicle was 1806 lb (820 kg) and its gross static mass was 1969 lb (894 kg). The height to the lower edge of the vehicle bumper was 15.7 in (400 mm), and the height to the upper edge of the bumper was 20.7 in (525 mm). Additional dimensions and information on the vehicle are given in Appendix B, Figure 23. The vehicle was directed into the installation using the cable reverse tow and guidance system, and was released to be free-wheeling and unrestrained just prior to impact.

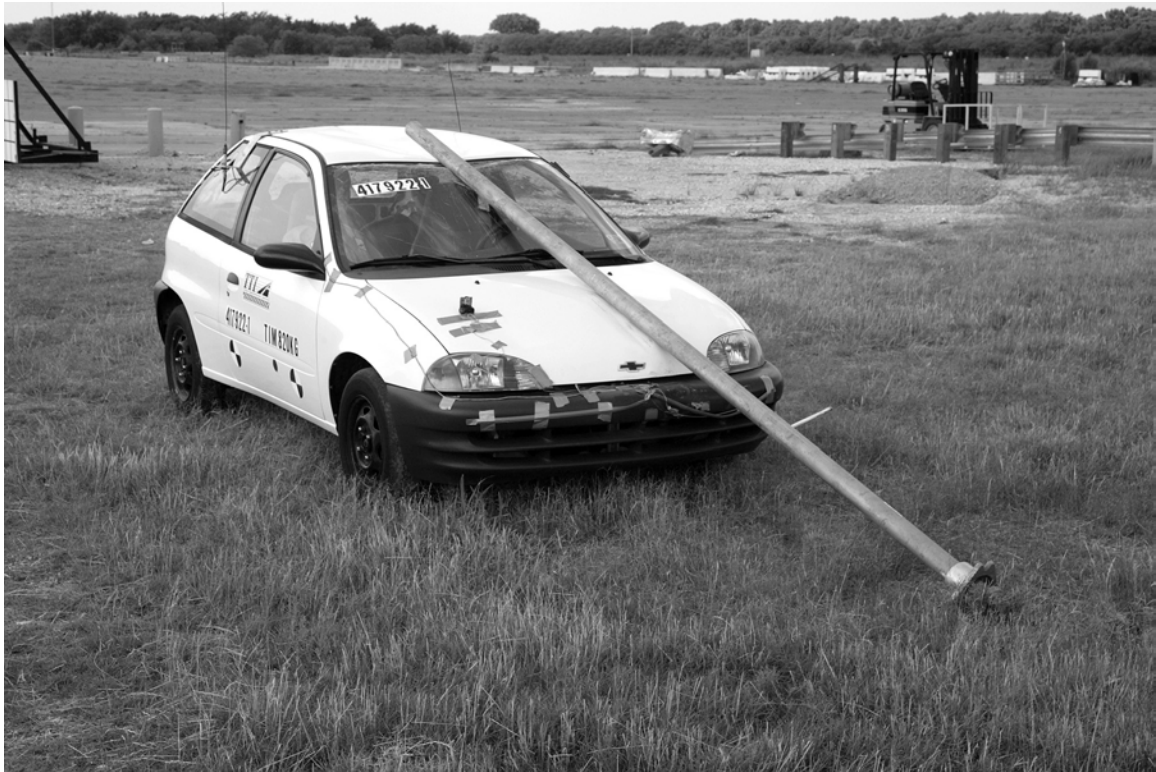
Figure 11. After Impact Trajectory for Test 417922-1.

Figures 11 and 12 show damage to the sign support. The right support remained attached to the base, and the sign panel was considered reusable. The left support and upper slip base separated from the base and the sign panel. The lower pipe clamp on the impacted pipe support released from the extruded aluminum sign panel when the inside clamp bolt pulled out of the aluminum channel. The lower outside clamp bolt remained with the sign panel. As the vehicle passed under the installation, the upper pipe clamp released from the aluminum panel. One of the slip base bolts remained in the base, one came to rest 11.2 ft (3.4 m) to the right of impact, and a third came to rest 61.3 ft (18.7 m) downstream of impact. The support then rode along with the vehicle and came to rest on the hood, windshield, and roof edge of the vehicle 100.1 ft (30.5 m) downstream of impact. The support was only slightly deformed and was considered to be reusable.

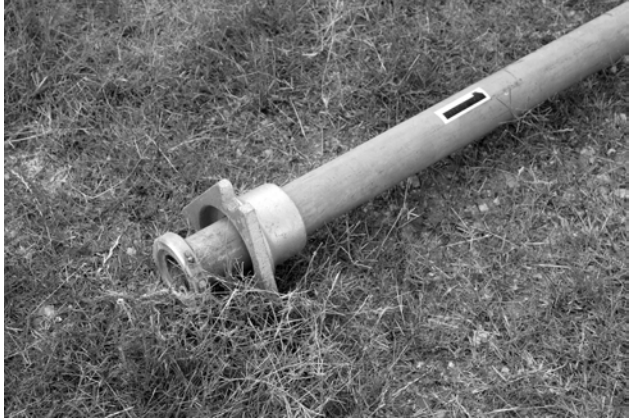
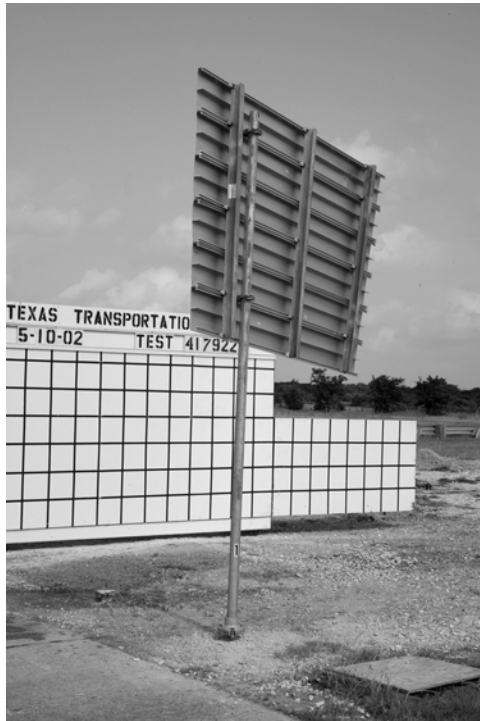
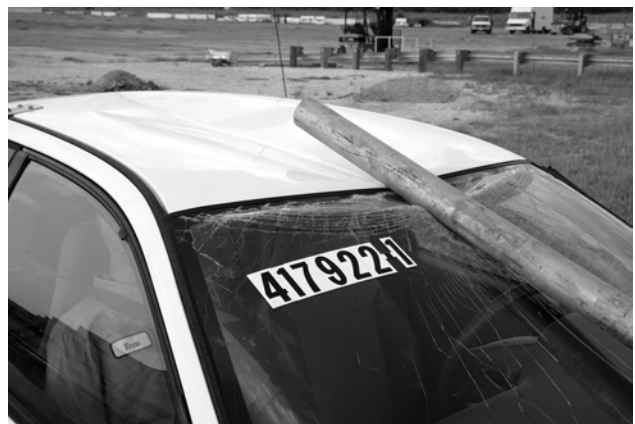
Figure 12. Installation after Test 417922-1.

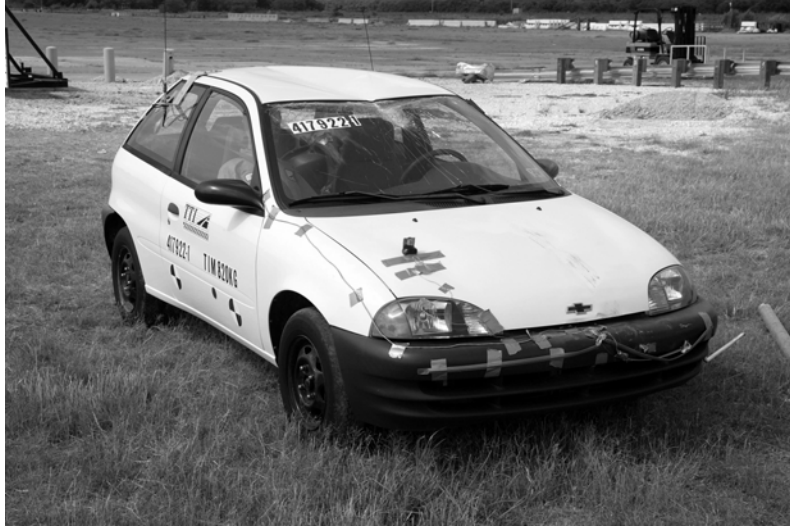
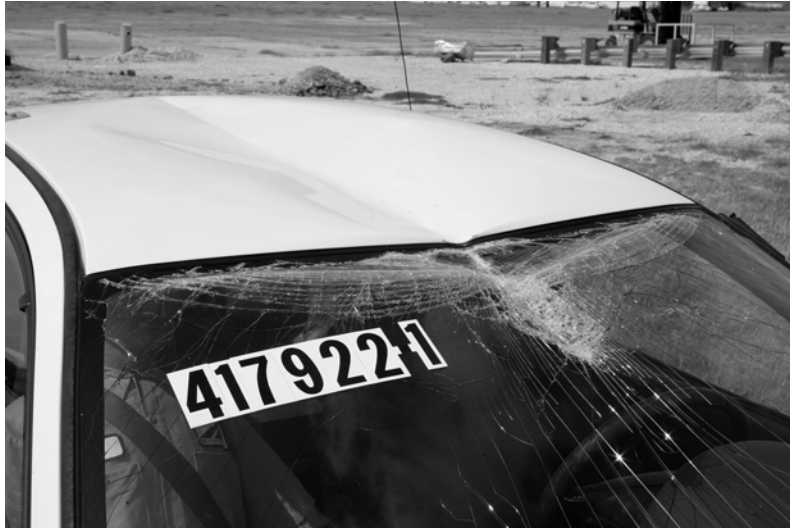
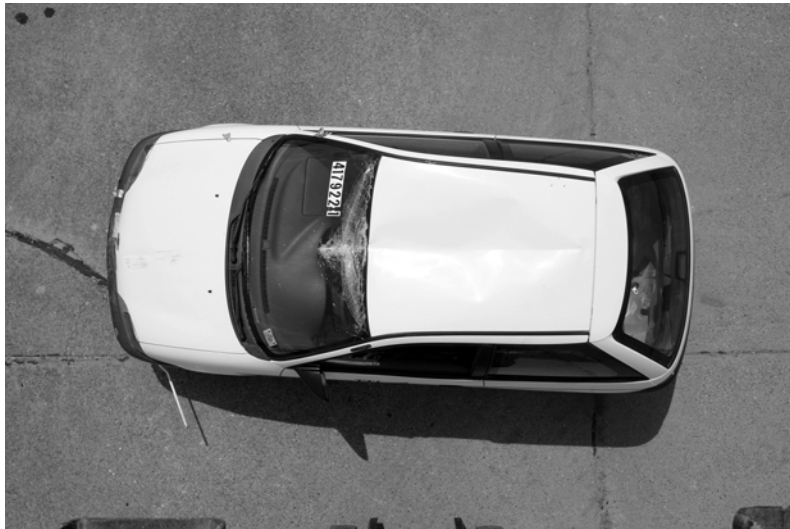
Figure 13. Vehicle after Test 417922-1.

The vehicle sustained minor scrapes to the front bumper and hood during initial contact with the sign support. As the vehicle traveled through the test site, the support fell against the roof and windshield of the vehicle. As shown in Figure 13, the windshield was shattered; however, visibility was not obstructed. The exterior of the roof was deformed downward a maximum of 2.8 in (72 mm). Maximum occupant compartment deformation in that area was 2 in (52 mm). Photographs of the interior of the vehicle are shown in Figure 14. Exterior vehicle crush and occupant compartment deformation are presented in Appendix B, Tables 3 and 4.

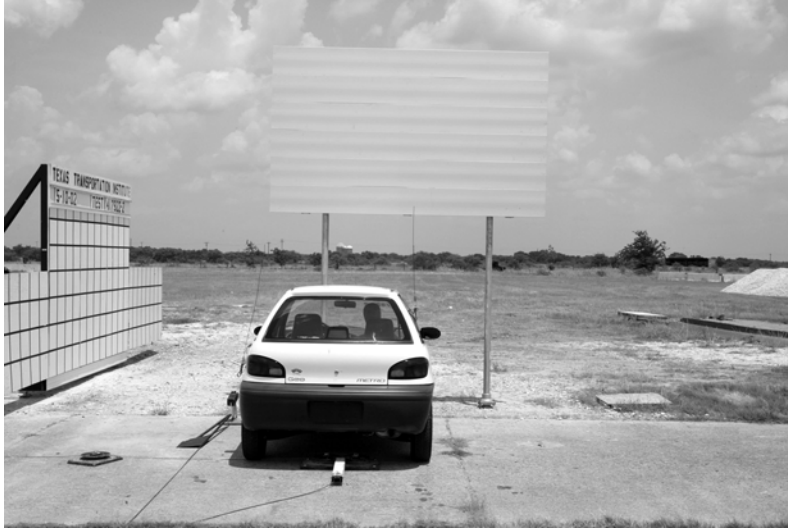
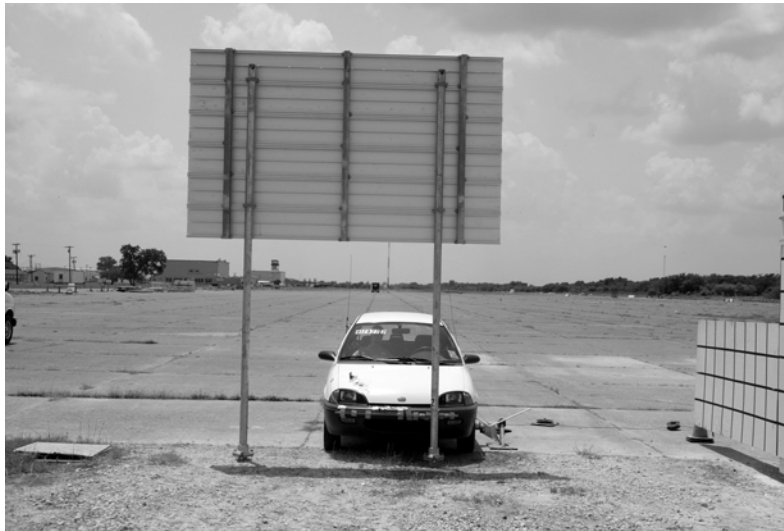
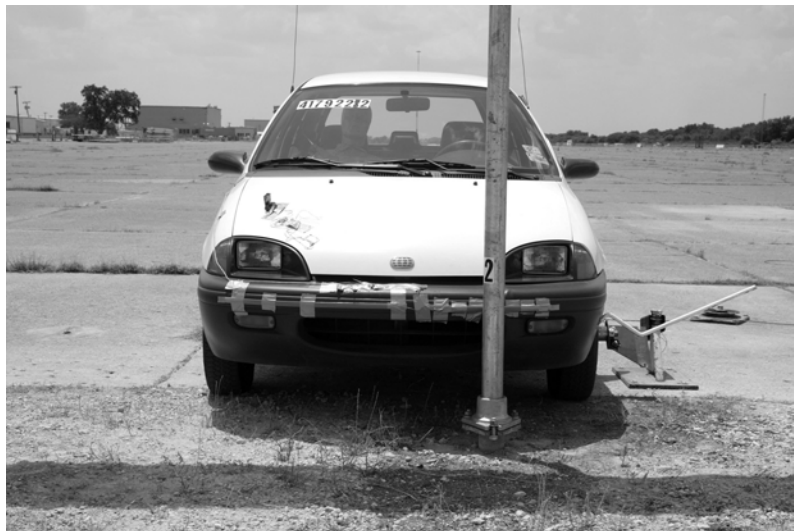
Figure 16. Vehicle/Installation Geometrics for Test 417922-2.

A 1997 Geo Metro, shown in Figures 16 and 17, was used for the crash test. Test inertia mass of the vehicle was 1806 lb (820 kg), and its gross static mass was 1943 lb (896 kg). The height to the lower edge of the vehicle bumper was 15.7 in (400 mm), and the height to the upper edge of the bumper was 20.7 in (525 mm). Additional dimensions and information on the vehicle are given in Appendix B, Figure 24. The vehicle was directed into the installation using the cable reverse tow and guidance system, and was released to be free-wheeling and unrestrained just prior to impact.

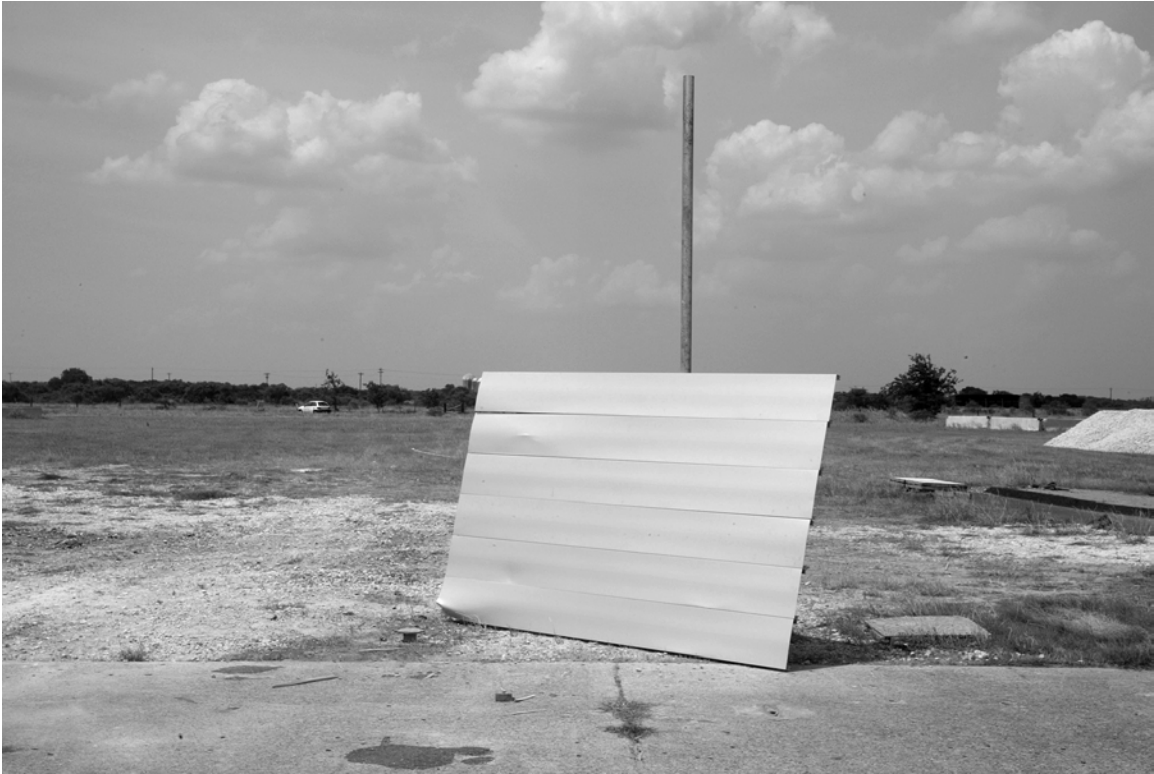
Figure 18. After Impact Trajectory for Test 417922-2.

Damage to the sign installation is shown in Figures 18 and 19. The right support remained attached to the base, but separated from the sign panel. The sign panel came to rest against this support. The left support and upper slip base separated from the lower base and the sign panel and traveled over the vehicle to come to rest 97.4 ft (29.7 m) downstream and 2.5 ft (0.8 m) to the left of impact. One of the slip base bolts came to rest 5.7 in (145 mm) to the left of the base, the second came to rest 2.6 ft (0.8 m) downstream and 20.0 ft (6.1 m) to the right of the base, and the third came to rest 225.1 ft (68.6 m) downstream and 2.6 ft (0.8 m) to the left of the base. The left support was deformed slightly and the lower casting used to attach the support to the sign panel fractured. The right support could be reused, but the sign panel would likely need to be replaced.

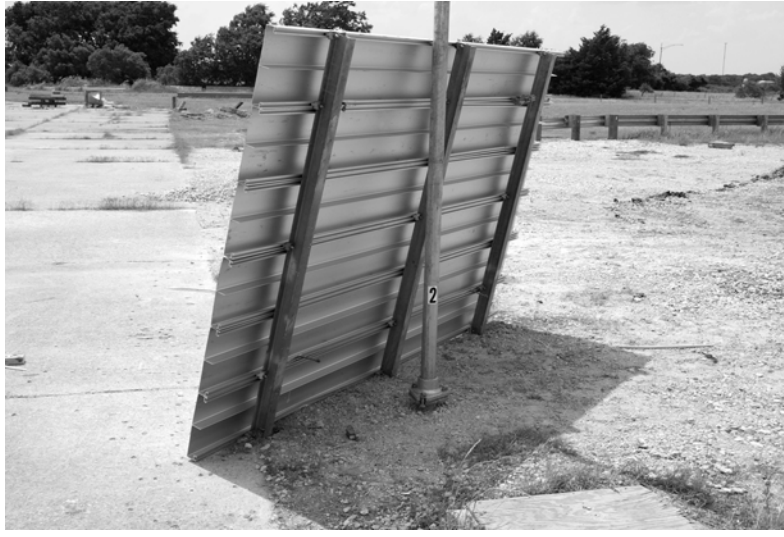
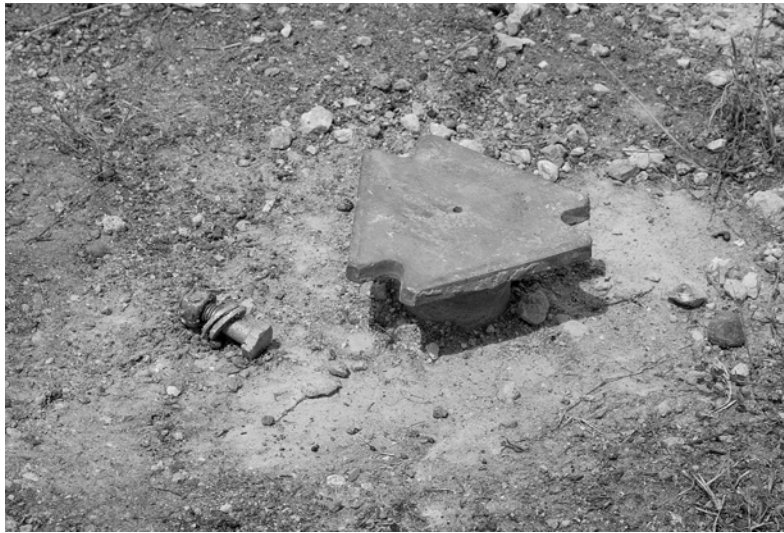
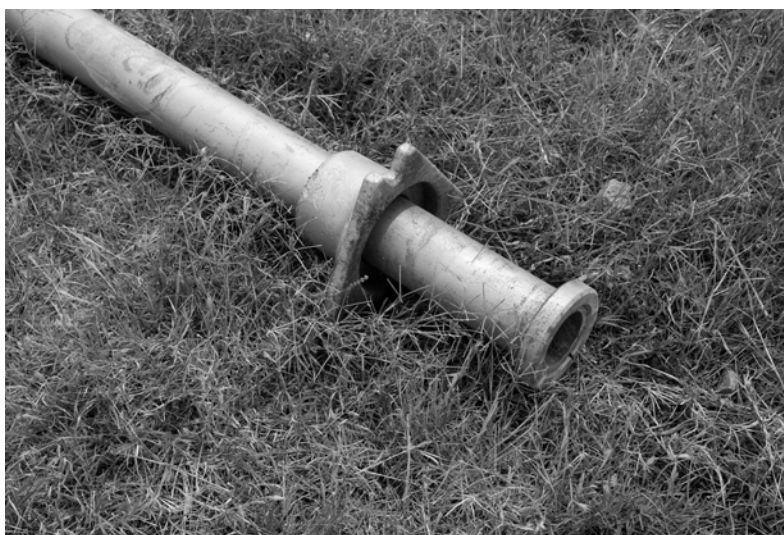
Figure 19. Installation after Test 417922-2.

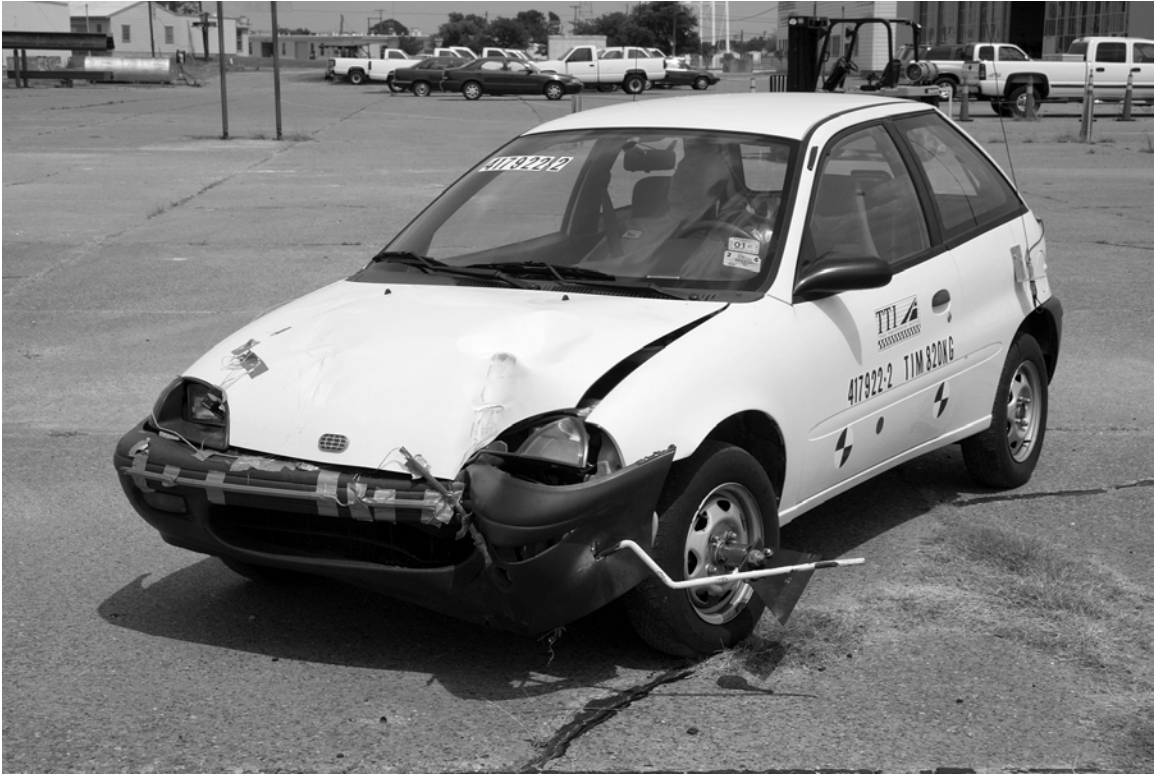
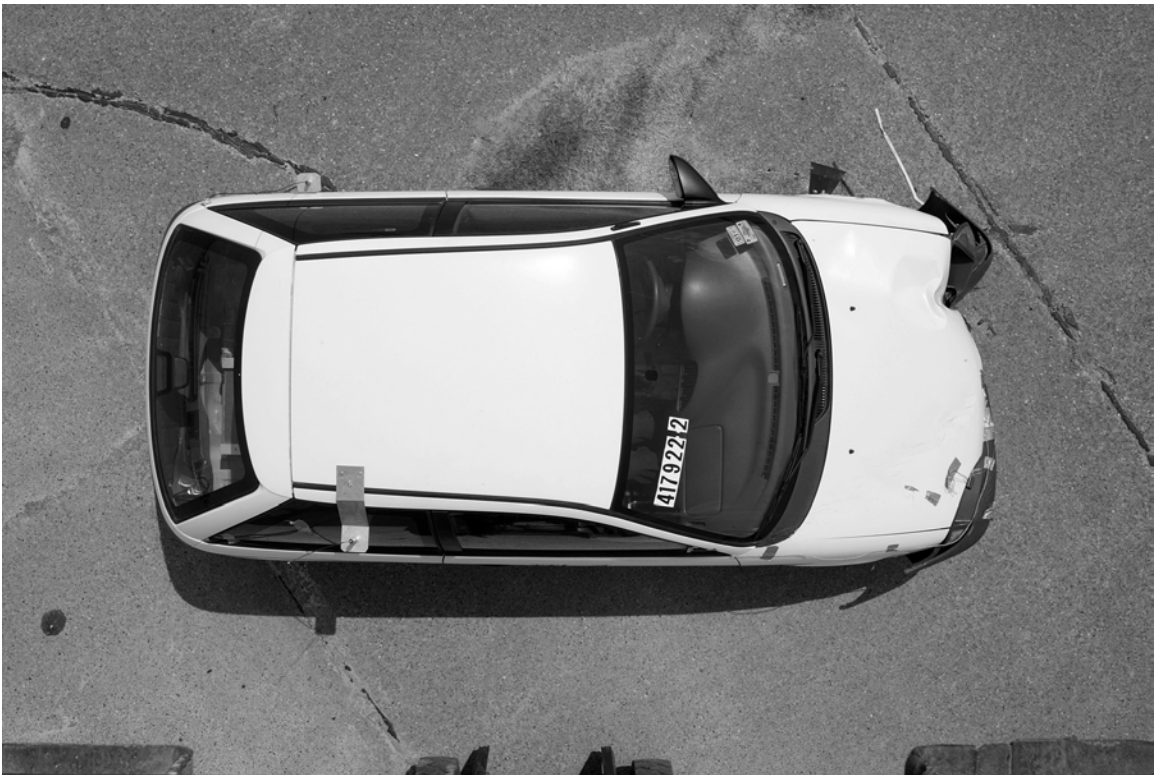
Figure 20. Vehicle after Test 417922-2.

The vehicle sustained minor dents and scrapes to the front bumper and hood during initial contact with the sign support, as shown in Figure 20. Also damaged were the left front quarter panel, radiator, and fan. Maximum exterior crush to the vehicle was 4.7 in (120 mm) in the frontal plane at the left quarter point at bumper height. There was no deformation of the occupant compartment. Figure 21 shows photographs of the interior of the vehicle. Exterior vehicle crush and occupant compartment deformation are presented in Appendix B, tables 5 and 6.

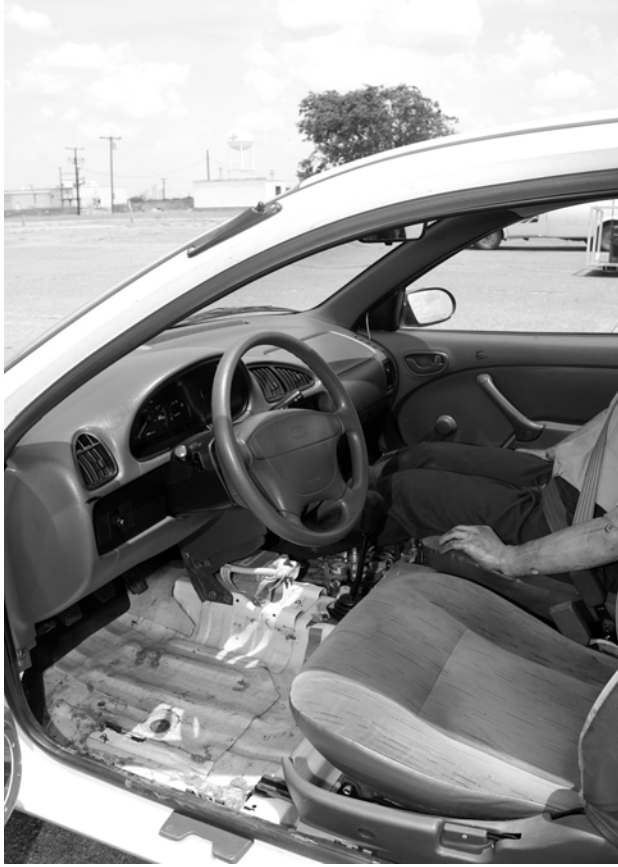
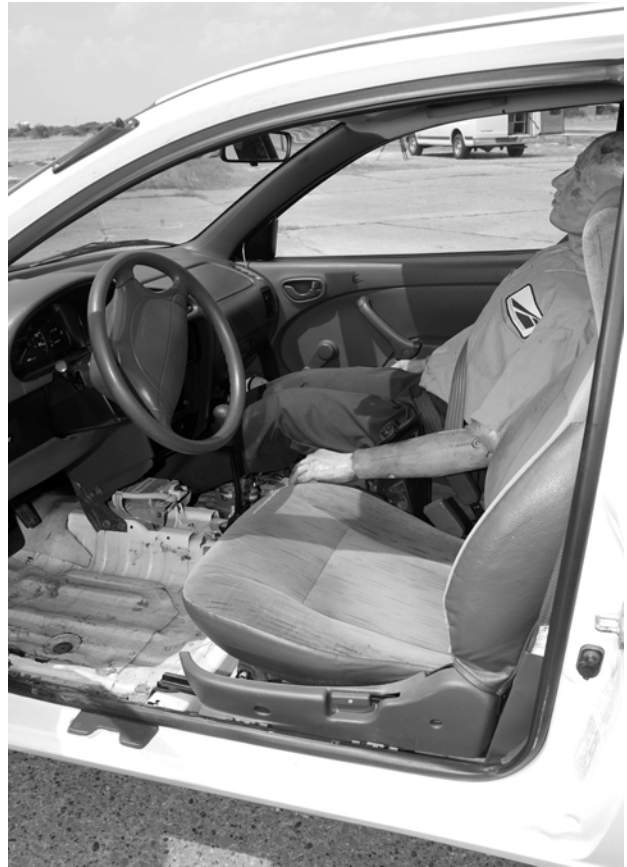
Before Test

After Test

Figure 21. Interior of Vehicle for Test 417922-2.

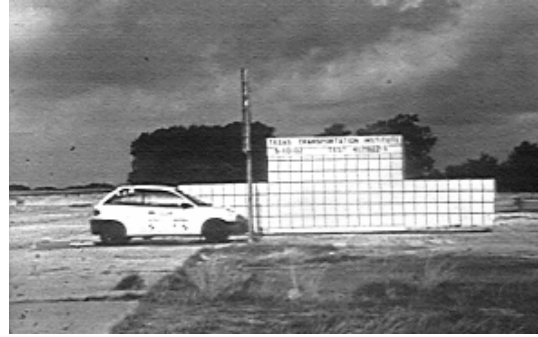
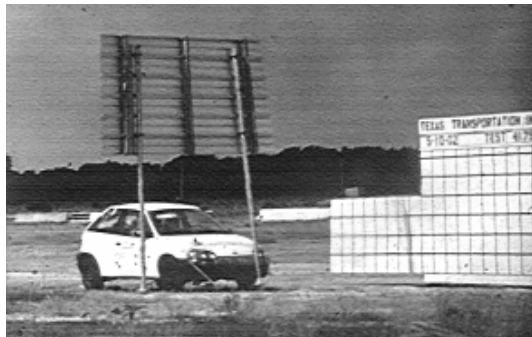
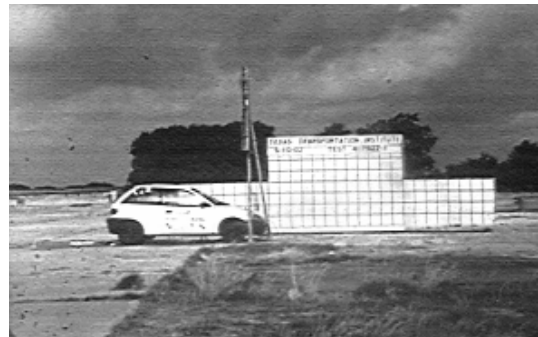
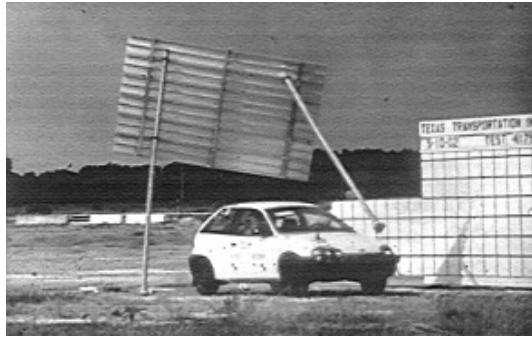
Figure 25. Sequential Photographs for Test 417922-1 (Oblique and Perpendicular Views).

Figure 25. Sequential Photographs for Test 417922-1 (Oblique and Perpendicular Views) (Continued).

The left front quarter point of the vehicle impacted the left pipe support traveling at a speed of 21.7 mi/h (34.9 km/h) and an impact angle of 0 degree. Shortly after impact, the left sign support began to move, and at 0.013 s, the upper base began to slip from the lower base. The upper base separated from the lower base at 0.024 s, and the vehicle lost contact with the support at 0.077 s (vehicle speed was 20.8 mi/h (33.4 km/h)). At 0.240 s, the lower post clamp on the left support separated and at 0.396 s, the upper clamp separated. The support subsequently released from the sign panel at 0.402 s with the vehicle traveling at a speed of 18.5 mi/h (29.8 km/h). The rotating support contacted the top edge of the roof/windshield frame at 0.768 s. Brakes on the vehicle were applied 2.3 s after impact. The vehicle subsequently came to rest 100.1 ft (30.5 m) directly downstream of impact with the left support resting against the hood and roof/windshield frame. Appendix C, Figure 25 shows sequential photographs of the test period.

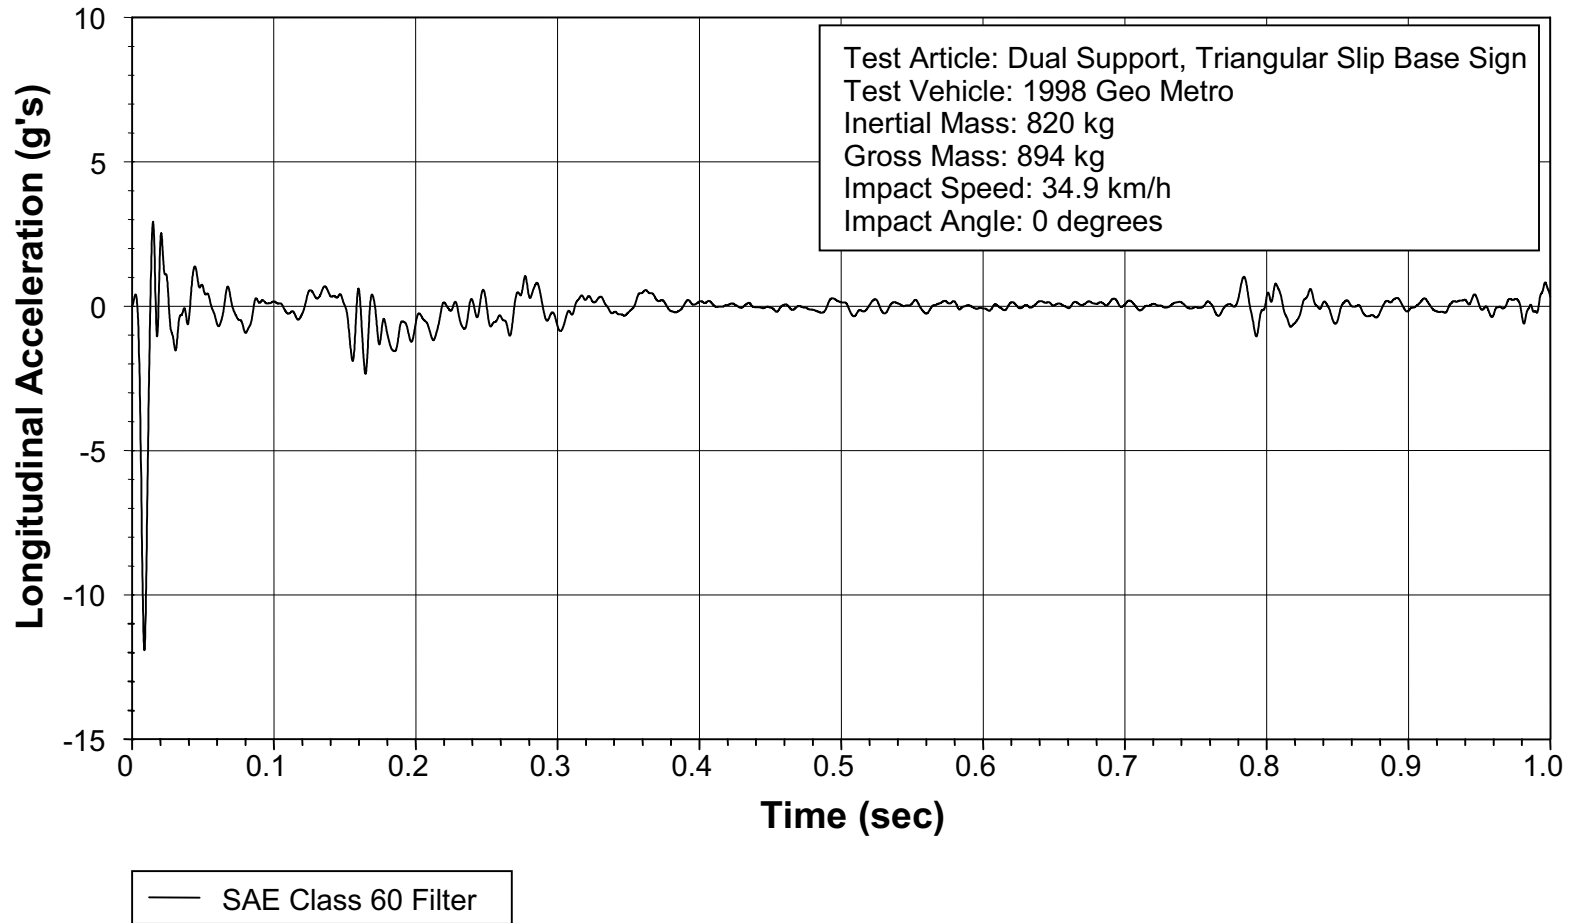
X Acceleration at CG

**Figure 29. Vehicle Longitudinal Accelerometer Trace for Test 417922-1
(Accelerometer Located at Center of Gravity).**

Data from the accelerometer located at the vehicle center of gravity were digitized for evaluation of occupant risk. In the longitudinal direction, the occupant impact velocity was 3.0 ft/s (0.9 m/s) at 0.732 s, the highest 0.010-s occupant ridedown acceleration was 0.6 g's from 1.014 to 1.024 s, and the maximum 0.050-s average acceleration was -0.9 g's between 0.163 and 0.213 s. In the lateral direction, the occupant impact velocity was 0.7 ft/s (0.2 m/s) at 0.732 s, the highest 0.010-s occupant ridedown acceleration was 0.3 g's from 1.124 to 1.134 s, and the maximum 0.050-s average was 0.4 g's between 0.205 and 0.255 s. These data and other pertinent information from the test are summarized in Figure 15. Vehicle angular displacements and accelerations versus time traces are presented in Appendix D, Figures 27 and 29 through 34, respectively.
