1. Report No. FWWATX78-2641F		2. Government Accession No.		3. Recipient's Catalog No.	
4. Title and Subtitle IMPACT BEHAVIOR OF THIN-WALL STEEL TUBE SIGNPOSTS AND DELINEATOR POST				5. Report Date November 1978

6. Performing Organization Code	
7. Author(s) H. E. Ross, Jr. and Kenneth C. Walker				8. Performing Organization Report No. 264-1F	
9. Performing Organization Name and Address Texas Transportation Institute Texas A&M University College Station, Texas 77843				10. Work Unit No.

IMPACT BEHAVIOR OF THIN-WALL STEEL
TUBE SIGNPOSTS AND DELINEATOR POST

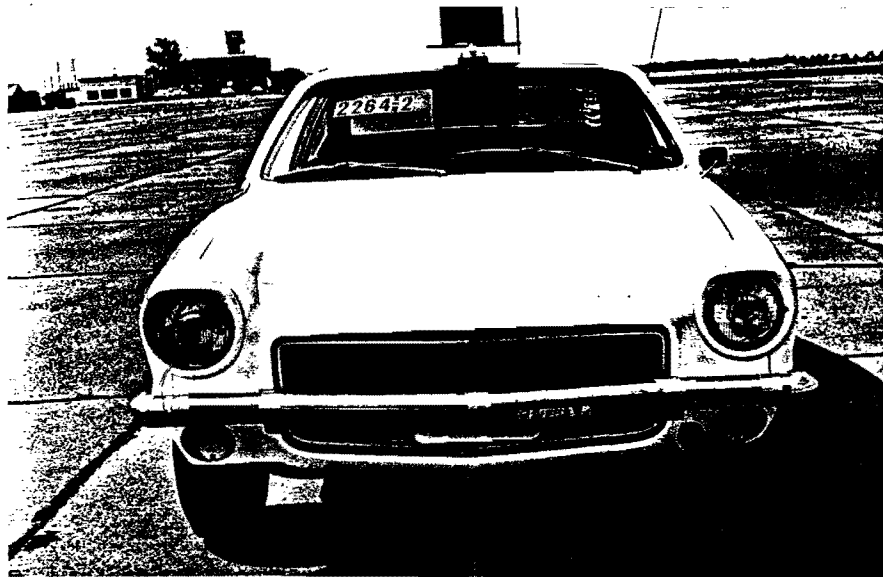
a) Top View

b) Front View

FIGURE 1. 1973 CHEVROLET VEGA.

The test vehicles were 1973 Chevrolet Vegas, one of which is shown in Figure 1. Dimensions of the vehicle are given in Figure 2. The vehicle was accelerated to test speed with a reverse tow system, and was kept on line with the test article by a cable guidance system.

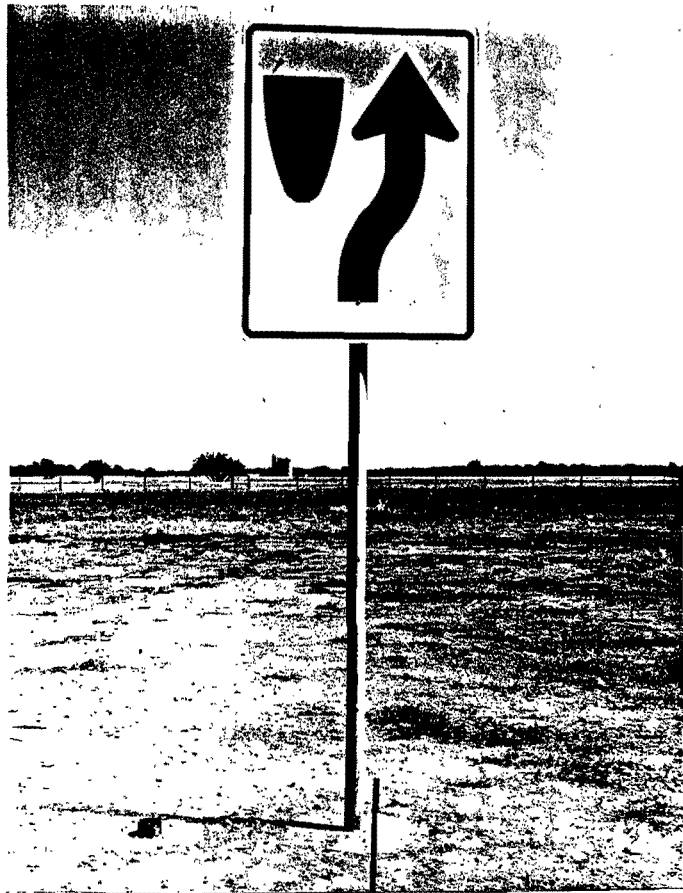
a) Front View

b) Side View

FIGURE 6. SIGN SYSTEM, TESTS 1 AND 2.

Test 3 configuration and tube size was the same as tests 1 and 2 except the post was inserted in an anchor sleeve as shown in Figure 4. The post was inserted 2 ft (0.61 m) into the sleeve and held with a single fastener to prevent twisting from wind loads. In tests 1, 2, and 3, three U-bolts and mounting clamps were used to fasten the 36 in. (91.4 cm) by 48 in. (121.9 cm) aluminum sign panel to the post. Details of the clamp are given in Figure 5. Photos of these installations can be seen in Figures 6 and 7.

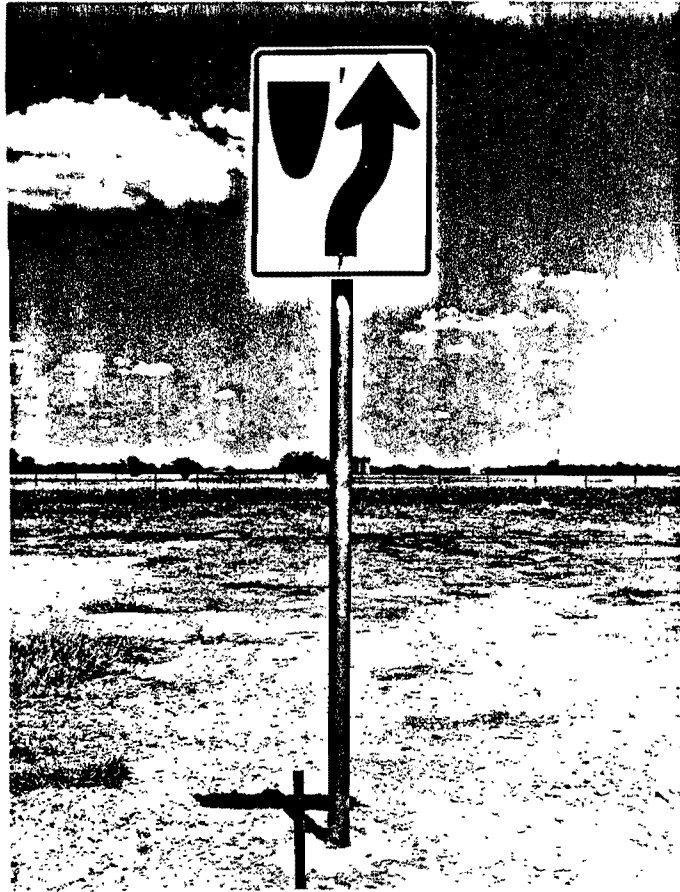
a) Test 4

b) Test 5

FIGURE 9. SIGN SYSTEM, TESTS 4 AND 5.

Tests 4 and 5 involved a type "A" configuration as shown in Figure 8. A 2.875 in. (7.30 cm) outside diameter by 0.065 in. (0.17 cm) thick tube was used in test 4, and a 2.375 in. (6.03 cm) outside diameter by 0.109 in. (0.28 cm) thick post was used in test 5. Two U-bolts and mounting clamps were used to fasten the 24 in. (61.0 cm) by 30 in. (76.2 cm) aluminum sign panel to the post. A photo of the installation for tests 4 and 5 is shown in Figure 9.

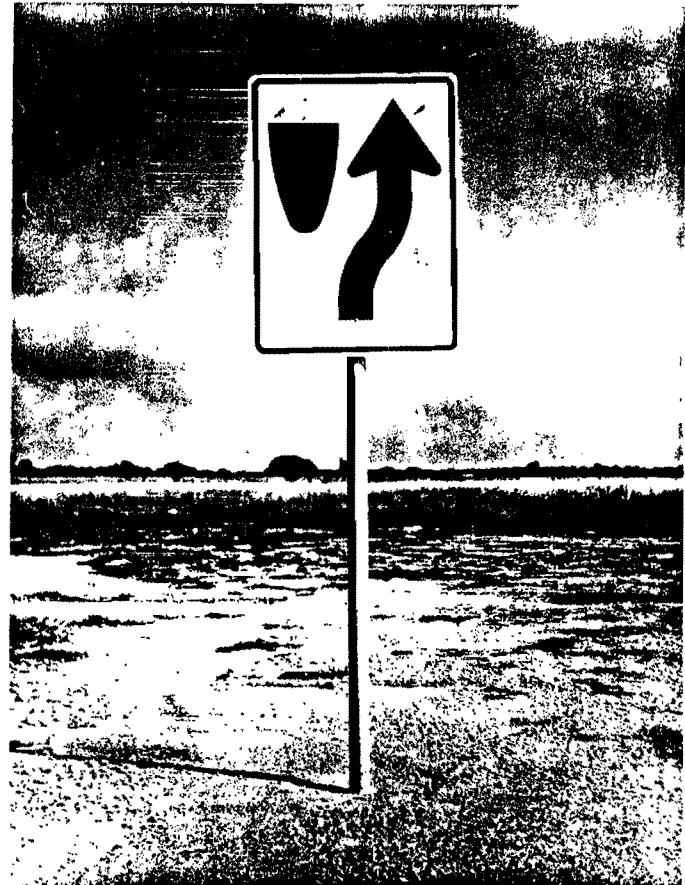
a) Test 6

b) Test 7

FIGURE 10. SIGN SYSTEM, TESTS 6 AND 7.

A milepost marker and delineator post were tested together in test 6. Installation details are given in Figure 8. The milepost marker was a 1.90 in. (4.83 cm) outside diameter by 0.065 in. (0.17 cm) thick post. A 12 in. (30.5 cm) by 48 in. (121.9 cm) aluminum panel was attached with three U-bolts and mounting clamps. A 1.66 in. (4.22 cm) outside diameter by 0.047 in. (0.12 cm) thick tube was used as a delineator post. A 3 in. (7.62 cm) outside diameter clear delineator was mounted with a 0.25 in. (0.64 cm) by 2.5 in. (6.35 cm) bolt and nut. The delineator post was mounted 15 in. (38.1 cm) to the right and 15 in. (38.1 cm) behind the milepost. The milepost installation and the delineator post are shown in Figure 10.

Test 7 involved a 3.5 in. (8.89 cm) outside diameter by 0.083 in. (0.17 cm) thick signpost in the type "F" configuration of Figure 4. Three U-bolts and mounting clamps were used to fasten a 36 in. (91.4 cm) by 48 in. (121.9 cm) aluminum sign panel. Figure 10 shows the installation for test 7.

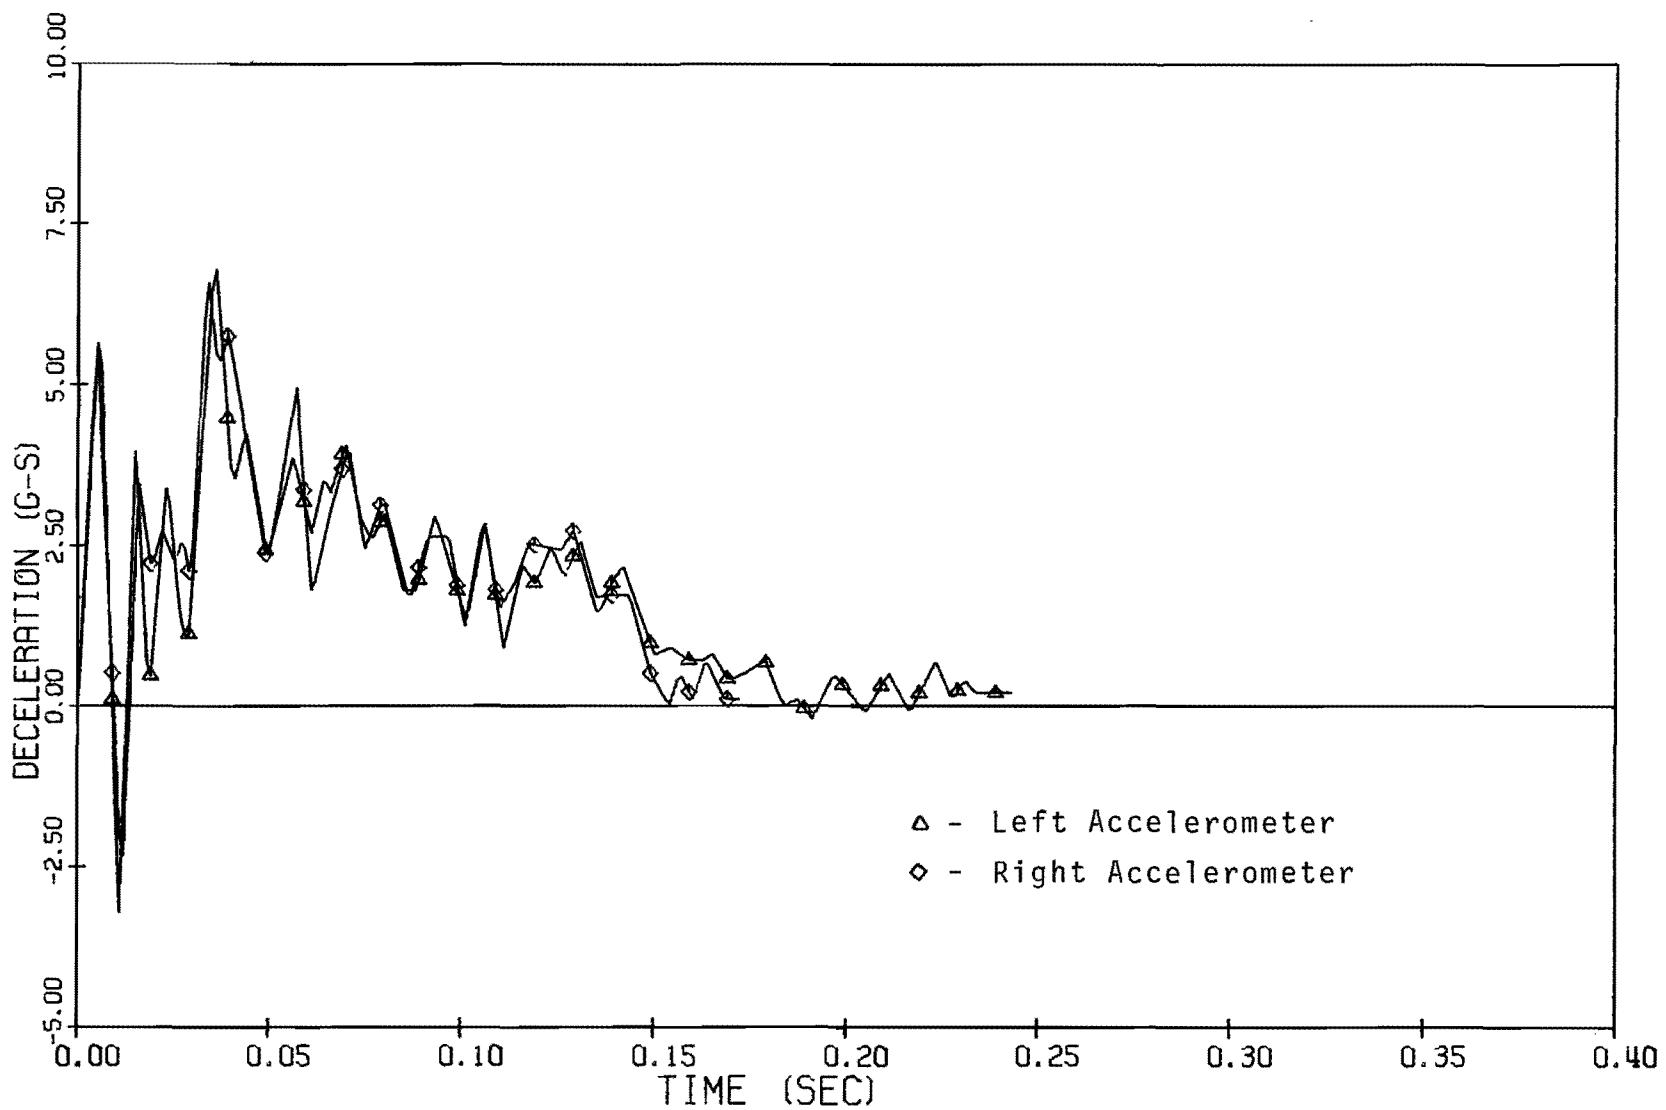
FIGURE 12. DECELERATION VERSUS TIME, TEST 1

Deceleration, change in momentum, and free missile travel versus time data are given in Figures 12, 13, and 14. Installation damage is shown in Figure 15. The sign panel and mounting hardware sustained little damage and could be reused. The remainder of the installation would require replacement.

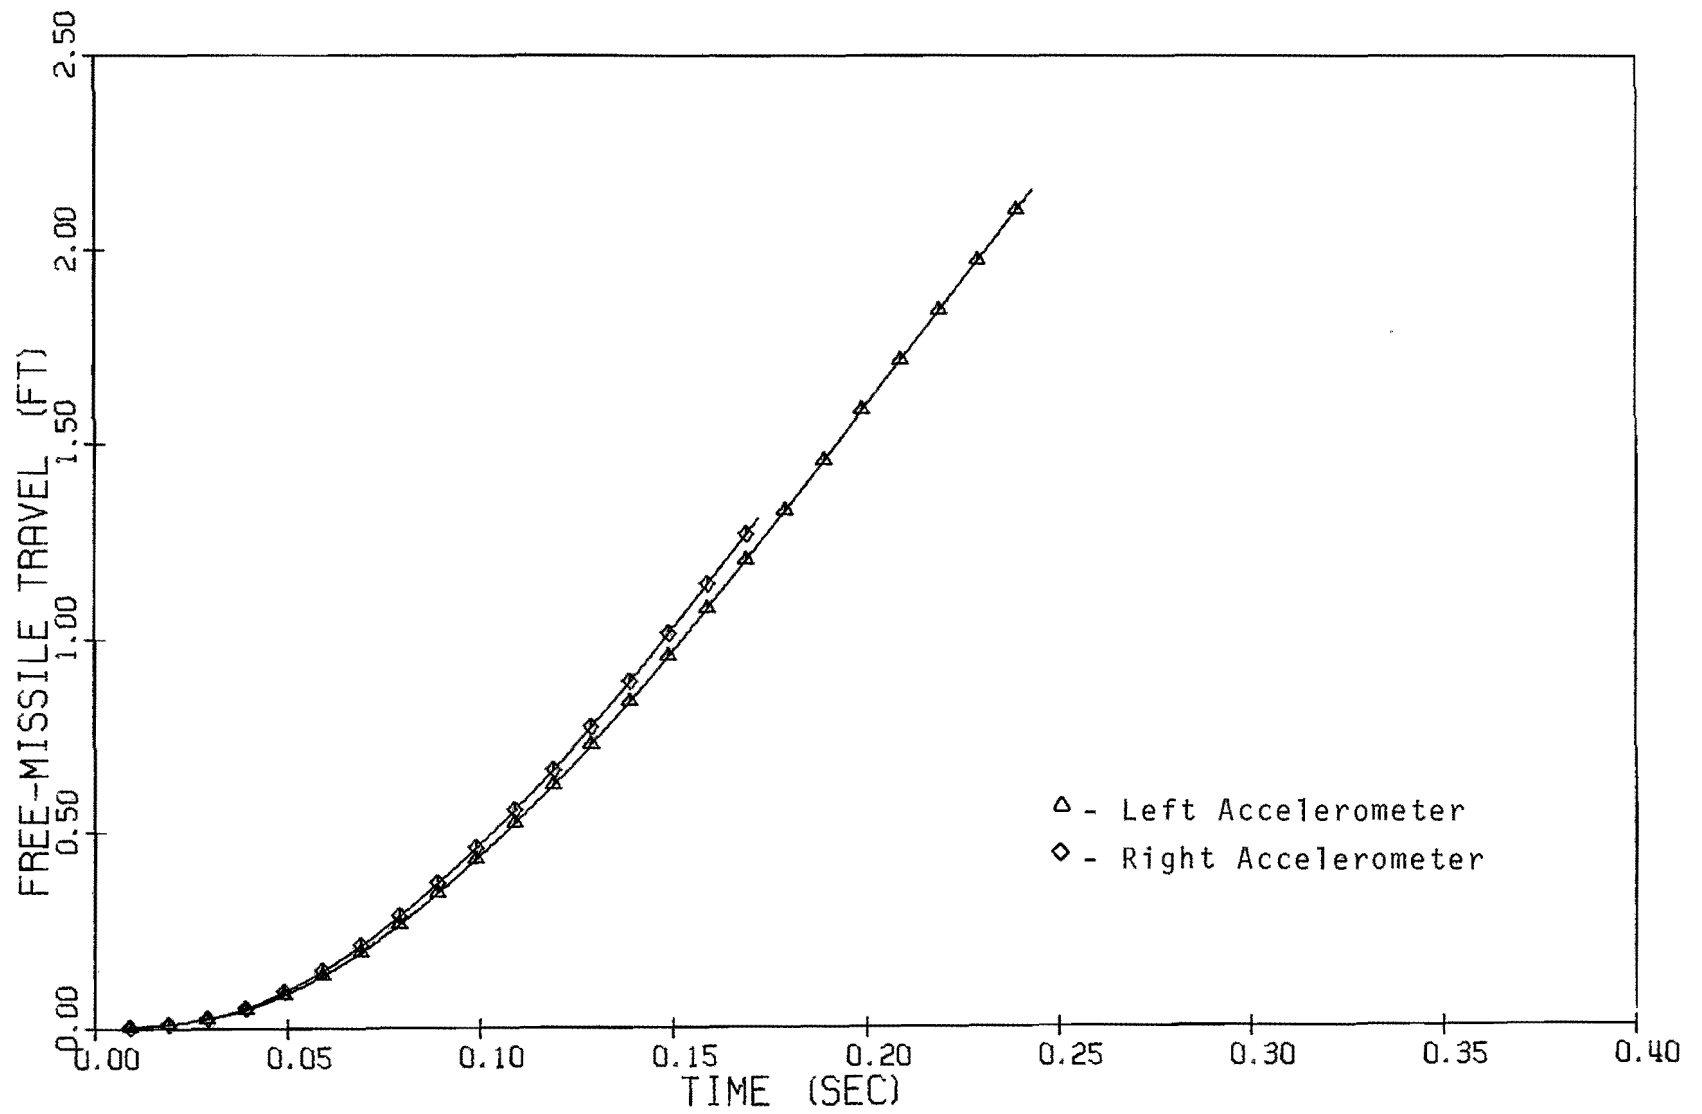
FIGURE 14. FREE MISSILE TRAVEL VERSUS TIME, TEST 1.

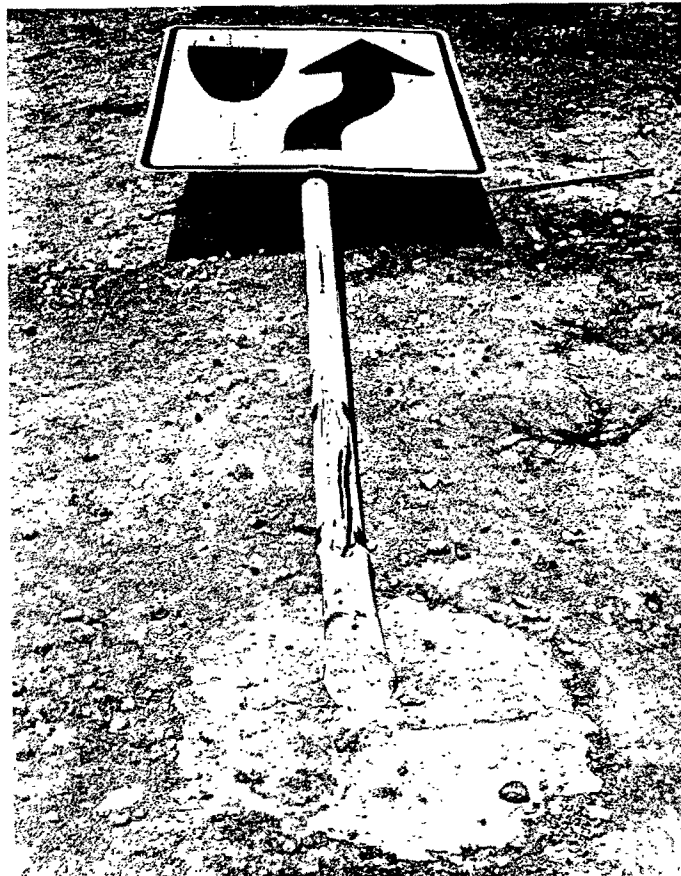
a) Side View

b) Front View

FIGURE 15. INSTALLATION DAMAGE, TEST 1.

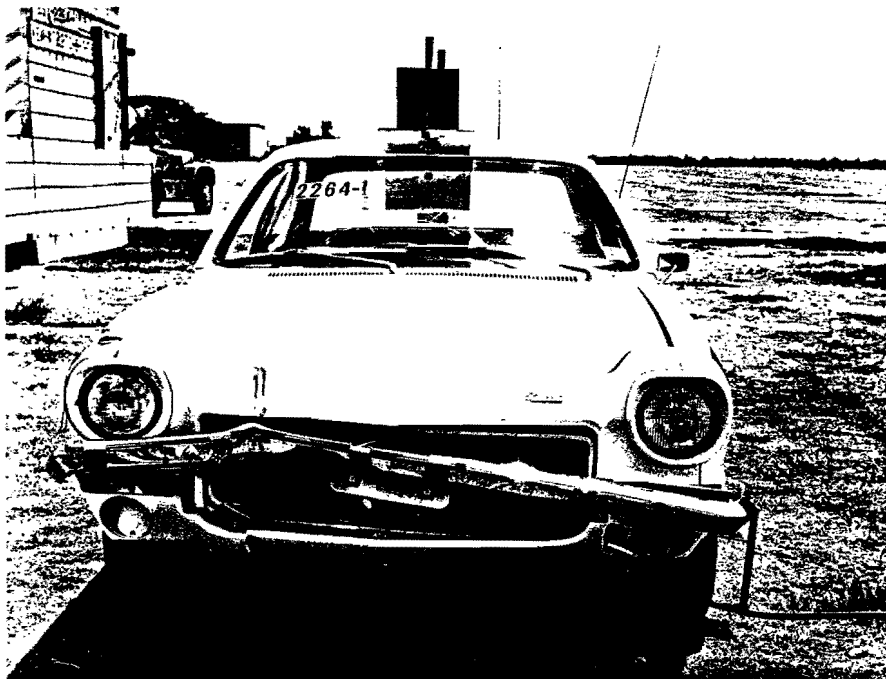
a) Top View

b) Front View

FIGURE 16. VEHICLE DAMAGE, TEST 1.

Figure 16 pictures the damage to the vehicle. Damage was light, and only the bumper and grille header panel were involved. TAD and SAE damage ratings are given in Table 3.

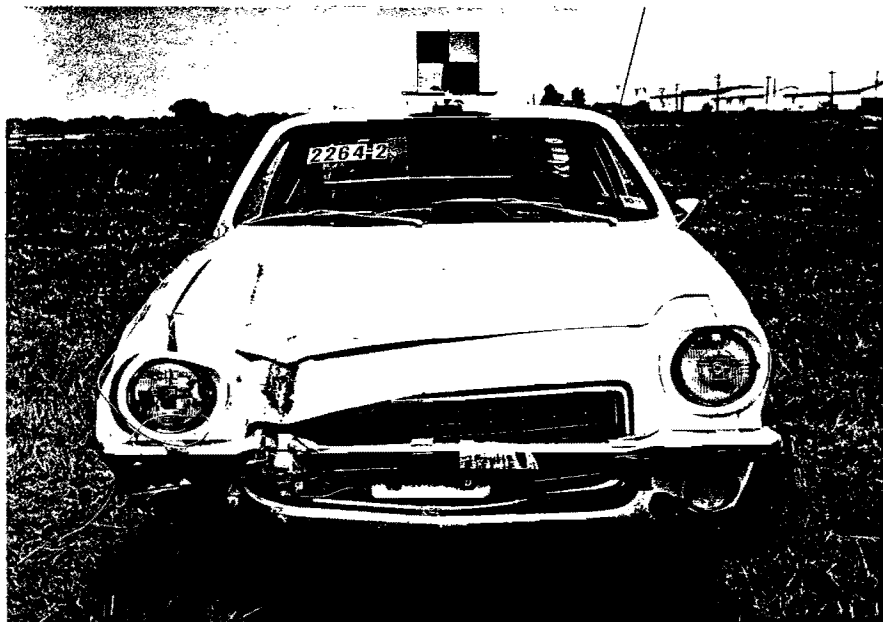
FIGURE 22. VEHICLE DAMAGE, TEST 2.

a) Top View

b) Front View

Vehicle damage is shown in Figure 22. Damage was assessed according to TAD and SAE damage scales and is given in Table 5.

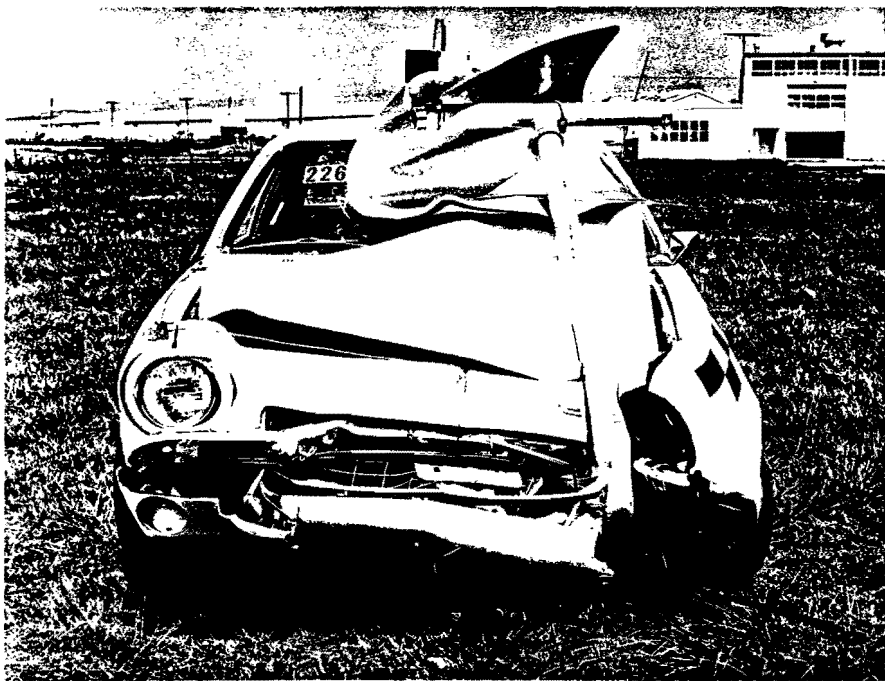
FIGURE 28. VEHICLE DAMAGE, TEST 3.

a) Top View

b) Front View

Figures 24, 25, and 26 show deceleration, change in momentum, and free missile travel versus time data. The anchor sleeve and concrete footing were undamaged but the post and panel were damaged beyond repair. The installation after impact can be seen in Figure 27. Damage to the vehicle was extensive. The bumper, grille header panel, hood, and fender were all crushed to some degree. The windshield was also broken. This can be seen in Figure 28.

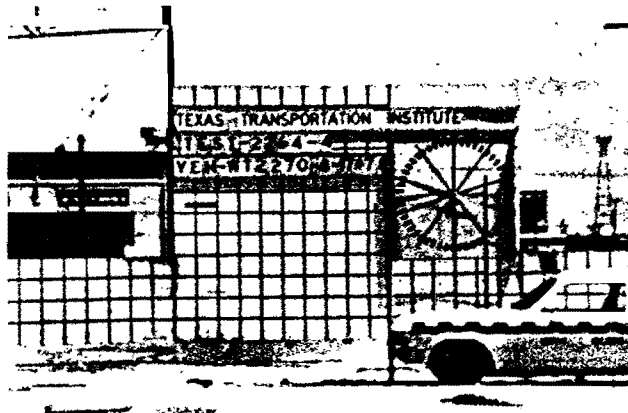
FIGURE 29. SEQUENTIAL PHOTOS, TEST 4.

0.000 sec

0.035 sec

0.041 sec

0.072 sec

0.081 sec

0.101 sec

The fourth test involved a post with the same diameter as the first three tests, but a smaller wall thickness. Table 9 summarizes the results of test 4. Figure 29 shows the sequential photos during impact, and the time-displacement event summary is contained in Table 10. The results of this test were far less severe than in previous tests, as can be seen in the vehicle's response. As the post began to bend away, the sign panel and mounting hardware slid off the post. The post started to wrap around the vehicle and was then restraightened as the car passed over it. The sign panel hit the roof and slid off after leaving the signpost.

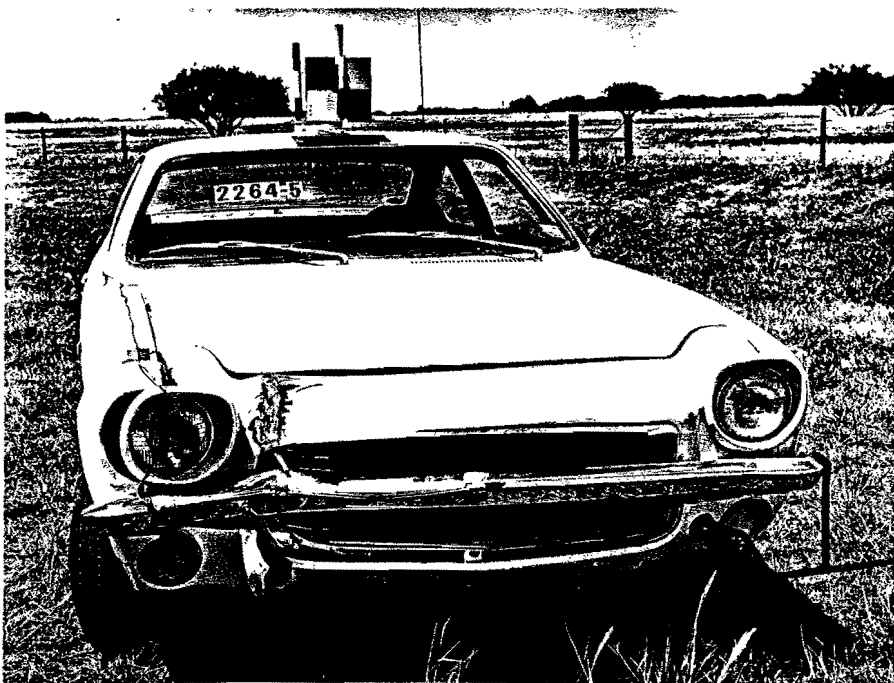
FIGURE 40. VEHICLE DAMAGE, TEST 5.

Data for the deceleration, change in momentum, and free missile travel versus time results are in Figures 36, 37, and 38. Damage to the installation would require replacement of the footing and signpost but the sign panel and hardware could be reused. This damage is shown in Figure 39. Damage to the vehicle was relatively minor. The bumper and grille header panel would require repair, but the fender and hood were not impacted. Photos of the vehicle after testing are in Figure 40. Damage to the vehicle was rated according to TAD and SAE rating scales and is given in Table 11.

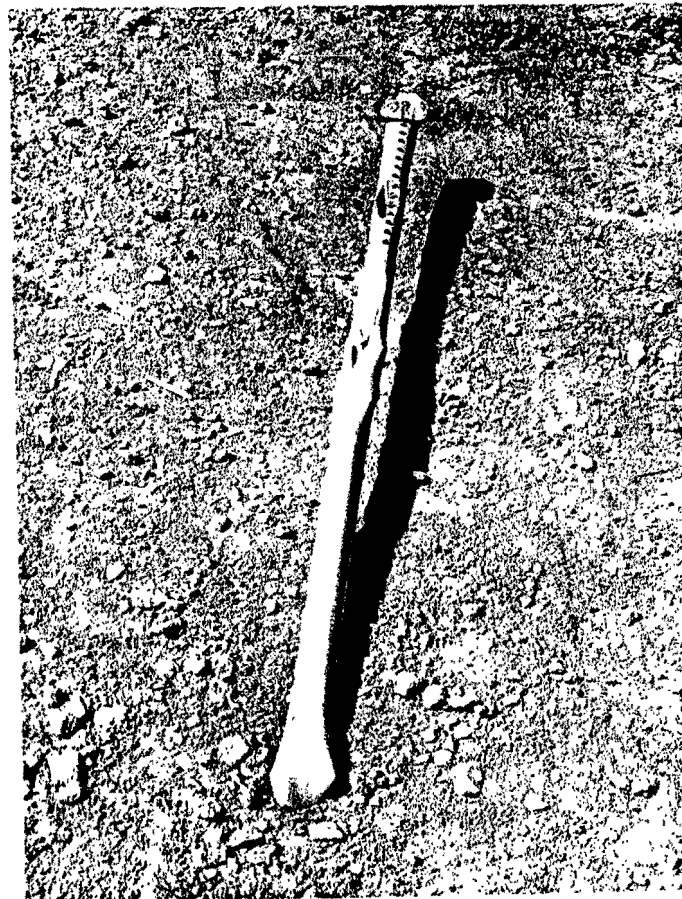
FIGURE 45. DELINEATOR DAMAGE, TEST 6.

Figures 42, 43, and 44 show deceleration, change in momentum, and free missile travel versus time data. Damage to both posts was total, and each installation would require complete replacement. This damage is shown in Figures 45 and 46.

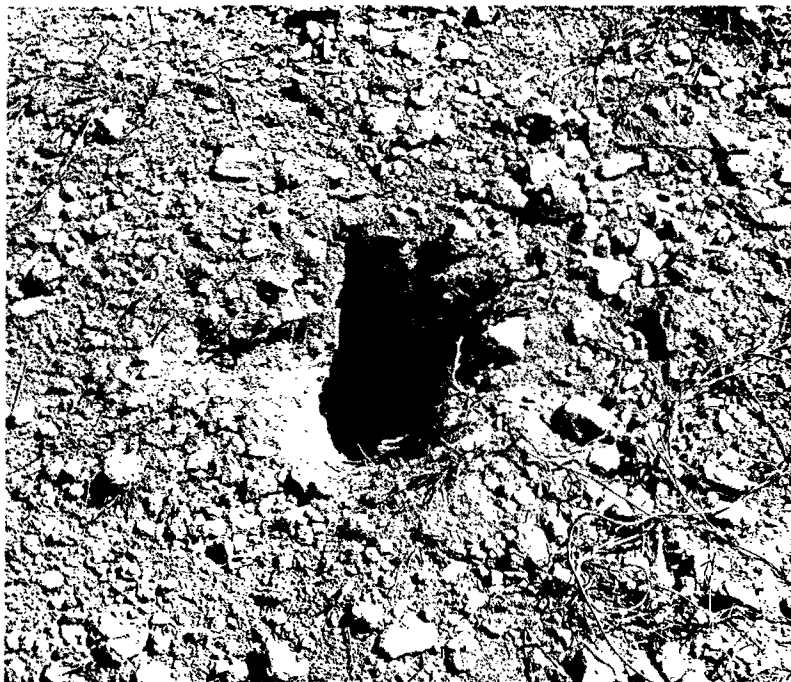
FIGURE 46. MILEPOST DAMAGE, TEST 6.

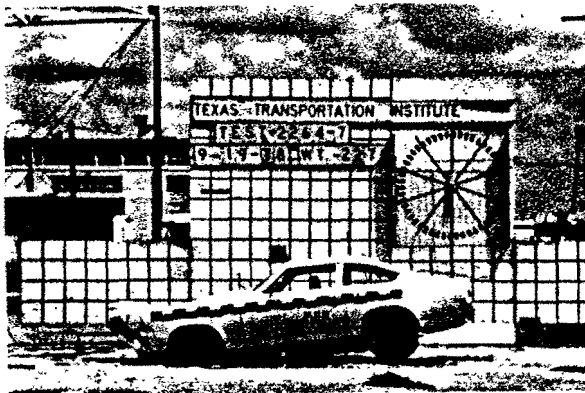
FIGURE 49. SEQUENTIAL PHOTOS, TEST 7.

The results of test 7 are summarized in Table 15; the sequential photos are given in Figure 49; and the time-displacement event summary is given in Table 16.

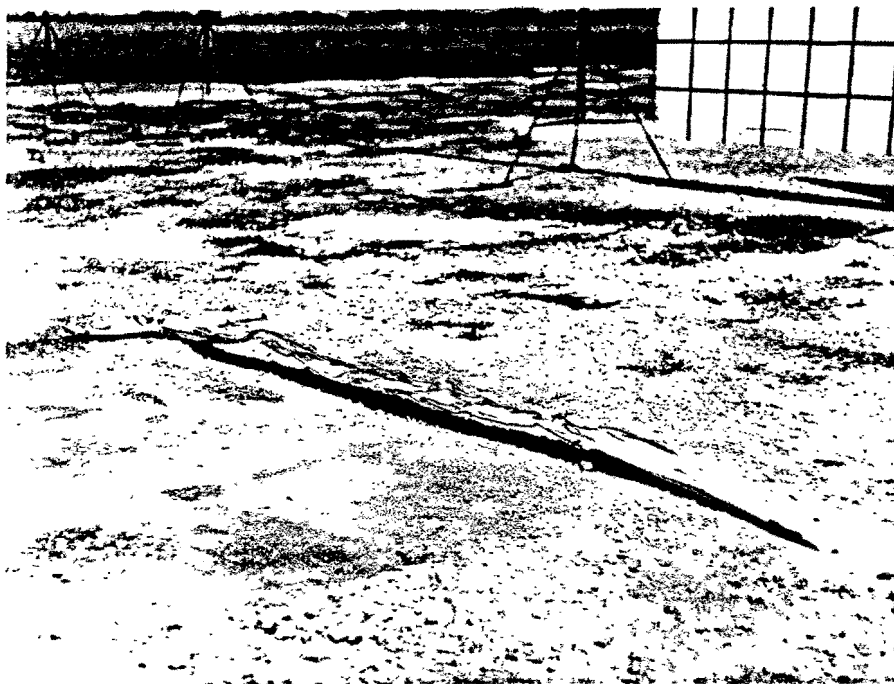
FIGURE 53. INSTALLATION DAMAGE, TEST 7.

Figures 50, 51, and 52 show deceleration, change in momentum, and free missile travel versus time data. Damage to the installation is shown in Figure 53.

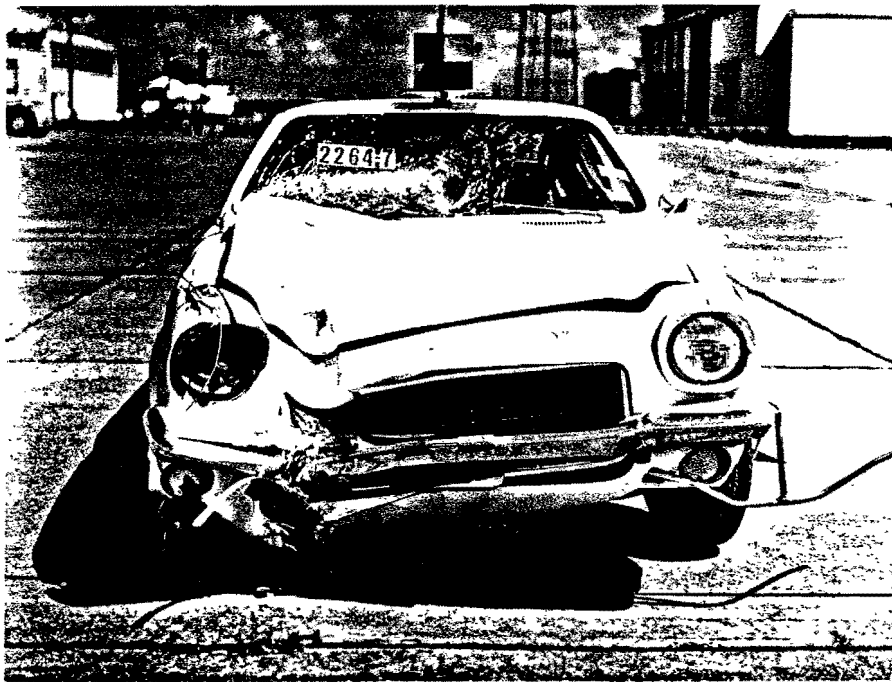
FIGURE 54. VEHICLE DAMAGE, TEST 7.

Vehicle damage is shown in Figure 54. The entire front of the car was damaged, including the windshield, fender, hood, bumper, and grille header panel. The TAD and SAE damage ratings are given in Table 15.
