1. Report No. FHWA/TX-81/50+280-2F		2. Government Accession No.		3. Recipient's Catalog No.	
4. Title and Subtitle Safety Treatment of Roadside Parallel-Drainage Structures				5. Report Date June 1981 (Revised May 1982)

16. Abstract <p>The purpose of the research was to develop traffic-safe end treatments for parallel-drainage structures that would not appreciably restrict water flow. Guidelines or warrants for use of the end treatments were also developed. Parallel-drainage culverts are used to convey water under driveways, side roads, or median crossovers.</p> <p>Preliminary designs were first evaluated using a computer simulation program and a full-scale test program. From these studies, tentative design parameters were selected, including the ditch and driveway slopes and the grate spacing.</p> <p>The end treatment developed in the preliminary studies was then subjected to full-scale prototype testing. These tests involved evaluation of the end treatment on a 6.7 to 1 driveway slope with a subcompact automobile. The end treatment was subjected to tests at 40 mph (64.4 km/h) and 50 mph (96.5 km/h). A benefit/cost analysis was conducted to determine warrants for the use of the t

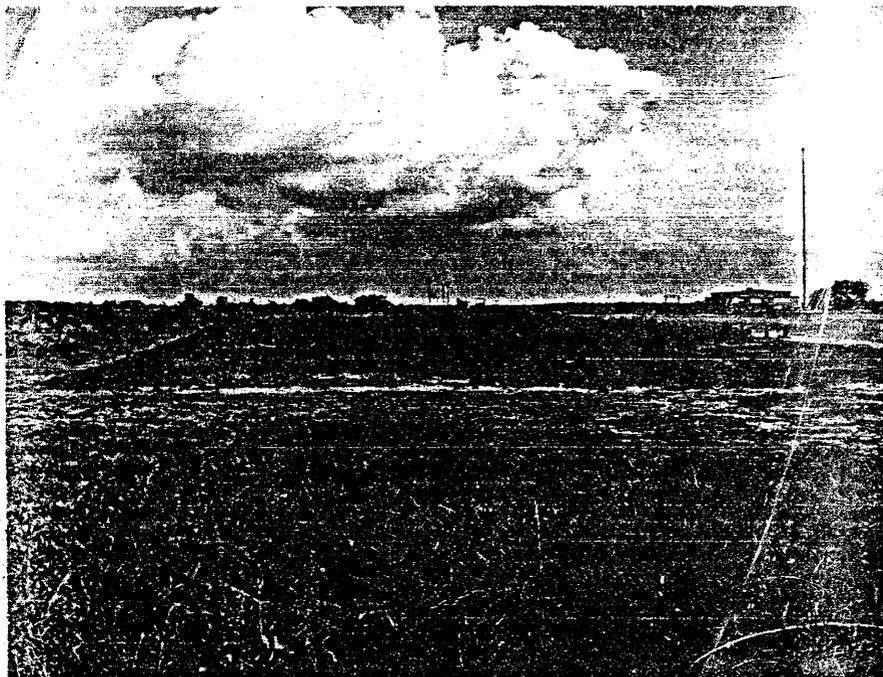
Side View

View Looking in Direction of Vehicle Travel

Figure 3. Photos of Earth Berm, Tests 1-1 through 1-4.

The first four tests were conducted on the earth berm shown in Figures 2 and 3. The final test in this series was conducted on the earth berm illustrated in Figure 5. The impact point for all tests was the center of the berm, and the vehicle path was perpendicular to the face of the berm.

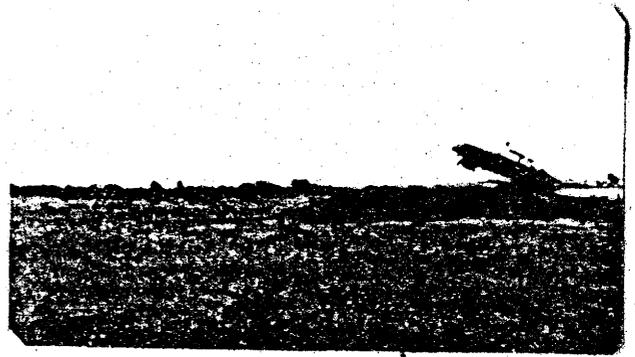
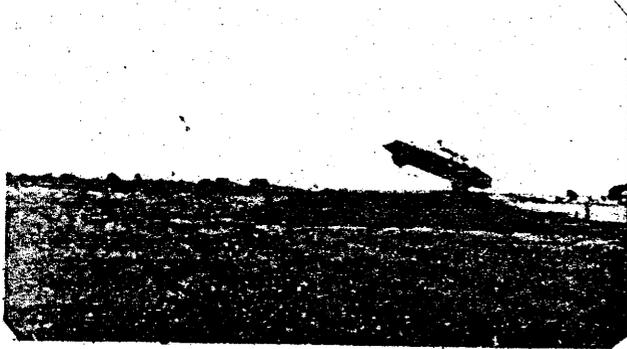
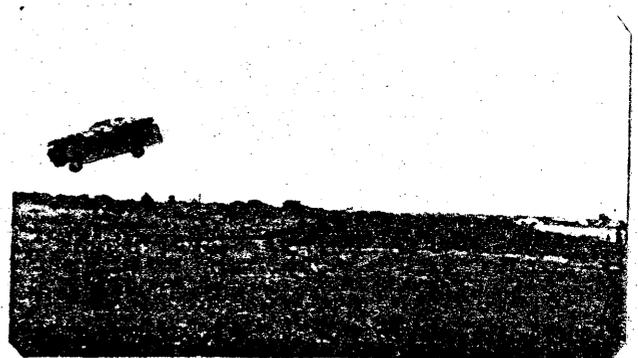
Figure 4. Sequential Photos, Test 1-4.

Tests 1-1 through 1-4 were conducted to determine an approximate maximum speed at which a driveway with a slope of approximately 4 to 1 could be traversed without attendant vehicle rollover. In each test the vehicle's speed was increased over that of the previous test. This process was continued until rollover occurred in test 1-4. Sequential photos of test 1-4 are shown in Figure 4. From these four tests it was determined that an automobile, approaching a driveway with a 4 to 1 slope from a head-on path (path 3 of Figure 1), would roll over (actually pitch over) at a speed somewhere between 40 mph (64.4 km/h) and 50 mph (80.5 km/h).

Figures 4 and B-24 contain sequential photos taken during impact. The vehicle was launched well over the berm and, although it rolled over only 40 degrees, the vehicle pitched over. This test was therefore a failure, and the damage was accordingly very severe. The damaged vehicle is shown in Figure B-25.

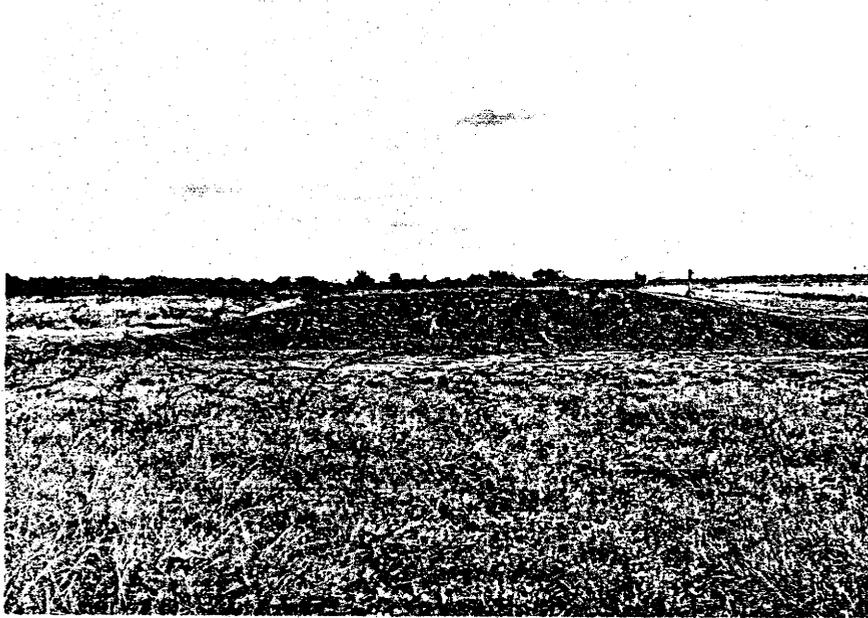
Figure 7. Test Installation Before Test 7-1.

Details of the culvert configuration for each of the culvert tests are given in Figure 5. The first test, 7-1, was conducted at 50 mph with an open culvert, i.e., no grate members. Photos of the installation are given in Figure 7 and sequential photos of the test are given in Figure 8. Large pitch and roll rates occurred after impact with the culvert, and the vehicle rolled over. In the next test, 7-2, a single grate member was placed across the culvert as shown in details 3 and 4 of Figure 5 and the photos of Figure 9. Very little improvement in vehicle behavior occurred and rollover again occurred.

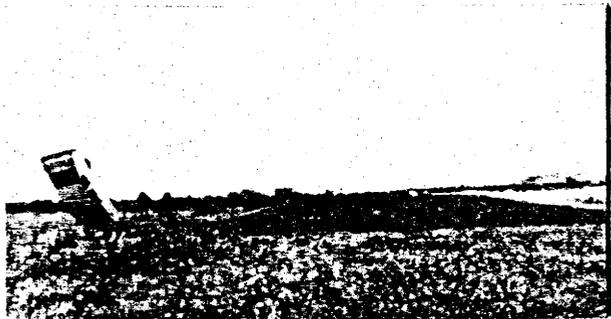
Figure 8. Sequential Photos, Test 7-1.

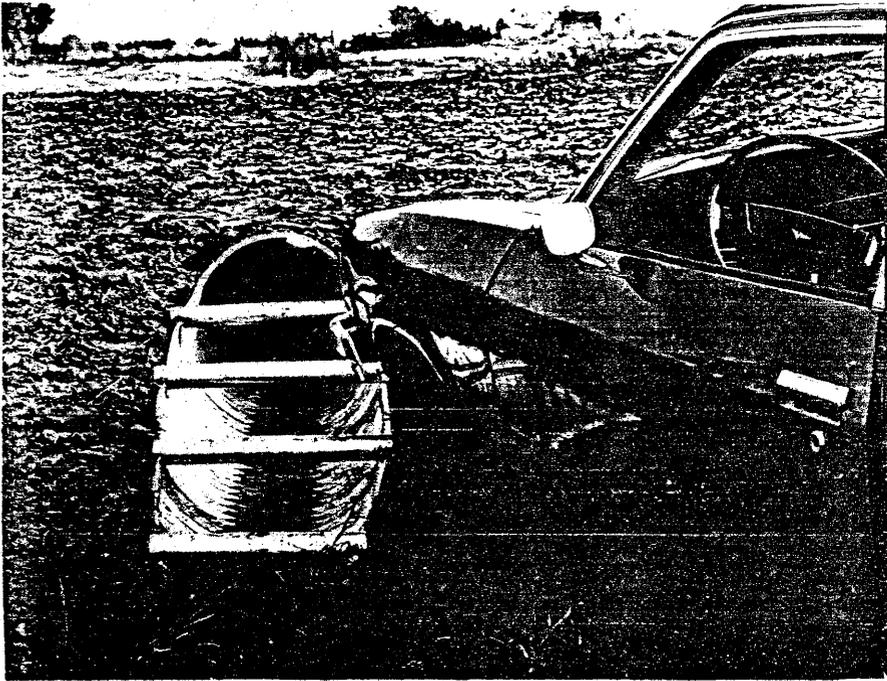
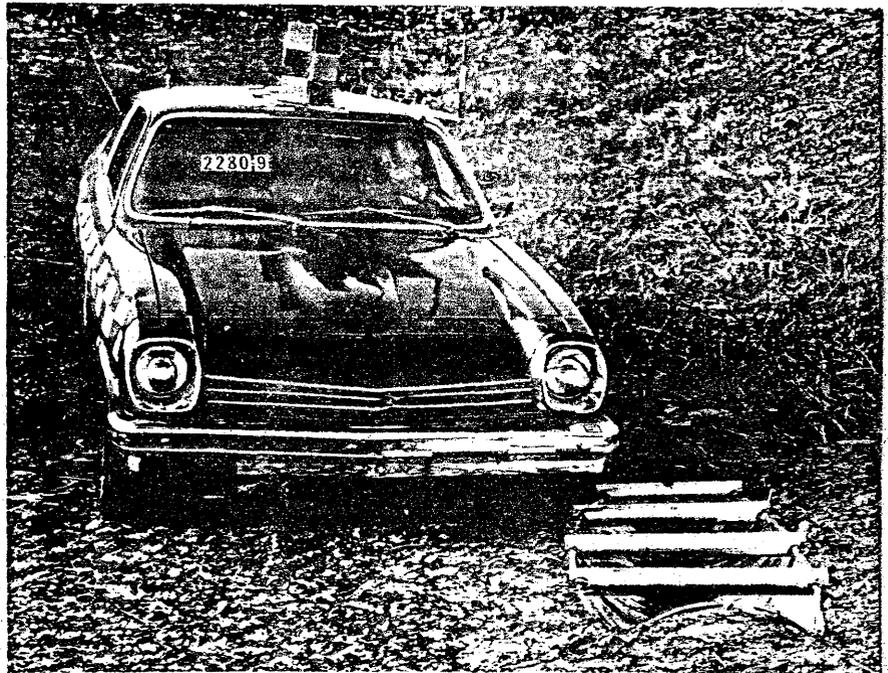
Figure 14. Test Site, Tests 9-1 and 9-2.

The final two tests, 9-1 and 9-2, were selected to verify the tentative conclusions reached as a result of the simulation work and the full-scale slope and culvert testing. A full-scale prototype of a ditch-driveway configuration was therefore constructed as shown in Figure 13 and the photos of Figure 14. Test 9-1 was conducted at 40 mph (64.4 km/h) and the approach path into the driveway was as shown in Figure 13. The path was such that the left side wheels crossed the culvert. No adverse vehicle behavior occurred during the test, and the results were considered acceptable.

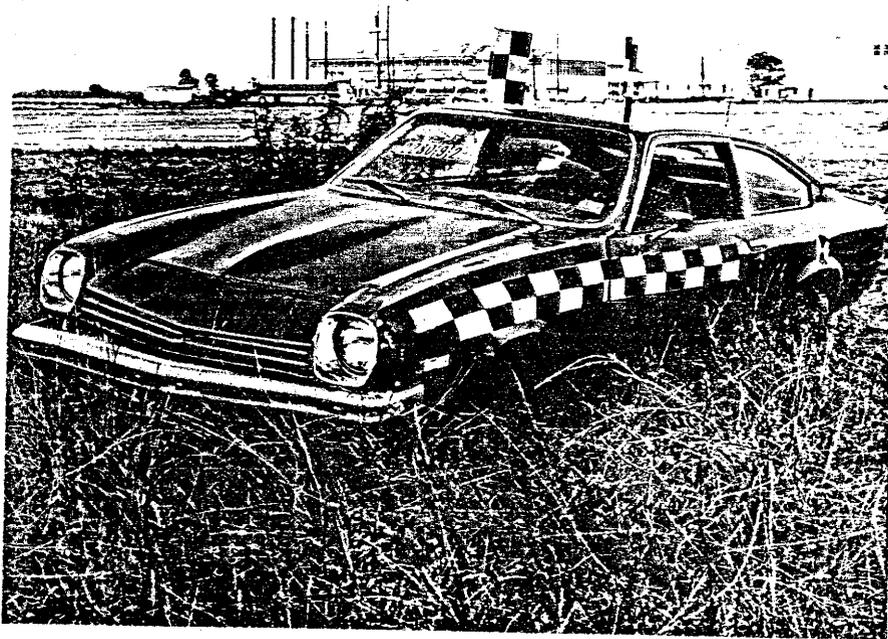
Figure 16. Vehicle After Test 9-2.

Test 9-2 was identical to test 9-1 except the speed was increased to 50 mph (80.5 km/h). Sequential photos of the test are shown in Figure 15. The vehicle remained upright and sustained only minor damage. Photos of the vehicle and the culvert after the test are shown in Figure 16.

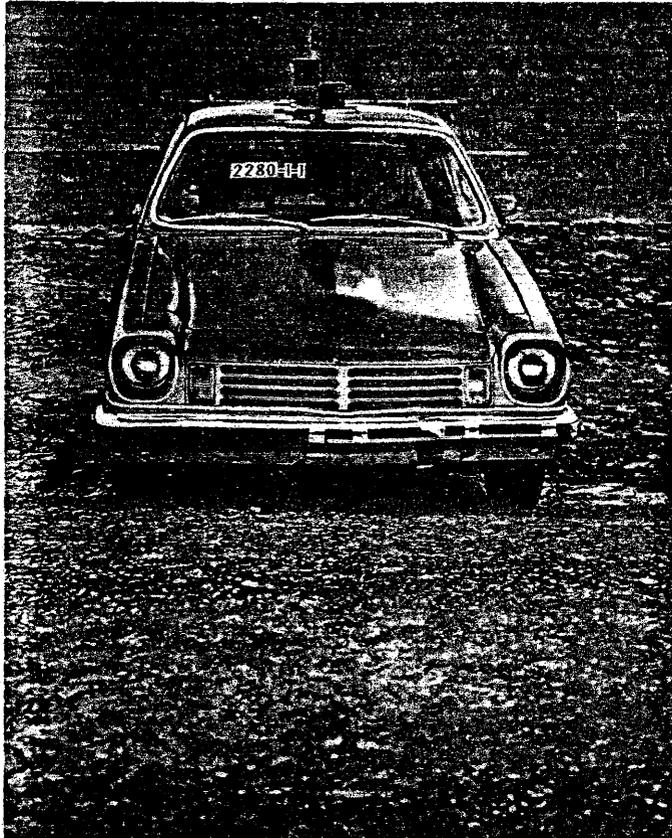
Figure B-2. Test Vehicle Before Test 1-1

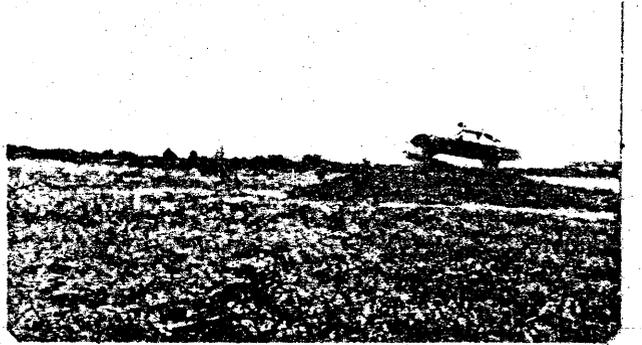
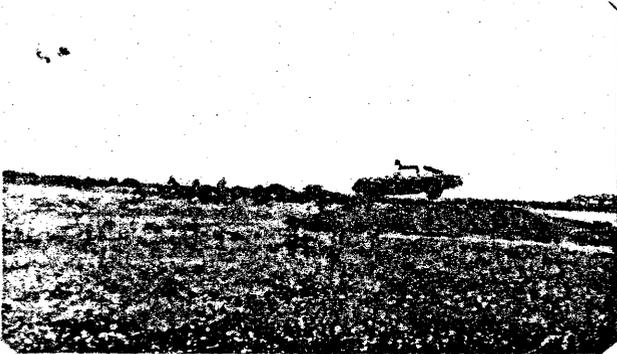
Figure B-3. Sequential Photos, Test 1-1.

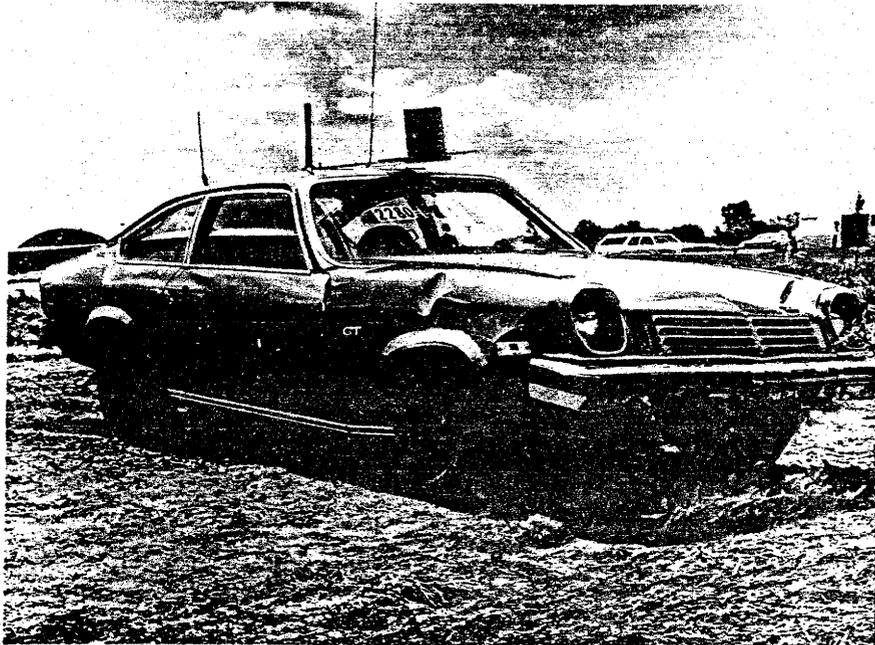
Figure B-16. Test Vehicle Before Test 1-3.

Test 1-3 was a repeat of test 1-2 except the speed was increased to 40 mph (64.4 km/h). The same vehicle was used in both tests. Figure B-16 contains a photo of the test vehicle before impact. Figures B-17 and B-18 contain sequential photos taken during impact. The vehicle was launched well over the earth berm and again rolled about 20 degrees while airborne. Vehicle damage was significant as shown in Figure B-19, and the vehicle was not used again.

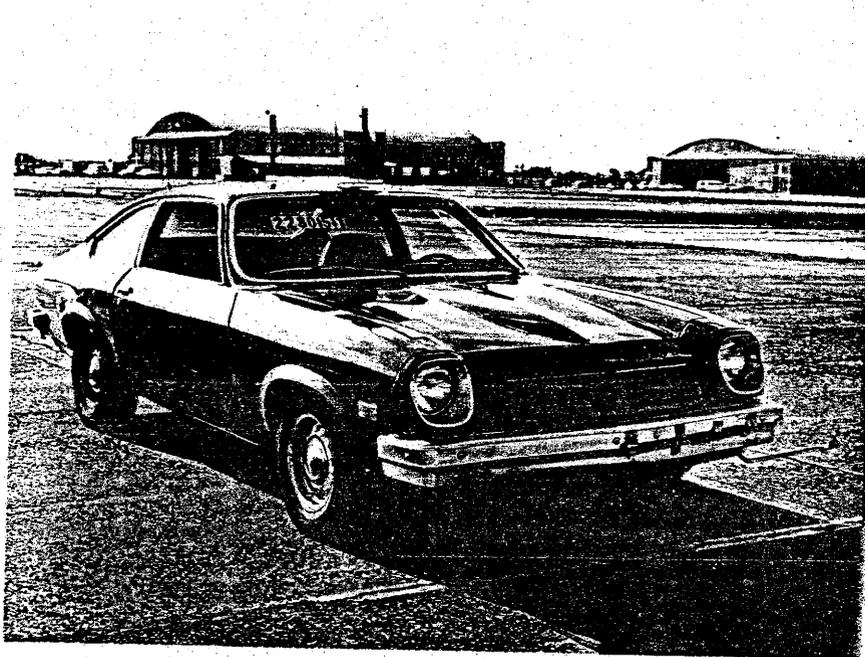
Figure B-31. Test Vehicle Before Test 5-1.

For test 5-1 the earth berm was flattened to a 6 to 1 slope as shown in Figure B-30. The test speed was 50 mph (80.5 km/h). A photo of the test vehicle before impact is contained in Figure B-31. Figures 6 and B-32 contain sequential photos taken during the event. The vehicle was launched beyond the berm but landed at a low pitch angle, and the maximum roll angle was only 7 degrees. Vehicle damage was not severe, as shown in Figure B-33.

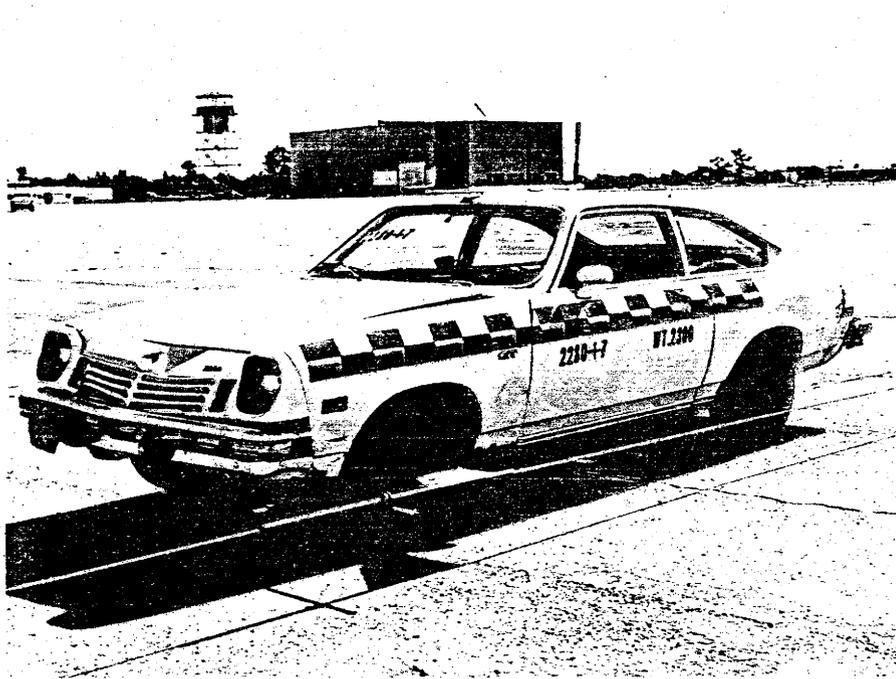
Figure B-38. Test Vehicle and Installation Before Test 7-1.

The initial test involved a culvert end with no grating as shown in Figures 7 and B-38. Figures 8 and B-39 contain sequential photos of the event. The test vehicle began to roll when the right rear wheel impacted the top of the culvert. When the car hit the ground it had already rolled approximately 60 degrees and continued to roll completely over. Figure B-40 contains photos of the damage done to the culvert installation and the test vehicle.

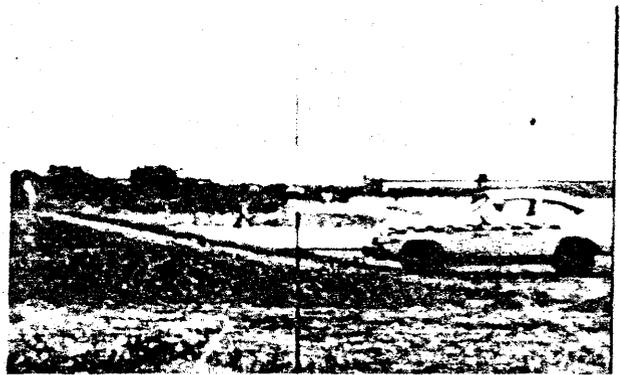
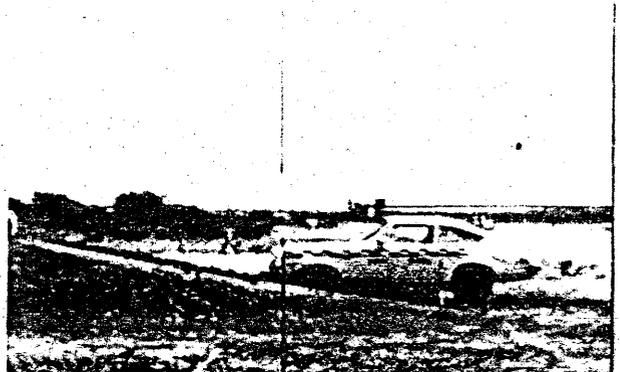
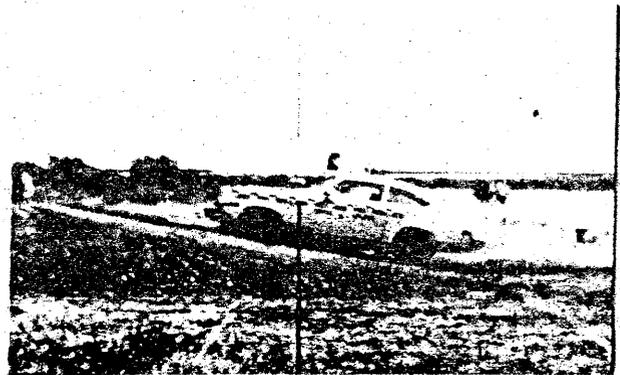
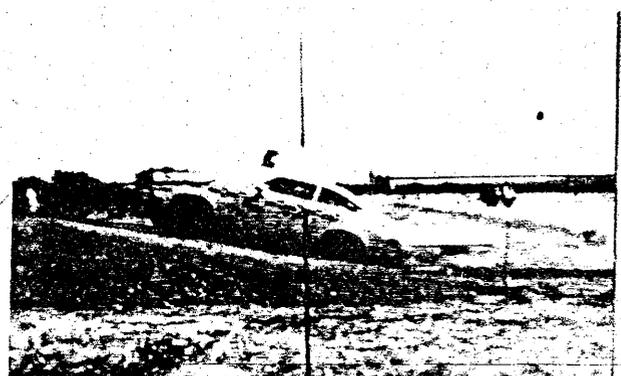
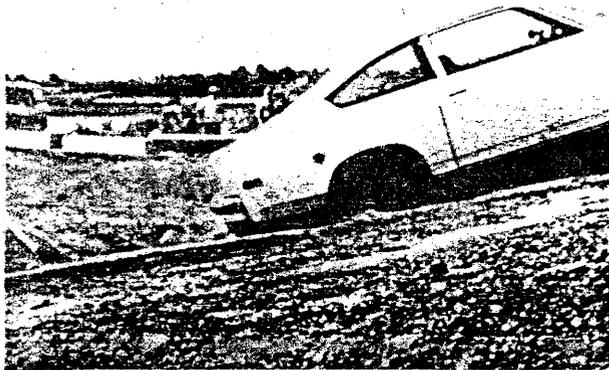
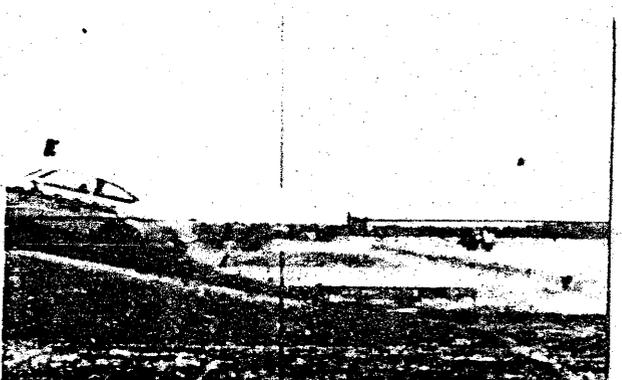
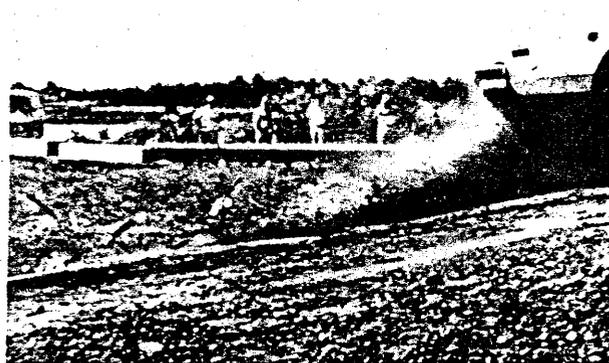
Figure B-39. Sequential Photos, Test 7-1.

Figure B-39. Sequential Photos, Test 7-1. (cont.)

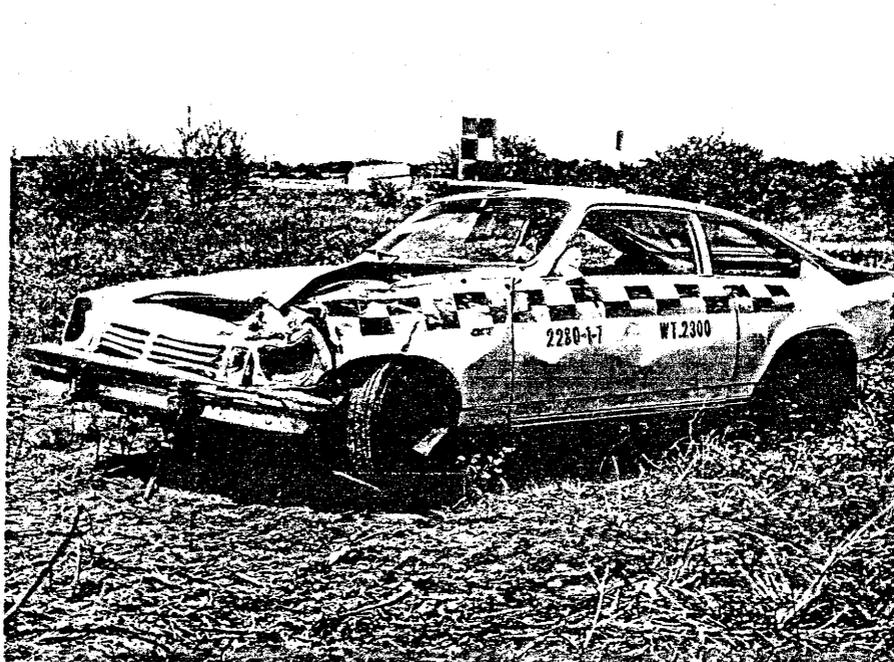
Figure B-40. Test Vehicle and Installation After Test 7-1.

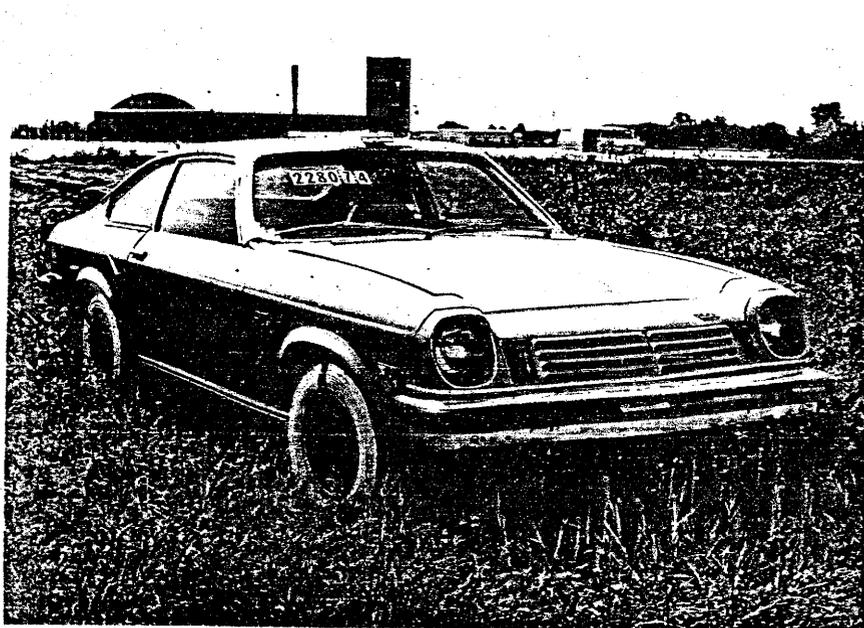
Figure B-59. Test Vehicle and Installation Before Test 7-5.

Figure B-59 contains photos of the vehicle and installation before test 7-5. The same test installation and vehicle were used for test 7-5 as were used for test 7-4. Sequential photos taken during impact are shown in Figures B-60 and B-61. Two of the four crossmembers failed during this test, causing the vehicle to begin to roll when the rear tire impacted the final crossmember. The car eventually rolled completely over. Both the test vehicle and the test installation sustained significant damage as shown in Figure B-62.

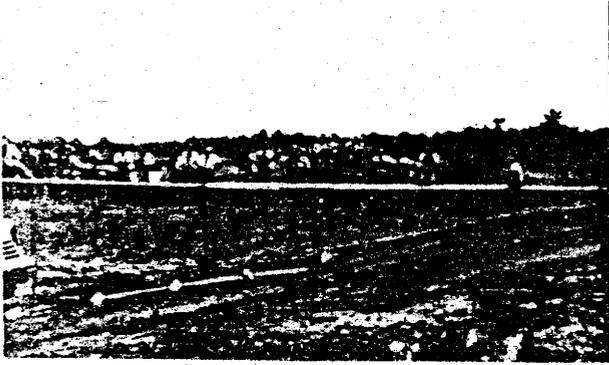
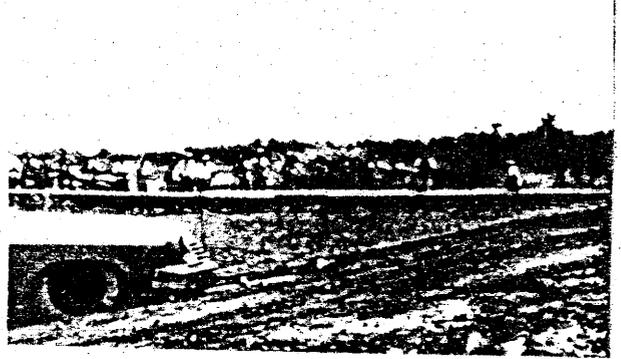
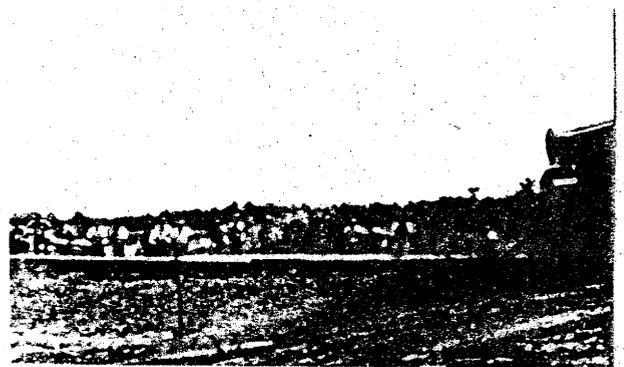
Figure B-61. Sequential Photos, Test 7-5.

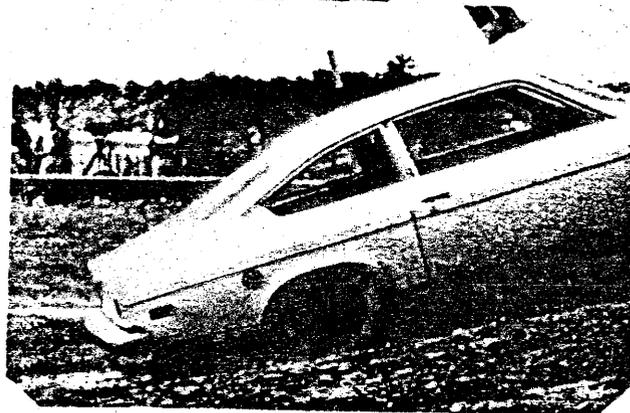
Figure B-67. Sequential Photos, Test 7-6.

In this test the culvert grating consisted of four 2.5 in. (6.35 cm) I.D. schedule 40 steel pipe spaced 24 in. (61 cm) apart. Figure 10 contains photos of the test vehicle and test installation before impact. Further details of this treatment are given in Figure 5. Figures 11 and B-67 contain sequential photos taken during the event. The car traversed the culvert and landed without rollover. It did, however, attain a roll angle of 40 degrees while the vehicle was airborne. Figure B-68 shows the damage done to the test vehicle as well as the test installation.

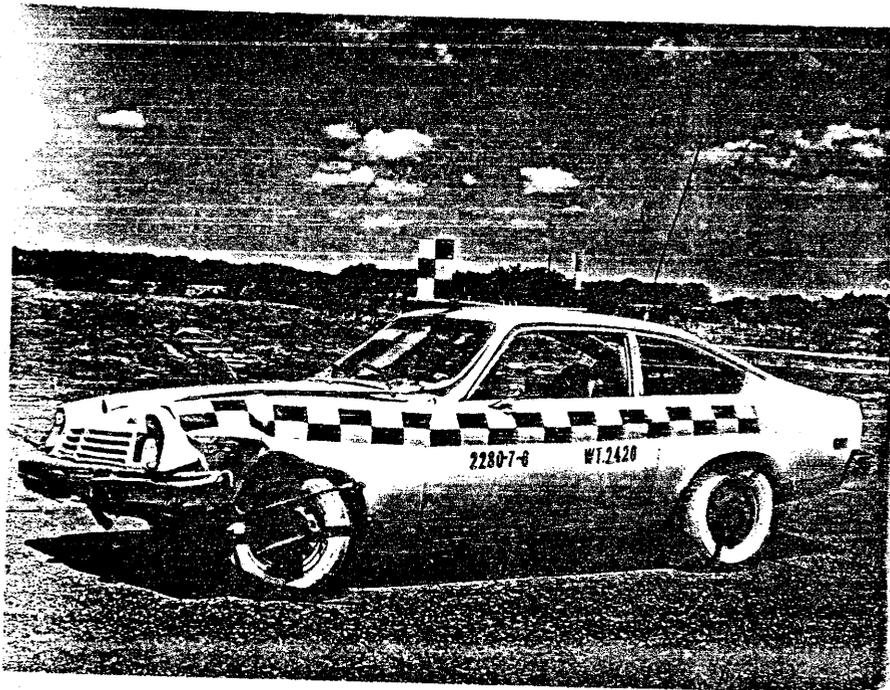
Figure B-68. Test Vehicle and Installation After Test 7-6.

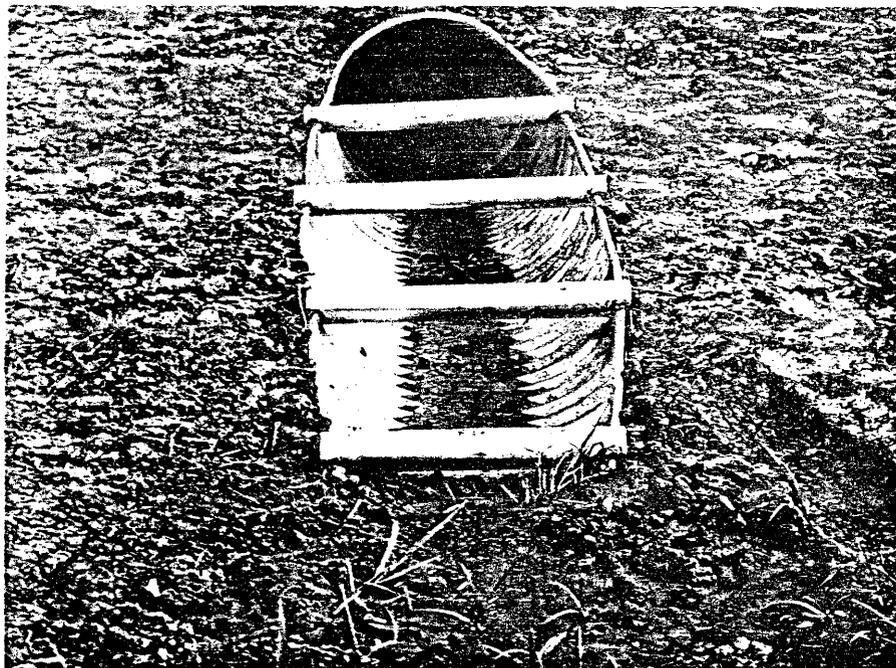
Figure B-73. Test Vehicle and Installation Before Test 9-1.

Figure B-73 contains photos of the test vehicle and installation before impact. Figures B-74, B-75, and B-76 contain sequential photos during the event. The test vehicle was airborne for only a short distance and landed without rolling over. Neither the car nor the test installation sustained major damage as shown in Figure B-77. Both were reused for test 9-2.

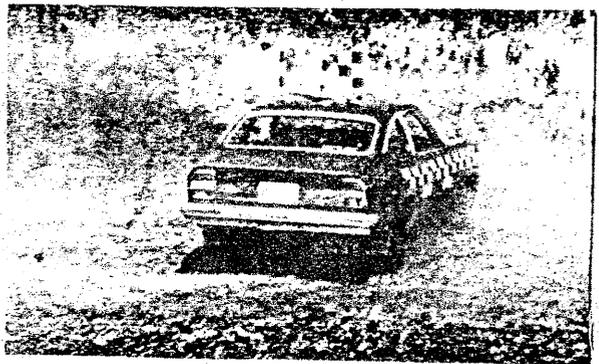
Figure B-74. Sequential Photos, Test 9-1; Pan Shot.
