1. Report No. TX-01/3911-S		2. Government Accession No.		3. Recipient's Catalog No.	
4. Title and Subtitle EVALUATION OF DESIGN AND RETROFIT CONCEPTS FOR SLIP-BASE SIGN SUPPORT SYSTEMS				5. Report Date February 2001

**EVALUATION OF DESIGN AND RETROFIT CONCEPTS
FOR SLIP-BASE SIGN SUPPORT SYSTEMS**

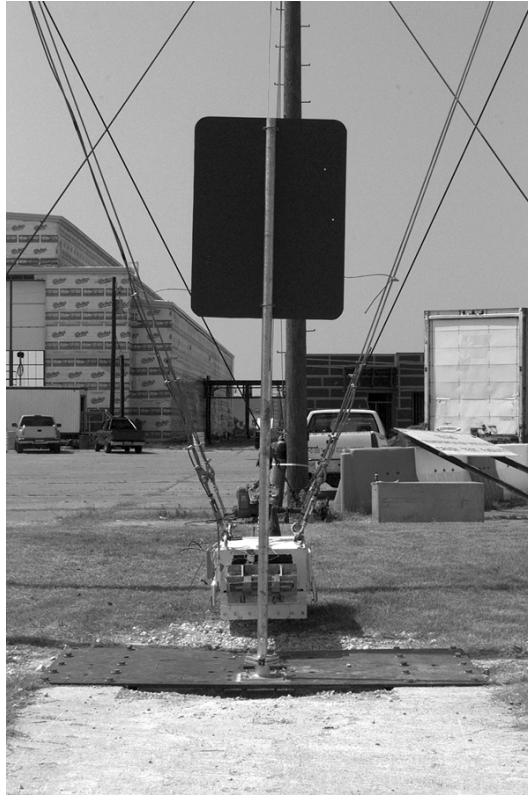
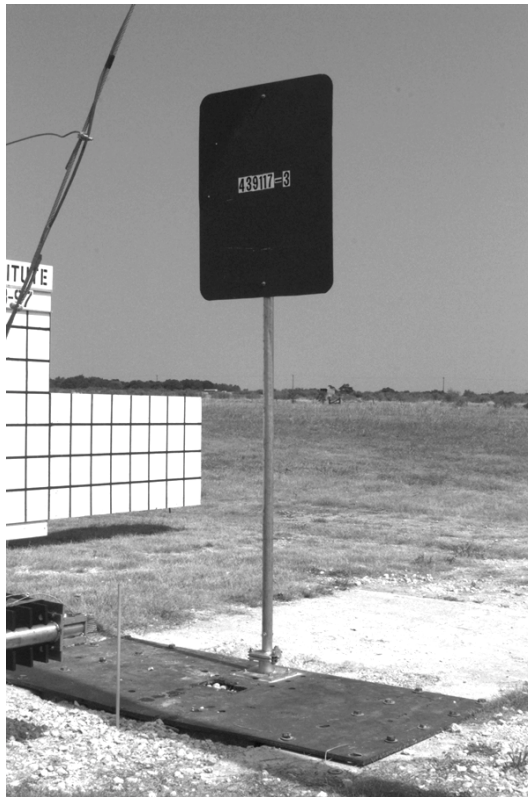
Figure 2. Typical Sign Support Installation before Pendulum Testing of Keeper Plates.

blank was mounted on a triangular slip base as shown in [Figure 1](#). The pipe support was American Society for Testing and Materials (ASTM) A53, grade A, type F (furnace butt welded) pipe with a yield strength of 270 MPa. The lower slip-base plate and pipe stub were welded to a base plate which was bolted to a steel reaction plate in the pendulum pit. The upper slip-base plate assembly consisted of a cast ductile iron triangular slip base plate with a 305 mm tall stub which fit inside the 51 mm diameter pipe support. The triangular slip base was oriented such that one of the sides was perpendicular to the direction of impact. The three 16 mm diameter, high-strength bolts were tightened to a prescribed torque of 51.5 N-m. Keeper plate thickness was 30 (standard), 28, 26, and 24 gauge for tests P3, P4, P5, and P6, respectively. Photographs of the typical sign support installation used in the pendulum tests are shown in [Figure 2](#).

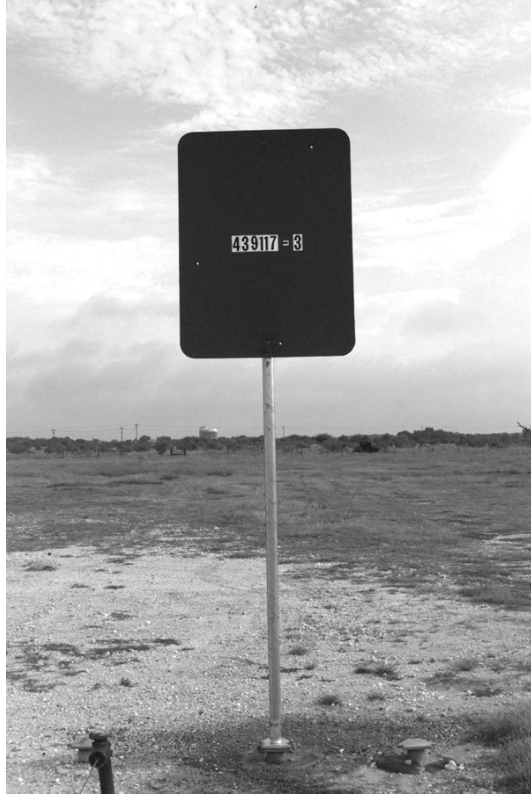
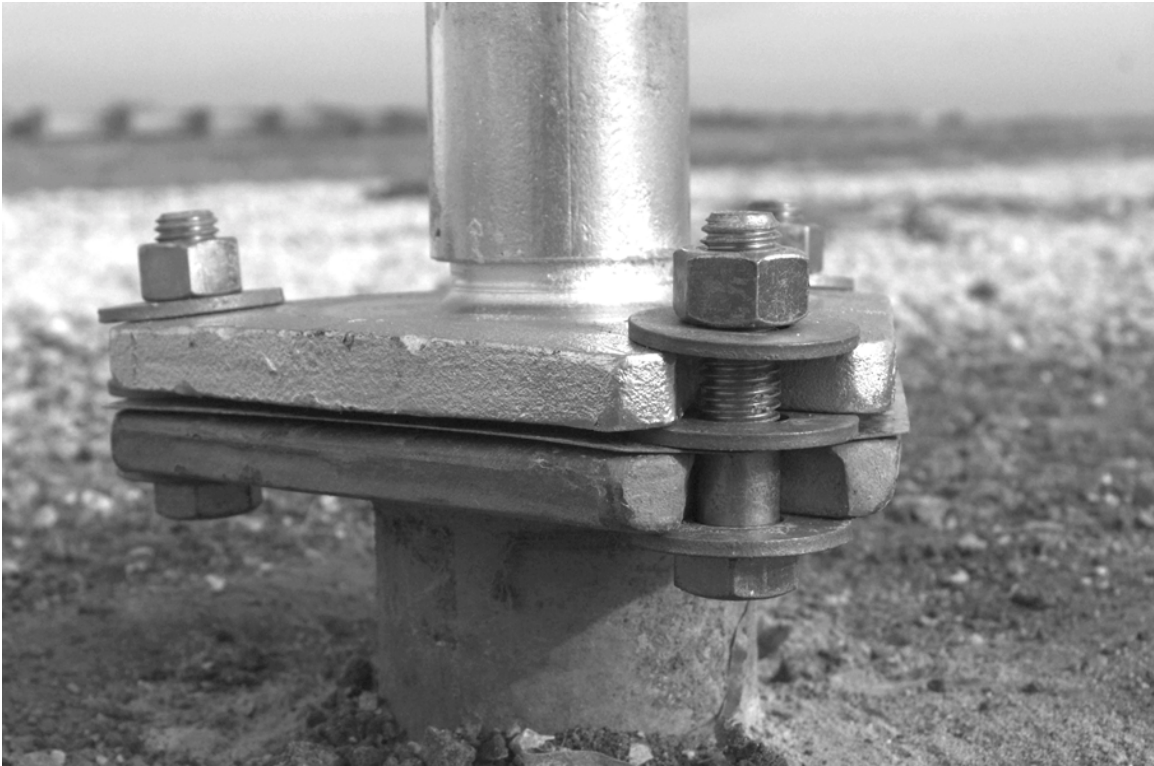
Figure 4. Sign Support Installation before Test 439117-3.

The triangular slip base was oriented such that one of the sides was perpendicular to the direction of impact. The three 16 mm diameter, high-strength bolts were tightened to a prescribed torque of 51.5 N-m. A 26 gauge bolt keeper plate was used in place of the standard 30 gauge plate. Additional details of the installation are shown in [Figure 3](#). Photographs of the sign support installation used in the low-speed crash test are shown in [Figure 4](#).

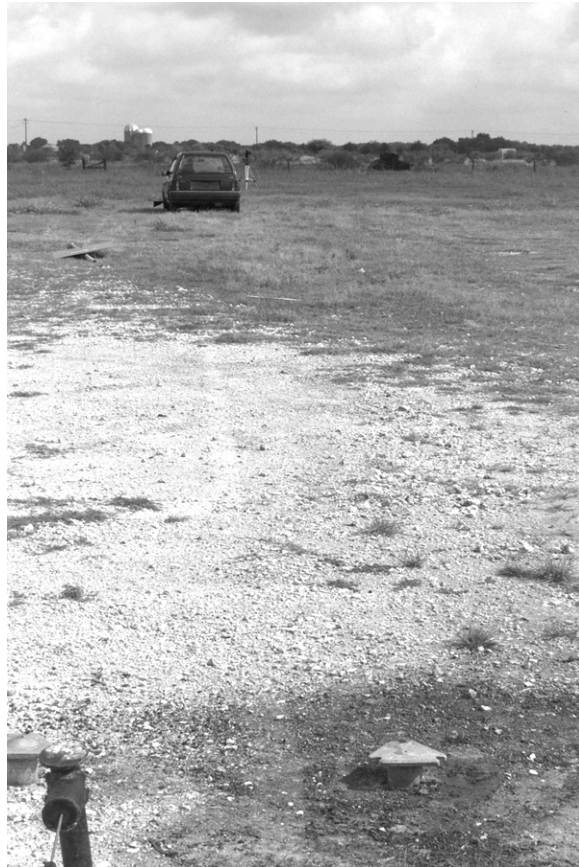
Figure 7. After Impact Trajectory for Test 439117-3.

The triangular slip base activated as designed. The support received minor damage during the impact as shown in Figures 7 and 8. Two of the holes in the 26 gauge bolt keeper plate tore out, and one slip bolt was still attached. The keeper plate and slip bolts came to rest near the base plate. No movement of the base in the high-density polyurethane foam was observed. The support, with the sign panel still attached but loosened, came to rest 22.9 m down and 1.8 m to the left of the base. All parts except for the keeper plate were considered reusable.

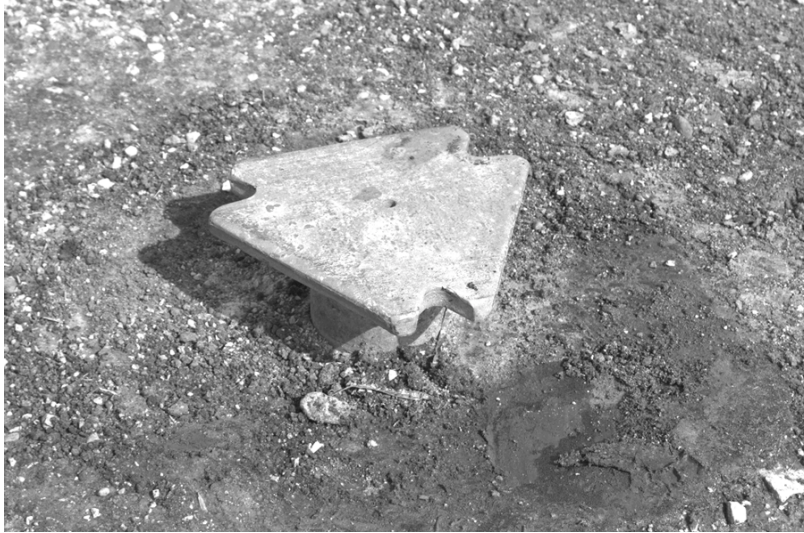
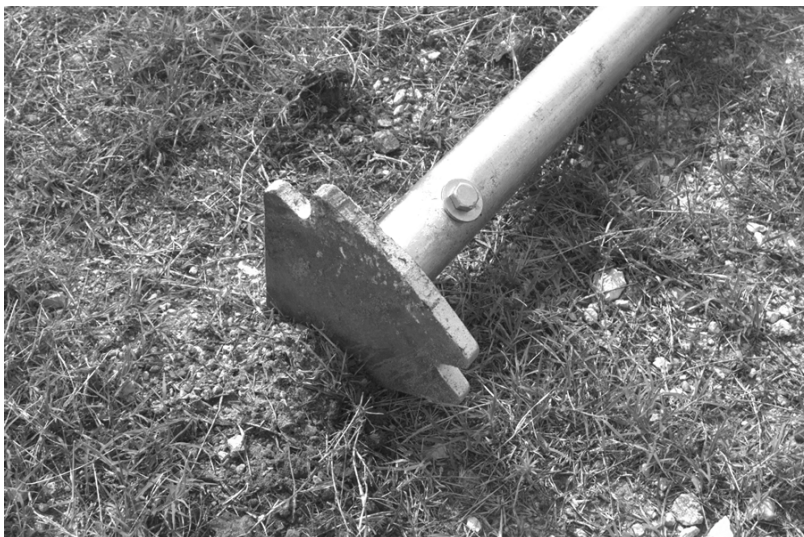
Figure 8. Installation after Test 439117-3.

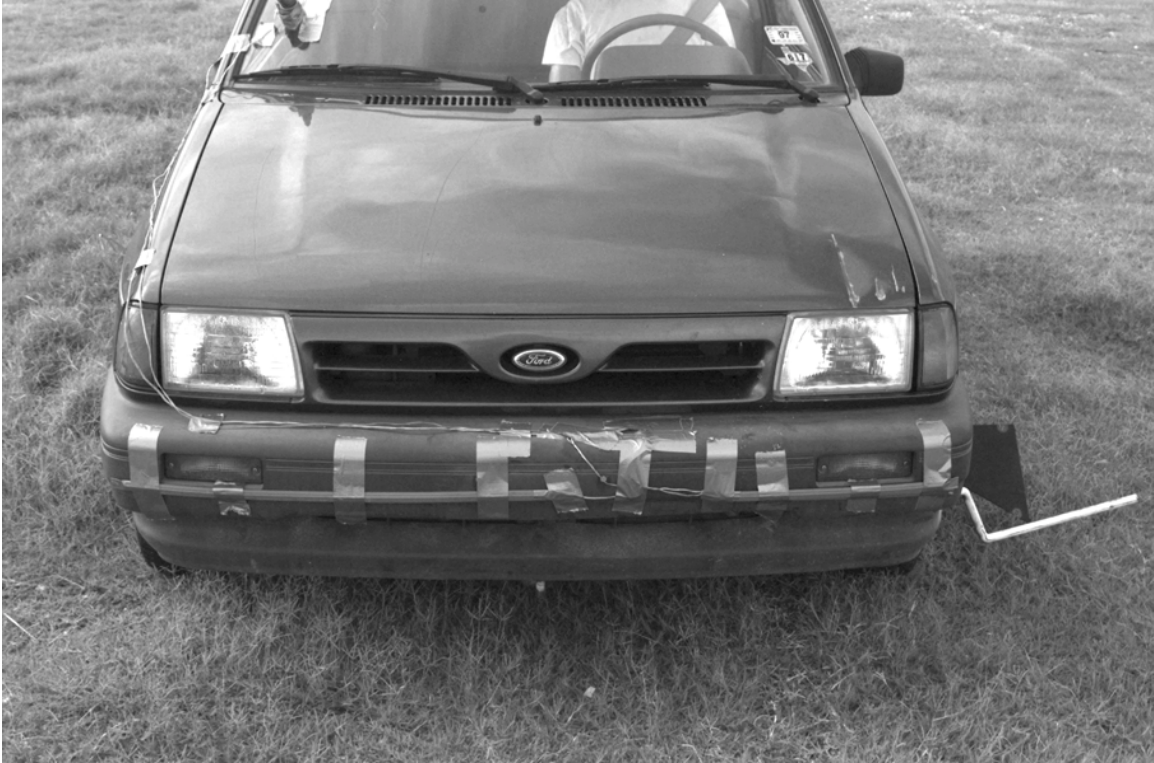
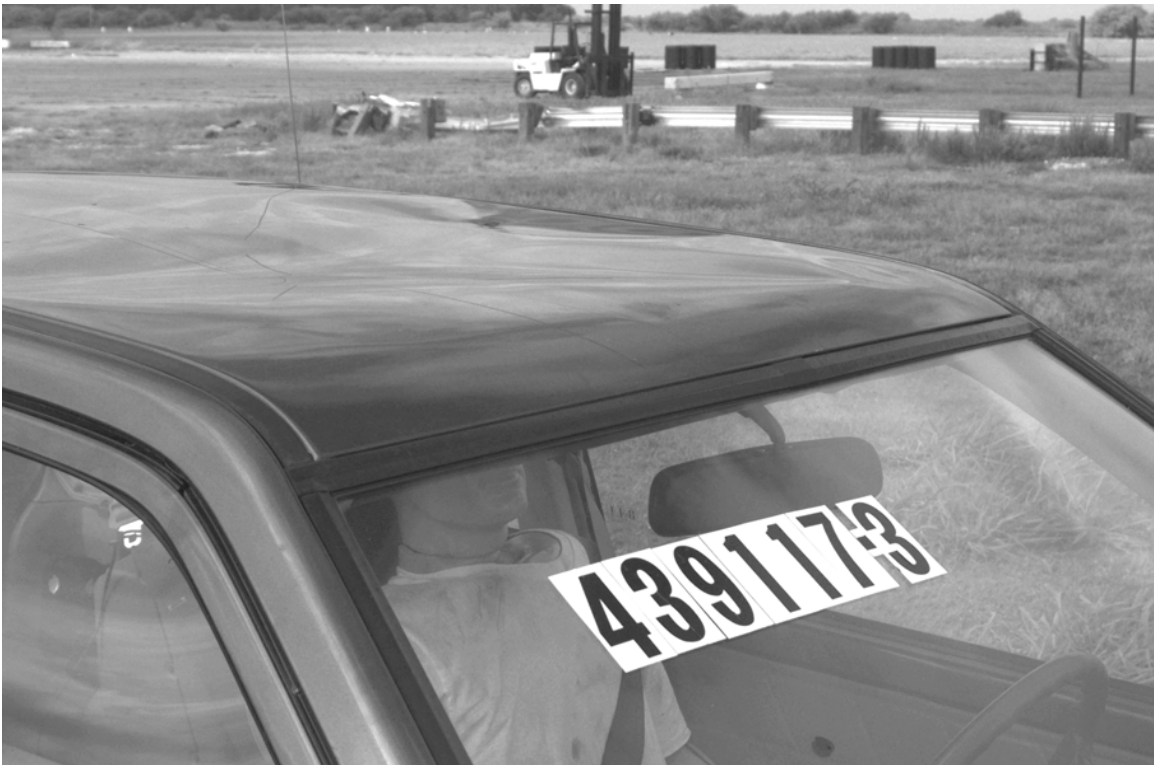
Figure 9. Vehicle after Test 439117-3.

Damage to the vehicle was relatively minor as shown in Figure 9. A small scrape was noted on the left front hood. A 17 mm deep indentation was found in the roof 500 mm rearward of the windshield. The indentation, which was caused by the sign panel and support slapping the roof, was 890 mm wide. There was no other measurable exterior crush to the vehicle. Maximum deformation into the occupant compartment was 10 mm in the roof area near the rear of the vehicle.

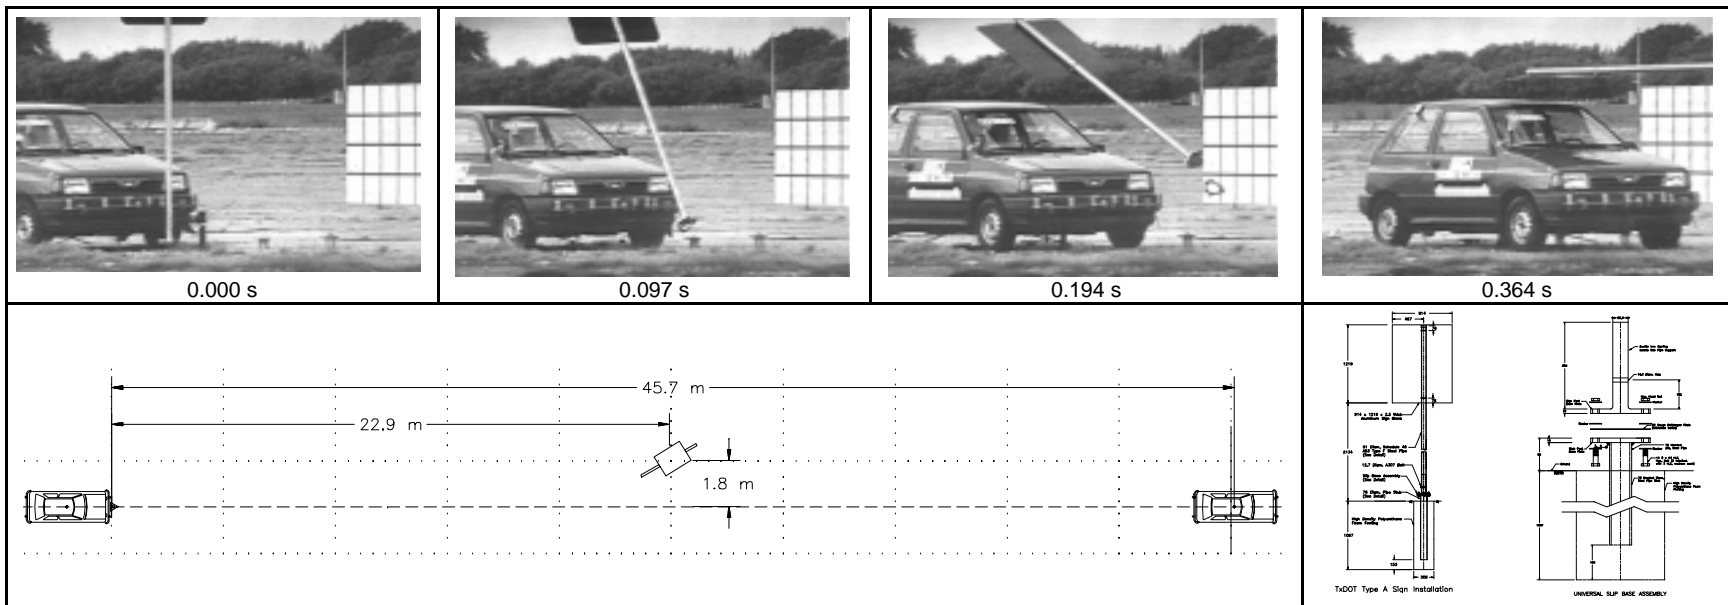
General Information		Impact Conditions		Test Article Debris Pattern (m)	
Test Agency	Texas Transportation Institute	Speed (km/h)	37.35	Longitudinal	22.9
Test No.	439117-3	Angle (deg)	0 - If qtrpt	Lateral	1.8
Date	08/11/97	Exit Conditions		Vehicle Damage	
Test Article		Speed (km/h)	33.41	Exterior	
Type	Sign Support	Angle (deg)	0	VDS	12FL1
Name or Manufacturer	TxDOT Type A Sign Installation	Occupant Risk Values		CDC	12FLEN1
Installation Height (m)	2.14	Impact Velocity (m/s)		Maximum Exterior	
Size and/or dimension		x-direction	1.51	Vehicle Crush (mm)	
and material of key	Single Steel Post w/ aluminum sign	y-direction	0.92	17	
elements	blank	Ridedown Accelerations (g's)		Interior	
Soil Type and Condition	Concrete Footing, Dry	x-direction	-0.99	OCDI	
Test Vehicle		y-direction	0.89	FS0000000	
Type	Production	Max. 0.050-s Average (g's)		Max. Occ. Compart.	
Designation	820C	x-direction	-0.74	Deformation (mm)

Model	1993 Ford Festiva	y-direction	0.55	10	
Mass (kg)		z-direction	0.63	Post-Impact Behavior	
Curb	805	Veh. Change in Velocity (m/s)		(during 1.0 s after impact)	
Test Inertial	820		1.09	Max. Roll Angle (deg)	
Dummy	76			0.7	
Gross Static	896			Max. Pitch Angle (deg)	
				-2.7	
				Max. Yaw Angle (deg)	
				-0.5

Figure 10. Summary of Results for Test 439117-3.

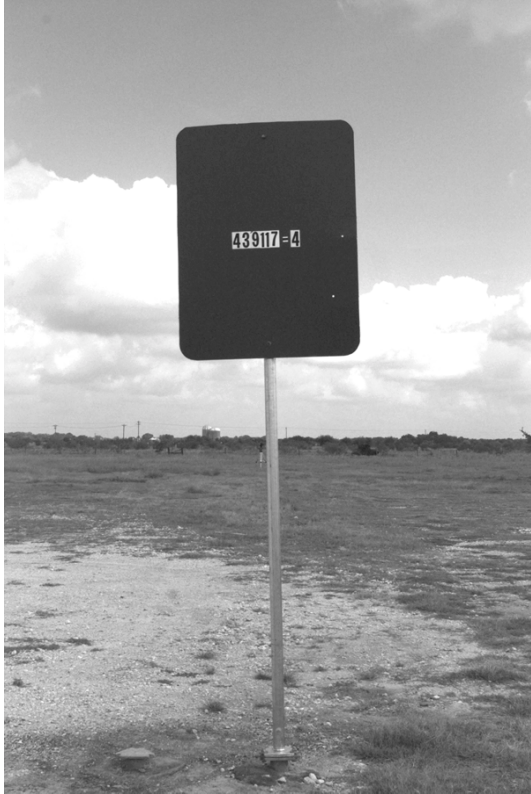
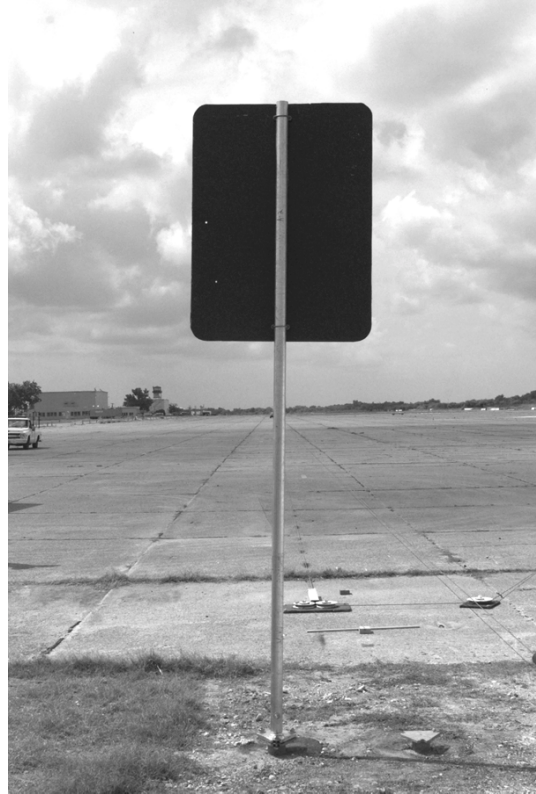
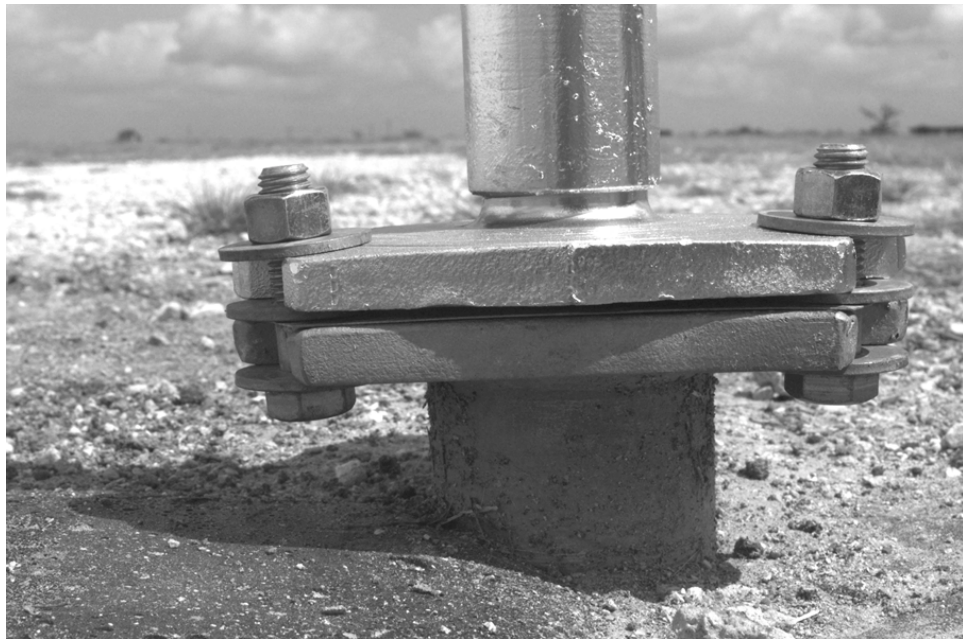
Figure 11. Sign Support Installation before Test 439117-4.

The test installation was identical to that impacted in the previous test (test 439117-3), except for the type of pipe used. In this test, the 51 mm diameter support was type F (furnace butt weld) pipe fabricated from ASTM A501 material. The yield strength of the pipe was 262 MPa, and the percent elongation was 40 percent. Photographs of the completed sign support system are shown in [Figure 11](#).

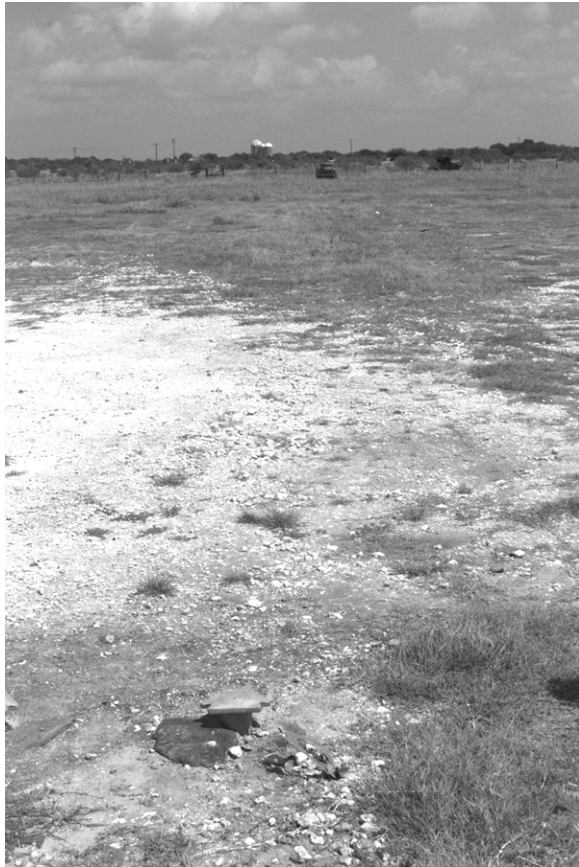
Figure 14. After Impact Trajectory for Test 439117-4.

Damage to the support is shown in [Figures 14 and 15](#). Two of the slip bolts tore through the 26 gauge keeper plate and were found to the left and slightly behind the base plate. The

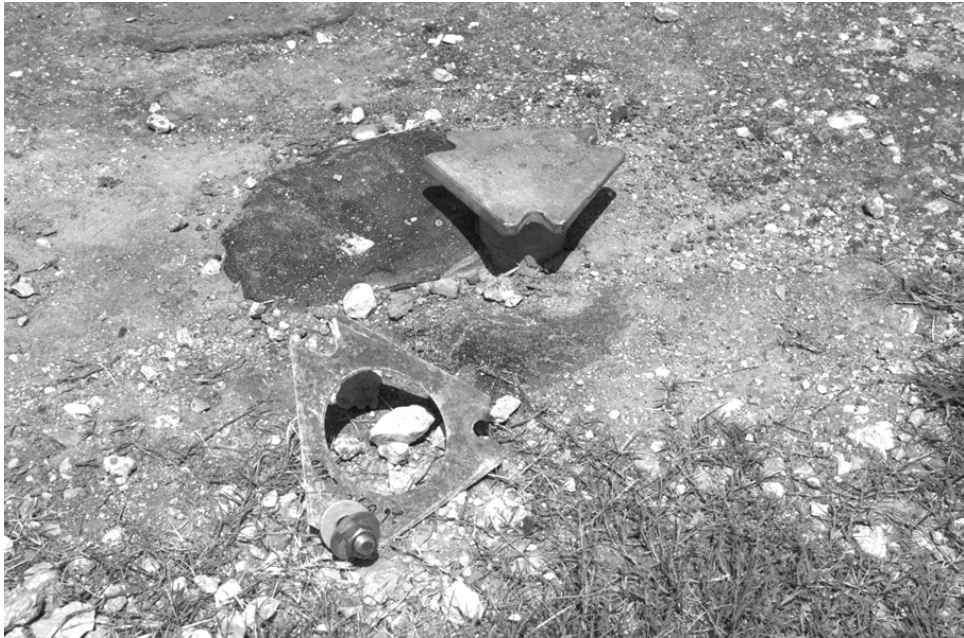
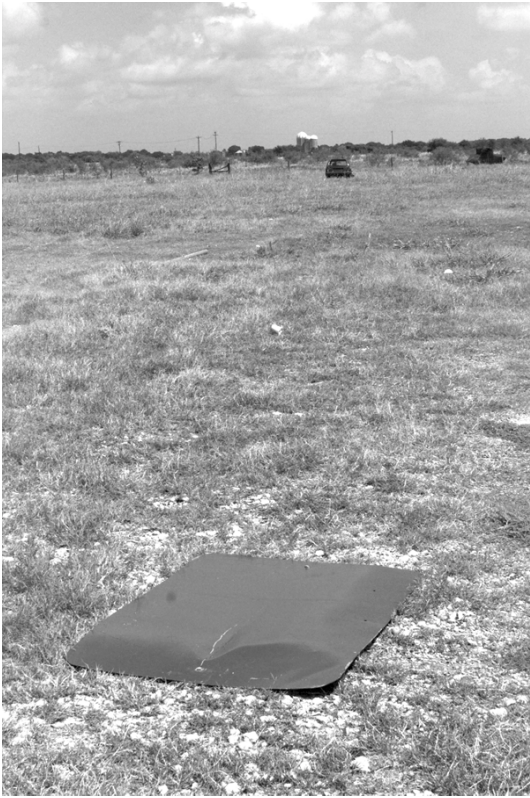
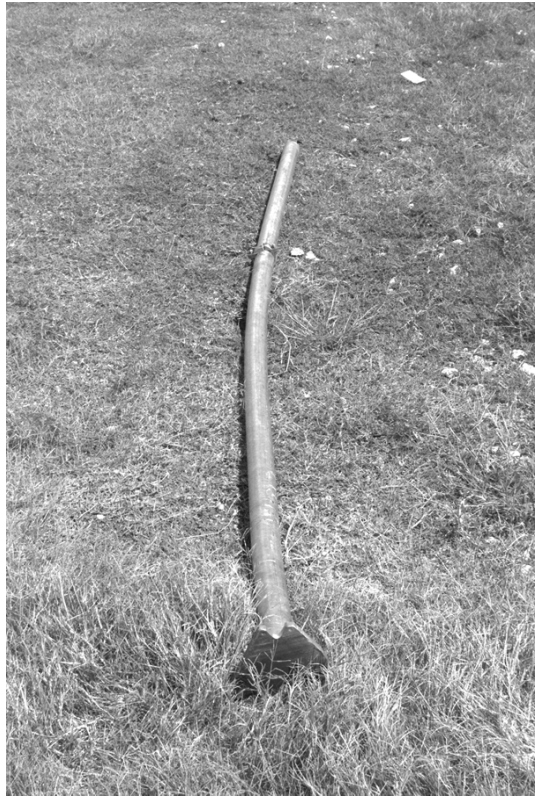
Figure 15. Installation after Test 439117-4.

keeper plate, with the remaining slip bolt attached, came to rest slightly to the right and behind the base plate. The sign panel detached from the support and was located 23.5 m downstream and 2.4 m to the right of the point of impact. The sign support had some permanent deformation at bumper height and came to rest 38.13 m downstream and 0.30 m to the right of the point of impact. All the components were considered reusable except the support pipe and bolt keeper plate.

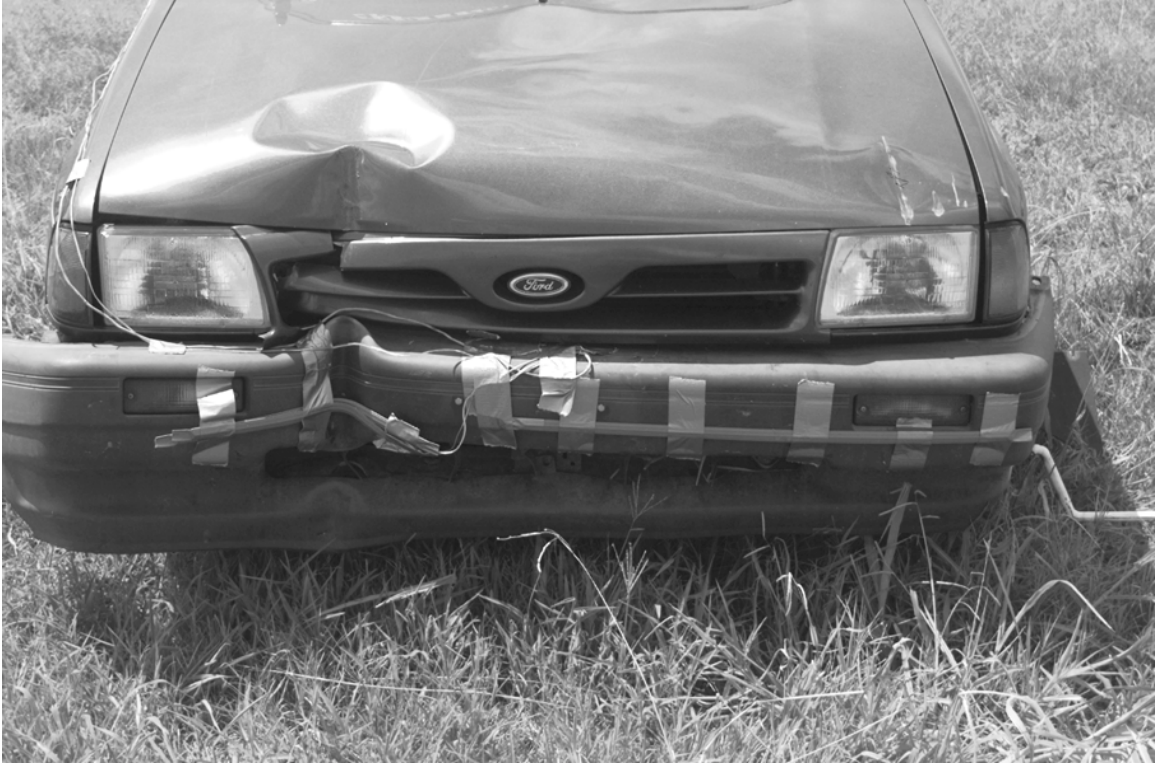
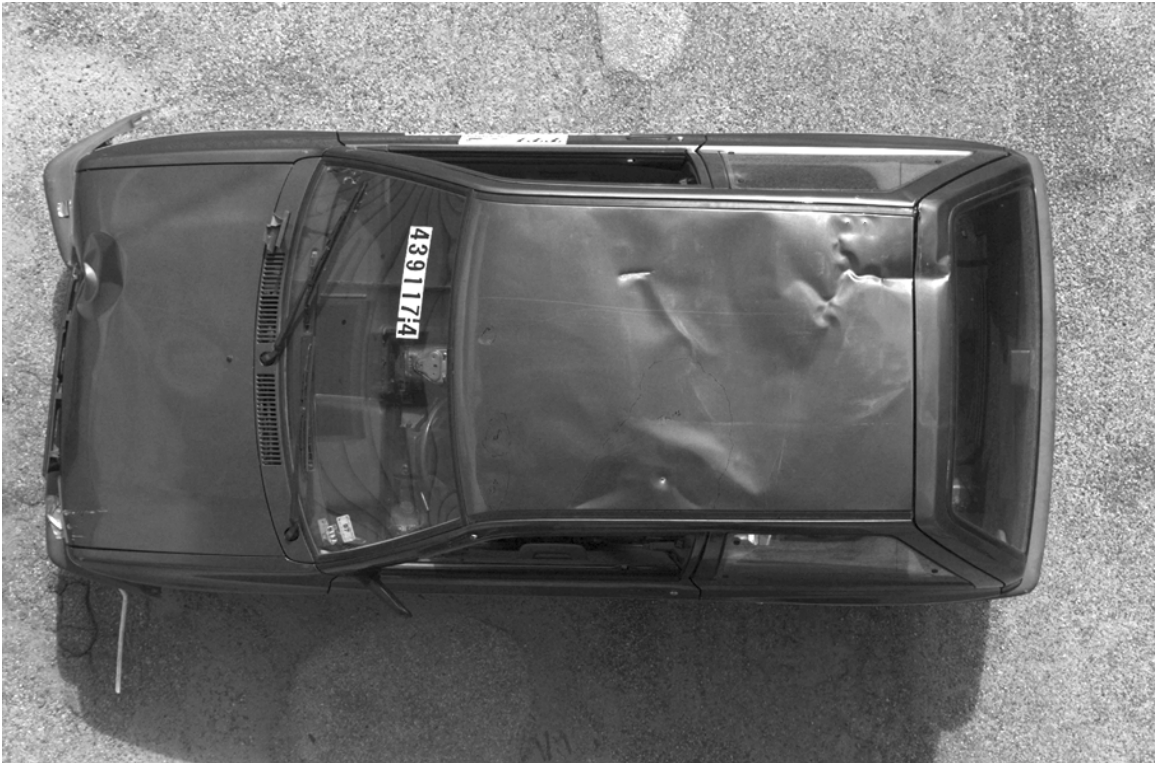
Figure 16. Vehicle after Test 439117-4.

Damage to the front bumper, hood, grill, and roof can be seen in [Figure 16](#). A dent in the roof measuring 900 mm wide, 1104 mm long, and 26 mm deep, resulted from secondary contact with the sign support and sign panel. Maximum exterior crush to the front of the vehicle at bumper height was 95 mm. The maximum deformation into the occupant compartment was 50 mm in the rear roof area.

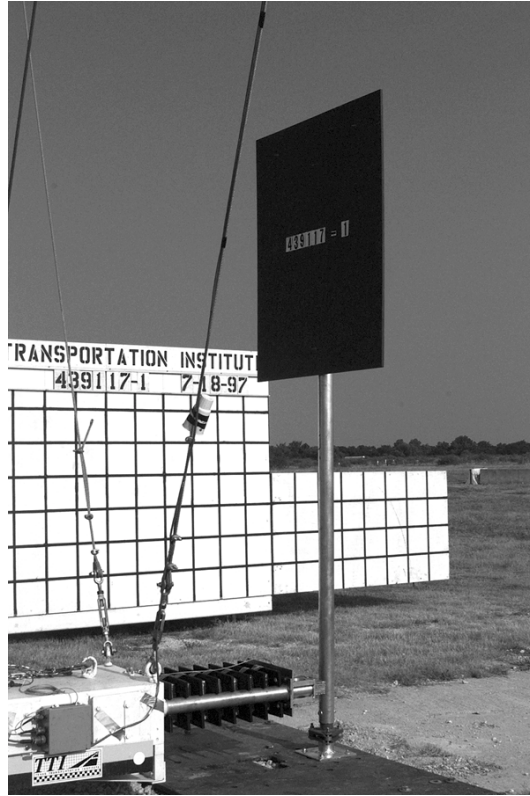
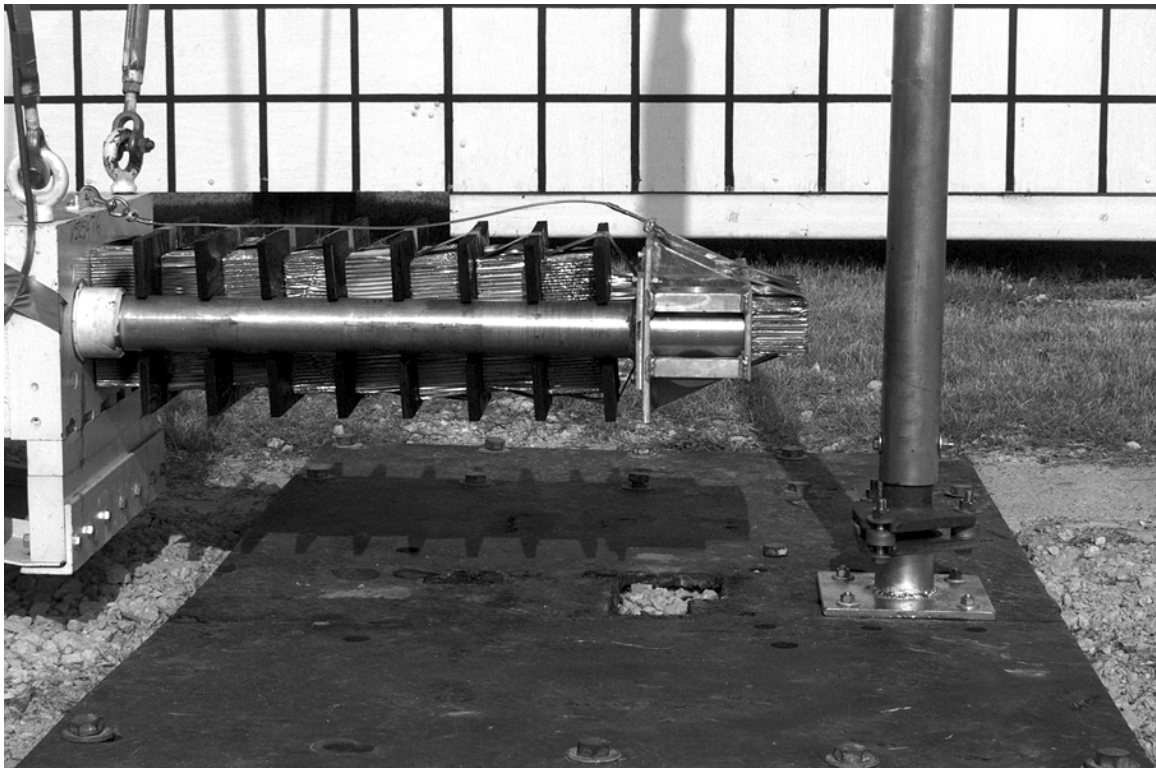
Figure 19. Typical Sign Support Installation before Pendulum Testing of Lifting Cone.

In each test, the triangular slip base was oriented such that one of the sides was perpendicular to the direction of impact. The three 16 mm diameter, high-strength bolts were tightened to a prescribed torque of 51.5 N-m. Details of the sign support installation with the different lifting cone retrofit options are shown in [Figure 18](#). Photographs of the typical sign support installation used in the pendulum tests are shown in [Figure 19](#).

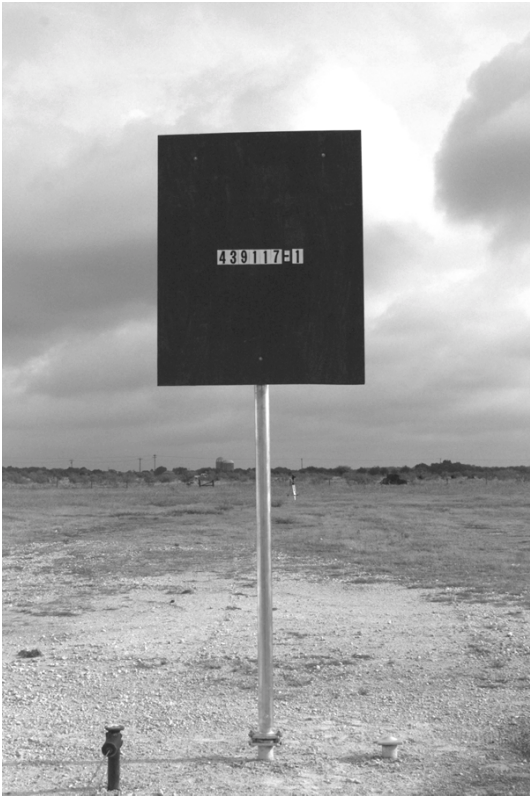
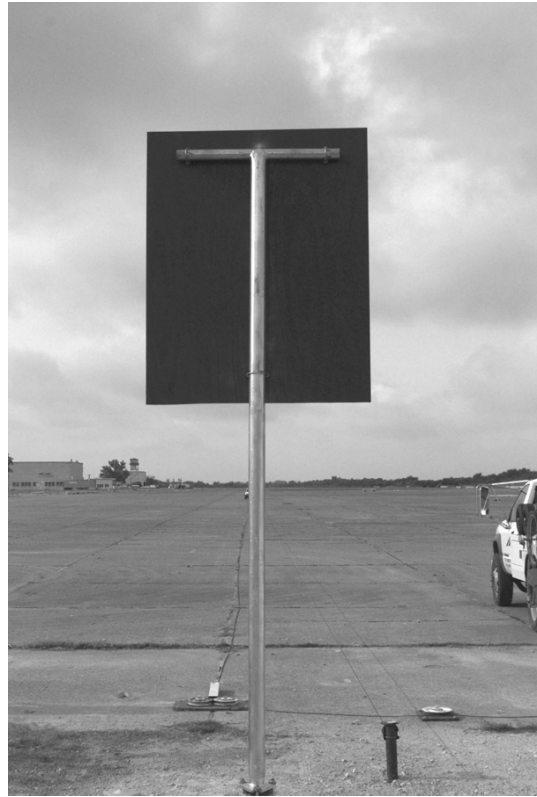
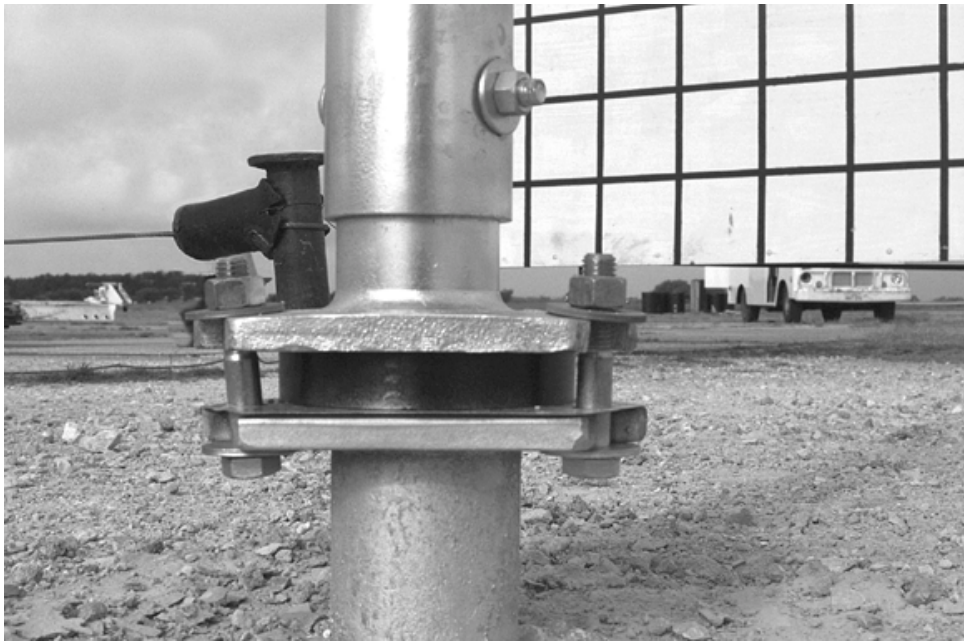
Figure 21. Installation before Test 439117-1.

The triangular slip base was oriented such that one of the sides was perpendicular to the direction of impact. The three 16 mm diameter, high-strength bolts were tightened to a prescribed torque of 51.5 N-m. Details of the test installation are shown in [Figure 20](#). [Figure 21](#) shows photographs of the sign support installation used in the low-speed crash test.

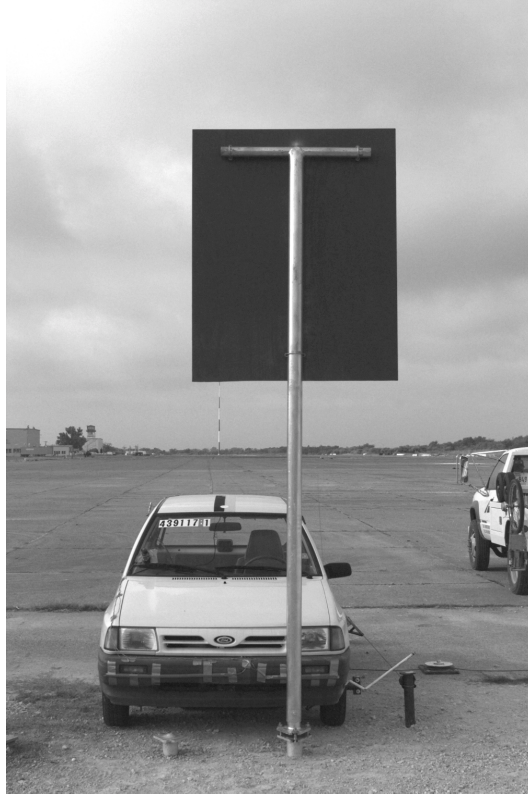
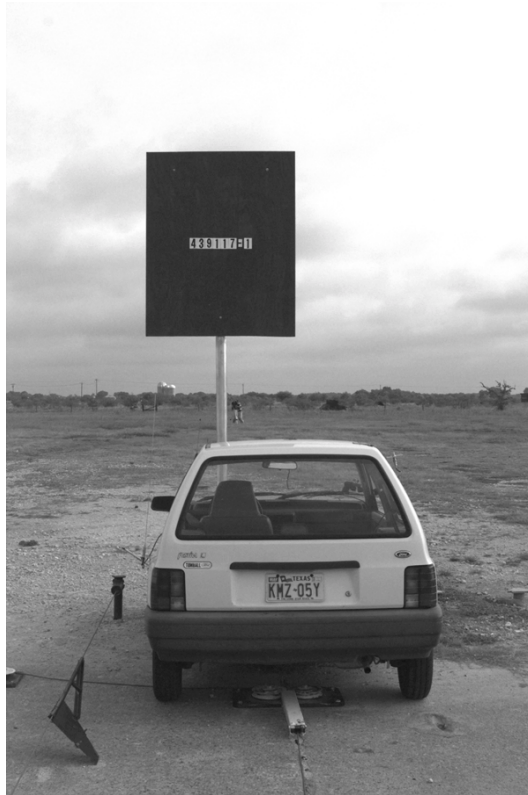
Figure 22. Vehicle/Installation Geometrics for Test 439117-1.

The crash test used a 1992 Ford Festiva, shown in [Figures 22](#) and [23](#). Test inertia weight of the vehicle was 820 kg, and its gross static weight was 896 kg. The height to the lower edge of the vehicle bumper was 410 mm, and it was 560 mm to the upper edge of the bumper. Additional dimensions and information on the vehicle are given in [Appendix C](#), [Figure 62](#). The vehicle was directed into the installation using the cable reverse tow and guidance system, and was released to be free-wheeling and unrestrained just prior to impact.

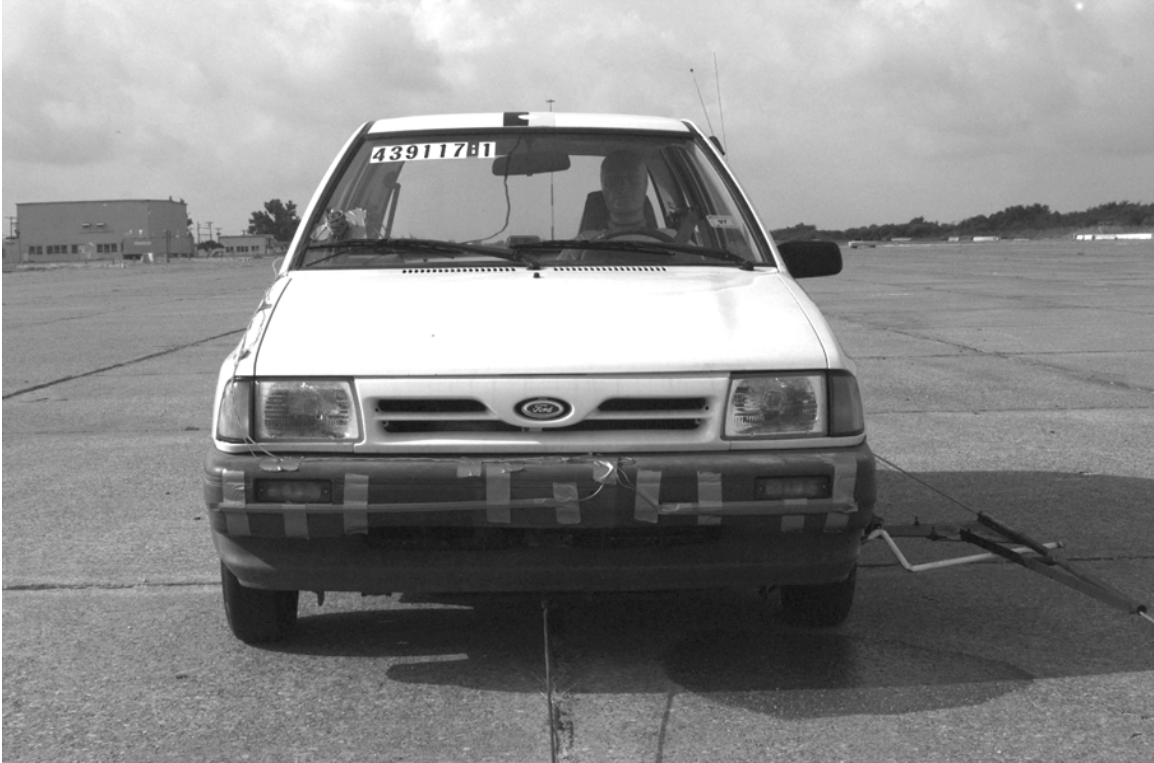
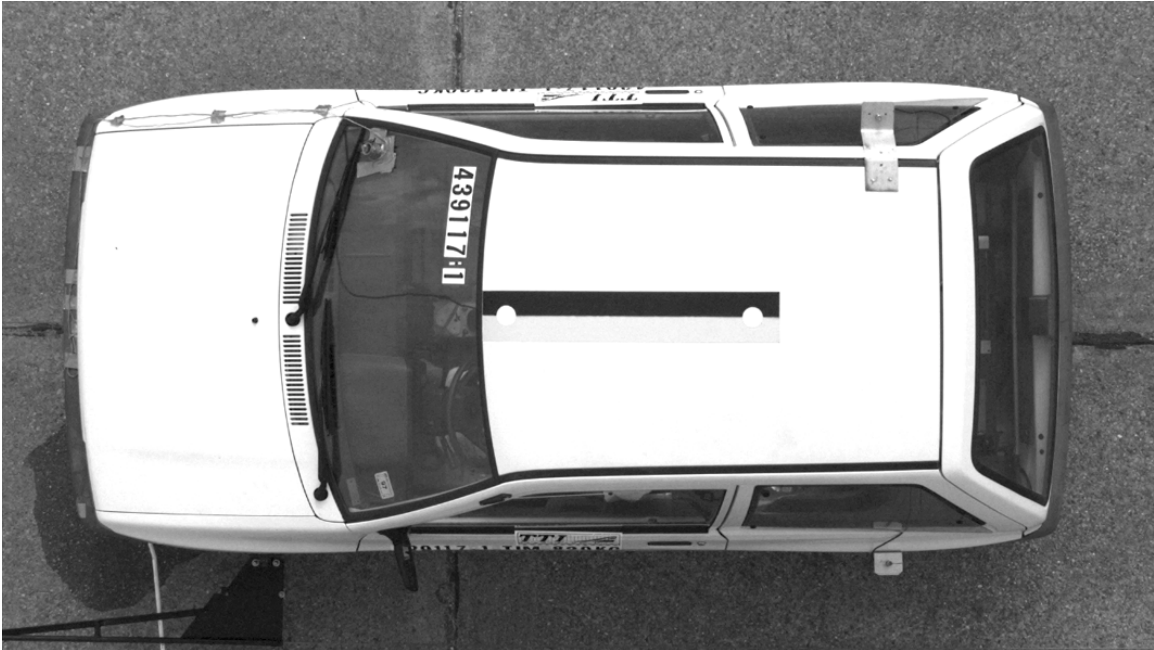
Figure 23. Vehicle before Test 439117-1.

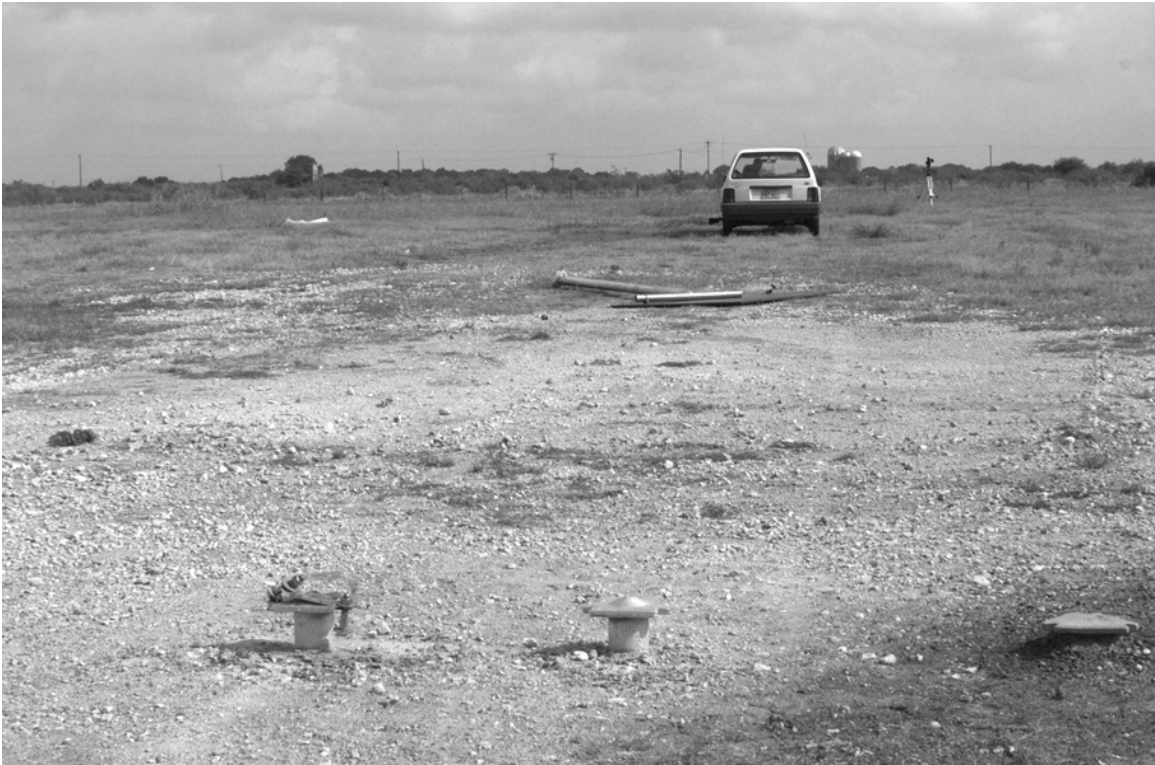
Figure 24. After Impact Trajectory for Test 439117-1.

Damage to the sign support is shown in [Figures 24](#) and [25](#). The plastic spacer ring provided the needed separation between the upper and lower slip bases to accommodate the lifting cone, and the slip base activated as designed. The keeper plate remained on the lower slip base with the two front slip bolts still attached. The rear hole of the keeper plate was torn through, and the slip bolt was thrown to the left of the impact point. The sign panel remained attached to the support with one of the upper U-bolts, and both came to rest 12.8 m down from impact and in line with the base. The plastic spacer ring was found 8.2 m down and 1.8 m to the right of the impact point. There was no movement observed at the base. All parts except the keeper plate were considered reusable.

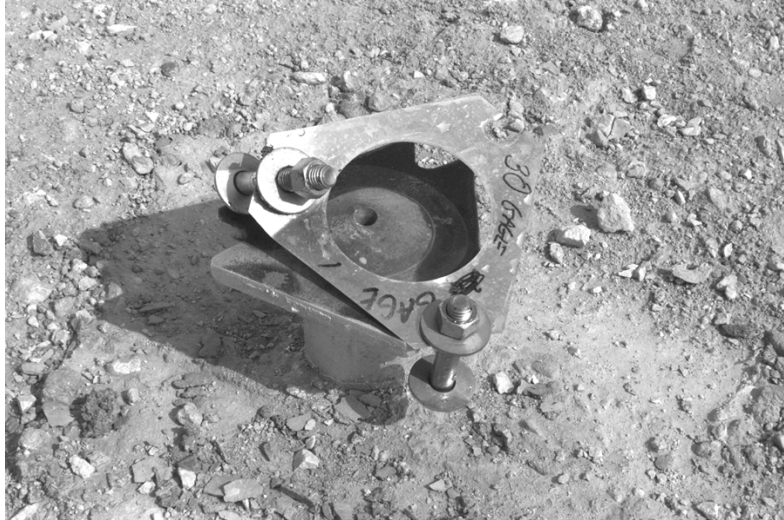
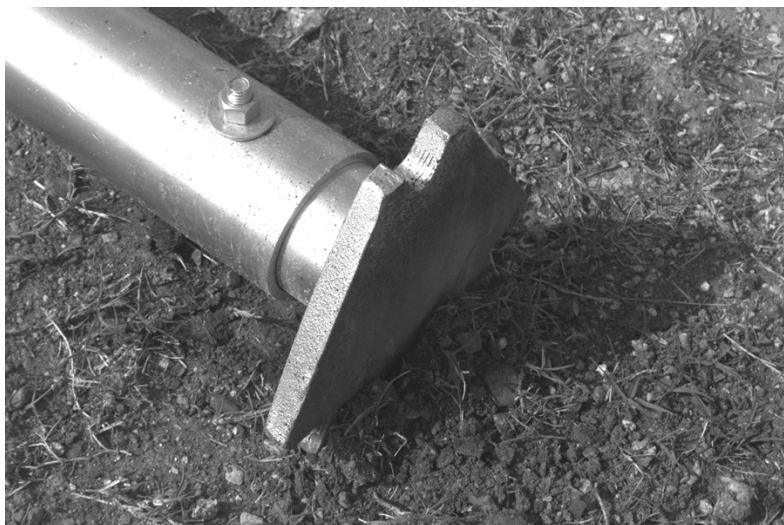
Figure 25. Installation after Test 439117-1.

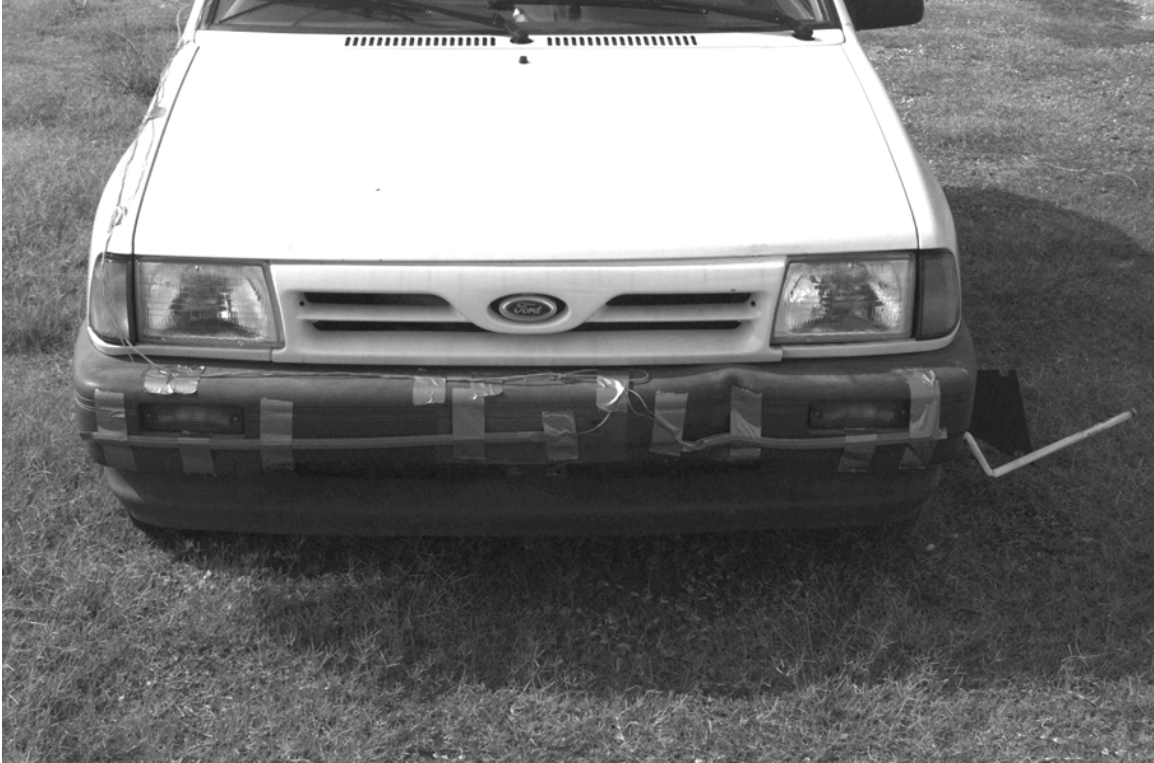
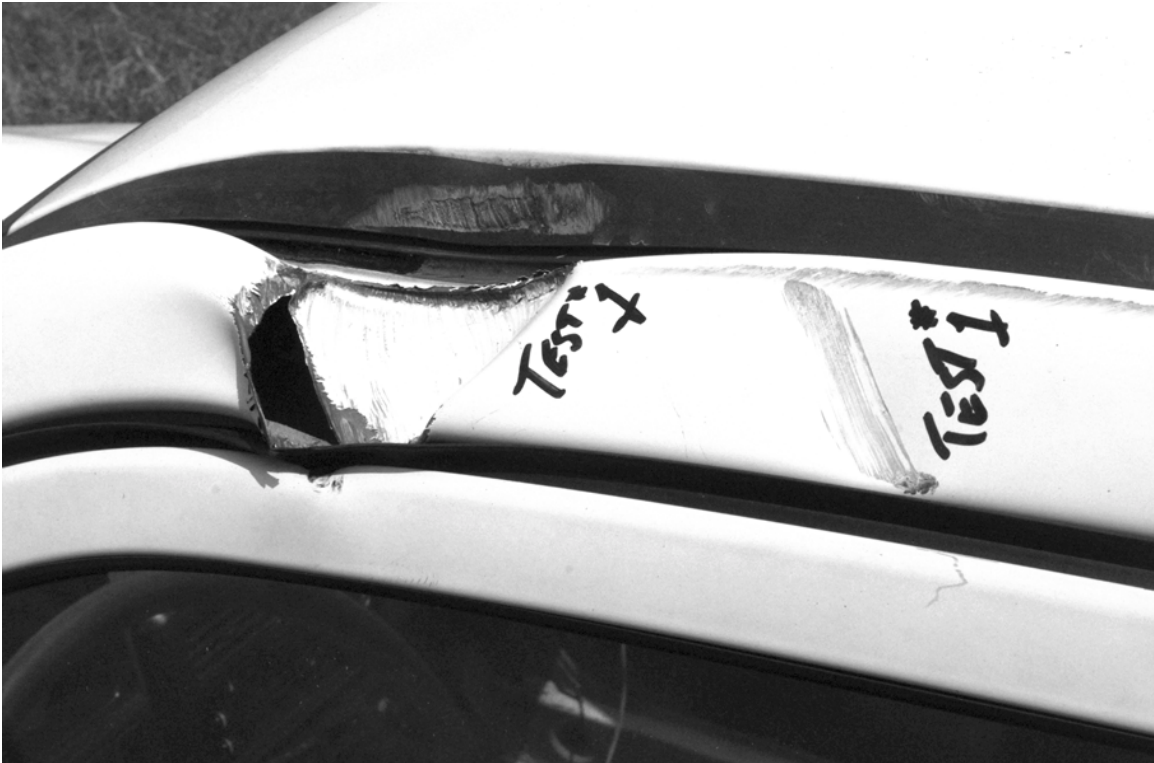
Figure 26. Vehicle after Test 439117-1.

The vehicle received only minor damage as shown in [Figure 26](#). Small scrapes on the rear roof were observed. A 20 mm deep cut in the A-pillar was noted 70 mm back from the windshield. Maximum exterior crush to the left side at bumper height was 40 mm from contact with the support. There was no deformation or intrusion into the occupant compartment.
