1. Report No. TX-01/3911-S		2. Government Accession No.		3. Recipient's Catalog No.	
4. Title and Subtitle EVALUATION OF DESIGN AND RETROFIT CONCEPTS FOR SLIP-BASE SIGN SUPPORT SYSTEMS				5. Report Date February 2001

**EVALUATION OF DESIGN AND RETROFIT CONCEPTS
FOR SLIP-BASE SIGN SUPPORT SYSTEMS**

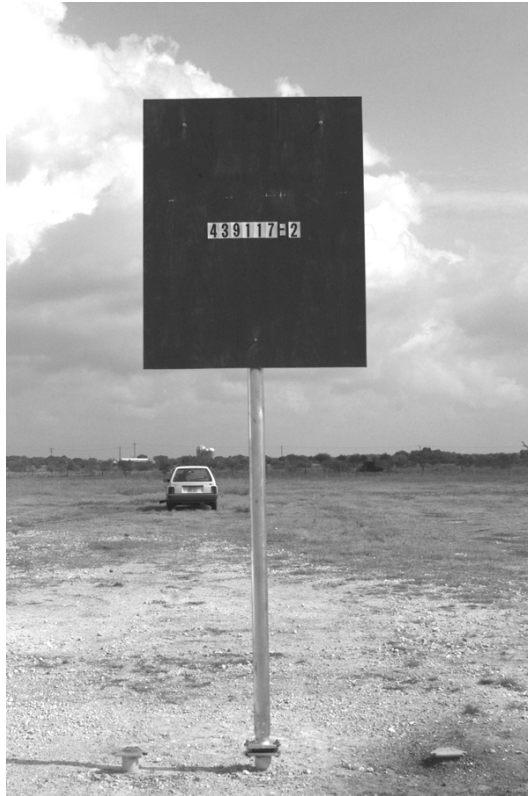
Figure 28. Sign Support Installation before Test 439117-2.

The test installation was identical to that impacted in the previous low-speed test (test 439117-1). A schematic of the test installation is shown in [Figure 20](#). Photographs of the completed sign support system are shown in [Figure 28](#).

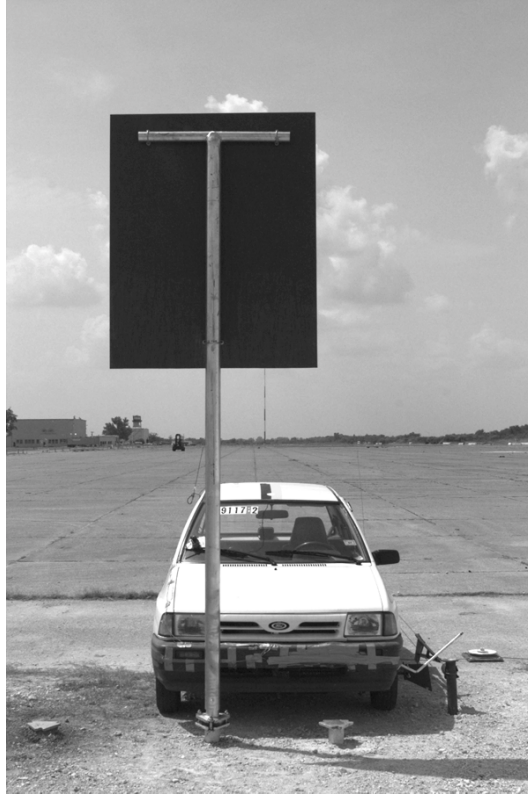
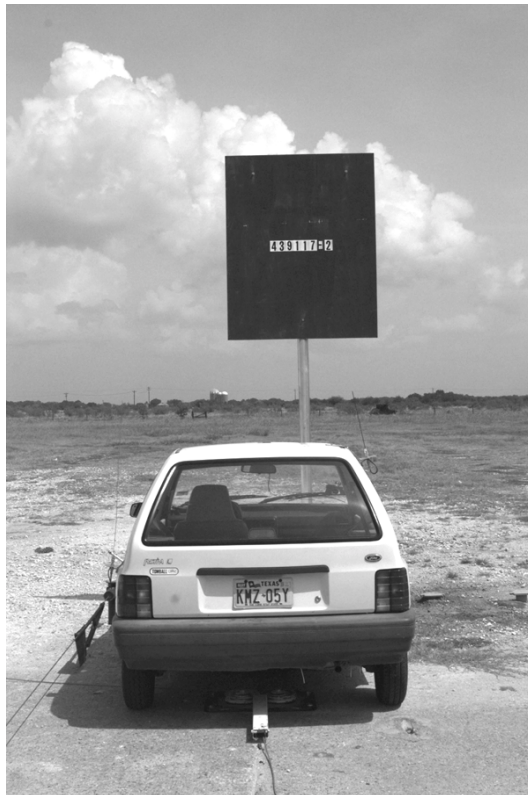
Figure 29. Vehicle/Installation Geometries for Test 439117-2.

The high-speed test reused the same 1992 Ford Festiva used in the low-speed test (test 439117-1). The condition of the vehicle prior to the test is shown in [Figures 29 and 30](#). Test inertia weight of the vehicle was 820 kg, and its gross static weight was 896 kg. Additional dimensions and information on the vehicle are given in Appendix C, [Figure 62](#). The vehicle was directed into the installation using the cable reverse tow and guidance system, and was released to be free-wheeling and unrestrained just prior to impact.

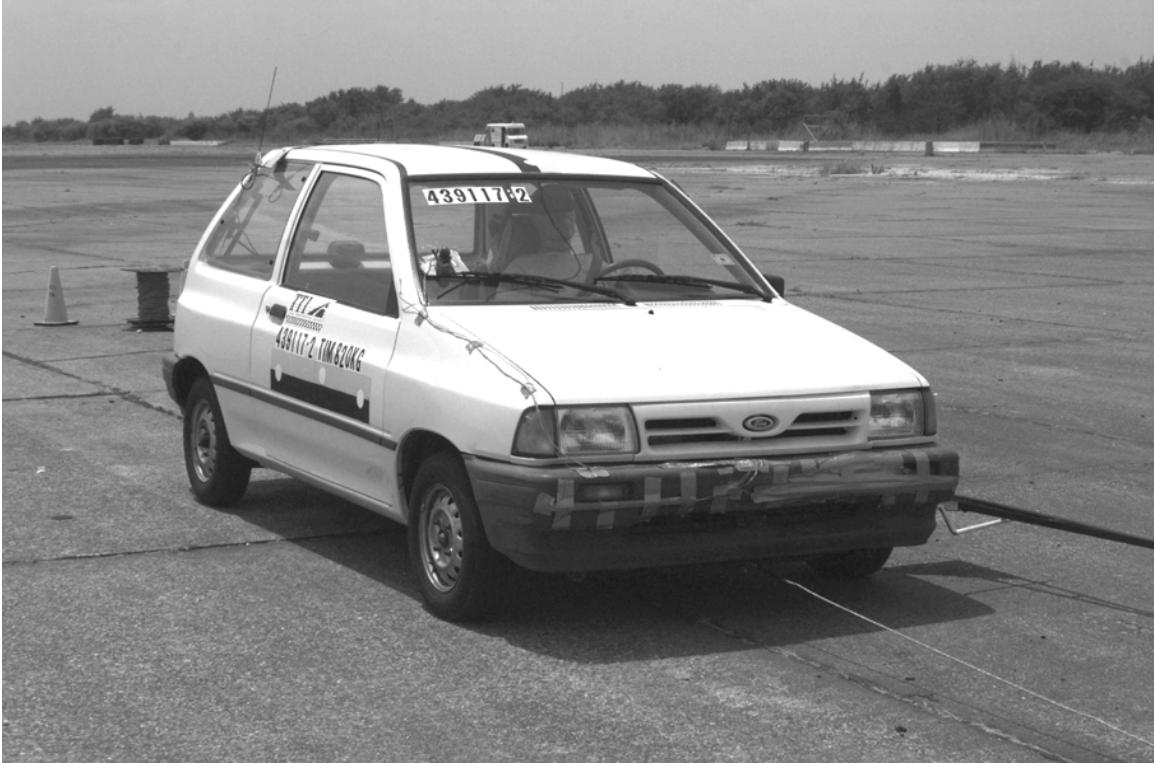
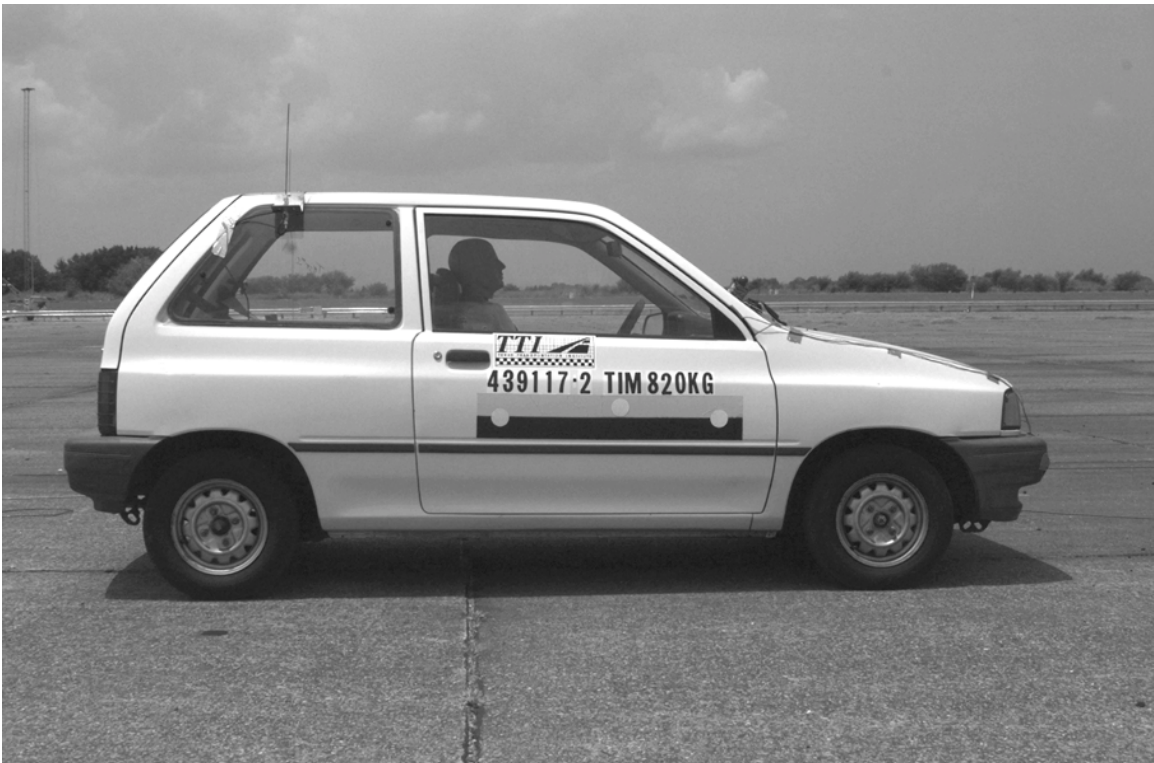
Figure 30. Vehicle before Test 439117-2.

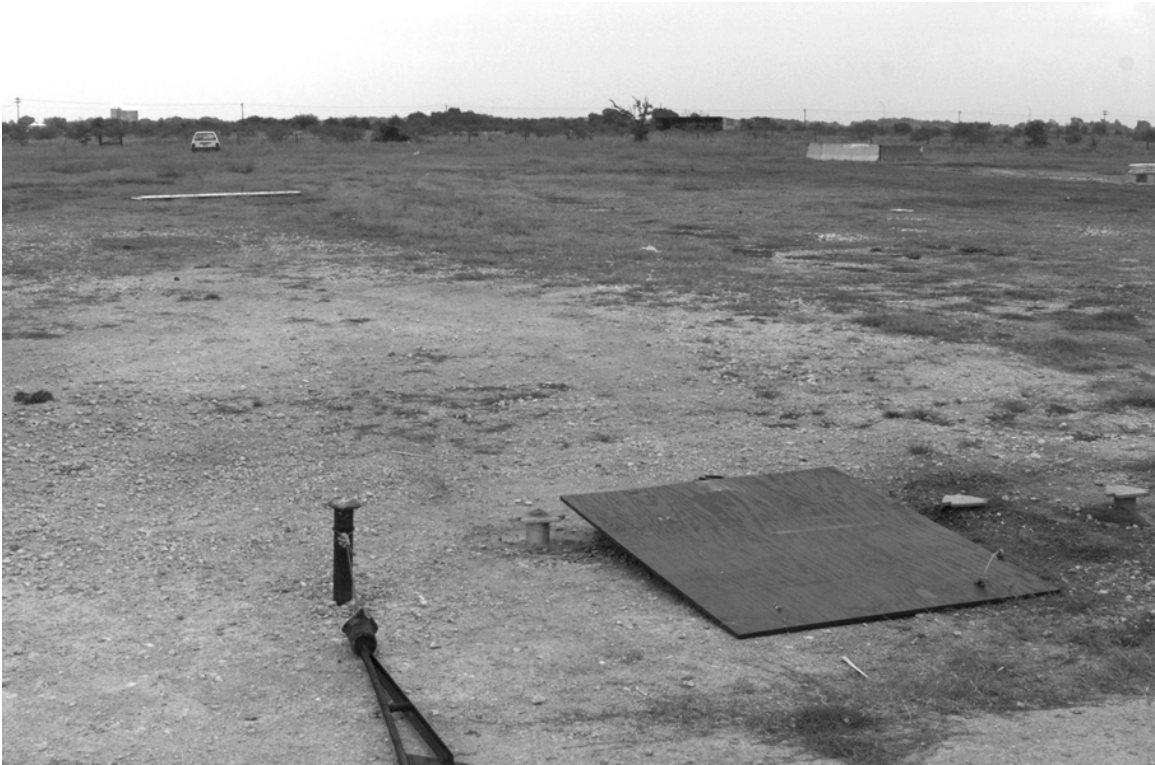
Figure 31. After Impact Trajectory for Test 439117-2.

Damage to the sign support structure was minimal as shown in [Figures 31 and 32](#). The spacer ring functioned as designed and allowed the slip base to activate. All three slip bolts tore through the keeper plate, and the keeper plate, plastic spacer ring, and slip bolts were found in proximity to the base. No movement of the base foundation was observed. The plywood sign panel detached from the support came to rest over the lower slip base. The support post came to rest 32.0 m down and in line with the base. All parts were reusable except for the keeper plate.

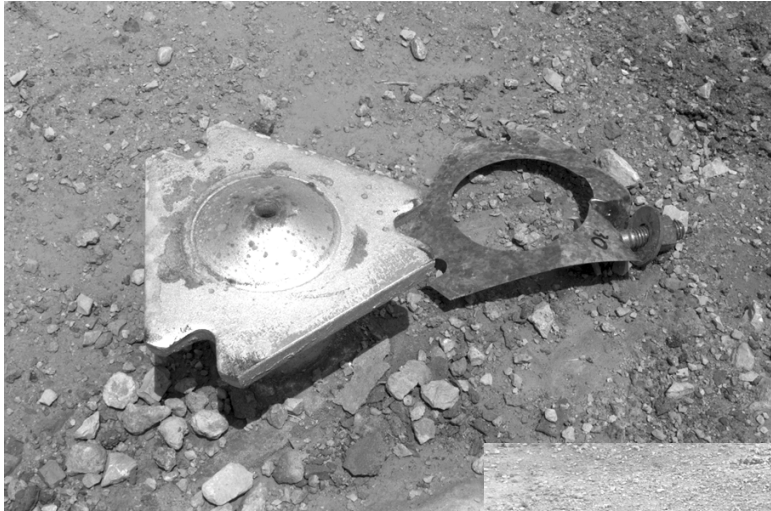
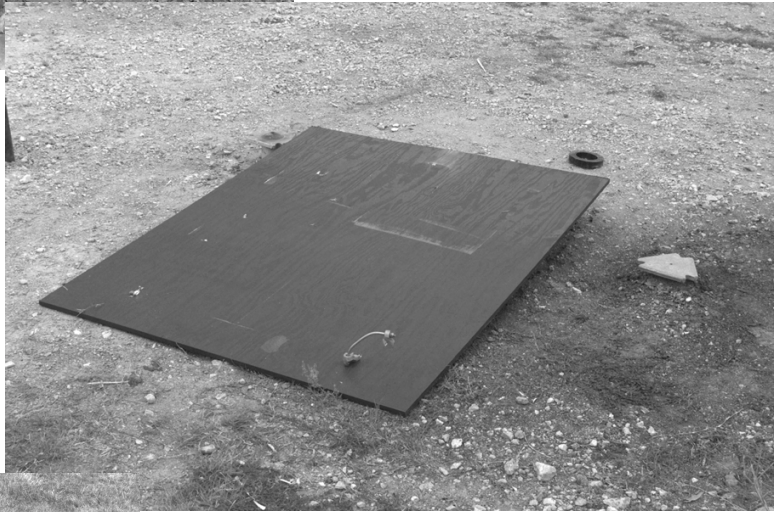
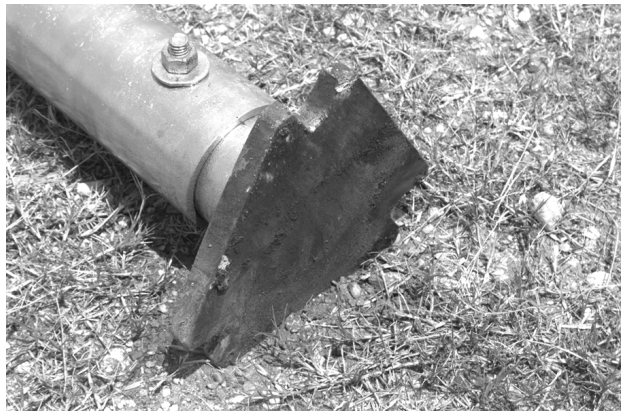
Figure 32. Installation after Test 439117-2.

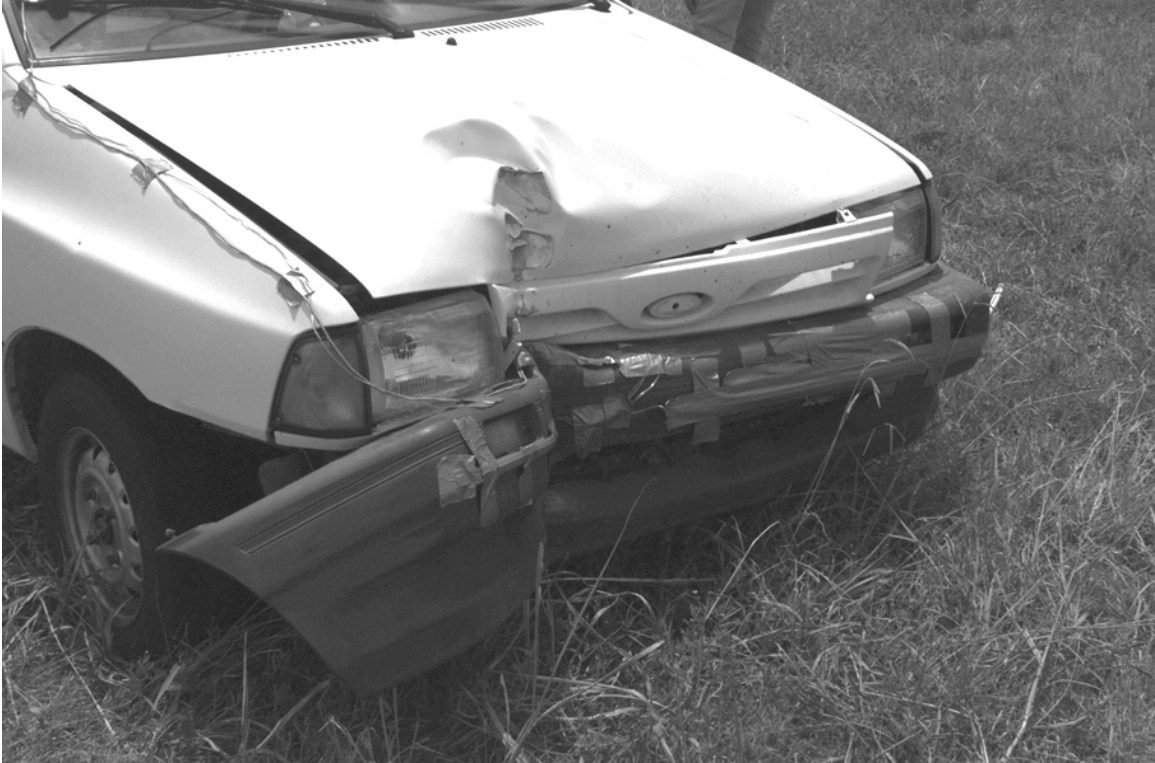
Figure 33. Vehicle after Test 439117-2.

The vehicle received damage to both bumpers, the hood, and the grill, as shown in [Figure 33](#). The hood was dented 215 mm to the right of its centerline, approximately 190 mm from the front of the vehicle. Maximum exterior crush to the vehicle at bumper height was 190 mm. There was no deformation or intrusion into the occupant compartment.

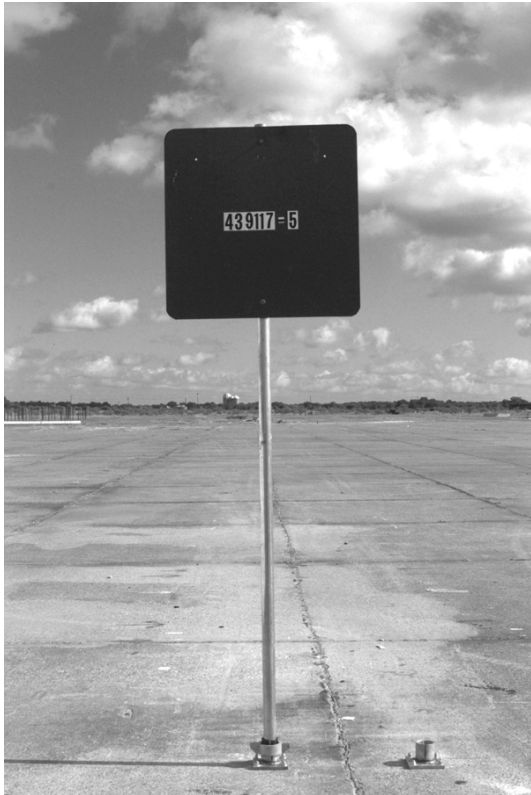
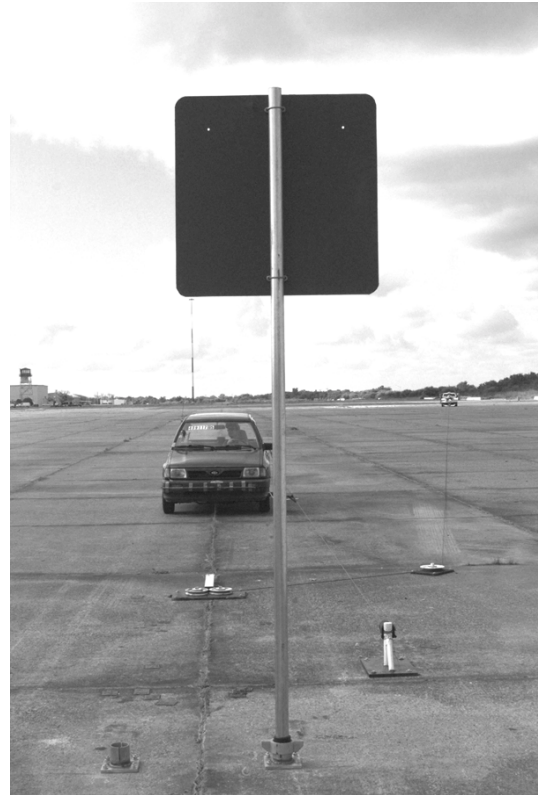
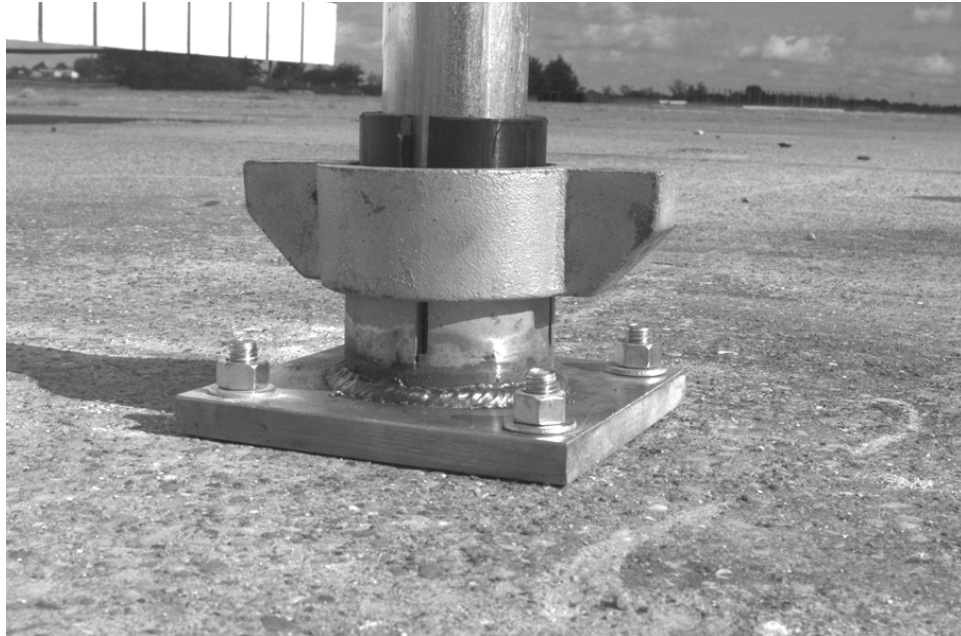
Figure 36. Sign Support Installation before Test 439117-5.

The anchor plate assembly was anchored to an existing concrete apron using four 13 mm diameter × 146 mm long carbon steel hex-head Rawl-Bolt anchors (Rawl Cat. No. 6936). The concrete apron is approximately 200 mm thick and is not reinforced. A 13 mm diameter drill bit was used to core the holes in the concrete apron for the mechanical anchors. These holes were drilled slightly deeper than the 102 mm anchor embedment to ensure adequate penetration for the bolts. After the holes were drilled, the holes were cleaned with a round wire brush and compressed air to remove the dust and any loose material. After cleaning, the anchor bolts were driven through the holes in the base plate and into the anchor holes until the bolt heads were firmly seated against the base plate. The anchors were then tightened by turning the bolt heads approximately three to four turns or until adequate hand torque was obtained. Additional details of the test assembly are shown in [Figure 35](#). Photographs of the completed test installation prior to the test are shown in [Figure 36](#).

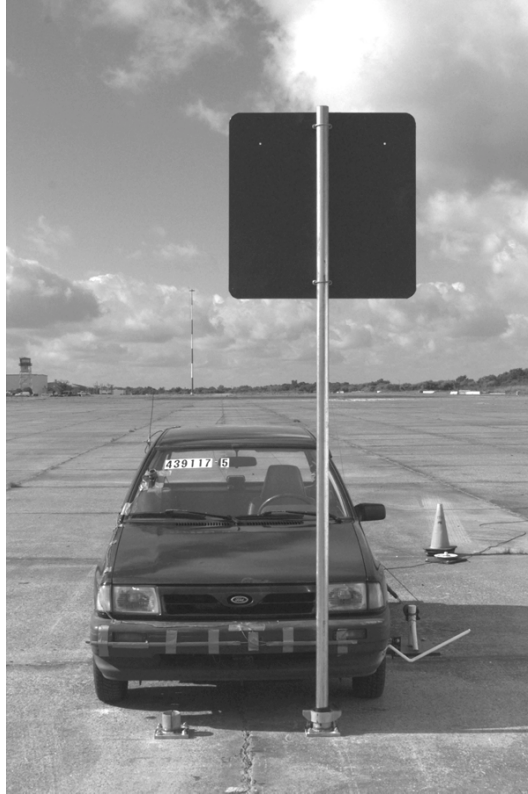
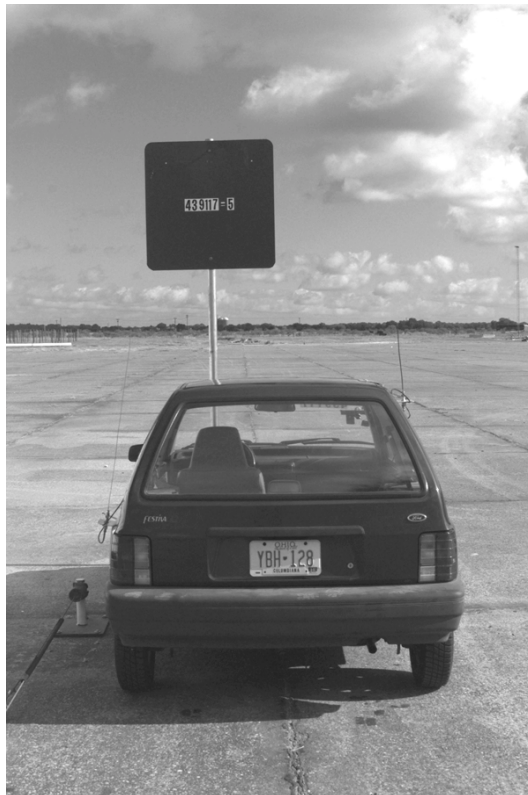
Figure 37. Vehicle/Installation Geometrics for Test 439117-5.

A 1991 Ford Festiva, shown in [Figures 37](#) and [38](#), was used for the crash test. Test inertia weight of the vehicle was 870 kg, and its gross static weight was 896 kg. The height to the lower edge of the vehicle bumper was 390 mm, and it was 590 mm to the upper edge of the bumper.

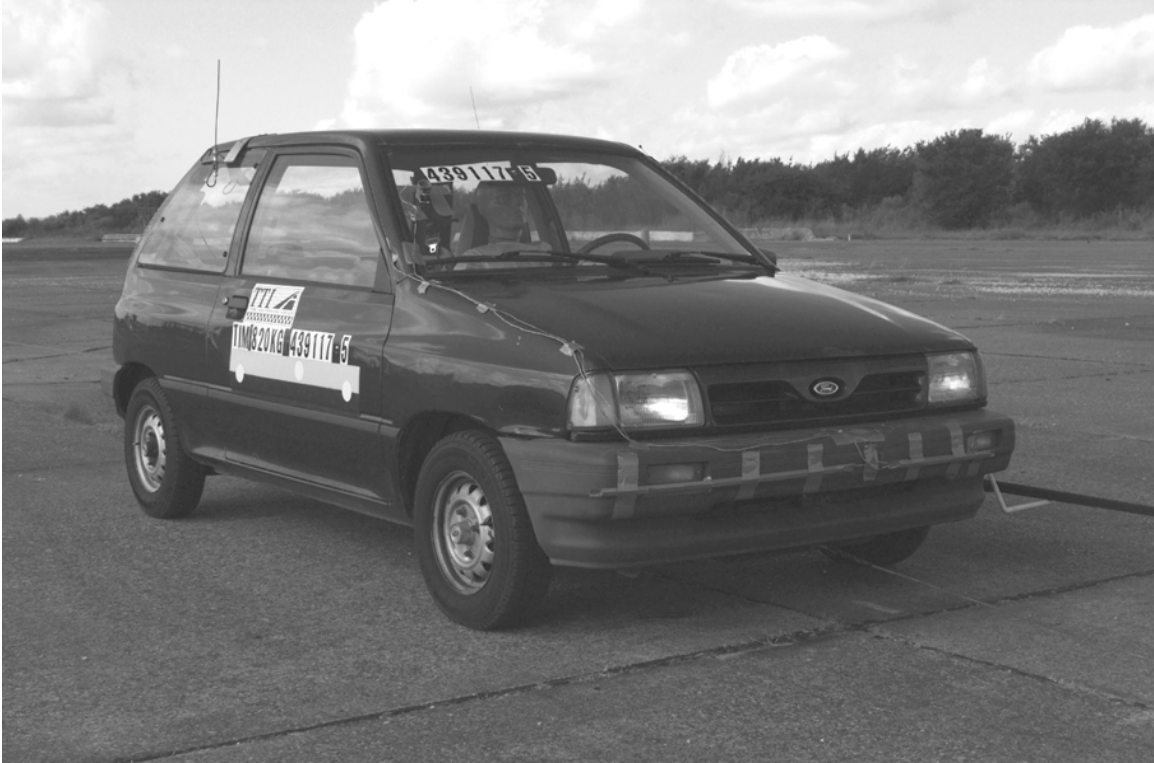
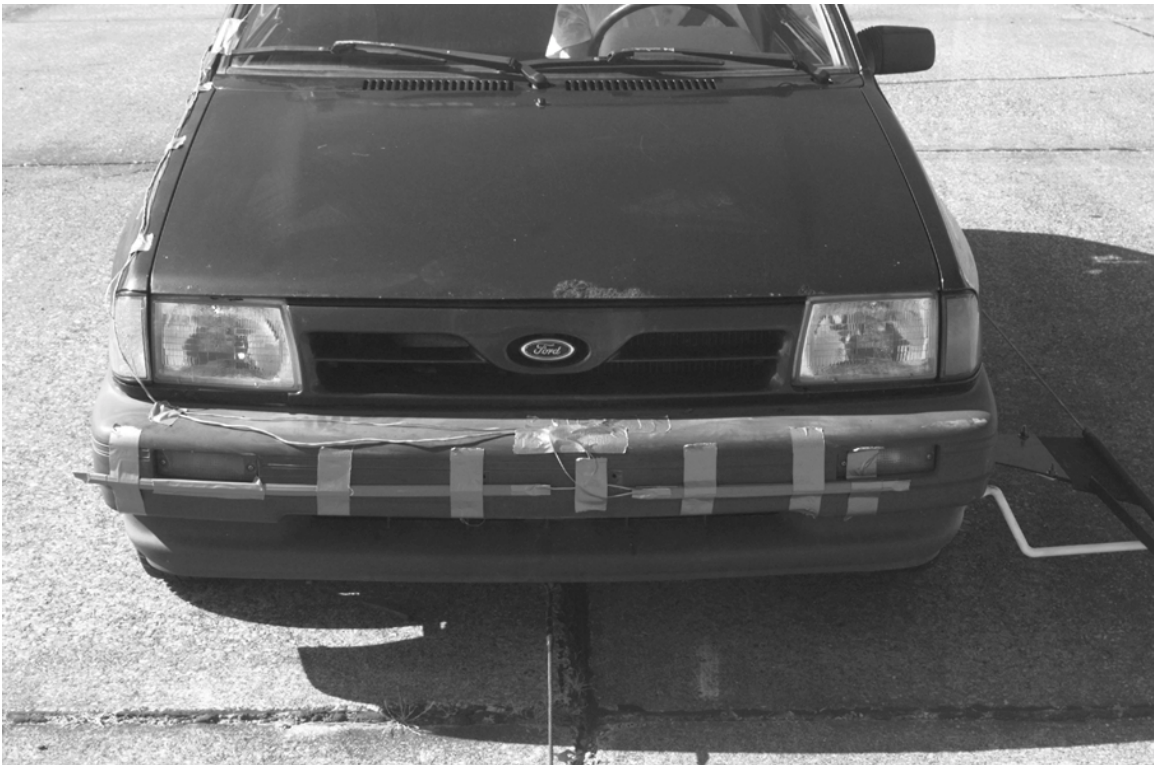
Figure 38. Vehicle before Test 439117-5.

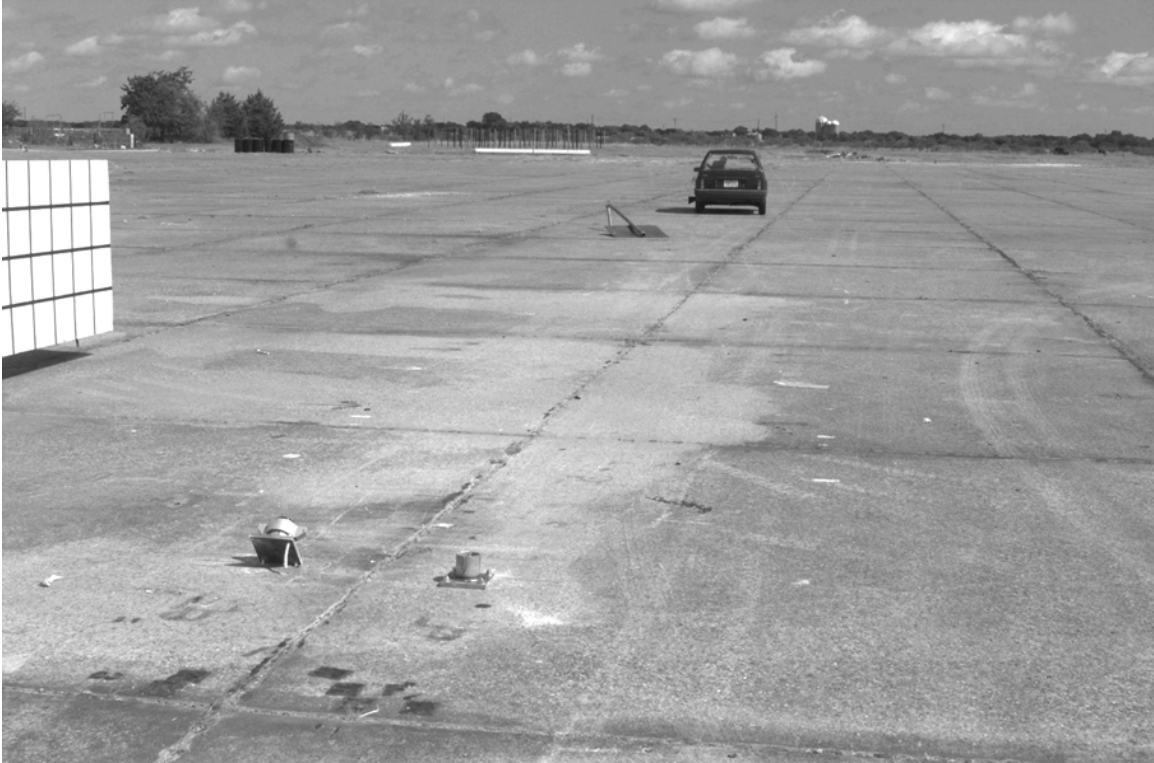
Figure 39. After Impact Trajectory for Test 439117-5.

The anchor bolts on the impact side completely pulled out of the concrete as shown in [Figures 39](#) and [40](#). The rear anchors were bent back and deformed. The plastic spacer insert and anchor cap remained attached to the base. The support post was bent 420 mm from the end. The sign support and attached panel came to rest 22.9 m from the point of impact.

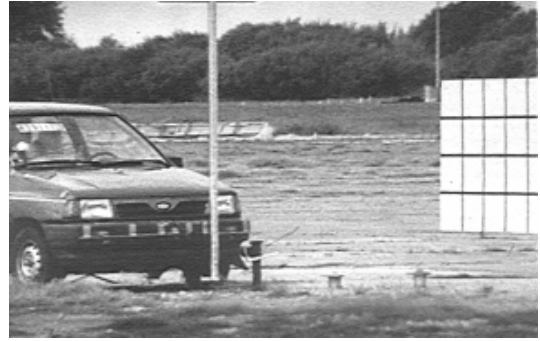
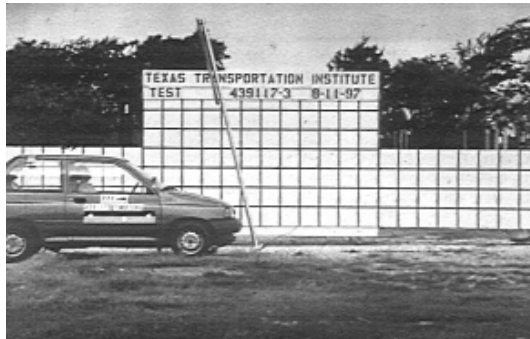
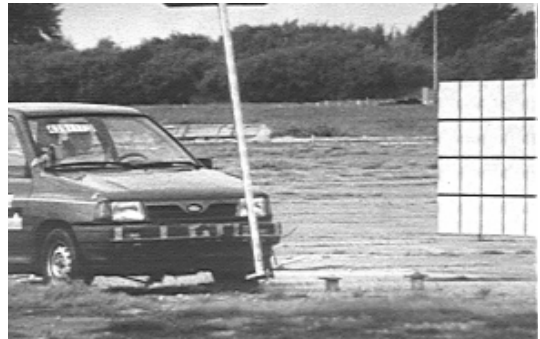
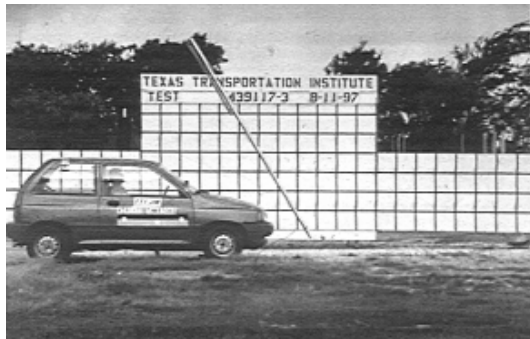
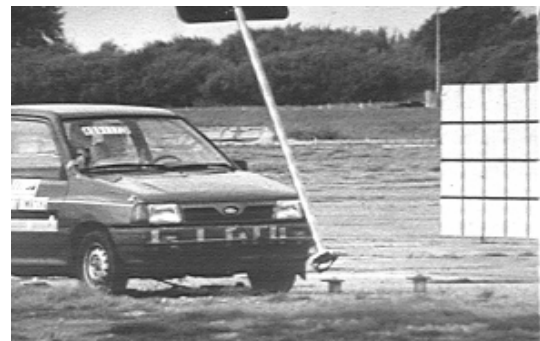
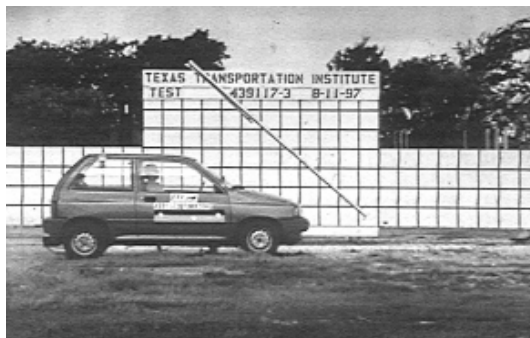
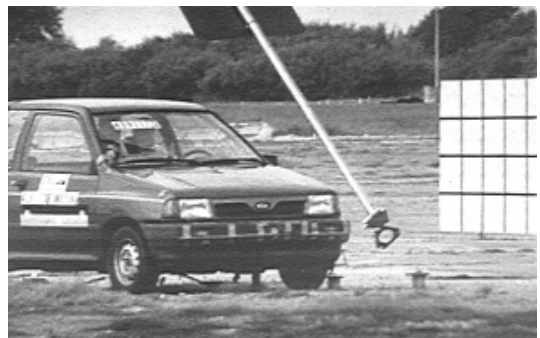
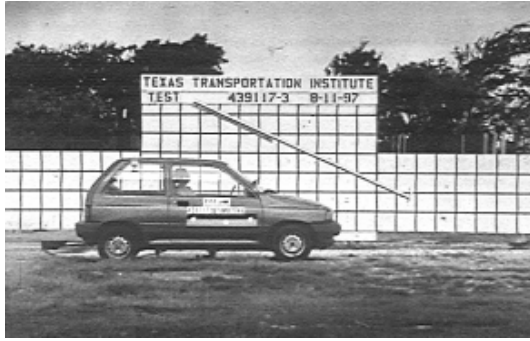
**Figure 64. Sequential Photographs for Test 439117-3
(Perpendicular and Oblique Views).**

The vehicle, traveling at 37.35 km/h, impacted the sign support at 0 degrees with the left quarter point of the vehicle aligned with the sign support. The support began to slip away from the base at 0.009 s and lost contact with the base at 0.024 s. At 0.034 s the support lost contact with the vehicle at which time the vehicle was traveling at 34.00 km/h. The middle and upper portions of the sign came in contact with the frontal and mid sections of the vehicle's roof at 0.257 s. The sign, with the support still attached, bounced off the roof at 0.330 s. The vehicle was traveling at 33.41 km/h at loss of contact with the sign support. The support, with sign panel still attached, came to rest 22.9 m downstream and 1.8 m to the left of the point of impact. Brakes on the vehicle were applied 2.0 s after impact, and the vehicle subsequently came to rest 45.8 m downstream from the impact point. Sequential photographs of the test period are shown in Appendix D, Figure 64.

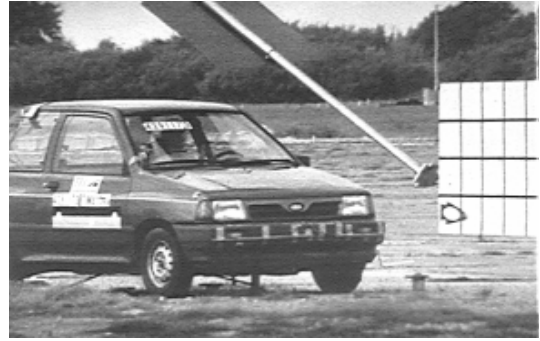
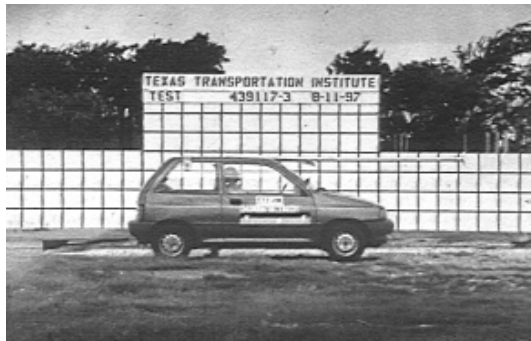
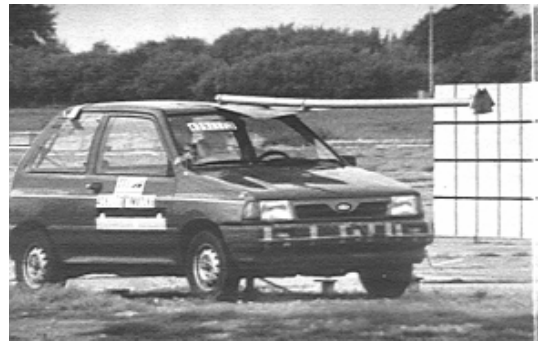
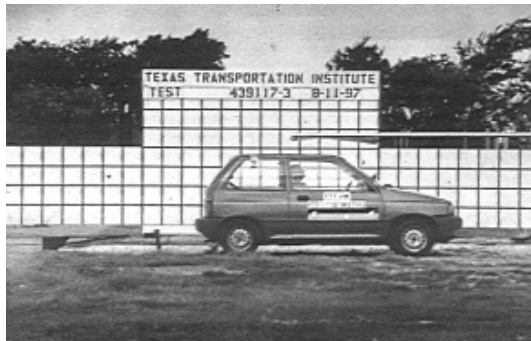
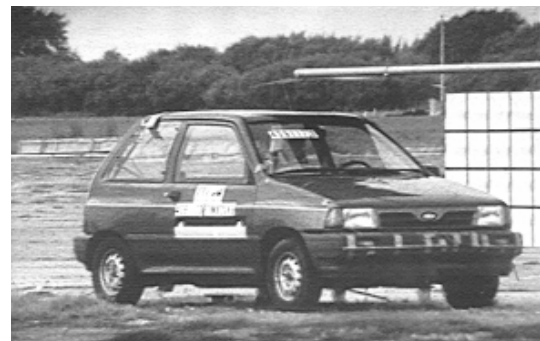
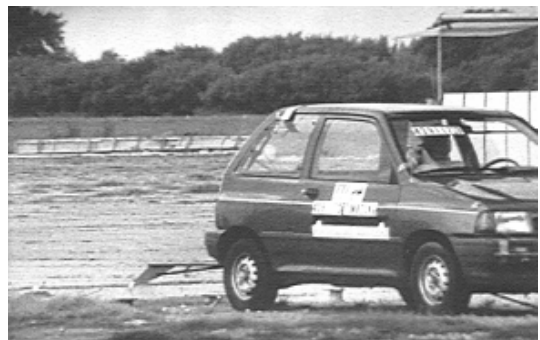
Figure 64. Sequential Photographs for Test 439117-3 (Perpendicular and Oblique Views) (Continued).

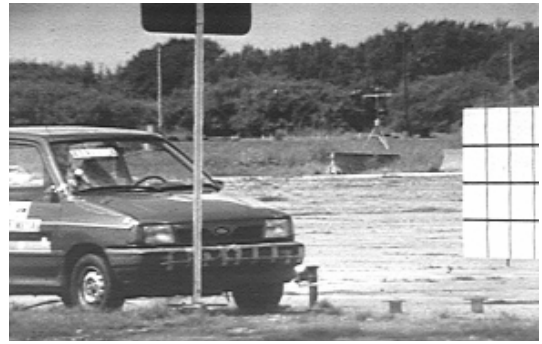
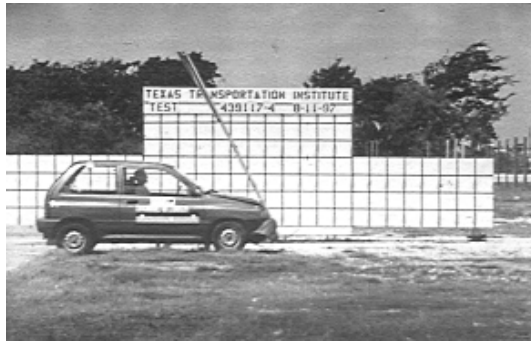
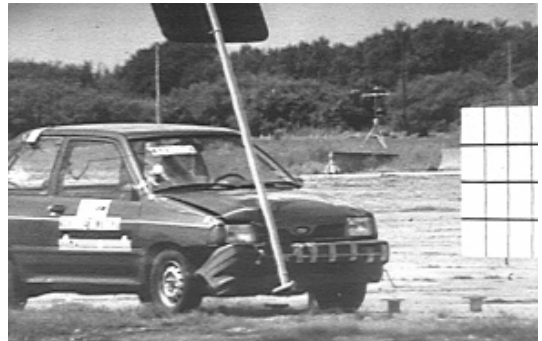
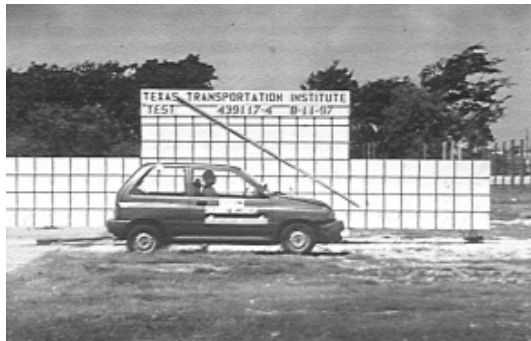
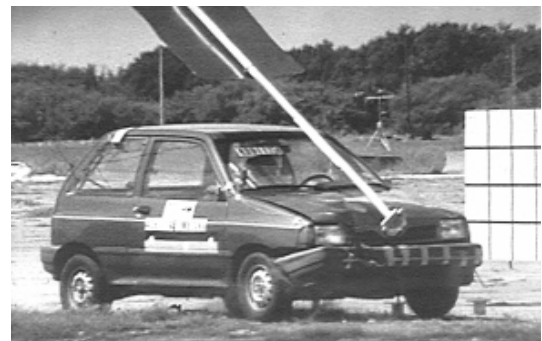
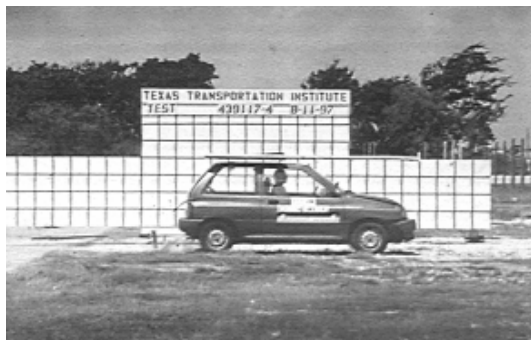
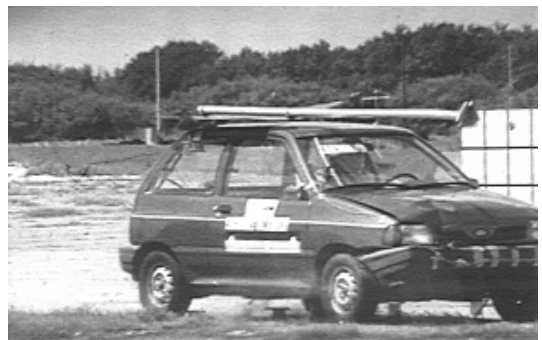
Figure 65. Sequential Photographs for Test 439117-4 (Perpendicular and Oblique Views).

The vehicle, traveling at 99.83 km/h, impacted the slip-base sign support at 0 degrees with the right quarter point of the vehicle aligned with the support. Upon impact, the two slip bolts on the impact side of the slip base tore through the 26 gauge keeper plate, allowing the sign support to break away from its base. After initially losing contact with the vehicle, the sign support contacted the front of the vehicle a second time at 0.046 s. At 0.119 s, the rotating sign support and sign panel contacted the rear of the vehicle's roof. The sign support lost contact with the vehicle at 0.156 s. At this time, the speed of the vehicle had been reduced to 97.67 km/h. The deformed sign support came to rest approximately 38.1 m downstream and 0.3 m to the right of the point of impact. Brakes on the vehicle were applied 2.0 s after impact, and the vehicle subsequently came to rest 122.6 m downstream and 1.8 m to the right of the point of impact. Sequential photographs of the test period are shown in Appendix D, [Figure 65](#).

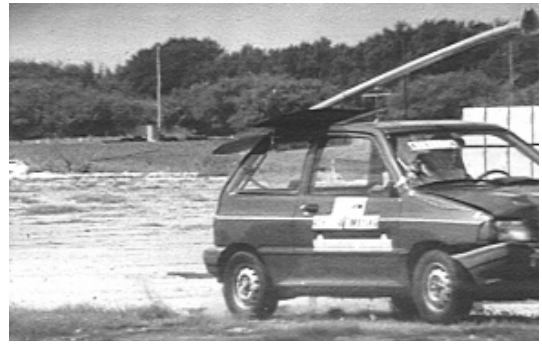
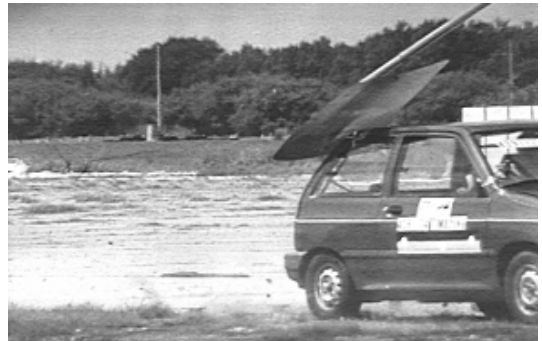
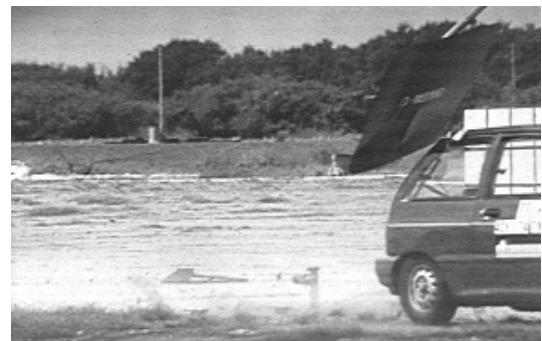
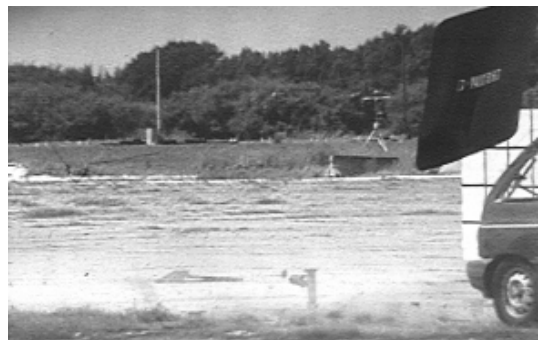
Figure 65. Sequential Photographs for Test 439117-4 (Perpendicular and Oblique Views) (Continued).

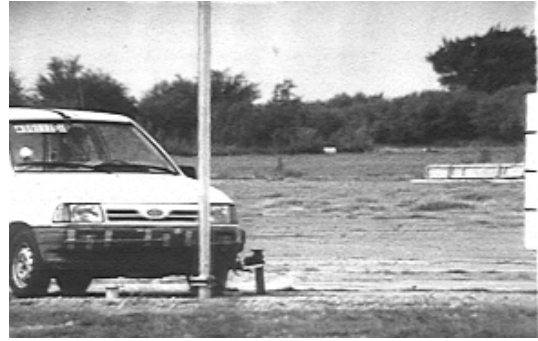
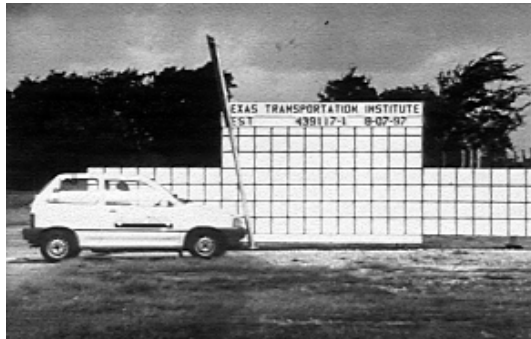
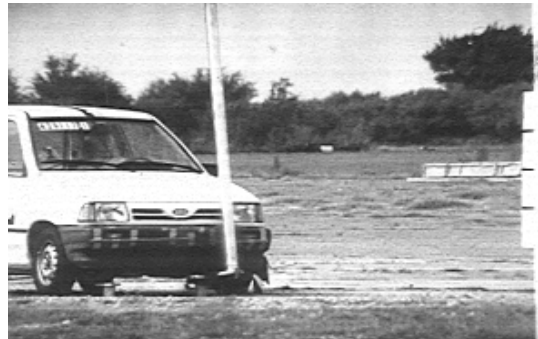
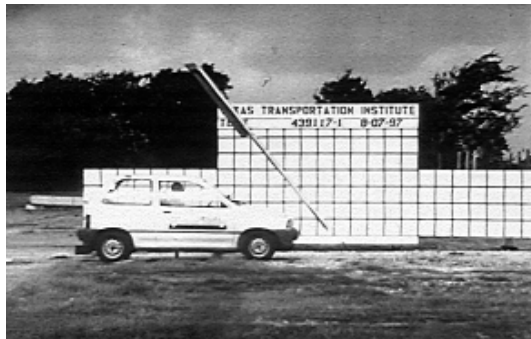
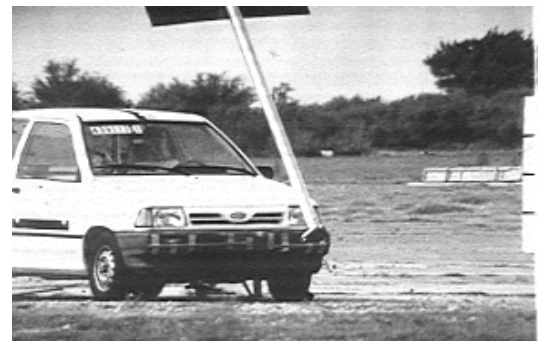
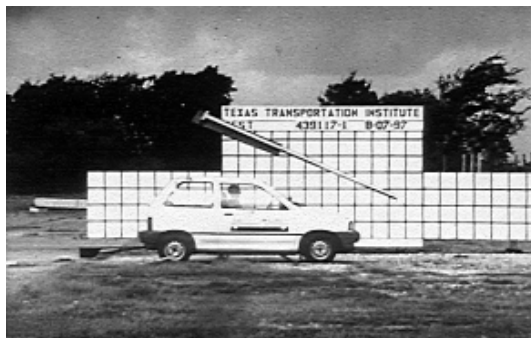
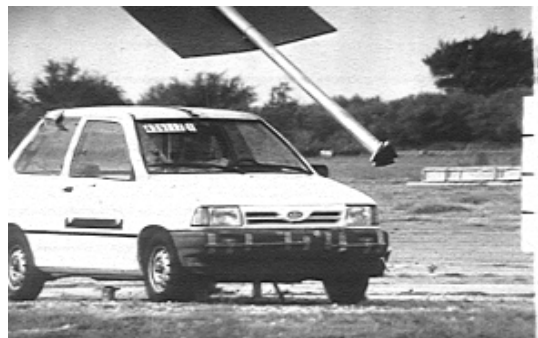
**Figure 66. Sequential Photographs for Test 439117-1
(Perpendicular and Oblique Views).**

The vehicle, traveling at 35.66 km/h, impacted the slip-base sign support at the left quarter point at 0 degrees. Shortly after impact the support and attached sign panel began to separate from the lower slip base. By 0.026 s, the support had completely detached from and cleared the lower base. At 0.326 s, the right side of the sign panel briefly contacted the vehicle's roof. The upper section of the sign panel came in contact with the rear roof section of the vehicle at 0.352 s. Shortly afterwards, the sign panel rebounded off the vehicle, and the support and panel dropped down along the driver's side. At loss of contact with the support, the vehicle was traveling at a speed of 32.31 km/h and continued in a straight path. Brakes on the vehicle were applied at 2.0 s after impact and the vehicle subsequently came to rest 33.5 m downstream from the point of impact. Sequential photographs of the impact period are shown in Appendix D, [Figure 66](#).

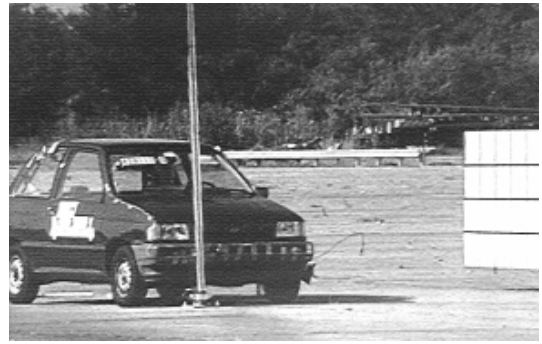
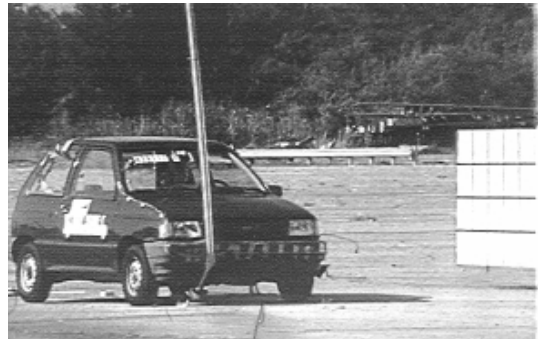
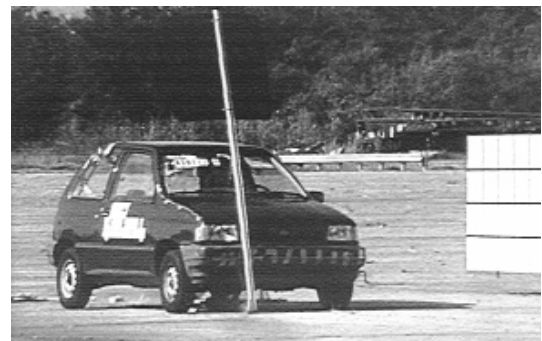
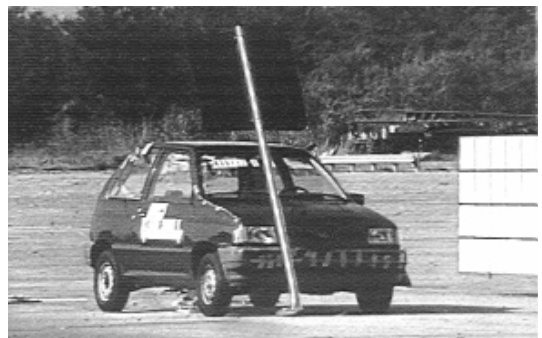
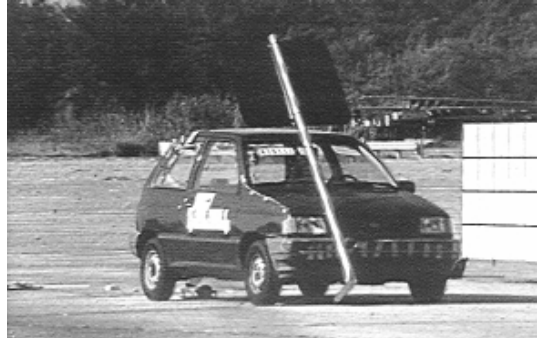
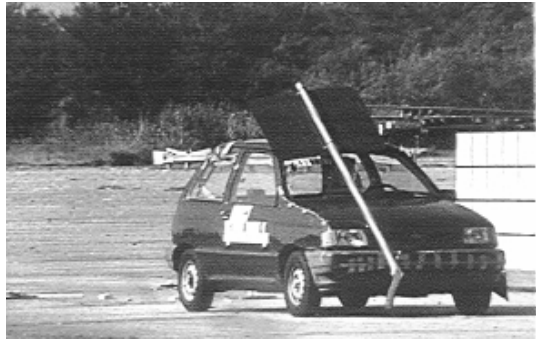
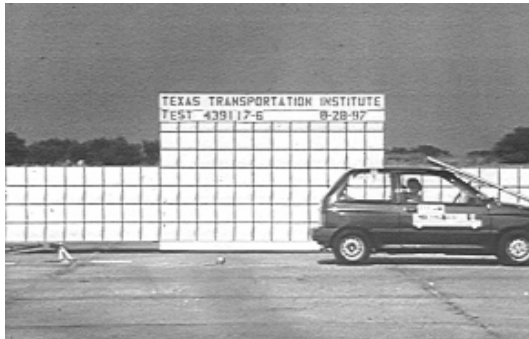
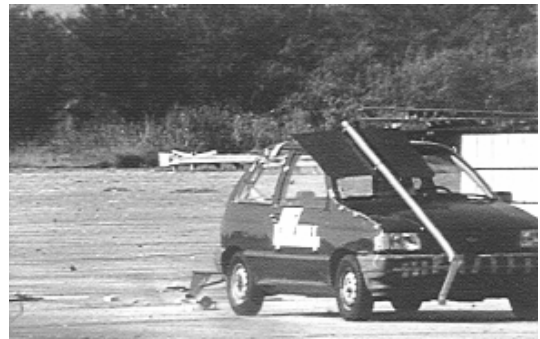
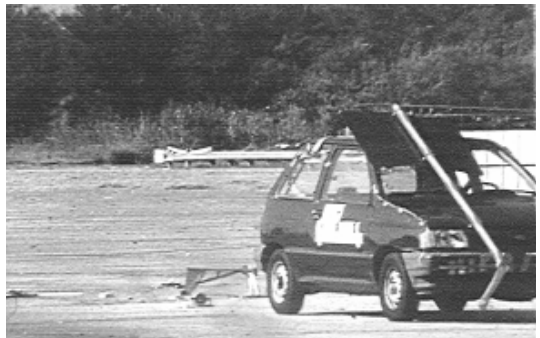
Figure 69. Sequential Photographs for Test 439117-6 (Perpendicular and Oblique Views).

Figure 69. Sequential Photographs for Test 439117-6 (Perpendicular and Oblique Views) (Continued).

The vehicle, traveling at 34.69 km/h, impacted the sign support at 0 degrees with the right quarter point of the vehicle aligned with the support. Shortly after impact the post began to move. At 0.014 s the base plate started to pull up. By 0.036 s the support began to deform at bumper height, and by 0.061 s the support had pulled out of the base. The support rotated around the front end of the vehicle and lightly contacted the vehicle's hood. At 0.565 s, the sign panel contacted the upper windshield and roof of the vehicle. The speed of the vehicle at this point in time was 27.12 km/h. Vehicle brakes were applied 4.55 s after impact, and the vehicle came to rest 35.07 m down from and 2.75 m to the right of the impact point. The sign and attached panel came to rest 1.22 m in front of the vehicle. Sequential photographs of the test period are shown in [Appendix D, Figure 69](#).

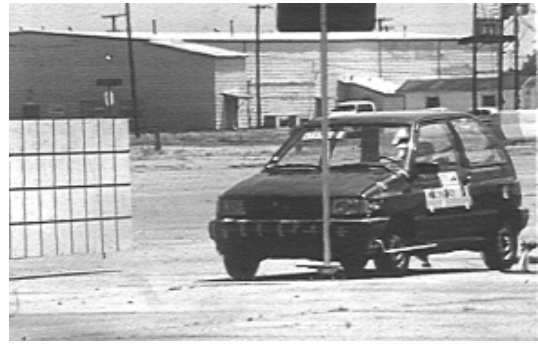
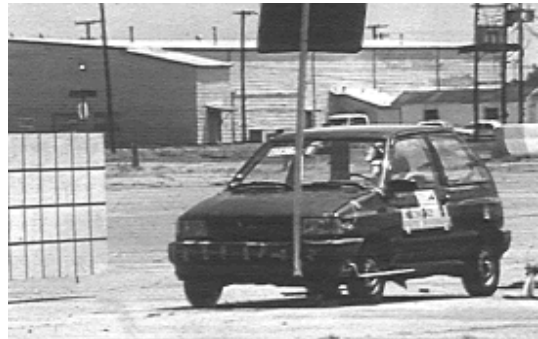
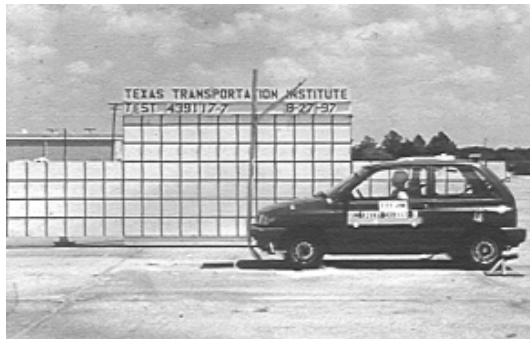
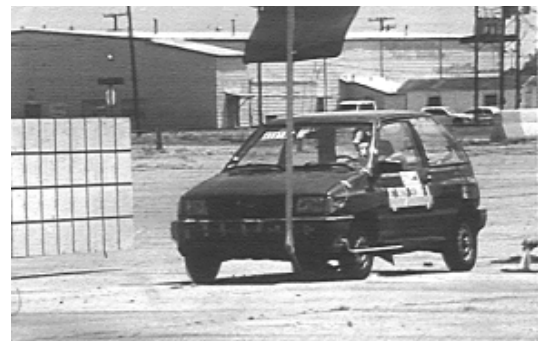
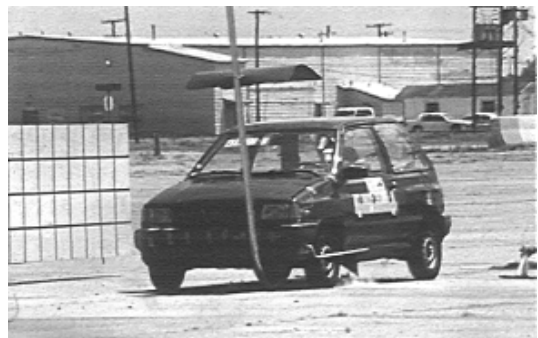
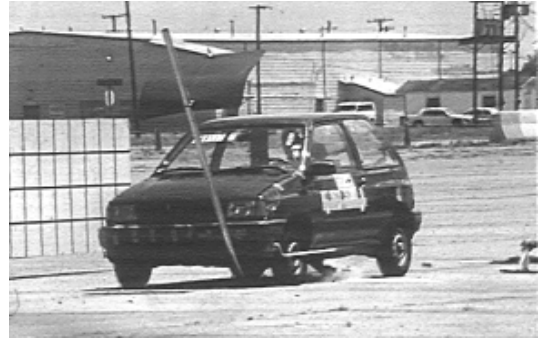
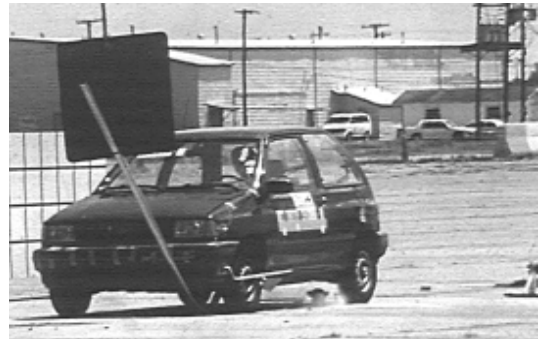
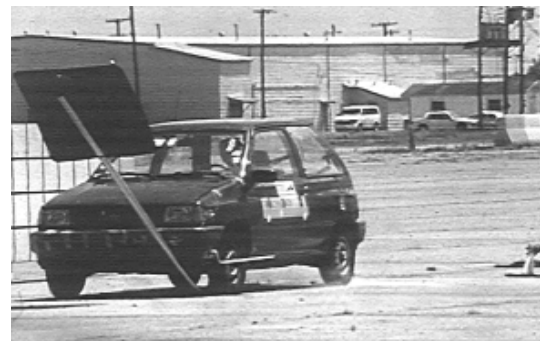
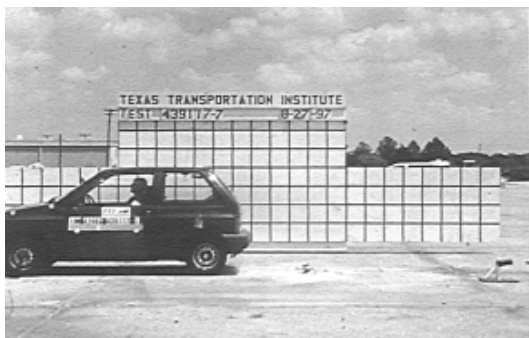
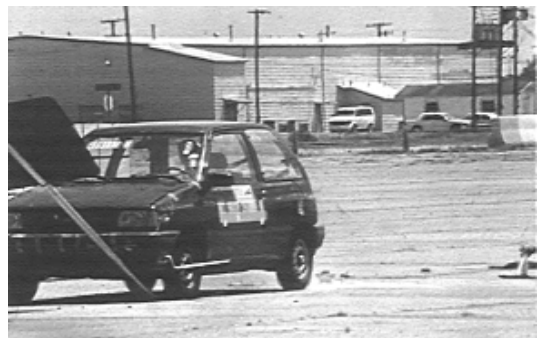
**Figure 70. Sequential Photographs for Test 439117-7
(Perpendicular and Oblique Views).**

Figure 70. Sequential Photographs for Test 439117-7 (Perpendicular and Oblique Views) (Continued).

The vehicle, traveling at 34.96 km/h, impacted the slip-base sign support at 0 degrees with the right quarter point of the vehicle aligned with the sign support. Shortly after impact the post began to move. At 0.009 s the base plate started to pull up. By 0.022 s, the support had deformed around the front end of the vehicle. At 0.051 s, the top of the sign blank separated from the post. At 0.064 s, a second bend began to form in the support near bumper height as the post was pulled out of the base. The lower section of the deformed support caught the undercarriage of the vehicle, and the sign rode along with the vehicle. Brakes were applied approximately 2.5 s after impact, bringing the vehicle to a stop 25.93 m down from and in line with the point of impact. The sign support came to rest beneath the vehicle. Sequential photographs of the test period are shown in Appendix D, [Figure 70](#).
