1. Report No. TX-01/3911-S		2. Government Accession No.		3. Recipient's Catalog No.	
4. Title and Subtitle EVALUATION OF DESIGN AND RETROFIT CONCEPTS FOR SLIP-BASE SIGN SUPPORT SYSTEMS				5. Report Date February 2001

**EVALUATION OF DESIGN AND RETROFIT CONCEPTS
FOR SLIP-BASE SIGN SUPPORT SYSTEMS**

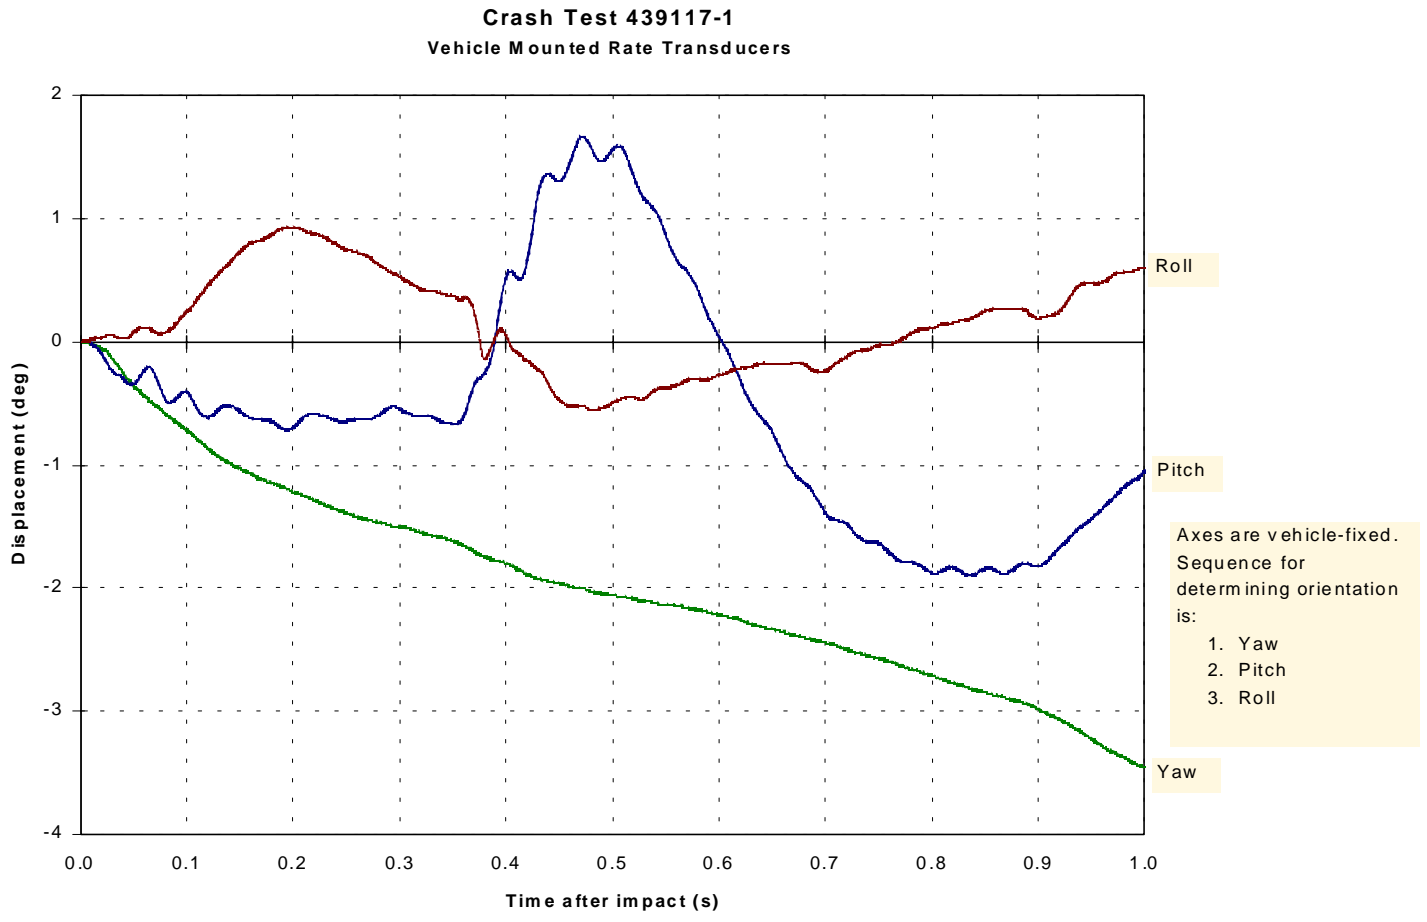
Figure 73. Vehicle Angular Displacements for Test 439117-1.

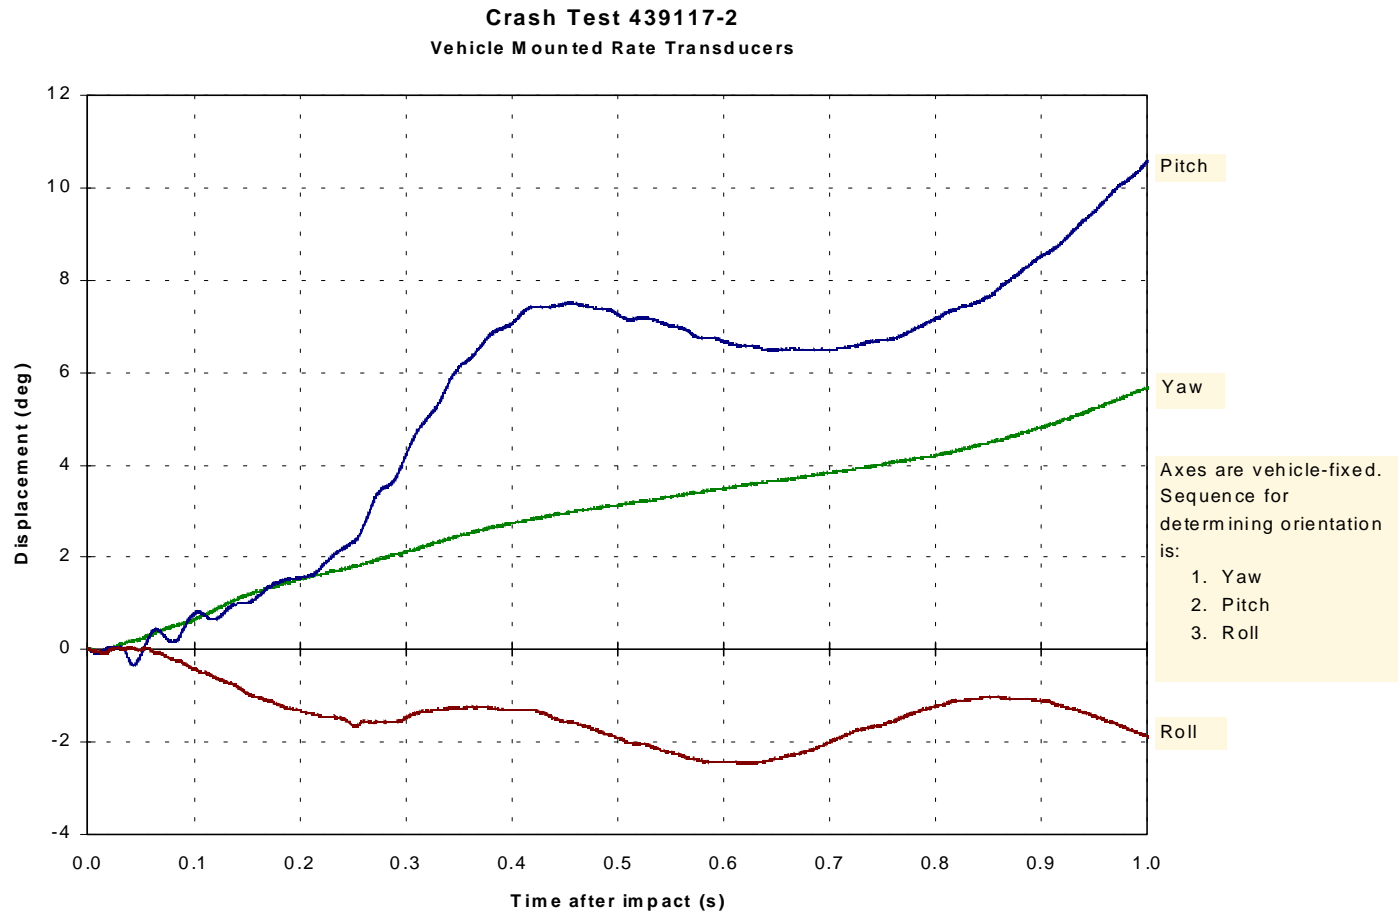
Figure 74. Vehicle Angular Displacements for Test 439117-2.

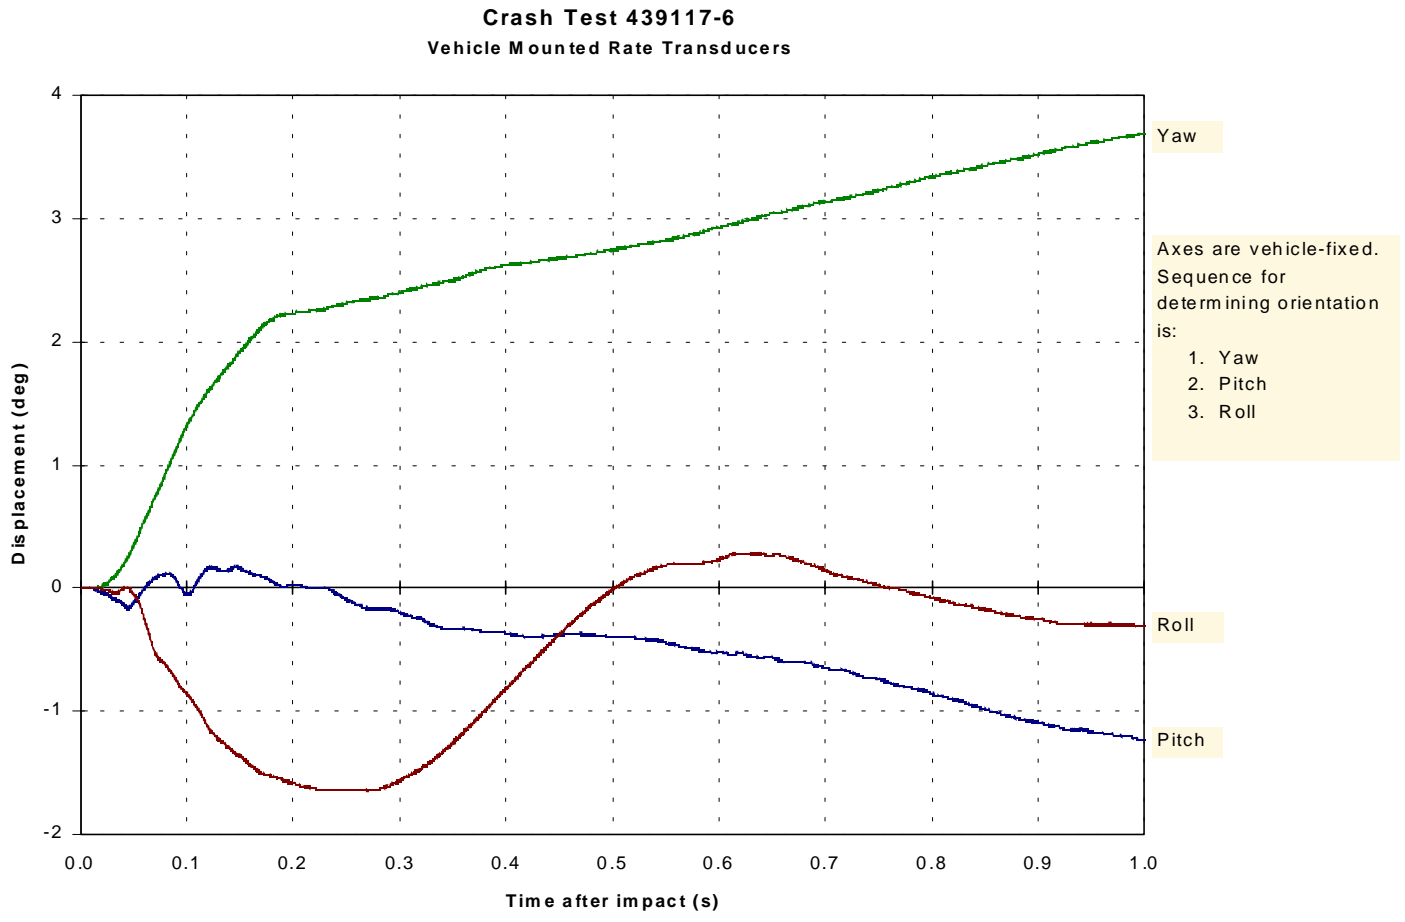
Figure 76. Vehicle Angular Displacements for Test 439117-6.
