# **MASH TL-3 TESTING AND EVALUATION OF A STEEL BRIDGE RAIL WITH PICKETS**

**Test Report 9-1002-12-2**

1. Report No. FHWA/TX-12/9-1002-12-2		2. Government Accession No.		3. Recipient's Catalog No.	
4. Title and Subtitle <i>MASH</i> TL-3 TESTING AND EVALUATION OF A STEEL BRIDGE RAIL WITH PICKETS				5. Report Date July 2012 Published: October 2012

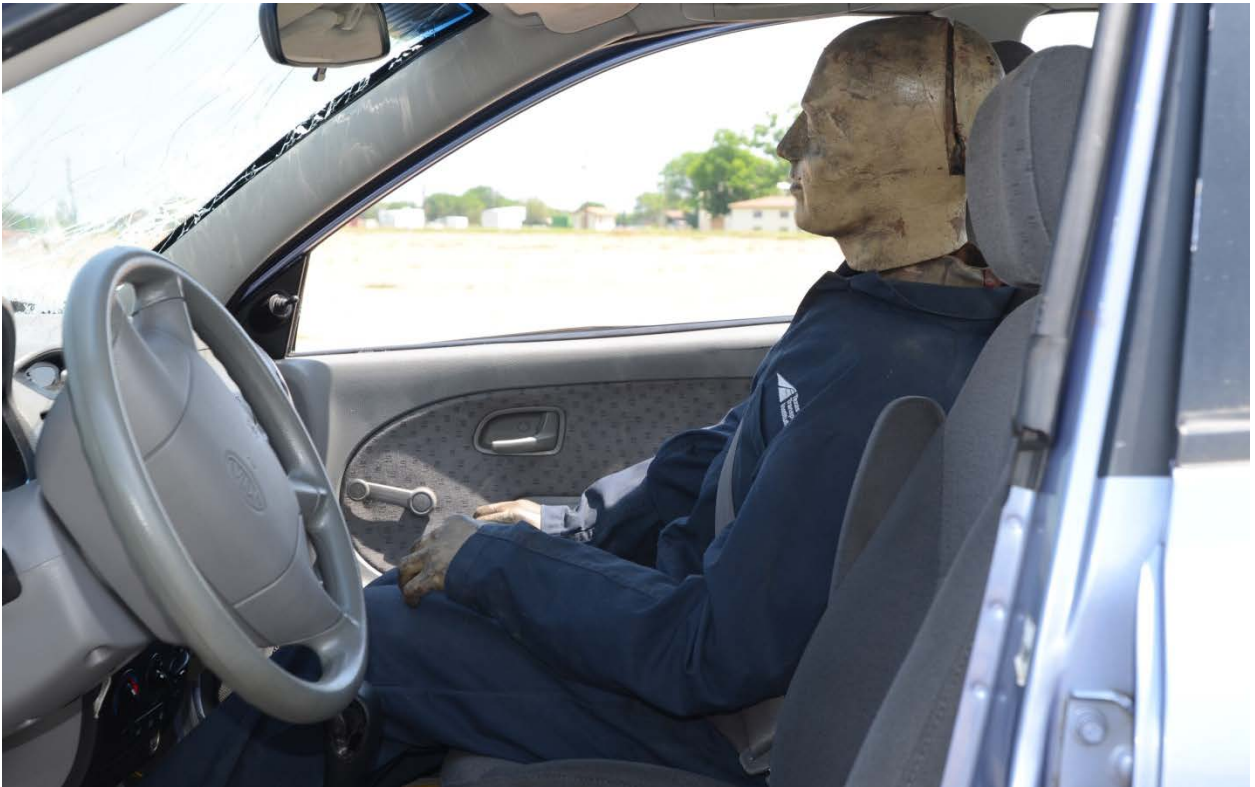
**Figure 5.6. Interior of Vehicle for Test No. 490022-2.**

After Test

Results: No detached elements, fragments, or other debris was present to penetrate or show potential for penetrating the occupant compartment, or present undue hazard to others. (PASS)  
Maximum occupant compartment deformation was 3.0 inches in the right floor pan area. (PASS)

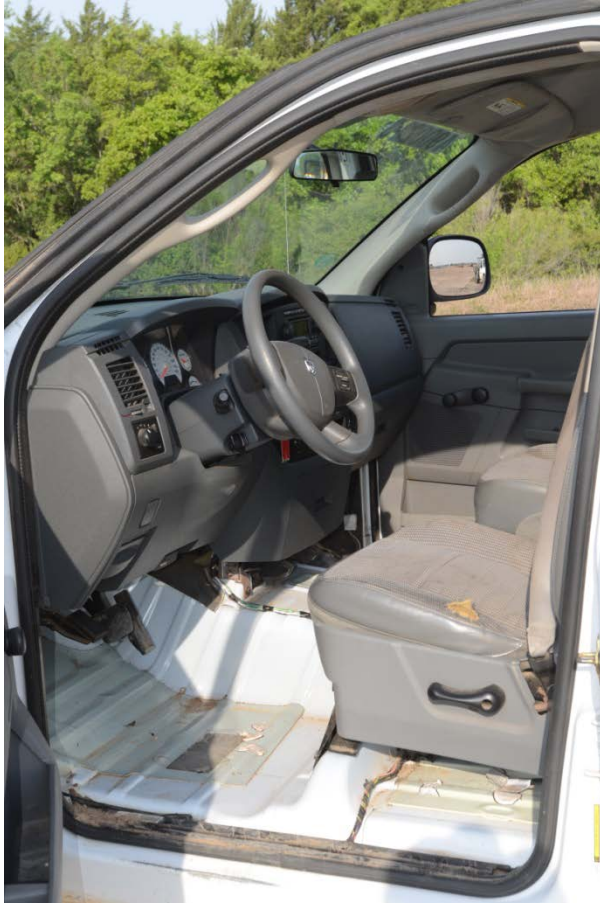
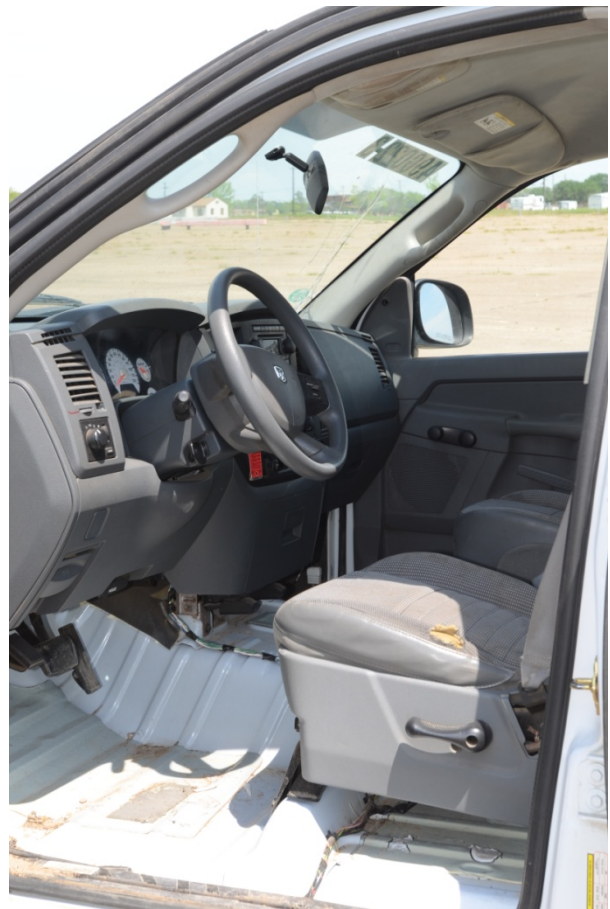
**Figure 6.6. Interior of Vehicle for Test No. 490022-3.**

Before Test

After Test

Results: No detached elements, fragments, or other debris were present to penetrate or show potential for penetrating the occupant compartment, or present undue hazard to others. (PASS)  
Maximum occupant compartment deformation was 2.75 inches in the lateral area across the cab at the front passenger kick panel. (PASS)

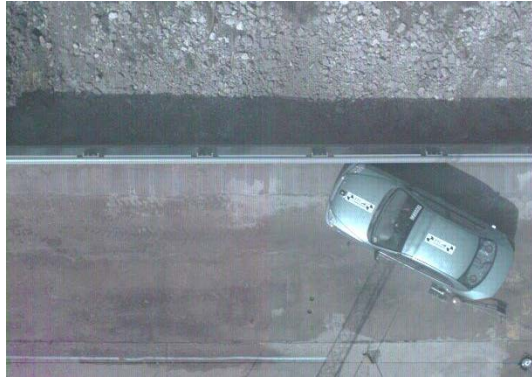
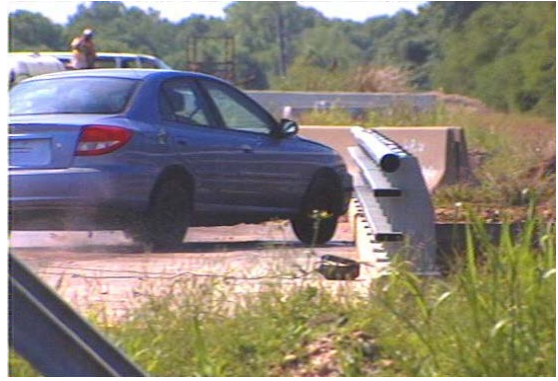
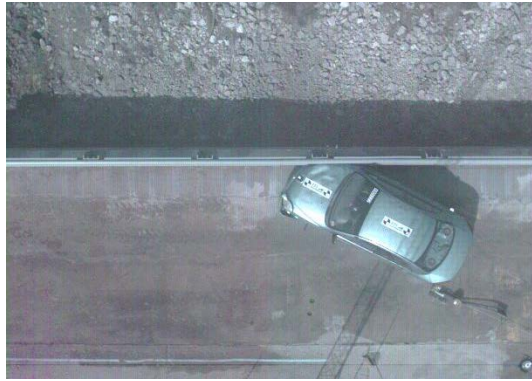
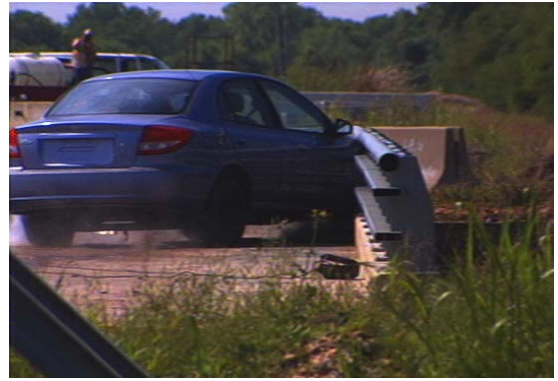
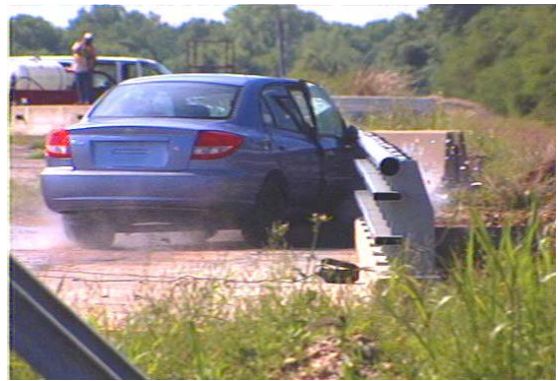
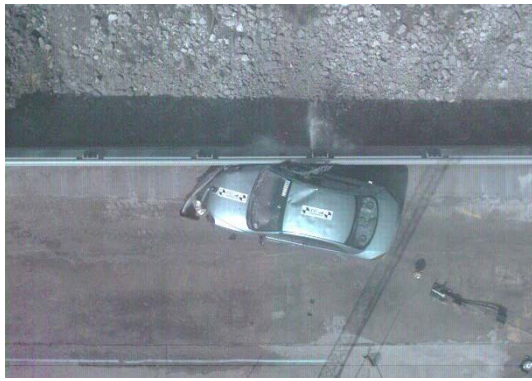
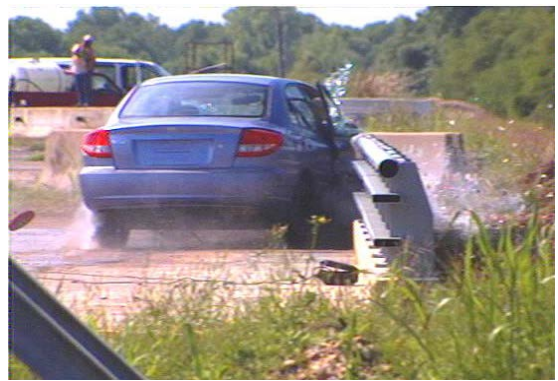
**Figure C1. Sequential Photographs for Test No. 490022-2 (Overhead and Rear Views).**

The TxDOT Picket Rail contained and redirected the 1100C vehicle. The vehicle did not penetrate, underide, or override the installation. Maximum dynamic deflection of the horizontal metal rail elements was 0.9 inch. No detached elements, fragments, or other debris was present to penetrate or show potential for penetrating the occupant compartment, or present undue hazard to others. Maximum occupant compartment deformation was 3.0 inches in the right floor pan area. The 1100C vehicle remained upright during and after the collision event. Maximum roll and pitch angles were 25 degrees and 8 degrees, respectively. Occupant compartment risk factors were within the limits specified in *MASH*. The 1100C vehicle crossed the exit box 60 ft downstream of loss of contact with the bridge rail.

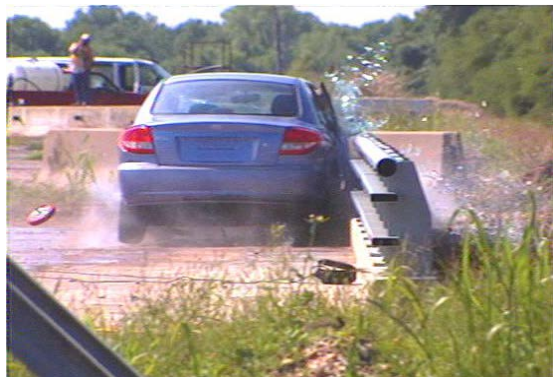
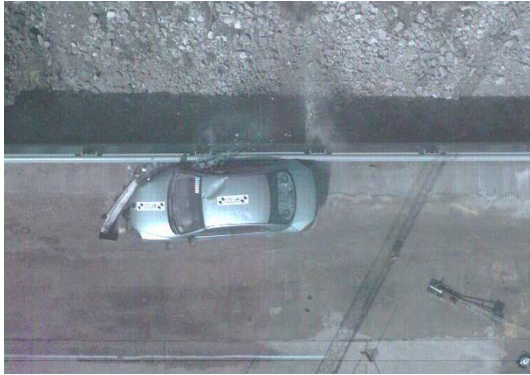
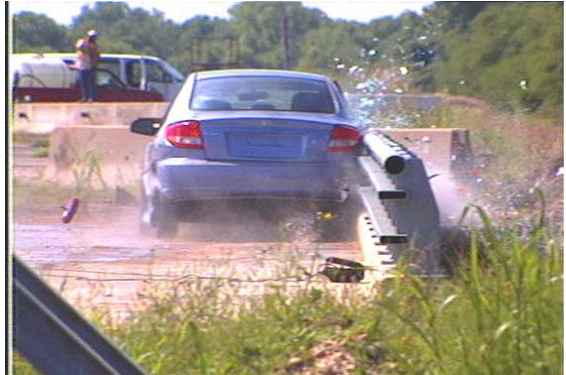
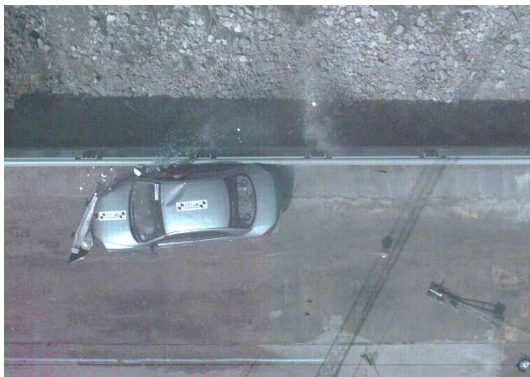
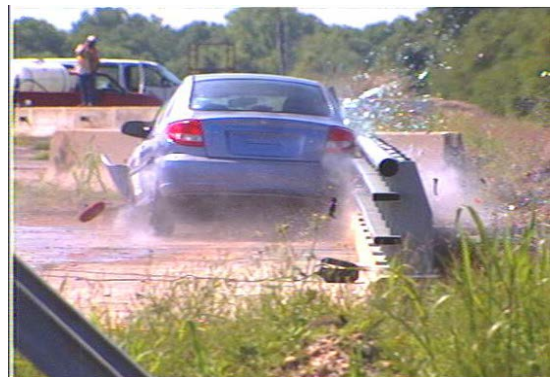
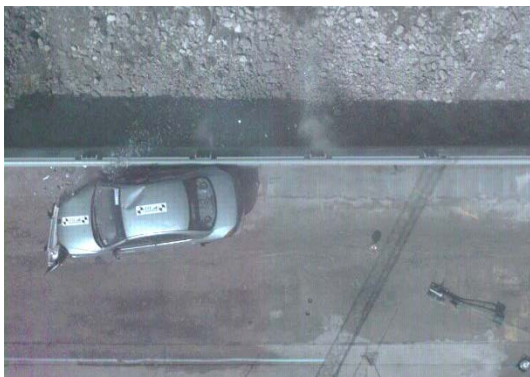
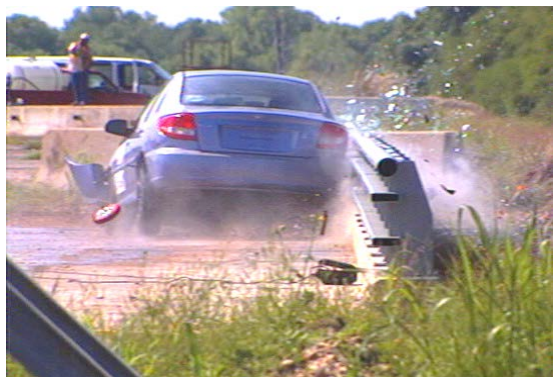
**Figure C1. Sequential Photographs for Test No. 490022-2 (Overhead and Rear Views) (continued).**

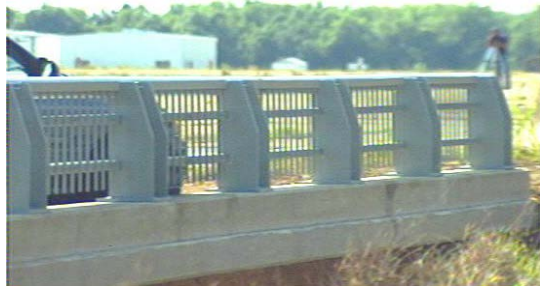
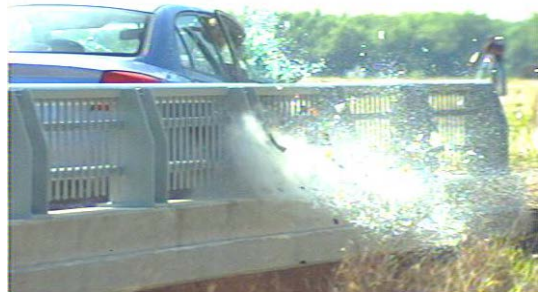
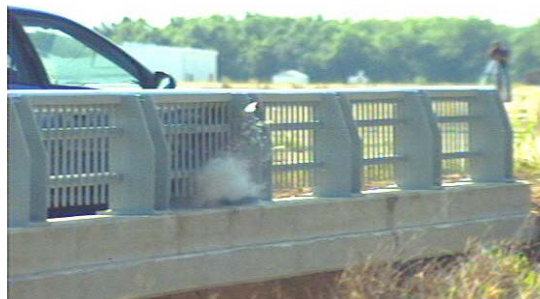
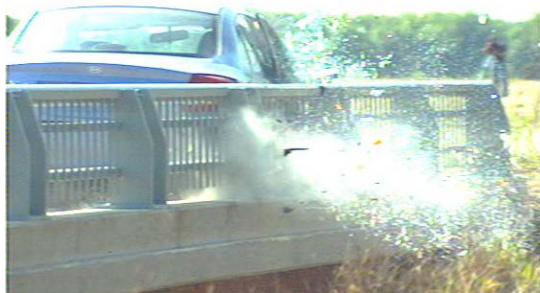
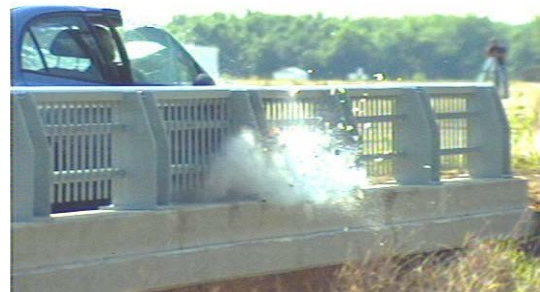
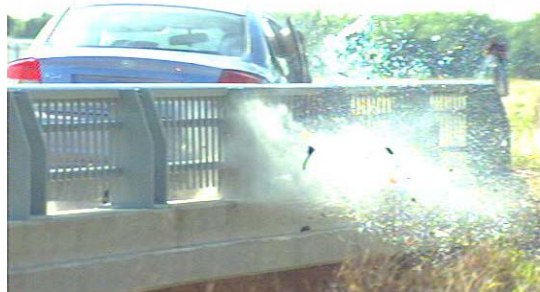
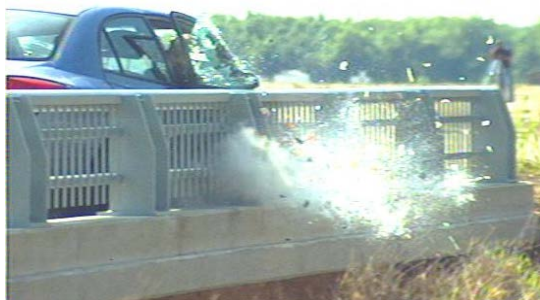
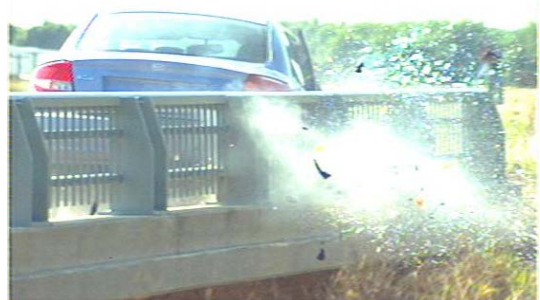
**Figure C2. Sequential Photographs for Test No. 490022-2  
(Rear of Bridge Rail View).**
