# **Horizontal Cracking in Portland Cement Concrete Pavements: Literature Review**

CTR Technical Report:	0-5549-1
Report Date:	February 2008; Revised June 2008
Project:	0-5549
Project Title:	Horizontal Cracking in Concrete Pavements
Sponsoring Agency:	Texas Department of Transportation
Performing Agency:	Center for Transportation Research at The University of Texas at Austin

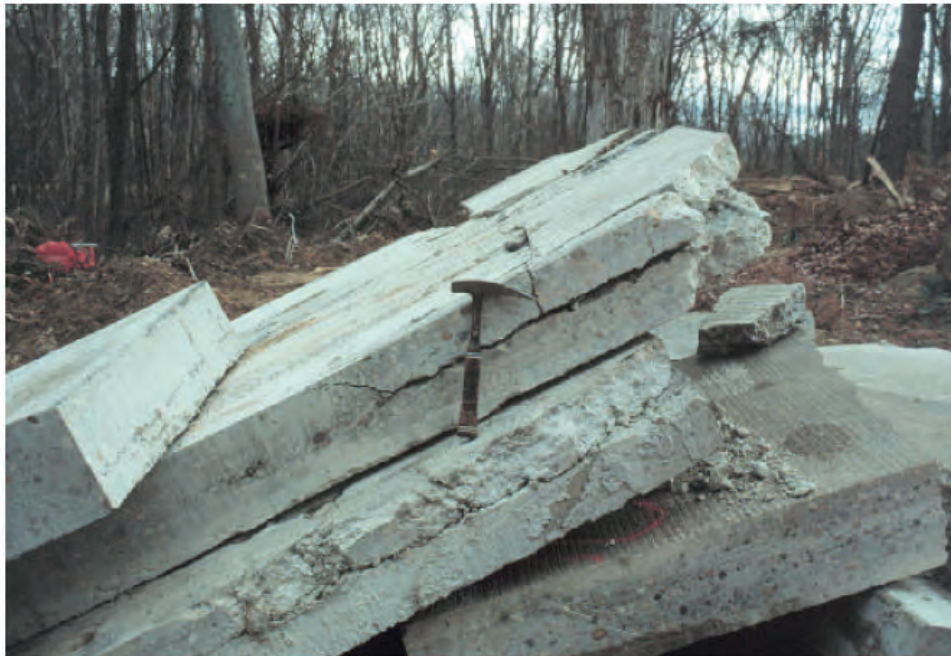
Figure 1.1 shows CRCP slabs in Virginia with horizontal cracking at the depth of the steel reinforcement. Horizontal cracks and what appears to be distresses caused by horizontal cracking are shown.

*Figure 1.1: Horizontal Cracking in CRCP in Virginia*

In a paper presenting various distresses in CRCP and action plans to address those distresses, Virginia, Elfino et al. (2001) describe distresses due to horizontal cracking in CRCP. They did not specifically use the term *horizontal cracking*; rather, they depict distresses due to horizontal cracking under “Localized Areas of Broken Concrete.” They did not perform any analysis or field evaluations. Instead, they described the distresses observed in the field due to horizontal cracking, and provided their explanations on the possible causes.

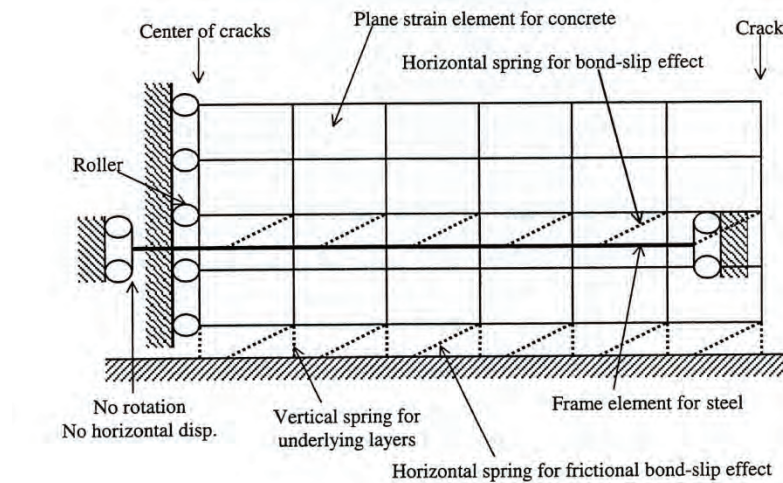
For the analysis, a finite element modeling was utilized as shown in Figure 1.2.

*Figure 1.2: Finite element model of CRCP*

Bond slip element was introduced to model the interface between concrete and longitudinal steel. Also, concrete was assumed to behave in plane strain mode.

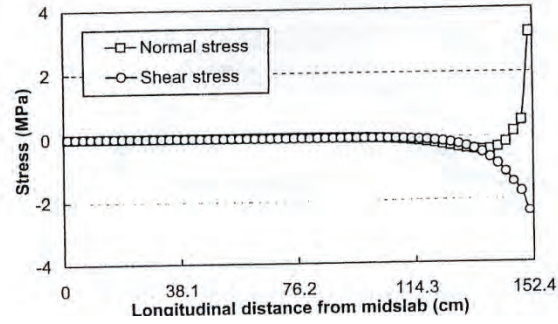
Figure 1.3 illustrates the distributions of normal and shear stresses in concrete at the steel depth. It shows that both normal and shear stresses are maximum near the transverse crack, and almost non-existent in the other regions. This finding supports the horizontal cracking behavior observed in the field, that horizontal cracking is initiated in the transverse crack region.

Figure 1.3: Stress distributions of concrete along longitudinal direction at steel depth

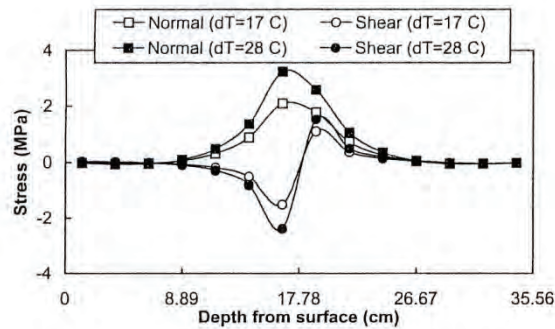
Figure 1.4 shows normal and shear stresses in concrete along the slab depth at transverse crack for two different temperature gradients. As expected, higher temperature differentials between the top and the bottom of the slab resulted in larger concrete stresses at the depth of steel.

Figure 1.4: Effect of temperature variation on stress distribution along slab depth

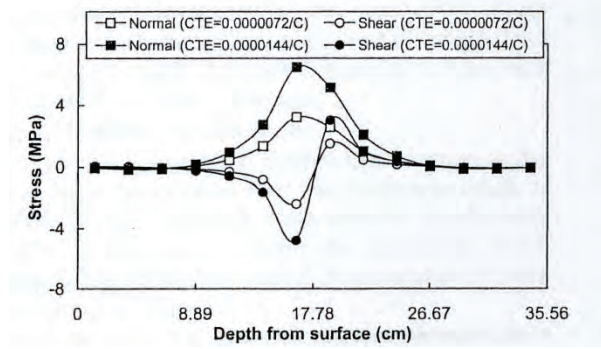
Figure 1.5 illustrates the effects of concrete coefficient of thermal expansion (CTE) on normal and shear stresses in concrete along the slab depth. Concrete with higher CTE yields larger stresses in concrete. The results are compatible with the field observations, where concrete with high CTE—concrete containing siliceous river gravel or sandstone—is more prone to horizontal cracking than concrete with low CTE—concrete containing crushed limestone.

*Figure 1.5: Effect of concrete coefficient of thermal expansion on concrete stress*

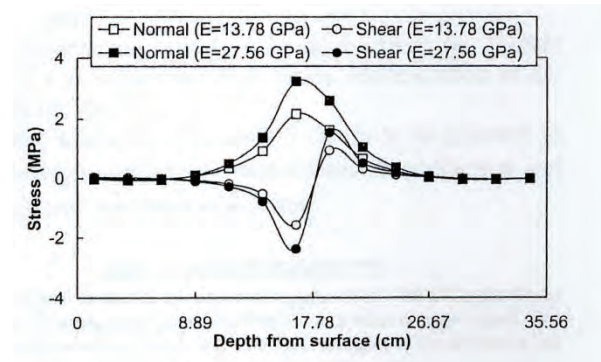
Figure 1.6 shows the effect of concrete modulus of elasticity on the normal and shear stresses in concrete along the slab depth. It is noted that concrete with higher modulus experiences larger normal and shear stresses. This finding also corroborates the field observations, where concrete with higher modulus such as concrete containing hard siliceous river gravel has higher potential for horizontal cracking than concrete with lower modulus.

*Figure 1.6: Effect of concrete modulus of elasticity on concrete*

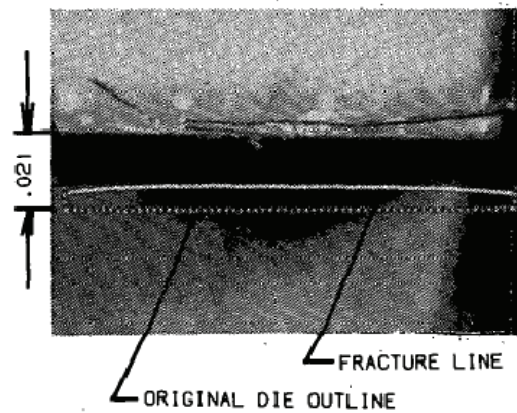
Kasem et al. (1987) addressed the problem of horizontal silicon die cracking in the commercial semiconductor application. The horizontal cracking can occur in a glass-sealed ceramic dual in-line (CERDIP) package with glass as a die bonding material as shown in Figure 1.8. The fracture mode has been attributed to the combined effects of mechanical and thermal stresses. Figure 1.9 illustrates that the saw-and-break die separation method is identified as the prime source of stress raisers and die edge damage.

Figure 1.8: Upper portion of die split by horizontal die cracking

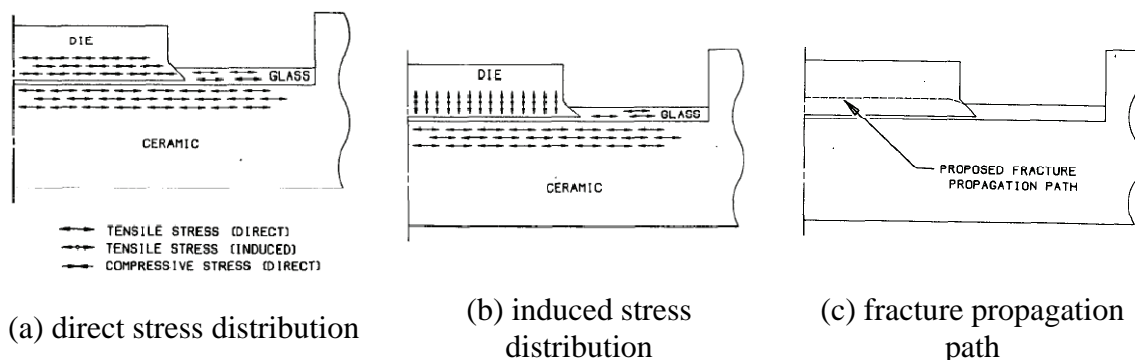
Figure 1.10 illustrates a measured stress map showing all possible tensile stresses, both direct and induced. The induced stresses are based on the fact that any direct stress induces a stress of the opposite sign perpendicular to it and equal in magnitude to the direct stress multiplied by Poisson ratio. Figure 1.10 (c) shows the plane subjected to the tensile stress. This plane, due to the properties of brittle materials, is the most likely to develop a crack. In this case, the crack would be a horizontal fracture along the saw-and-break plane, which carries the highest stress fields.

Figure 1.10: Stress map showing direct and induced stresses

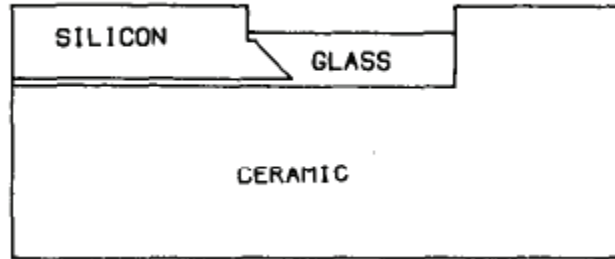
A finite element analysis for the thermal stress and strain that is induced by the manual die attach process was conducted. The thermal stress contours and the package thermal distortion have been obtained for both transient and steady-state conditions for a package with a die that was 70 percent sawn through, roller broken, and manually attached. Figure 1.11 shows the right half of a Cerdip 16-lead package cross section with symmetrical boundary conditions.

*Figure 1.11: Sixteen-lead Cerdip half cross section*

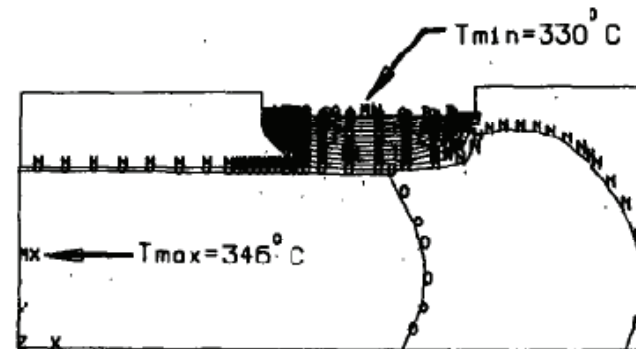
Figure 1.12 shows temperature distribution in Cerdip 60 seconds after removal from heater block, which is at 460°C (860°F). It indicates that 60 seconds was long enough for the glass surface to reach the glass solidification temperature of 330°C (626°F) from a die bonding. At that point in time the entire package is nearly at thermal equilibrium, with a maximum bulk temperature of 346°C (655°F). This means that the silicon is stress-free as the glass begins to solidify.

*Figure 1.12: Temperature distribution 60 sec after removal from heater block*

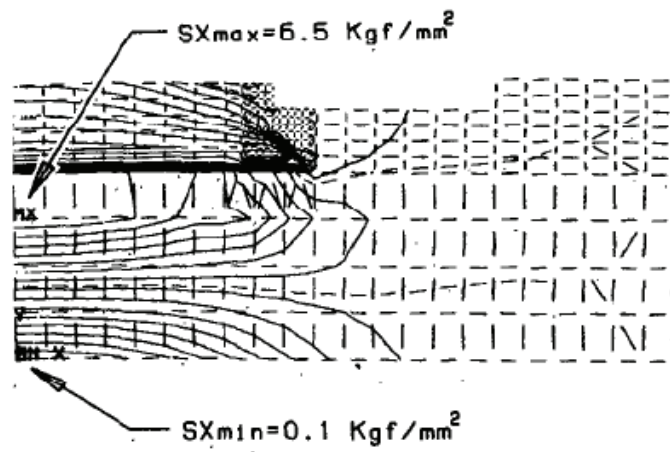
Figure 1.13 shows the steady-state tensile stress distribution inside the package at room temperature. A maximum tensile stress of  $9.24 \times 10^{-3}$  psi occurs inside the ceramic base. However, the highest shear stress field occurs on the die step and in the die attach layer. The direction of the principal tensile stress on the die edge is about 20° to the edge. The solution is in good agreement with the observed fracture pattern in Fig. 10(c). This confirms that a horizontal crack is very likely to propagate once the stress on the chip reached the fracture limit.

*Figure 1.13: Steady-state tensile stress distribution inside package*
