MONITORING THE USE OF IMPERVIOUS FABRICS, GEOMEMBRANES,
IN THE CONTROL OF EXPANSIVE SOILS

Test Results Through August 31, 1985

Report 187-12

Texas State Department of Highways
and Public Transportation

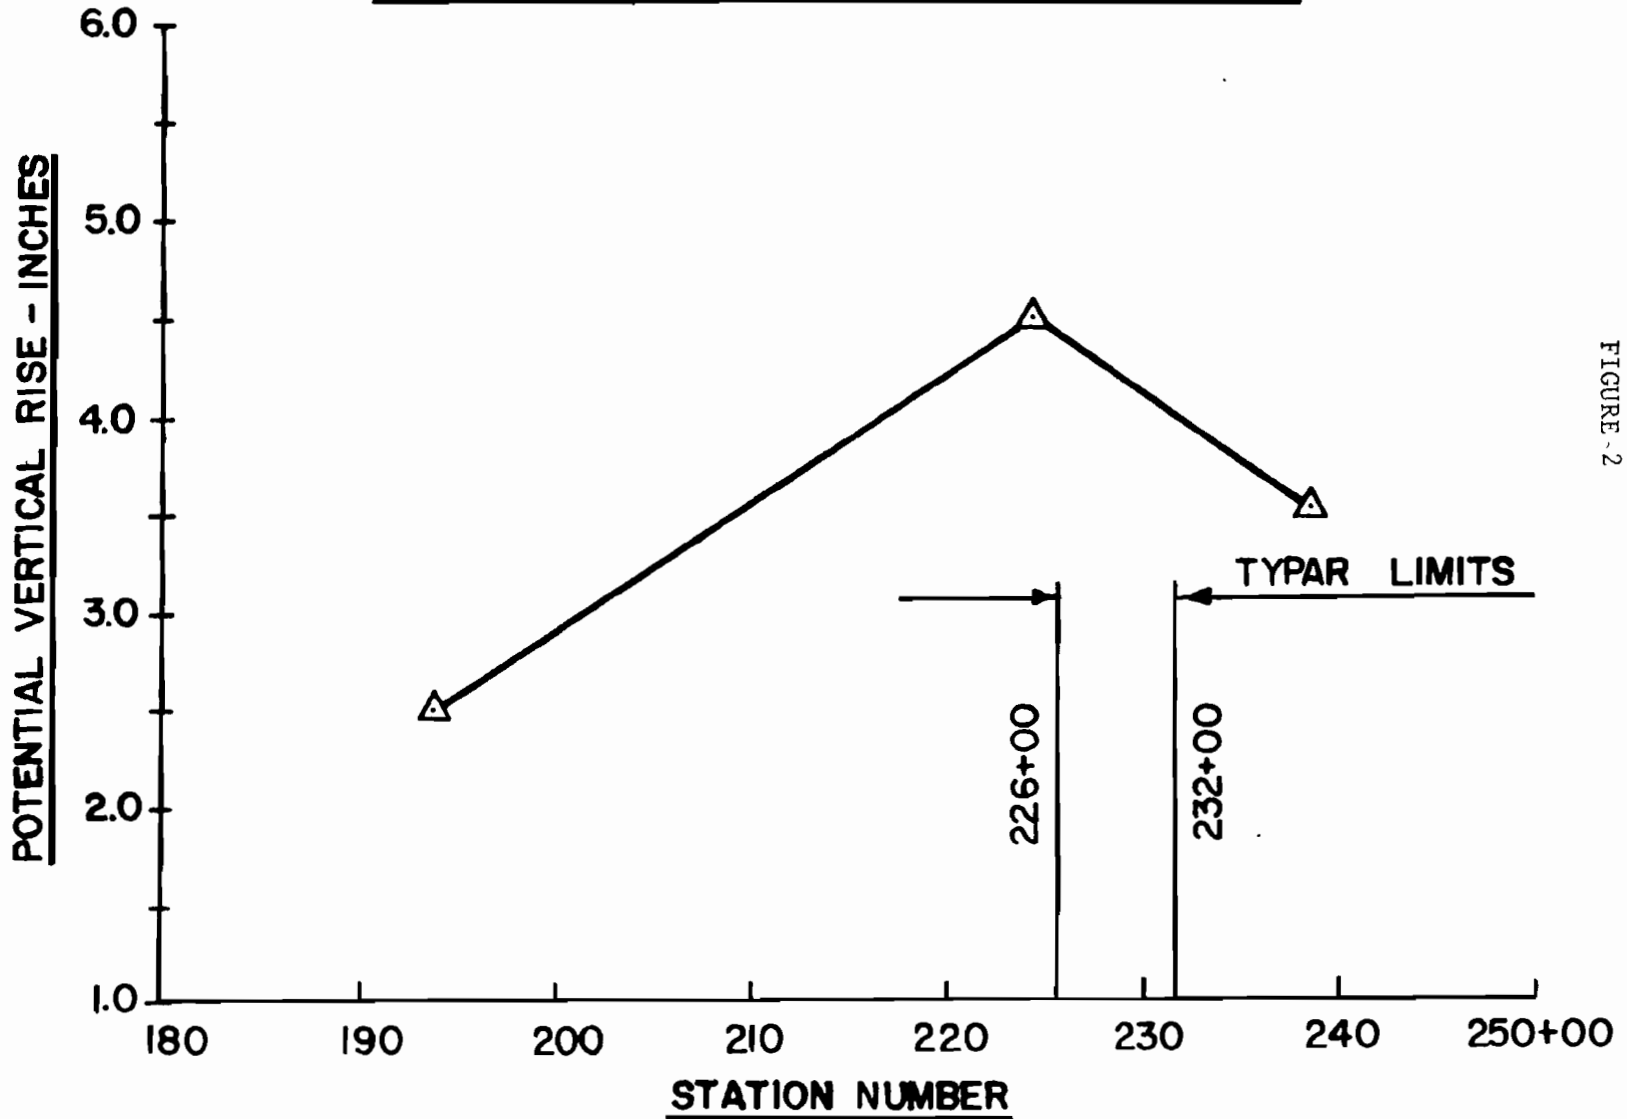
FIGURE - 2

GENERAL McMULLEN DRIVE

CALCULATED POTENTIAL VERTICAL RISE
