1. Report No. 271-1F		2. Government Accession No.		3. Recipient's Catalog No.	
4. Title and Subtitle Speed Reduction in Rural Communities			5. Report Date April 1983

SPEED REDUCTION IN RURAL COMMUNITIES

Two locations were chosen in District Eleven for trial application of the device. The locations selected for trial were US Highway 59 approaches to the City of Timpson and State Highway 19 south of Crockett. Equipment failure ultimately lead to the operation of the system in Timpson only.

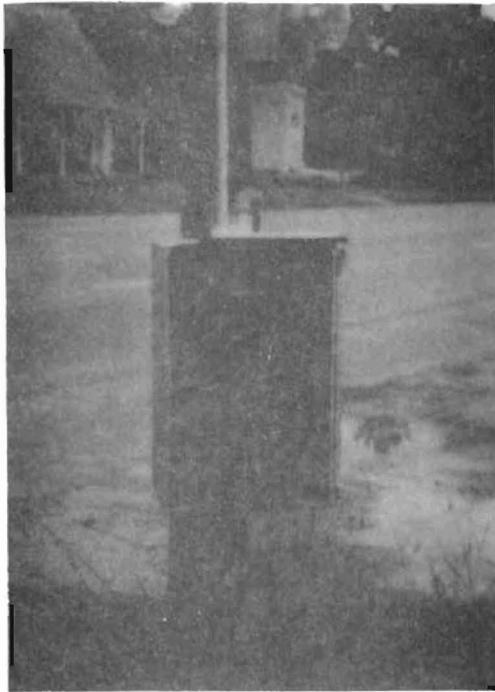
Speed Analysis System
And Flasher Controller

Figure 1 provides a view of the installation on US Highway 59 in Timpson and summarized study data. The results shown in the figure indicate that the system was not effective in reducing the 85 percentile speed or the average speed. The number of the vehicles traveling in

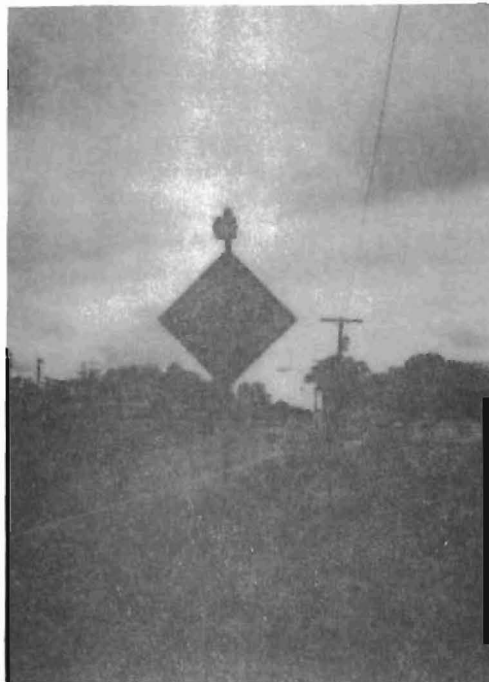
Warning Sign And Flasher

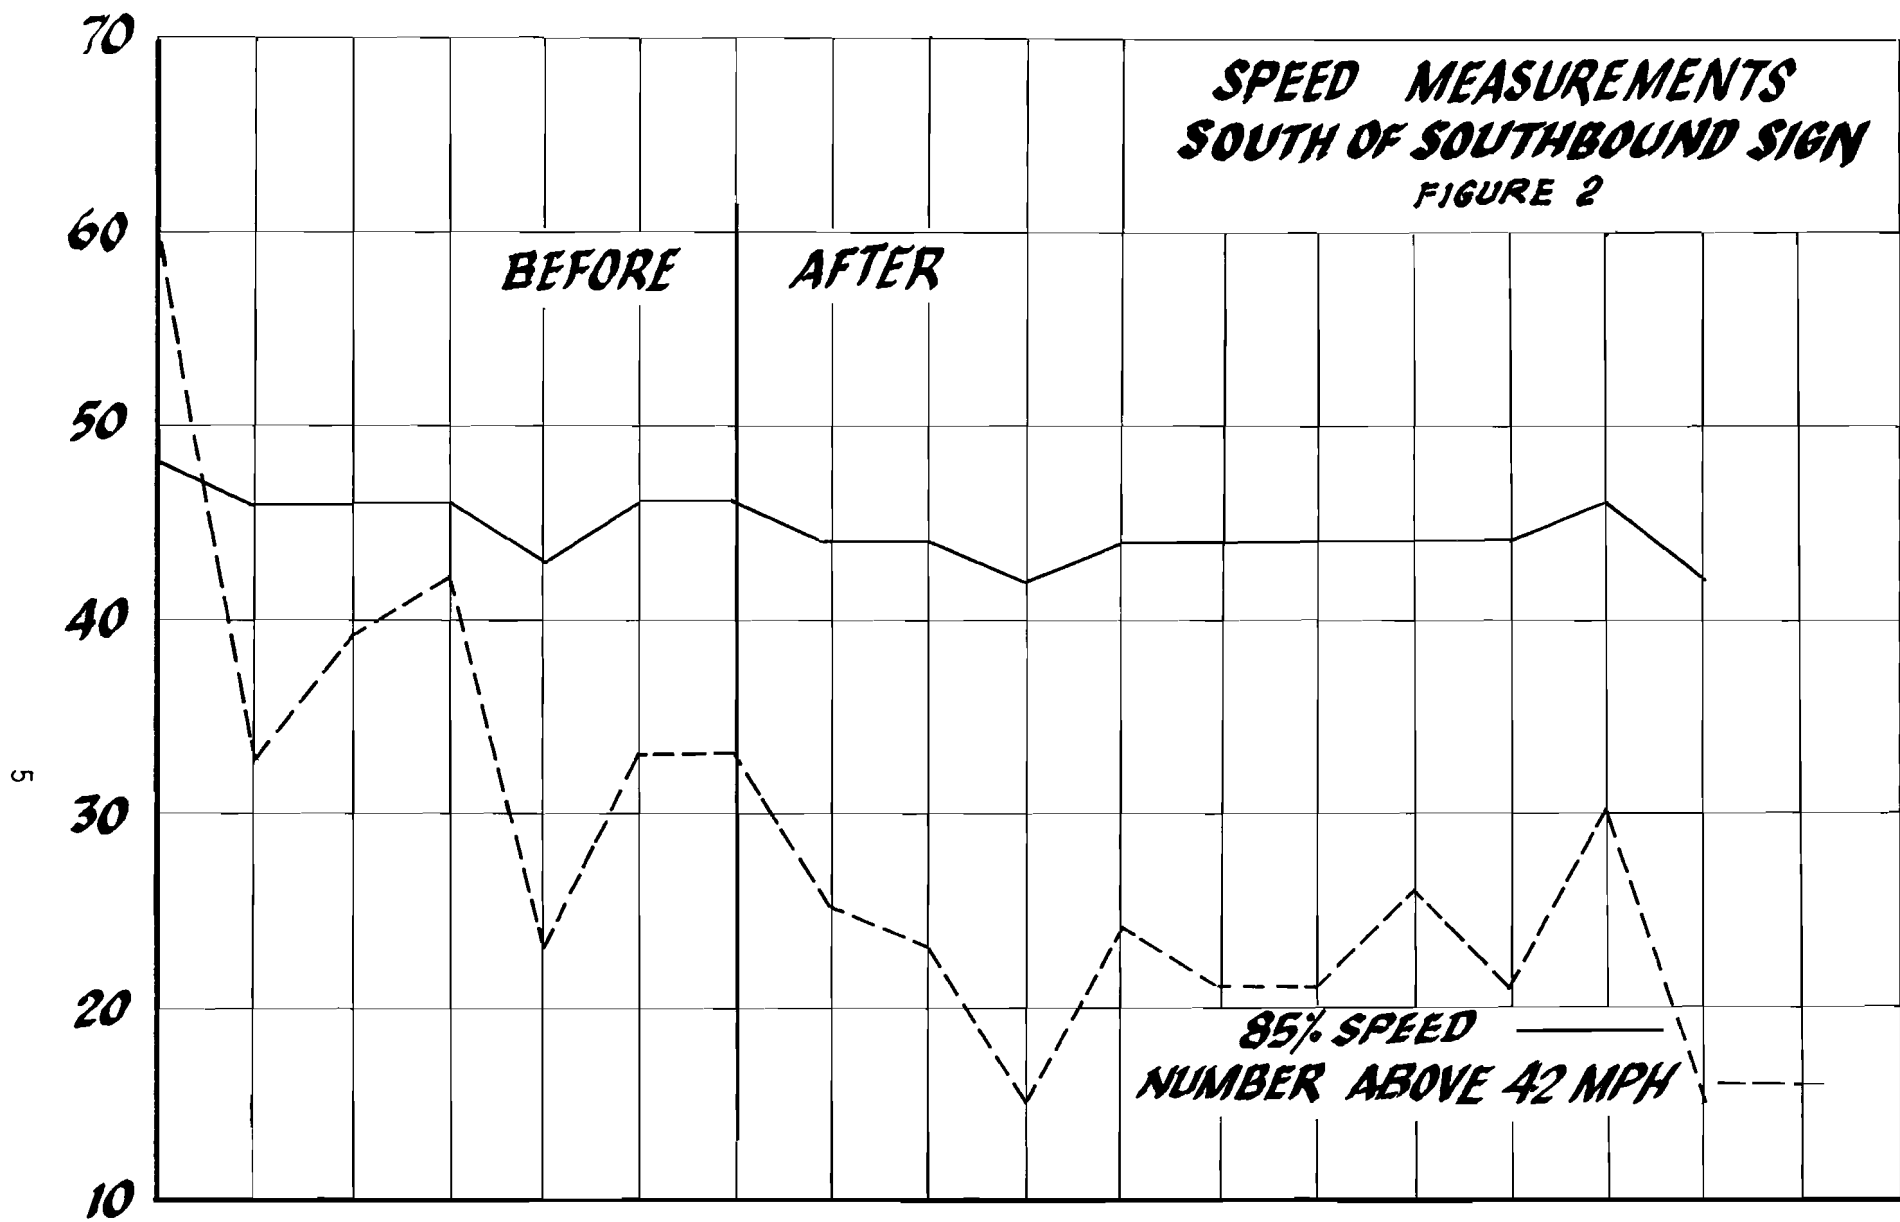
**SPEED MEASUREMENTS
SOUTH OF SOUTHBOUND SIGN
FIGURE 2**

DATE 6-2 6-3 6-4 6-5 6-8 6-9 6-15 9-21 9-25 9-28 9-29 9-30 10-5 10-13 11-23 31 3-12

SAMPLE SIZE 128 122 127 128 126 125 125 126 124 127 125 125 125 125 126 125 130

excess of 42 m.p.h., which was the threshold speed set in the unit, did show a reduction as is shown in Figures 2 and 4 when compared with the 85 percentile speed. When compared with the average daily traffic, as is shown in Figures 3 and 5 the number of vehicles under 42 m.p.h. tracks almost perfectly with the normal variations in total traffic.
