Guidelines for Routine Maintenance of Concrete Pavements

Project Title: Develop Guidelines for
Routine Maintenance of Concrete Pavement

TEXAS TRANSPORTATION INSTITUTE

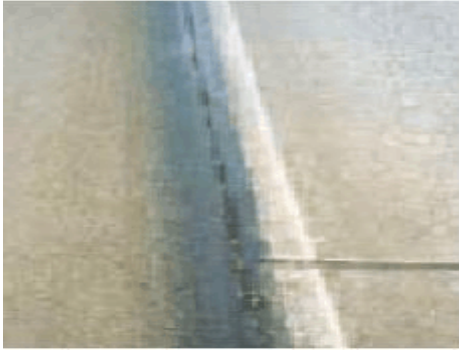
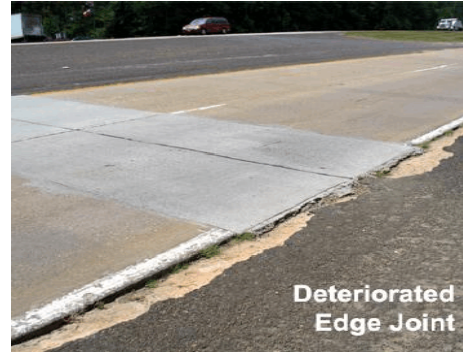
Description: Edge/shoulder drop-offs are normally associated with the use of a flexible shoulder on pavements where the main lanes are concrete. Large differences in elevation of the main lanes versus the shoulder can be safety problems and should be addressed by maintenance forces. Frequently, the edge/shoulder joint has deteriorated and is now open. Water will enter this joint and cause erosion of the layers supporting the concrete. This can lead to rapid failure of the concrete slab. This problem has been largely eliminated in Texas in new pavements because of the use of tied concrete shoulders. The edge/shoulder problem is particularly severe with old, narrow jointed concrete pavements, which may have been only 18 or 20 feet wide.

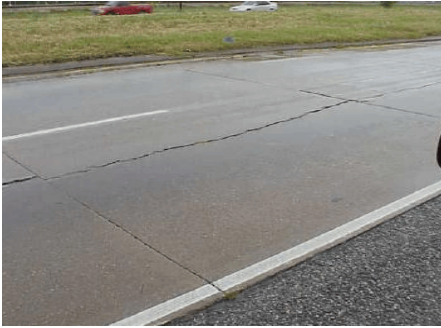
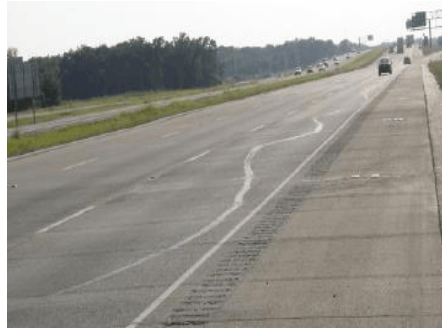
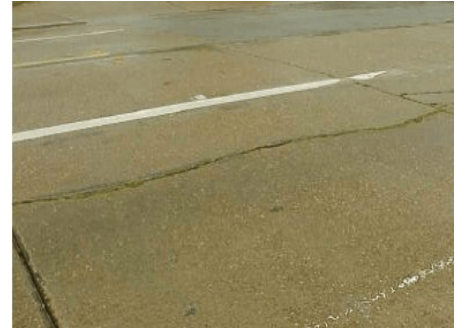
Description: Longitudinal cracks are cracks that are approximately parallel to the centerline of the roadway. Such cracks are generally straight, but in some instances they may be curved. In severe cases, the pavements may also be faulted on one side of the crack.

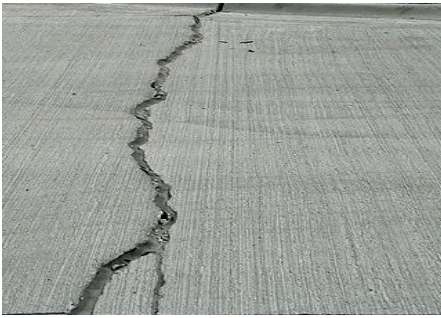
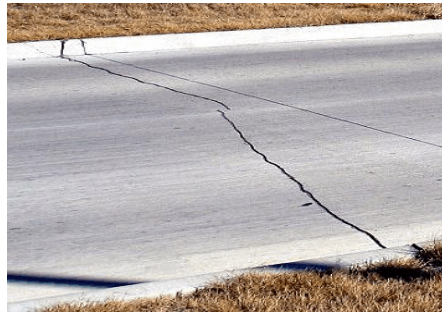
Description: Transverse cracks are generally straight cracks that follow a course approximately at right angles to the centerline of the pavement.

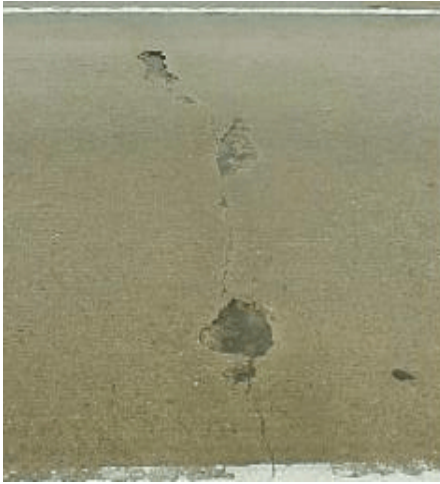
Description: Crack spalling is the loss of concrete around an existing transverse crack. The depth of the spall is frequently around 1 inch and typically extends 6 to 12 inches from the existing crack. Spalling may occur along the whole length, or only a portion of the length of the crack and may occur on either side of a crack. Spalling is a problem in several areas of Texas causing substantially reduction in the ride quality of the pavement, and can cause accelerated structural failure of the slab.

The progression of crack spalling may result in additional cracking in the slab or even present a safety issue. The repair of crack spalling is also necessary to prevent more debris from entering the joint. Crack spalling is progressive and when both sides of a crack have spalled, a pothole is likely to follow.

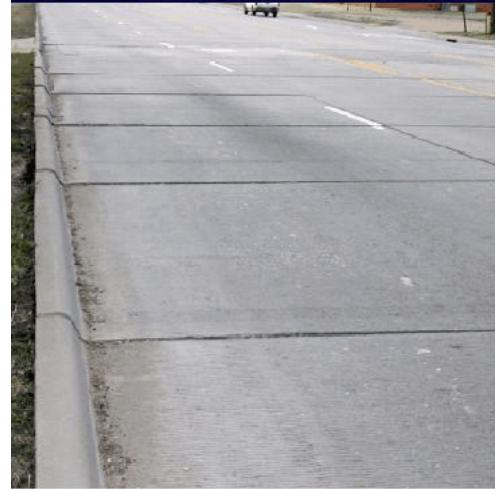
Description: Joint faulting is the differential vertical displacement of the slab edge across a transverse joint. The difference in elevation results in a step deformation. The approach slab edge is usually higher than the departure slab edge due to impact effects as the load moves across the joint and the effect of pumping.

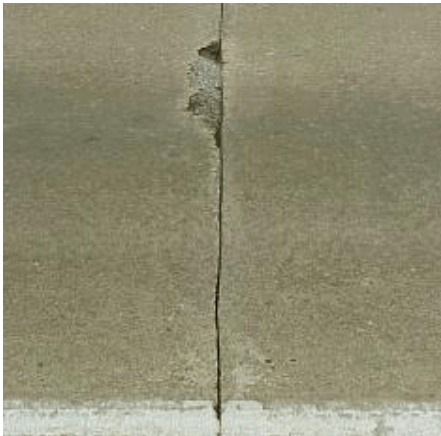
Description: Joint spalling is the chipping of the concrete slab at the edges of longitudinal or transverse joints. The spalling may occur along the whole length, or only a portion of the length of the joint and may occur on either side of the joint. Joint spalling is due to excessive local pressure at the joint. This pressure may be due to a combination of traffic action, thermal expansion, and/or steel corrosion. After both sides of a joint have spalled, the spalling may progress into a pothole.

Joint spalling will reduce the riding quality of the pavement. The progression of joint spalling may result in additional cracking in the slab or even present a safety issue. The repair of joint spalling is also necessary to prevent more debris from entering the joint.

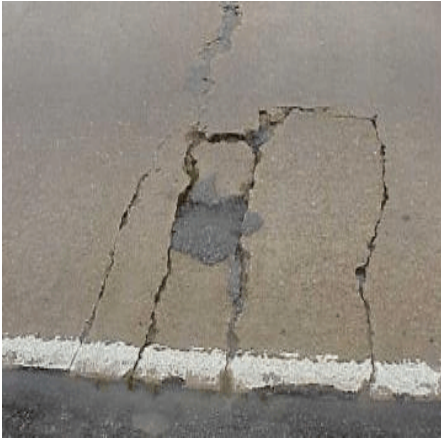
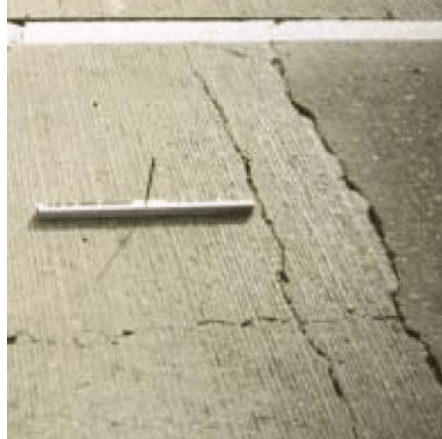
Description: A punchout is a full-depth block of pavement, formed at the edge, when a longitudinal crack forms between two existing transverse cracks. The existing cracks are closely spaced, usually less than 4 feet apart. The punchout is often rectangular, but some may appear in other shapes. Punchouts are most common in continuously reinforced concrete pavements.

The interconnecting cracks will not create any riding or safety problems. The cracks will allow additional moisture to come into contact with the base materials, resulting in accelerated erosion and pumping.

The punchout will develop spalled edges, settlement, and rupturing reinforcement under heavy loads. Once spalling and settlement have occurred, safety and riding quality problems will follow. Also, the punchout will expand to nearby cracks if it is not immediately repaired.

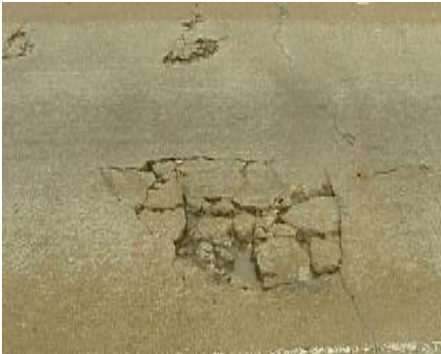
Partial Depth Punchout

Alternative Repair Strategy to Full
Depth Repair

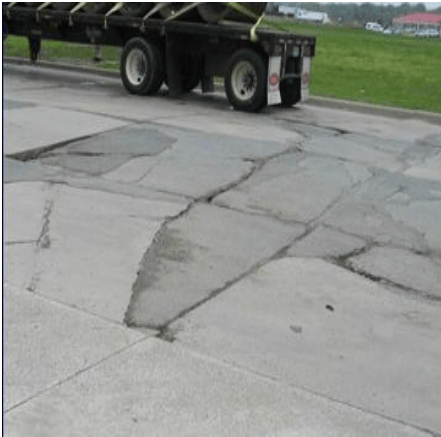
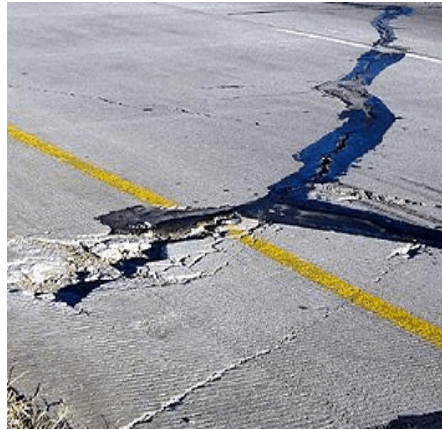
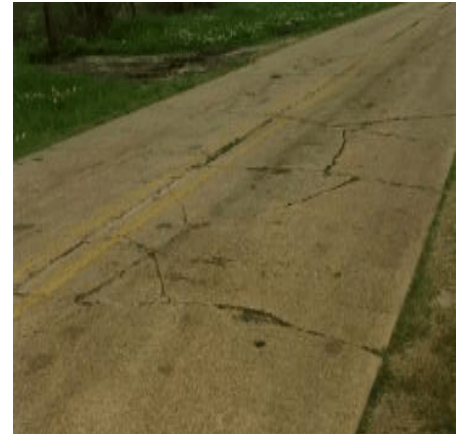
Description: Shattered slabs are formed when a series of cracks intersect to divide the slab into four or more pieces. Although the pieces still remain in their original position, they may settle below the original elevation of the pavement. Also, the intersecting cracks are usually accompanied by severe spalling.

Shattered slabs decrease the riding quality of the pavement as well as the structural capacity.

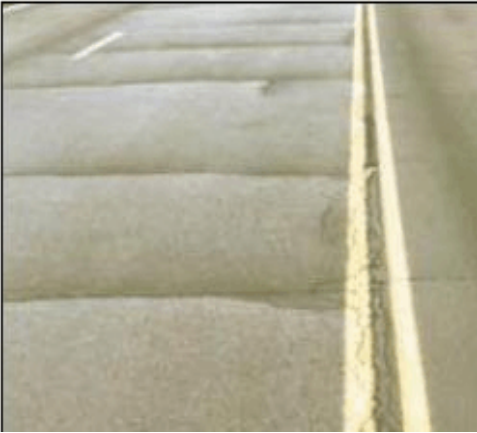
Reflection Cracking

Description: Typically, within a few years, cracks will form above the joints and cracks in the existing concrete pavements. These cracks are typically very straight and regular, matching the joint pattern of the existing concrete pavements.

Possible Causes: Thermal stresses caused by the opening and closing of the underlying slab joint as the slab length changes due to temperature changes, combined with shear stresses associated with load transfer across the cracks or slabs, induce cracks in the asphalt surface layer.
