DIAGNOSTIC STUDIES OF HIGHWAY VISUAL COMMUNICATION SYSTEMS

PILOT SITE NUMBER 2

INTERSTATE 30 IN BENTON, ARKANSAS

TM2(108)-2

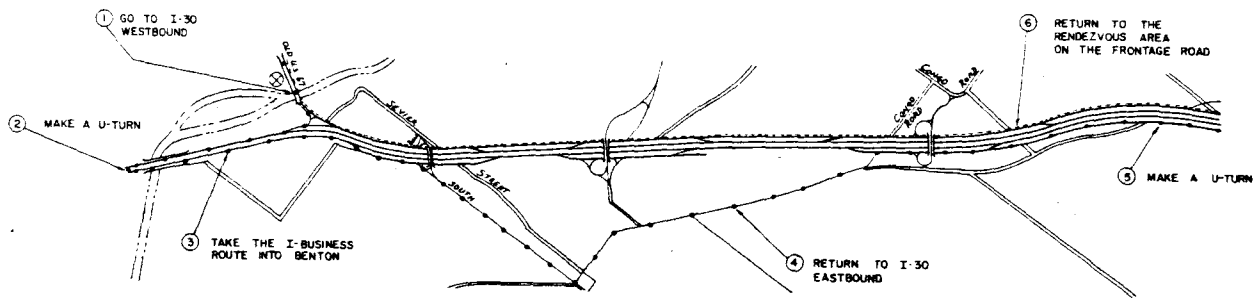
STRIP MAP OF STUDY SITE 2 INDICATING DRIVING ROUTES
 FIGURE 1

A strip map of the study section is presented in Figure 1. All frontage roads shown are two-way.

ROUTE 1

- - - - - INBOUND
 - - - - - OUTBOUND
 X RENDEZVOUS POINT

ROUTE 2

HPR-2(108)
 PILOT SITE NO. 2
 INTERSTATE HIGHWAY 30
 BENTON, ARKANSAS
