Report Number: SS 15.11

A REPORT ON ACCIDENTS
ON TEST SECTIONS OF
A PLANT MIX SEAL OVERLAY
ON FORT WORTH FREEWAYS

TEXAS HIGHWAY DEPARTMENT

Special Study No. 15.11

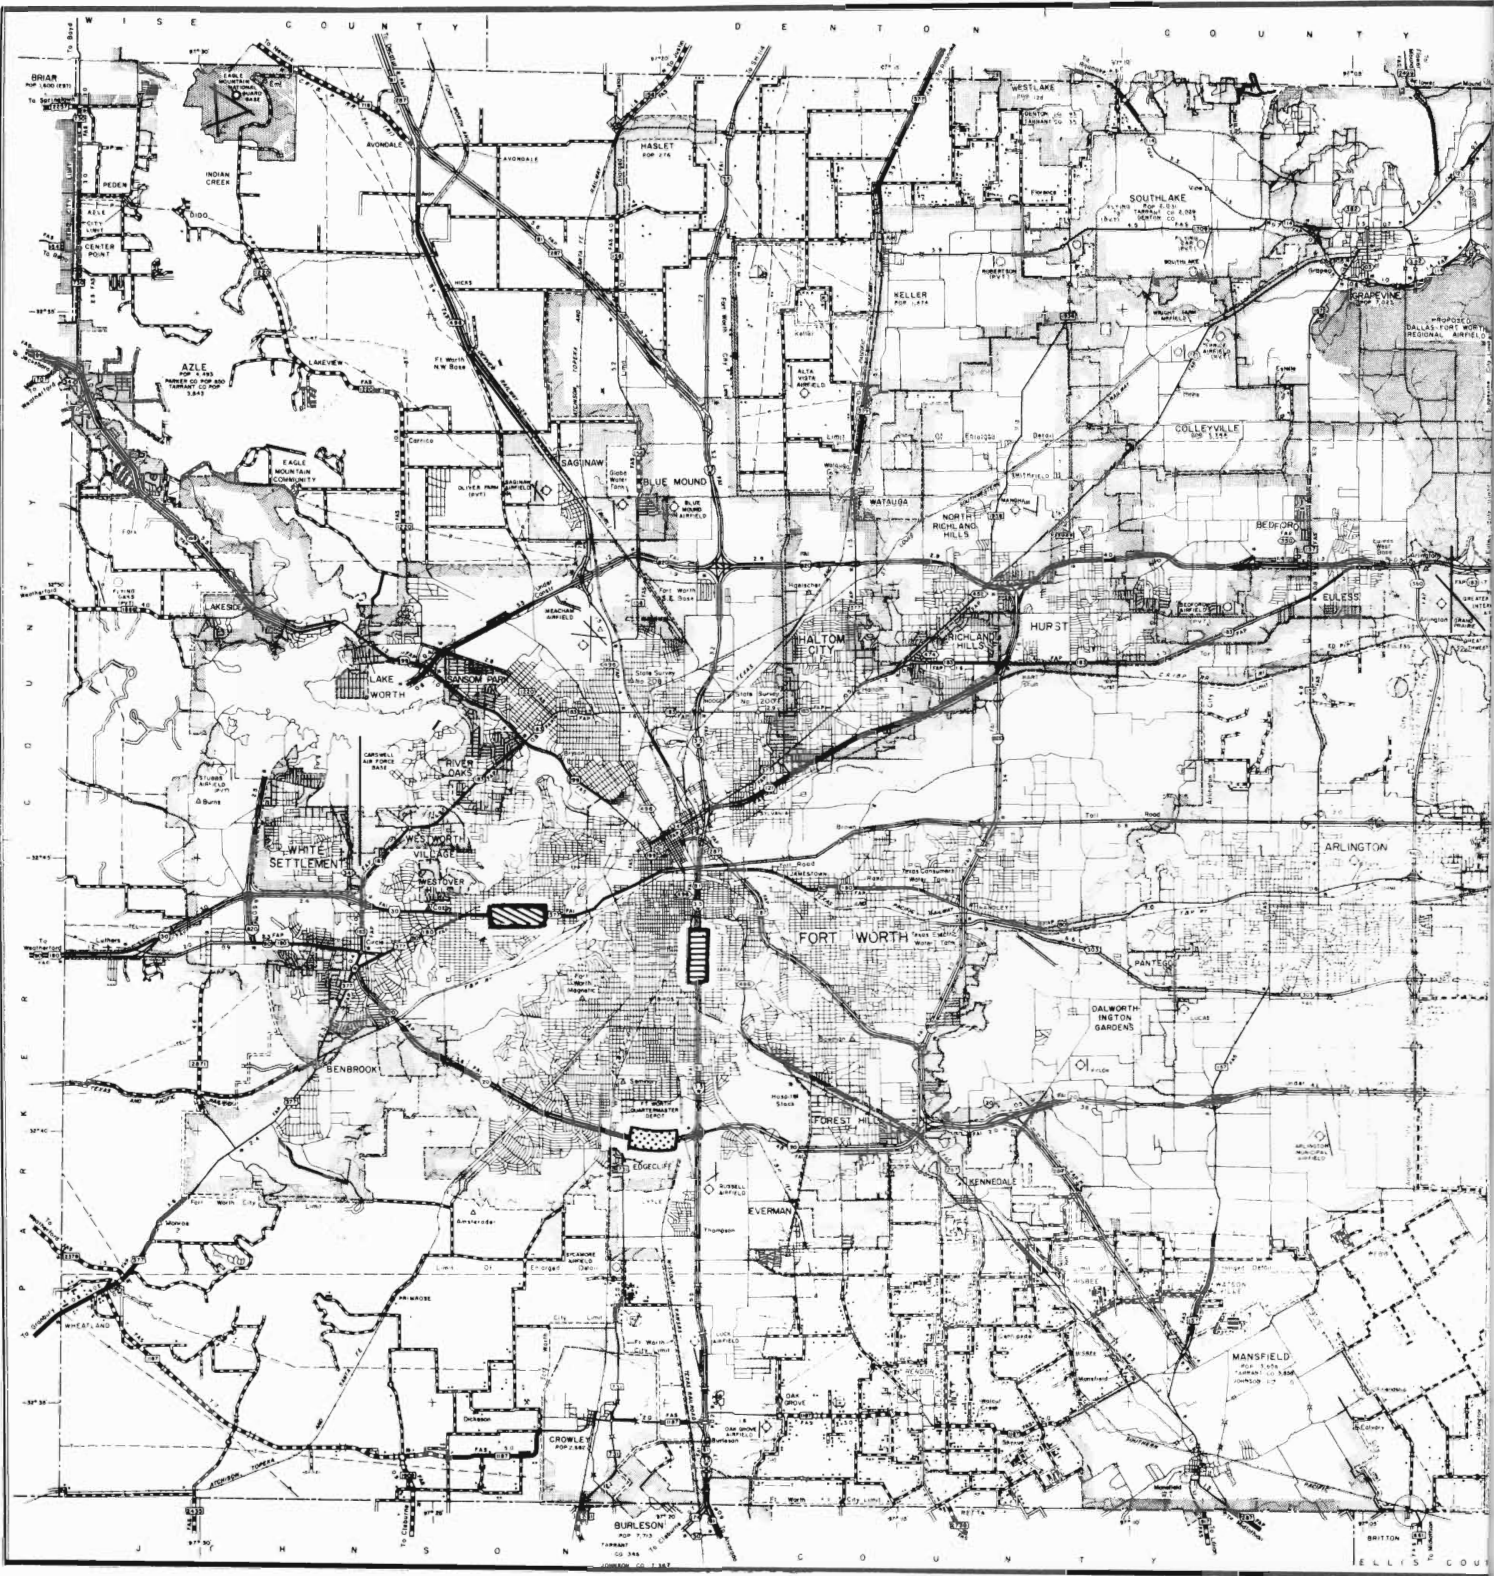
FIGURE 1

I-30-W. Freeway (68,000 ADT)
-

I-35W-S. Freeway (68,000 ADT)
-

I-20-S.W. Loop (38,000 ADT)

During the summer of 1973, a plant mix seal overlay was placed on sections of I-35W (South Freeway), I-30 (West Freeway) and I-820, I-20 (Southwest Loop). The location of these sections is shown in Figure 1.
