1. Report No.	2. Government Accession No.	3. Recipient's Catalog No.	
4. Title and Subtitle "A Survey and Evaluation of Remedial Measures for Earth Slope Stabilization"		5. Report Date August 1974

6. Performing Organization Code	
7. Author(s) Rudolph J. Schweizer and Stephen G. Wright		8. Performing Organization Report No. Research Report 161-2F

9. Performing Organization Name and Address The Center for Highway Research The University of Texas at Austin Austin, Texas 78712		10. Work Unit No.	
		11. Contract or Grant No. Research Study 3-8-71-161

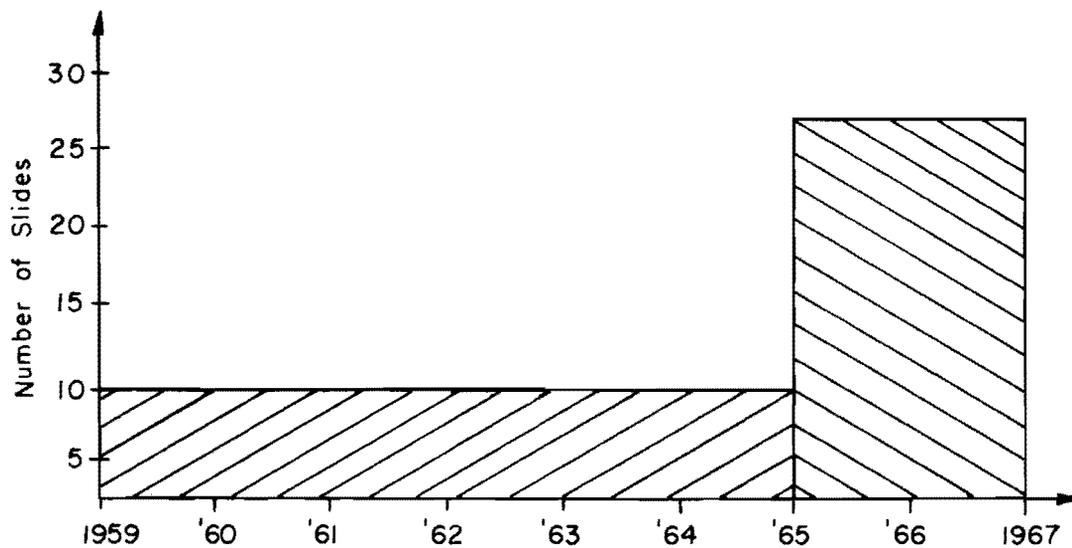
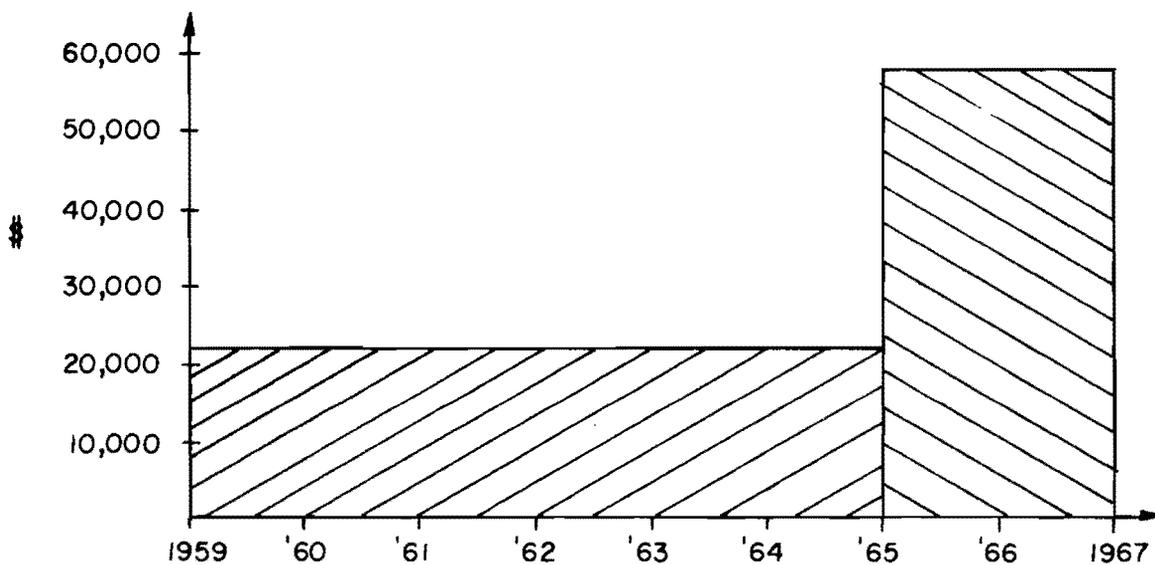
b.) Average Number of Failures  
Per Year.

a.) Average Yearly Cost for Minor  
Instability Problems.

Fig 2.1. Summary of costs and frequency of occurrence for slope failures surveyed in England (Symons, 1970).

While the study by Symons indicated that the problem was not sufficiently serious to warrant fundamental design changes, it illustrated that particular care is necessary to insure adequate subdrainage in slide susceptible areas, and that control of embankment material and construction must be increased as deeper cuts and larger embankments become more necessary.

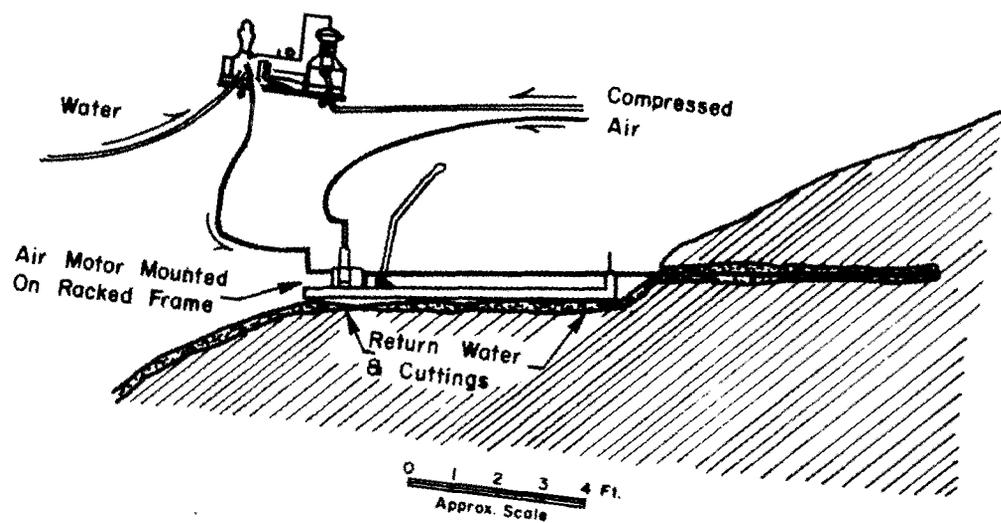
Fig 3.1. Schematic of hydrauger drill for drilling horizontal drains (after Smith and Stafford, 1957).

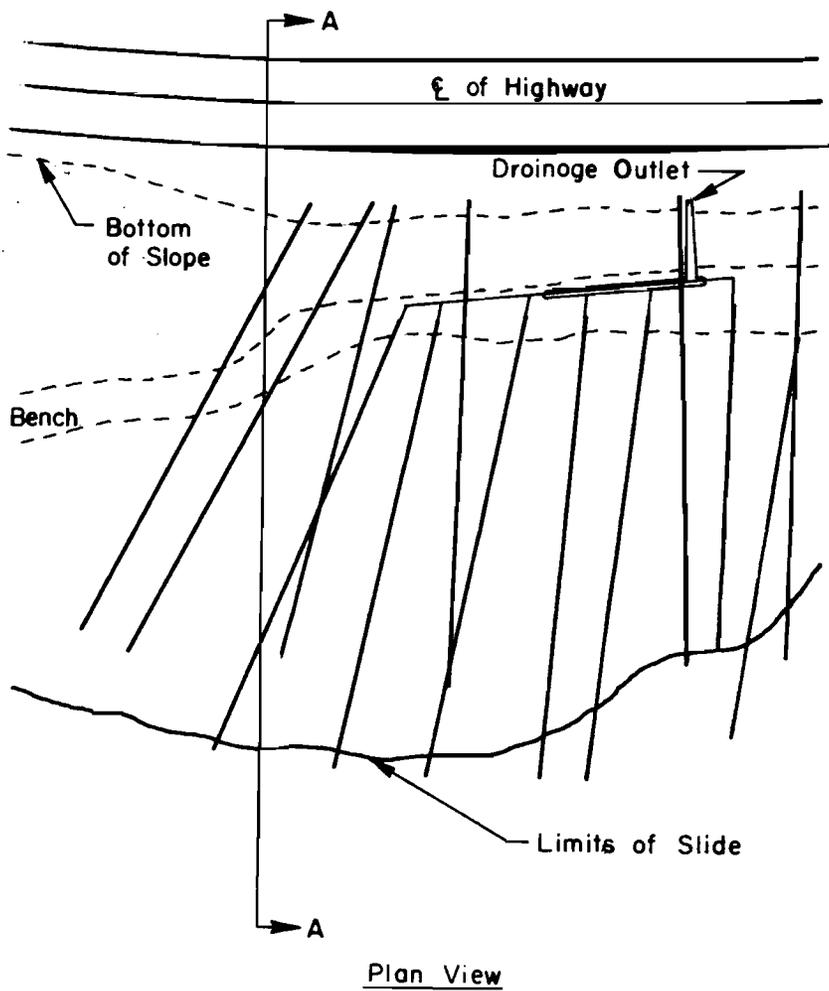
Fig 3.2. Plan view of slide area and horizontal drainage system - Willits Slide (Smith and Stafford, 1957).

The slide occurred in a cut on U.S. Highway 101 approximately 2-1/2 miles south of Willits, California, as illustrated in Figs 3.2 and 3.3. Seepage was noted during construction in 1947 but was not considered alarming. Maximum height of the cut was approximately 60 feet and 2:1 side slopes were used. The slide occurred in 1950, following three winters of unusually wet weather. The material in the cut slope consisted of 20 feet of stiff blue clay overlain by layered terrace gravel and clay. Failure was on the interface of the blue clay and the overlying strata. The head scarp was approximately 220 feet perpendicular to the highway centerline and was about 300 feet wide at the toe of the slope.

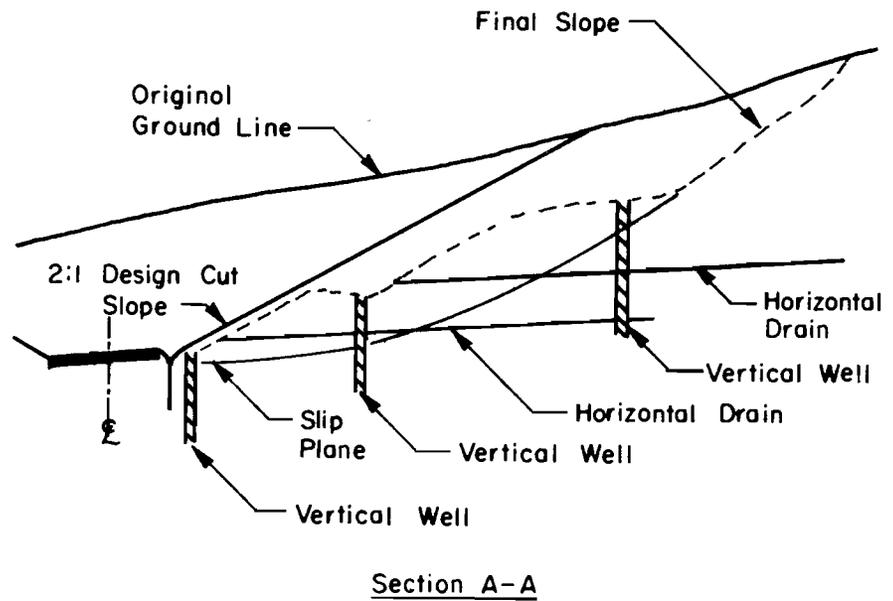
Fig 3.3. Cross section of slide and drainage system - Willits Slide (Smith and Stafford, 1957).

horizontal drains and vertical wells. The vertical wells were used to interconnect the gravel layers which were separated by the impervious clay of the surface deposit, and the horizontal drains were used to drain the water from the area in the vicinity of the slide.

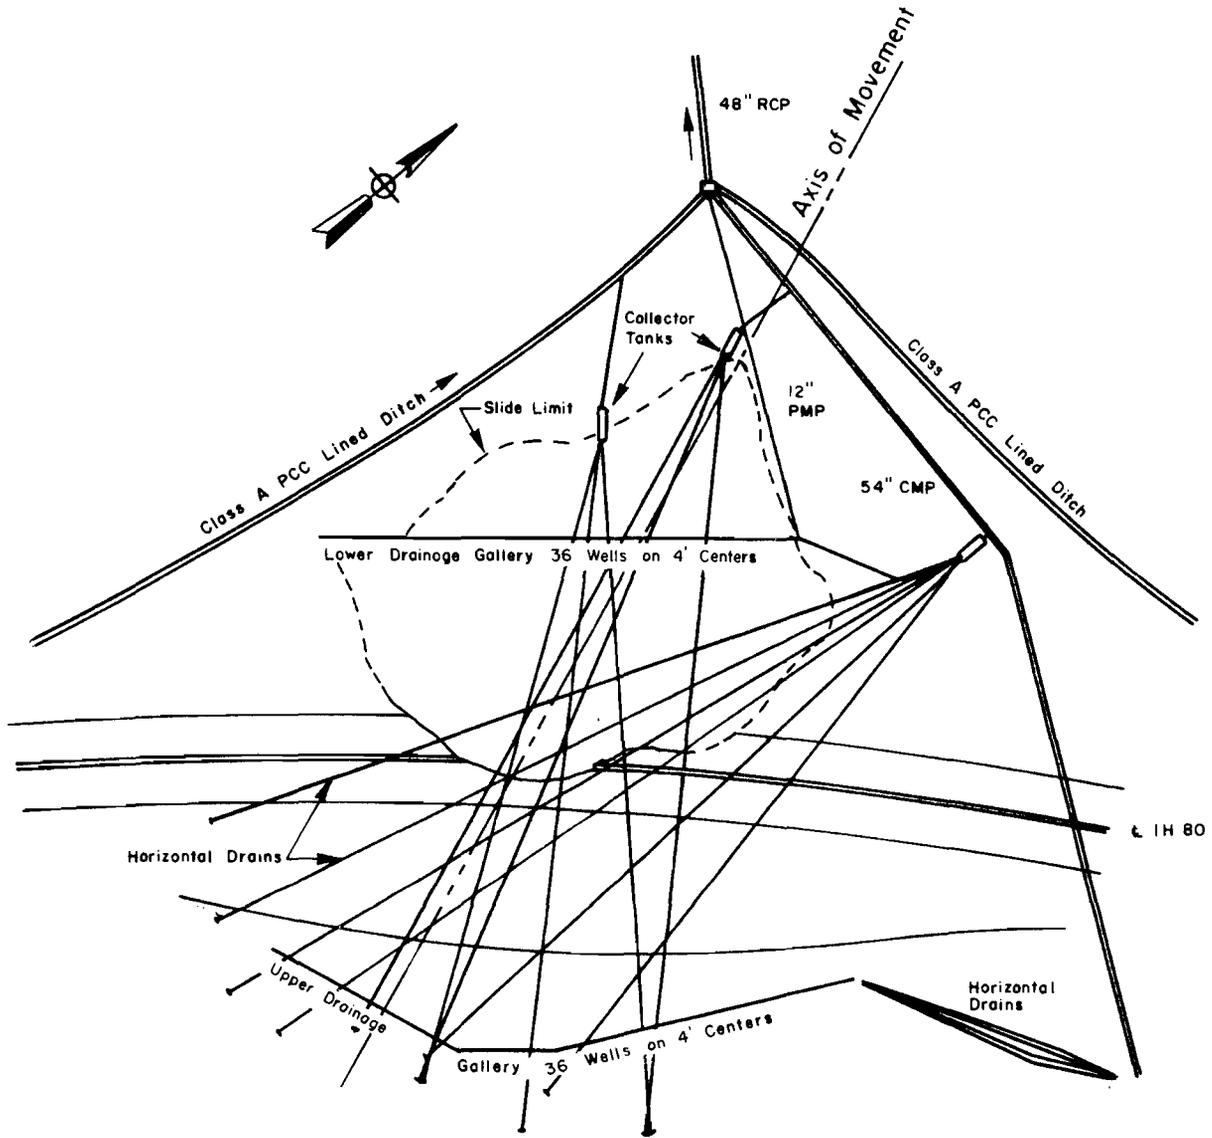
Fig 3.4. Plan view of drainage system - Pinole slide (Smith et al, 1970).

engineers decided that the use of horizontal drains would be an expedient to any permanent correction. Twelve horizontal drains, ranging in length from 550 to 830 feet, were placed in fan patterns from three different locations near the toe of the slide. Total flow produced was 12,000 gallons per day. The groundwater table was lowered 7 feet at the toe of the proposed detour upslope of the slide, 3 feet at the center of the sliding mass, and 1 foot at the toe of the slide. It was felt that the drains increased the stability enough to allow the construction of a six-lane detour at the southern edge of the embankment without further movement taking place. The plan and cross section of the remedial measures taken at the Pinole slide are illustrated in Figs 3.4 and 3.5, respectively.

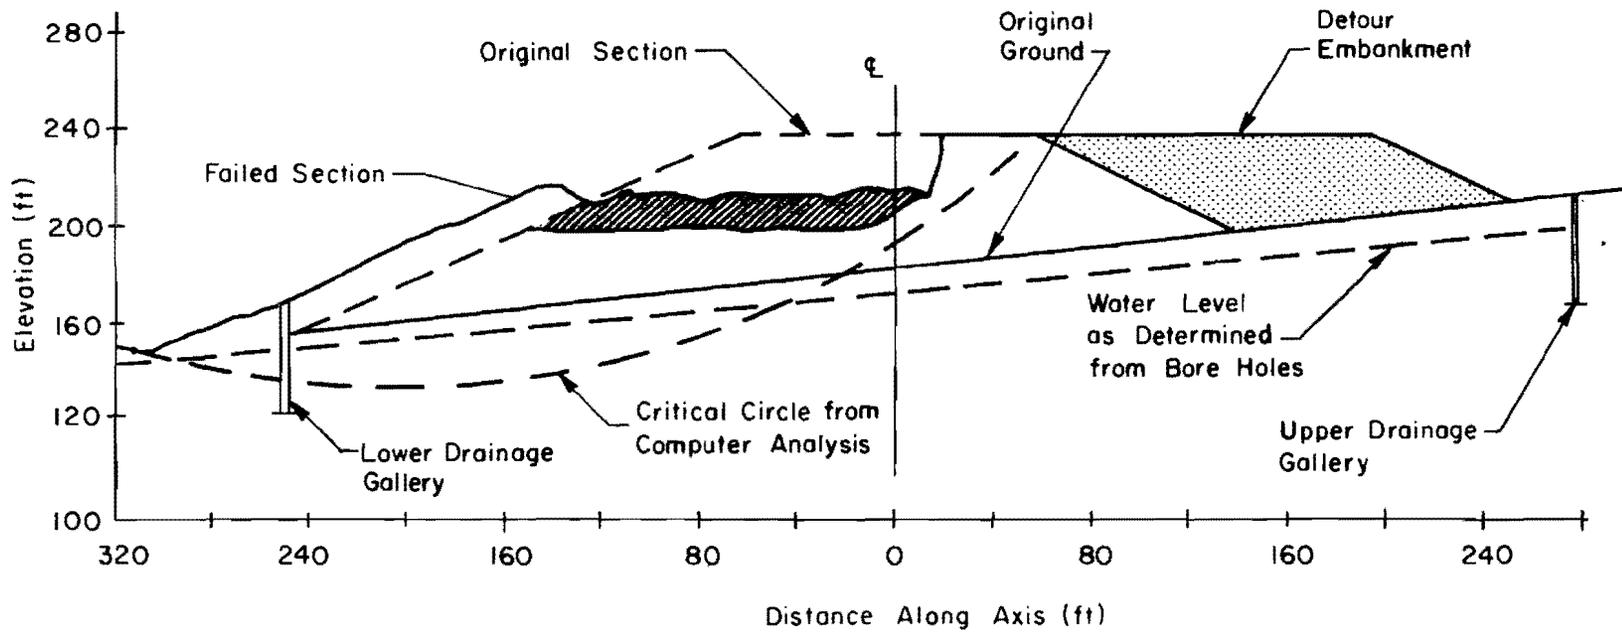
Fig 3.5. Cross section of slide along axis of movement - Pinole slide (Smith et al, 1970).

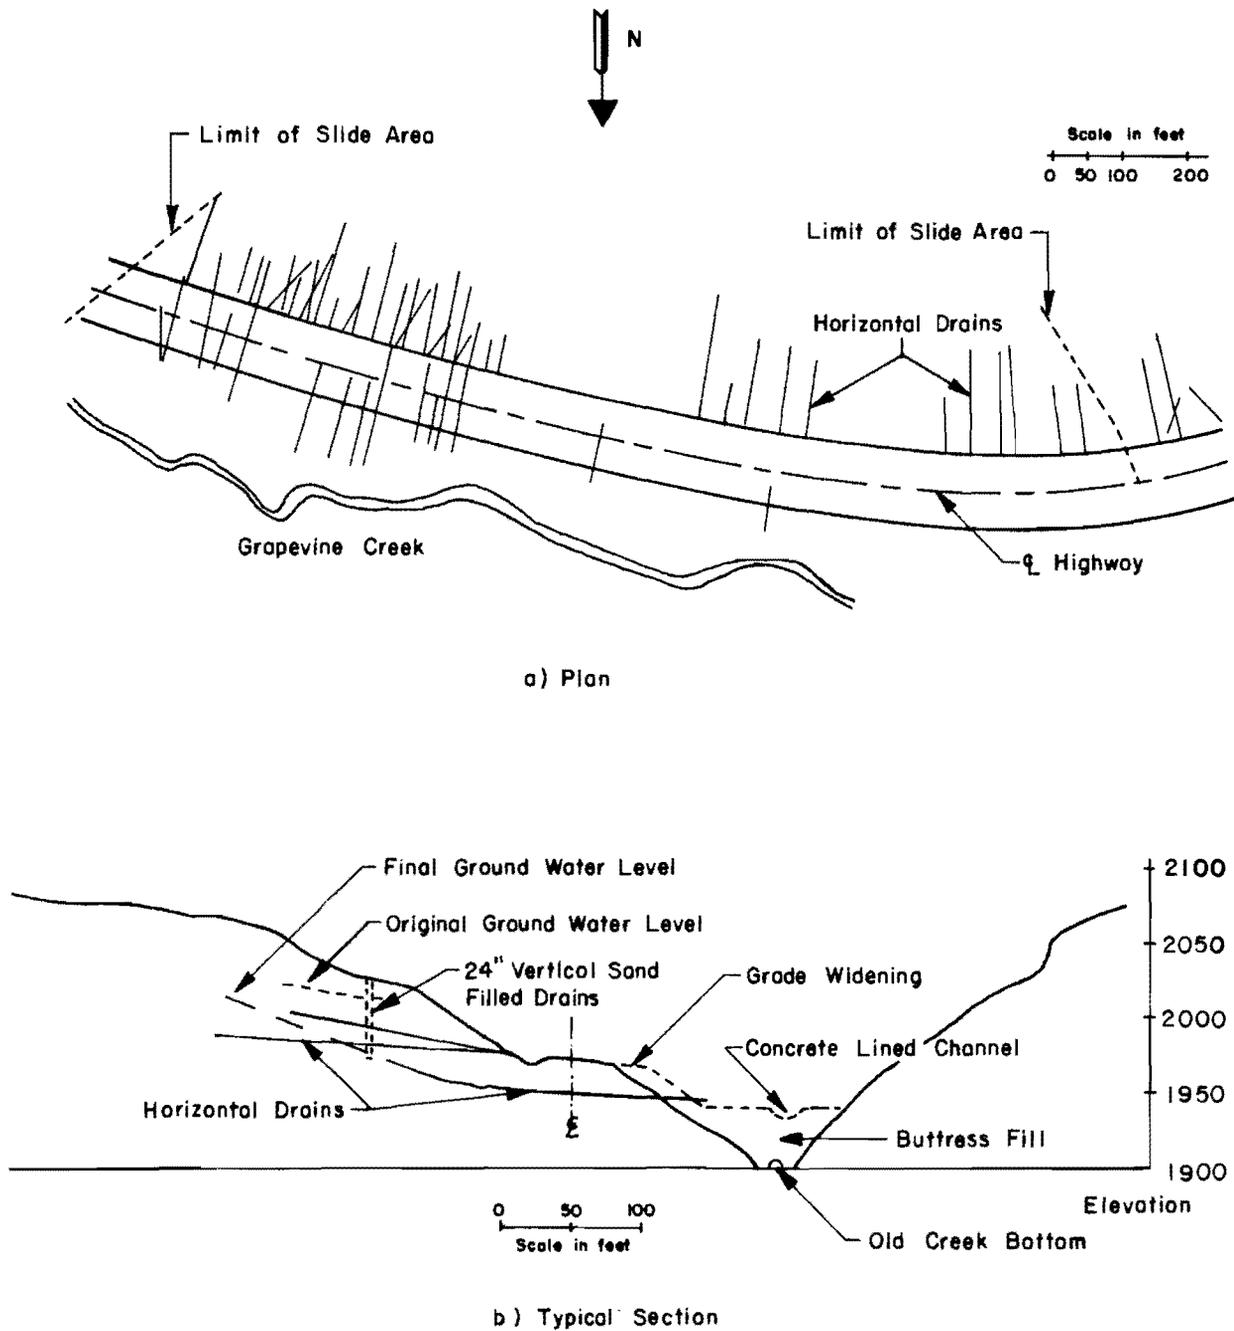
Fig 3.6. Drainage system and remedial measures - Grapevine slide (Scott, 1936, 1941).

Excessive seepage forces threatened to slowly move the highway into Grapevine Creek at the bottom of the canyon (Fig 3.6). The material on the southern side of the highway was a sandy clay/shale, overlain by thin layers of silt, sand, and plastic clay. The stabilization consisted of two distinctly separate operations:

The first operation consisted of placing 24-inch-diameter vertical sand filled drains in the area most highly stratified with alternate layers of impervious clay and water bearing sand and gravel. Horizontal drains were then installed from 2 to 3 feet above roadway grade into the side slope at

angles ranging from 2 to 20 degrees above the horizontal. Lengths of the drains averaged 100 feet; the maximum length was 170 feet. Two-inch-diameter perforated pipes were installed in the 4-inch hydrauger holes. A 200-gallon per hour maximum flow was reported in some of the horizontal drains.

The second stage of the correction procedure was the construction of a 40-foot hill along 2000 feet of the highway in the Grapevine Creek bed. The elevation of the creek bed was raised 40 feet by placing a concrete lined channel on top of the earth buttress. While the buttress was being constructed, horizontal drains were being used to reduce seepage forces and lower the groundwater table in the cut/fill section. The plan and cross section in Fig 3.6 illustrates the measures used in the stabilization of this slope. No further problems have been reported since completion of the remedial measures in 1942.

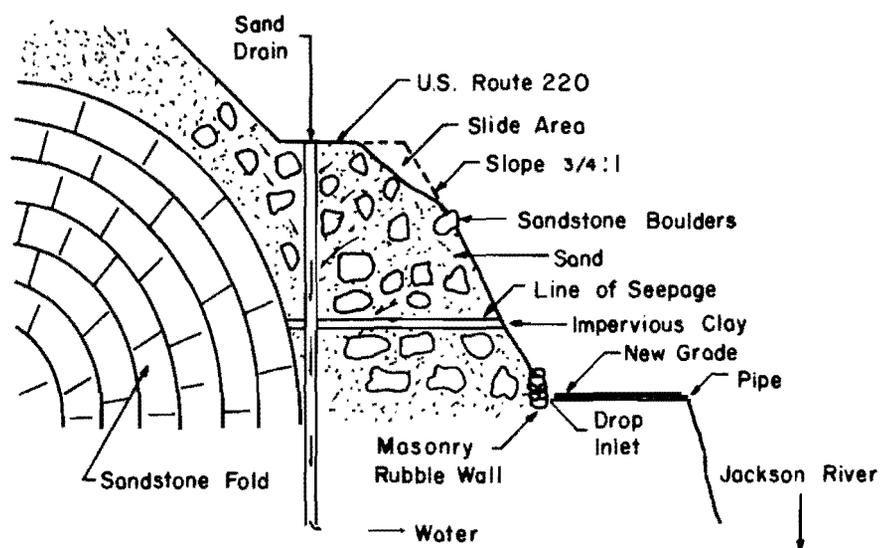
Fig 3.7. Remedial drainage - U.S. 220, Alleghany County, Virginia (Parrott, 1955).

U.S. 220, Virginia. Although several early instances appear in which some type of vertical drain was incorporated into the overall landslide stabilization scheme (Forbes, 1947), the first reported use found of vertical sand drains alone to correct an active landslide was during the relocation and widening of U.S. Highway 220 in Alleghany County, Virginia, in 1947 (Parrott, 1955). The relocated highway lies parallel to and 70 feet downhill from the original U.S. 220 with the Jackson River located 50 feet further down the slope, as indicated by the cross section in Fig 3.7.

Excavation for the new route in the area of interest showed that the road would pass through a thick mantle of talus, mostly sandy soil interspersed with large boulders. This soil was classified as an A-2 sandy silt, and it was in this material that a slide first showed evidence of developing. The area between the new grade and U.S. Highway 220 was described as the potential problem area, as illustrated by the cross section in Fig 3.7.

grade. Upon completion of the first hole it was discovered that the water would not drain freely from the bottom of the holes. As a result of this finding, explosive charges were set in the bottom of each hole to provide a freely draining path for the water within the slope. Ten 6-inch-diameter vertical sand drains, filled with a well-graded concrete sand and sealed with a bituminous cap, were installed in this manner. This group of ten vertical drains allowed seepage to drain vertically into the alluvial sand and gravel and discharge freely at the base of the 80-foot holes into the Jackson River. No other drainage was necessary, and the stabilization procedure remains effective to date.

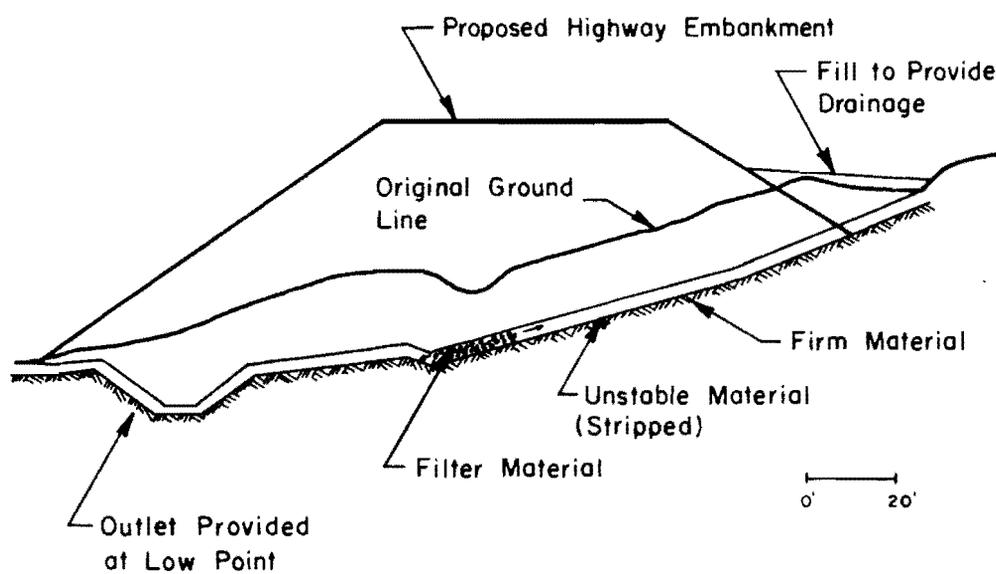
Fig 3.8. Typical cross section of stripping employed for slide prevention - Redwood Highway, California (Root, 1958).

The primary use of stripping is as prevention of landslides in areas where the construction of highway embankments will endanger the stability of a hillside. The main function of stripping has been to insure stability on hillside fill sections. Figure 3.8 illustrates the use of stripping on a hillside section of the Redwood Highway in Humboldt County, California.

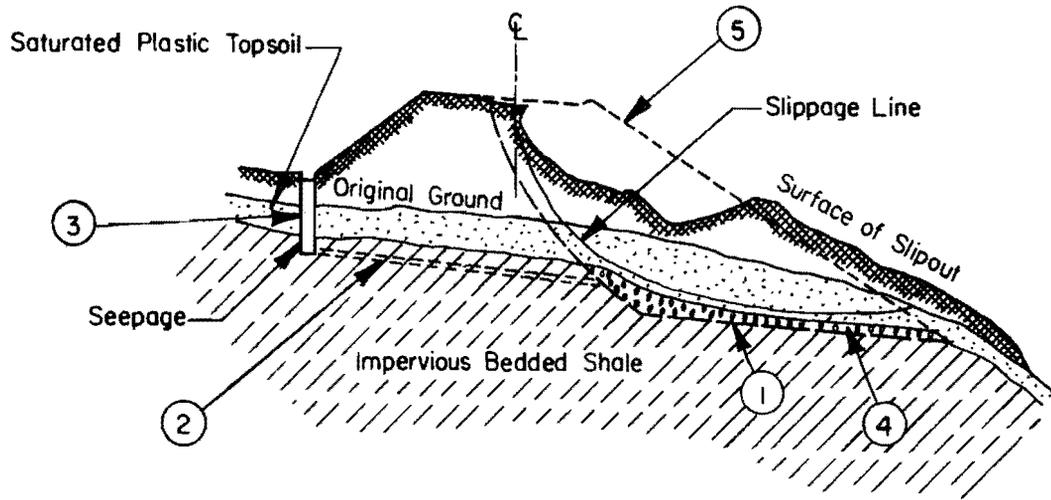
| 3. Construct Intercepting Trench | |

Fig 3.9. Corrective measures - Castaic - Alamos Creek slides (Dennis and Allan, 1941).

Although stripping is most economically used as a prevention of landslides, several case histories illustrate the successful use of this method as a slide correction. The use of this as a remedial measure is economically limited to embankments of relatively small cross section and slides of shallow depths. This type of slide may be attributed to excessive groundwater and the presence of a soft clay layer immediately beneath the embankment. The procedure for correction of the Castaic-Alamos Creek slides is illustrated in Figs 3.9 and 3.10. Both slides occurred in 1938 and stabilization by stripping has proven successful.

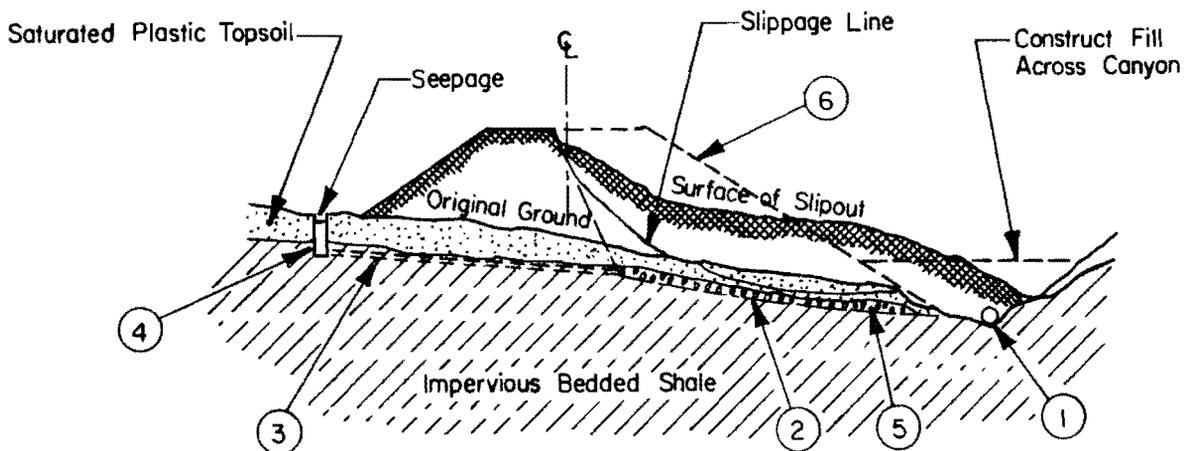
| 3. Place Perforated Pipe in Boring | 6. Rebuild Fill |

Fig 3.10. Corrective measures - Castaic - Alamos Creek slides (Dennis and Allan, 1941).

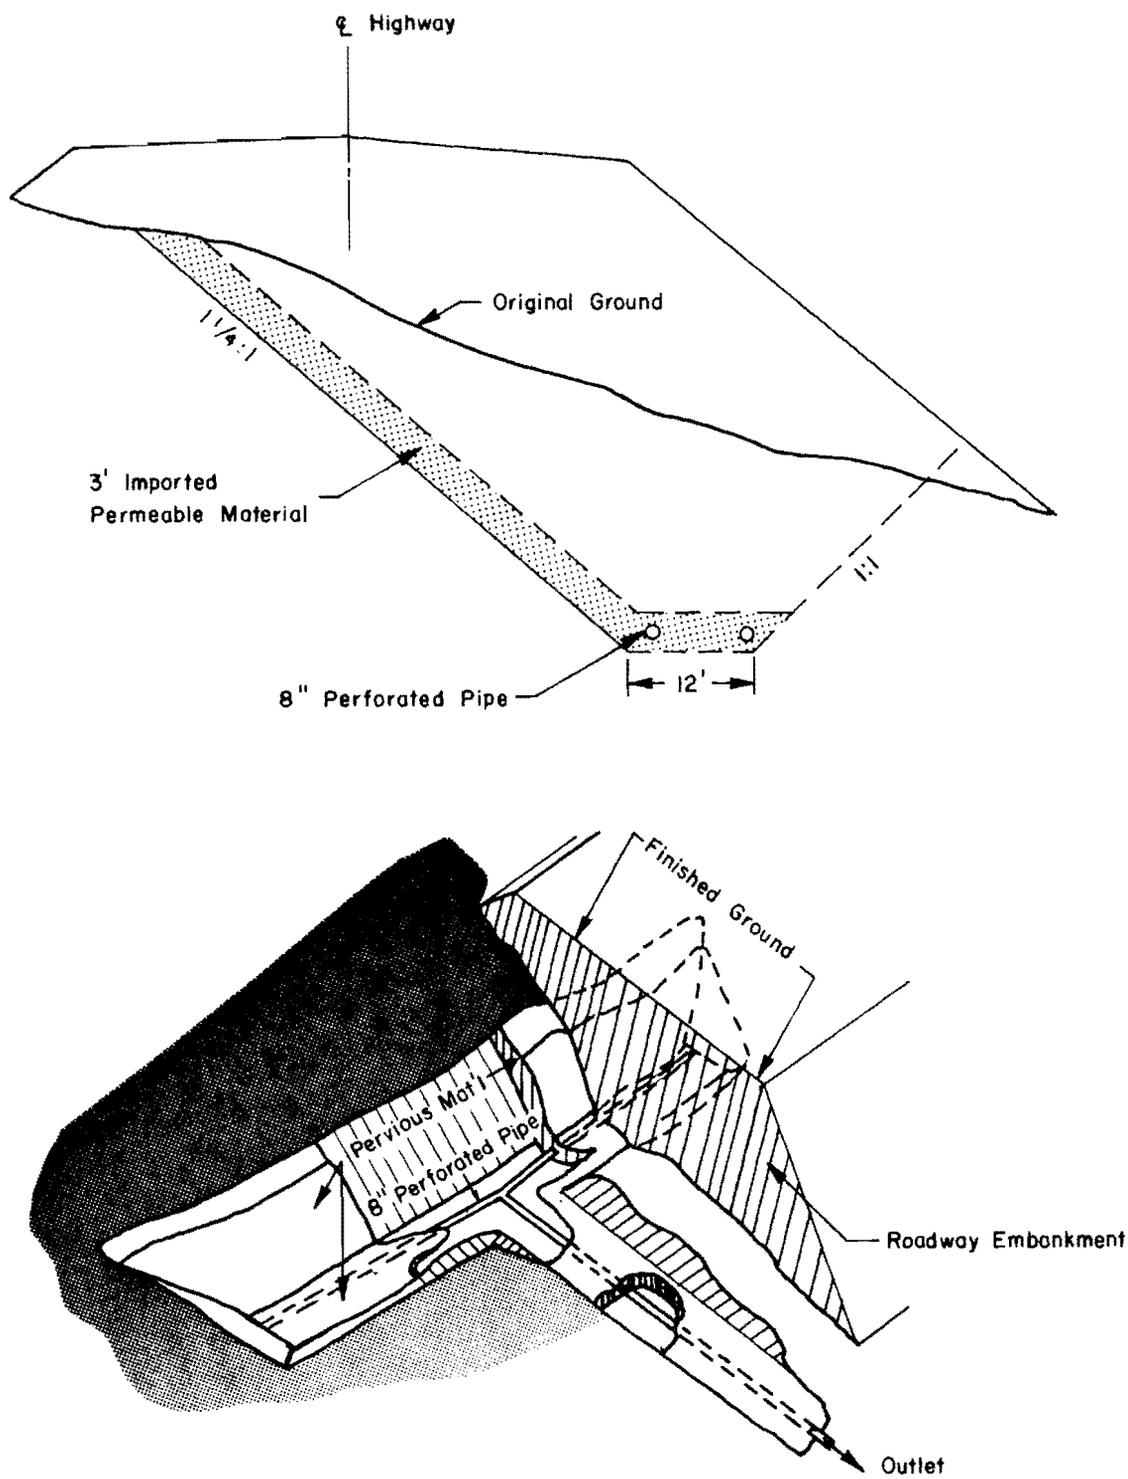
Fig 3.11. Longitudinal stabilization trench (Smith, 1964).

Figure 3.11 illustrates the use of stabilization trenches during the construction of Interstate Highway 5 in northern California described by Smith (1964). The bottom width of the trench, 12 feet, was determined by the minimum convenient width for use of conventional construction equipment. The side slopes ranged from 1:1 to 1-1/2:1. The trenches used along IH 5 were

blanketed with 3 feet of permeable material with perforated pipes placed in the bottom to facilitate removal of subsurface water. Outlets, which in essence were transverse stabilization trenches, were provided to remove water from the lower end of the trench.

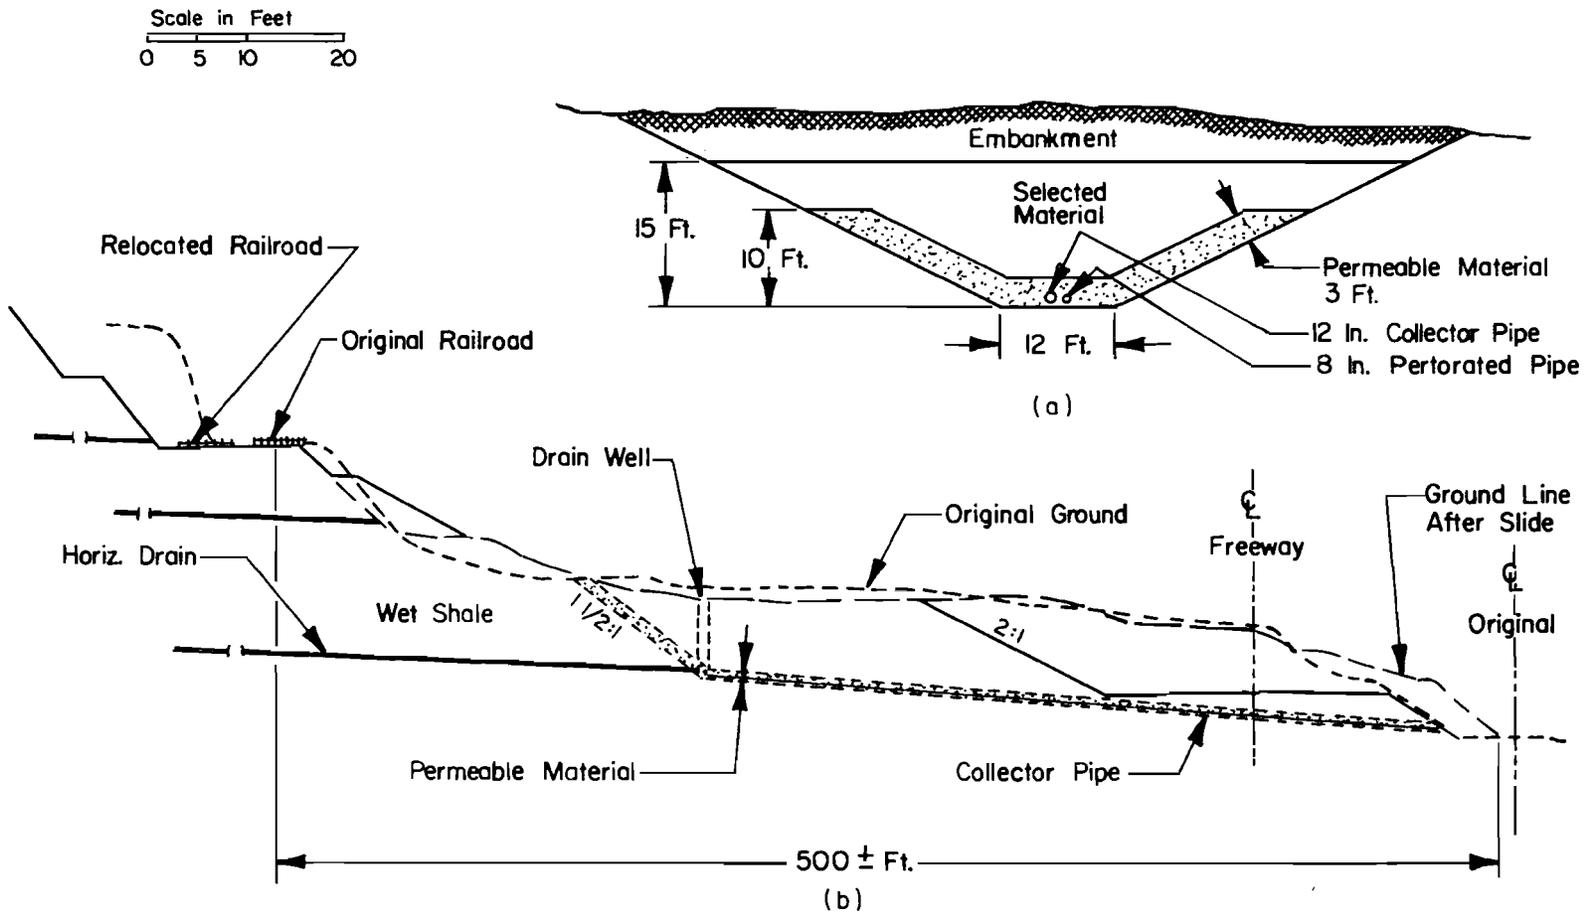
Fig 3.12. Transverse stabilization trenches - Towle slide (Cedergren, 1962).

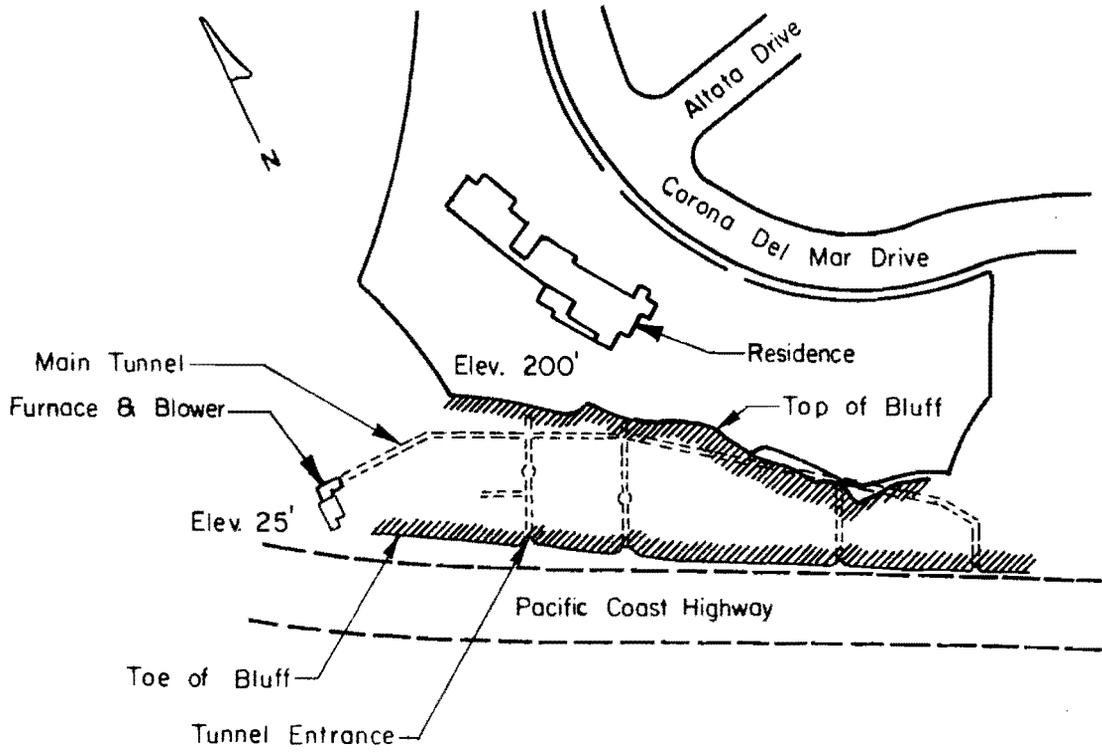
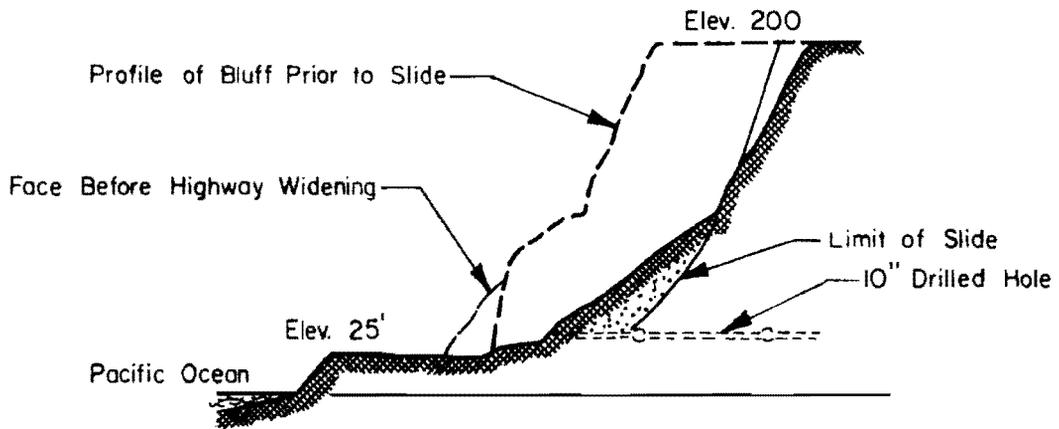
Fig 3.13. Drainage system - Pacific Palisades (Hill, 1934).

Hill (1934) reports the use of a unique drainage system to control a landslide on the Pacific Palisades near Santa Monica, California. The landslide threatened expensive property on top of the 180-foot bluff. A network of interconnected tunnels and drilled holes were driven into the clay stratum near the base of the bluff, as shown in Fig 3.13. Air, heated by a natural gas furnace, was blown through the network to dry out the clay and increase

its strength. Excellent results were achieved using this procedure and it was also noted that the capitalized cost of operation of the blower was considerably less than the cost of any permanent construction that could be built to control future movements of the bluff.

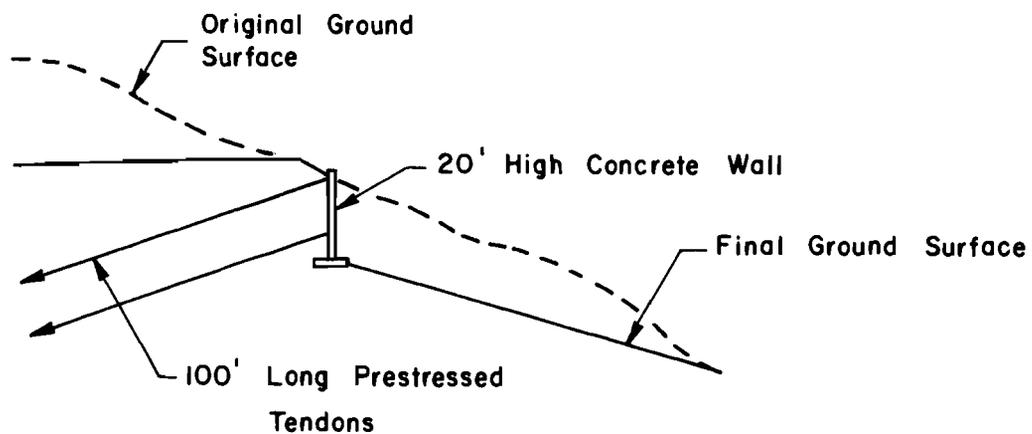
(a) Tied-Back Retaining Wall (Reti, 1964)

Fig 4.1. Examples of anchored and tied-back retaining systems.

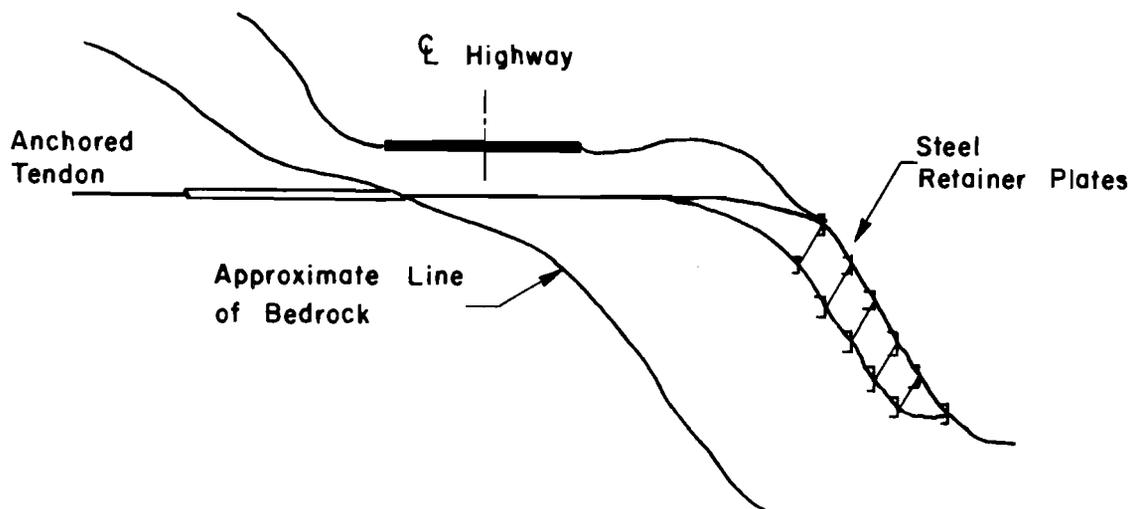
(b) Baffle Restraint System (Cutler, 1932 ; Allen 1937)

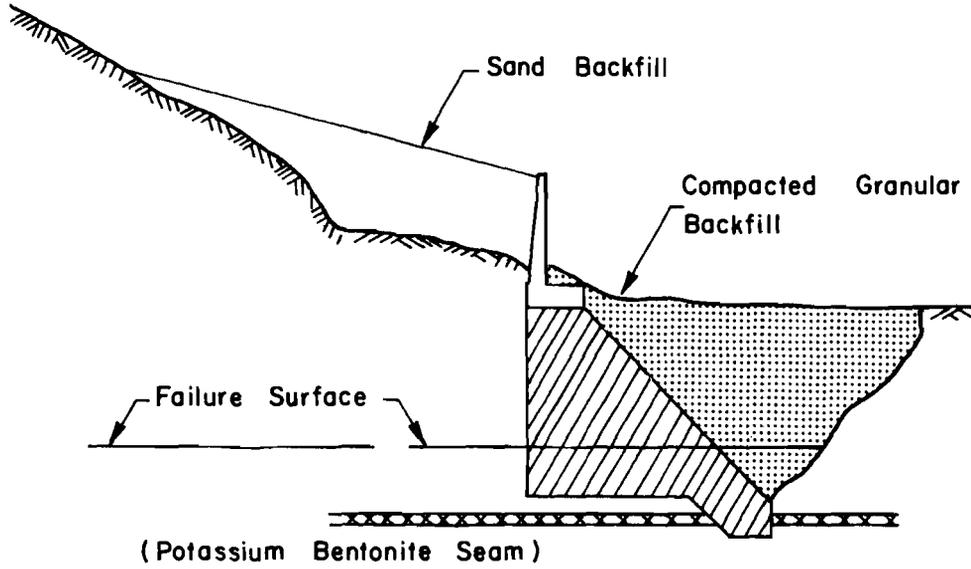
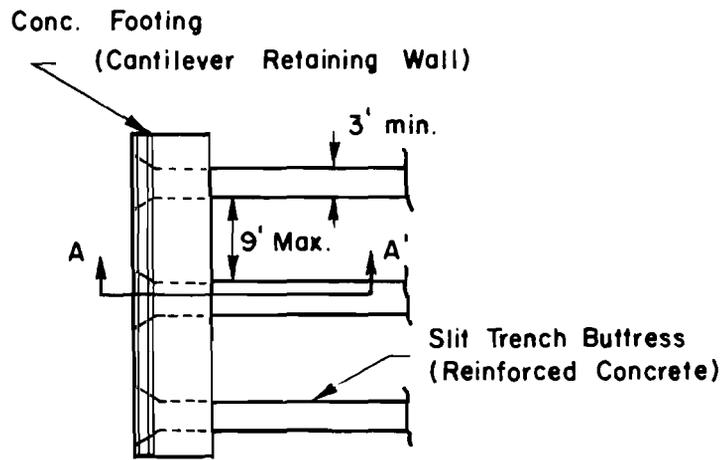
a) Cross Section

b) Plan

Fig 4.2. Slit trench buttress - cantilever retaining wall used for Minneapolis Freeway slide (Shannon and Wilson, 1968).

As knowledge of soil mechanics has increased, various types of restraint structures have been successfully applied to correct landslide problems. Root (1958) mentions timber bulkheads, timber and metal cribbing, concrete retaining walls, rubble and masonry retaining walls, concrete and timber piling, and toe buttressing as successful prevention and correction techniques. Reti (1964) and Gould (1970) report a successful correction of a hilltop stability problem using the anchored retaining wall illustrated in Fig 4.1a. Cutler (1932) and Allen (1937) report the use of the unique anchored baffle system illustrated in Fig 4.1b for restraint of shallow movement. However, in the case histories reported in the literature this method was unsuccessful when the soil beneath the retainer plates became saturated. For the Minneapolis Freeway slide Shannon and Wilson (1968) reported that the slit-trench buttress and retaining wall system shown in Fig 4.2 was found to be the most economical and permanent solution.

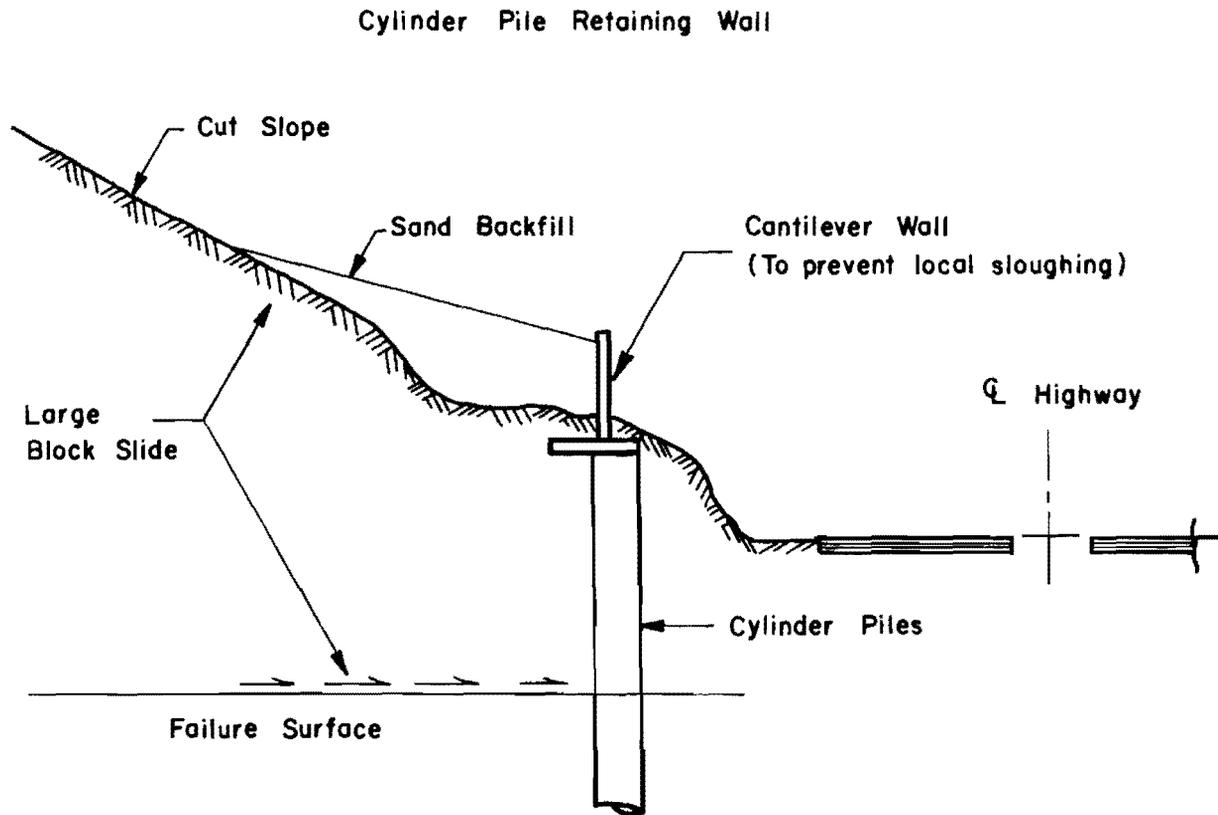
Fig 4.3. Cylinder pile retaining wall system.

Cantilever type retaining walls were used to support cut slopes along the Seattle Freeway. However, this method proved unsuccessful and the Washington State Highway Department developed an elaborate alternate design employing

massive cylinder pile retaining walls, illustrated in Fig 4.3 (Shannon and Wilson, 1963). These walls were successful in correcting the problem.

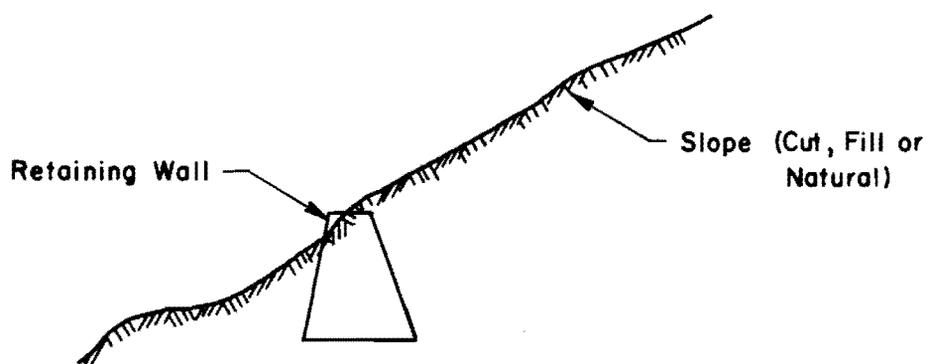
a) Concrete Gravity Retaining Walls – Applicable to both cut and fill sections.

Fig 4.4. Example uses of retaining walls for slope stabilization.

A number of examples found in the literature for typical restraint structures used as slide preventive and corrective measures are illustrated in Figs 4.4 through 4.6. While a relatively large number of case histories involving such restraint structures was found in the literature, few of these

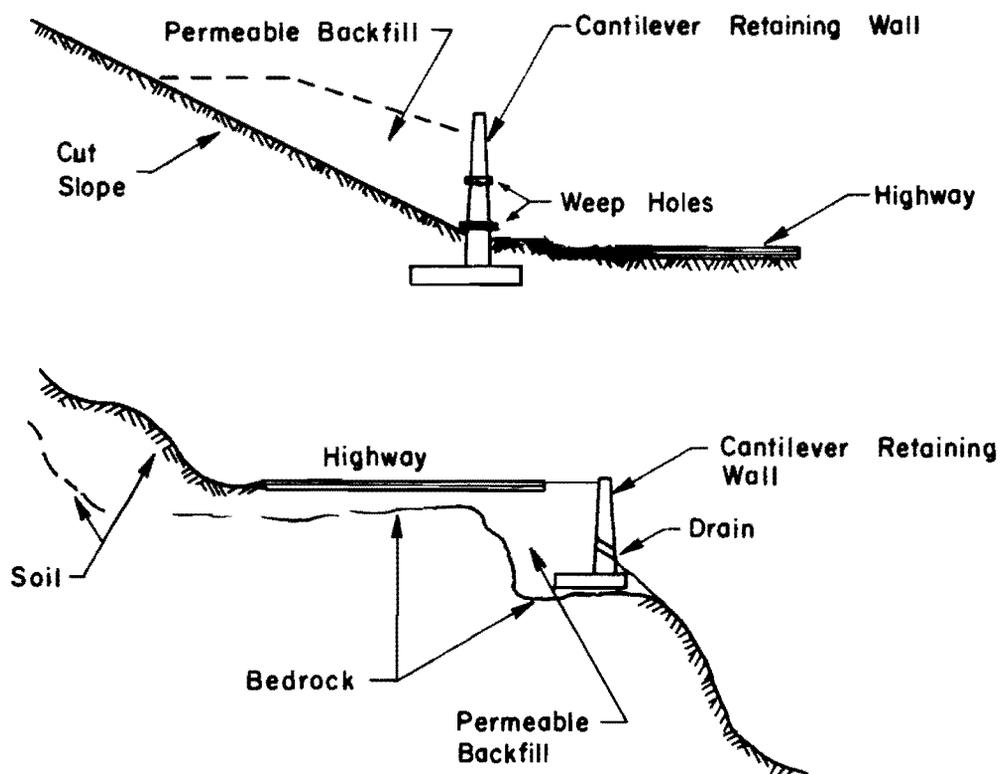
b) Cantilever Retaining Walls – Commonly used to control movements of small soil masses or sidehill fill sections.

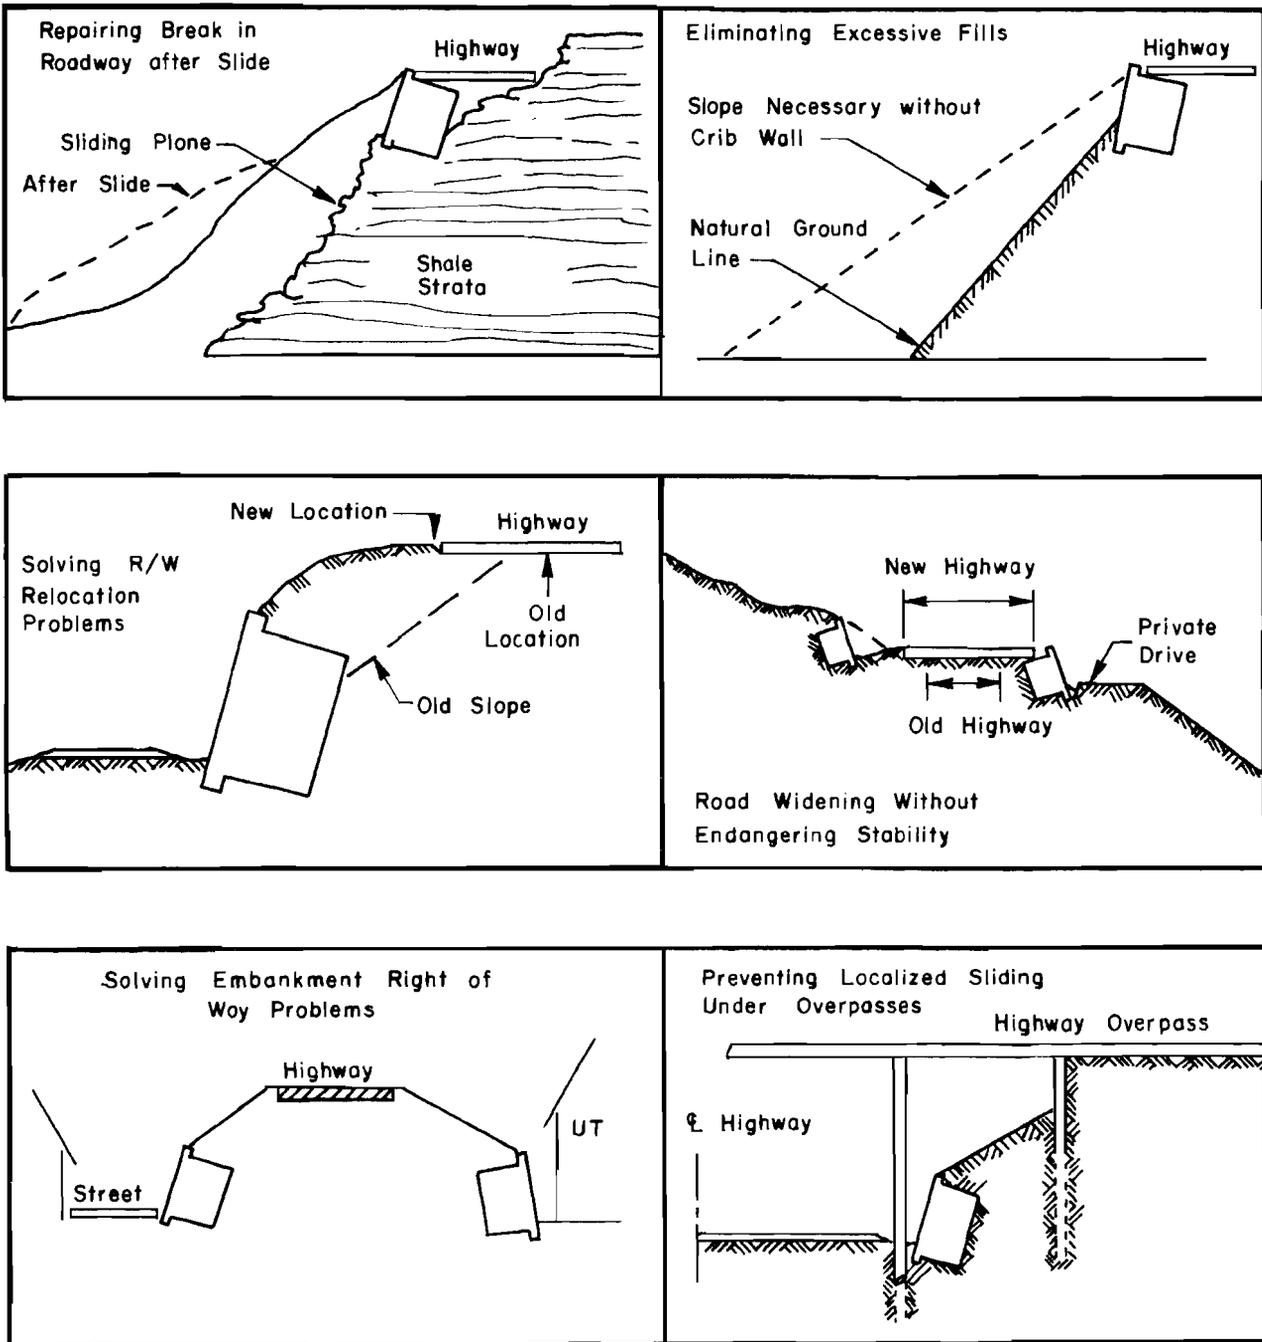
Fig 4.5. Examples of crib buttressing related to highway landslide prevention and correction.
