1. Report No.	2. Government Accession No.	3. Recipient's Catalog No.	
4. Title and Subtitle "A Survey and Evaluation of Remedial Measures for Earth Slope Stabilization"		5. Report Date August 1974

6. Performing Organization Code	
7. Author(s) Rudolph J. Schweizer and Stephen G. Wright		8. Performing Organization Report No. Research Report 161-2F

9. Performing Organization Name and Address The Center for Highway Research The University of Texas at Austin Austin, Texas 78712		10. Work Unit No.	
		11. Contract or Grant No. Research Study 3-8-71-161

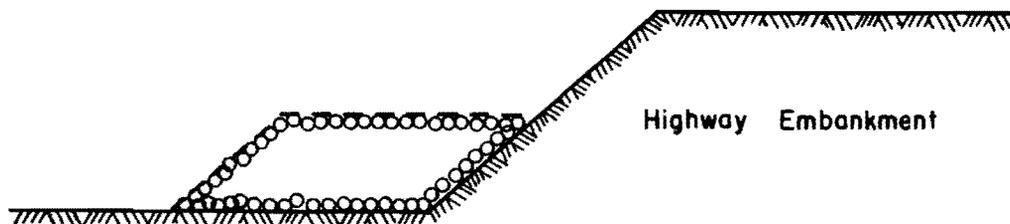
a.) Earth or Rockfill Toe Buttress (Berm)

Fig 4.6. Example uses of free-draining toe buttress fills.

A number of examples found in the literature for typical restraint structures used as slide preventive and corrective measures are illustrated in Figs 4.4 through 4.6. While a relatively large number of case histories involving such restraint structures was found in the literature, few of these

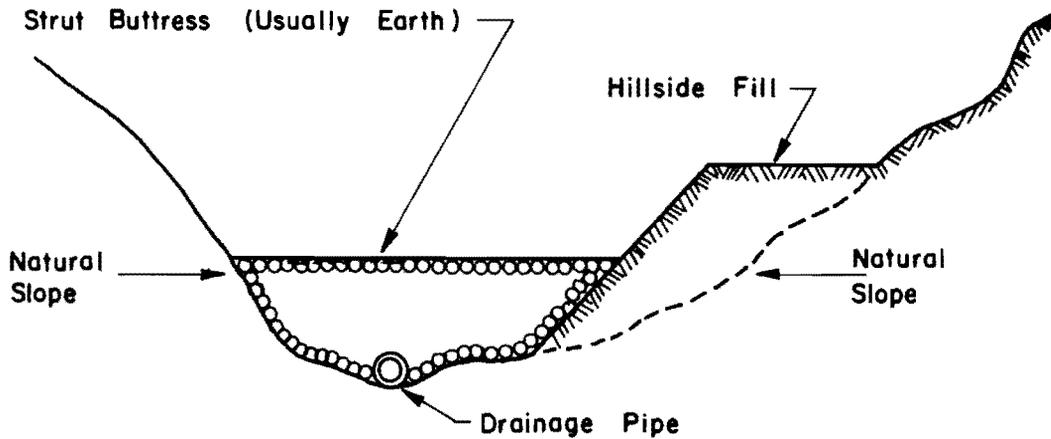
b.) Toe Strut Buttress (Usually Earth)

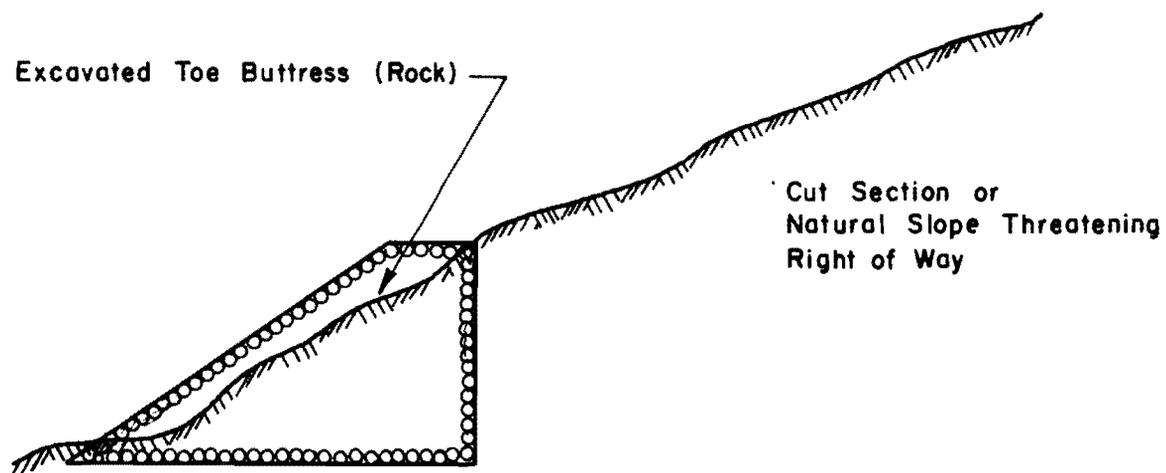
c.) Excavated Toe Buttress (Rock)

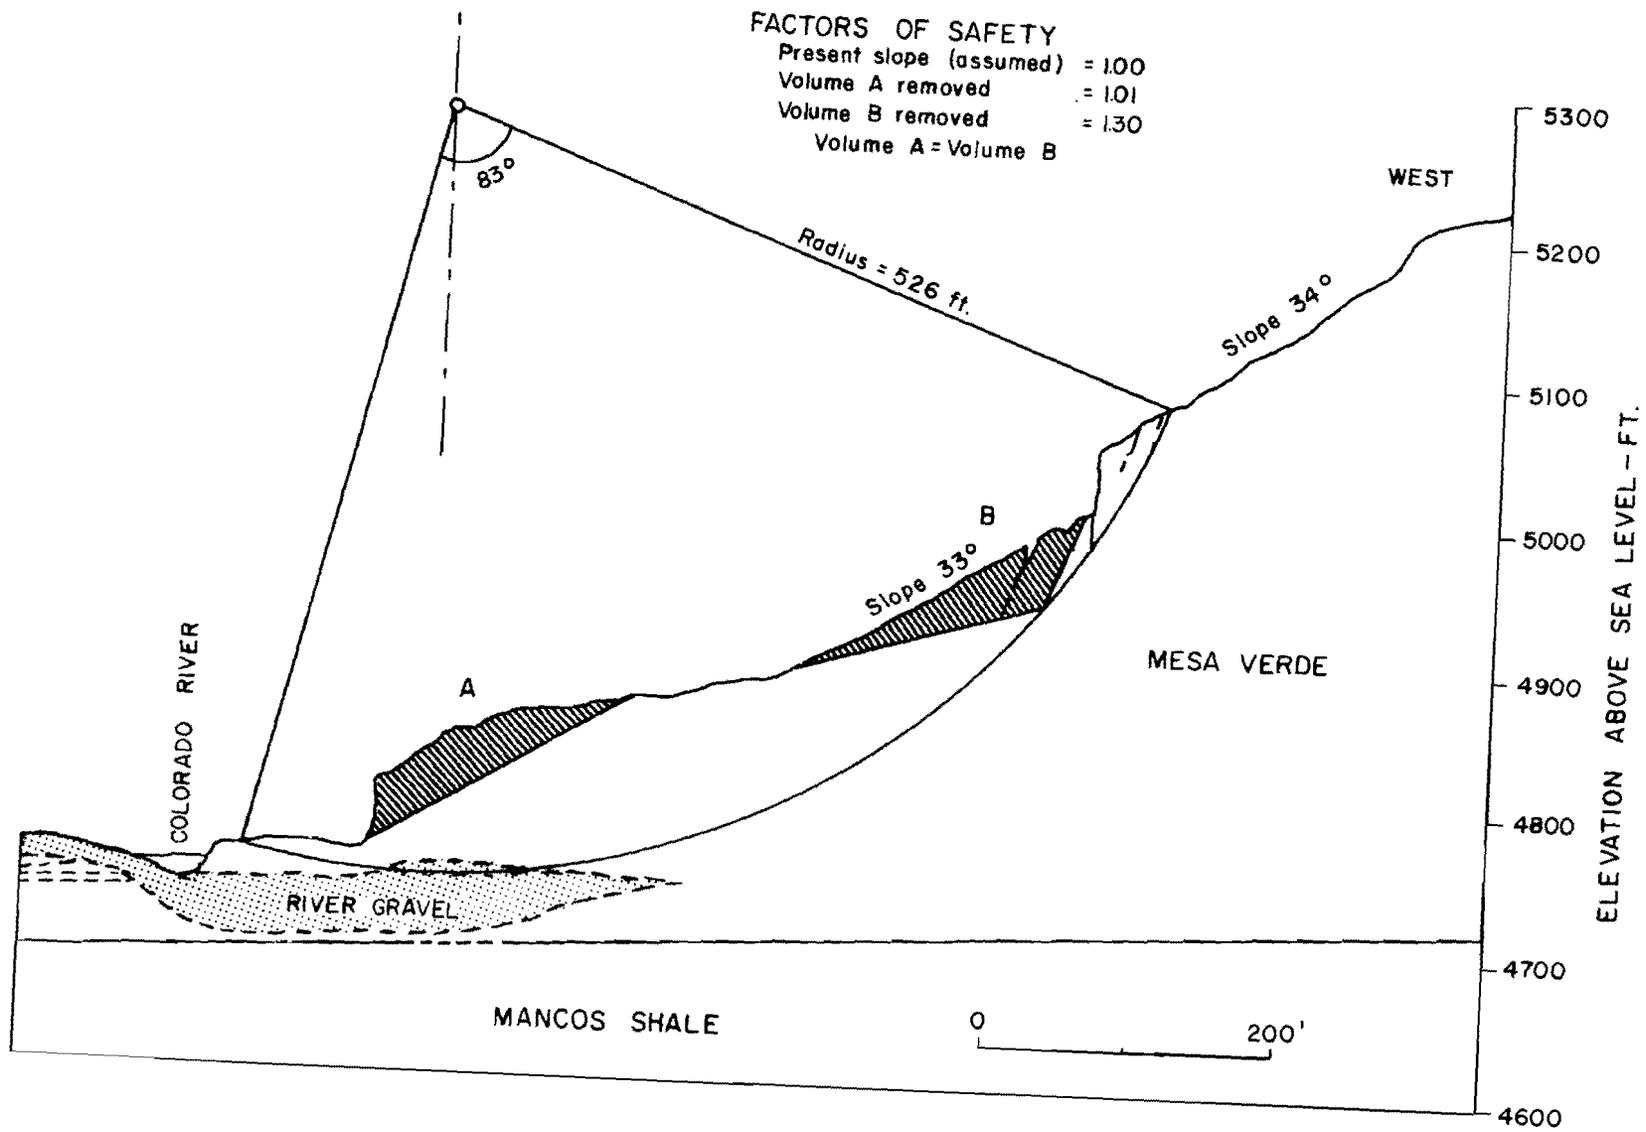
Fig 6.1. Comparative evaluation of excavation alternatives - Cameo slide (Peck and Ireland, 1953).

Only two case histories were found in the literature relating to removal of the head of the slope. Both were summarized by the Committee on Landslide Investigation in 1958 (Highway Research Board, 1958). In one of these, the stabilization of the Cameo slide reported by Peck and Ireland (1953) and illustrated in Fig 6.1, stability analyses disclosed that removal of the head of the slide (shaded area B in figure) would provide a factor of safety of 1.3, while removal of a similar volume of material near the toe of the slope (area A) would produce a factor of safety of only 1.01, based on an initial factor of safety of unity. Removal of area B resulted in a permanent solution to the problem.

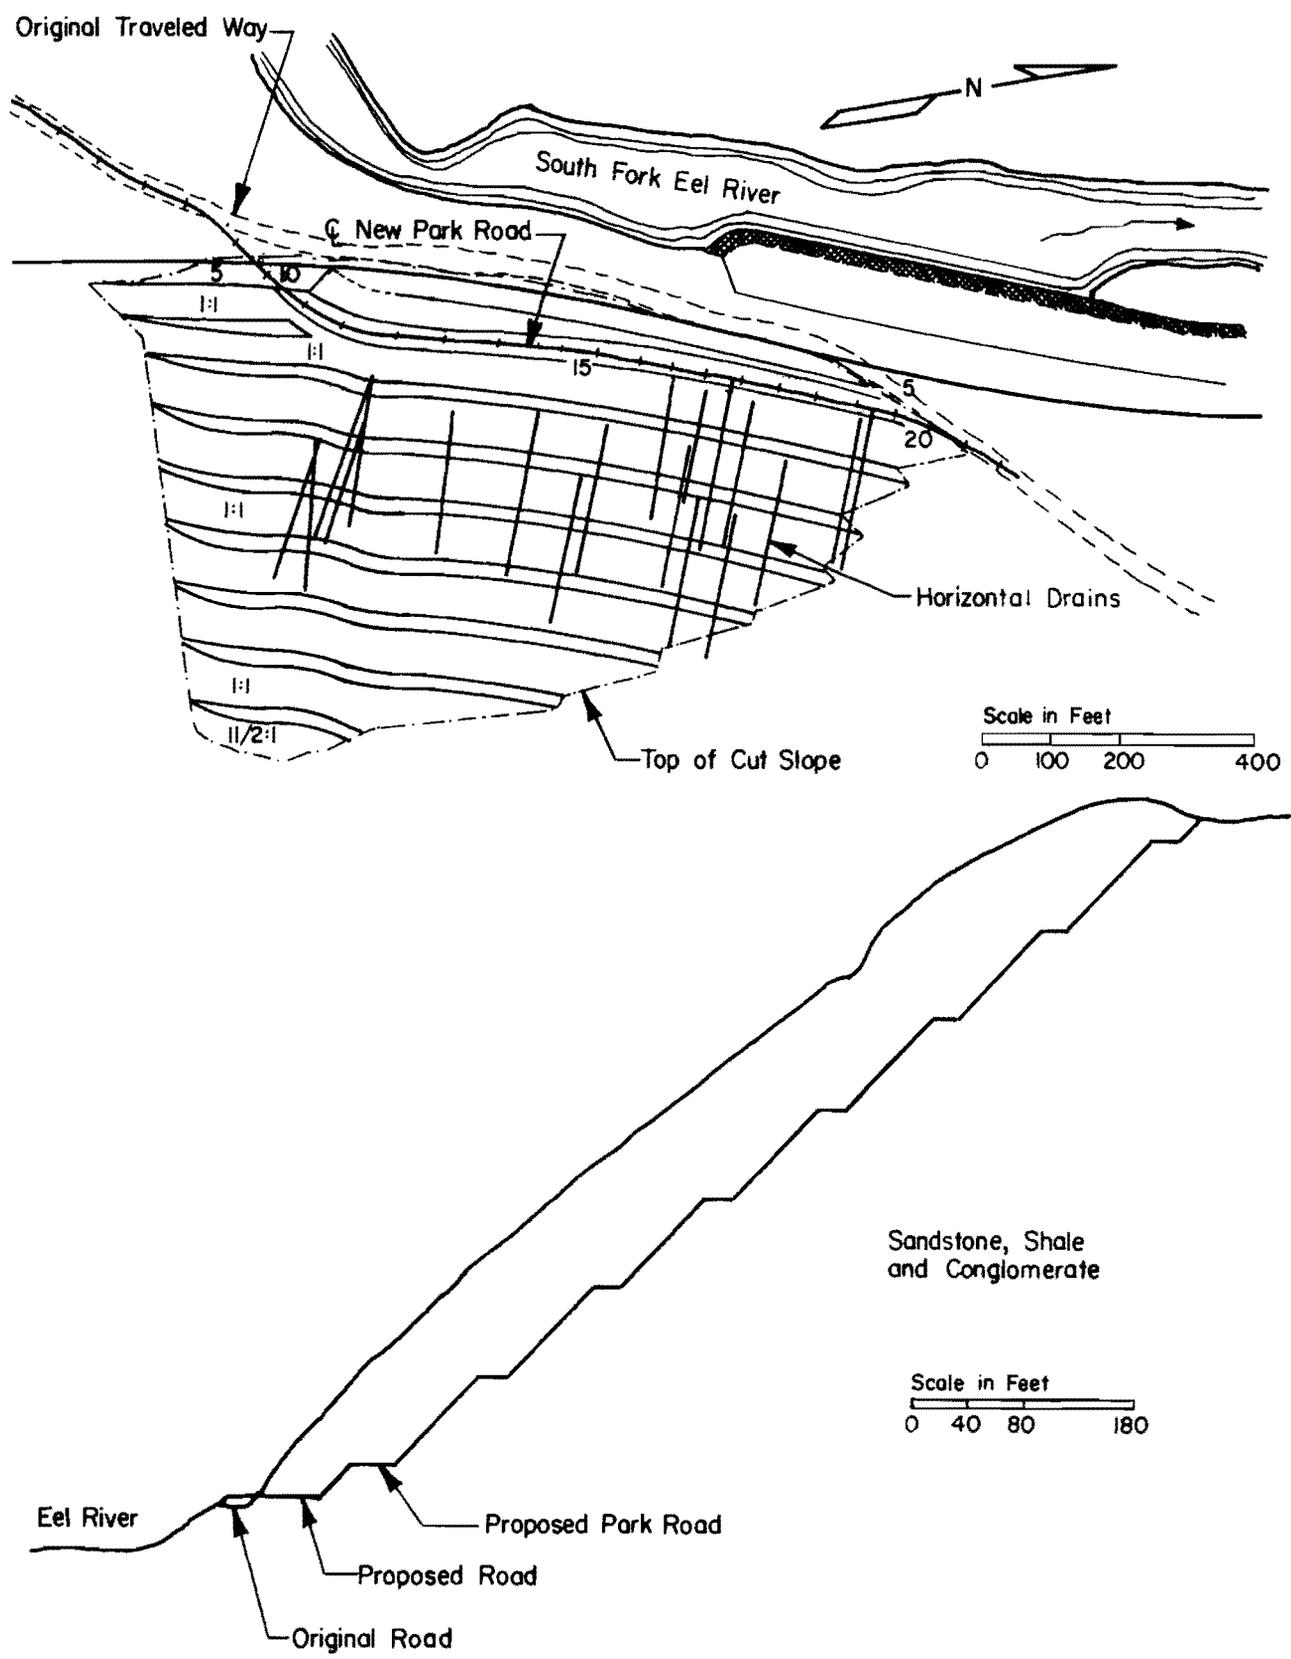
Fig 6.2. Combined benching and drainage for slope stabilization - Dyerville cut (Cedergren, 1962).

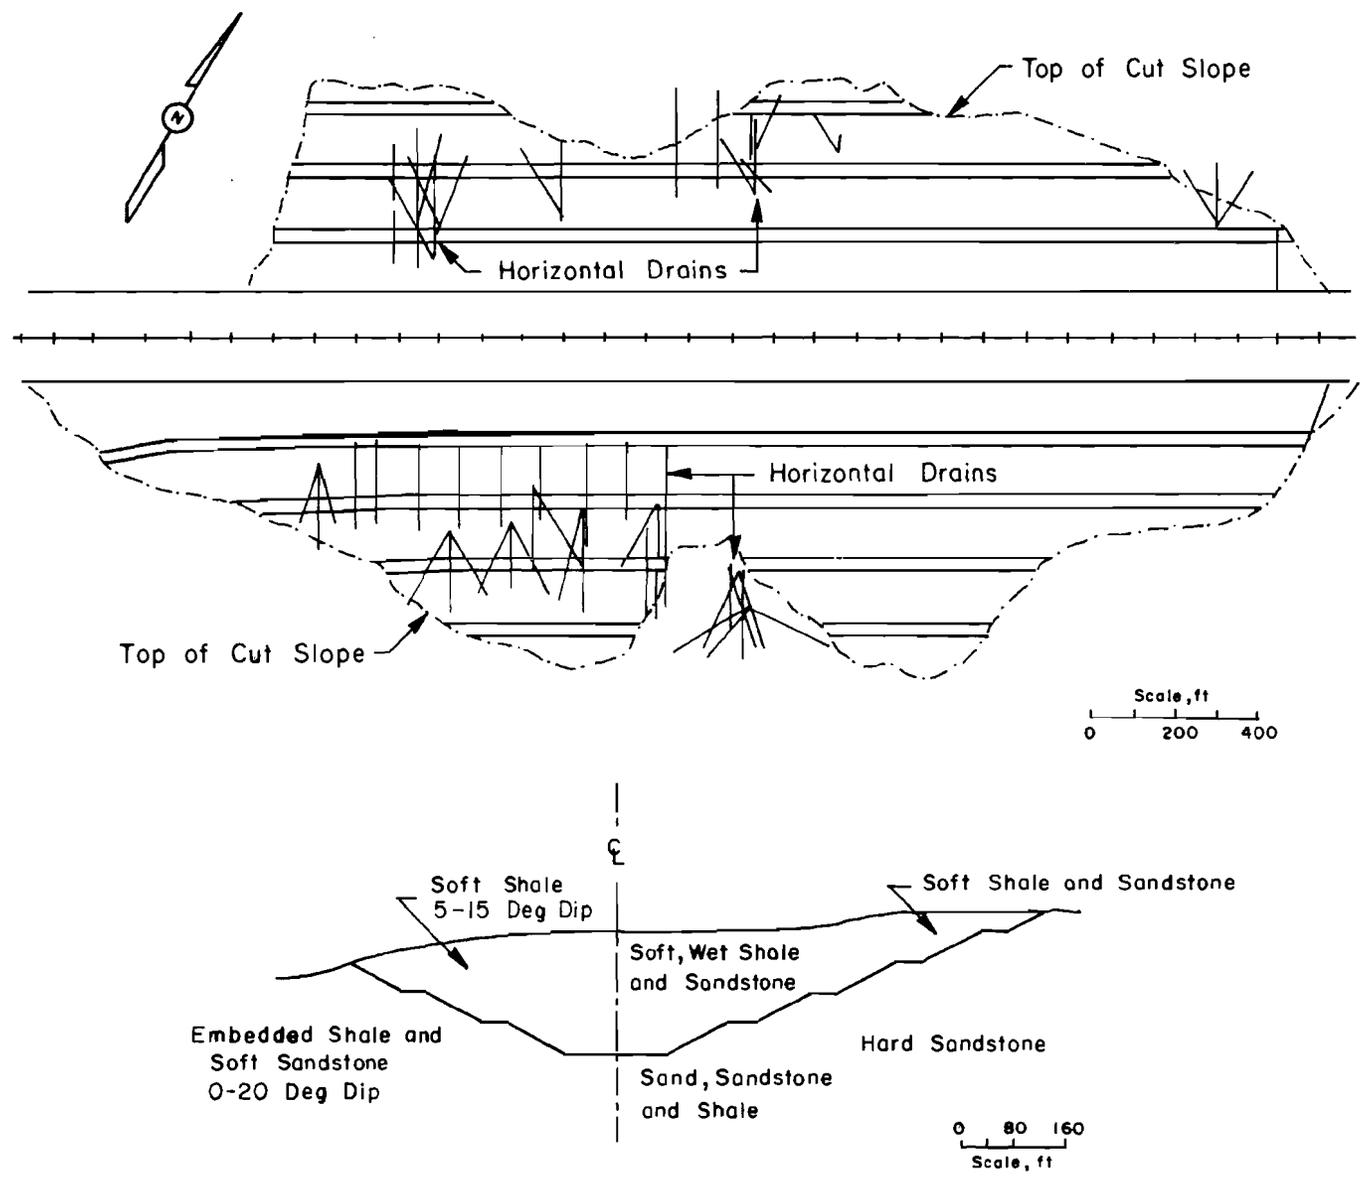
Fig 6.3. Combined benching and drainage for slope stabilization - Carquinez "Big Cut" (Cedergren, 1962).

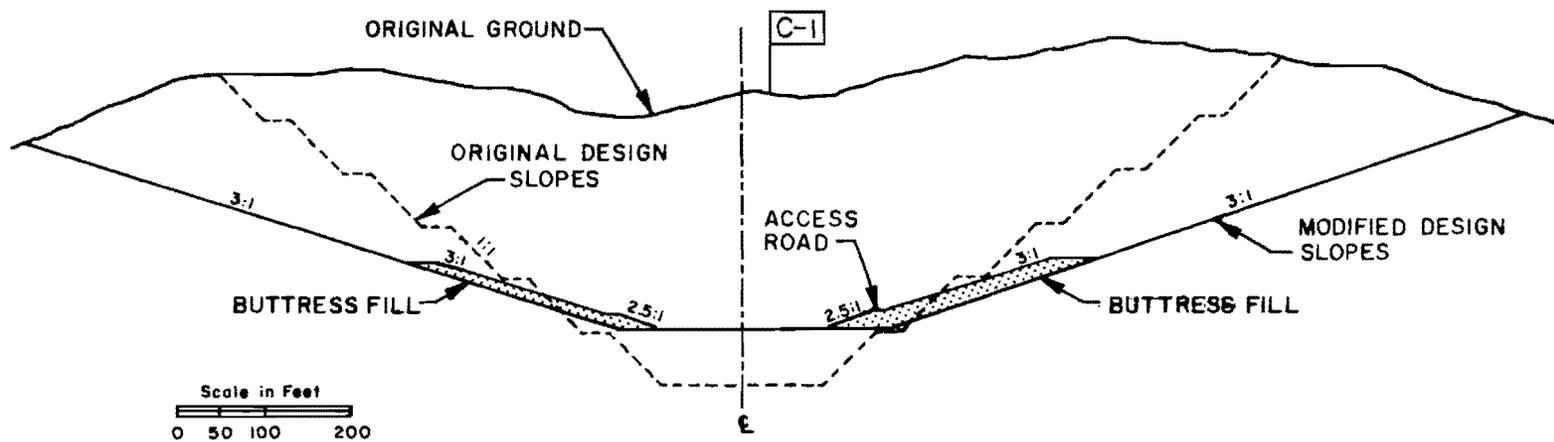
Fig 6.4. Slope flattening and grade change - Mulholland cut, San Diego Freeway (Cedergren, 1962).

An excellent example of the use of slope flattening and regrading as a remedial measure is provided by the 320-foot Mulholland Cut for the San Diego Freeway illustrated in Fig 6.4 (Cedergrén, 1962). During construction it was noted that the 1:1 benched slopes, originally designed for the predominately sandstone and interbedded shale cut, were unstable. Subsequently the cut was redesigned by employing uniform 3:1 side slopes, raising the highway grade line 60 feet, and constructing earth fill buttresses against the bottom 70 feet of the final cut. The redesigned slope proved to be the most economical alternative and has remained stable since completion.

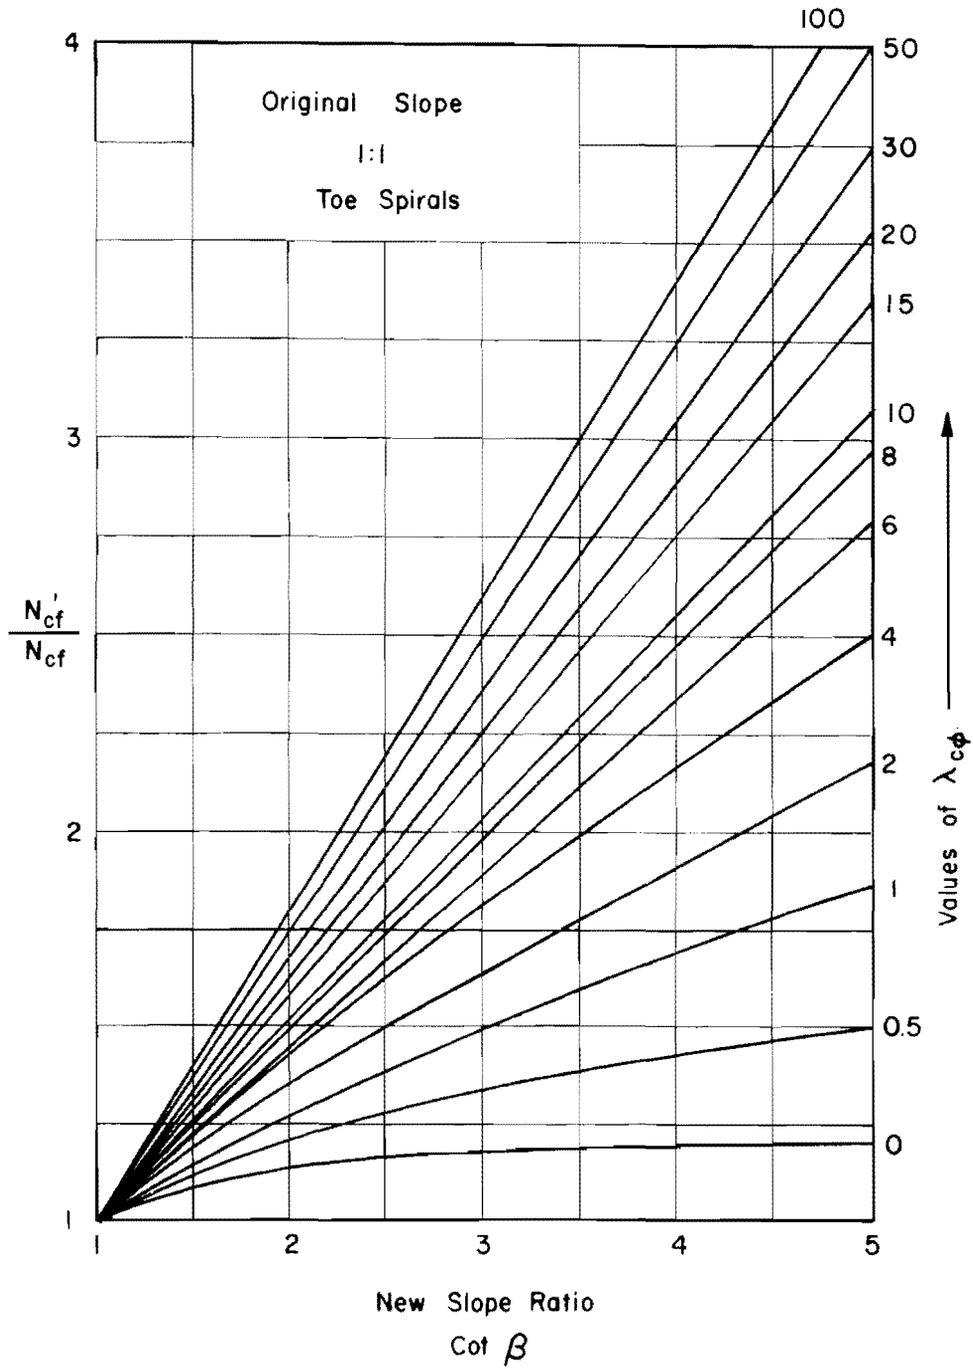
Fig 8.1. Stability chart for evaluating the effectiveness of slope flattening - 1:1 original slope.

The influence of slope flattening was investigated for slope inclinations ranging from 1:1 to 5:1. For each of these slopes the values of  $N_{cf}$  were calculated for values of  $\lambda_{c\phi}$  in the range from zero to 100, assuming that the most critical failure surface (spiral) passes through the toe of the slope. The results of these analyses were then used to calculate the ratios between the values of  $N_{cf}$ , corresponding to the flattened slopes, and the values of  $N_{cf}$  for the original slopes, each ratio corresponding to a particular value of  $\lambda_{c\phi}$ . These ratios, which represent the ratios between the new factor of safety with the slope flattened and the original factor of safety, are presented in chart form in Figs 8.1 through 8.3, each chart representing a given initial slope ratio ( $\cot \beta$ ).

- (1) if the desired increase in stability ( $N_{cf}/N_{cf}$ ) is known, the new slope ratio ( $\cot \beta$ ) required to attain this increase may be found; or
- (2) if the new slope ratio is known or perhaps limited by right-of-way restrictions and excavation costs, the corresponding increase in stability may be determined for the given excavation scheme.

It is interesting to note that the influence of slope flattening is most significant in those cases where the value of  $\lambda_{c\phi}$  is relatively high, corresponding, as can be noted from Eq 8.1, to materials having relatively low values of cohesion compared to their frictional resistances. Consequently, slope flattening generally provides the greatest increase in stability for cohesionless materials, where the depths of sliding are usually shallow, while in cohesive soil deposits, where slide movements may be relatively deep, the influence of slope flattening is minimal. This conclusion appears to be in agreement with the literature reviewed in previous sections of this report, and it should be noted that under certain circumstances (limited right-of-way

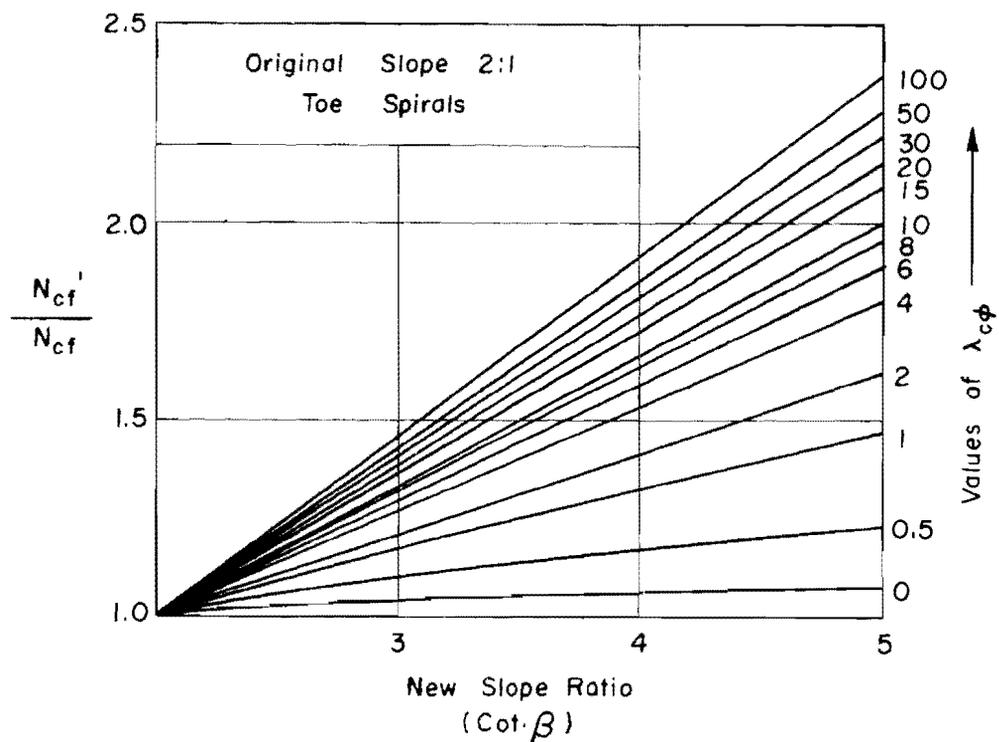
Fig 8.2. Stability chart for evaluating the effectiveness of slope flattening - 2:1 original slope.

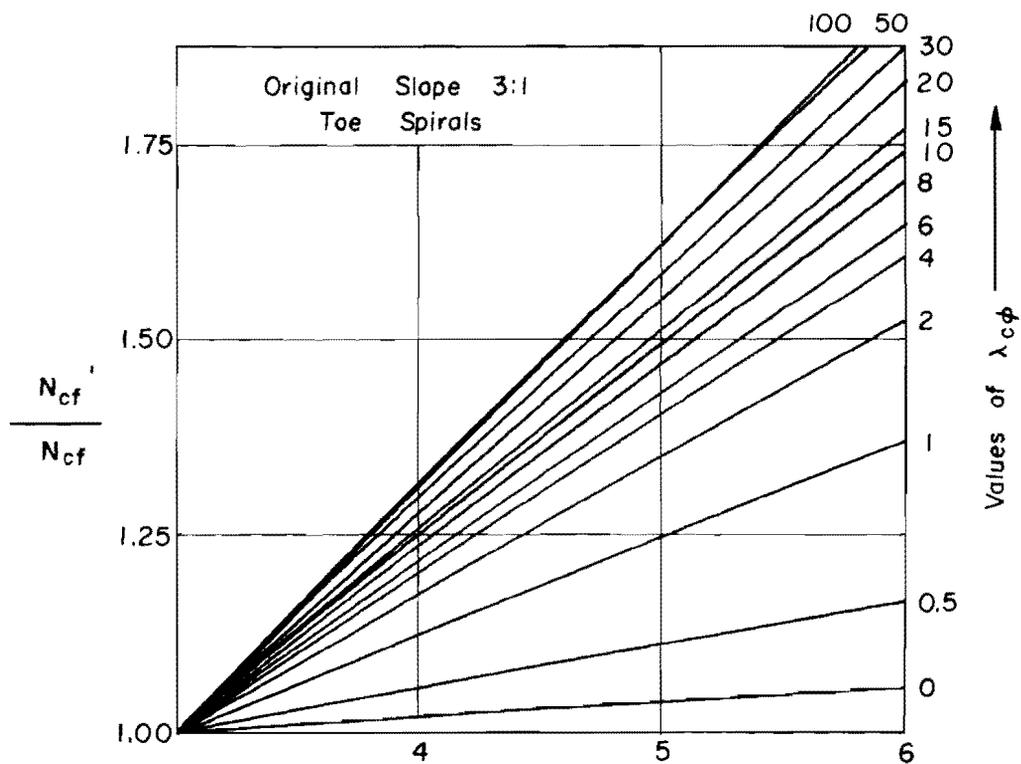
Fig 8.3. Stability chart for evaluating the effectiveness of slope flattening - 3:1 original slope.

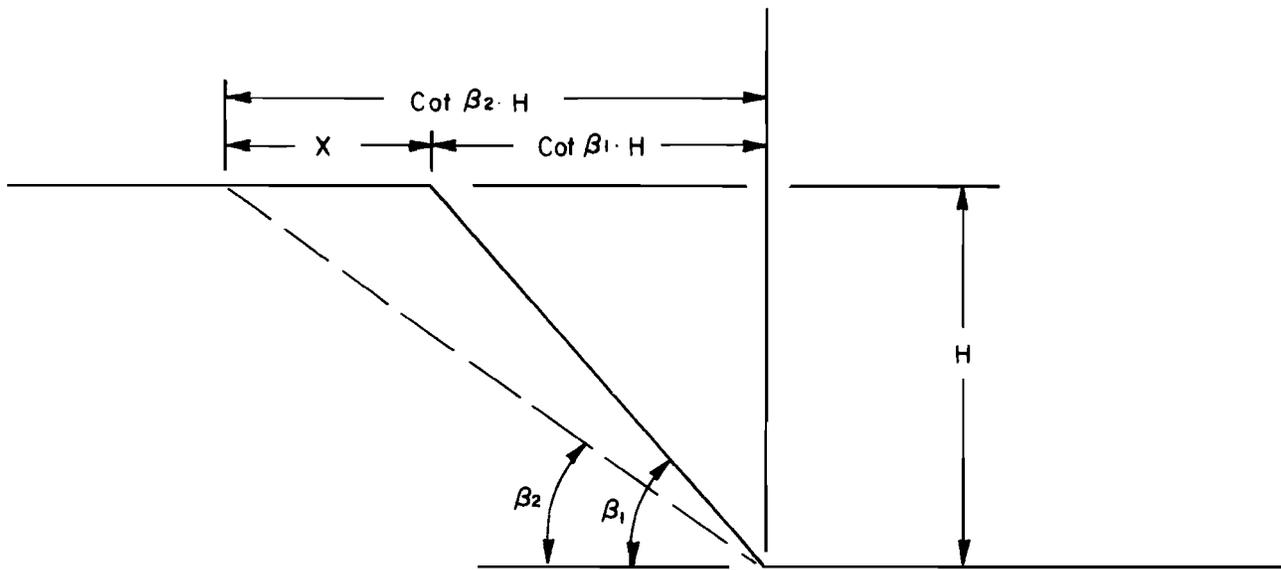
Fig 8.4. Geometry of original and flattened slope.

The volume of excavation and the distance that the top of the slope must be moved back to achieve the desired increase in stability may be calculated by considering the geometry involved in slope flattening. Figure 8.4 illustrates this geometry. The distance that the top of the slope must be moved back to attain the new slope ratio required for stability is expressed by Eq 8.3:

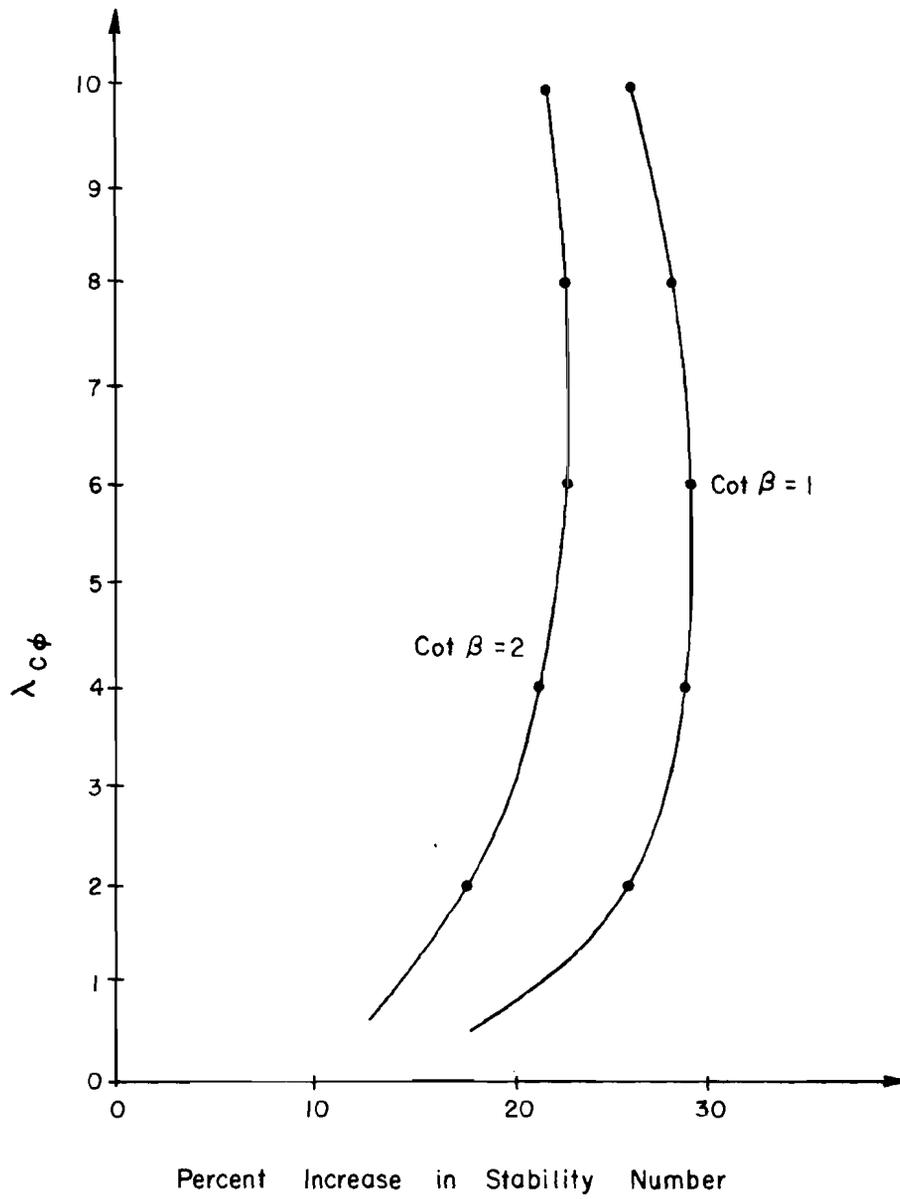
Fig 8.5. Effectiveness of typical bench as a function of  $\lambda_{c\phi}$ .

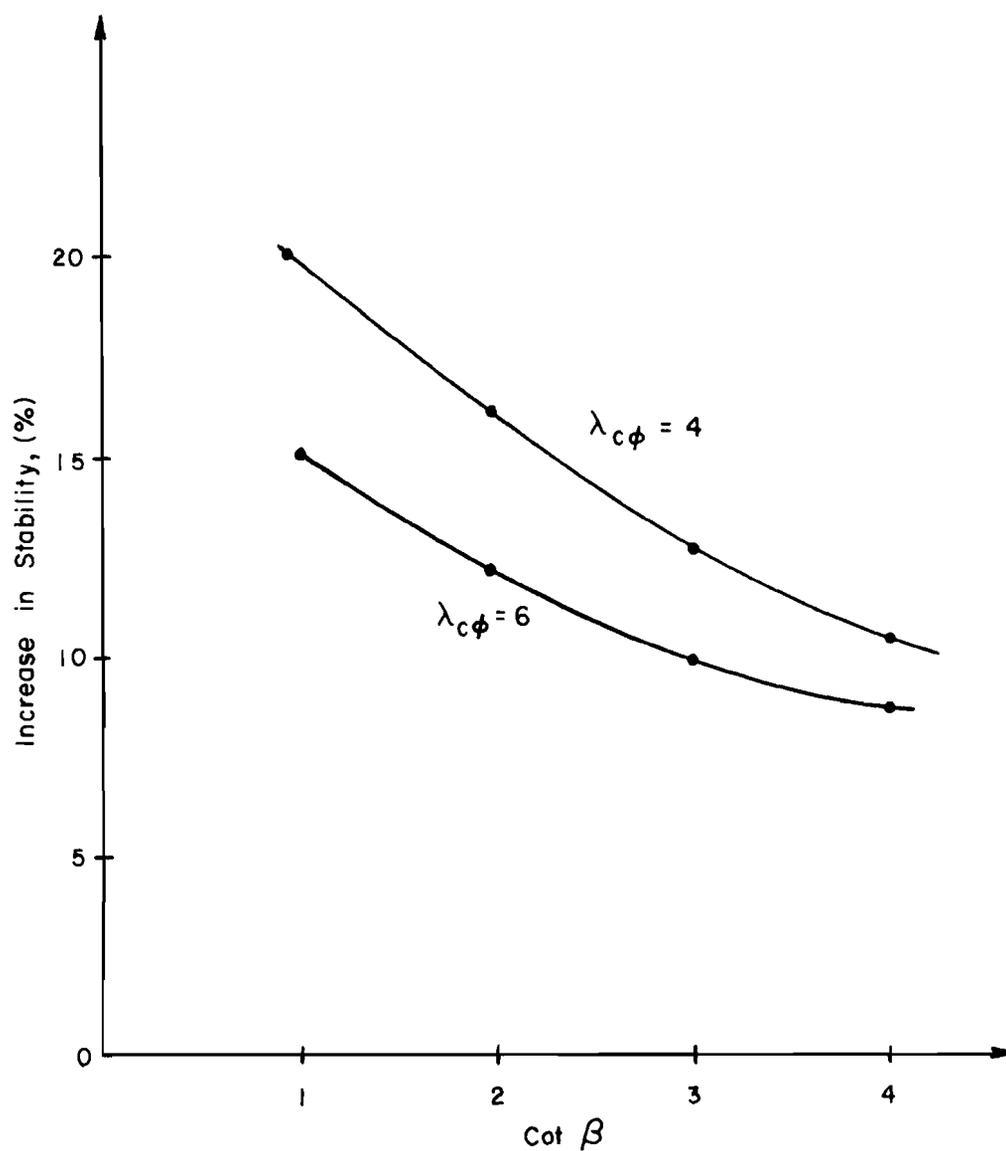
Fig 8.6. Effectiveness of a typical bench as a function of slope ratio (cot  $\beta$ ).

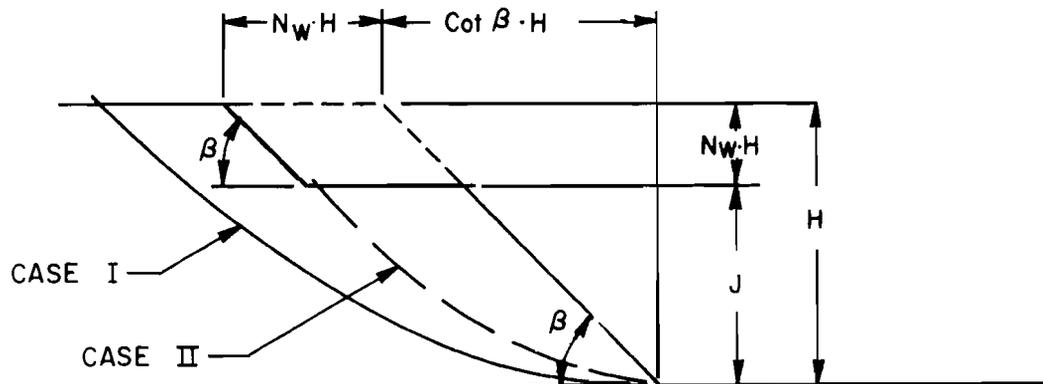
Fig 8.7. Critical circles with same factor of safety.

The method used in the development of stability charts for benched slopes required the solution of two separate problems. It was determined that for a particular height factor ( $N_h$ ),  $\lambda_{c\phi}$ , and  $\cot \beta$ , there existed a minimum width factor ( $N_w$ ) where the factor of safety for the lower portion of the slope (Case II) is identical to the factor of safety for the entire slope (Case I). Case I and Case II critical circles are illustrated in Fig 8.7. For this minimum bench width, the height of the slope is effectively reduced, and any bench wider than the minimum value appears to be uneconomical because no further increase in stability is achieved.

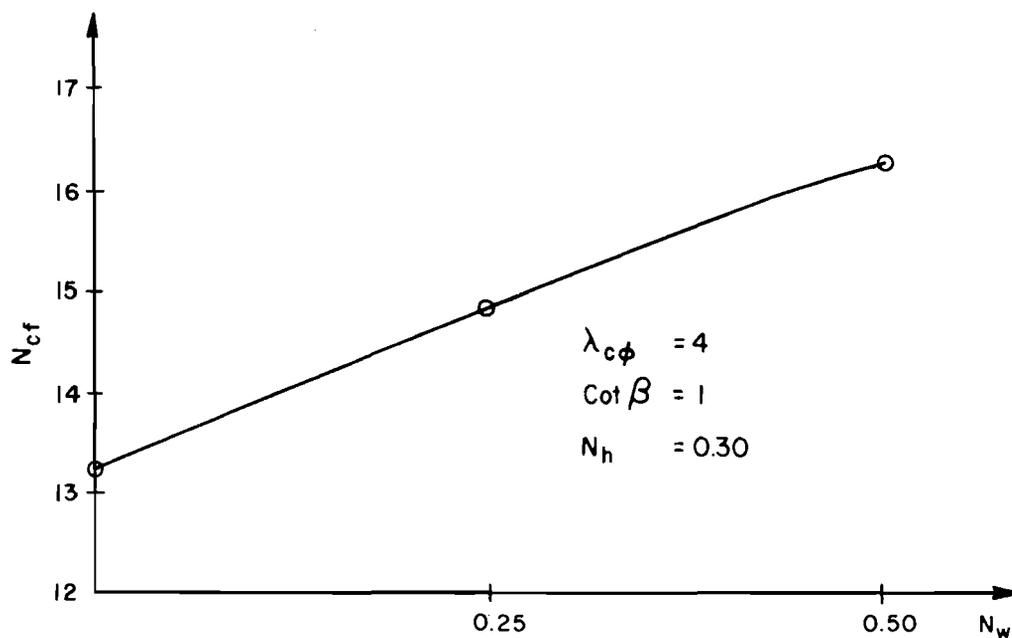
Fig 8.8a. Variation in stability number ( $N_{cf}$ ) with bench width - Case I critical circle.

The first step in the solution was to obtain the stability number corresponding to Case I as a function of bench width for a particular  $\lambda_{c\phi}$ ,  $\cot \beta$ , and height factor. An example of this curve is shown in Fig 8.8a for a slope where  $\cot \beta = 1$ ,  $\lambda_{c\phi} = 4$ , and  $N_h = 0.30$ . Following this, a stability number for the portion of the slope beneath the bench was determined. By plotting the stability number for the lower portion of the slope (Case II) on the same graph with the stability number for the entire slope (Case I), the optimum bench width factor and corresponding  $N_{cf}$  value were obtained as shown in Fig 8.8b.

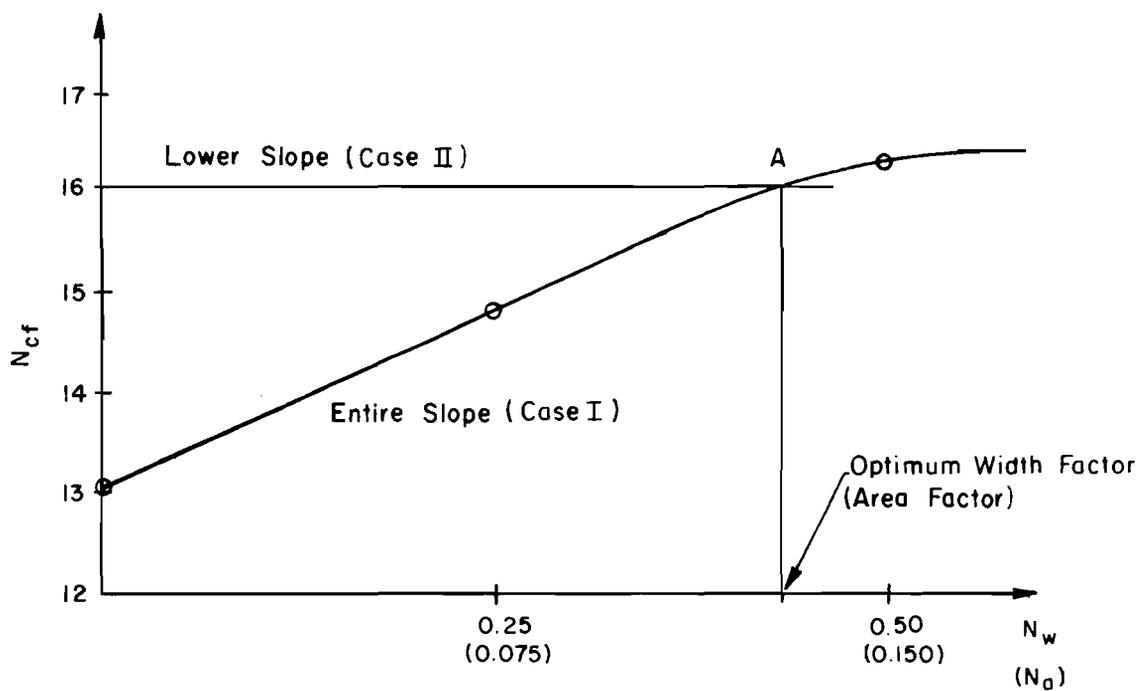
Fig 8.8b. Determination of optimum bench width factor and corresponding stability number.

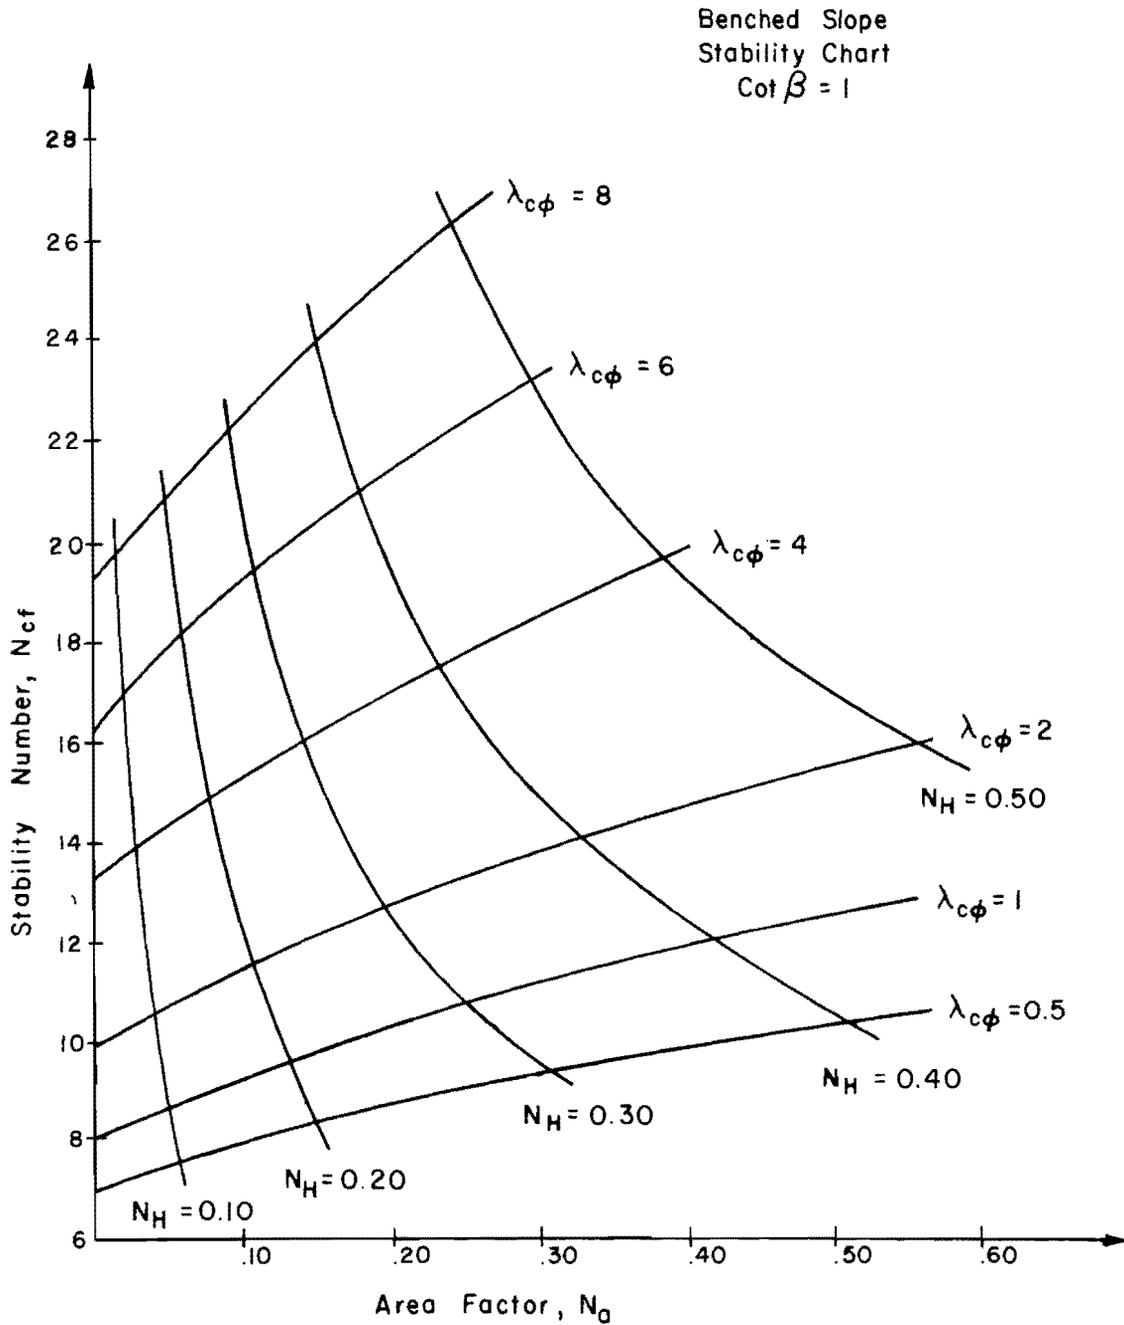
Fig 8.9. Stability chart for determining optimum bench sizes and corresponding stability numbers - 1:1 slope.

The procedure illustrated in Fig 8.8 was repeated for slope ratios of 1:1 and 2:1, values of  $\lambda_{c\phi}$  from 0.5 to 8.0, and height factors ranging from 0.1 to 0.5. In this manner curves of stability number versus area factor,  $N_a$ , could be developed as a function of  $\lambda_{c\phi}$  and  $N_h$ . The completed charts for determining the stability of benched slopes are shown in Figs 8.9 and 8.10.

By entering Fig 8.9 with the known  $\lambda_{c\phi}$  value and the stability number ( $N_{cf}$ ) required to increase the factor of safety, it is possible to determine the optimum bench dimensions. By linearly interpolating between  $\lambda_{c\phi} = 4$  and  $\lambda_{c\phi} = 6$ , the height factor ( $N_h$ ) and area factor ( $N_a$ ) may be read directly. From Fig 8.9

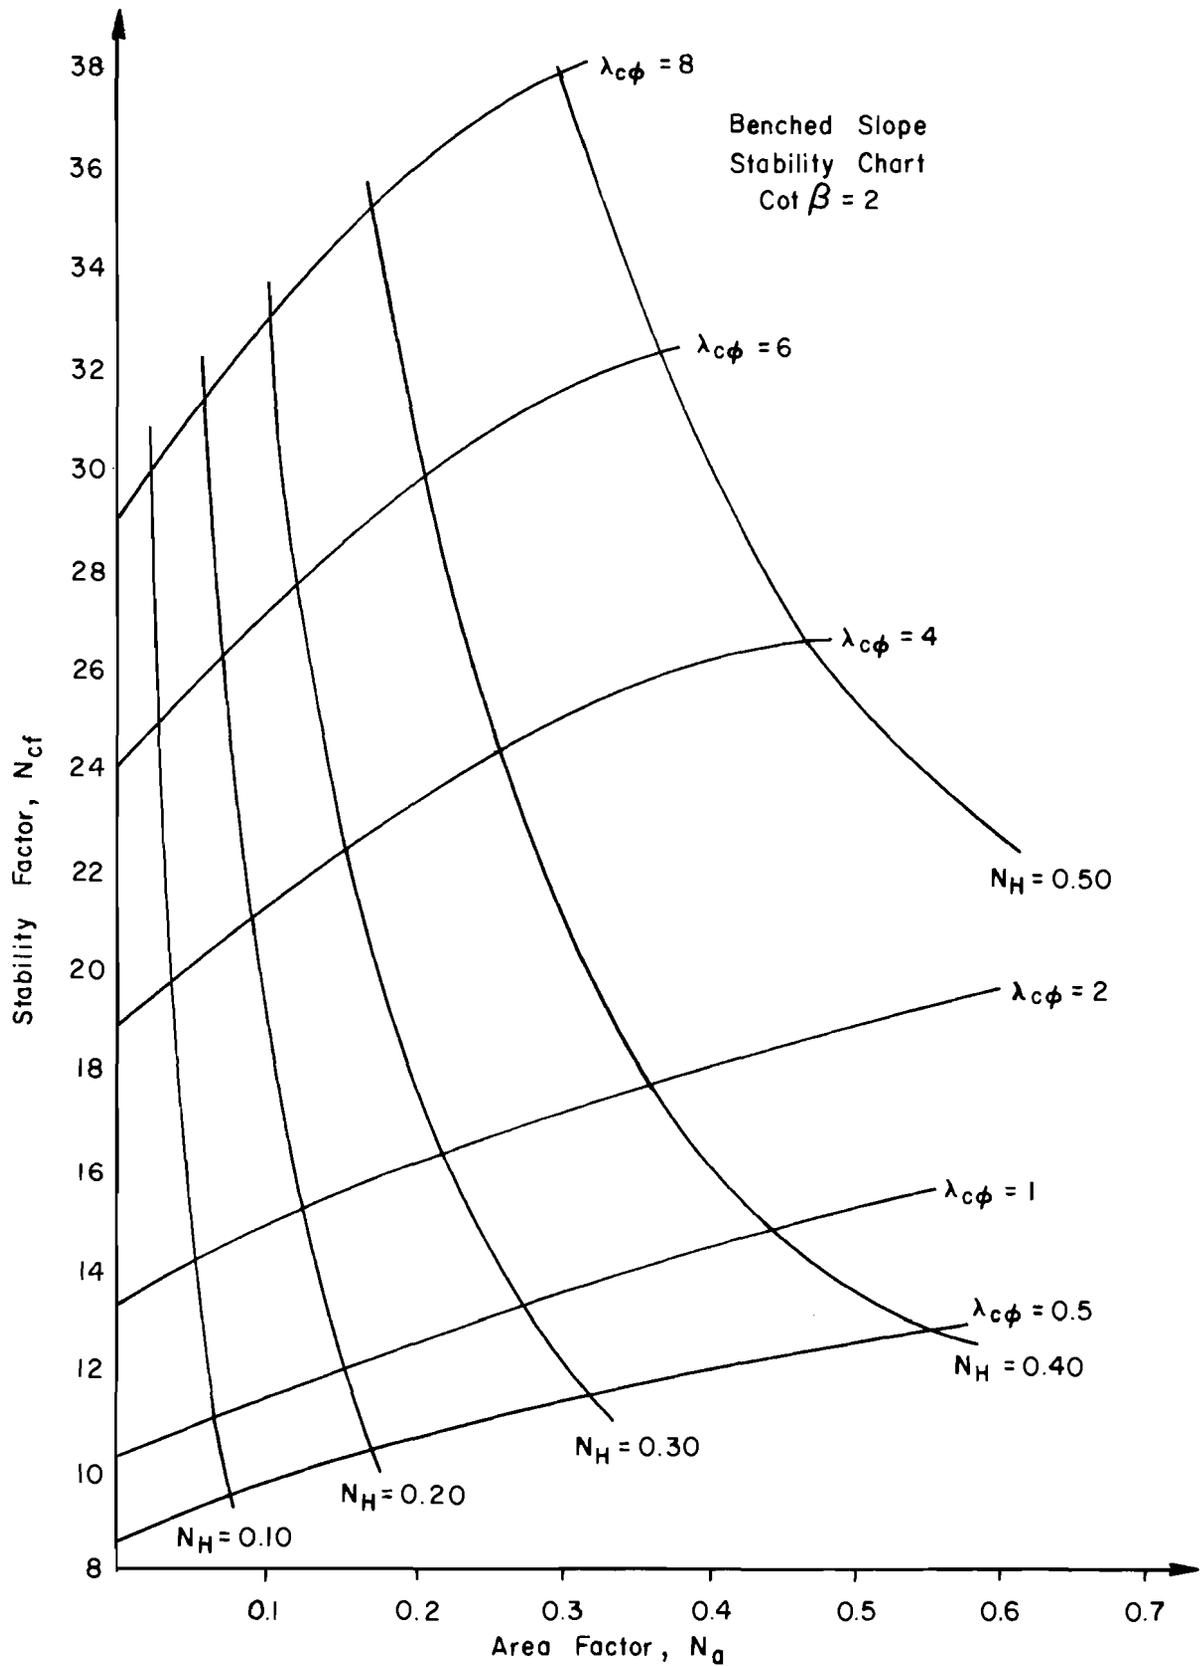
Fig 8.10. Stability chart for determining optimum bench sizes and corresponding stability numbers - 2:1 slope.

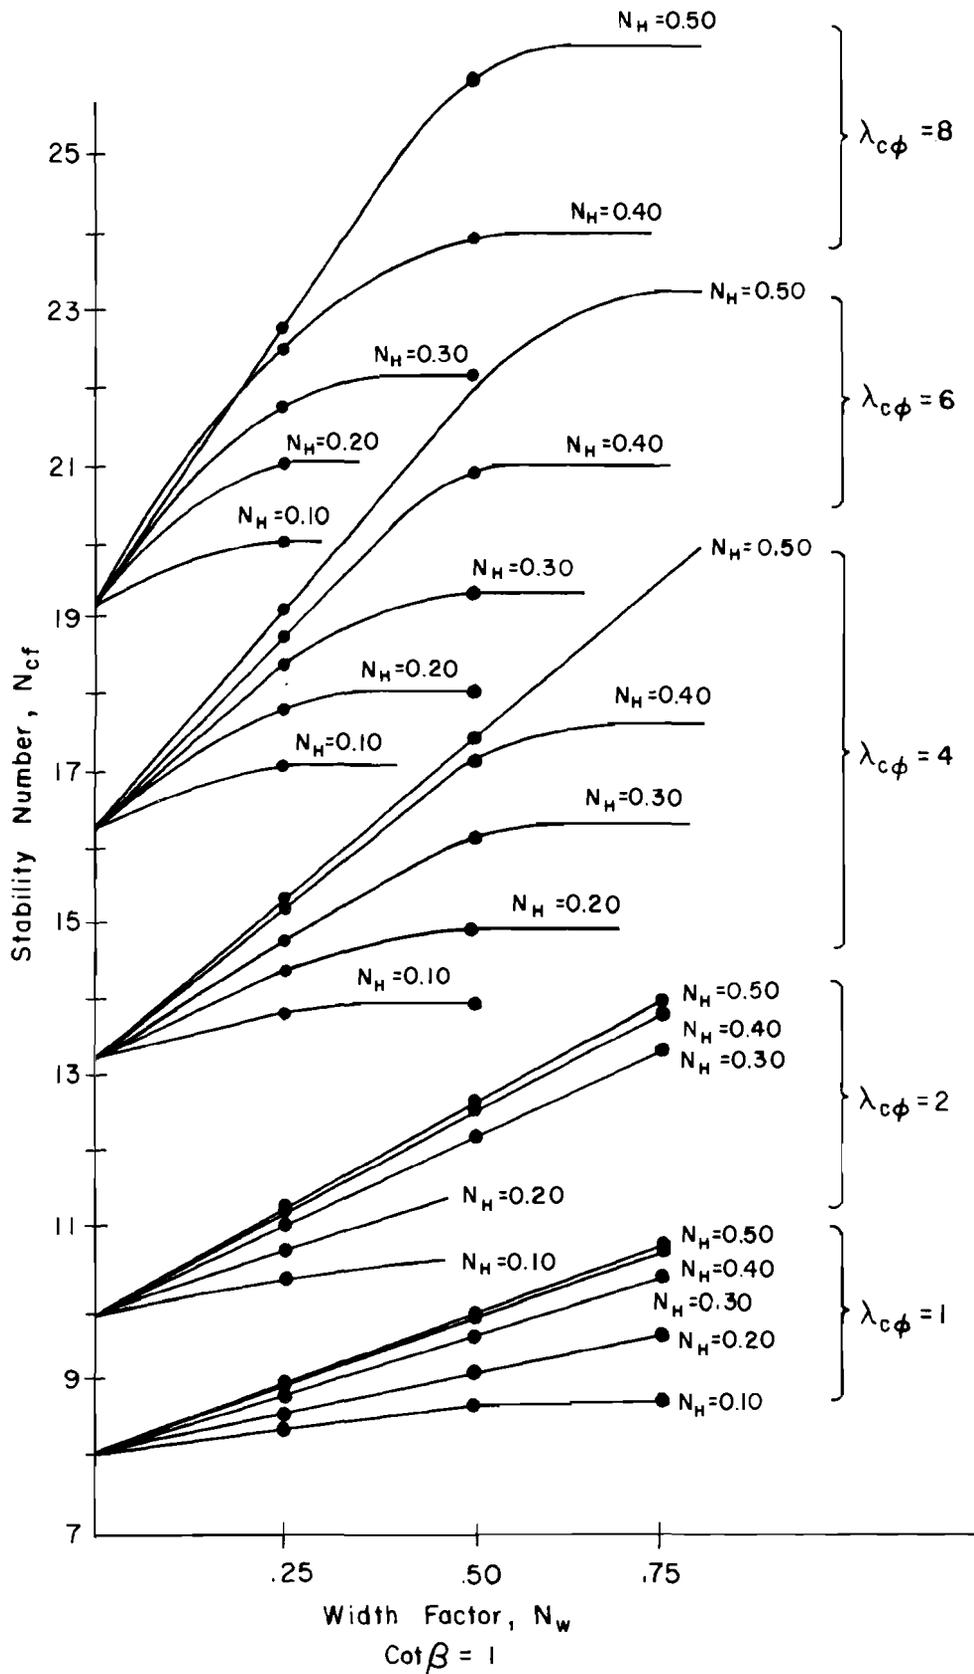
Fig 8.11. Stability numbers for selected bench dimensions 1:1 slope.

To further aid the engineer in understanding the effects of benching upon the stability of a slope, Figs 8.11 and 8.12 were prepared. These charts

illustrate the increase in stability produced by a given height and width of bench as a function of  $\lambda_{c\phi}$ . With  $\lambda_{c\phi}$  and the stability number ( $N_{cf}$ ) required to produce a given factor of safety known, the engineer may directly select a height and width factor that will produce these results. It should be noted that the points on these curves do not necessarily illustrate the most economical dimensions for the bench. However, if the width of the bench is restricted by right-of-way requirements, a height factor may be obtained such that the desired stability number can be obtained.
