1. Report No.	2. Government Accession No.	3. Recipient's Catalog No.	
4. Title and Subtitle "A Survey and Evaluation of Remedial Measures for Earth Slope Stabilization"		5. Report Date August 1974

6. Performing Organization Code	
7. Author(s) Rudolph J. Schweizer and Stephen G. Wright		8. Performing Organization Report No. Research Report 161-2F

9. Performing Organization Name and Address The Center for Highway Research The University of Texas at Austin Austin, Texas 78712		10. Work Unit No.	
		11. Contract or Grant No. Research Study 3-8-71-161

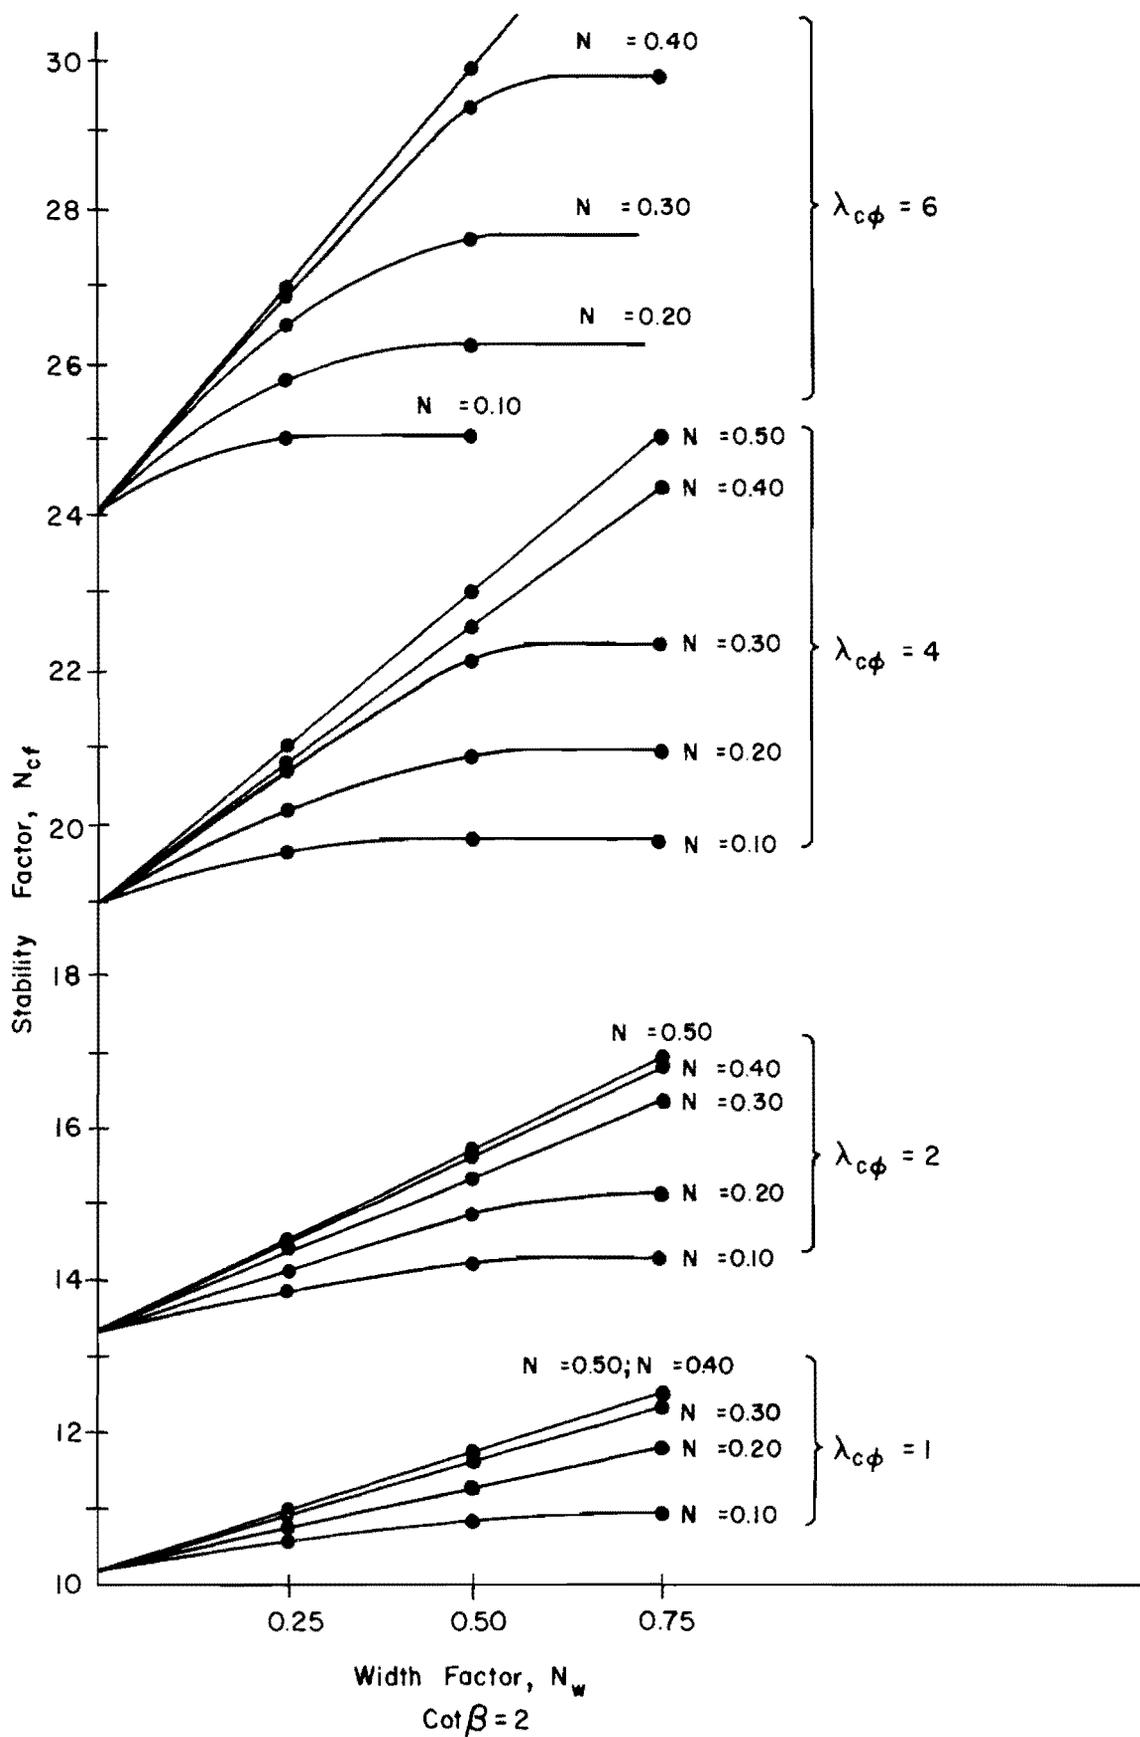
Fig 8.12. Stability numbers for selected bench dimensions - 2:1 slope.

To further aid the engineer in understanding the effects of benching upon the stability of a slope, Figs 8.11 and 8.12 were prepared. These charts

illustrate the increase in stability produced by a given height and width of bench as a function of  $\lambda_{c\phi}$ . With  $\lambda_{c\phi}$  and the stability number ( $N_{cf}$ ) required to produce a given factor of safety known, the engineer may directly select a height and width factor that will produce these results. It should be noted that the points on these curves do not necessarily illustrate the most economical dimensions for the bench. However, if the width of the bench is restricted by right-of-way requirements, a height factor may be obtained such that the desired stability number can be obtained.
