A STUDY OF
CONSTRUCTION EQUIPMENT AND INITIAL PAVEMENT ROUGHNESS
AS MEASURED WITH A PROFILOGRAPH

Research Report 49-2

Development of a Construction Control Profilograph
Research Project 1-8-63-49

Conducted by
Highway Design Division, Research Section
The Texas Highway Department

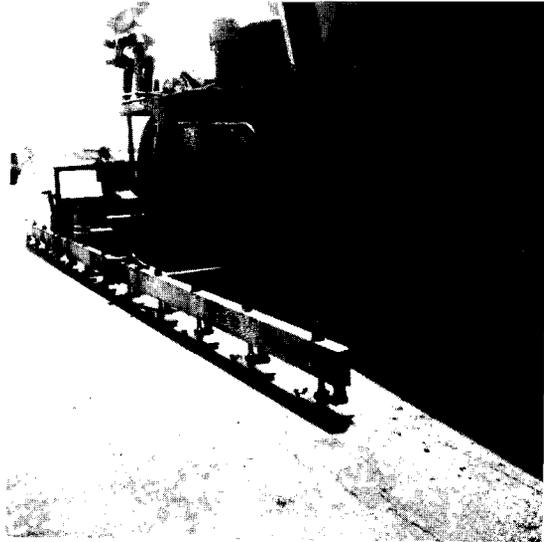
FIGURE 1

OBLIQUE VIEW OF BLAW-KNOX PAVER

The paver used was a PF 180 Blaw-Knox (see Figures 1 and 2). The tires on the rear axle were the large pneumatic type and the tires on the two axles under the hopper were hard rubber. The laydown machine was equipped with an electronically controlled screed. The "stringline" was actually a structural member supported by several manually adjusted shoes (see Figure 1). Differential movement experienced by the structural "stringline" activated the electric sensor shown in Figure 3 and from there corrections were made by a hydraulic and mechanical linkage to the screed. The tampers operated at a vibration rate of 1,500 r.p.m. and move 1/64" below the screed plate.

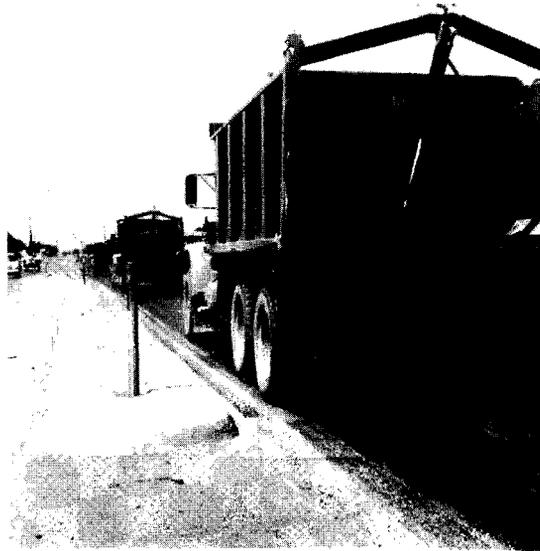
FIGURE 7

HAUL TRUCK EQUIPPED WITH SPECIAL DUMPING GATE

The haul truck consisted of a fleet of diesel powered, 12 cubic yard, tandem axle vehicles. These trucks were of the bob-tail variety and were equipped with a specially constructed hydraulic dumping gate (see Figure 7).
