LABORATORY INVESTIGATION OF DELAMINATION
AND DEBONDING OF THIN-BONDED OVERLAYS
DUE TO VEHICULAR VIBRATION

Research Project 1920

EFFECT OF VEHICULAR VIBRATION ON DEBONDING
AND DELAMINATION OF CONCRETE OVERLAYS

Center for Geotechnical and Highway Materials Research
The University of Texas at El Paso
Research Report 1920-1, Volume 2
March, 1992

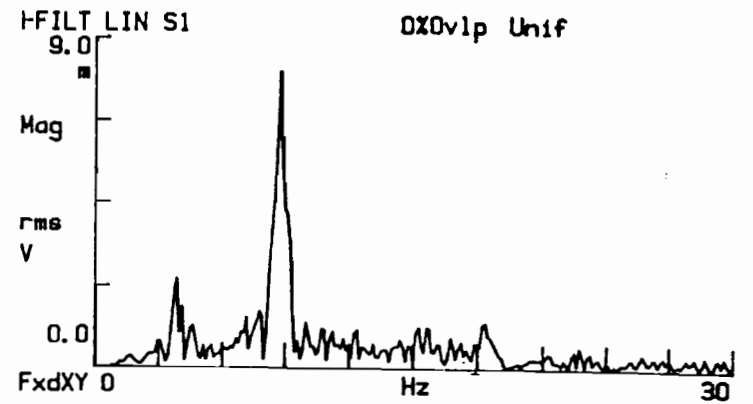
Figure B.12 Displacement Spectra of Short Span of Hawkins Bridge at 12:07 P.M.
Top : Peak-Hold Average
Bottom : Arithmetic Average
