NCHRP Report 350 Crash Testing and Evaluation of the S-Square® Mailbox System

Research/Test Report 0-5210-7

**NCHRP REPORT 350 CRASH TESTING AND EVALUATION
OF THE S-SQUARE® MAILBOX SYSTEM**

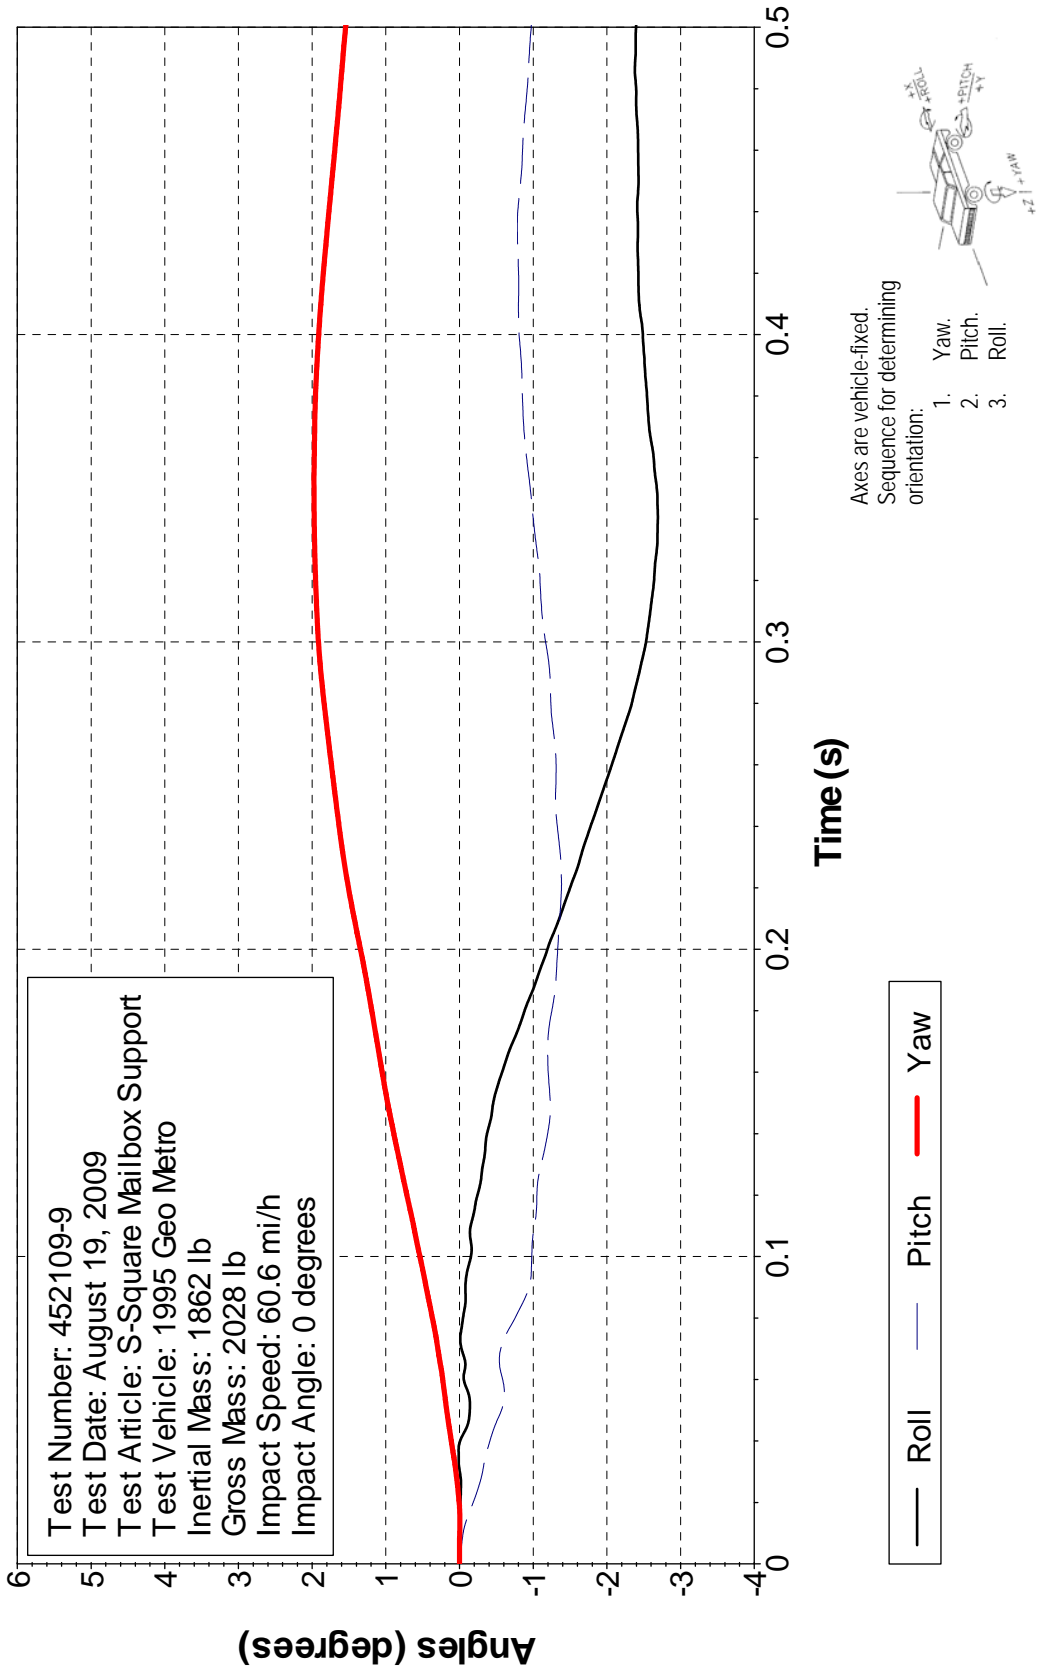
Figure 22. Vehicle Angular Displacements for Test No. 452109-9.

Roll, Pitch, and Yaw Angles

Data from the accelerometer, located at the vehicle center of gravity, were digitized for evaluation of occupant risk. In the longitudinal direction, no occupant contact occurred, and the maximum 0.050-s average acceleration was -1.0 G between 0.002 and 0.052 s. In the lateral direction, no occupant impact contact occurred, and the maximum 0.050-s average was -0.8 G between 0.006 and 0.056 s. [Figure 11](#) presents these data and other pertinent information from the test. [Figures 22 through 28](#) in [Appendix D](#) present the vehicle angular displacements and accelerations versus time traces.

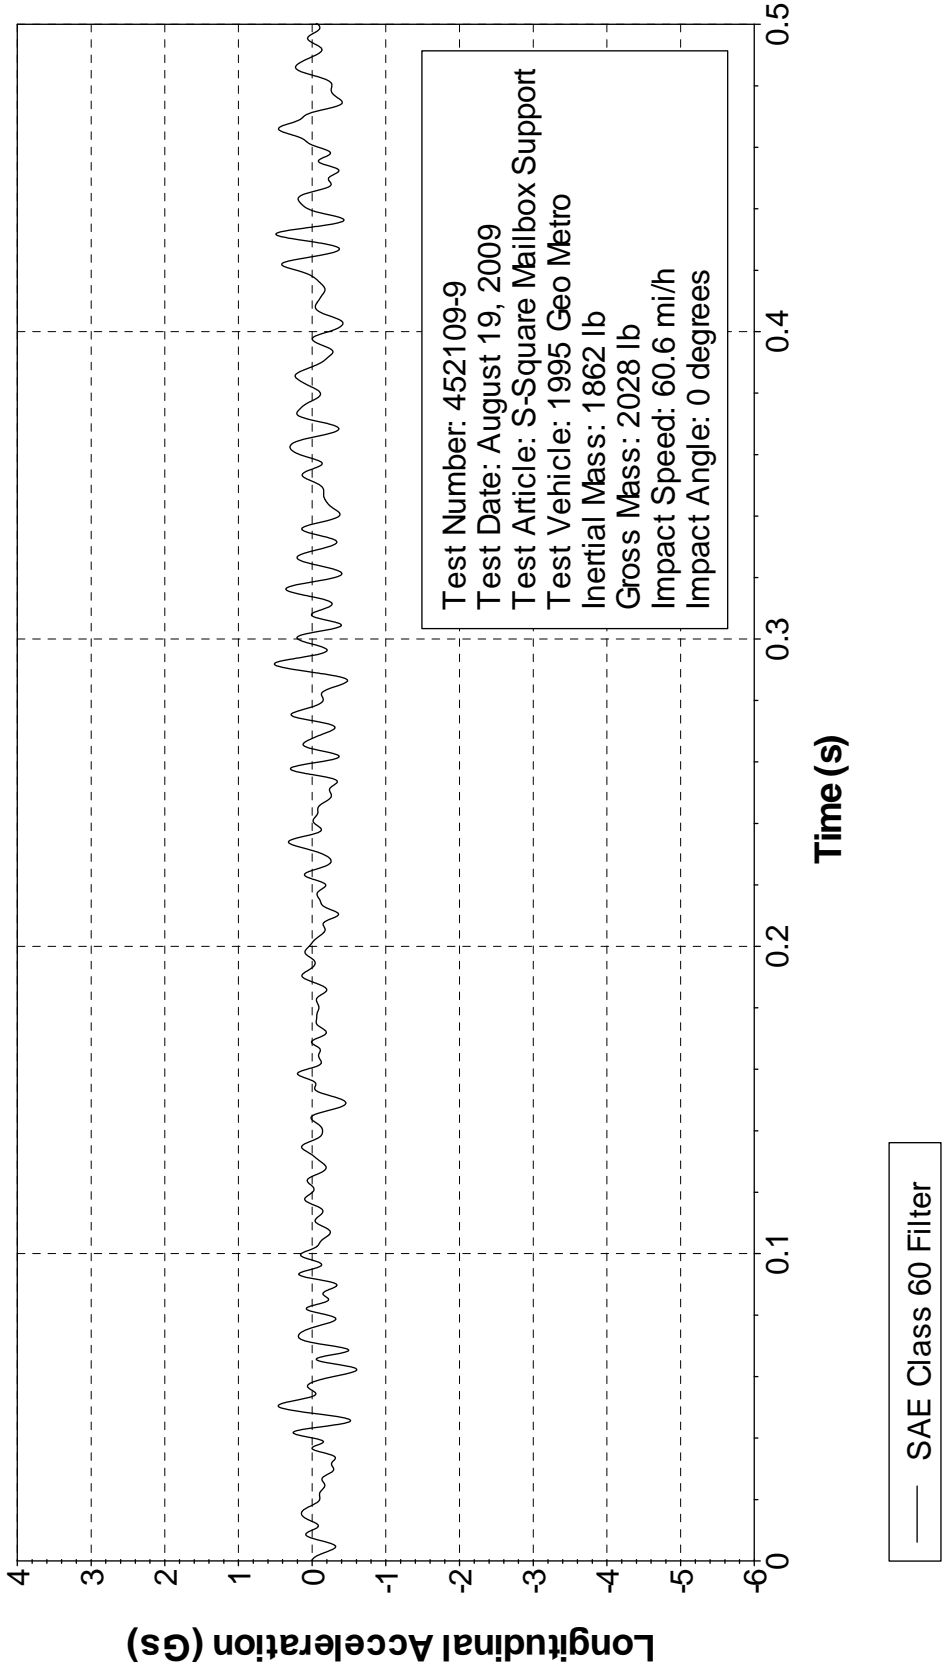
Figure 26. Vehicle Longitudinal Accelerometer Trace for Test No. 452109-9 (Accelerometer Located over Rear Axle).

X Acceleration over Rear Axle

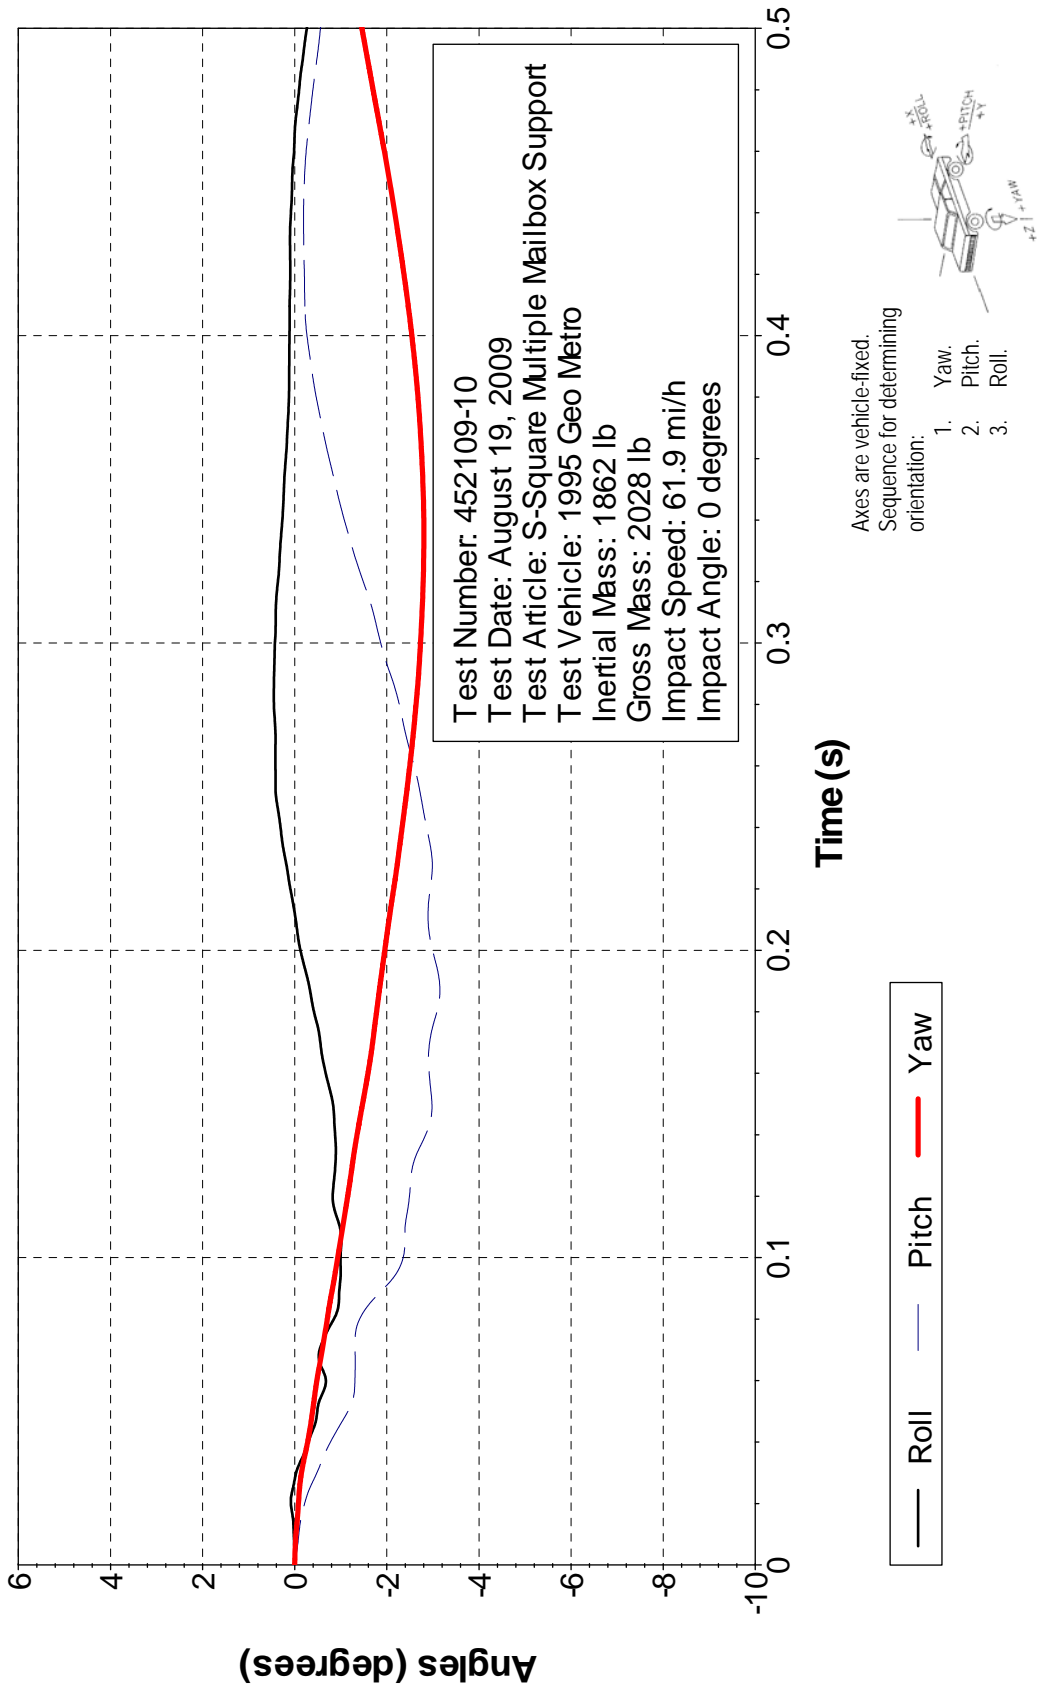
Roll, Pitch, and Yaw Angles

Figure 29. Vehicle Angular Displacements for Test 452109-10.

Data from the accelerometer, located at the vehicle center of gravity, were digitized for evaluation of occupant risk. In the longitudinal direction, the occupant impact velocity was 3.0 ft/s at 0.482 s; the highest 0.010-s occupant ridedown acceleration was -1.4 G from 0.869 to 0.879 s, and the maximum 0.050-s average acceleration was -1.2 G between 0.000 and 0.050 s. In the lateral direction, the occupant impact velocity was 3.3 ft/s at 0.482 s; the highest 0.010-s occupant ridedown acceleration was 0.4 G from 1.654 to 1.664 s, and the maximum 0.050-s average was -0.7 G between 0.039 and 0.089 s. Figure 18 presents these data and other pertinent information from the test. Figures 29 through 35 in Appendix D present the vehicle angular displacements and accelerations versus time traces.

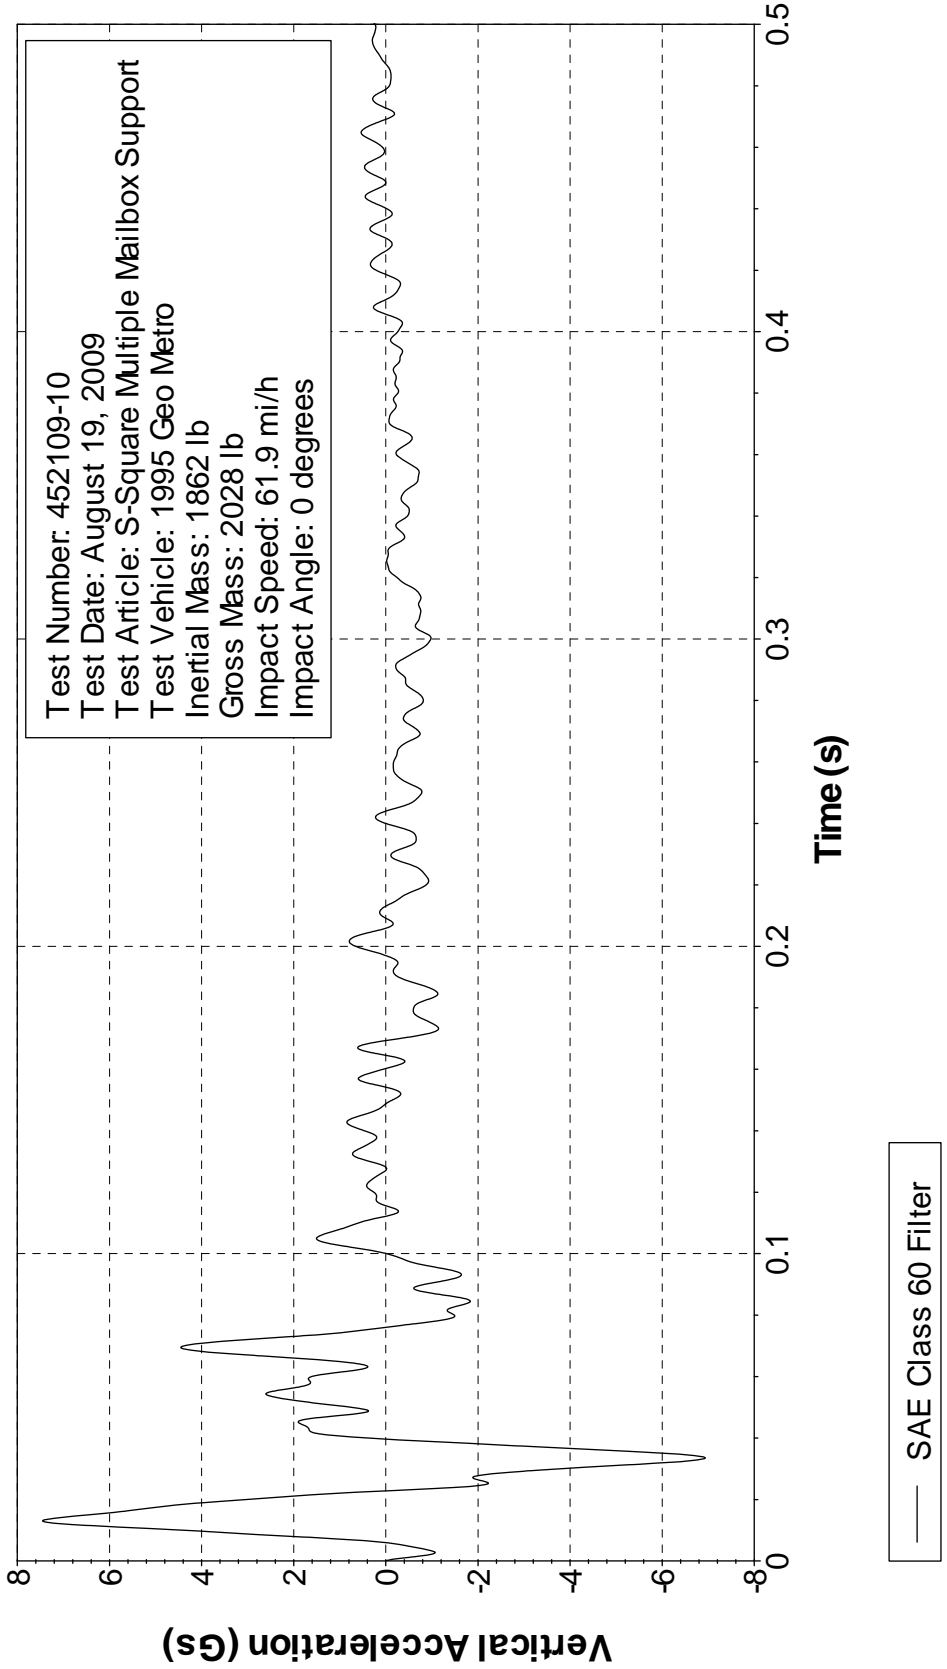
Z Acceleration at CG

Figure 32. Vehicle Vertical Accelerometer Trace for Test 452109-10 (Accelerometer Located at Center of Gravity).

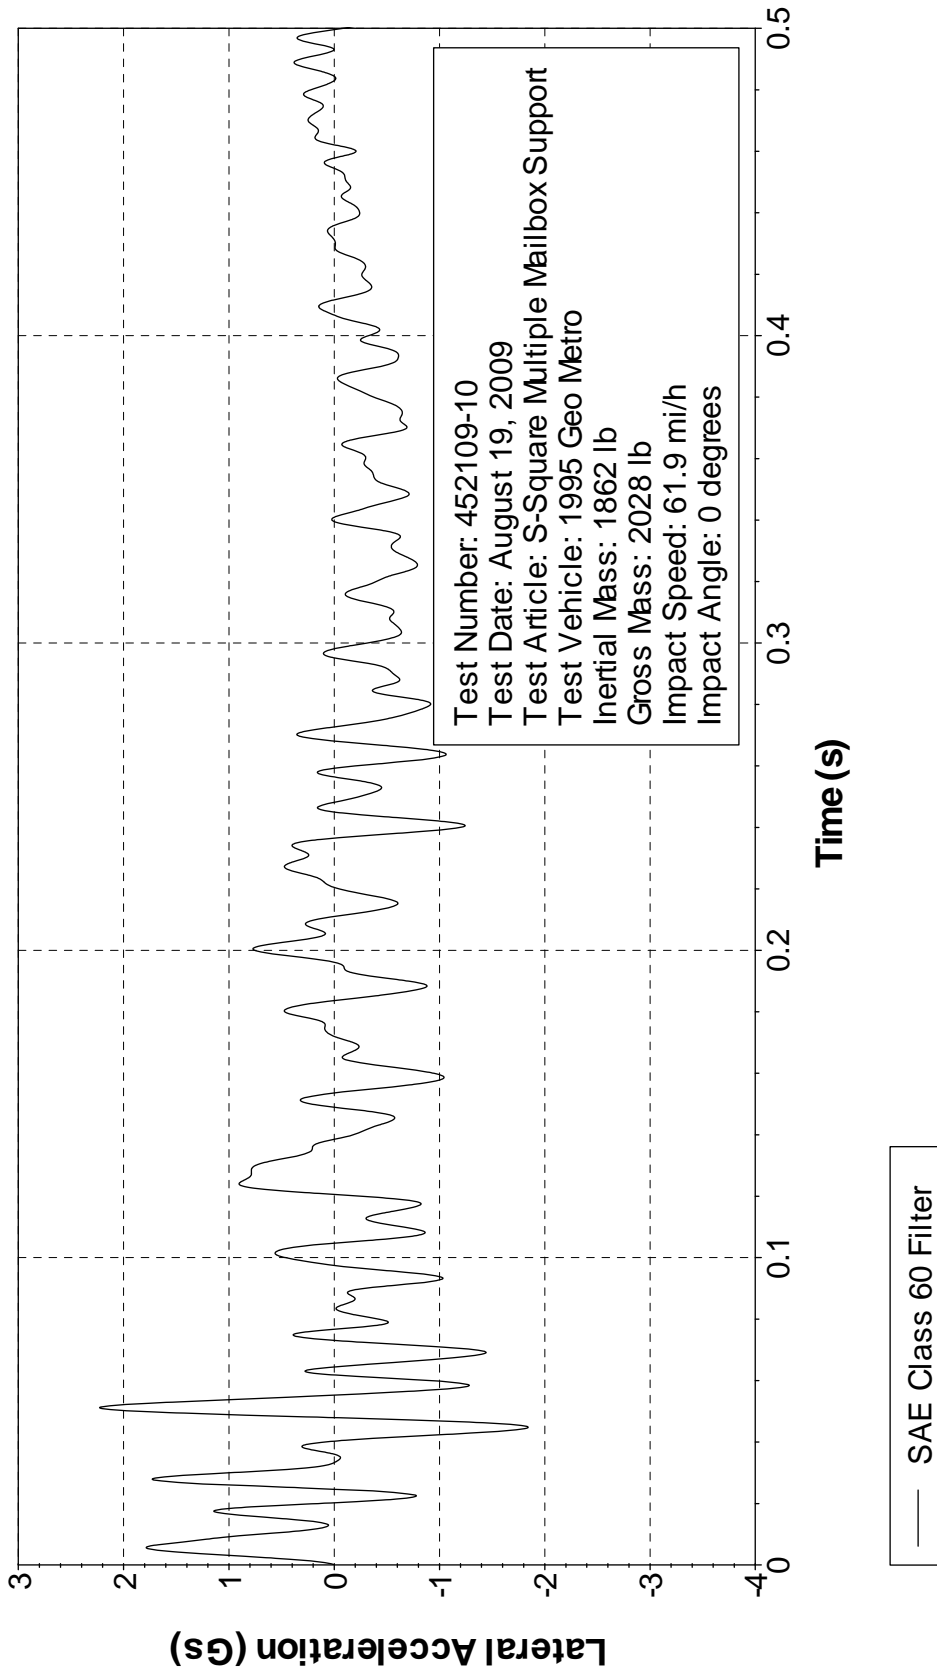
Y Acceleration over Rear Axle

Figure 34. Vehicle Lateral Accelerometer Trace for Test 452109-10
(Accelerometer Located over Rear Axle).

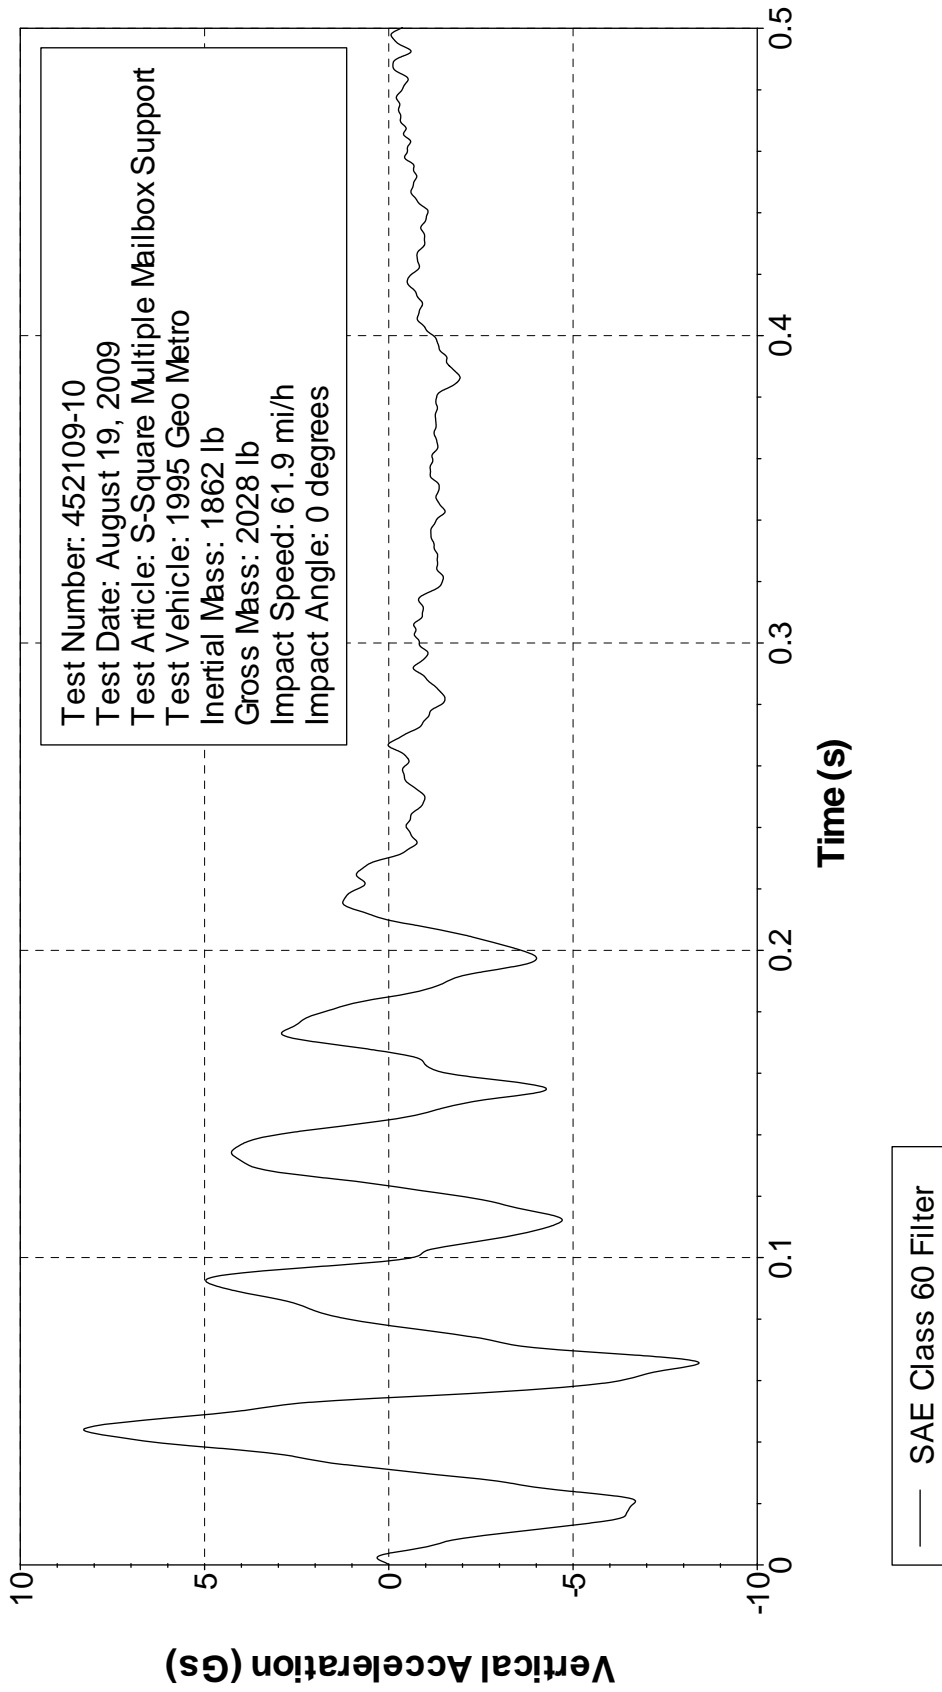
Z Acceleration over Rear Axle

Figure 35. Vehicle Vertical Accelerometer Trace for Test 452109-10
(Accelerometer Located over Rear Axle).
