DEVELOPMENT GUIDANCE FOR SIGN DESIGN STANDARDS

Test Report 0-6363-1

TEXAS TRANSPORTATION INSTITUTE
THE TEXAS A&M UNIVERSITY SYSTEM
COLLEGE STATION, TEXAS

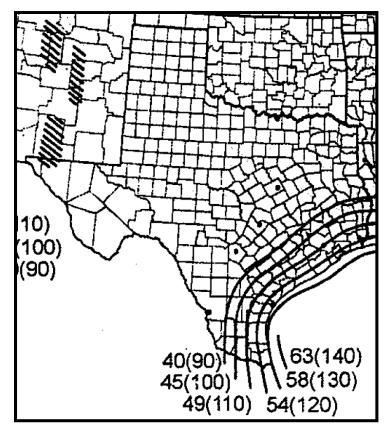
Figure 2.1. Texas Isotachs Wind Load Chart.

The design wind pressure is based on the basic wind speed and the anticipated design life of the structure. The basic wind speed is associated with the annual probability of 0.02 (or a 50 year mean recurrence interval), and is prescribed by isotachs contained in the AASHTO *Standard Specifications for Structural Supports for Highway Signs, Luminaires and Traffic Signals*. Figure 2.1 shows that the basic wind speed varies with geographical location across Texas and ranges from 90 mph to 130 mph near the coast. The current basic wind speed is modified by an importance factor based on the recommended minimum design life of a structure. The recommended minimum design life for roadside sign structures is 10 years.

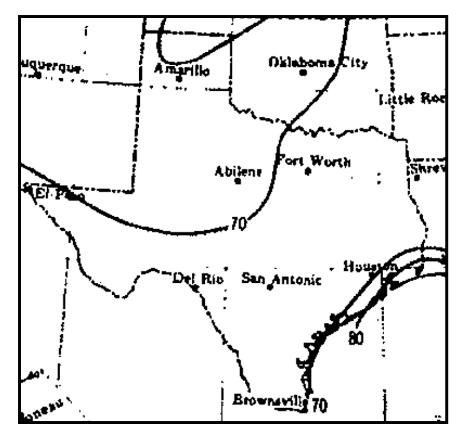
Figure 2.2. Appendix C: 10-Year Recurrence Interval Wind Load Chart.

The design wind pressure is based on the 10 year recurrence (based on design life) interval wind speed. The 10-year recurrence wind speed is prescribed by isotachs contained in Appendix C of the AASHTO *Standard Specifications for Structural Supports for Highway Signs, Luminaires and Traffic Signals.* Figure 2.2 shows the basic wind speed varies with geographical location across Texas and ranges from 60 mph to 80 mph near the coast. Again, the recommended minimum design life for roadside sign structures is 10 years.

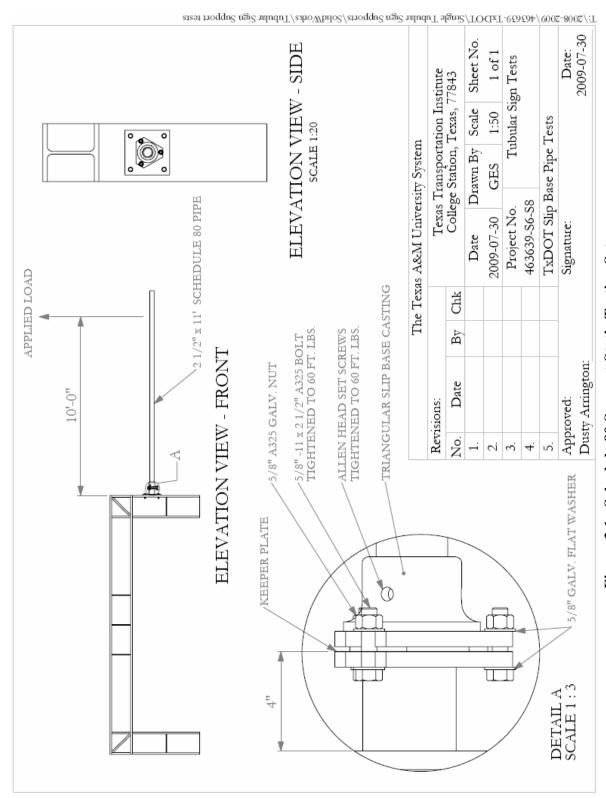
Figure 3.1. Schedule 80 Support Static Testing Setup.

To determine the maximum allowable force, three static tests (S6-S8 as described in Appendix A) on schedule 80 support posts were preformed utilizing standard slipbase connections. Each static test consisted of a cantilevered slipbase connection attached to a rigid load frame. An 11-ft, 2.5-inch schedule 80 sign support was then inserted into each slipbase, which was installed with standard hardware. Each test article was then loaded perpendicular to the support post at an effective height of 10 ft. Deflection was also recorded at the point of load application. Each test sample was then loaded until the article failed or the load reached a maximum and then began trending downwards. Figure 3.1 shows the test setup of this series of testing.

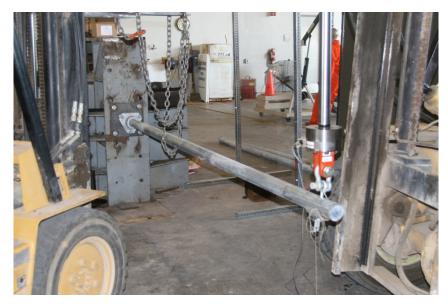
Figure 3.2. Schedule 80 Support Static Testing Setup before Load Application.

Figure 3.2 shows the test setup before load application, and Figure 3.3 shows the test setup at the point of maximum loading. Table 3.1 presents a summary of recorded loads. The testing resulted in an average failure load of 1022 lb. All three tests yielded the post support plastically at the slipbase interface. Notice that all the recorded failure loads are within 10 percent of the average failure load meeting the AASHTO requirement of a maximum allowable 681-lb wind load.

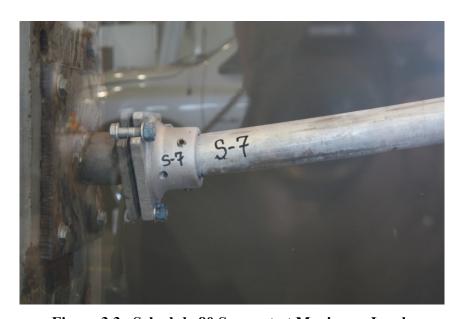
Figure 3.3. Schedule 80 Support at Maximum Load.

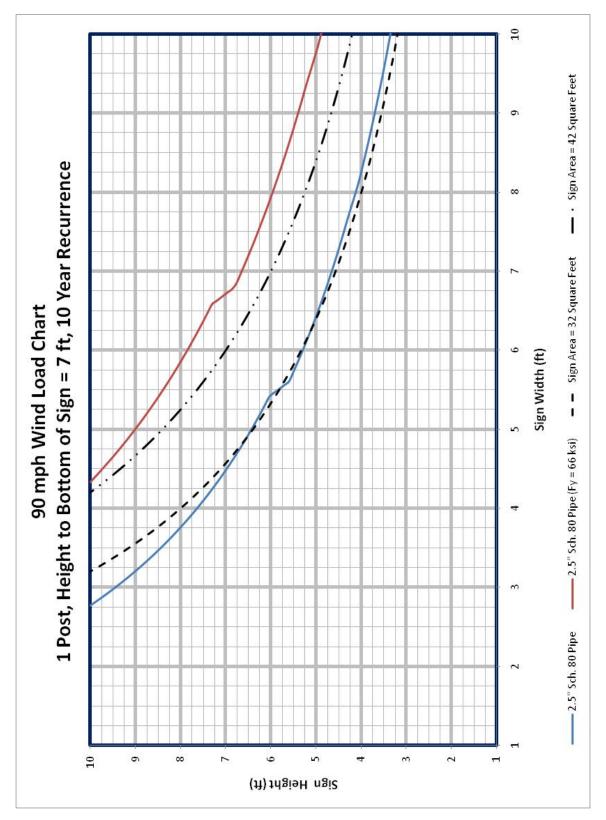
Figure 3.4. Updated Schedule 80 Wind Load Chart (Current Pressure Method).

Figure 3.4 is a wind load generated using two basic yield stresses. This wind load chart was generated using the current method of calculating wind pressures, not the legacy method described in Appendix C of the current AASHTO *Standard*. All calculations represented in this chart assume a 7 ft mounting height of the sign. The calculations also assume a 10-year recurrence interval (standard practices for roadside sign supports). The blue line represents the capacity of a 2.5-inch schedule 80 support post assuming a yield stress equal to 46 ksi (TxDOT's minimum requirement). The red line represents the 2.5-inch schedule 80 support post assuming a yield stress equal to 66 ksi (actual test sample values).

Using the maximum allowable design wind load force (681 lb) from the static testing above and an assumed sign area of 42 ft², the support can sustain a wind pressure of 16.2 lb/ft². A 90 mph wind speed, assuming again a 6 ft tall sign mounted at 7 ft height, results in a wind pressure of 16.4 lb/ft² (total wind force of 689 lb). This again leads to the conclusion that the test samples would be capable of sustaining a 42 ft² sign.

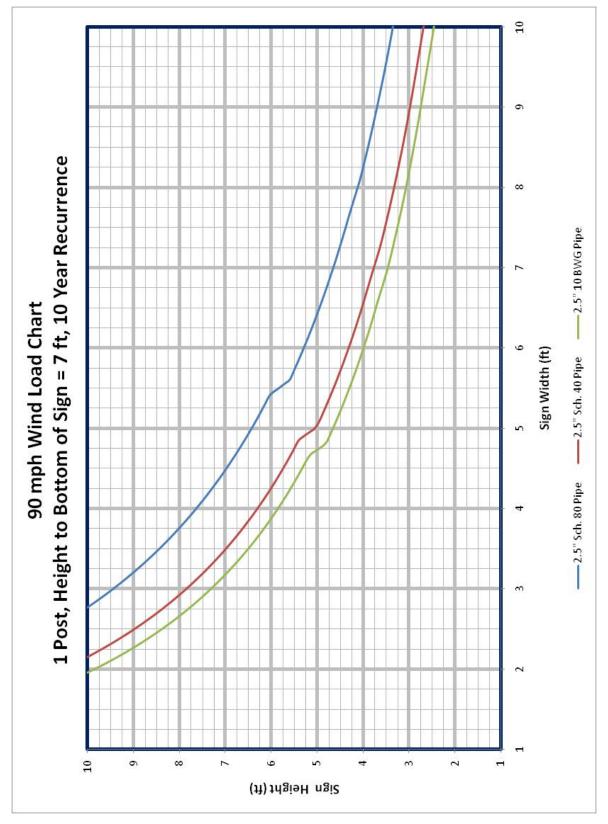
Figure 4.1. 2.5-Inch Pipe Support Wind Load Chart Comparison (Current Pressure Method).

Using the section properties detailed in Table 4.1 and the current wind pressure method described in AASHTO, the research team generated wind load charts (see Figure 4.1) for all three 2.5-inch pipe sections (10 BWG, schedule 40, and schedule 80) to demonstrate their relative capacities. Furthermore, Figure 4.1 shows that the schedule 40 pipe support does fall between the 10 BWG and the schedule 80 sections. However, the capacity is fairly close to that of the 10 BWG, showing that there will be only a few instances where a schedule 40 could be used instead of a schedule 80 support.

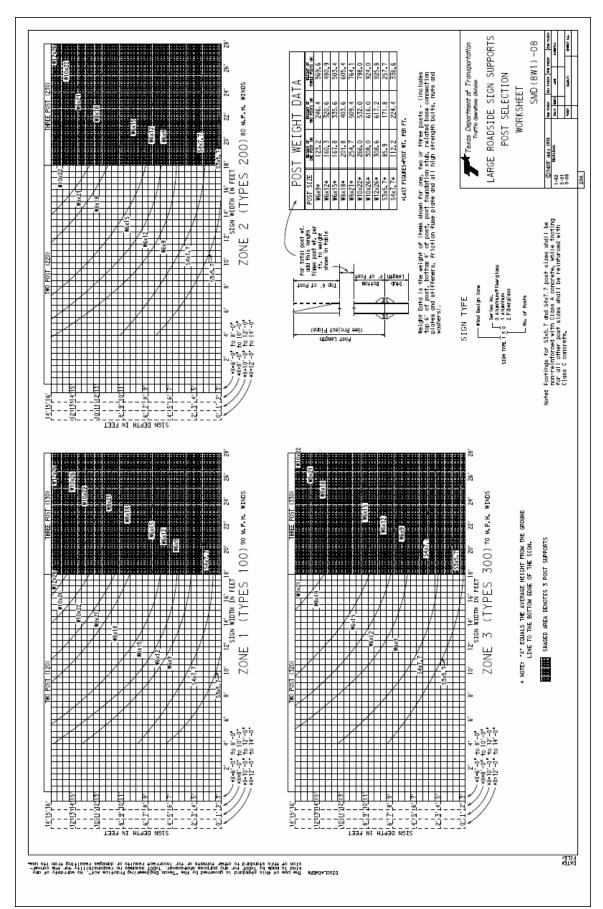
Figure 5.1. Current TxDOT Large Guide Sign Wind Load Charts.

Current large guide sign support selection charts were obtained from TxDOT's standards website for review. Figure 5.1 is an image of the current standard obtained. Figure 5.2 is an enlarged image of Zone 1 of the current selection chart. This chart was developed many years ago, and there is no record of who developed it or how it was developed. Therefore, to evaluate this chart's accuracy, new wind load charts were generated using the current support specifications according to the legacy wind pressure method detailed in Appendix C of AASHTO *Standard*. Figure 5.3 shows the resulting chart, which assumes the same conditions defined by Zone 1 (90 mph wind speed) of the TxDOT support selection chart. Also, Figure 5.3 assumes a 7-ft mounting height and that the sign is mounted on two support posts.

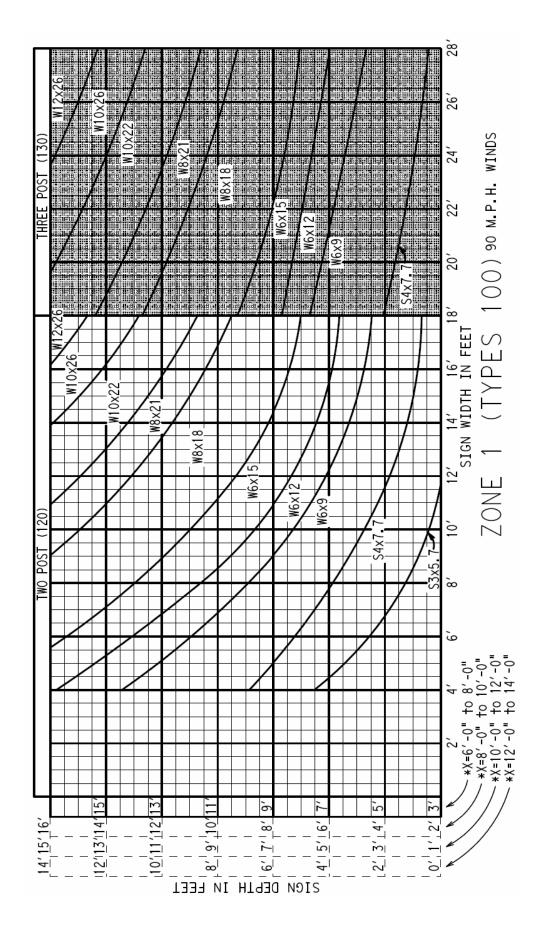
Figure 5.2. Current TxDOT Large Guide Sign Zone 1 Wind Load Charts.

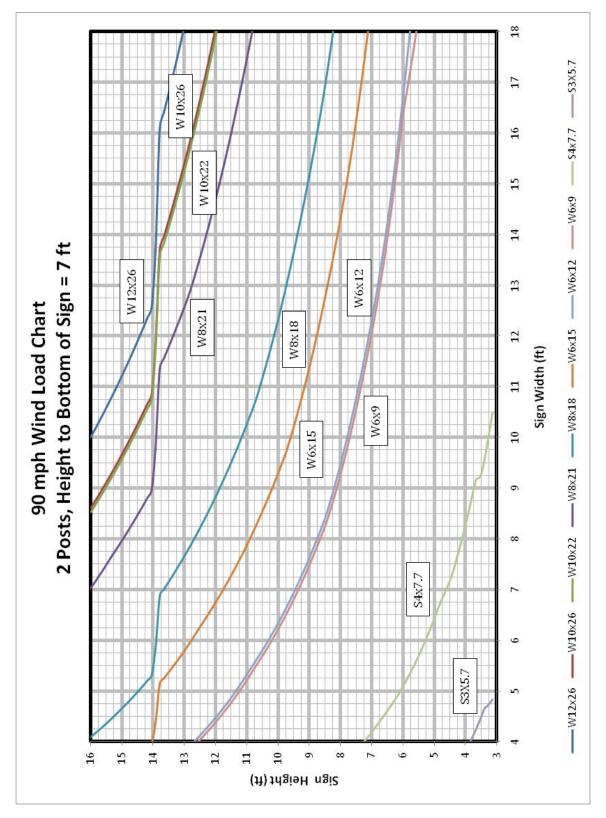
Figure 5.3. Wind Capacities of Current Large Guide Sign Supports (Legacy Method).

Second, several of the support assemblies wind load capacities fall directly on atop one another. This is counterintuitive. One would expect that if the strength of the beam was increased, it would result in an increase in the wind load capacity. This, however, is not the case.

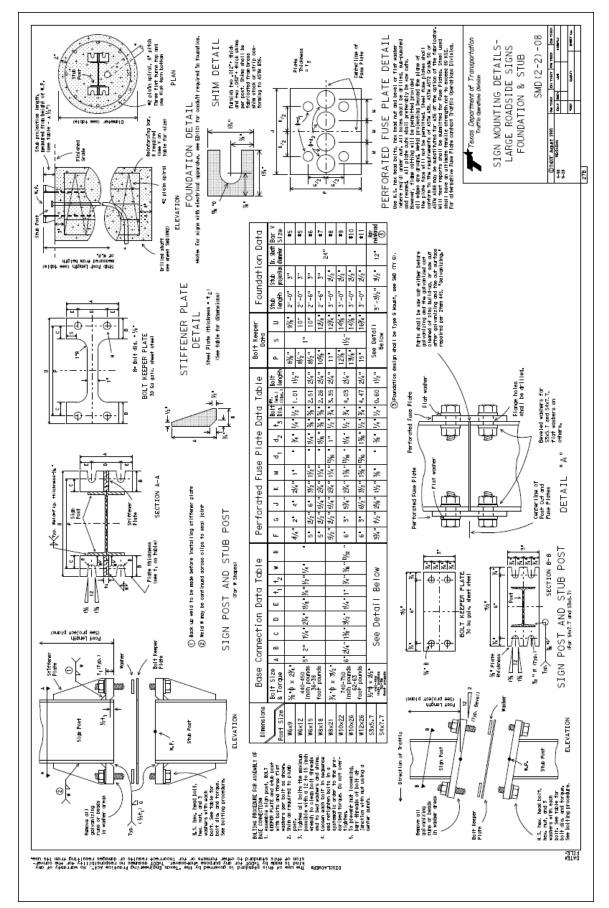
Figure 5.4. Current TxDOT Large Guide Sign Supports Slipbase and Fuse Plate Details.

The answer lies in the fuse plate capacity. Figure 5.4 is an image of the current TxDOT standard detailing the slipbase and fuse plate connections. Table 5.1 is an enlarged image of the design table detailing the sizes of each of the components corresponding to each support section's size. Also, Figure 5.4 is the current generic fabrication diagram for all fuse plate designs; the sections that have equivalent wind load capacities share the same fuse plate details. Researchers conducted further investigation into the cause of the phenomena.

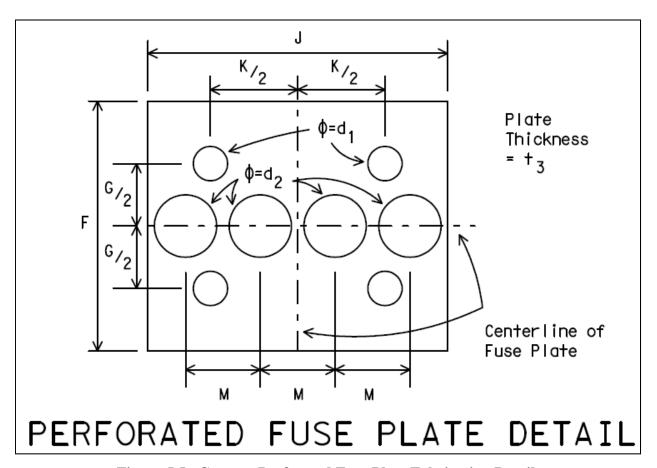
Figure 5.5. Current Perforated Fuse Plate Fabrication Detail.

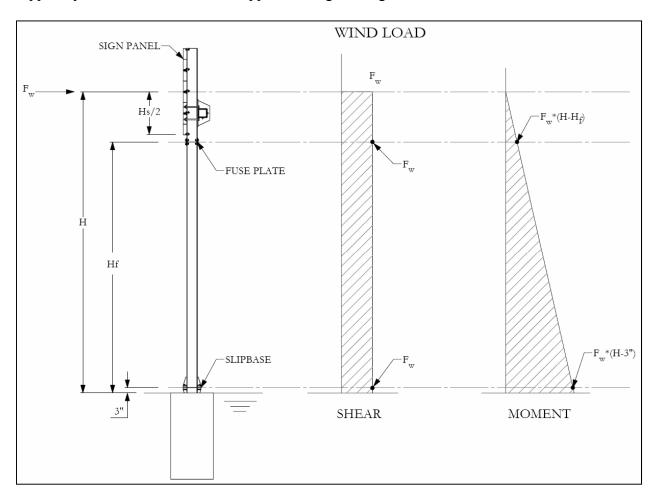
Figure 5.6 is a diagram showing the forces resisted by the support section under a wind loading event. The shear force is constant across the length of the support. However, the moment increases linearly until it reaches a maximum value at ground level. This diagram details the forces that must be resisted to support the sign during the wind load event. Three important locations that need to be investigated are the height of the fuse plate, the height of the slipbase, and, finally, the forces at ground level. The first location equates to the minimum moment capacity of the fuse plate connection to support. The second corresponds to the minimum capacity of the slipbase connection. Finally, the final location corresponds to the minimum capacity of the support post. If any of the calculated capacities exceed those of the support components, then the support system will not be able to support that sign configuration.

Figure 5.6. Large Guide Sign Support Force Diagram for Wind Load Condition.

When the calculated capacities are substituted into this analysis, it was determined (for the typical mounting height of 10 ft) the fuse plate was primarily the limiting factor in many cases. To visualize this, Table 5.2 shows the equivalent moment capacity of all three components (fuse plate, slipbase, and post section) at the same location (height of slipbase). This allows for a direct comparison of the capacities of the components. In Table 5.2, the cells that are highlighted in red are instances where the fuse plate controls; those in green are instances where the post controls.

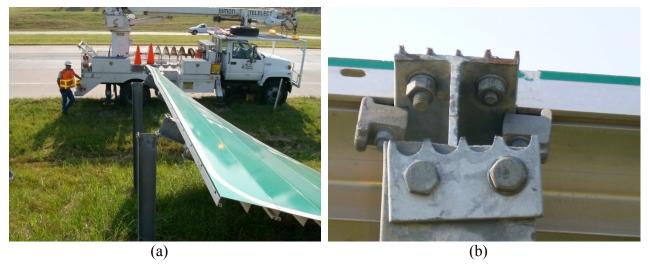
Figure 5.7. Typical Fuse Plate Failure Mode Reported by Districts.

Many districts, including Atlanta, Lubbock, and Waco Districts, have reported similar failures, (see Figures 5.7 (a) and (b)). The Atlanta district was contacted specifically because of the abnormally high number of instances of fuse plate failure in recent history. The district representatives conveyed the following field maintenance problems during the conversation with TTI.

- Localized high wind events causing fuse plate failure (high winds typically not in excess of design wind load conditions)
- Fuse plate connecting bolts were becoming loose over time (varied between a few days to a few months)
- Some sign locations were failing between two and three times a year.
- Dual fuse plate and single fuse plate designs were equally represented in failures.
- After further investigation, the W8×18 sign supports made up an abnormally large percentage of the sign installations failing under high wind loading events.

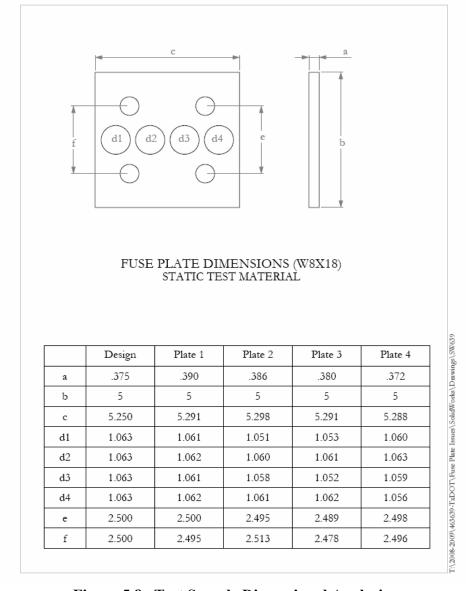
Figure 5.8. Test Sample Dimensional Analysis.

Fuse plate tensile testing was performed to verify the calculated capacity of the machined fuse plate; a local supplier sent four test samples. TTI requested that the supplier send ungalvanized samples to allow for verification of primary dimensions. Figure 5.8 details the measured dimensions of each of the test samples, and lists the intended design measurements.

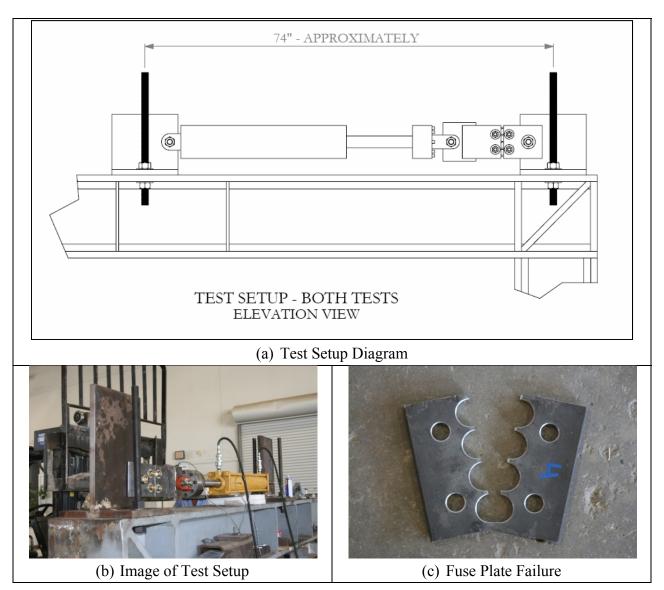
Figure 5.9. Fuse Plate Tensile Test (S12–S14).

Three of the samples were then chosen at random for testing (S12–S14). Loading was applied using a hydraulic cylinder. Care was taken to ensure bending stresses were not induced into the fuse plate during loading. This ensures that failure loads are not artificially reduced by combined stresses due to bending. Appendix B gives a recorded force-time history of the load event. Figure 5.9 (a-c) details the test setup and typical failure witnessed during the testing.

A total net area of cross sections through the fuse plate along the axis of perforations was calculated to be equal to 0.375 inches². A36 steel has a minimum ultimate stress of 58 ksi. This equates to a predicted failure load of 21.8 kips. The three static tests resulted in the following failure forces: 34.3 kips (S12), 33.3 kips (S13), and 32.0 kips (S14). Each test failure capacity was significantly higher than the calculated capacity. S12 was 57 percent above the minimum, S13 was 53 percent above the minimum, and S14 was 47 percent above the minimum. This testing has ensured that fuse plates are being fabricated according to TxDOT requirements and

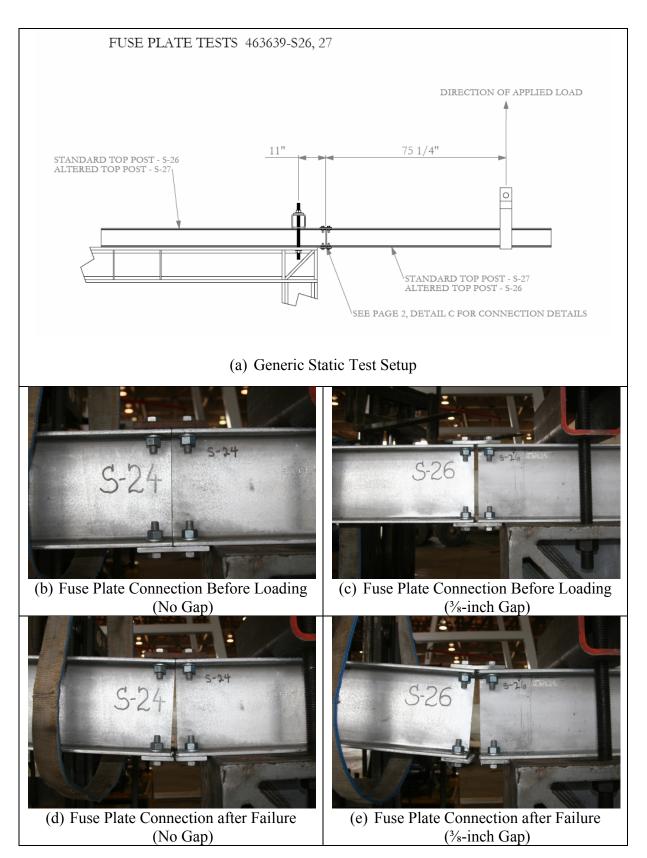
Figure 5.10. W8×18 Fuse Plate Fuse Plate Connection Capacity Verification (S24–S27).

Figure 5.10 (a) details the basic test setup. The spliced beam was clamped to the rigid load frame, and then a vertical load was applied approximately 75 inches from the fuse plate connection. Appendix C gives further details of the test installation. Photos b and d in Figure 5.10 show the gapless fuse plate connection (S24 and S25) before and after failure of the fuse plate connection. Meanwhile, photos c and e in Figure 5.10 are images of the fuse plate connections with a 3/8-inch gap (S26 and S27) before and after failure of the fuse plate connection.

- Test S24 tension fuse plate failed at a vertical load of 3.2 kips. This equates to a 19.2 kip*ft fuse plate connection moment capacity.
- Test S25 tension fuse plate failed at a vertical load of 4.3 kips. This equates to a 26.6 kip*ft fuse plate connection moment capacity.
- Test S26 tension fuse plate failed at a vertical load of 3.9 kips. This equates to a 24.7 kip*ft fuse plate connection moment capacity.
- Test S27 tension fuse plate failed at a vertical load of 3.0 kips. This equates to a 18.7 kip*ft fuse plate connection moment capacity.

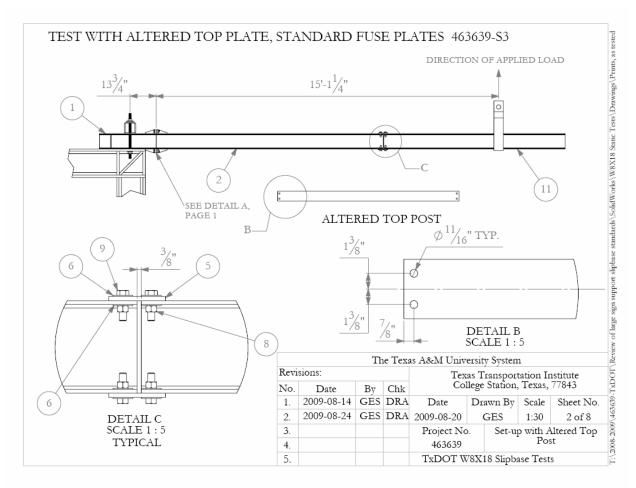
Figure 5.11. W8×18 Support Assembly Capacity Verification (S3).

A single static test was performed to and verify that a full W8×18 support system will provide capacities in excess of those calculated. Figure 5.11 details the setup for this test, and Appendix C gives further details. This test consisted of the testing of W8×18 post section, W8×18 slipbase, and W8×18 fuse plate connection all assembled into a single support. The ground stub was clamped to the rigid load frame to simulate a rigid foundation. Then, a vertical load was applied 16 ft 3 inches from the clamp location. Figure 5.12 shows the test setup before load application, and Figure 5.13 shows the test article under maximum load.

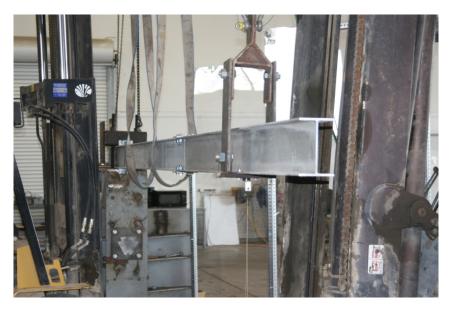
Figure 5.12. W8×18 Support Ready for Load Application (S3).

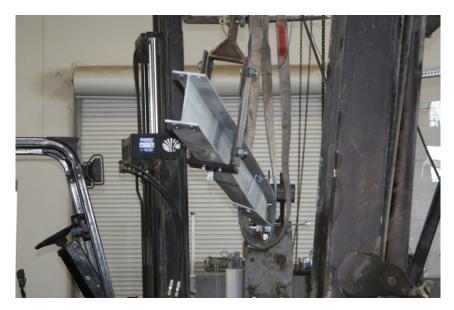
Figure 5.13. W8×18 Support at Maximum Load (S3).

Test S3 reached a maximum load of 3.5 kips. The calculated equivalent capacity of the fuse plate connection is 3.0 kips, and that of the base post section with an unbraced length of 16 ft 3 inches is 0.1 kips. This calculation includes reductions according to lateral torsional buckling (LTB) effects. Figure 5.13 shows that the beam did, in fact, fail due to LTB. The results of the static testing show the post assemblies provide capacities in excess of those calculated.

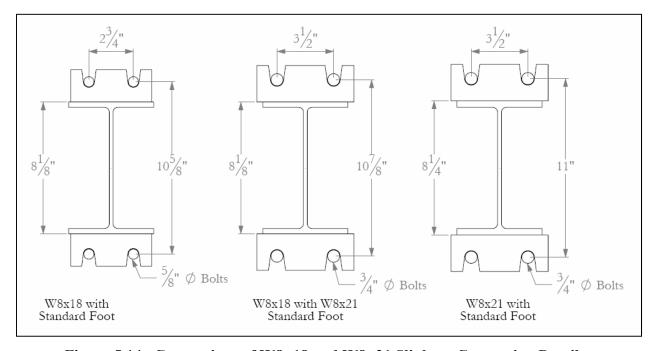
Figure 5.14. Comparison of W8×18 and W8×21 Slipbase Connection Details.

One option to make the connection more consistent across these two sections is to utilize the stronger W8×21 slipbase connection details on the weaker W8×18 post section. As this connection detail will be stronger than the original configuration, it will not affect the structural capacity of the system. Figure 5.14 shows diagrams of each of the configurations. The addition

of the W8×21 feet on the W8×18 section may allow for the attachment of a W8×18 post on a W8×21 base, and vice versa. The sections appear to be compatible; however, it is not recommended to mix sections like this due to possible maintenance and structural capacity issues. TTI recommends that fuse plate details for these sections should be left as is due to unknown effects on impact performance.

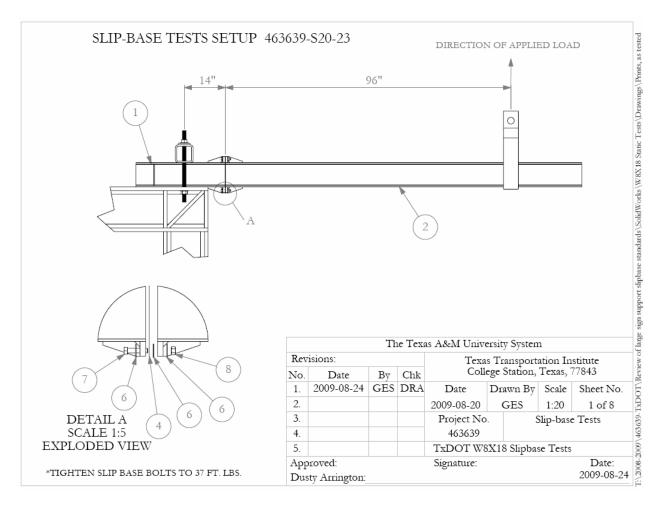
Figure 5.15. W8×18 Slipbase Connection Capacity Static Test Setup.

Figure 5.15 details the test setup. First, a W8×18 foundation stub is clamped to the rigid load frame. A short section of W8×18 support post is then fastened to the foundation stub using the current W8×18 slipbase connection details. A vertical load is then applied 9 ft 2 inches from the clamp location, until it reaches a maximum.

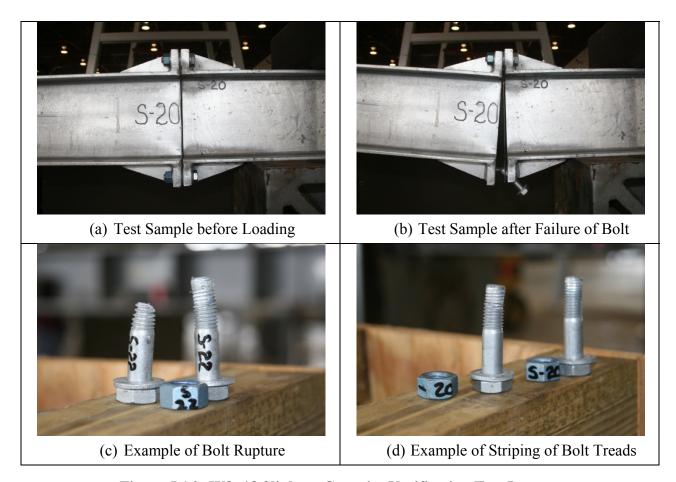
Figure 5.16. W8×18 Slipbase Capacity Verification Test Images.

An unfactored equivalent vertical load capacity of the W8×18 post section and A325 bolted connection were calculated to be 7.9 and 6.4 kips, respectively. Therefore, it is expected that the system will fail due to bolt rupture in the slipbase connection. S20 reached a vertical load capacity of 6.4 kips, S21 reached a vertical load capacity of 6.3 kips, S22 reached a vertical load capacity of 6.5 kips. These values correspond exactly with the calculated values. This also shows that the W8×18 post section may benefit in some situations from using the stronger W8×21 slipbase configuration. Photos a–d in Figure 5.16 are representative images from the static load tests.

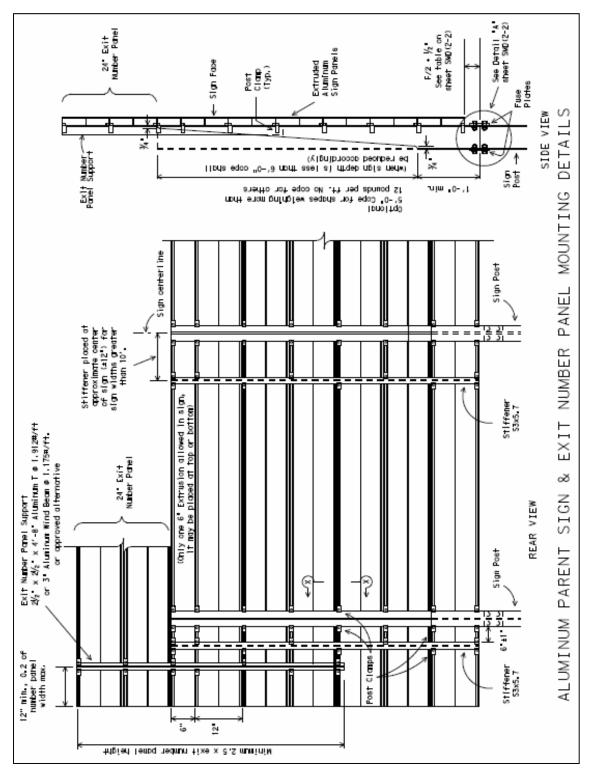
Figure 6.1. Current TxDOT Vertical Stiffener Detail Sheet.

As the true design intent of the vertical stiffeners is unknown, TTI researchers have theorized the intent is to increase the torsional stiffness of the sign panel. This facilitates the activation of the fuse plate connections in the event of an errant vehicle striking the panel. To verify this assumption and to develop torsional stiffness relationships, static tests were performed with two main objectives. The first was to determine the torsional capacity relationship for sign panels without vertical stiffeners. The second objective was to determine how much additional torsional stiffness is gained by adding the standard vertical stiffeners. Figure 6.1 shows an image of current TxDOT vertical stiffener details for large guide signs.

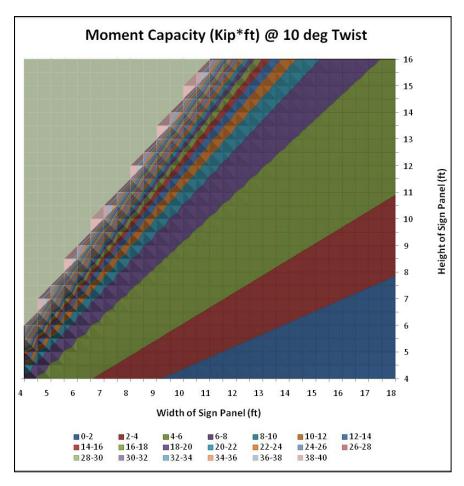
Figure 6.3. Predicted Maximum Sign Panel Assembly Torsional Capacity.

All experimental data were analyzed and used to extrapolate the torsional capacity for all sign panel configurations. From testing, it was determined that sign clips have an increased chance of failing if sign panel twist exceeds 10 degrees. Figure 6.3 shows a graphical representation of the stiffness extrapolation of all sign panel configurations at a 10-degree twist angle. This would equate to the predicted maximum static torsional capacity of each sign configuration.

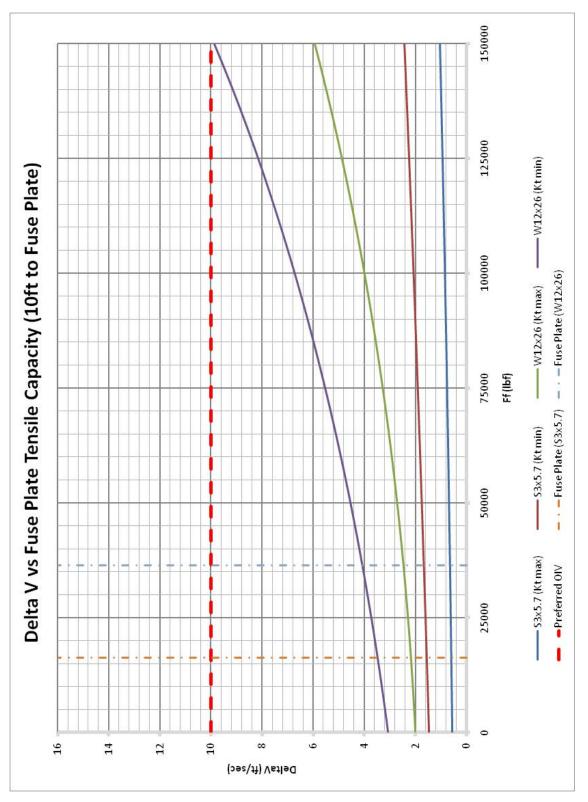
Figure 7.1. Predicted OIV Analysis.

To address the condition of increasing the stiffness beyond OIV limits, simulation was performed according to the method described in NCHRP Synthesis 318 (4). This analysis allows the prediction of OIV values when impacting a dual support system with fuse plate connections. The method predicts the OIV values given certain system properties, such as weight per foot of the beam and rupture strength of the fuse plate connection. A simulation was then performed for each post assembly configuration. Each simulation was then utilized to predict the maximum allowable rupture fuse plate force which predicts a OIV value less than or equal to 10 ft/sec (maximum value set by *MASH*). The analysis predicts the activation force of the slipbase given the tensile force in each bolt. This force can be determined from the applied torque given a specified conversion factor (K). This factor varies with bolt construction; however, upper and lower limits on K are described in the conversion method. Instead of determining the K value for each bolt experimentally, the analysis was performed with both the maximum and minimum values, giving a range of solutions. Figure 7.1 is a plot of the results of the simulation. As seen in Figure 7.1, the fuse plate tensile force have to be increased beyond realistic values to cause OIV values to exceed mandated limits.

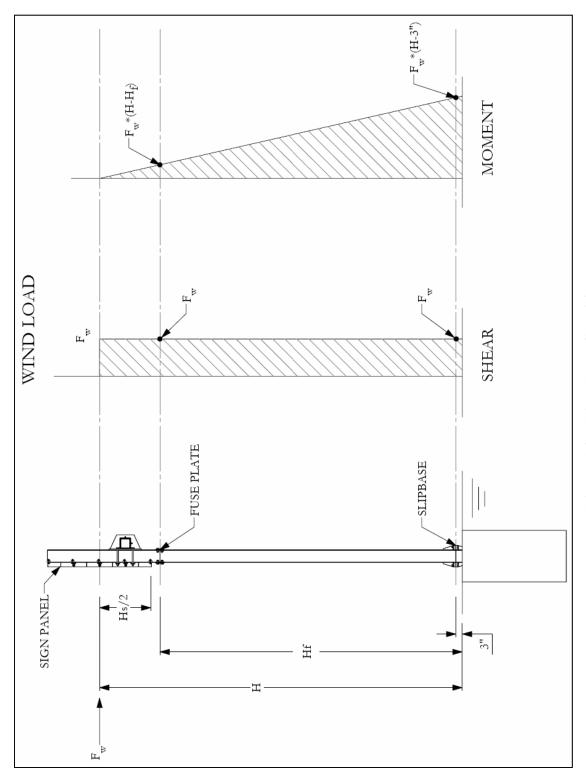
Figure 7.2. Wind Load Condition.

event. Diagrams of wind loading (Figure 7.2) and impact loading (Figure 7.3) can be found below. This is not always possible; however, to ensure impact performance, the impact loading condition should be the overriding controlling factor. If both conditions can be achieved, the minimum fuse plate connection strength should be used.

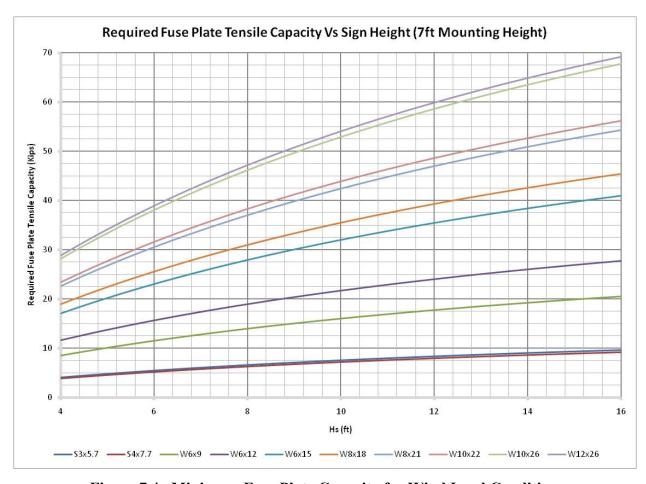
Figure 7.4. Minimum Fuse Plate Capacity for Wind Load Condition.

To facilitate this analysis, a chart of minimum fuse plate capacities for wind loading is plotted in Figure 7.4 for a minimum mounting height of 7 ft for each post section. If the fuse plate capacity falls below the plotted line in Figure 7.4, the fuse plate will control the maximum sign area instead of the post section, leading to inefficiencies in the system design. Table 7.1 is a list of maximum fuse plate tensile capacities that will ensure that the fuse plate connection will fail before the post will yield or buckle. Notice all maximum tensile capacities are in excess of the minimum required in Figure 7.4, except for the W6×9 support condition. Figure 7.4 shows that a minimum capacity of approximately 22 kips is required to ensure that the post will control in a wind load condition. However, the maximum tensile capacity for impact loading is only 17 kips. For this reason, it is not possible to ensure that the fuse plate will not control in all wind load conditions. This special situation is primarily due to the fact that a W6×9 is a "non-compact section." This means that the bending capacity of this section will drop off more rapidly than a "compact section" allowing this condition to occur.

Again, Figure 7.4 is a graphical representation of the extrapolated torsional capacity of varying sign configurations at a rotation of 10 degrees. When comparing the values in Table 7.2 to the chart in Figure 7.5, it is quickly evident that for a majority of the sign configurations, the static capacity of the sign panels are far less than the static capacities of the fuse plate

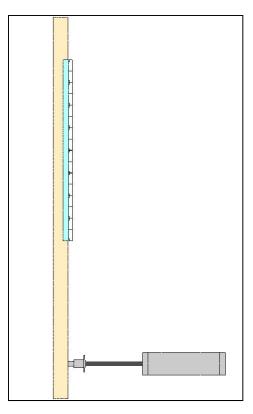
Figure 7.6. Simplified LSDYNA Impact Simulation Setup.

To verify, the research team performed a simplified series of LS-DYNA simulations. This simulation was constructed to represent a $10 \text{ ft} \times 8 \text{ ft}$ sign panel mounted on a W8×18 post continuous post section with a 7-ft sign mounting height; the slipbase and fuse plate connections were not incorporated into this model. The model was then impacted using a simulated 1800 kg vehicle surrogate modeled after TTI's pendulum impact vehicle. Due to the simplifications of this model, validation against static testing was not performed. Since the researchers were looking for a capacity amplification factor, the validation of the model was not required. Figure 7.6 is an image of the simplified simulation setup.

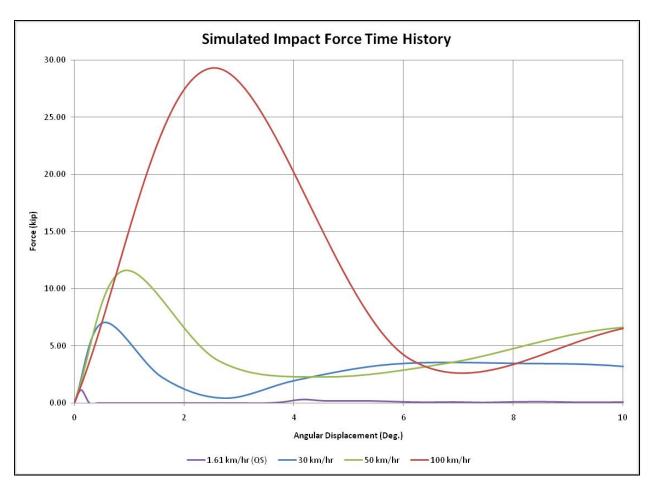
Figure 7.7. Simulated Force Times Histories.

The impact force-time history induced by the impacting surrogate vehicle was recorded for four different loading rates: quasi-static (QS), 18.6 mph, 31.1 mph, and 62.1 mph. Figure 7.7 shows all four force-time histories plotted on a single chart. The resultant maximum forces were then recorded: QS = 1.1 kips, 18.6 mph = 7.0 kips, 31.1 mph = 11.6 kips, and 62.1 mph = 29.3 kips. These forces resulted in the following amplification factors: 18.6 mph = 6, 31.1 mph = 10, and 62.1 mph = 25.

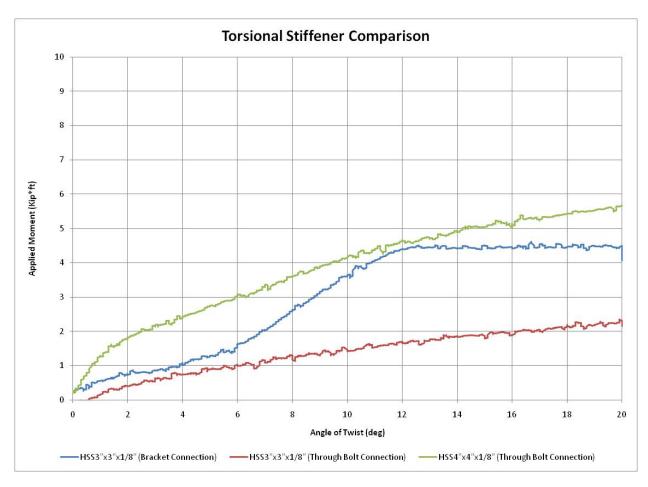
Figure 7.10. Measured Force Times Histories of Torsional Stiffeners.

Figure 7.10 and 7.11 have the test results. Figure 7.10 compares the capacities of various torsional stiffeners, while Figure 7.11 compares those of torsional stiffeners with and without sign panels. Figures 7.10 and 7.11 show that the attachment method makes a significant difference in the stiffness of the torsional stiffener. The HSS3×3×1/8-inch stiffener actually yielded after the maximum load was reached when installed using the sleeve bracket. Figure 7.11 shows that the summation of the individual stiffness approximates the combined stiffness.

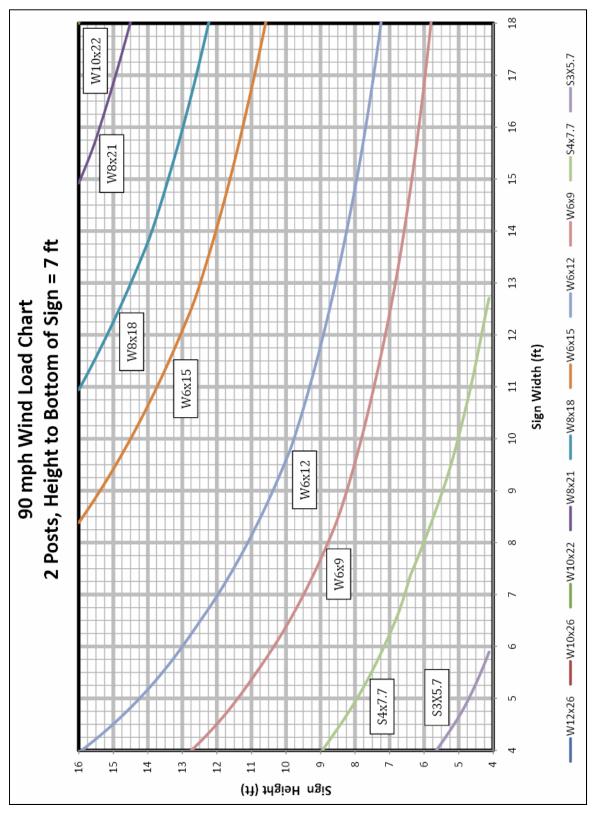
Figure 7.12. 90 mph Selection Chart for Optimized Fuse Plate Hbs = 7 ft (Current Method).

Two impact conditions were selected for high-speed testing. The first was selected to provide the highest stiffness for a 10-ft wide sign panel. Figure 7.12 is the updated wind load chart (according to current method) for a 90 mph wind zone and a mounting height of 7 ft. A 10 ft × 16 ft sign panel was selected which has a predicted static torsional capacity of 81.1 kip*ft. This is well in excess of the capacity required to fail the W8×18 fuse plate connection selected from Figure 7.12. Therefore, no torsional stiffeners will be installed. This installation will verify that the sign panel without stiffeners will provide sufficient capacity to fail the optimized W8×18 fuse plate connection without failing the OIV requirements.

To visualize the benefit of the optimized fuse plate connections when compared to the current fuse plate design, one must compare the support selection charts. Figures 7.12 and 7.14 both represent charts generated for 90 mph wind zones according to the current method of calculating wind pressures. Both charts assume dual supports and a sign mounting height of 7 ft. Figure 7.14 was generated for the optimized fuse plate design, and Figure 7.12 was generated for the current fuse plate design. Note the substantial increase in almost all the support assemblies' wind load capacity.

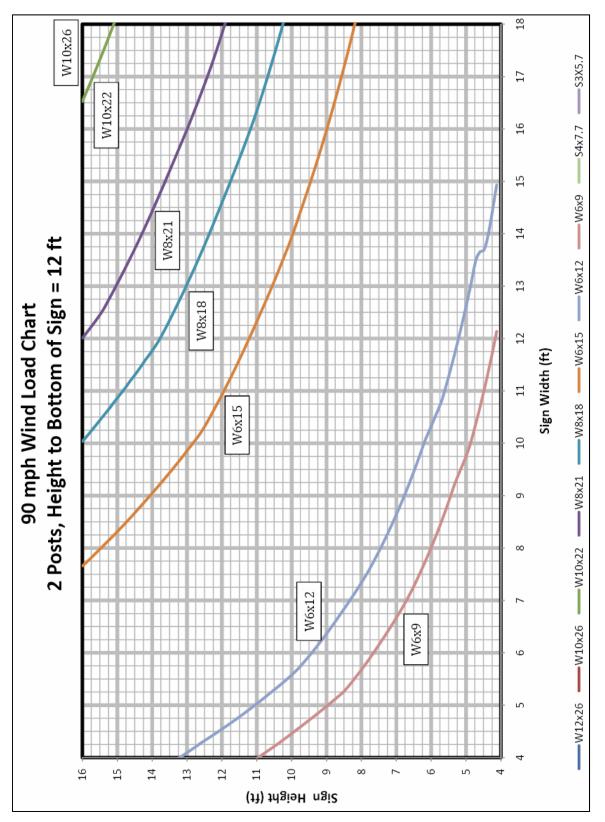
Figure 7.13. 90 mph Selection Chart for Optimized Fuse Plate Hbs = 12 ft (Current Method).

The second test was formulated to provide the weakest system to verify that the fuse plate would fail before the weakened post would yield/buckle when struck by an impacting vehicle. Again, a 10-ft wide sign panel was selected for testing. Figure 7.13 is a plot of updated wind load charts using current method of determining wind pressures. A 10 ft \times 4 ft sign was selected to be mounted on a W6×9 post assembly. A 10 ft \times 4 ft sign assembly has a capacity of 1.6 kip*ft.

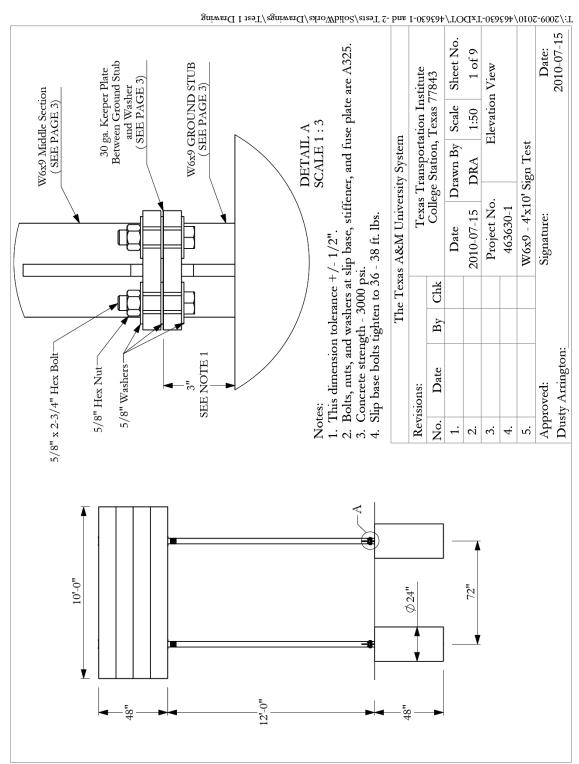
Figure 7.15. Details of the TxDOT W6×9 – 4-ft \times 10-ft Large Sign Support Test Installation.

Figure 7.15 is a diagram of the test installation as tested, and Figure 7.16 presents photographs of the installation as tested. Appendix E, Figure E1 features further fabrication details and specifications.

The middle section was fabricated from an 11 ft-5 inch long section of W6×9 beam section. This section again had the same hole pattern that was found in the top section at one end. This again allowed for the splicing of the top and middle sections using a milled fuse plate. The other end of the middle section had two slipbase feet, meeting TxDOT's W6×9 specifications, welded to each flange. These plates were made from $2\times5\times^3/4$ -inch plates. The two slots were cut into each plate at a spacing of $2^3/4$ inches. Each slot was fabricated to receive a 5%-inch slipbase connecting bolt. Then, a $2\times5\times^1/2$ -inch gusset plate supported the slipbase feet. The slipbase foot assembly was centered on each of the external flanges of the W6×9 beam support section.

The ground stub was installed in a 48-inch deep 24-inch diameter concrete foundation. The foundation was reinforced with eight 42-inch #5 vertical rebar. The foundations were shear reinforced using a single #2 spiral rebar with a 6-inch pitch with three flat turns at the top and one flat turn at the bottom. The foundations were spaced 72 inches on center. Each ground stub protruded 3 inches out of the foundation.

All hot rolled W-sections conform to A992 material specifications. Every tube section conforms to A500 grade B specification. All bolts and nuts meet A325 material specifications. The State of Texas Prison System supplied all extruded sign panels and post clamps, which meet AASHTO and TxDOT material specifications. All other steel sections and plate meet A36 specifications. The concrete used in the foundation has a compression strength in excess of 3000 psi.

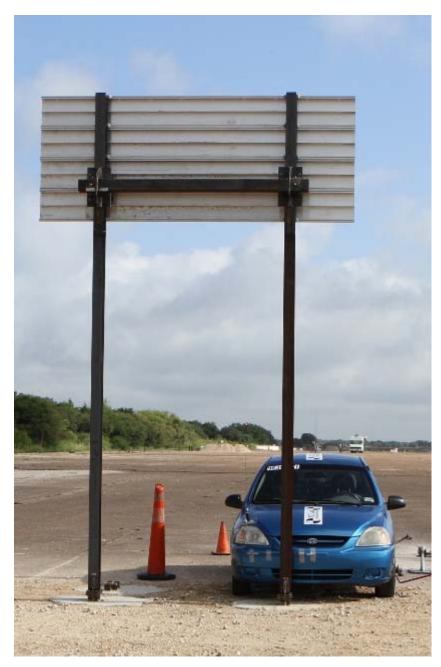
Figure 7.17. Vehicle/Installation Geometrics for Test No. 463630-1.

Figures 7.17 and 7.18 show the 2004 Kia Rio used for the crash test. Test inertia weight of the vehicle was 2414 lb, and its gross static weight was 2575 lb. The height to the lower edge of the vehicle bumper was 8.50 inches, and it was 22.75 inches to the upper edge of the bumper. Table E1 in Appendix E gives additional dimensions and information on the vehicle. The vehicle was directed into the installation using the cable reverse tow and guidance system, and was released to be free-wheeling and unrestrained just prior to impact.

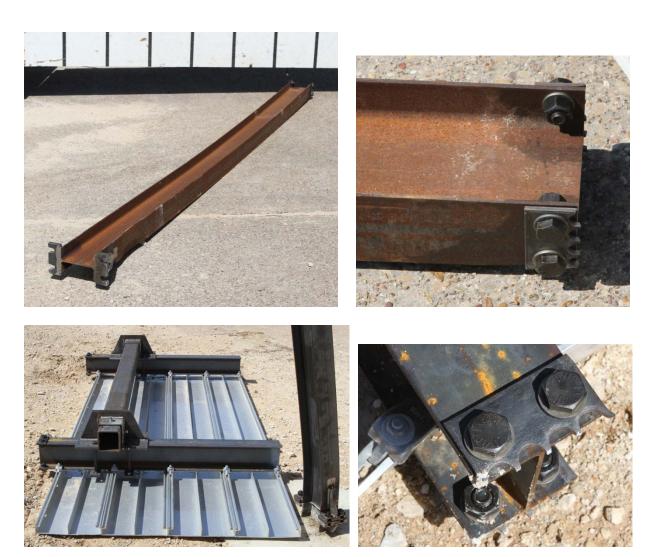
Figure 7.20. Installation after Test No. 463630-1.

Figures 7.20 and 7.21 show damage to the sign support. The slipbase and fuse plates (hinge connections) activated as designed. The right support leg remained standing but was leaning 15 degrees in the direction of where the left support leg originally was installed before the test. The left support leg was resting on the ground surface 9 ft toward the field side. The sign panel was resting on the ground surface face down on the impact side of the installation. The lower left corner of the sign panel was deformed.

Results: When impacted by the 1100C vehicle, the W6×9 4-ft \times 10-ft large sign support activated by breaking away at the slipbase and at the upper hinge connections. (PASS)

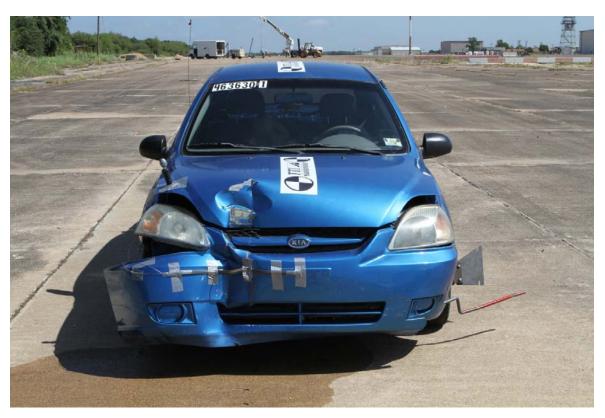
Figure 7.21. Vehicle after Test No. 463630-1.

Figure 7.21 shows that the 1100C vehicle sustained minimal damage. The front bumper, hood, radiator, and radiator support were deformed, and the right headlight was broken. Maximum external crush to the vehicle at the right front quarter point at bumper height was 3.5 inches. No occupant compartment deformation occurred. Figure 7.22 shows photographs of the interior of the vehicle. Tables E2 and E3 in Appendix E, provide the exterior crush and occupant compartment measurements.

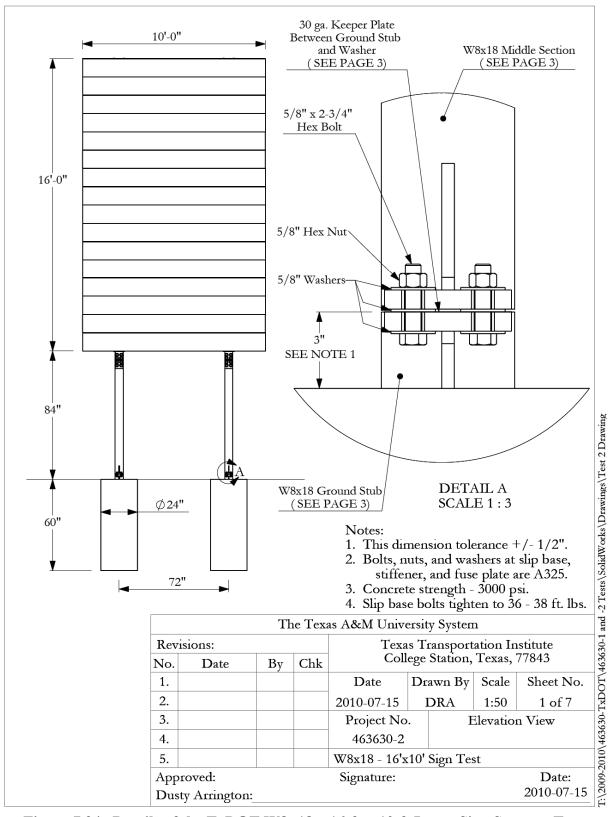
Figure 7.24. Details of the TxDOT W8×18 – 16-ft × 10-ft Large Sign Support Test Installation.

Torsional stiffeners were not used in this installation. Figure 7.24 is a diagram of the test installation as tested, and Figure 7.25 presents photographs of the installation as tested. Further fabrication details and specifications can be found in Appendix F, Figure F1.

The ground stub was installed in a 60-inch deep 24-inch diameter concrete foundation, which was reinforced with eight 54-inch # 5 vertical rebar. The foundations were shear

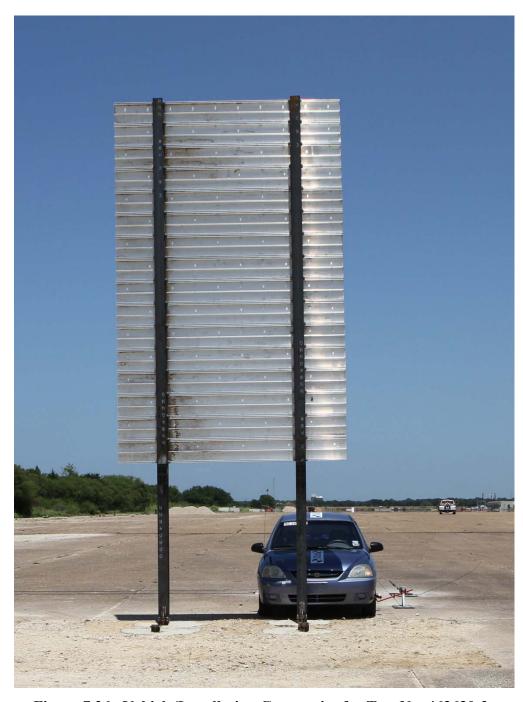
Figure 7.26. Vehicle/Installation Geometrics for Test No. 463630-2.

Figures 7.26 and 7.27 show the 2005 Kia Rio used for the crash test. Test inertia weight of the vehicle was 2431 lb, and its gross static weight was 2606 lb. The height to the lower edge of the vehicle bumper was 8.50 inches, and it was 22.75 inches to the upper edge of the bumper. Tables F1 and F2 in Appendix F give additional dimensions and information on the vehicle. The vehicle was directed into the installation using the cable reverse tow and guidance system, and was released to be free-wheeling and unrestrained just prior to impact.

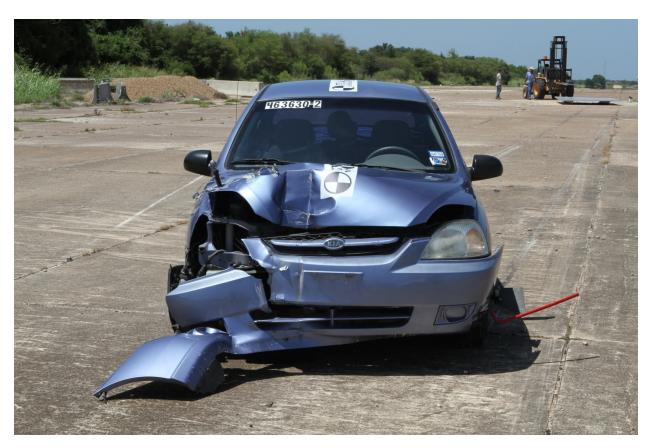
Figure 7.30. Vehicle after Test No. 463630-2.

Figure 7.30 shows the damaged 1100C vehicle. The front bumper, hood, radiator, and radiator support were deformed, and the right headlight was broken. Maximum external crush to the vehicle in the front plane at the right front quarter point at bumper height was 10.0 inches. No occupant compartment deformation occurred. Figure 7.31 contains photographs of the interior of the vehicle. Tables F3 and F4 in Appendix F provide the exterior crush and occupant compartment measurements.
