DEVELOPMENT GUIDANCE FOR SIGN DESIGN STANDARDS

Test Report 0-6363-1

TEXAS TRANSPORTATION INSTITUTE
THE TEXAS A&M UNIVERSITY SYSTEM
COLLEGE STATION, TEXAS

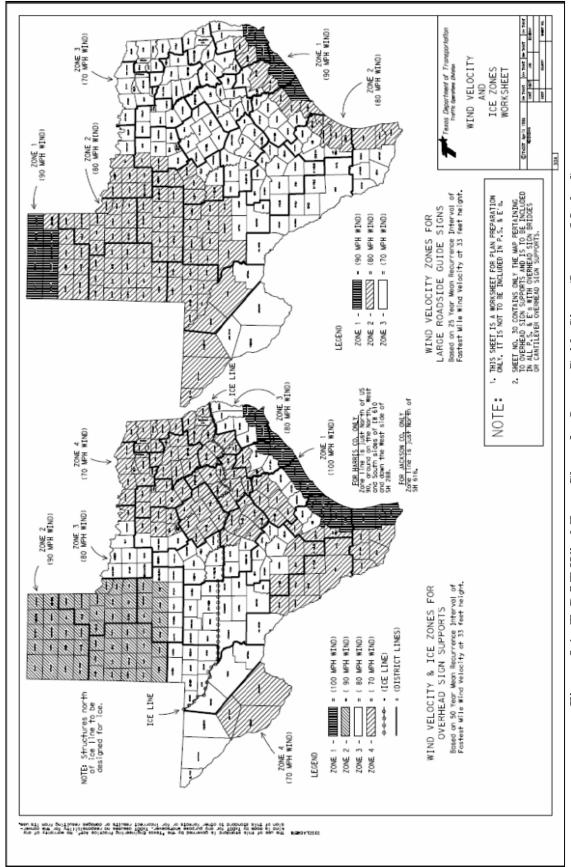
Figure 8.1. TxDOT Wind Zone Chart for Large Guide Signs (Legacy Method).

TxDOT has decided to proceed with generating the wind load charts according to the legacy method of calculating wind pressures. This is to remain consistent with other wind load dependent structures in TxDOT's inventory. If the charts were generated according to the current wind pressure method, this task would require the addition of a second Texas wind load chart, which would only be used for large guide signs. Figure 8.1 shows all other designs would require the use of the legacy wind chart. This would lead to confusion in the design process and may lead to either over- or under-designed structures. The chart breaks Texas into three basic wind zones: Zone 1 (90 mph), Zone 2 (80 mph), and Zone 3 (70 mph).

Again, Figure 8.1 describes the loading in a wind load condition. The process of determining the maximum sign area for each sign support was automated to give results for all support configurations and mounting heights. The results of this process provide for efficient use of each section; however, this process requires the use of 30 selection charts; one chart for each post section, and a chart for each post section for each wind load condition. Currently, TxDOT utilizes three charts to cover all of the sections and all three wind zones.

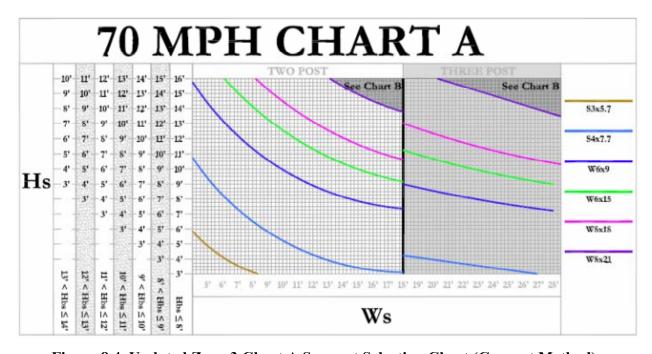
Figure 8.4. Updated Zone 3 Chart A Support Selection Chart (Current Method).

To simplify the chart design, the geometry of the capacities of the sections was modified to a simple arc. This arc was best suited to the raw data from the wind load analysis. The vertical height of the axis was then adjusted to account for different mounting heights. This resulted in a simplified selection chart. The final series of charts included two charts for each wind zone. A total of three wind zones were simulated. This brings the total number of charts to six, which is twice the number of current support selection charts that TxDOT currently utilized. Figures 8.4 through 8.9 show the final updated wind charts for the current fuse plate designs, according to the legacy method of determining wind pressures. Appendices G1 and G2 have representative proof calculations.

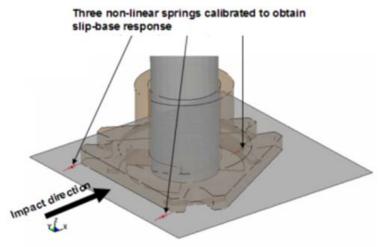
Figure 9.1. Finite Element Model of Slipbase Sign Support System.

Figure 9.1 shows the upper triangular slipbase casting was explicitly modeled to properly account for the inertial properties of the sign support system. The casting was modeled using solid elements and a rigid material representation. Since the bottom triangular slip-plate remains fixed to the foundation without any significant movement, it was not explicitly modeled. The bolts of the triangular slipbase were also not modeled explicitly. Instead, three nonlinear springs were modeled (see Figure 9.1). One end of each spring was attached to the top slipbase casting, and the other end was attached to the rigid bottom plate. The force-deflection properties of the springs were calibrated using crash test results. The complexity of the slipbase model was greatly reduced using the abovementioned modeling techniques without significant loss of accuracy of results. This technique enabled multiple impact simulations to be conducted within the resources of the project.

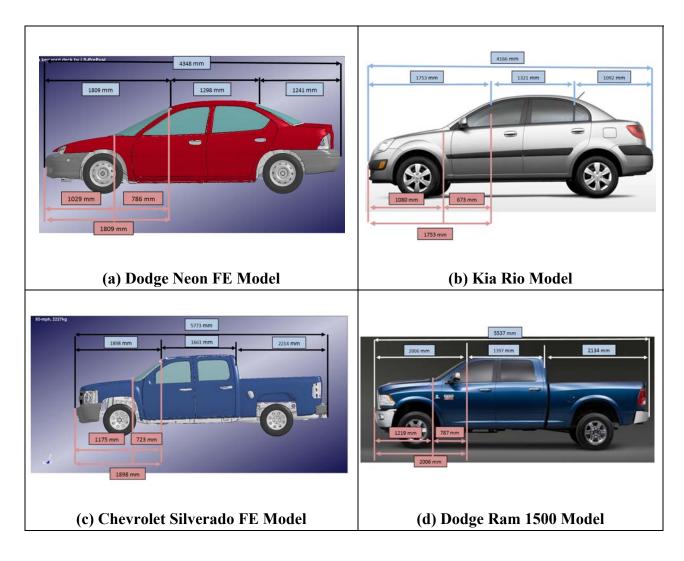
Figure 9.2. Vehicles Finite Element Models Employed in the Computer Simulations.

Figure 9.2 illustrates the finite element models of the small passenger car (Dodge Neon) and the pickup truck (Chevrolet Silverado) used in the computer simulations, and compares these with the actual vehicle models employed in the tests (Kia Rio, and Dodge Ram 1500 pickup, respectively).

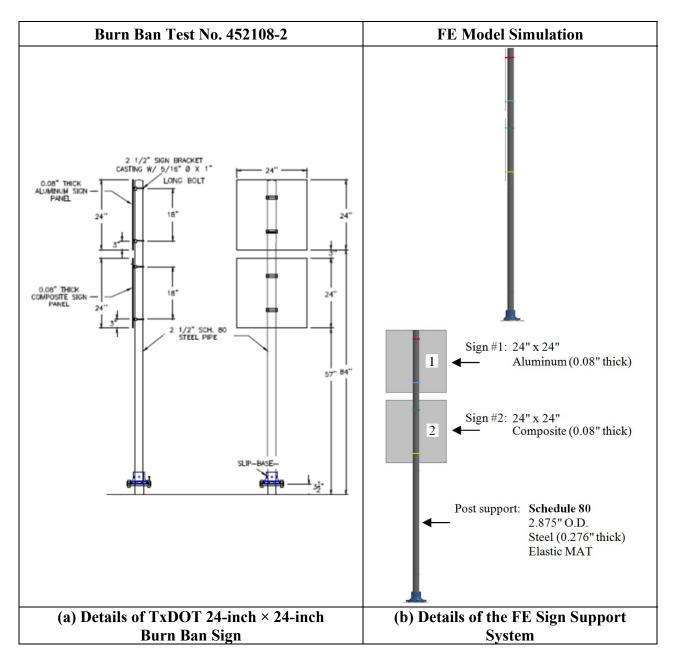
Figure 9.3. Comparison between Burn Ban Test No. 452108-2 and FE Model Sign Support Slipbase System Configurations.

Figure 9.3 shows the finite element model of the sign support for the FE computer simulation aimed at replicating burn ban test no. 452108-2. The support post was a 2.875-inch O.D., 0.276-inch schedule 80 steel pipe, which was modeled using elastic material properties. A 24-inch \times 24-inch \times 0.080-inch thick aluminum sign panel was constrained to the schedule 80 support using nodal rigid body constraints at the location of connecting bolts. The mounting height to the bottom of the confirmation sign was 7 ft. A second 24-inch \times 24-inch \times 0.080-inch thick composite sign was constrained to the schedule 80 support in the same manner as the first sign.

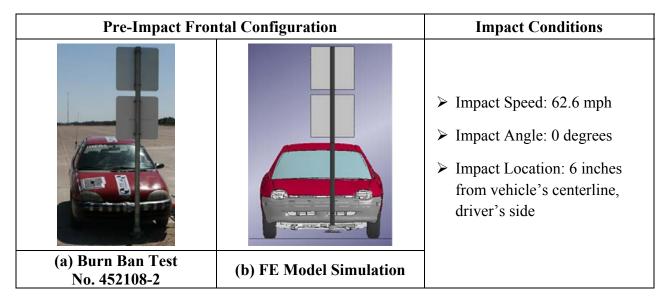
Figure 9.4. Comparison between Burn Ban Test No. 452108-2 and FE Model Impact Conditions.

Figure 9.4 shows the Dodge Neon vehicle model impacted the single sign support slipbase model at 62.6 mph and 0 degrees to match the actual crash test conditions. The impact location was 6 inches from the vehicle's centerline, on the driver's side. The properties of the slipbase were calibrated to match the pipe support kinematics after slipbase release and roof sign impact location.

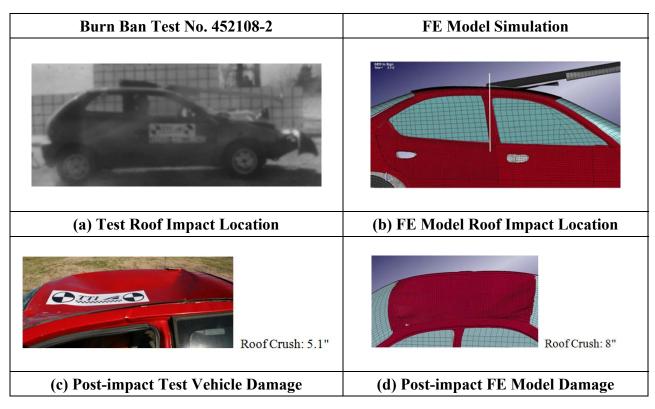
Figure 9.5. Comparison between Burn Ban Test No. 452108-2 and FE Model Impact Results.

Figure 9.5 compares the results of the roof impact location and roof deformation to those of the crash test. A reasonable correlation was achieved between simulation and test results. The FE simulation predicted a roof crush of 8 inches, while the maximum roof deformation recorded in the test was 5.1 inches.

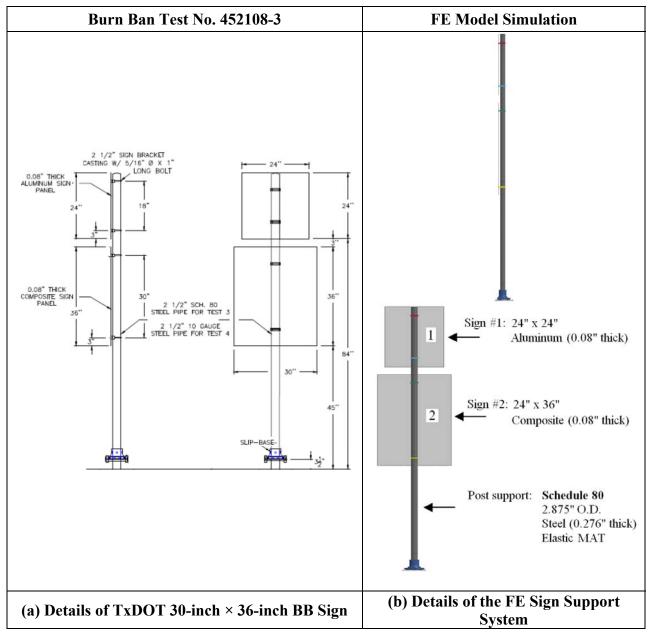
Figure 9.6. Comparison between Burn Ban Test No. 452108-3 and FE Model Sign Support Slipbase System Configurations.

Figure 9.6 shows the finite element model of the sign support for the FE computer simulation aimed at replicating burn ban test no. 452108-3. The support post was a 2.875-inch O.D., 0.276-inch thick schedule 80 steel pipe, which was modeled using elastic material properties. A 24-inch \times 24-inch \times 0.080-inch thick aluminum sign panel was constrained to the schedule 80 support using nodal rigid body constraints at the location of connecting bolts. The mounting height to the bottom of the confirmation sign was 7 ft. A second 30-inch \times 36-inch \times 0.080-inch thick composite sign was constrained to the schedule 80 support in the same manner as the first sign.

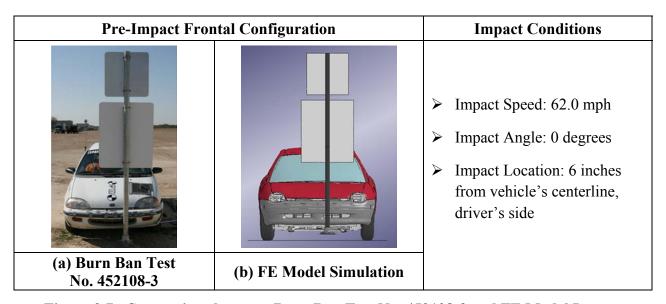
Figure 9.7. Comparison between Burn Ban Test No. 452108-3 and FE Model Impact Conditions.

Figure 9.7 shows the Dodge Neon vehicle impacted the single sign support slipbase model at 62.0 mph and 0 degrees to match the actual crash test conditions. The impact location was 6 inches from the vehicle's centerline, on the driver's side. The properties of the slipbase were calibrated to match the pipe support kinematics after slipbase release and roof sign impact location.

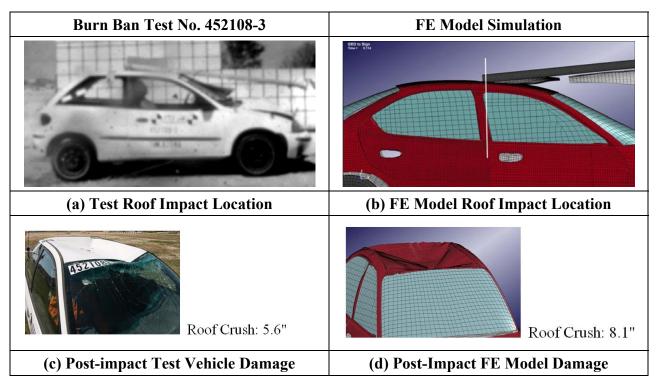
Figure 9.8. Comparison between Burn Ban Test No. 452108-3 and FE Model Impact Results.

Figure 9.8 compares the results of the roof impact location and roof deformation to those of the crash test. A reasonable correlation was achieved between simulation and test results. FE simulation predicted the roof crush predicted to be 8.1 inches, while the maximum roof deformation recorded in the test was 5.6 inches.

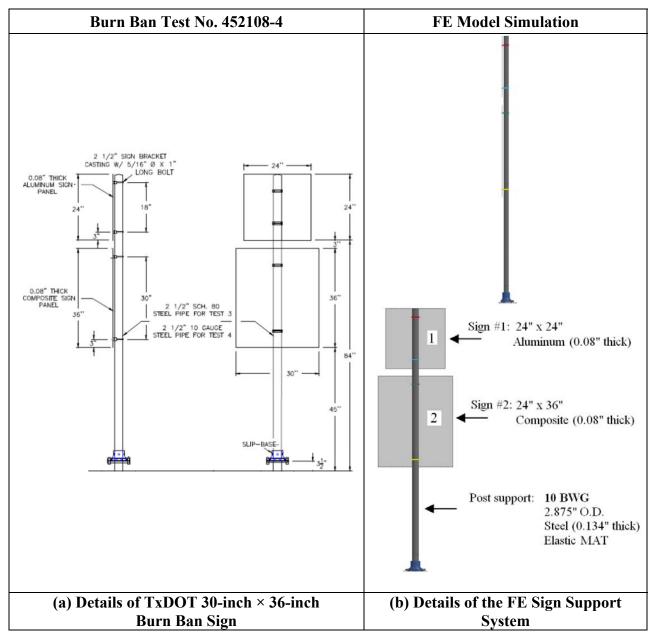
Figure 9.9. Comparison between Burn Ban Test No. 452108-4 and FE Model Sign Support Slipbase System Configurations.

Figure 9.9 shows the finite element model of the sign support for the FE computer simulation aimed at replicating burn ban test no. 452108-4. The support post was a 2.875-inch O.D., 0.134-inch thick BWG 10 steel pipe, which was modeled using elastic material properties. A 24-inch \times 24-inch \times 0.080-inch thick aluminum sign panel was constrained to the schedule 80 support using nodal rigid body constraints at the location of connecting bolts. The mounting height to the bottom of the confirmation sign was 7 ft. A second 30-inch \times 36-inch \times 0.080-inch thick composite sign was constrained to the schedule 80 support in the same manner as the first sign.

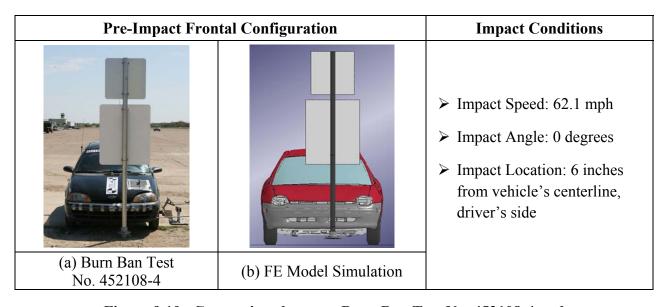
Figure 9.10. Comparison between Burn Ban Test No. 452108-4 and FE Model Impact Conditions.

Figure 9.10 shows the Dodge Neon vehicle model impacted the single sign support slipbase model at 62.1 mph and 0 degrees to match the actual crash test conditions. The impact location was 6 inches from the vehicle's centerline, on the driver's side. The properties of the slipbase were calibrated to match the pipe support kinematics after slipbase release and roof sign impact location.

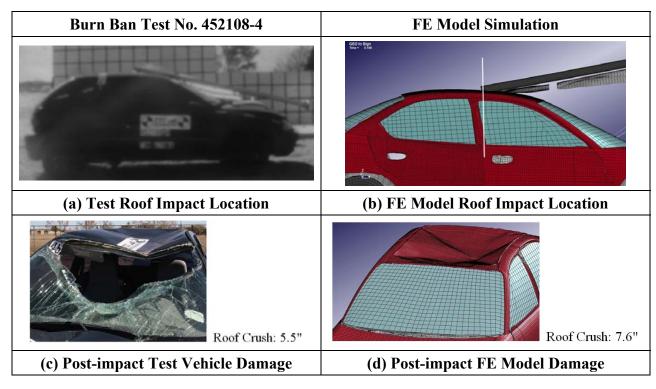
Figure 9.11. Comparison between Burn Ban Test No. 452108-4 and FE Model Results.

Figure 9.11 compares the results of the roof impact location and roof deformation to those of the crash test. A reasonable correlation was achieved between simulation and test results. FE simulation predicted the roof crush to be 7.6 inches, while the maximum roof deformation recorded in the test was 5.5 inches (windshield damage of the Geo Metro was not due to the impact event in the test, but occurred while the vehicle was transported from the test site).

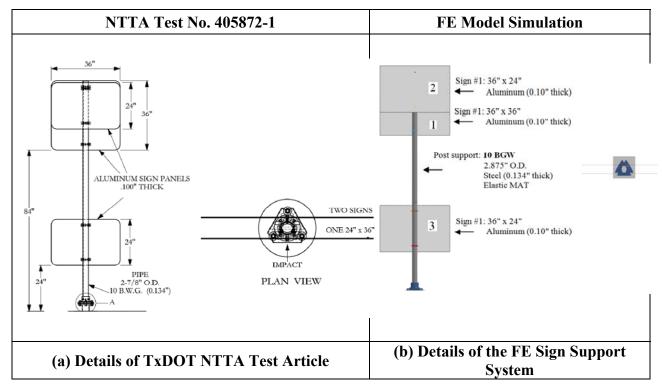
Figure 9.12. Comparison between NTTA Test No. 405870-1 and FE Model Sign Support Slipbase System Configurations.

Figure 9.12 shows the finite element model of the sign support for the FE computer simulation aimed at replicating NTTA test no. 405872-1. The support post was a 2.875-inch O.D., 0.134-inch 10 BWG steel pipe, which was modeled using elastic material properties. All sign panels were 0.10-inch aluminum sheet. A 36-inch \times 36-inch \times 0.1-inch thick aluminum sign panel was mounted at 7 ft to the bottom of the panel from ground level. A second panel measuring 36 inches wide \times 24 inches high and was mounted at 8 ft to the bottom of the panel on the opposite side of the support. The third panel was 36 inches wide \times 24 inches high and was mounted at 24 inches on the back side of the support. Signs were constrained to the pipe support using nodal rigid body constraints at the location of connecting bolts.

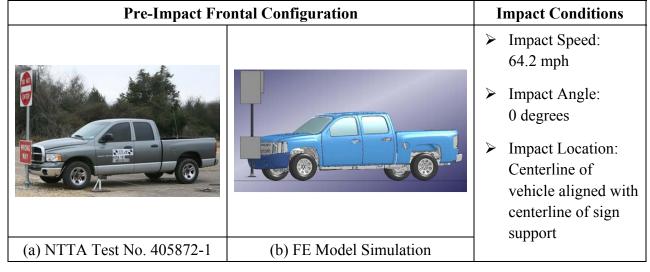
Figure 9.13. Comparison between NTTA Test No. 405870-1 and FE Model Impact Conditions.

Figure 9.13 shows the Chevrolet Silverado vehicle model impacted the single sign support slipbase model at 64.2 mph and 0 degrees to match the actual crash test conditions. The centerline of the vehicle was aligned with the centerline of the sign support.

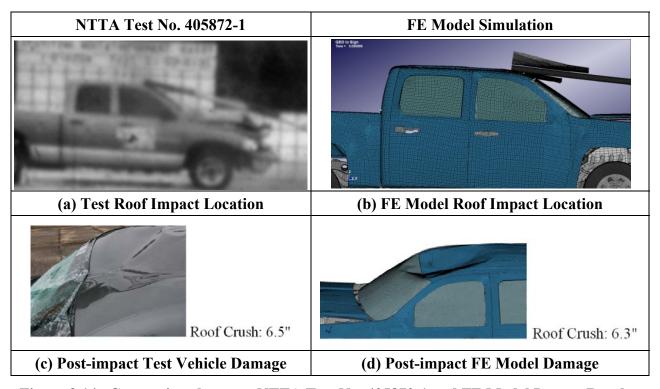
Figure 9.14. Comparison between NTTA Test No. 405870-1 and FE Model Impact Results.

Figure 9.14 compares the results of the roof impact location and roof deformation to those of the crash test. A reasonable correlation was achieved between simulation and test results. The FE simulation predicted the roof crush predicted at 6.3 inches, while the maximum roof deformation recorded in the test was 6.5 inches.

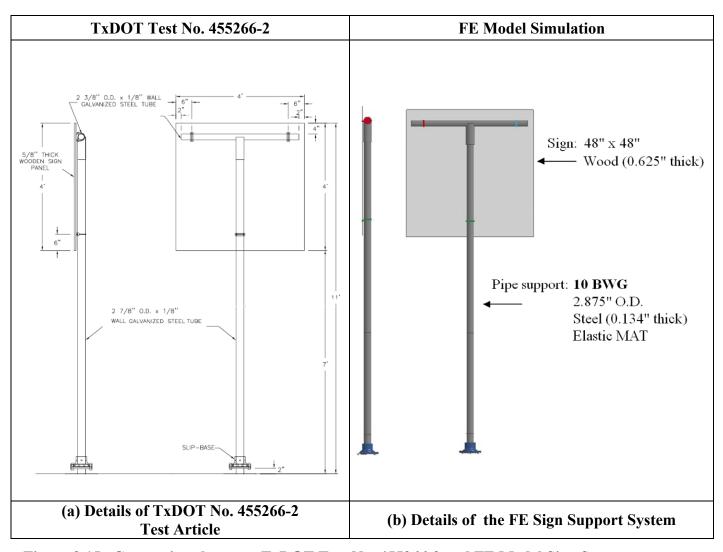
Figure 9.15. Comparison between TxDOT Test No. 455266-2 and FE Model Sign Support Slipbase System Configurations.

Figure 9.15 shows the finite element model of the sign support for the FE computer simulation aimed at replicating TxDOT test no. 455266-2. The support post was a 2.875-inch O.D., 0.134-inch 10 BWG steel pipe, which was modeled using elastic material properties. A T-shaped bracket was attached to the vertical support to provide bracing for the sign panel. The T-bracket consisted of a 3.25-inch O.D. stub welded to a 2.375-inch O.D. horizontal steel tube. A 48-inch \times 48-inch \times 0.625-inch thick wooden sign panel was attached to the 2.375-inch O.D. horizontal member and 2.875-inch O.D. vertical support using constrained nodal rigid body. The mounting height to the bottom of the sign blank was 7 ft.

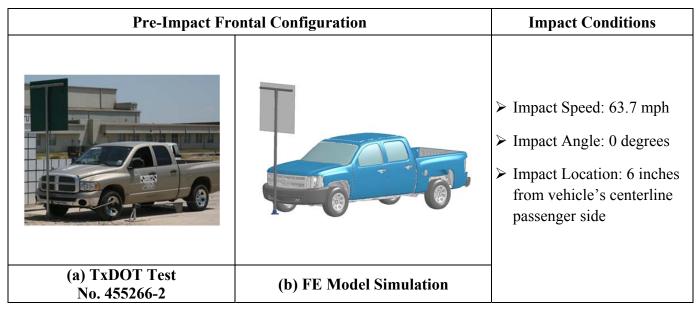
Figure 9.16. Comparison between TxDOT Test No. 455266-2 and FE Model Impact Conditions.

Figure 9.16 shows the Chevrolet Silverado vehicle model impacted the single sign support slipbase model at 63.7 mph and 0 degrees to match the actual crash test conditions. The impact location was 6 inches from the vehicle's centerline, on the passenger side.

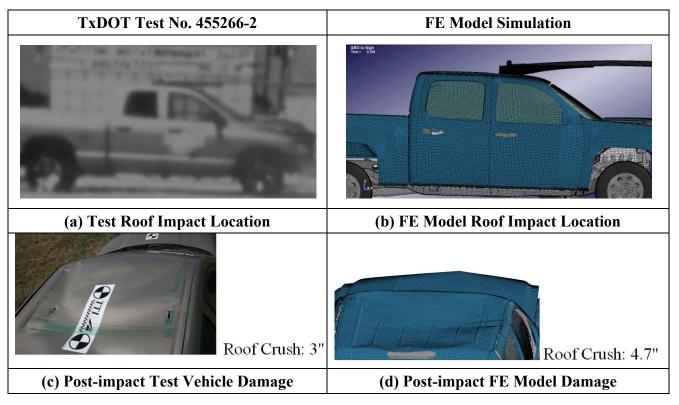
Figure 9.17. Comparison between TxDOT Test No. 455266-2 and FE Model Impact Results.

Figure 9.17 compares the results of the roof impact location and roof deformation to those of the crash test. A reasonable correlation was achieved between simulation and test results. The FE simulation predicted the roof crush at 4.7 inches, while the maximum roof deformation recorded in the test was 3 inches.

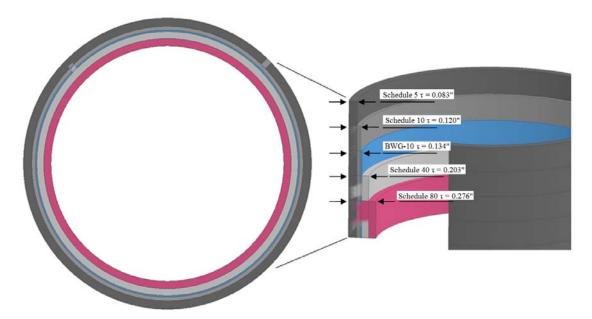
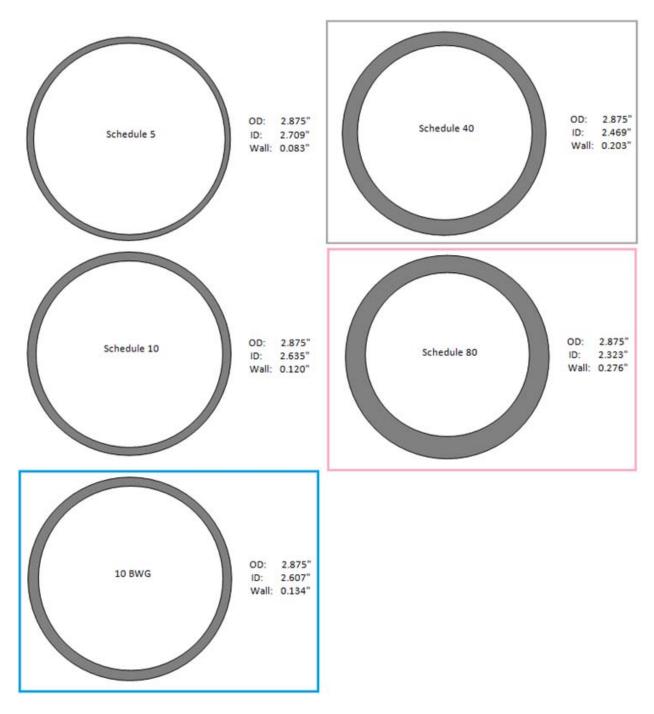
Figure 9.18. Thickness Comparison of Size 2.5-Inch Pipe Supports for Use on Slipbase Systems.

Pipe supports were modeled with elastic material properties. Three different types of 2.875-inch outside diameter steel pipe support generally employed for use on slipbase systems were considered for simulations (see Figure 9.18). Having all the same outside diameter, these pipe supports differ only in the inside diameter:

- BWG 10 with a wall thickness of 0.134 inches.
- Schedule 40 with a wall thickness of 0.203 inches.
- Schedule 80 with a wall thickness of 0.276 inches.

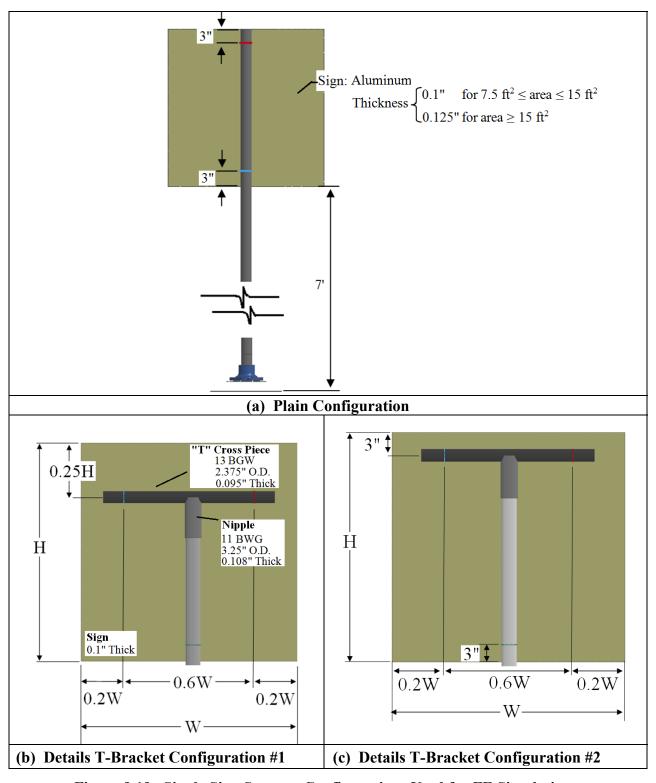
Figure 9.19. Single Sign Support Configurations Used for FE Simulations.

For plain poles, the sign was constrained to the pipe support at two locations: 3 inches from top and 3 inches from bottom of sign edge (see Figure 9.19[a]). Figure 9.19(b) and (c) show two different T-bracket post configurations that were considered. For configuration #1, the sign was constrained at 3 inches above the bottom of sign edge to the pipe support, and at 0.2 (W) inches (where W = sign width) from both lateral sides to the horizontal T-cross support. This configuration was considered to comply with TxDOT sign mounting standards reported in SMD (SLIP-2)-08 for rectangular signs with a maximum width of 8 ft (5). With this configuration, the T-cross piece resulted to be at a distance of 0.25 times the height of the sign from the top of sign edge. Figure 9.19(b) shows that the sign sizes evaluated with this project had heights ranging from 3.5–4 ft and resulted in a considerable distance from the T-cross piece member and the top edge of the sign. Consequently, a second configuration for T-bracket support was defined, where the sign was constrained to the horizontal T-cross support at 3 inches below the top of the sign edge regardless of the actual height of the sign (see Figure 9.19[c]). This new T-bracket configuration with the T-cross piece closer to the top edge of the sign also helped raise the height of the C.G. of the all sign support systems. Since the C.G. also corresponds to the center of rotation of the sign support system, it is expected that this configuration will help avoid impact with the vehicle roof and/or limit the occupant compartment deformation due to a less violent impact.

With pickup truck simulations, the BWG 10 plain and the schedule 80 plain supports caused 7 and 10 inches of roof crush, respectively. When the BWG 10 pipe was connected to a T-bracket sign support, outcomes suggested a resulting lower compartment deformation. When using the first T-bracket model configuration (Figure 9.19[b]), the roof deformation was calculated at 5.8 inches. However, when the second T bracket configuration (Figure 9.19[c]) was used, the roof crush was 5.1 inches. Pickup truck impacts were also simulated against schedule 80 and schedule 40 pipe types with a T-bracket configuration #2 and resulted in roof impact and occupant compartment deformation of 7 inches and 5.9 inches, respectively.

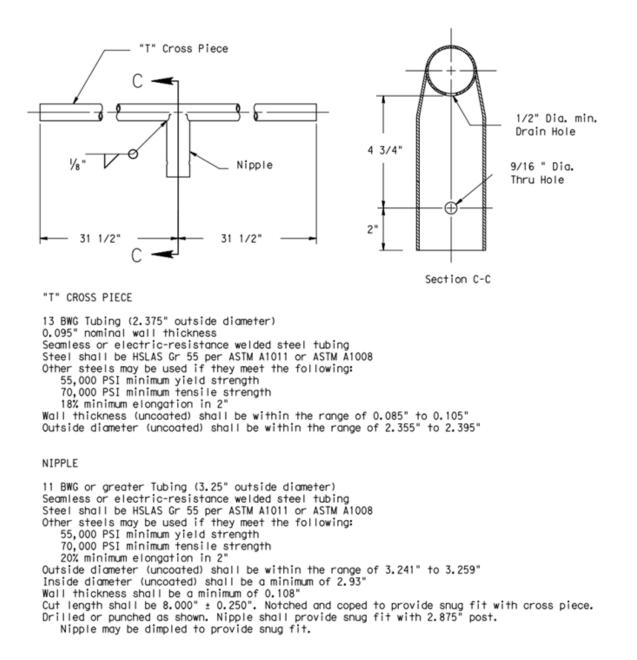
Figure 9.20. Prefabricated "T" Bracket-Texas Universal Triangular Slipbase System (9).

Geometry and material modeling of the T-bracket components was performed to comply with TxDOT standard specifications for the prefabricated T-bracket–Texas universal triangular slipbase system, reported in Figure 9.20 (10). The T-cross piece was modeled as 13 BWG tubing, with a 2.375-inch O.D. and a wall thickness of 0.095 inches. The nipple was modeled as 11 BWG tubing, with a 3.25-inch O.D. and a wall thickness of 0.108 inches. Both T-cross and nipple pieces were modeled with elastic material properties.

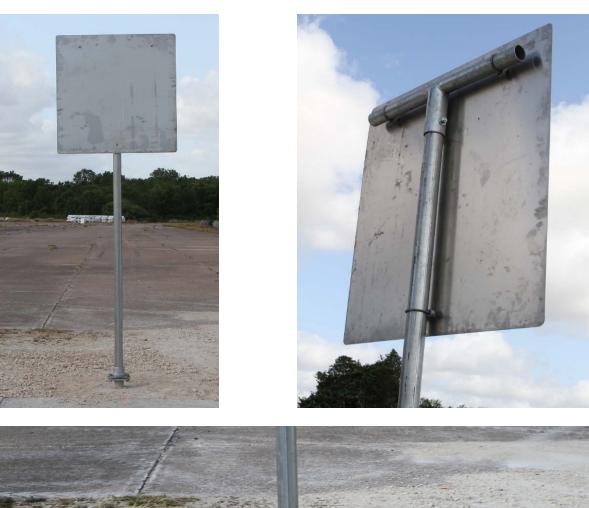
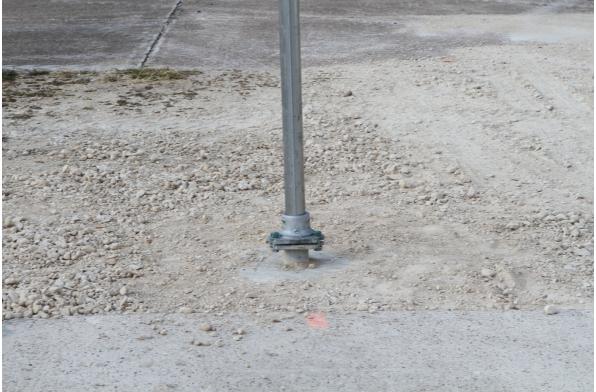
Figure 9.30. Sign Support System prior to Test Nos. 463631-1 and 2.

Figures 9.27 through 9.29 show a schematic of the triangular slipbase sign support installation, with further details in Appendix H, Figure H1. Figure 9.30 presents photographs of the completed test installation.

The same triangular slipbase sign support system used for Test nos. 463631-1 and 463631-2 was installed in the impact position and was offset 6 inches to the right of the vehicle centerline. The test installation was installed in a concrete footing installed in standard soil meeting AASHTO standard specifications for "Materials for Aggregate and Soil Aggregate Subbase, Base and Surface Courses," designated M147-65(2004), grading B. Figure 9.52 presents photographs of the completed test.

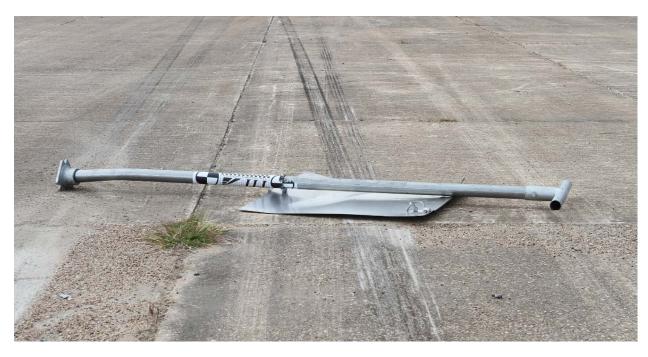
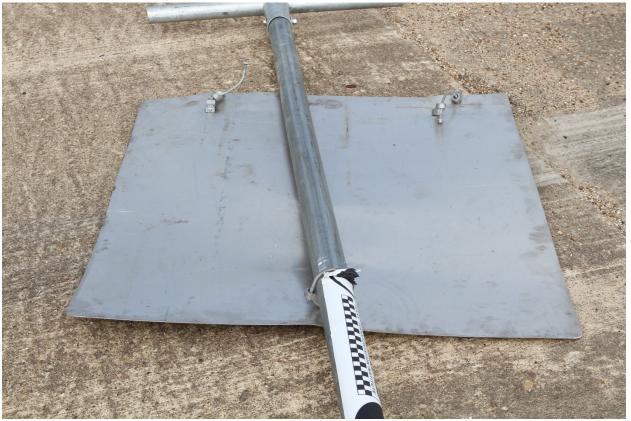
Figure 9.33. Installation after Test No. 463631-1.

Figure 9.33 shows the sign support activated as designed by slipping away at the base connection. The support was slightly deformed at bumper height of the vehicle. The sign panel clamp connections with the horizontal member failed after impact and interaction with the vehicle's roof. The support with sign panel was resting 180 ft downstream of the impact point.

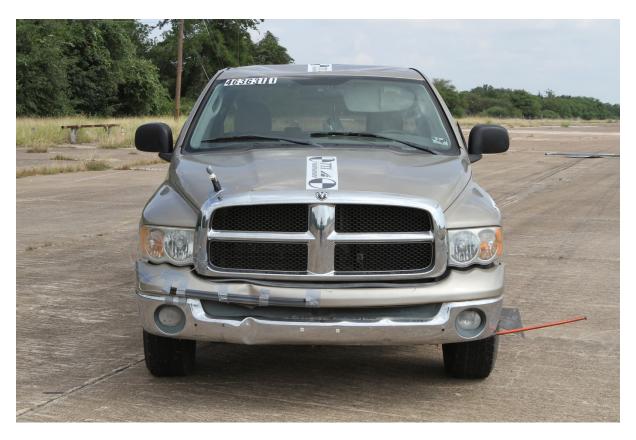
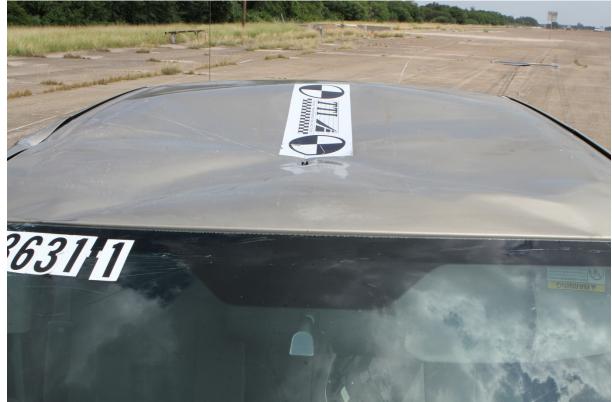
Figure 9.34. Vehicle after Test No. 463631-1.

Figure 9.34 shows the 2270P vehicle sustained damage to the center front. The right front bumper quarter point and the roof were deformed. A small dent at the right hood quarter point was recorded. The windshield was cracked at the top near the roof line and on the right side. The maximum exterior crush to the front plane of the vehicle was 1.0 inch at bumper height. The roof was deformed into the occupant compartment 3.625 inches, and a puncture hole slightly right of center over the front passenger compartment resulted from impact and interaction with the bolt of the sign clamp on the left side of the sign panel. Figure 9.35 has photographs of the interior of the vehicle. Tables H3 and H4 in Appendix H show the exterior vehicle crush and occupant compartment measurements.

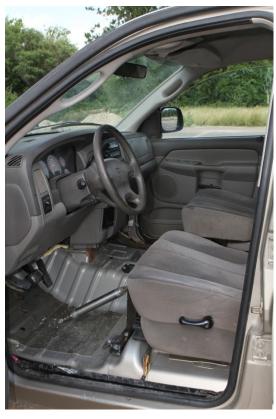
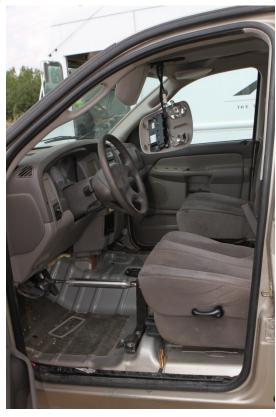
Figure 9.35. Interior of Vehicle for Test No. 463631-1.

Before Test

After Test

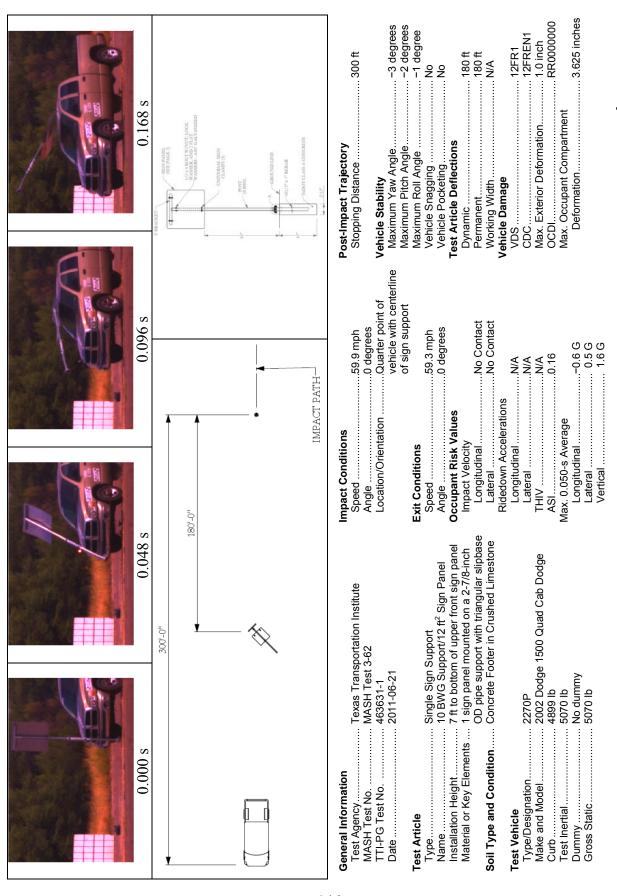
Figure 9.36. Summary of Results for MASH Test 3-62 on the 10 BWG Steel Pipe Slipbase Support with 12 ft² Sign Panel (Test No. 463631-1).

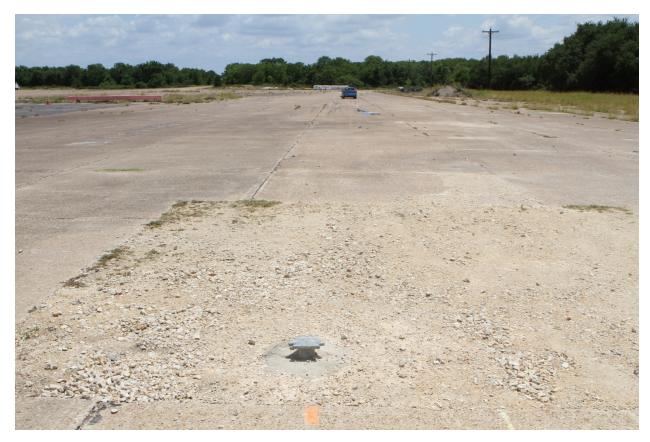
Figure 9.39. Position of Sign Support/Vehicle after Impact for Test No. 463631-2.

As shown in Figures 9.39 and 9.40, the sign support activated as designed by slipping away at the base connection. The support was slightly deformed at the insertion site with the slipbase support. The sign panel detached from the pipe support. The support and the sign panel were resting 120 ft and 111 ft downstream, 36 ft right of the impact point, respectively.

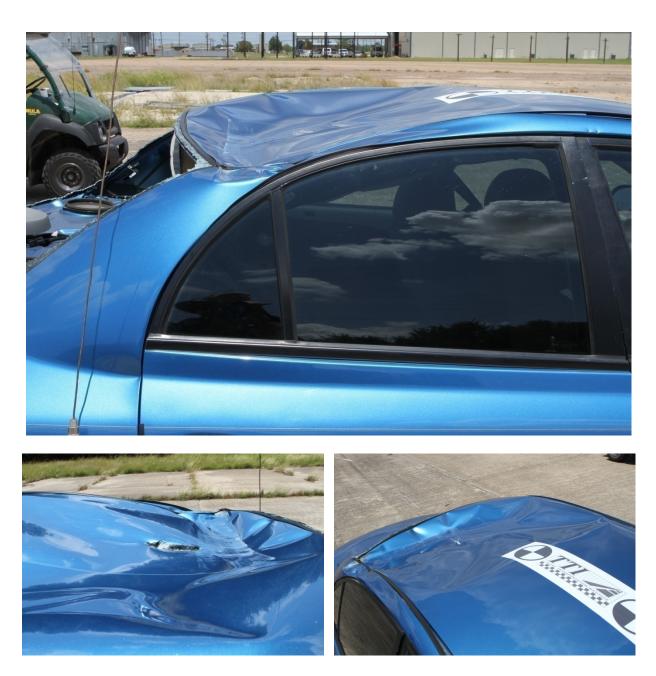
Figure 9.42. Vehicle Roof Deformation after Test No. 463631-2.

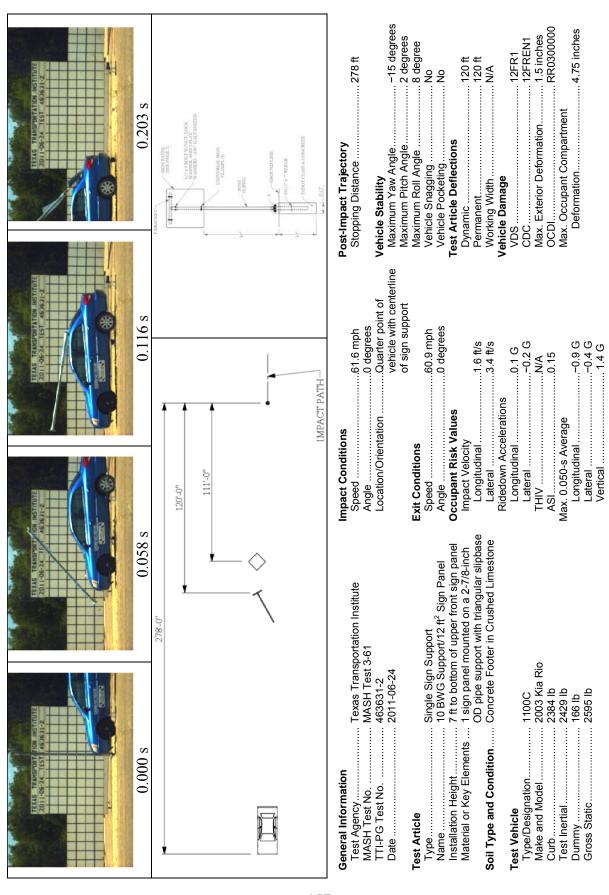
Figure 9.44. Summary of Results for MASH Test 3-61 on the 10 BWG Steel Pipe Slipbase Support with 12 ft² Sign Panel (Test No. 463631-2).

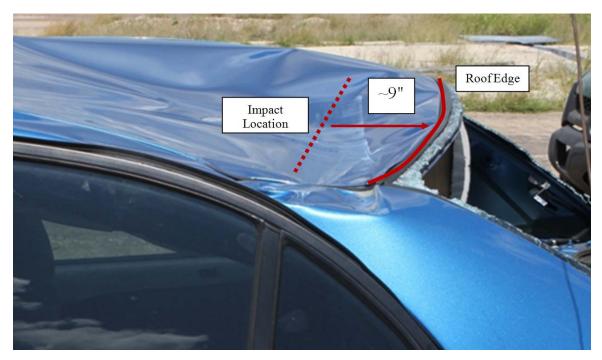
Figure 9.45. Distance of Sign Impact Location to the Roof Edge for Test No. 463631-2.

In Test no. 463631-2, the sign impacted the roof of the passenger car at around 9 inches from the edge of the vehicle's roof (see Figure 9.45). The FE simulation with the same geometry and impact conditions predicted the sign impact at the roof edge. Consequently, there was a 9 inch gap between the predicted (FE) and the resulting (test) roof impact location.

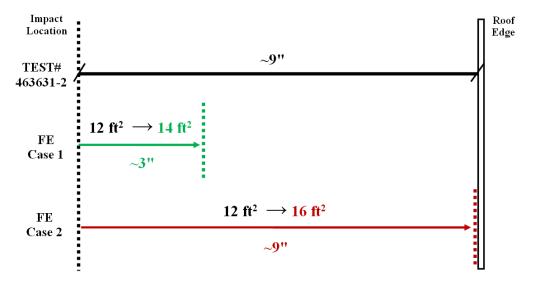
Figure 9.46. Comparison of FE Predicted Sign Impact Locations with Different Sign Areas.

According to the previously performed FE simulations for a 62-mph impact, a sign support with a 14 ft² sign area would impact the passenger car around 3 inches behind the impact location predicted with a 12 ft² sign area. On the other hand, a sign support with a 16 ft² sign area would impact the passenger car around 9 inches behind the impact location predicted with a 12 ft² sign area. Consequently, the use of a single sign support with 16 ft² sign area would fill the gap of 9 inches discussed earlier in terms of roof impact location (see Figure 9.46).

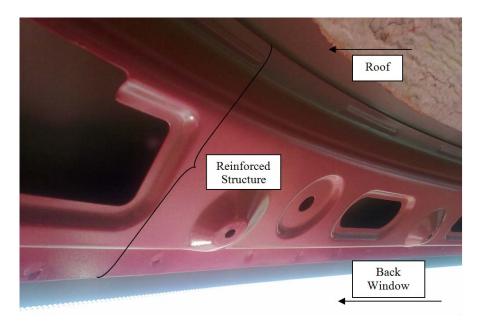
Figure 9.47. Reinforced Structure at the Small Passenger Vehicle's Roof Edge.

A closer investigation of the vehicle body, however, revealed the presence of a reinforced structure along the edge of the roof, which extends for 5 inches into the occupant compartment (see Figure 9.47).

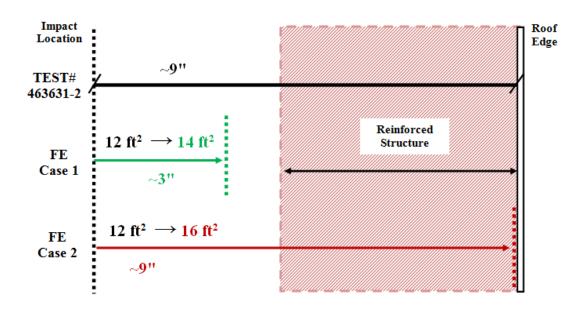
Figure 9.48. Reinforced Structure at the Small Passenger Vehicle's Roof Edge.

It is believed that impacting the reinforced structure would help in containing the roof deformation caused during contact between the sign support system and the vehicle. Thus, the new goal is not necessarily to impact the edge of the roof, but a contact anywhere in the 5-inch region before the end of the roof would be considered desirable according to the consideration made above. The new gap to be filled would be now 4 inches (9 inches initial gap—5 inches of reinforced structure) (see Figure 9.48).

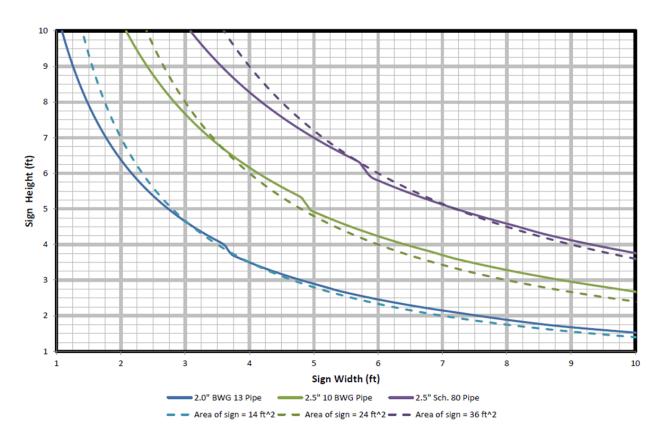
Figure 9.49. 90-mph Wind Load Chart for Single Sign Post with 7-ft Mounting Height.

Moreover, the new 90-mph wind load showed that the capacity of a 2.0-inch nominal diameter 13 BWG pipe with a wedge and socket system covers all sign areas up to 14 ft², for a single sign post with a 7-ft mounting height (see Figure 9.49). Signs with an area up to 24 ft² can be mounted on a 2.5-inch nominal diameter 10 BWG pipe with a slipbase support.

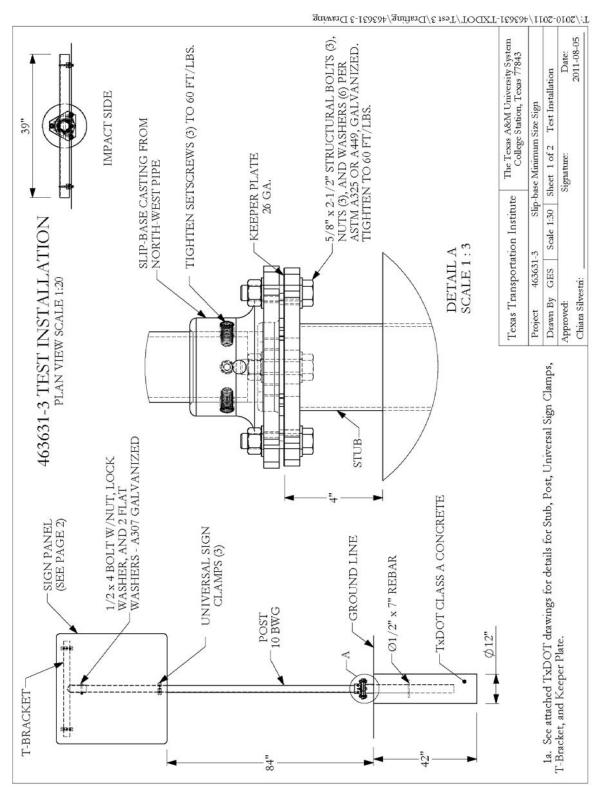
Figure 9.50. Details of the Sign Support System Used for Test No. 463631-3.

A 45-inch \times 45-inch \times 0.1-inch thick aluminum sign blank was attached to the 2.375-inch O.D. horizontal member and 2.875-inch O.D. vertical support using a total of three mounting clamps. The mounting clamp used to attach the sign panel to the vertical support was located 3 inches from the lower edge of the sign panel. The two clamps employed to connect the sign panel to the horizontal member were located 4.25 inches from the upper edge of the sign panel and 6 inches from the side edge of the sign panel. The mounting height to the bottom of the sign blank was 7 ft. Figures 9.50 and 9.51 give the details of the sign support systems; Figure J1 in Appendix J provides further details.

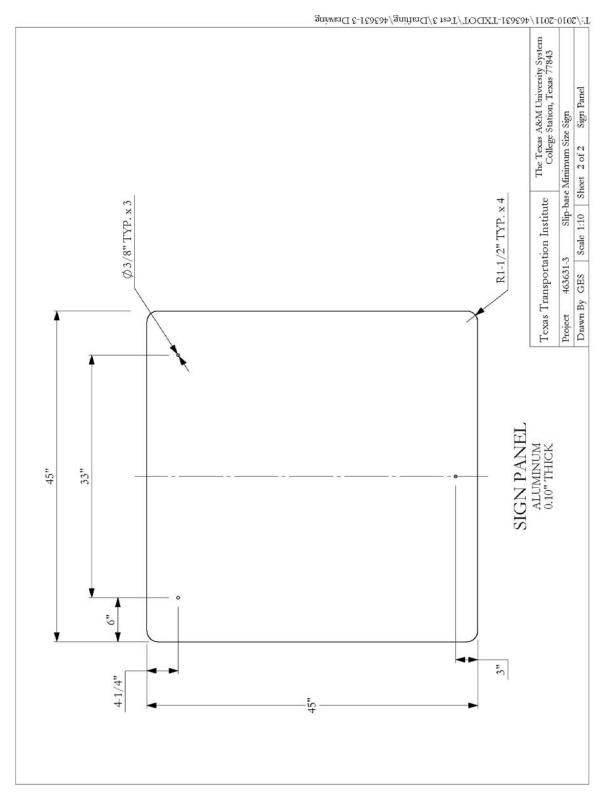
Figure 9.51. Details of the Sign Panel Used for Test No. 463631-3.

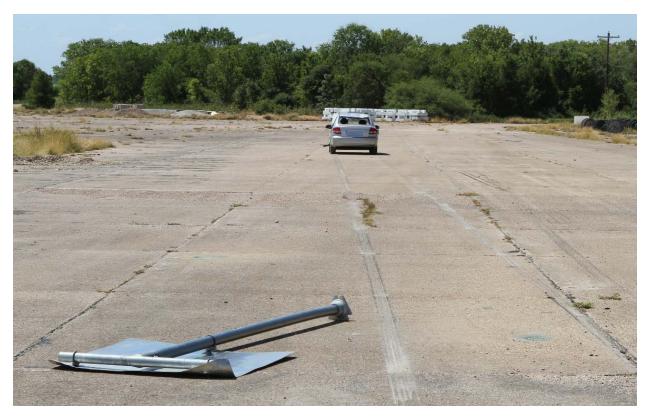
Figure 9.55. Position of Sign Support/Vehicle after Impact for Test No. 463631-3.

As shown in Figures 9.55 and 9.56, the sign support activated as designed by slipping away at the base connection. The support was very slightly deformed at bumper height. The sign panel remained attached to the pipe support. The support and the sign panel were resting 90 ft downstream and 9 ft left of the impact point.

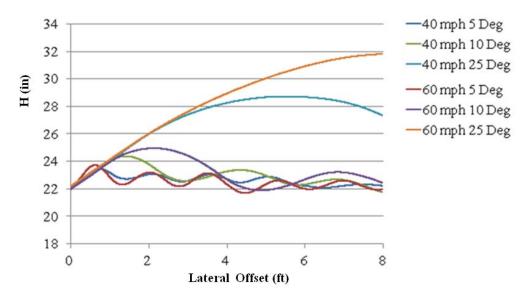
Figure 10.5. Relative Bumper Impact Height for Chevron Installation in a 6H:1V Ditch.

Figure 10.5 shows the relative bumper impact height for the pole support, calculated for different vehicle speed, angles and for a range of lateral offset distances of chevron installation. Analyses show that when the vehicle enters the ditch with an angle smaller than 25 degrees, it is most likely the tires will stay in contact with the ground throughout the whole ditch, no matter what the vehicle's entering speed. The bumper's distance from ground, also referred to as the relative bumper impact height, oscillates around a constant value (22 inches) due to the vehicle's suspension dynamic. On the other hand, if the vehicle enters the ditch at a 25-degree angle, it becomes airborne. The distance of the bumper from ground level can increase from the initial

22 inch value (bumper impact location on pole when on flat level ground) up to 32 inches when the vehicle has a speed of 60 mph.

Trajectory analyses were evaluated for a passenger car entering a 6H:1V slope ditch at different speeds (40 and 60 mph) and angles (5, 10, and 25 degrees). A 6H:1V slope ditch was chosen since it appears to be a reasonable upper limit of maximum common ditch slope in Texas. Also, lateral offset between 2 ft and 8 ft from the pavement surface was considered, since TxDOT standards allow chevron signs installation between 2-ft and 8-ft lateral distance from the road. Trajectory analyses were evaluated using a computer program called CarSim® (18). Figures 10.5 and 10.6 report the results from the trajectory analysis.

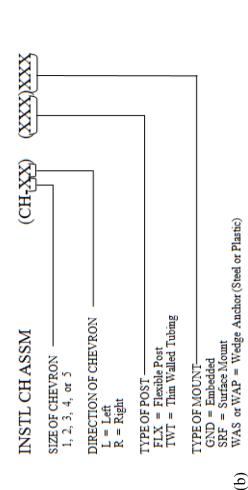
Figure 10.9. "Chevrons" Section in the Proposed New Layout TxDOT D&OM(1)-11, Option #1.

CHEVE	ONS - Intended to give	CHEVRONS - Intended to give notice of sharp change of alignment with direction of travel	ent with direction o	f travel
Sign					
	CH-1L/R	CH-2L/R	CH-3L/R	CH-4L/R	CH-5L/R
	Minimum	Low Speed Road (<55mph)	High Speed Road (≥55mph)	Expressway	Freeway
Size (WxL)	12"x18"	18"x24"	24"x30"	30"x36"	36"x48"
Post Type	TWT, FLX	TWT, FLX	TWT, FLX	TWT, FLX	TWI, FLX
Mount Type	WAS, WAP	WAS, WAP	WAS, WAP	WAS, WAP	WAS, WAP
NOTE	Conform to AS Conform reflect	 Conform to ASTM B-209 Alloy 6061-T6 Conform reflective sheeting as per DMS 8300

The main idea behind the new layout options was to include a section only for chevron type signs with all appropriate information regarding sizes, directions, post, and mount types for chevrons. Also, the same acronyms reported in the descriptive codes were recalled throughout the standard sheet when describing post and mount types for delineators, objects markers, and chevrons. Moreover, it was decided to organize delineator, object markers, and chevron material and placement details in two separate sheets. According to the researchers, this approach results in a more neat and effective presentation of all information. Figures 10.8 through 10.15 report on sections of this proposed layout.

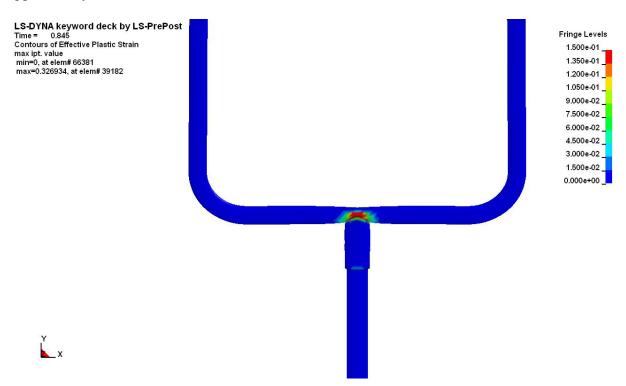
Figure 11.5. Simulation of Current TxDOT Design.

The first simulation was generated to represent the current U-bracket and support configurations. The U-pipe was simulated as a 2.375-inch 10 BWG pipe (55 ksi yield) section that had a 39-inch center to center vertical support spacing. The height of the U-bracket vertical supports was simulated to be 11 ft-9 inches The U-bracket nipple was simulated as a 3.25-inch 11 BWG pipe (55 ksi yield) support that was necked down to accept the U-pipe at one end. The geometry was a best-fit interpretation of the actual geometry since exact dimension drawings were not available. Finally, a 2.875-inch schedule 80 pipe support was simulated to support the U-bracket. A constant rate displacement was applied perpendicular to the U-bracket at 154.5 inches above the rigid fixed end support. The displacement was increased until a large yield region developed in the U-pipe near at the nipple attachment location (see Figure 11.5). This simulation predicts that the U-pipe will yield at the weld location before the schedule 80 support will yield.

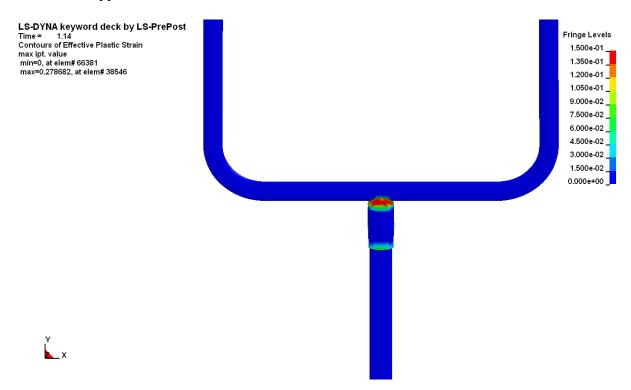
Figure 11.6. Simulation of Schedule 80 U-Pipe.

In an attempt to increase the capacity of the system, the thickness of the U-pipe section was increased to schedule 80 from BWG10. The change did prevent the yielding zone in the U-pipe, however, the nipple then became the limiting factor, evident in the large yield region shown in Figure 11.6. This simulation predicts that the nipple will yield before yielding the schedule 80 support.

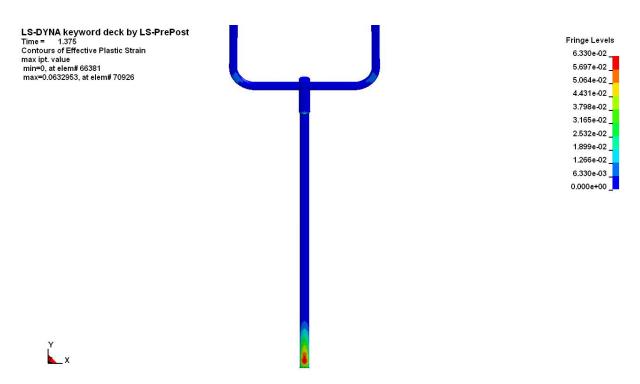
Figure 11.7. Simulation of Modified Nipple Design.

In an attempt to strengthen the connection between the nipple and the U-pipe, a new design was proposed where the nipple no longer necked down to attach to the U-pipe. Instead, the nipple was extended and a hole was drilled through it. The nipple was then threaded through the hole, and the entire assembly was welded up, giving a much larger connection area between the U-pipe and the modified nipple. This larger area helped to strengthen the connection and resulted in the schedule 80 support post yielding at the rigid fixed end condition (see Figure 11.7). Figure 11.8 shows a full detailed drawing comparing the new proposed U-bracket design to the current TxDOT design. This simulation predicted that the modified design would have a higher capacity than that of the schedule 80 pipe support.
