DEVELOPMENT GUIDANCE FOR SIGN DESIGN STANDARDS

Test Report 0-6363-1

TEXAS TRANSPORTATION INSTITUTE
THE TEXAS A&M UNIVERSITY SYSTEM
COLLEGE STATION, TEXAS

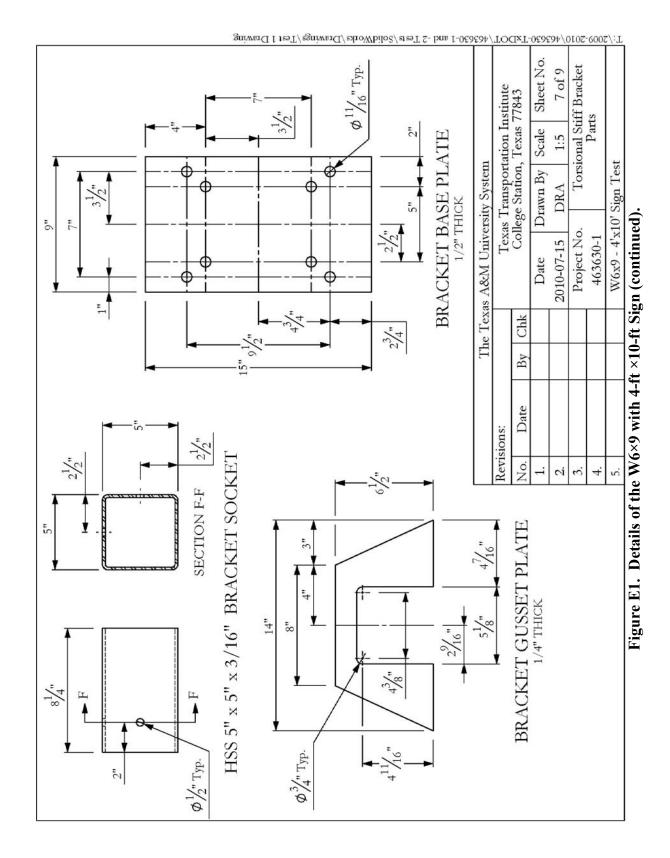
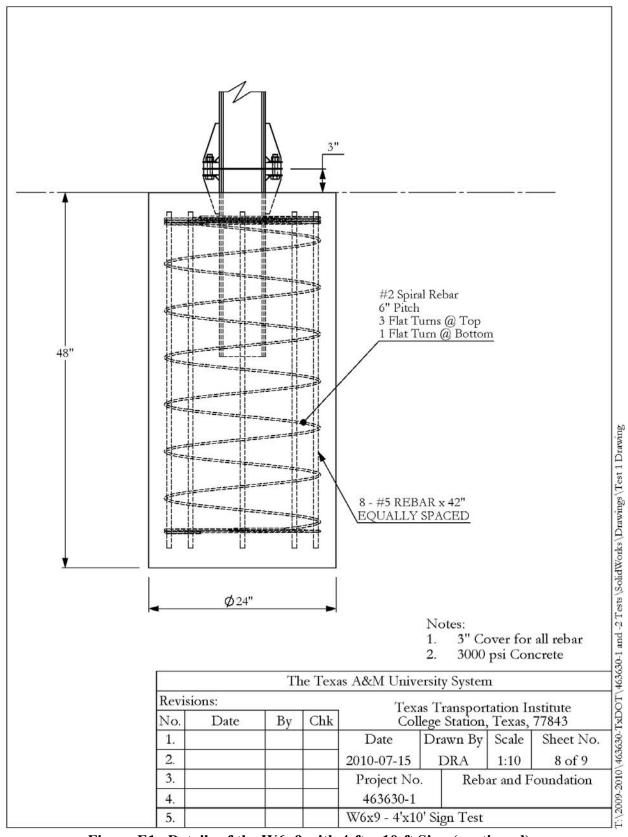
Figure E1. Details of the W6×9 with 4-ft \times 10-ft Sign (continued).

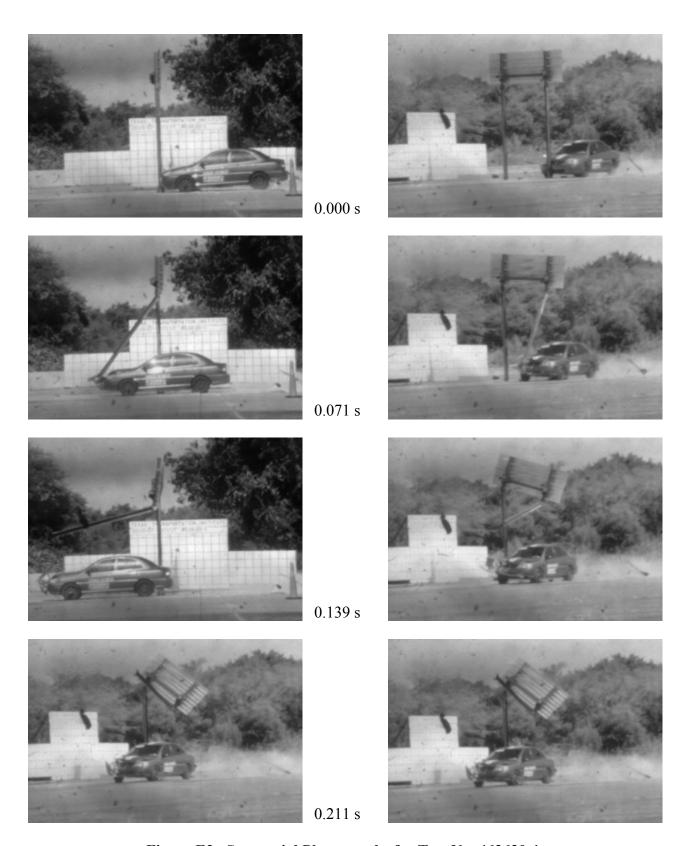
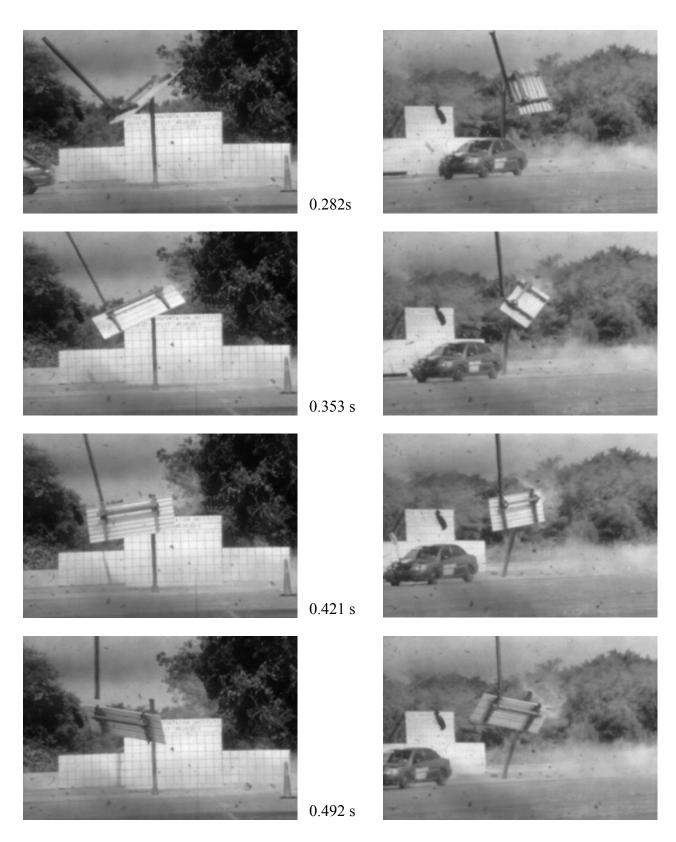
Figure E2. Sequential Photographs for Test No. 463630-1 (Perpendicular and Frontal Oblique Views).

Figure E2. Sequential Photographs for Test No. 463630-1 (Perpendicular and Oblique Frontal Views) (continued).

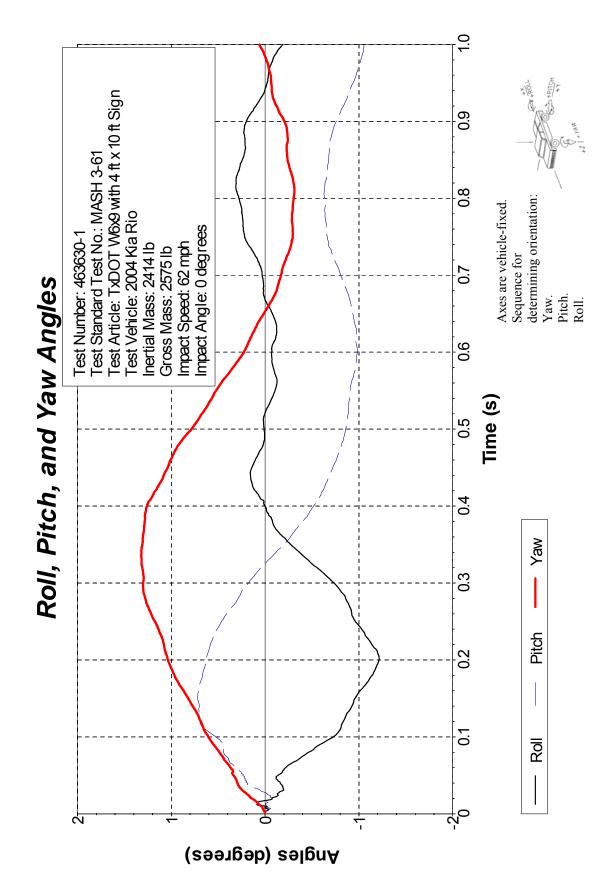
Figure E3. Vehicle Angular Displacements for Test No. 463630-1.

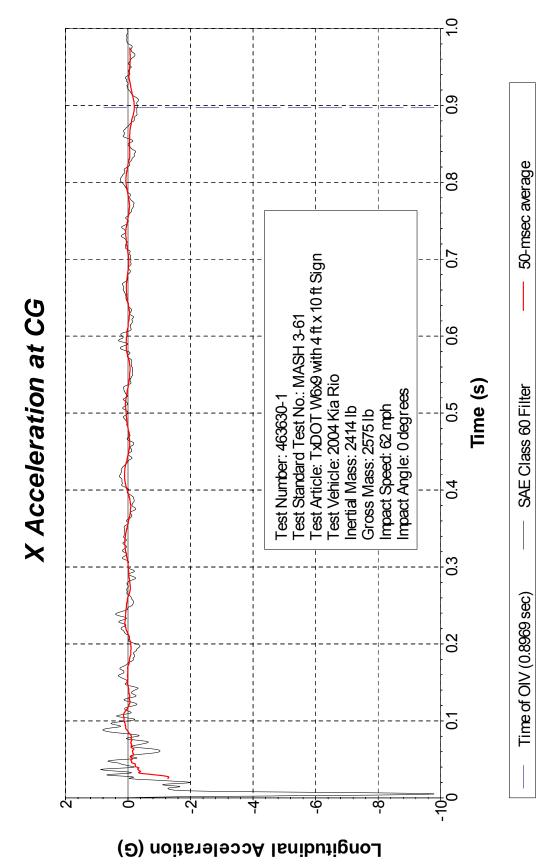
Figure E4. Vehicle Longitudinal Accelerometer Trace for Test No. 463630-1 (Accelerometer Located at Center of Gravity).

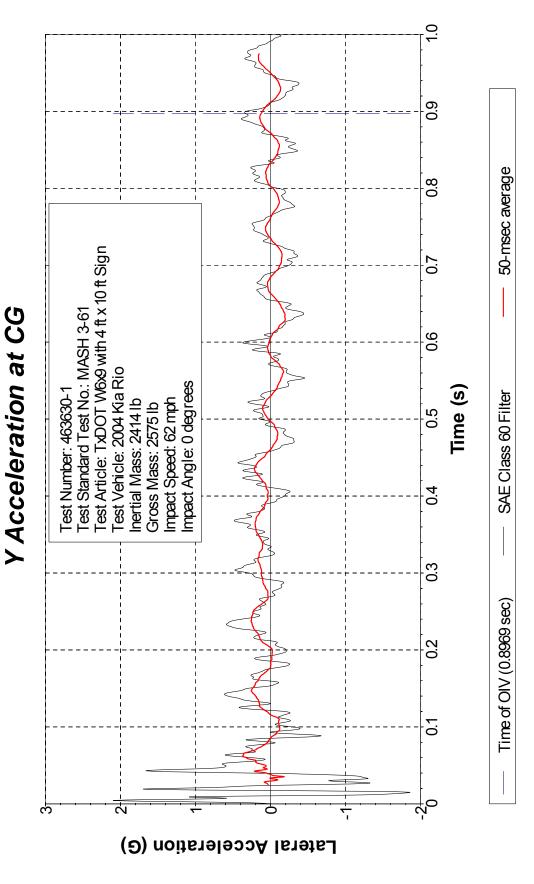
Figure E5. Vehicle Lateral Accelerometer Trace for Test No. 463630-1 (Accelerometer Located at Center of Gravity).

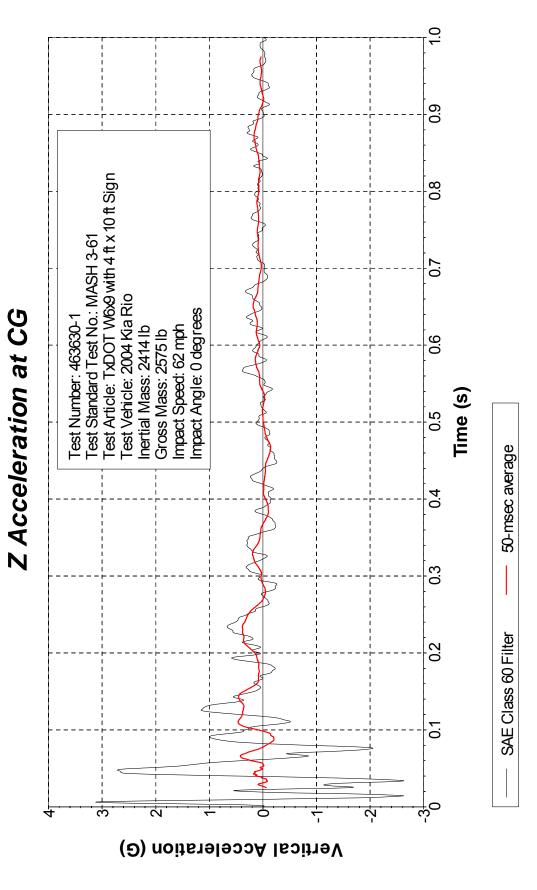
Figure E6. Vehicle Vertical Accelerometer Trace for Test No. 463630-1 (Accelerometer Located at Center of Gravity).

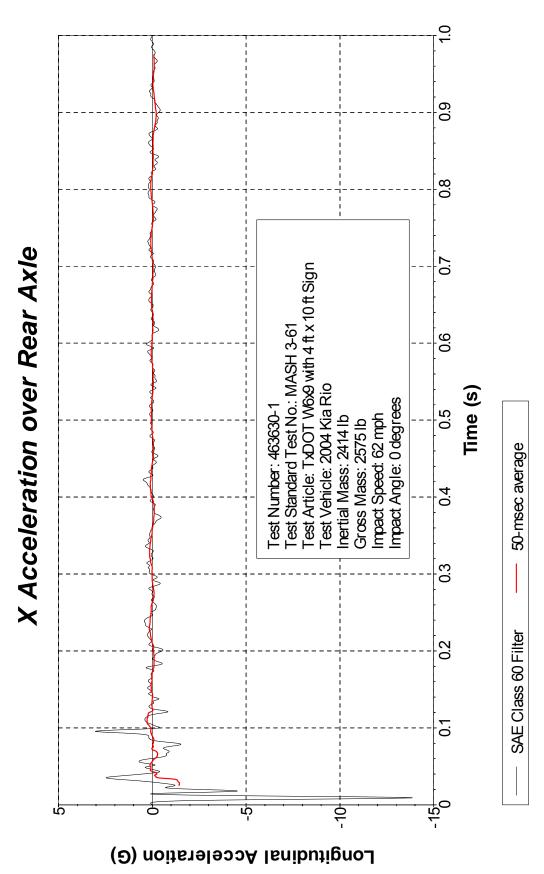
Figure E7. Vehicle Longitudinal Accelerometer Trace for Test No. 463630-1 (Accelerometer Located over Rear Axle).

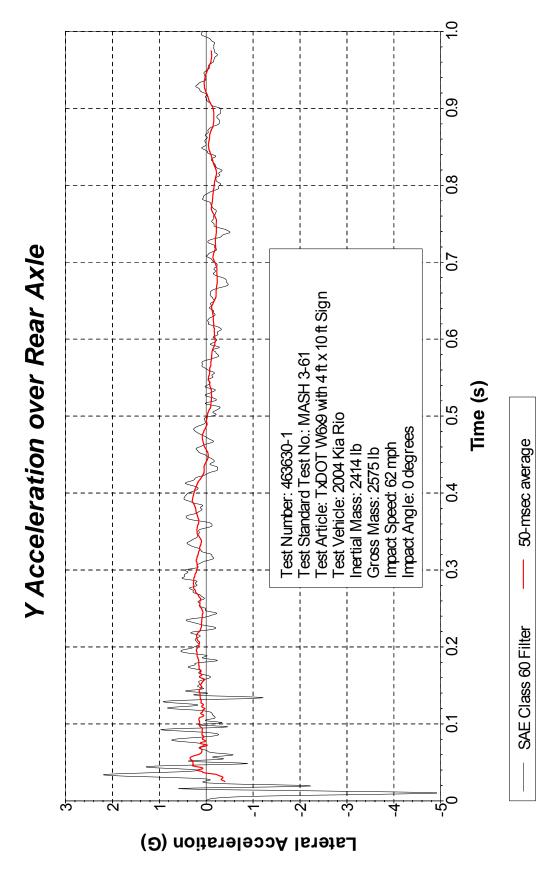
Figure E8. Vehicle Lateral Accelerometer Trace for Test No. 463630-1 (Accelerometer Located over Rear Axle).

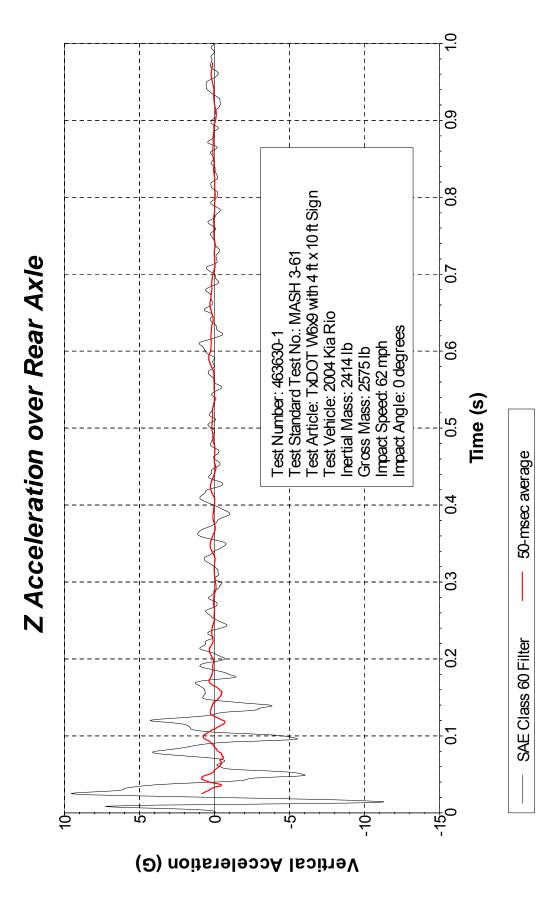
Figure E9. Vehicle Vertical Accelerometer Trace for Test No. 463630-1 (Accelerometer Located over Rear Axle).

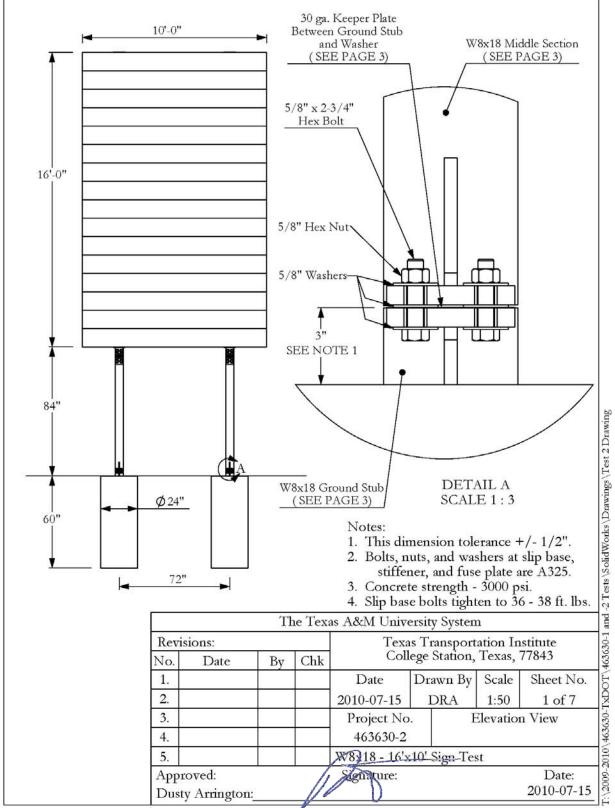
Figure F1. Details of the W8×18 with 16-ft × 10-ft Sign.

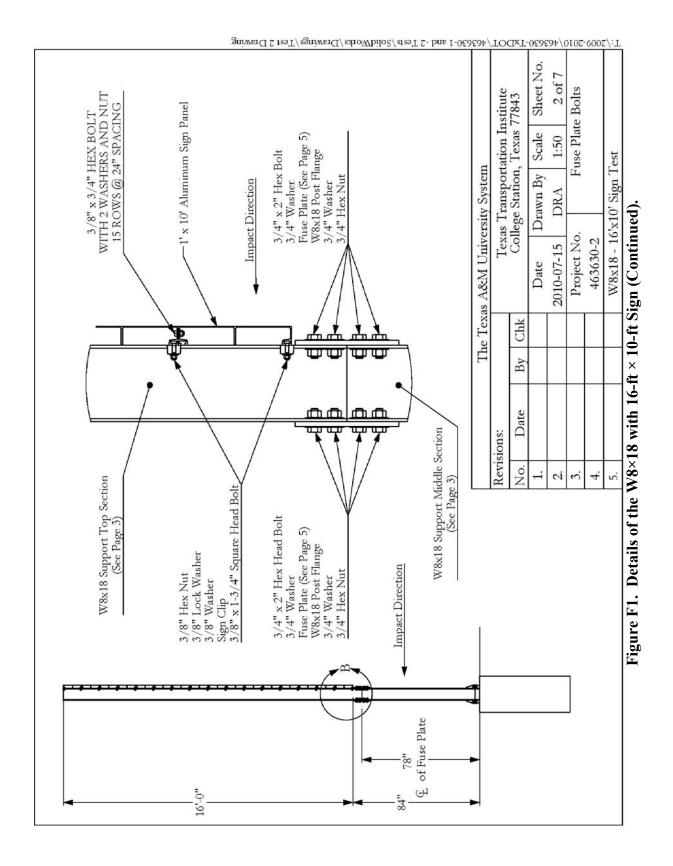
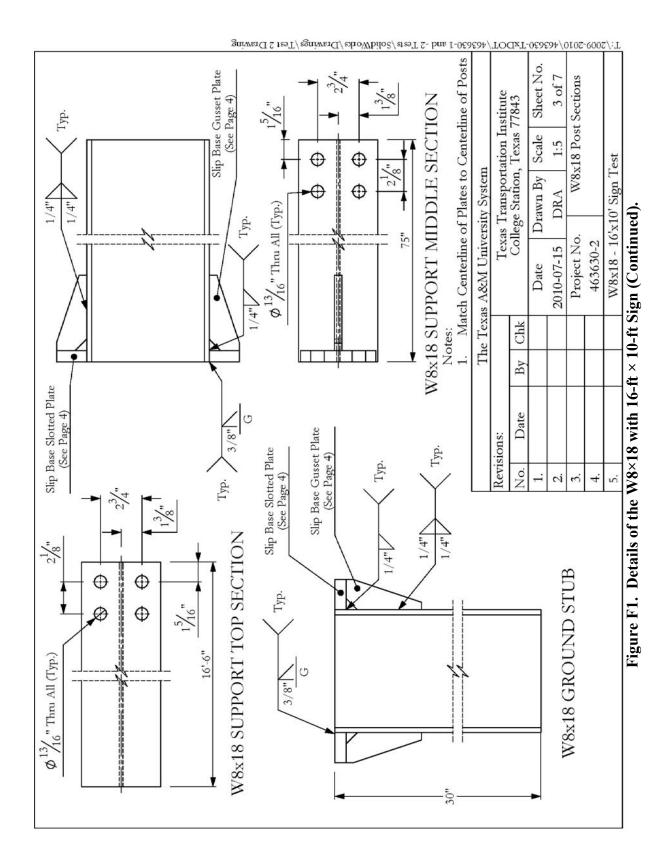
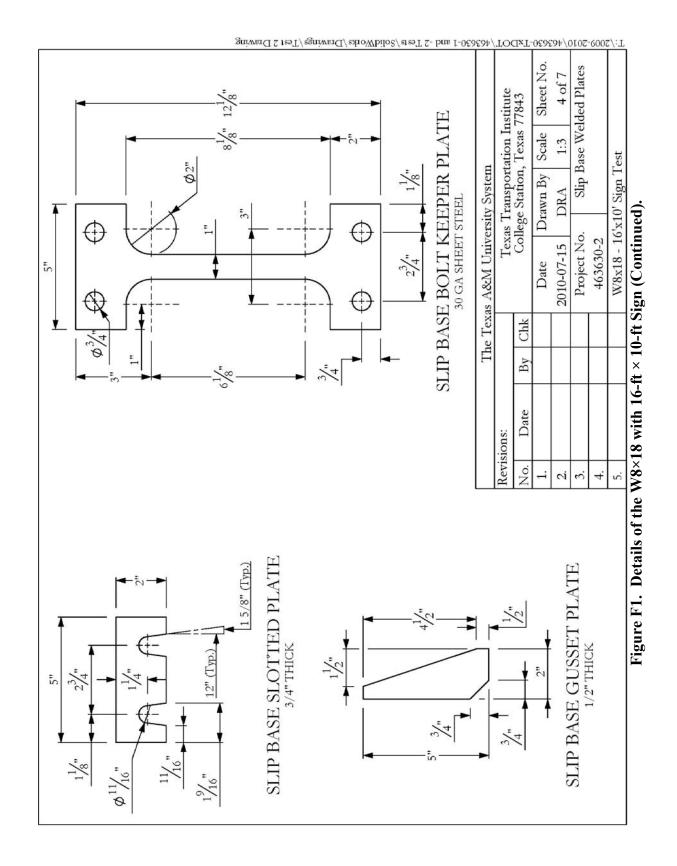
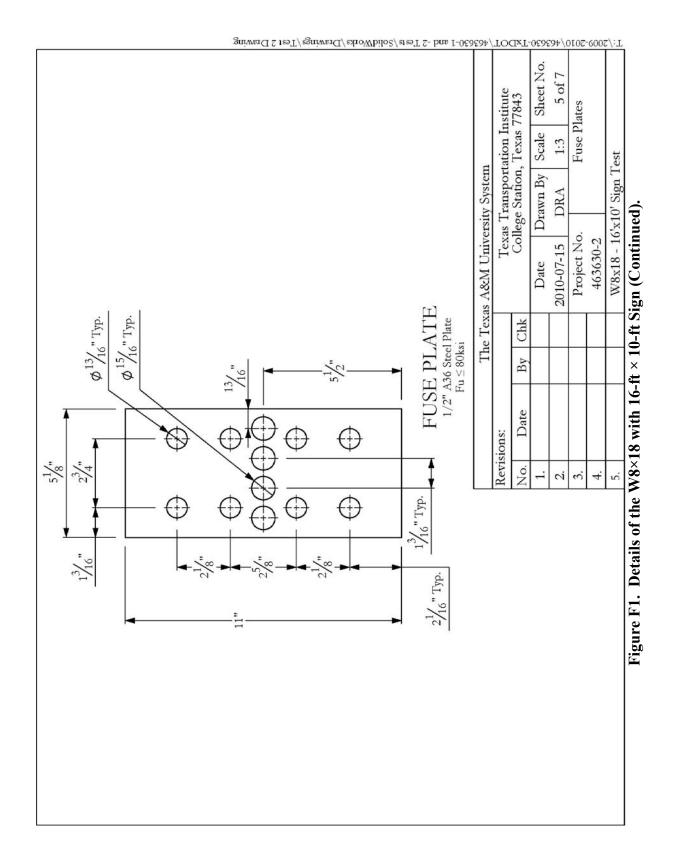
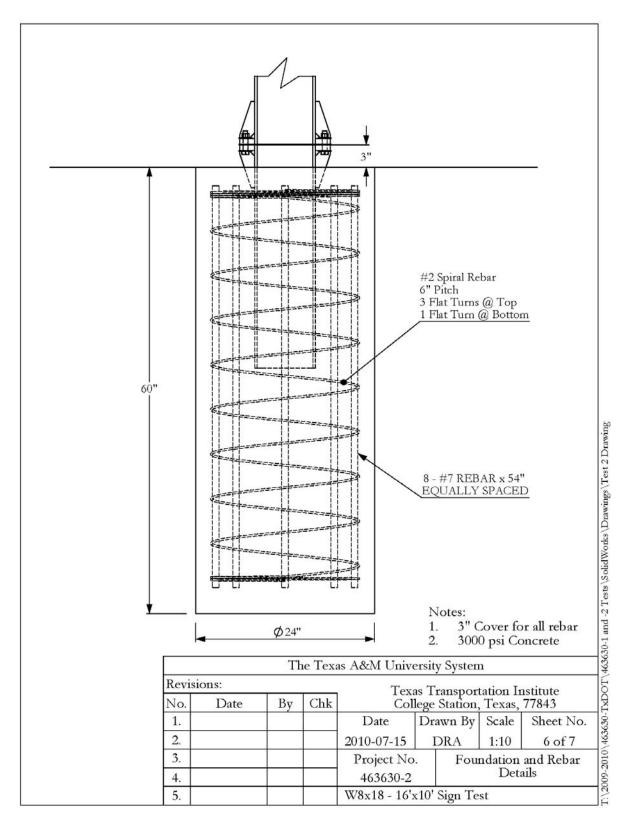
Figure F1. Details of the W8×18 with 16-ft × 10-ft Sign (Continued).

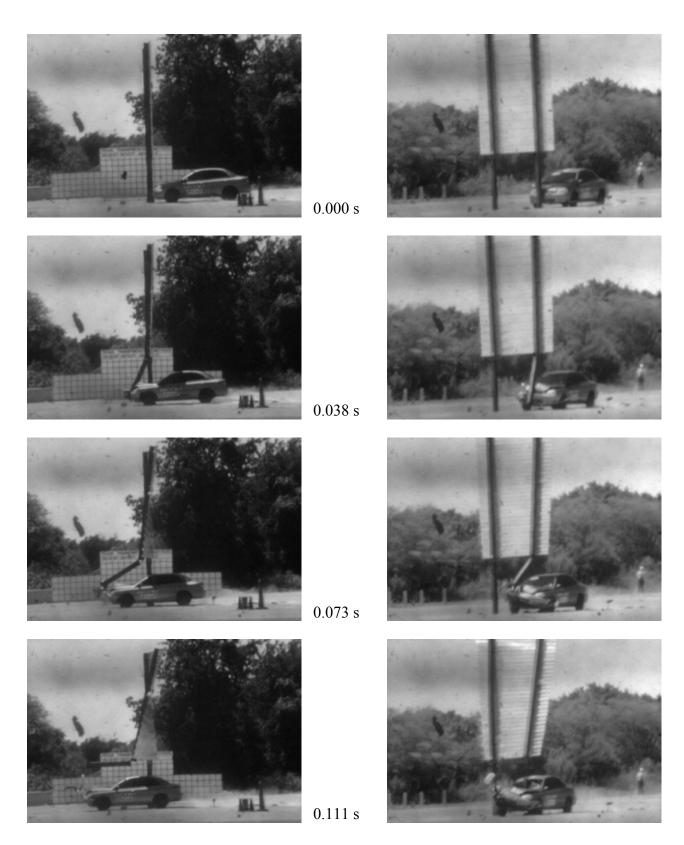
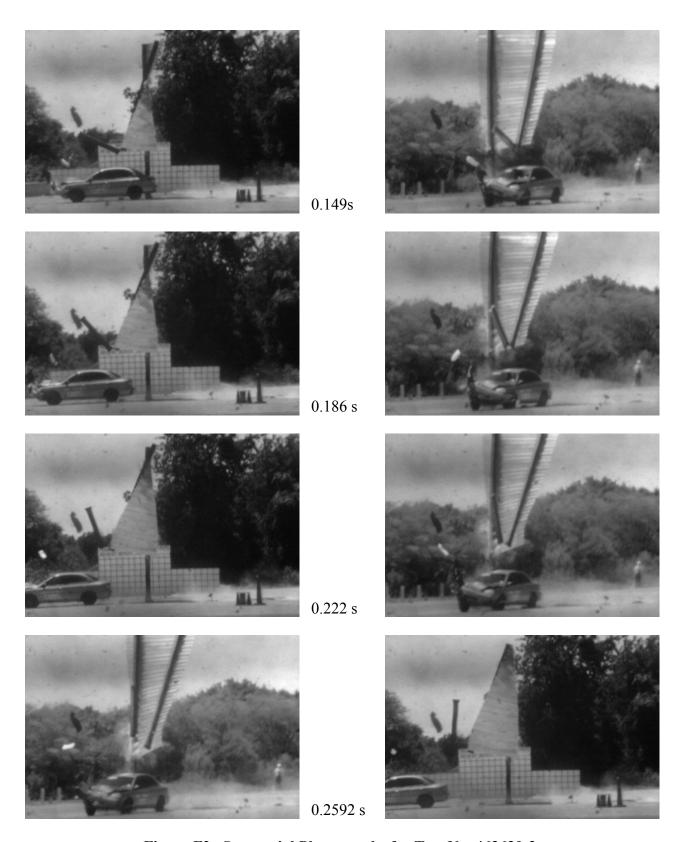
Figure F2. Sequential Photographs for Test No. 463630-2 (Perpendicular and Frontal Oblique Views).

Figure F2. Sequential Photographs for Test No. 463630-2 (Perpendicular and Oblique Frontal Views) (continued).

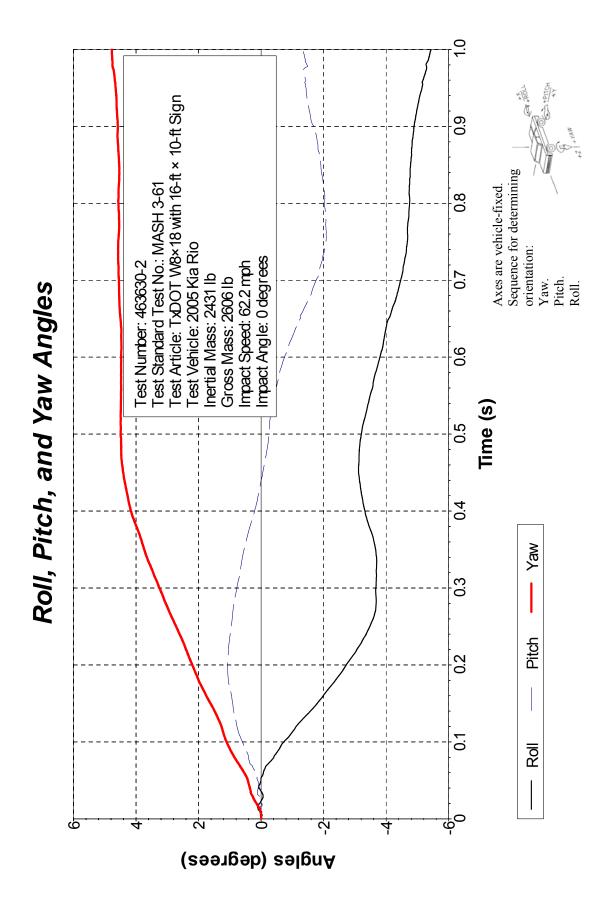
Figure F3. Vehicle Angular Displacements for Test No. 463630-2.

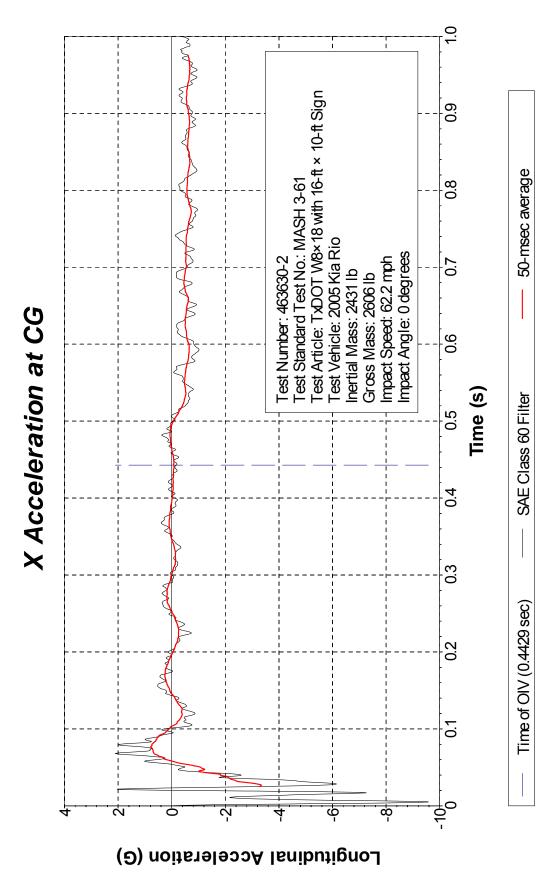
Figure F4. Vehicle Longitudinal Accelerometer Trace for Test No. 463630-2 (Accelerometer Located at Center of Gravity).

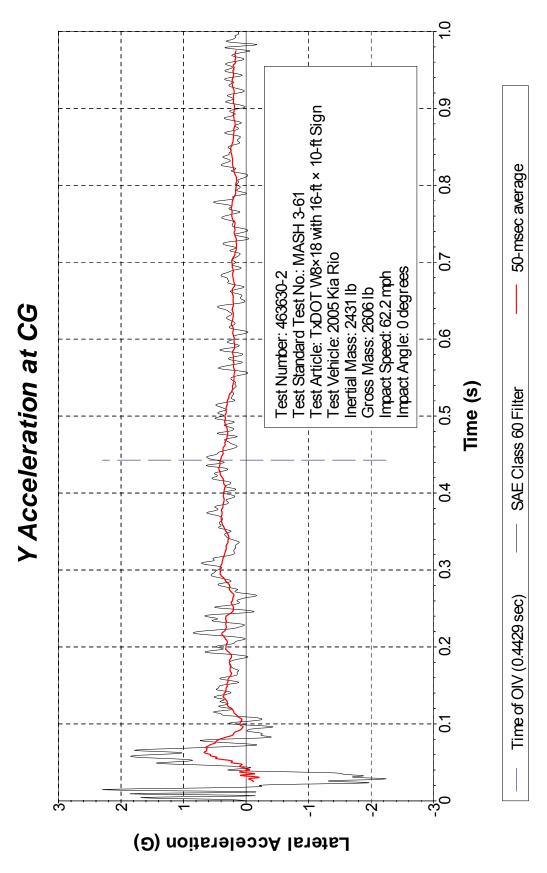
Figure F5. Vehicle Lateral Accelerometer Trace for Test No. 463630-2 (Accelerometer Located at Center of Gravity).

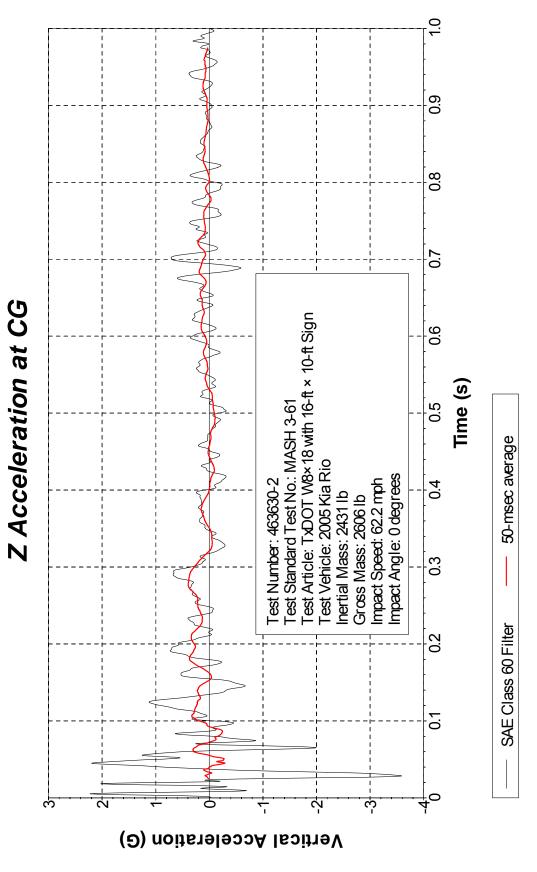
Figure F6. Vehicle Vertical Accelerometer Trace for Test No. 463630-2 (Accelerometer Located at Center of Gravity).

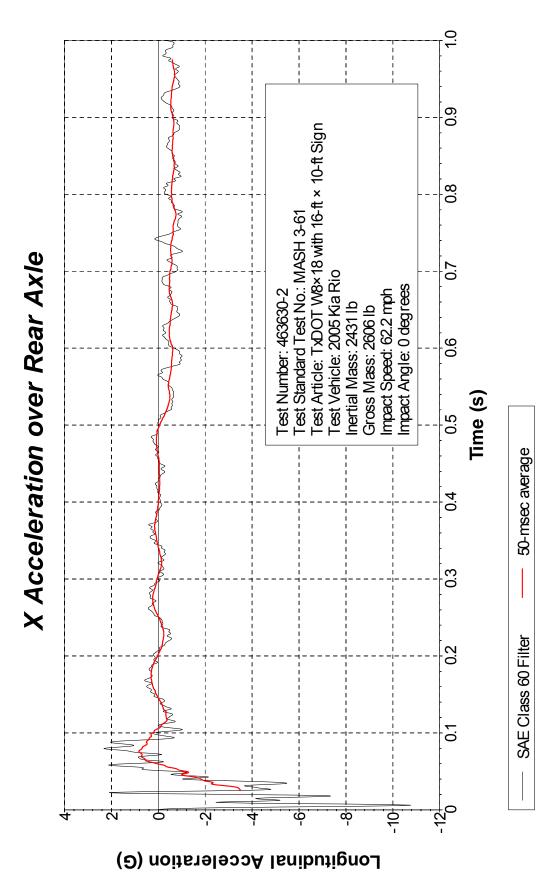
Figure F7. Vehicle Longitudinal Accelerometer Trace for Test No. 463630-2 (Accelerometer Located over Rear Axle).

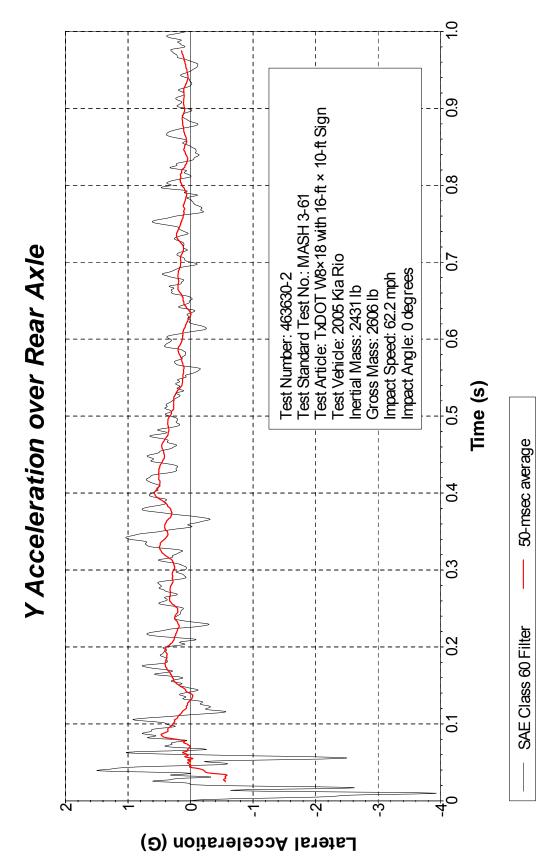
Figure F8. Vehicle Lateral Accelerometer Trace for Test No. 463630-2 (Accelerometer Located over Rear Axle).

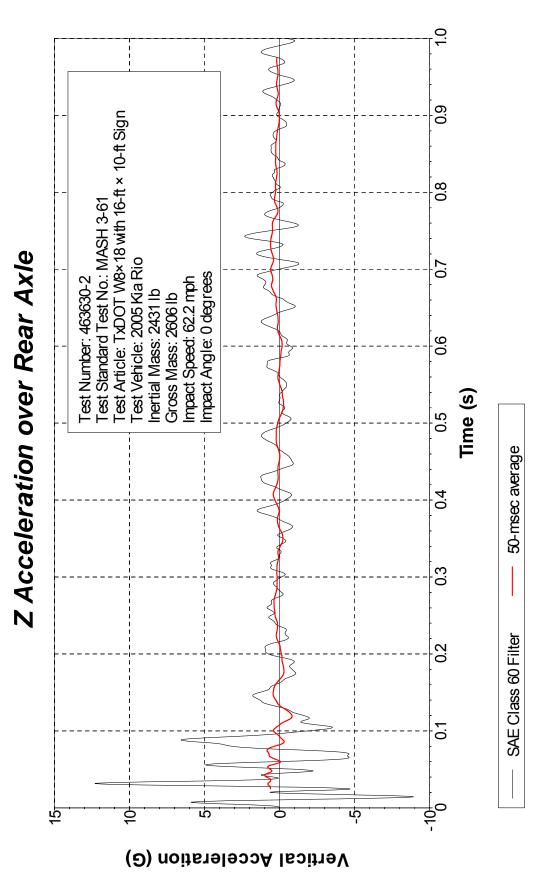
Figure F9. Vehicle Vertical Accelerometer Trace for Test No. 463630-2 (Accelerometer Located over Rear Axle).

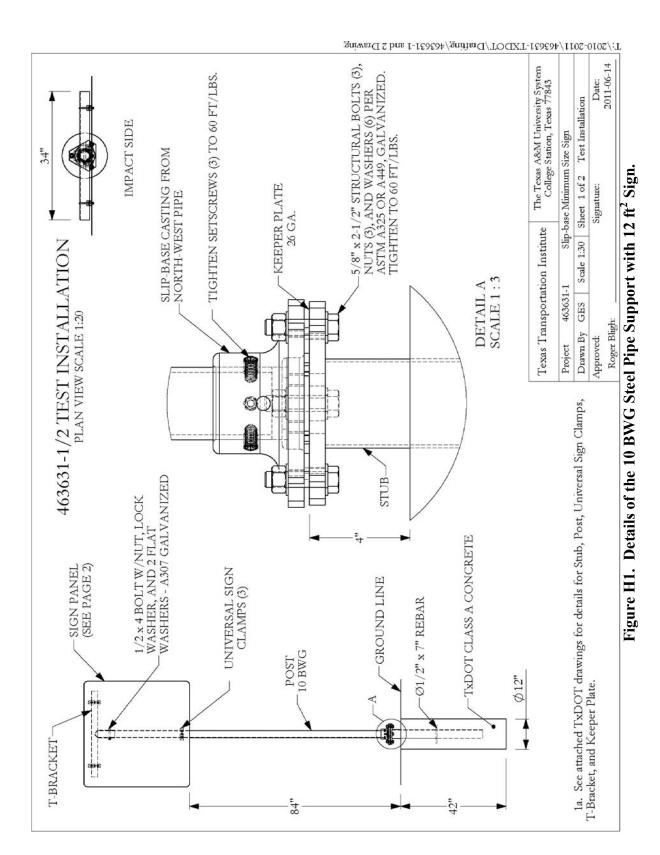
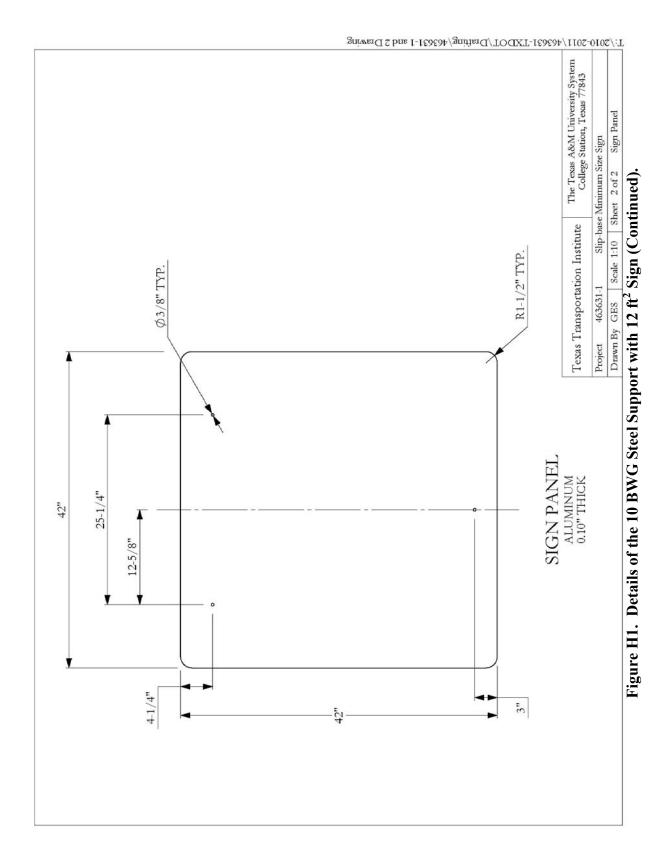
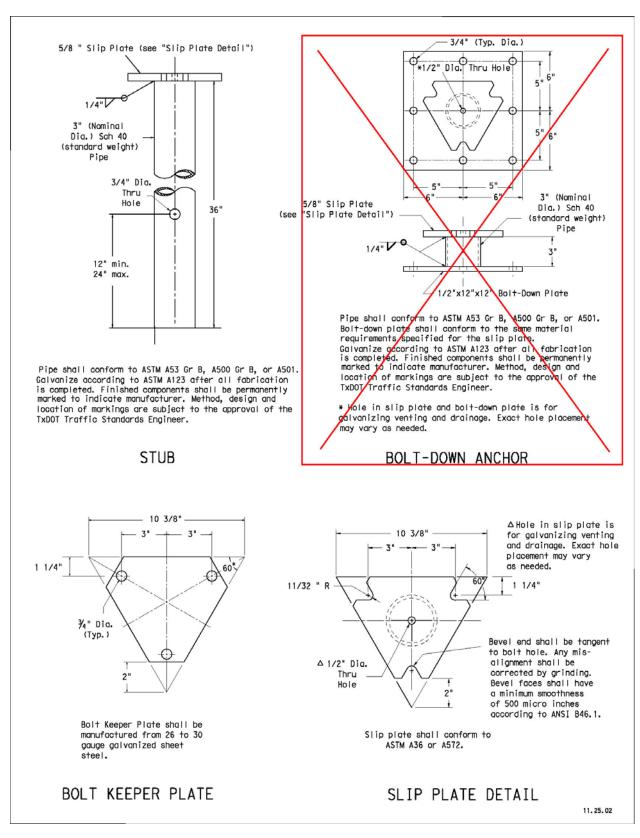
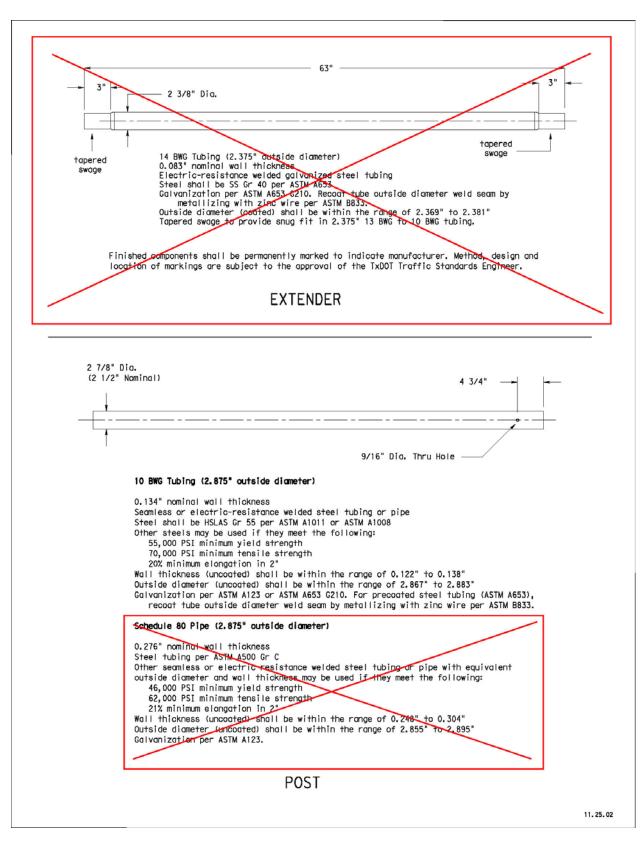
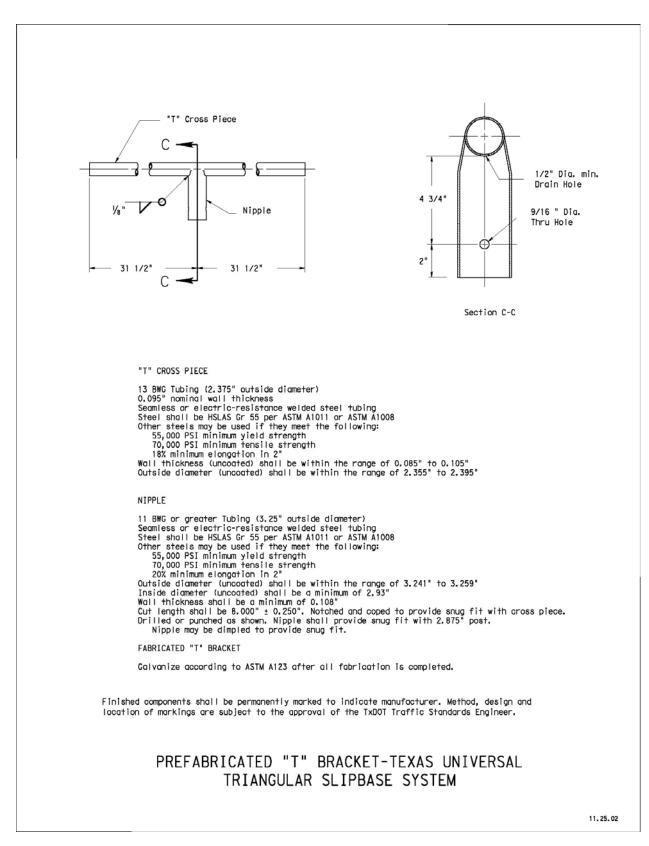
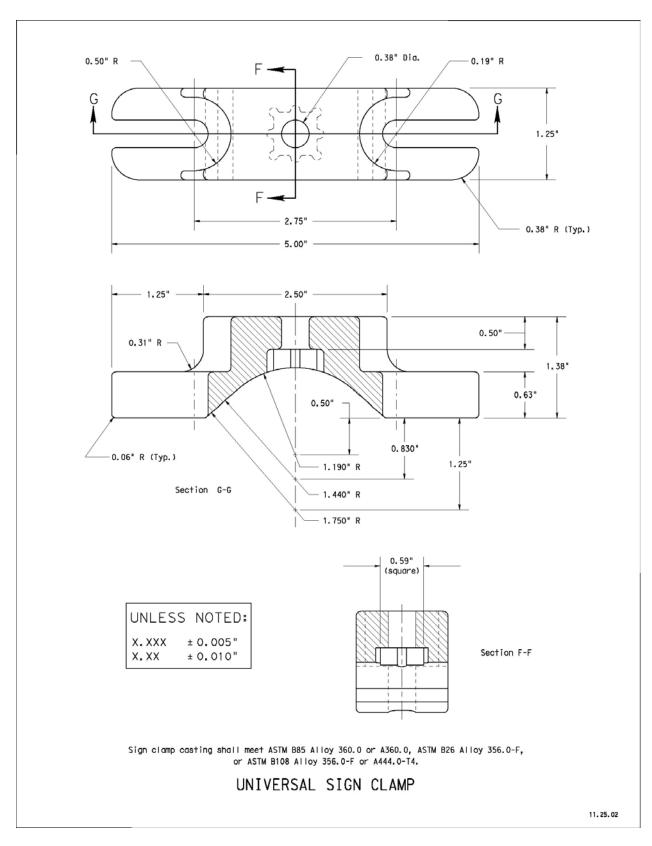
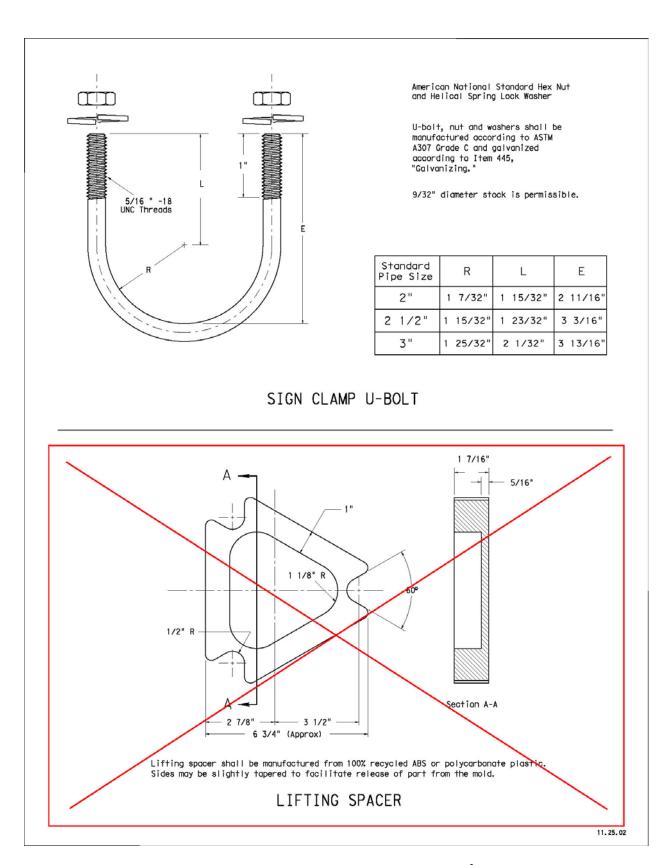
Figure H1. Details of the 10 BWG Steel Support with 12 ft² Sign (Continued).

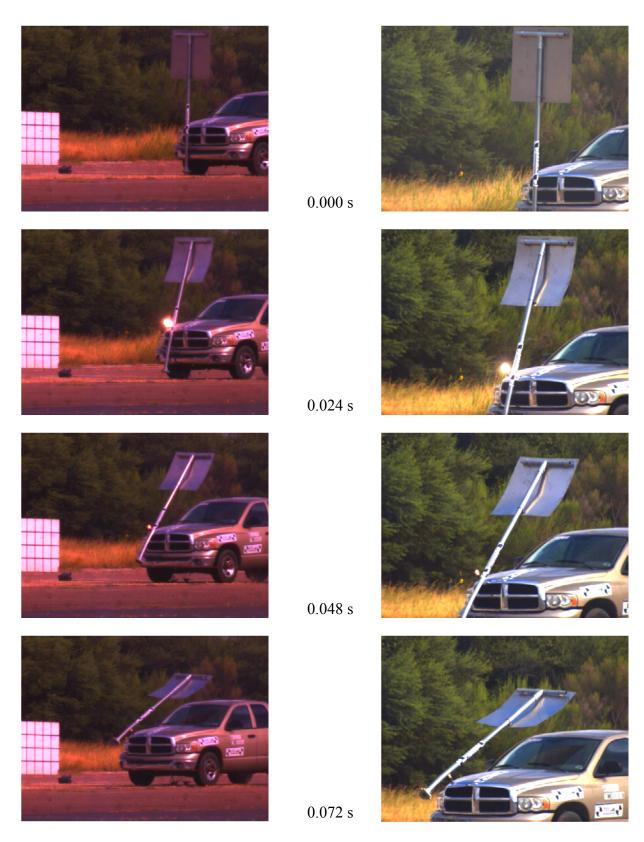
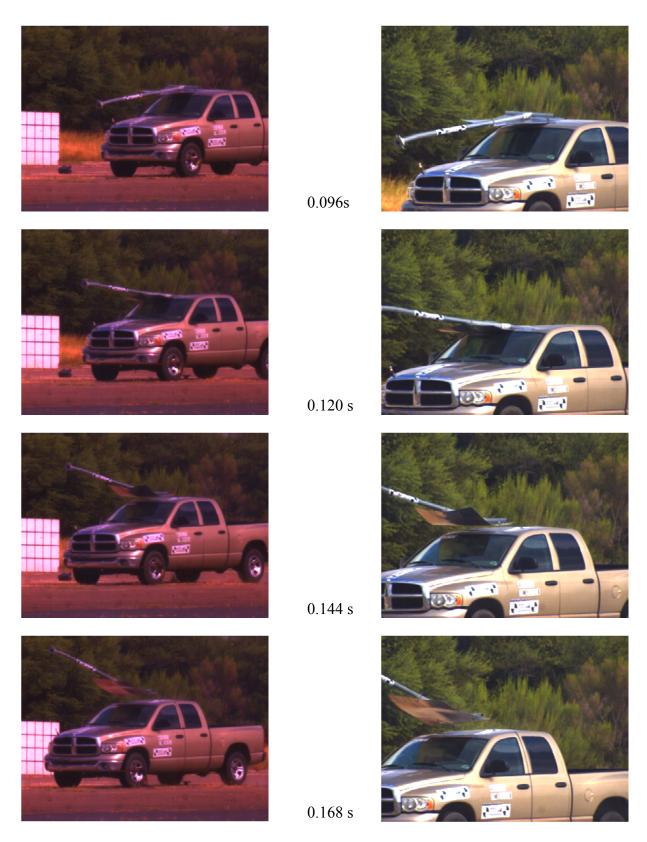
Figure H2. Sequential Photographs for Test No. 463631-1 (Oblique Views).

Figure H2. Sequential Photographs for Test No. 463631-1 (Oblique Views) (continued).

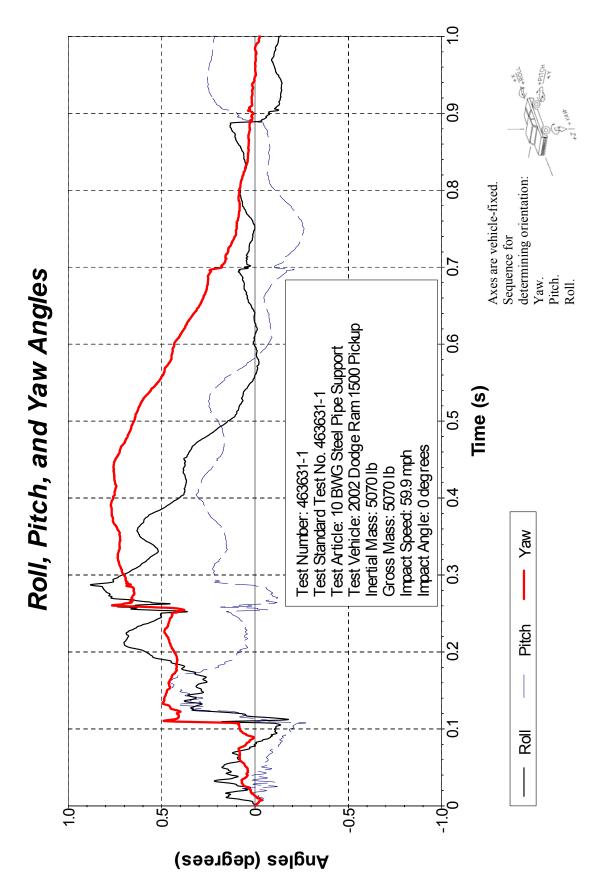
Figure H3. Vehicle Angular Displacements for Test No. 463631-1.

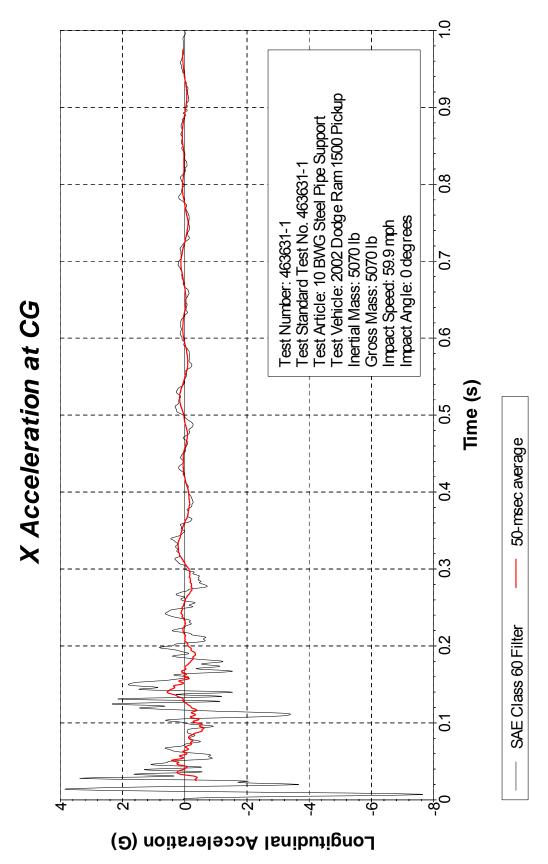
Figure H4. Vehicle Longitudinal Accelerometer Trace for Test No. 463631-1 (Accelerometer Located at Center of Gravity).

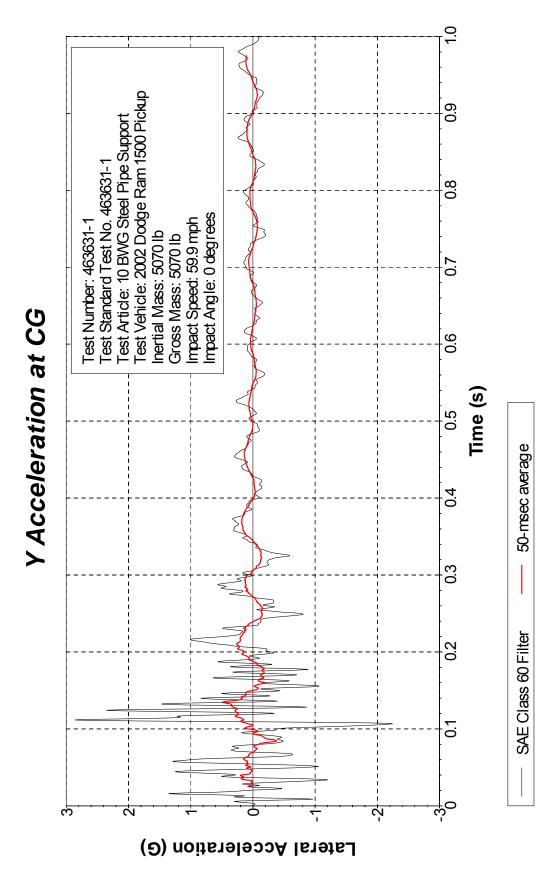
Figure H5. Vehicle Lateral Accelerometer Trace for Test No. 463631-1 (Accelerometer Located at Center of Gravity).

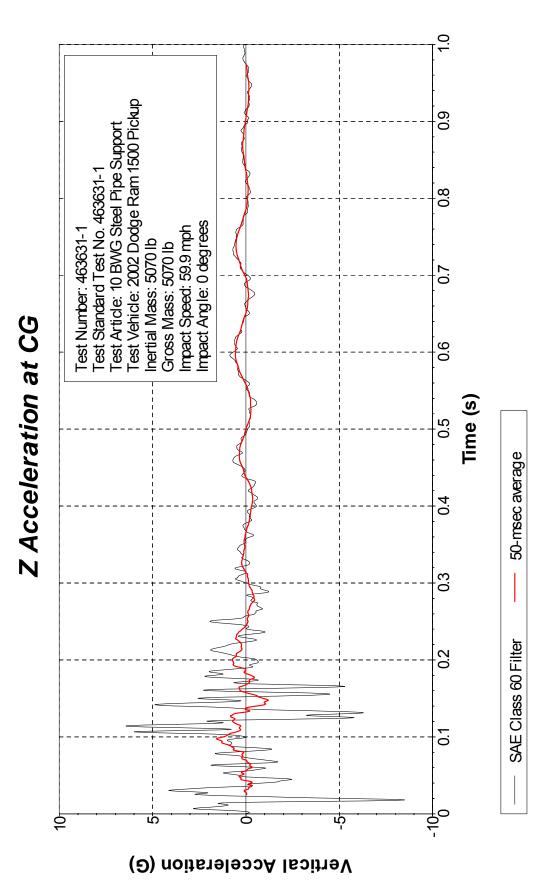
Figure H6. Vehicle Vertical Accelerometer Trace for Test No. 463631-1 (Accelerometer Located at Center of Gravity).

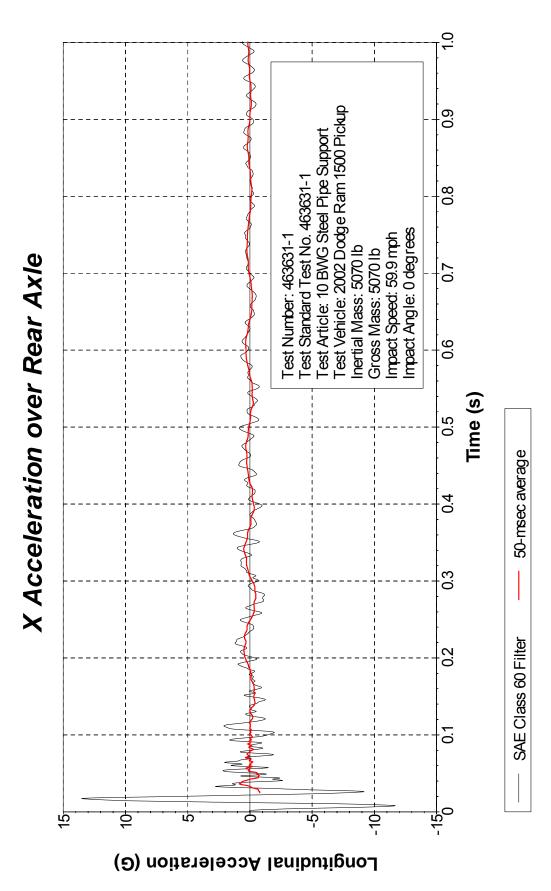
Figure H7. Vehicle Longitudinal Accelerometer Trace for Test No. 463631-1 (Accelerometer Located over Rear Axle).

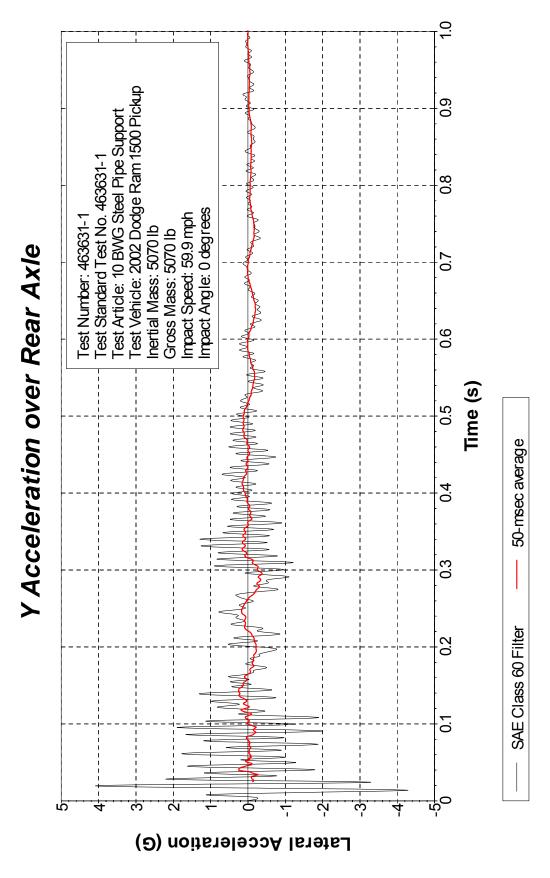
Figure H8. Vehicle Lateral Accelerometer Trace for Test No. 463631-1 (Accelerometer Located over Rear Axle).

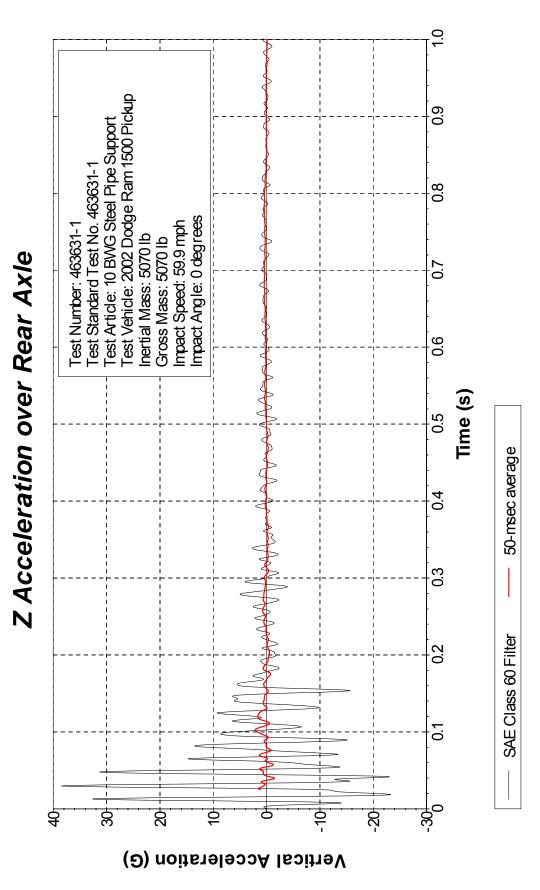
Figure H9. Vehicle Vertical Accelerometer Trace for Test No. 463631-1 (Accelerometer Located over Rear Axle).
