DEVELOPMENT GUIDANCE FOR SIGN DESIGN STANDARDS

Test Report 0-6363-1

TEXAS TRANSPORTATION INSTITUTE
THE TEXAS A&M UNIVERSITY SYSTEM
COLLEGE STATION, TEXAS

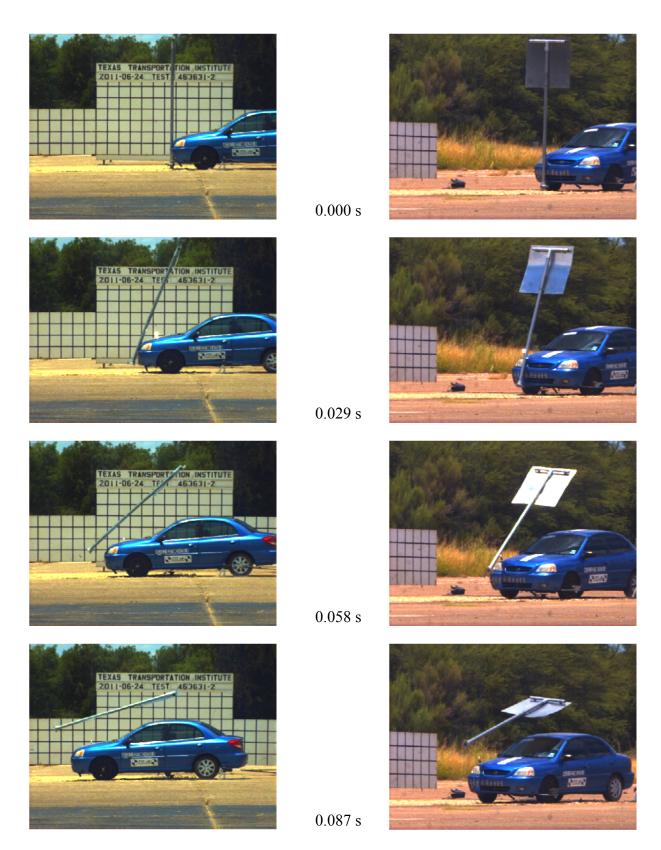
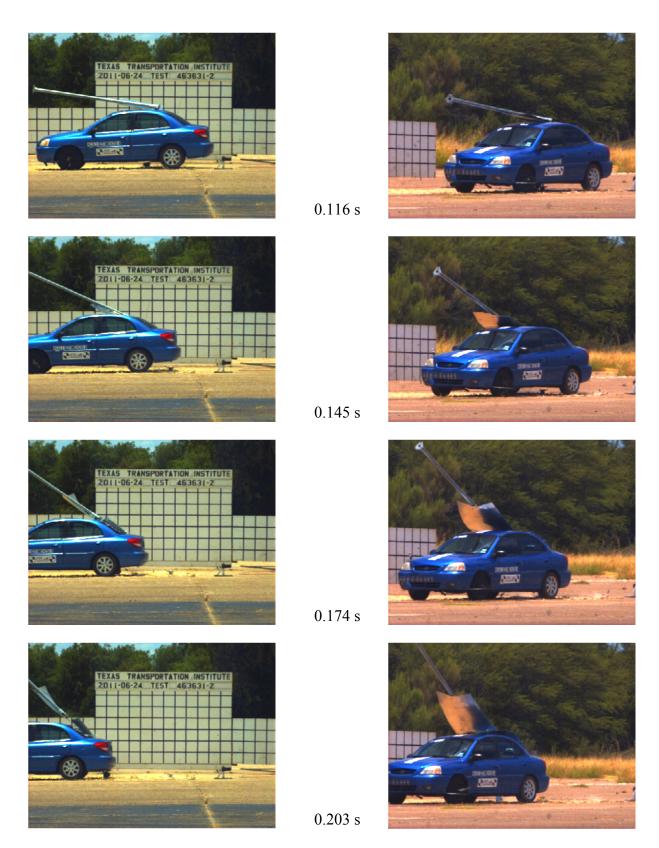
Figure I1. Sequential Photographs for Test No. 463631-2 (Perpendicular and Oblique Views).

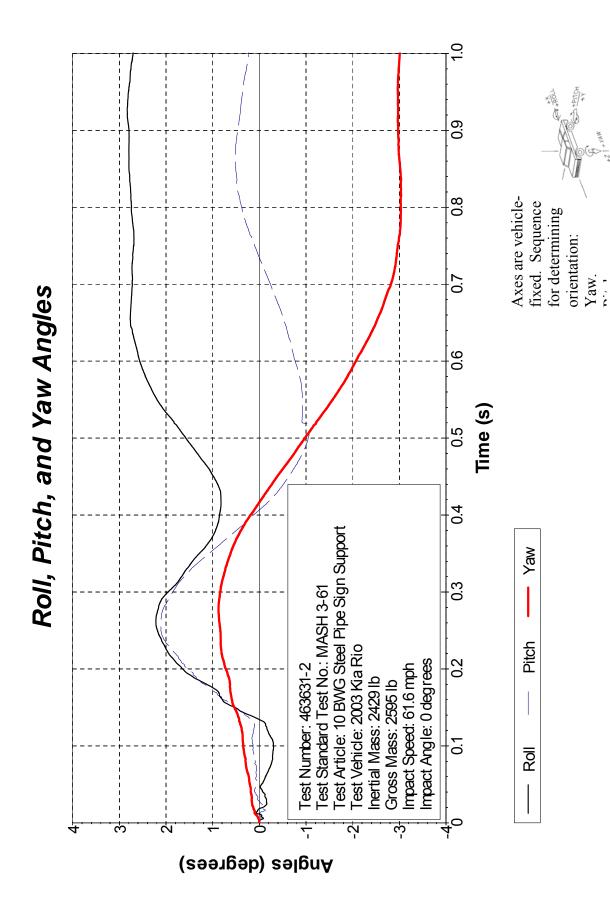
Figure I2. Vehicle Angular Displacements for Test No. 463631-2.

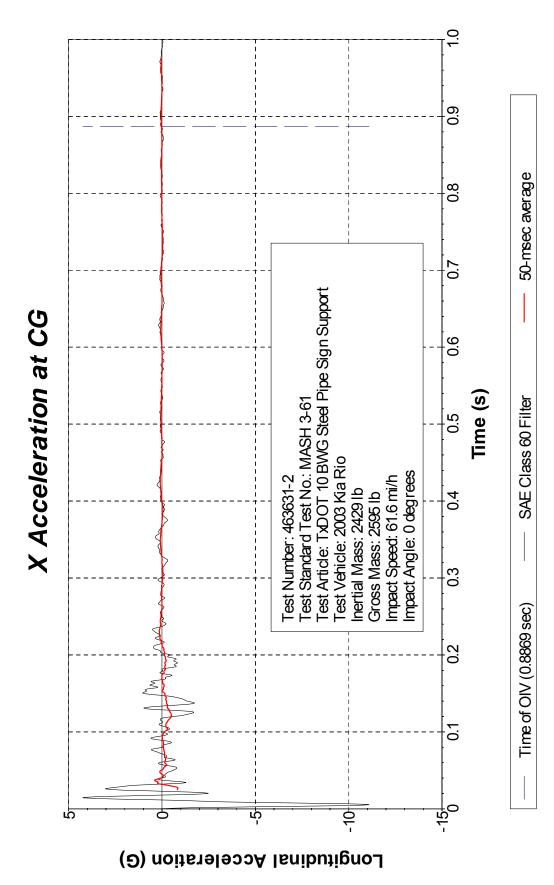
Figure 13. Vehicle Longitudinal Accelerometer Trace for Test No. 463631-2 (Accelerometer Located at Center of Gravity).

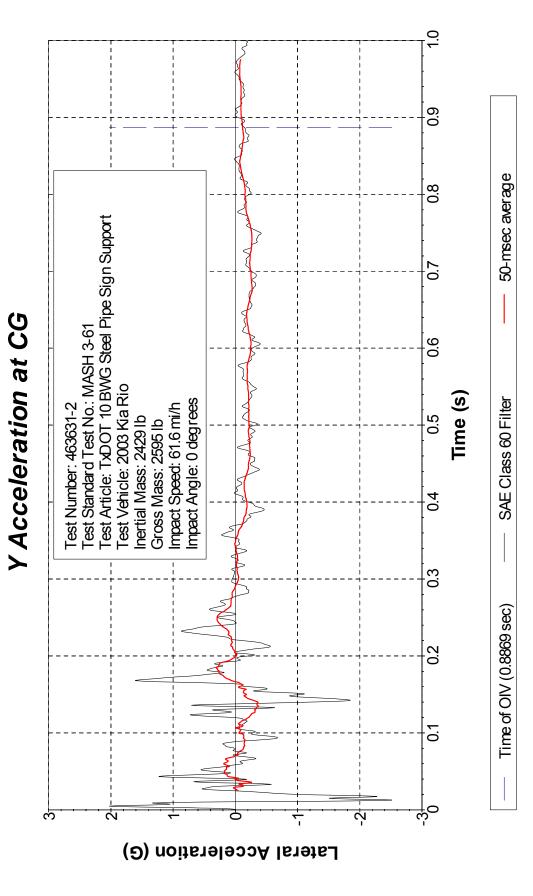
Figure I4. Vehicle Lateral Accelerometer Trace for Test No. 463631-2 (Accelerometer Located at Center of Gravity).

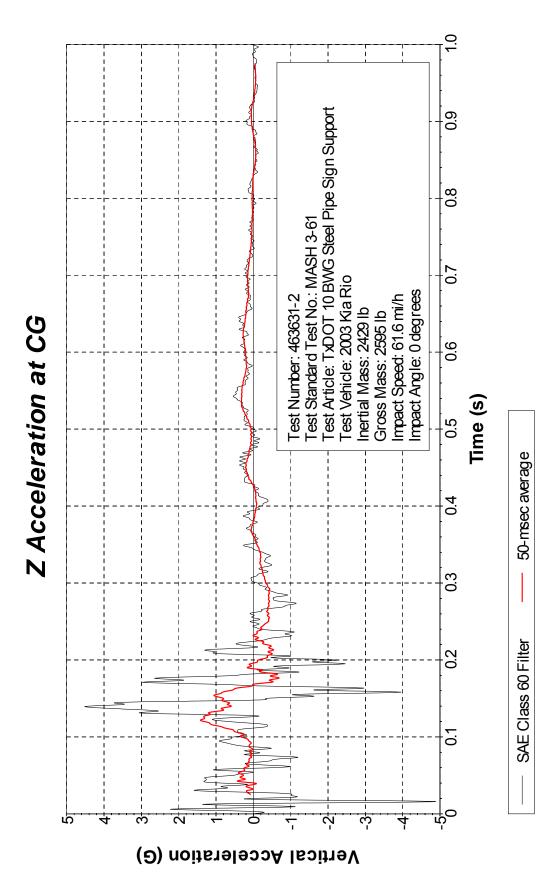
Figure I5. Vehicle Vertical Accelerometer Trace for Test No. 463631-2 (Accelerometer Located at Center of Gravity).

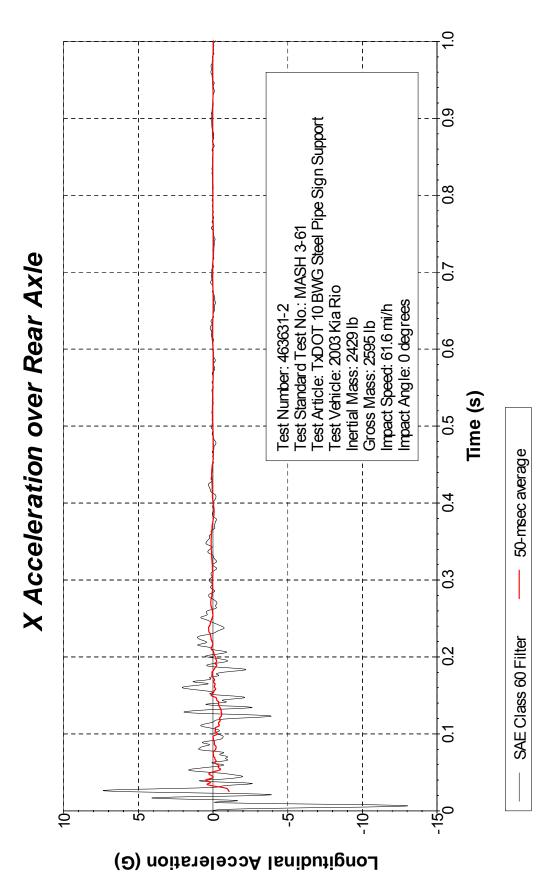
Figure 16. Vehicle Longitudinal Accelerometer Trace for Test No. 463631-2 (Accelerometer Located over Rear Axle).

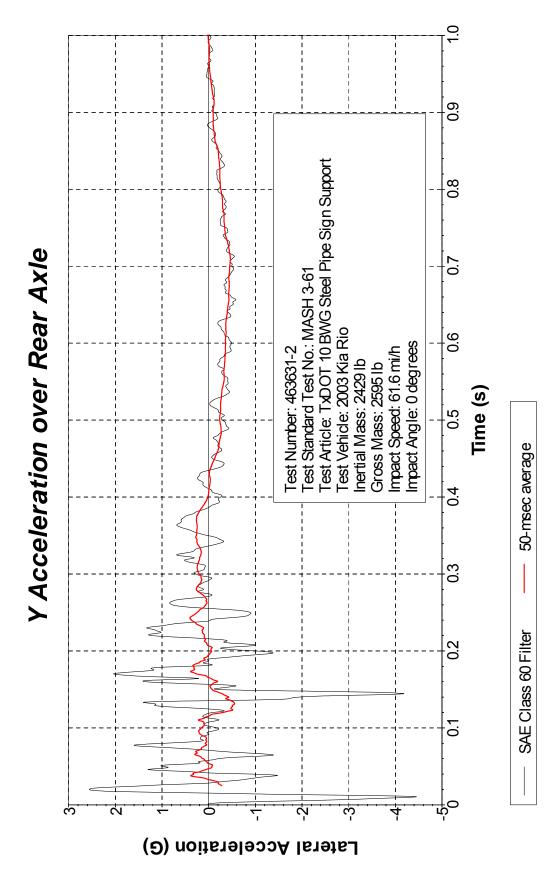
Figure I7. Vehicle Lateral Accelerometer Trace for Test No. 463631-2 (Accelerometer Located over Rear Axle).

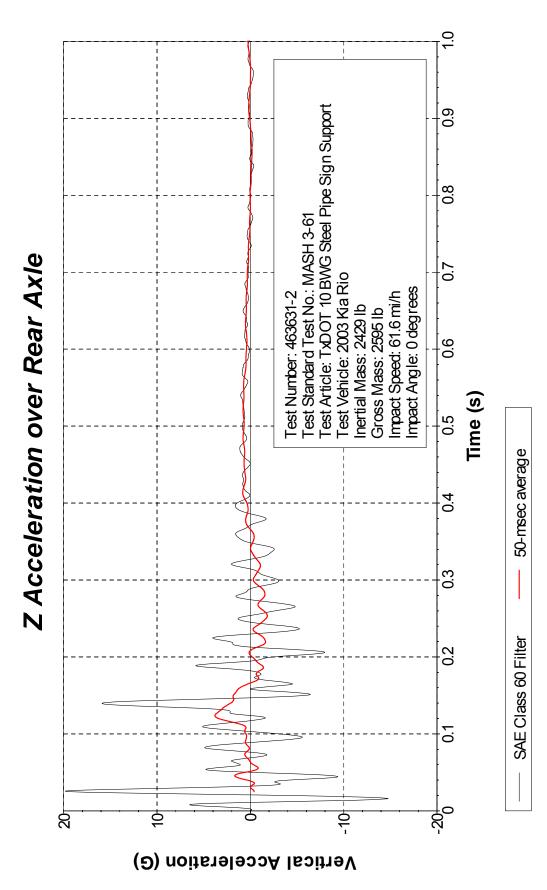
Figure 18. Vehicle Vertical Accelerometer Trace for Test No. 463631-2 (Accelerometer Located over Rear Axle).

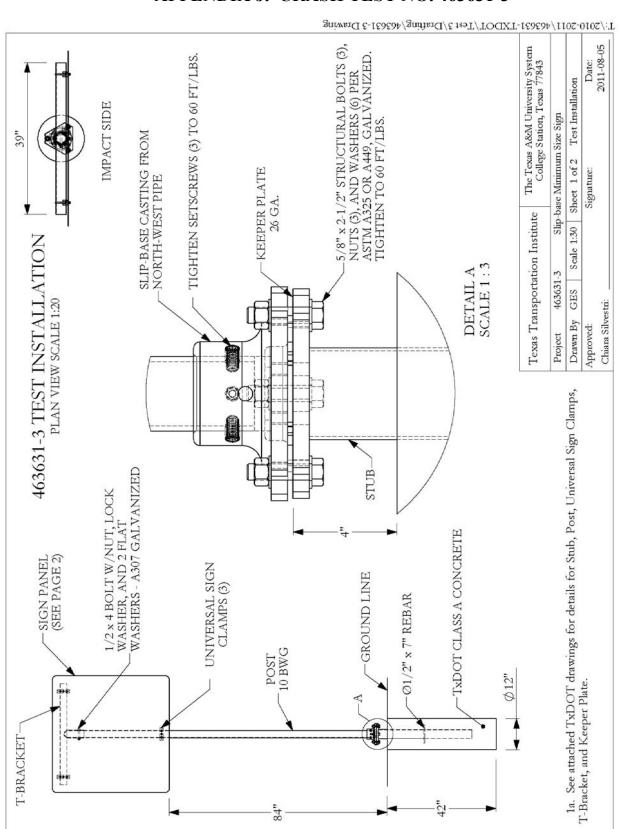
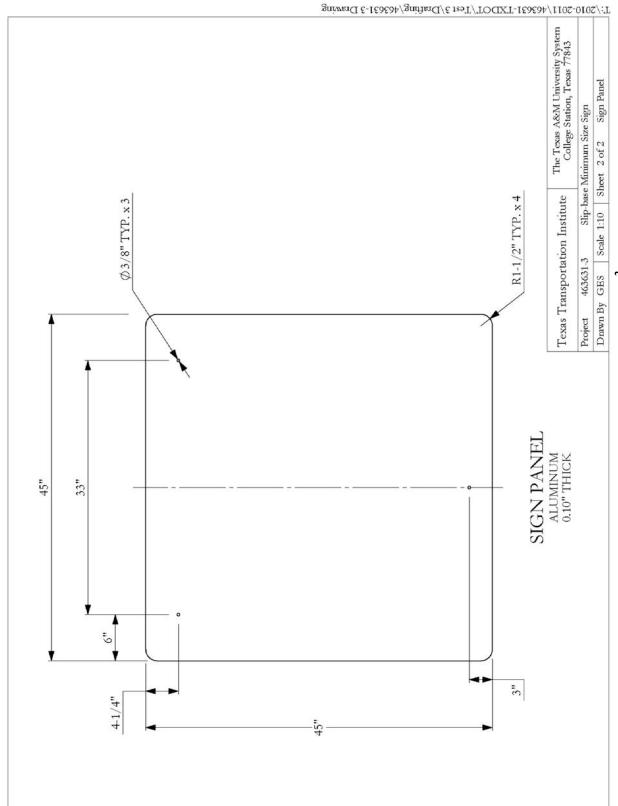
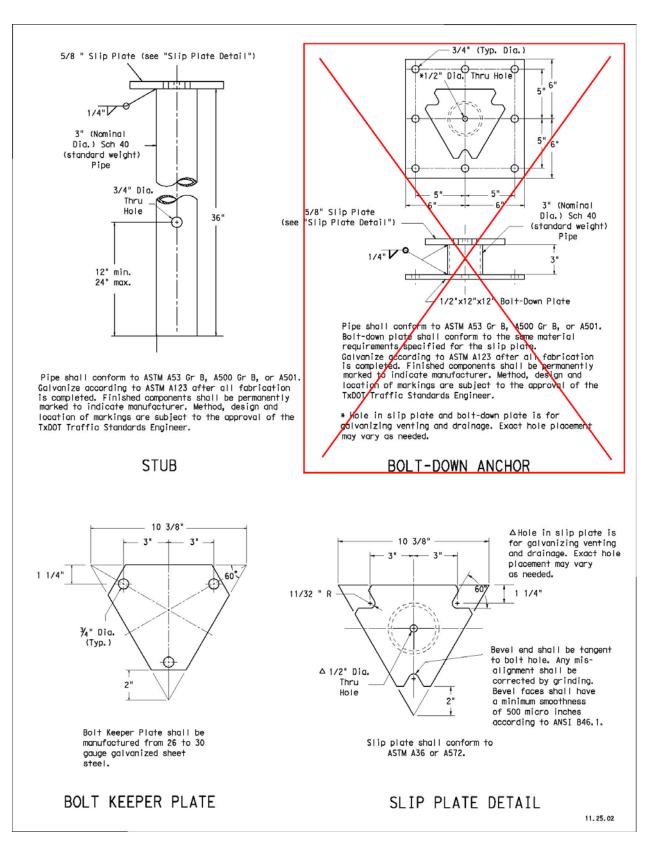
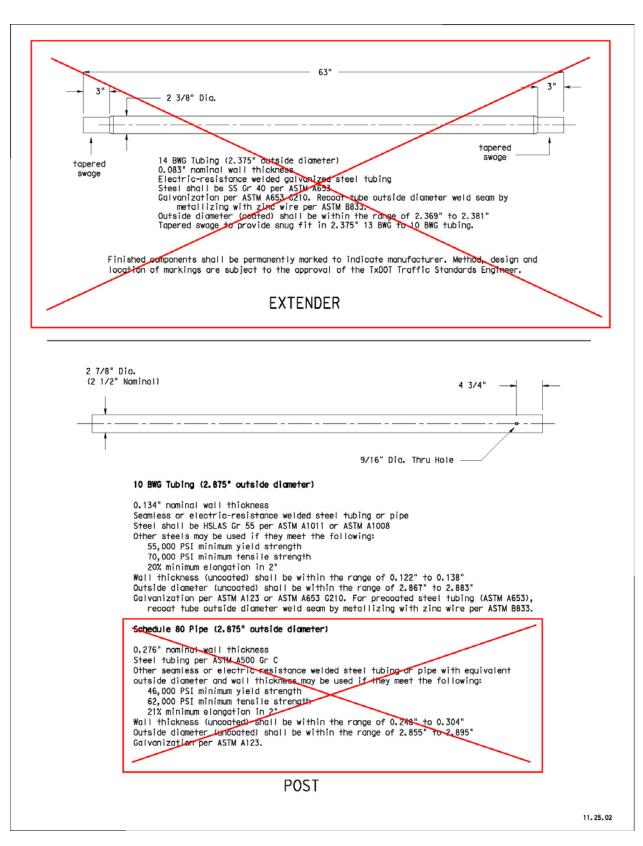
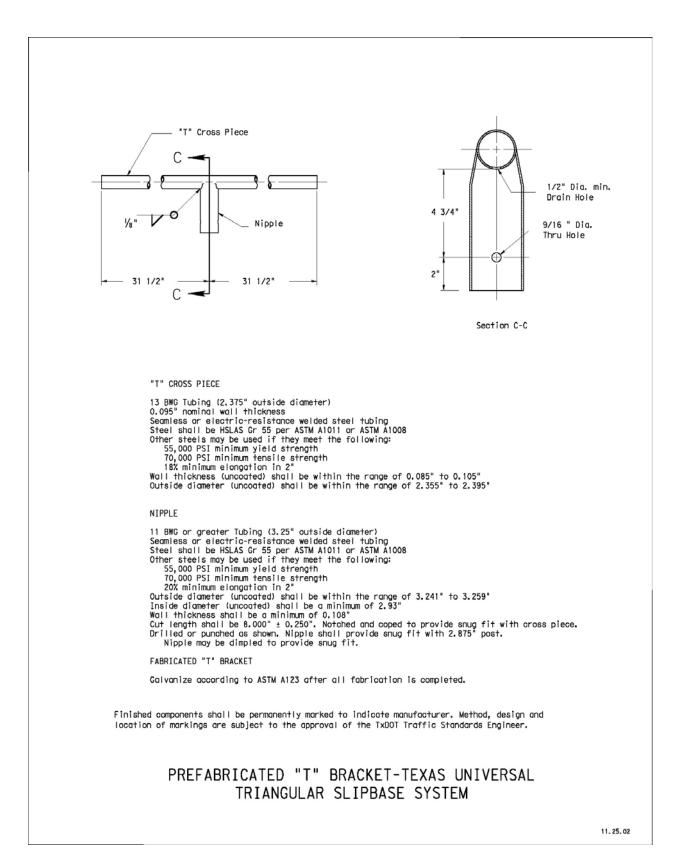
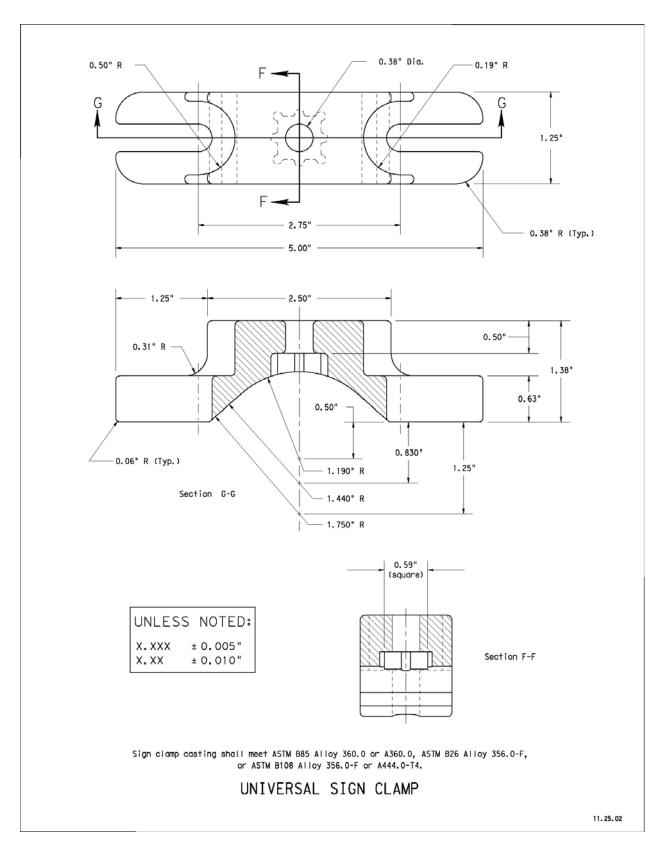
Figure J1. Details of the 10 BWG Steel Support with 14 ft² Sign.

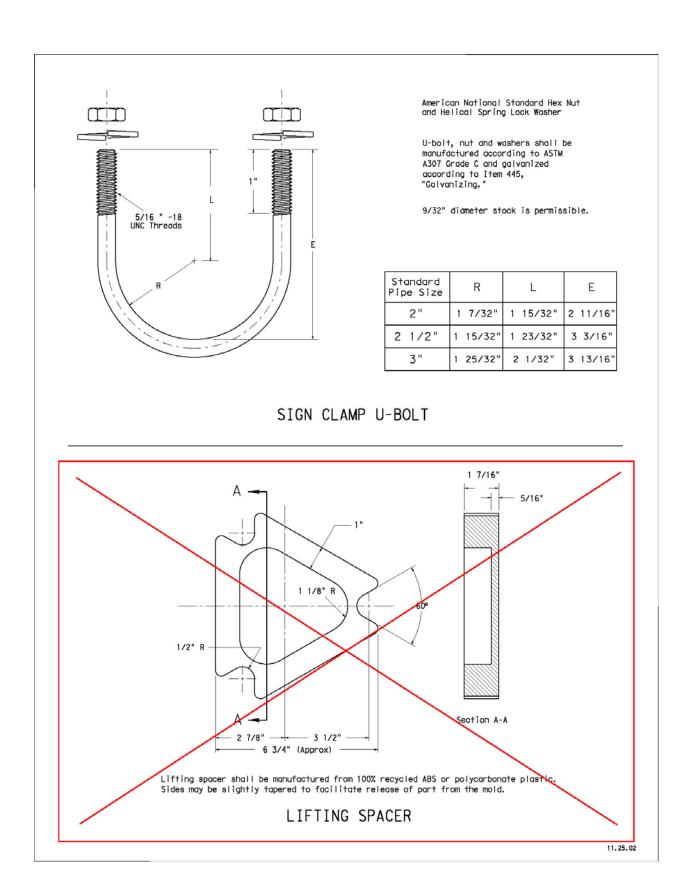
Figure J1. Details of the 10 BWG Steel Support with 14 ft² Sign (Continued).

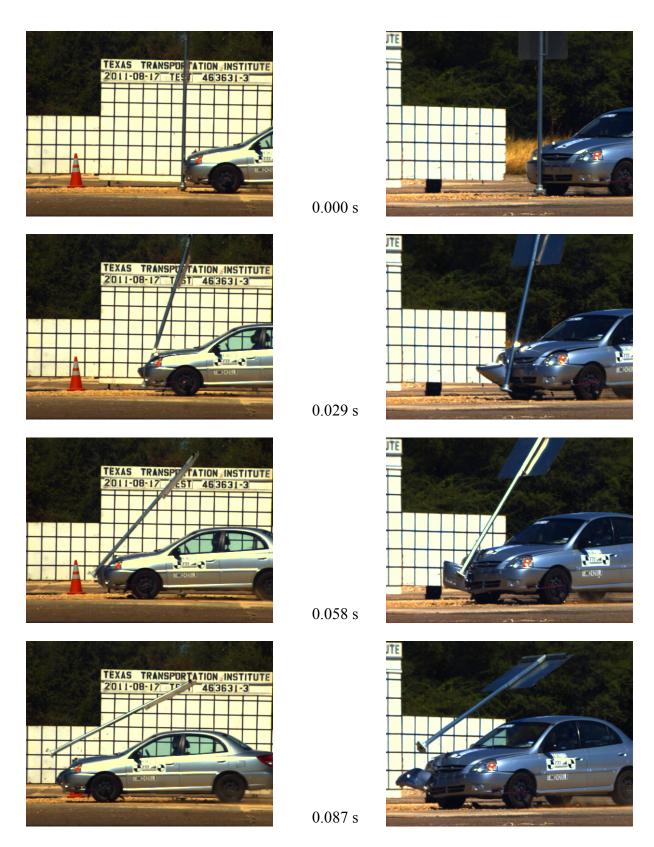
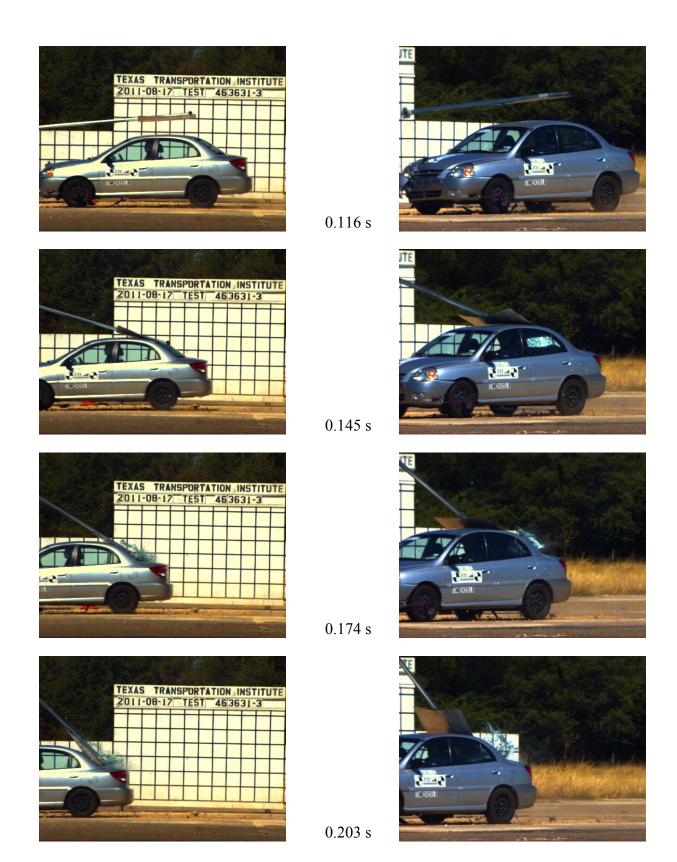
Figure J2. Sequential Photographs for Test No. 463631-3 (Perpendicular and Oblique Views).

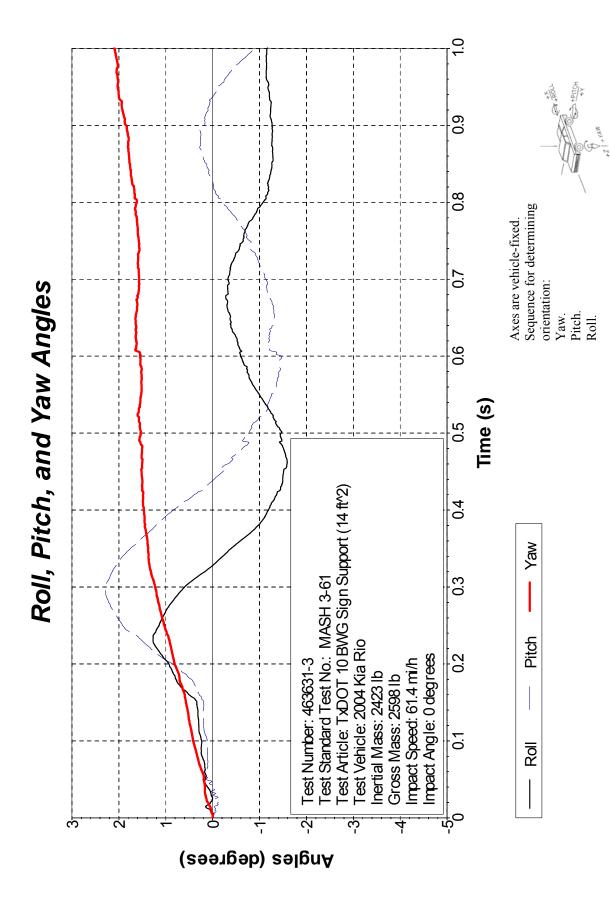
Figure J3. Vehicle Angular Displacements for Test No. 463631-3.

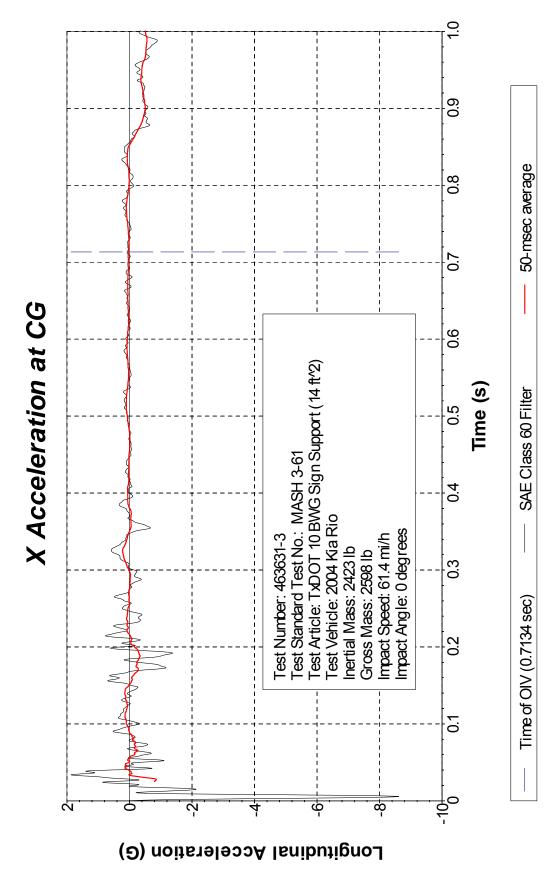
Figure J4. Vehicle Longitudinal Accelerometer Trace for Test No. 463631-3 (Accelerometer Located at Center of Gravity).

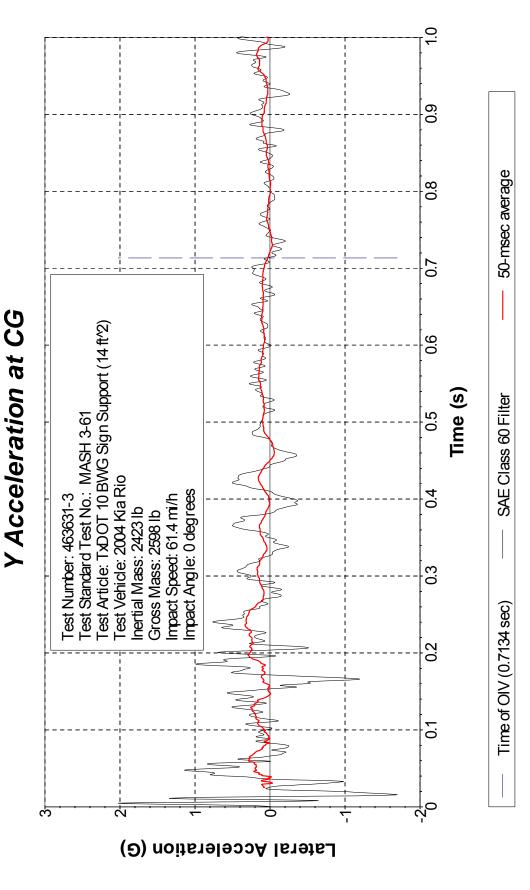
Figure J5. Vehicle Lateral Accelerometer Trace for Test No. 463631-3 (Accelerometer Located at Center of Gravity).

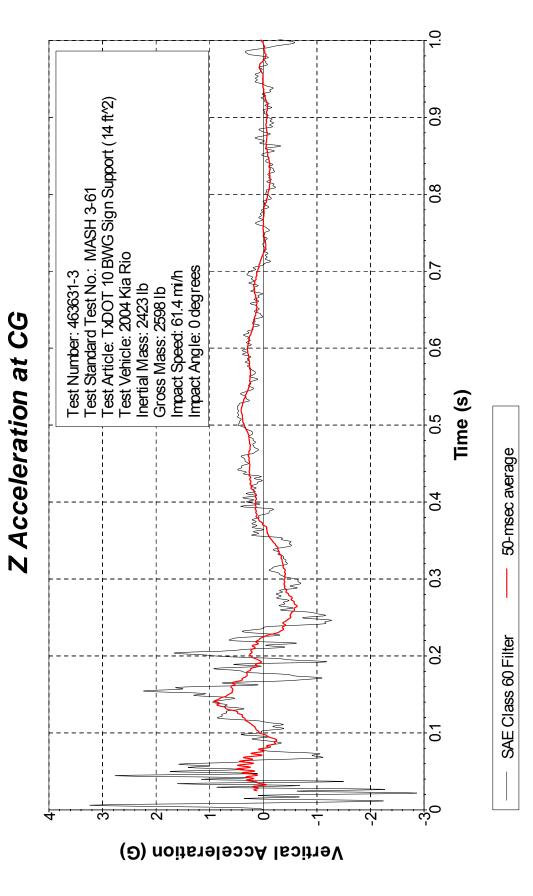
Figure J6. Vehicle Vertical Accelerometer Trace for Test No. 463631-3 (Accelerometer Located at Center of Gravity).

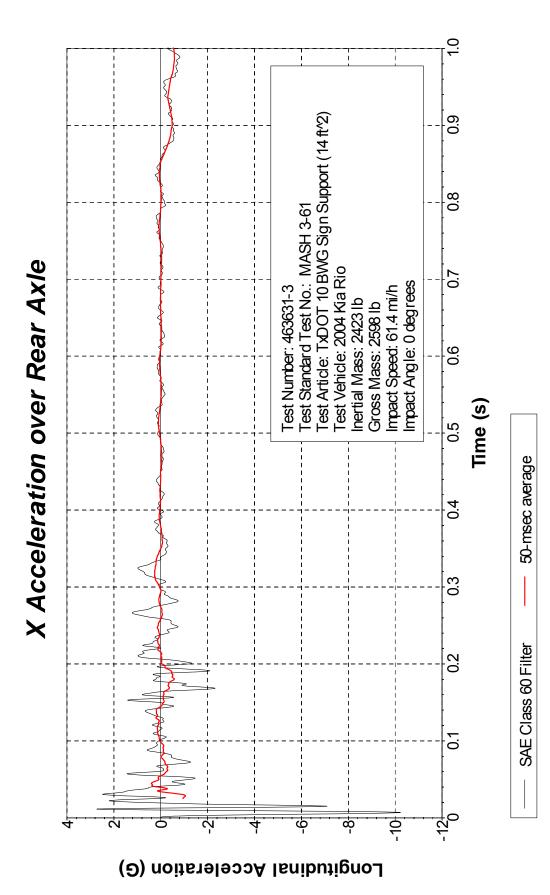
Figure J7. Vehicle Longitudinal Accelerometer Trace for Test No. 463631-3 (Accelerometer Located over Rear Axle).

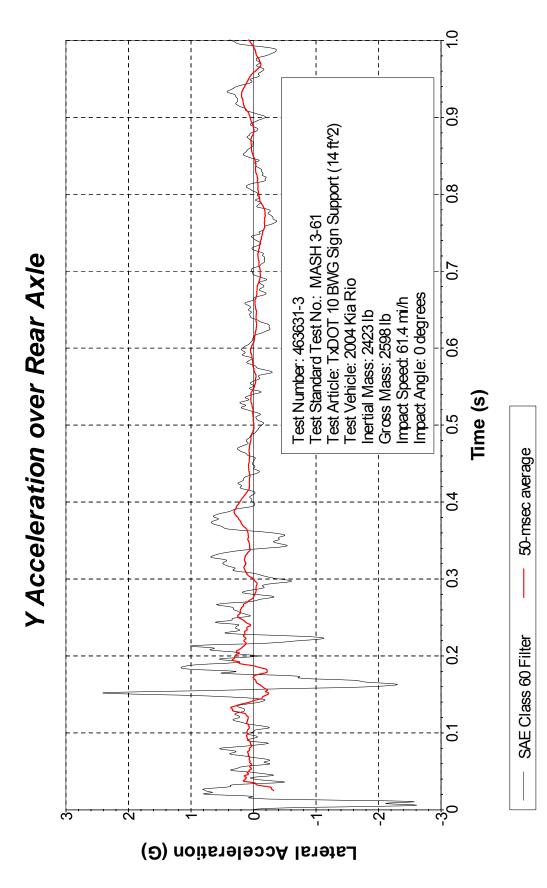
Figure J8. Vehicle Lateral Accelerometer Trace for Test No. 463631-3 (Accelerometer Located over Rear Axle).

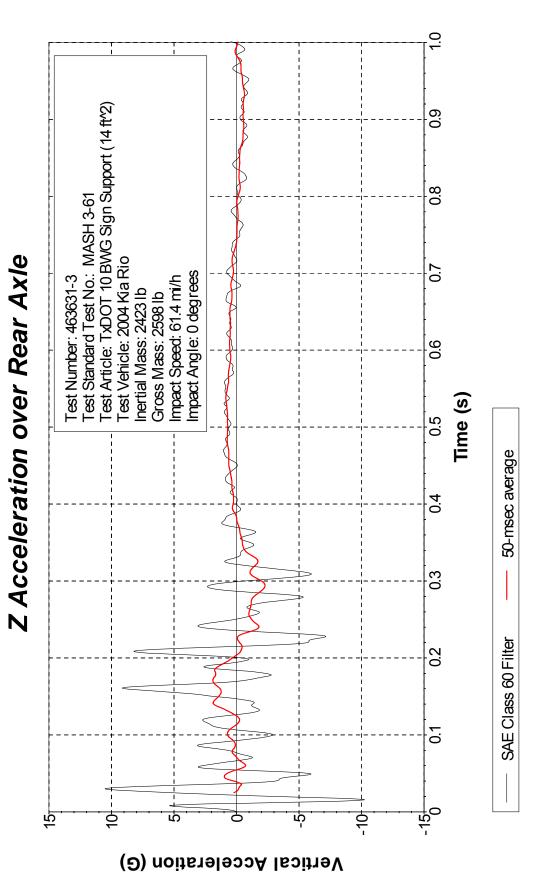
Figure J9. Vehicle Vertical Accelerometer Trace for Test No. 463631-3 (Accelerometer Located over Rear Axle).

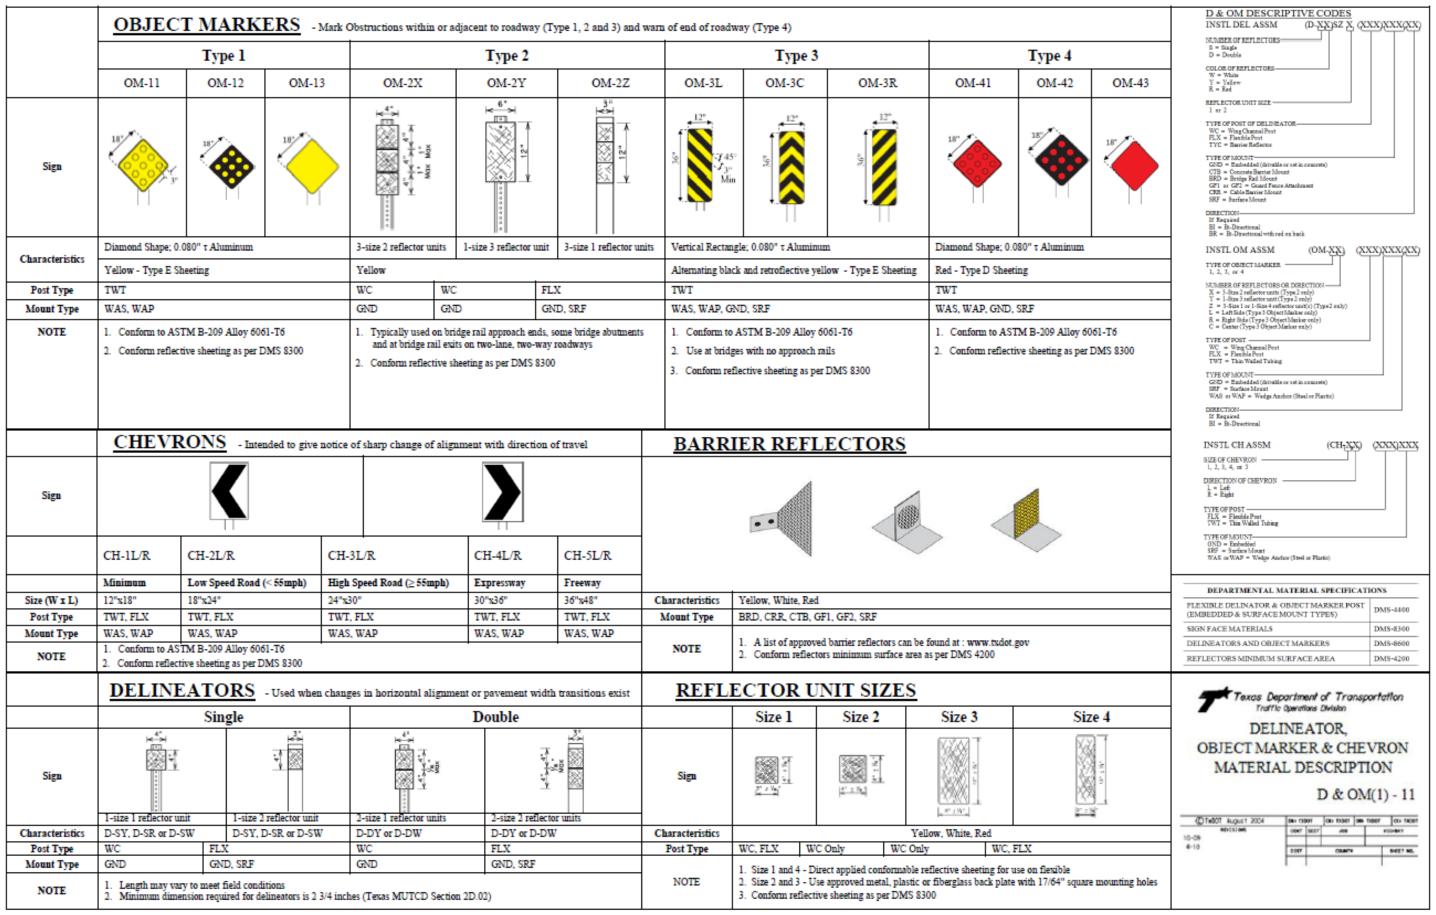
Figure K1. Proposed TxDOT D&OM(1)-11, Option #1.

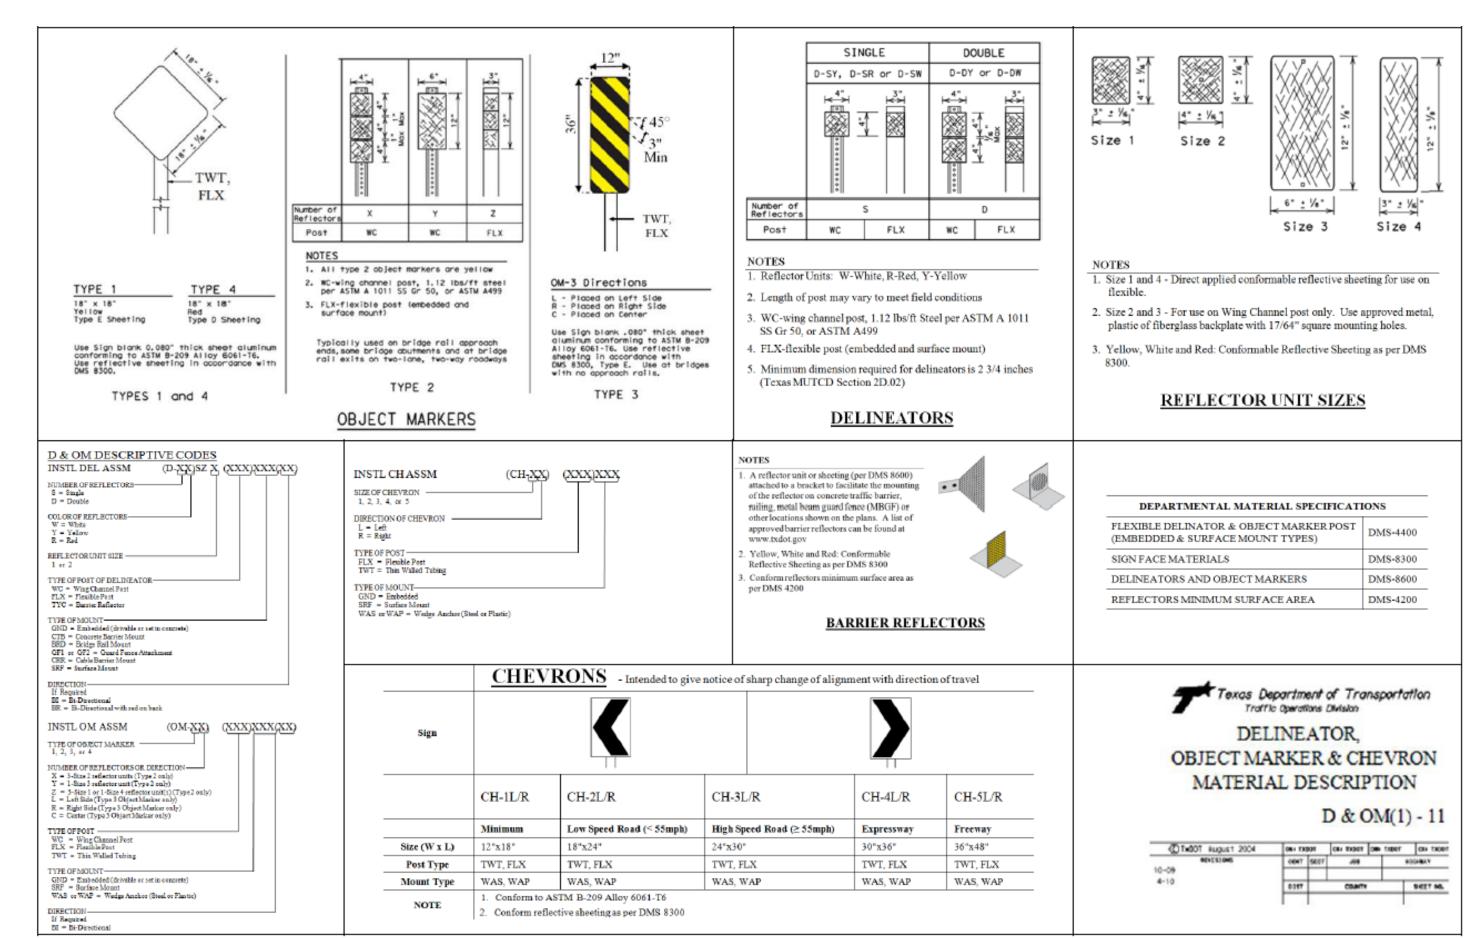
Figure K2. Proposed TxDOT D&OM(1)-11, Option #2.

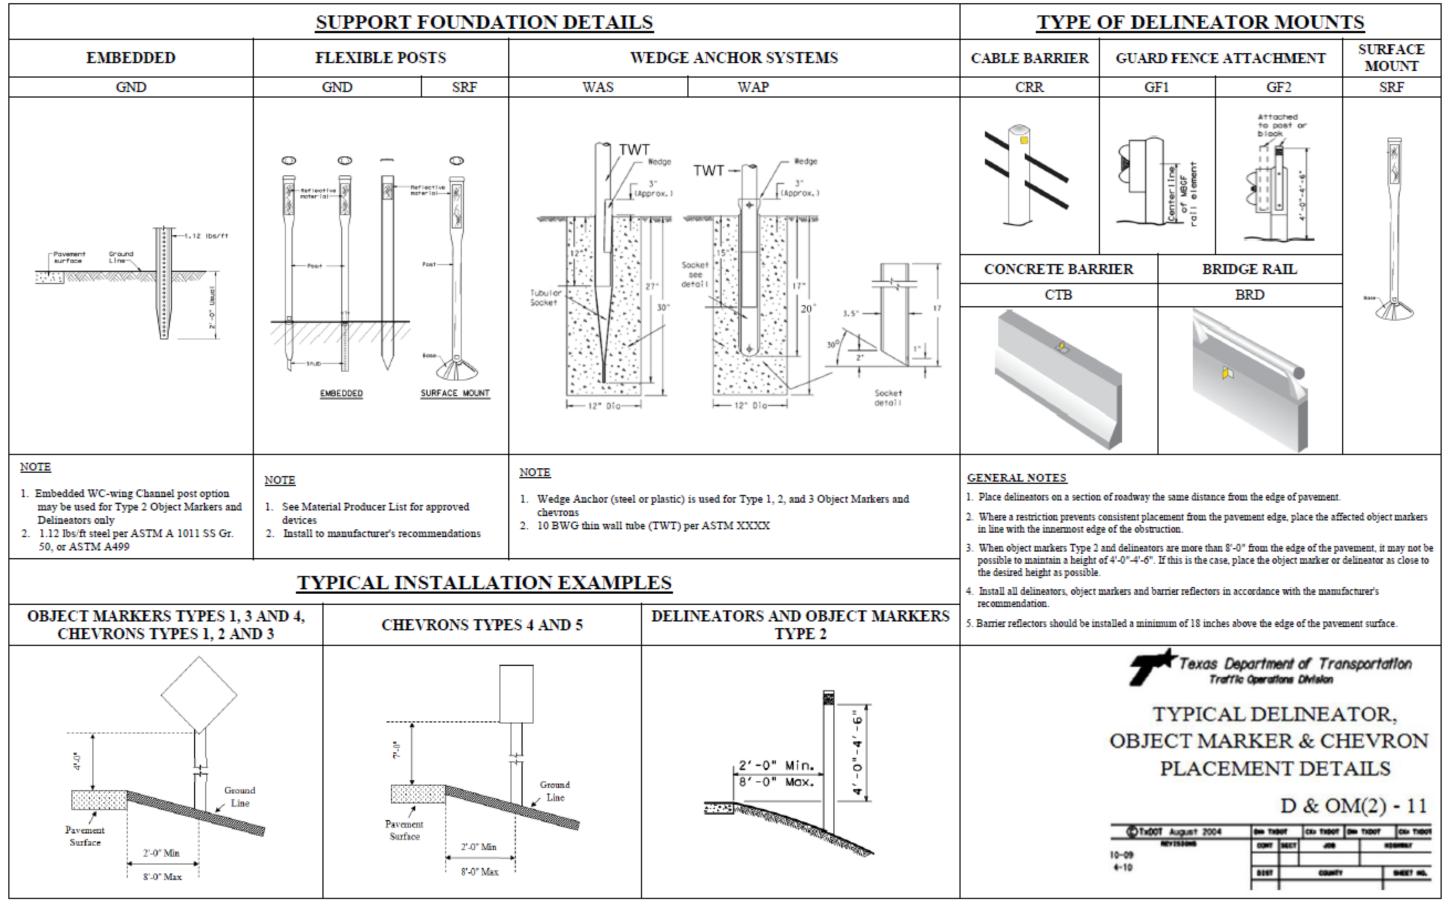
Figure K3. Proposed TxDOT D&OM(2)-11.

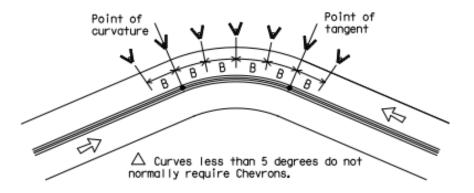
The Chevron may be used to provide additional emphasis and guidance for a change in horizontal alignment. A Chevron may be used as a supplement to delineation.
