**DEVELOP A RETROFIT DESIGN FOR GUARD FENCE SYSTEM TO  
ENHANCE MOTORCYCLE SAFETY  
COOPERATIVE RESEARCH PROGRAM**

Texas Department of Transportation  
<https://tti.tamu.edu/documents/0-6994-R1.pdf>

**TEXAS A&M TRANSPORTATION INSTITUTE PROVING GROUND**

1. Report No. FHWA/TX-23/0-6994-R1	2. Government Accession No.	3. Recipient's Catalog No.	
4. Title and Subtitle DEVELOP A RETROFIT DESIGN FOR GUARD FENCE SYSTEM TO ENHANCE MOTORCYCLE SAFETY		5. Report Date Published: August 2024

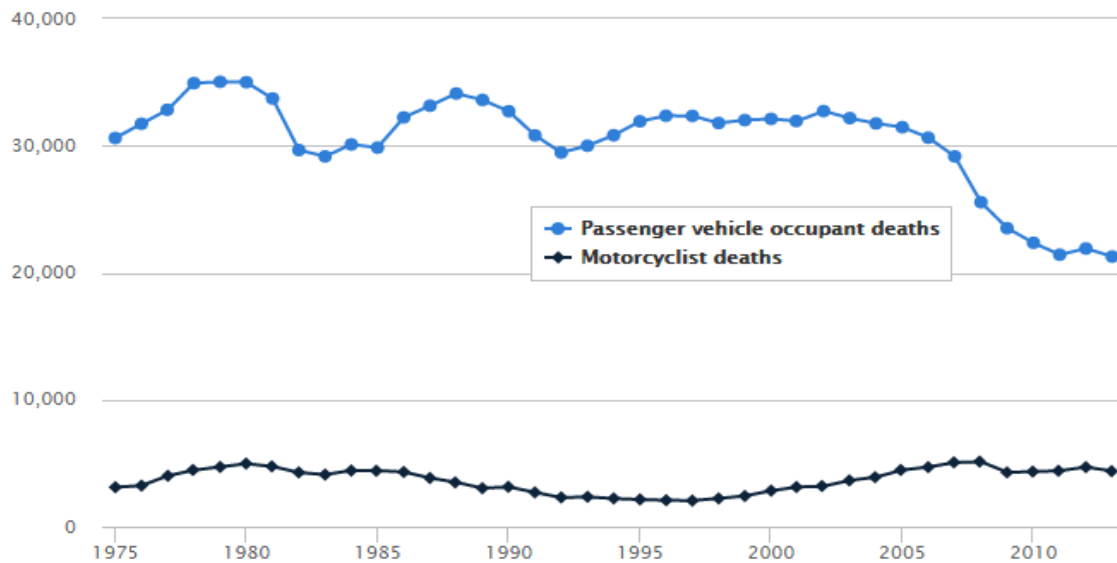
Figure 2.1 illustrates how motorcycle deaths remained almost constant from 1975 to 2013 in the United States (5). There was a small decrease from about 1980 to 1995 and then an increase from 1997 to 2009.

**Figure 2.1. Passenger Vehicle Occupant Deaths and Motorcyclist Deaths in the United States from 1975–2013 (5).**

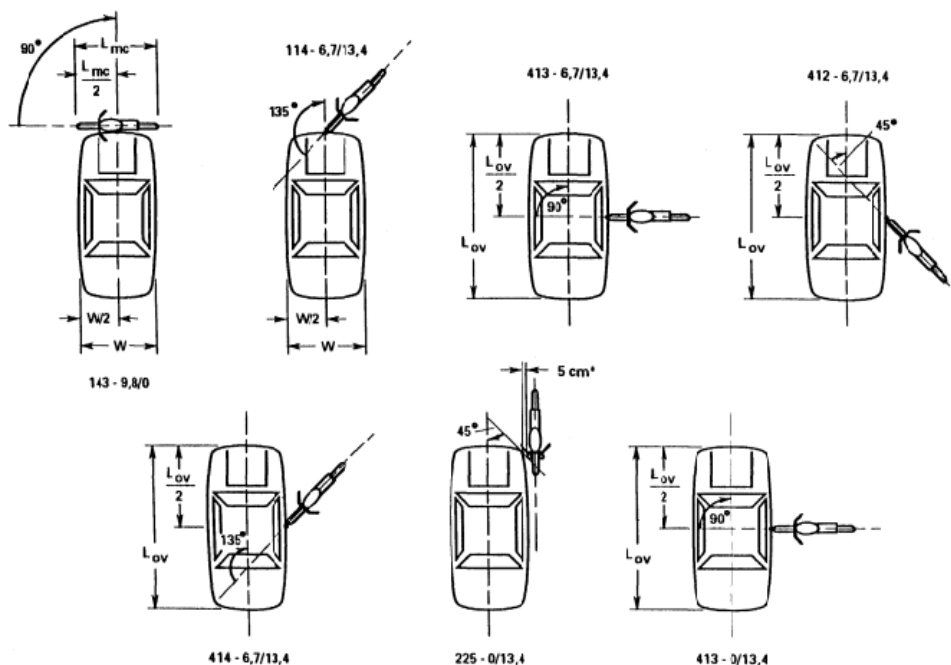
Figure 2.2 illustrates the seven impact configurations specified by ISO 13232-2 to determine severity of motorcycle (MC) impact against an opposing vehicle (OV). Table 2.1 gives the details of the seven configurations.

**Figure 2.2. ISO 13232-2 Impact Configurations (12).**

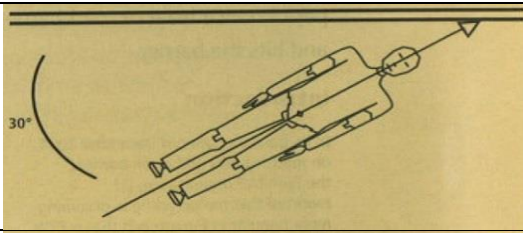
<b>Test 1. Dummy aligned w/ launch path</b>

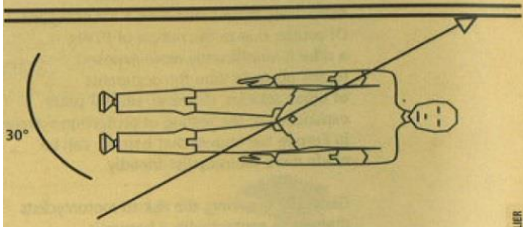
<b>Test 2. Dummy parallel to the test item</b>

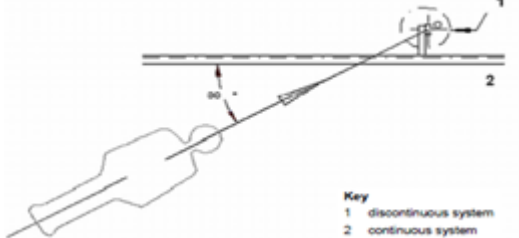
<p><b>Test 1.</b> <b>Launch Configuration 1:</b> <b>Post-Centered Impact</b></p>

<p>Key 1 discontinuous system 2 continuous system</p>
<p><b>Test 2.</b> <b>Launch Configuration 2:</b> <b>Post-Offset Impact</b></p>

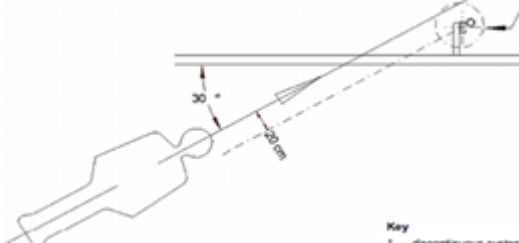
<p>Key 1 discontinuous system</p>
<p><b>Test 3.</b> <b>Launch Configuration 3:</b> <b>Midspan Impact</b></p>

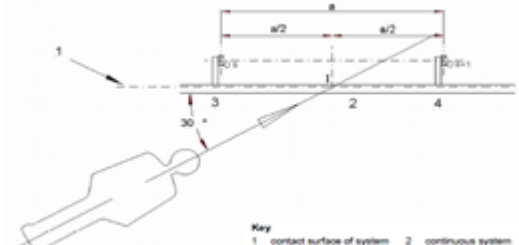
<p>Key 1 contact surface of system 2 continuous system 3 post n. 4 post n+1</p>

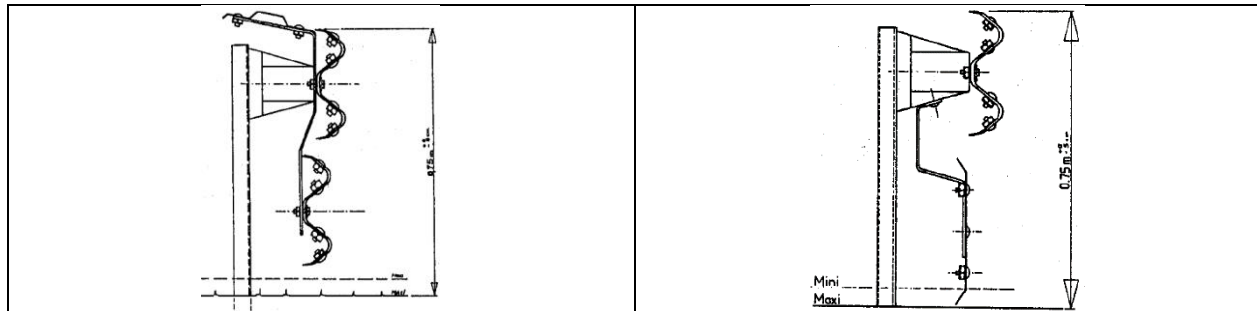
Three tests were performed by Quincy et al. (19): two with one design, and one with another design (Figure 2.3). Tests were performed with a dummy placed on a platform lying on its back (head forward) ejected with a sled. Impact speed and angles for the tests were 34.2 mi/h (all tests), and 32 degrees (Design 1) and 30 degrees (Design 2), respectively.

**Figure 2.3. Metal Beam Guardrail Design 1 (left) and Design 2 (right).**

The deceleration levels and HIC criteria registered on different parts of the dummy were lower than the limit values. After this research was conducted, the motorcycle barrier was approved by the French Transportation Ministry, and some highways were provided with these barriers. However, sufficient accident data were not available to evaluate the system.

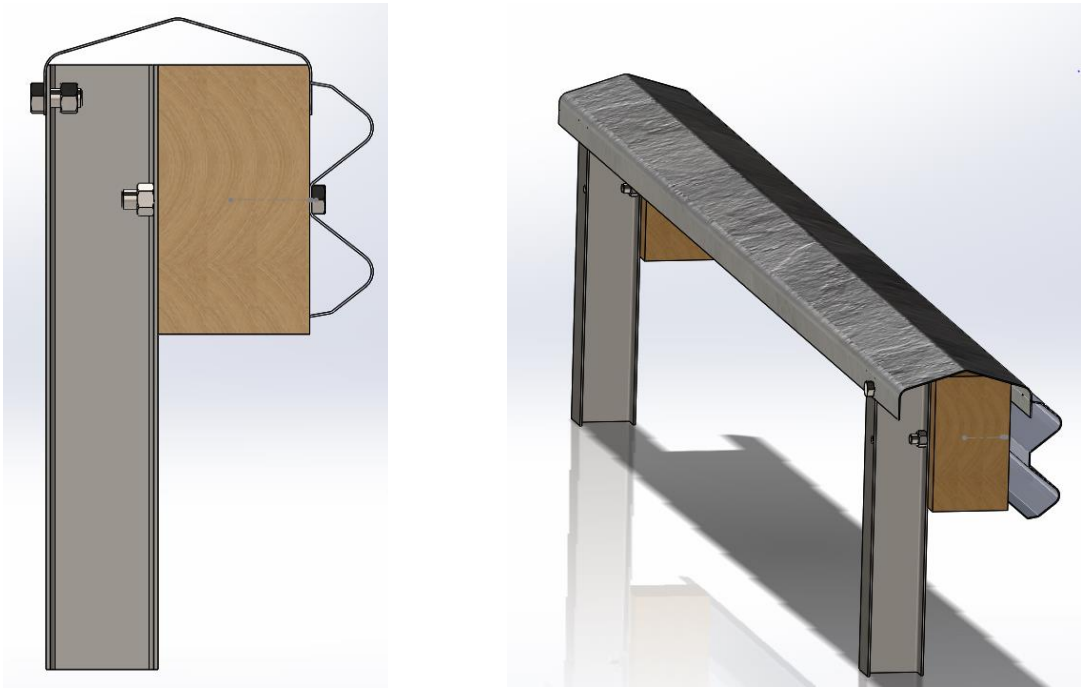
Figure 4.1 shows a bent plate top protection attached to a standard MGS. Option 1 consists of a plate bent to form a smooth vertex on top, gently sloping down and outward from the vertex and bent down at the ends to provide some vertical distance for attachment to the steel post. The top protection bent plate can be provided with the same material and thickness as that of the W-beam rail. Table 4.1 lists the advantages and disadvantages of Option 1.

**Figure 4.1. Option 1 Conceptual Drawing for Bent Plate Top Protection.**

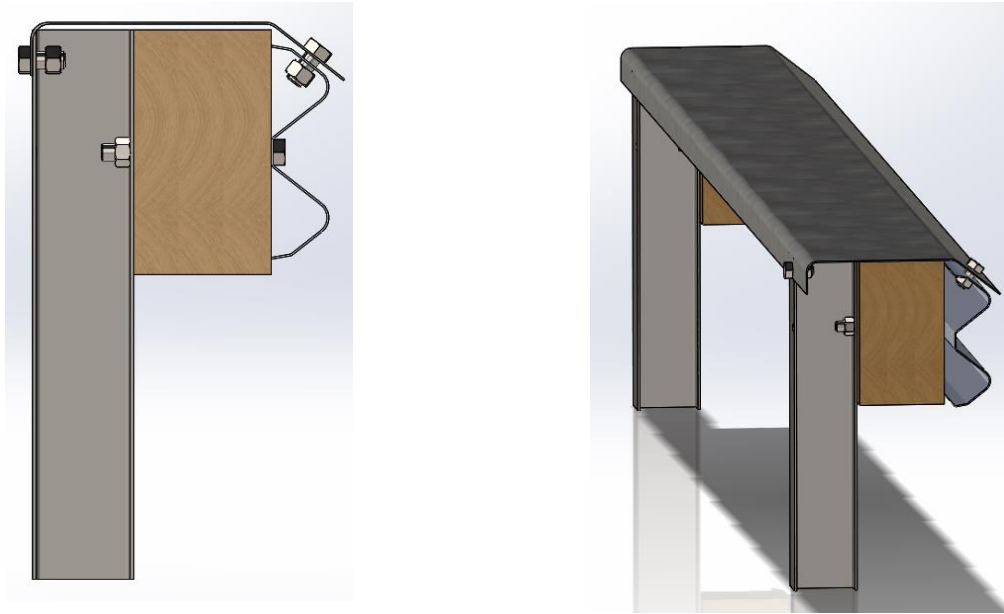
Figure 4.2 shows a flat plate top protection attached to a standard steel-post MGS with 8-inch blockouts. Option 2 consists of a flat plate bent vertically at one end and sloped at the other end to accommodate attachment to the existing W-beam rail. Attachment is provided by a bolted connection at suitable intervals. Bent radius can be determined based on the required smoothness on top with reasonable dimensions. Top protection can be provided with the same material and thickness as that of a W-beam rail. Thickness can be reduced to a certain extent to provide adequate flexibility for

better rider protection during an impact event. Table 4.2 lists the advantages and disadvantages of Option 2.

**Figure 4.2. Option 2 Conceptual Drawing for Flat Plate Top Protection.**

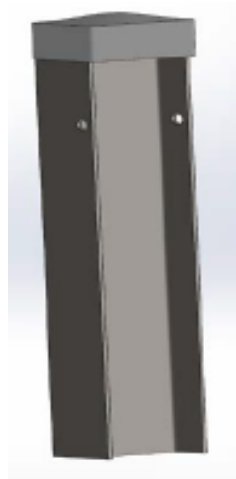
Figure 4.3 shows a top protection cap for discrete posts of the standard MGS. Option 3 consists of a cap attached to the top of the steel post. Attachment is relatively easy and does not require a bolted connection. Top protection can be provided with a suitable thickness and appropriate dimensions that allow flexibility for implementation. Table 4.3 lists the advantages and disadvantages of Option 3.

**Figure 4.3. Option 3 Conceptual Drawing for Top Protection Cap for MGS Steel Posts.**

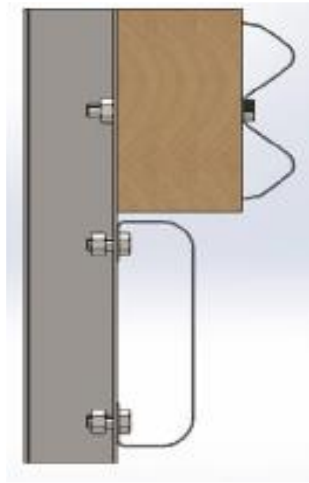
Figure 4.4 shows a flat bottom protection for a steel-post MGS. Option A consists of a round-cornered flat bottom plate attached to the posts with two bolts (at the top and bottom of the plate). The plate is spaced at a suitable distance from the post to allow adequate deformation when a motorcyclist impacts while sliding. The plate is smoothly bent at the ends to provide sufficient length for bolting. The thickness and material of the bottom plate can be the same as those of the standard MGS top rail. However, thickness can be investigated through computer simulations to provide flexibility to dissipate adequate energy after motorcyclist impact to lower injury risk. The distance

between the flat bottom rail and the existing W-beam rail should be minimized to prevent any chance for motorcyclist limbs entangling between the rail and bottom protection. Table 4.4 lists the advantages and disadvantages of Option A.

**Figure 4.4. Option A Conceptual Drawing for Flat Plate for Bottom Protection.**

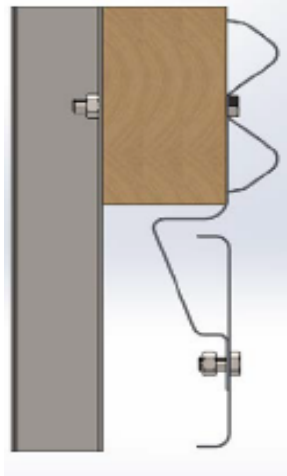
Figure 4.5 shows a flat plate bottom protection for a steel-post MGS. Option B consists of a continuous rubrail attached to the upper W-beam rail and blockout through discrete connection plates. The plates are inserted between the top rail and the blockout through a single bolt connection. The rubrail could be inclined at an angle. The thickness and material of the plates and rubrail can be the same as those of a standard W-beam. However, thickness can be reduced based on computer simulations to provide

flexibility and energy dissipation during motorcyclist impact. The distance between the flat bottom rail and the existing W-beam rail should be minimized to reduce the chance for motorcyclist limbs entangling between the rail and bottom protection. Table 4.5 lists the advantages and disadvantages of Option B.

**Figure 4.5. Option B Conceptual Drawing for Flat Plate Attached to Connection Plates.**

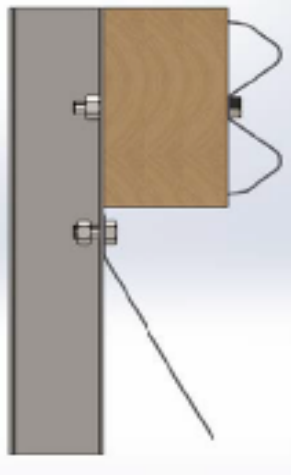
Figure 4.6 shows the inclined plate for bottom protection for a steel-post MGS. Option C consists of a continuous plate attached to the front of the posts of the MGS and then bent to form an incline at the bottom to accommodate a sliding rider during an impact event. The thickness and material of the plate can be the same as those of the standard MGS top rail. However, thickness can be reduced based on computer simulations to provide flexibility and therefore energy dissipation during motorcyclist impact. The bottom end of the plate should be at a suitable height from the ground to prevent accumulation of debris at the bottom. The advantages and disadvantages for this option are similar to Option A (Table 4.4).

**Figure 4.6. Option C Conceptual Drawing for Inclined Plate Attached to Posts.**

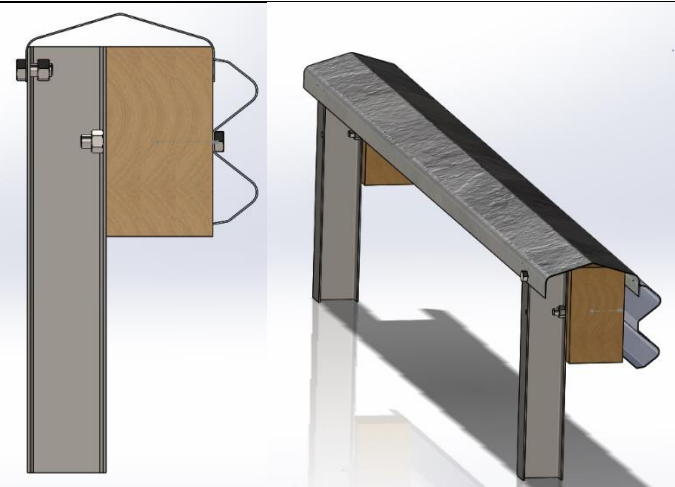
Design Option	Visual Concept
Option 1

Table 4.6. Proposed Design Options for Top Protection.

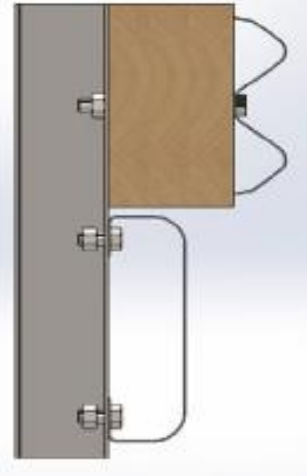
Design Option	Visual Concept
Option A

Table 4.7. Proposed Design Options for Bottom Protection.

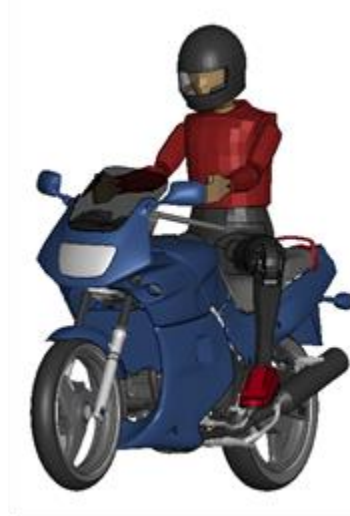
An FE model of the selected design was developed, and LS-DYNA was used to perform impact simulations. The design was evaluated according to *MASH* TL-3 and according to upright and sliding motorcyclist impact configurations. Figure 5.1 shows the motorcycle and Hybrid III 50th percentile ATD model. The ATD FAST Hybrid III 50th percentile model was developed by LSTC. The simulation results were used to evaluate whether any design modifications were required to the developed design system to increase the likelihood of meeting the project objectives before proceeding with full-scale crash testing.

**Figure 5.1. Motorcycle and ATD FE Model.**

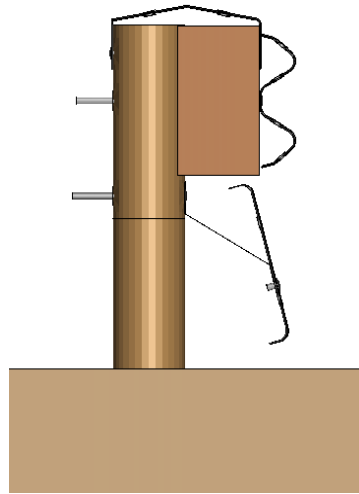
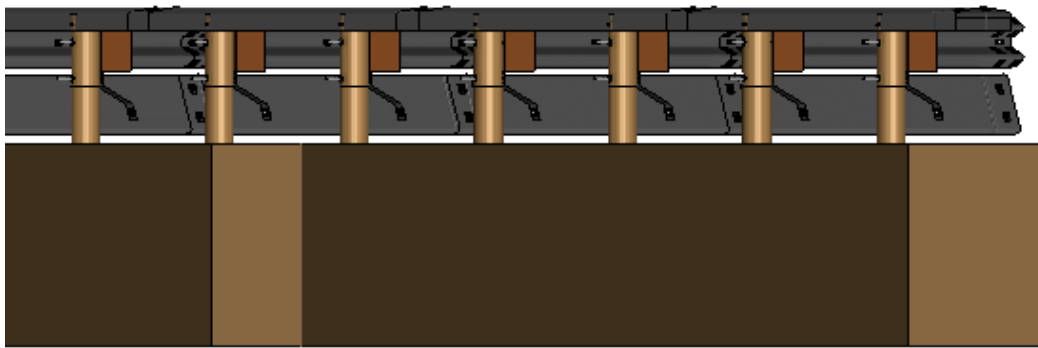
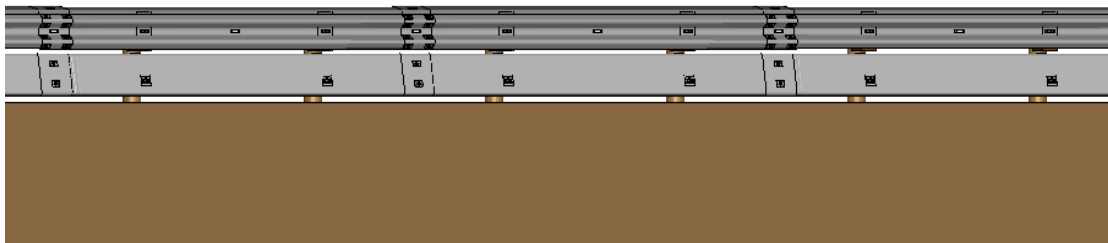
**Figure 5.2. FE Model of Retrofit Guardrail System.**

Figure 5.2 shows the model that was developed to retrofit the existing guardrail system to address errant motorcyclists' safety. This model included the top rail and rubrail design options.

(a) Side View

(b) Perspective Rear

(c) Perspective Front

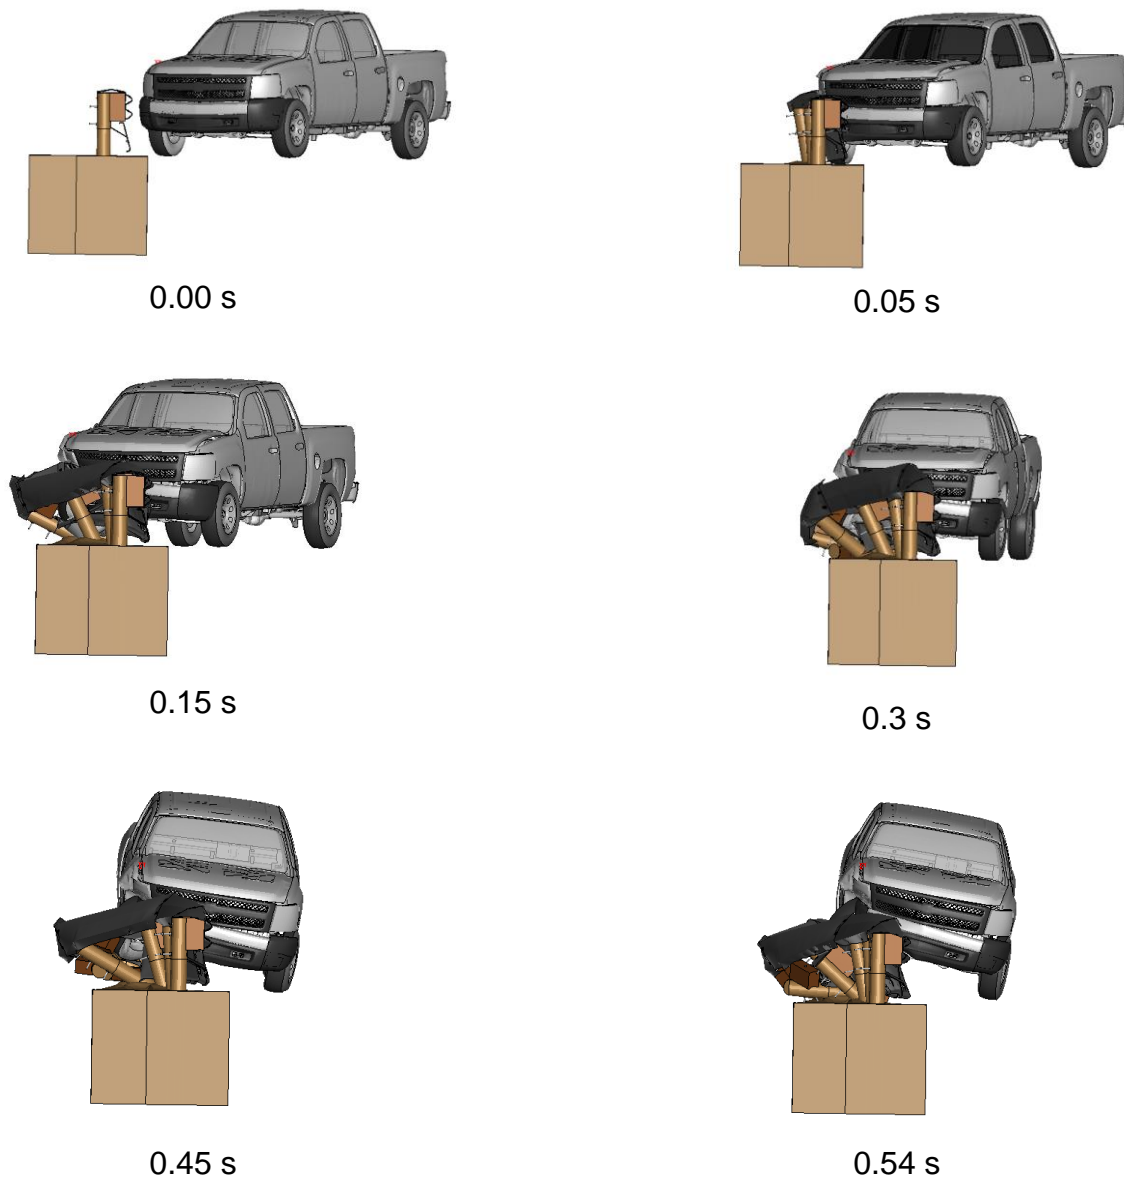
**Figure 5.4. Sequential Images of *MASH* Test 3-11 Impact with Barrier.**

A pickup truck FE model was used to impact the retrofit guardrail system according to *MASH* Test 3-11. The impact speed was 62 mi/h, and the impact angle was 25 degrees. Figure 5.4 shows sequential images of the simulation impact.

The pickup truck was successfully contained and redirected during impact with the guardrail system. The vehicle remained stable throughout the event, and the occupant risk values were below the *MASH* limit. During the impact event, however, it was noted that the pickup truck pushed down on the rubrail element and seemed to keep riding on top of it. Although it appeared that riding on top of the rubrail did not

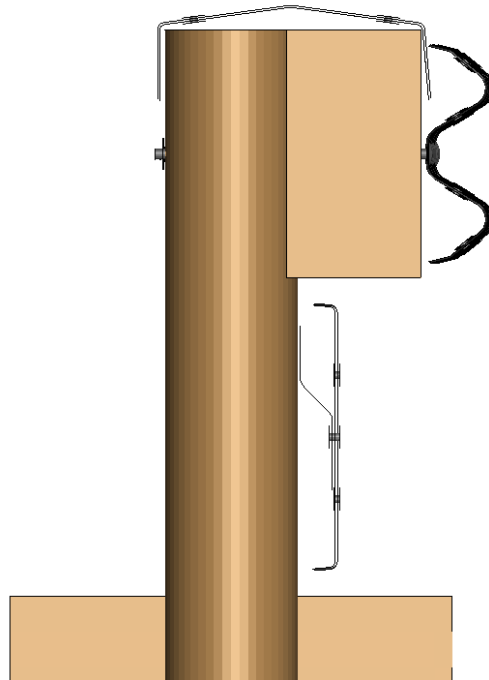
**Figure 5.5. FE Model of Modified Retrofit Guardrail System.**

A modification was made to the system to attach the rubrail with minimal offset from the wood posts to reduce some of the noted pickup truck interaction with the rubrail. Figure 5.5 shows a cross-section view of the modified system.

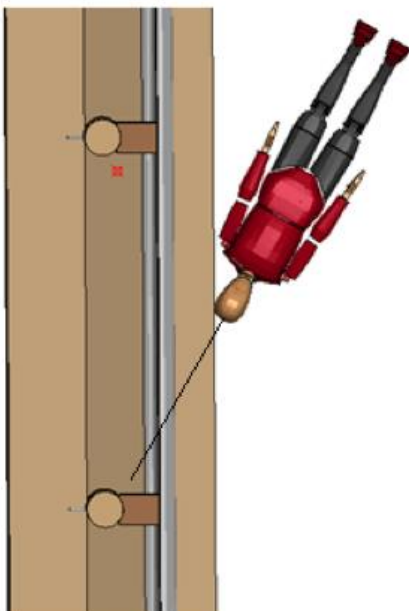
**Figure 5.6. ATD Sliding Impact with System.**

After the system was modified, simulations were conducted with the ATD model sliding into the system at a speed of 37 mi/h and an angle of 30 degrees. Figure 5.6 shows a layout of the simulation event with the ATD impacting in line with the wood post. The rubrail indicated the ability to contain and redirect the ATD during impact, and no snagging of limbs on discrete elements was observed.

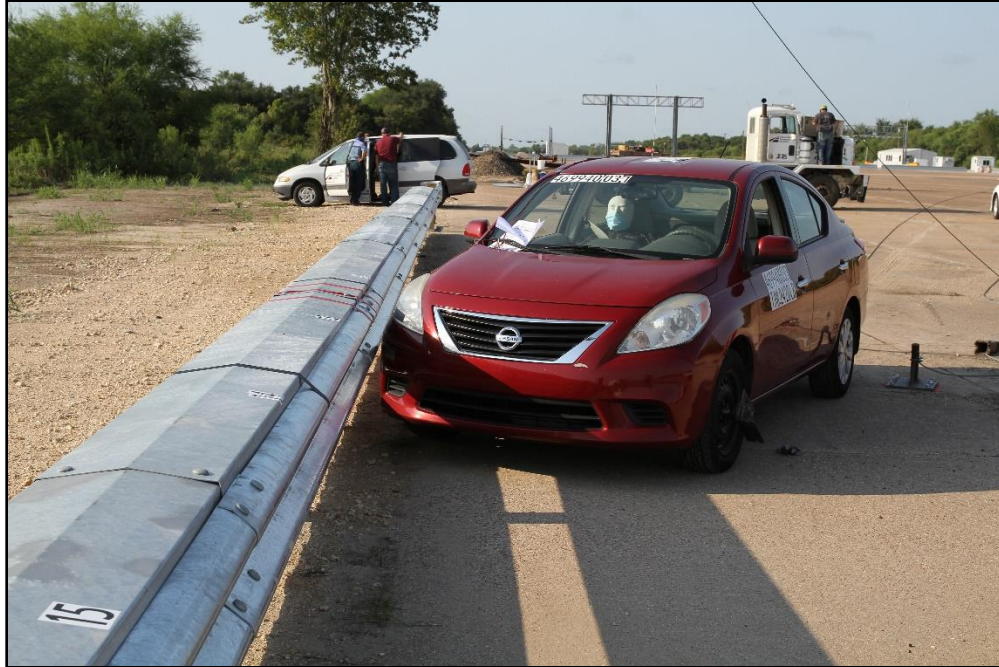
**Figure 9.1. Enhanced Motorcycle Guard Fence System/Test Vehicle Geometrics for Test 469940-03-1.**

See Table 9.1 for the *MASH* impact conditions and Table 9.2 for the exit parameters for Test 469940-03-1. Figure 9.1 and Figure 9.2 depict the target impact setup.

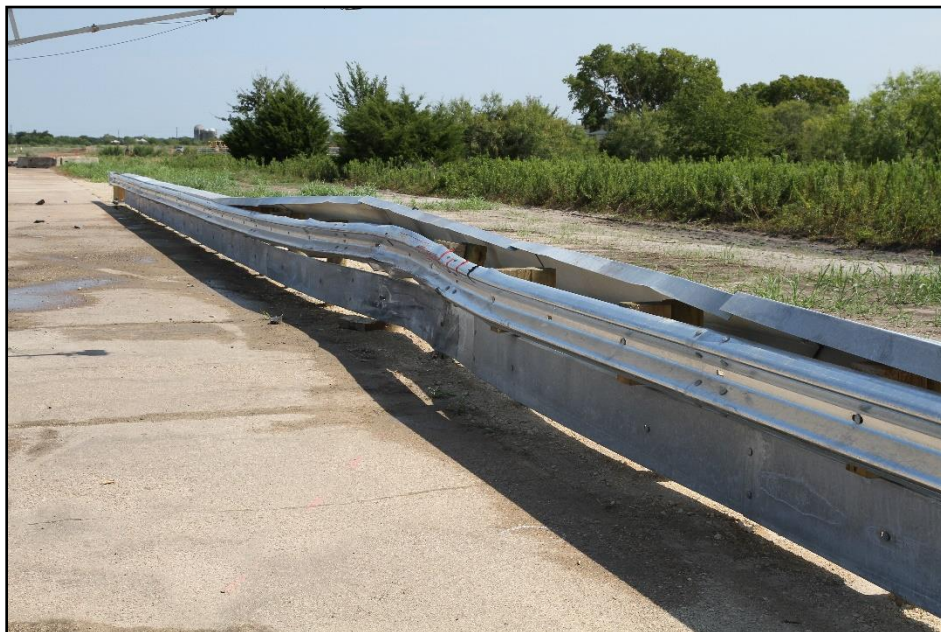
**Figure 9.5. Enhanced Motorcycle Guard Fence System at Impact Location after Test 469940-03-1.**

There was no movement at the end terminals. Post 13 was cracked at grade, the blockout was missing from post 14, and the lower channel was detached from post 14. Table 9.6 details the soil gap and post lean information.

Table 9.7 describes the deflection and working width of the enhanced motorcycle guard fence system. Figure 9.5 and Figure 9.6 show the damage to the enhanced motorcycle guard fence system.

Test Parameter	Measured
Permanent Deflection/Location	10.5 inches toward field side, 1 ft upstream from the centerline of post 14
Dynamic Deflection	19.5 inches toward field side at the midspan between posts 13 and 14
Working Width <sup>a</sup> and Height	37.3 inches, at a height of 36.8 inches, at the top rail at the midspan of posts 12 and 13

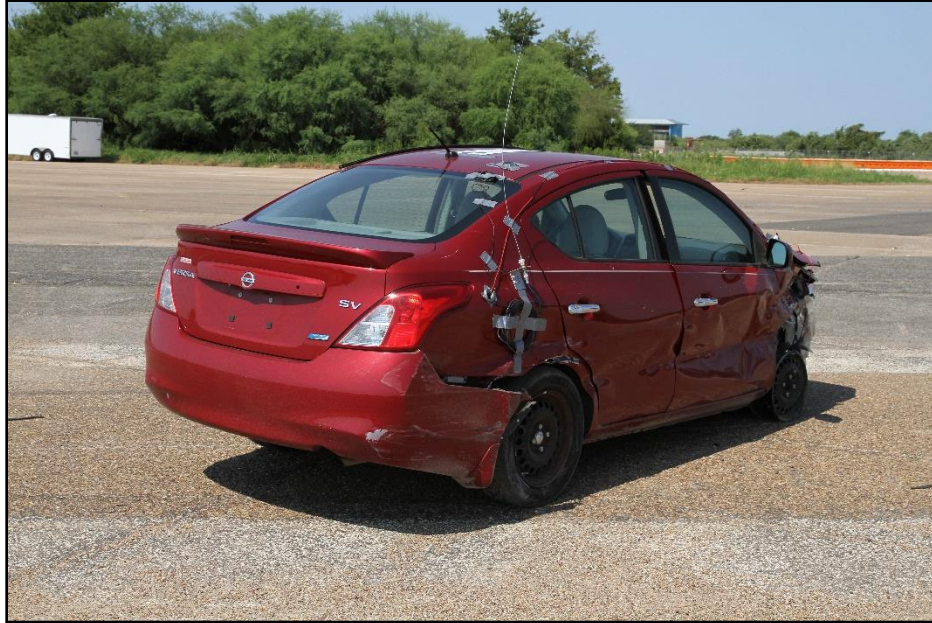
**Figure 9.8. Rear Impact Side of Test Vehicle after Test 469940-03-1.**

Figure 9.7 and Figure 9.8 show the damage sustained by the vehicle. Figure 9.9 and Figure 9.10 show the interior of the test vehicle. Table 9.8 and Table 9.9 provide details on the occupant compartment deformation and exterior vehicle damage. Figures C.2 and C.3 in Appendix C.1 provide exterior crush and occupant compartment measurements.

<b>Side Windows</b>	Side windows remained intact
<b>Maximum Exterior Deformation</b>	8 inches in the right plane at the right front corner at bumper height
<b>VDS</b>	01RFQ2
<b>CDC</b>	01FREW1
<b>Fuel Tank Damage</b>	None
<b>Description of Damage to Vehicle:</b>	The front bumper, hood, grill, right front fender and headlight, radiator support, right front strut and tower, right front control arm, right front tire and rim, right front door, right rear door, and right rear fender and bumper were damaged. The right front door had a 2-inch gap at the top.

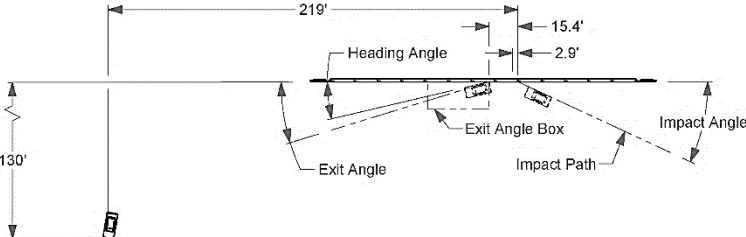
**Figure 9.11. Summary of Results for *MASH* Test 3-10 on Enhanced Motorcycle Guard Fence System.**

Figure 9.11 summarizes the results of *MASH* Test 469940-03-1.

Name		Enhanced Motorcycle Guard Fence System					
	Length		181 ft 3 inches					
	Key Materials		Round timber posts, cap rail, W-beam guardrail, rubrail					
	Soil Type and Condition		Type A Grade 2 crushed limestone					
	<b>TEST VEHICLE</b>							
	Type/Designation		1100C					
	Year, Make and Model		2014 Nissan Versa					
	Inertial Weight (lb)		2440					
	Dummy (lb)		165					
	Gross Static (lb)		2605					
	<b>IMPACT CONDITIONS</b>							
	Impact Speed (mi/h)		63.1					
	Impact Angle (deg)		25.1					
	Impact Location		35.2 inches upstream from the centerline of post 13					
	Impact Severity (kip-ft)		58.4					
	<b>EXIT CONDITIONS</b>							
	Exit Speed (mi/h)		43.4

Trajectory/Heading Angle (deg)		17.0/13.2					
	Exit Box Criteria		Vehicle crossed exit box 29 ft downstream					
	Stopping Distance		219 ft downstream 130 ft to the traffic side					
	<b>TEST ARTICLE DEFLECTIONS</b>							
	Dynamic (inches)		19.5					
	Permanent (inches)		10.5					
	Working Width/Height (inches)		37.25/36.8					
	<b>VEHICLE DAMAGE</b>							
	VDS		01RFQ2					
	CDC		01FREW1					
	Max. Ext. Deformation (inches)		8					
	Max Occupant Compartment Deformation		None					
<b>OCCUPANT RISK VALUES</b>								
Long. OIV (ft/s)	19.2	Long. Ridedown (g)	8	Max 50-ms Long. (g)	-7.4	Max Roll (deg)	8.1	
Lat. OIV (ft/s)	21.7	Lat. Ridedown (g)	9.9	Max 50-ms Lat. (g)	-8.8	Max Pitch (deg)	3.3	
THIV (m/s)	9.5	ASI	1.16	Max 50-ms Vert. (g)	2.4	Max Yaw (deg)	62.1

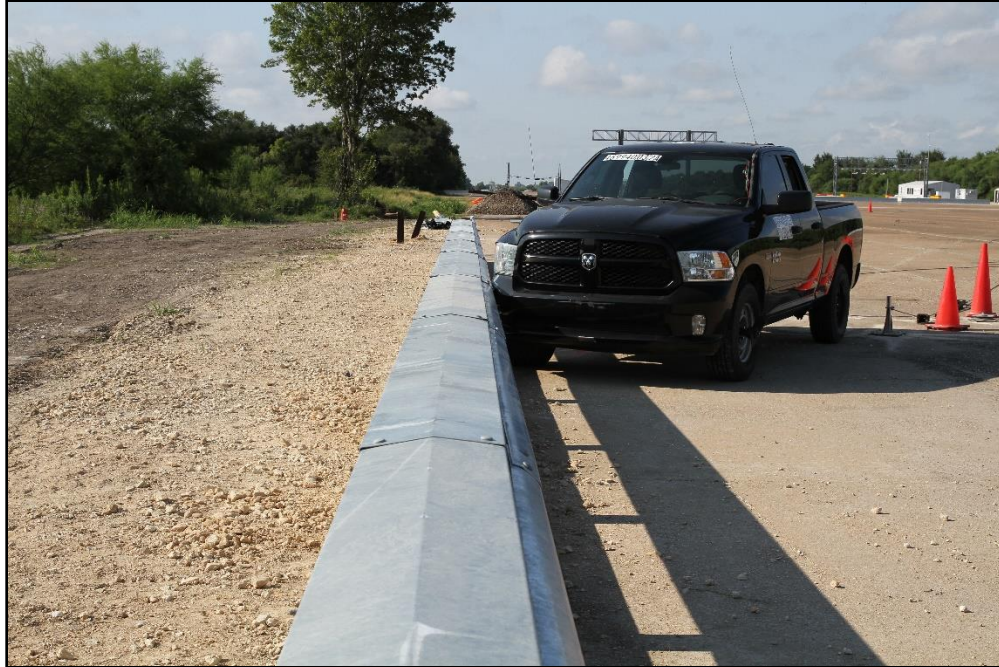
**Figure 10.1. Enhanced Motorcycle Guard Fence System/Test Vehicle Geometrics for Test 469940-03-2.**

See Table 10.1 for the *MASH* impact conditions and Table 10.2 for the exit parameters for Test 469940-03-2. Figure 10.1 and Figure 10.2 depict the target impact setup.

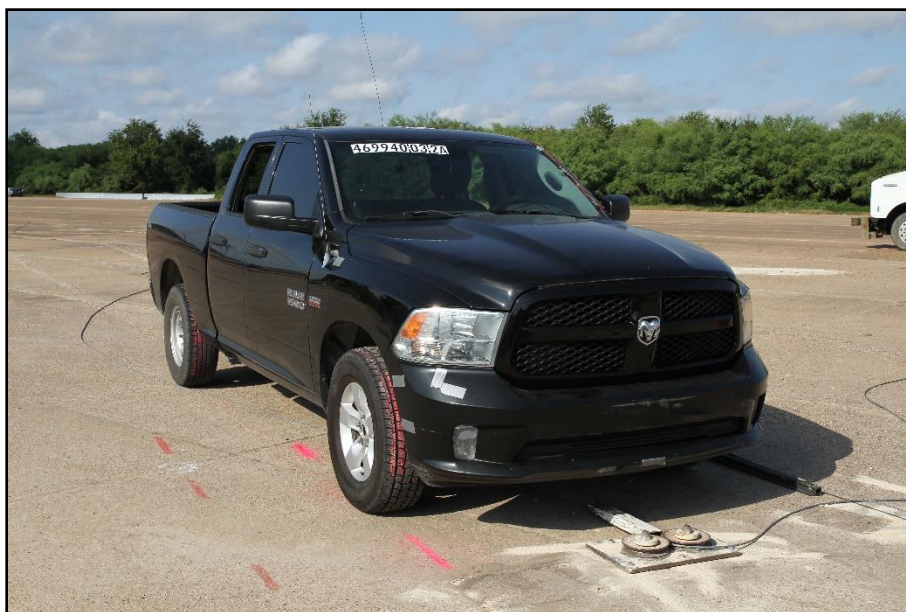
**Figure 10.3. Impact Side of Test Vehicle before Test 469940-03-2.**

Figure 10.3 and Figure 10.4 show the 2014 RAM 1500 used for the crash test. Table 10.4 shows the vehicle measurements. Figure D.1 in Appendix D.1 gives additional dimensions and information on the vehicle.

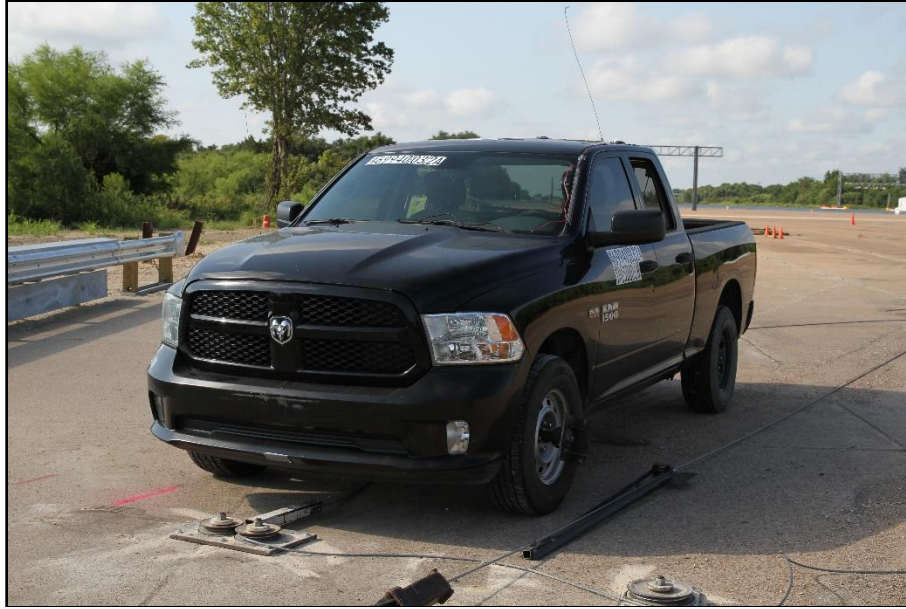
**Figure 10.4. Opposite Impact Side of Test Vehicle before Test 469940-03-2.**

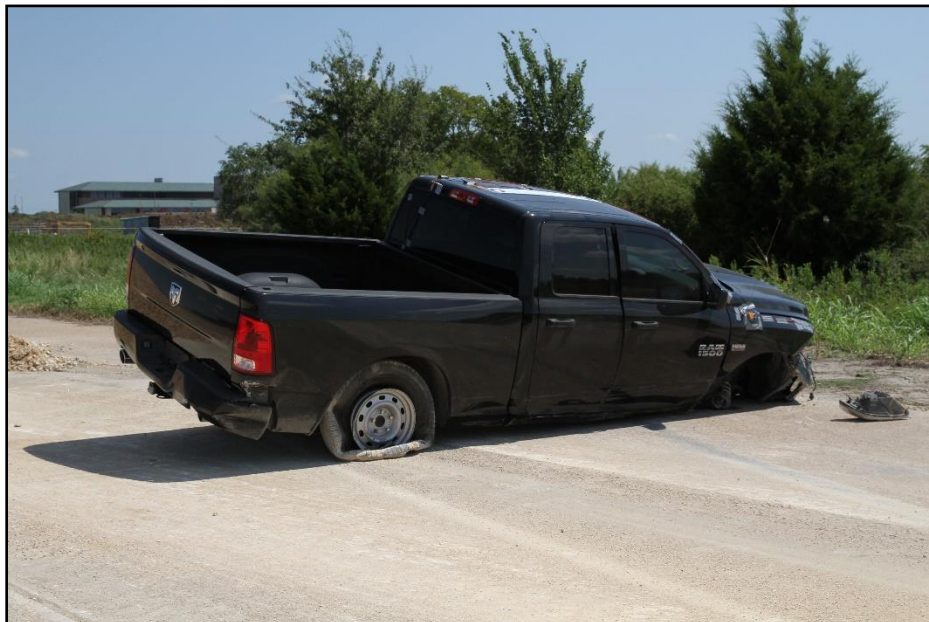
**Figure 10.8. Rear Impact Side of Test Vehicle after Test 469940-03-2.**

Figure 10.7 and Figure 10.8 show the damage sustained by the vehicle. Figure 10.9 and Figure 10.10 show the interior of the test vehicle. Table 10.7 and Table 10.8 provide details on the occupant compartment deformation and exterior vehicle damage. Figures D.2 and D.3 in Appendix D.1 provide exterior crush and occupant compartment measurements.

<b>Side Windows</b>	The side windows remained intact
<b>Maximum Exterior Deformation</b>	8 inches in the front and side plane at the right front corner at bumper height
<b>VDS</b>	01RFQ3
<b>CDC</b>	01FREW2
<b>Fuel Tank Damage</b>	None
<b>Description of Damage to Vehicle:</b>	The front bumper, hood, grill, right headlight, right front fender, right front upper and lower control arms, right front tire and rim, right front door, right rear door, right rear fender, right rear tire and rim, and rear bumper were damaged. The right front door had a 1.5-inch gap at the top.

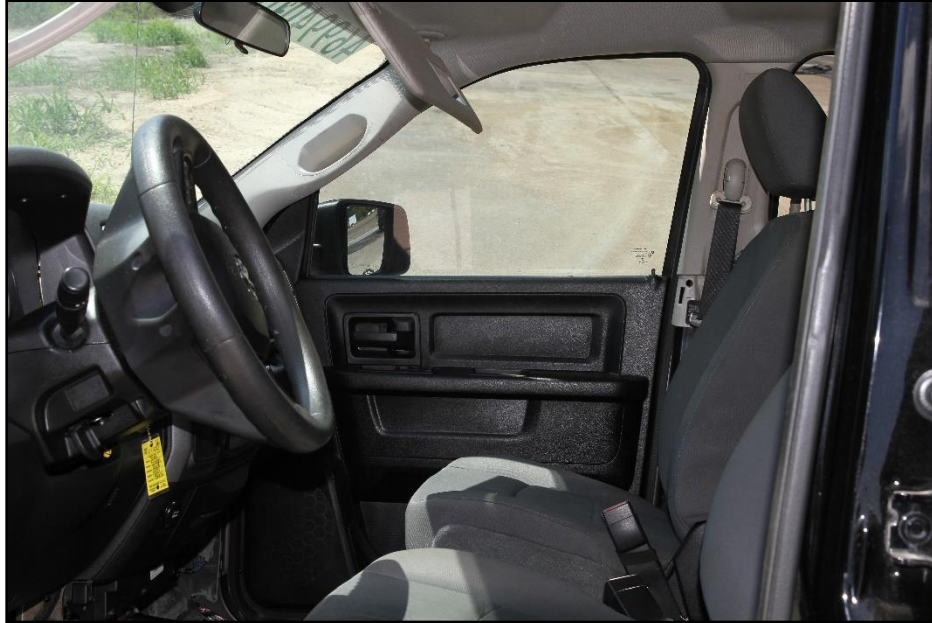
**Figure 10.9. Overall Interior of Test Vehicle after Test 469940-03-2.**

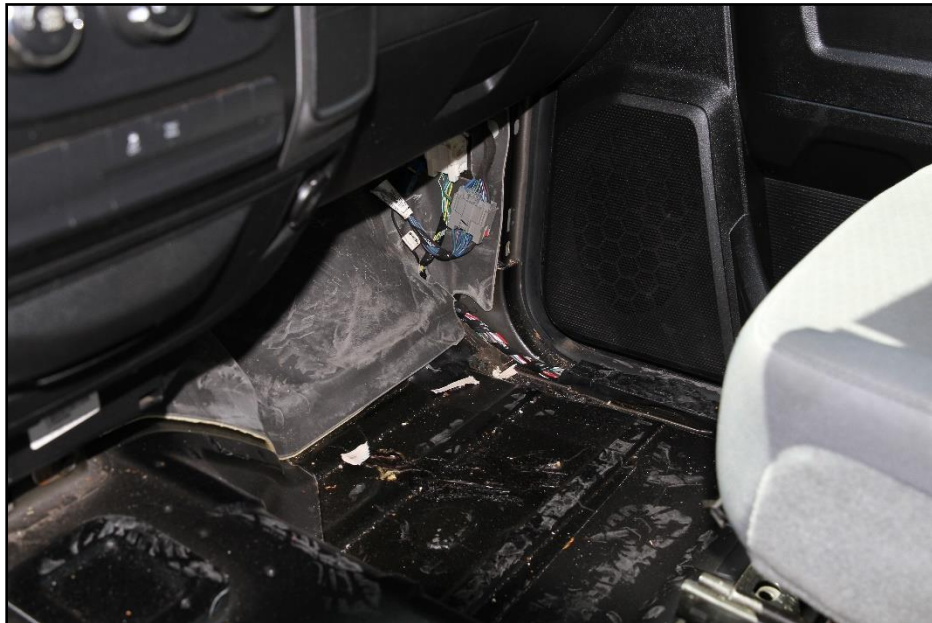
**Figure 10.10. Interior of Test Vehicle on Impact Side after Test 469940-03-2.**

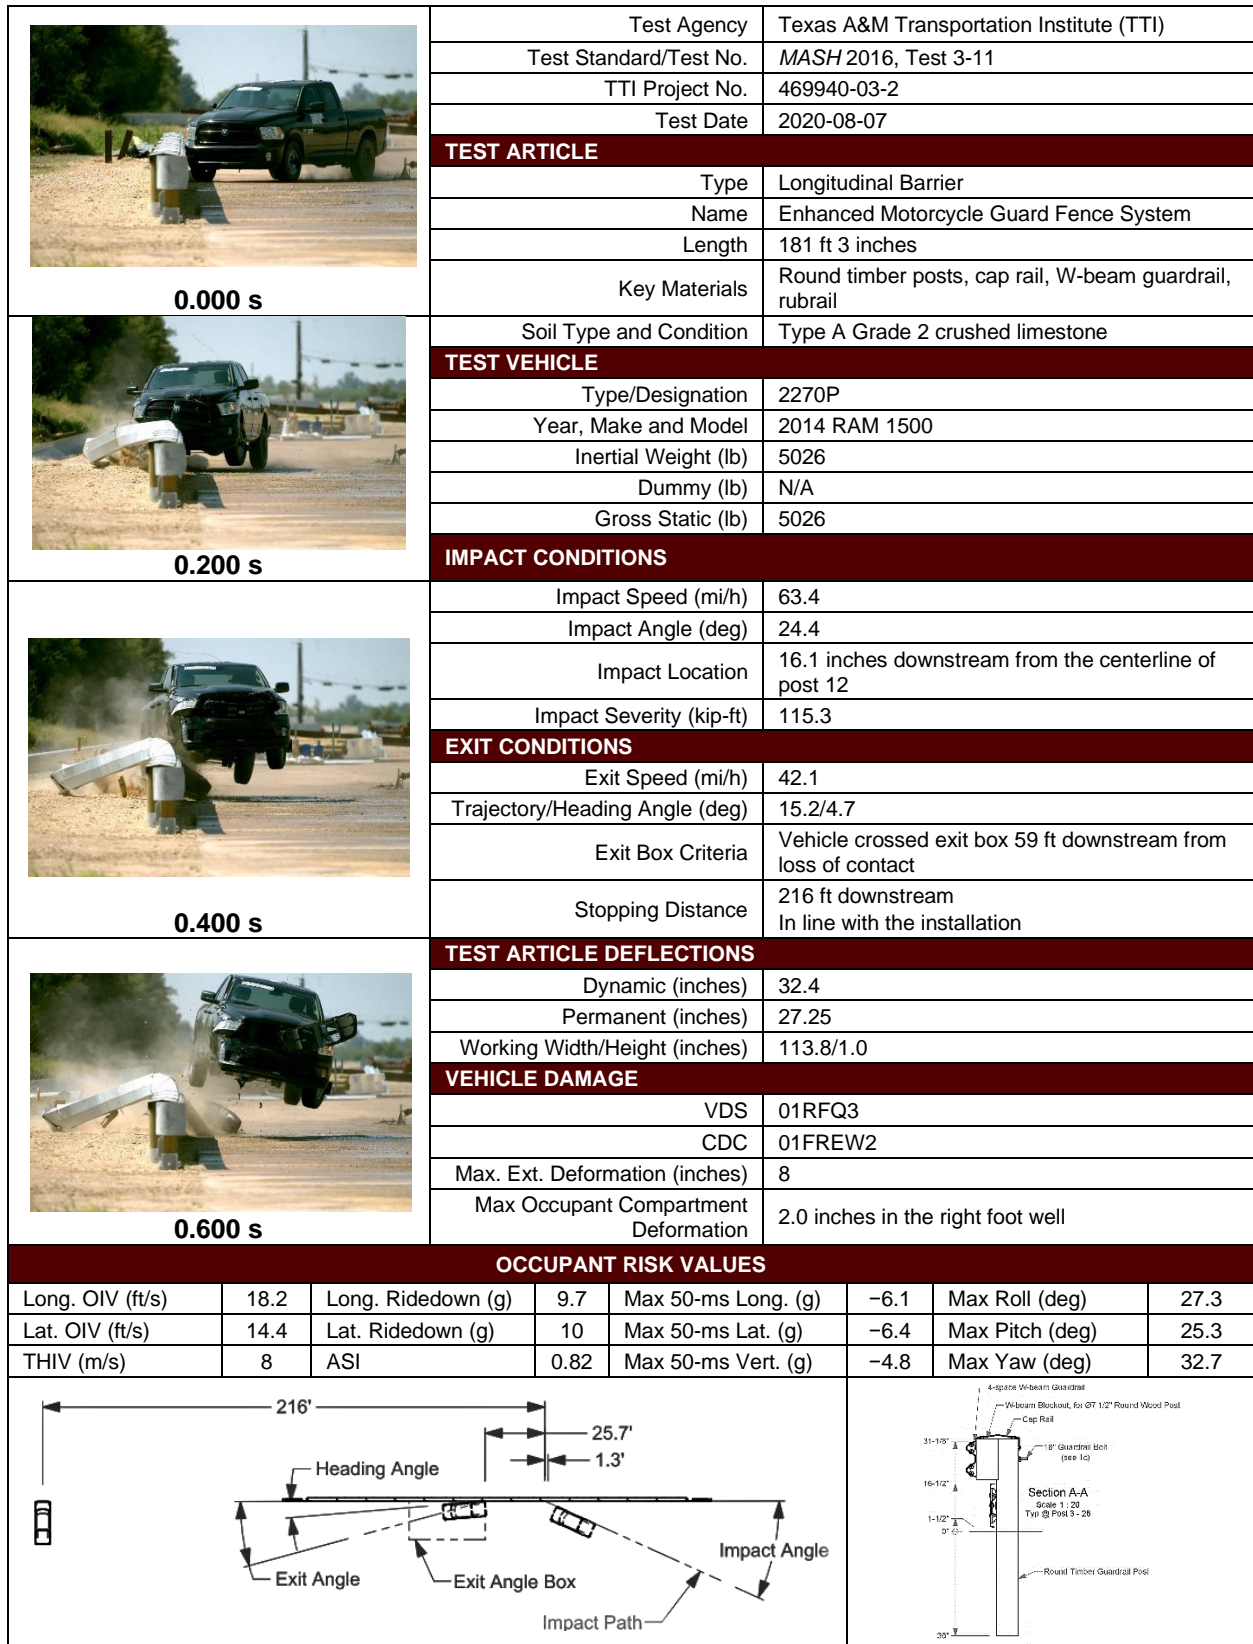
**Figure 10.11. Summary of Results for *MASH* Test 3-11 on Enhanced Motorcycle Guard Fence System.**

Figure 10.11 summarizes the results of *MASH* Test 469940-03-2.

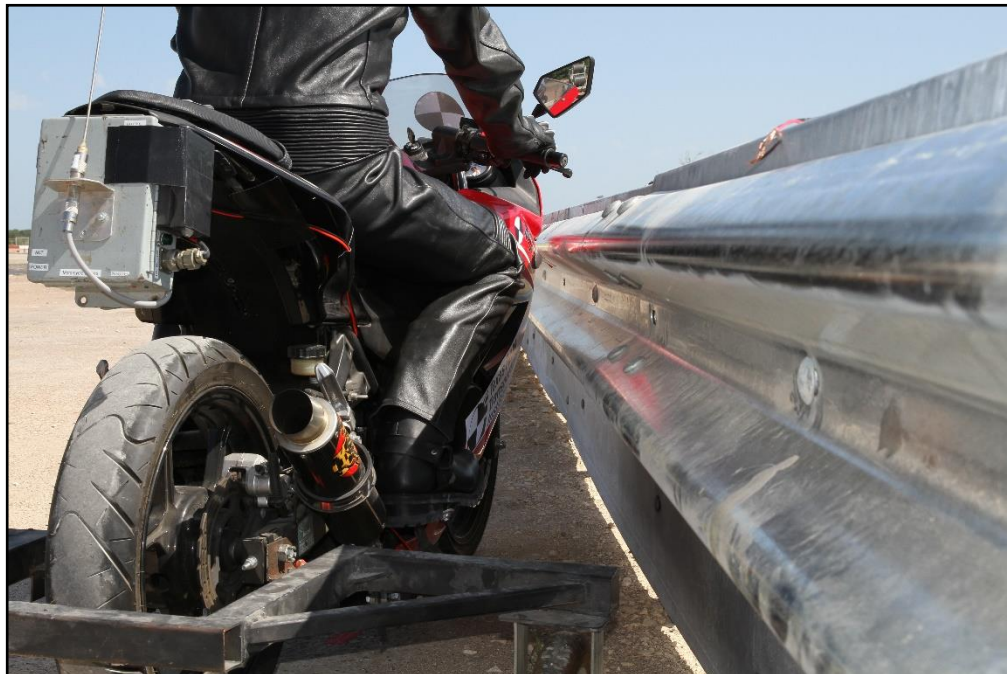
**Figure 11.2. Enhanced Motorcycle Guard Fence System/Test Vehicle Impact Location for Test 469940-03-3.**

See Table 11.1 for the impact conditions and Table 11.2 for the exit parameters for Test 469940-03-3. Figure 11.1 and Figure 11.2 depict the target impact setup.

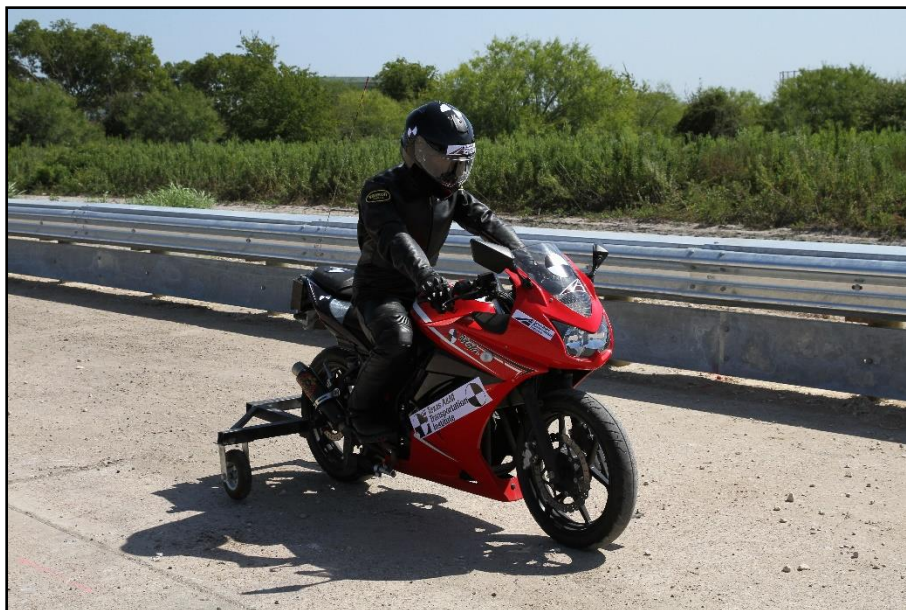
**Figure 11.3. Impact Side of Test Vehicle before Test 469940-03-3.**

Figure 11.3 and Figure 11.4 show the 2012 Kawasaki 250 Ninja used for the crash test. Table 11.4 shows the vehicle measurements. Figure E.1 in Appendix E.1 gives additional dimensions and information on the vehicle.

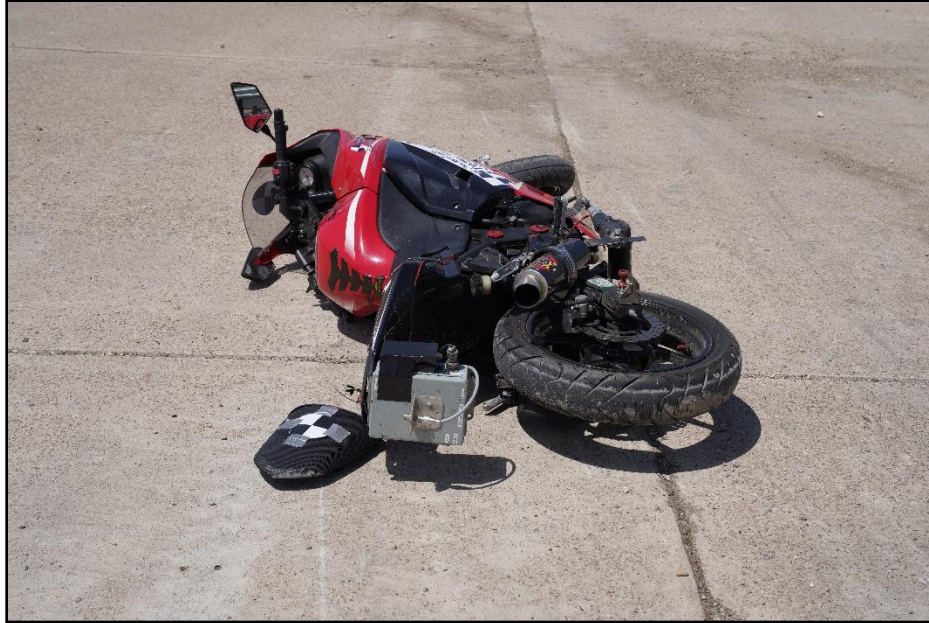
**Figure 11.8. Rear Impact Side of Test Vehicle after Test 469940-03-3.**

The front fairing, right and left side fairings, and right turn signal were damaged. No damage to the fuel tank was observed.

Figure 11.7, Figure 11.8, and Figure 11.9 show the damage sustained by the vehicle.

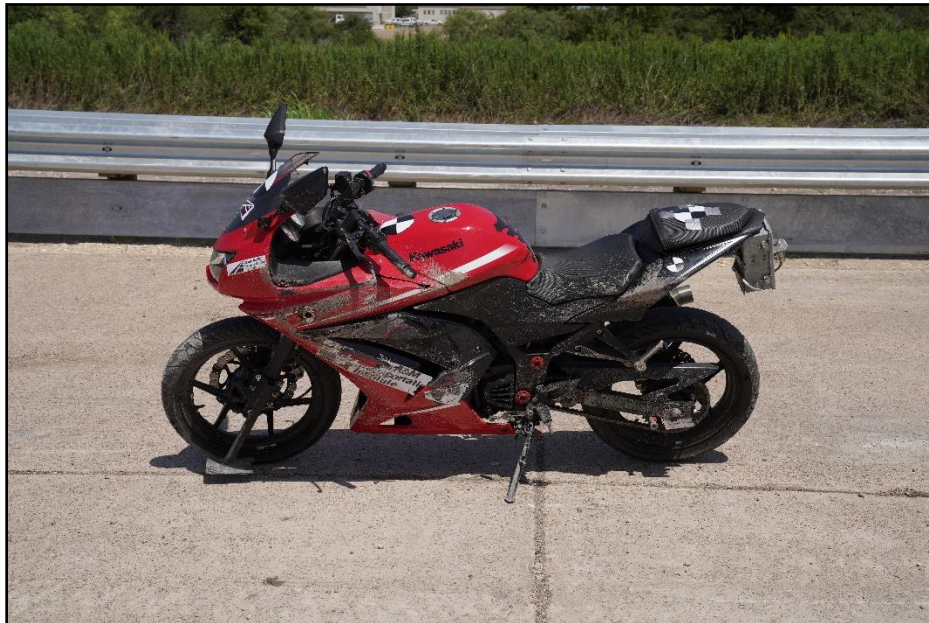
**Figure 11.9. Opposite Impact Side of Test Vehicle after Test 469940-03-3.**

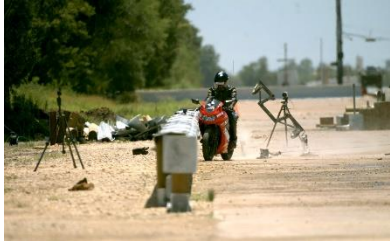
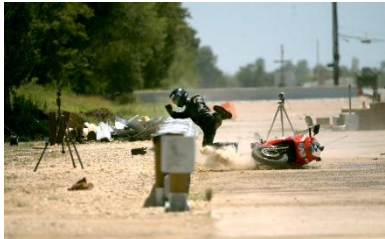
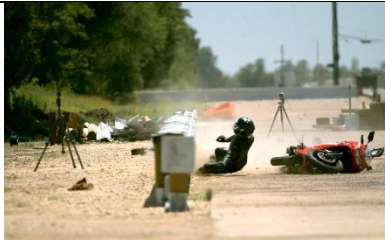
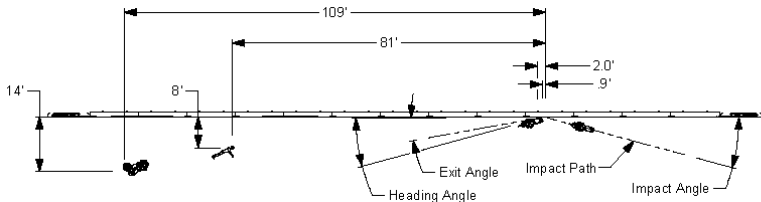
<p><b>0.000 s</b></p>	Test Agency	Texas A&M Transportation Institute (TTI)
	Test Standard/Test No.	N/A
	TTI Project No.	469940-03-3
	Test Date	2020-08-04

<p><b>0.100 s</b></p>	<b>TEST ARTICLE</b>	
	Type	Longitudinal Barrier
	Name	Enhanced Motorcycle Guard Fence System
	Length	181 ft 3 inches

<p><b>0.200 s</b></p>	Key Materials	Round timber posts, cap rail, W-beam guardrail, rubrail
	Soil Type and Condition	AASHTO M147-65(2004), Type 1, Grade D crushed concrete
	<b>TEST VEHICLE</b>	
	Type/Designation	Motorcycle

<p><b>0.300 s</b></p>	Year, Make and Model	2012 Kawasaki 250 Ninja
	Inertial Weight (lb)	400
	Dummy (lb)	200
	Gross Static (lb)	600

<b>IMPACT CONDITIONS</b>	
	Impact Speed (mi/h)	38.2
	Impact Angle (deg)	14.8
	Impact Location	24 inches upstream from the centerline of post 10

<b>EXIT CONDITIONS</b>	
	Exit Speed (mi/h)	32.4
	Trajectory/Heading Angle (deg)	7.0/1.5
	Stopping Distance	109 ft downstream 14 ft to the traffic side

**Figure 11.10. Summary of Results for Upright Motorcycle Test on Enhanced Motorcycle Guard Fence System.**

Figure 11.10 summarizes the results of Test 469940-03-3.
