**DEVELOP A RETROFIT DESIGN FOR GUARD FENCE SYSTEM TO  
ENHANCE MOTORCYCLE SAFETY  
COOPERATIVE RESEARCH PROGRAM**

Texas Department of Transportation  
<https://tti.tamu.edu/documents/0-6994-R1.pdf>

**TEXAS A&M TRANSPORTATION INSTITUTE PROVING GROUND**

1. Report No. FHWA/TX-23/0-6994-R1	2. Government Accession No.	3. Recipient's Catalog No.	
4. Title and Subtitle DEVELOP A RETROFIT DESIGN FOR GUARD FENCE SYSTEM TO ENHANCE MOTORCYCLE SAFETY		5. Report Date Published: August 2024

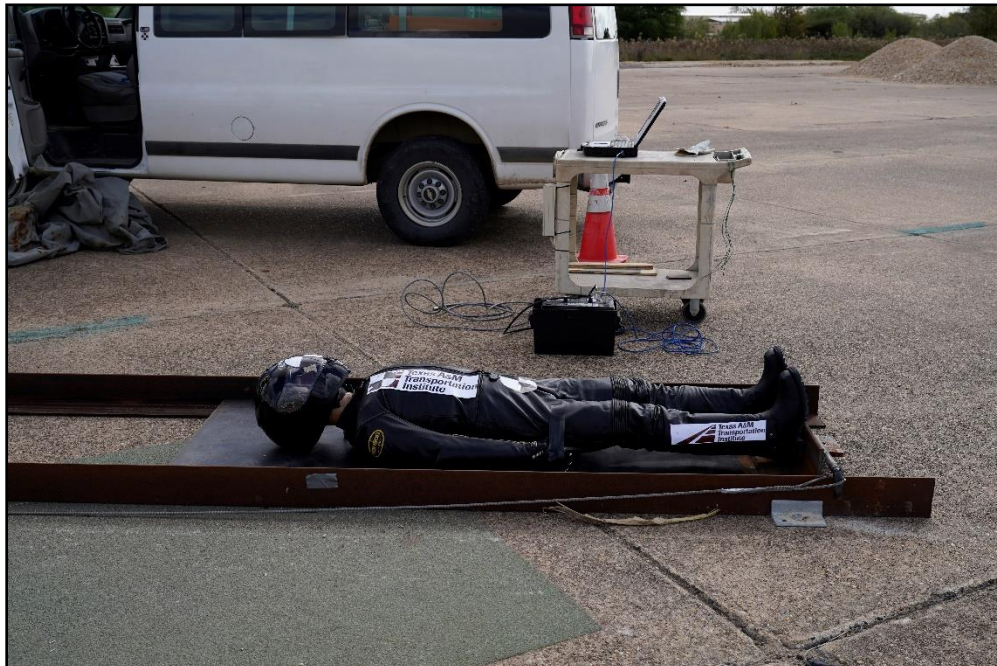
**Figure 12.1. Right Side of the ATD prior to Test 469940-03-4A.**

See Table 12.1 for the impact conditions and Table 12.2 for the exit parameters for Test 469940-03-4A. Figure 12.1 and Figure 12.2 show the ATD prior to impact.

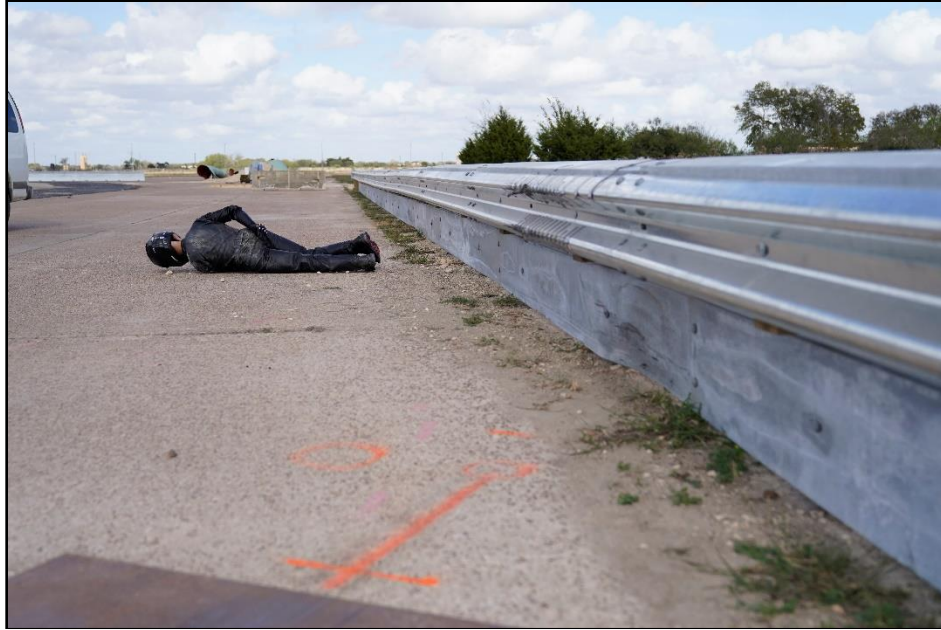
**Figure 12.3. Enhanced Motorcycle Guard Fence System at Impact Location on the Traffic Side after Test 469940-03-4A.**

The rubrail was deformed and scuffed at impact. Table 12.5 describes the deflection and working width of the enhanced motorcycle guard fence system. Figure 12.3 and Figure 12.4 show the damage to the enhanced motorcycle guard fence system.

Test Parameter	Measured
Permanent Deflection/Location	2.4 inches toward field side, 13 inches upstream from the centerline of post 9
Dynamic Deflection	4 inches toward field side, 13 inches upstream from the centerline of post 9
Working Width <sup>a</sup> and Height	18.6 inches, at a height of 31.1 inches, at the guardrail bolt on the field side of post 9

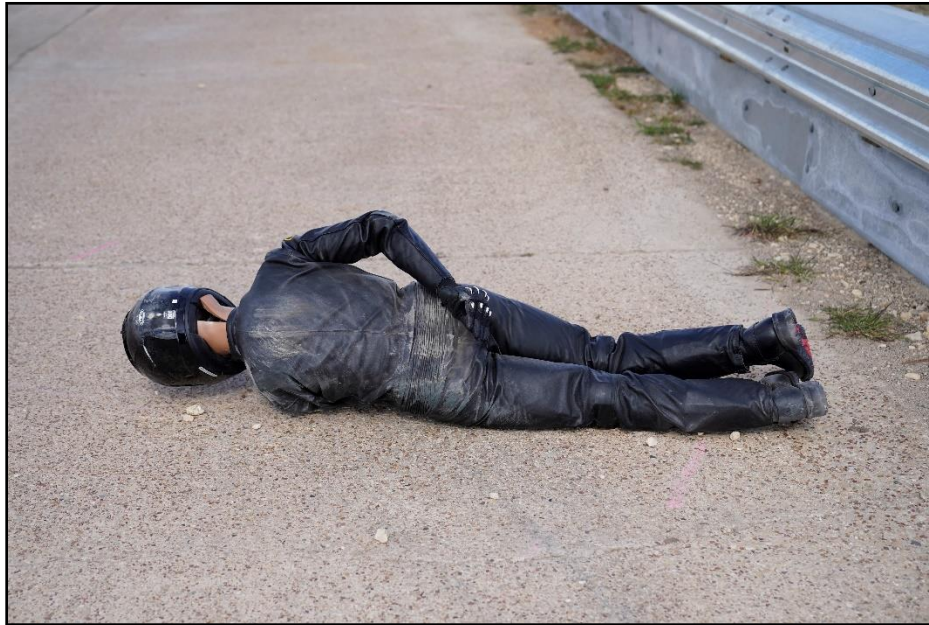
**Figure 12.5. Backside of the ATD after Test 469940-03-4A.**

Figure 12.5 and Figure 12.6 show the overall damage sustained by the ATD. Figure 12.7 and Figure 12.8 show the helmet and neck damage sustained by the ATD. Table 12.6 provides details on the calculated injury criteria for the head and neck of the ATD.

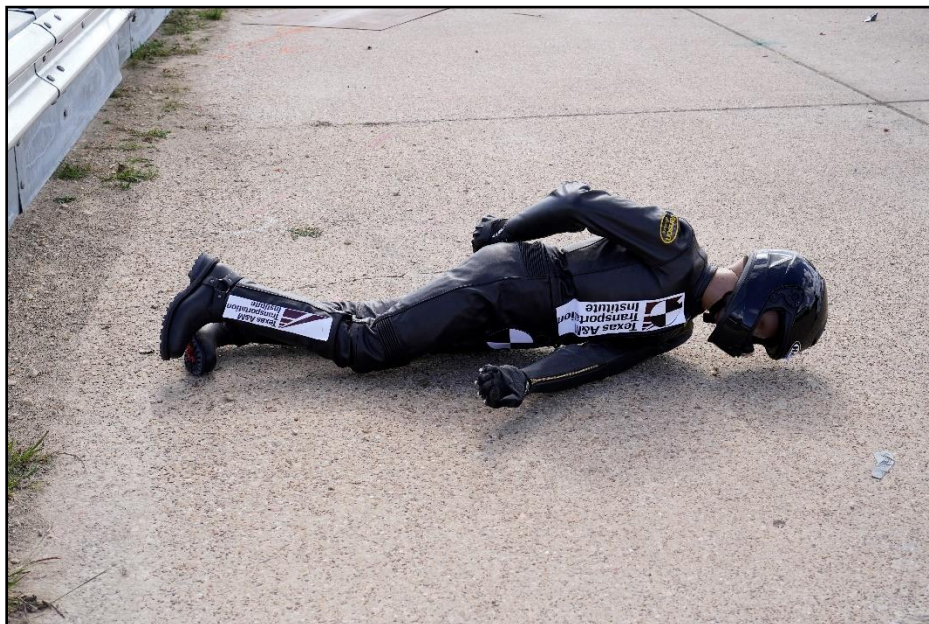
**Figure 12.6. Front of the ATD after Test 469940-03-4A.**

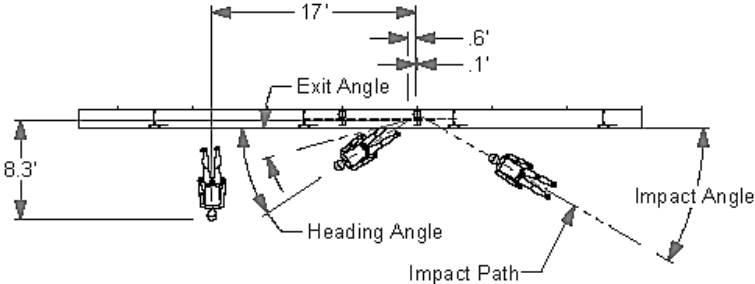
<p><b>0.000 s</b></p>	Test Agency	Texas A&M Transportation Institute (TTI)
	Test Standard/Test No.	EN 1317-8 (Modified)
	TTI Project No.	469940-03-4A
	Test Date	2020-11-20

<p><b>0.100 s</b></p>	<b>TEST ARTICLE</b>	
	Type	Longitudinal Barrier
	Name	Enhanced Motorcycle Guard Fence System
	Length	181 ft 3 inches

<p><b>0.200 s</b></p>	Key Materials	Round timber posts, cap rail, W-beam guardrail, rubrail
	Soil Type and Condition	Type A Grade 2 crushed limestone
	<b>IMPACT CONDITIONS</b>	
	Impact Speed (mi/h)	37.2

<p><b>0.300 s</b></p>	Impact Angle (deg)	30.2
	Impact Location	0.85 inch to the left of the centerline of post 9
	Dummy (lb)	200
	<b>EXIT CONDITIONS</b>

Exit Speed (mi/h)	N/A
	Trajectory/Heading Angle (deg)	N/A
	Stopping Distance	17 ft downstream 8.3 ft to the traffic side
	<b>TEST ARTICLE DEFLECTIONS</b>

The enhanced motorcycle guard fence system successfully redirected the ATD during impact. There was no snagging of the ATD limbs with the wood posts or other elements of the longitudinal barrier. The ATD neck axial tension and compression forces measured during the impact did exceed the EN 1317-8 limits. Modifications were investigated, as described in Chapter 13, to potentially reduce the injury criteria for the sliding ATD impact.

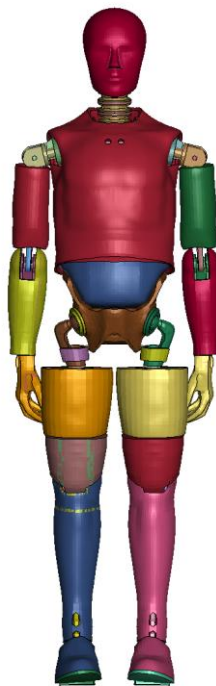
Finite element models of various new design options were developed, and LS-DYNA was used to perform impact simulations with inclusion of the developed models, available Hybrid III 50th percentile ATD (dummy) model (Figure 13.1), and available rider helmet model. To allow for a sliding position of the dummy, the seated pelvis was removed from the model and the legs were straightened. The developed model was calibrated by comparing results of the developed FE barrier system model against available full-scale crash test data. Once the FE model was calibrated, the same model was used to apply the proposed design retrofit changes and conduct predictive simulations.

**Figure 13.1. ATD Finite Element Model.**

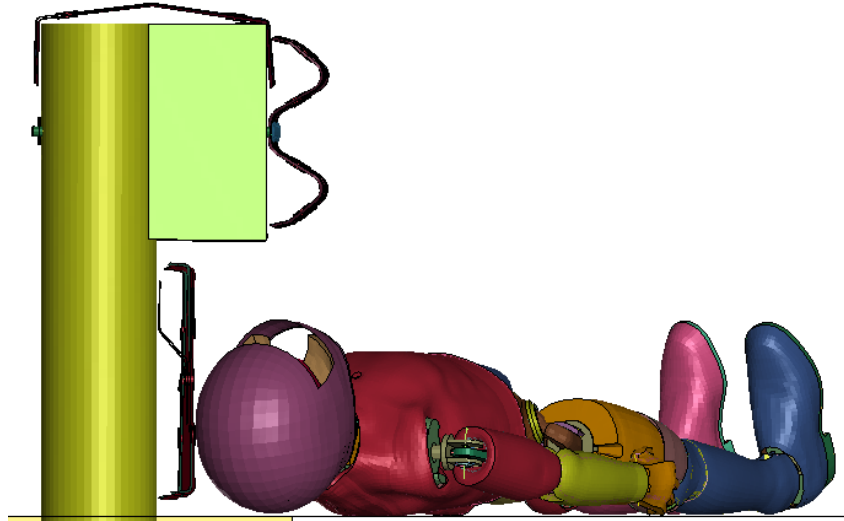
Previous testing was conducted with a sliding motorcyclist into a guardrail system with a vertical rubrail attachment (Chapter 12). To validate the dummy and helmet FE models, a computer simulation was conducted with impact conditions that replicated the full-scale crash test. Figure 13.2 shows the dummy model at impact with the system.

**Figure 13.2. Computer Simulation of Sliding Dummy Impact.**

The overall behavior of the dummy model was similar to the crash test. A quantitative comparison was conducted by comparing the injury criteria values from the full-scale crash test and the computer simulation. Table 13.1 shows the injury criteria values.

Some of the injury criteria values were comparable. The neck shear force and neck axial force were higher in the simulation than in the crash test. Also, the Mx and My moments were higher in the simulation than in the crash test. The dummy and helmet models used in the validation simulation were used in the design evaluation simulations discussed in the next section. Researchers noted that the models may overpredict certain injury criteria values.

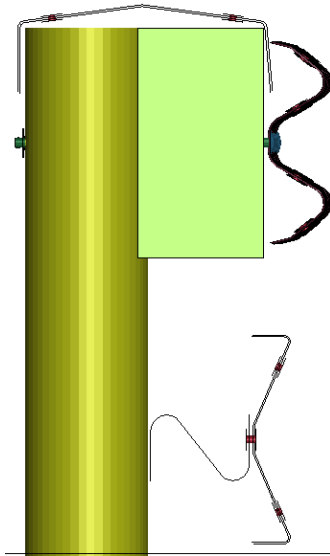
A modified version of the vertical channel rubrail that had a V-shape profile with attachment to an S-shape bracket was developed. Figure 13.3 shows a cross-section view of the rubrail shape.

**Figure 13.3. V-Shape Rubrail Design Option.**

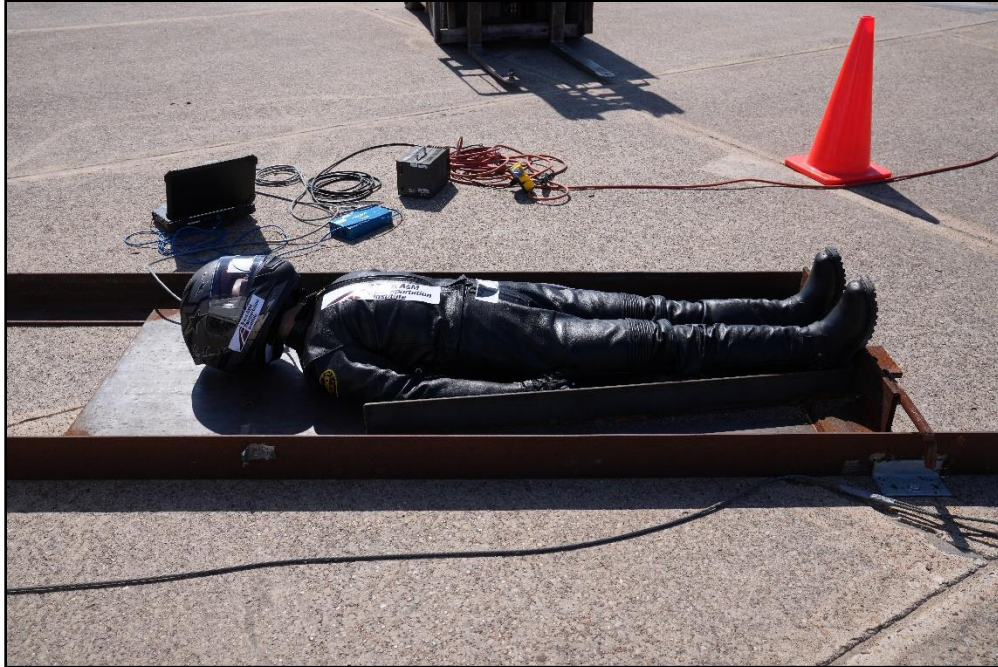
**Figure 14.1. Side View of the ATD on the Sled Delivery System Prior to Test 469942-01-1.**

See Table 14.1 for the impact conditions and Table 14.2 for the exit parameters for Test 469942-01-1. Figure 14.1 and Figure 14.2 depict the ATD prior to testing.

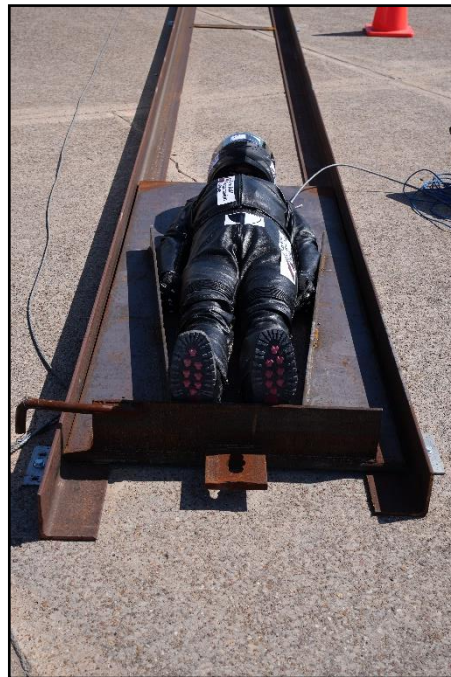
**Figure 14.2. In-Line View of the ATD on the Sled Delivery System Prior to Test 469942-01-1.**

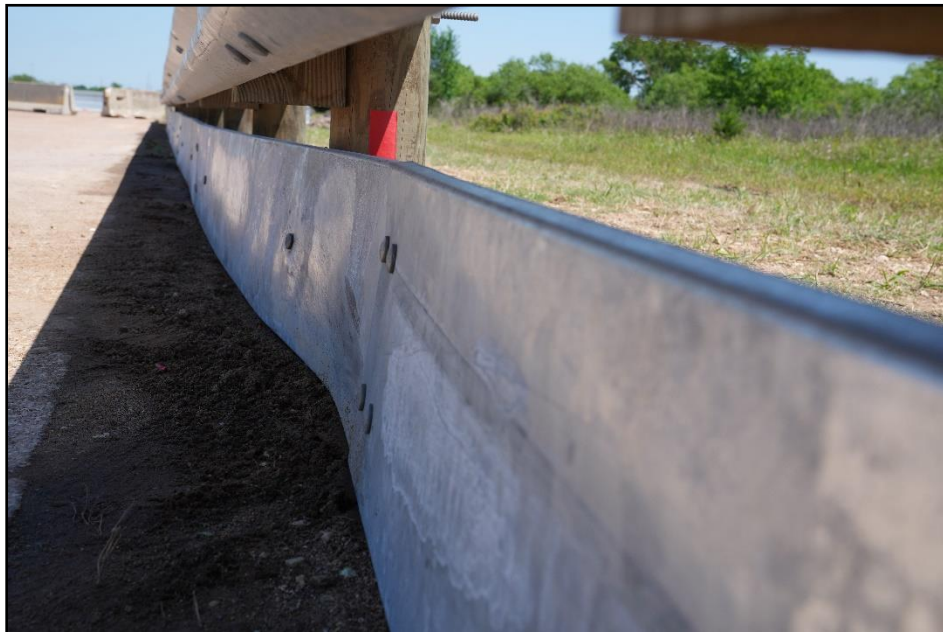
**Figure 14.4. Enhanced Motorcycle Guard Fence System Rubrail at Impact Location after Test 469942-01-1.**

The rubrail was deformed and scuffed at impact, and there were also scuffs on the W-beam at impact. Table 14.5 describes the deflection and working width of the enhanced motorcycle guard fence system. Figure 14.3 and Figure 14.4 show the damage to the enhanced motorcycle guard fence system.

<b>Test Parameter</b>	<b>Measured</b>
Permanent Deflection/Location	5.5 inches toward field side, 15 inches upstream from the centerline of post 15
Dynamic Deflection	9.3 inches toward field side, 15 inches upstream from the centerline of post 15
Working Width <sup>a</sup> and Height	19.5 inches, at a height of 30.0 inches, at the guardrail bolt on the field side of post 15

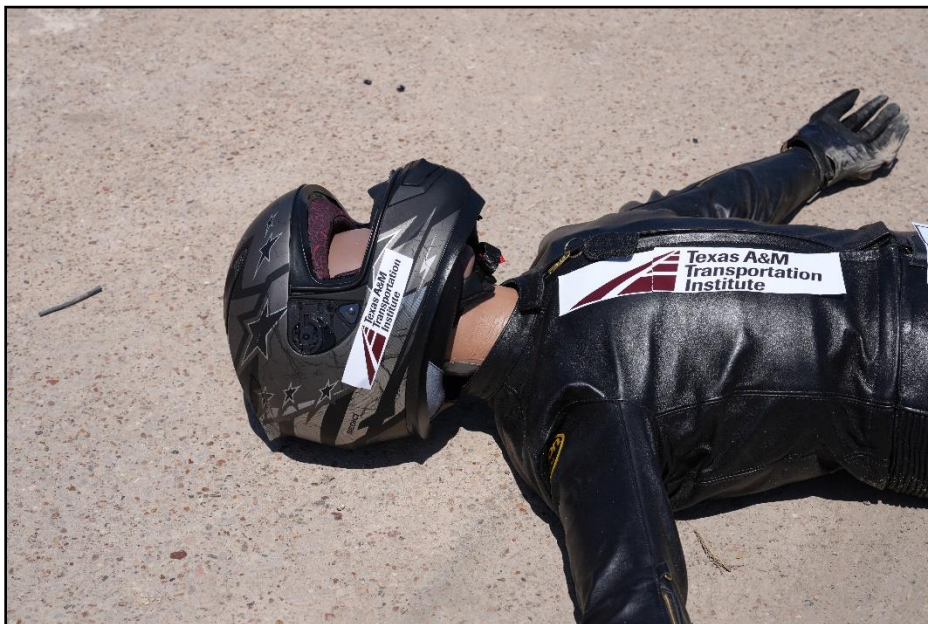
**Figure 14.6. Upper Torso Detail of the ATD after Test 469942-01-1.**

Figure 14.5 and Figure 14.6 show the damage sustained by the front of the ATD. Figure 14.7 and Figure 14.8 show the damage sustained by the back of the ATD. Table 14.6 provides details on the calculated injury criteria for the head and neck of the ATD.

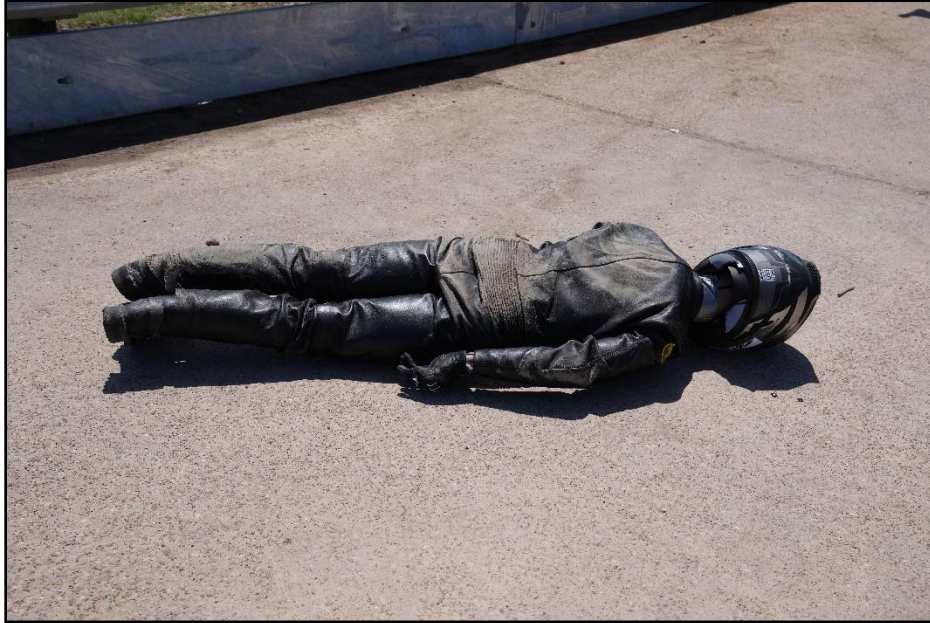
**Figure 14.7. Backside of the ATD after Test 469942-01-1.**

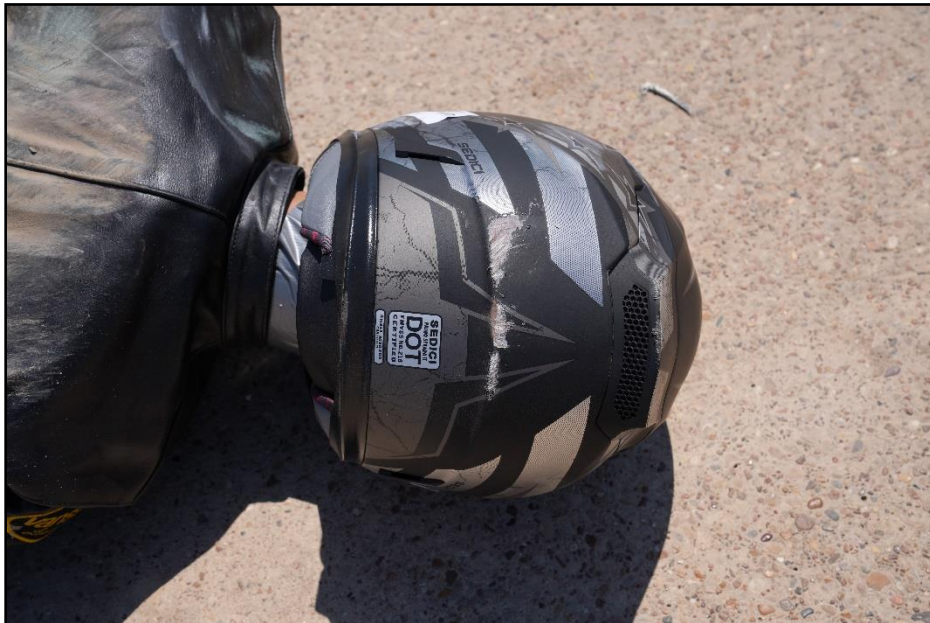
**Figure 14.8. Backside Detail of the ATD Helmet after Test 469942-01-1.**

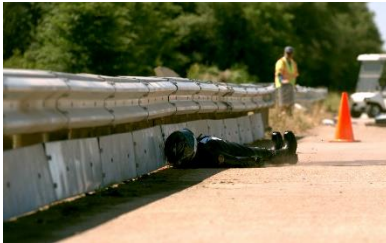
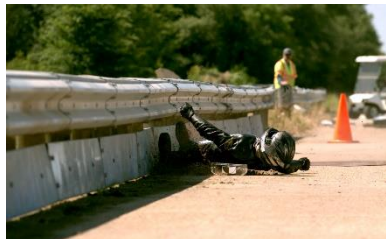
<p><b>0.000 s</b></p>	<table><tr><td>Test Agency</td><td>Texas A&amp;M Transportation Institute (TTI)</td></tr><tr><td>Test Standard/Test No.</td><td>EN 1317-8 (Modified)</td></tr><tr><td>TTI Project No.</td><td>469942-01-1</td></tr><tr><td>Test Date</td><td>2022-04-27</td></tr></table>	Test Agency	Texas A&M Transportation Institute (TTI)	Test Standard/Test No.	EN 1317-8 (Modified)	TTI Project No.	469942-01-1	Test Date	2022-04-27																
	Test Agency	Texas A&M Transportation Institute (TTI)																							
	Test Standard/Test No.	EN 1317-8 (Modified)																							
	TTI Project No.	469942-01-1																							
Test Date	2022-04-27

<b>IMPACT CONDITIONS</b>																								
	Impact Speed (mi/h)	41.4																							
	Impact Angle (deg)	29.7																							
Impact Location	Centerline of the ATD's head aligned with the center of post 15																								
Dummy (lb)	200																								
<b>EXIT CONDITIONS</b>																									
Exit Speed (mi/h)	N/A																								
Trajectory/Heading Angle (deg)	N/A																								
Stopping Distance	16 ft downstream 106 inches to the traffic side

<b>TEST ARTICLE DEFLECTIONS</b>																								
	Dynamic (inches)	9.25																							
	Permanent (inches)	5.5																							
Working Width/Height (inches)	19.5/30.0																								
<b>ATD DAMAGE</b>																									
HIC <sub>36</sub>	344																								
F <sub>x</sub> (N)	568																								
F <sub>z</sub> —Tension (N)	1993																								
F <sub>z</sub> —Compression (N)	4709																								
Moc <sub>x</sub> (Nm)	72																								
Moc <sub>y</sub> —Flexion (Nm)	29																								
Moc <sub>y</sub> —Extension (Nm)	32

The enhanced motorcycle guard fence system successfully redirected the ATD during impact. There was no snagging of the ATD limbs with the wood posts or other elements of the longitudinal barrier. The ATD neck axial tension was significantly reduced with the modified design and was below the specified limit. However, the ATD neck compression forces still exceeded the EN 1317-8 limit. Modifications were investigated, as described in Chapter 15, to potentially reduce the neck compression force for the sliding ATD impact.

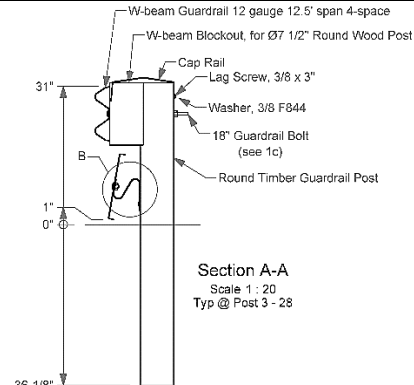
Impact Point - Center of Post 15

Impact Angle

W-beam Guardrail 12 gauge 12.5' span 4-space

W-beam Blockout, for Ø7 1/2" Round Wood Post

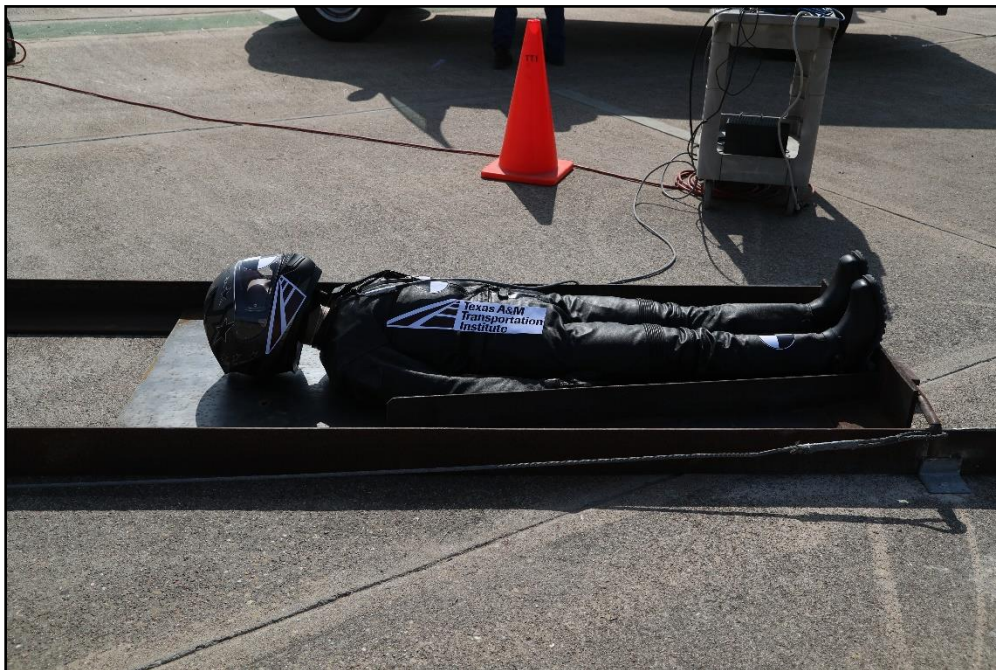
**Figure 16.1. Side View of the ATD on the Sled Delivery System prior to Test 469943-01-1A.**

See Table 16.1 for the impact conditions and Table 16.2 for the exit parameters for Test 469943-01-1A. Figure 16.1 and Figure 16.2 depict the ATD prior to testing.

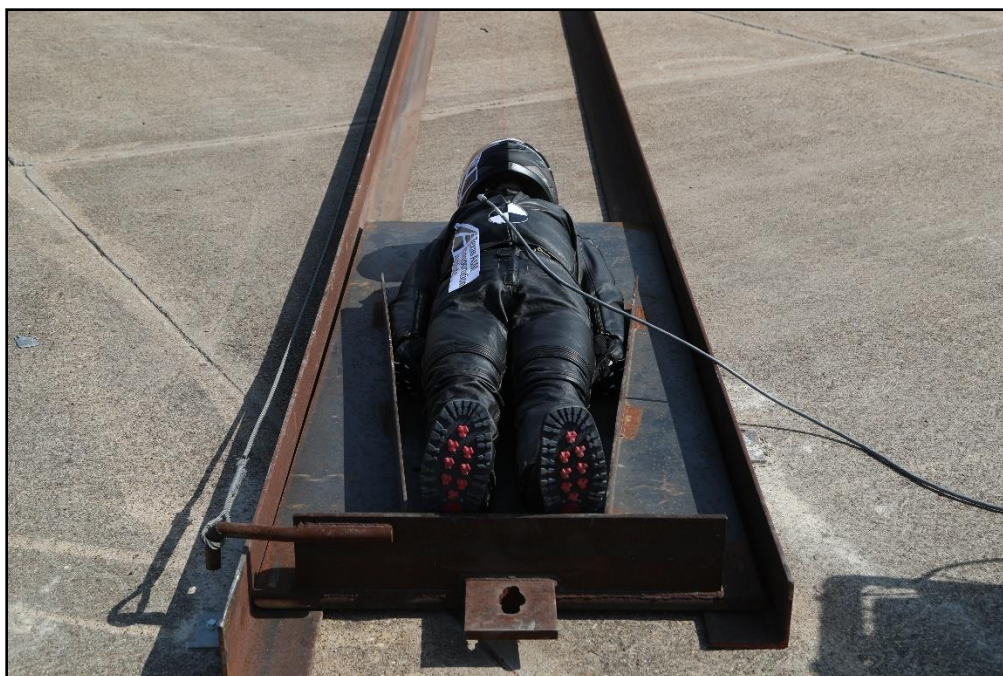
**Figure 16.2. In-Line View of the ATD on the Sled Delivery System prior to Test 469943-01-1A.**

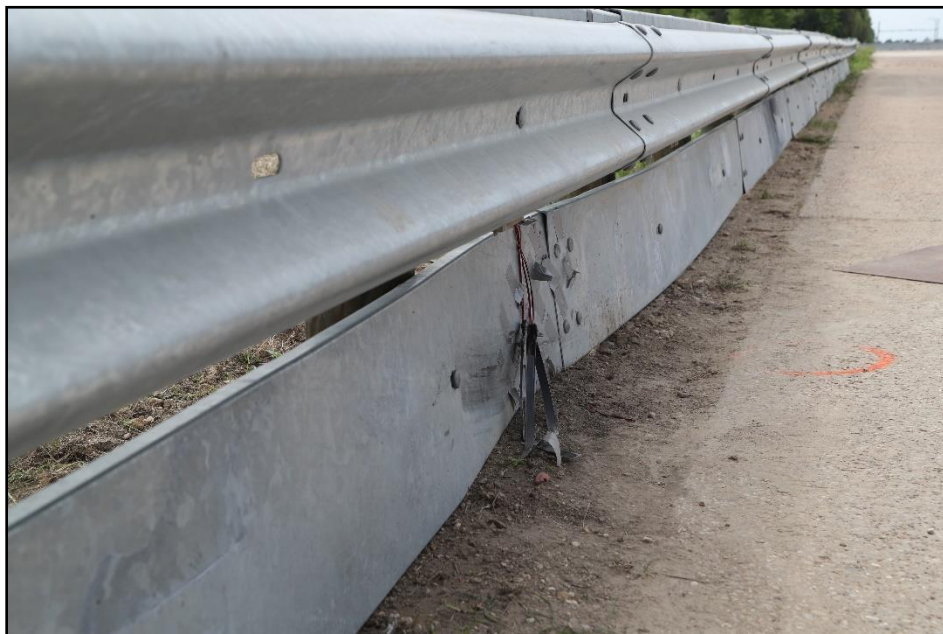
**Figure 16.4. Enhanced Motorcycle Guard Fence System Rubrail at Impact Location after Test 469943-01-1A.**

The rubrail was deformed and scuffed at impact. Table 16.5 describes the deflection and working width of the enhanced motorcycle guard fence system. Figure 16.3 and Figure 16.4 show the damage to the enhanced motorcycle guard fence system.

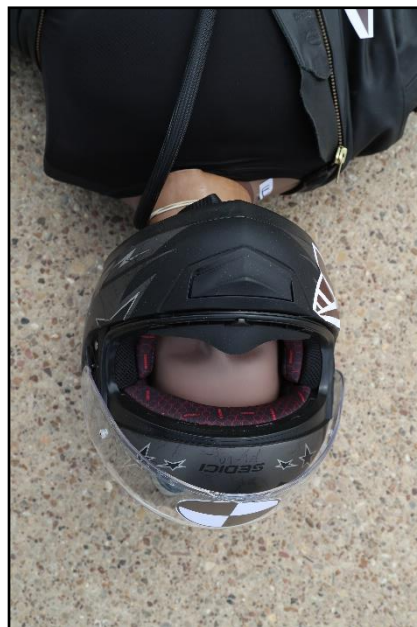
**Figure 16.6. ATD Head and Helmet after Test 469943-01-1A.**

Figure 16.5 and Figure 16.6 show the damage sustained by the front of the ATD. Figure 16.7 and Figure 16.8 show the damage sustained by the back of the ATD. Table 16.6 provides details on the calculated injury criteria for the head and neck of the ATD.

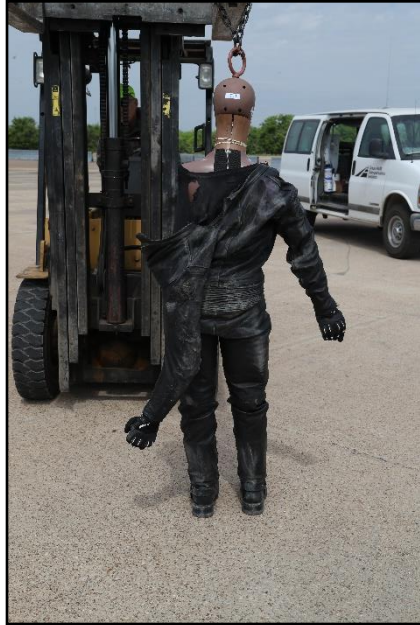
**Figure 16.7. ATD after Test 469943-01-1A.**

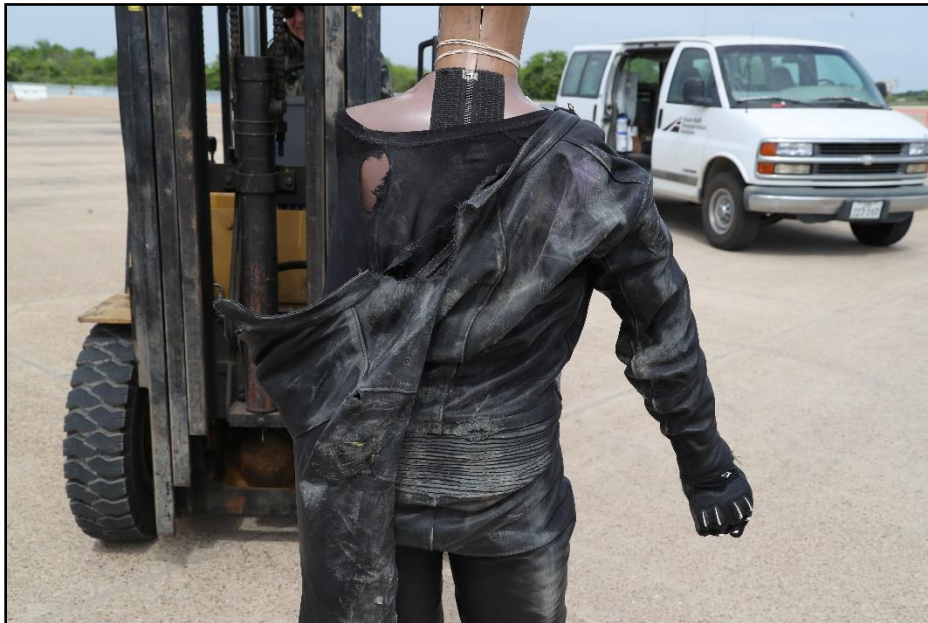
**Figure 16.8. Rear Side of ATD after Test 469943-01-1A.**

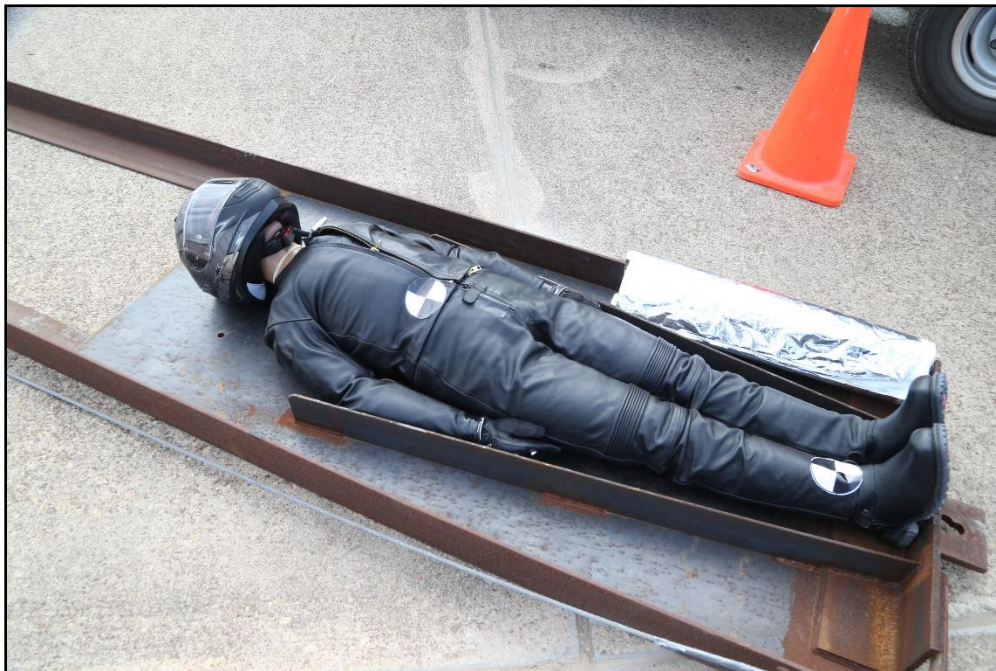
**Figure 17.1. Side View of the ATD on the Sled Delivery System prior to Test 469943-01-2.**

See Table 17.1 for the impact conditions and Table 17.2 for the exit parameters for Test 469943-01-2. Figure 17.1 and Figure 17.2 depict the target impact setup.

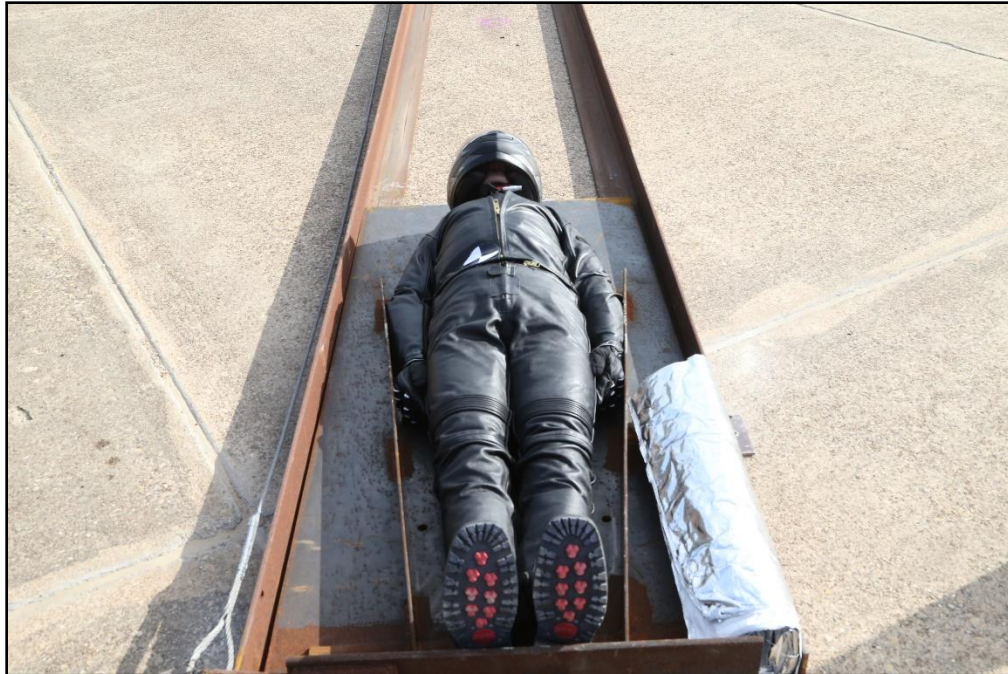
**Figure 17.2. In-Line View of the ATD on the Sled Delivery System prior to Test 469943-01-2.**

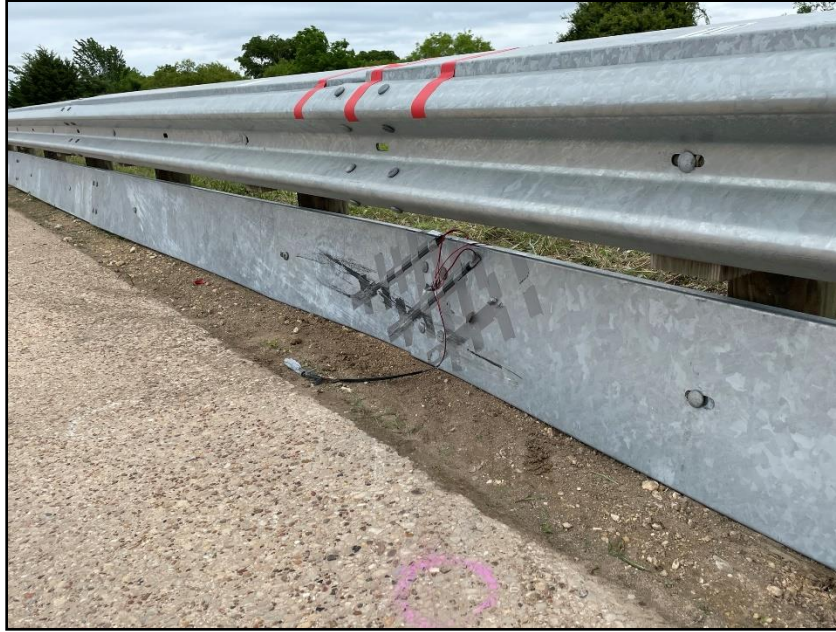
**Figure 17.3. Traffic Side of the Enhanced Motorcycle Guard Fence System at Impact Location after Test 469943-01-2.**

There was some scuffing on the rubrail at impact, and the rail was deformed. Table 17.5 describes the deflection and working width of the enhanced motorcycle guard fence system. Figure 17.3 and Figure 17.4 show the damage to the enhanced motorcycle guard fence system.

Test Parameter	Measured
Permanent Deflection/Location	4.5 inches toward field side, 4 inches downstream from the center of the joint
Dynamic Deflection	8.5 inches toward field side, 4 inches downstream from the center of the joint
Working Width <sup>a</sup> and Height	17.3 inches, at a height of 31 inches, at the guardrail bolt on the field side of post 15

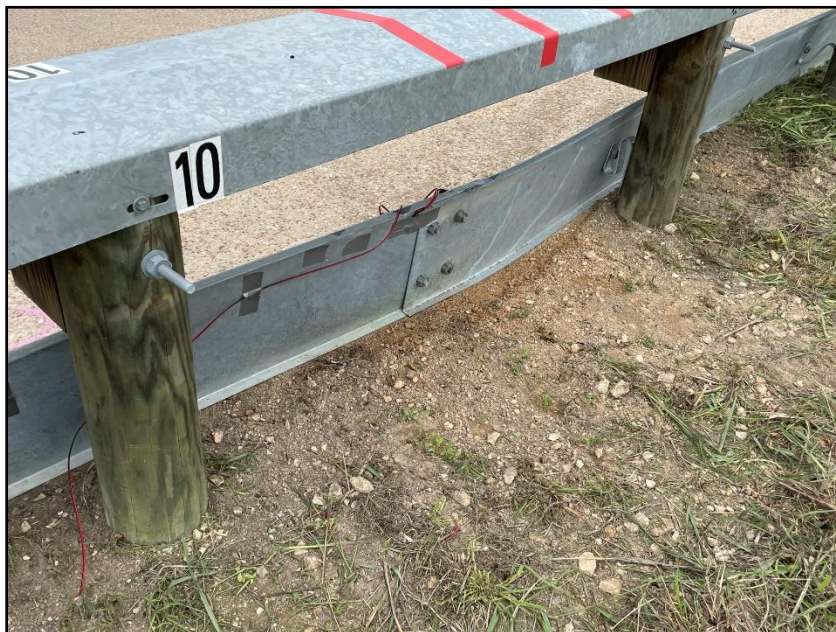
**Figure 17.4. Field Side of the Enhanced Motorcycle Guard Fence System at Impact Location after Test 469943-01-2.**

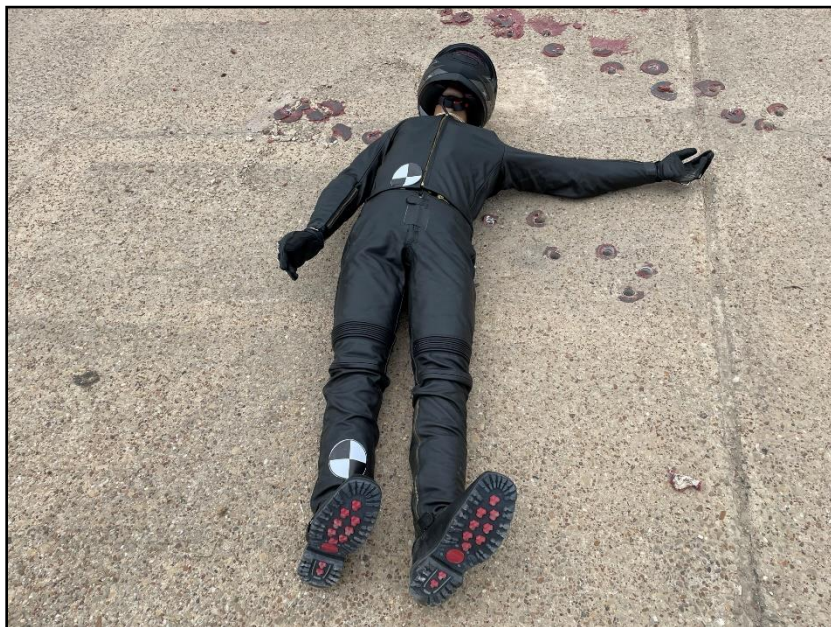
**Figure 17.6. Front of the ATD after Test 469943-01-2.**

Figure 17.5 and Figure 17.6 show the damage sustained by the front of the ATD. Figure 17.7 and Figure 17.8 show detailed damage of the head and shoulder of the ATD. Table 17.6 provides details on the calculated injury criteria for the head and neck of the ATD.

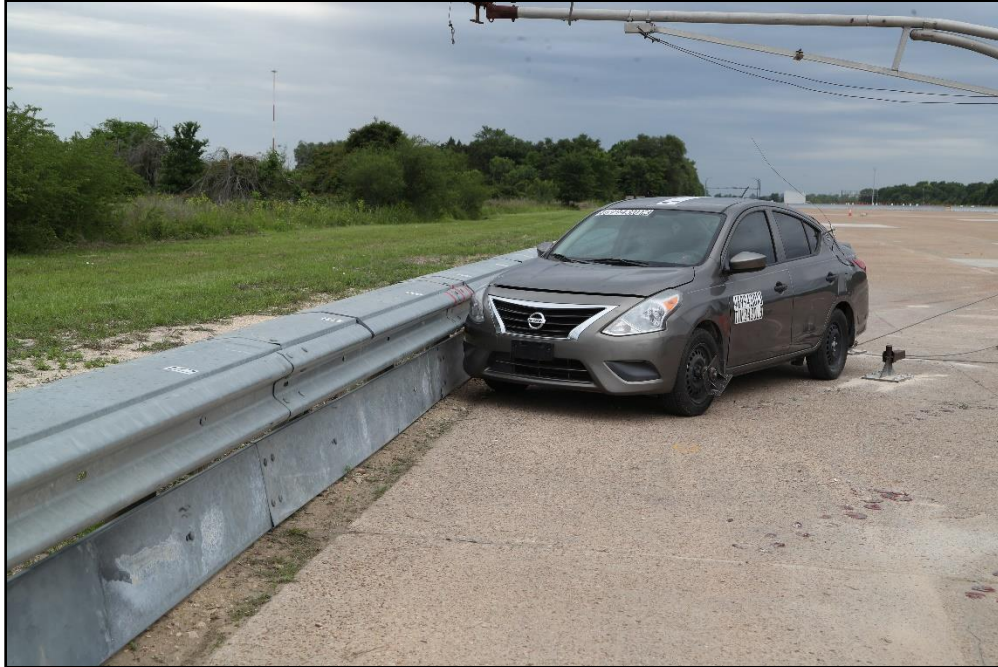
**Figure 18.1. Enhanced Motorcycle Guard Fence System/Test Vehicle Geometrics for Test 469943-01-3.**

See Table 18.1 for the *MASH* impact conditions and Table 18.2 for the exit parameters for Test 469943-01-3. Figure 18.1 and Figure 18.2 depict the target impact setup.

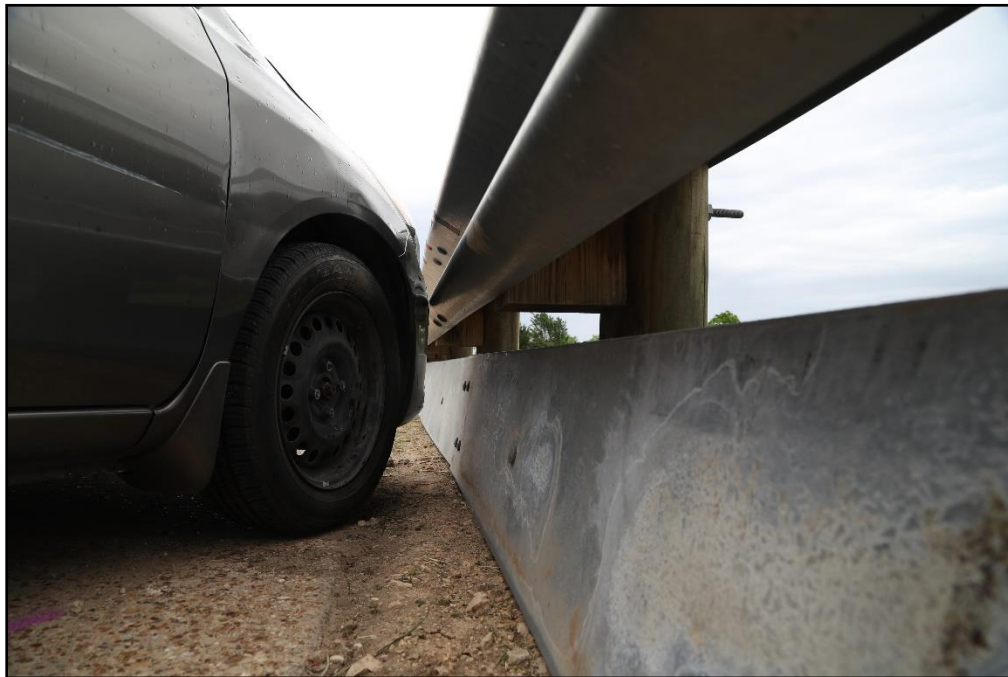
**Figure 18.2. Enhanced Motorcycle Guard Fence System/Test Vehicle Impact Location for Test 469943-01-3.**

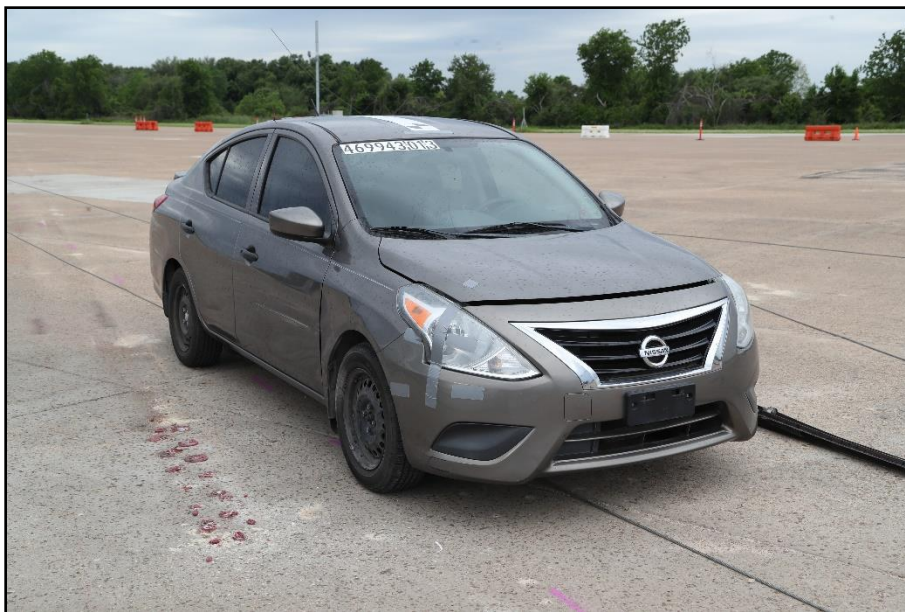
**Figure 18.3. Impact Side of Test Vehicle before Test 469943-01-3.**

Figure 18.3 and Figure 18.4 show the 2017 Nissan Versa used for the crash test. Table 18.4 shows the vehicle measurements. Figure J.1 in Appendix J.1 gives additional dimensions and information on the vehicle.

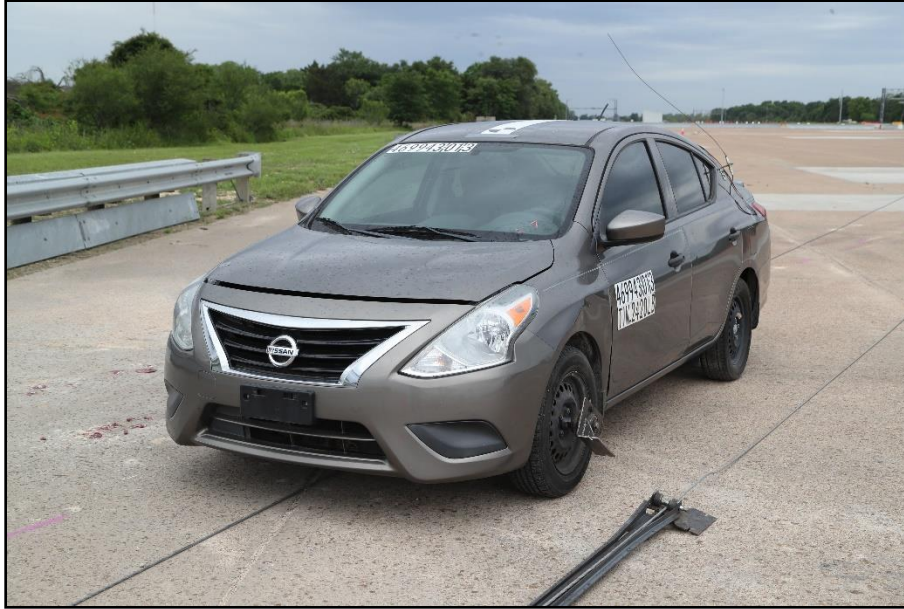
**Figure 18.4. Opposite Impact Side of Test Vehicle before Test 469943-01-3.**

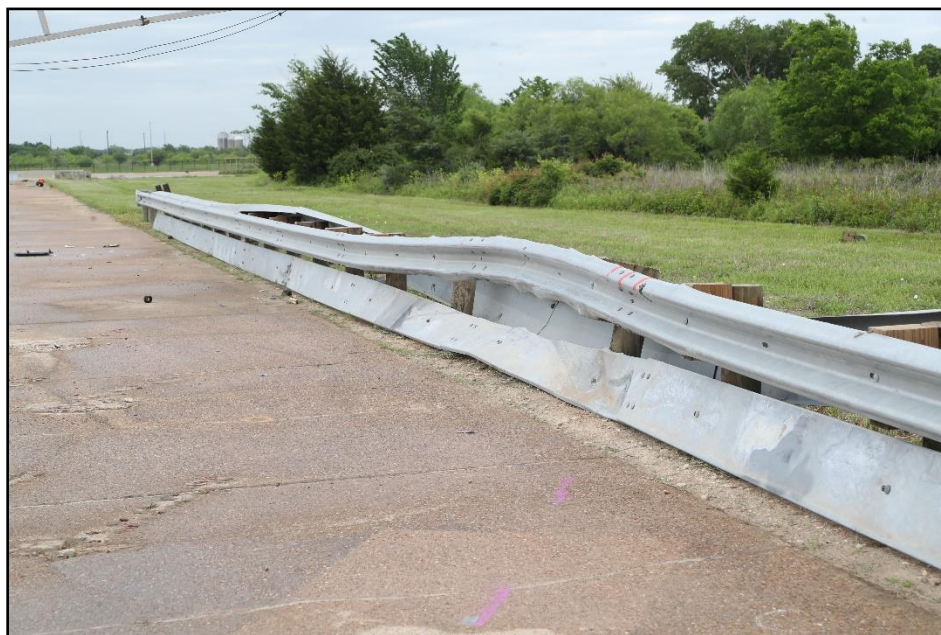
**Figure 18.5. Traffic-Side View of the Enhanced Motorcycle Guard Fence System at Impact Location after Test 469943-01-3.**

Table 18.7 describes the deflection and working width of the enhanced motorcycle guard fence system. Figure 18.5 and Figure 18.6 show the damage to the enhanced motorcycle guard fence system.

Test Parameter	Measured
Permanent Deflection/Location	15.4 inches toward field side at post 14
Dynamic Deflection	22.8 inches toward field side at the main rail 1 ft downstream of post 14
Working Width <sup>a</sup> and Height	51.9 inches, at a height of 39.4 inches, at the top rail cover joint between posts 14 and 15

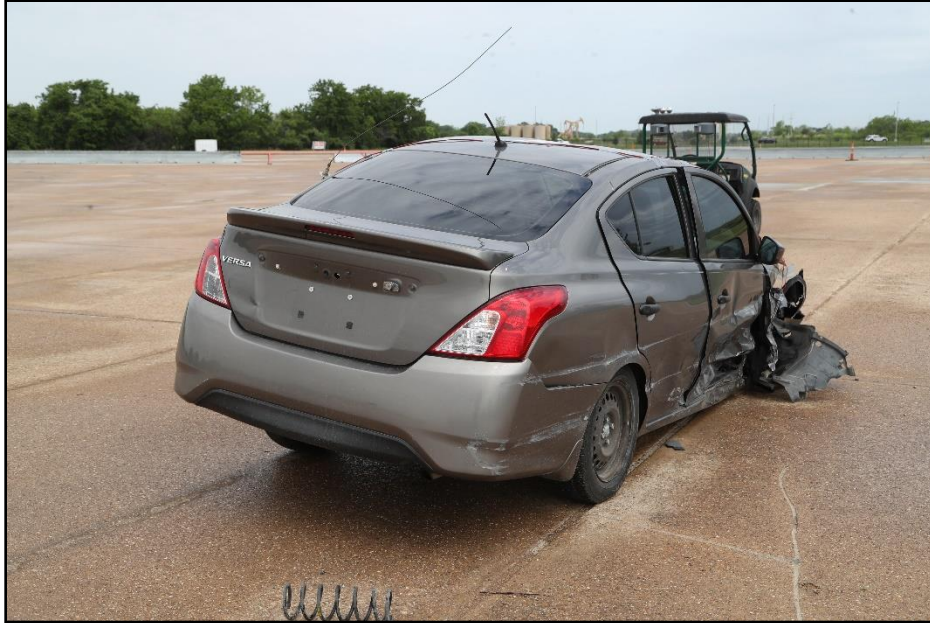
**Figure 18.8. Rear Impact Side of Test Vehicle after Test 469943-01-3.**

Figure 18.7 and Figure 18.8 show the damage sustained by the vehicle. Figure 18.9 and Figure 18.10 show the interior of the test vehicle. Table 18.8 and Table 18.9 provide details on the occupant compartment deformation and exterior vehicle damage. Figures J.2 and J.3 in Appendix J.1 provide exterior crush and occupant compartment measurements.

<b>Side Windows</b>	The side windows remained intact
<b>Maximum Exterior Deformation</b>	8 inches in the front plane at the right front corner above bumper height
<b>VDS</b>	01RFQ2
<b>CDC</b>	01FREW1
<b>Fuel Tank Damage</b>	None
<b>Description of Damage to Vehicle:</b>	The front bumper, grill, right front headlight, right front fender, right front frame rail, right front tire, wheel, strut, right front drive axle, right front door, right rear door, right rear quarter panel, and rear bumper were damaged. The lower portion of the right front door was pulled up 3 inches, and there was a 5-inch long, 1.5-inch wide hole in the front right door. The right front door had a 1.25-inch gap at the top.

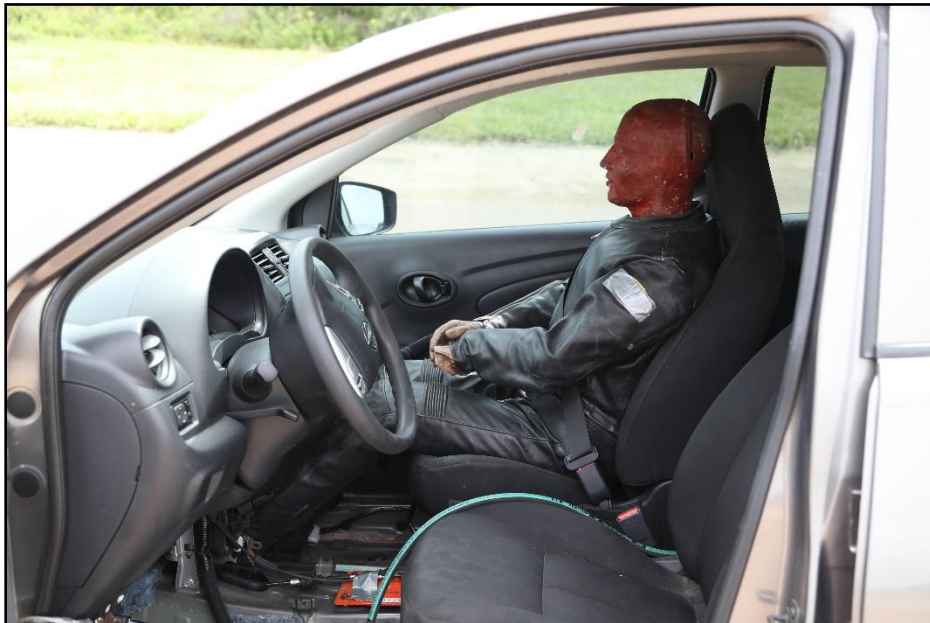
**Figure 18.9. Overall Interior of Test Vehicle after Test 469943-01-3.**

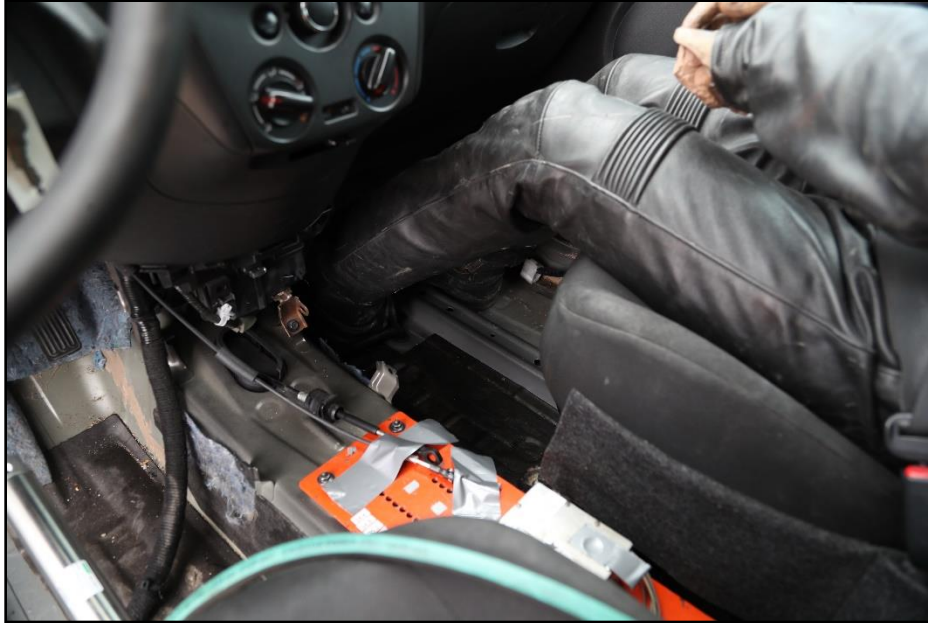
**Figure 18.10. Interior of Test Vehicle on Impact Side after Test 469943-01-3.**

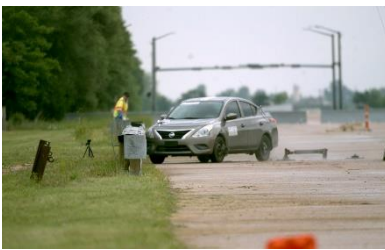
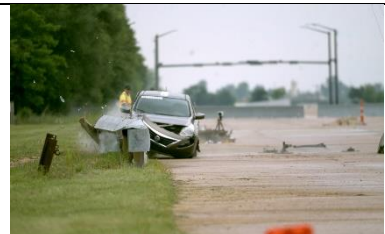
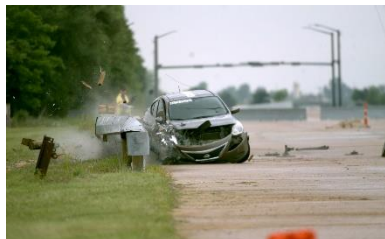
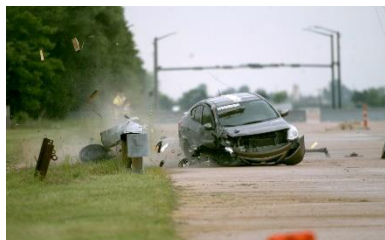
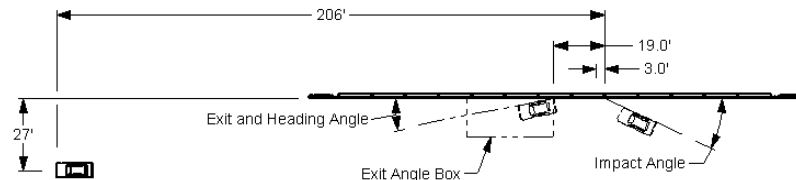
Name		Enhanced Motorcycle Guard Fence System					
	Length		181 ft 3 inches					
	Key Materials		Round timber posts, cap rail, W-beam guardrail, rubrail					
	Soil Type and Condition		Type A Grade 2 crushed limestone					
	<b>TEST VEHICLE</b>							
	Type/Designation		1100C					
	Year, Make and Model		2017 Nissan Versa					
	Inertial Weight (lb)		2434					
	Dummy (lb)		165					
	Gross Static (lb)		2599					
	<b>IMPACT CONDITIONS</b>							
	Impact Speed (mi/h)		62.2					
	Impact Angle (deg)		24.7					
	Impact Location		36.4 inches upstream from the centerline of post 13					
	Impact Severity (kip-ft)		55.0					
	<b>EXIT CONDITIONS</b>							
	Exit Speed (mi/h)		41.4

Trajectory/Heading Angle (deg)		11.6/11.2					
	Exit Box Criteria		Vehicle crossed the exit box 31 ft downstream from loss of contact					
	Stopping Distance		206 ft downstream 27 ft to the traffic side					
	<b>TEST ARTICLE DEFLECTIONS</b>							
	Dynamic (inches)		22.8					
	Permanent (inches)		15.4					
	Working Width/Height (inches)		51.9/39.4					
	<b>VEHICLE DAMAGE</b>							
	VDS		01RFQ2					
	CDC		01FREW1					
	Max. Ext. Deformation (inches)		8					
	Max Occupant Compartment Deformation		1 inch in the right foot well and in the front side panel					
<b>OCCUPANT RISK VALUES</b>								
Long. OIV (ft/s)	14.5	Long. Ridedown (g)	10.6	Max 50-ms Long. (g)	-7.1	Max Roll (deg)	17.8	
Lat. OIV (ft/s)	18.8	Lat. Ridedown (g)	10.1	Max 50-ms Lat. (g)	-9.3	Max Pitch (deg)	5.4	
THIV (m/s)	7.2	ASI	1.24	Max 50-ms Vert. (g)	-2.7	Max Yaw (deg)	49.2

**Figure 18.11. Summary of Results for *MASH* Test 3-10 on Enhanced Motorcycle Guard Fence System.**

Figure 18.11 summarizes the results of *MASH* Test 469943-01-3.
