**DEVELOP A RETROFIT DESIGN FOR GUARD FENCE SYSTEM TO  
ENHANCE MOTORCYCLE SAFETY  
COOPERATIVE RESEARCH PROGRAM**

Texas Department of Transportation  
<https://tti.tamu.edu/documents/0-6994-R1.pdf>

**TEXAS A&M TRANSPORTATION INSTITUTE PROVING GROUND**

1. Report No. FHWA/TX-23/0-6994-R1	2. Government Accession No.	3. Recipient's Catalog No.	
4. Title and Subtitle DEVELOP A RETROFIT DESIGN FOR GUARD FENCE SYSTEM TO ENHANCE MOTORCYCLE SAFETY		5. Report Date Published: August 2024

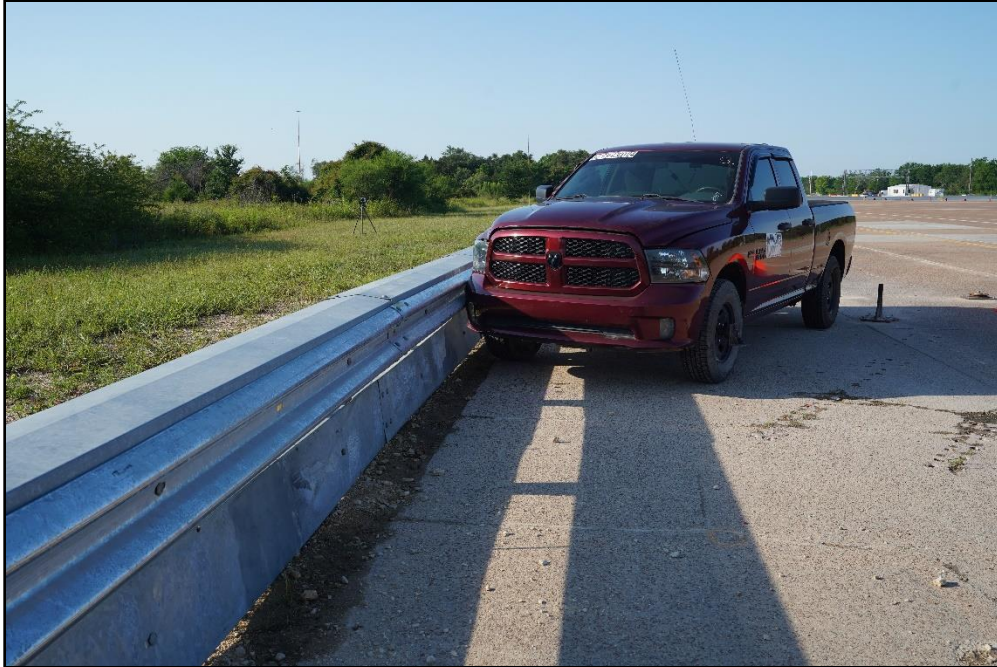
**Figure 19.1. Enhanced Motorcycle Guard Fence System/Test Vehicle Geometrics for Test 469943-01-4.**

See Table 19.1 for the *MASH* impact conditions and Table 19.2 for the exit parameters for Test 469943-01-4. Figure 19.1 and Figure 19.2 depict the target impact setup.

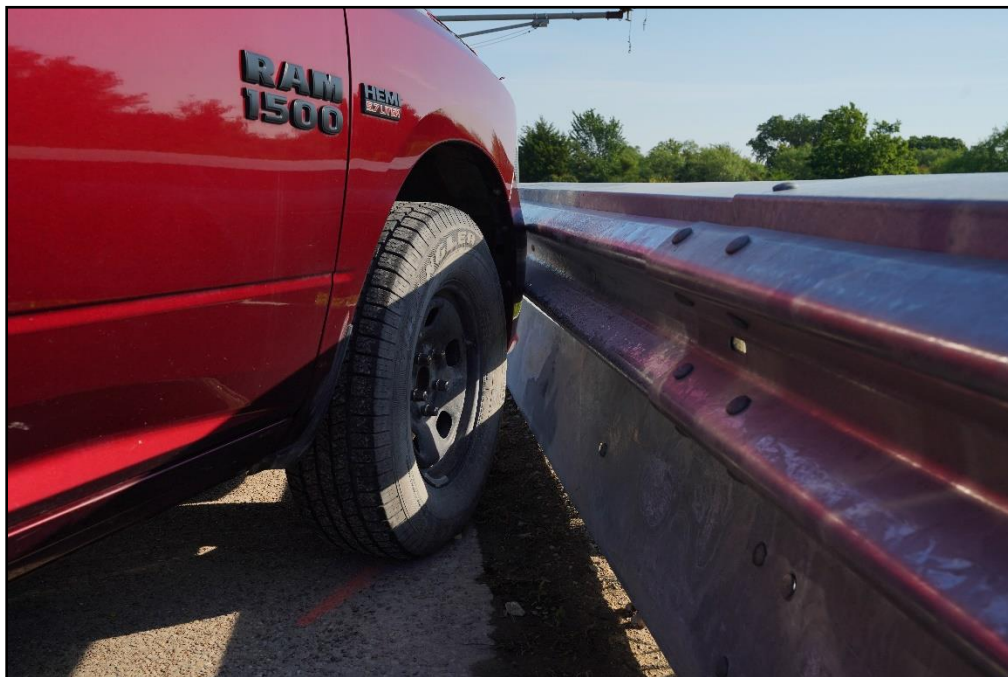
**Figure 19.2. Enhanced Motorcycle Guard Fence System/Test Vehicle Impact Location for Test 469943-01-4.**

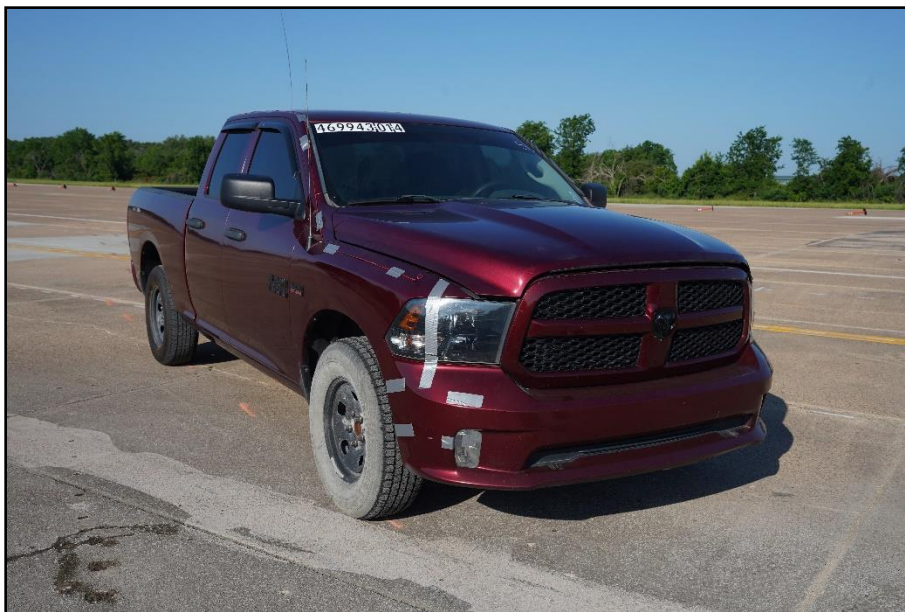
**Figure 19.3. Impact Side of Test Vehicle before Test 469943-01-4.**

Figure 19.3 and Figure 19.4 show the 2017 RAM 1500 used for the crash test. Table 19.4 shows the vehicle measurements. Figure K.1 in Appendix K.1 gives additional dimensions and information on the vehicle.

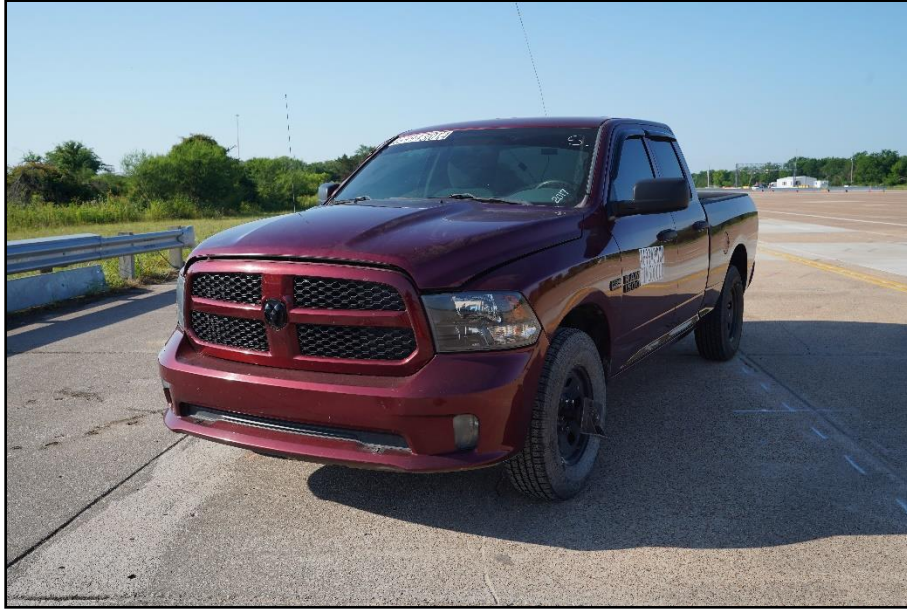
**Figure 19.4. Opposite Impact Side of Test Vehicle before Test 469943-01-4.**

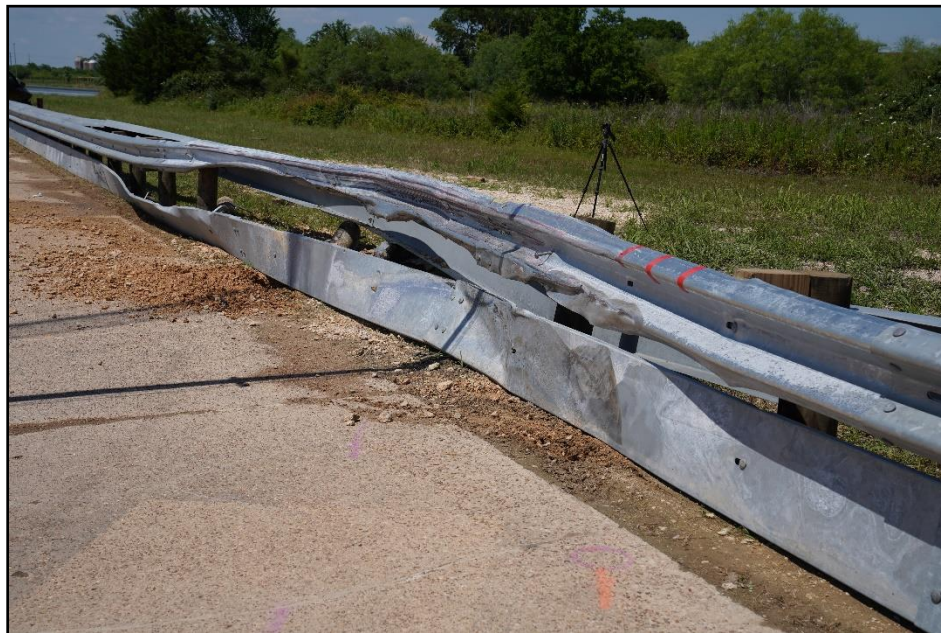
**Figure 19.5. Traffic-Side View of the Enhanced Motorcycle Guard Fence System at Impact Location after Test 469943-01-4.**

Table 19.7 describes the deflection and working width of the enhanced motorcycle guard fence system. Figure 19.5 and Figure 19.6 show the damage to the enhanced motorcycle guard fence system.

Test Parameter	Measured
Permanent Deflection/Location	32 inches toward field side at post 14
Dynamic Deflection	41.4 inches toward field side at the main rail at post 14
Working Width <sup>a</sup> and Height	57.3 inches, at a height of 34.0 inches, at the top rail cover between posts 13 and 14

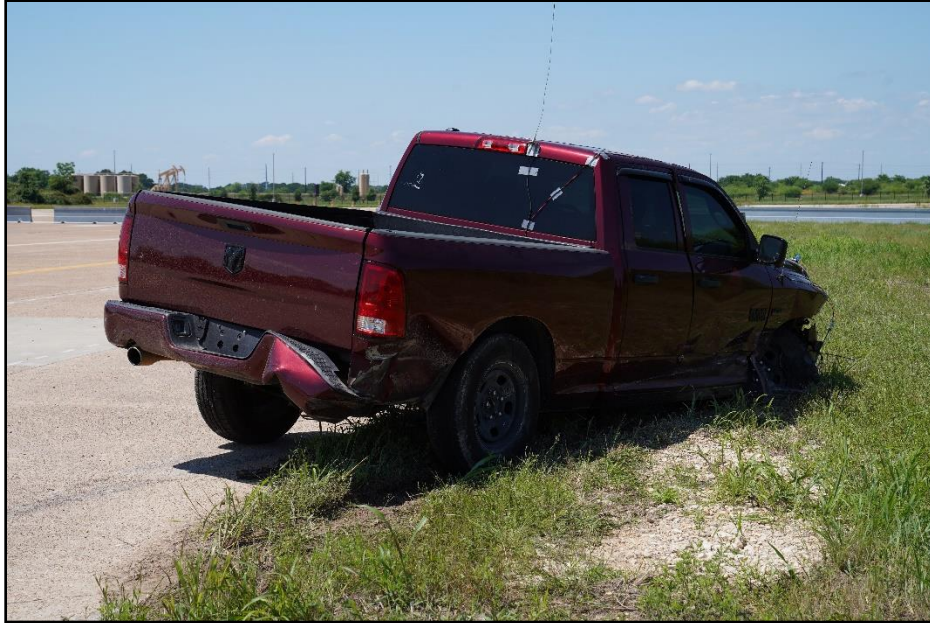
**Figure 19.8. Rear Impact Side of Test Vehicle after Test 469943-01-4.**

Figure 19.7 and Figure 19.8 show the damage sustained by the vehicle. Figure 19.9 and Figure 19.10 show the interior of the test vehicle. Table 19.8 and Table 19.9 provide details on the occupant compartment deformation and exterior vehicle damage. Figures K.2 and K.3 in Appendix K.1 provide exterior crush and occupant compartment measurements.

<b>Side Windows</b>	The side windows remained intact
<b>Maximum Exterior Deformation</b>	10 inches in the front plane at the right front corner above bumper height
<b>VDS</b>	01RFQ3
<b>CDC</b>	01FREW2
<b>Fuel Tank Damage</b>	None
<b>Description of Damage to Vehicle:</b>	The right front bumper, right headlight, right front lower A arm, right front tire and wheel, right front fender, right side quarter panels, and rear bumper were damaged. The right front door had a 1-inch gap at the top.

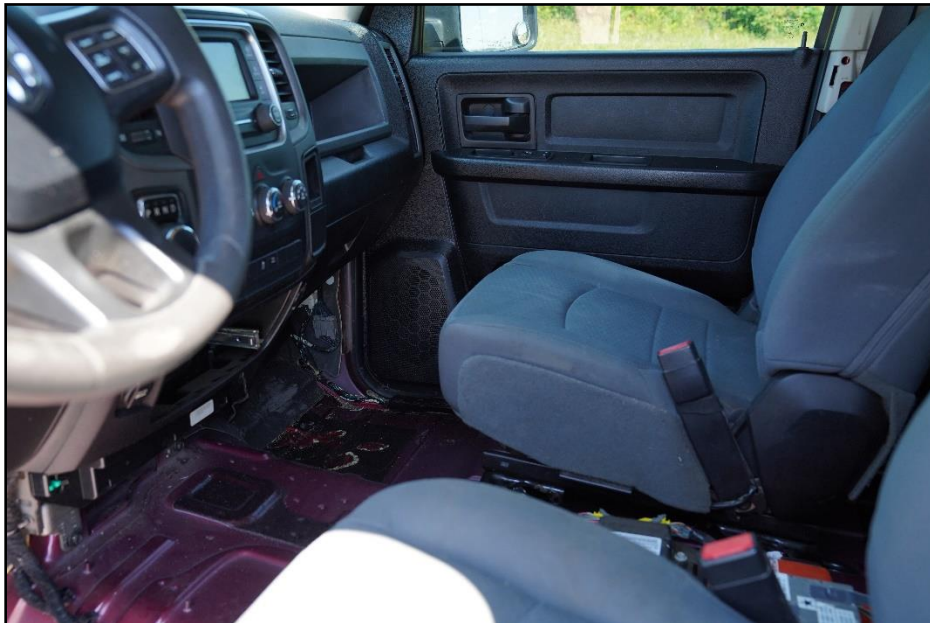
**Figure 19.9. Overall Interior of Test Vehicle after Test 469943-01-4.**

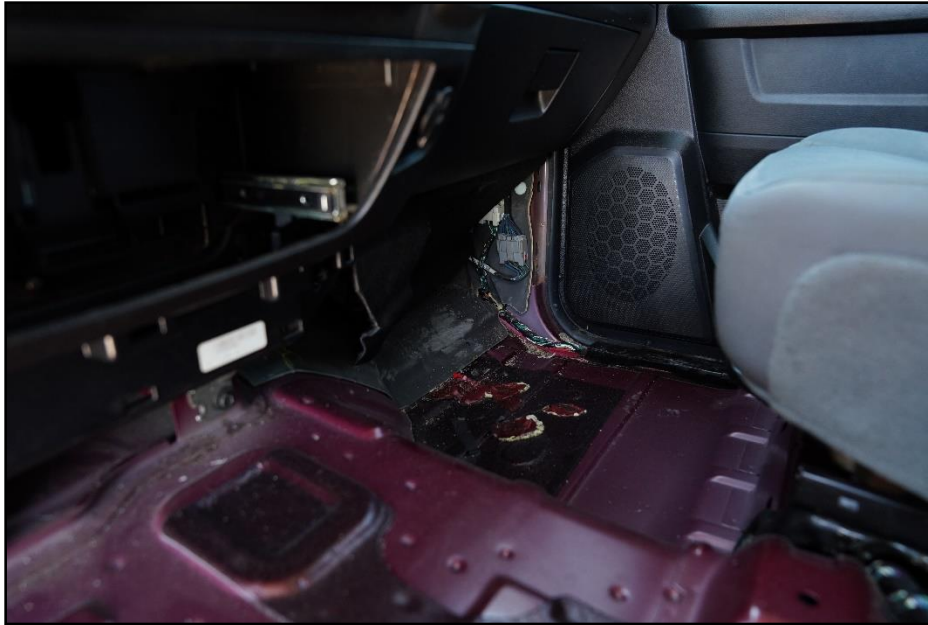
**Figure 19.10. Interior of Test Vehicle on Impact Side after Test 469943-01-4.**

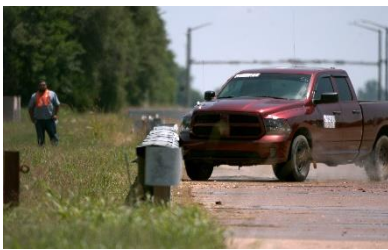
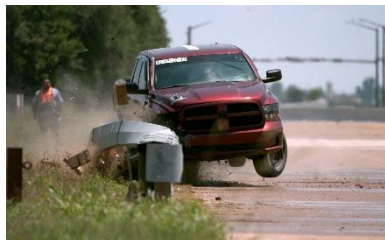
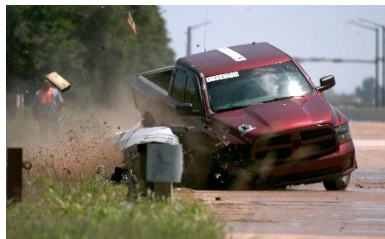
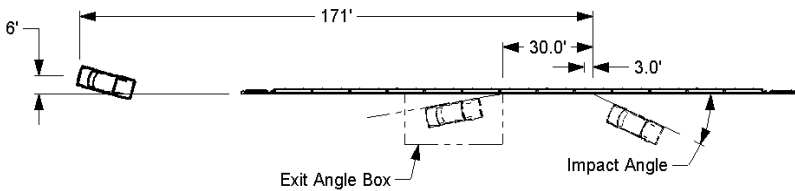
Name		Enhanced Motorcycle Guard Fence System					
	Length		181 ft 3 inches					
Key Materials		Round timber posts, cap rail, W-beam guardrail, rubrail						
Soil Type and Condition		Type A Grade 2 crushed limestone						
<b>Test VEHICLE</b>								
Type/Designation		2270P						
Year, Make and Model		2017 RAM 1500						
Inertial Weight (lb)		5032						
Dummy (lb)		N/A						
Gross Static (lb)		5032						
<b>IMPACT CONDITIONS</b>								
Impact Speed (mi/h)		65.0						
Impact Angle (deg)		24.7						
Impact Location		13 <sup>3</sup> / <sub>16</sub> inches upstream of centerline of post 12						
Impact Severity (kip-ft)		124.1						
<b>EXIT CONDITIONS</b>

Exit Speed (mi/h)		Not measurable. Exit was out of camera frame.						
Trajectory/Heading Angle (deg)		Not measurable. Exit was out of camera frame.						
Exit Box Criteria		Vehicle did not cross the exit box						
Stopping Distance		171 ft downstream 6 ft to the field side						
<b>Test ARTICLE DEFLECTIONS</b>								
Dynamic (inches)		41.4						
Permanent (inches)		32						
Working Width/Height (inches)		57.3/34.0						
<b>VEHICLE DAMAGE</b>								
VDS		01RFQ3						
CDC		01FREW2						
Max. Ext. Deformation (inches)		10						
Max Occupant Compartment Deformation		No occupant compartment deformation						
<b>OCCUPANT RISK VALUES</b>								
Long. OIV (ft/s)	14.7	Long. Ridedown (g)	8.7	Max 50-ms Long. (g)	-5.1	Max Roll (deg)	13.9	
Lat. OIV (ft/s)	15	Lat. Ridedown (g)	8.6	Max 50-ms Lat. (g)	-6.2	Max Pitch (deg)	9.4	
THIV (m/s)	5.9	ASI	0.76	Max 50-ms Vert. (g)	3	Max Yaw (deg)	40.5

**Figure 19.11. Summary of Results for *MASH* Test 3-11 on Enhanced Motorcycle Guard Fence System.**

Figure 19.11 summarizes the results of *MASH* Test 469943-01-4.

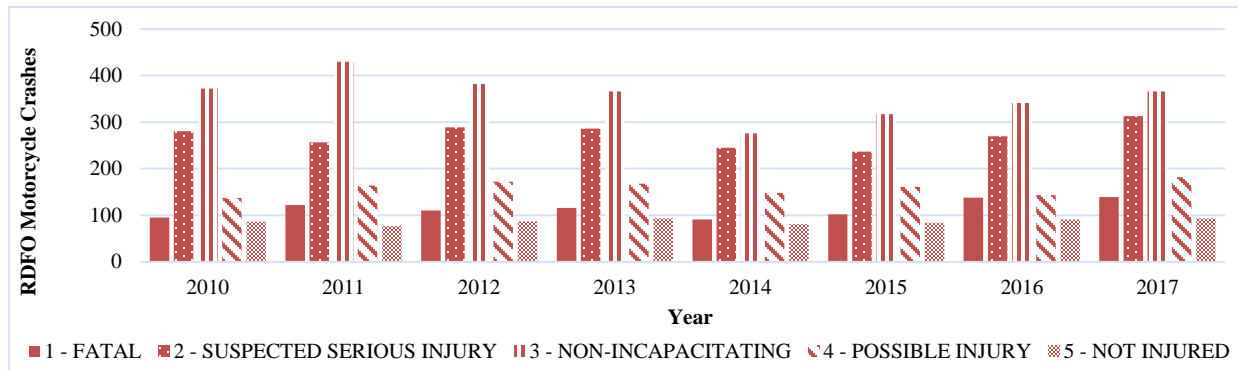
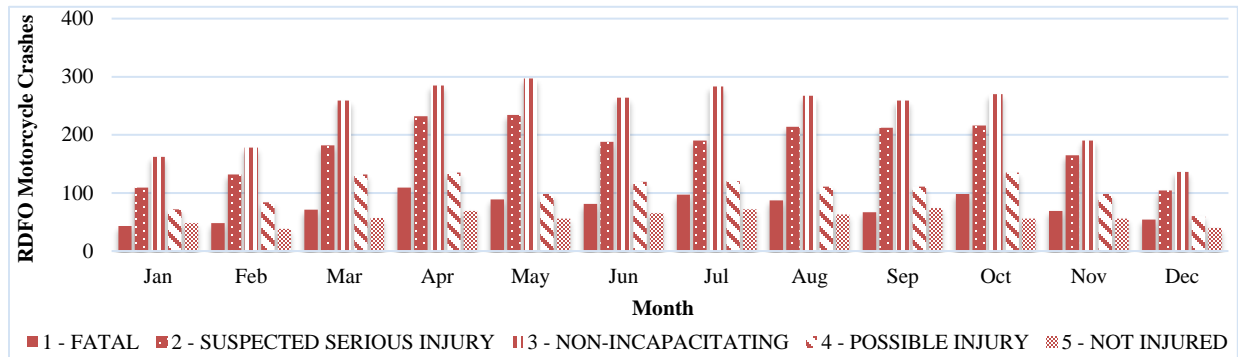
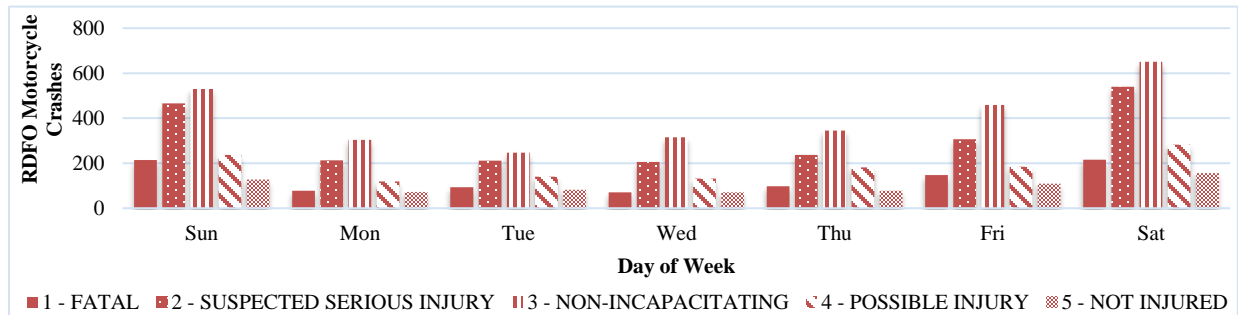
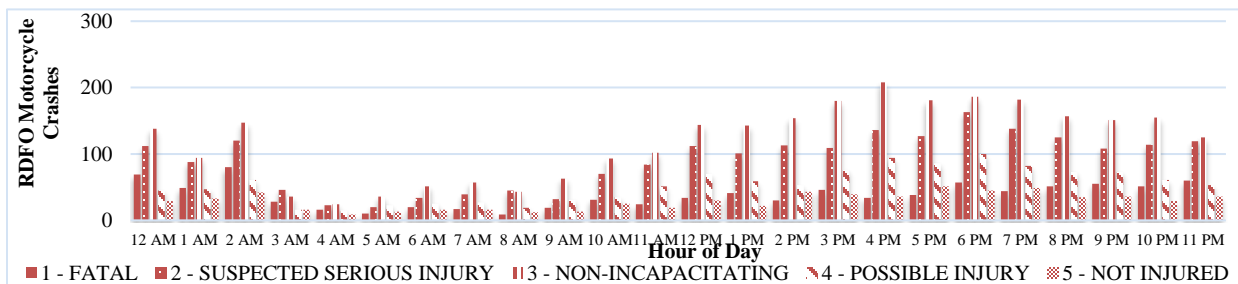
**Figure 20.1. Temporal Distribution of RDFO Motorcycle Crashes.**

Figure 20.1 depicts the temporal features of RDFO motorcycle crashes that resulted in a fatality or injury (FI, or KABC). As the figure shows, FI crashes, particularly fatal and suspected serious injury RDFO motorcycle crashes, have been increasing in past years (Figure 20.1[a]). The crashes from 2010 to 2017 occurred mainly during summer months (Figure 20.1[b]) and on the weekends (Figure 20.1[c]), indicating high recreational activity. The RDFO FI motorcycle crashes also tended to occur during peak hours (Figure 20.1[d]). However, unlike the vehicle crashes, the crash frequency and severity of RDFO motorcycle crashes remained high until 2:00 a.m.

a) Year

b) Month

c) Day of Week

d) Hour of Day

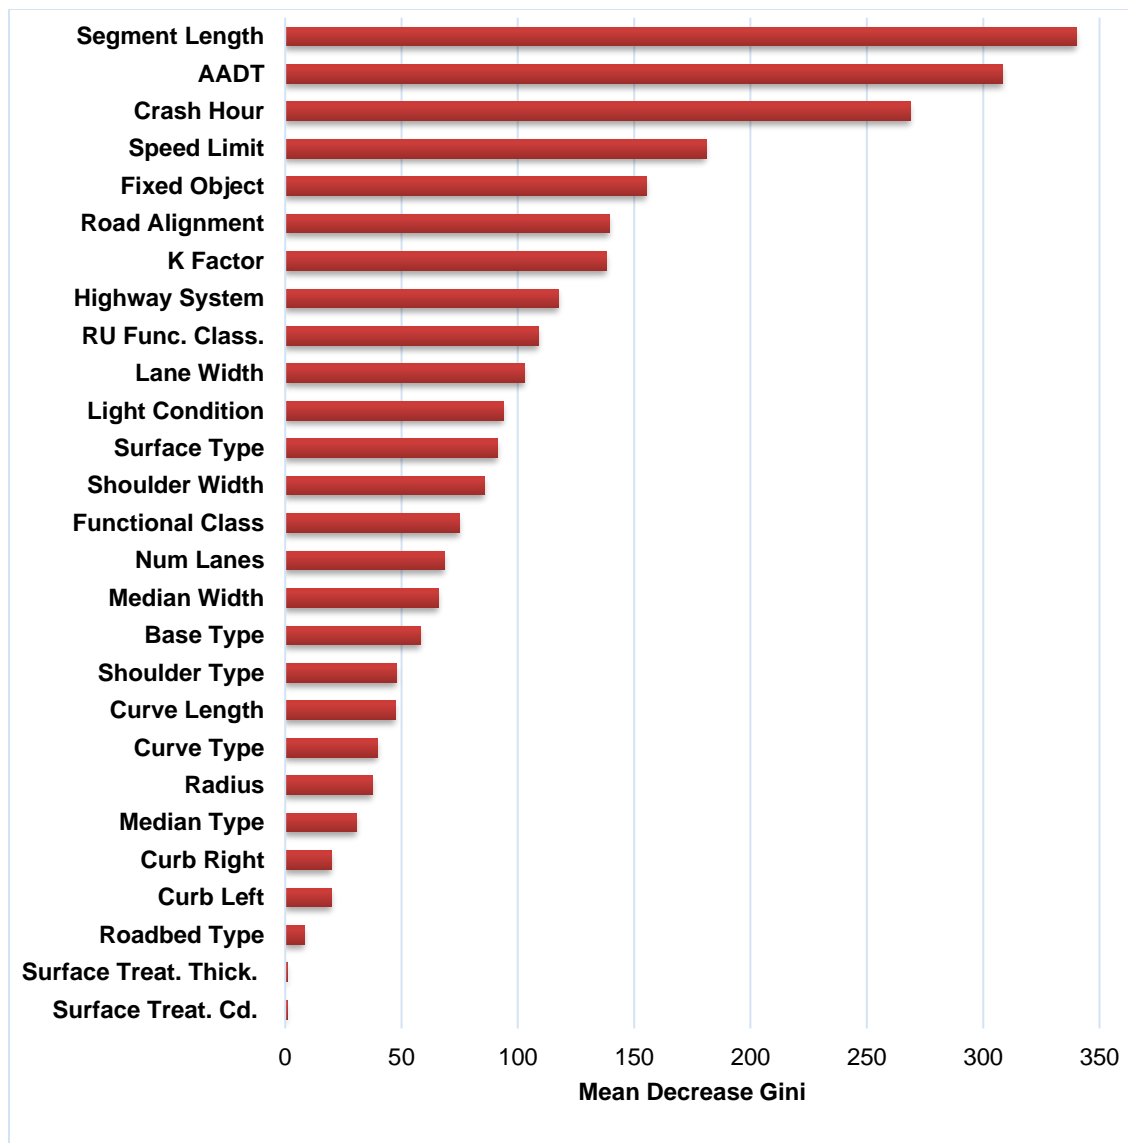
**Figure 20.2. Important Variables Associated with Motorcycle Crash Severity.**

To assess how external roadway and roadside factors affect the crash severity of motorcycle crashes, the researchers used random forests. Figure 20.2 shows the importance of the crash-contributing variables in determining the severity outcome of a crash. As the figure illustrates, the most important variables associated with the RDFO motorcycle crash severity are segment length, AADT, crash hour, speed limit, fixed object, road alignment, K-factor, highway system, rural-urban (RU) classification, lane width, lighting conditions, surface type, and shoulder width. The variables of segment length and AADT are related to exposure, while all the others are related to risk.

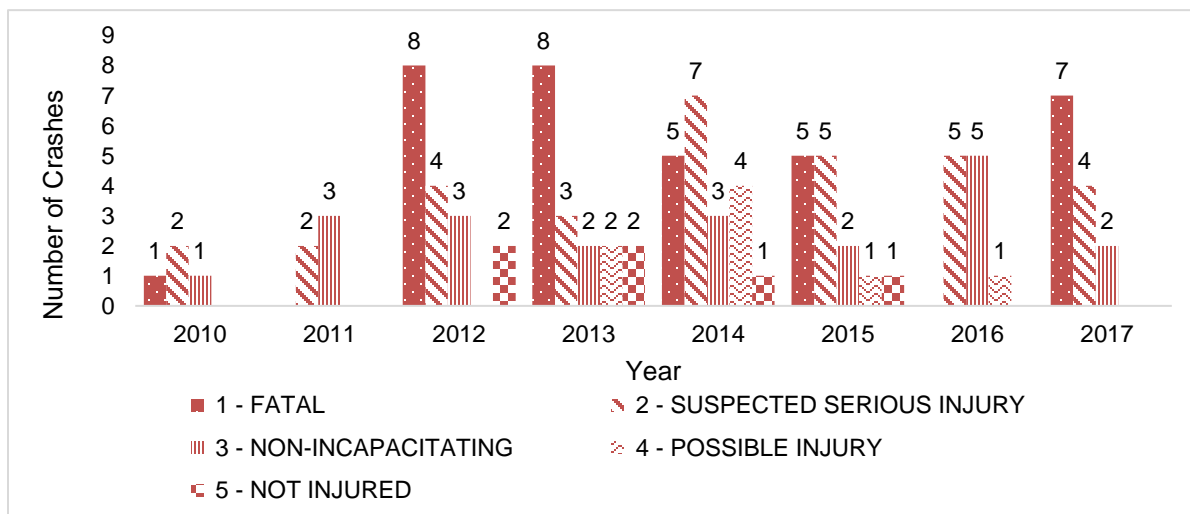
**Figure 20.4. Number of Severe Crashes at High-Risk Sites.**

Figure 20.4 shows the number of crashes per crash severity and year at high-risk sites. As shown, the number of fatal and injury crashes at the high-risk sites was higher than the possible and non-injury crashes. Thus, these sites have the potential for safety improvement and were the candidate sites for installing the retrofit guardrails. Figure 20.5 shows the low- to high-risk locations where the RDFO motorcycle crashes occurred.

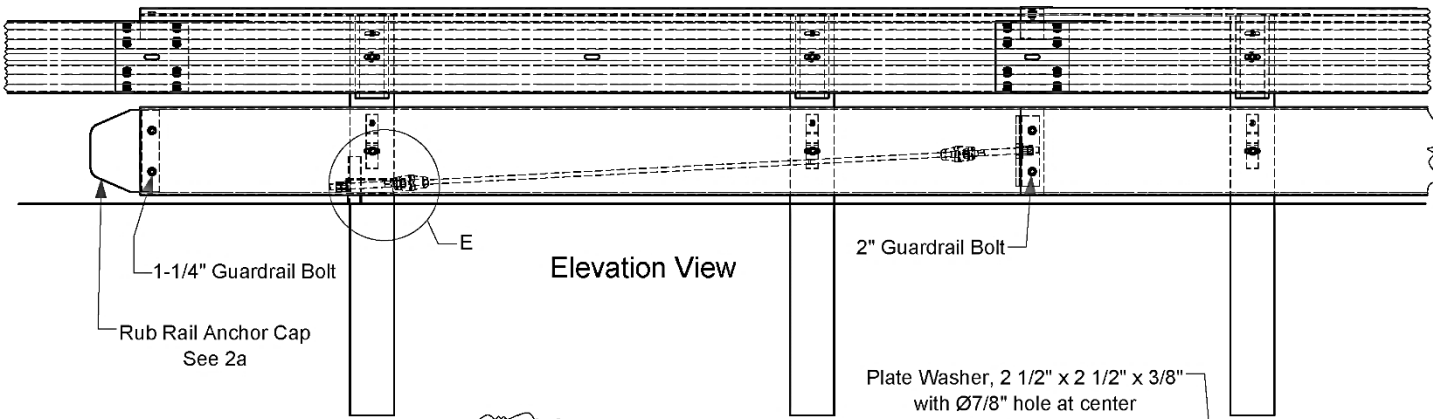
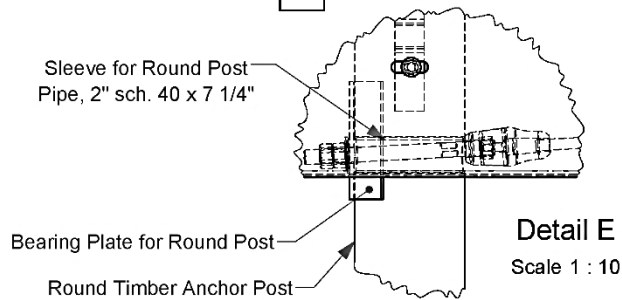
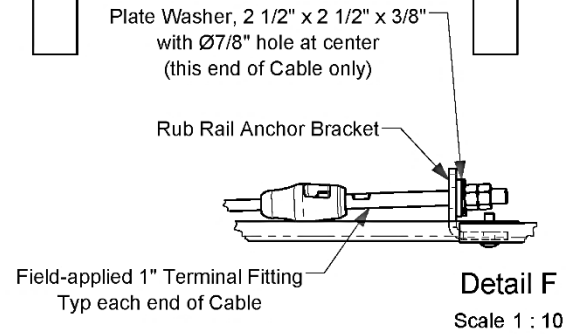
## Rub Rail Anchor Details

**2a.** Rub Rail Anchor Cap is placed on field side of Rub Rail in this location. It will be on the traffic side on the upstream end of the installation to minimize snagging.

Project #469940-03 Motorcycle Rail		2020-07-29
Drawn by GES/WS	Scale 1:25	Sheet 2 of 7 Rub Rail Anchor Details

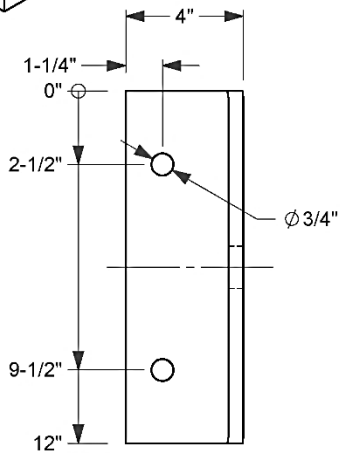
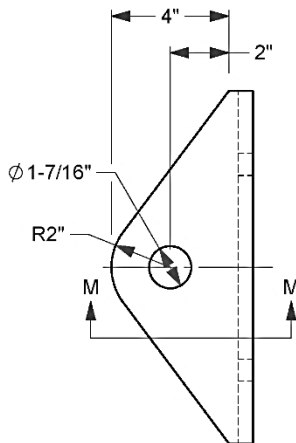
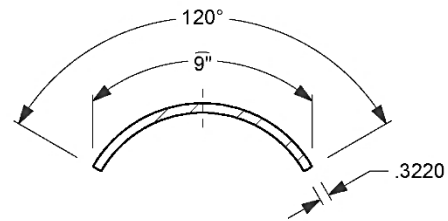
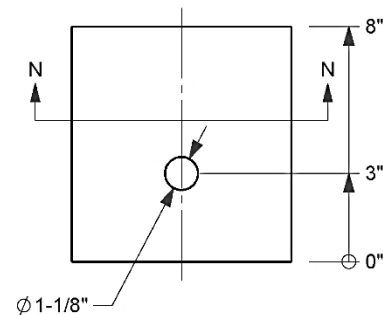
### Rub Rail Anchor Bracket

Plate, 12" x 1/2" x 8"  
ASTM A572 Grade 50

### Section N-N

### Bearing Plate for Round Post

Pipe, 8" sch. 40  
See 7a

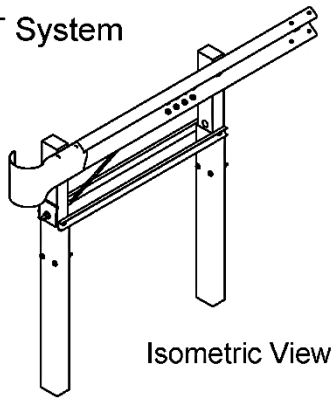
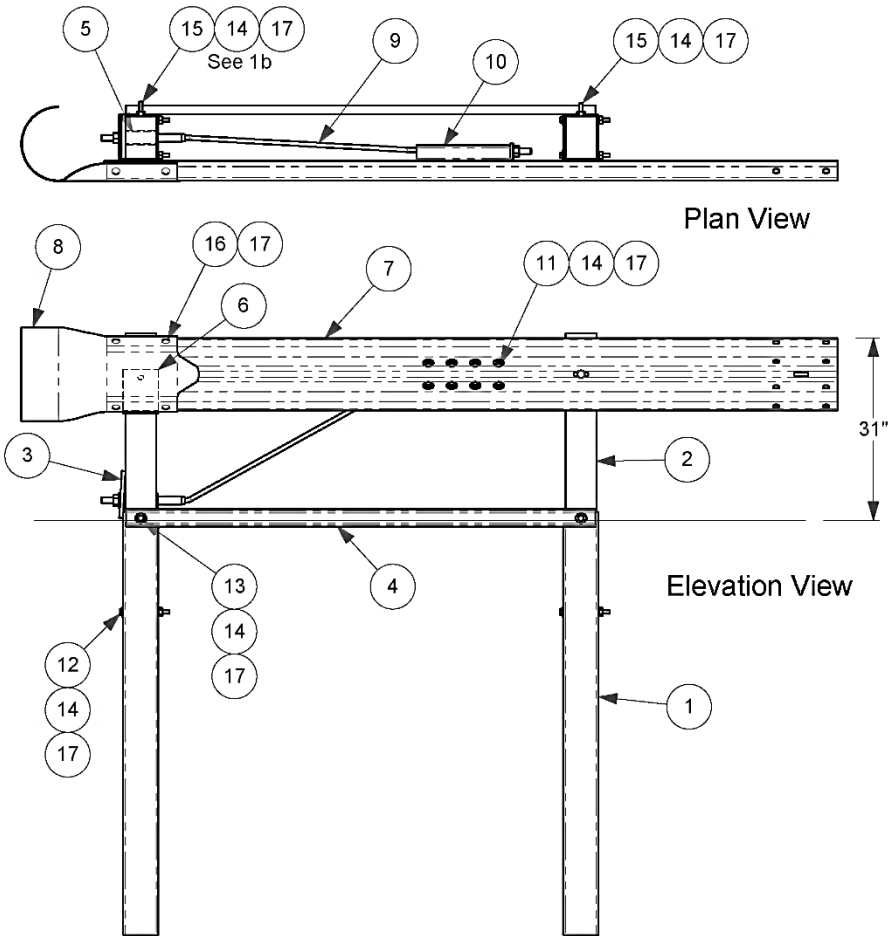
# DAT System

- 1a. All bolts are ASTM A307.  
 1b. Hardware secures Shelf Angle Bracket to Post. Rail is supported by Shelf Angle Bracket and does not attach directly to Post.

Roadside Safety and Physical Security Division - Proving Ground
DAT (Downstream Anchor Terminal)		2019-07-26
Drawn by GES	Scale 1:25	Sheet 1 of 3

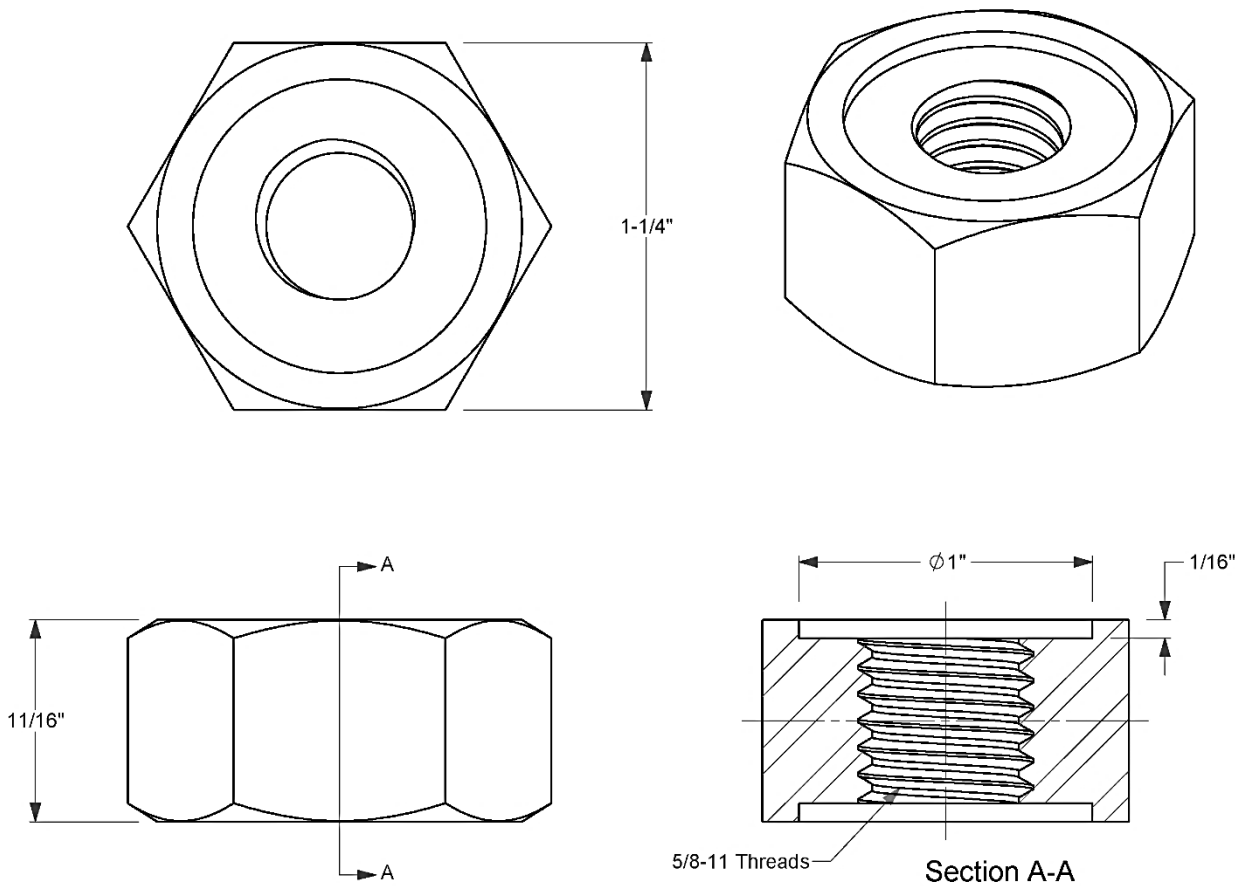
1a. Material is ASTM A 563 Grade A.

Roadside Safety and Physical Security Division - Proving Ground
Recessed Guardrail Nut		2019-06-27
Drawn by GES	Scale 2:1	Sheet 1 of 1

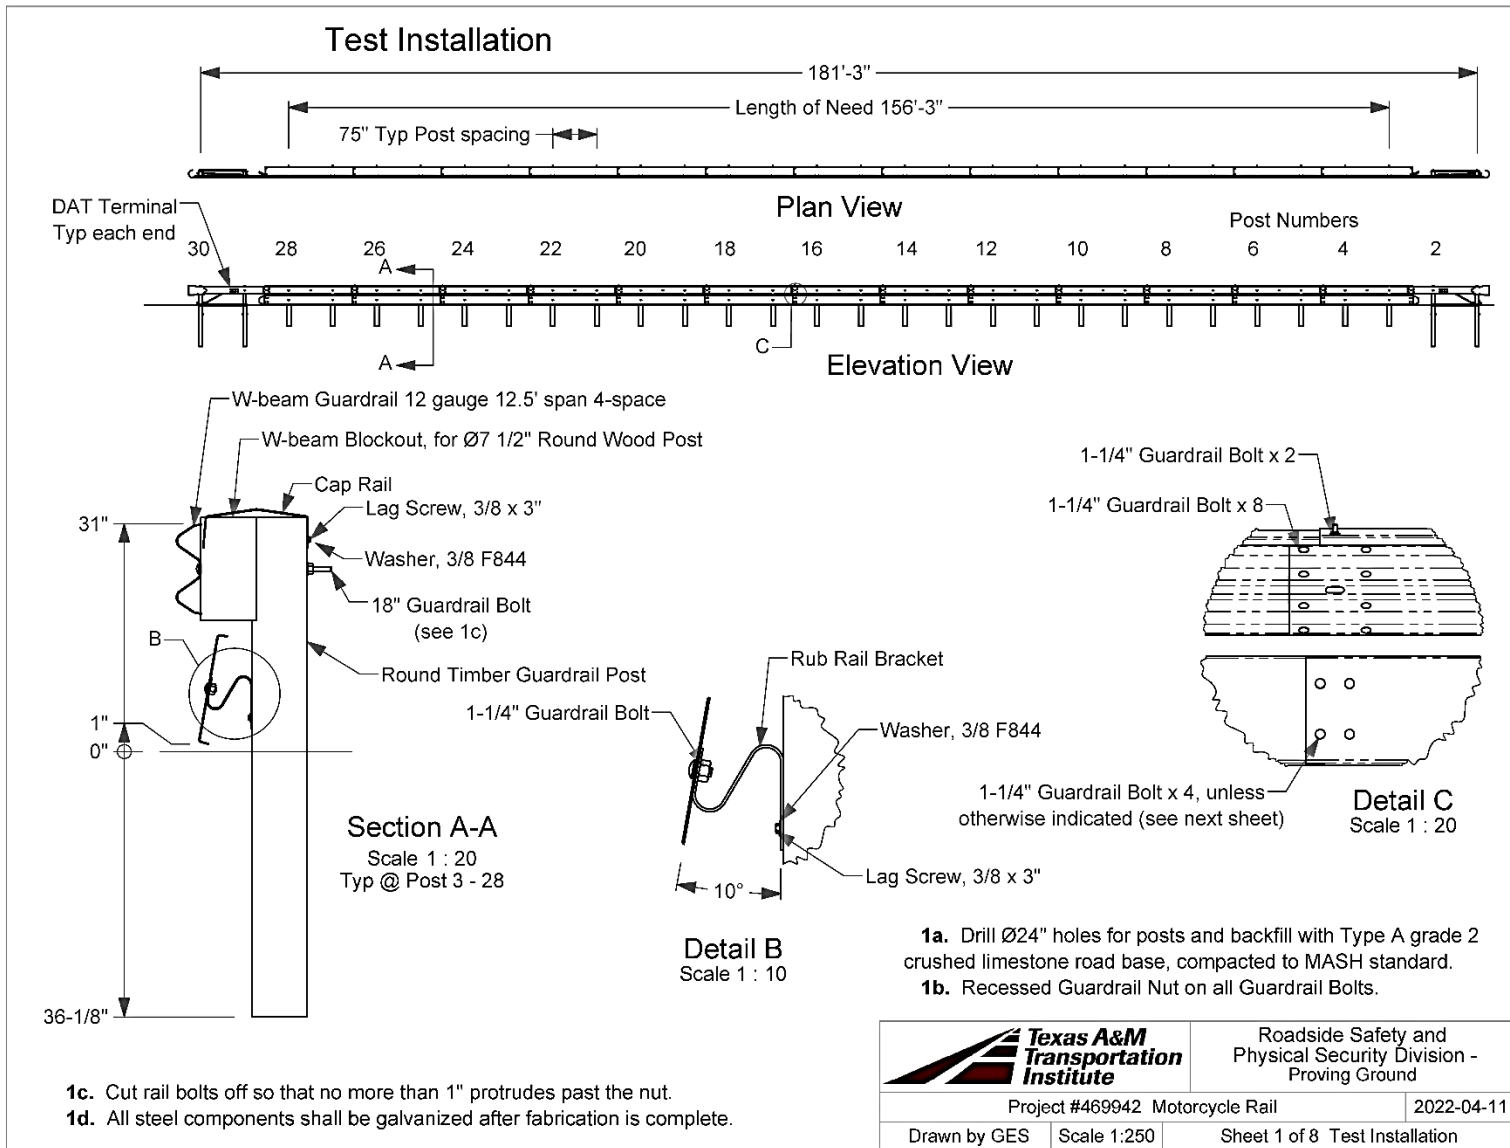
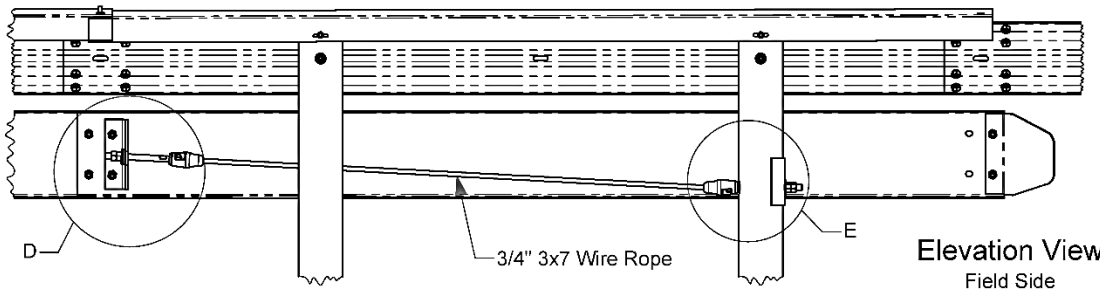
# Rub Rail Anchor Details

Typ each end of Rail

Plate Washer, 2 1/2" x 2 1/2" x 3/8"  
with Ø7/8" hole at center  
(this end of Cable only)

2" Guardrail Bolt x 2

Sheet 2 of 8 Rub Rail Anchor Details

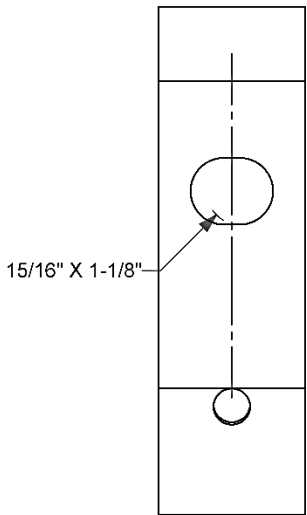
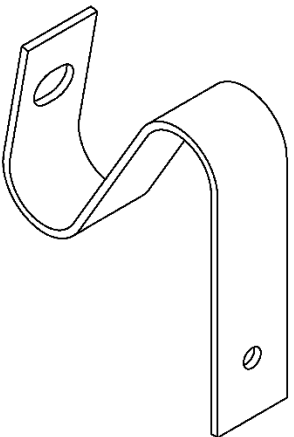
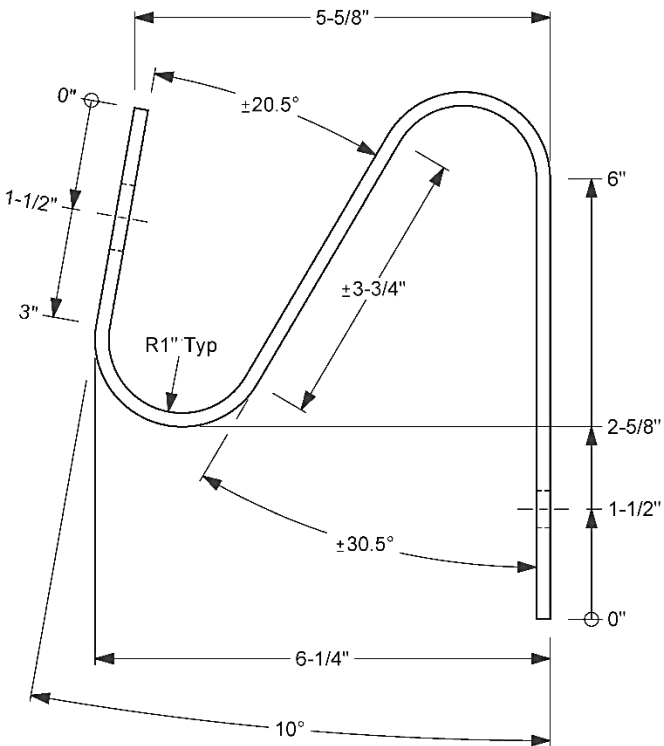
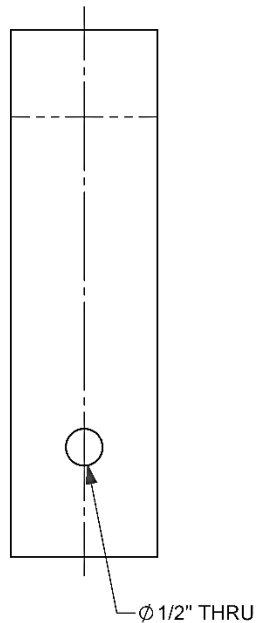
Sheet 5 of 8 Rub Rail Bracket

**Rub Rail Bracket**  
Plate, 2" x 3/16" x 18 3/4"  
ASTM A36

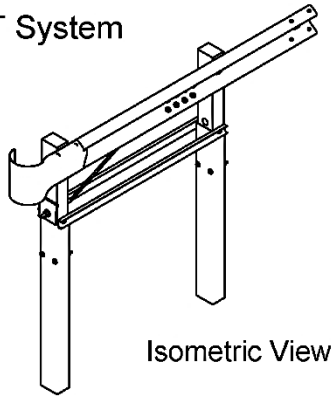
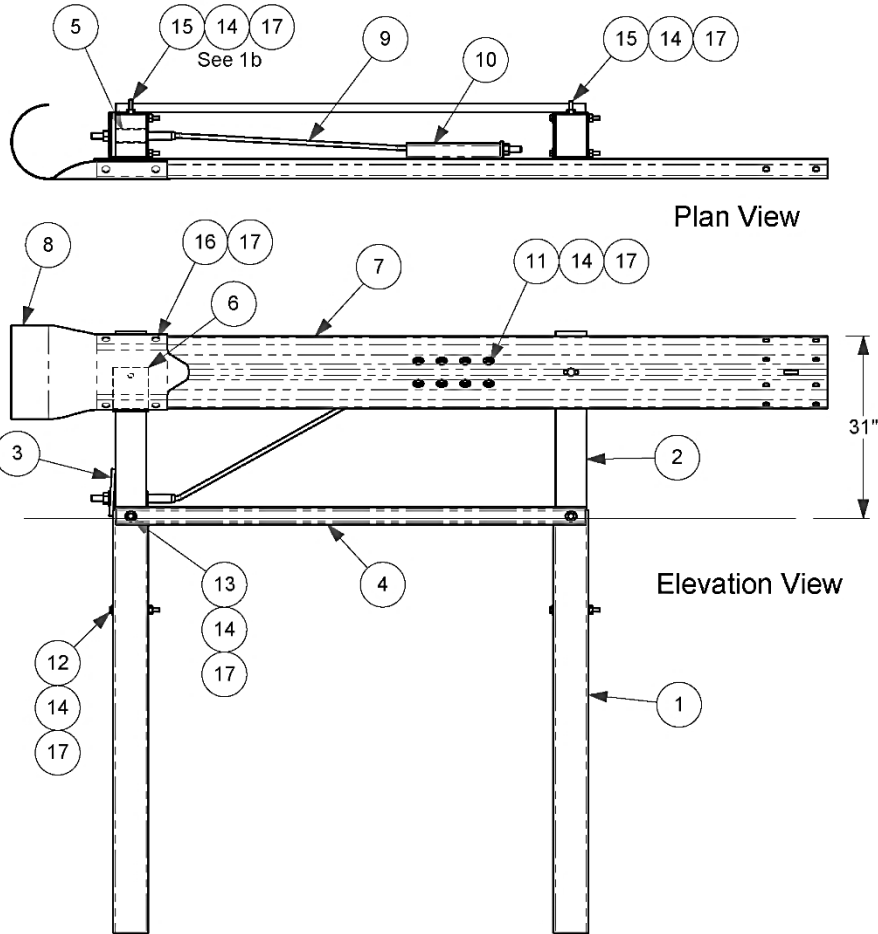
## DAT System

#	Part Name	Qty.
1	Foundation Tube	2
2	Terminal Timber Post	2
3	BCT Bearing Plate	1
4	DAT Strut	2
5	BCT Post Sleeve	1
6	Shelf Angle Bracket	1
7	DAT Terminal Rail	1
8	W-beam End Section	1
9	Anchor Cable Assembly	1
10	Guardrail Anchor Bracket	1
11	Bolt, 5/8 x 2" hex	8
12	Bolt, 5/8 x 8" hex	4
13	Bolt, 5/8 x 10" hex	2
14	Washer, 5/8 F844	16
15	10" Guardrail Bolt	2
16	1-1/4" Guardrail Bolt	4
17	Recessed Guardrail Nut	20

1a. All bolts are ASTM A307.

1b. Hardware secures Shelf Angle Bracket to Post. Rail is supported by Shelf Angle Bracket and does not attach directly to Post.

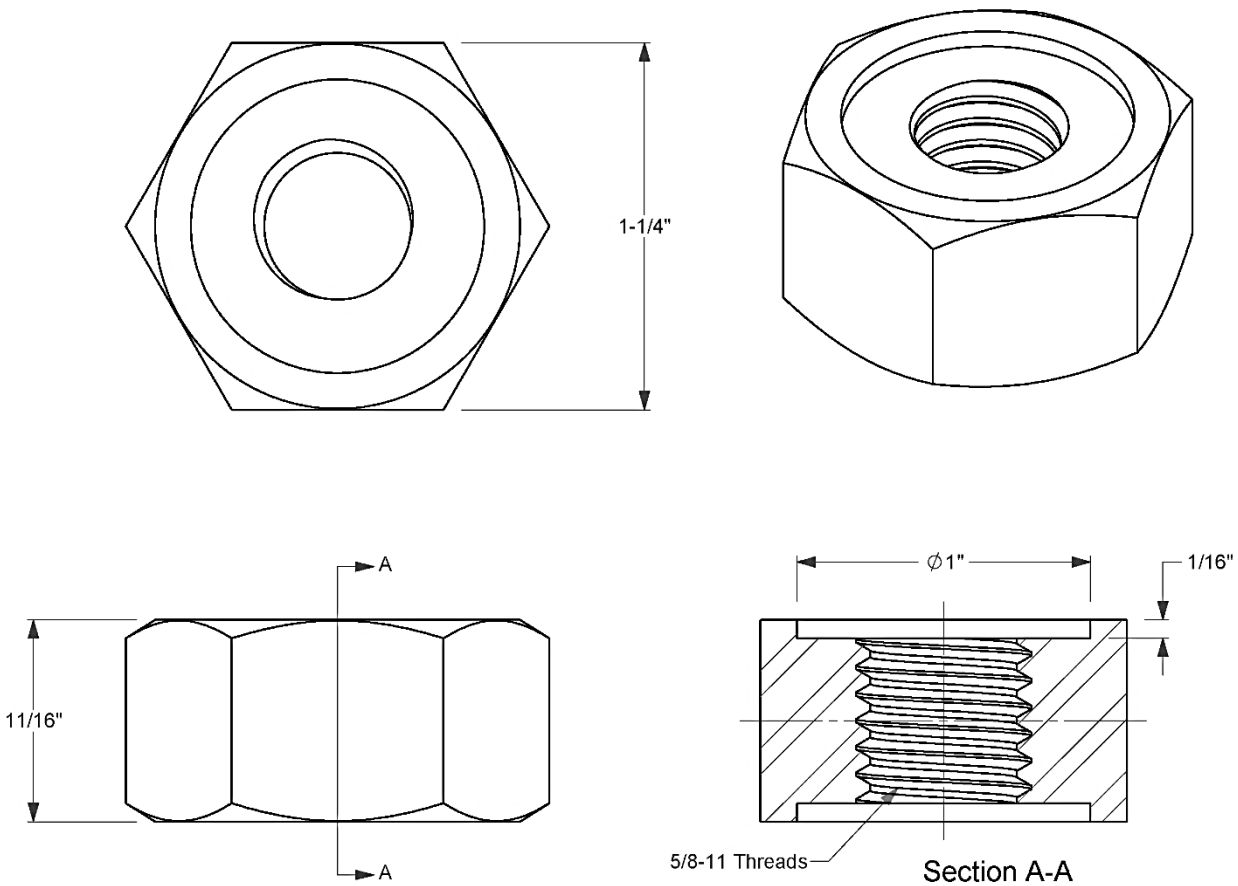
Recessed Guardrail Nut

1a. Material is ASTM A 563 Grade A.

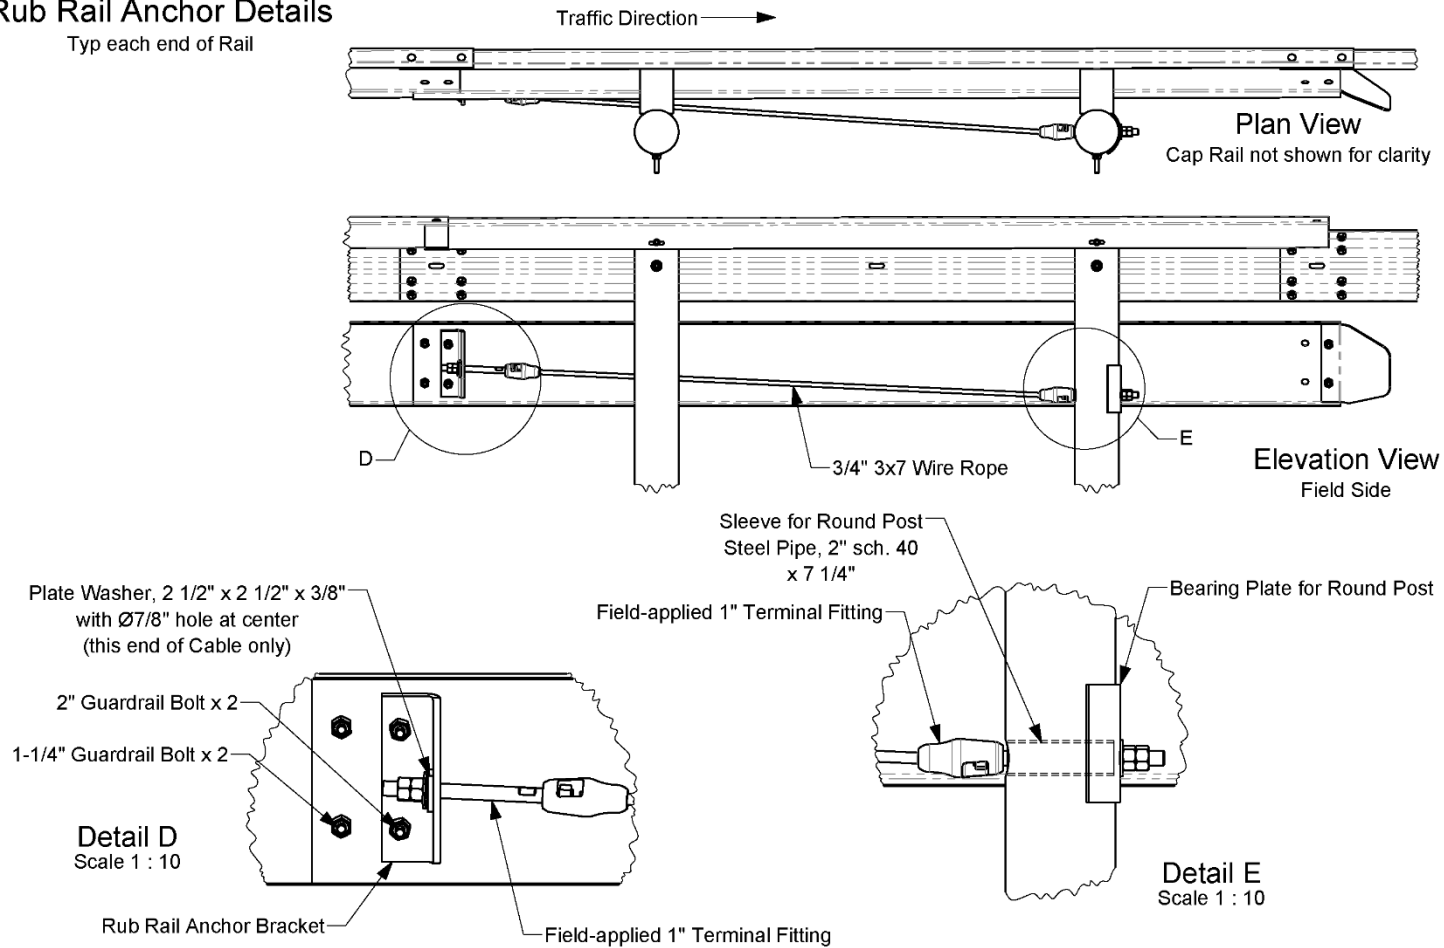
## Rub Rail Anchor Details

Type each end of Rail

**2a.** Rub Rail Anchor Cap is placed on field side of Rub Rail in this location. It will be on the traffic side on the upstream end of the installation to minimize snagging.

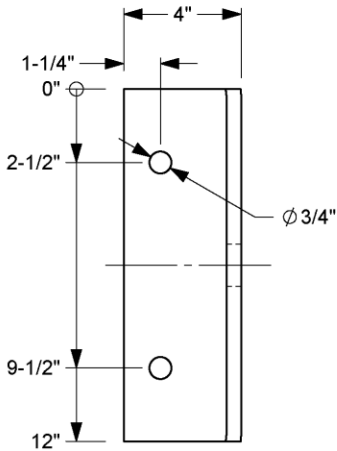
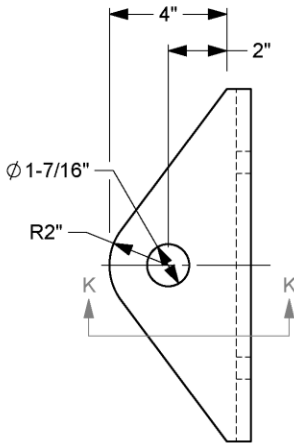
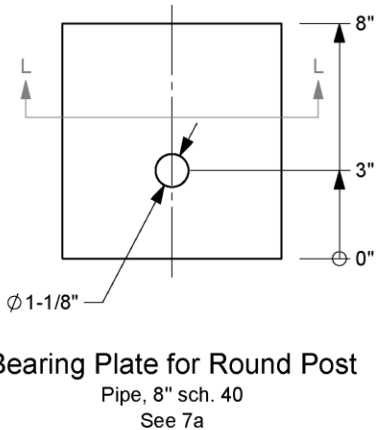
Roadside Safety and Physical Security Division - Proving Ground	
Project #469943-01		Motorcycle Rail	2022-12-01
Drawn by GES	Scale 1:5	Sheet 7 of 8 Anchor Bracket and Bearing Plate

**Rub Rail Anchor Bracket**  
Plate, 12" x 1/2" x 8"  
ASTM A572 Grade 50

**Bearing Plate for Round Post**  
Pipe, 8" sch. 40  
See 7a

**7a.** Bearing Plate for Round Post may be fabricated from schedule 40 pipe, as indicated, or 3/8" plate at contractor's discretion. Contractor shall specify which option was used for the installation and provide material certs.

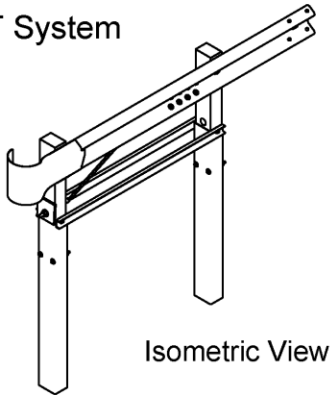
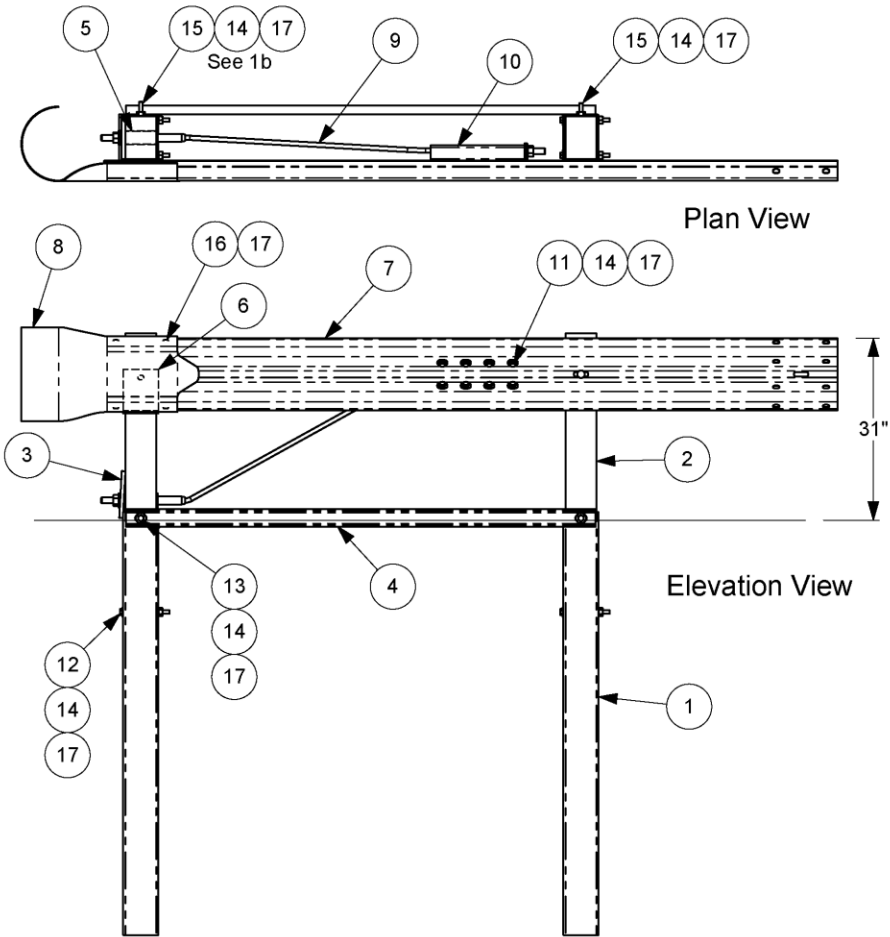
DAT System

#	Part Name	Qty.
1	72" Foundation Tube	2
2	Tube Post	2
3	BCT Bearing Plate	1
4	DAT Strut	2
5	BCT Post Sleeve	1
6	Shelf Angle Bracket	1
7	9'-4" span Terminal Rail	1
8	W-beam End Section	1
9	Anchor Cable Assembly	1
10	Guardrail Anchor Bracket	1
11	Bolt, 5/8 x 2" hex	8
12	Bolt, 5/8 x 8" hex	4
13	Bolt, 5/8 x 10" hex	2
14	Washer, 5/8 F844	16
15	10" Guardrail Bolt	2
16	1-1/4" Guardrail Bolt	4
17	Recessed Guardrail Nut	20

1a. All bolts are ASTM A307.  
1b. Hardware secures Shelf Angle Bracket to Post. Rail is supported by Shelf Angle Bracket and does not attach directly to Post.
