**DEVELOP A RETROFIT DESIGN FOR GUARD FENCE SYSTEM TO  
ENHANCE MOTORCYCLE SAFETY  
COOPERATIVE RESEARCH PROGRAM**

Texas Department of Transportation  
<https://tti.tamu.edu/documents/0-6994-R1.pdf>

**TEXAS A&M TRANSPORTATION INSTITUTE PROVING GROUND**

1. Report No. FHWA/TX-23/0-6994-R1	2. Government Accession No.	3. Recipient's Catalog No.	
4. Title and Subtitle DEVELOP A RETROFIT DESIGN FOR GUARD FENCE SYSTEM TO ENHANCE MOTORCYCLE SAFETY		5. Report Date Published: August 2024

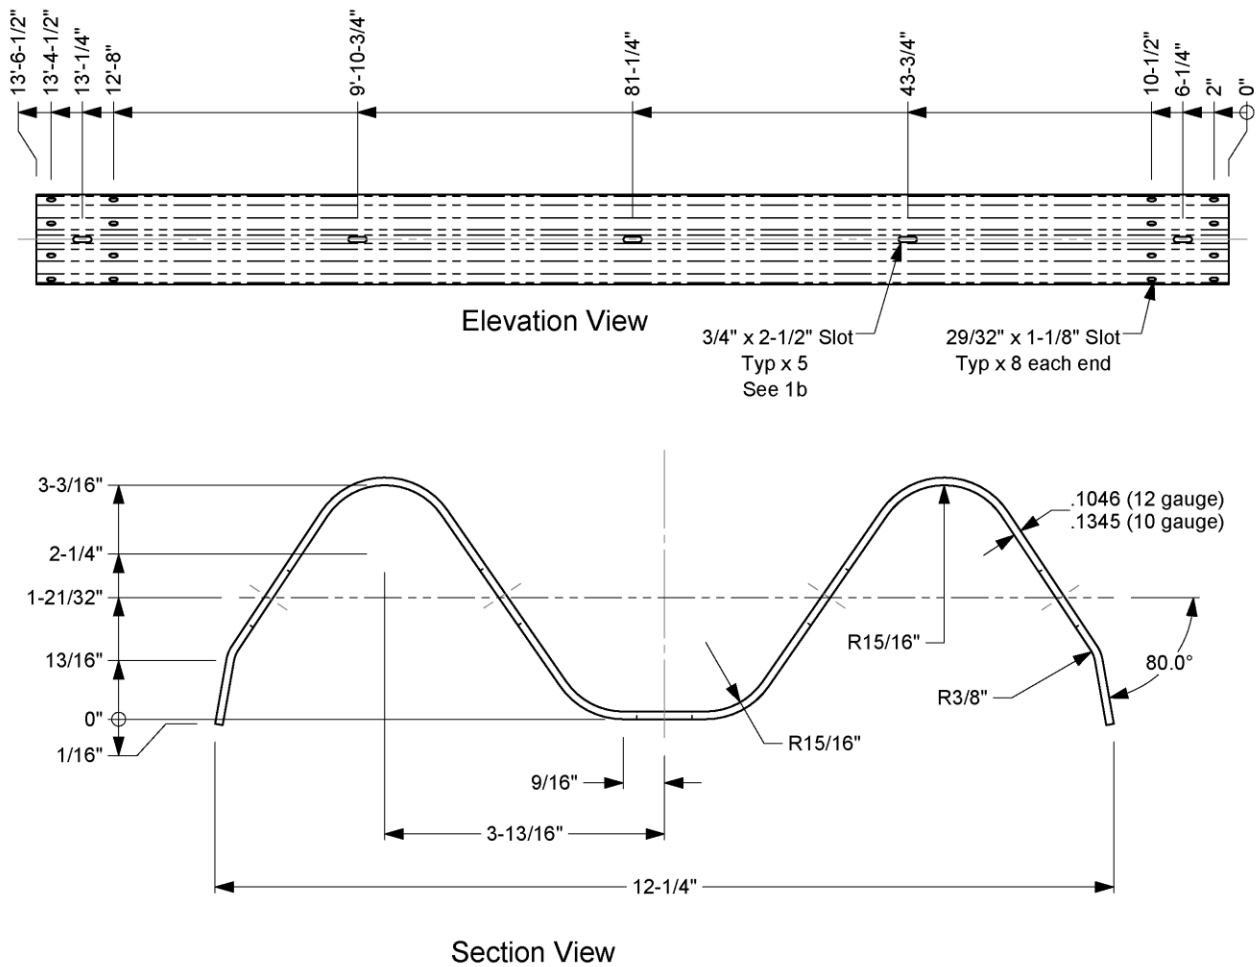
1a. Manufacture per AASHTO M180 specifications.

1b. 4-space Guardrail is shown. Slots typical x 3 for 2-space W-beam spaced at 75", and typical x 9 for 8-space W-beam spaced at 18-3/4". Slots are typical x 4 at 37-1/2" for 9'-4-1/2" span W-beam.

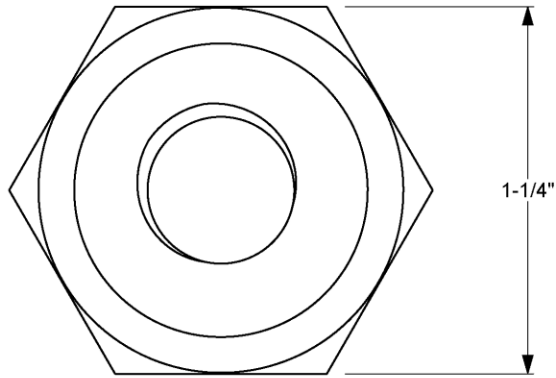
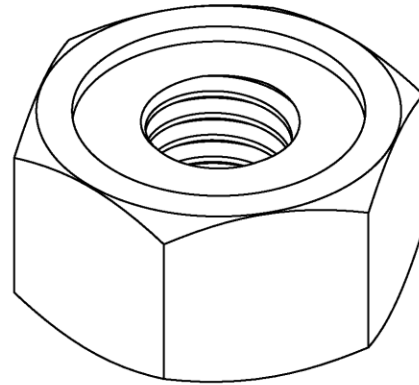
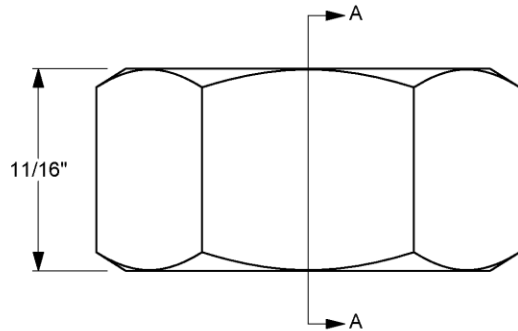
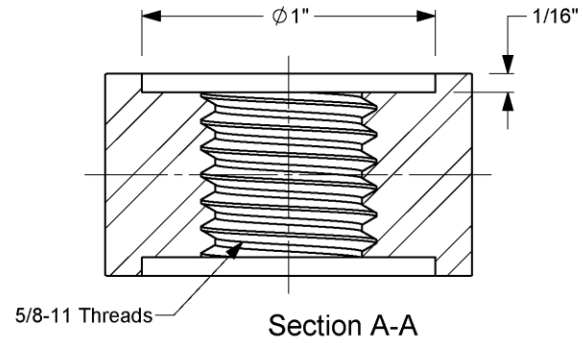
# Recessed Guardrail Nut

1a. Material is ASTM A 563 Grade A.

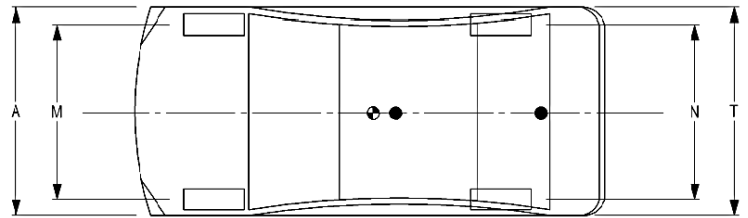
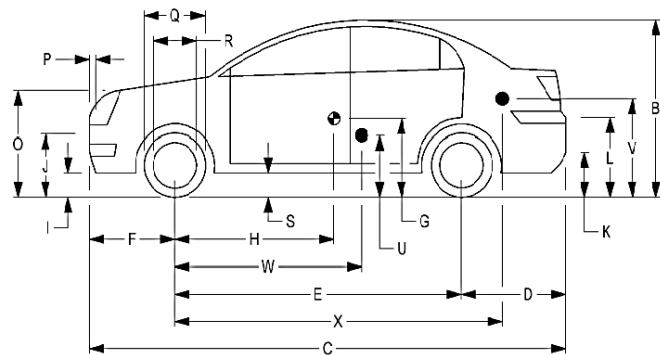
**Figure C.2. Exterior Crush Measurements for Test 469940-03-1.**

Geometry: inches

A <u>66.70</u>	F <u>32.50</u>	K <u>12.50</u>	P <u>4.50</u>	U <u>15.50</u>
B <u>59.60</u>	G <u>          </u>	L <u>26.00</u>	Q <u>24.00</u>	V <u>21.25</u>
C <u>175.40</u>	H <u>40.20</u>	M <u>58.30</u>	R <u>16.25</u>	W <u>40.20</u>
D <u>40.50</u>	I <u>7.00</u>	N <u>58.50</u>	S <u>7.50</u>	X <u>79.75</u>
E <u>102.40</u>	J <u>22.25</u>	O <u>30.50</u>	T <u>64.50</u>

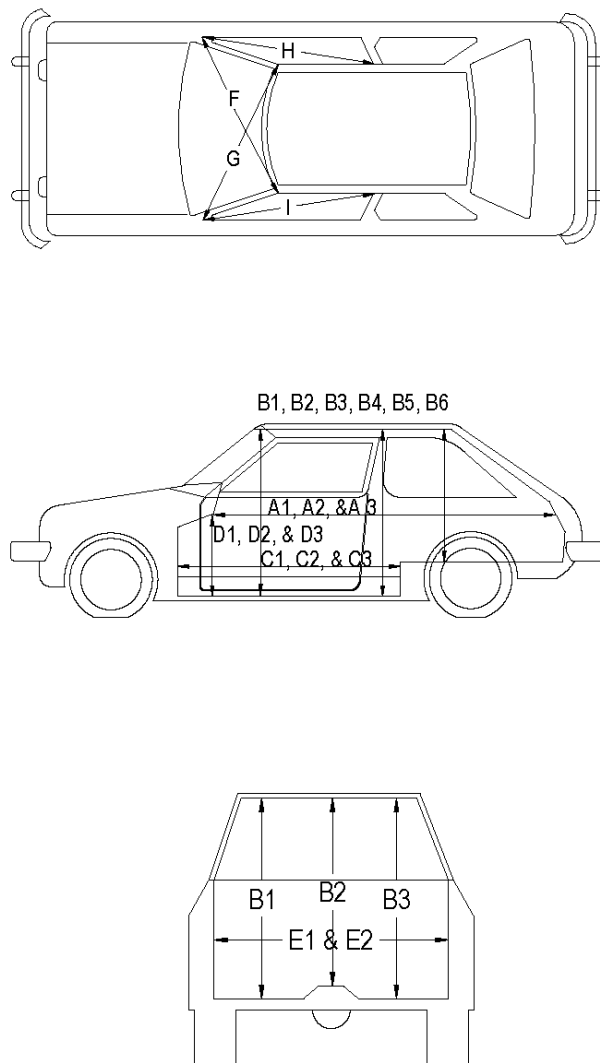
**Figure C.3. Occupant Compartment Measurements for Test 469940-03-1.**

**OCCUPANT COMPARTMENT  
DEFORMATION MEASUREMENT**

Before	After (inches)	Differ.
A1	75.00	75.00	0.00
A2	74.00	74.00	0.00
A3	74.00	74.00	0.00
B1	43.00	43.00	0.00
B2	37.00	37.00	0.00
B3	43.00	43.00	0.00
B4	46.50	46.50	0.00
B5	42.50	42.50	0.00
B6	46.50	46.50	0.00
C1	26.00	26.00	0.00
C2	0.00	0.00	0.00
C3	26.00	26.00	0.00
D1	12.50	12.50	0.00
D2	0.00	0.00	0.00
D3	10.00	10.00	0.00
E1	45.00	45.00	0.00
E2	48.75	48.75	0.00
F	47.50	47.50	0.00
G	47.50	47.50	0.00
H	39.00	39.00	0.00
I	39.00	39.00	0.00
J*	48.50	48.50	0.00

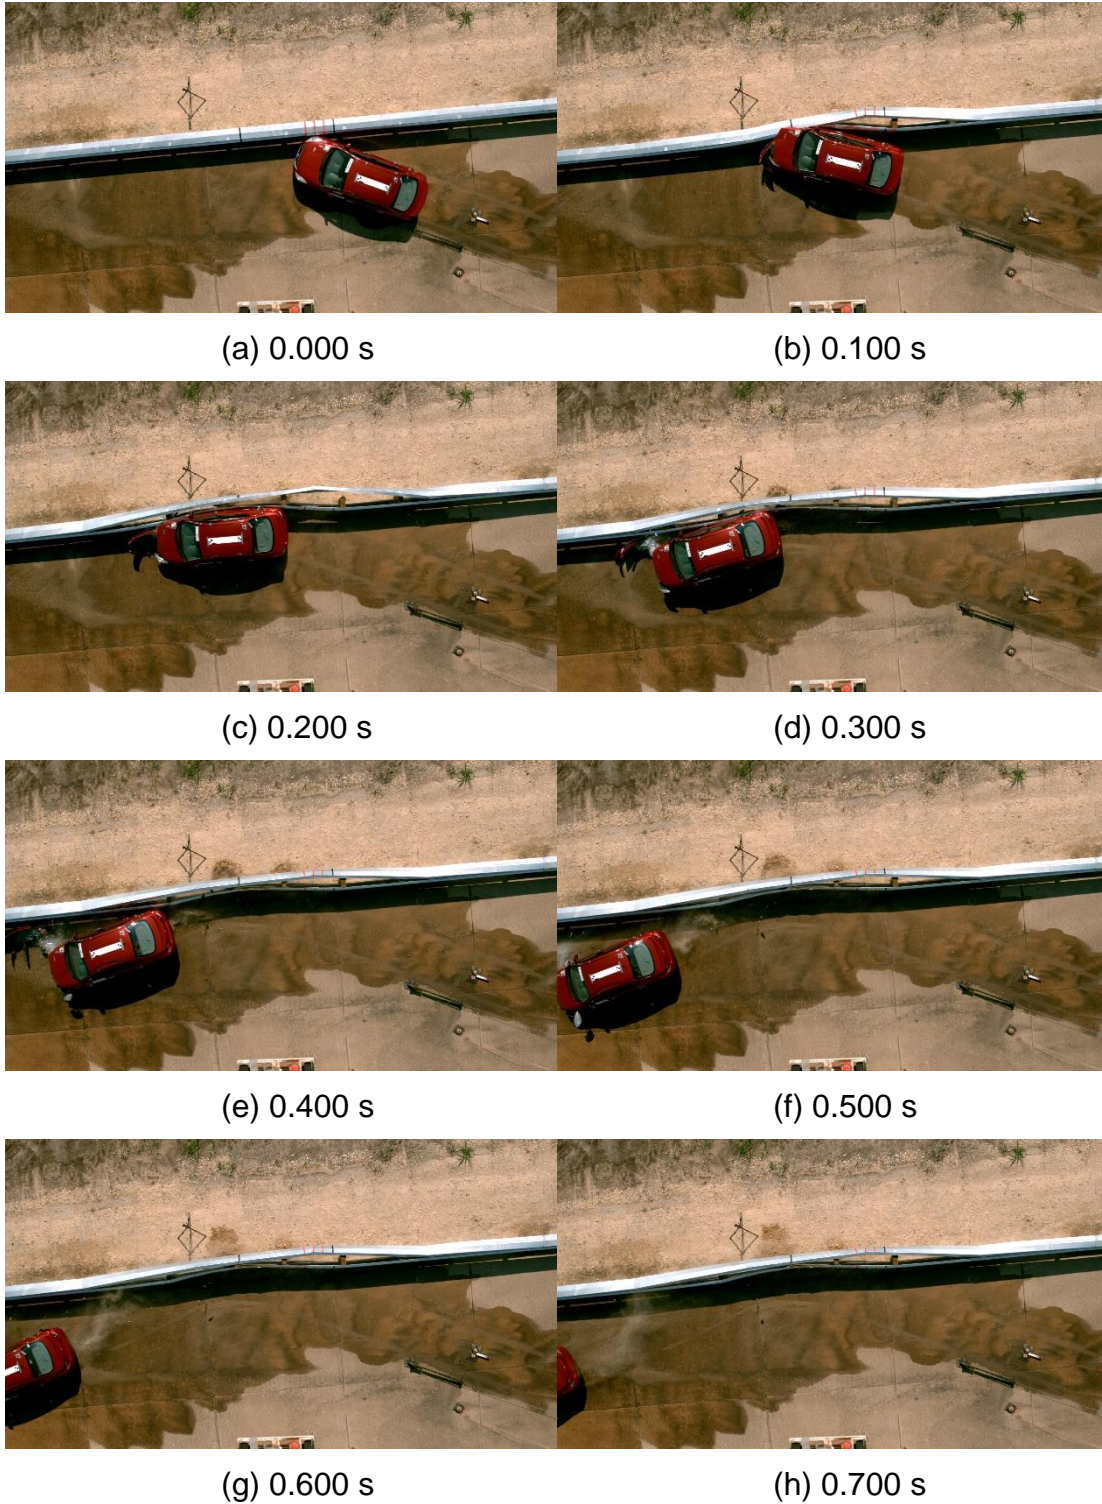
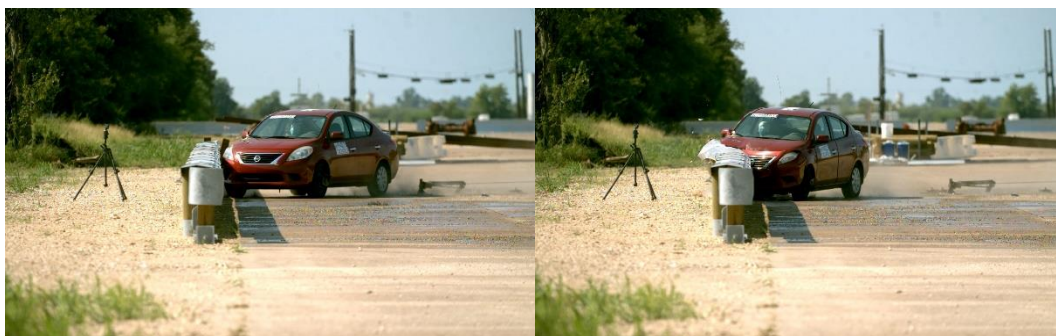
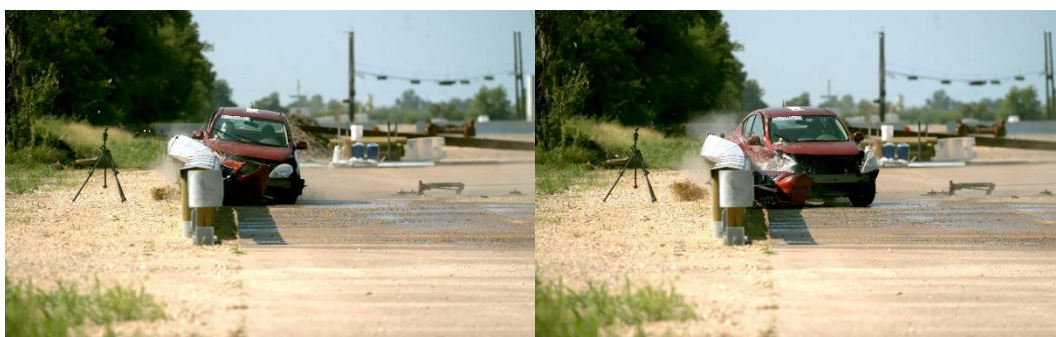
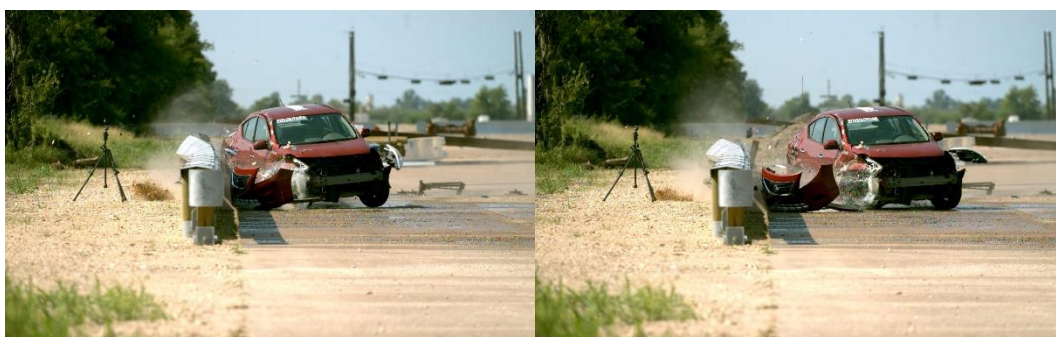
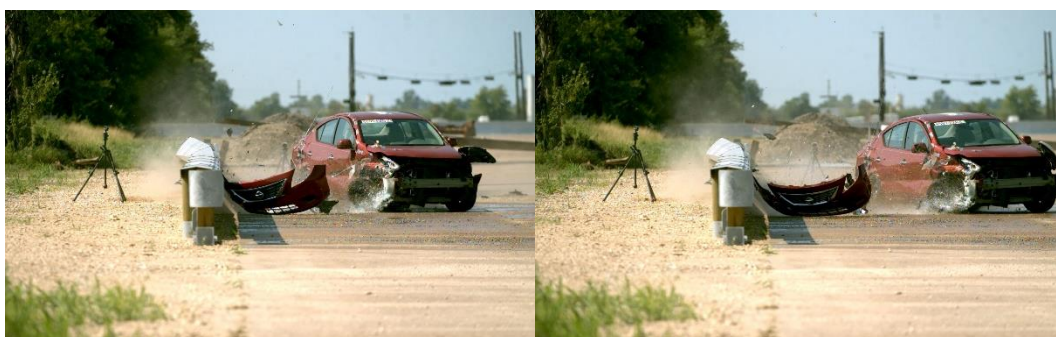
**Figure C.4. Sequential Photographs for Test 469940-03-1 (Overhead Views).**

(a) 0.000 s

(b) 0.100 s

(c) 0.200 s

(d) 0.300 s

(e) 0.400 s

(f) 0.500 s

(g) 0.600 s

(h) 0.700 s

For the upright motorcycle and ATD crash test (Test 469940-03-3), there was no observed snagging of the ATD on discrete elements of the enhanced motorcycle guard fence system. The ATD slid along the system and eventually came to rest on the traffic side of the system.

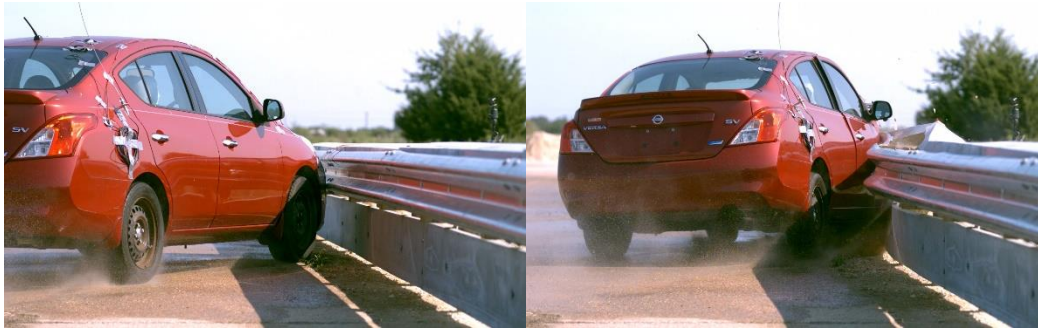
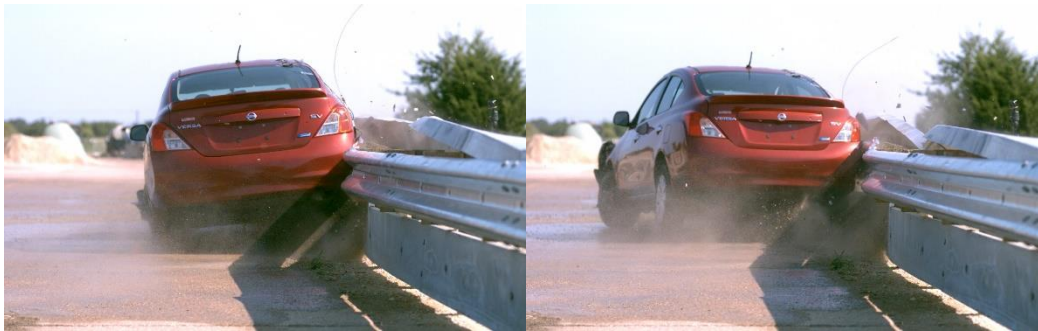
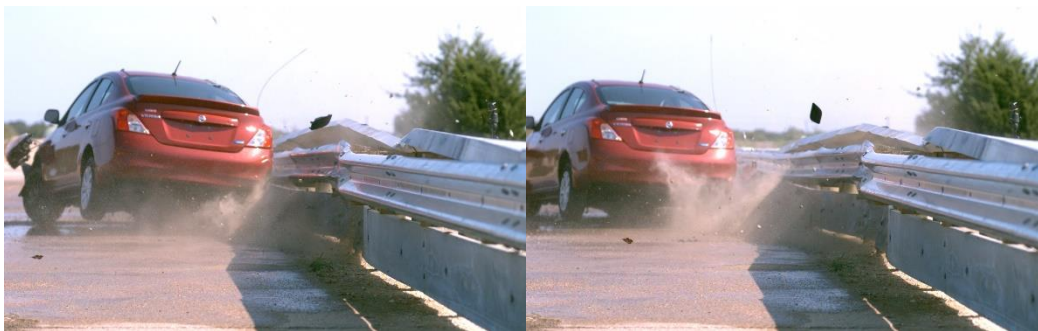
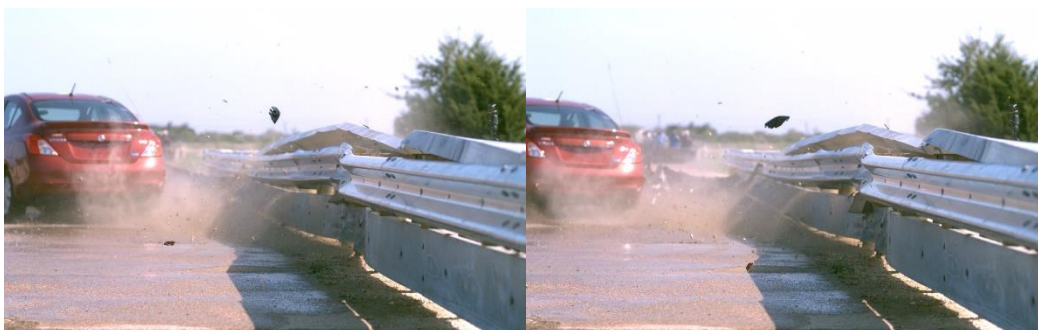
**Figure C.6. Sequential Photographs for Test 469940-03-1 (Rear Views).**

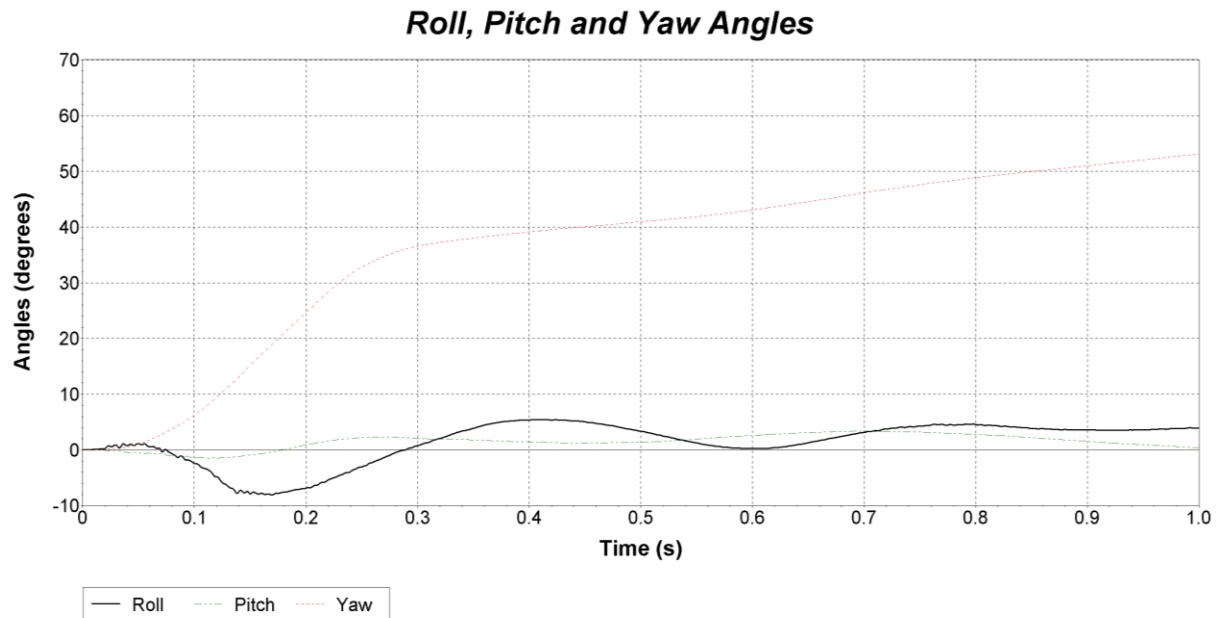
Axes are vehicle-fixed.  
Sequence for determining  
orientation:

1. Yaw.
2. Pitch.
3. Roll.

**Figure C.7. Vehicle Angular Displacements for Test 469940-03-1.**

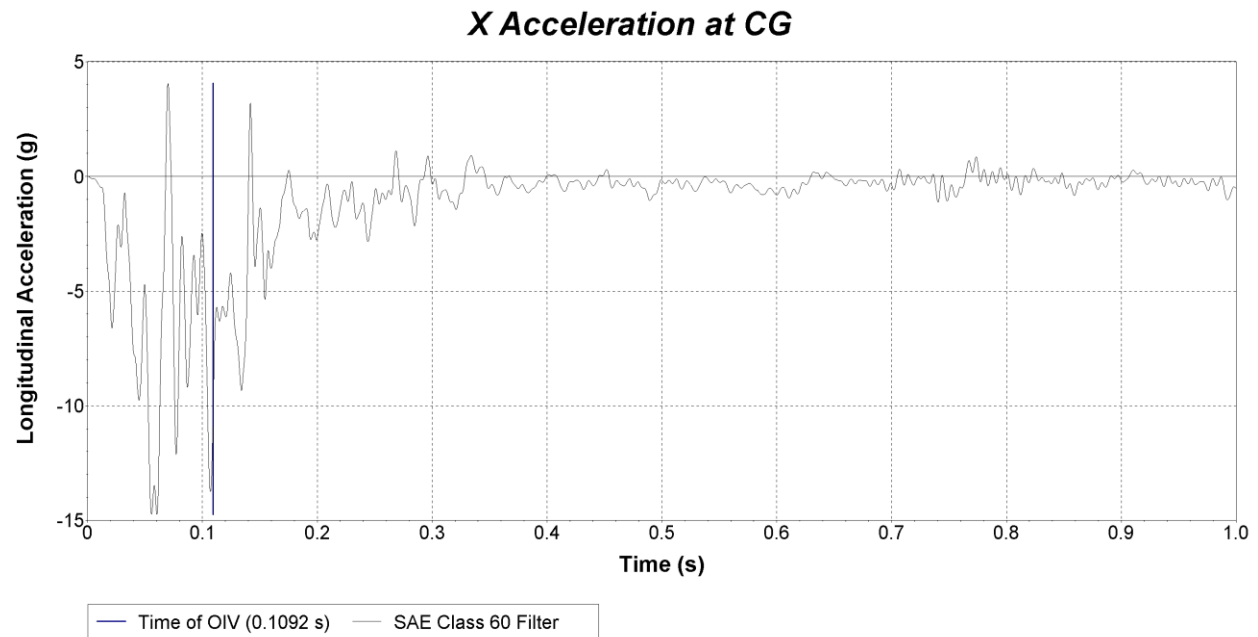
**Figure C.8. Vehicle Longitudinal Accelerometer Trace for Test 469940-03-1  
(Accelerometer Located at Center of Gravity).**

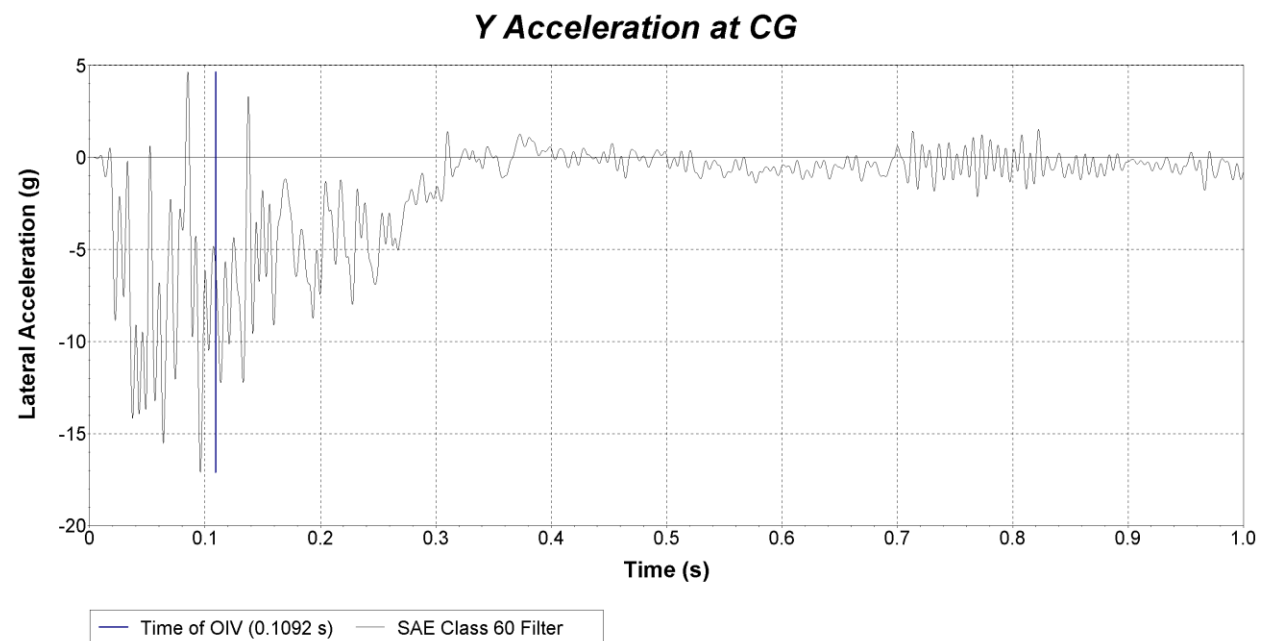
**Figure C.9. Vehicle Lateral Accelerometer Trace for Test 469940-03-1  
(Accelerometer Located at Center of Gravity).**

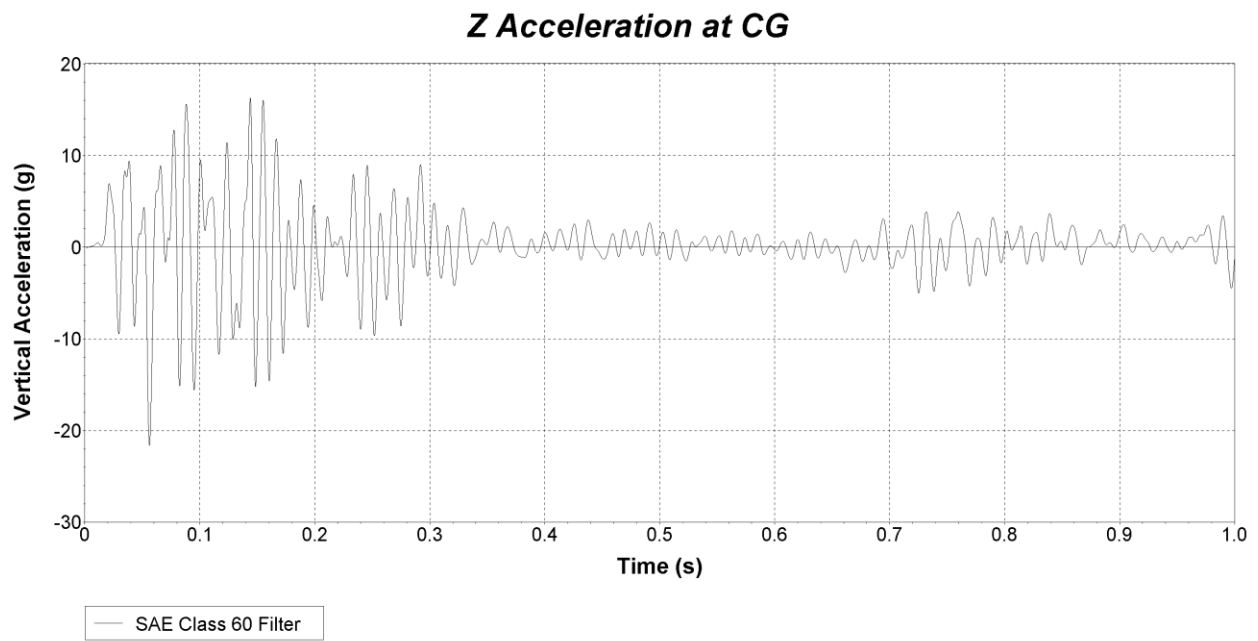
**Figure C.10. Vehicle Vertical Accelerometer Trace for Test 469940-03-1  
(Accelerometer Located at Center of Gravity).**

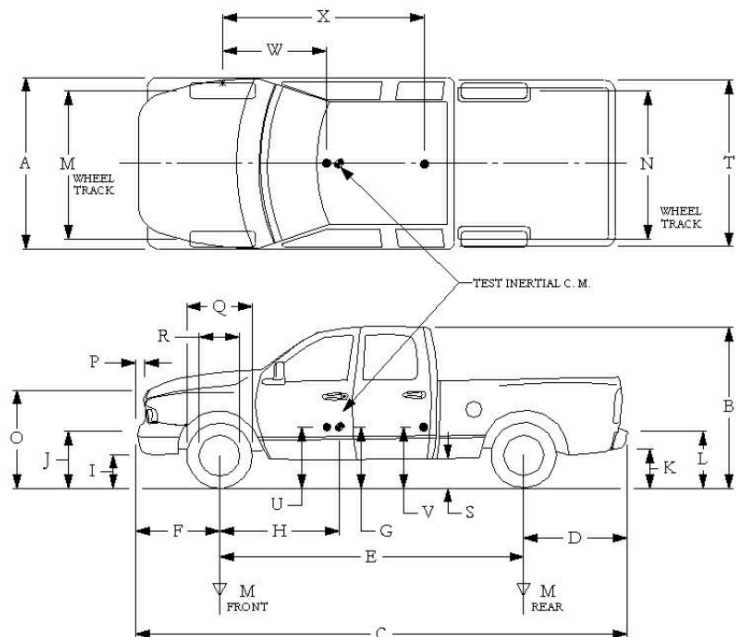
lb LF: 1390 RF: 1441 LR: 1124 RR: 1071

Figure D.1. Vehicle Properties for Test 469940-03-2.

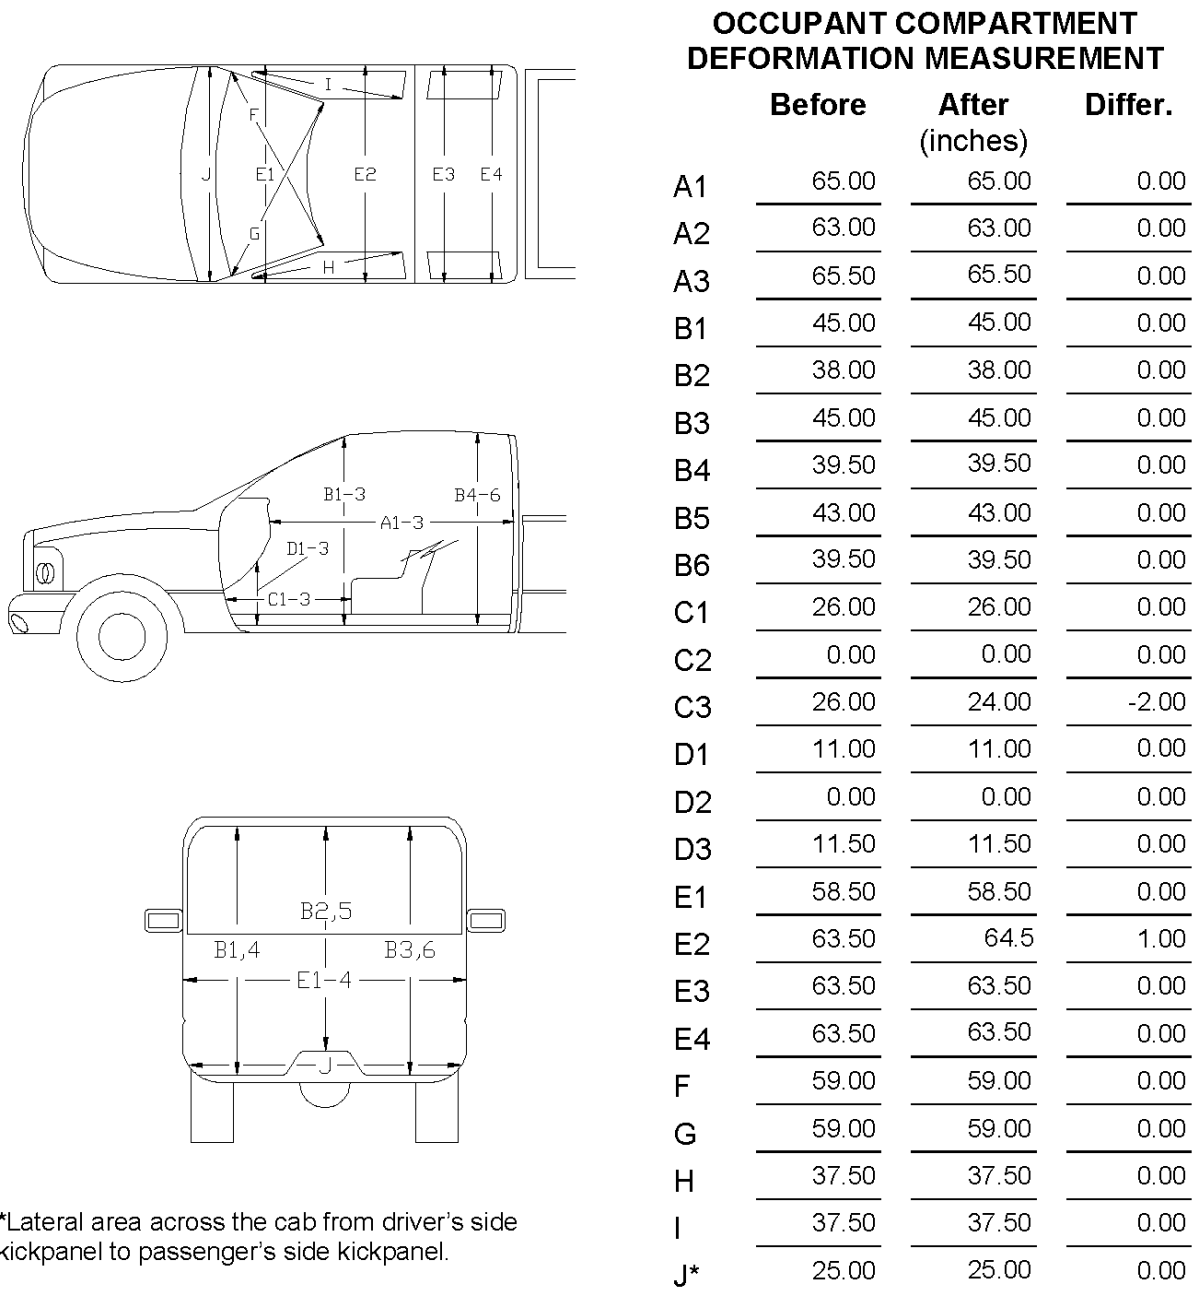
**Figure D.3. Occupant Compartment Measurements for Test 469940-03-2.**

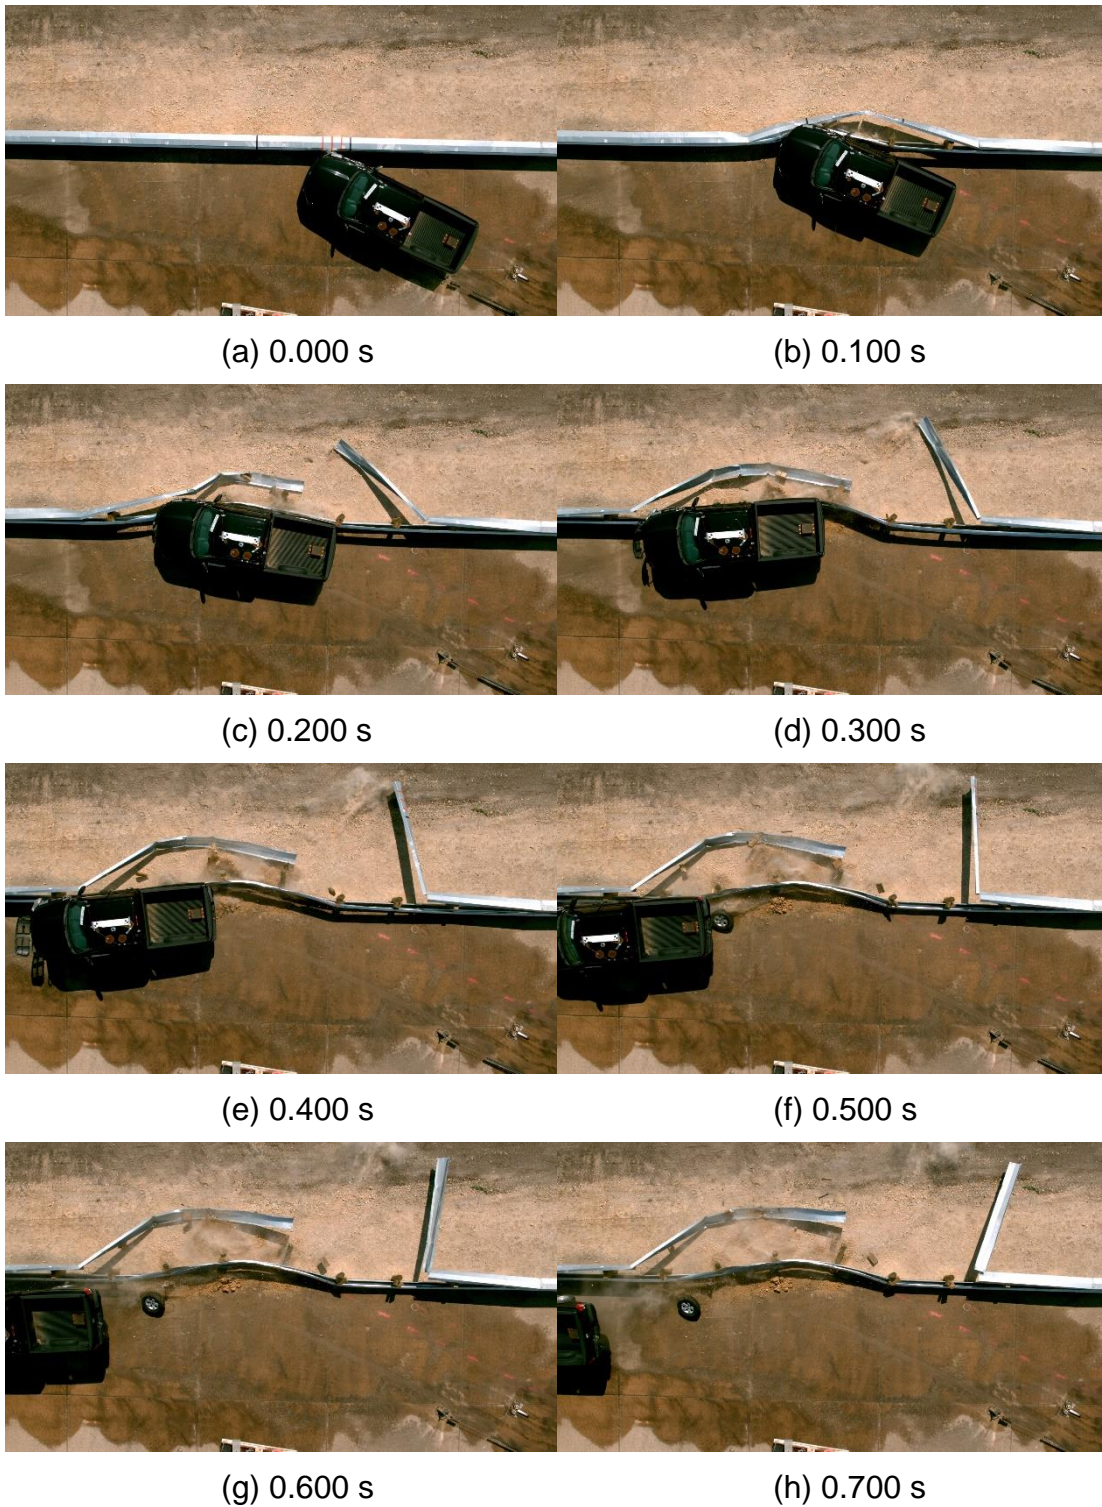
**Figure D.4. Sequential Photographs for Test 469940-03-2 (Overhead Views).**

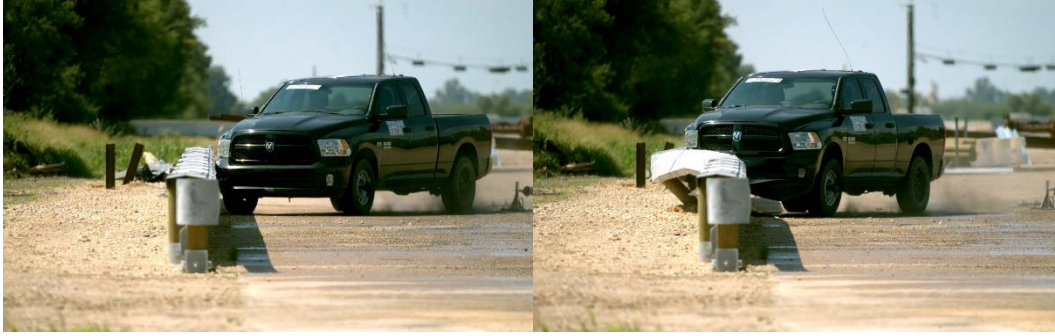
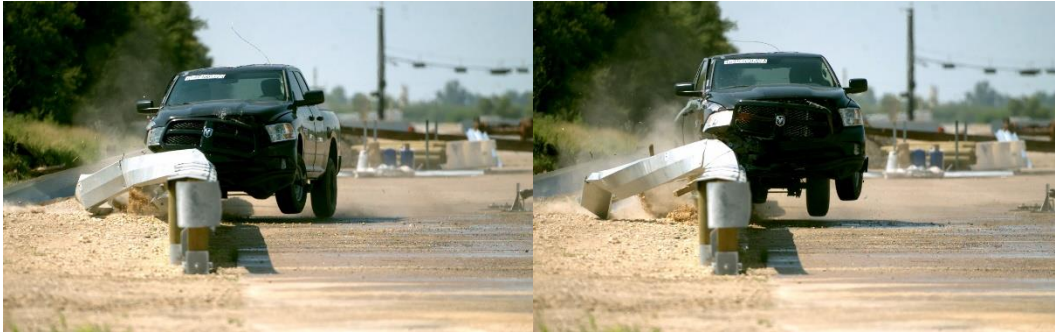
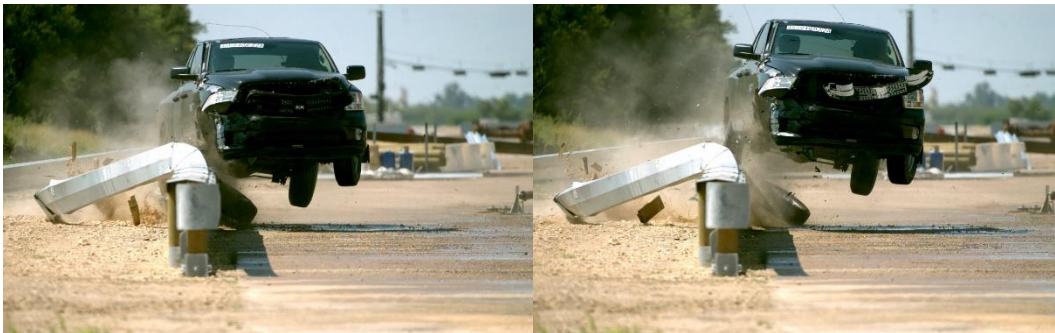
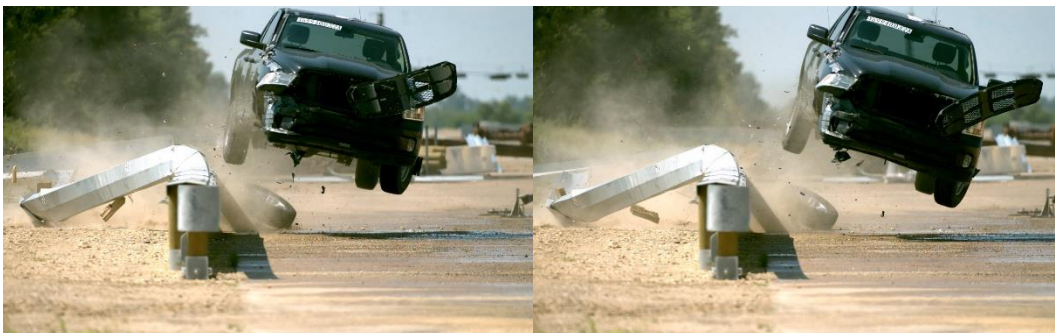
**Figure D.5. Sequential Photographs for Test 469940-03-2 (Frontal Views).**

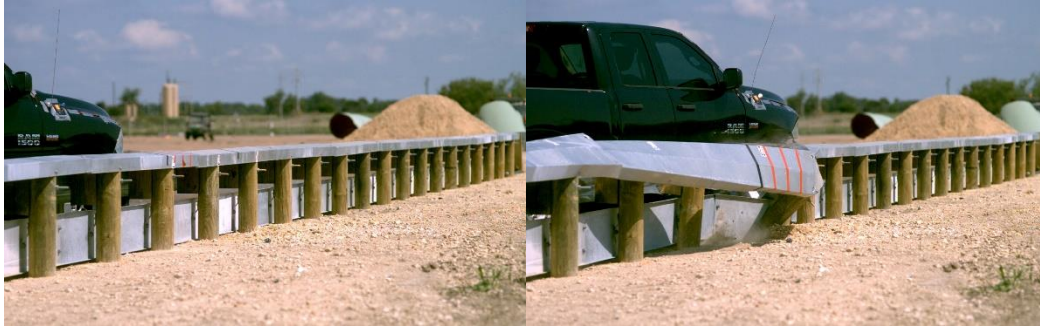
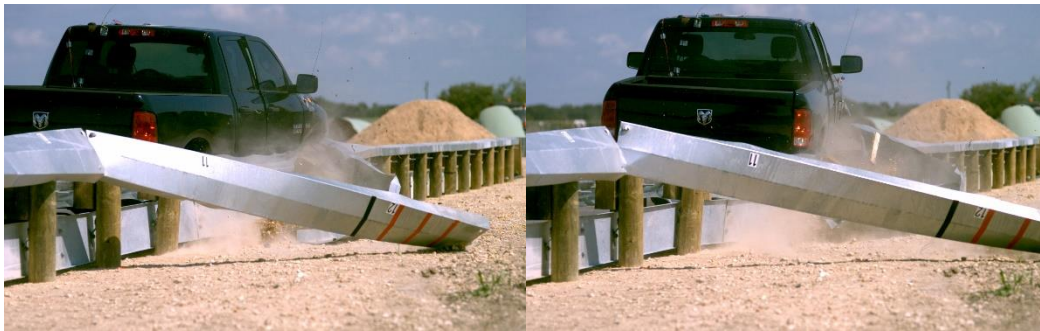
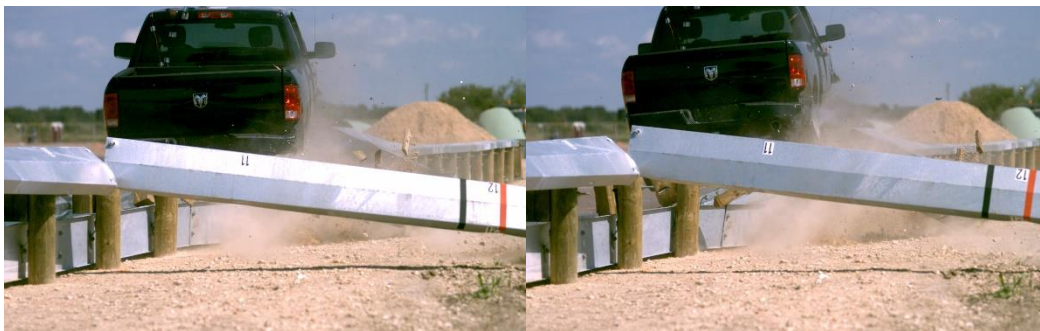
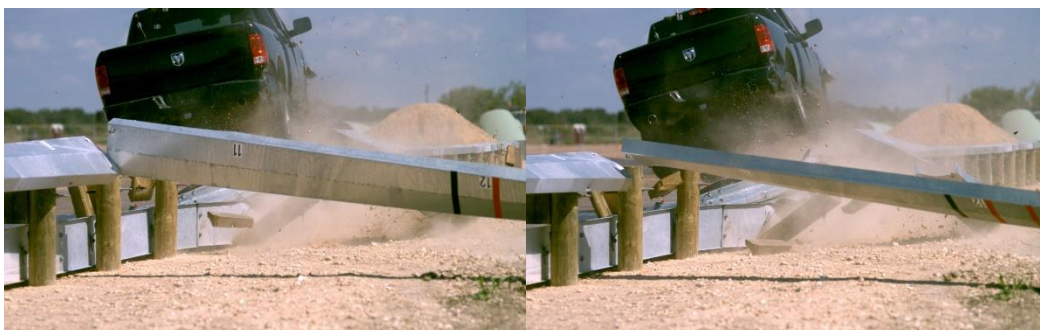
**Figure D.6. Sequential Photographs for Test 469940-03-2 (Rear Views).**

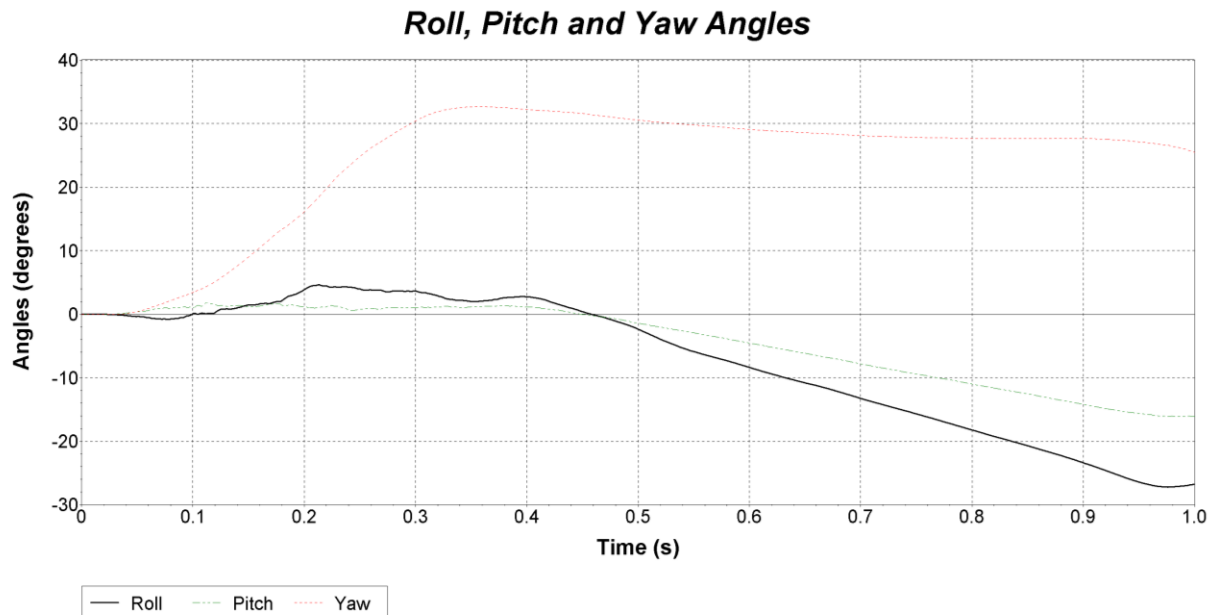
Axes are vehicle-fixed.  
Sequence for determining  
orientation:

4. Yaw.
5. Pitch.
6. Roll.

**Figure D.7. Vehicle Angular Displacements for Test 469940-03-2.**

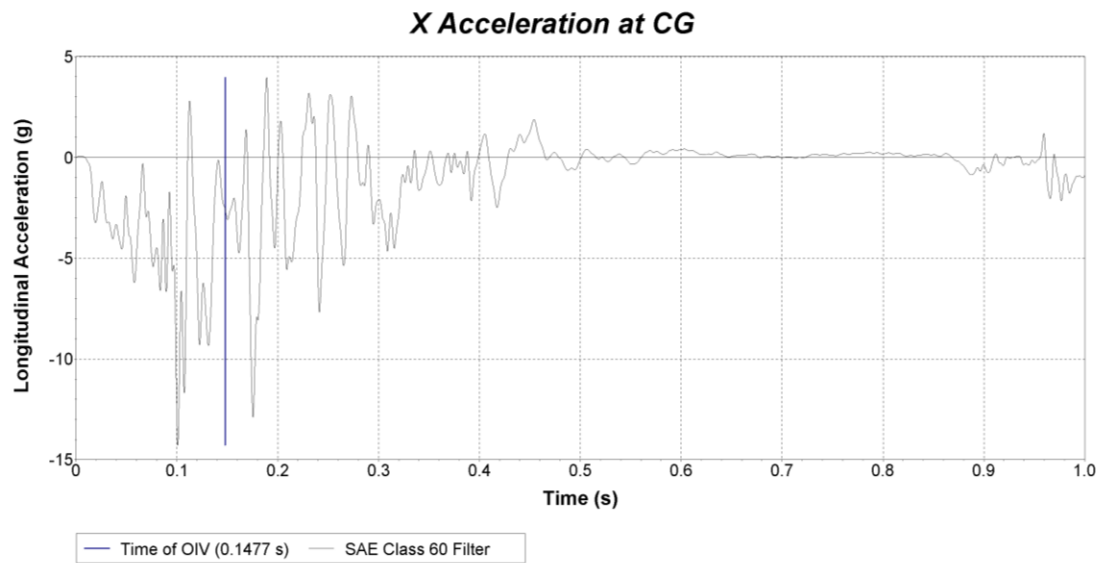
**Figure D.8. Vehicle Longitudinal Accelerometer Trace for Test 469940-03-2 (Accelerometer Located at Center of Gravity).**

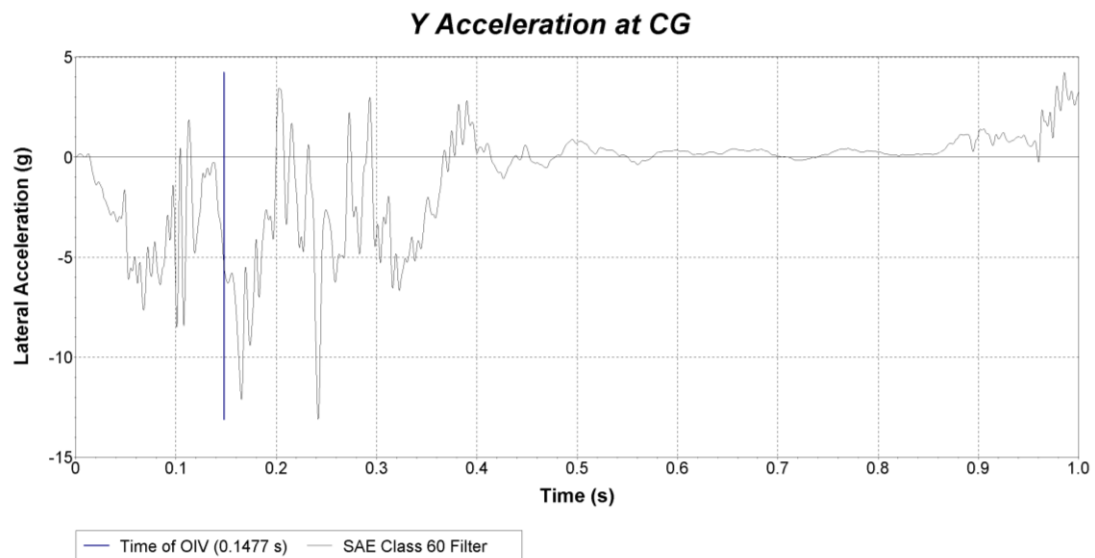
**Figure D.9. Vehicle Lateral Accelerometer Trace for Test 469940-03-2 (Accelerometer Located at Center of Gravity).**

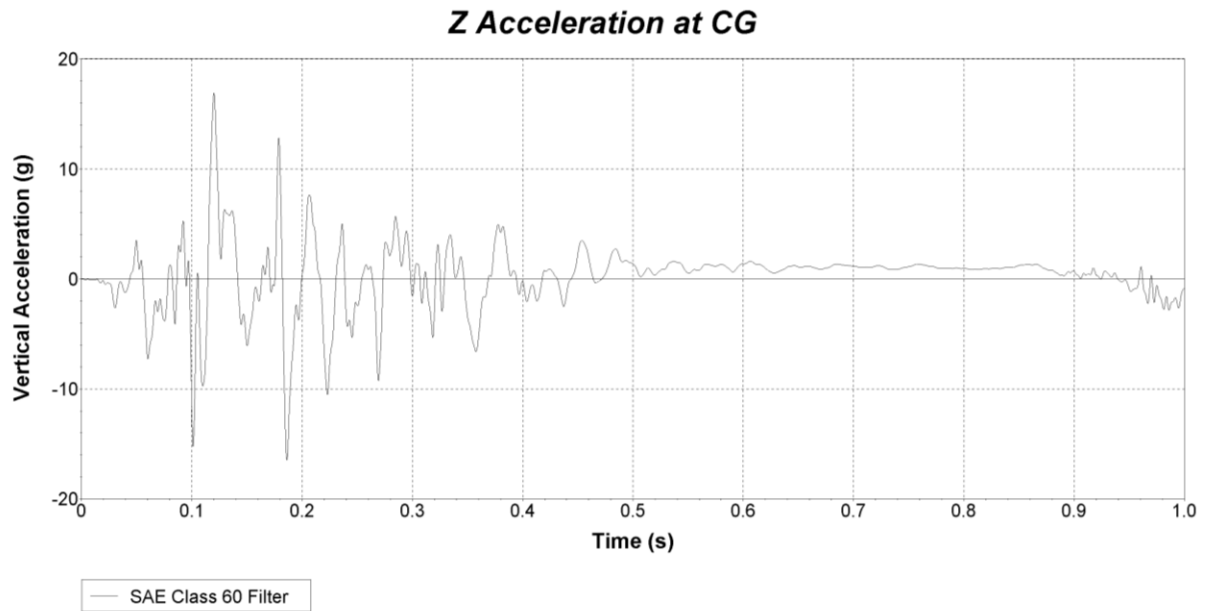
**Figure D.10. Vehicle Vertical Accelerometer Trace for Test 469940-03-2  
(Accelerometer Located at Center of Gravity).**

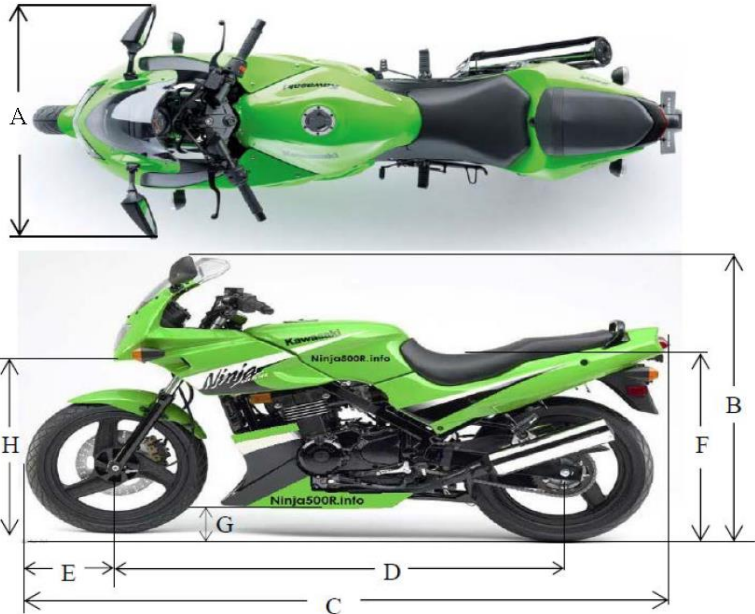
A	<u>30</u>	C	<u>78.5</u>	E	<u>12.5</u>	G	<u>5</u>
B	<u>45.8</u>		<u>55</u>	F	<u>30.5</u>	H	<u>26.5</u>
Wheel Center Height Front	<u>11.3</u>	Wheel Well Clearance (Front)	<u>1.5</u>	Bottom Frame Height - Front	<u>8</u>		
Wheel Center Height Rear	<u>11.8</u>	Wheel Well Clearance (Rear)	<u>6.75</u>	Bottom Frame Height - Rear	<u>9</u>

Figure E.1. Vehicle Properties for Test 469940-03-3.

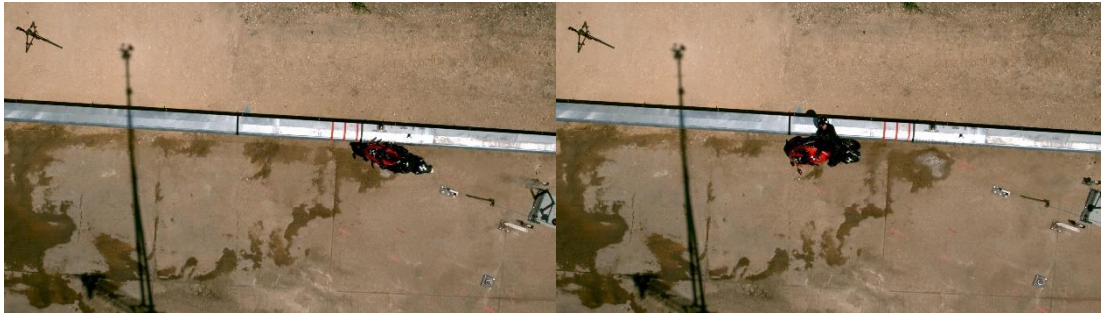
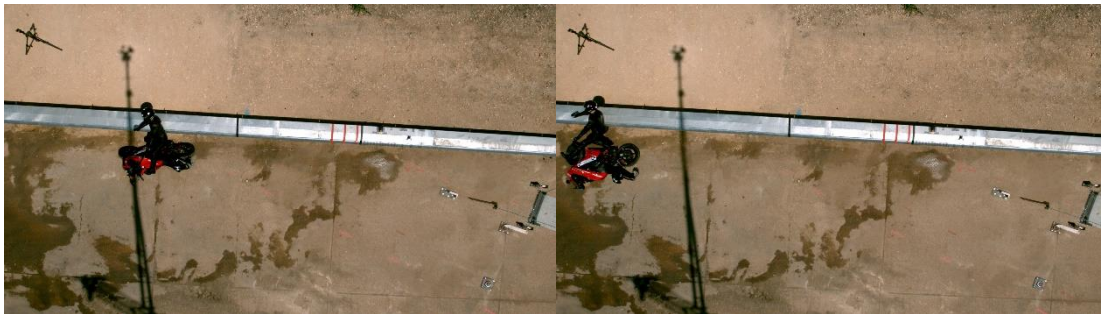
**Figure E.2. Sequential Photographs for Test 469940-03-3 (Overhead Views).**
