**DEVELOP A RETROFIT DESIGN FOR GUARD FENCE SYSTEM TO  
ENHANCE MOTORCYCLE SAFETY  
COOPERATIVE RESEARCH PROGRAM**

Texas Department of Transportation  
<https://tti.tamu.edu/documents/0-6994-R1.pdf>

**TEXAS A&M TRANSPORTATION INSTITUTE PROVING GROUND**

1. Report No. FHWA/TX-23/0-6994-R1	2. Government Accession No.	3. Recipient's Catalog No.	
4. Title and Subtitle DEVELOP A RETROFIT DESIGN FOR GUARD FENCE SYSTEM TO ENHANCE MOTORCYCLE SAFETY		5. Report Date Published: August 2024

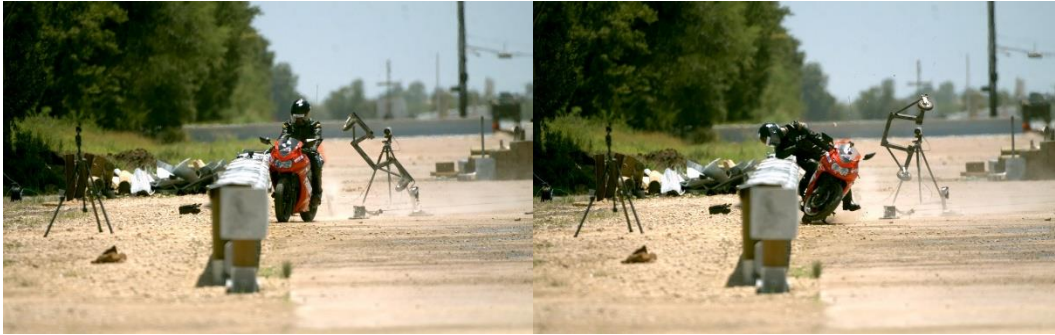
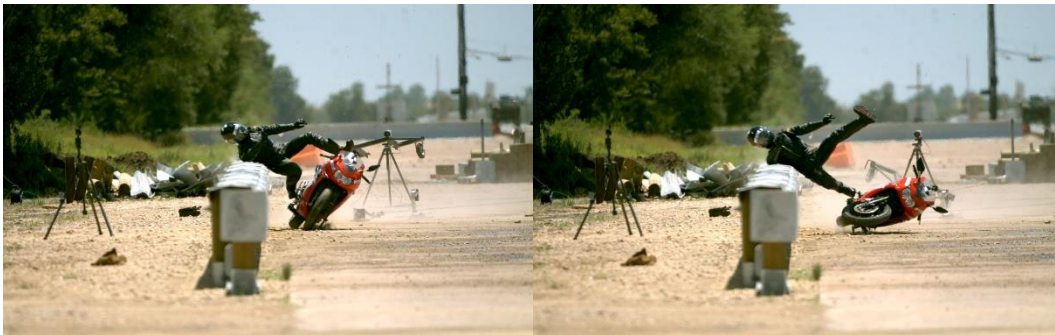
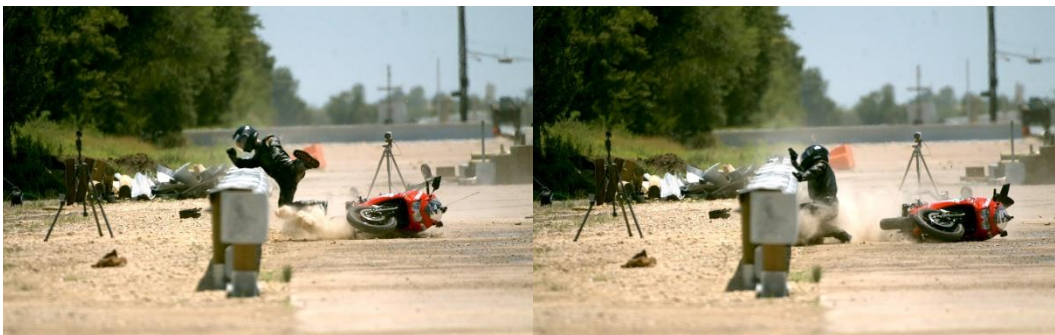
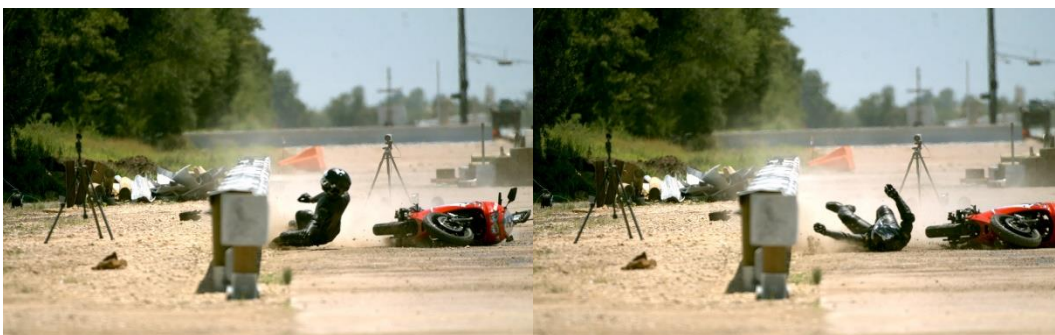
**Figure E.3. Sequential Photographs for Test 469940-03-3 (Frontal Views).**

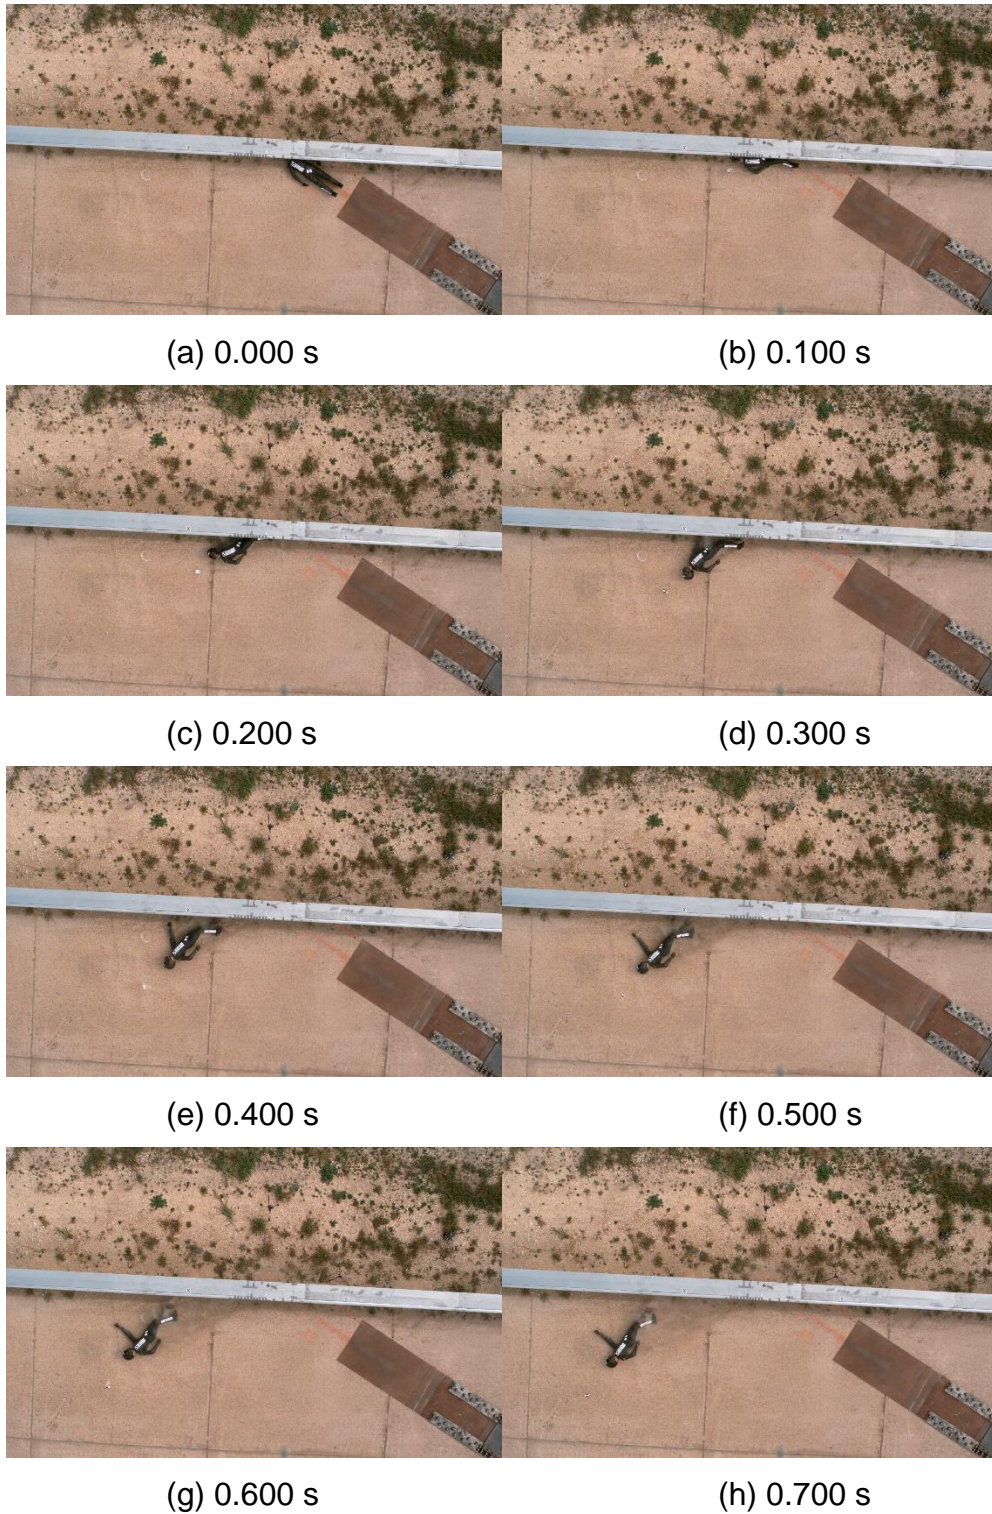
**Figure F.1. Sequential Photographs for Test 469940-03-4A (Overhead Views).**

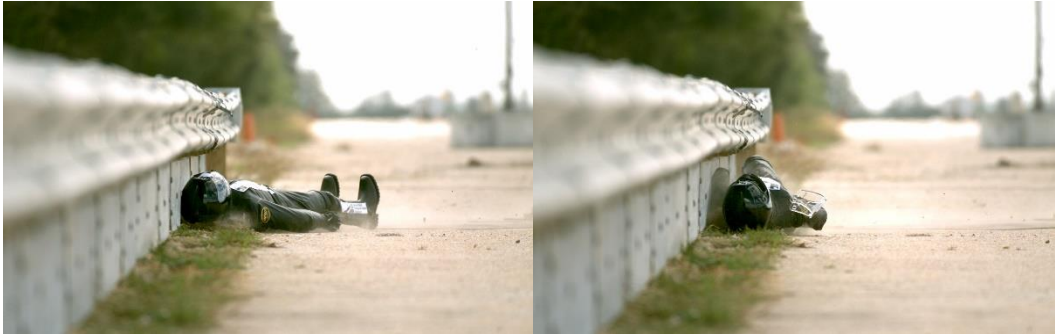
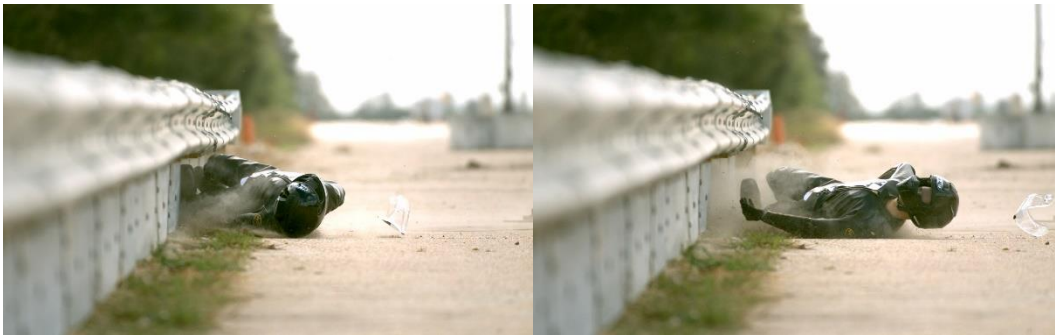
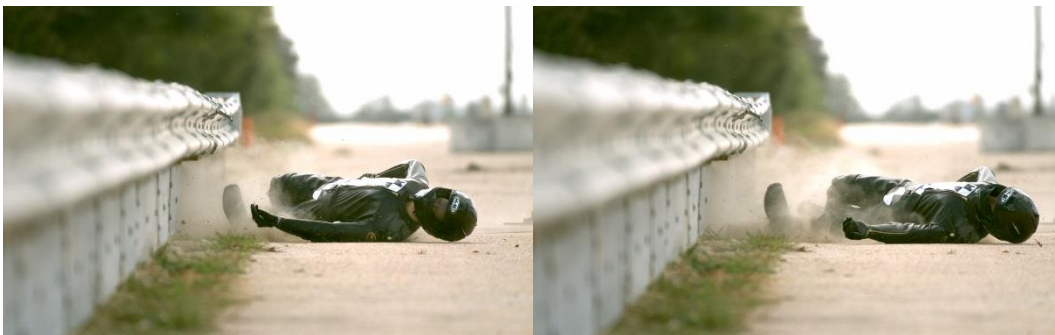
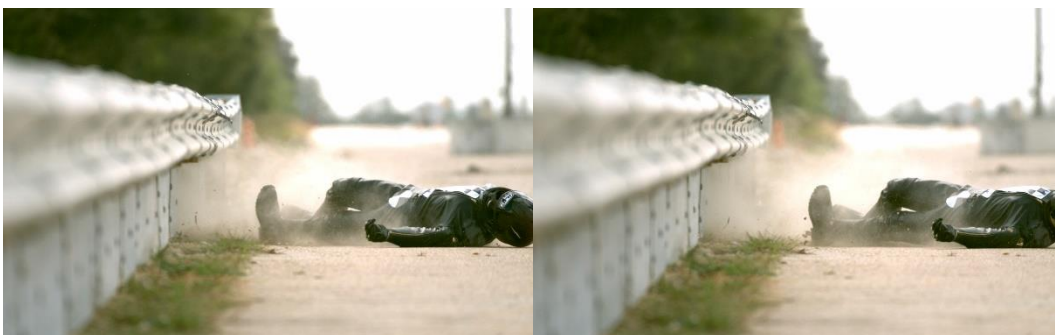
**Figure F.2. Sequential Photographs for Test 469940-03-4A (Frontal Views).**

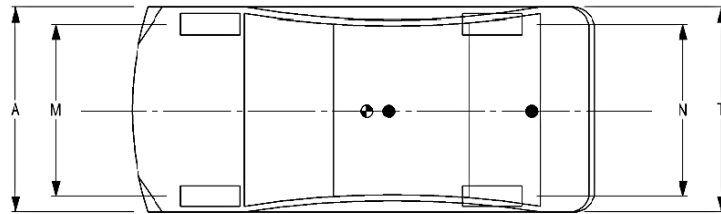
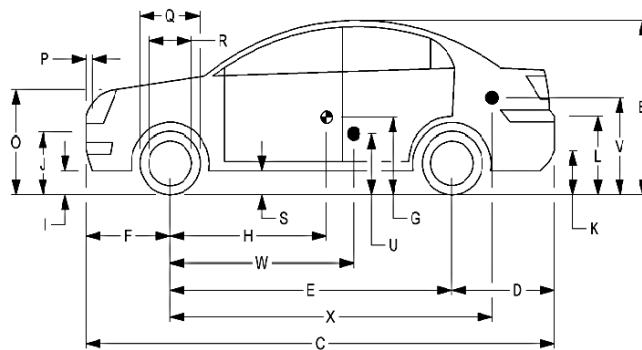
**Geometry:** inches

A <u>66.70</u>	F <u>32.50</u>	K <u>12.50</u>	P <u>4.50</u>	U <u>15.50</u>
B <u>59.60</u>	G <u>0.00</u>	L <u>26.00</u>	Q <u>24.00</u>	V <u>21.25</u>
C <u>175.40</u>	H <u>41.22</u>	M <u>58.30</u>	R <u>16.25</u>	W <u>41.25</u>
D <u>40.50</u>	I <u>7.00</u>	N <u>58.50</u>	S <u>7.50</u>	X <u>79.75</u>
E <u>102.40</u>	J <u>22.50</u>	O <u>30.50</u>	T <u>64.50</u>	
Wheel Center Ht Front <u>11.50</u>		Wheel Center Ht Rear <u>11.50</u>		W-H <u>0.03</u>

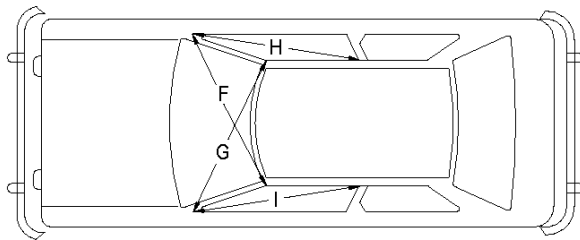
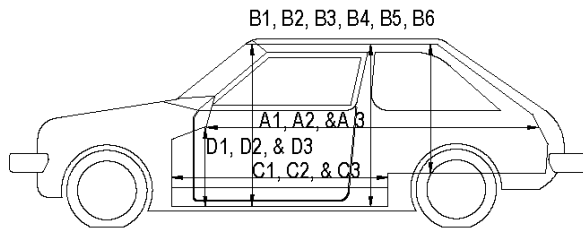
### OCCUPANT COMPARTMENT DEFORMATION MEASUREMENT

Before	After (inches)	Differ.
A1	67.50	67.50	0.00
A2	67.25	67.25	0.00
A3	67.75	67.75	0.00
B1	40.50	40.50	0.00
B2	39.00	39.00	0.00
B3	40.50	40.50	0.00
B4	36.25	36.25	0.00
B5	36.00	36.00	0.00
B6	36.25	36.25	0.00
C1	26.00	26.00	0.00
C2	0.00	0.00	0.00
C3	26.00	25.00	-1.00
D1	9.50	9.50	0.00
D2	0.00	0.00	0.00
D3	9.50	9.50	0.00
E1	51.50	51.50	0.00
E2	51.00	51.00	0.00
F	51.00	51.00	0.00
G	51.00	51.00	0.00
H	37.50	37.50	0.00
I	37.50	37.50	0.00
J*	51.00	50.00	-1.00

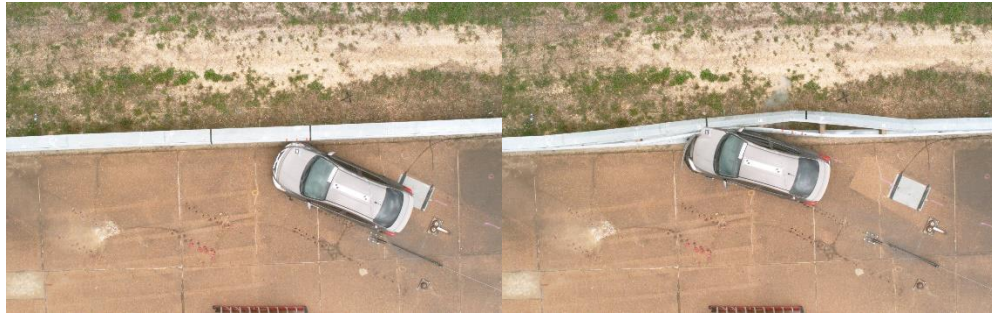
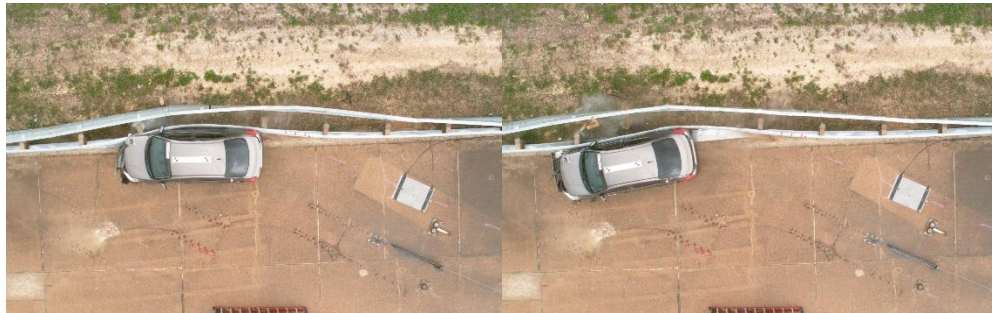
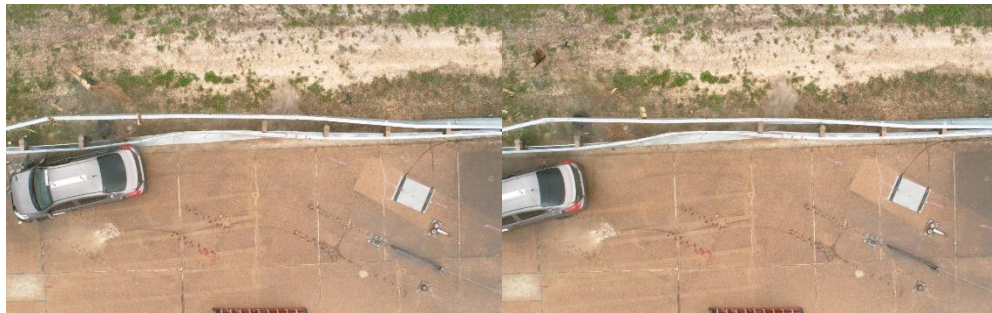
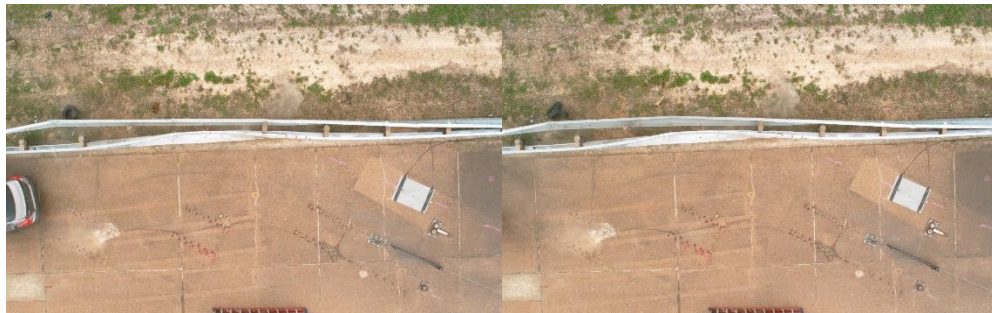
**Figure J.4. Sequential Photographs for Test 469943-01-3 (Overhead Views).**

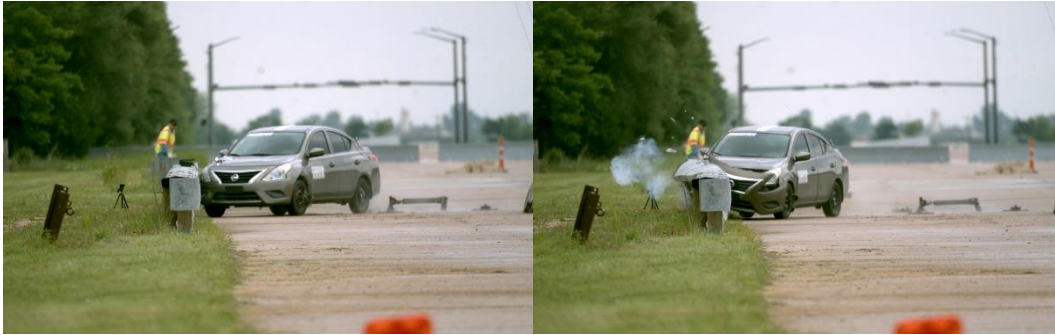
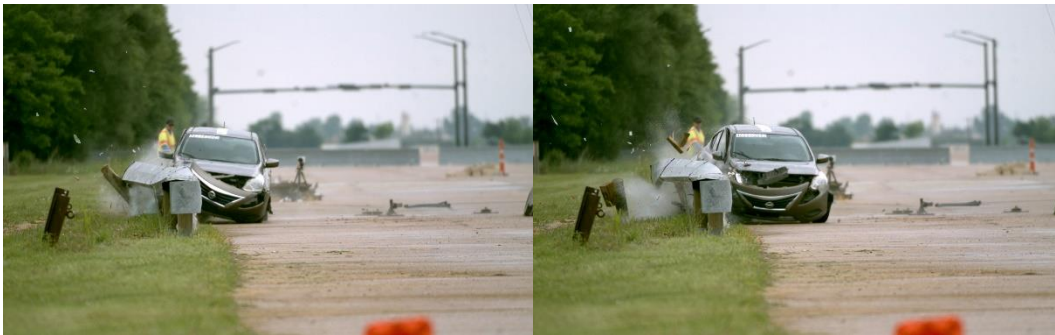
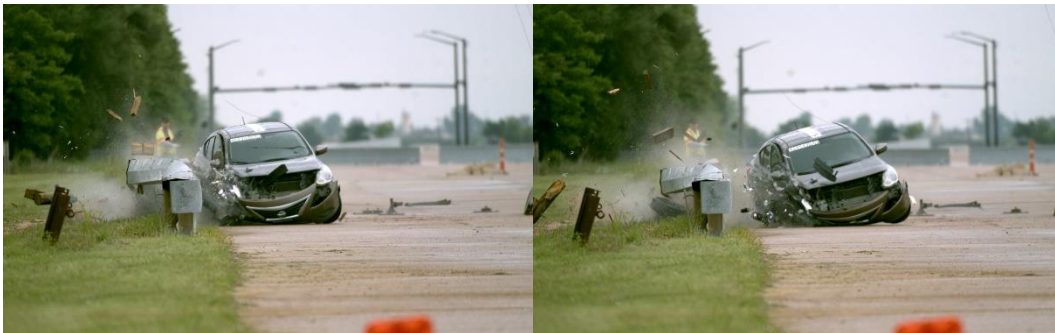
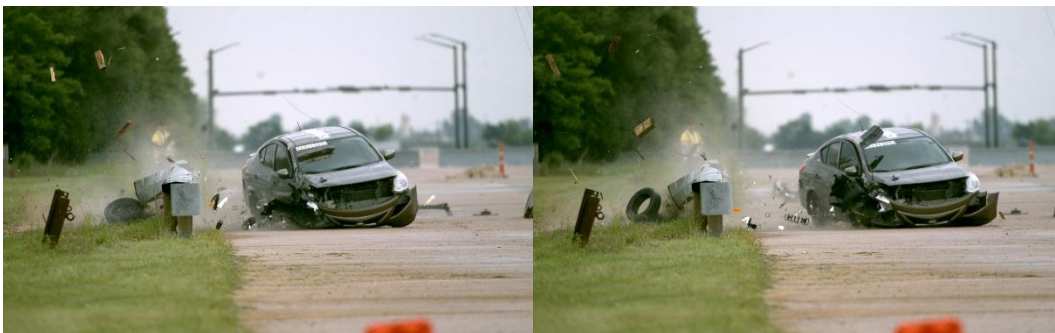
**Figure J.5. Sequential Photographs for Test 469943-01-3 (Frontal Views).**

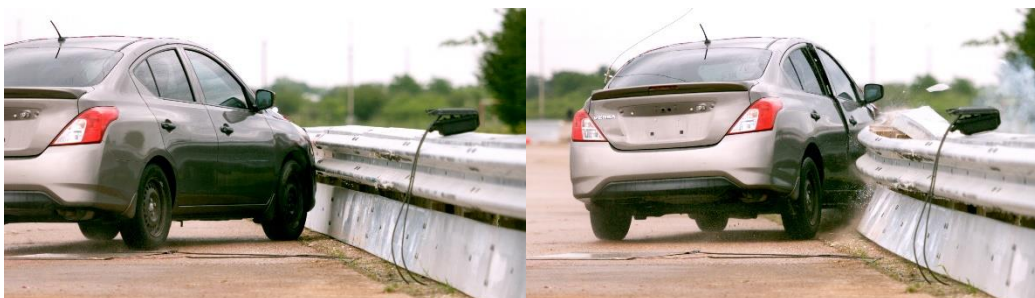
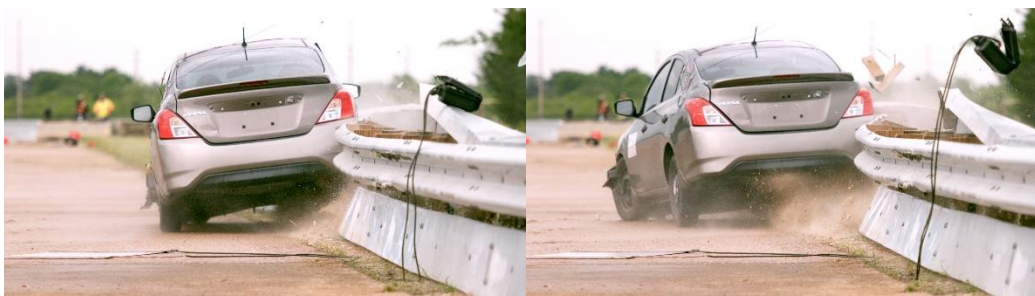
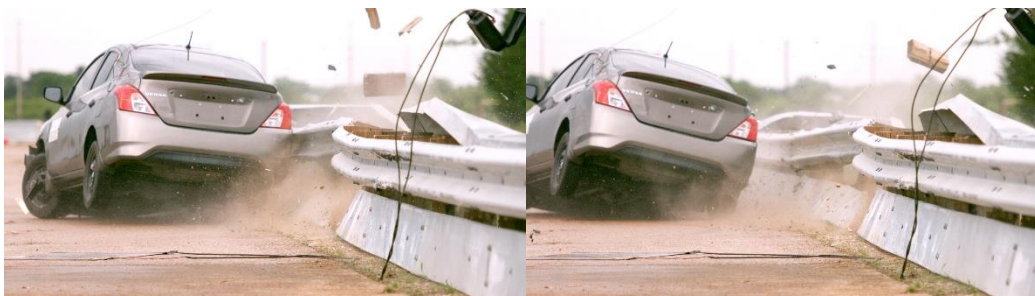
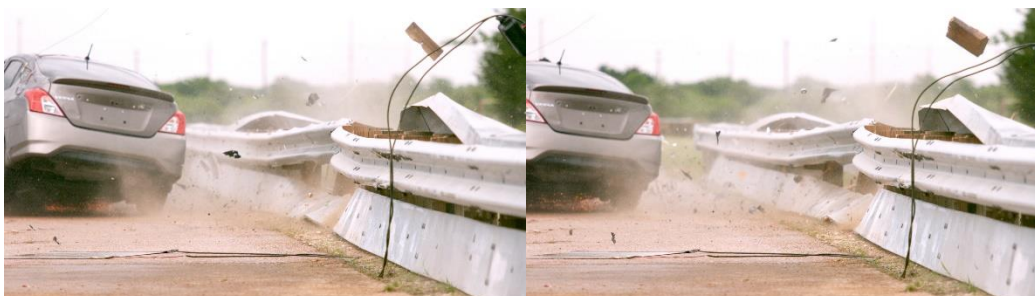
**Figure J.6. Sequential Photographs for Test 469943-01-3 (Rear Views).**

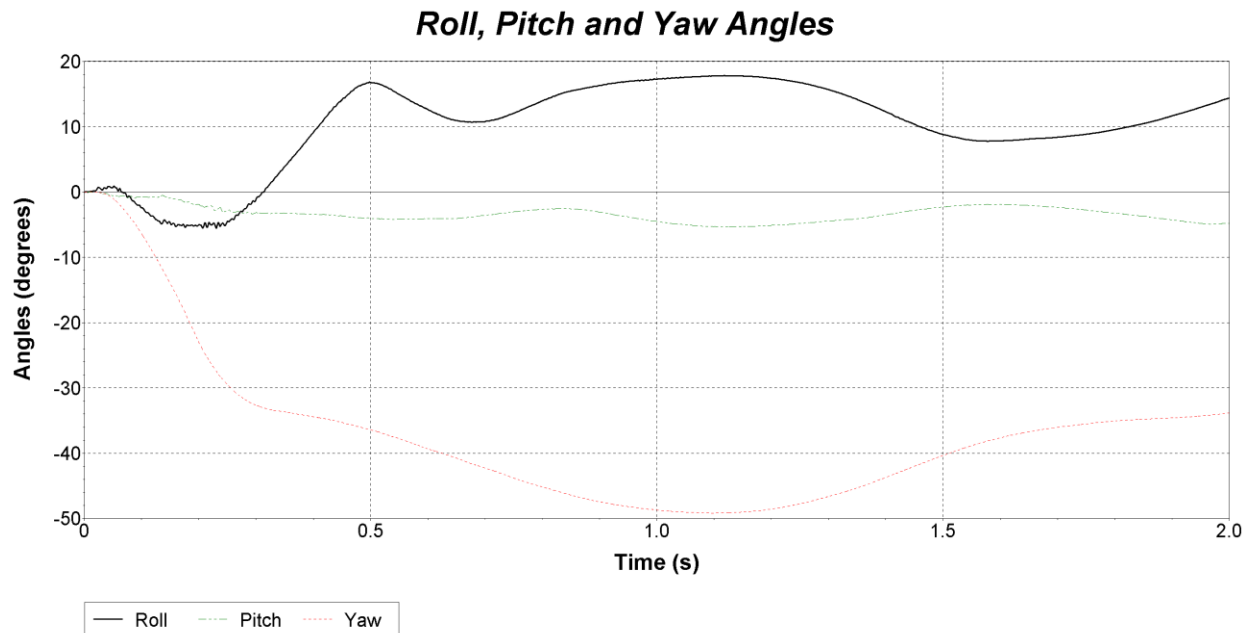
Axes are vehicle-fixed.  
Sequence for determining orientation:

**Figure J.7. Vehicle Angular Displacements for Test 469943-01-3.**

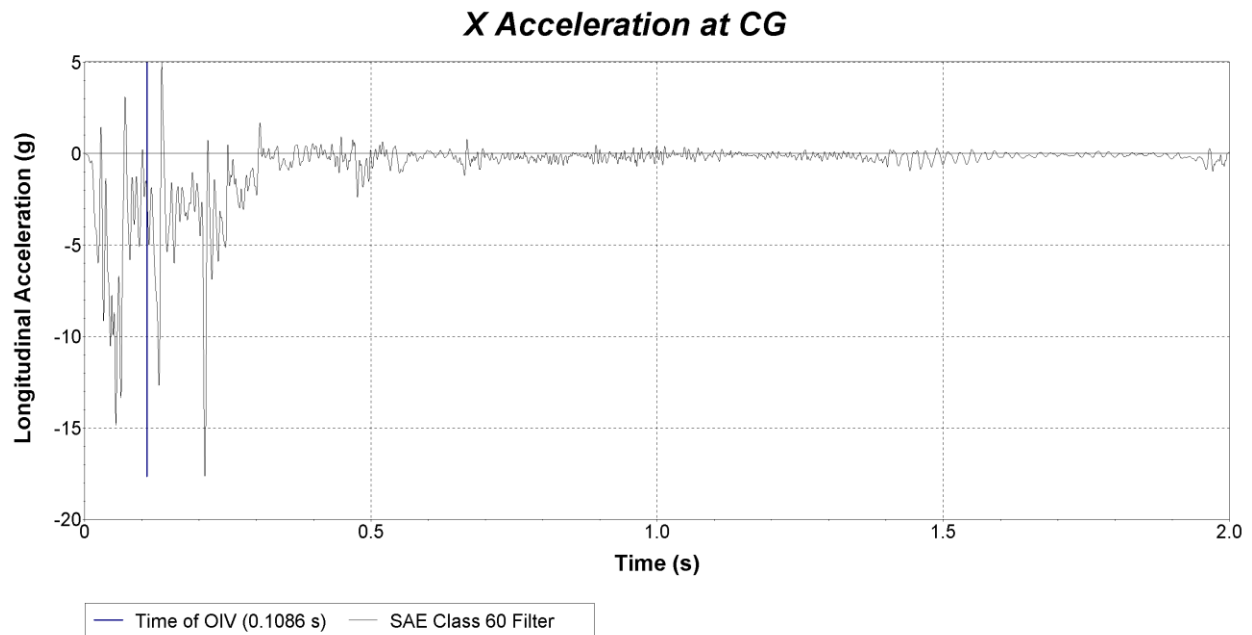
**Figure J.8. Vehicle Longitudinal Accelerometer Trace for Test 469943-01-3  
(Accelerometer Located at Center of Gravity).**

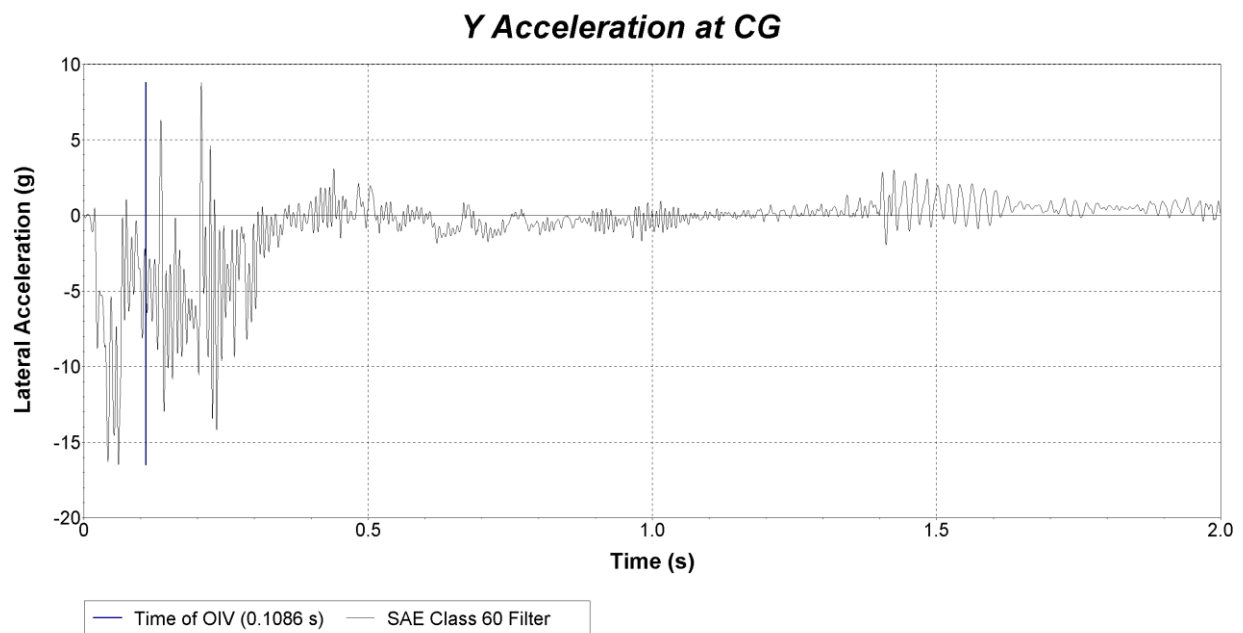
**Figure J.9. Vehicle Lateral Accelerometer Trace for Test 469943-01-3  
(Accelerometer Located at Center of Gravity).**

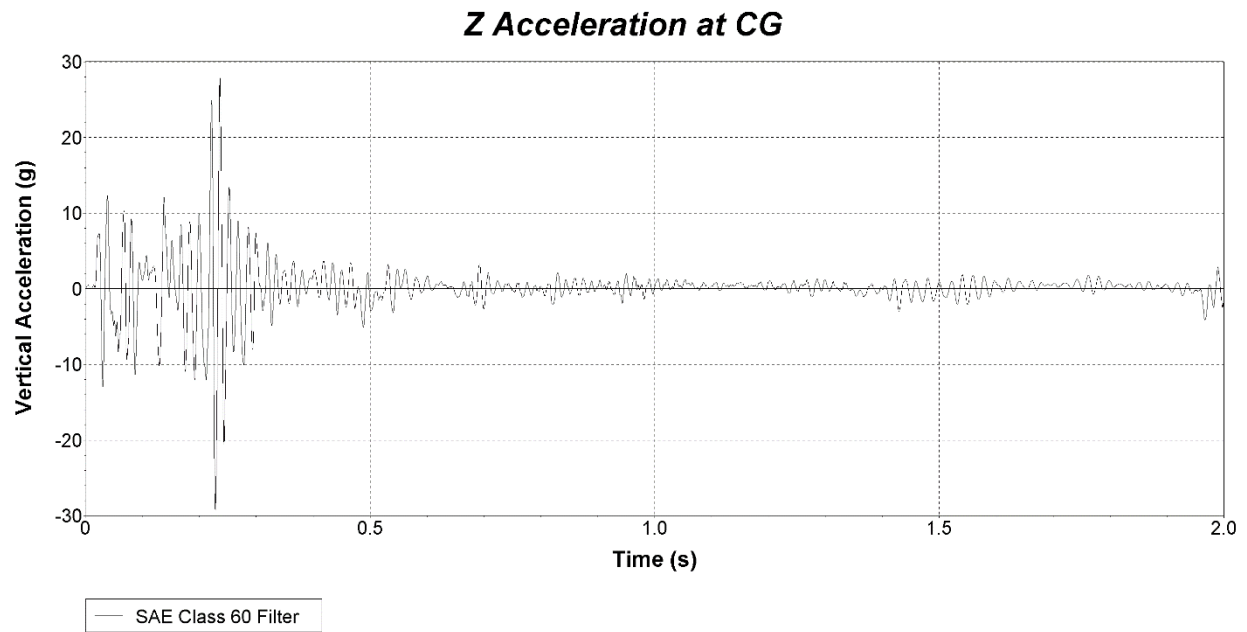
**Figure J.10. Vehicle Vertical Accelerometer Trace for Test 469943-01-3  
(Accelerometer Located at Center of Gravity).**

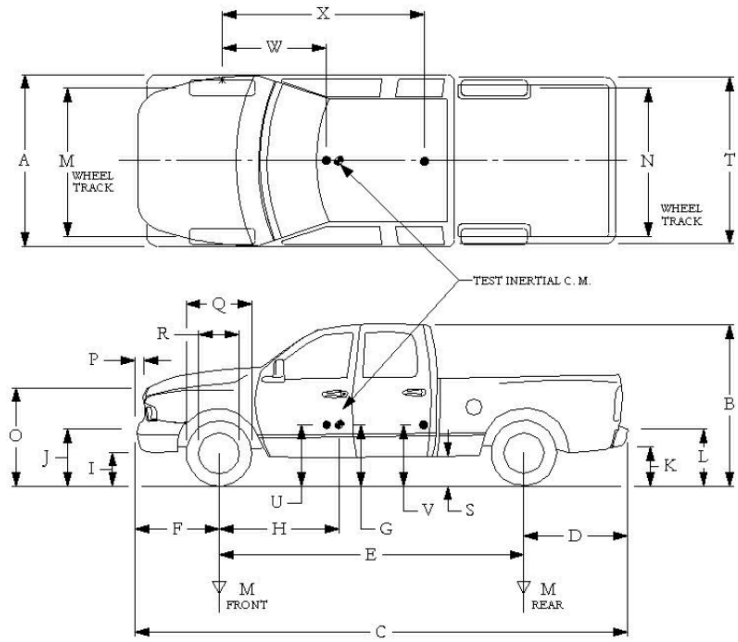
**Geometry:** inches

A	78.50	F	40.00	K	20.00	P	3.00	U	26.75
B	74.00	G	28.62	L	30.00	Q	30.50	V	30.25
C	227.50	H	61.06	M	68.50	R	18.00	W	61.50
D	44.00	I	11.75	N	68.00	S	13.00	X	79.00
E	140.50	J	27.00	O	46.00	T	77.00		
Wheel Center Height Front		14.75	Wheel Well Clearance (Front)		6.00	Bottom Frame Height - Front		12.50	
Wheel Center Height Rear		14.75	Wheel Well Clearance (Rear)		9.25	Bottom Frame Height - Rear		22.50

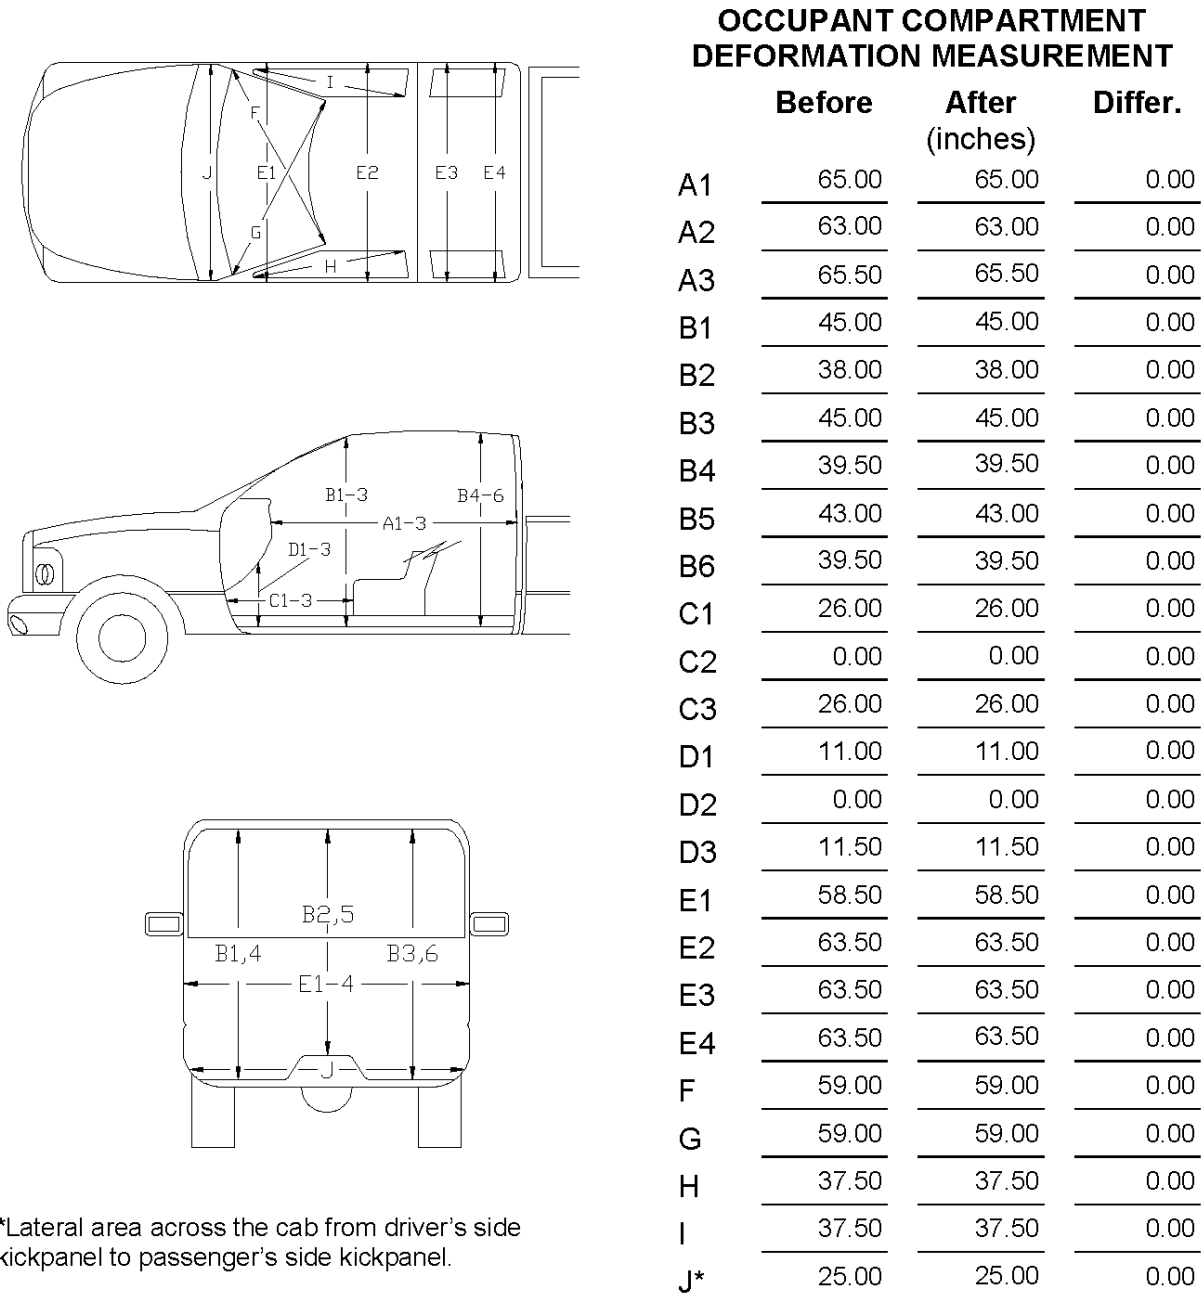
**Figure K.3. Occupant Compartment Measurements for Test 469943-01-4.**

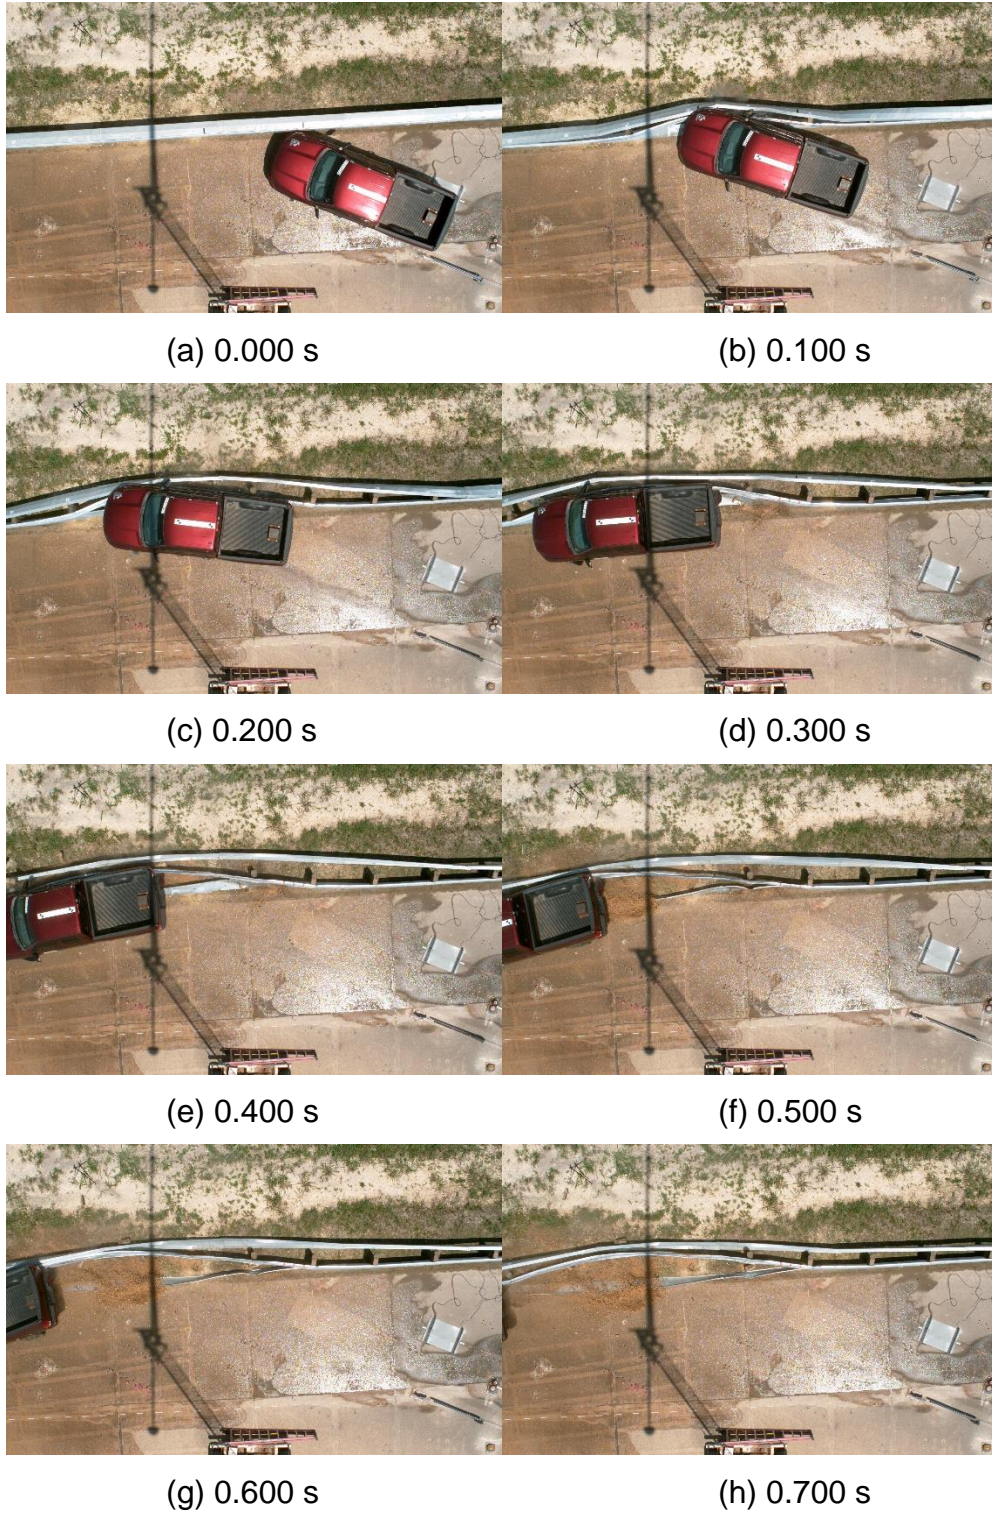
**Figure K.4. Sequential Photographs for Test 469943-01-4 (Overhead Views).**

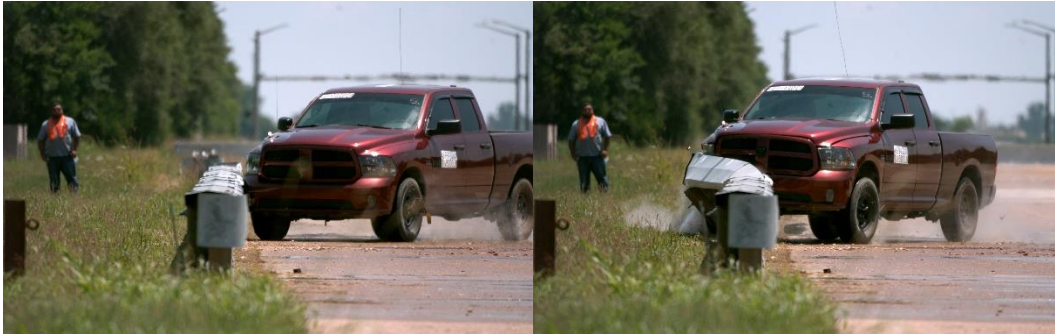
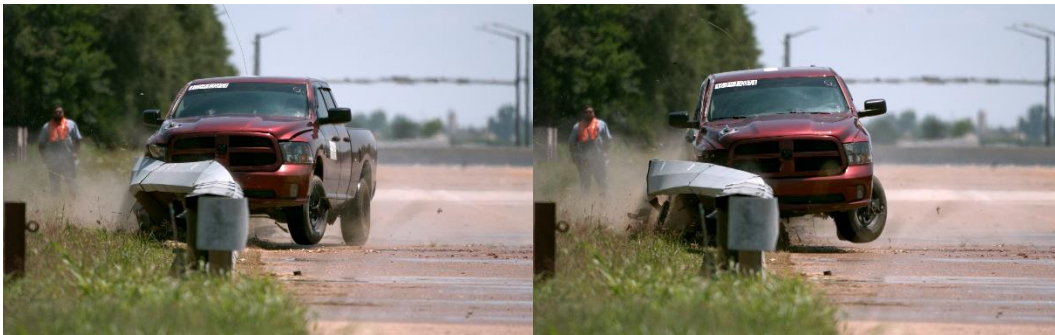
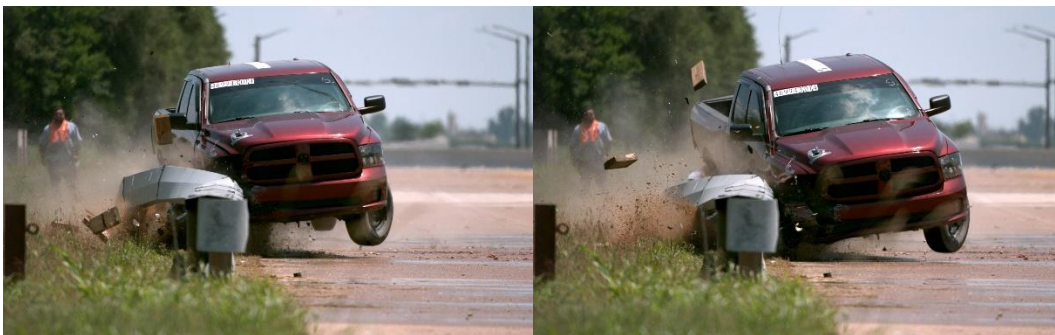
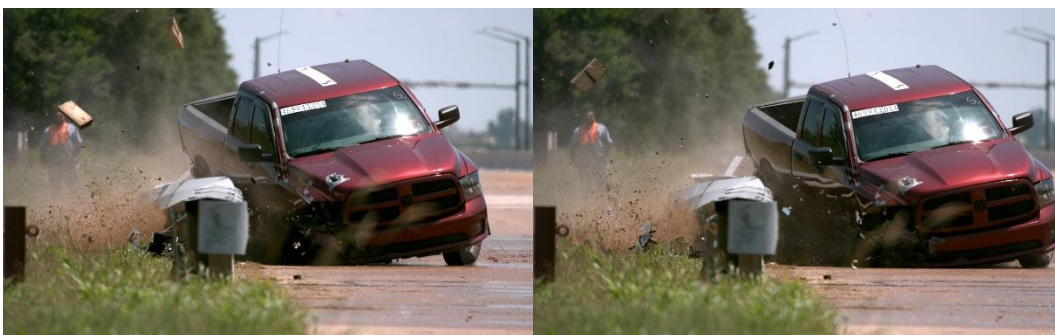
**Figure K.5. Sequential Photographs for Test 469943-01-4 (Frontal Views).**

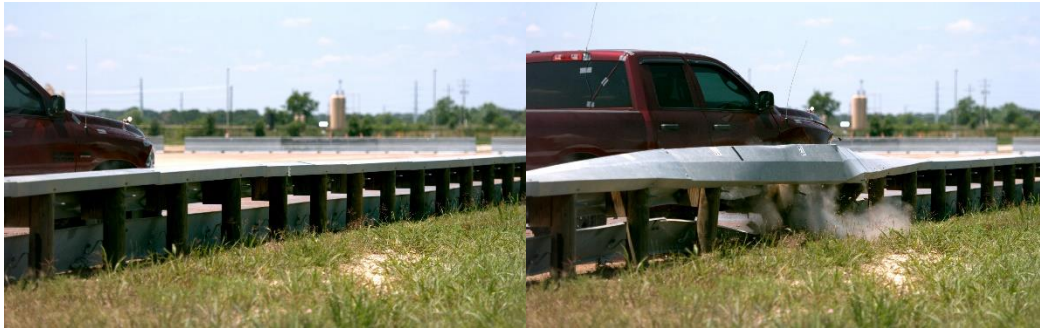
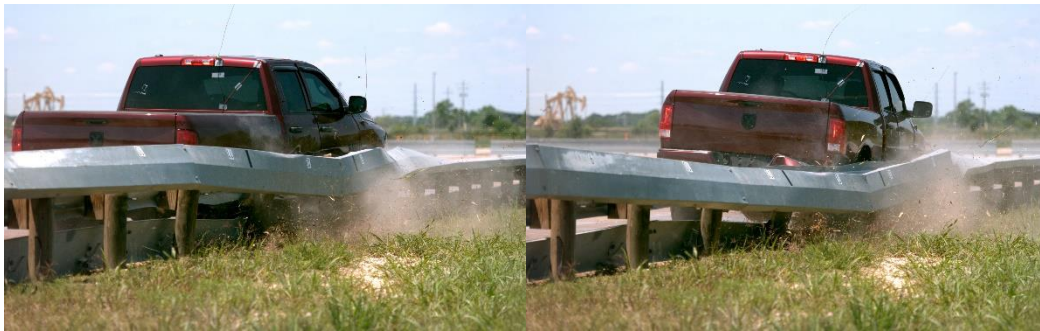
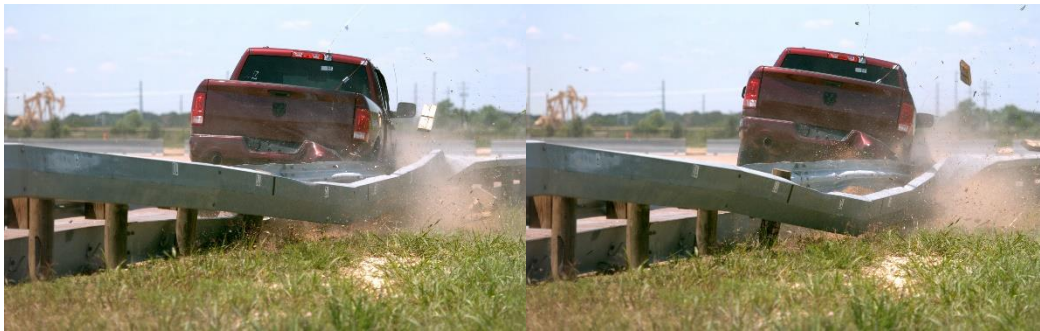
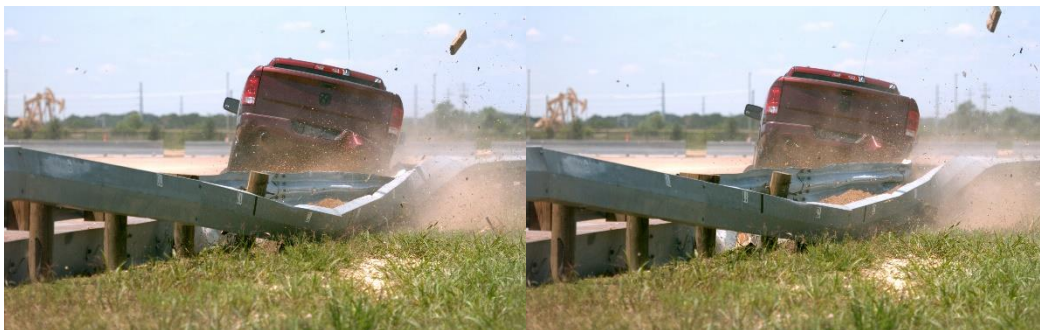
**Figure K.6. Sequential Photographs for Test 469943-01-4 (Rear Views).**

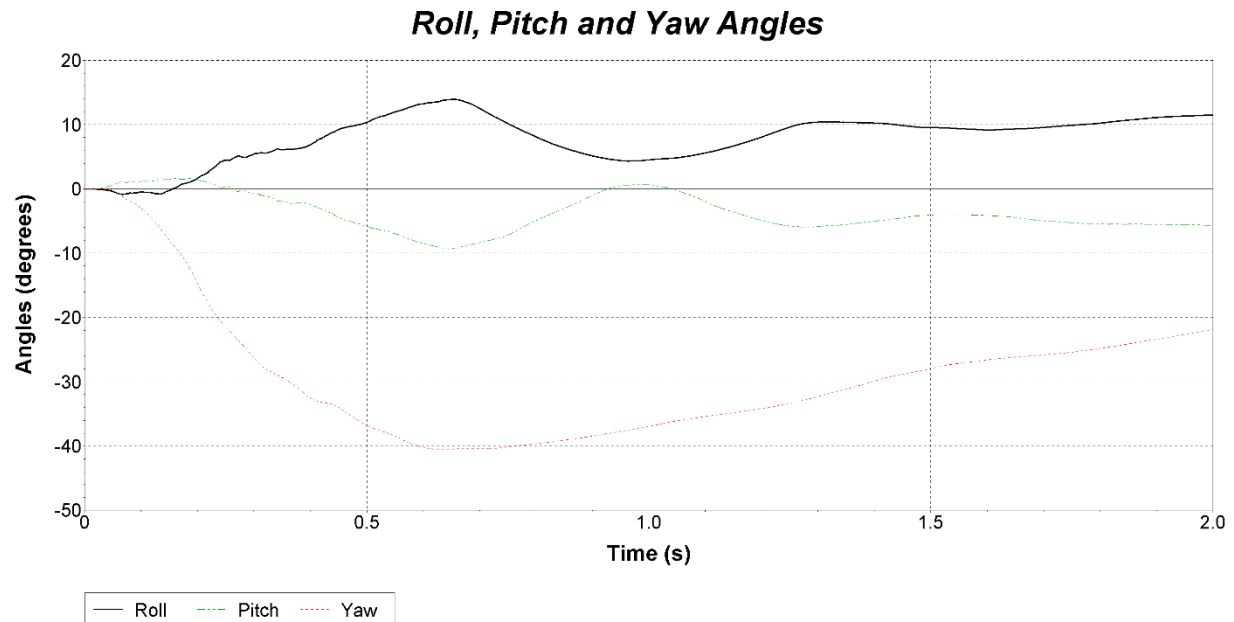
Axes are vehicle-fixed.  
Sequence for determining  
orientation:

**Figure K.7. Vehicle Angular Displacements for Test 469943-01-4.**

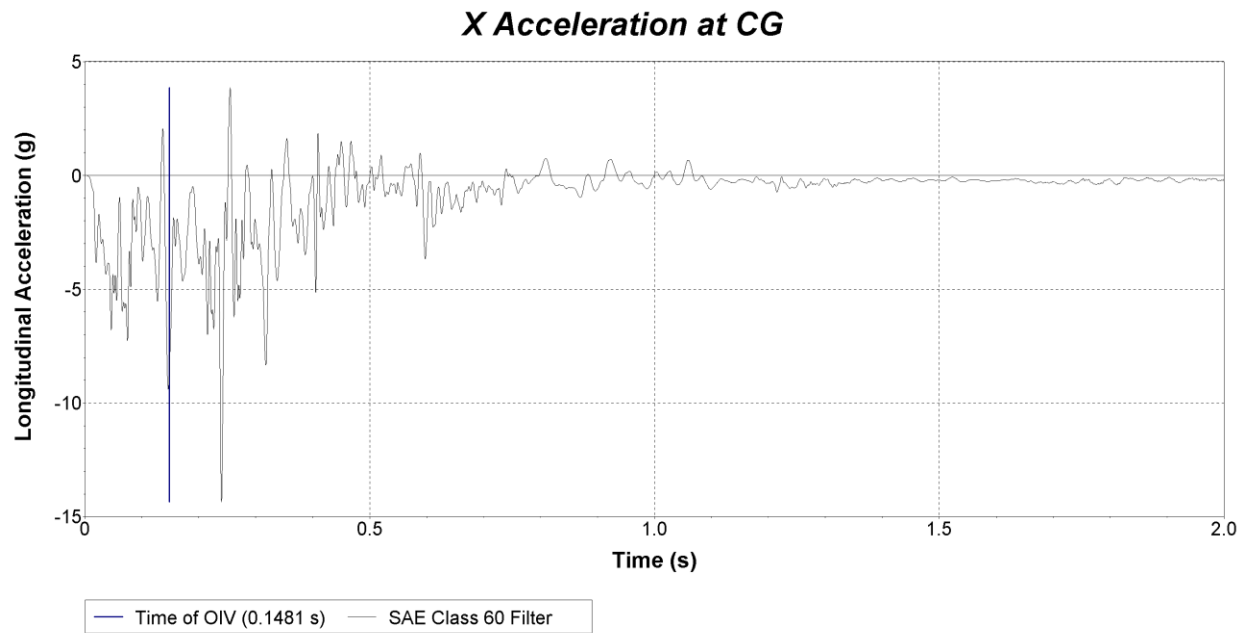
**Figure K.8. Vehicle Longitudinal Accelerometer Trace for Test 469943-01-4  
(Accelerometer Located at Center of Gravity).**

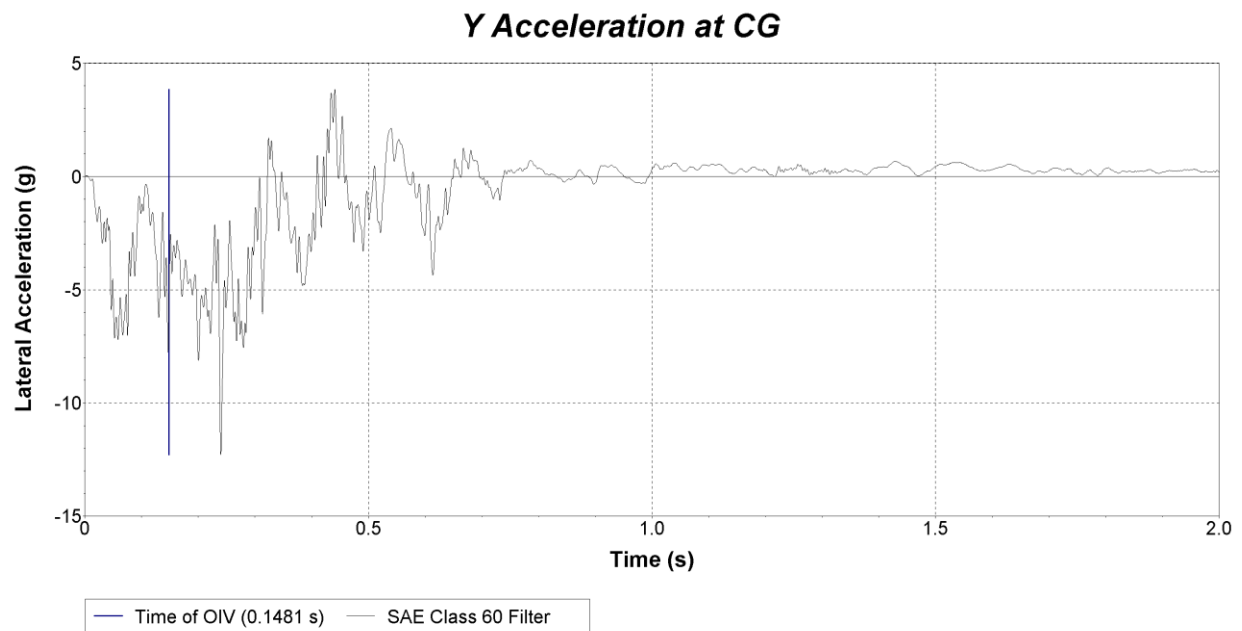
**Figure K.9. Vehicle Lateral Accelerometer Trace for Test 469943-01-4  
(Accelerometer Located at Center of Gravity).**

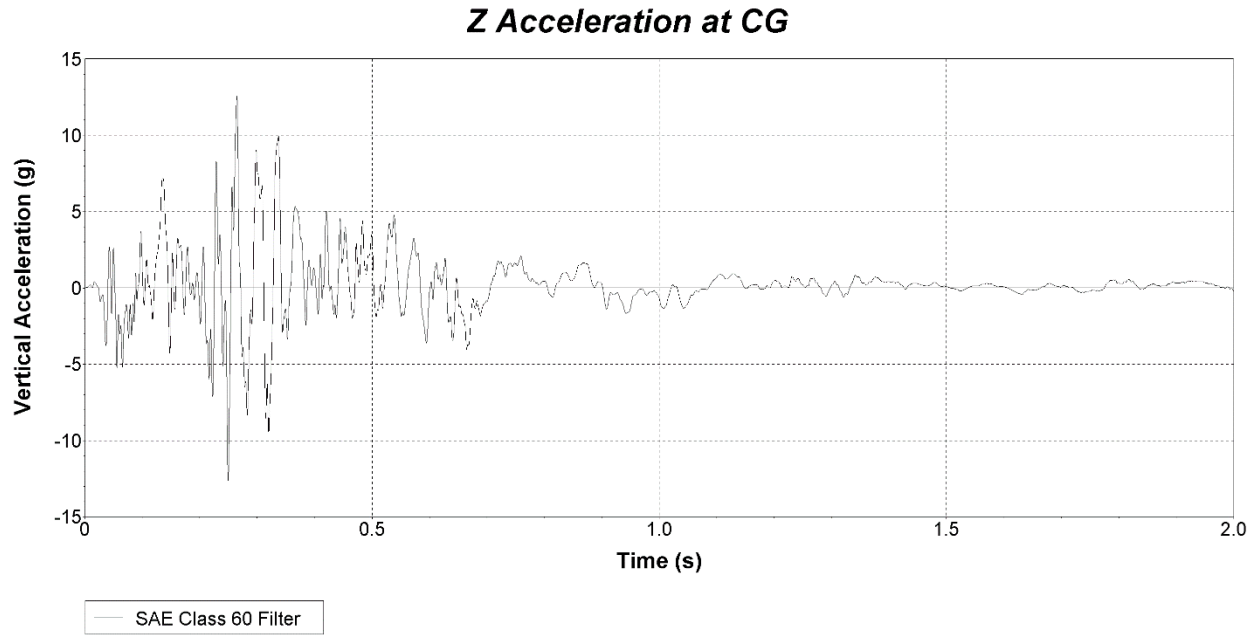
**Figure K.10. Vehicle Vertical Accelerometer Trace for Test 469943-01-4  
(Accelerometer Located at Center of Gravity).**
