**Test Report No. 0-7021-01-R1**

**DEVELOPING AN ENHANCED PROTECTION OF MEDIAN OPENINGS  
BETWEEN PARALLEL BRIDGE STRUCTURES**

Sponsored by the  
**Texas Department of Transportation  
and the  
Federal Highway Administration**

**TEXAS A&M TRANSPORTATION INSTITUTE PROVING GROUND**

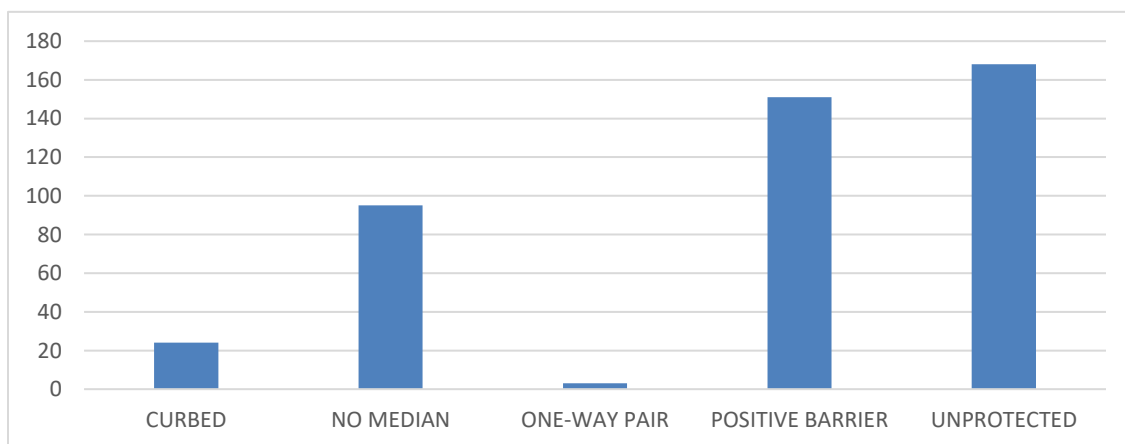
Figure 2.16 and Figure 2.17 show the median type and width where crashes occurred. As shown, most of the crashes took place on highways with either unprotected medians or positive barriers, such as guardrails. This finding corresponds to the initial issue investigated in this project: the thought that guardrails and sloped medians funnel errant vehicles to the opening between parallel structures. Last, the median width of locations with median opening crashes was 28 ft on average, while the range was between 2 ft to 65 ft.

**Figure 2.16. Median Opening Crashes by Median Type.**

**Figure 2.17. Median Opening Crashes by Median Width.**

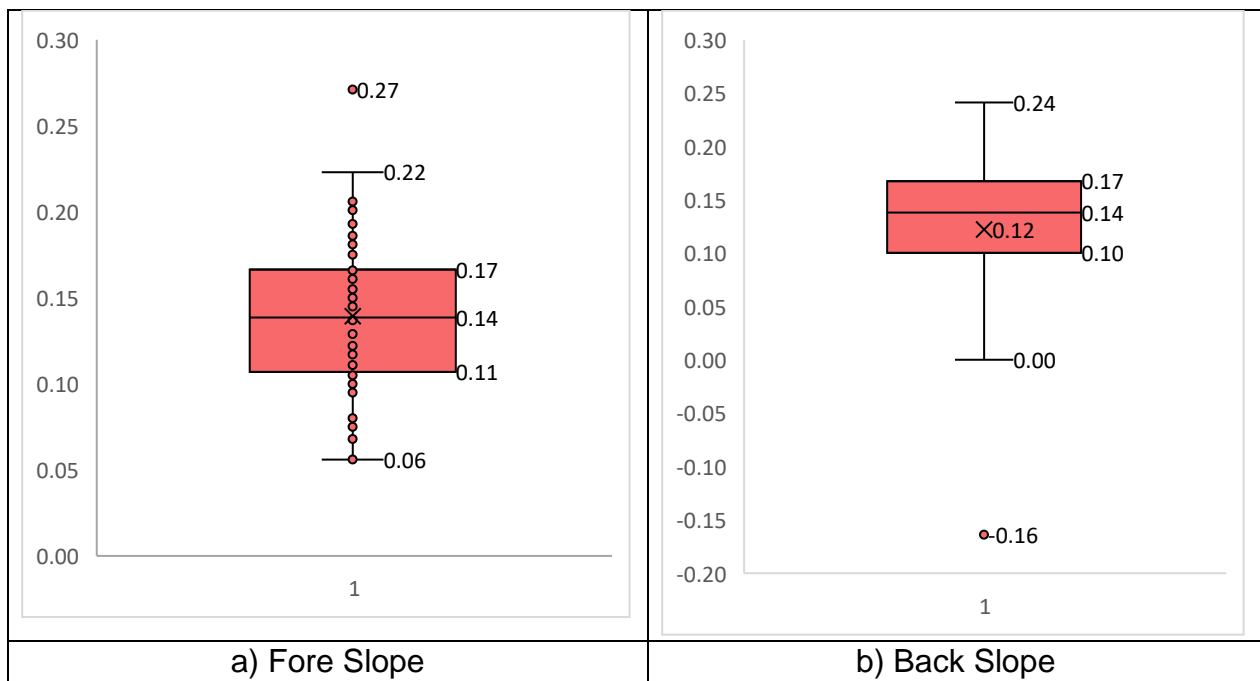
**Figure 2.18. Median Opening Crashes by Box Plot of Slope Degree.**

All of the parallel structure crash locations were reviewed using Google Earth in order to calculate the slope of the median involved in the crash. Of the 312 crashes investigated, 98 were determined to have occurred in locations where the slope was considered non-negligible. The slopes of the medians for the 98 locations were obtained through a slope/image analysis process that was able to calculate the slope of the medians from Google Earth photos. The research team inspected both the fore and back slope in this analysis. The results indicated that the average slope of the median where these crashes occurred was 0.14 percent. Figure 2.18 shows the results of the analysis.

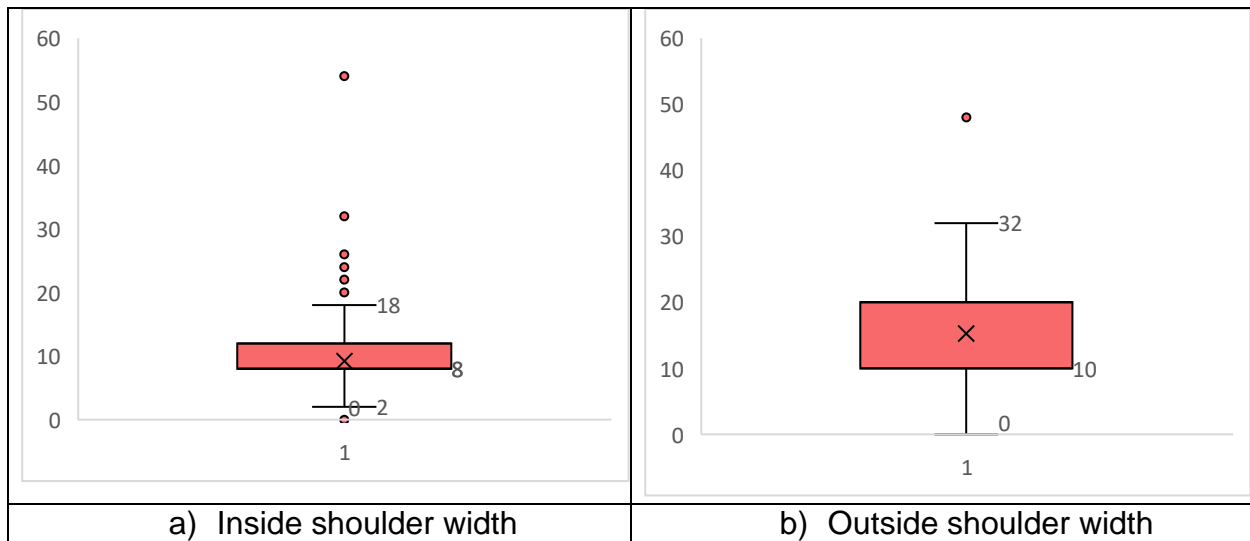
Figure 2.21 and Figure 2.22 show the type and width of roadway shoulders where the median opening crashes occurred. As the figures show, median opening crashes occurred on highways with surfaced shoulders. The widths of the inside and outside shoulders of roadways with median opening crashes were 8 ft and 10 ft, respectively.

**Figure 2.21. Median Opening Crashes by Shoulder Type.**

**Figure 2.22. Median Opening Crashes by Shoulder Width.**

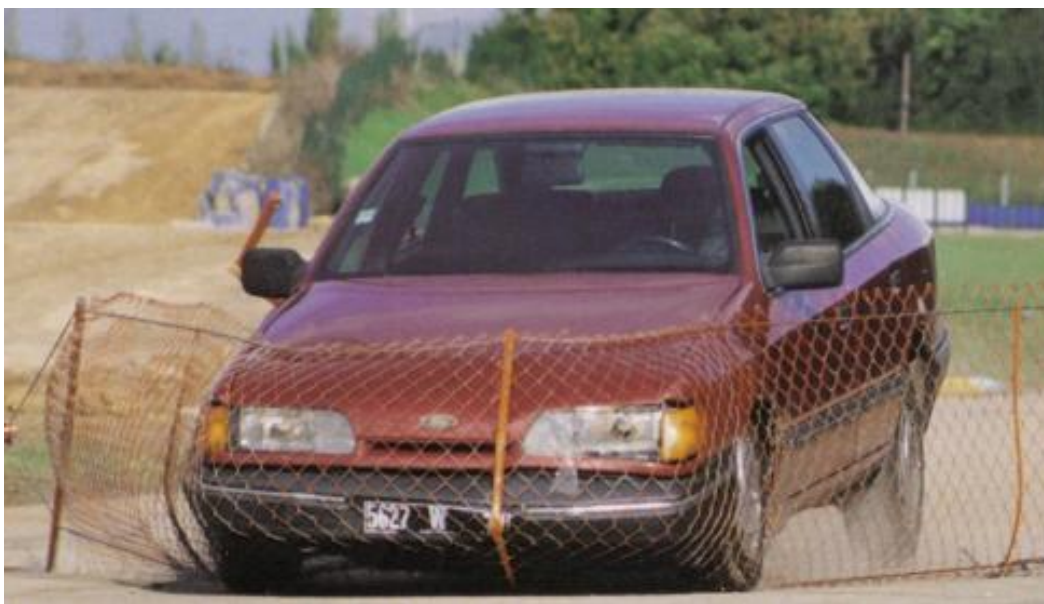
**Figure 3.1. Vehicle Arresting Net (3).**

The Dragnet vehicle arresting barrier (3) system uses a mesh net to span between two end posts. This mesh is connected to a set of steel tapes that unspool during a vehicular impact. The pull out of this steel tape dissipates the impact energy and safely brings the vehicle to a stop. The two end posts are bolted to concrete piers that are embedded 4 ft below grade. The span distance of the net can vary depending on the installation, and the top of the net rests at approximately 48 inches above grade. Because the net is anchored at the two ends, additional measures must be taken to maintain proper height above grade when installed in a sloped median. Figure 3.1 shows a photo of this system.

The Dragnet can safely stop a 20,000-lb truck traveling 52 mi/h in 200 ft. The Dragnet can stop a lighter passenger vehicle in a much shorter distance, depending on the impacting speed. The Dragnet also has modifications available to arrest much larger vehicles traveling at faster speeds. Maintenance is relatively simple after an impact, with the replacement of only the steel tapes and mesh net. Standard groundskeeping or median maintenance is also relatively simple. While the net prevents large equipment from mowing in that specific area, the equipment can easily drive around the system and resume mowing. Groundskeeping teams can then mow closely around the system with smaller equipment.

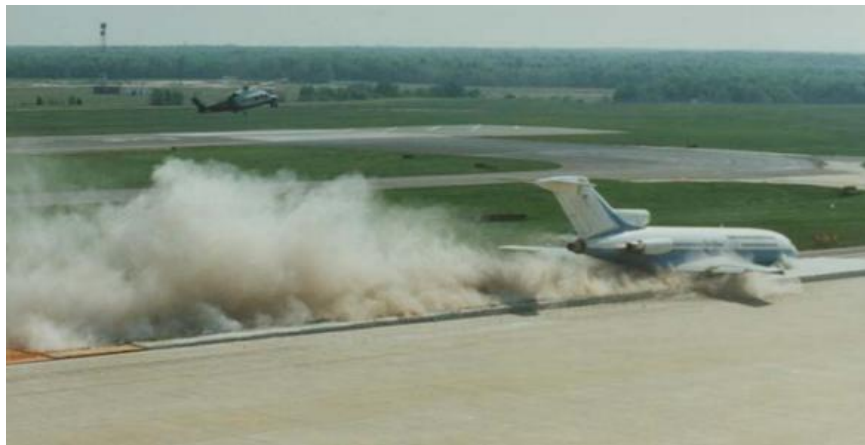
**Figure 3.3. EMAS Airplane Test (5).**

An engineered material arresting system (EMAS) (5) is a cellular cement arresting bed. The material is a set mixture of portland cement, an air entraining foaming agent, and water. Each cement brick is 4 ft wide by 8 ft long with varying thicknesses. A 1-inch topcoat of cement slurry is applied on top of the test bed. The installation is 40 ft wide by 376 ft wide, with a taper to 25 inches deep. While the specific application described in (5) used a flat installation surface, the system can be modified for sloped conditions. When impacted, the system deforms and applies a drag force that safely and predictably decelerates the test vehicle. Figure 3.3 shows a photo of this system arresting an airplane.

This system was evaluated using a B-727 aircraft weighing 131,600 lb (5). The B-727 was traveling at 55 knots (approximately 63.3 mi/h) and was successfully brought to rest with a stopping distance of 278 ft. Maintenance to the system after impact only involves replacing damaged cement bricks. The unaffected bricks may be left in place. Because this system will be placed at grade level, groundskeeping will not be required in this area. Despite this system being designed for aircraft use, a modified cement brick composition could be developed for roadway vehicles. Table 3.2 lists advantages and disadvantages of the EMAS.

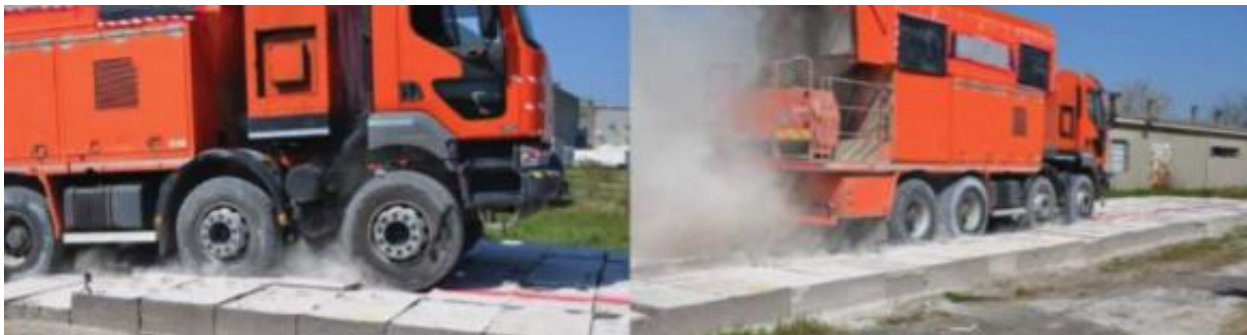
**Figure 3.4. Vehicle Evaluation of Arresting Bed (6).**

The EMAS alternative to runaway truck ramp system (6) is an arresting bed intended as an alternative to traditional gravel or gravity-based runaway truck ramps. This design consists of a variable number of deformable cement blocks similar to the airport EMAS. The cementitious block units are 110 cm in length and 70 cm in width, and they range from 15 cm to 60 cm in thickness. The total length of the system is 38.5 m long and 5.5 m wide. The design was implemented on flat ground; however, the system's units can be modified to allow for median slope applications. Figure 3.4 shows a photo of this system arresting a truck.

This system was evaluated using a 88,000-lb truck traveling at 35 mi/h (6). The system successfully brought the vehicle to rest in 83.3 ft. Maintenance to the system after impact only involves replacing damaged cement bricks. The unaffected bricks may be left in place. Groundskeeping will not be required in this area because the cement blocks prevent vegetation from growing. Table 3.3 lists advantages and disadvantages of this system.

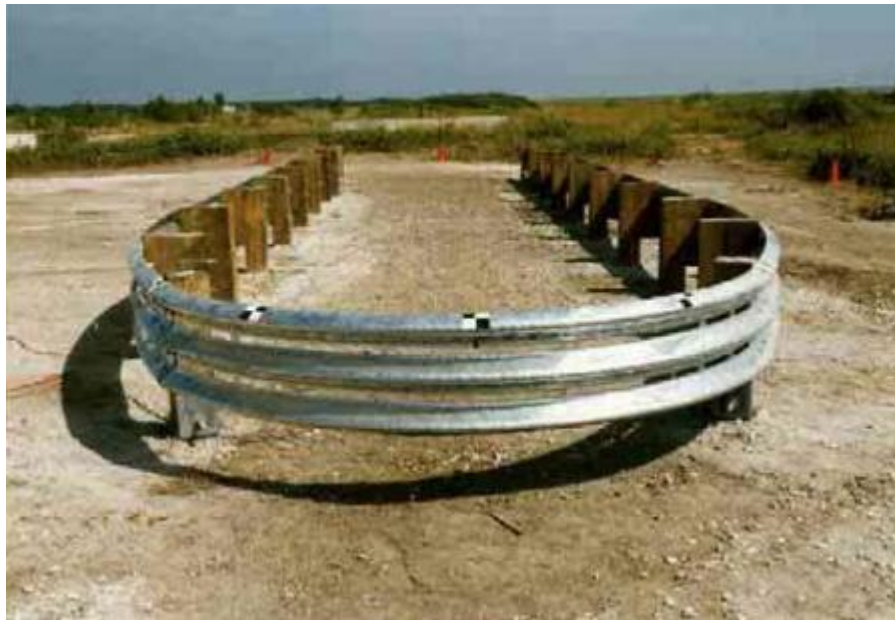
**Figure 3.5. MwRSF Bullnose System (7).**

The bullnose system (7–9) is a guardrail installation developed by researchers at the Midwest Roadside Safety Facility (MwRSF) for the purpose of protecting large gore areas. It is composed of a thrie-beam rail mounted to 22 wood posts (11 posts on each side). A steel cable is installed behind the first thrie-beam section to prevent rail rupture. The thrie beam has a radius of 1580 mm, and the barrier is a nominal height of 804 mm. The system is 4500 mm wide and 20,144 mm long. This bullnose system was designed and tested on flat ground. Because of the complexity of the system, a large development effort would be required to modify it for sloped medians. Figure 3.5 shows a photo of the bullnose system.

The system was successfully evaluated head on with an 886-kg small car impacting the system at 103.3 km/h (7–9). The test vehicle came to rest 6.55 m downstream. Furthermore, this bullnose system successfully brought a 2010-kg pickup truck impacting at 103.5 km/h to a stop in 16.33 m. After the test, much of the system requires costly replacement. Because of the design of the bullnose, groundskeeping crews will not be able to use large equipment to maintain the protected area. Therefore, smaller equipment will be required for upkeep. Table 3.4 lists advantages and disadvantages of the bullnose system.

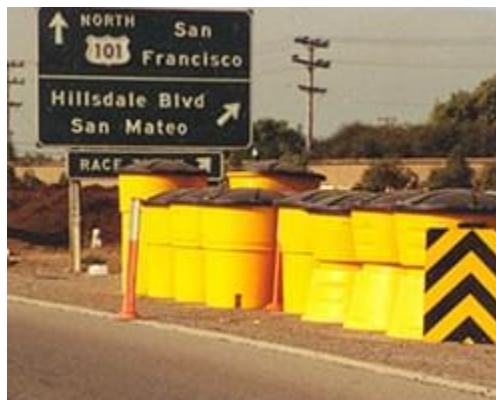
**Figure 3.6. Sand Barrel Application (10).**

Several sand barrel systems exist in the current market, and each varies slightly from manufacturer to manufacturer. Sand barrel systems arrest vehicles by displacing large volumes of sand. The sand barrels typically consist of three main parts: the plastic barrel, the sand filling, and the plastic lid. The sand barrels range widely in weight, from 200 to over 2000 lb when filled. The barrels are arranged in consecutive rows, but the overall system configuration varies per speed application. These systems were designed for installation on a flat surface, so it would need to be modified for a sloped median. Figure 3.6 shows a photo of a sand barrel array. These systems obstruct groundskeeping equipment, so groundskeeping will require manual effort with little help from larger equipment. Table 3.5 lists advantages and disadvantages of sand barrel systems.

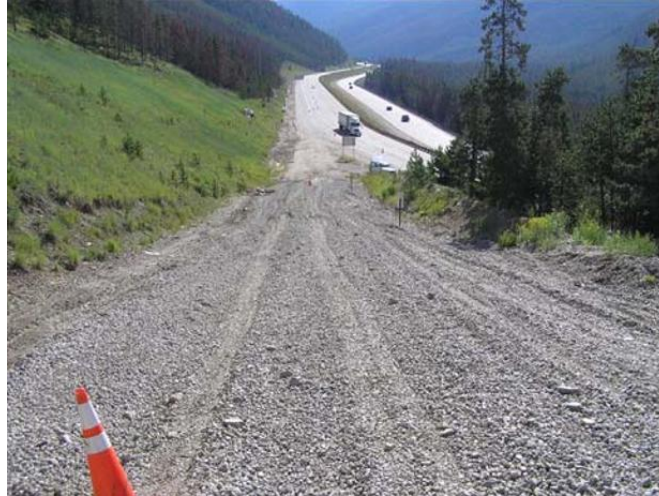
**Figure 3.7. Truck Escape Ramp in Colorado (12).**

State DOTs have varying research and guidelines regarding runaway truck ramps (also known as truck escape ramps) (11, 12). These guidelines describe the physical geometry of the runaway truck ramp required for the design vehicle size and speed. Figure 3.7 shows a photo of a runaway truck ramp. The AASHTO's *A Policy on Geometric Design of Highways and Streets* (Green Book) (13) provides several common recommendations:

Truck escape ramps use gravity and/or frictional resistance to safely arrest vehicles. Most use a gravel-like material that slowly decelerates the impacting vehicle. The frictional resistance of this material is a key element that needs to be carefully considered when designing a truck escape ramp. To aid the frictional material in slowing the vehicle, engineers often design truck escape ramps with an upward grade to force the impacting vehicle to fight against gravity when traveling forward. After a truck escape ramp is used, repair crews would regrade the ramp to smooth any tracks that were made by the impacting vehicle. While the repair effort may be minimal, the groundskeeping effort could be large. The gravel-like material would prevent large equipment from accessing the area but would allow vegetation to grow through the depth of the ramp. Therefore, manual groundskeeping would be required for the filled area. Table 3.6 lists advantages and disadvantages of truck escape ramps.

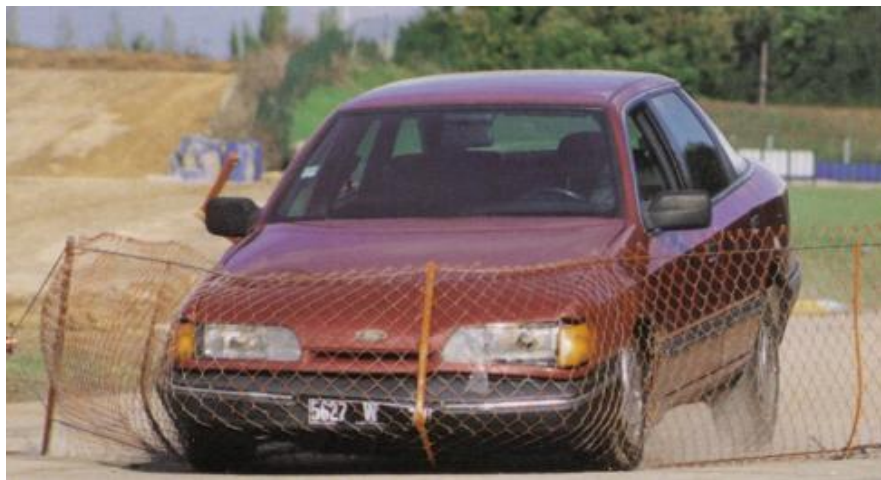
**Figure 3.8. Vehicle Arresting Net (3).**

The research team developed a MOPS based upon the readily available technologies investigated and the analytical crash data reviewed. After the technology investigation, TxDOT and the research team chose to pursue the use of net-based vehicle arresting technology. Consequently, the research team worked with Impact Absorption, a roadside safety company, to adapt its net arrestor product to the median opening condition. This system uses a mesh net that spans between two end anchors. This mesh is connected to a set of steel tapes that unspool after the net wraps around the front of a vehicle during an impact. The unspooling of this steel tape dissipates the impact energy and helps to safely bring the vehicle to a stop. The two end anchors are attached to concrete piers. The net is anchored at the midspan of the median ditch section to hold the net at the appropriate catch height. This configuration will minimize the risk of underriding the net during an impact. More details regarding the specific energy absorbers and the net configuration are included in the final installation drawings. Figure 3.8 shows a photo of this system.

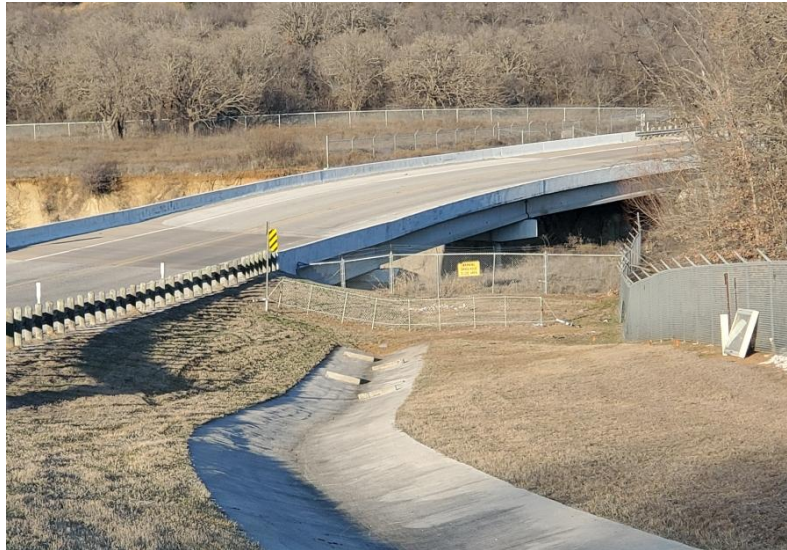
Figure 3.9 shows the installation. This is a similar condition to the median opening, as it shows the net anchored at the center of the ditch.

**Figure 3.9. Net Arrestor Installed in Wise County (photo courtesy of A. Cruz).**

The net arrestor system has been installed in Texas to provide hazard protection similar to the median opening scenario. In Wise County, the net arrestor was installed on FM 1658 to protect the roadside ditch area adjacent to the bridge ends (4).

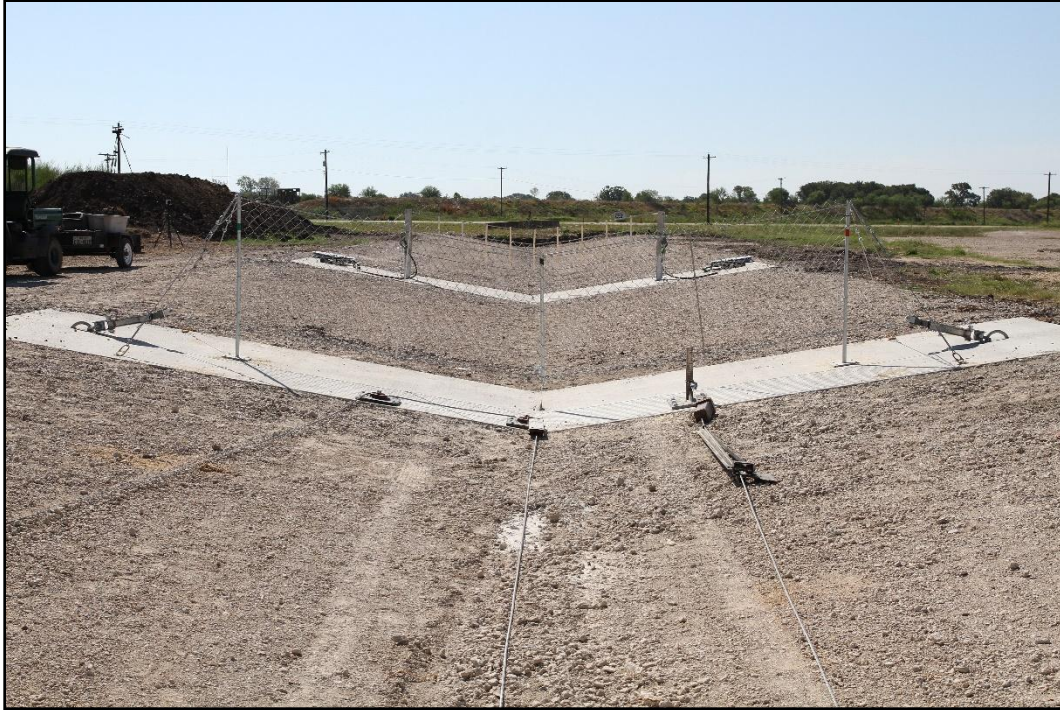
**Figure 4.3. Upstream In-Line View of the Median Opening Protection System prior to Crash Tests 440210-01-1&2.**

Figure 4.1 presents the overall information on the MOPS, Figure 4.2 presents the overall information for the first net, and Figure 4.3 through Figure 4.8 provide photographs of the installation. Appendix A provides further details on the MOPS. Drawings were provided by TTI Proving Ground, and construction was performed by TTI Proving Ground personnel and Impact Absorption installers. TTI Proving Ground personnel supervised installation efforts.

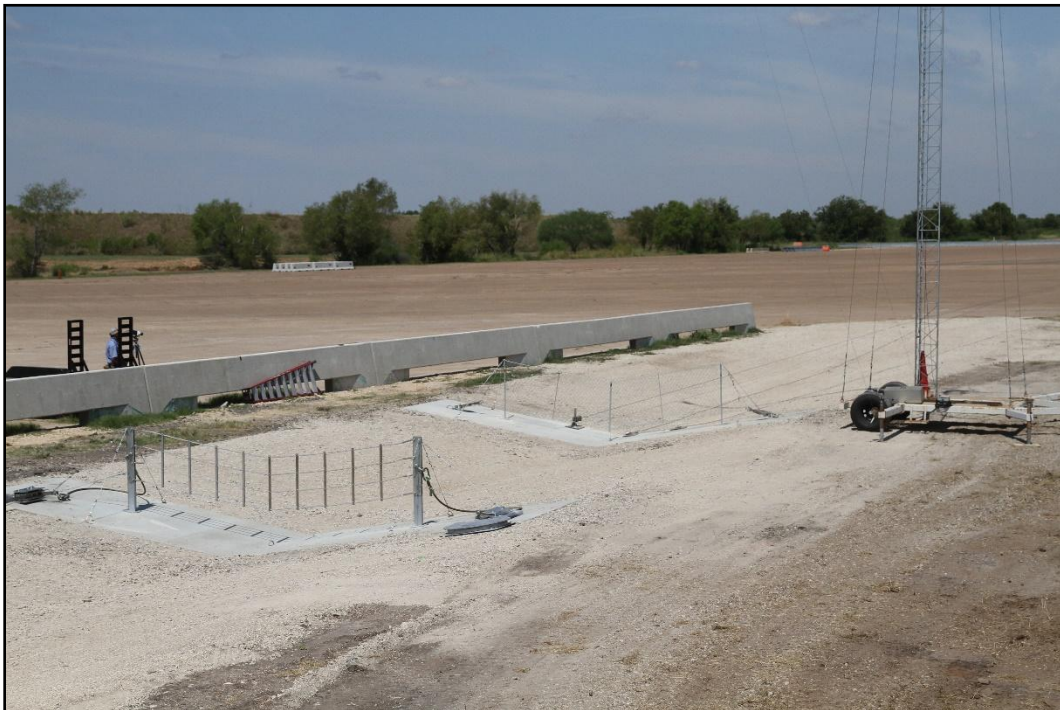
**Figure 4.4. Oblique View of the Median Opening Protection System prior to Crash Tests 440210-01-1&2.**

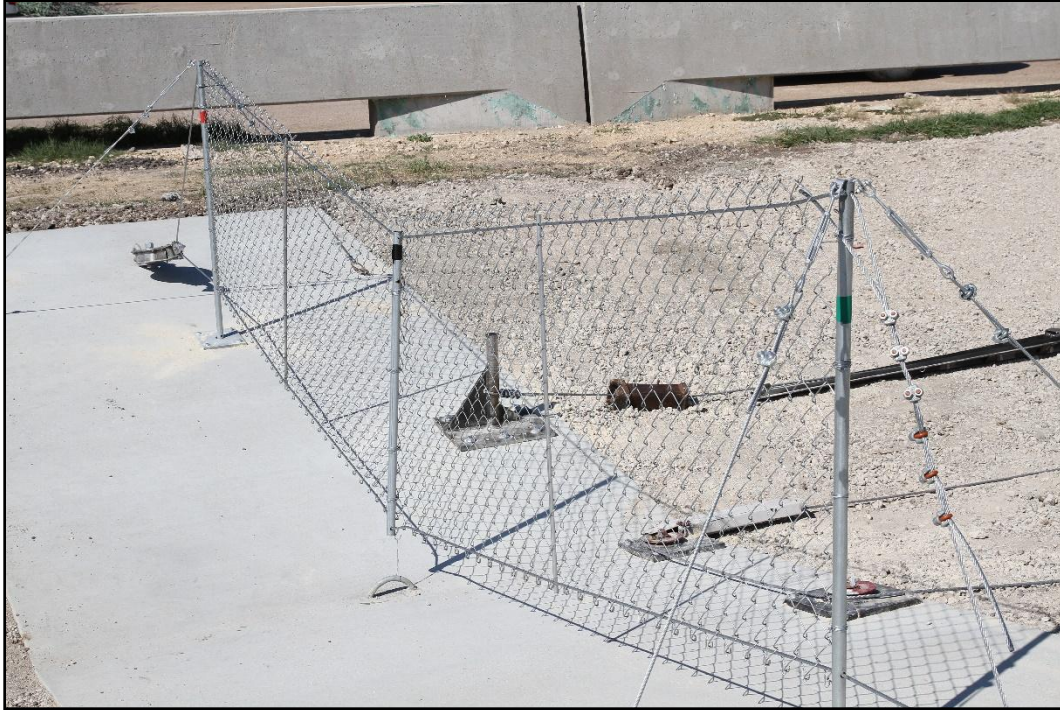
**Figure 4.5. First Median Opening Protection System prior to Crash Tests 440210-01-1&2.**

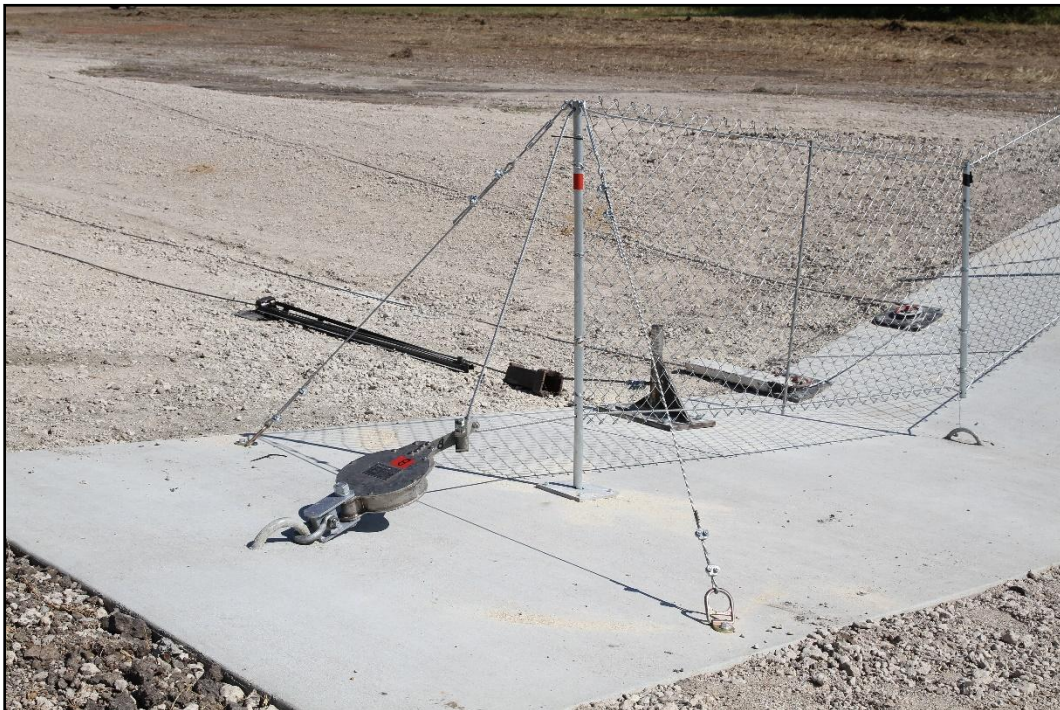
**Figure 4.6. Anchor Hardware for the First Median Opening Protection System prior to Crash Tests 440210-01-1&2.**

the inclusion of drilled shaft anchors. The nets require a 4-ft-deep drilled shaft at each end. These drilled shafts can be poured continuously with the mowstrip; thus, it is convenient to make the compressive strength of the mowstrip slab the same as the drilled shafts. The drilled shafts require a 4000 psi concrete mix; consequently, the mowstrip is recommended to have this same compressive strength.

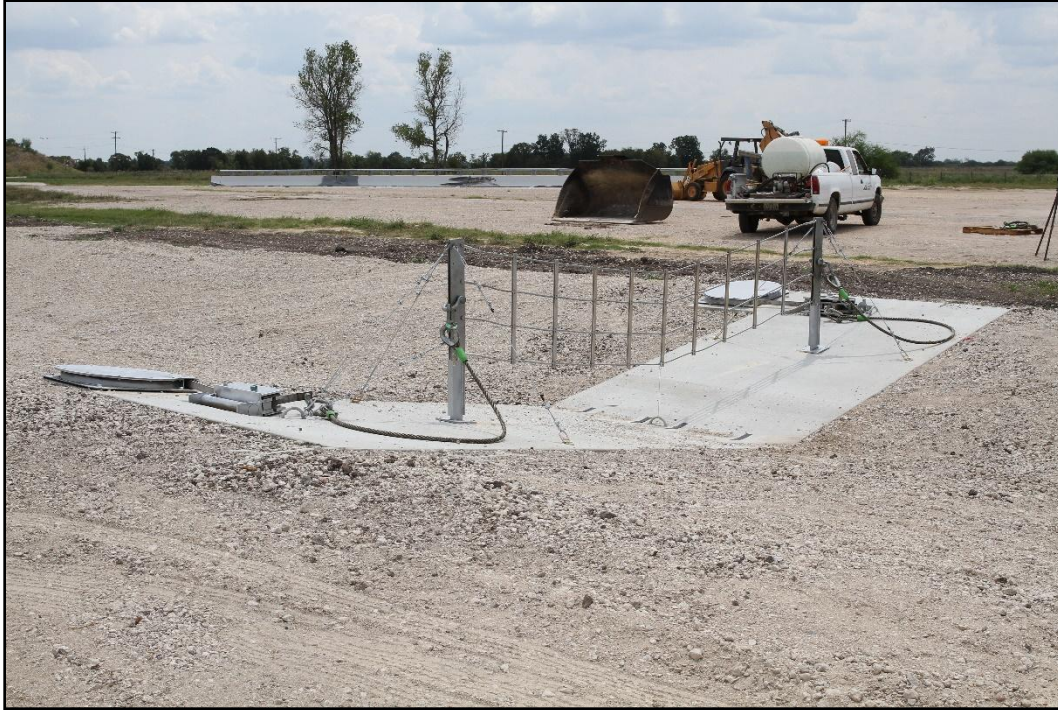
**Figure 4.7. Second Median Opening Protection System Net prior to Crash Tests 440210-01-1&2.**

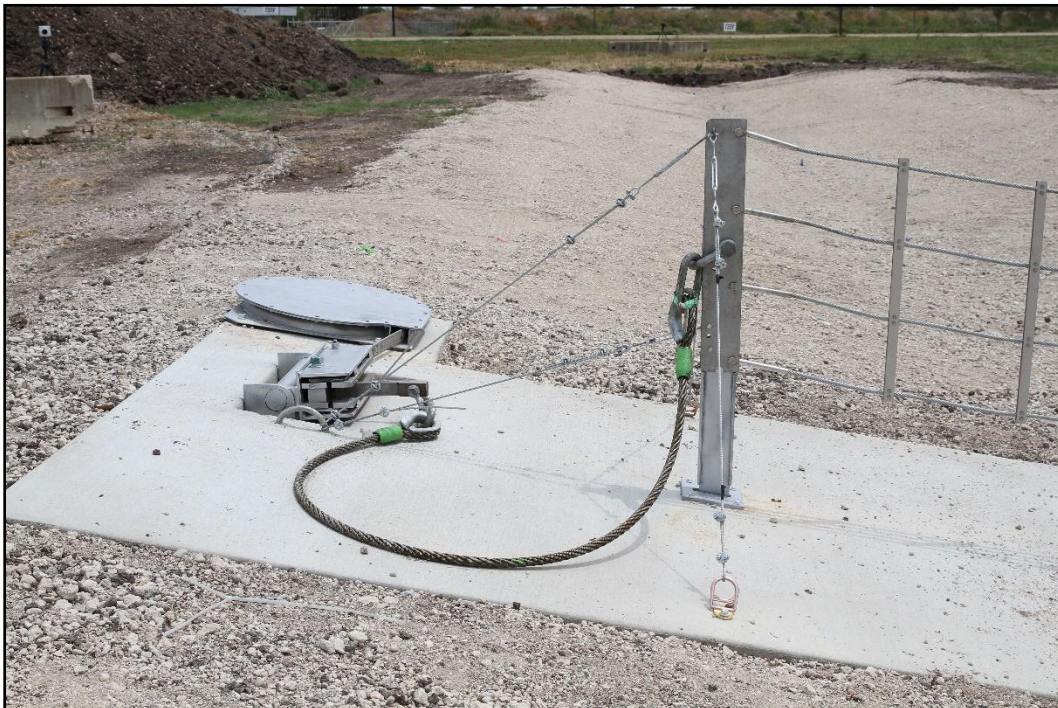
**Figure 4.8. Anchor Hardware for the Second Median Opening Protection System Net prior to Crash Tests 440210-01-1&2.**

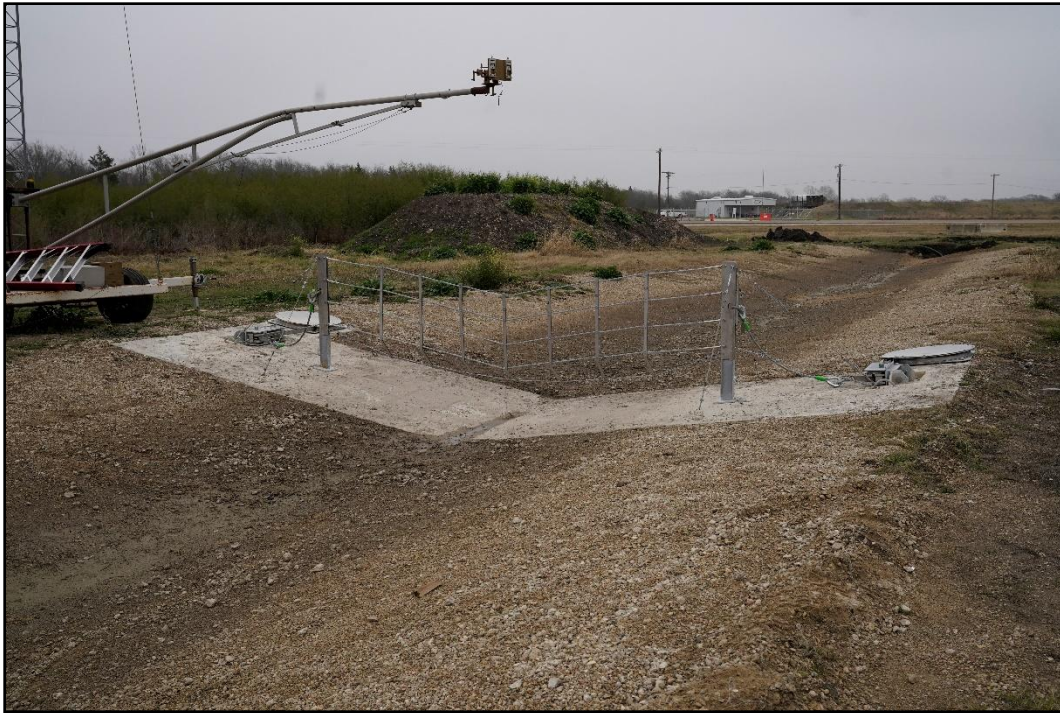
**Figure 4.10. Second Median Opening Protection System Net prior to Crash Tests 440210-01-4, 440211-01-3, 440211-01-5, and 440213-01-6.**

In Crash Test 440210-01-2, the test vehicle impacted the second net, causing the swivel mount for the second net's energy absorber to release the energy absorber. This was not intended in the design and was undesirable for future testing. Therefore, a new swivel mount was designed and utilized for all subsequent testing, including a retest of Test 440210-01-2 (440210-01-4). Test 3-40 (440210-01-1) was not repeated because the test vehicle did not contact the second net, and therefore the swivel mount design had no effect on the test results. Figure 4.9 presents the overall information for the second net after modifications, and Figure 4.10 through Figure 4.13 provide photographs of the installation.

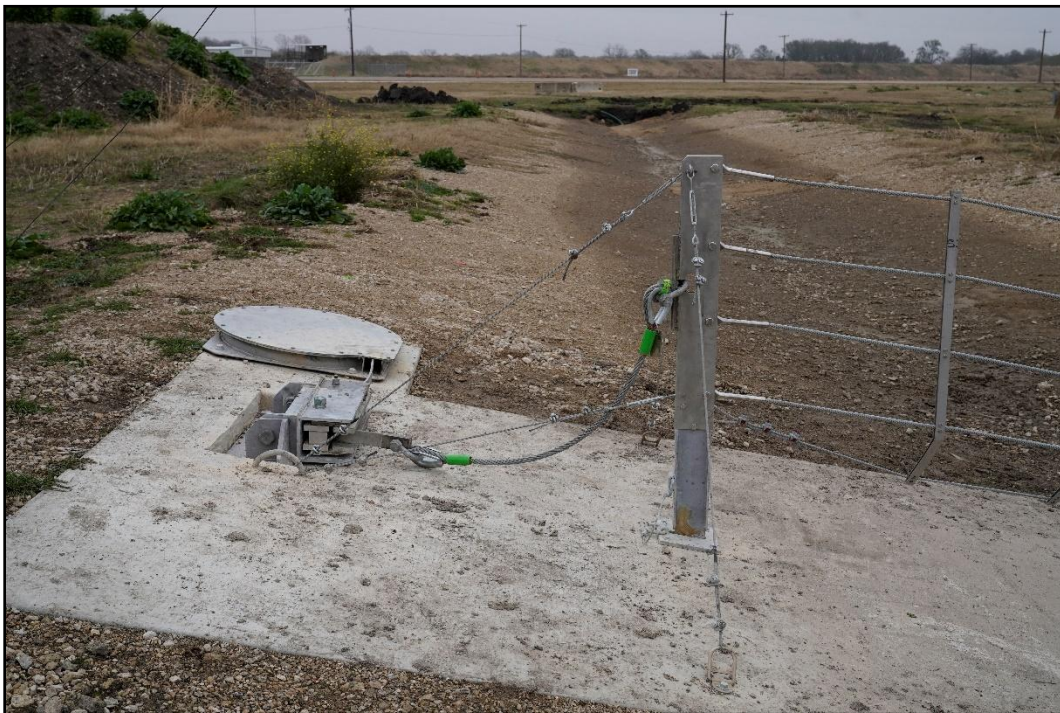
**Figure 4.11. Anchor Hardware for the Second Median Opening Protection System Net prior to Crash Tests 440210-01-4, 440211-01-3, 440211-01-5, and 440213-01-6.**

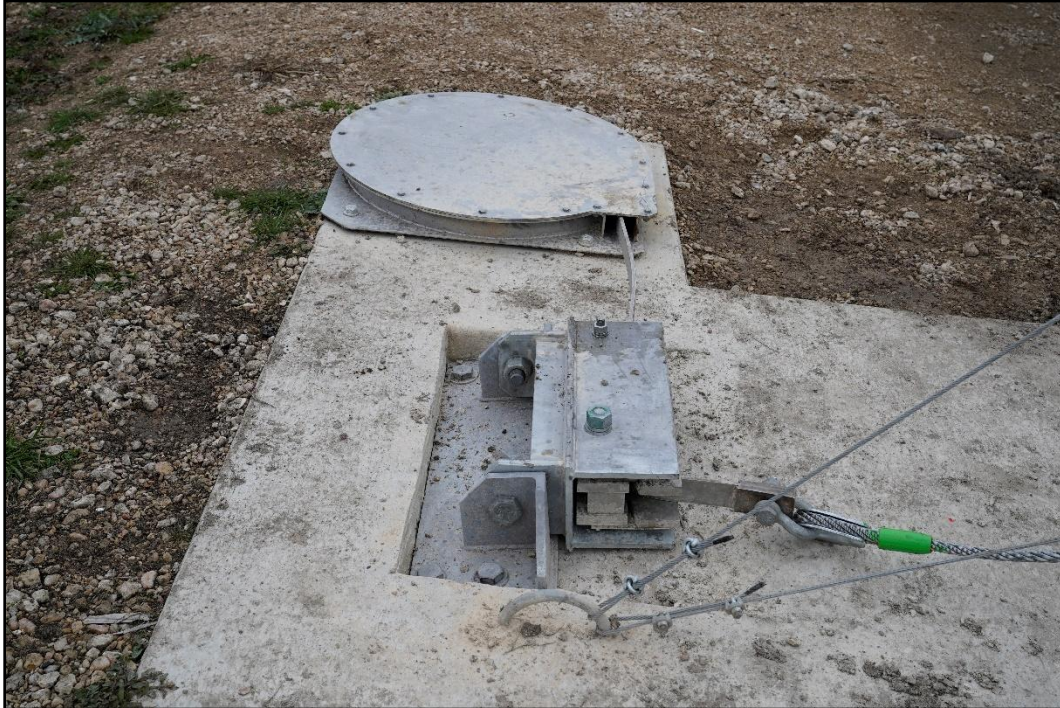
**Figure 4.13. Swivel Mound System and Cannister for the Second Net prior to Crash Tests 440210-01-4, 440211-01-3, 440211-01-5, and 440213-01-6.**

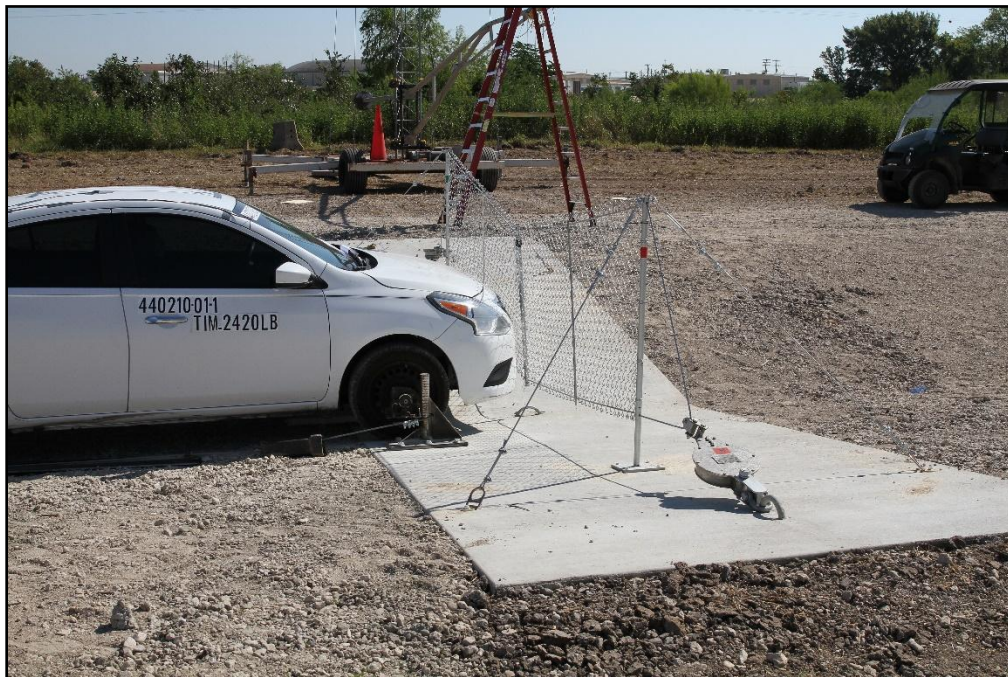
**Figure 7.2. MOPS/Test Vehicle Impact Location for Test 440210-01-1.**

See Table 7.1 for the *MASH* impact conditions and Table 7.2 for the exit parameters for Test 440210-01-1. Figure 7.1 and Figure 7.2 depict the target impact setup.

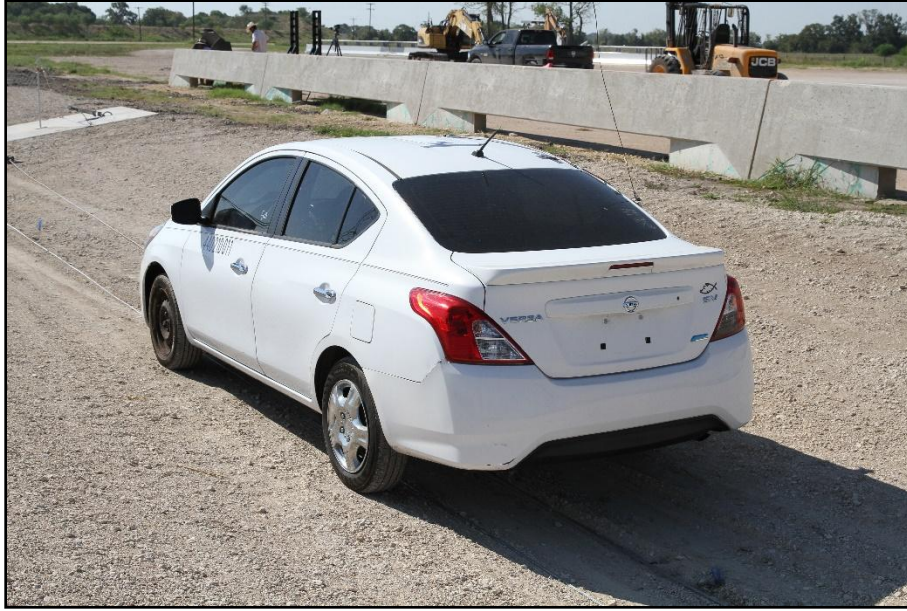
**Figure 7.4. Back of Test Vehicle before Test 440210-01-1.**

Figure 7.3 and Figure 7.4 show the 2016 Nissan Versa used for the crash test. Table 7.4 shows the vehicle measurements. Figure B.1 in Appendix B.1 gives additional dimensions and information on the vehicle.

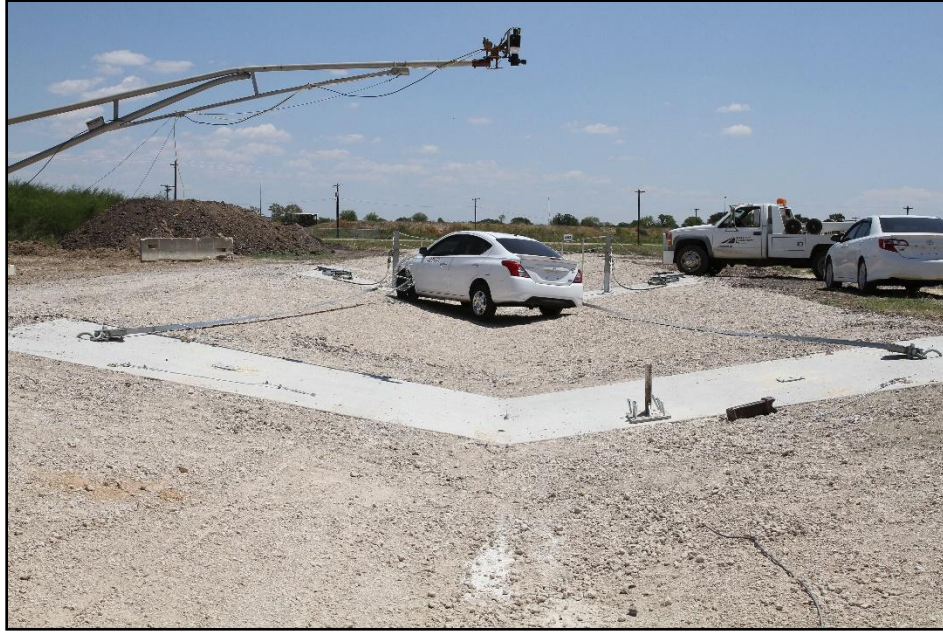
**Figure 7.5. MOPS after Test 440210-01-1.**

There was no movement or cracking noted on the foundation of the first net. The right and left post baseplates and the concrete immediately downstream of them had some scuffing, and the four oblique support cables all released from the net but remained attached to the concrete foundation. When facing the installation from upstream, the left tape pulled out from the canister 31 ft 11 inches, and the right tape pulled out 36 ft 7 inches. The fence remained attached to the tape and wrapped around the front and sides of the car. The left intermediate post fractured, and a section of it landed 46 ft downstream and 3 ft to the left of impact. Both the leftmost and rightmost posts deformed and sheared from the bottom cable. The test vehicle did not contact the second net (most downstream net) in the installation.

Table 7.6 describes the deflection and working width of the MOPS. Figure 7.5 and Figure 7.6 show the damage to the MOPS.

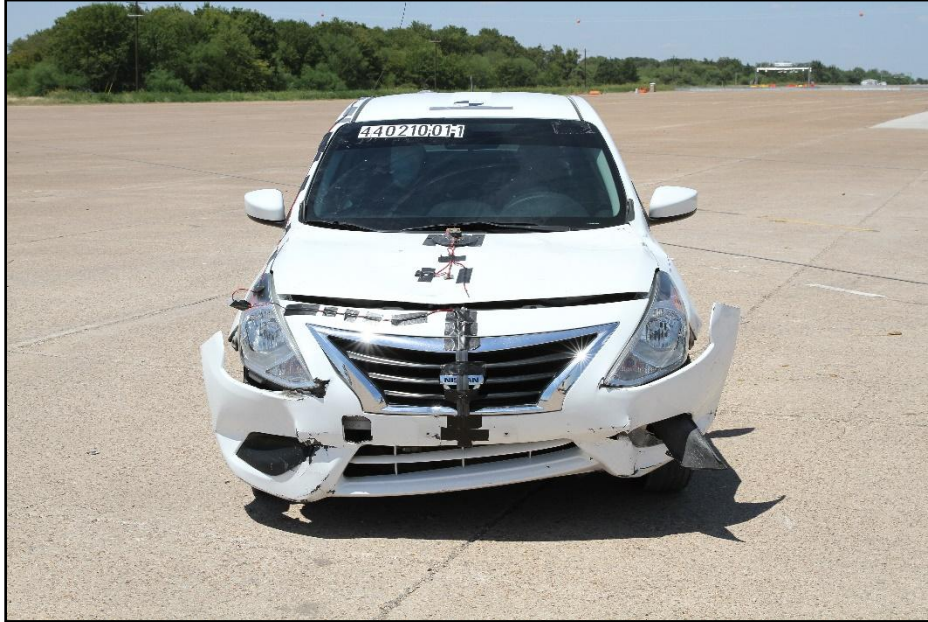
**Figure 7.7. Test Vehicle after Test 440210-01-1.**

Figure 7.7 and Figure 7.8 show the damage sustained by the vehicle. Figure 7.9 and Figure 7.10 show the interior of the test vehicle. Table 7.7 and Table 7.8 provide details on the occupant compartment deformation and exterior vehicle damage. Figures B.2 and B.3 in Appendix B.1 provide exterior crush and occupant compartment measurements.

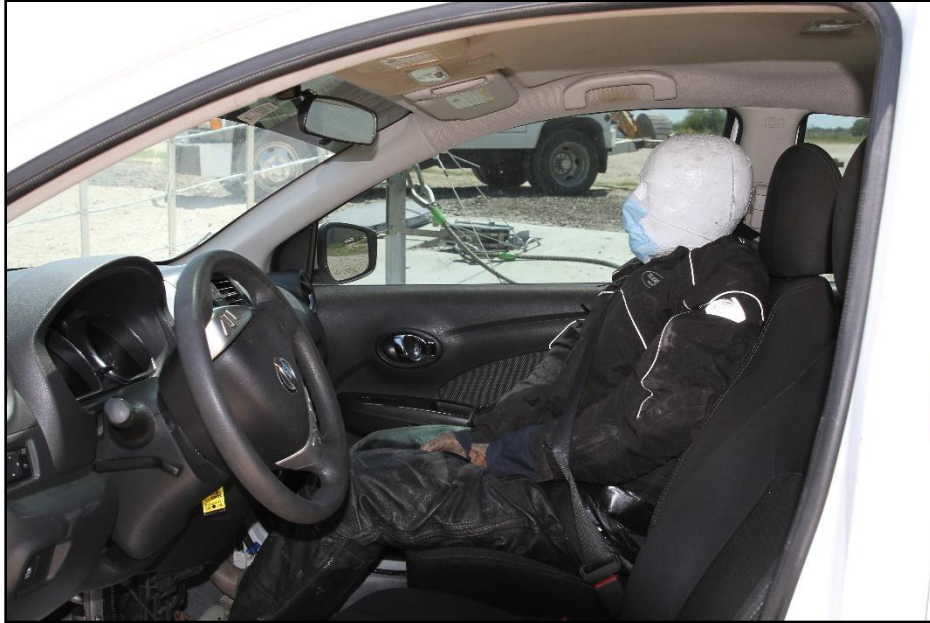
**Figure 7.9. Overall Interior of Test Vehicle after Test 440210-01-1.**

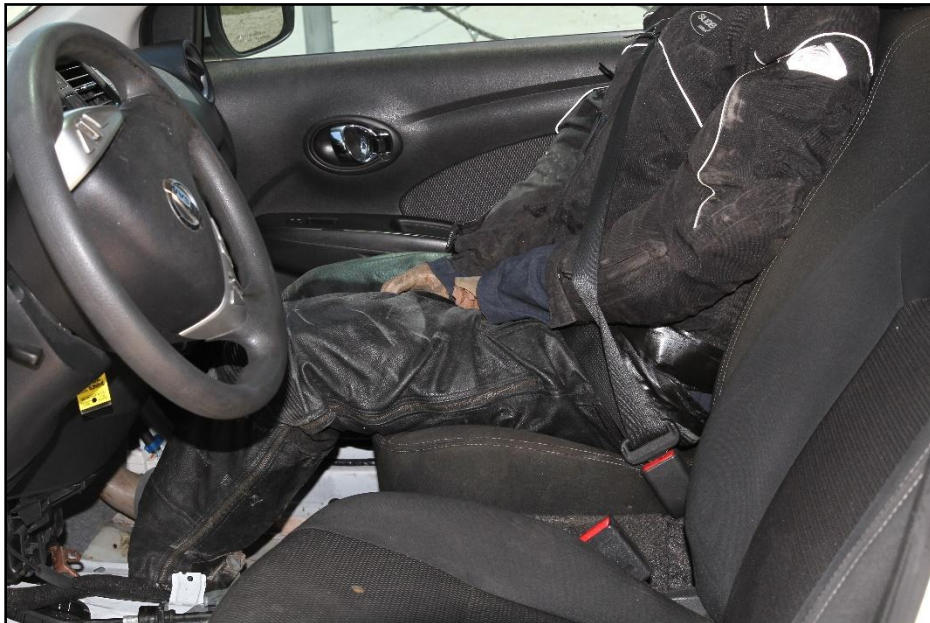
**Figure 7.10. Interior of Test Vehicle after Test 440210-01-1.**

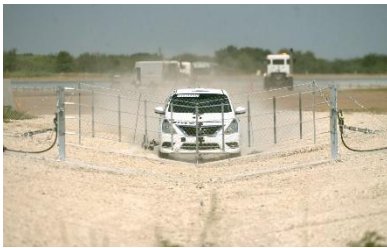
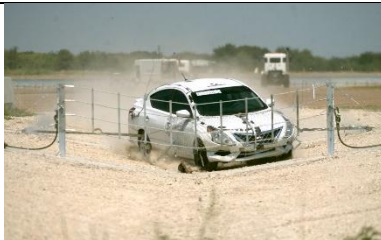
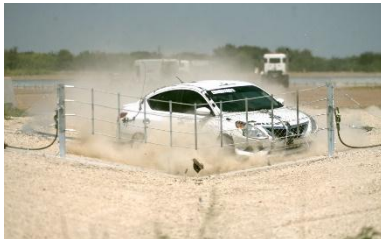
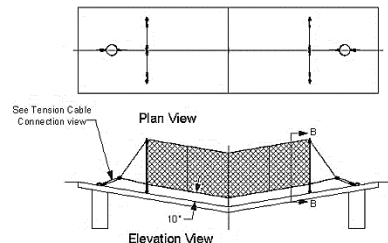
<b>1.050 s</b>	Name	MOPS					
	Length	50 ft					
	Key Materials	Wire mesh nets, wire rope net, energy absorbers					
	Soil Type and Condition	AASHTO M147-65(2004), Type 1, Grade D Crushed Concrete					
<b>TEST VEHICLE</b>							
	Type/Designation	1100C					
	Year, Make and Model	2016 Nissan Versa					
	Inertial Weight (lb)	2420					
	Dummy (lb)	165					
	Gross Static (lb)	2585					
<b>IMPACT CONDITIONS</b>							
	Impact Speed (mi/h)	62.0					
	Impact Angle (deg)	0.0					
	Impact Location	Centerline of the vehicle aligned 2.7 inches to the left of the centerline of the MOPS					
	Kinetic Energy (kip-ft)	311					
<b>EXIT CONDITIONS</b>

Exit Speed (mi/h)	Vehicle did not exit the installation					
	Stopping Distance	45 ft downstream 5 ft to the left side					
<b>TEST ARTICLE DEFLECTIONS</b>							
	Dynamic (ft)	45					
	Permanent (ft)	45					
<b>VEHICLE DAMAGE</b>							
	VDS	12FC1					
	CDC	12FCEN1					
	Max. Ext. Deformation (inches)	1					
	Max Occupant Compartment Deformation	No occupant compartment deformation					
<b>OCCUPANT RISK VALUES</b>							
Long. OIV (ft/s)	17.9	Long. Ridedown (g)	3.9	Max 50-ms Long. (g)	-3.5	Max Roll (deg)	6.3
Lat. OIV (ft/s)	0.7	Lat. Ridedown (g)	1.9	Max 50-ms Lat. (g)	-1.6	Max Pitch (deg)	8.8
THIV (m/s)	5.5	ASI	0.3	Max 50-ms Vert. (g)	1.3	Max Yaw (deg)	35

**Figure 7.11. Summary of Results for MASH Test 3-40 on MOPS.**

Figure 7.11 summarizes the results of *MASH* Test 440210-01-1.

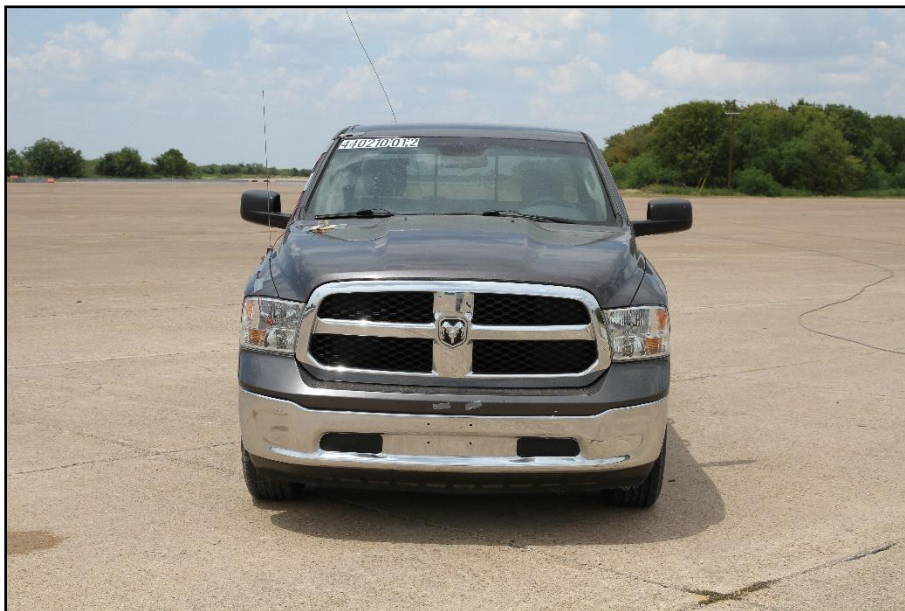
**Figure 8.3. Front of Test Vehicle before Test 440210-01-2.**

Figure 8.3 and Figure 8.4 show the 2015 RAM 1500 used for the crash test. Table 8.4 shows the vehicle measurements. Figure C.1 in Appendix C.1 gives additional dimensions and information on the vehicle.

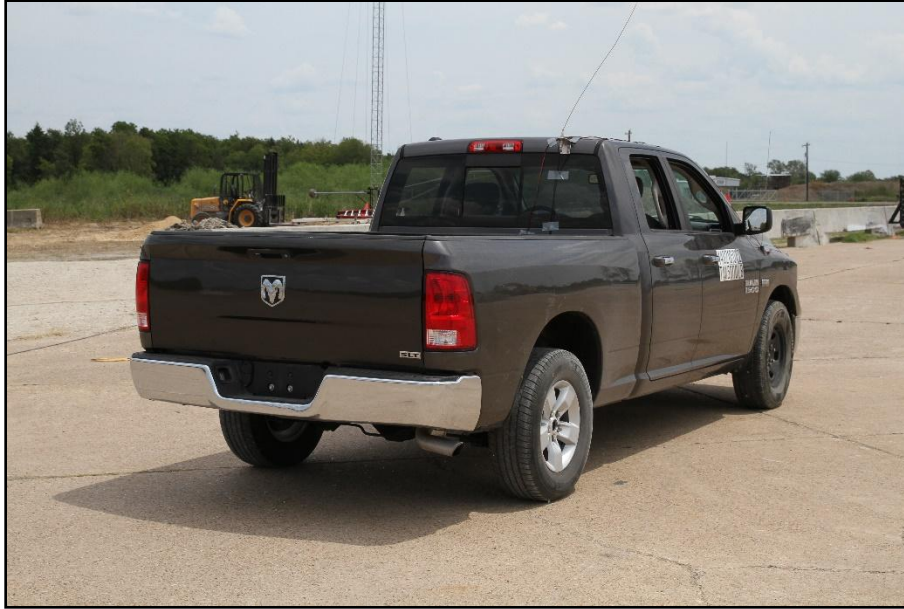
**Figure 8.4. Back of Test Vehicle before Test 440210-01-2.**
