**Test Report No. 0-7021-01-R1**

**DEVELOPING AN ENHANCED PROTECTION OF MEDIAN OPENINGS  
BETWEEN PARALLEL BRIDGE STRUCTURES**

Sponsored by the  
**Texas Department of Transportation  
and the  
Federal Highway Administration**

**TEXAS A&M TRANSPORTATION INSTITUTE PROVING GROUND**

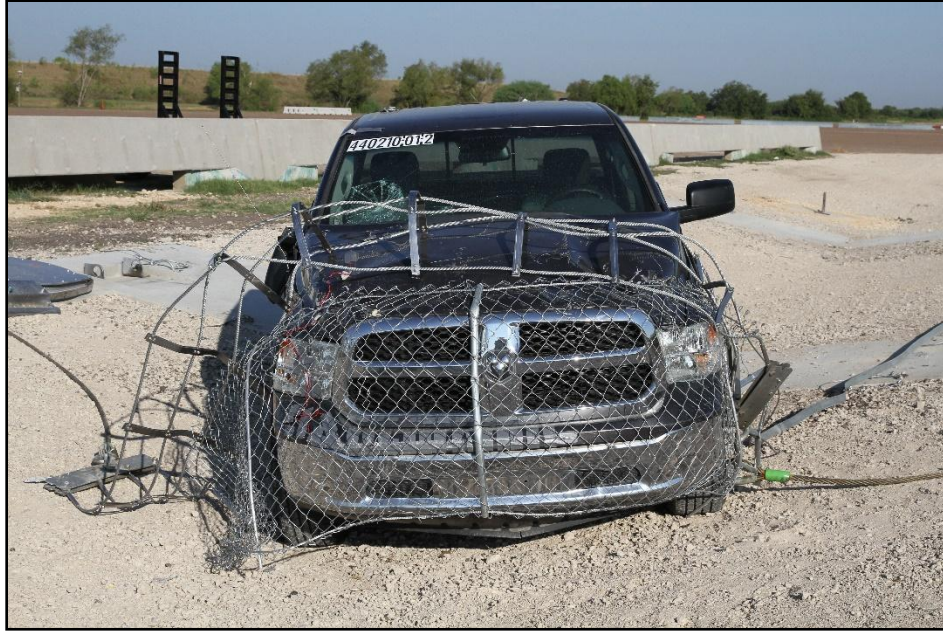
**Figure 8.5. MOPSSs after Test 440210-01-2.**

Table 8.6 describes the deflection and working width of the MOPS. Figure 8.5 and Figure 8.6 show the damage to the MOPS.

<b>Test Parameter</b>	<b>Measured</b>
Permanent Deflection/Location	67 ft toward field side
Dynamic Deflection	67 ft toward field side

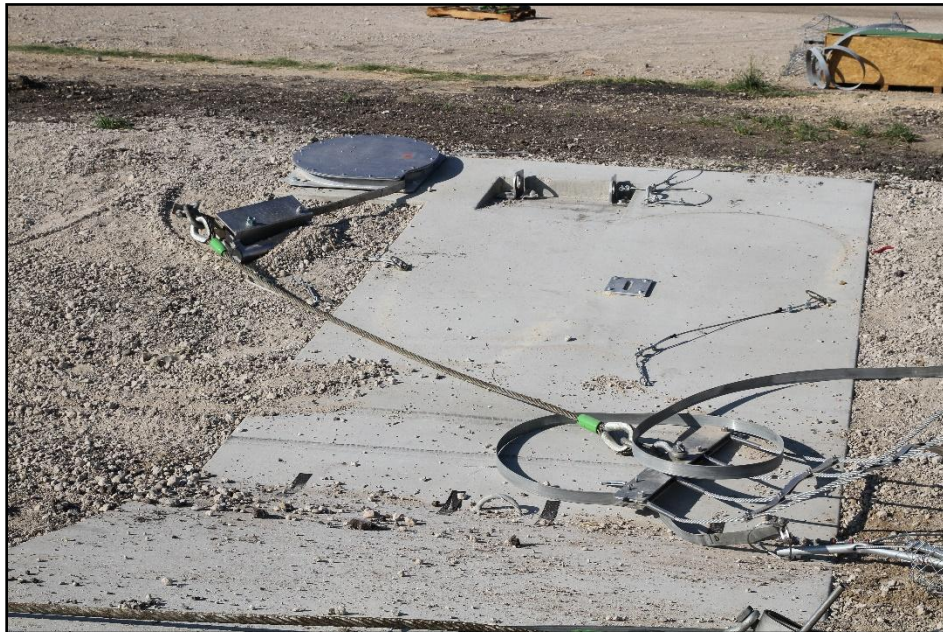
**Figure 8.6. Second Net Swivel Anchor and Energy Absorbers after Test 440210-01-2.**

In Crash Test 440210-01-2, the test vehicle impacted the second net, causing the swivel mount for the second net's energy absorber to release the energy absorber. This was not intended in the design and was undesirable for future testing. Therefore, a new swivel mount was designed and utilized for all subsequent testing, including a retest of Test 440210-01-2 (440210-01-4). Test 3-40 (440210-01-1) was not repeated because the test vehicle did not contact the second net, and therefore the swivel mount design had no effect on the test results. Figure 4.9 presents the overall information for the second net after modifications, and Figure 4.10 through Figure 4.13 provide photographs of the installation.

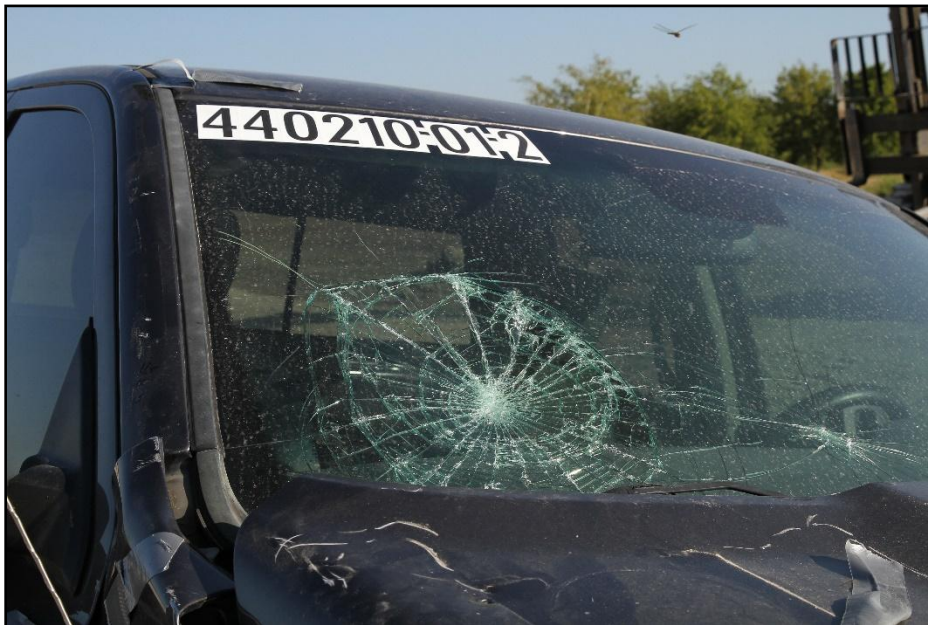
**Figure 8.8. Windshield of Test Vehicle after Test 440210-01-2.**

Figure 8.7 and Figure 8.8 show the damage sustained by the vehicle. Figure 8.9 and Figure 8.10 show the interior of the test vehicle. Table 8.7 and Table 8.8 provide details on the occupant compartment deformation and exterior vehicle damage. Figures C.2 and C.3 in Appendix C.1 provide exterior crush and occupant compartment measurements.

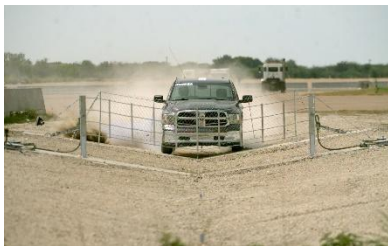
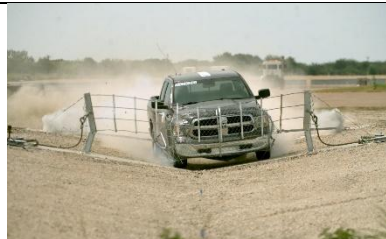
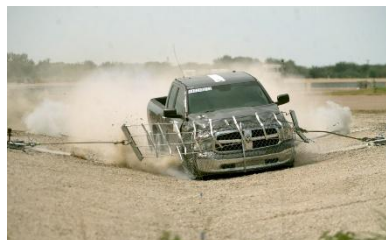
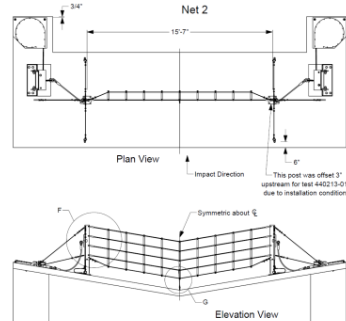
**Figure 8.11. Summary of Results for MASH Test 3-41 on MOPS.**

Name	MOPS					
	Length	50 ft					
	Key Materials	Wire mesh nets, wire rope net, energy absorbers					
	Soil Type and Condition	AASHTO M147-65(2004), Type 1, Grade D Crushed Concrete					
	<b>TEST VEHICLE</b>						
	Type/Designation	2270P					
	Year, Make and Model	2015 RAM 1500					
	Inertial Weight (lb)	5020					
	Dummy (lb)	N/A					
	Gross Static (lb)	5020					
	<b>IMPACT CONDITIONS</b>						
	Impact Speed (mi/h)	62.1					
	Impact Angle (deg)	0.3					
	Impact Location	Centerline of the vehicle aligned 4.8 inches to the left of the centerline of the MOPS					
	Kinetic Energy (kip-ft)	647.2					
	<b>EXIT CONDITIONS</b>						
	Exit Speed (mi/h)	N/A					
	Stopping Distance	67 ft downstream 4 ft to the left side

<b>TEST ARTICLE DEFLECTIONS</b>						
	Dynamic (ft)	67					
	Permanent (ft)	67					
	<b>VEHICLE DAMAGE</b>						
	VDS	12FC3					
	CDC	12CEN2					
	Max. Ext. Deformation (inches)	1.5					
	Max Occupant Compartment Deformation	1.5 inches in the windshield and right rear fender					
<b>OCCUPANT RISK VALUES</b>							
Long. OIV (ft/s)	13.4	Long. Ridedown (g)	7.6	Max 50-ms Long. (g)	-5.7	Max Roll (deg)	6.8
Lat. OIV (ft/s)	3.1	Lat. Ridedown (g)	2.1	Max 50-ms Lat. (g)	-1.6	Max Pitch (deg)	6.1
THIV (m/s)	4.2	ASI	0.5	Max 50-ms Vert. (g)	-2.1	Max Yaw (deg)	25.7

Figure 8.11 summarizes the results of *MASH* Test 440210-01-2. In Test 440210-01-2, the test vehicle impacted the second net, causing the swivel mount for the second net's energy absorber to release the energy absorber. This was not intended in the design and was undesirable for future testing. Therefore, a new swivel mount was designed and utilized for all subsequent testing, including a retest of 440210-01-2 (440210-01-4).

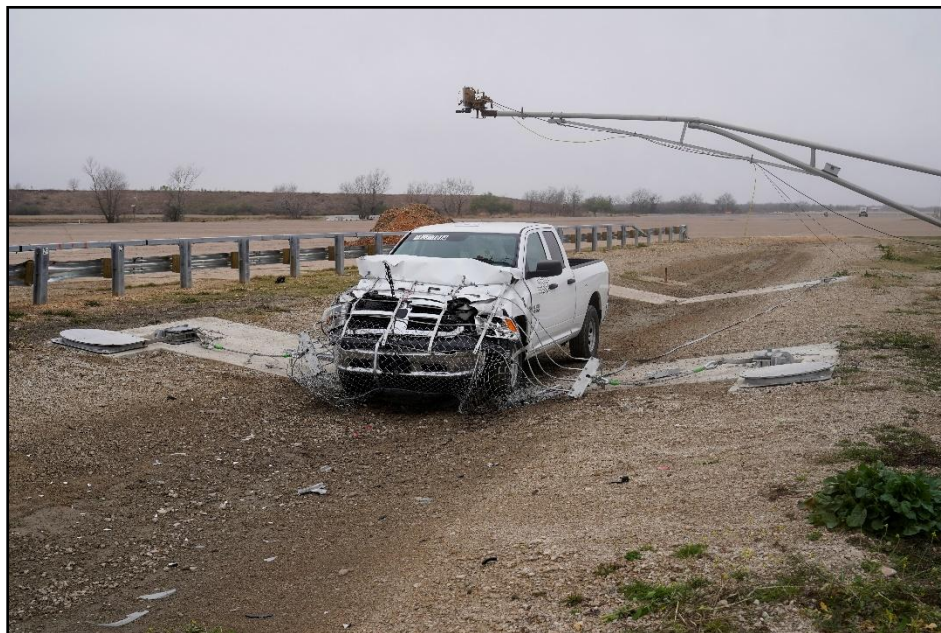
**Figure 9.5. MOPS after Test 440210-01-4.**

The first net was wrapped around the front bumper of the vehicle, while the second net was wrapped over the hood. Both nets remained attached to their straps. There was some slight gouging of the concrete at the second net. Table 9.6 describes the deflection and working width of the MOPS. Figure 9.5 and Figure 9.6 show the damage to the MOPS.

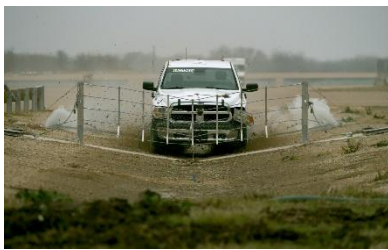
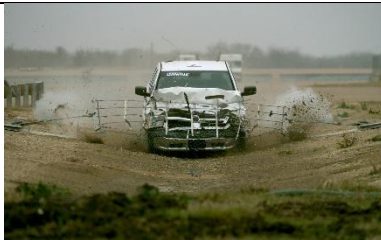
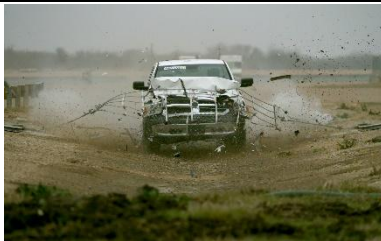
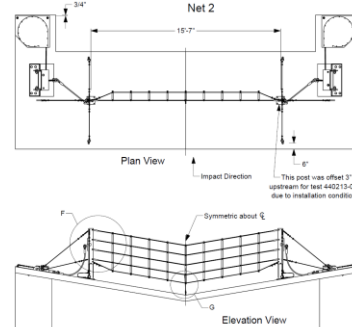
**Figure 9.11. Summary of Results for MASH Test 3-41 on MOPS.**

Name		MOPS					
	Length		50 ft					
	Key Materials		Wire mesh nets, wire rope net, energy absorbers					
	Soil Type and Condition		AASHTO M147-65(2004), Type 1, Grade D Crushed Concrete					
	TEST VEHICLE							
	Type/Designation		2270P					
	Year, Make and Model		2016 RAM 1500					
	Inertial Weight (lb)		5069					
	Dummy (lb)		N/A					
	Gross Static (lb)		5069					
	IMPACT CONDITIONS							
	Impact Speed (mi/h)		62.8					
	Impact Angle (deg)		0.0					
	Impact Location		Centerline of the vehicle aligned 7.3 inches to the right of the centerline of the MOPS					
	Kinetic Energy (kip-ft)		668.3					
	EXIT CONDITIONS							
	Exit Speed (mi/h)		Vehicle did not exit the installation

Stopping Distance		52.7 ft downstream In line					
	TEST ARTICLE DEFLECTIONS							
	Dynamic (ft)		59.7					
	Permanent (ft)		52.7					
	VEHICLE DAMAGE							
	VDS		12FC4					
	CDC		12CEN3					
	Max. Ext. Deformation (inches)		10					
	Max Occupant Compartment Deformation		No occupant compartment deformation					
	OCCUPANT RISK VALUES							
Long. OIV (ft/s)	15.7	Long. Ridedown (g)	13.3	Max 50-ms Long. (g)	-9.6	Max Roll (deg)	8.2	
Lat. OIV (ft/s)	1.1	Lat. Ridedown (g)	2.2	Max 50-ms Lat. (g)	-1.1	Max Pitch (deg)	5.3	
THIV (m/s)	4.8	ASI	0.9	Max 50-ms Vert. (g)	2.9	Max Yaw (deg)	2.1

Figure 9.11 summarizes the results of *MASH* Test 440210-01-4.

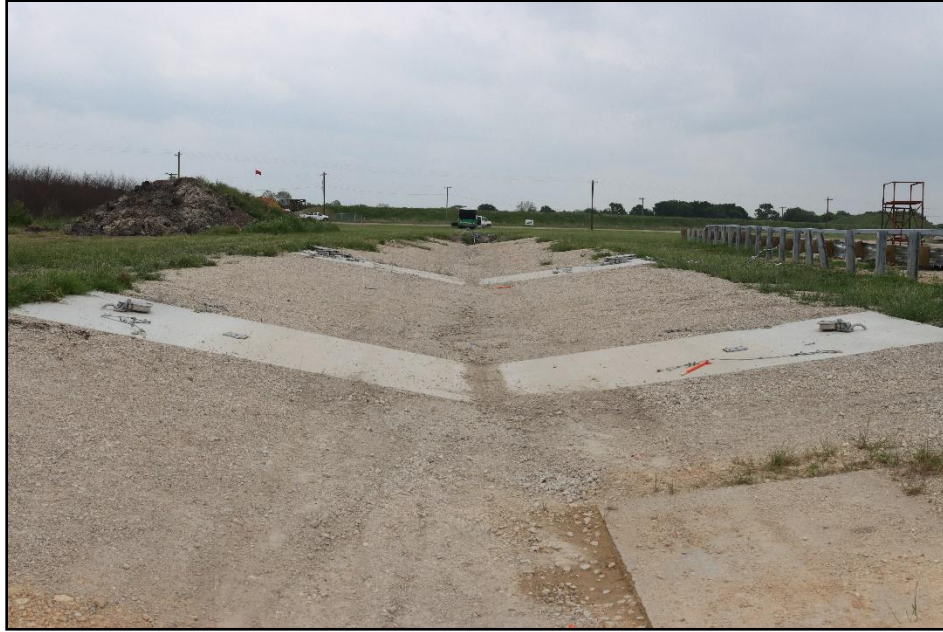
**Figure 10.1. Crash Site after Test 440211-01-3.**

The steel straps from the first net landed 197 ft downstream and 268 ft downstream, and the first net was 312 ft downstream. The second net ruptured and was still attached to the right side of the test vehicle and was laying 15 ft to the right from center. Table 10.6 describes the deflection and working width of the MOPS. Figure 10.1 and Figure 10.2 show the damage to the MOPS.

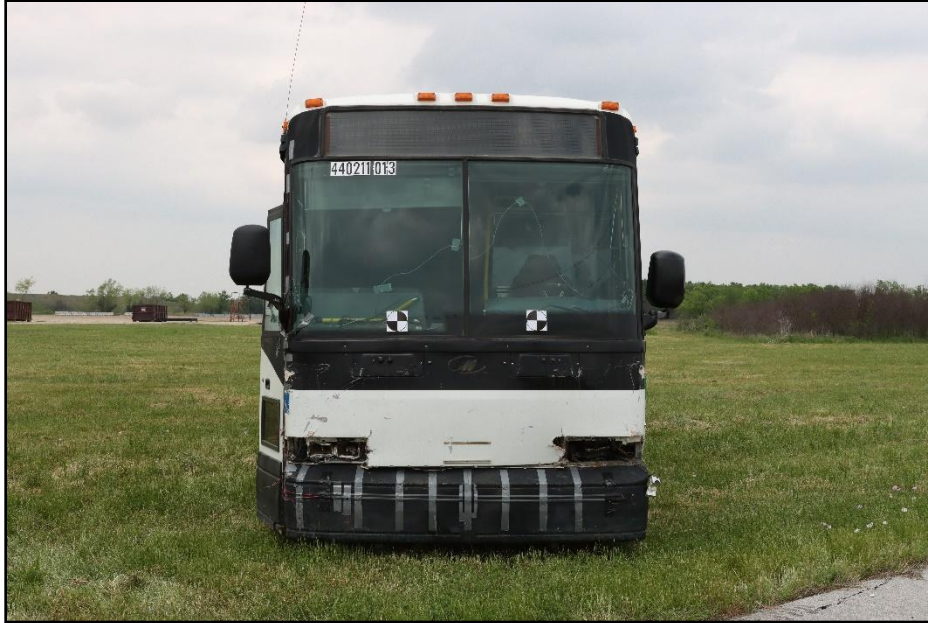
**Figure 10.3. Front of Test Vehicle after Test 440211-01-3.**

<b>Side Windows</b>	The side windows remained intact
<b>Maximum Exterior Deformation</b>	Maximum exterior deformation was not measured due to installation failure
<b>VDS</b>	12FC1
<b>CDC</b>	12FCEN1
<b>Fuel Tank Damage</b>	None
<b>Description of Damage to Vehicle:</b>	The front bumper, headlights, and front side panels were damaged.

Figure 10.3 and Figure 10.4 show the damage sustained by the vehicle. Figure 10.5 and Figure 10.6 show the interior of the test vehicle. Table 10.7 provide details on the exterior vehicle damage. Due to the failure of the installation, occupant compartment deformation was not measured.

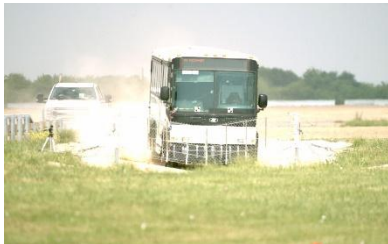
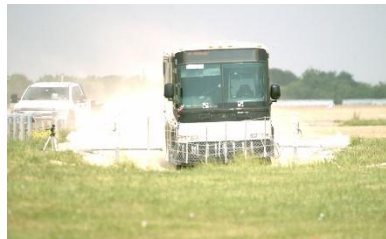
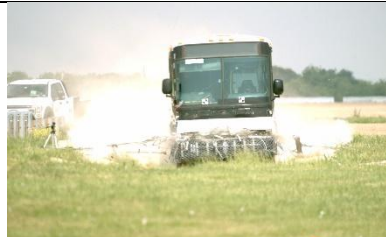
**Figure 10.7. Summary of Results for Research and Development Test on MOPS.**

Name		MOPS					
	Length		50 ft					
Key Materials		Wire mesh nets, wire rope net, energy absorbers						
Soil Type and Condition		AASHTO M147-65(2004), Type 1, Grade D Crushed Concrete						
<b>TEST VEHICLE</b>								
Type/Designation		Passenger Bus						
Year, Make and Model		2004 MCI D4500						
Curb (lb)		37,120						
Inertial Weight (lb)		50,160						
<b>IMPACT CONDITIONS</b>								
Impact Speed (mi/h)		51.8						
Impact Angle (deg)		2.8						
Impact Location		Centerline of the vehicle aligned 8 inches to the left of the centerline of the first MOPS net, and 17.8 inches to the left of the centerline of the second net						
Kinetic Energy (kip-ft)		4499.3

<b>EXIT CONDITIONS</b>								
Exit Speed (mi/h)		N/A						
Stopping Distance		524 ft downstream In line						
<b>TEST ARTICLE DEFLECTIONS</b>								
Dynamic (inches)		N/A						
Permanent (inches)		N/A						
<b>VEHICLE DAMAGE</b>								
VDS		12FC1						
CDC		12FCEN1						
Max. Ext. Deformation (inches)		Not measured						
Max Occupant Compartment Deformation		Not measured						
<b>OCCUPANT RISK VALUES</b>								
Long. OIV (ft/s)	2.7	Long. Ridedown (g)	2.1	Max 50-ms Long. (g)	-1.5	Max Roll (deg)	5.5	
Lat. OIV (ft/s)	3.2	Lat. Ridedown (g)	1.9	Max 50-ms Lat. (g)	-0.9	Max Pitch (deg)	7.1	
THIV (m/s)	1.3	ASI	0.3	Max 50-ms Vert. (g)	-2.8	Max Yaw (deg)	1.7

Figure 10.7 summarizes the results of Test 440211-01-3. The second net's wire rope cables failed during the impact. Upon inspection of the damaged test article, it was determined that swage fittings on each of the wire ropes were not installed correctly in the factory. This caused the wire ropes to slip out from the swage fittings and

consequently allowed the test vehicle to penetrate through the net. Therefore, the research team performed the test again with properly manufactured nets, and this effort is documented in the next chapter.

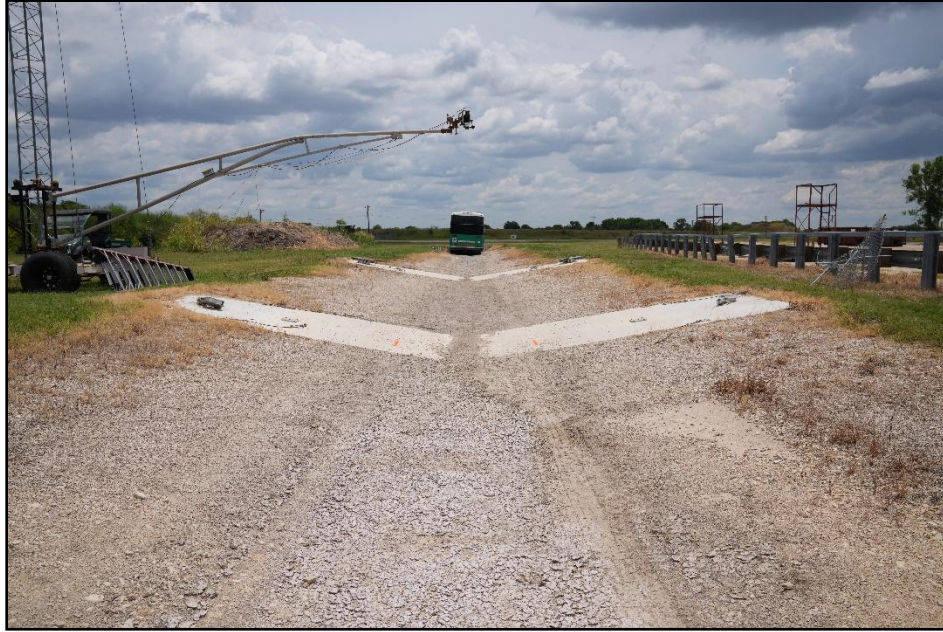
**Figure 11.1. Crash Site after Test 440211-01-5.**

The strap from the left cannister on the first net ruptured. The first net landed to the right of impact. The strap from the left cannister on the second net spooled out 71.5 ft. The strap from the right cannister on the second net ruptured and wrapped around the front of the bus. Table 11.6 describes the deflection and working width of the MOPS. Figure 11.1 and Figure 11.2 show the damage to the MOPS.

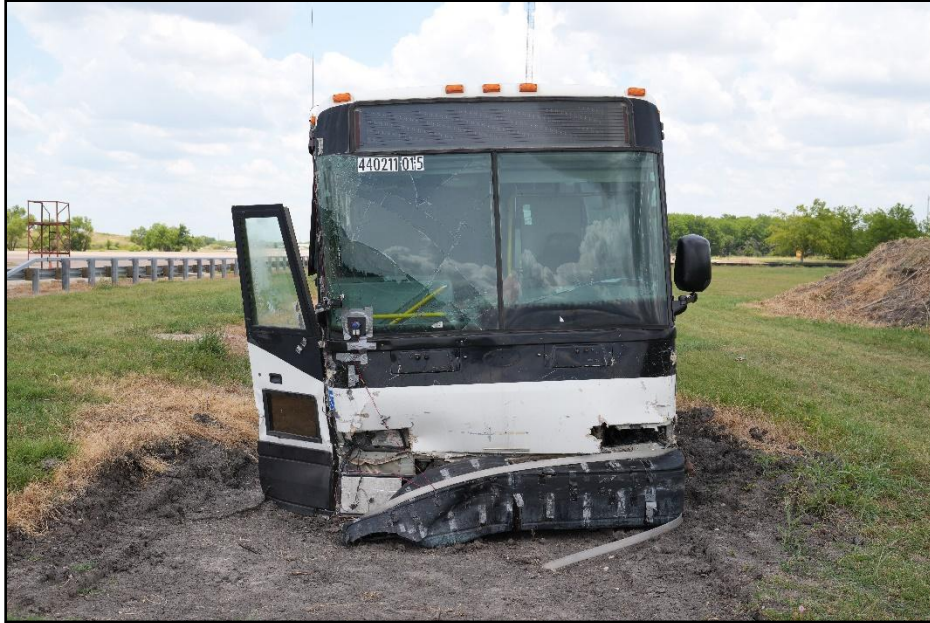
**Figure 11.3. Front of Test Vehicle after Test 440211-01-5.**

<b>Side Windows</b>	The side windows remained intact
<b>Maximum Exterior Deformation</b>	Maximum exterior deformation was not measured due to installation failure
<b>VDS</b>	12FC2
<b>CDC</b>	12FCEN1
<b>Fuel Tank Damage</b>	None
<b>Description of Damage to Vehicle:</b>	The front bumper, windshield, right-side mirror, and side panels were damaged. The windshield had some cracking and minor deformation. Due to the MOPS failing to contain and arrest the test vehicle, no measurements were taken on the deformation of the windshield.

Figure 11.3 and Figure 11.4 show the damage sustained by the vehicle. Figure 11.5 and Figure 11.6 show the interior of the test vehicle. Table 11.7 provides details on the exterior vehicle damage. Due to the failure of the installation, occupant compartment deformation was not measured.

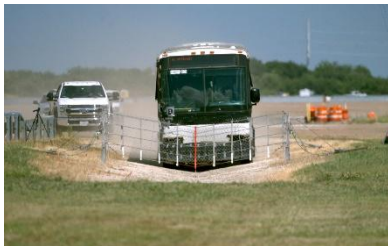
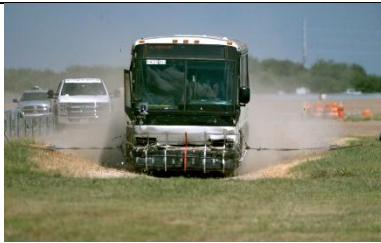
**Figure 11.7. Summary of Results for Research and Development Test on MOPS.**

Test Agency		Texas A&M Transportation Institute (TTI)					
	Test Standard/Test No.		Research and Development Test					
	TTI Project No.		440211-01-5					
	Test Date		2022-06-30					
<b>TEST ARTICLE</b>								
		Type	Non-Redirective Crash Cushions					
		Name	MOPS					
		Length	50 ft					
		Key Materials	Wire mesh nets, wire rope net, energy absorbers					
		Soil Type and Condition	AASHTO M147-65(2004), Type 1, Grade D Crushed Concrete

<b>TEST VEHICLE</b>							
	Type/Designation		Passenger Bus					
	Year, Make and Model		2004 MCI D4500					
	Curb (lb)		37,120					
		Inertial Weight (lb)	50,340					
<b>IMPACT CONDITIONS</b>								
		Impact Speed (mi/h)	50.5					
		Impact Angle (deg)	0.7					
		Impact Location	Centerline of the vehicle aligned 10.6 inches to the left of the centerline of the first MOPS net and 1.8 inches to the right of the centerline of the second net					
		Kinetic Energy (kip-ft)	4276.3

<b>EXIT CONDITIONS</b>								
		Exit Speed (mi/h)	N/A					
		Stopping Distance	201 ft downstream 3 ft to the left side					
<b>TEST ARTICLE DEFLECTIONS</b>								
		Dynamic (inches)	N/A					
		Permanent (inches)	N/A					
<b>VEHICLE DAMAGE</b>								
		VDS	12FC2					
		CDC	12FCEN1					
		Max. Ext. Deformation (inches)	Not measured					
		Max Occupant Compartment Deformation	Not measured

<b>OCCUPANT RISK VALUES</b>							
	Long. OIV (ft/s)	1.4	Long. Ridedown (g)	1.1	Max 50-ms Long. (g)	-1.0	Max Roll (deg)	2.9
	Lat. OIV (ft/s)	4.1	Lat. Ridedown (g)	1.1	Max 50-ms Lat. (g)	-0.5	Max Pitch (deg)	7.5
	THIV (m/s)	1.3	ASI	0.16	Max 50-ms Vert. (g)	-1.6	Max Yaw (deg)	2.0

Figure 11.7 summarizes the results of Test 440211-01-5. Upon investigation of the damaged test article, it was determined the bearings in the energy absorber failed during the impact. These bearings were reused throughout the previous tests without repair or replacement. The lack of repair or replacement following an impact event was believed to be the cause of the bearing failure and subsequent strap rupture. Because of the failing bearings, the test was repeated with new bearings installed within the energy absorbers. This identification of component failure and the need to replace the bearings after impact events provided additional information for future in-field use and maintenance planning.

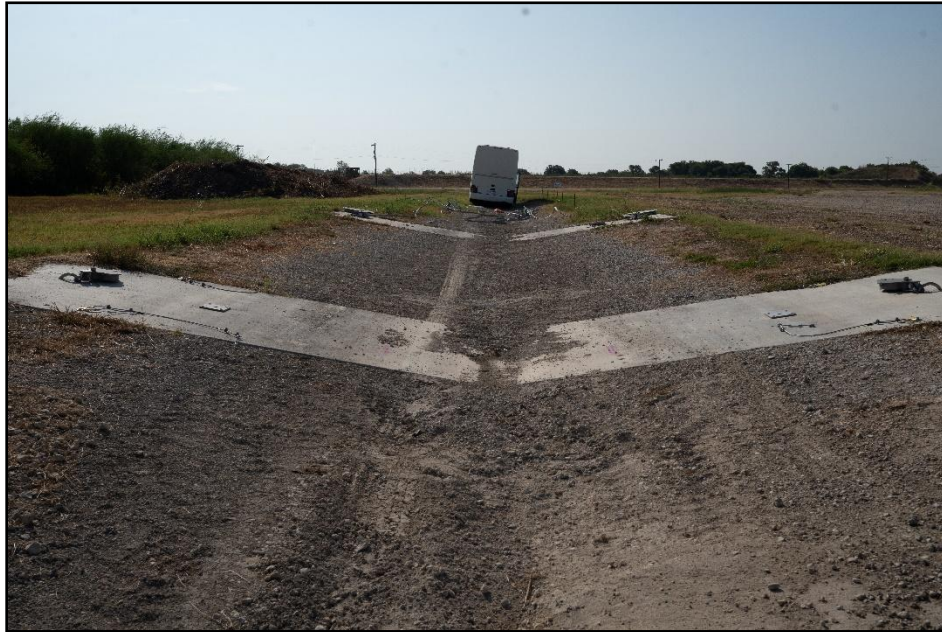
**Figure 12.1. Crash Site after Test 440213-01-6.**

Both straps on the first net paid out before releasing from their cannisters. The cable on the left side of the second net failed after spooling out 50 ft. Table 12.6 describes the deflection and working width of the MOPS. Figure 12.1 and Figure 12.2 show the damage to the MOPS.

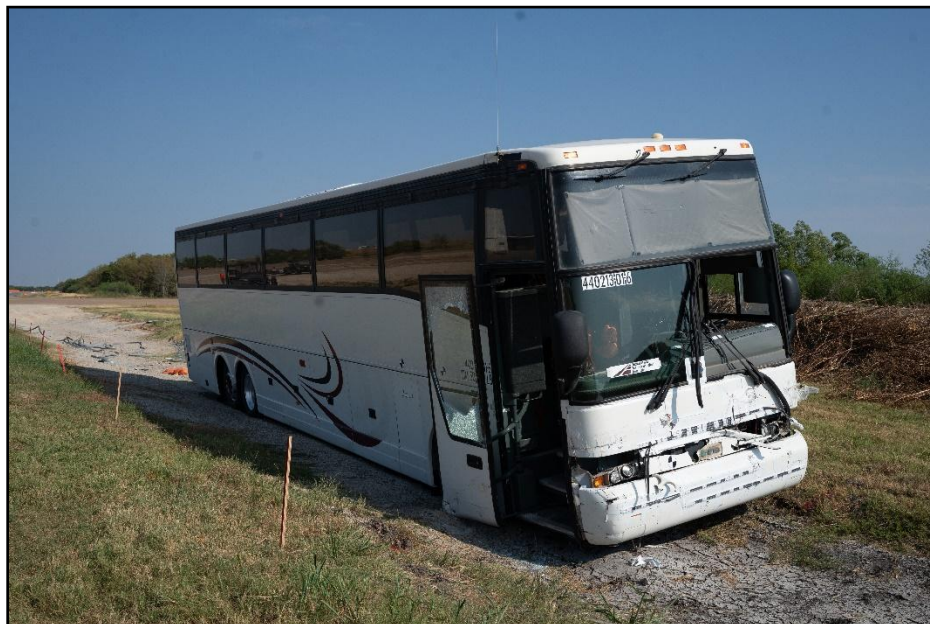
**Figure 12.3. Front of Test Vehicle after Test 440213-01-6.**

Figure 12.3 and Figure 12.4 show the damage sustained by the vehicle. Figure 12.5 and Figure 12.6 show the interior of the test vehicle. Table 12.7 provides details on the exterior vehicle damage. Due to the failure of the installation, occupant compartment deformation was not measured.

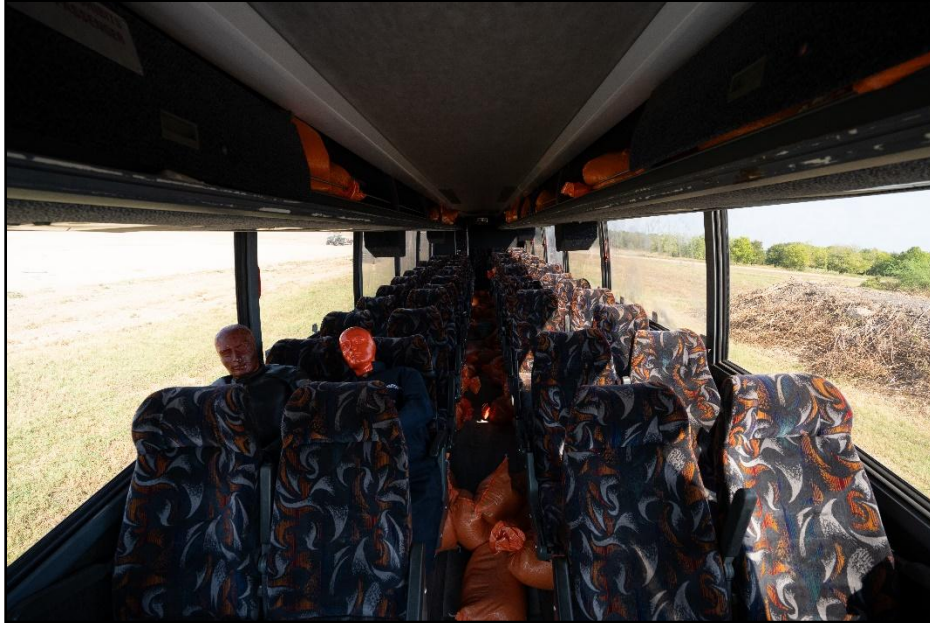
**Figure 12.4. Oblique of Test Vehicle after Test 440213-01-6.**

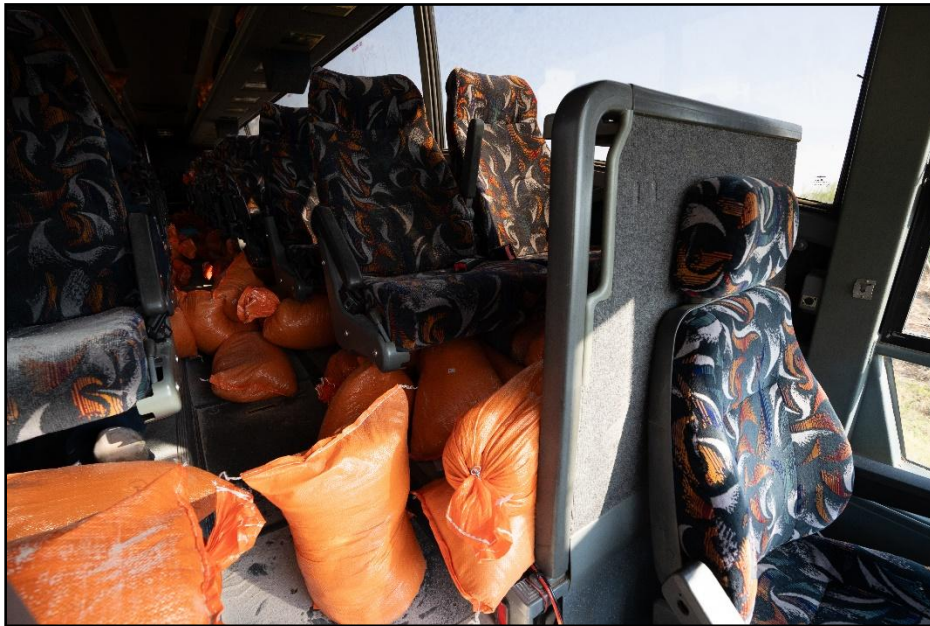
**Figure 12.5. Rear Interior of Test Vehicle after Test 440213-01-6.**

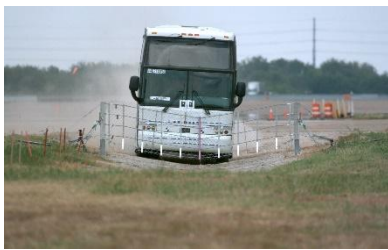
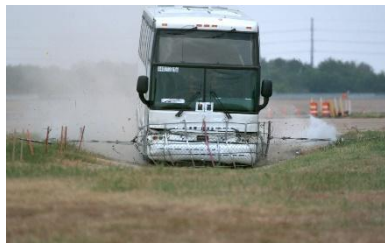
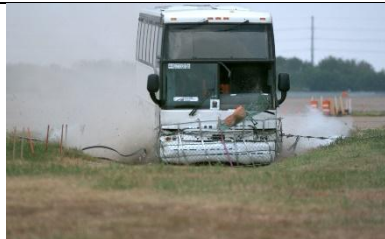
Type			Non-Redirective Crash Cushions			
	Name			MOPS			
	Length			50 ft			
	Key Materials			Wire mesh nets, wire rope net, energy absorbers

0.100 s	Impact Angle (deg)			0.7			
	Impact Location			Centerline of the vehicle aligned 16.6 inches to the right of the centerline of the first MOPS net and 7.3 inches to the right of the centerline of the second net			
	Kinetic Energy (kip-ft)			4190.4			
	EXIT CONDITIONS

**Figure 12.7. Summary of Results for Research and Development Test on MOPS.**

Figure 12.7 summarizes the results of Test 440213-01-6. After investigation of the test results, the research team believed unequal loading between the wire ropes of the second net caused the wire ropes to rupture. Once the wire ropes began to rupture, a zipper-like behavior occurred, with other wire ropes rupturing soon after. A modification in the wire rope design is recommended for evaluation in future research.

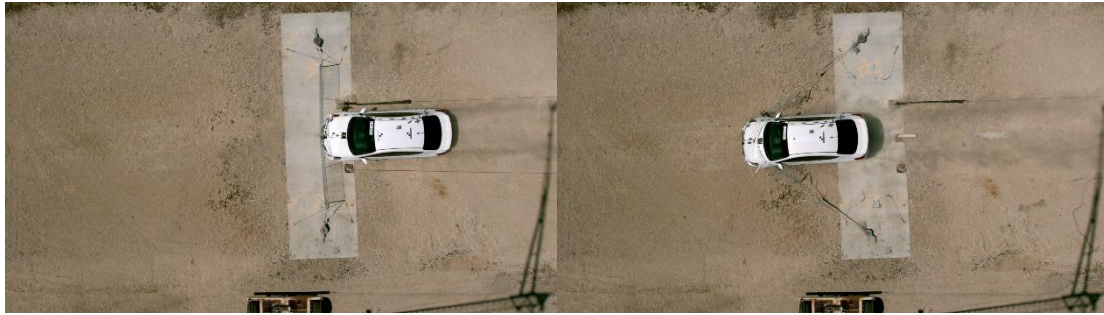
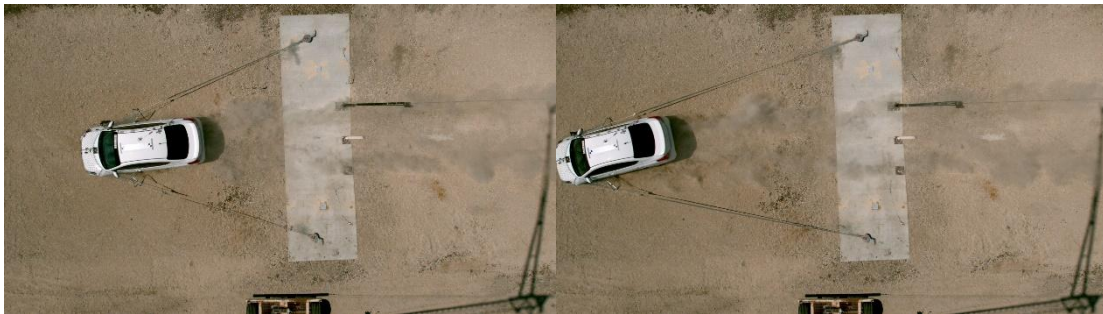
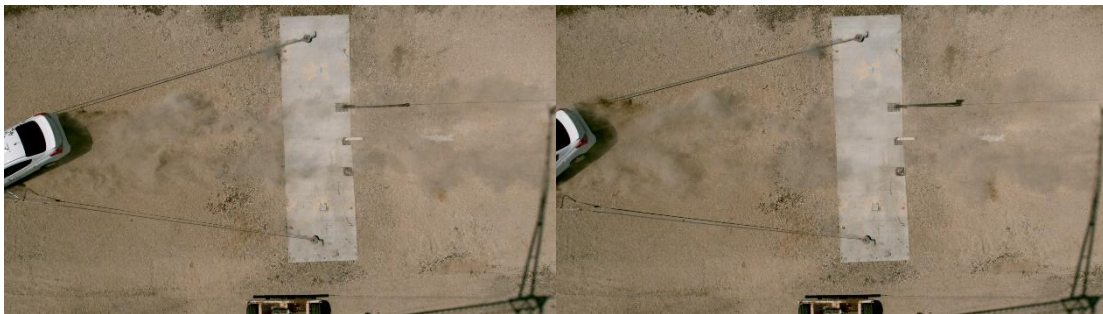
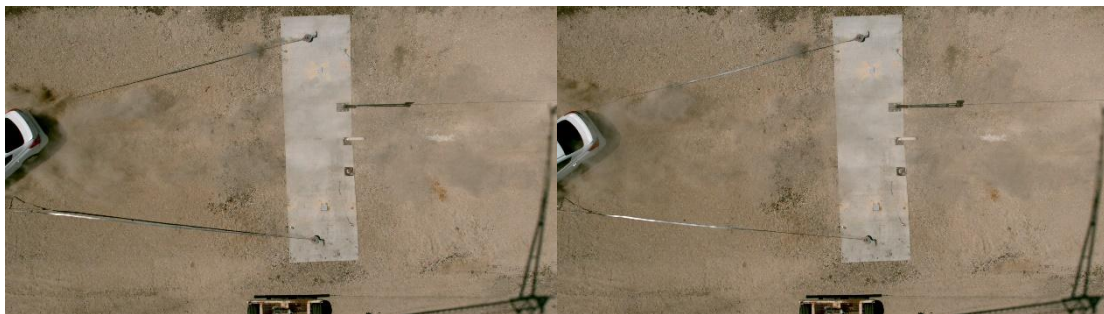
**Figure B.4. Sequential Photographs for Test 440210-01-1 (Overhead Views).**

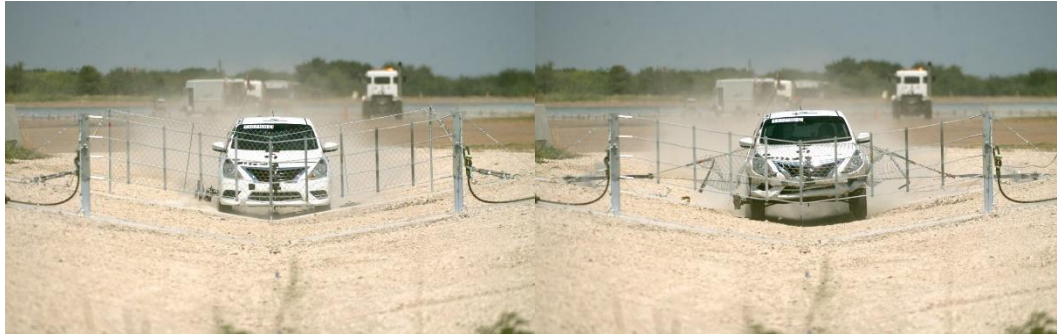
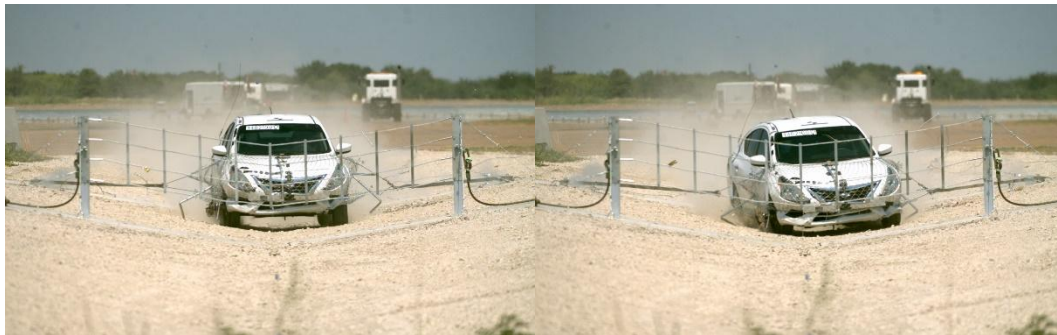
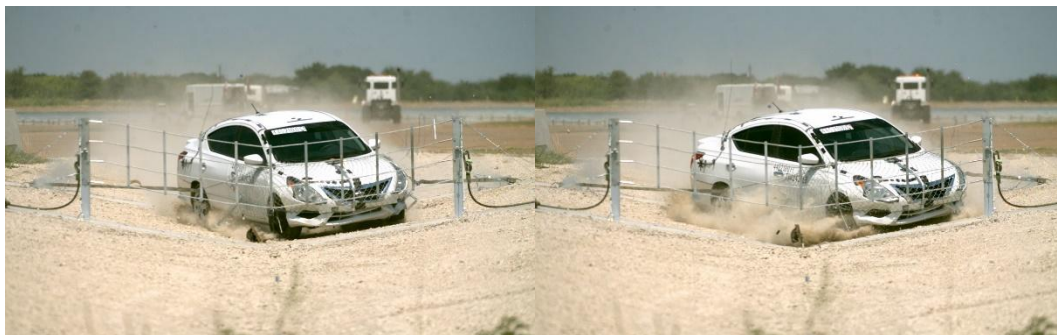
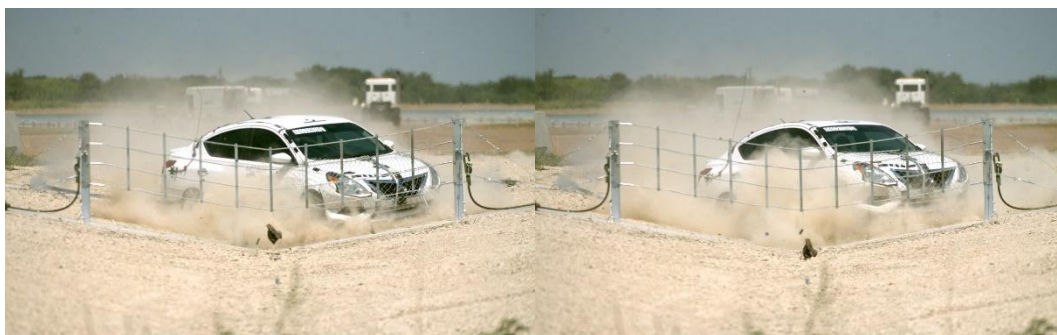
**Figure B.5. Sequential Photographs for Test 440210-01-1 (Frontal Views).**

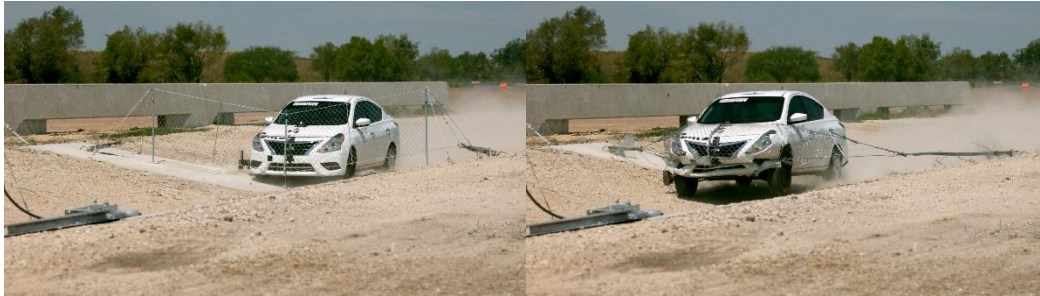
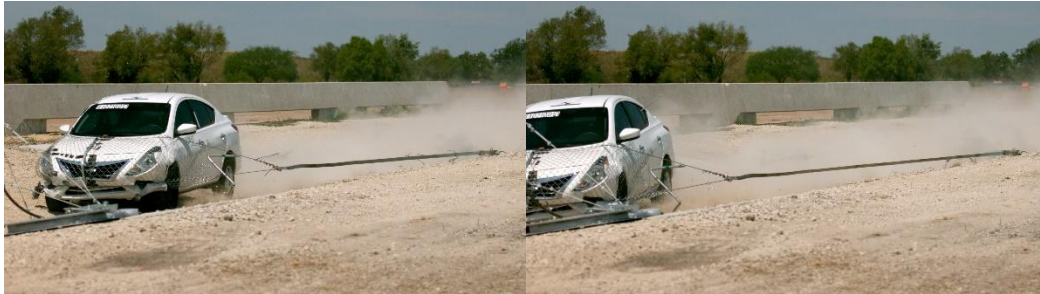
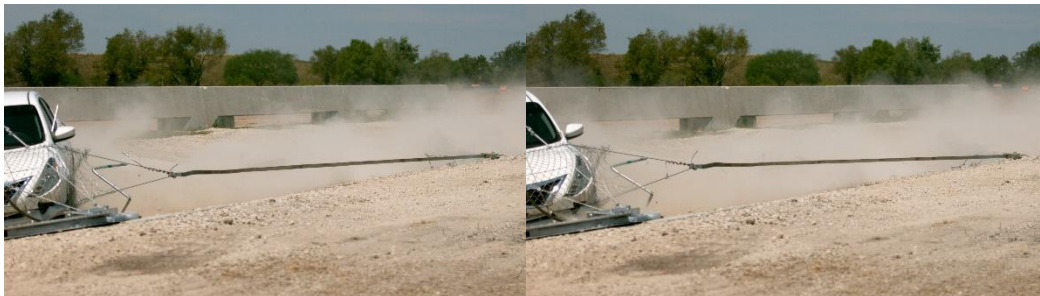
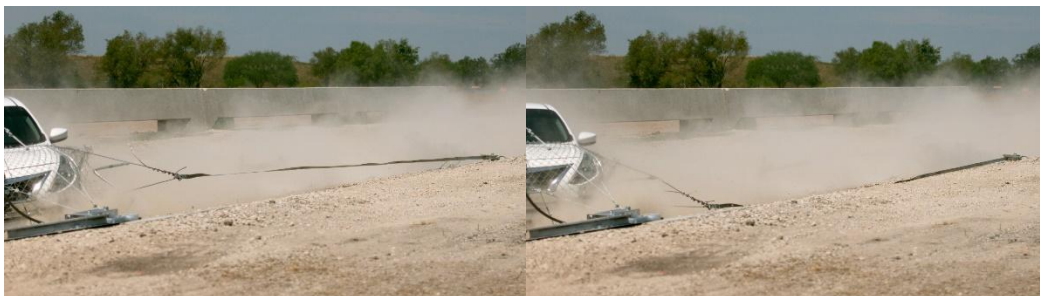
**Figure B.6. Sequential Photographs for Test 440210-01-1 (Oblique Views).**

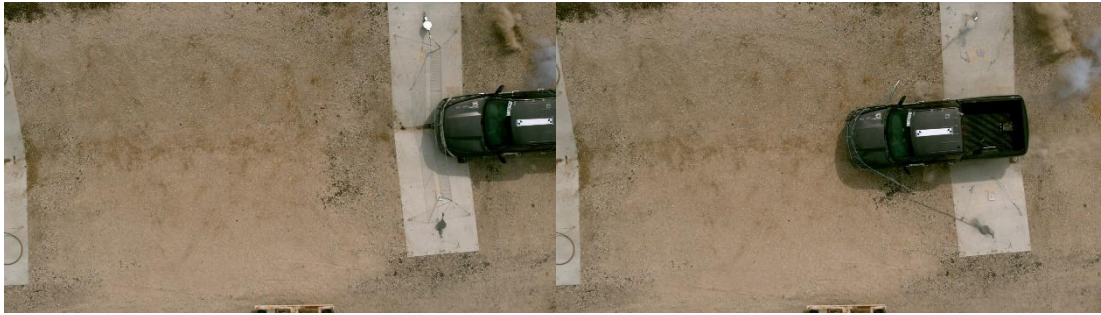
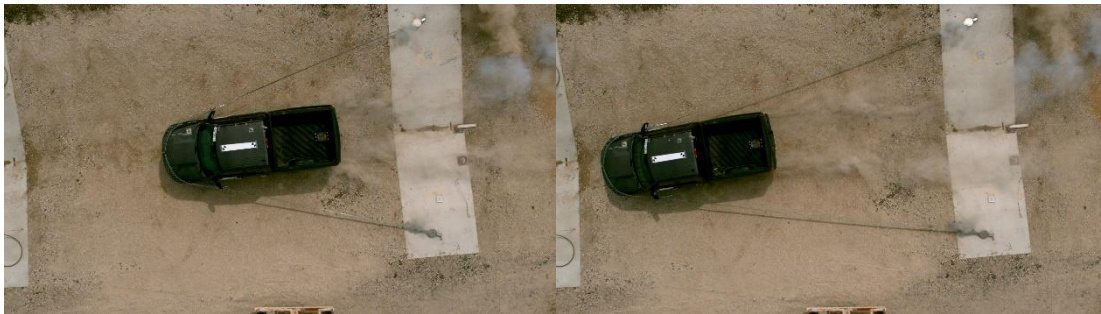
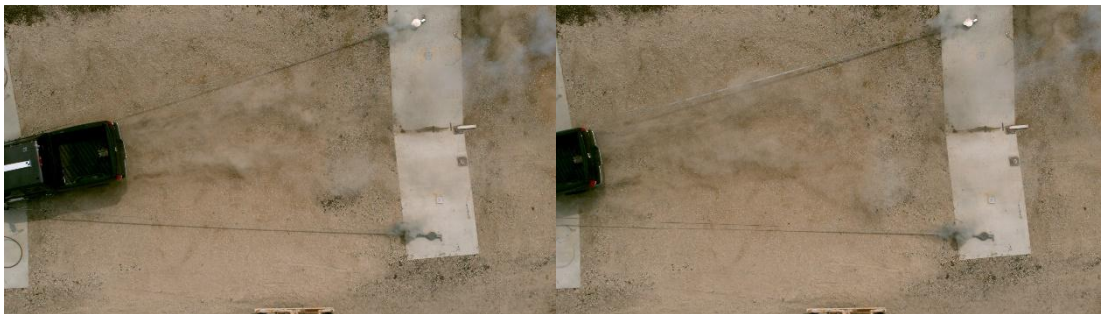
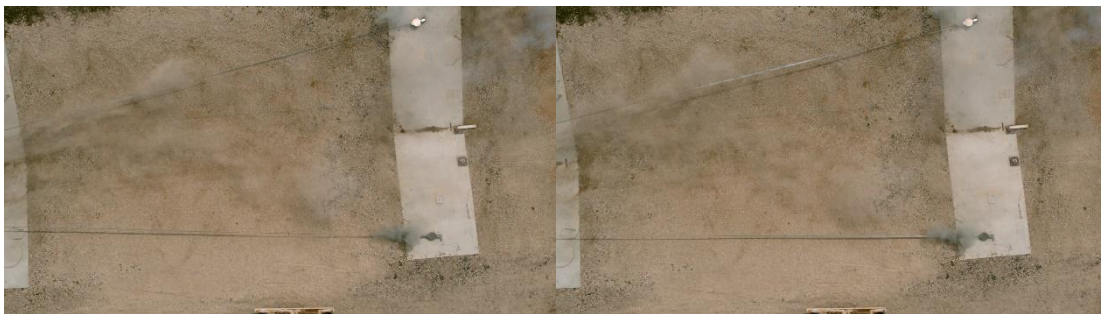
**Figure C.4. Sequential Photographs for Test 440210-01-2 (Overhead Views).**

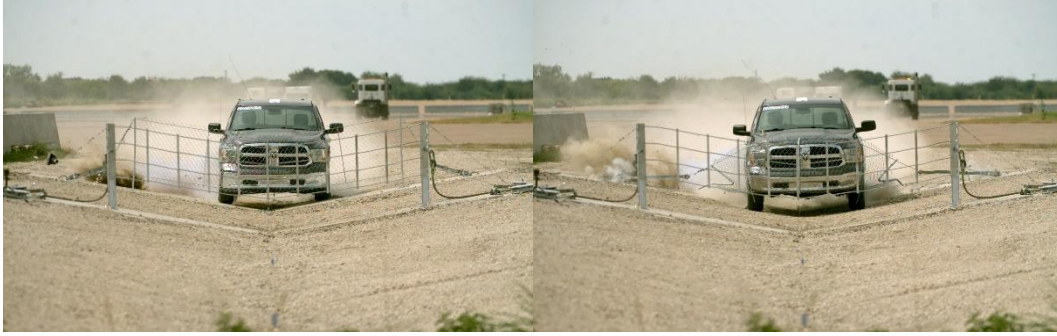
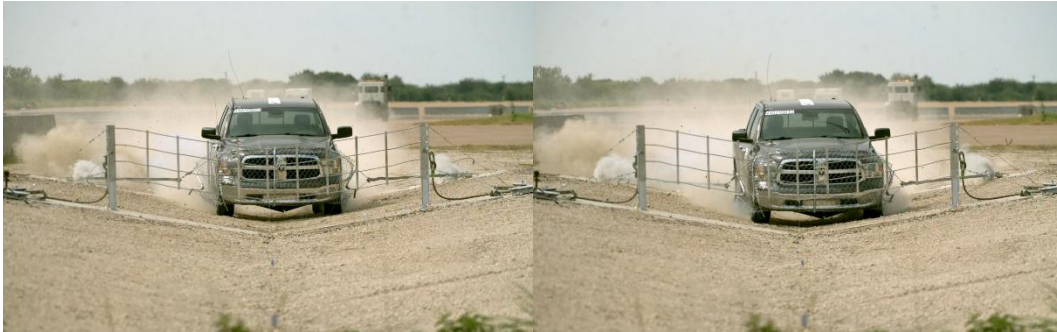
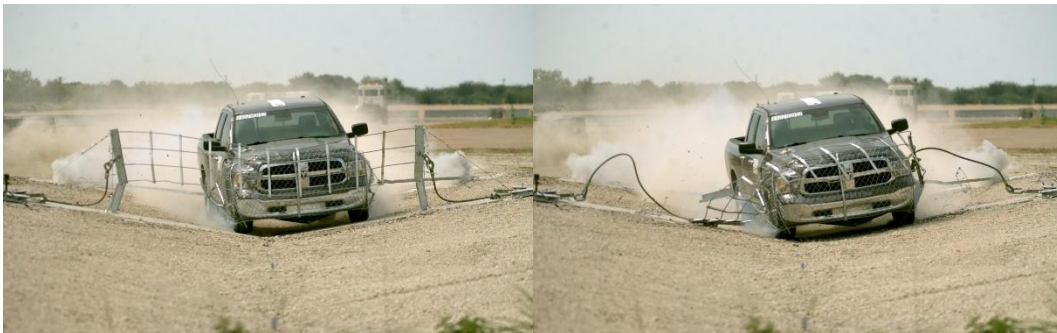
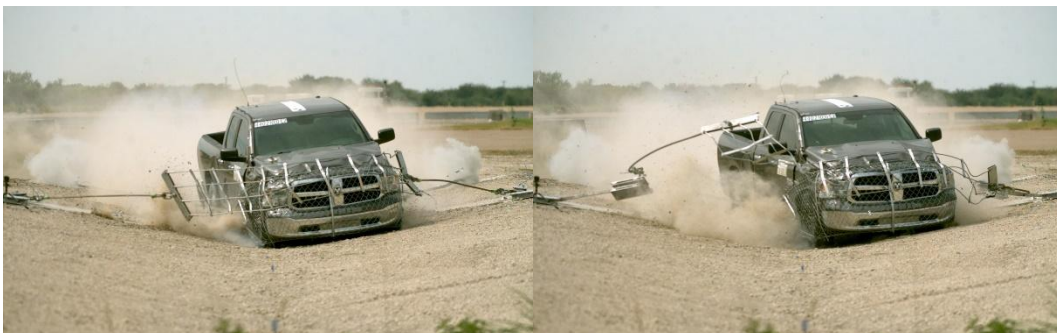
**Figure C.5. Sequential Photographs for Test 440210-01-2 (Frontal Views).**

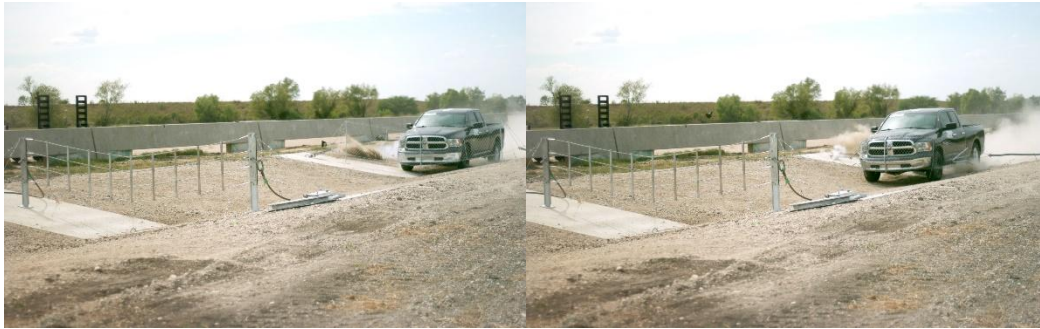
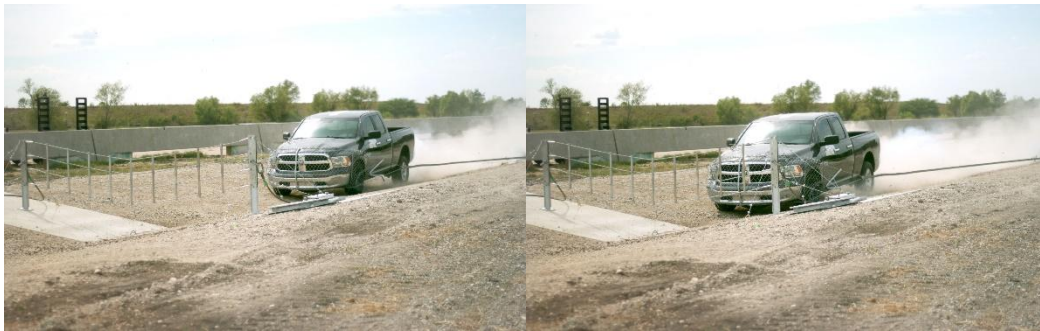
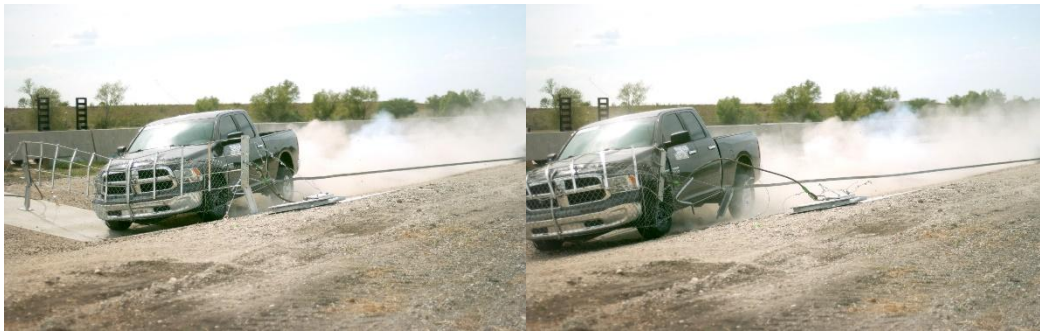
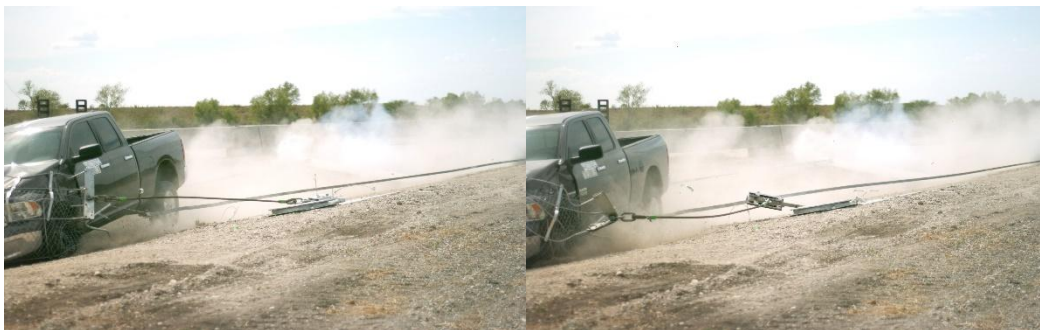
**Figure C.6. Sequential Photographs for Test 440210-01-2 (Oblique Views).**

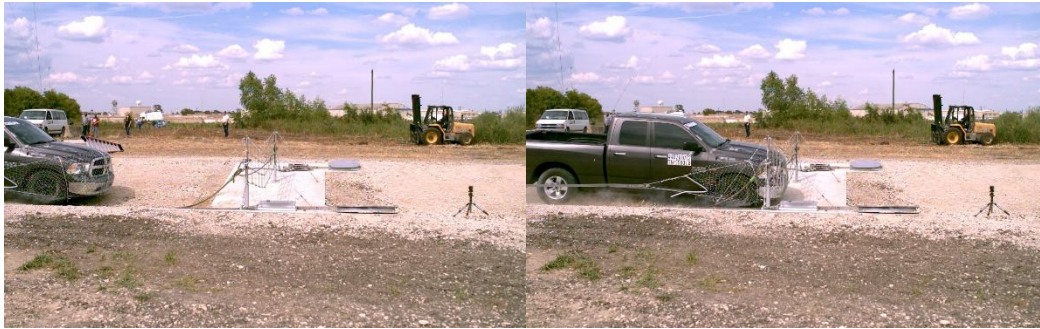
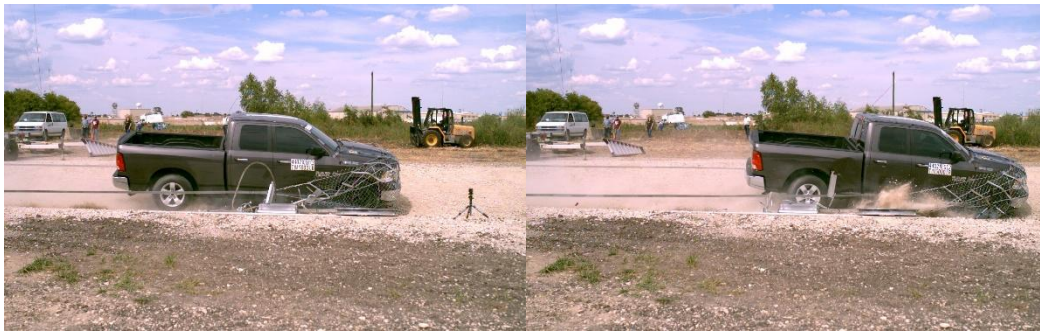
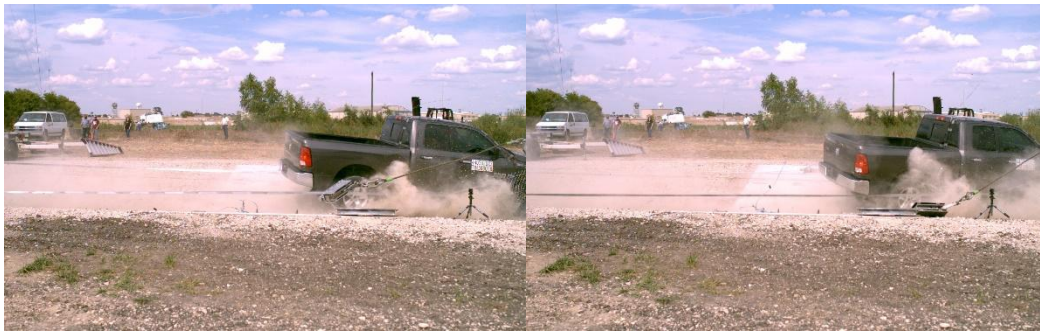
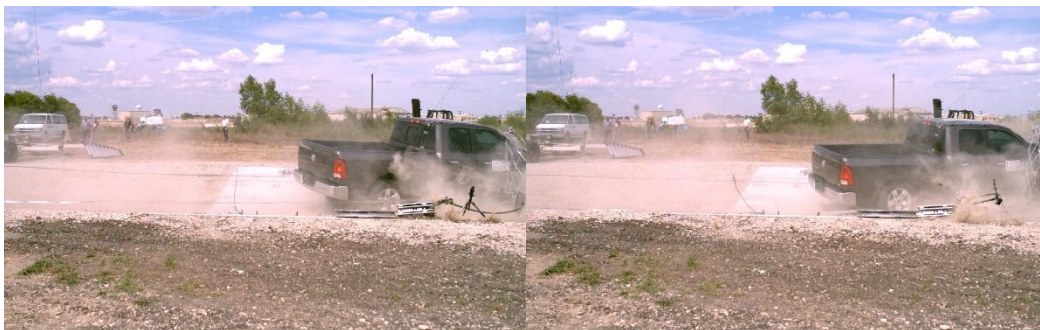
**Figure C.7. Sequential Photographs for Test 440210-01-2 (Right Angle Views).**
