**Test Report No. 0-7021-01-R1**

**DEVELOPING AN ENHANCED PROTECTION OF MEDIAN OPENINGS  
BETWEEN PARALLEL BRIDGE STRUCTURES**

Sponsored by the  
**Texas Department of Transportation  
and the  
Federal Highway Administration**

**TEXAS A&M TRANSPORTATION INSTITUTE PROVING GROUND**

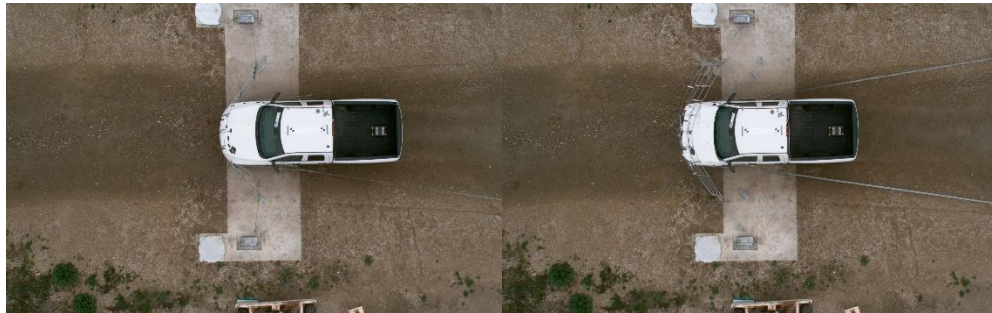
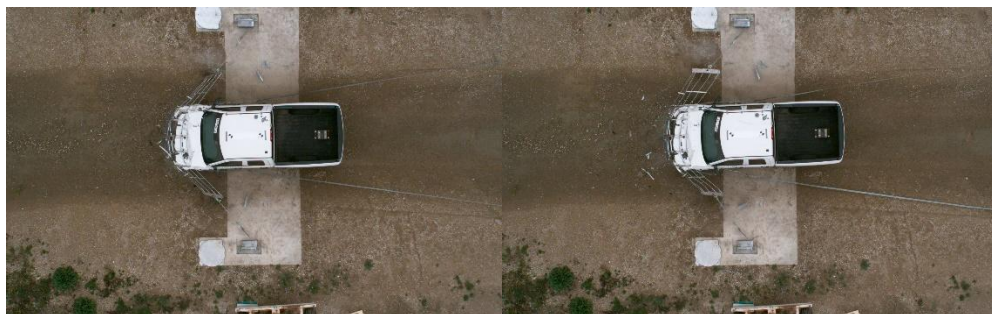
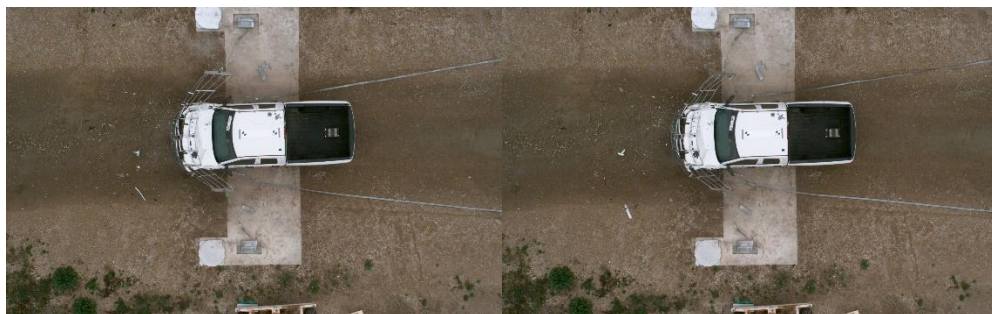
**Figure D.4. Sequential Photographs for Test 440210-01-4 (Overhead Views).**

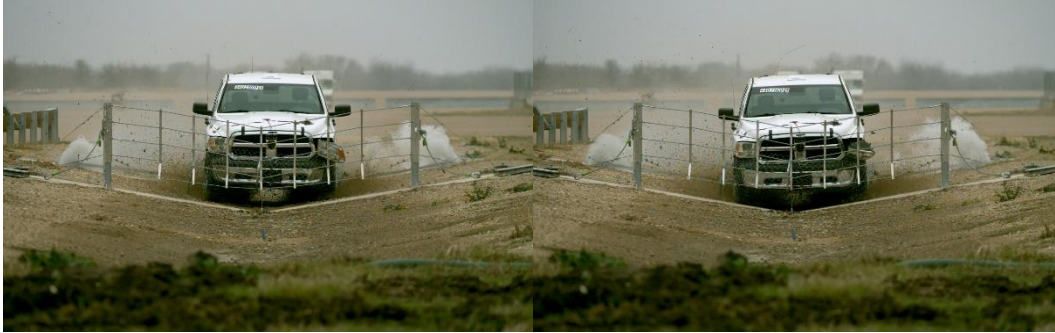
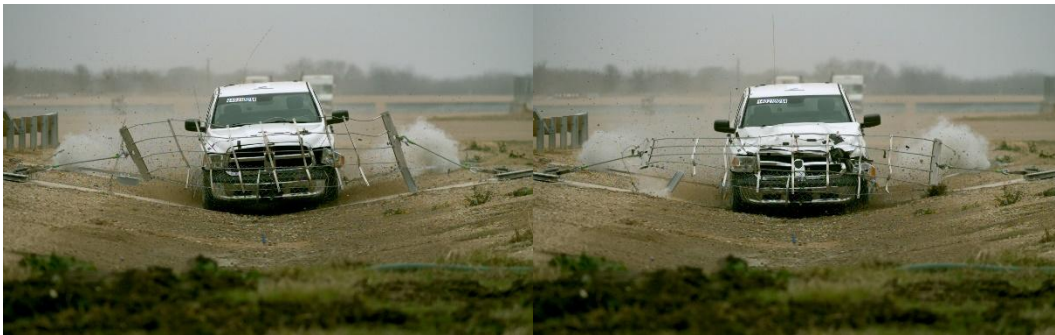
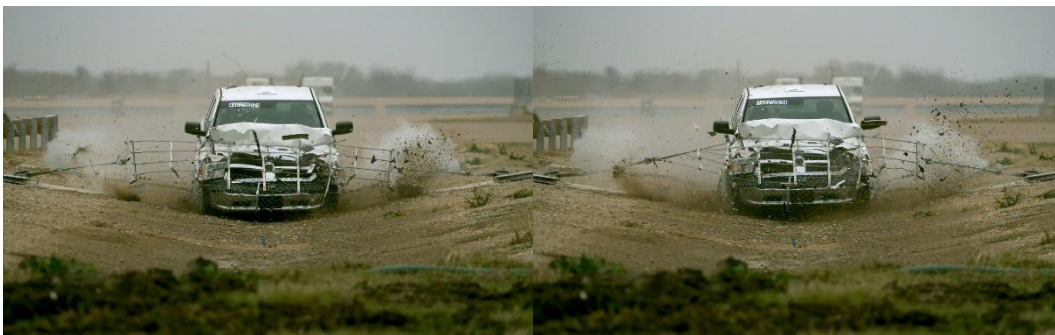
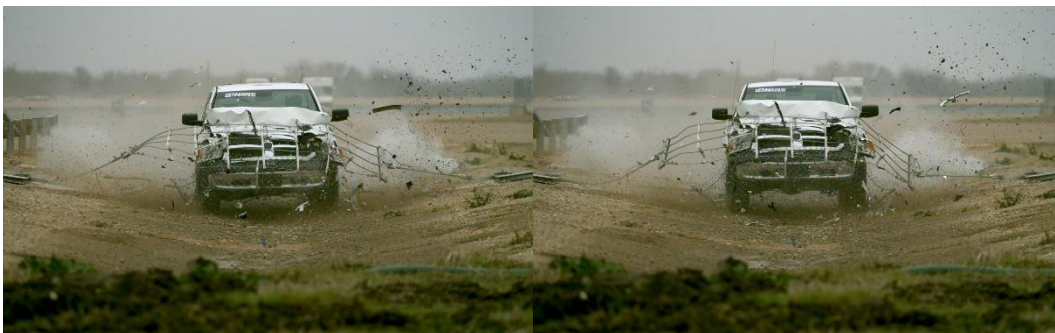
**Figure D.5. Sequential Photographs for Test 440210-01-4 (Frontal Views).**

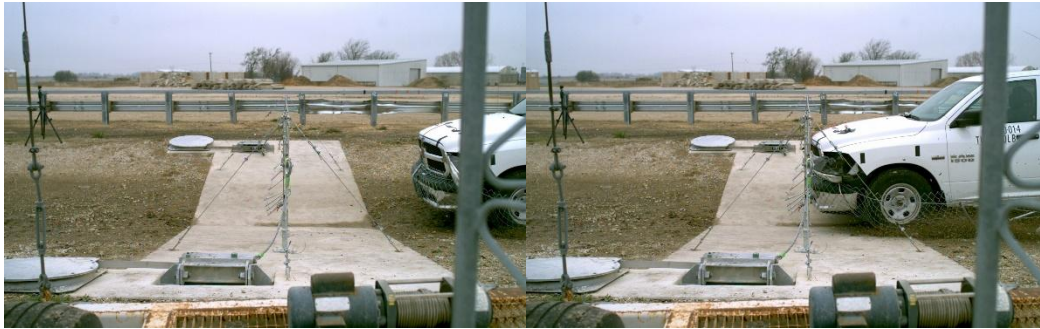
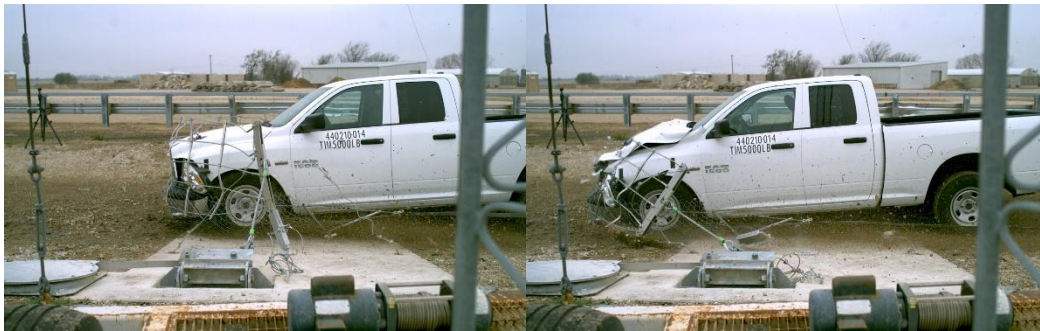
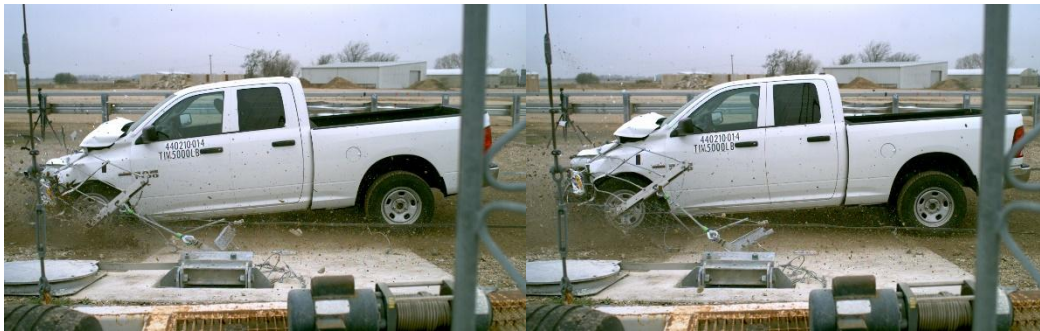
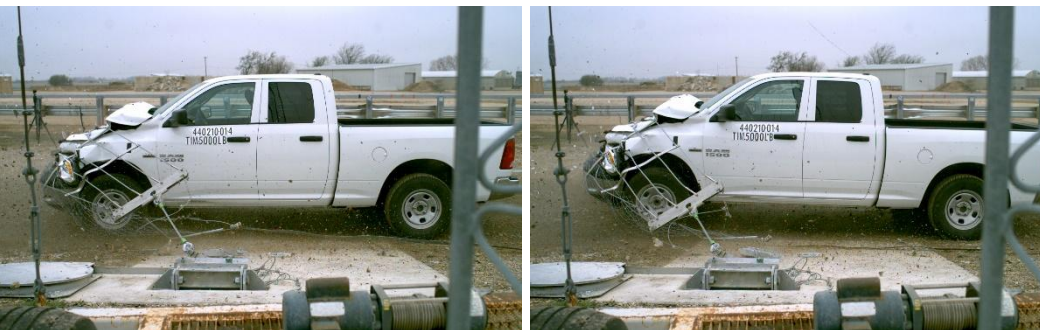
**Figure D.6. Sequential Photographs for Test 440210-01-4 (Right Angle Views).**

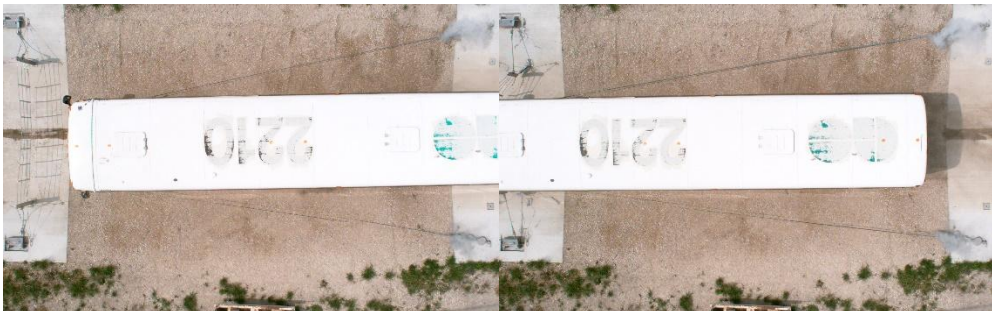
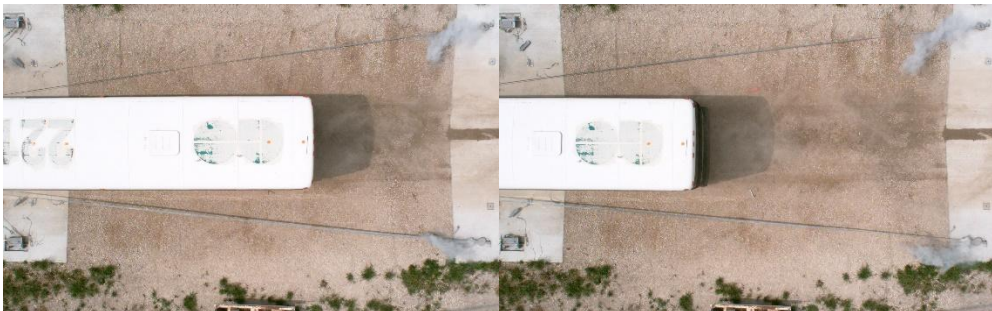
**Figure E.2. Sequential Photographs for Test 440211-01-3 (Overhead Views).**

(c) 0.300 s

(d) 0.450 s

(e) 0.600 s

(f) 0.750 s

(g) 0.900 s

(h) 1.050 s

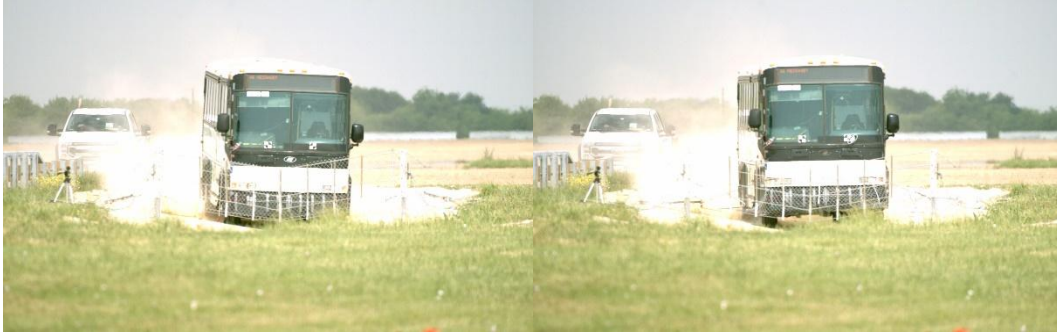
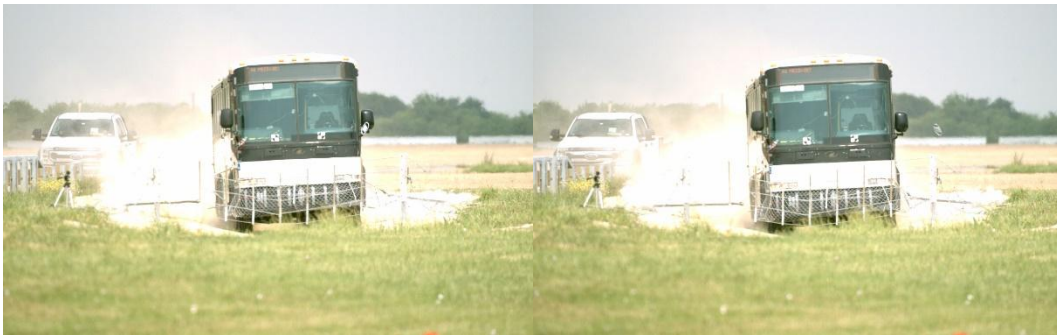
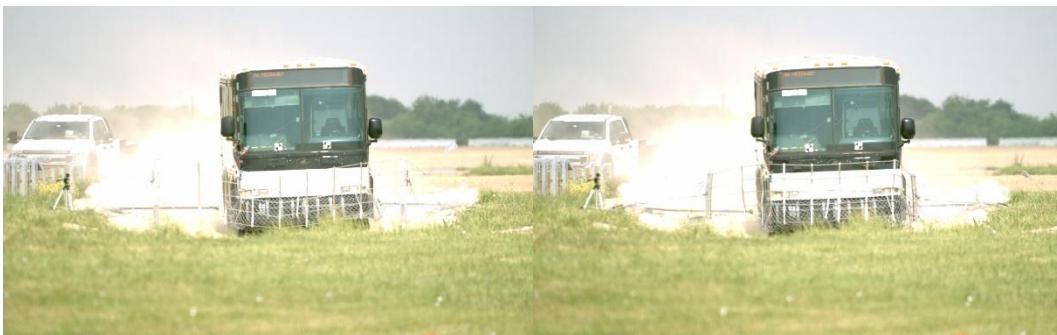
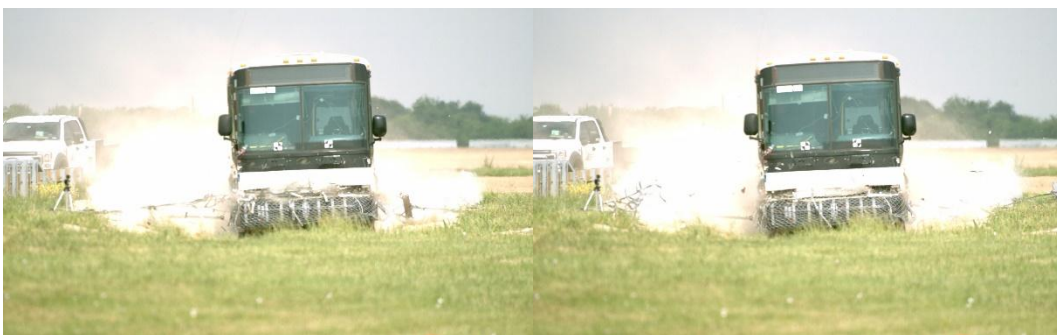
**Figure E.3. Sequential Photographs for Test 440211-01-3 (Frontal Views).**

(a) 0.000 s

(b) 0.150 s

(c) 0.300 s

(d) 0.450 s

(e) 0.600 s

(f) 0.750 s

(g) 0.900 s

(h) 1.050 s

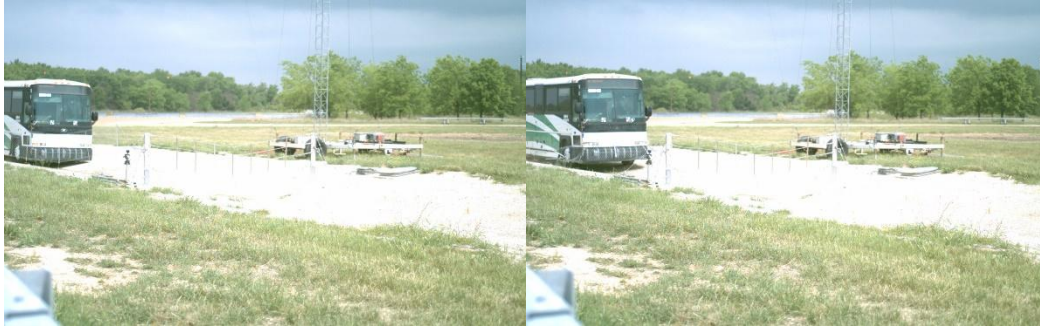
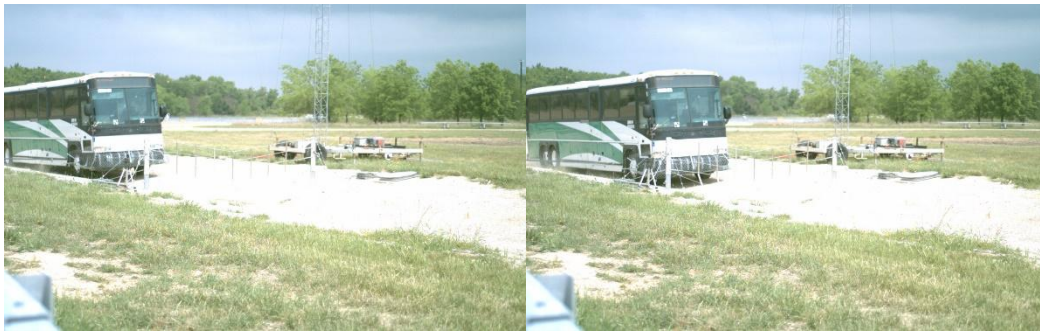
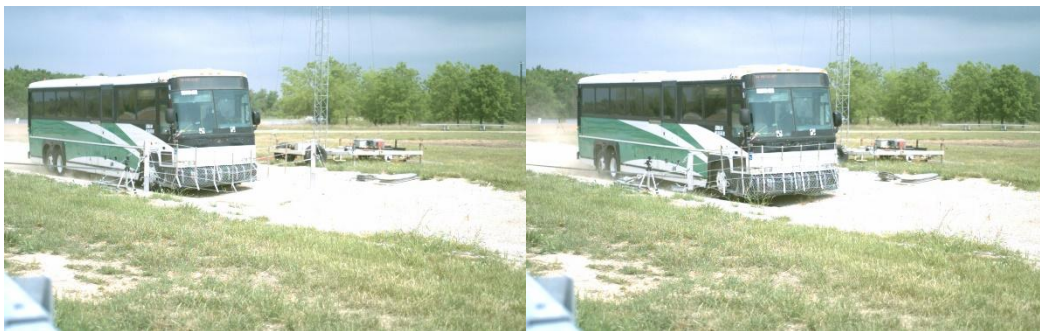
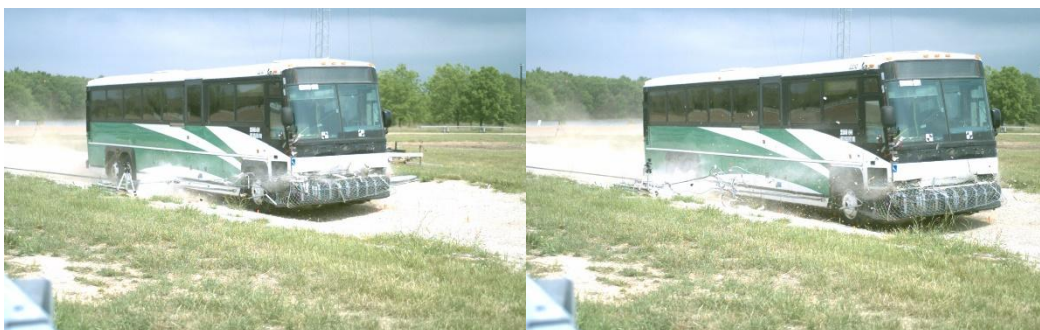
**Figure E.4. Sequential Photographs for Test 440211-01-3 (Oblique Views).**

(a) 0.000 s

(b) 0.150 s

(c) 0.300 s

(d) 0.450

(e) 0.600 s

(f) 0.750 s

(g) 0.900 s

(h) 1.050 s

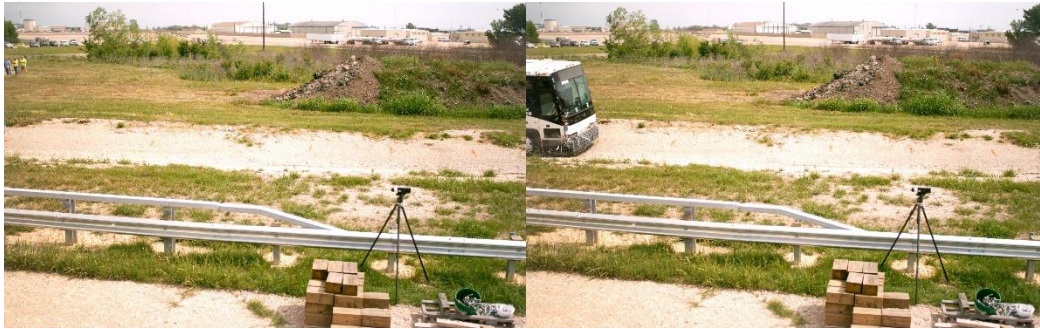
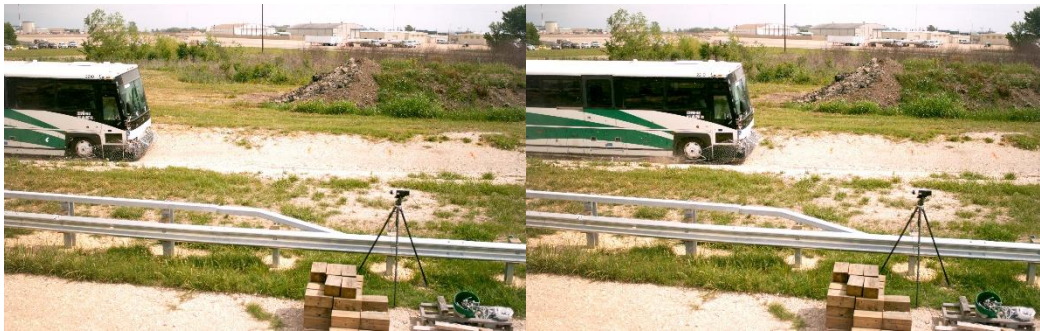
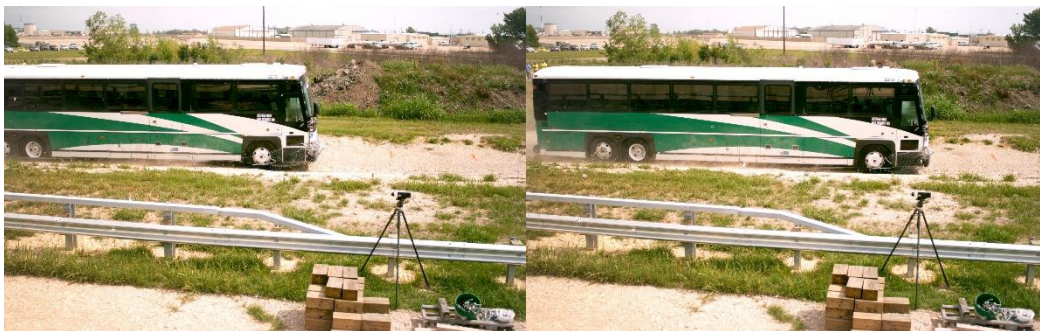
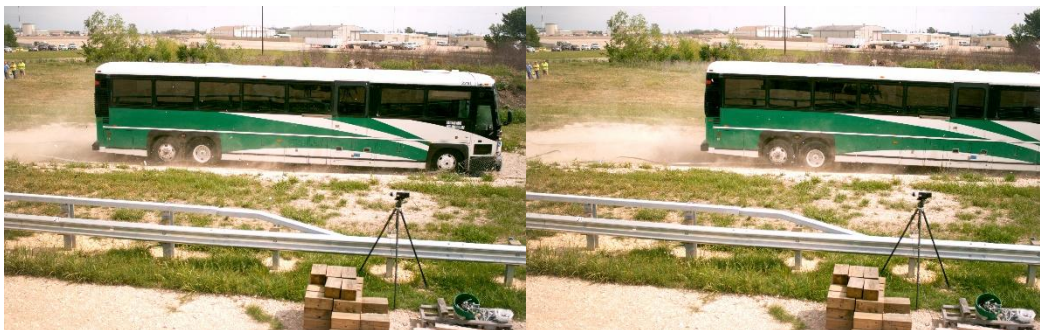
**Figure E.5. Sequential Photographs for Test 440211-01-3 (Right Angle Views).**

(a) 0.000 s

(b) 0.100 s

(c) 0.200 s

(d) 0.300 s

(e) 0.400 s

(f) 0.500 s

(g) 0.600 s

(h) 0.700 s

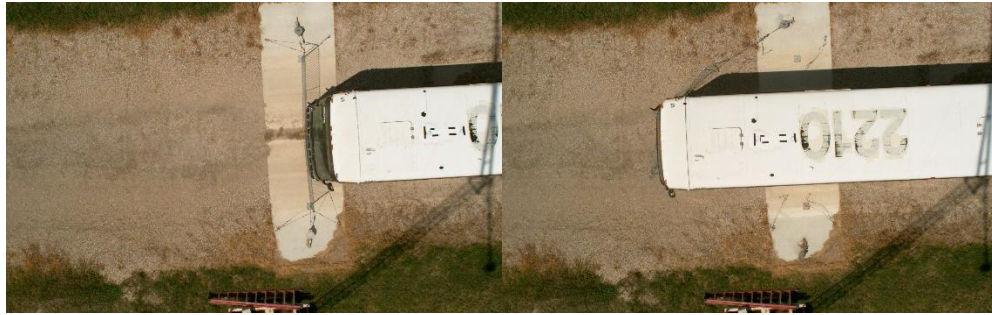
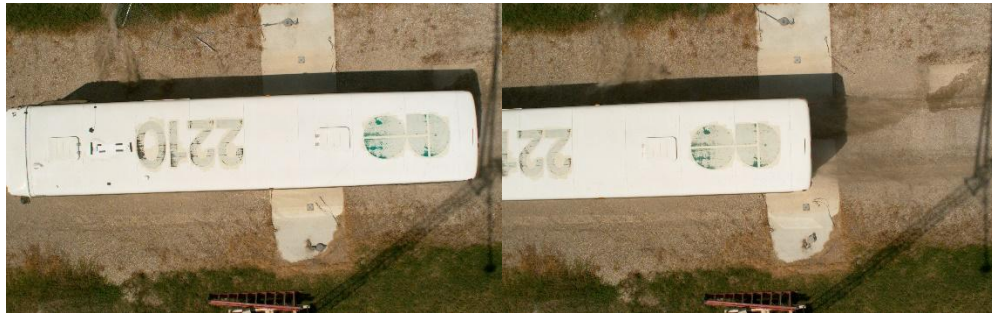
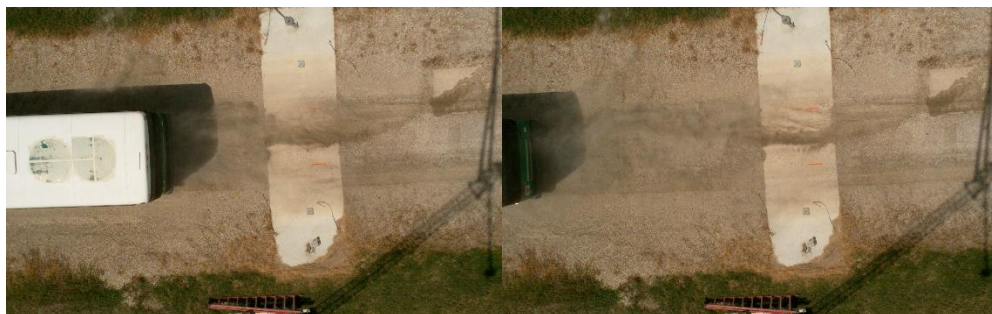
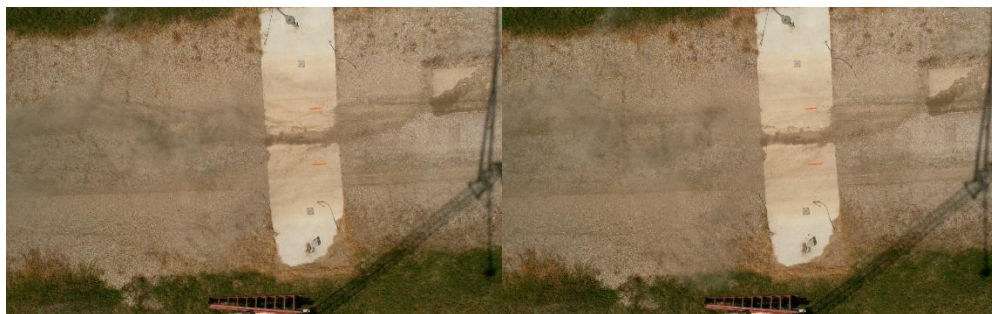
**Figure F.2. Sequential Photographs for Test 440211-01-5 (Overhead Views).**

(a) 0.000 s

(b) 0.200 s

(c) 0.400 s

(d) 0.600 s

(e) 0.800 s

(f) 1.000 s

(g) 1.200 s

(h) 1.400 s

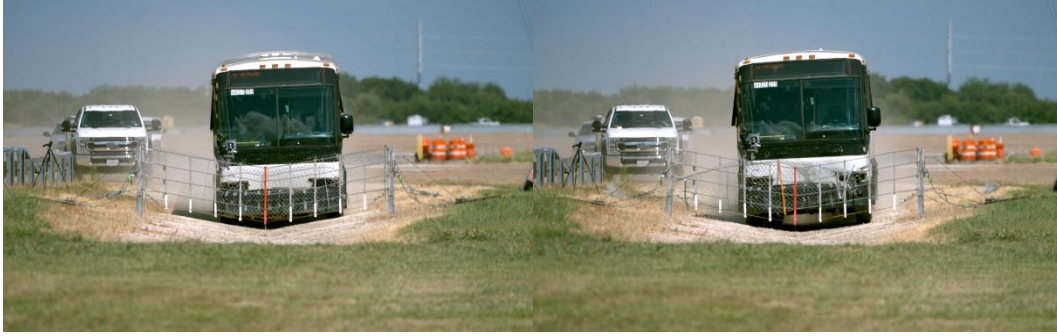
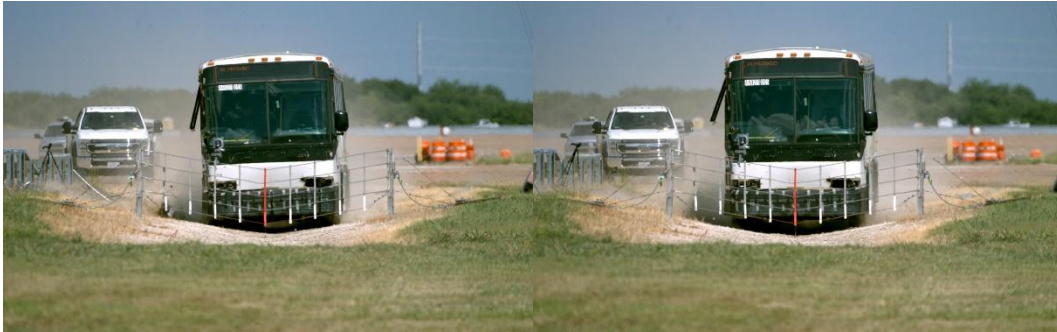
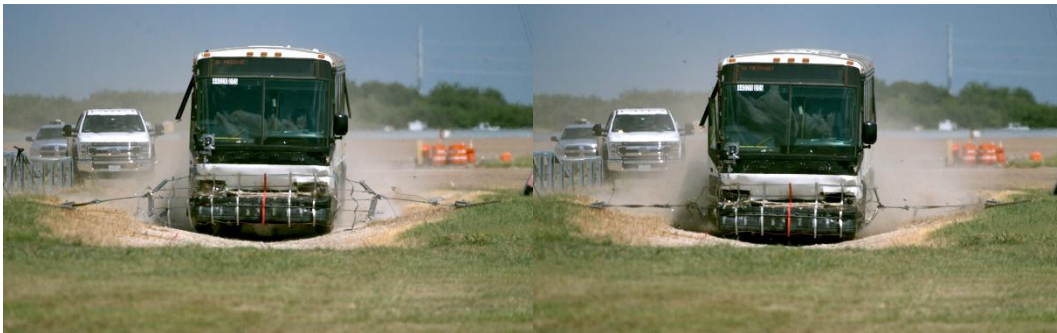
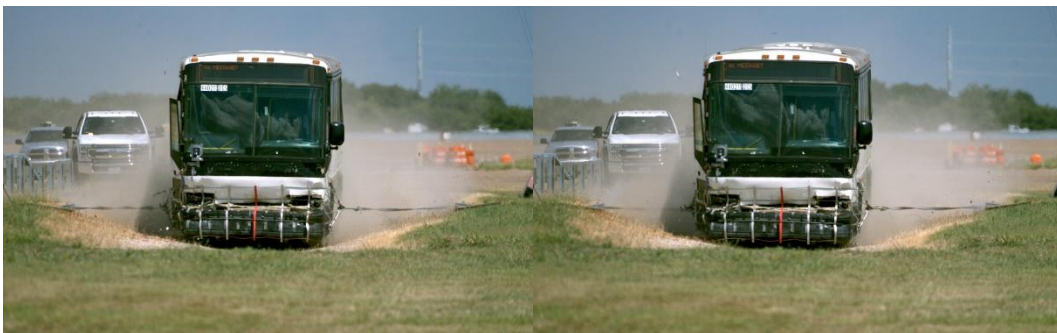
**Figure F.3. Sequential Photographs for Test 440211-01-5 (Frontal Views).**

(a) 0.000 s

(b) 0.200 s

(c) 0.400 s

(d) 0.600 s

(e) 0.800 s

(f) 1.000 s

(g) 1.200 s

(h) 1.400 s

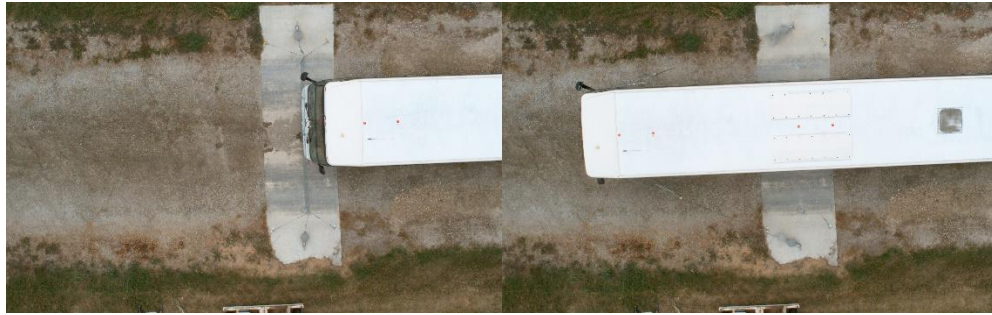
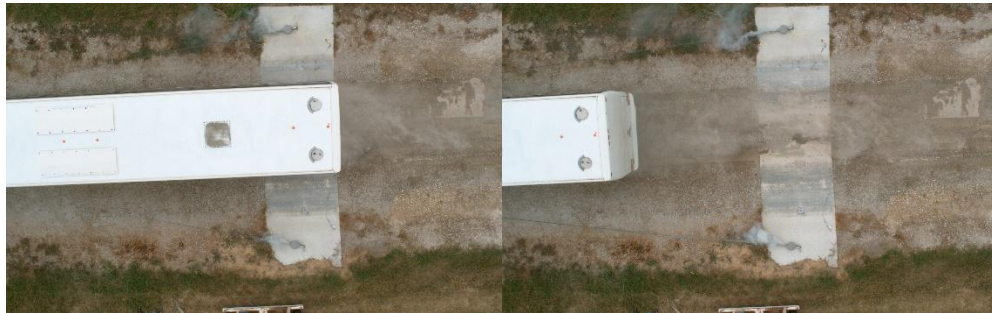
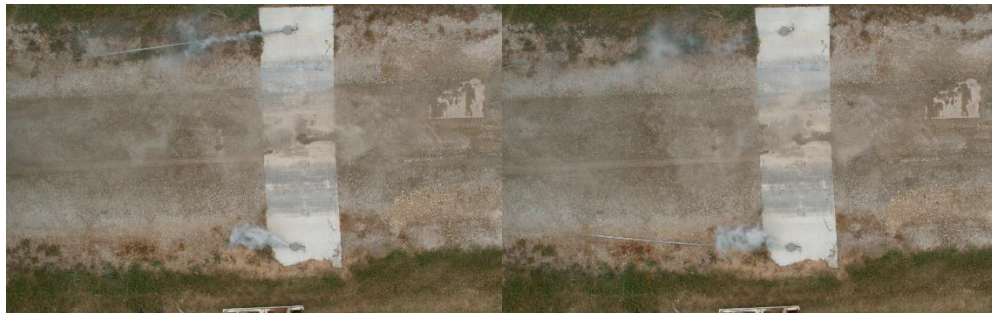
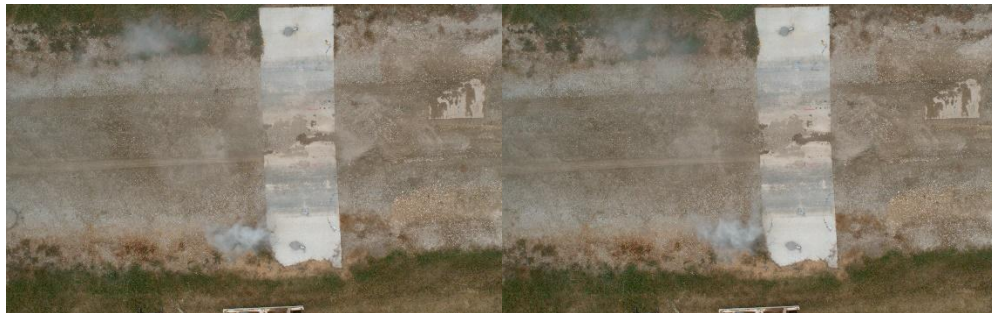
(a) 0.000 s

(b) 0.300 s

(c) 0.600 s

(d) 0.900 s

(e) 1.200 s

(f) 1.500 s

(g) 1.800 s

(h) 2.100 s
