1. Report No. <b>FHWA/TX-00/1792-5</b>	2. Government Accession No.	3. Recipient's Catalog No.	
4. Title and Subtitle <b>TESTING AND EVALUATION OF SLIP BASE SIGN SUPPORTS</b>		5. Report Date <b>May 2001</b>

6. Performing Organization Code	
7. Author(s) <b>Roger P. Bligh, D. Lance Bullard, Jr., Wanda L. Menges, and Sandra K. Schoeneman</b>		8. Performing Organization Report No. <b>Report 1792-5</b>

9. Performing Organization Name and Address <b>Texas Transportation Institute The Texas A&amp;M University System College Station, Texas 77843-3135</b>		10. Work Unit No. (TRAIS)

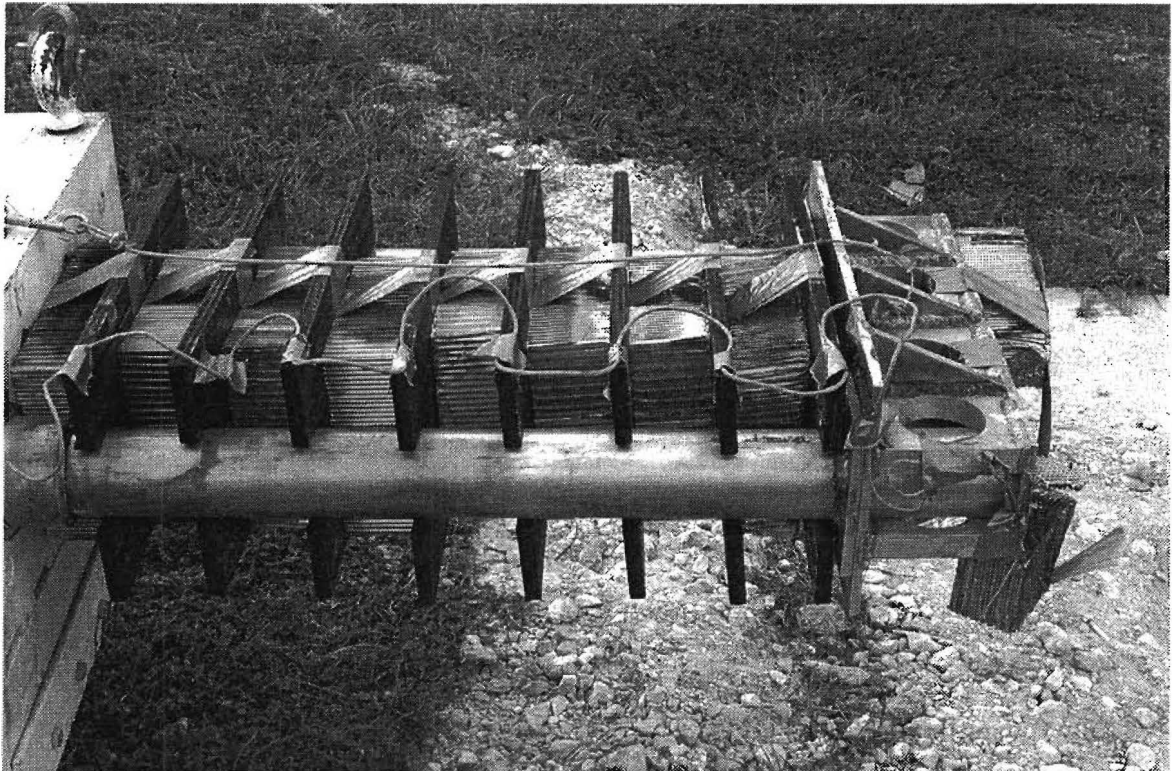
**Figure 31. Slip Base Sign Support before Test 417929-P3.**

Details of the sign support installation used for this pendulum test are shown in figure 30. Photographs of the completed sign support installation are shown in figure 31.

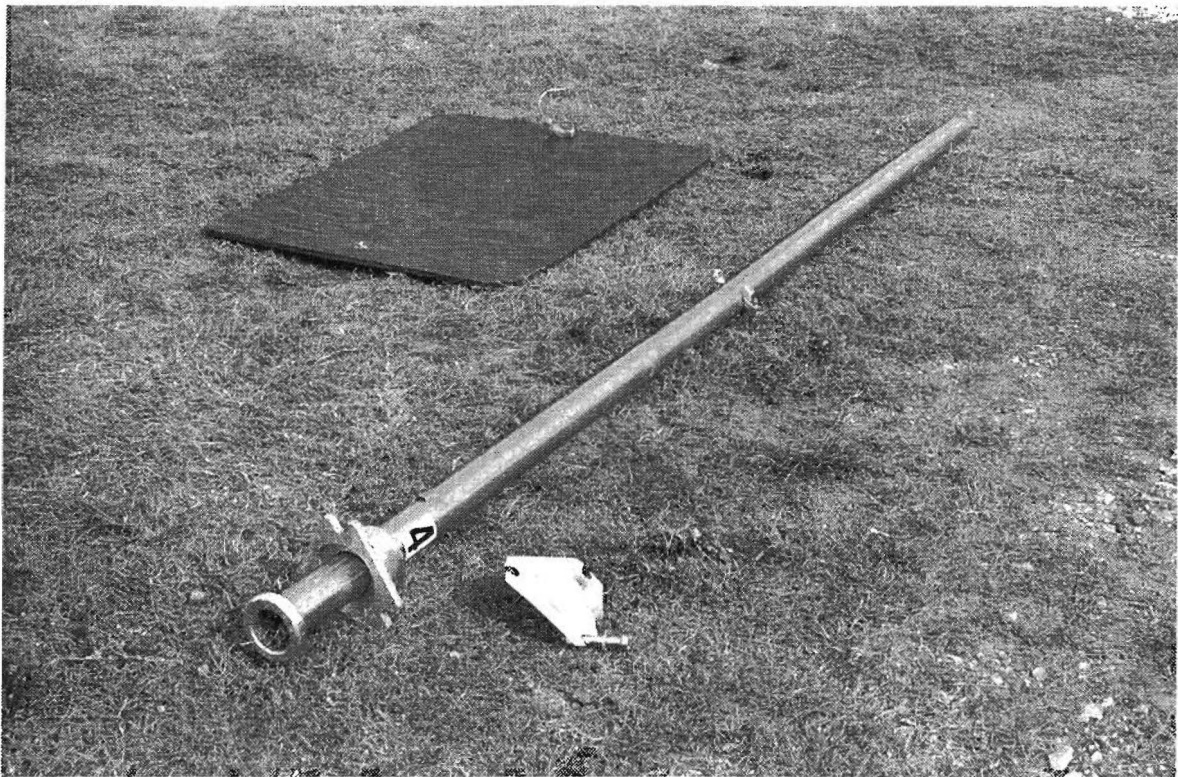
**Figure 40. Slip Base Sign Support after Test 417929-P4.**

Photographs of the test installation after the test are shown in figures 39 through 41. The triangular spacer cap was found 0.8 m (2.6 ft) in front of the test installation. The locking ring and upper slip base casting stayed attached to the pole. There was no observable permanent deformation to the schedule 10 support post, and it was considered reusable. The bolt keeper plate, with one bolt still attached, came to rest adjacent to the bottom end of the support post 12.9 m (42.3 ft) down from the point of impact. The plywood sign panel detached from the support post during the impact and came to rest adjacent to the support 13.7 m (44.9 ft) down from the impact point. Maximum crush of the honeycomb nose was 45 mm (1.8 in.).

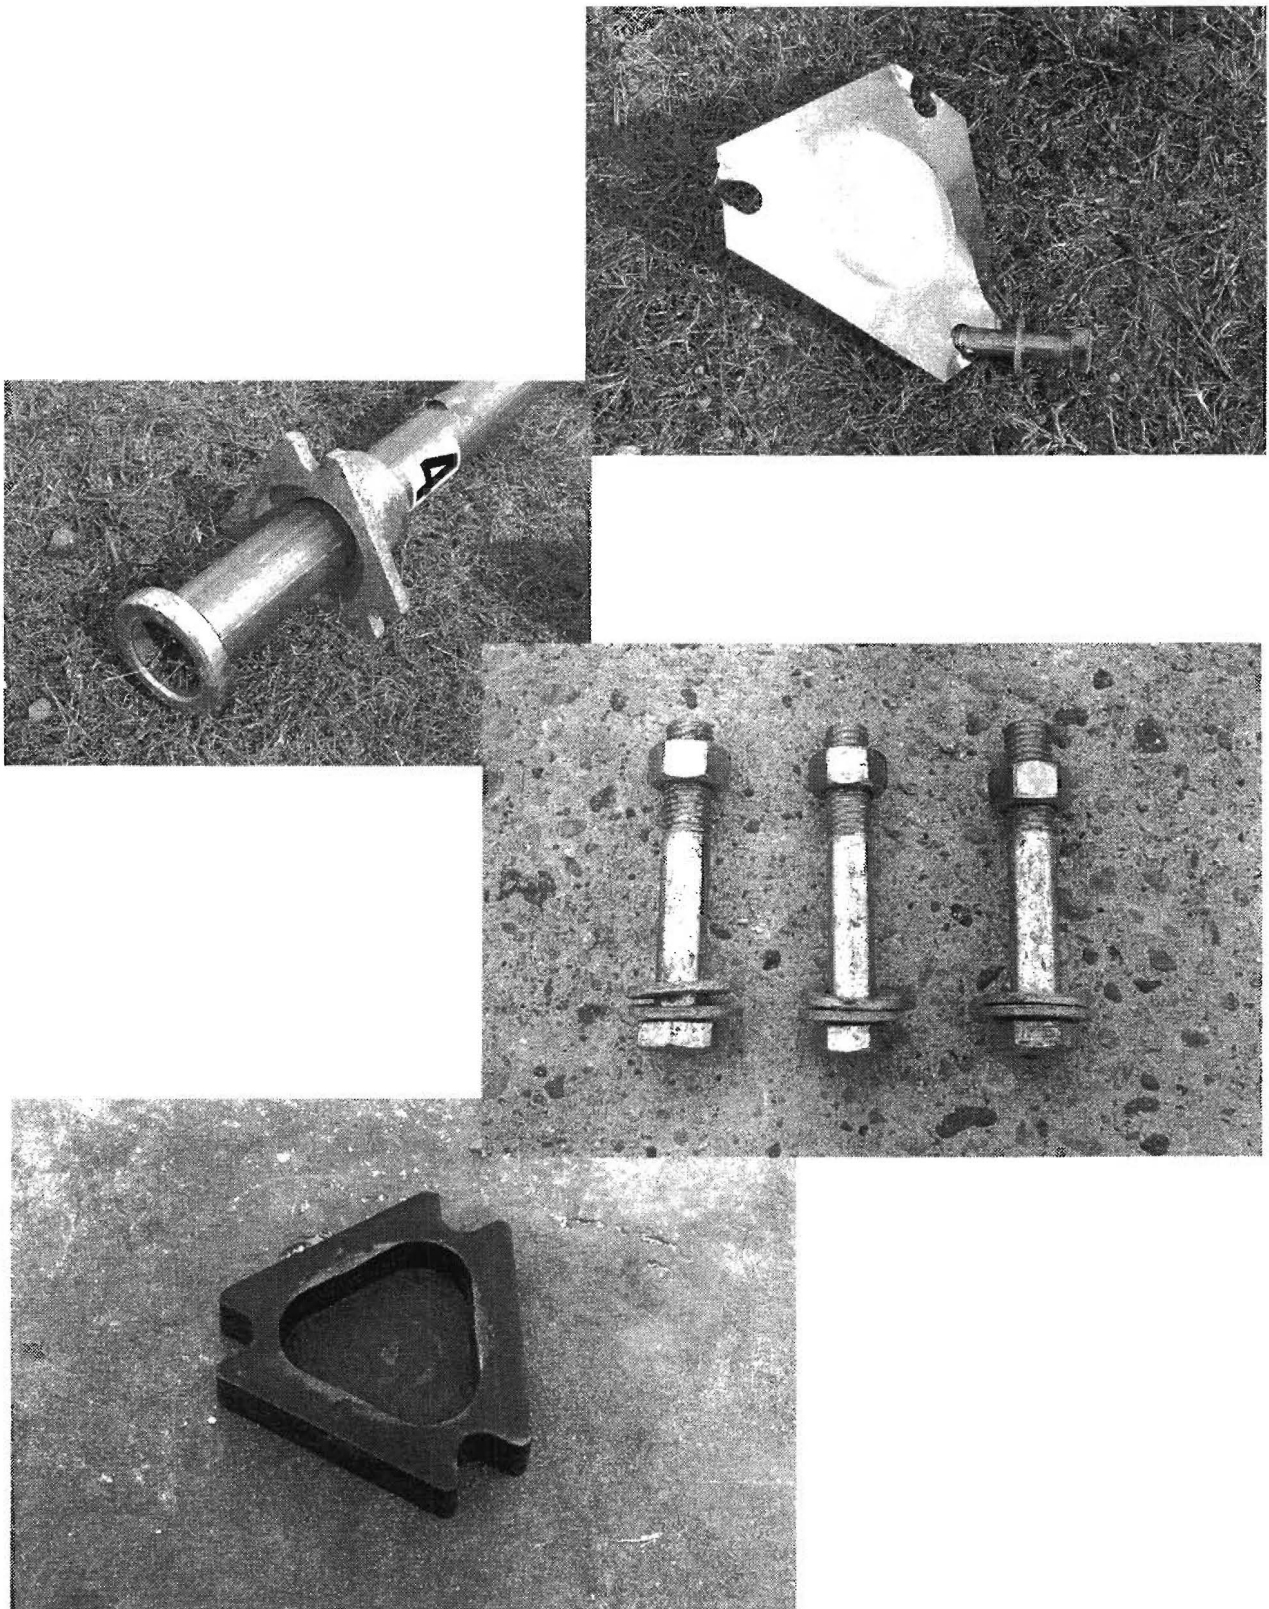
**Figure 41. Bolts and Keeper Plate Damage after Test 417929-P4.**

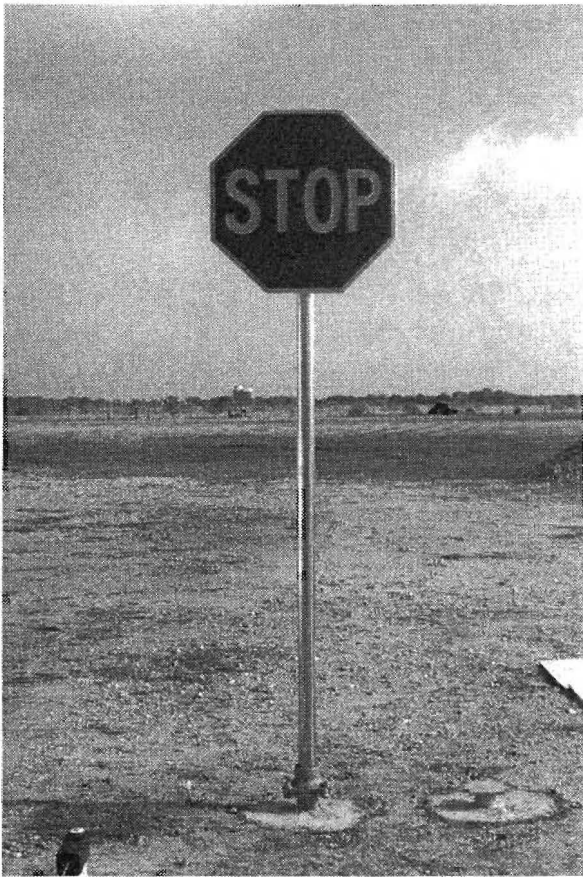
**Figure 44. Single Slip Base Steel Sign Support  
with Concrete Footing before Test 417929-6.**

strength washers were used under both the head and nut of each bolt. Additional details of the installation are shown in figure 43. Photographs of the completed sign support installation are shown in figure 44.

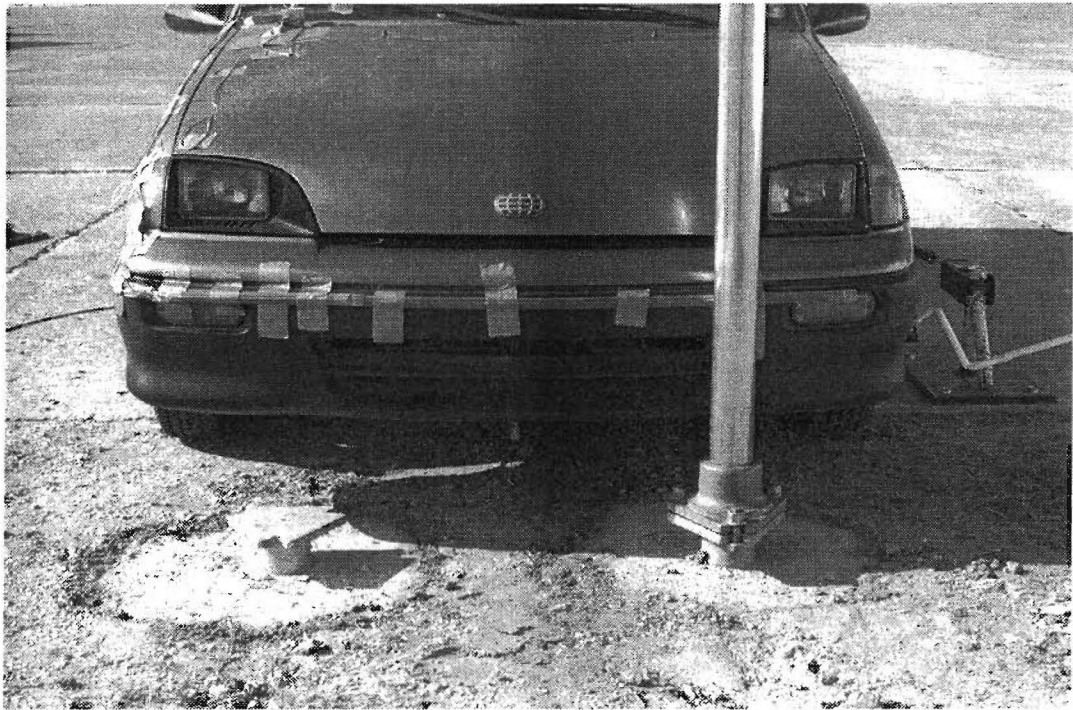
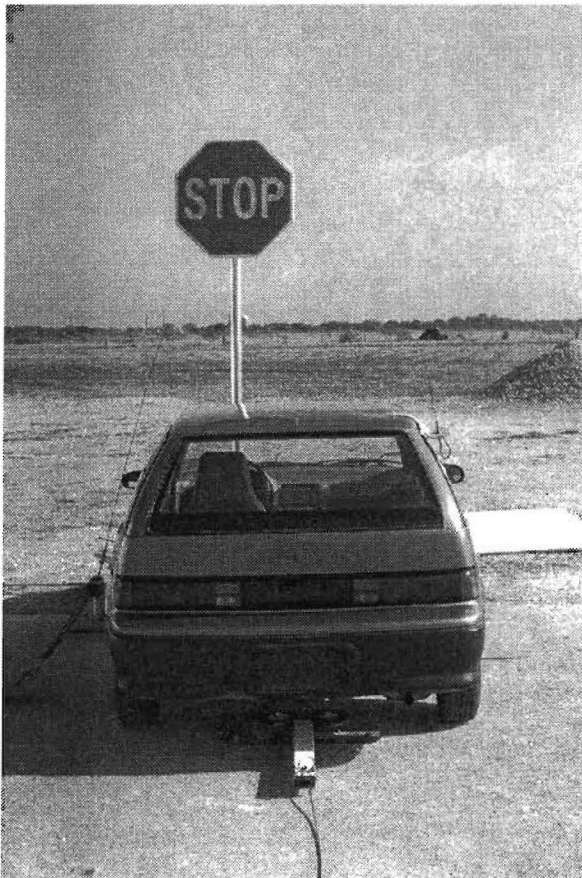
Figure 45. Vehicle/Installation Geometrics for Test 417929-6.

A 1994 Geo Metro, shown in figures 45 and 46, was used for the crash test. Test inertia weight of the vehicle was 820 kg (1806 lb) and its gross static weight was 896 kg (1974 lb). The height to the lower edge of the vehicle bumper was 370 mm (14.6 in.), and it was 450 mm (17.7 in.) to the upper edge of the bumper. Additional dimensions and information on the vehicle are given in Appendix E, figure 100. The vehicle was directed into the installation using the cable reverse tow and guidance system, and was released to be free-wheeling and unrestrained just prior to impact.

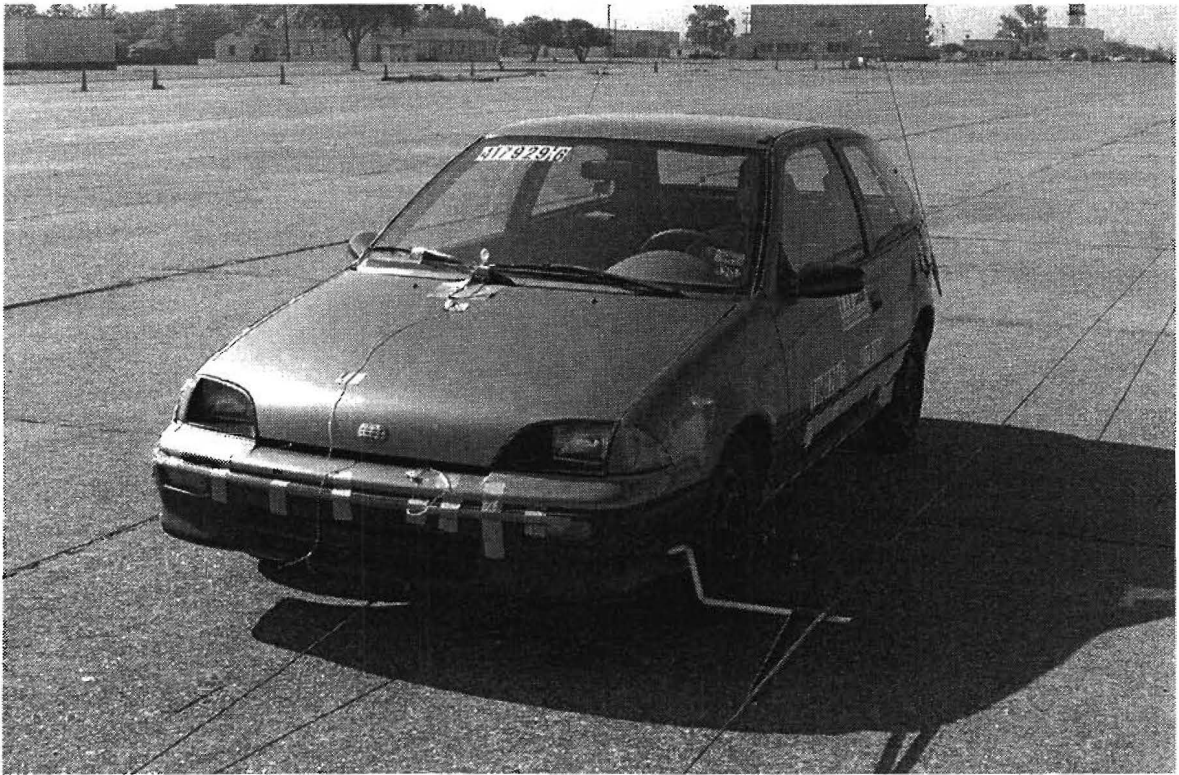
**Figure 46. Vehicle before Test 417929-6.**

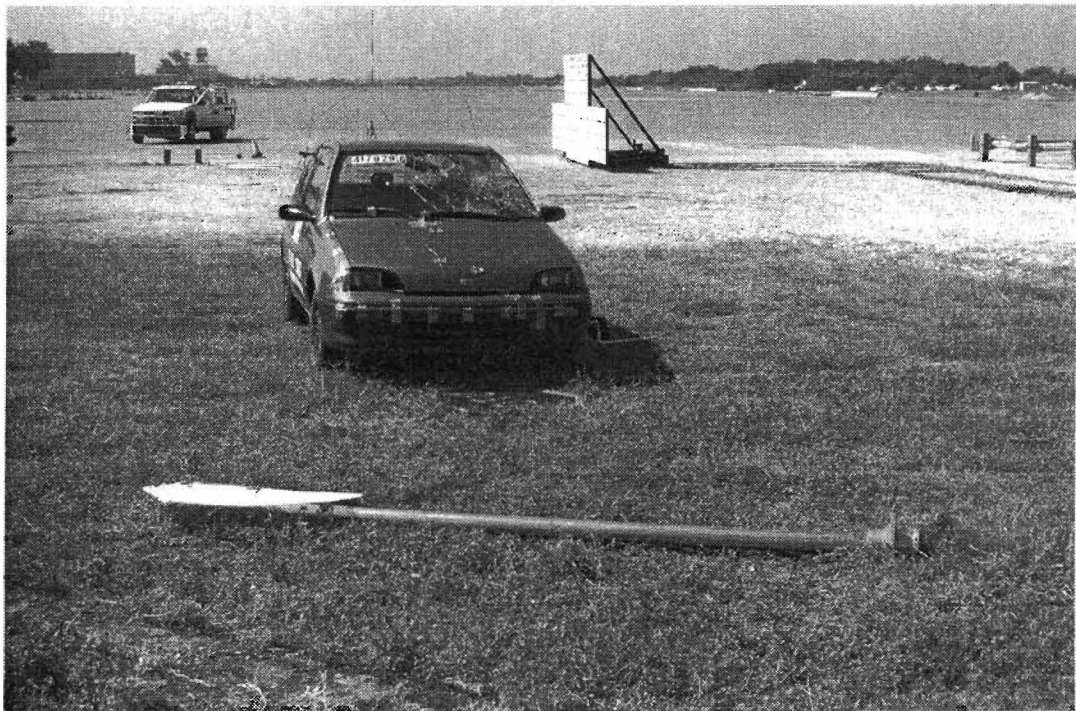
**Figure 47. After Impact Trajectory for Test 417929-6.**

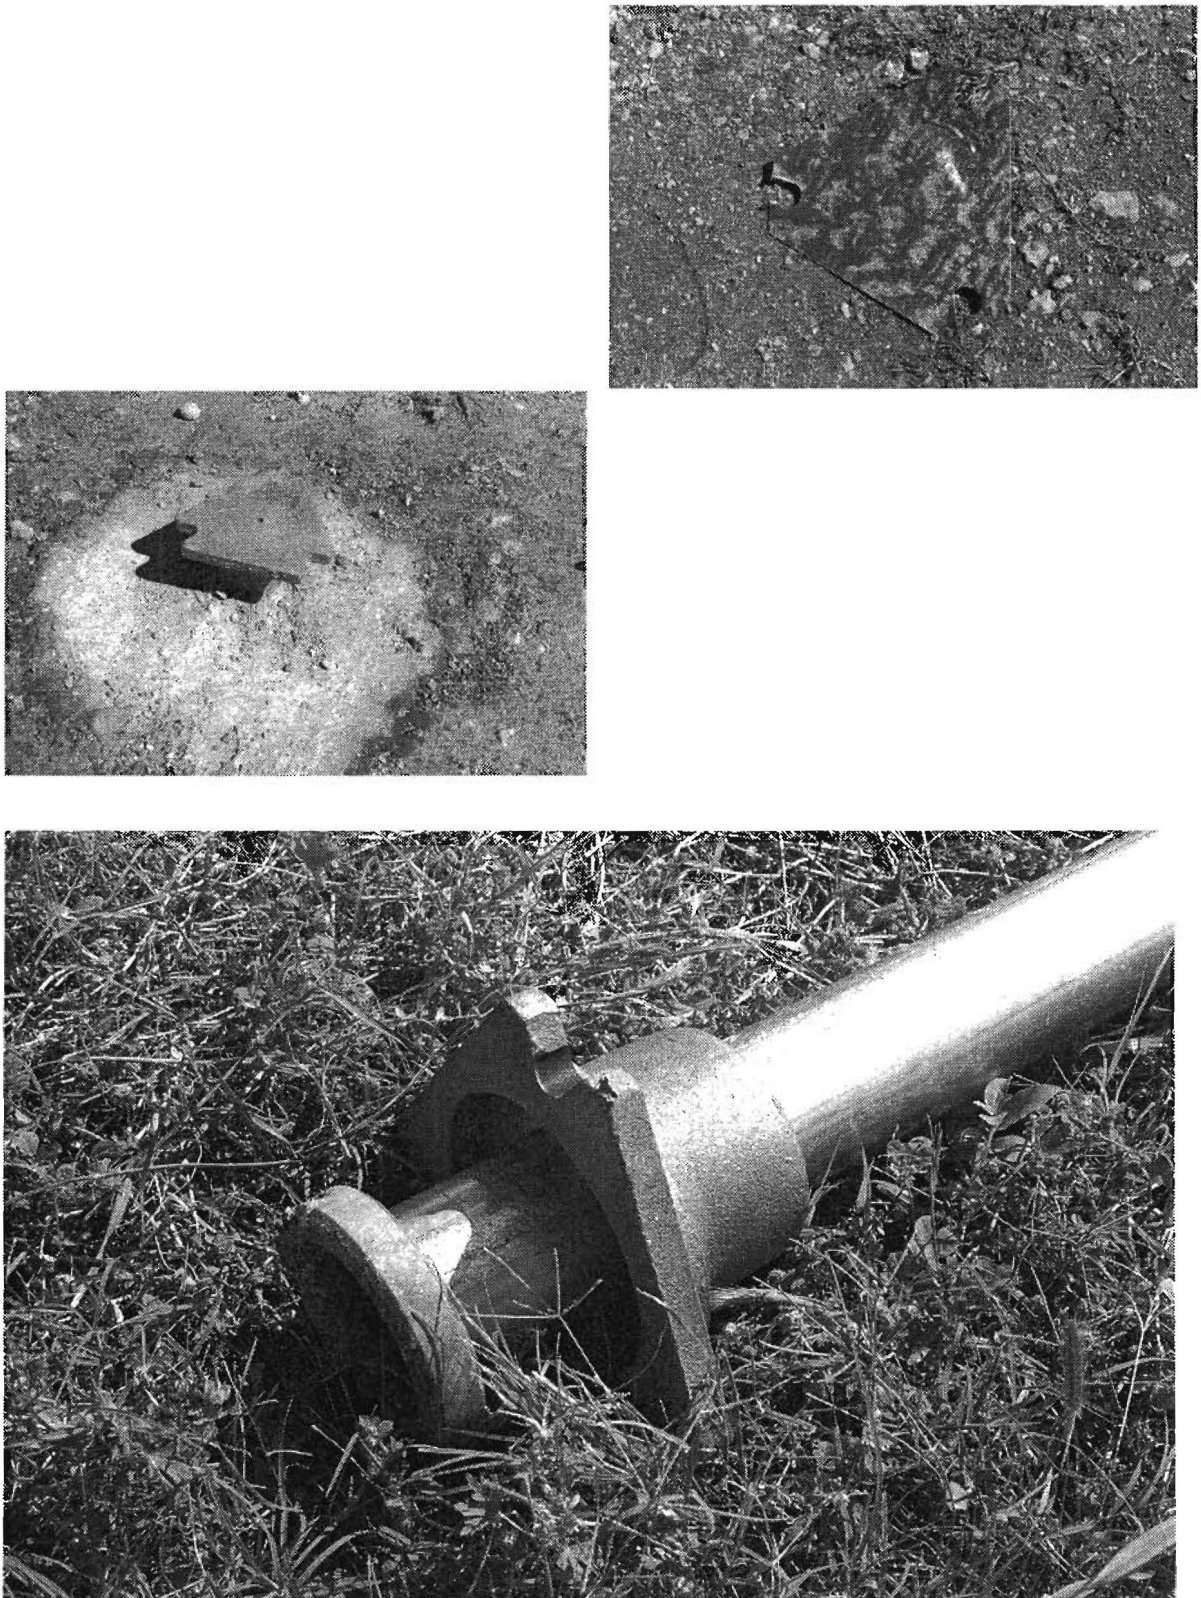
**Figure 48. Installation after Test 417929-6.**

Damage to the test installation is shown in figures 47 and 48. The upper slip base casting and split ring locking collar remained attached to the support post as intended. There was no observable deformation to the support post and the slip base assembly and post were considered reusable. The plastic sign substrate separated into several pieces as shown in figures 49 and 50. The reflective portion of the sign panel separated from the backing and was broken. The top edge of the backing of the sign panel was cracked. The post and sign panel backing came to rest 33.5 m (109.9 ft) downstream from the point of impact. The remaining debris was scattered 4.6 m (15.1 ft) to the left and 4.6 m (15.1 ft) to the right of the impact point.

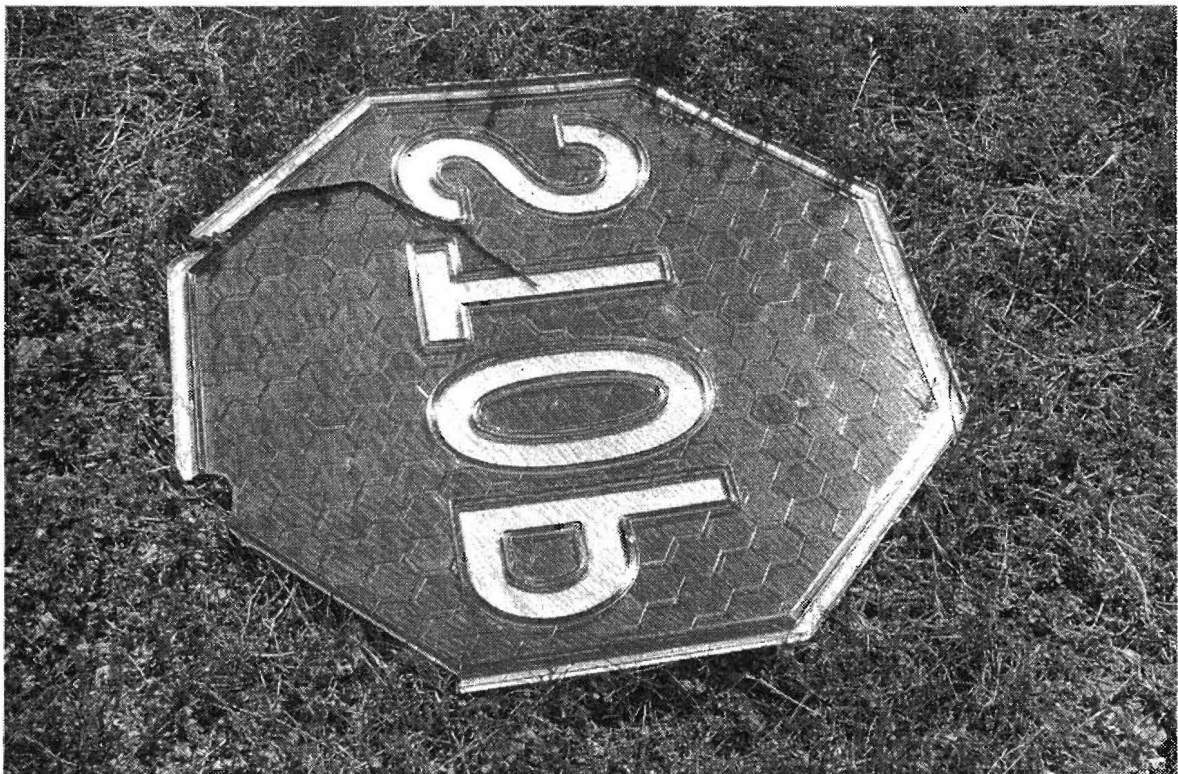
**Figure 50. Separation of Plastic Sign Substrate.**

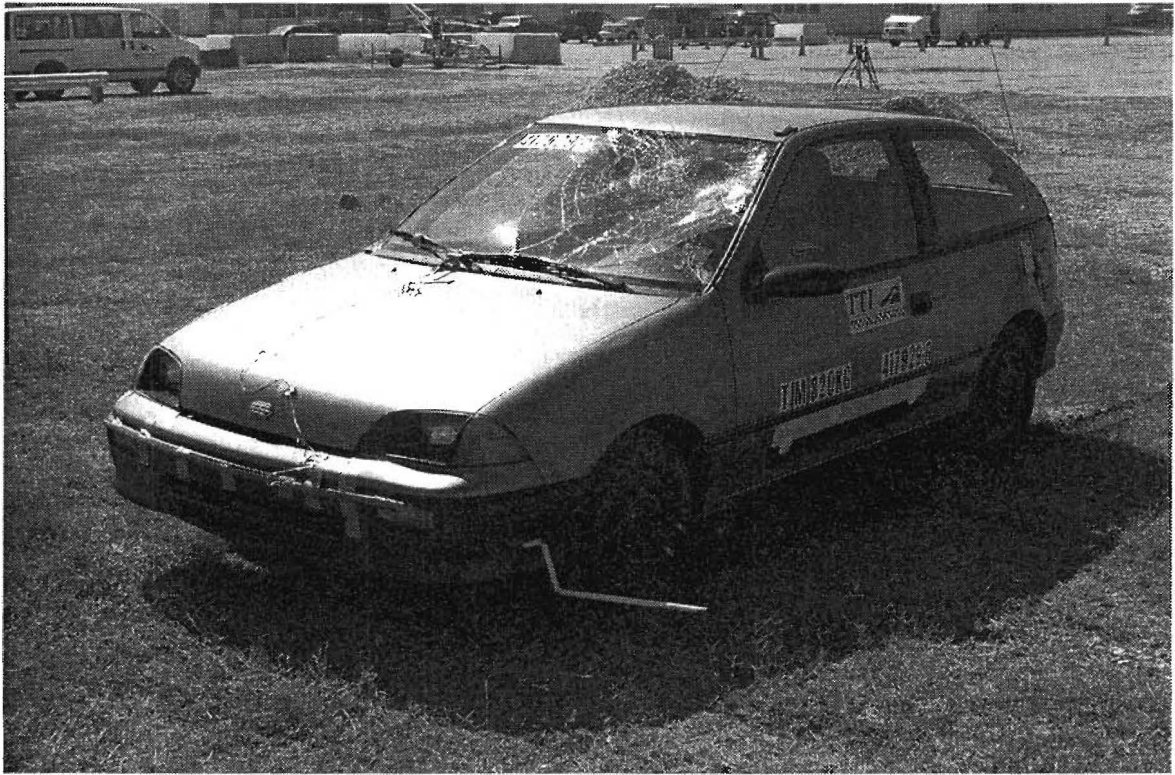
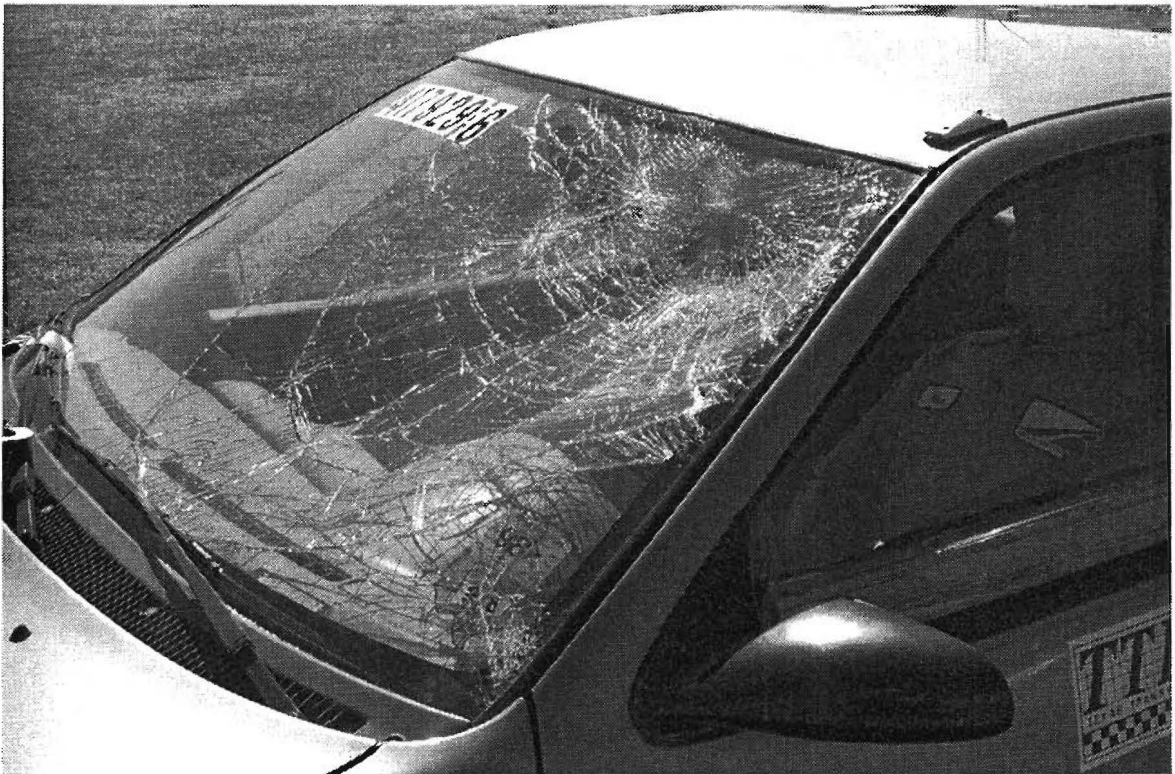
**Figure 51. Vehicle after Test 417929-6.**

Damage to the vehicle is shown in figure 51. The vehicle received minimal damage to the front end and bumper. The windshield was shattered and deformed inward by the sign panel and schedule 10 support post. Glass was sprayed into the occupant compartment. The interior of the vehicle is shown in figure 52.

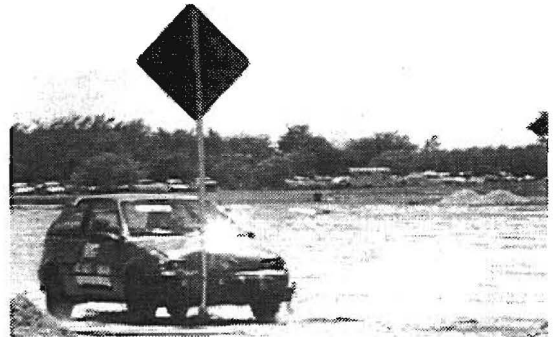
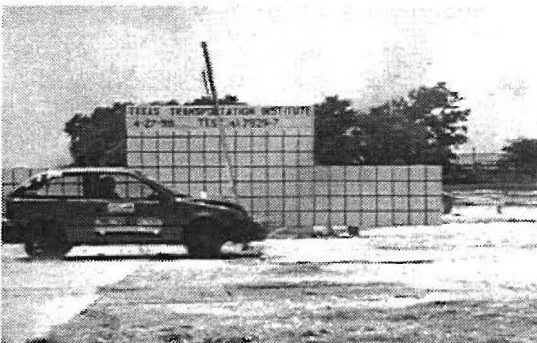
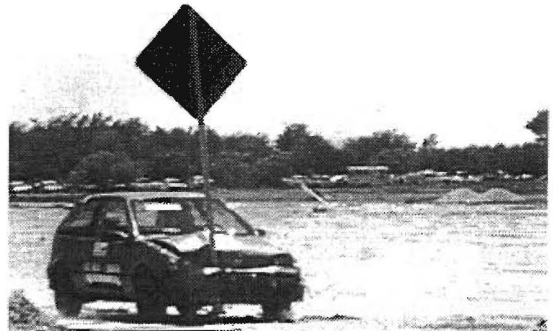
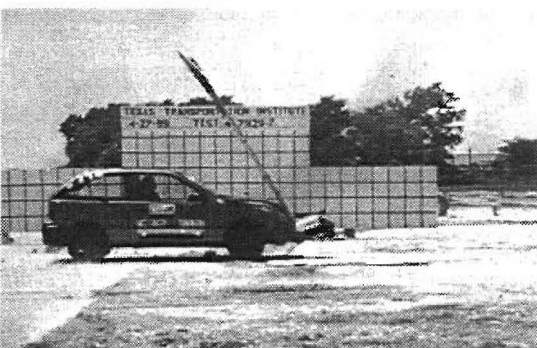
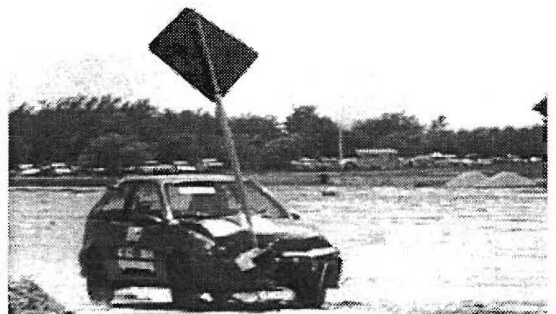
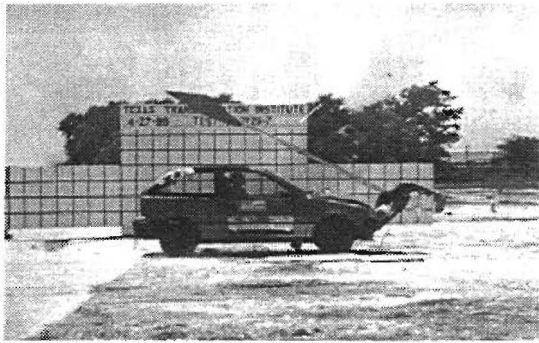
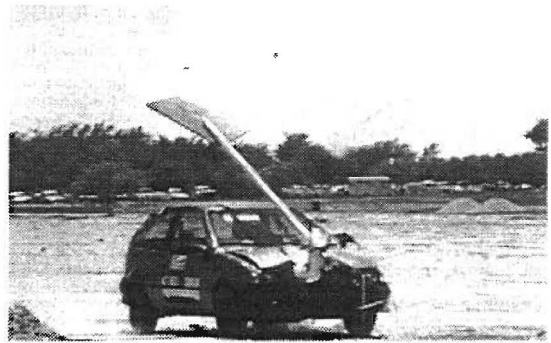
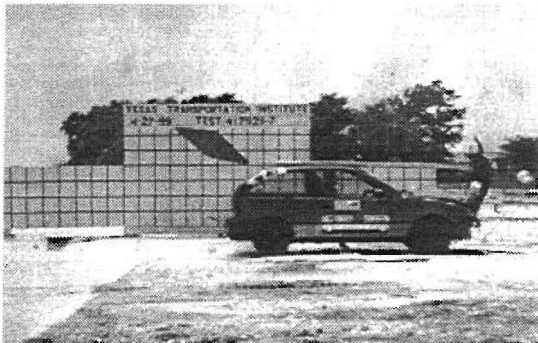
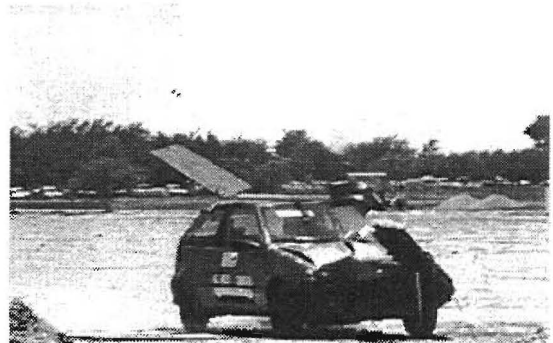
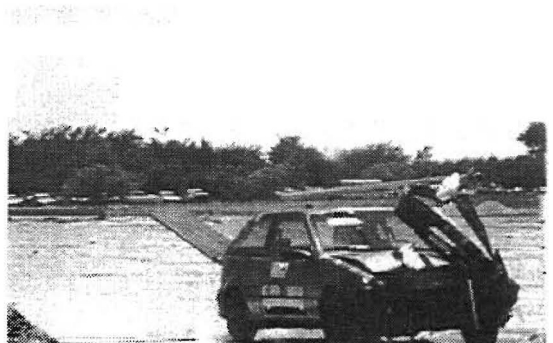
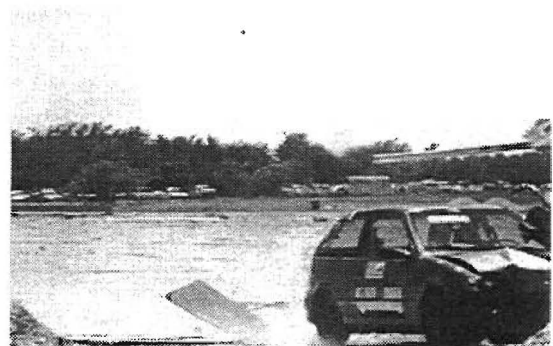
**Figure 97. Sequential Photographs for Test 417929-7  
(Perpendicular and Frontal Views).**

**Figure 97. Sequential Photographs for Test 417929-7  
(Perpendicular and Frontal Views) (Continued).**

0.148 s, the rotating support post contacted the roof of the vehicle, and at 0.153 s, the post was parallel to the ground. At 0.185 s, the post lost contact with the roof of the vehicle, and the vehicle was traveling at a speed of 93.8 km/h (58.3 mi/h). Brakes on the vehicle were applied at 1.63 s, and the vehicle subsequently came to rest 112.8 m (370.1 ft) downstream from the point of impact. Sequential photographs of the test can be found in Appendix D, figure 97.

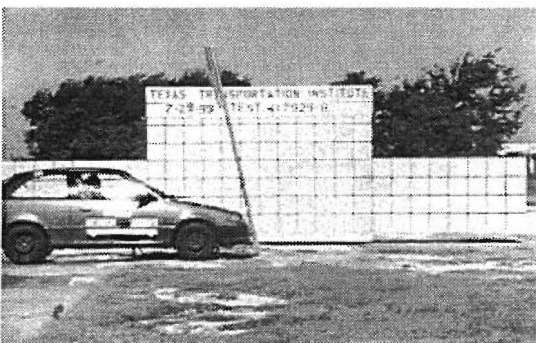
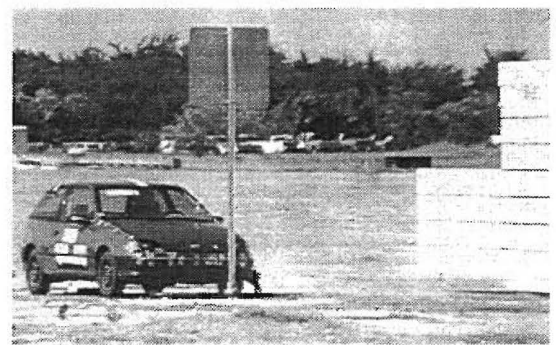
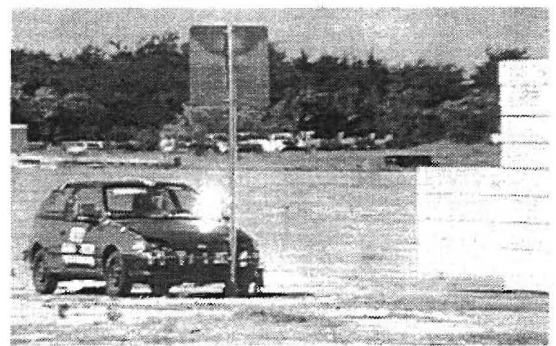
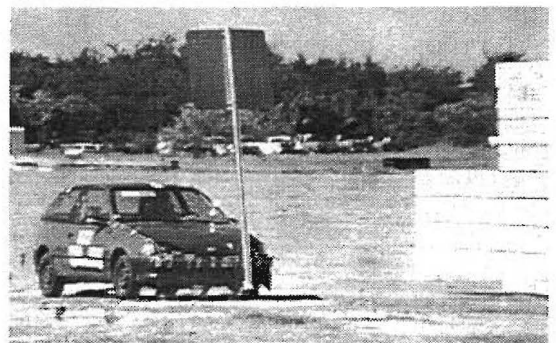
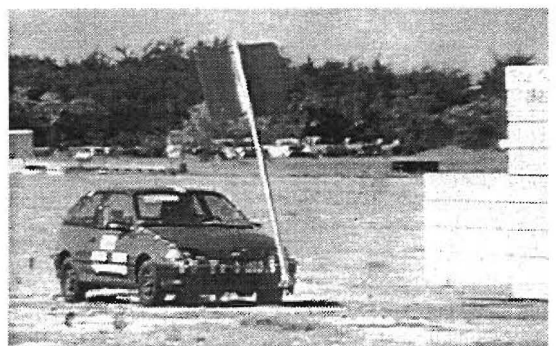
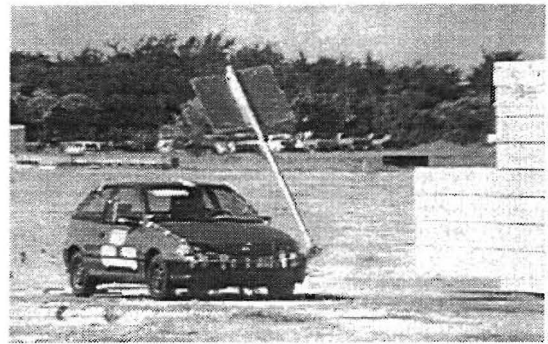
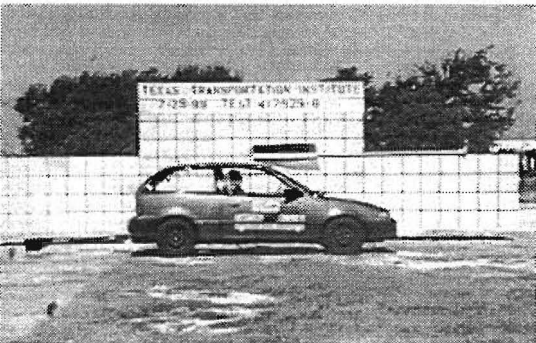
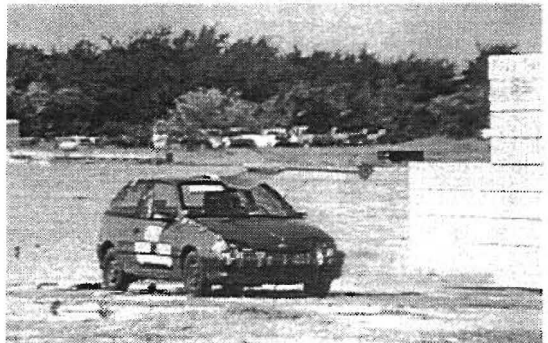
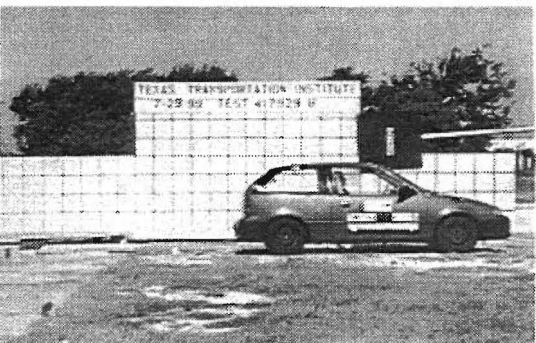
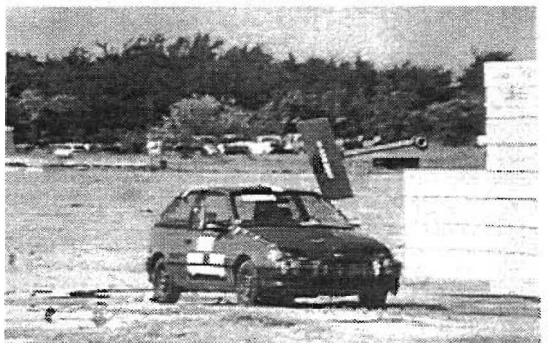
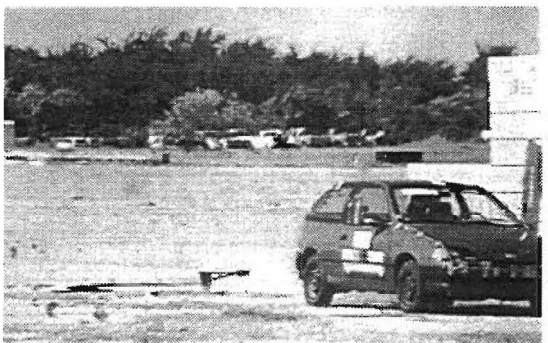
**Figure 98. Sequential Photographs for Test 417929-8  
(Perpendicular and Frontal Views).**

**Figure 98. Sequential Photographs for Test 417929-8  
(Perpendicular and Frontal Views) (Continued).**

The vehicle impacted the sign support head-on at a speed of 33.0 km/h (20.4 mi/h). The support post flexed slightly before activation of the slip base occurred. At 0.024 s the slip base began to activate, and by 0.034 s the post had lost contact with the lower slip plate and begun to rotate away from the vehicle. The vehicle lost contact with the post at 0.066 s while traveling 31.3 km/h (19.4 mi/h). By 0.292 s, the upper right corner of the sign panel contacted the vehicle's roof approximately 152 mm (6 in.) rearward of the windshield, and by 0.305 s the support post was parallel to the ground. The top edge of the sign panel was in full contact with the front of the roof at 0.329 s. The contact with the vehicle stopped the rotation of the support, and the sign panel began to roll off the driver's side of the vehicle. By 0.453 s, the sign panel had lost contact with the vehicle, and the vehicle was traveling at a speed of 29.5 km/h (18.3 mi/h). At 0.870 s, the left side of the sign panel contacted the driver's side mirror as it was falling to the ground, and at 0.963 s the mirror separated from the vehicle. Brakes on the vehicle were applied at 3.0 s as the vehicle exited the test site. The vehicle came to rest 29.0 m (95.1 ft) down from the impact point. Sequential photographs of the test can be found in Appendix D, figure 98.

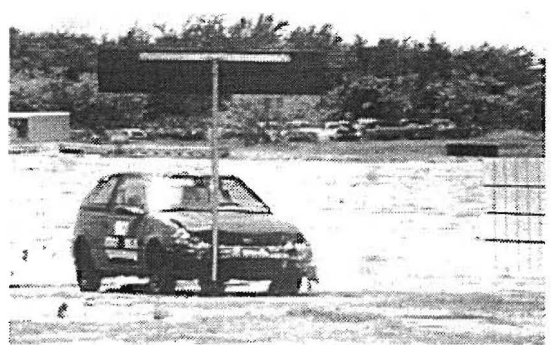
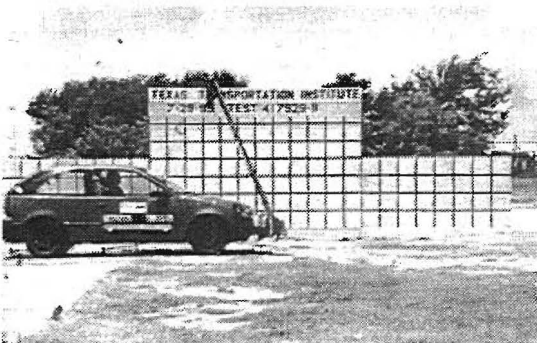
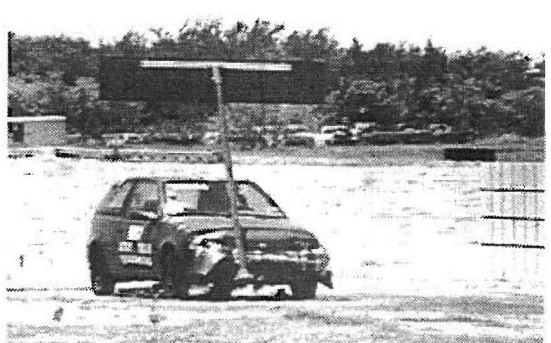
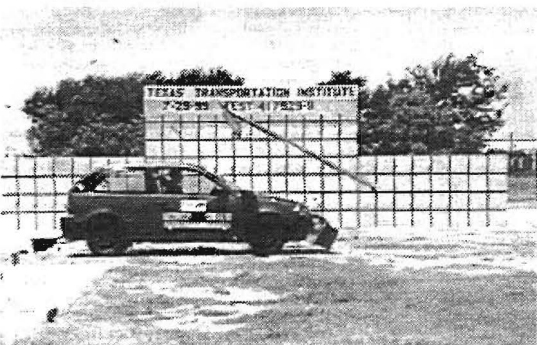
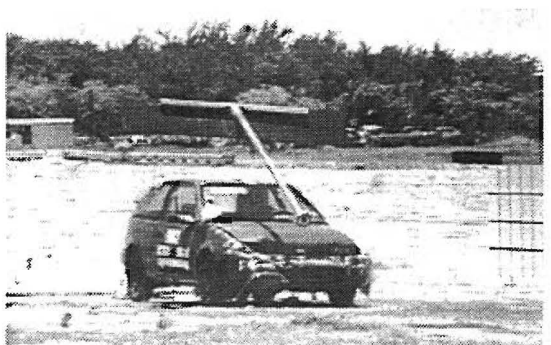
**Figure 99. Sequential Photographs for Test 417929-9  
(Perpendicular and Frontal Views).**

The vehicle impacted the sign support head-on at a speed of 35.3 km/h (21.9 mi/h). The pole flexed appreciably prior to activation of the slip base. At 0.027 s, the slip base began to activate, and by 0.039 s, the post had lost contact with the lower slip plate. The vehicle lost contact with the rotating post at 0.081 s while traveling at a speed of 32.4 km/h (20.1 mi/h). By 0.255 s the post was parallel to the ground surface, and at 0.289 s the top edge of the sign panel contacted the vehicle at the top of the windshield near the edge of the roof. The sign panel contacted the top half of the windshield across the A-pillars. The bottom of the support continued to rotate upward and pivot about the top of the support, which was in contact with the vehicle. At 0.369 s, the sign panel temporarily lost contact with the vehicle while the vehicle was traveling at a speed of 32.3 km/h (20.1 mi/h). At 0.716 s, the sign panel recontacted the windshield, and by 0.836 s the sign panel had again lost contact with the windshield. The top of the support post contacted the vehicle hood at 1.269 s as the base was rotating over the vehicle. At 1.403 s the slip base of the post contacted the ground. Brakes on the vehicle were applied as it exited the test site, and the vehicle came to rest 38.1 m (125.0 ft) from impact point. Sequential photographs of the test can be found in Appendix D, figure 99.

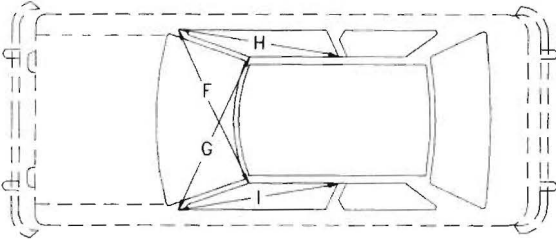
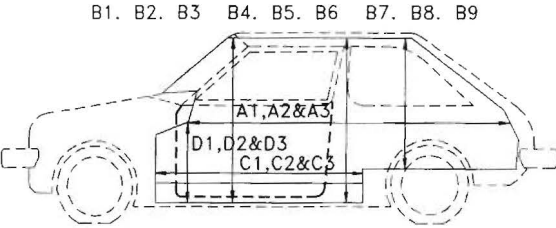
Occupant Compartment Deformation

A1 1505 A2 2087 A3 1505 B1 983 B2 937 B3 982 B4 965 B5 860 B6 963 B7 660 B8 670 B9 645 C1 707 C2 710 C3 709 D1 300 D2 105 D3 298 E1 1247 E2 1249 F 1205 G 1205 H 900 I 900	- - - - 911 - 955 813 955 655 640 625 - - - - - - - - - - - -
