CRASH TEST AND EVALUATION OF THE TxDOT T631 BRIDGE RAIL

Test Report 9-1002-12-10

The objective of this research was to evaluate the impact performance of the new TxDOT Type T631 bridge rail. The TxDOT Type T631 bridge rail is intended to serve as a low-cost replacement for the TxDOT Type T6 bridge rail for *MASH* TL-2 applications. The TxDOT T631 bridge rail is intended for new construction. The crash testing was performed in accordance with the requirements of *MASH* TL-2.

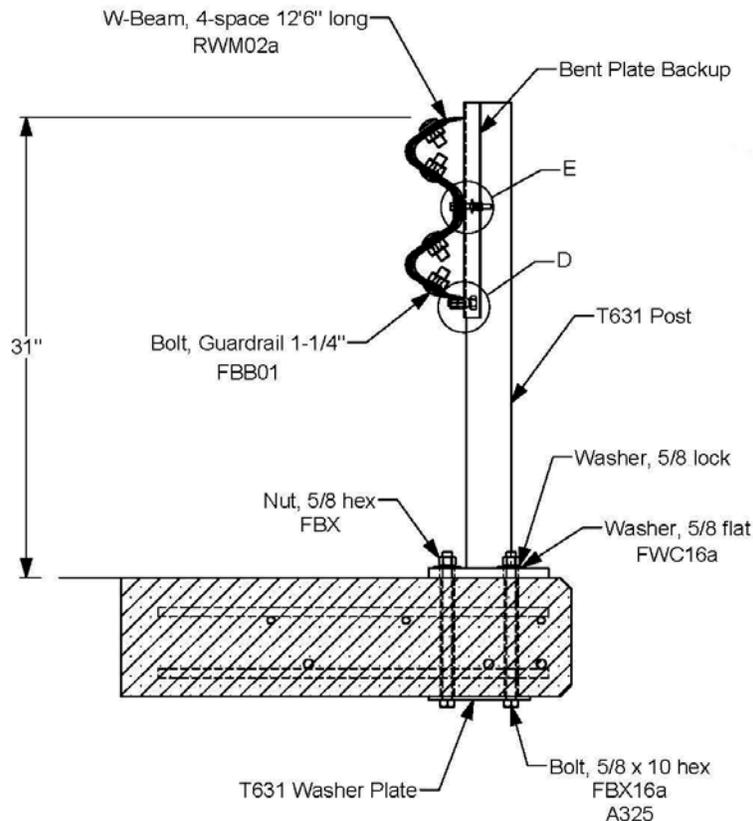
Figure 2.1. Cross Section of the T631 Bridge Rail.

Bridge rail Posts 7 through 23 were installed as S3×5.7 American Society for Testing and Materials (ASTM) A992 structural steel posts welded to base plates and subsequently bolted through the bridge deck cantilever (see Figure 2.1). The base plates were 8 inches × 8 inches × $\frac{5}{8}$ inch thick ASTM A529 grade 55 steel and were welded to the bottom of each of Posts 7 through 23 with continuous $\frac{1}{4}$ -inch fillet welds. The center lines of the posts and base plates coincided. The base plates contained four $\frac{3}{4}$ -inch × 1-inch oblong bolting slots. Each base plate was attached to the bridge deck cantilever with four $\frac{5}{8}$ -inch diameter × 10-inch long FBX16a ASTM A325 bolts from below with an 8-inch × 6 $\frac{3}{4}$ -inch × $\frac{1}{4}$ -inch thick ASTM A36 steel washer plate on the bottom and corresponding $\frac{5}{8}$ -inch flat washers, lock washers, and hex nuts on top.

For this test installation, a reinforced concrete bridge deck cantilever was constructed by adding on to the existing concrete runway mat. The cantilever was 30 inches wide × 101 ft 6 inches long × 8 inches thick reinforced concrete with a minimum specified unconfined compressive strength of 4000 psi. The centerlines of Posts 7 through 23 were located laterally approximately 5½ inches from the field side edge of the cantilevered deck slab.

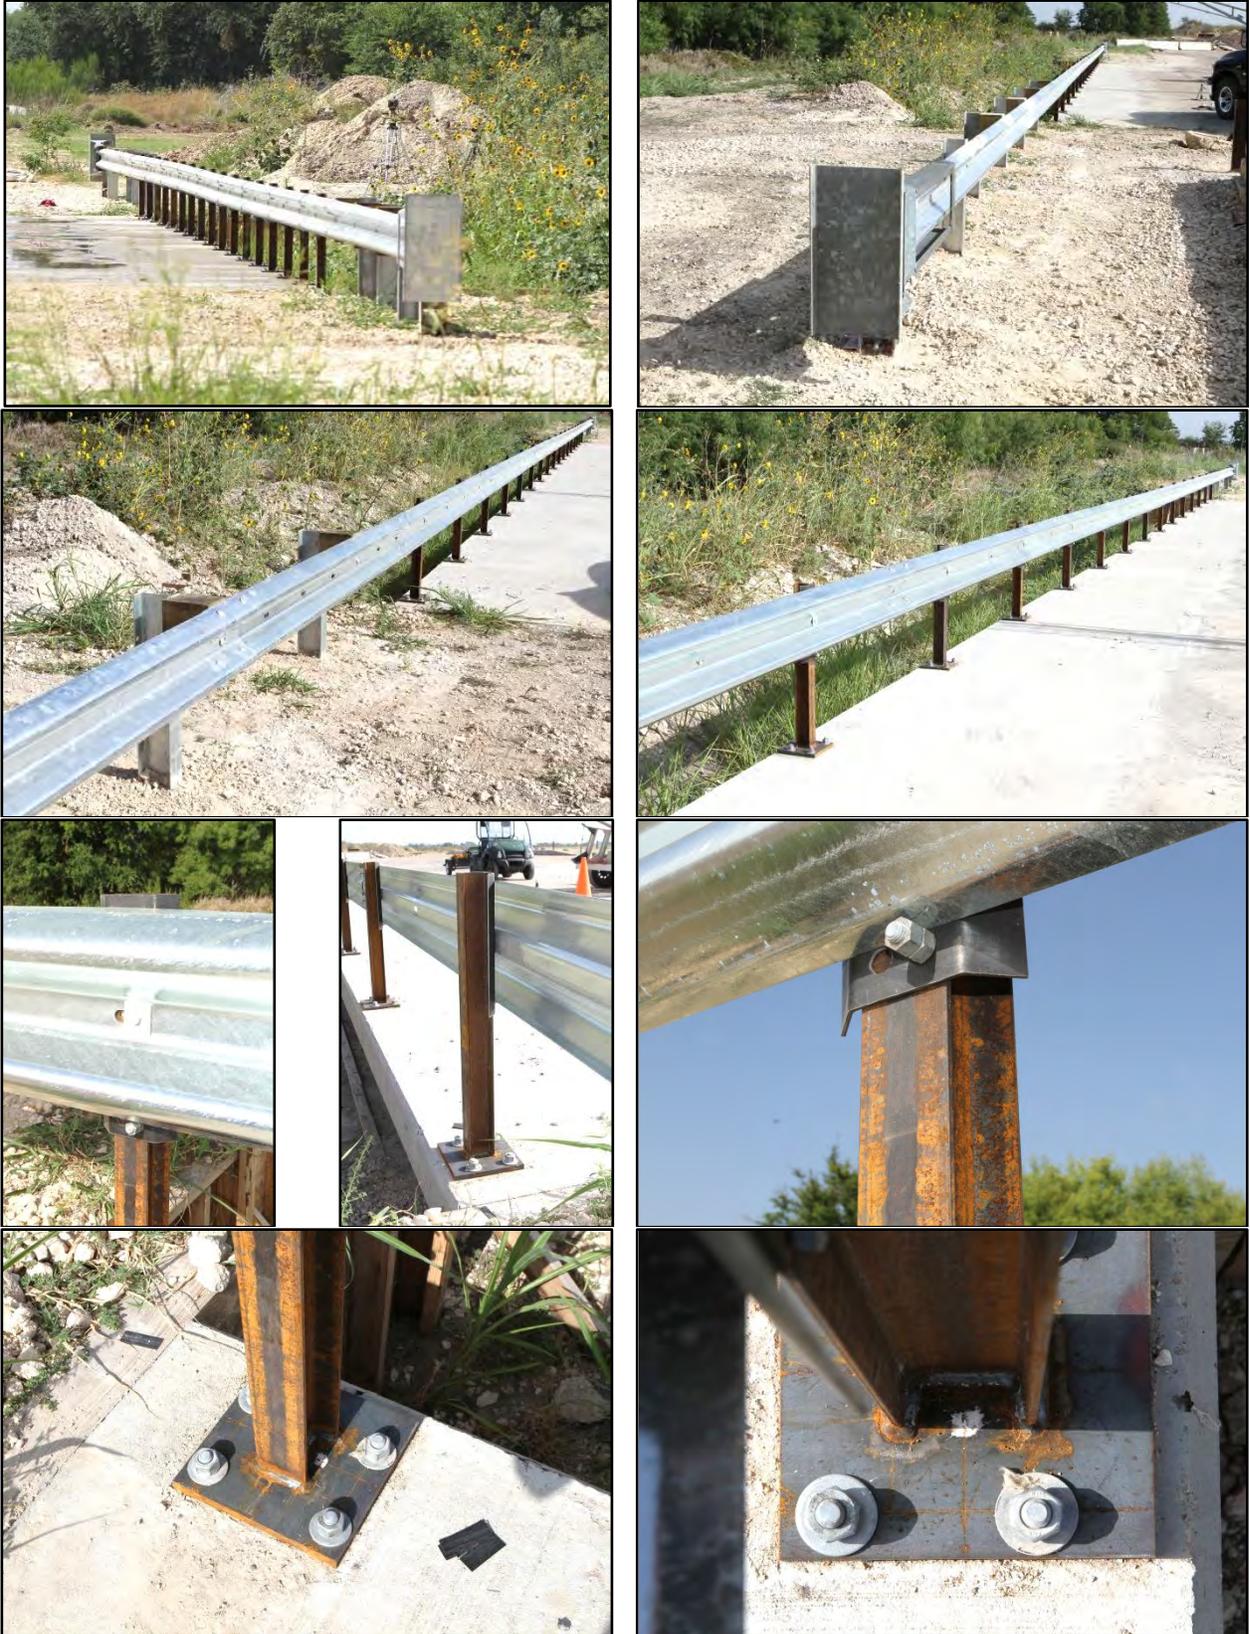
Figure 2.2. T631 Bridge Rail Installation before Test No. 490023-6-1a.

The test installation consisted of a W-beam rail element and structural steel posts welded to steel baseplates that anchored to a concrete cantilever deck. The bridge rail was anchored on each end using a standard 25-ft ET-PLUS end terminal. The total installation length was 168 ft 9 inches. Twenty-eight posts were equally spaced at 6 ft 3 inches on center. The height of the W-beam rail element was approximately 31 inches to the top of the W-beam rail element.

[Appendix A](#) provides detailed drawings for the installation, and [Figure 2.2](#) provides photographs of the completed installation.

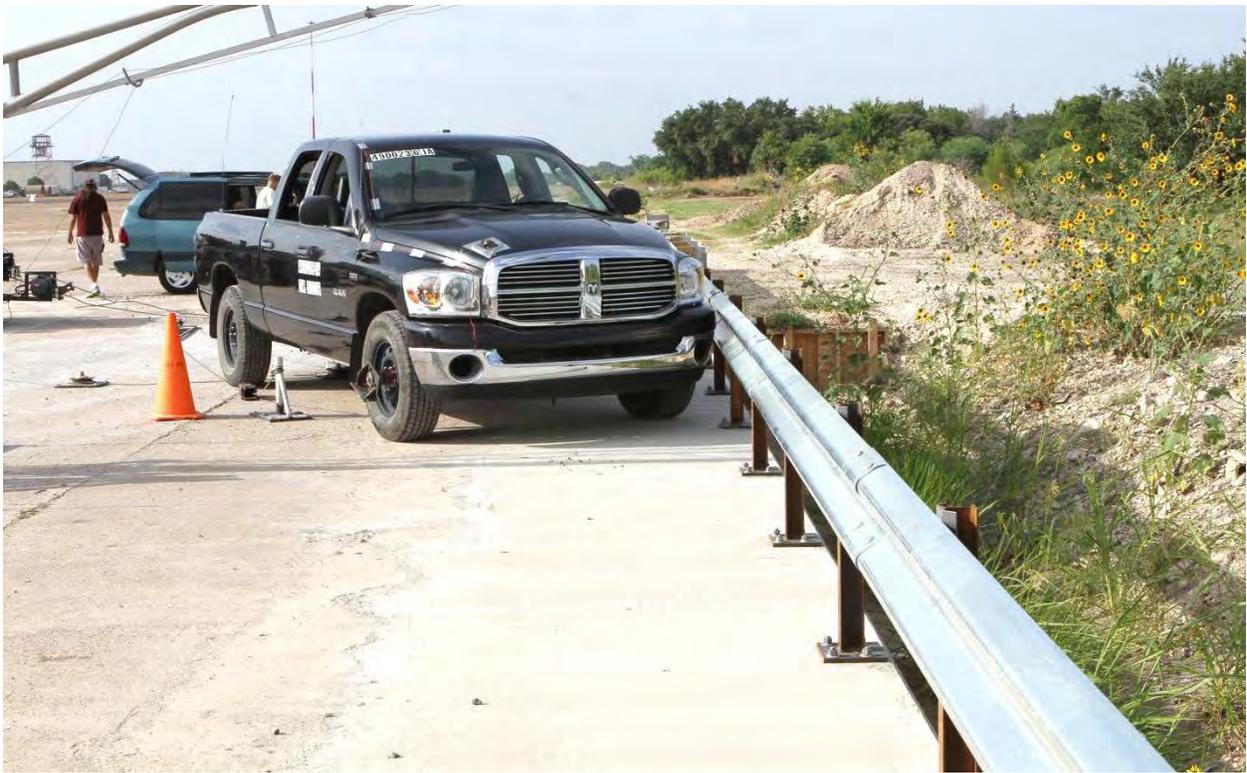
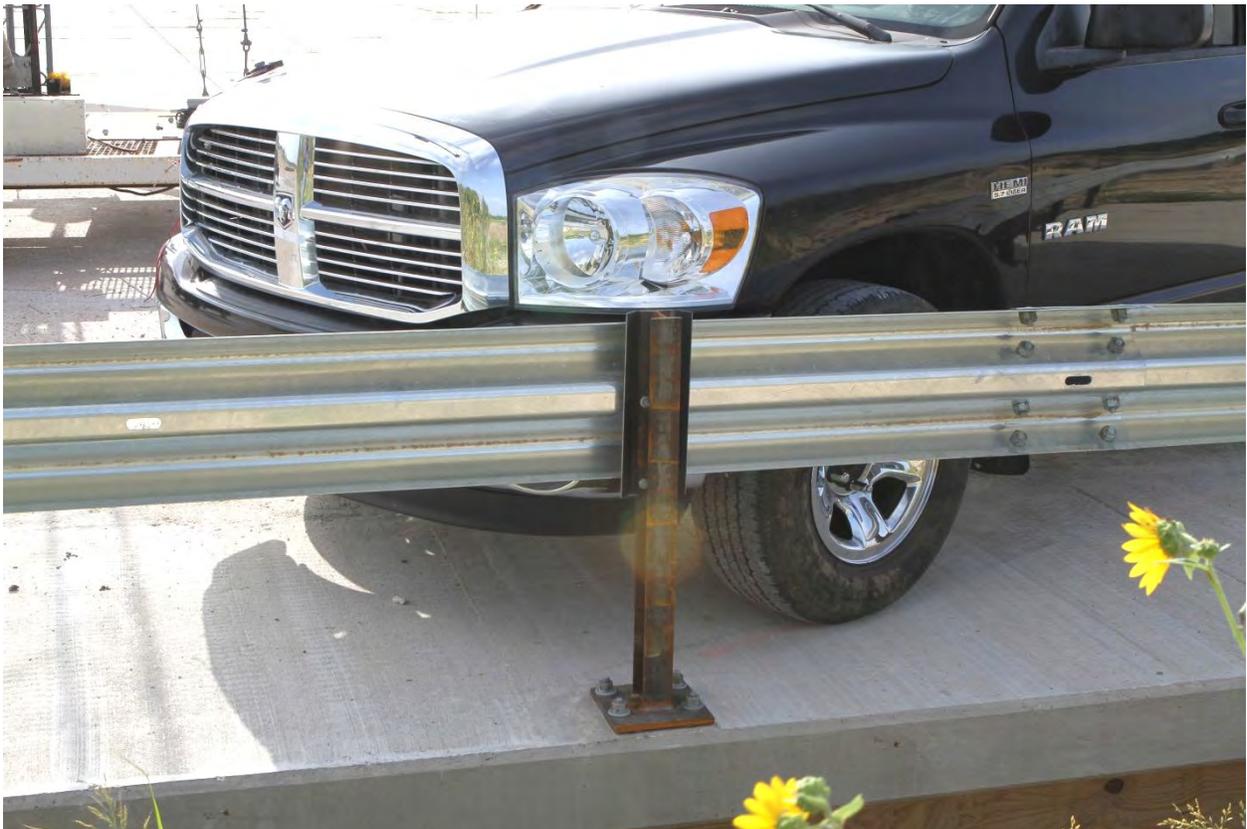
Figure 5.1. Vehicle/Installation Geometrics for Test No. 490023-6-1a.

Figures 5.1 and 5.2 show the 2008 Dodge Ram 1500 pickup truck used for the crash test. Test inertia weight of the vehicle was 5050 lb, and its gross static weight was 5050 lb. The height to the lower edge of the vehicle bumper was 15.50 inches, and it was 27.50 inches to the upper edge of the bumper. The height to the vehicle's center of gravity was 28.25 inches. Tables C1 and C2 in Appendix C give additional dimensions and information on the vehicle. The vehicle was directed into the installation using the cable reverse tow and guidance system, and was released to be freewheeling and unrestrained just prior to impact.

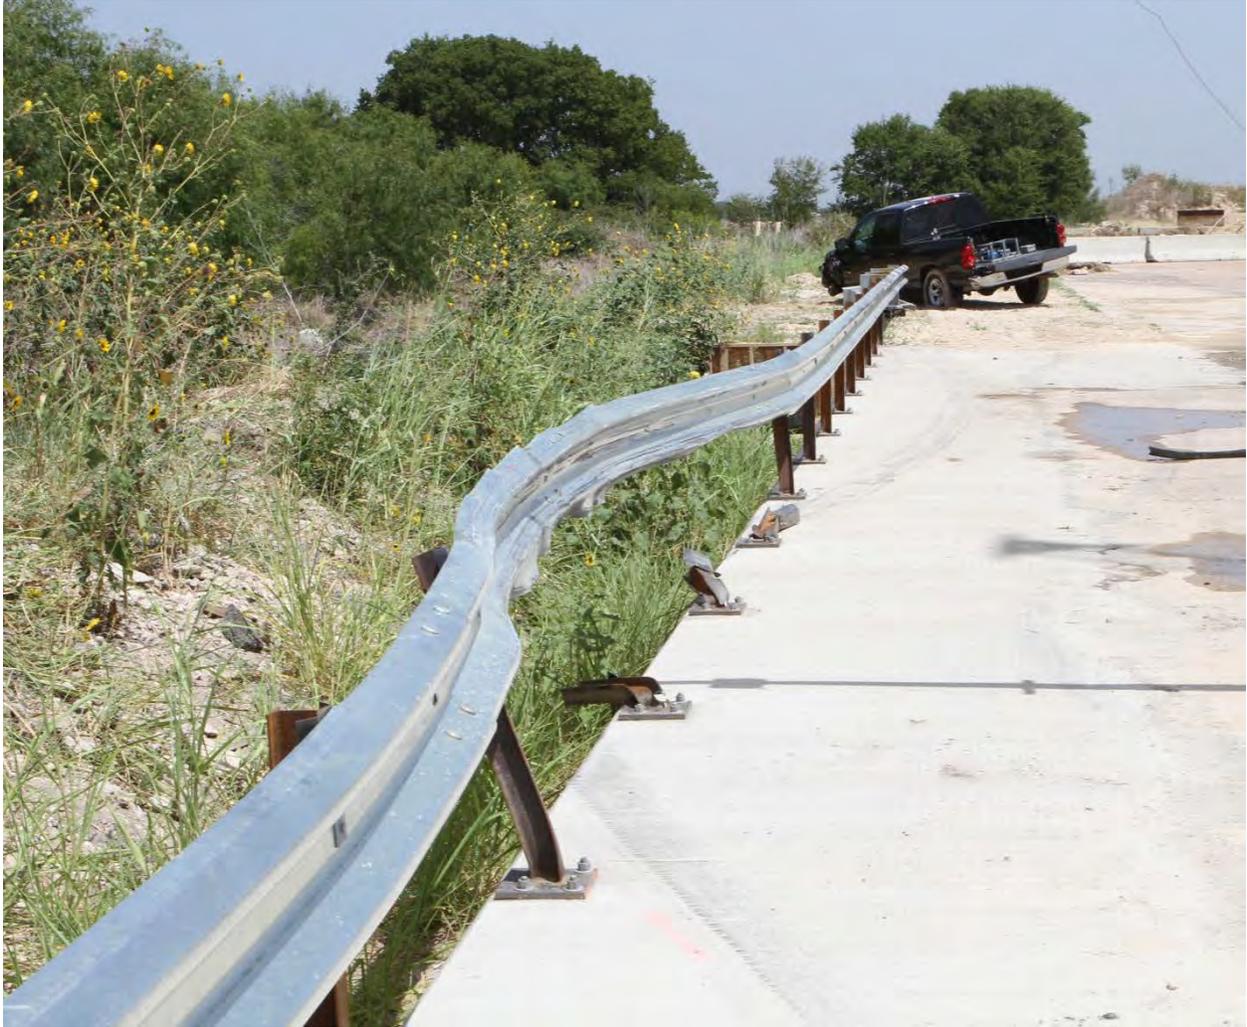
Figure 5.3. Test Article/Vehicle Positions after Test No. 490023-6-1a.

The 2008 Dodge Ram 1500 pickup truck, traveling at an impact speed of 44.9 mi/h, impacted the T631 bridge rail 6 inches downstream of post 11 at an impact angle of 24.9 degrees. At approximately 0.093 s, the left front tire reached the edge of the bridge deck and began to drop off the edge of the bridge deck. Post 11 fractured at the base plate at 0.114 s, and the rear of the vehicle contacted the bridge rail at 0.285 s. At 0.354 s, the left front tire rode back up onto the bridge deck while the left rear tire slipped off the bridge deck. At 0.545 s, the vehicle lost contact with the bridge rail and was traveling at an exit speed and angle of 30.0 mi/h and 6.3 degrees, respectively. Brakes on the vehicle were not applied, and the vehicle came to rest 119 ft downstream of impact with the rear of the vehicle 2 ft from the traffic face of the bridge rail. Figures C1 and C2 in Appendix C show sequential photographs of the test period.

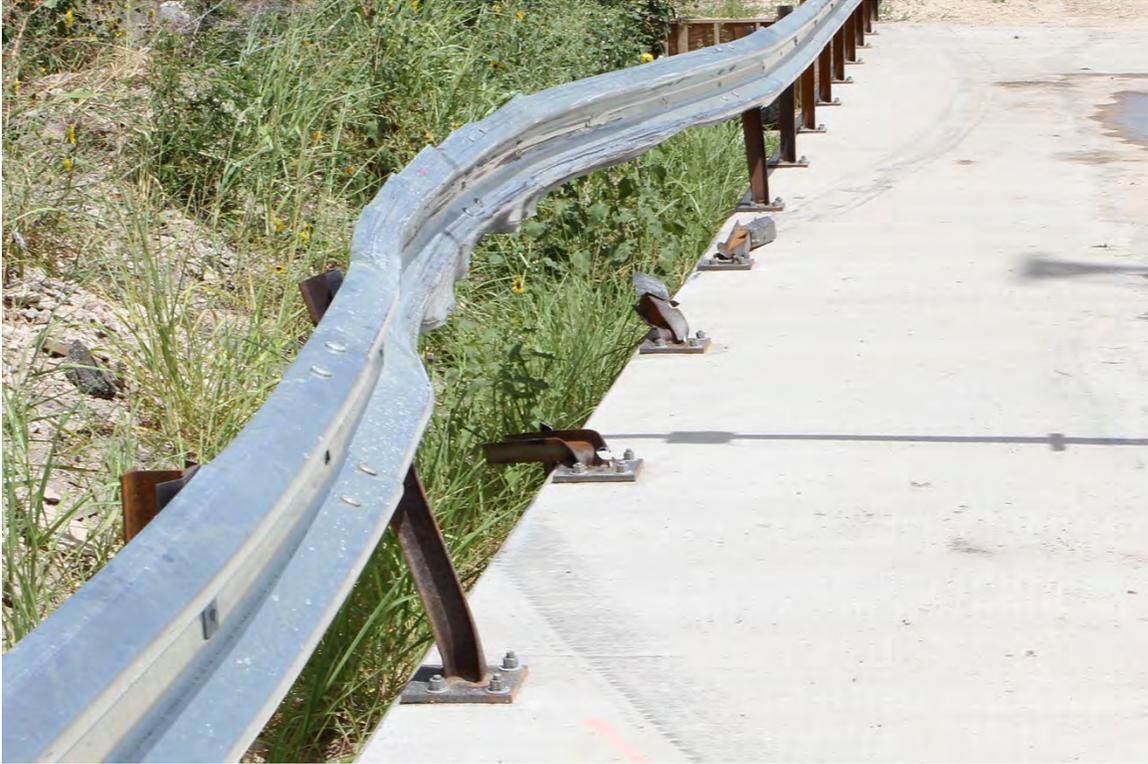
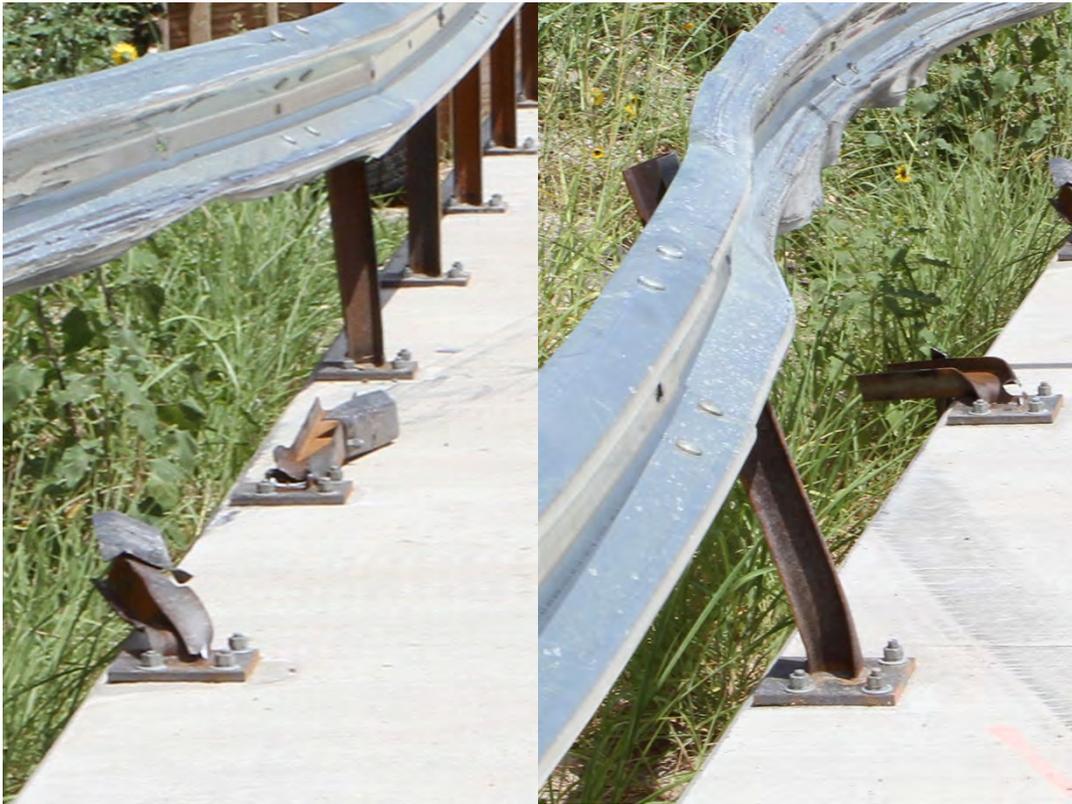
Figure 5.4. Installation after Test No. 490023-6-1a.

Post 1 was pulled downstream 0.25 inch, and Posts 10 and 11 were leaning toward the field side 2 degrees and 20 degrees, respectively. Posts 12 through 14 were leaning downstream 90 degrees; there was a partial tear at the base, and the rail separated from the posts. Post 15 was leaning towards the field side 5 degrees and downstream 14 degrees, and the rail separated from the post. The vehicle contacted the installation a second time at the downstream terminal post and anchor. Figures 5.3 and 5.4 show damage to the installation. The vehicle was in contact with the bridge rail 22.25 ft. Maximum dynamic deflection of the bridge rail was 25.7 inches, and permanent deformation was 21.5 inches. Working width was 30.0 inches, and vehicle intrusion was 28.8 inches.

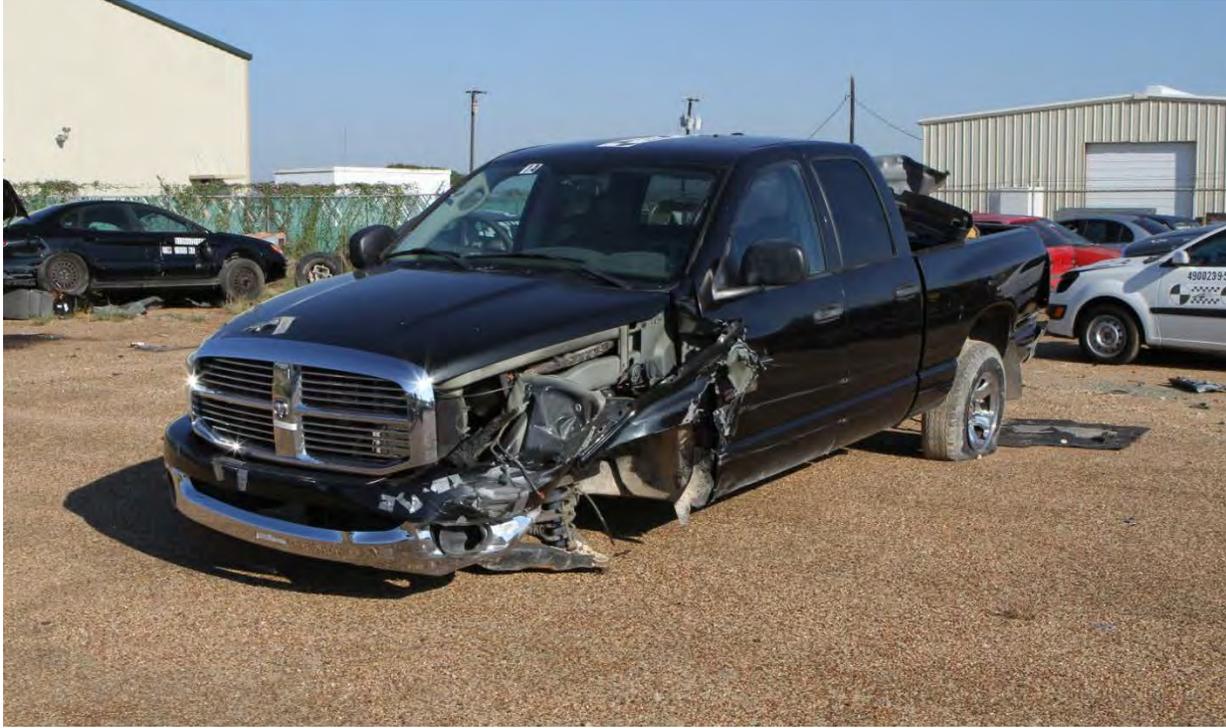
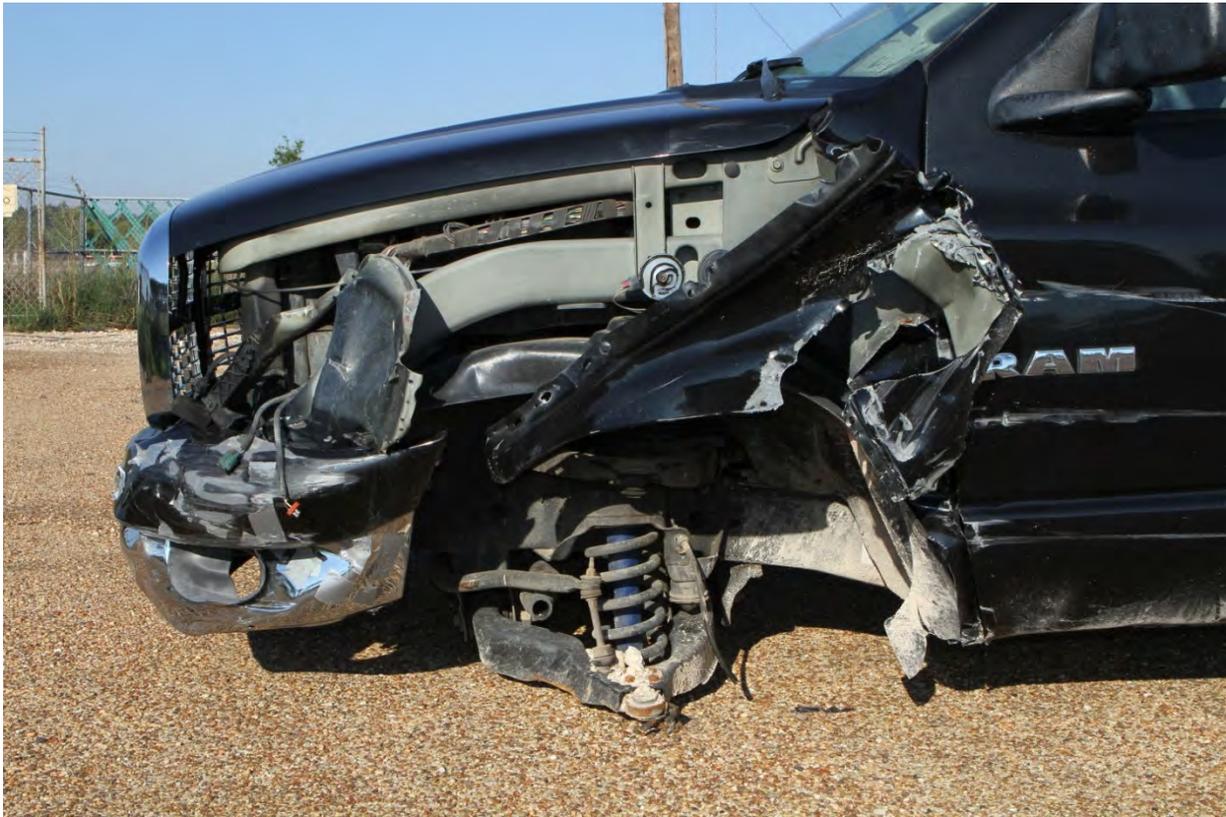
Figure 5.5. Vehicle after Test No. 490023-6-1a.

Figure 5.5 shows damage to the exterior of the vehicle. The left front wheel assembly broke from the upper and lower ball joints; the left upper and lower ball joints, A-arms, and left front tie rod end were deformed. Also damaged were the front bumper, left front fender, left front brake line, left front door, left front tire and wheel rim, left rear tire, left rear exterior bed, and the left rear bumper. Maximum exterior crush to the vehicle was 6 inches in the side plane at the left front corner at bumper height. No occupant compartment deformation or intrusion occurred. Figure 5.6 provides photographs of the interior of the vehicle. Tables C3 and C4 in Appendix C provide exterior crush and occupant compartment measurements.

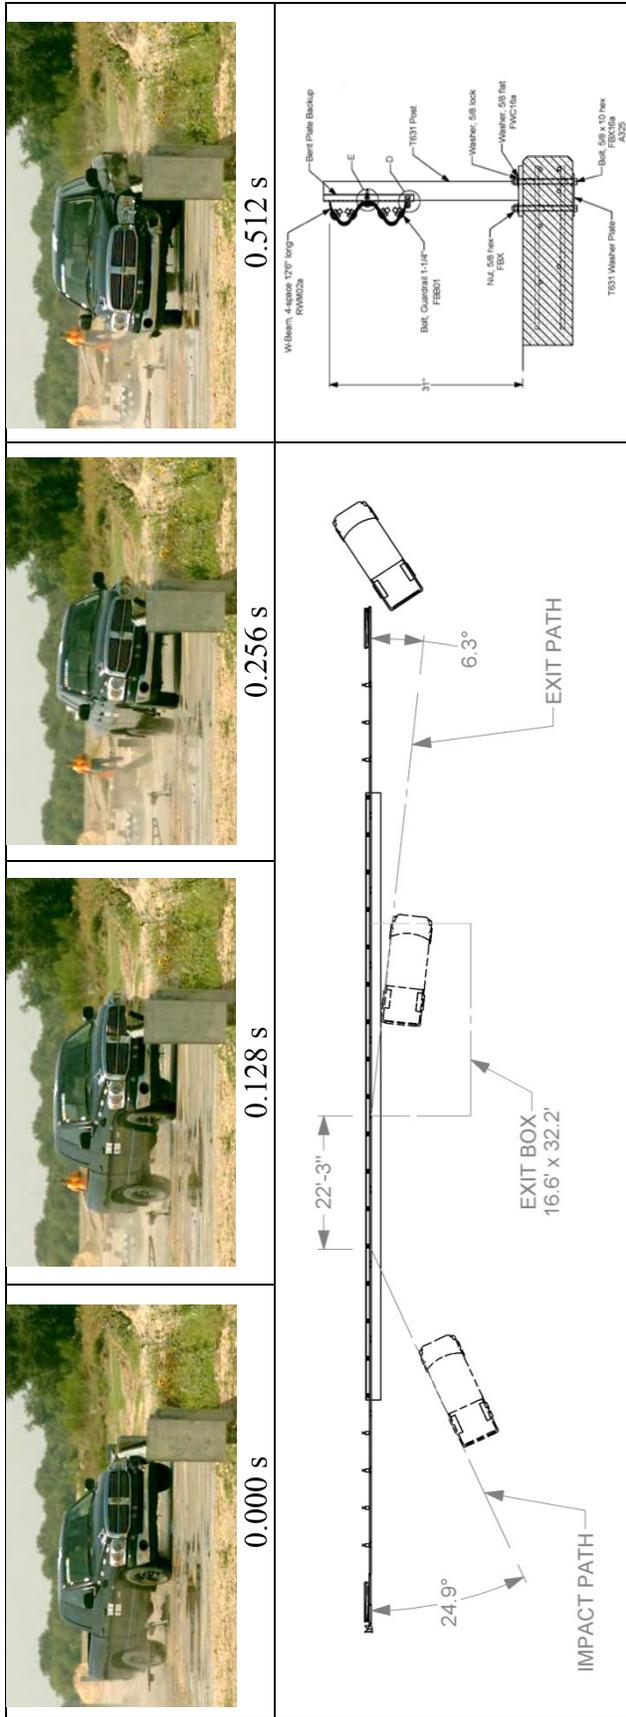
General Information		Post-Impact Trajectory
Test Agency	Texas A&M Transportation Institute (TTI)	Stopping Distance
Test Standard	MASH Test 2-11	119 ft downstrm
TTI Test No.	490023-6-1a	2 ft twd traffic
Test Date	2013-08-08	
Test Article		Vehicle Stability
Type	Bridge Rail	Maximum Yaw Angle
Name	TxDOT T631 Bridge Rail	35 degrees
Installation Length	168.75 ft	Maximum Pitch Angle
Material or Key Elements	S3x5.7 A992 structural steel posts welded to base plates bolted through the bridge deck cantilever	3 degrees
	Concrete Deck, Dry	Maximum Roll Angle
		6 degrees
		Vehicle Snagging
		No
		Vehicle Pocketing
		No
Soil Type and Condition		Test Article Deflections
Type/Designation	2270P	Dynamic
Make and Model	2008 Dodge Ram 1500 Pickup	25.7 inches
Curb	5094 lb	Permanent
Test Inertial	5050 lb	21.5 inches
Dummy	No Dummy	Working Width
Gross Static	5050 lb	30.0 inches
		Vehicle Intrusion

28.8 inches
		Vehicle Damage
		VDS
		11LFQ5
		CDC
		11LDEW4
		Max. Exterior Deformation
		6 inches
		OCDI
		LF00000000
		Max. Occupant Compartment Deformation
		None

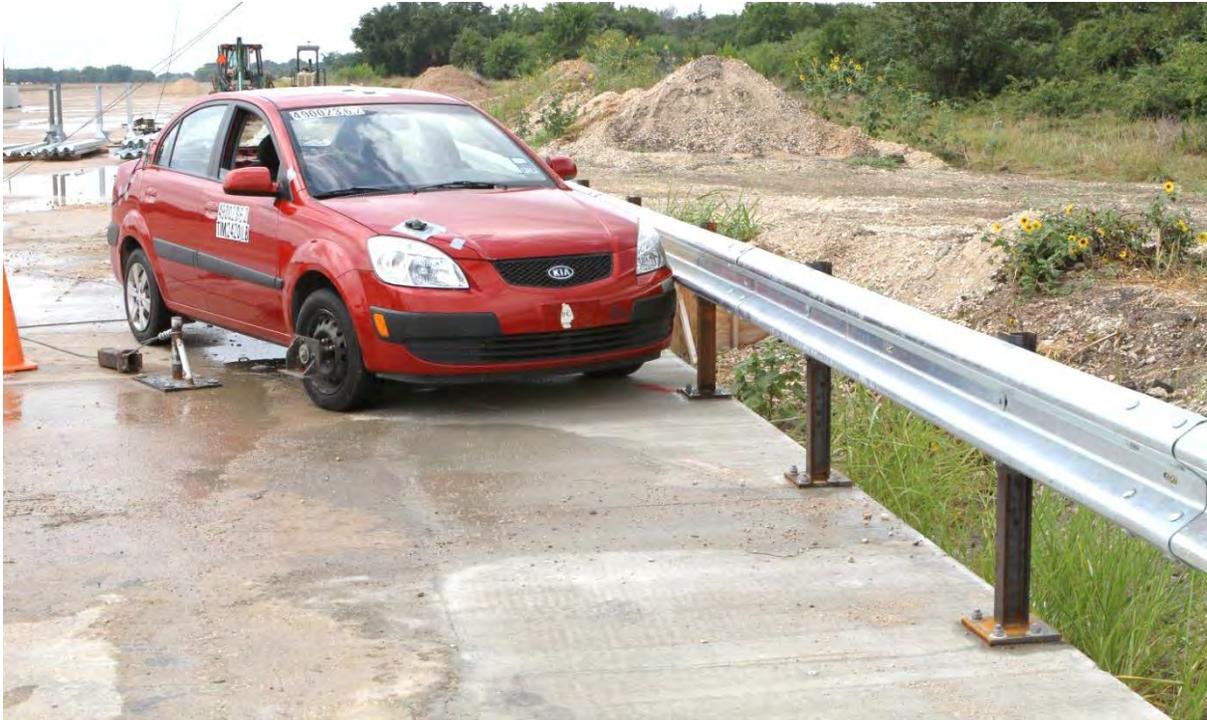
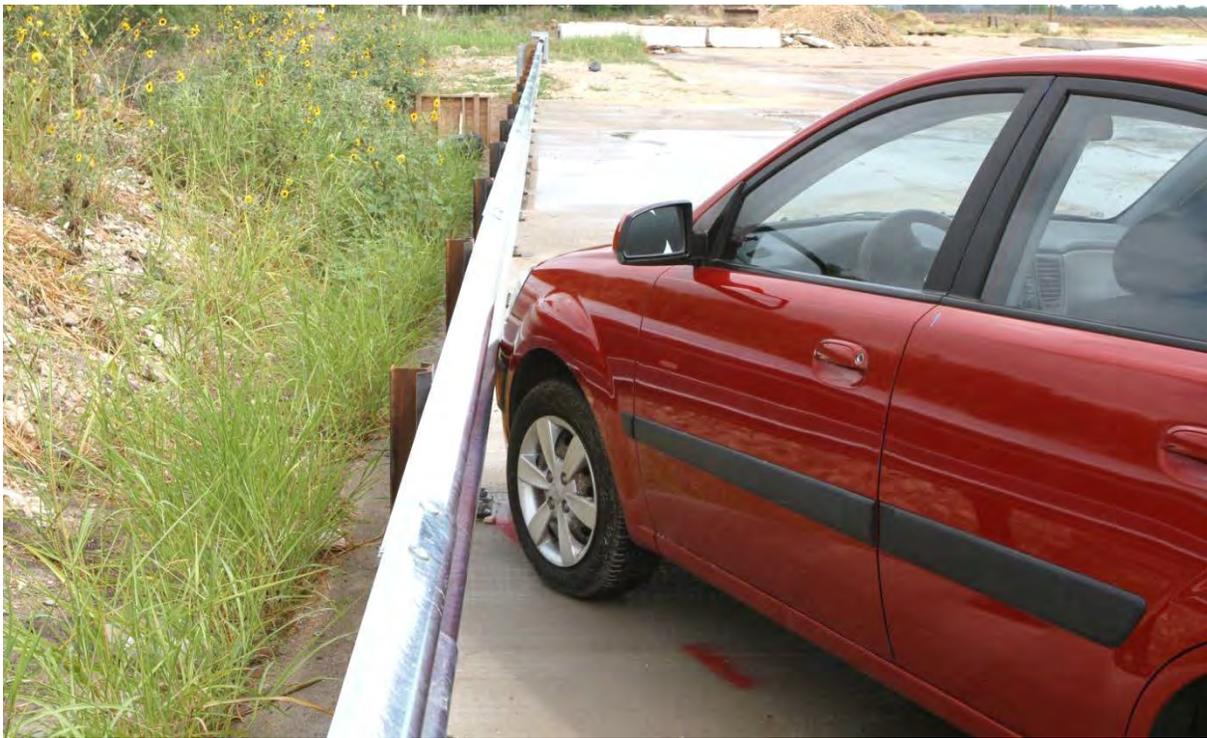
Figure 6.1. Vehicle/Installation Geometrics for Test No. 490023-6-2.

Figures 6.1 and 6.2 show the 2008 Kia Rio used for the crash test. Test inertia weight of the vehicle was 2421 lb, and its gross static weight was 2586 lb. The height to the lower edge of the vehicle bumper was 6.75 inches, and it was 21.50 inches to the upper edge of the bumper. Table D1 in Appendix D gives additional dimensions and information on the vehicle. The vehicle was directed into the installation using the cable reverse tow and guidance system, and was released to be free-wheeling and unrestrained just prior to impact.

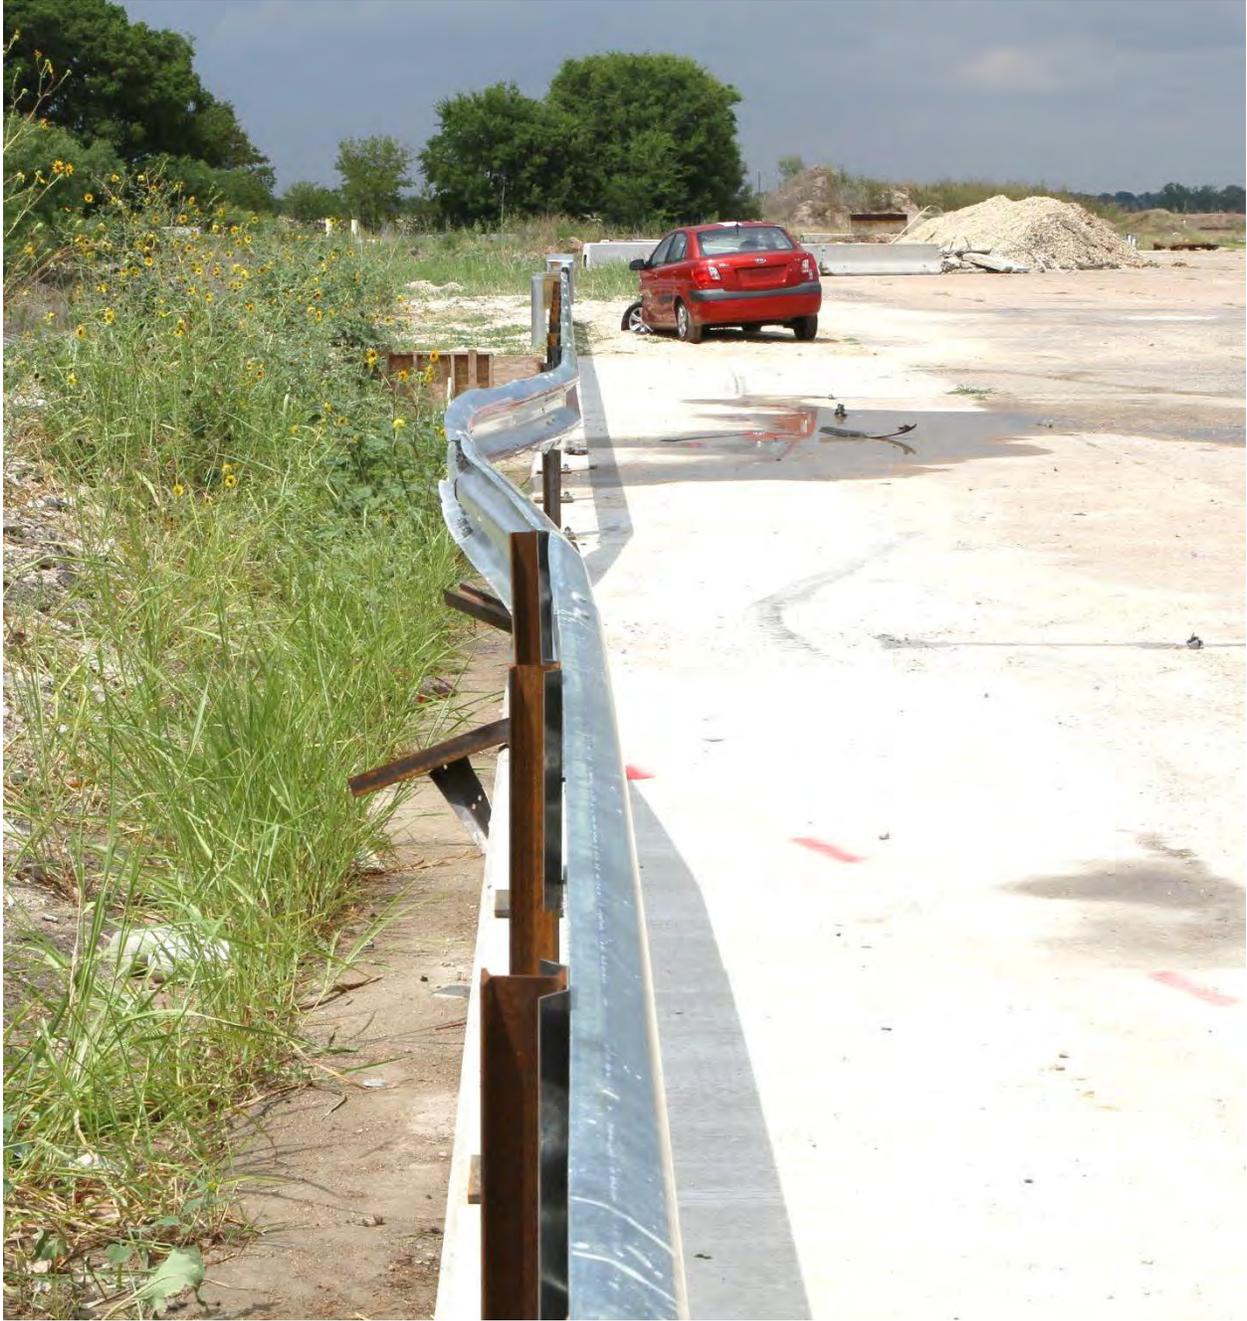
Figure 6.3. Test Article/Vehicle Positions after Test No. 490023-6-2.

The 2008 Kia Rio, traveling at an impact speed of 43.8 mi/h, impacted the T631 bridge rail 6 ft 3 inches upstream of Post 11 at an impact angle of 25.2 degrees. At approximately 0.038 s, the left front tire contacted Post 10, and at 0.061 s, the rail element detached from Post 10. The left front tire reached the edge of the bridge deck by 0.086 s and began to drop downward. At 0.105 s, the rail element pulled away from Post 11, and at 0.156 s, the bumper contacted the bridge deck. The rail element separated from Post 12 at 0.232 s and caught on the left front tire. By 0.242 s, the vehicle contacted Post 12, and at 0.339 s, the left rear tire rode over the base of Post 11. At 0.345 s, the vehicle was traveling parallel with the guardrail. The left front tire contacted Post 13, which detached from the rail element, and the left rear tire rode over the base of Post 13 at 0.550 s. At 0.638 s, the vehicle lost contact with the rail element and was traveling at an exit speed and angle of 20.1 mi/h and 9.3 degrees, respectively. Brakes on the vehicle were not applied, and the vehicle came to rest 49 ft downstream of impact and 3 ft in front of the traffic face of the guardrail. Figures D1 and D2 in Appendix D show sequential photographs of the test period.

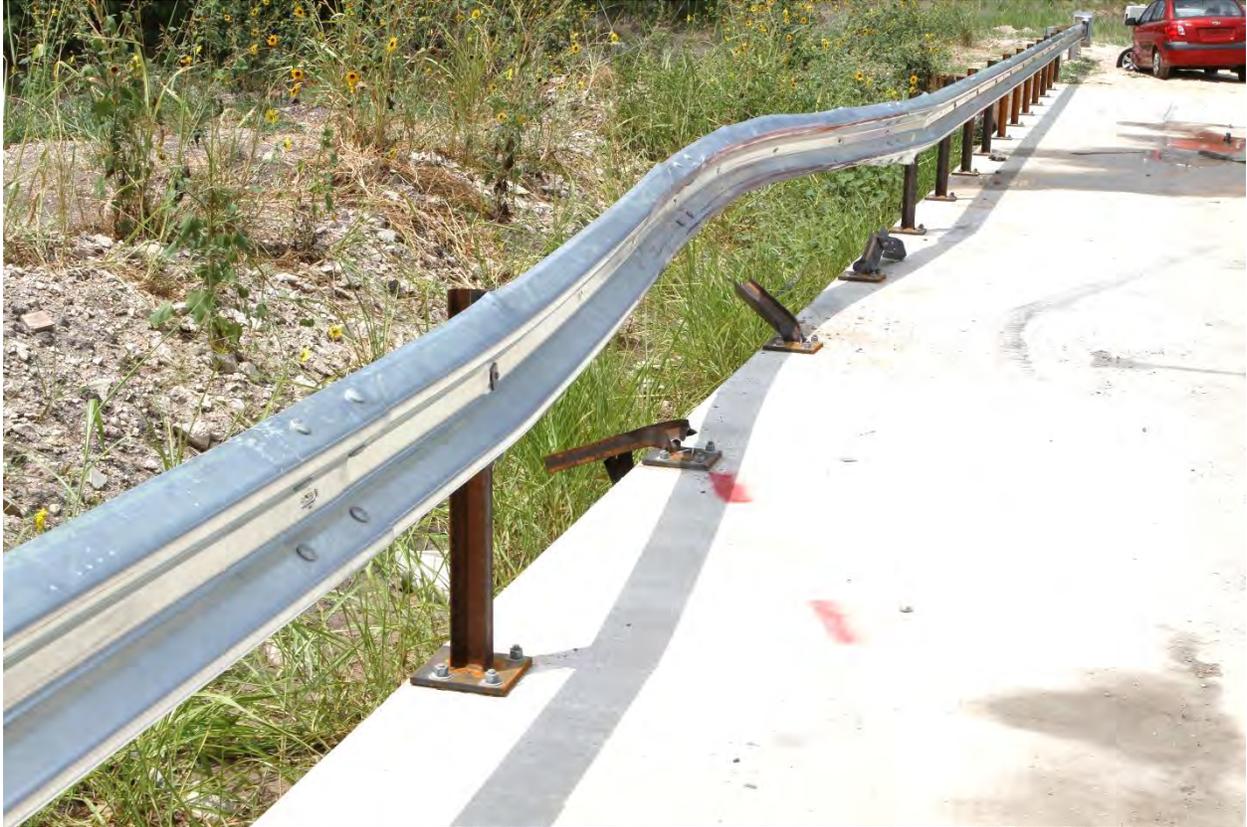
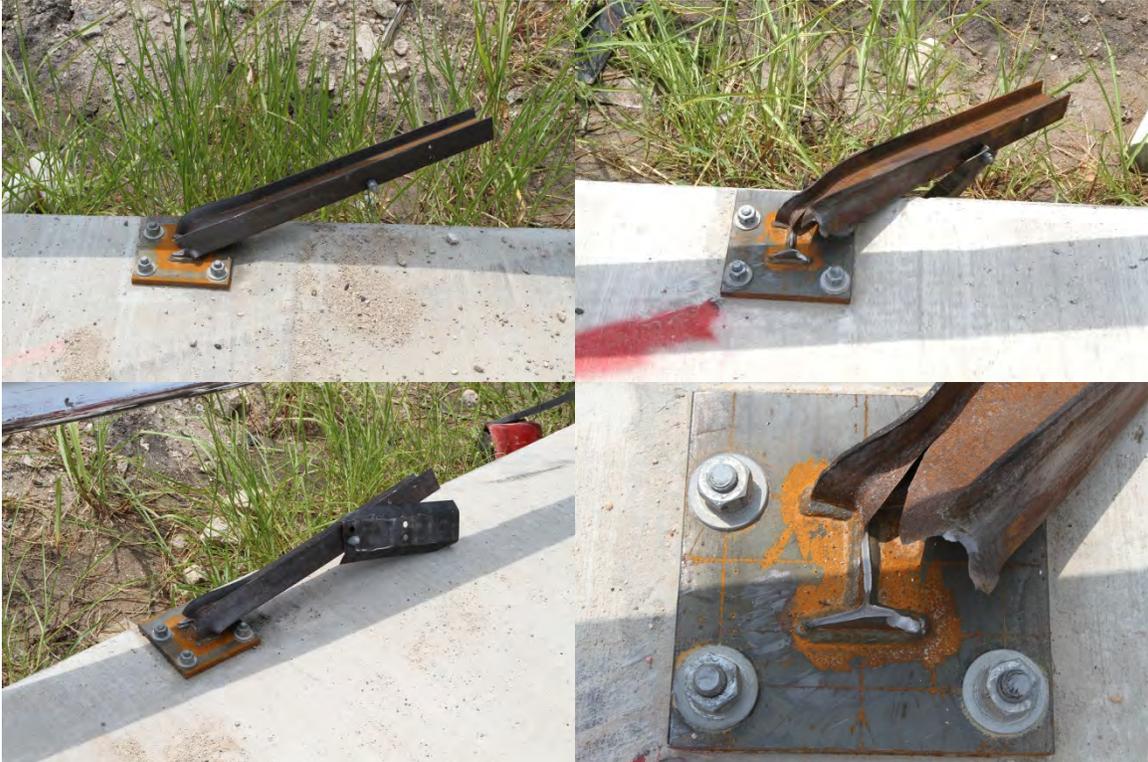
Figure 6.4. Installation after Test No. 490023-6-2.

Post 9 was leaning towards the field side 4 degrees. Post 10 was leaning towards the field side 95 degrees and the front flange and webbing were torn. Post 11 was leaning downstream 85 degrees and towards the field side 10 degrees; the front flange was partially torn, and the backup plate released. Post 12 was leaning downstream 85 degrees and the back flange was partially torn. Post 12 was leaning downstream 8 degrees. Figures 6.3 and 6.4 show damage to the installation. The 1100C vehicle was in contact with the bridge rail 17.8 ft. Maximum dynamic deflection of the bridge rail during the test was 22.6 inches, and maximum permanent deformation was 15.0 inches. Working width was 25.5 inches, and vehicle penetration was 30.3 inches.

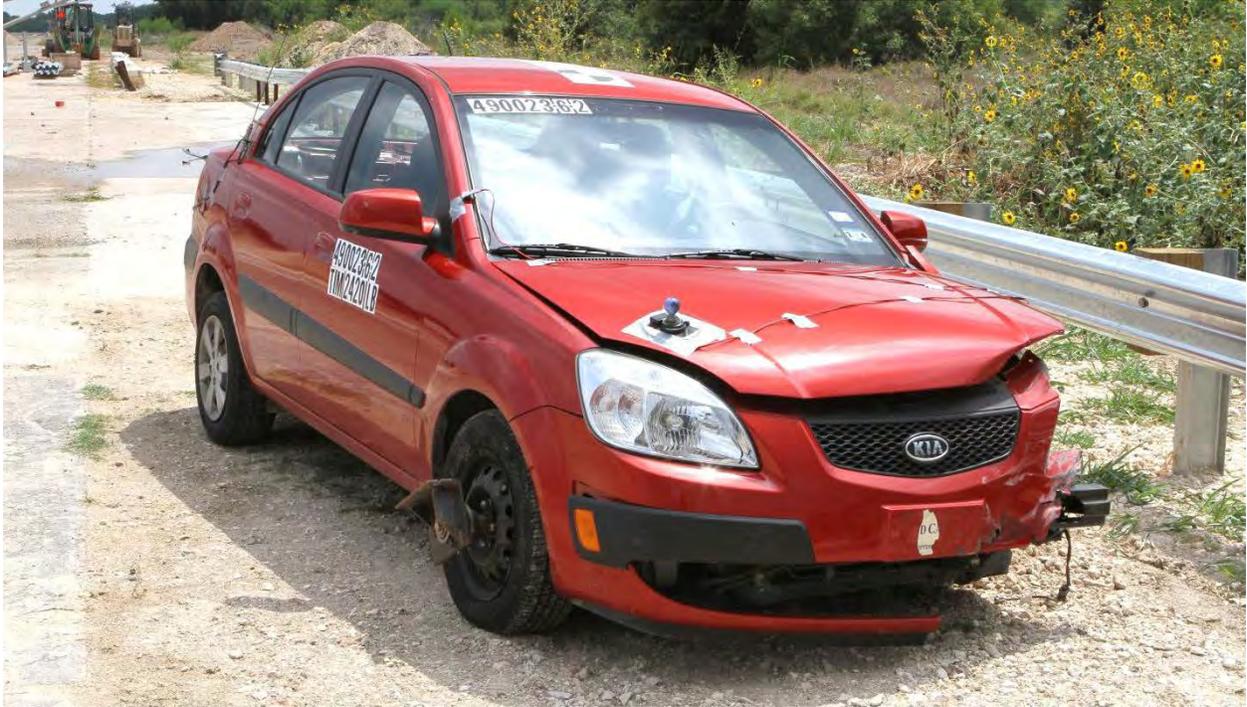
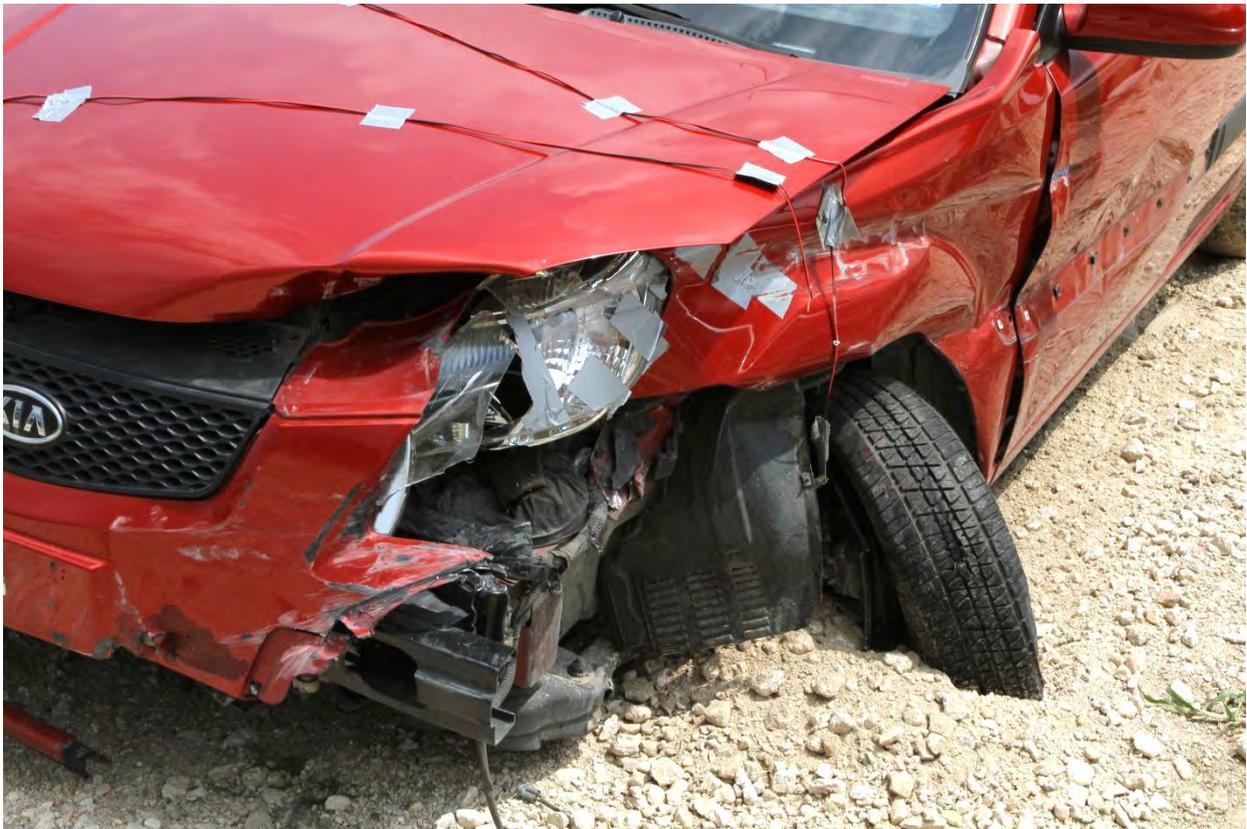
Figure 6.5. Vehicle after Test No. 490023-6-2.

Figure 6.5 shows damage to the 1100C vehicle. The left strut, strut tower, and left tie rod end were deformed. Also damaged were the front bumper, hood, left front fender, left front tire and wheel rim, and the left front door. Maximum exterior crush to the vehicle was 9.5 inches in the side plane at the left front corner at bumper height. No occupant compartment deformation or intrusion occurred. Figure 6.6 provides photographs of the interior of the vehicle. Tables D3 and D4 in Appendix D provide exterior crush and occupant compartment measurements.

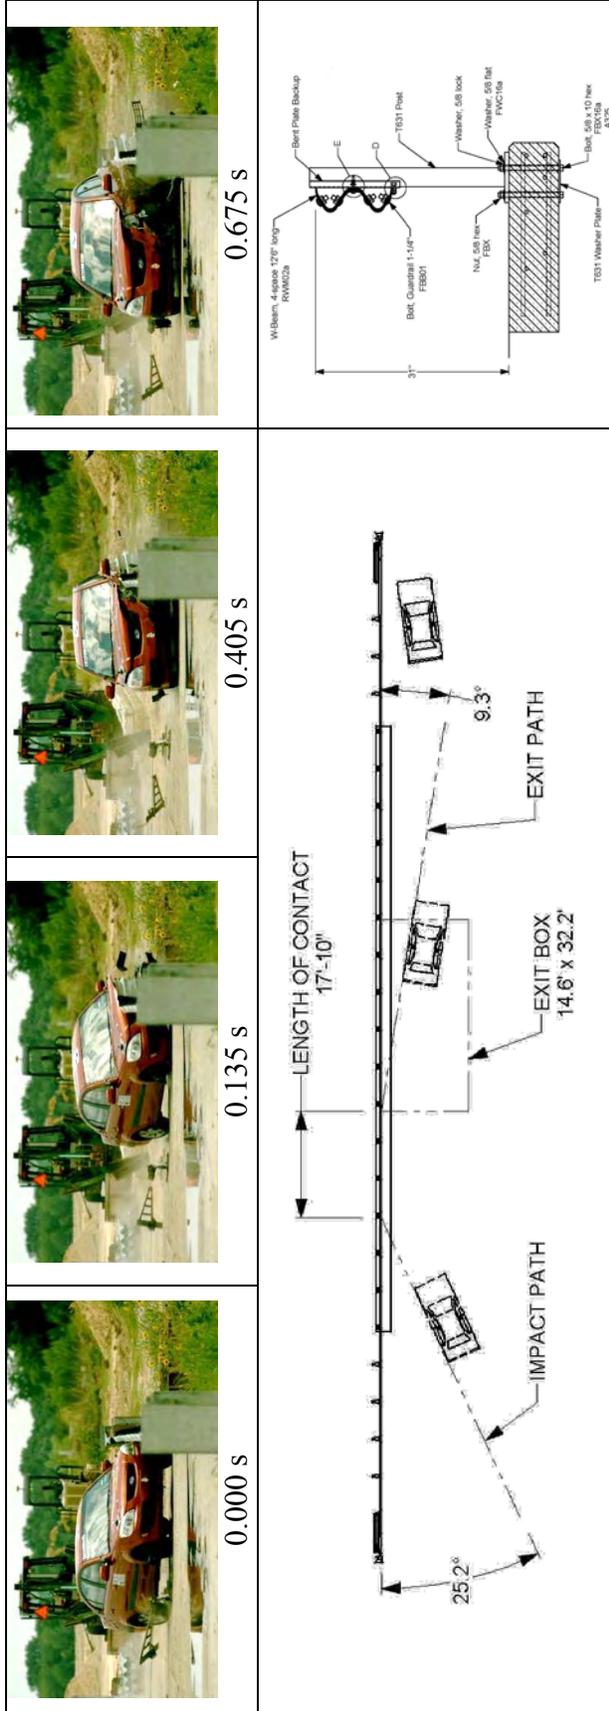
General Information	
Test Agency	Texas A&M Transportation Institute (TTI)
Test Standard Test No.	MASH Test 2-10
TTI Test No.	190023-6-2
Test Date	2013-08-15
Test Article	
Type	Bridge Rail
Name	TxDOT T631 Bridge Rail
Installation Length	168.75 ft
Material or Key Elements
Soil Type and Condition	
Type/Designation	Concrete Deck, Dry
Make and Model	1100C
Curb	2008 Kia Rio
Test Inertial	2418 lb
Dummy	2421 lb
Gross Static	165 lb
	2586 lb
Impact Conditions	
Speed	43.8 mi/h
Angle	25.2 degrees
Location/Orientation	Post 10
Impact Severity	28.1 kip-ft
Exit Conditions	
Speed	20.1 mi/h
Angle	9.3 degrees
Occupant Risk Values	
Impact Velocity	
Longitudinal	20.3 ft/s
Lateral	5.3 ft/s
Ridedown Accelerations	
Longitudinal	6.7 G
Lateral	5.3 G
THIV	23.7 km/h (6.6 m/s)
PHD	7.0 G
ASI	0.62
Max. 0.050-s Average	
Longitudinal	-4.9 G
Lateral	3.3 G
Vertical	1.8 G
Impact Conditions	
Speed	43.8 mi/h
Angle	25.2 degrees
Location/Orientation	Post 10
Impact Severity	28.1 kip-ft

Exit Conditions	
Speed	20.1 mi/h
Angle	9.3 degrees
Occupant Risk Values	
Impact Velocity	
Longitudinal	20.3 ft/s
Lateral	5.3 ft/s
Ridedown Accelerations	
Longitudinal	6.7 G
Lateral	5.3 G
THIV	23.7 km/h (6.6 m/s)
PHD	7.0 G
ASI	0.62
Max. 0.050-s Average	
Longitudinal	-4.9 G
Lateral	3.3 G
Vertical	1.8 G
Post-Impact Trajectory	
Stopping Distance	49 ft downstrm
	3 ft twd traffic
Vehicle Stability	
Maximum Yaw Angle	35 degrees
Maximum Pitch Angle	3 degrees
Maximum Roll Angle	7 degrees
Vehicle Snagging	No
Vehicle Pocketing	No
Test Article Deflections	
Dynamic	22.6 inches
Permanent	15.0 inches
Working Width	25.5 inches
Vehicle Intrusion	30.3 inches
Vehicle Damage	
VDS	11LFQ4
CDC	11FLEW4
Max. Exterior Deformation	9.5 inches
OCDI	LF0000000
Max. Occupant Compartment Deformation	None
