CRASH TEST AND EVALUATION OF THE TxDOT T631 BRIDGE RAIL

Test Report 9-1002-12-10

The objective of this research was to evaluate the impact performance of the new TxDOT Type T631 bridge rail. The TxDOT Type T631 bridge rail is intended to serve as a low-cost replacement for the TxDOT Type T6 bridge rail for *MASH* TL-2 applications. The TxDOT T631 bridge rail is intended for new construction. The crash testing was performed in accordance with the requirements of *MASH* TL-2.

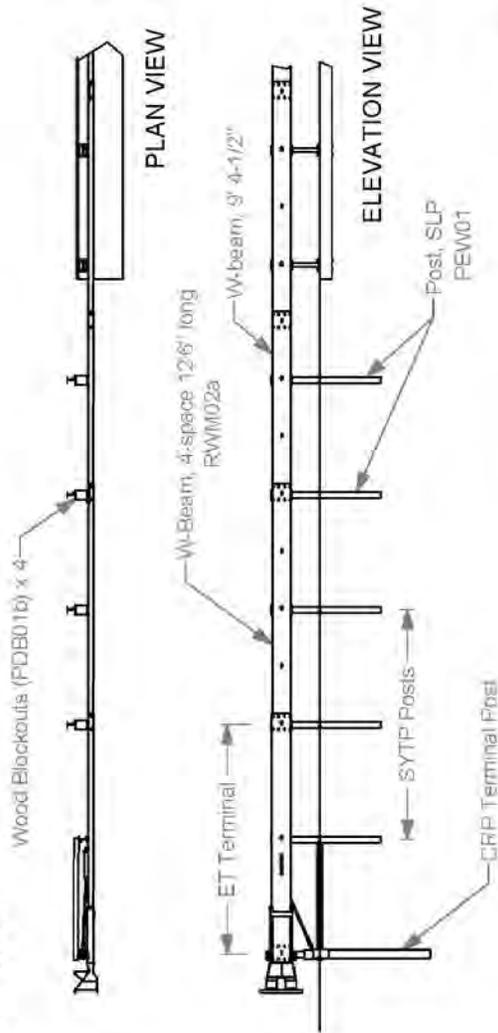
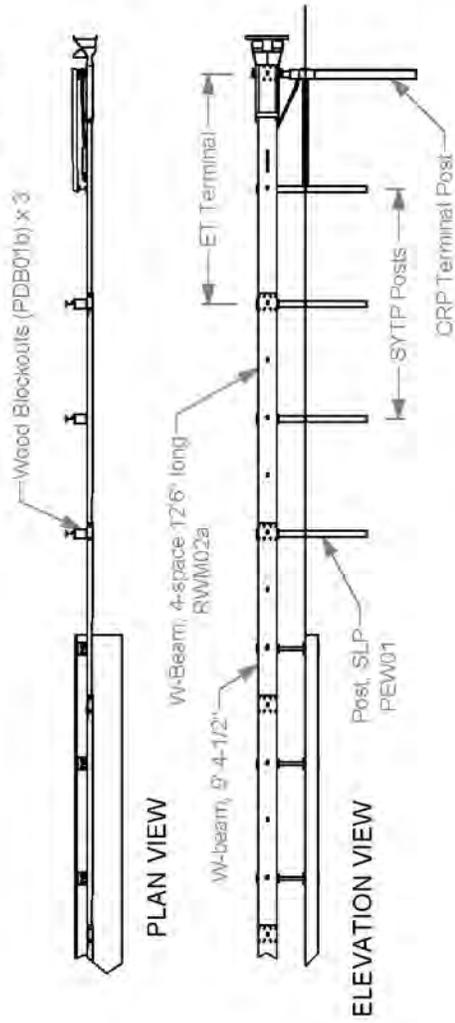
Project 490023-6 T631 TL-2 Bridge Rail 2013-08-08
Drawn By GES Scale: 1:100 Sheet 3 of 6 Rail End Details

END DETAILS

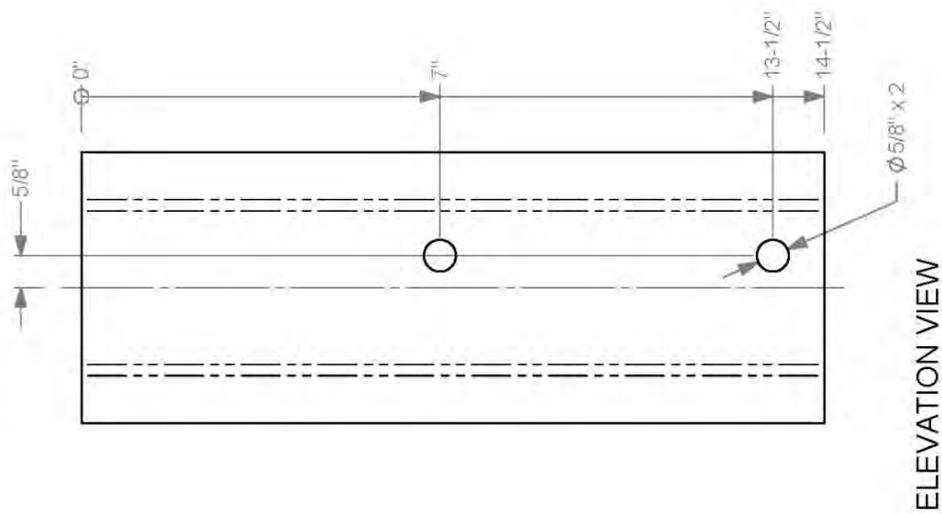
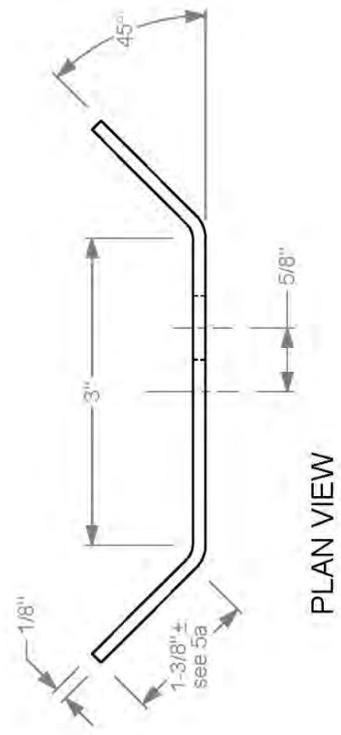
Roadside Safety and Physical Security Division - Proving Ground		2013-08-08
	Project 490023-6	T631 TL-2 Bridge Rail	Sheet 5 of 6
Drawn By	GES	No Scale	Bent Plate

Bent Plate Backup

5a. This dimension is approximate. Part is made from 6" wide A36 plate. Use Industry Standard for bend radius.

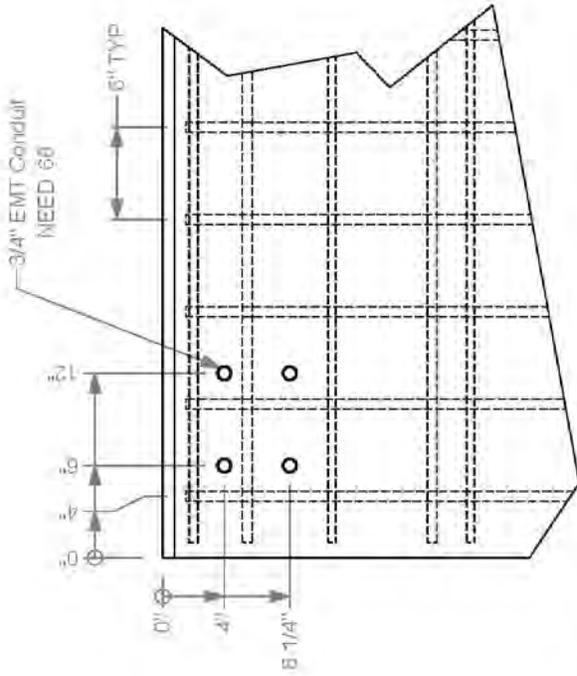
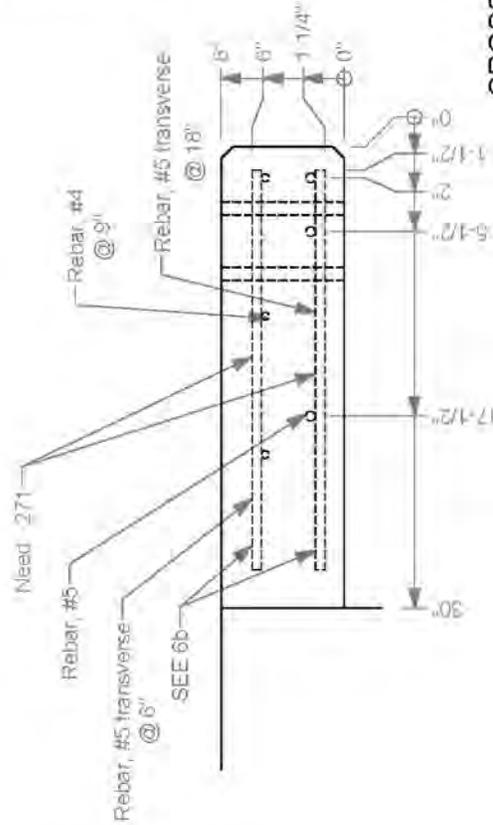
CONCRETE AND REBAR DETAILS

- 6a. Concrete is Class S (4000 psi). Rebar is grade 60. Minimum rebar laps are 15" for #4 bars (top mat) and 19" for #5 bars (bottom mat).
- 6b. Transverse Bars weld to existing rebar protruding from the runway (not shown)
- 6c. Chamfer exposed edges of the deck 3/4".

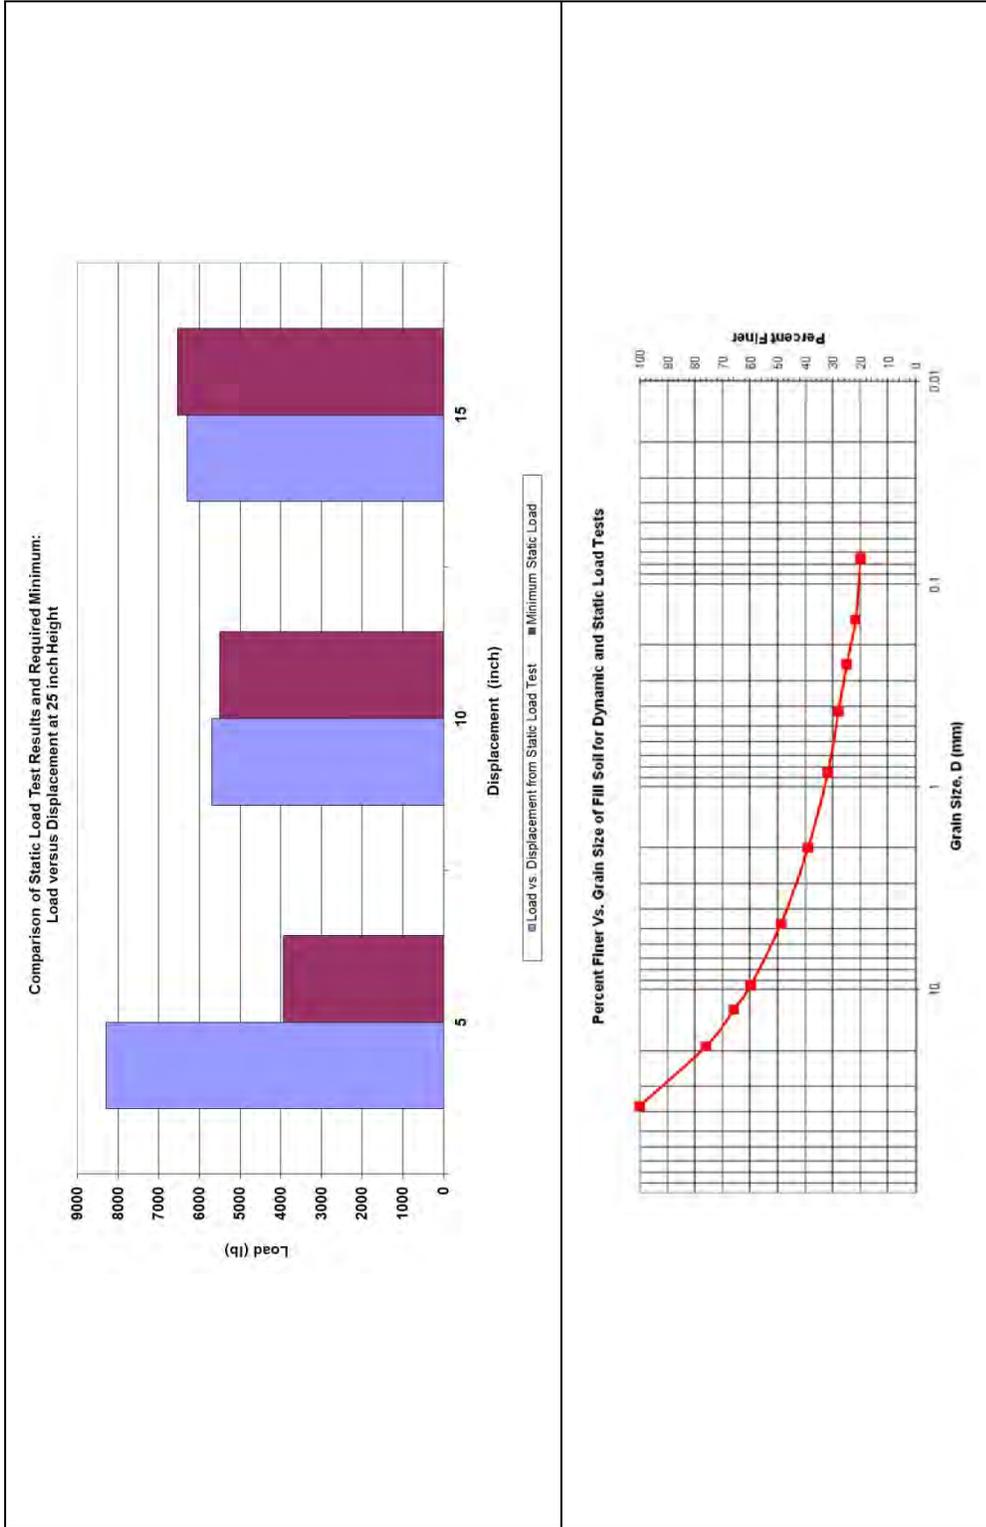
Figure C2. Test Day Static Soil Strength Documentation for Test No. 490023-6-1a.

Description of Fill Placement Procedure 6-inch lifts tamped with a pneumatic compactor

On the day of Test No. 490023-1a, August 13, 2013, load on the post at deflections of 5 inches, 10 inches, and 15 inches was 8300 lbf, 5700 lbf, and 6300 lbf, respectively. The strength of the backfill material was slightly below minimum requirements at 15 inches (see [Figure C2](#) in [Appendix C](#)); however, the soil was considered appropriate for testing. On the day of Test No. 490023-2, August 15, 2013, load on the post at deflections of 5 inches, 10 inches, and 15 inches was 7800 lbf, 8838 lbf, and 7926 lbf, respectively. The strength of the backfill material met minimum requirements (see [Figure C3](#) in [Appendix C](#)).

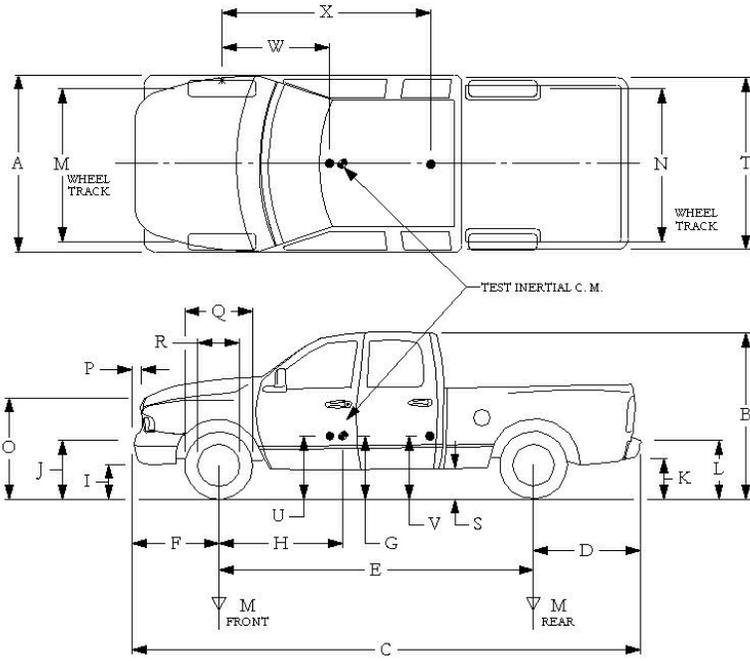
A	<u>78.25</u>	F	<u>36.00</u>	K	<u>19.50</u>	P	<u>3.88</u>	U	<u>28.75</u>
B	<u>76.00</u>	G	<u>28.25</u>	L	<u>29.00</u>	Q	<u>30.50</u>	V	<u>31.50</u>
C	<u>225.75</u>	H	<u>61.68</u>	M	<u>68.50</u>	R	<u>18.38</u>	W	<u>61.60</u>
D	<u>47.25</u>	I	<u>15.50</u>	N	<u>68.00</u>	S	<u>16.00</u>	X	<u>75.00</u>
E	<u>140.50</u>	J	<u>27.50</u>	O	<u>46.00</u>	T	<u>77.50</u>		
	Wheel Center Height Front	<u>14.75</u>		Wheel Well Clearance (Front)	<u>6.00</u>		Bottom Frame Height - Front	<u>18.75</u>	
	Wheel Center Height Rear	<u>14.75</u>		Wheel Well Clearance (Rear)	<u>11.25</u>		Bottom Frame Height - Rear	<u>26.00</u>

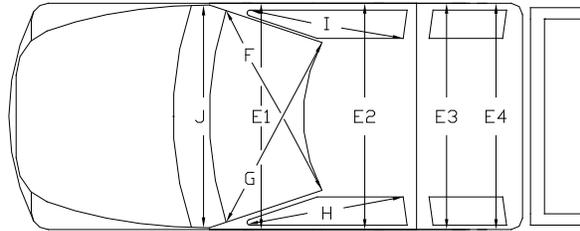
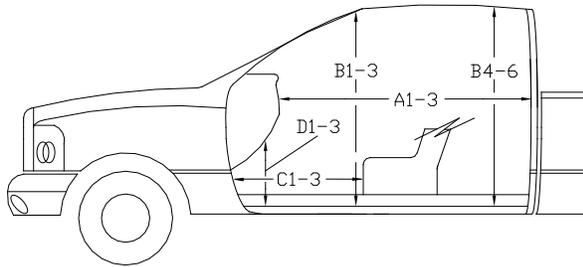
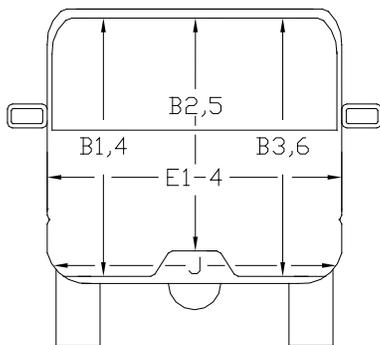
OCCUPANT COMPARTMENT DEFORMATION MEASUREMENT

Before (inches)	After (inches)
A1	64.50	64.50
A2	64.50	64.50
A3	64.50	64.50
B1	45.12	45.12
B2	42.50	42.50
B3	45.12	45.12
B4	42.00	42.00
B5	44.75	44.75
B6	42.00	42.00
C1	29.00	29.00
C2	----	----
C3	26.75	26.75
D1	13.00	13.00
D2	----	----
D3	11.75	11.75
E1	62.75	62.75
E2	64.75	64.75
E3	64.12	64.12
E4	64.50	64.50
F	60.00	60.00
G	60.00	60.00
H	39.00	39.00
I	39.00	39.00
J*	62.17	62.17

*Lateral area across the cab from driver's side kick panel to passenger's side kick panel.

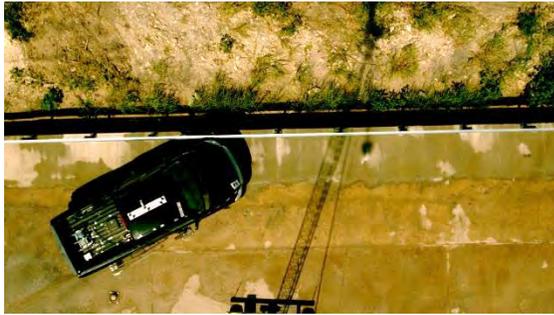
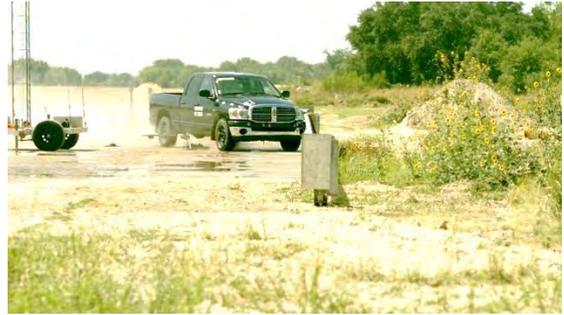
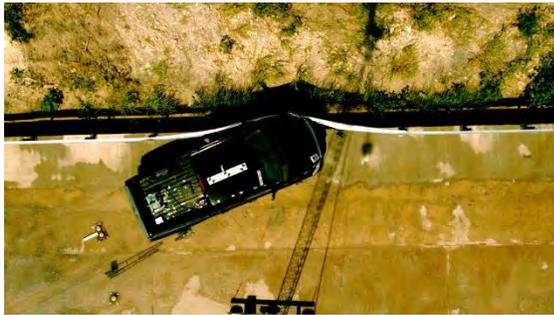
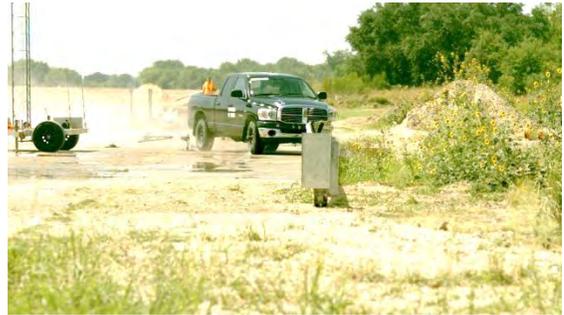
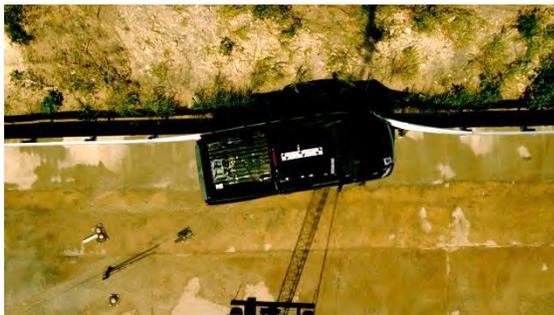
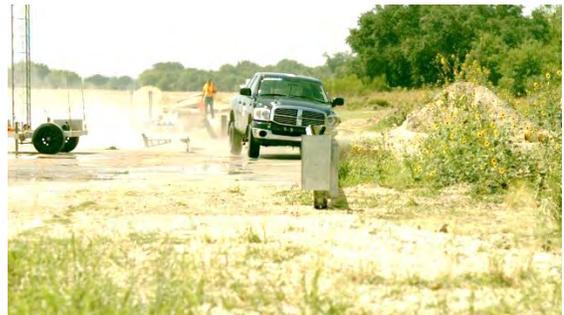
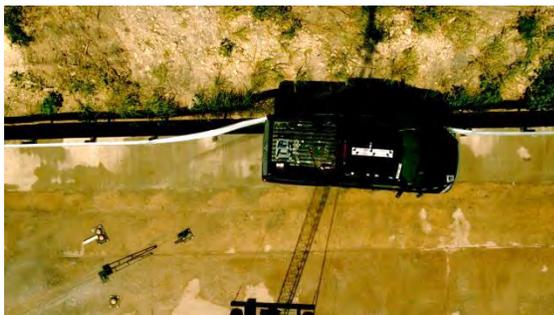
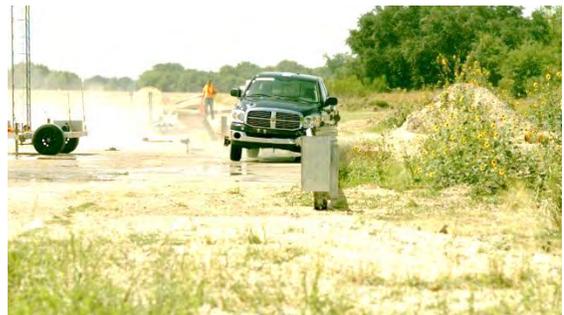
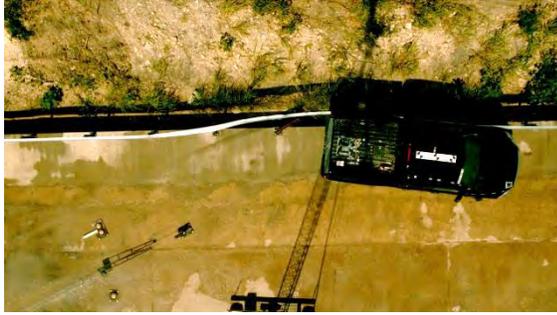
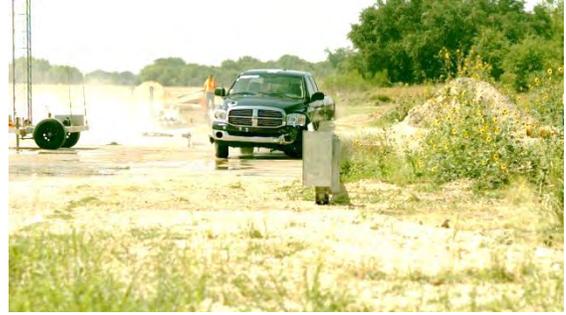
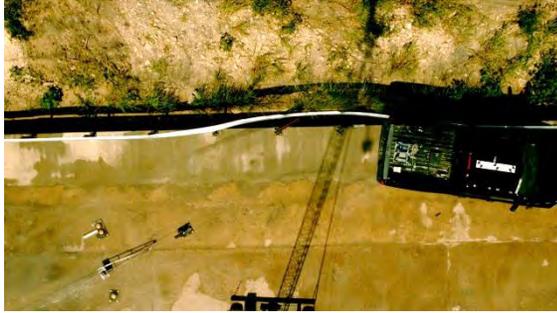
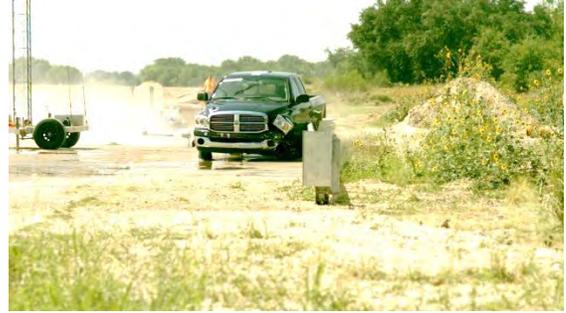
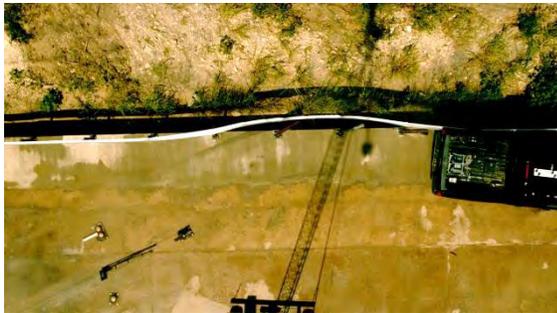
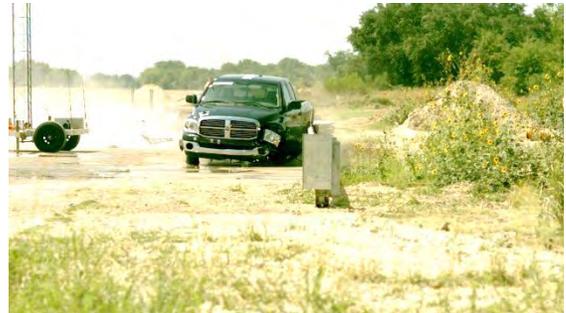
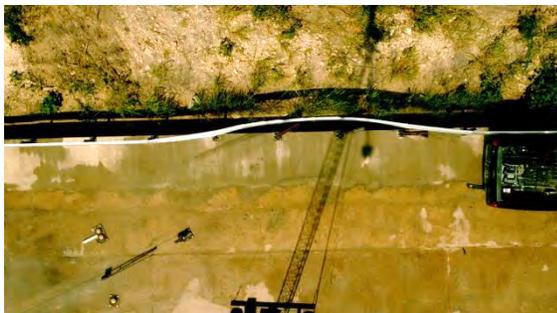
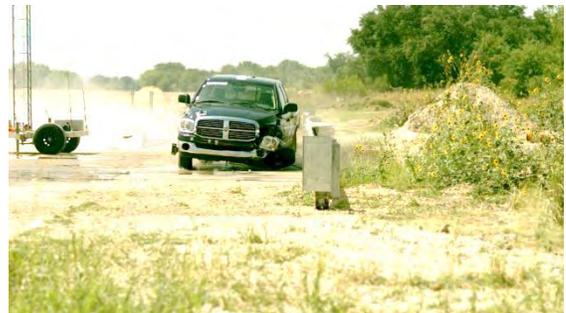
Figure D1. Sequential Photographs for Test No. 490023-6-1a (Overhead and Frontal Views).

**Figure D1. Sequential Photographs for Test No. 490023-6-1a
(Overhead and Frontal Views) (continued).**

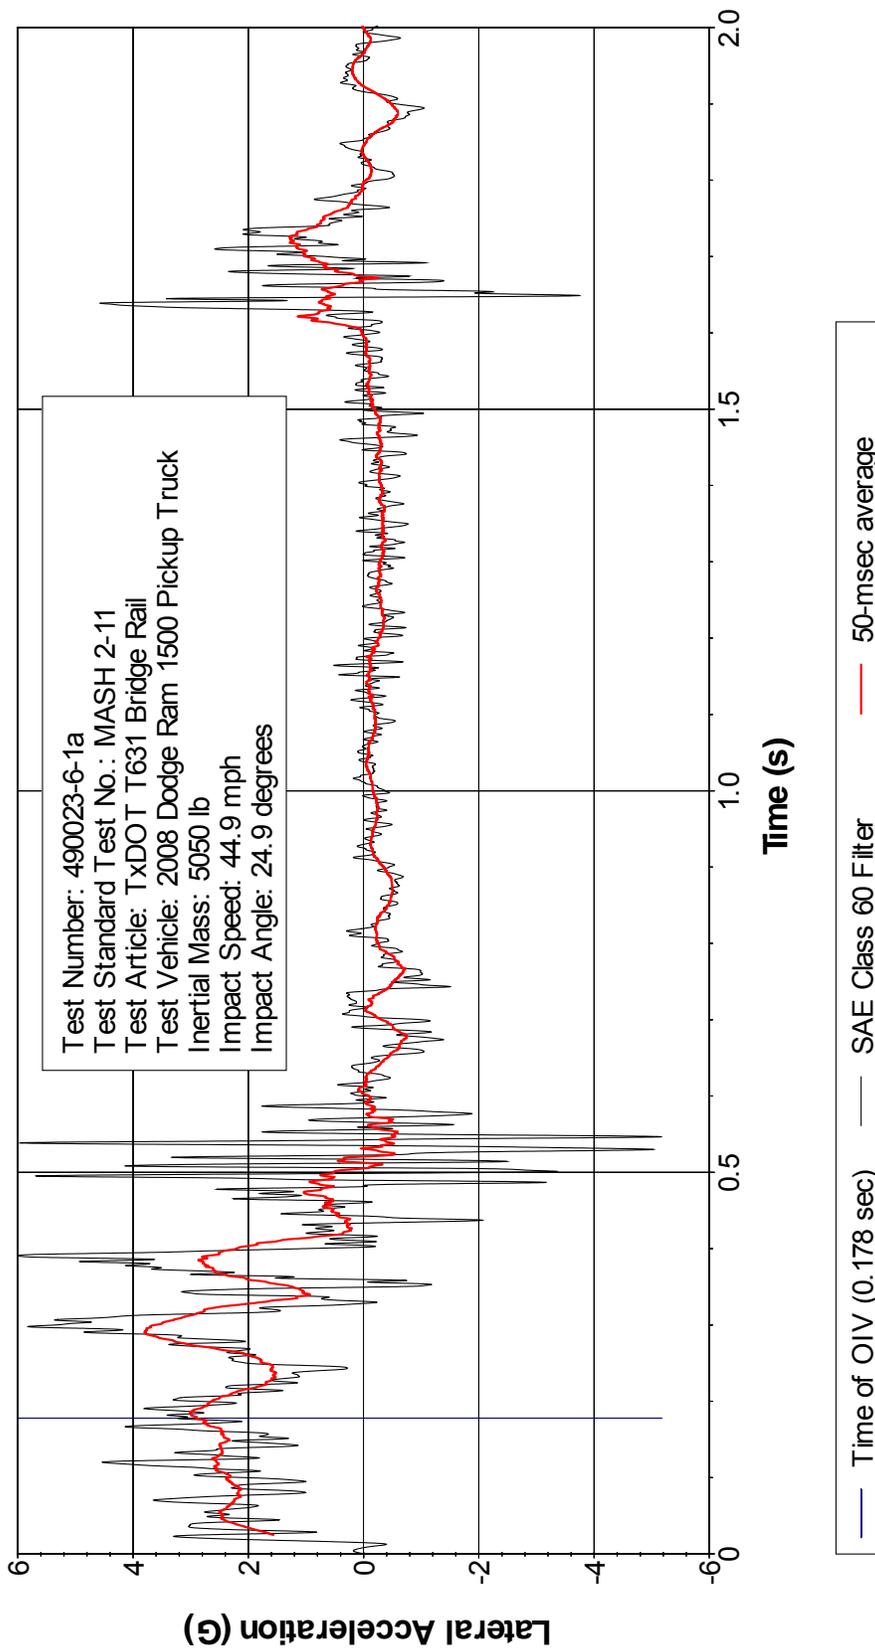
Figure D5. Vehicle Lateral Accelerometer Trace for Test No. 490023-6-1a (Accelerometer Located at Center of Gravity).

Y Acceleration at CG

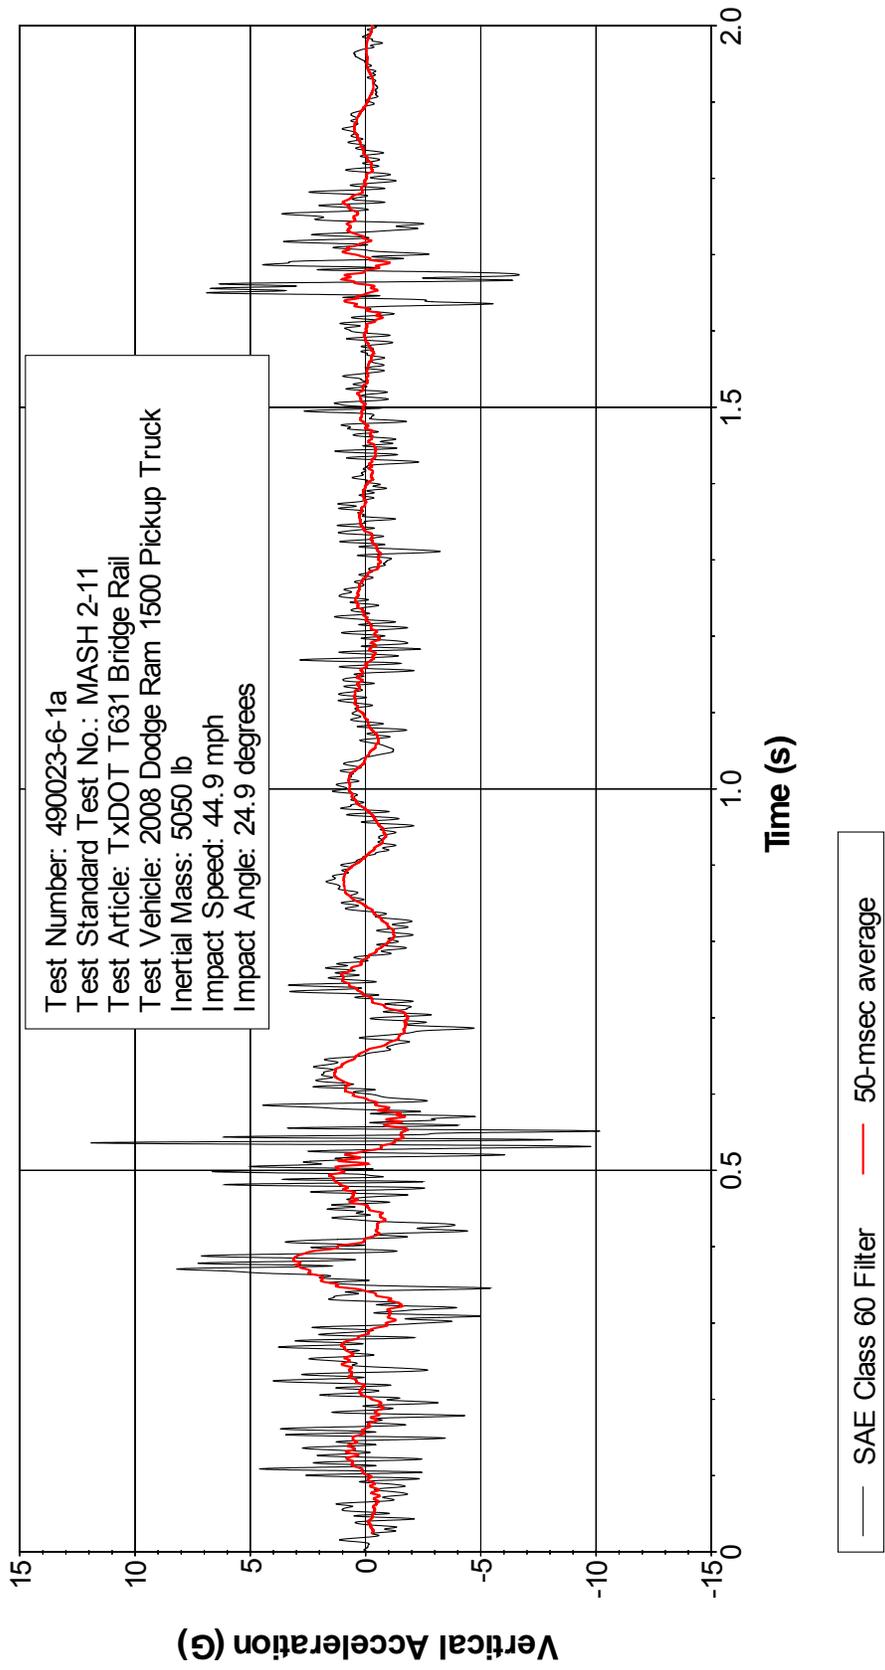
Figure D6. Vehicle Vertical Accelerometer Trace for Test No. 490023-6-1a (Accelerometer Located at Center of Gravity).

Z Acceleration at CG

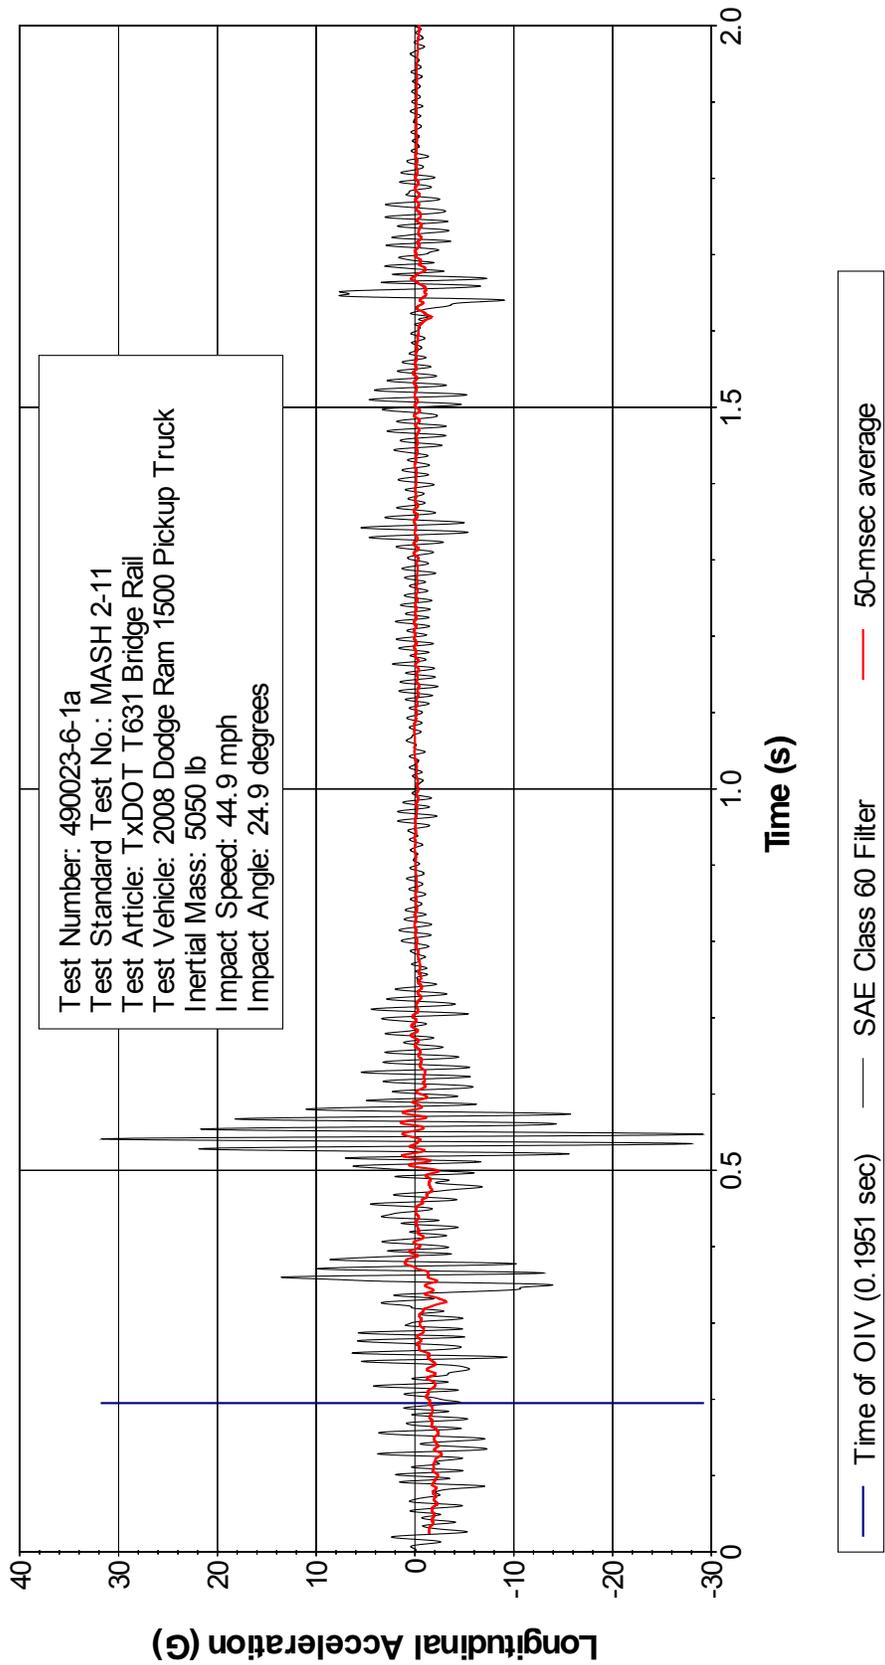
Figure D7. Vehicle Longitudinal Accelerometer Trace for Test No. 490023-6-1a (Accelerometer Located Rear of Center of Gravity).

X Acceleration Rear of CG

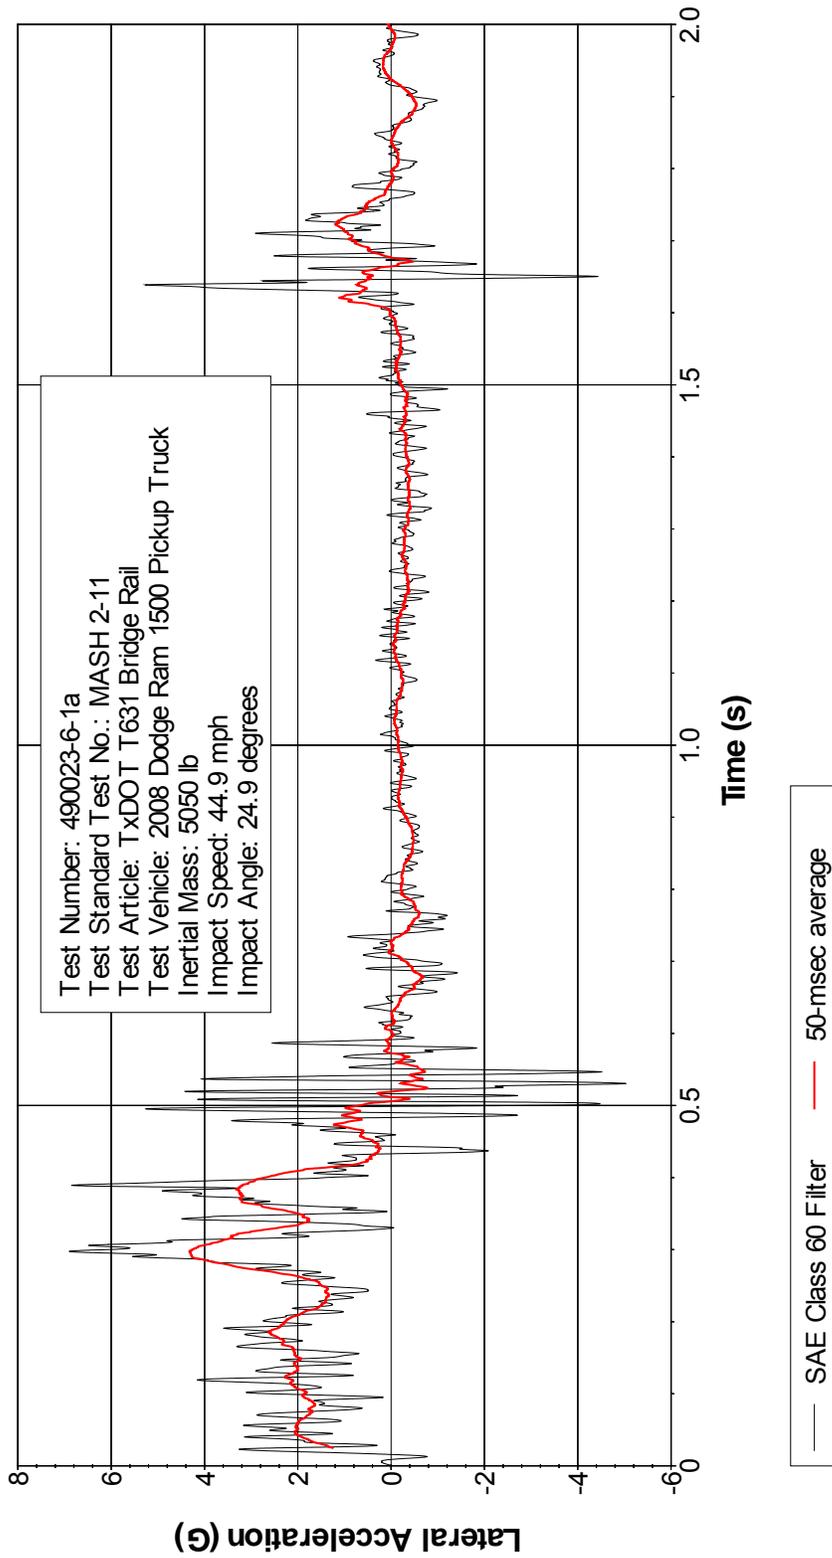
Figure D8. Vehicle Lateral Accelerometer Trace for Test No. 490023-6-1a (Accelerometer Located Rear of Center of Gravity).

Y Acceleration Rear of CG

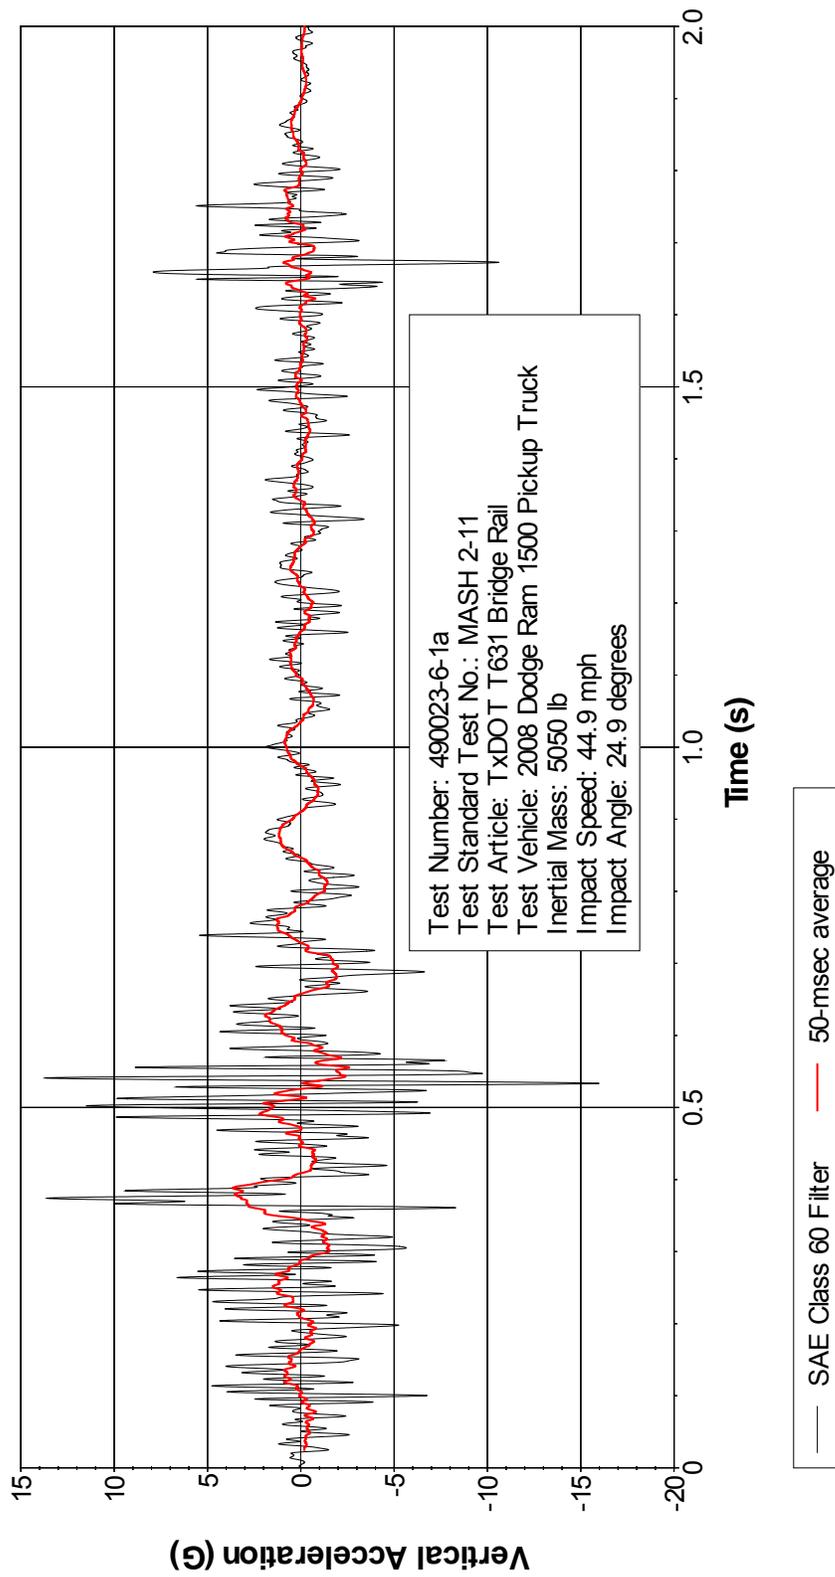
Figure D9. Vehicle Vertical Accelerometer Trace for Test No. 490023-6-1a (Accelerometer Located Rear of Center of Gravity).

Z Acceleration Rear of CG

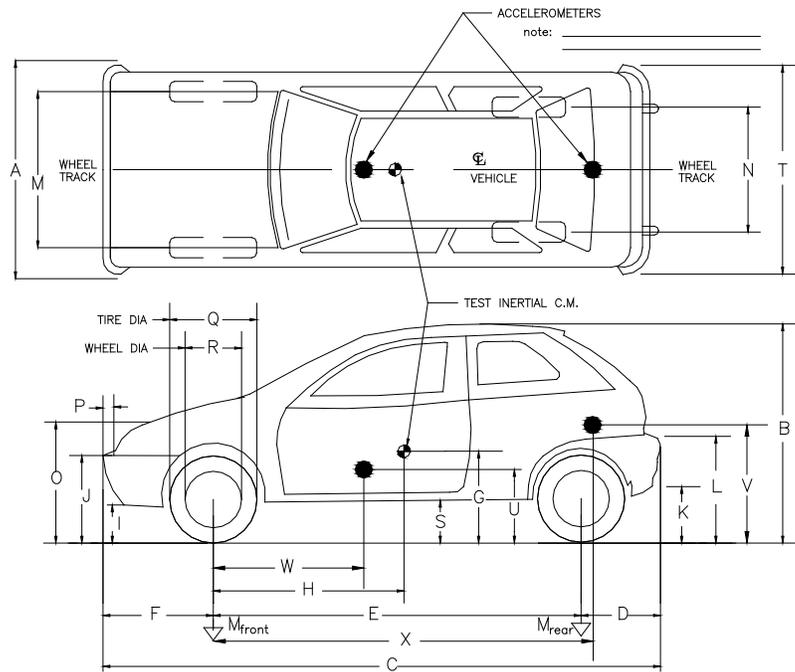
Geometry: inches

A	<u>66.38</u>	F	<u>33.00</u>	K	<u>11.25</u>	P	<u>4.12</u>	U	<u>14.00</u>
B	<u>58.00</u>	G	<u>---</u>	L	<u>24.75</u>	Q	<u>22.18</u>	V	<u>20.50</u>
C	<u>165.75</u>	H	<u>36.42</u>	M	<u>57.75</u>	R	<u>15.38</u>	W	<u>46.50</u>
D	<u>34.00</u>	I	<u>6.75</u>	N	<u>51.12</u>	S	<u>8.00</u>	X	<u>108.00</u>
E	<u>98.75</u>	J	<u>21.50</u>	O	<u>28.00</u>	T	<u>66.13</u>

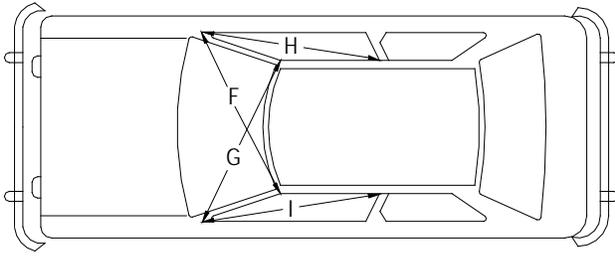
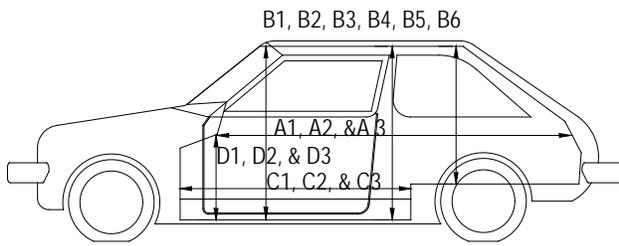
Table E3. Occupant Compartment Measurements for Test No. 490023-6-2.

OCCUPANT COMPARTMENT DEFORMATION MEASUREMENT

Before (inches)	After (inches)
A1	71.50	71.50
A2	70.50	70.50
A3	71.50	71.50
B1	42.50	42.50
B2	34.75	34.75
B3	43.00	43.00
B4	34.75	34.75
B5	35.25	35.25
B6	34.75	34.75
C1	55.00	55.00
C2	43.50	43.50
C3	55.00	55.00
D1	12.00	12.00
D2	6.75	6.75
D3	12.00	12.00
E1	53.75	53.75
E2	53.75	53.75
F	53.50	53.50
G	53.50	53.50
H	35.75	35.75
I	35.75	35.75
J*	52.75	52.75

*Lateral area across the cab from driver's side kick panel to passenger's side kick panel.

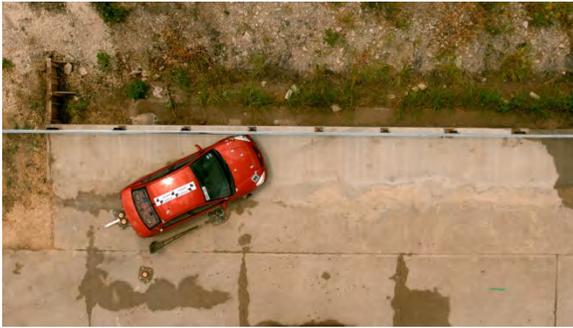
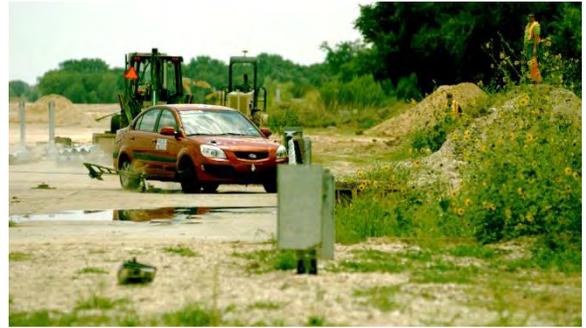
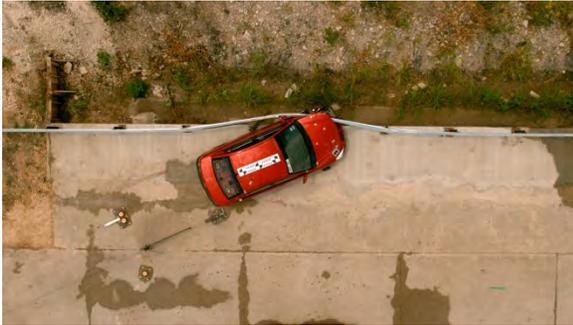
E2. SEQUENTIAL PHOTOGRAPHS

0.000 s

0.135 s

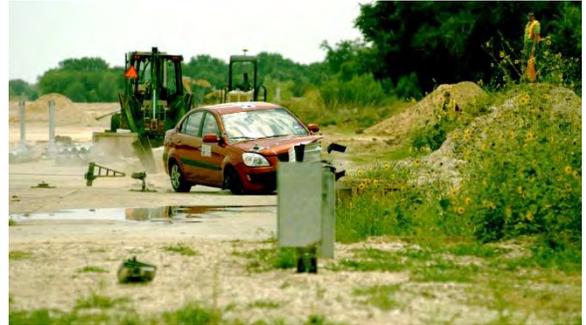
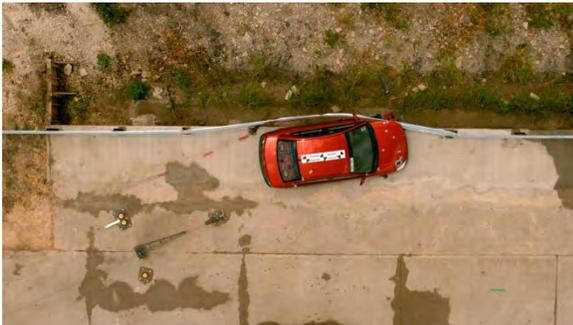
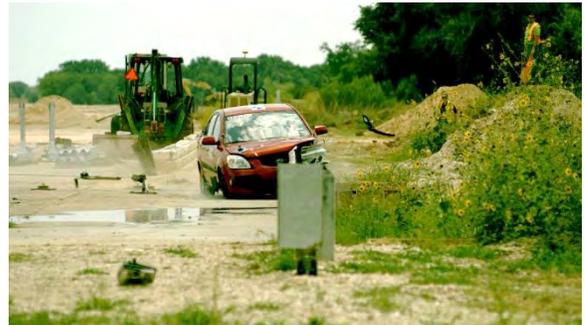
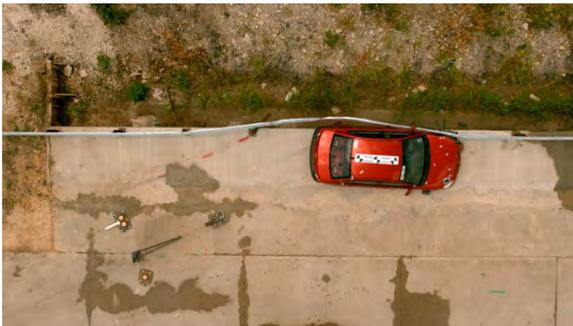
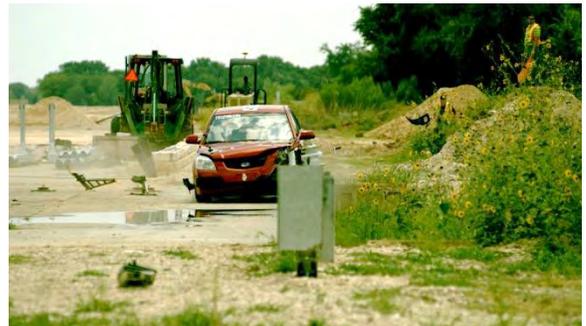
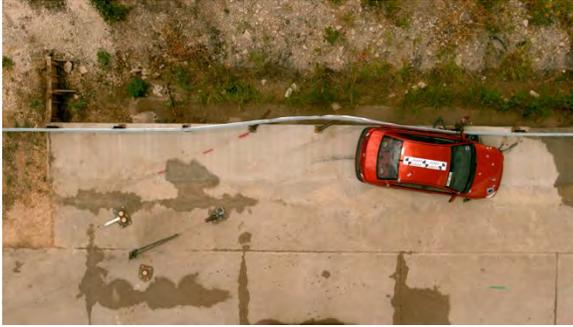
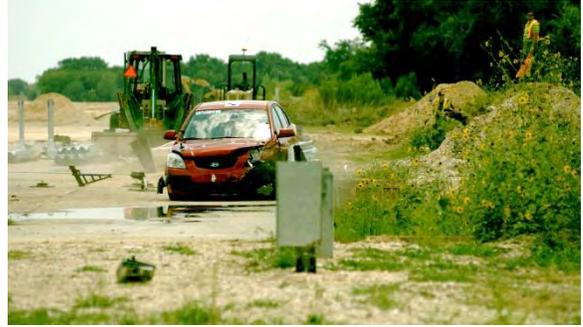
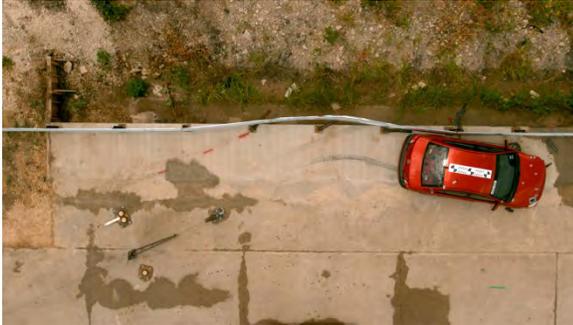
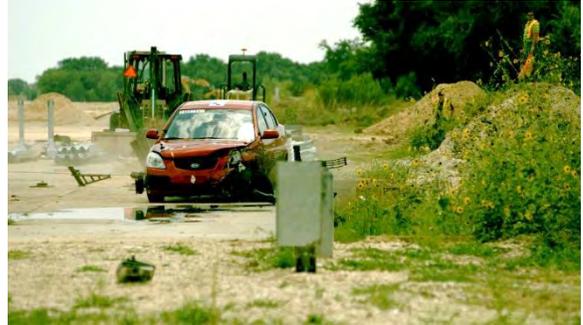
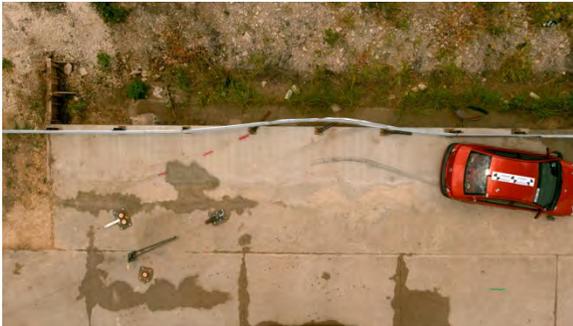
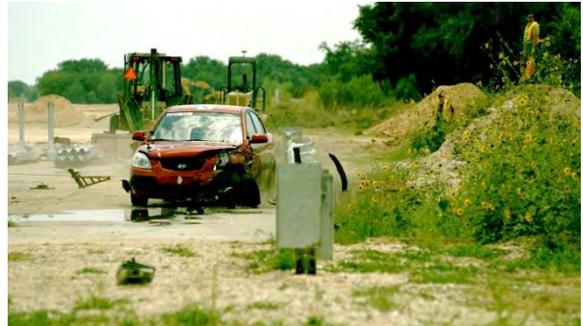
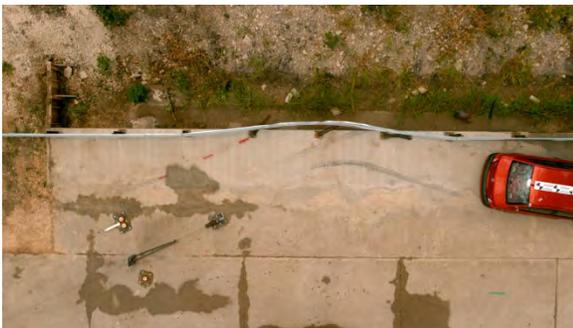
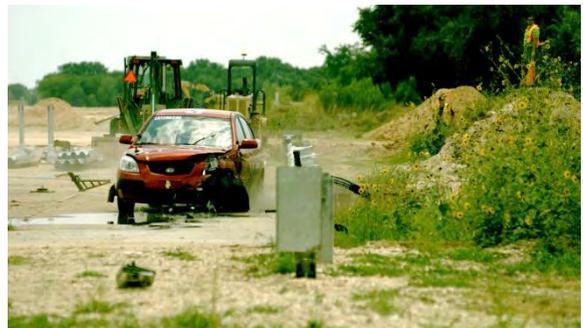
Figure E1. Sequential Photographs for Test No. 490023-6-2 (Overhead and Frontal Views).

Figure E1. Sequential Photographs for Test No. 490023-6-2 (Overhead and Frontal Views) (continued).

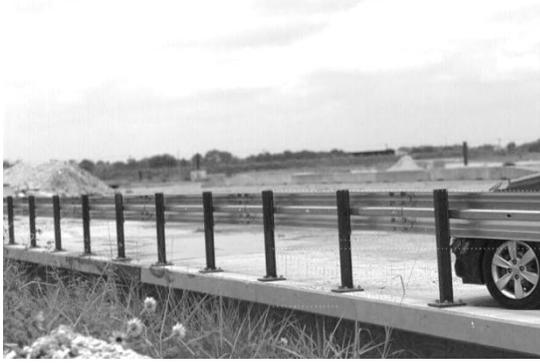
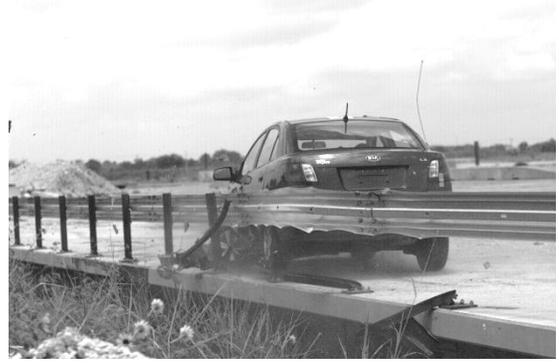
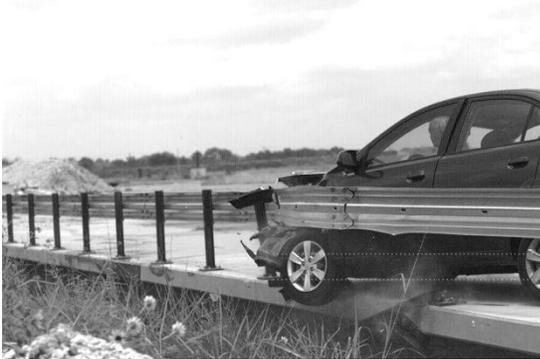
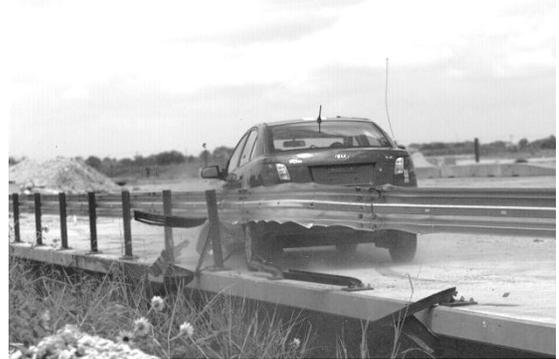
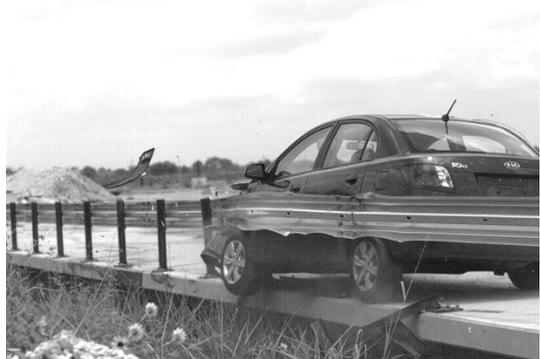
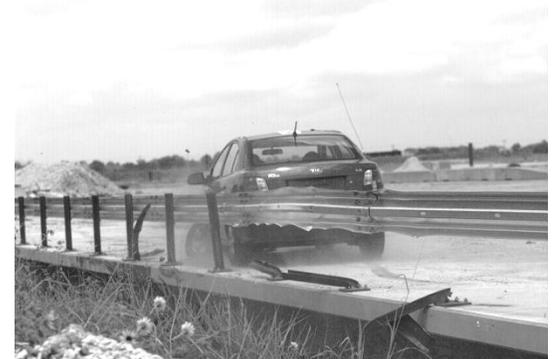
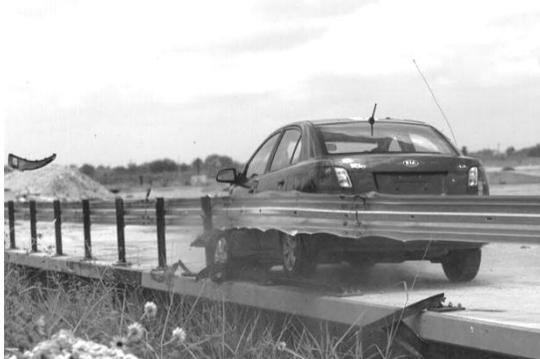
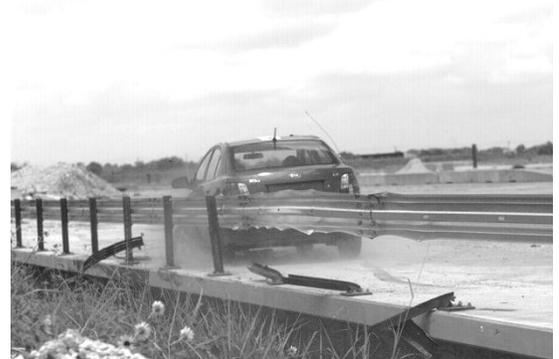
Figure E2. Sequential Photographs for Test No. 490023-6-2 (Rear View).
